REFURBISHMENT CASE STUDY 31

HARLAWHILL HOUSE PRESTONPANS

INTERIM REPAIR WORK

HARLAWHILL HOUSE, PRESTONPANS

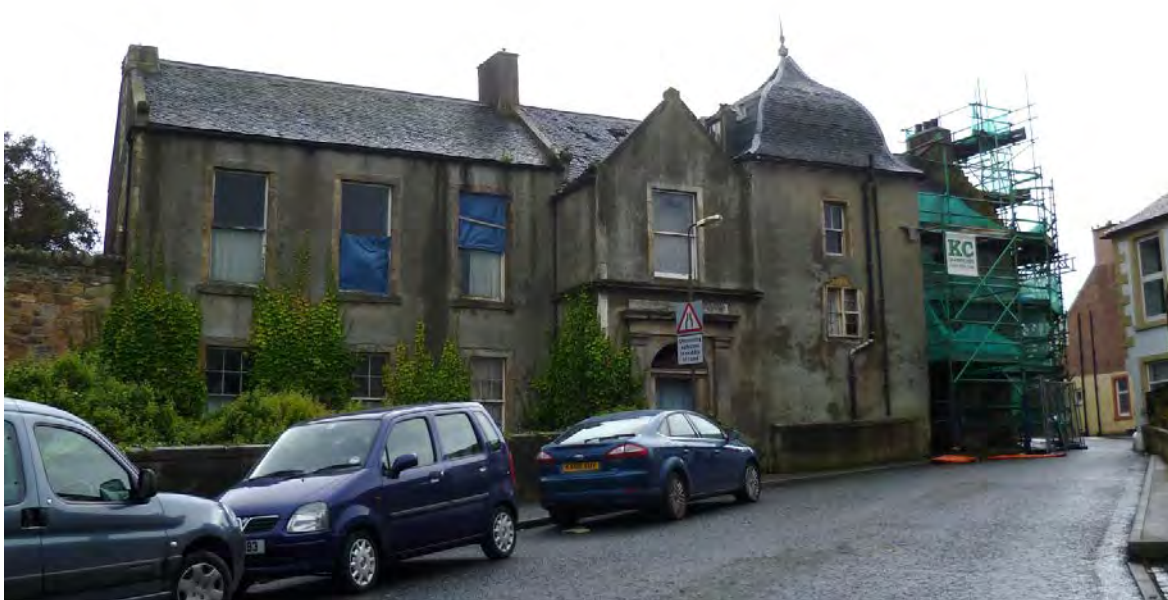
Figure 1. Harlawhill House viewed from the north in 2014 with the early 19th-century east wing and gabled two-storey entrance porch. The distinctive 17th-century ogee roofed tower sits adjacent to the porch.

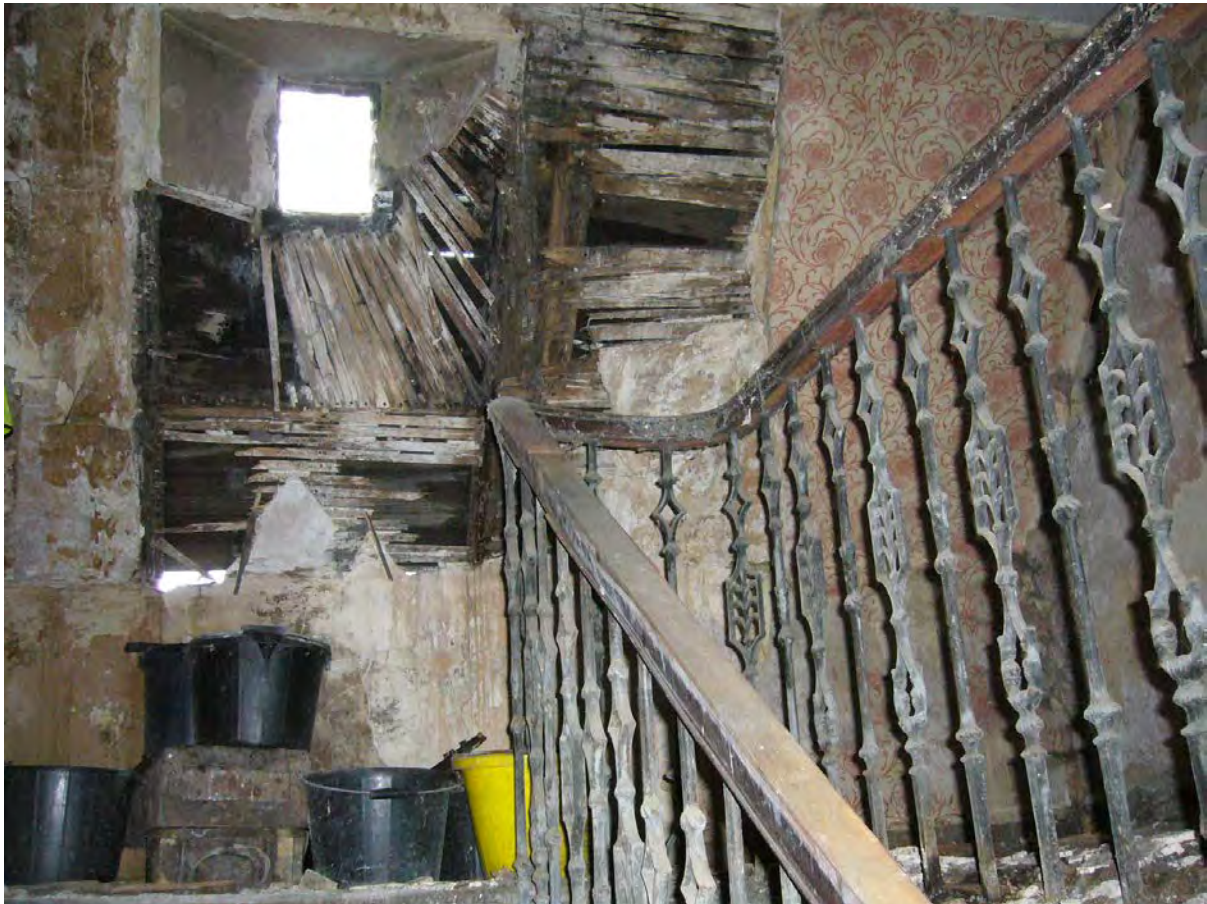
Figure 3. The decay evident in the stairwell resulting from longstanding water penetration due to a complex roof plan and drainage arrangements. The timber half landing on which the buckets sit is entirely decayed and unsafe.

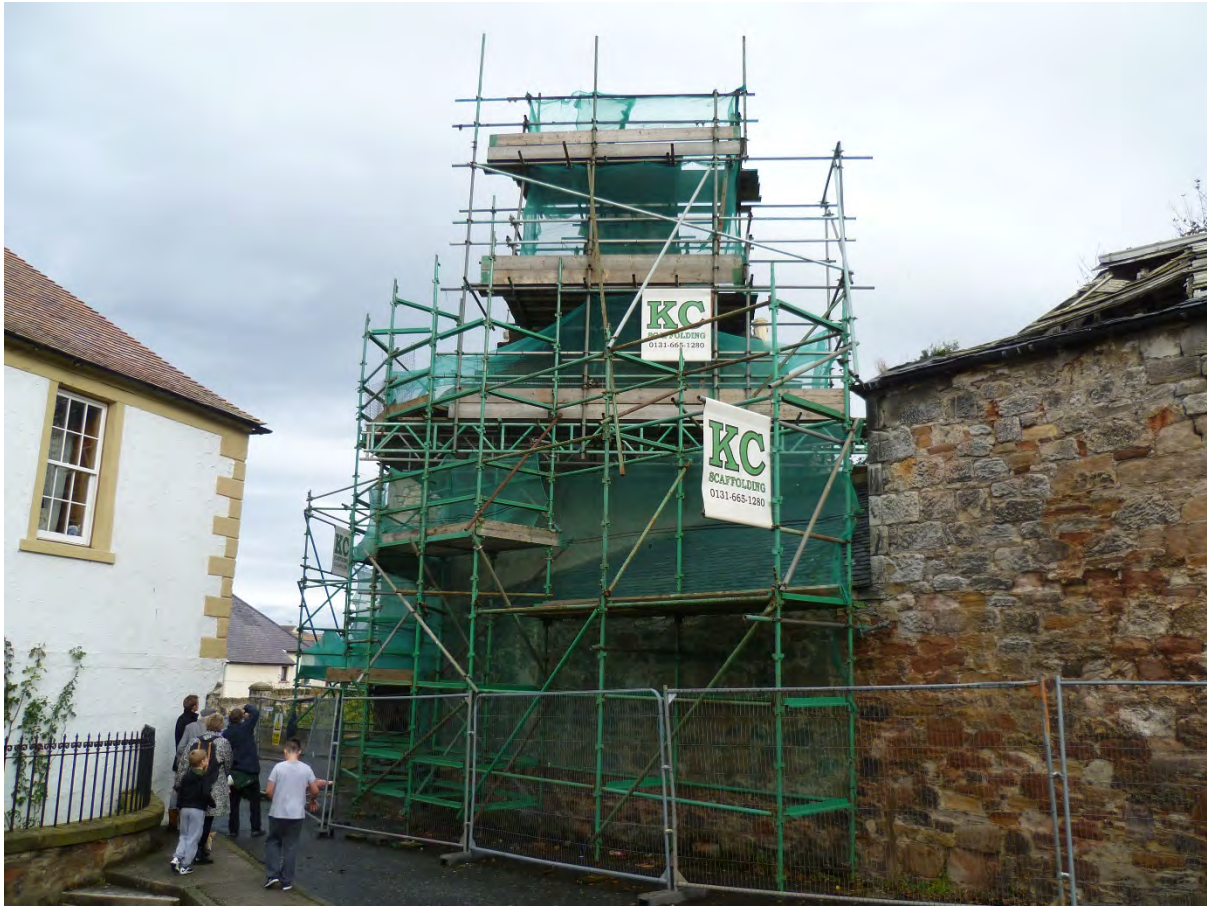
The poor condition of Harlawhill House has been known for a number of years. Falling debris from the roof and west gable in late 2012 required East Lothian Council to undertake investigation. Inspection via a cherry picker, which included removal of part of the gable's rendered finish, revealed holes through the masonry to the chimney flues. This resulted in the erection of a scaffolding system on the west gable in order to reduce the risk to the public of further falling debris (Figure 4). Due to the scaffolding the public road had to be closed.

Figure 4. The protective scaffold put up on the west gable. This resulted in closure of the road.

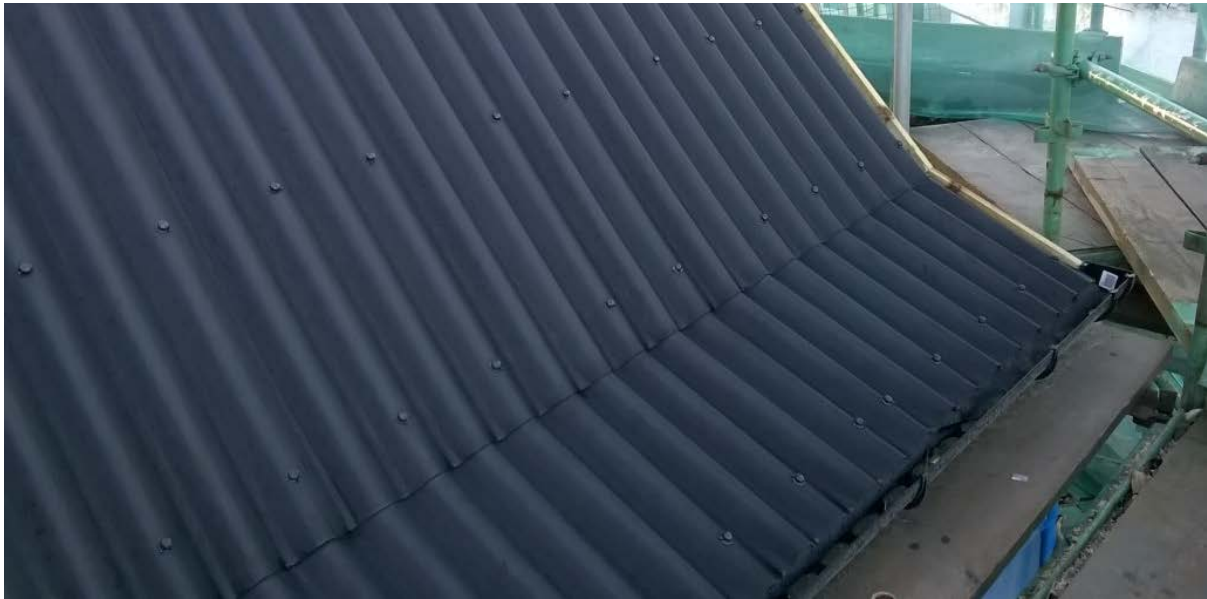
Figure 5. The new corrugated sheet roof covering to the west wing roof, laid over the existing rafters and sarking.

The construction phase began in June 2015 with the dismantling of the chimney on the west gable, and the removal of several of the crow steps. The masonry from the chimney and the crow steps was laid aside within the property for re-use. The majority of the cement render was removed from all elevations, as well as spoil. All slates were removed from the roof pitch over the west wing and the sarking below was found to be reasonably sound. This surface was then sheeted with particle board, the lower eaves level being profiled to accommodate the existing bell cast. The

lightweight profiled roofing sheet was fastened down with screw fixings (Figure 5).

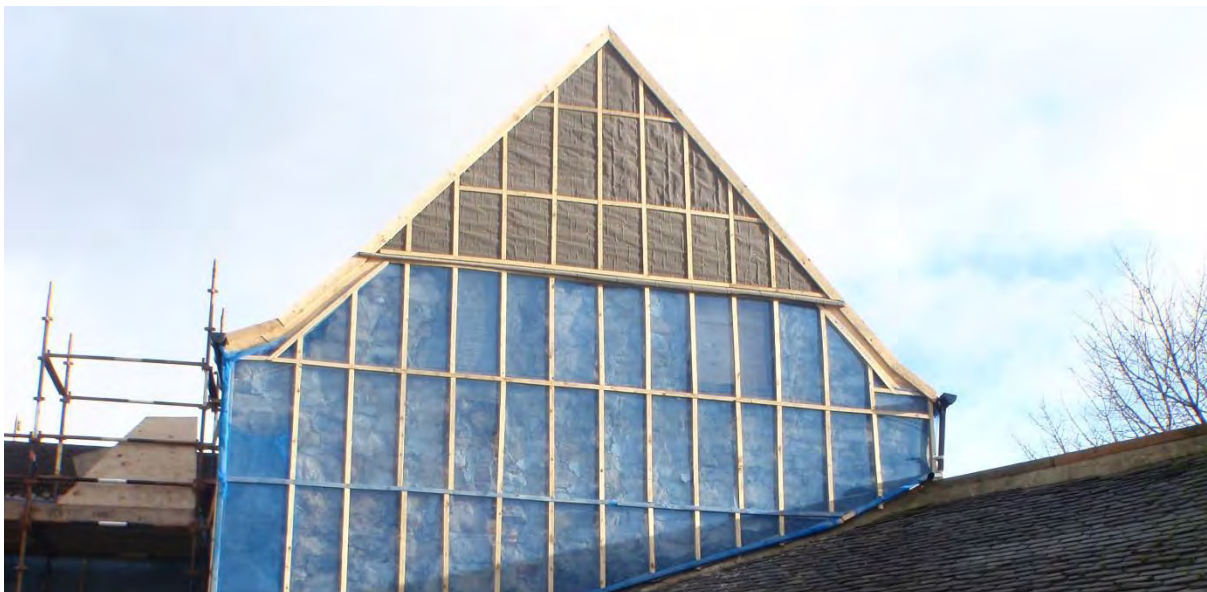
Figure 6. The completed work to the gable end of the west wing, showing the temporary roof covering, the vertical cladding and the netting protection.

The gable end where the chimney had been removed was overclad with vertical timber sheeting covered with roofing felt. The lower part of the gable was covered with netting on a wooden framework to prevent any fall of masonry (Figure 6). Limited mortar repairs were carried out on masonry around the flue area. On the rear elevation the brick chimney stack was taken down, and the dormer window in the attic was reinforced with particle board. The work to these areas progressed as planned and the time taken and materials used were within budget.

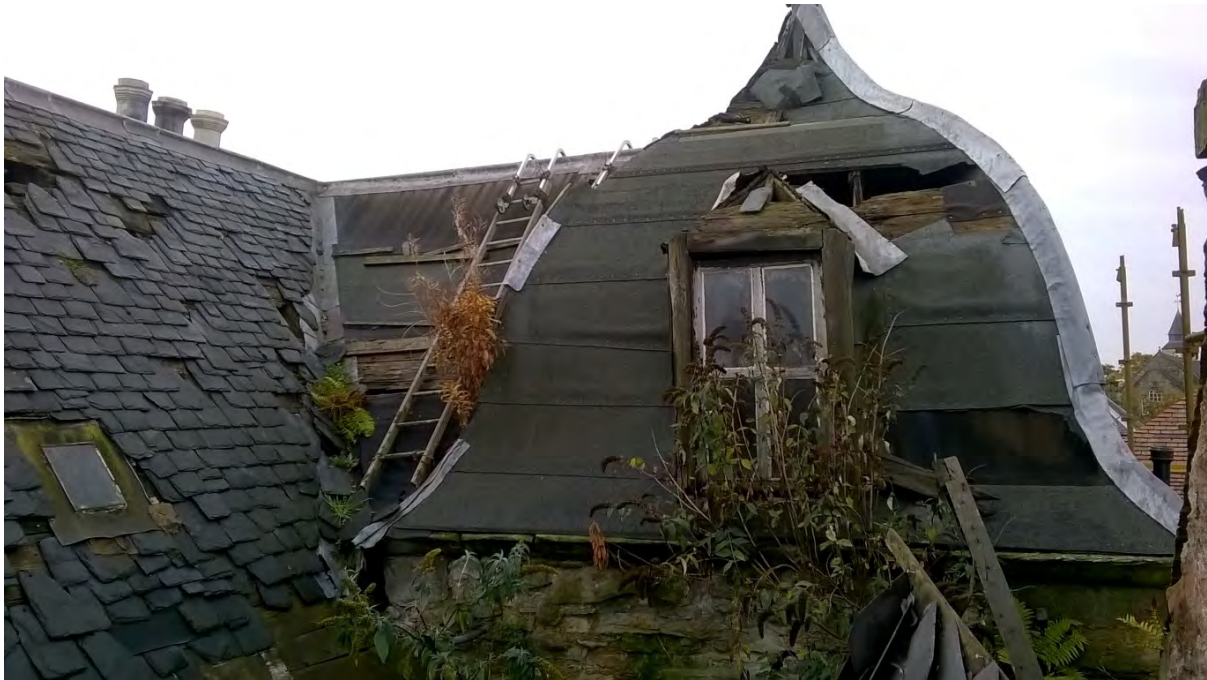
The focus of the works then moved to the tower and the areas of roof over the hall and stairwell. On closer inspection the tower roof turned out to be extensively decayed structurally on the east side due to significant water ingress and consequent timber decay (Figure 7). This situation could only be appreciated once the slates had been removed, exposing a structure much less sound than expected. The existing roofing felt had been letting in water for many years and the roof timbers and sarking were nearly all rotted through with no strength for the planned torch-on felt.

Figure 7. The tower roof viewed from the east side. The extensive decay and loss of the structural timber on this pitch, combined with lack of access into the roof space below, meant that removal was the only option.

It was clear that the intention of using a felt covering for the ogee roof could not proceed as there was no firm timber upon which to attach the felt. Recent internal collapses in the upper parts of the stairwell meant that the underside of the tower roof could not be accessed internally, so no internal bracing or support was possible. As a result of the extensive damage, any future restoration scheme would almost certainly require the complete re-building of the ogee roof and replacement of its component parts.

compromising the interior and increasing the chance of decay and collapse. Therefore, the difficult decision was made to dismantle the ogee roof entirely and replace it with a flat felt-covered roof to protect the tower masonry and the fragile interiors below. This was completed with roofing felt and timber battens (Figure 8). A run on the new flat roof over the tower drains water away from the pavement, and an alternative route for the water over the former hall area was identified. Although the complete removal of the roof was not an ideal end-point in conservation terms, it was considered the best solution in the circumstances in order to safeguard the remaining building structure.

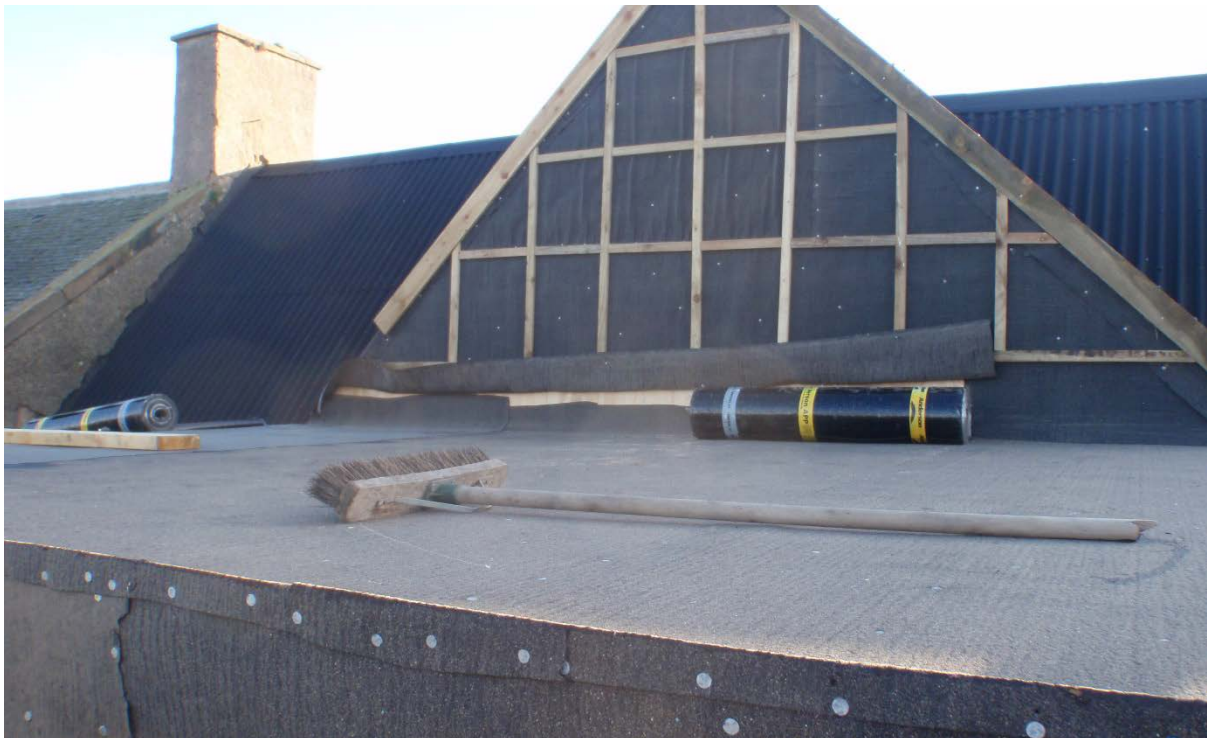
Figure 8. The new flat roof over the tower, with a run or angle to the right to shed water. The covering to the joining roof pitch can be seen behind, with the new temporary roof over the central part of the building behind.

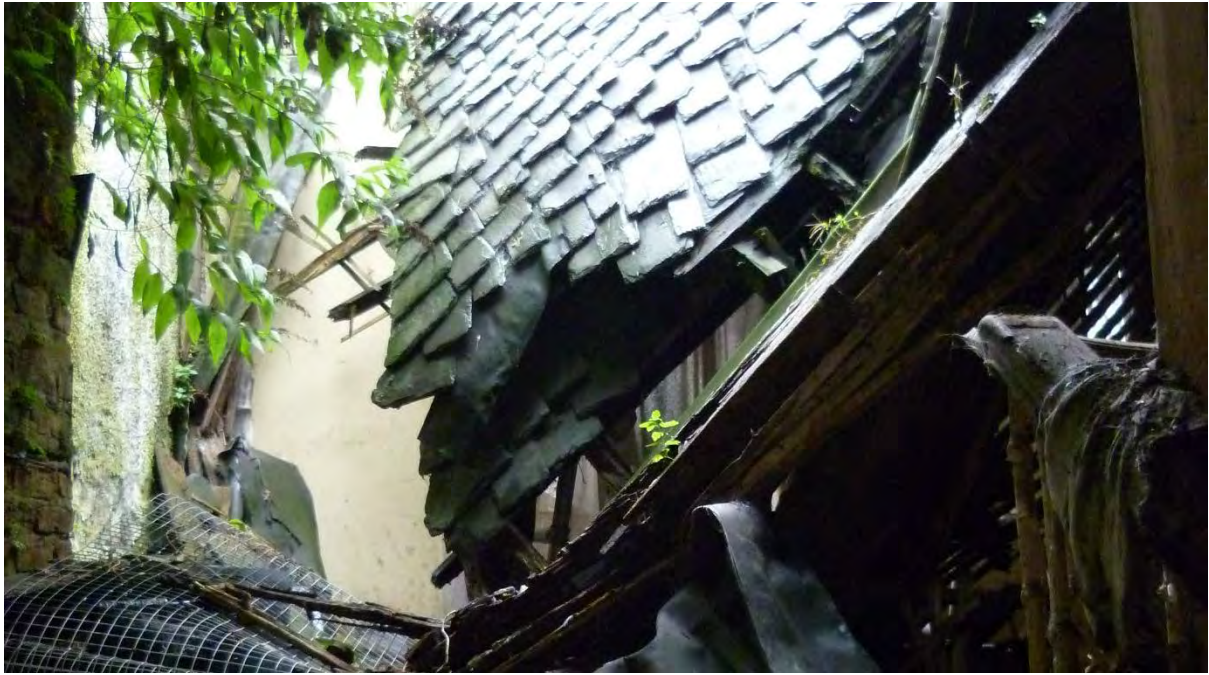
The hall roof had decayed extensively over the years and collapsed at some stage in the past (Figure 9). The resulting debris included a tumble of slates, sarking, rafters and joists, mixed up with debris from the floor below and the stair landing wall. This material was left in situ due to the hazards and expense of removal.

Figure 9. The remains of the collapsed hall roof viewed from the stairwell. The handrail of the stairwell balustrade can be seen far right.

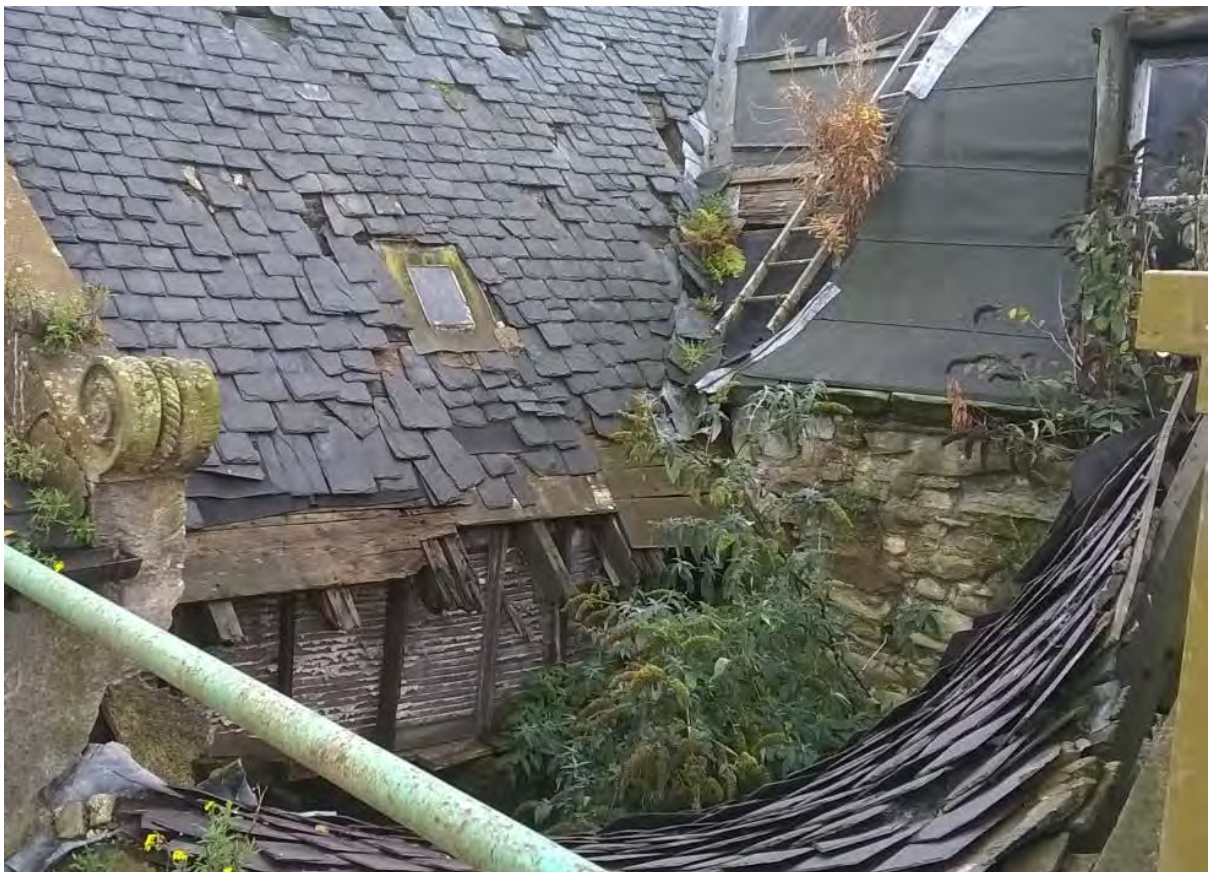
Due to the loss of the hall roof, there was no simple way to access the north pitch of the stairwell roof, as there was no place from where access equipment could be based (Figure 10).

Figure 10. The void where the hall roof had been. The condition of near collapse of adjacent roofs is very obvious in this image taken from the corner of the east range.

A flat roof to replace the fallen one was required, both for access to the adjacent north pitch of the stair and to provide a covering to the hall/porch that the building had not had for many years. It was agreed that a new flat

roof over the hall was desirable to largely complete the temporary roof covering over the core of the building. However, this work was not part of the Dangerous Building Notice and so required additional funds. Funds were re-allocated from savings made by not having to apply torch-on felt to the ogee roof. By working carefully from the scaffold, the contractor was able to extend new timber joists of standard dimension over the void where the hall roof had been. Particle board was then fastened over the joists and covered with a torch-on mineral felt. The new flat roof was given a run to the garden on the east side (Figure 11) to shed water away from this vulnerable area of the building.

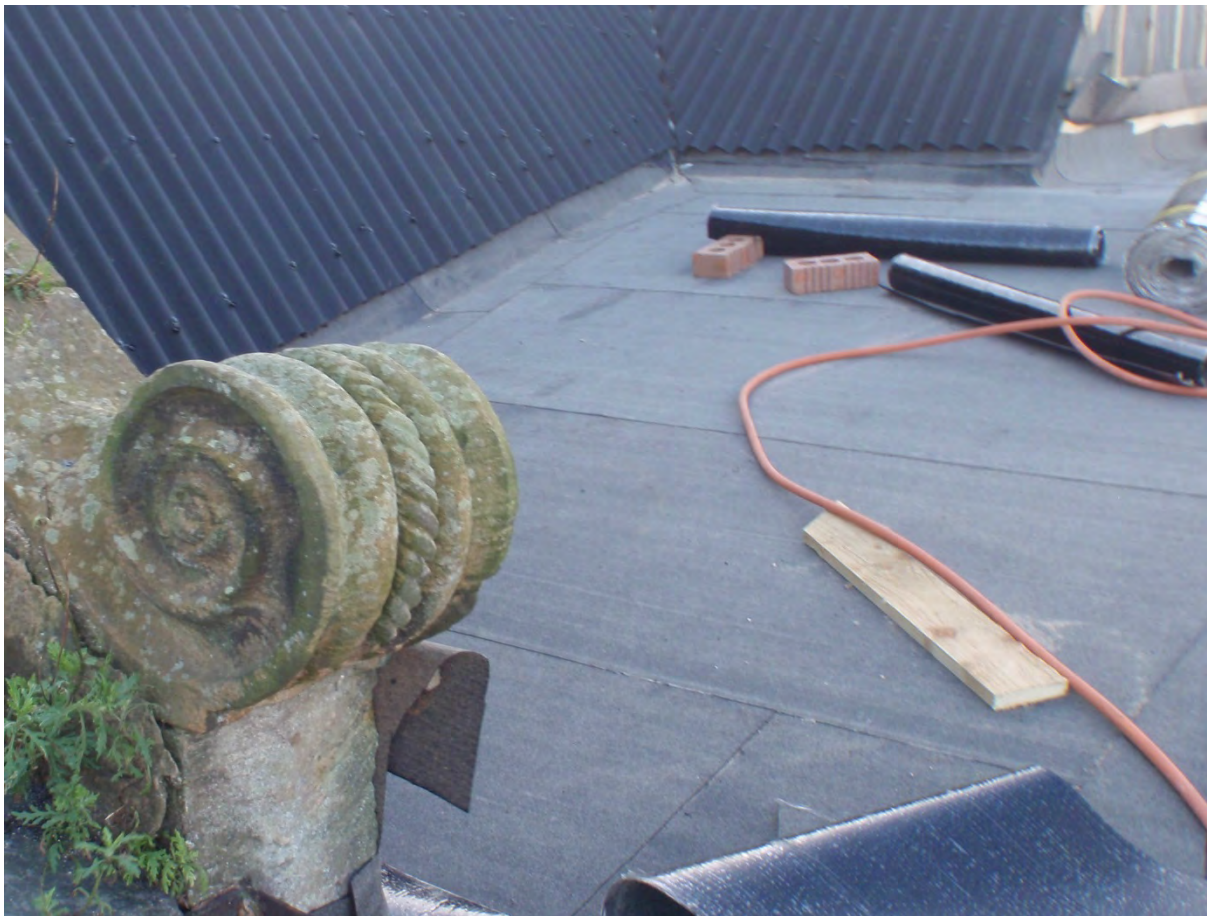
Figure 11. The new flat roof over the hall, which provided access to work on the stairwell roof. The re-covered north pitch of the stairwell roof can also be seen top right.

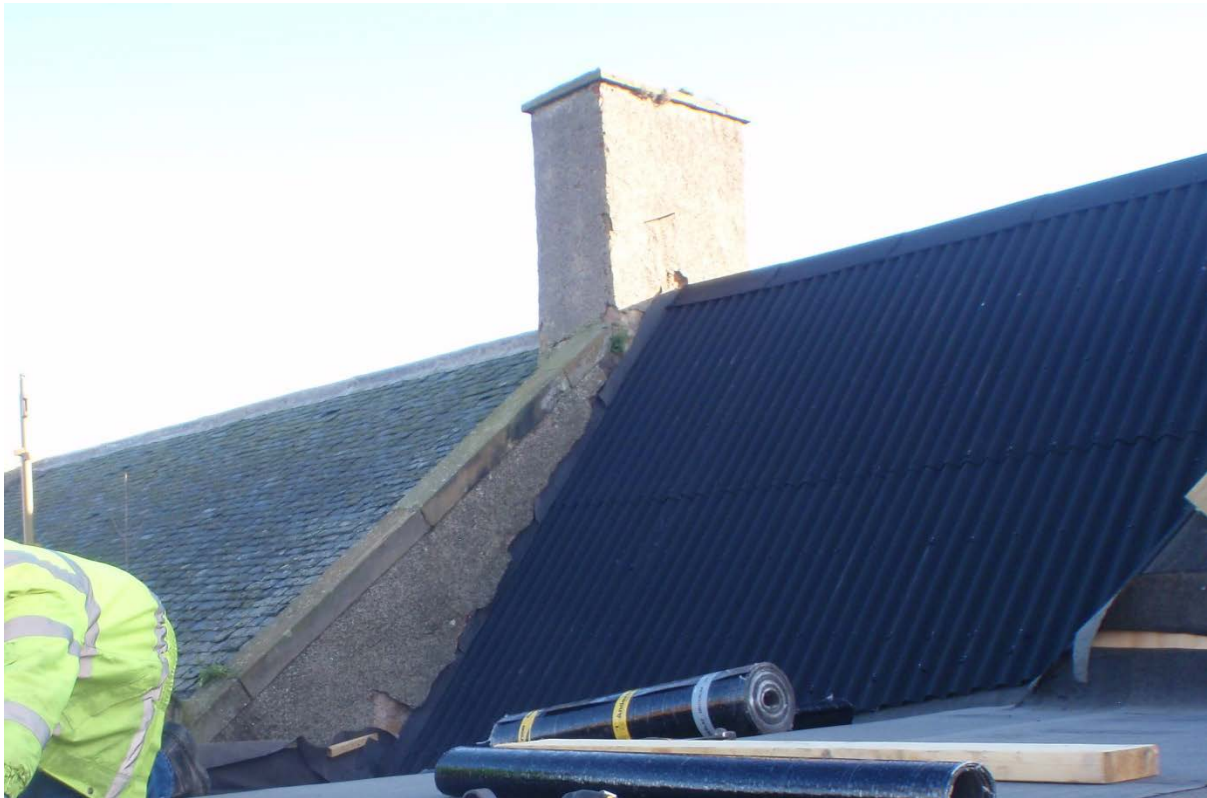
Figure 12. The new roof covering to the stairwell roof, viewed from the new tower roof. The slated pitch of the east wing to the left was not part of the works.

The new temporary covering for the north pitch of the stairwell roof was the same as the corrugated material used elsewhere. Due to the fragility of the roof structure and the sarking, work to the stairwell roof had to proceed with great care. Working from the new hall roof, operatives removed the slates, laid a new timber covering onto the existing sarking and then covered this with the corrugated roofing material. Water from this roof pitch drains onto the new hall roof. Following this work the central core of the house has protection from water ingress, something it had

lacked for decades (Figure 12). This protection will allow the fabric at the centre of the house to gradually dry out.

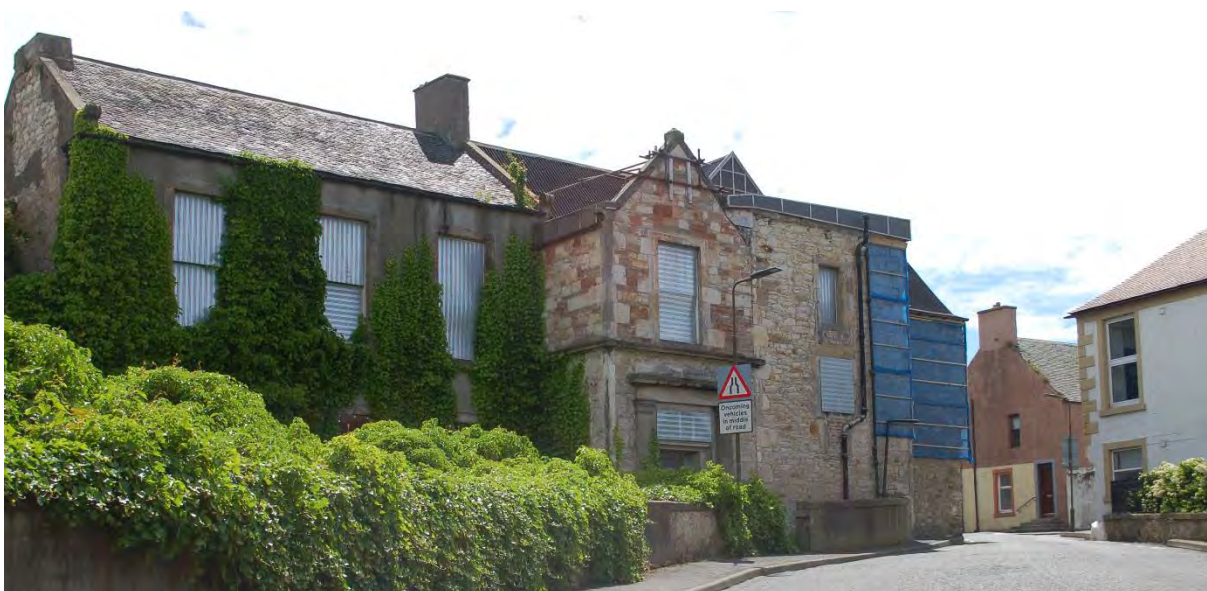
Figure 13. Harlawhill house at the end of the interim works. The appearance of the building has changed, but it is now secure and dry for the first time in many decades.
