# Kirkcudbright

Conservation works to an 18<sup>th</sup> century townhouse

Historic Scotland Refurbishment Case Study 13

Craig Fabian and Laura Dobbie

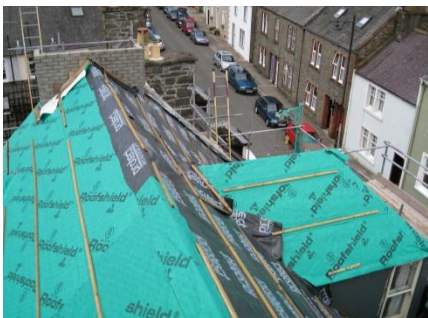
*Fig. 6: Roofing membrane installed on roof after it was stripped of its slate.*

As some of the slates were coming to the end of their life, and the fastenings were much corroded (sometimes called “nail sickness”) the roof was fully stripped. Approximately 40% of the existing roof slate was redressed and reinstated, while the remainder was replaced with a matching slate. There were asbestos tiles on the dormers, which were removed and replaced with slate. The slates had been laid on a ¾” sarking board, some of which was degraded and rotten. This was removed and replaced with new treated boards of the same dimensions. Structural roof timbers were also checked and minor repairs were undertaken where necessary. While the roof was stripped there was an opportunity to install a vapour open membrane over the top of the sarking board and underneath the slate (Fig 6). This type of roofing felt has been determined suitable for use on certain slate roofs<sup>1</sup> without the need for roof vents or additional ridge/eaves ventilation. The slates were fastened back in place with copper nails, which have a longer life span than ferrous metal or galvanised nails.

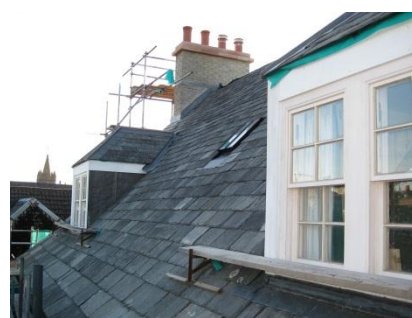
*Fig. 8: Reslatted roof - rear view of property*

There was zinc and lead roof flashing throughout. The decision was made to replace all the flashing with new lead flashing (Fig. 7) . It was discovered that water was penetrating the junction of the slate and the sandstone skew on the south gable wall causing considerable damage on the interior side. New lead flashing was installed along this skew. The re-slatted roof is shown in Fig. 8.

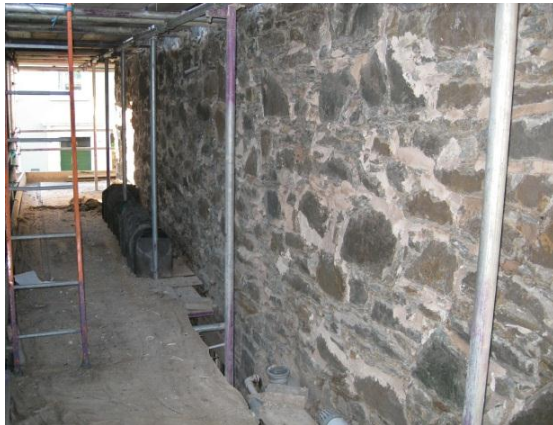
*Fig. 9: Repointing work to the external walls*

There were patches of cement on all facades of the building. Water was penetrating directly through the south gable wall, causing a build-up of damp inside. This was possibly exacerbated by the presence of a thin layer of cement render which had been applied to much of the gable wall in a misguided attempt to stop rain penetration over the years. Instead of solving the problem, this cement render trapped water in the wall, preventing evaporation due to its impermeable nature. The decision was taken to remove all cement render and other patching (Fig. 9). Cement render was also removed from the utility room addition to the rear and the exterior yellow paint was removed from the facades of number 27. After removal the walls were repointed with a lime mortar. Lime mortar is a flexible, vapour permeable mortar, suitable for use on rubble stone walls. Small 'pinning' stones were used to fill in spaces between large stones where required. The additional entry door to number 29 was also in-filled with stone (Fig. 10). A lime harl, also vapour permeable, was then applied to all elevations, including the additions to the rear. This had the added result of unifying the exterior aesthetically. Georgian houses with a rubble masonry exterior walls would typically have been lime harled (Fig. 11).

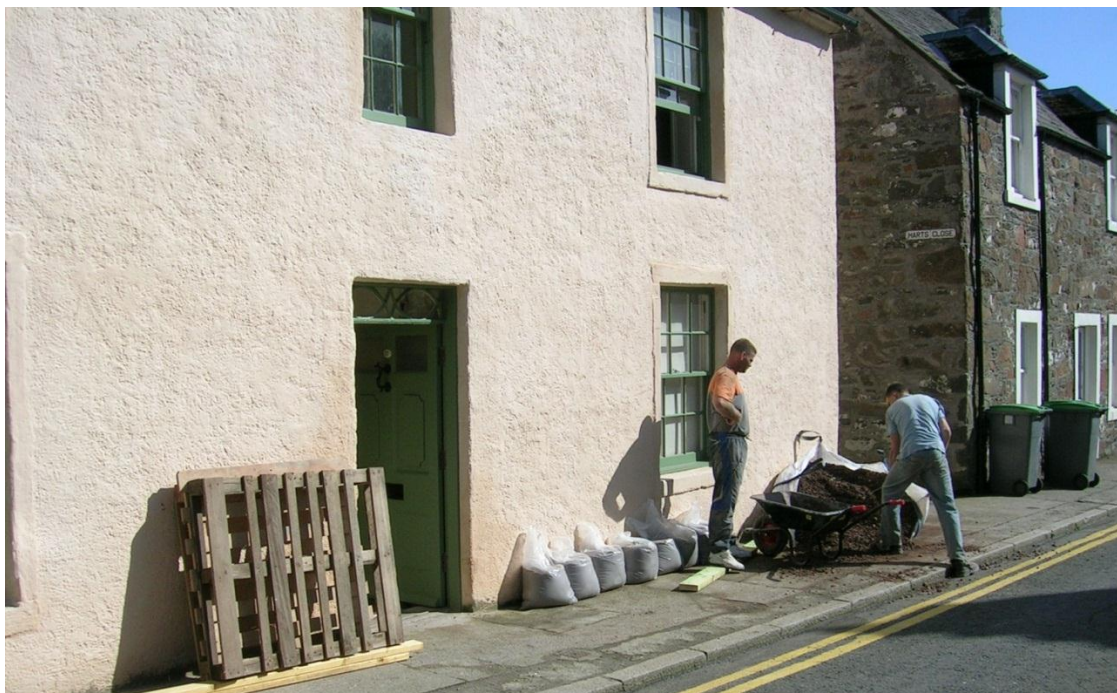
*Fig. 11: A portion of the front facade after application of the lime harl.*

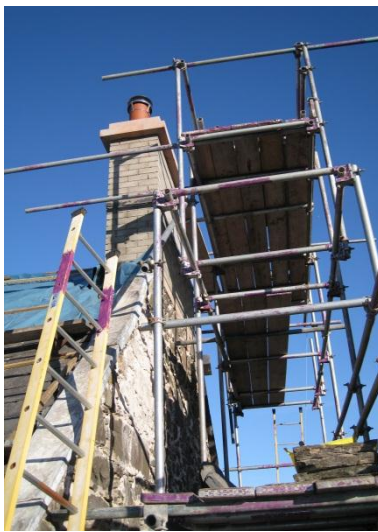
*Fig. 12: Construction of south gable chimney stack*

The chimney stack at the south gable end of the house had been demolished at some point during the building's lifetime. Replacement skew cope stones had been inserted at the time of the demolition but were a different size to the existing ones, putting the skew out of line. Without the chimney stack the front elevation appeared unbalanced and the owners decided to reinstate the chimney on the gable wall (Fig. 12). The new chimney stack was built of brick finished with a sandstone cope, and four clay chimney cans on top (Fig. 13).

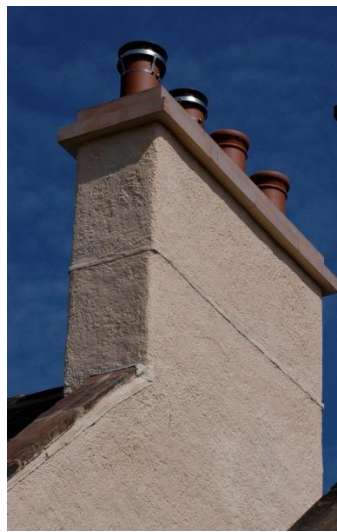
*Fig. 13: Reinstated lime harled chimney stack*

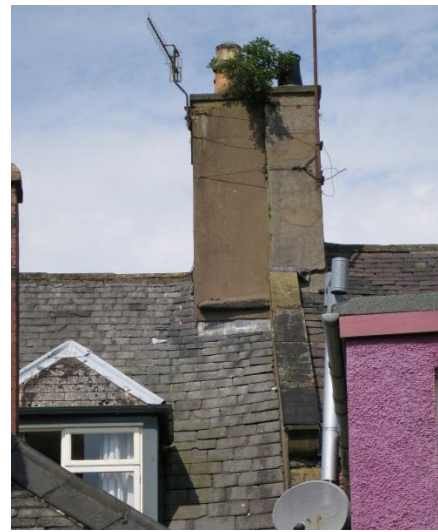
*Fig. 14: North chimney, in line with chimney of adjoining property, prior to repair.*

The chimney stack on the north end of the building had been raised when the adjoining property was built (Fig. 14); this stack was repaired with lime mortar and both stacks were rendered with lime.

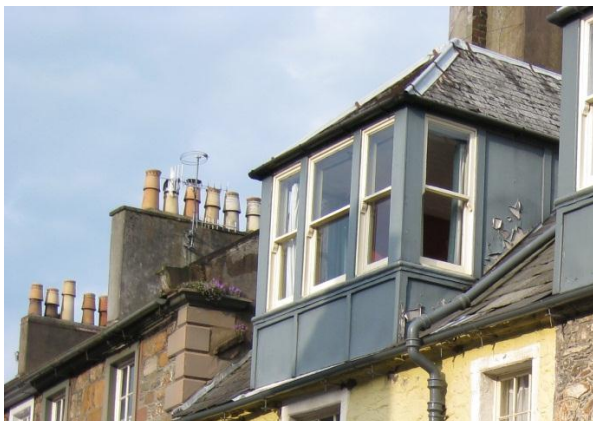
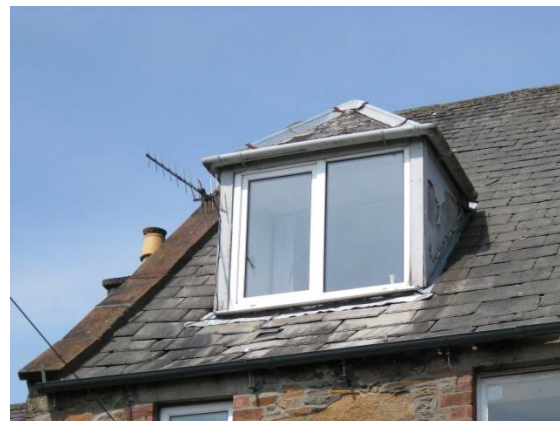
It is thought that the four timber-frame, tile roofed dormers were added circa. 1937, replacing older roof lights. The dormers are not symmetrically placed, due to the location of the roof rafters beneath. They were added to provide additional usable floor area in the attic and to provide more natural light. While generally in good condition the exposed softwood cheeks had started to rot from water penetration so they were replaced (Fig. 15 and 16).

*Fig. 15: Front dormer prior to upgrade and improvement works*

*Fig. 16: Rear dormer prior to upgrade and improvement work*

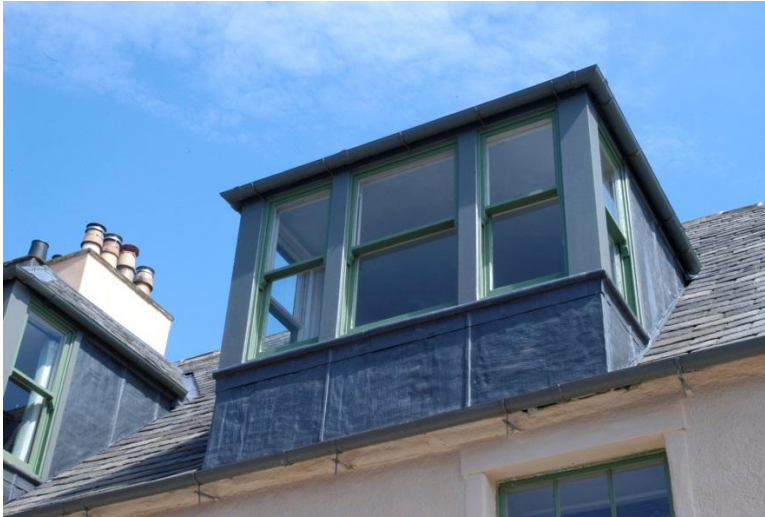
*Fig. 17: Front dormer (street facing) with new lead cladding*

The cheeks were then covered with lead (Fig. 17). The lead provided better protection from the elements and also reduces the visual impact of the dormers. As a dark grey roofing material, it allows the dormers to blend into the roofscape (Fig. 18).

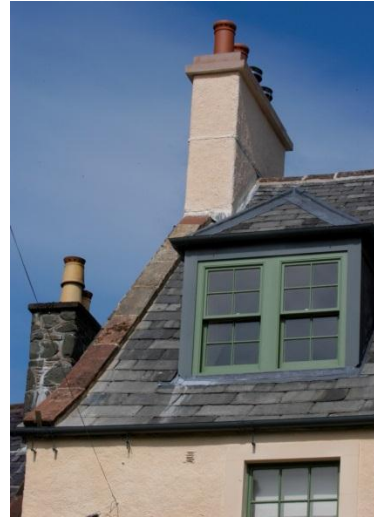
*Fig. 18: Rear dormer with lead flashing and cladding*

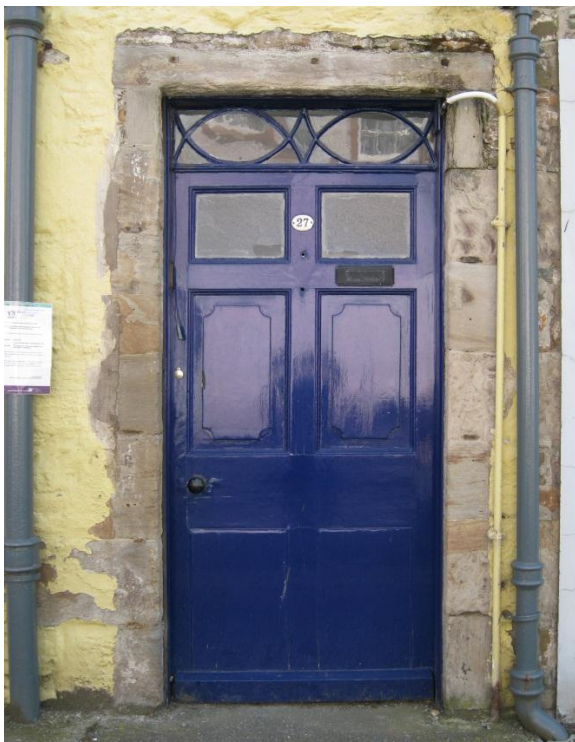
The existing front door was in good condition, though it was starting to rot at the bottom due to water ingress along the threshold (Fig. 21). A portion of the bottom panel was removed and the replacement panel incorporating a wood drip detail was added to prevent wind-blown rain from coming in beneath (Fig. 22).

*Fig. 21: The front door of the property before works were carried out*

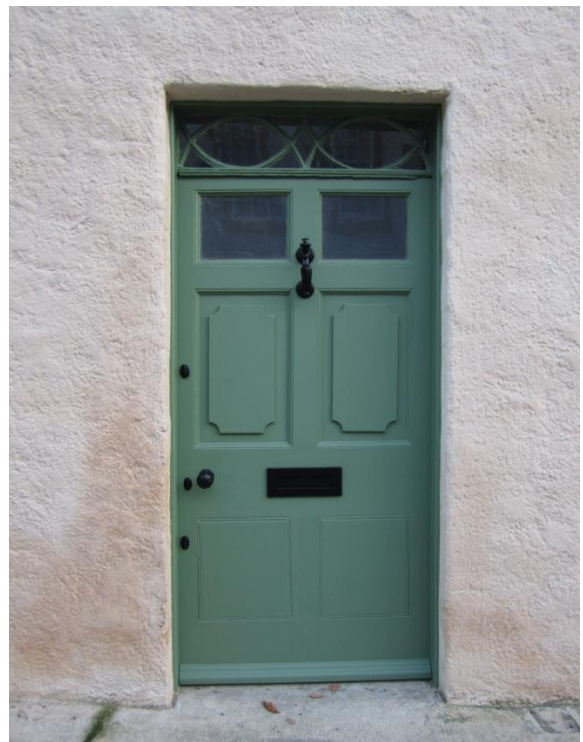
*Fig. 22: The front door after refurbishment, with an improved drip rail across the bottom*

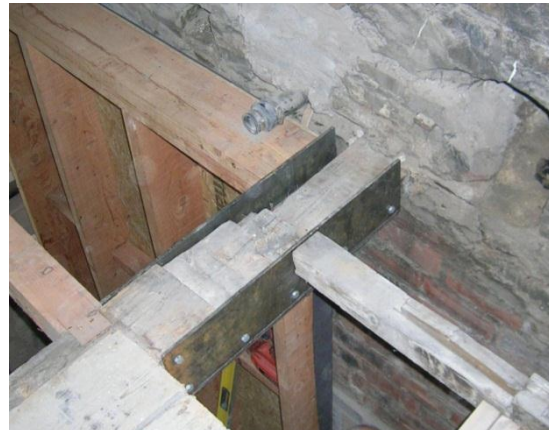
*Fig. 24: Structural steel supports required under existing floor beams*

The late 19<sup>th</sup> century staircase at the front of the house was removed. This required some structural strengthening work as a section of new floor joists had to be installed and tied into the existing floor joists (Fig. 23). This work proved more difficult and time consuming than originally thought, and required the insertion of steel flitch beams (steel plates supporting wood) to support the TV room floor (Fig. 24).

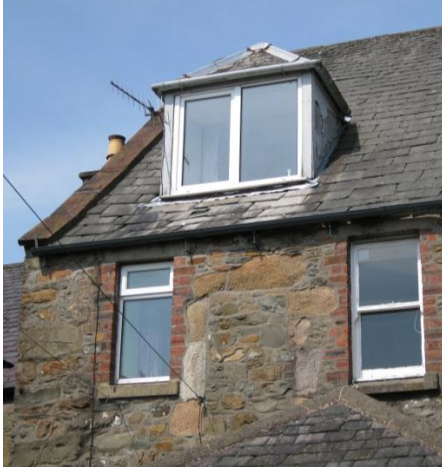
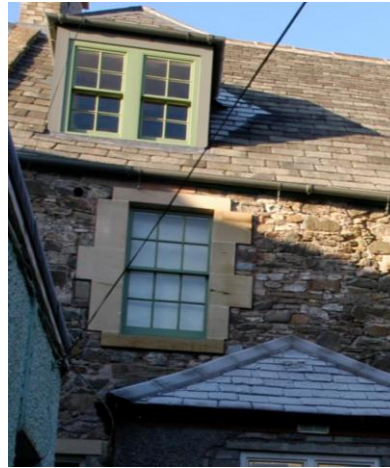
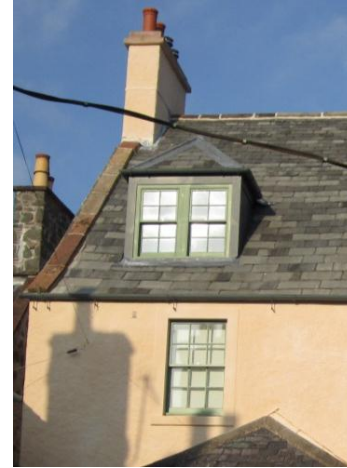
*Fig. 38: The original opening for the bathroom can be seen between the two windows. These two later windows were removed and in-filled, and the original window reinstated.*

*Fig 39: The new stone surround for the window*

*Fig. 40: Window reinstated at a higher position than the original window in this location*

The previously in-filled bathroom window on the second floor was reinstated during the works. However the previous sill height of the window was determined too low, and unsafe at upper storey level should someone fall against it. The owners, in discussion with the local authority, agreed to raise the window and the sill height in order to address this issue (Figs. 38, 39 and 40).
