Downie's Cottage, Braemar

Repairs and upgrades to a Highland cottage

This publication should be quoted as:
Historic Environment Scotland
Refurbishment Case Study 22

Roger Curtis

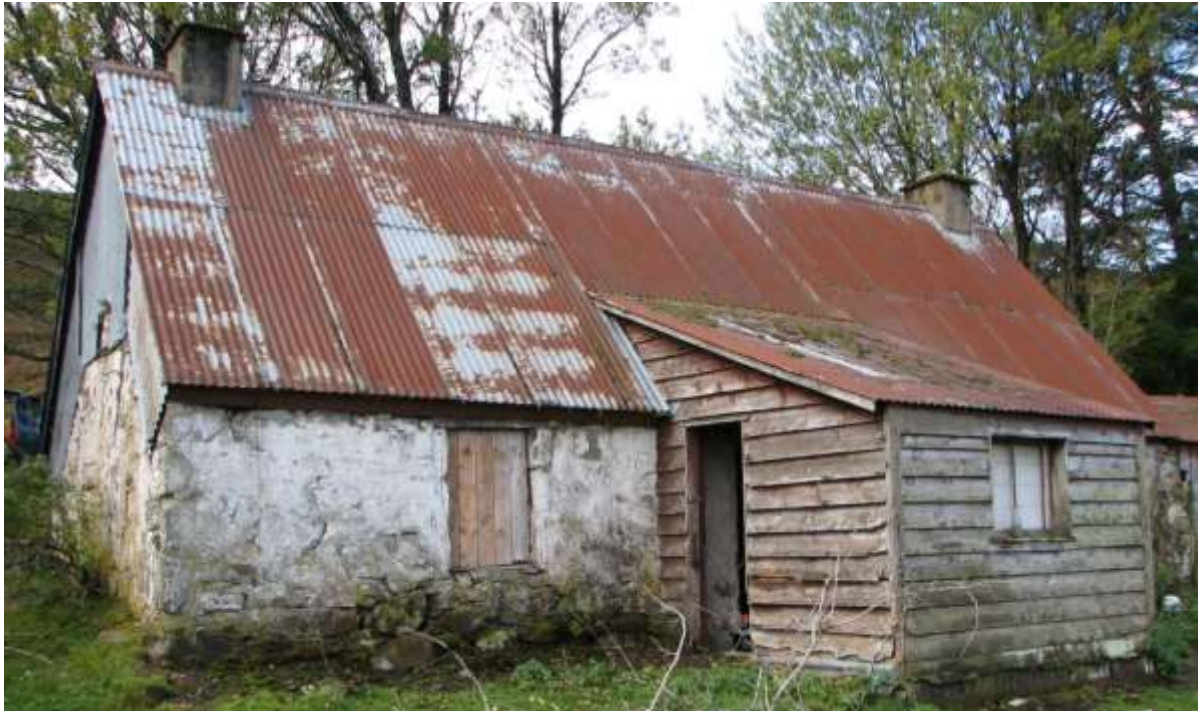
Figure 4. The Croft house in 2011 prior to the refurbishment. The corrugated iron roof covering is of relatively recent date but has largely ensured the survival of the building and the heather thatch beneath.

The galvanised corrugated iron was in satisfactory condition considering its age. The thatch underneath, which is an important part of the history and significance of the building, was left in-situ. Occasional fastenings were replaced, and the wires that held the roof to the walls were refastened and replaced as necessary with a heavy 12 gauge fencing wire. The existing corrugated iron was retained, with localised repairs. It was then cleaned with a wire brush, treated with a rust stabiliser and painted with a 2 part epoxy paint in a traditional 'red oxide' colour.

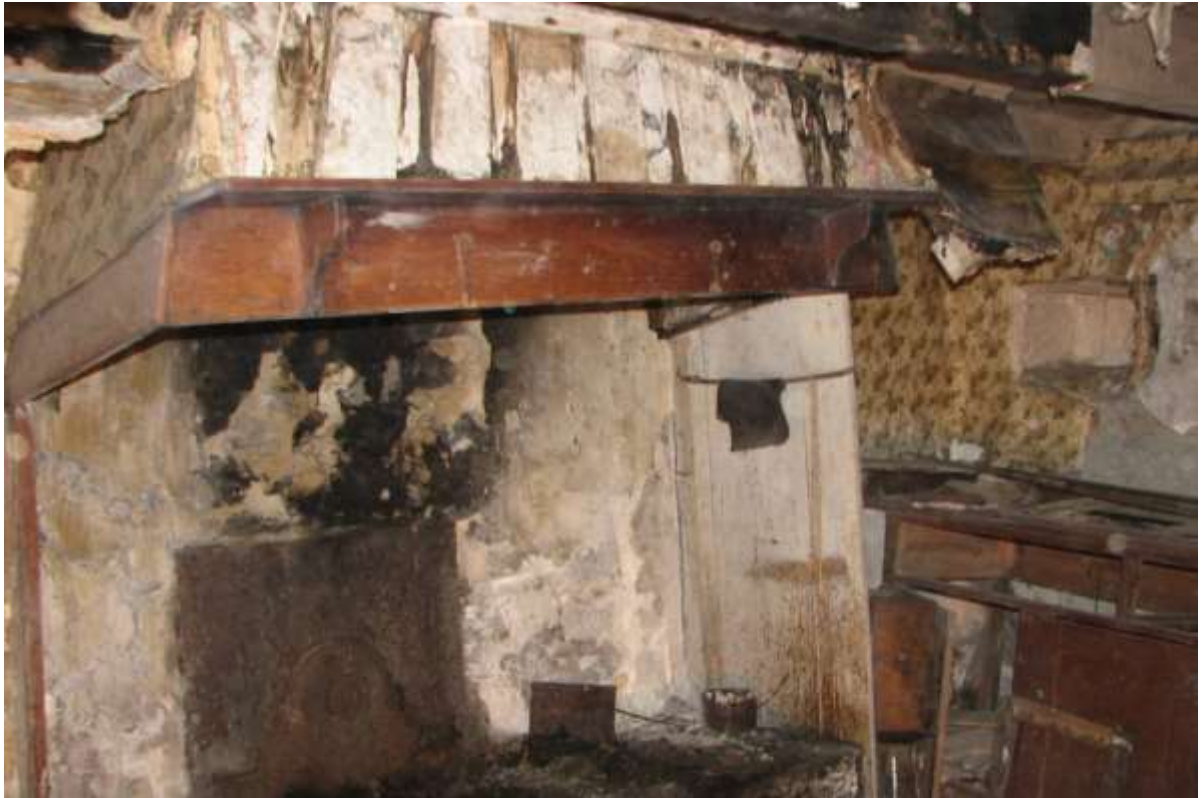
Figure 9. The hanging lum in the kitchen prior to works; a very rare survivor of a once common feature in rural homes.

Whilst one of the most interesting and significant features of the building, it only required modest repair, mostly associated with the fitting of an insulated flue liner. A double-skinned sectioned flue liner was used, following the line of the existing timber lined flue. The void between the liner and the flue interior was left clear; some modern practice requires this to be filled with a granular filler, but this is not appropriate in traditional flues of timber or masonry.

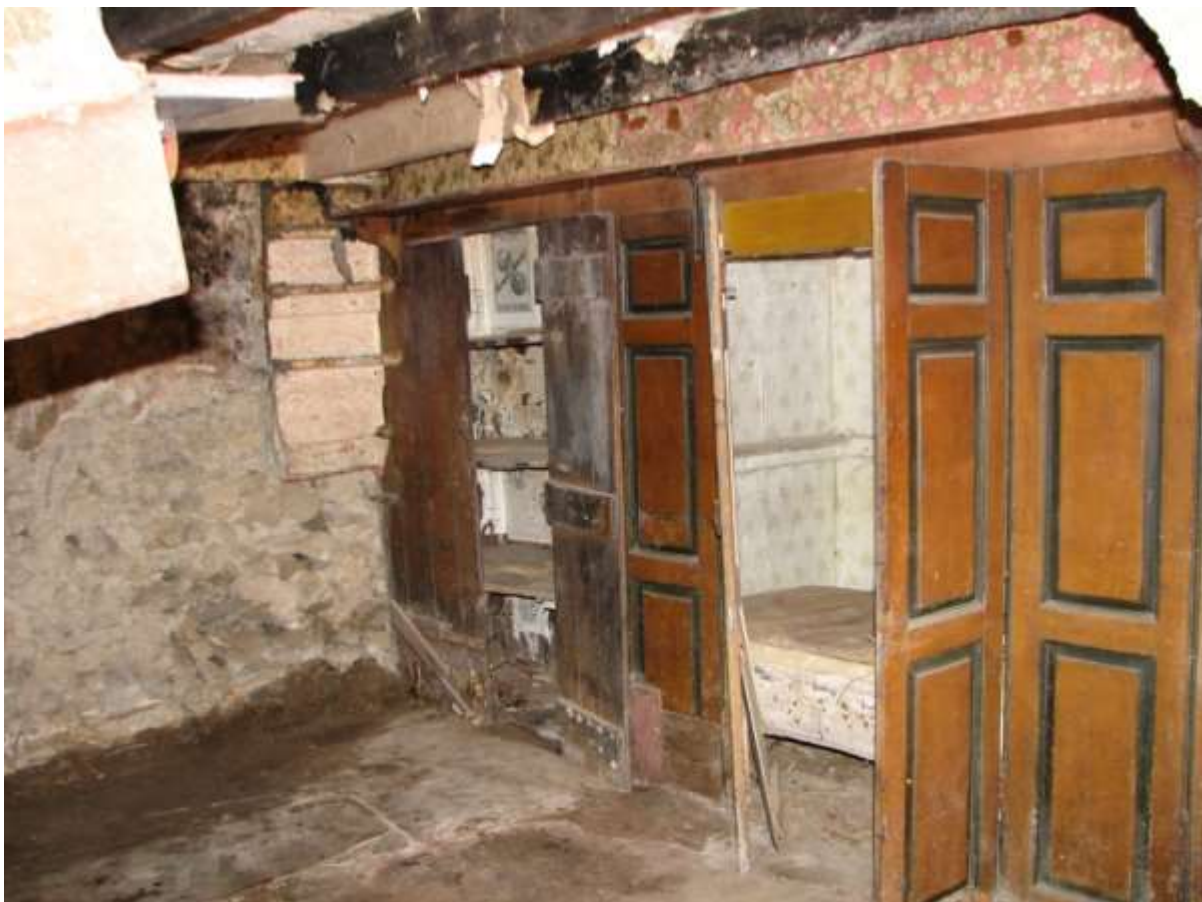
Figure 11. The box bed in the kitchen. Note the straw filled mattress just visible through the open shutter leaf.

Where the lower sections of the box beds were in contact with the ground there were areas of timber decay. The damaged timbers were cut back, and new pieces were spliced on as seen in Figure 25. The splices used a diagonal joint that gives the best balance of strength and aesthetics. The new wood was a redwood of standard C17 grade, but care had been taken to allow it to settle in dry conditions before use. The bed frame on the kitchen box bed was retained and the area was re-upholstered as a form of sofa.

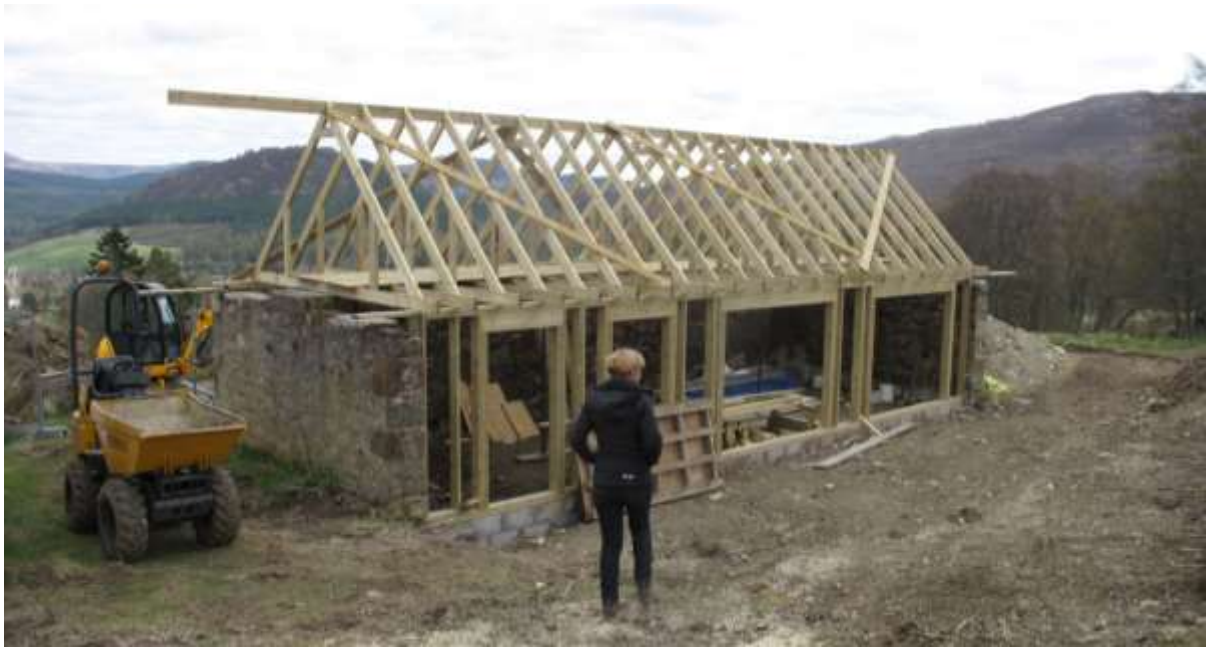
Figure 15. The new roof structure on the byre.

A design for the roof and the open side to the south was straightforward and the reconstruction of this building was begun first to give a storage facility for the construction work on the croft house (Figure 15). The roof timbers were grade C16 softwood, with trusses of standard dimension made up on site. This allowed the slight changes in level of the existing masonry to be easily accommodated. Roof construction on traditional buildings is structurally simple and proven; pre-manufactured trusses are not necessary, even on much larger buildings. The chosen roof covering was corrugated iron, of traditional profile (sinusoidal). The roof was painted with a 2 part epoxy based system, of traditional colour to match the croft house roof.

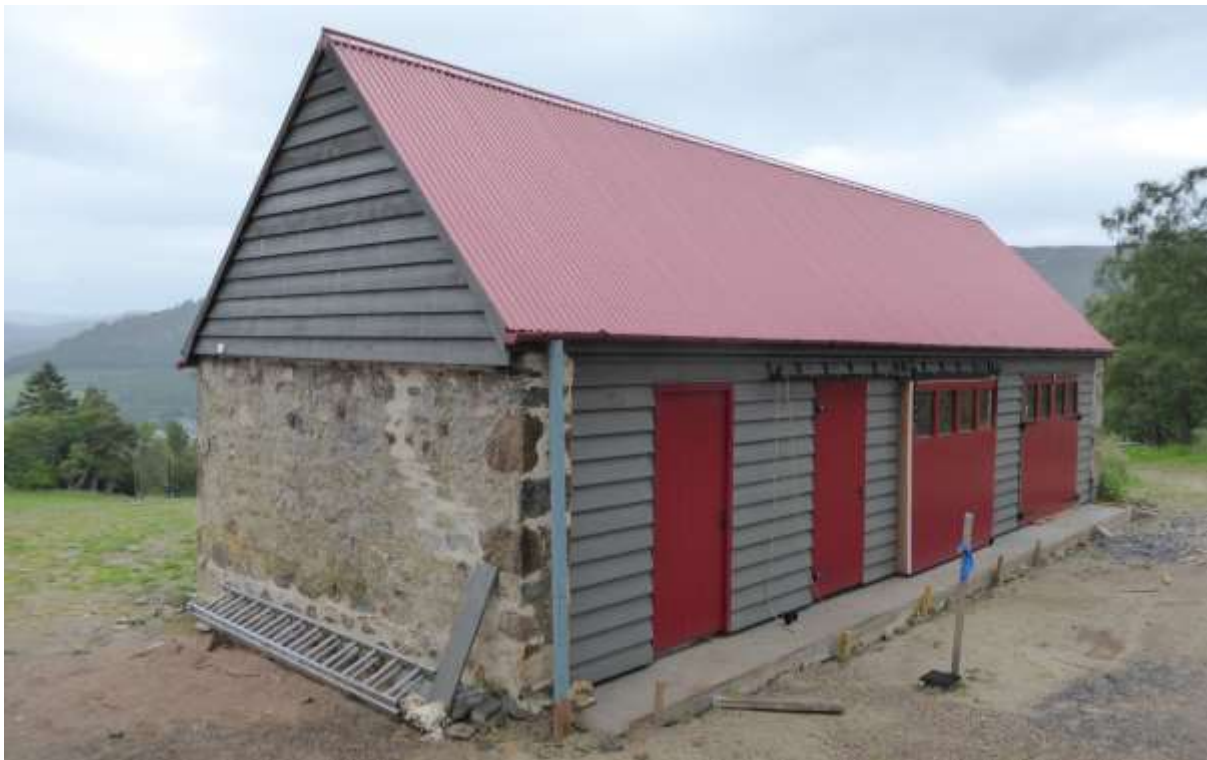
Figure 16. The restored byre with new doors and roof, blending in well with adjacent structures.

The byre had always been open to the south for the storage of agricultural equipment, but as an enclosed space was required a new timber front was designed, with large opening doors. The design and construction was simple and easily assembled, using standard timber lengths and fastenings. This gave a useful enclosed space that was entirely consistent in spirit to the croft house, and to other buildings in the vicinity (Figure 16).

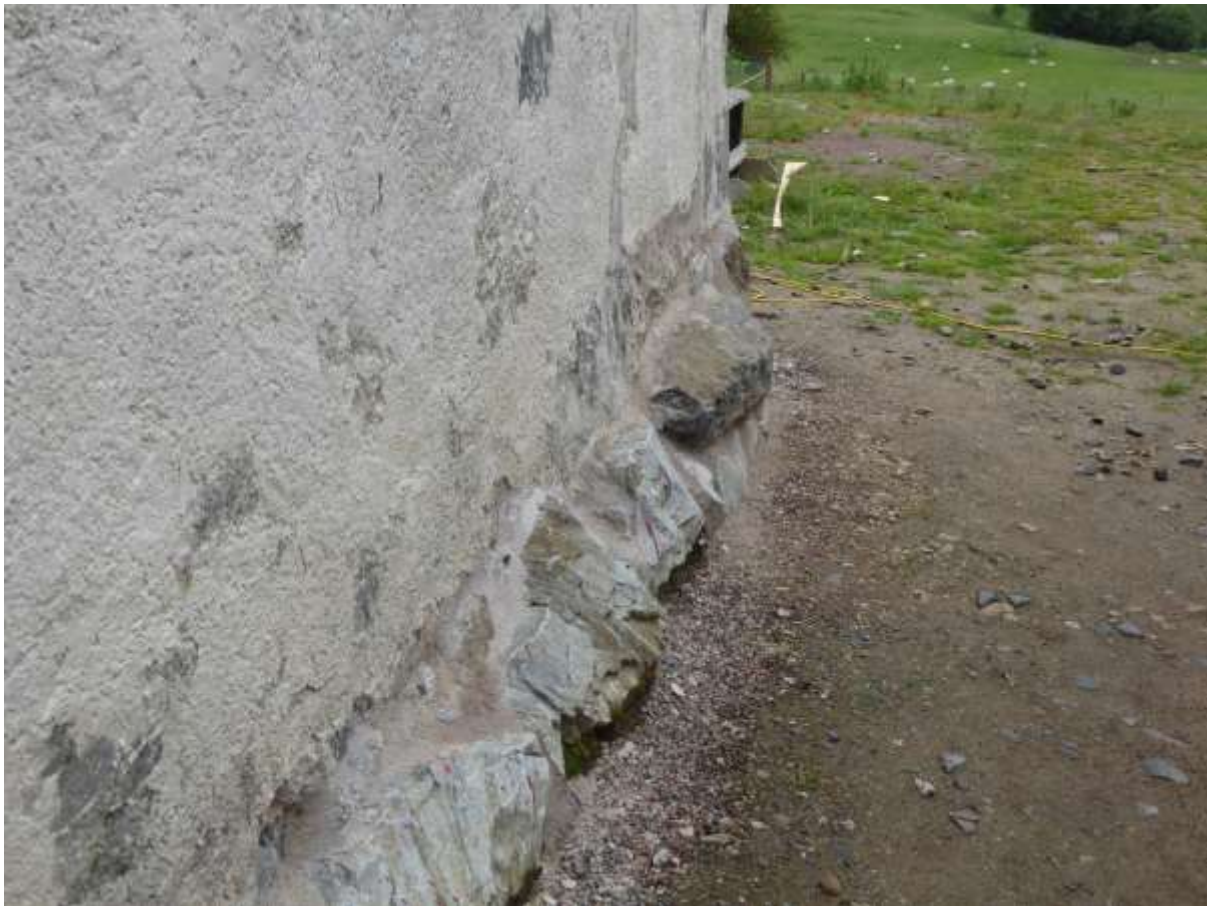
Vernacular buildings of this type do not have foundations as they are understood today; the thickness of the walls increases the footprint and mean that the pressure on the ground is modest. Typically, to provide support to the fabric a base course of large stones is usually set into the ground, to a depth of a 300 mm (Figure 17), often a few inches wider than the above ground wall. However, at Downie's it was in places less. While this can be alarming to those from a modern construction background, it is generally sufficient. At the cottage, this base course occasionally touched bedrock and the walls were stable and in most areas the foundations required only simple re-pointing. However, the northwest corner was on a glacial gravel and there had been some settlement (the wall collapse at the southwest end was largely due to issues with the ditch and tree roots).

Figure 17. The foundation stones at the base of the wall.

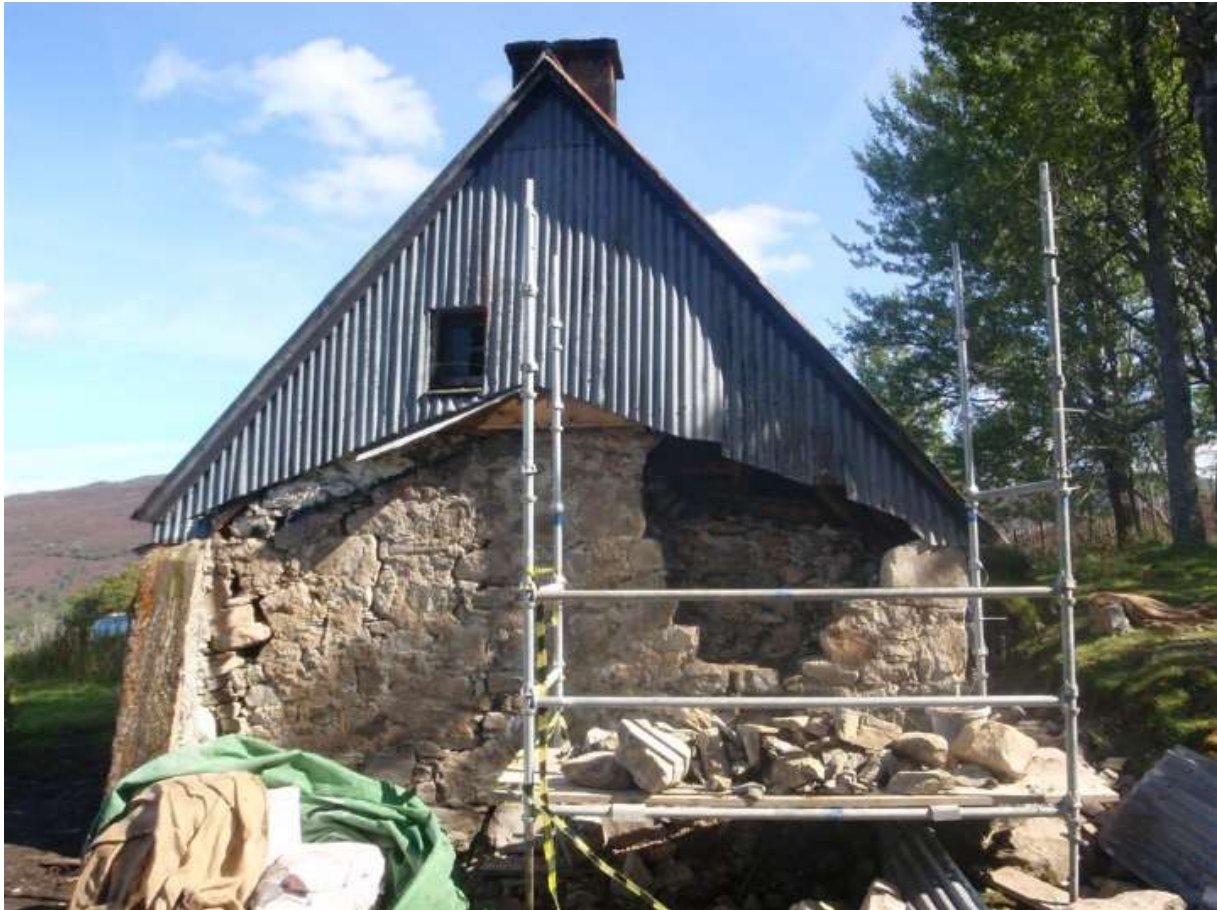
While the roof was in good condition, external ground conditions had led in some areas to settlement of masonry and collapse. This settlement appeared to be from 3 causes: poor drainage behind the house and a build-up of soil and organic material against this elevation causing leaching and decay of the lime mortar; fallen limbs

from the trees; and on the southwest gable and corner where the bedrock changed to glacial gravel resulting in a poor foundation. Half of the rear wall was rebuilt with salvaged stones and a lime mortar. While at first sight in satisfactory condition, the west gable was not stable, and previous buttressing indicated that there had been problems here for some time. The gable end was dismantled and rebuilt (Figure 18), including the existing flue. Other areas of the masonry walls were repointed with a hot lime mix, and finished with limewash.

Figure 18. Rebuilding work on the west gable wall in 2013.

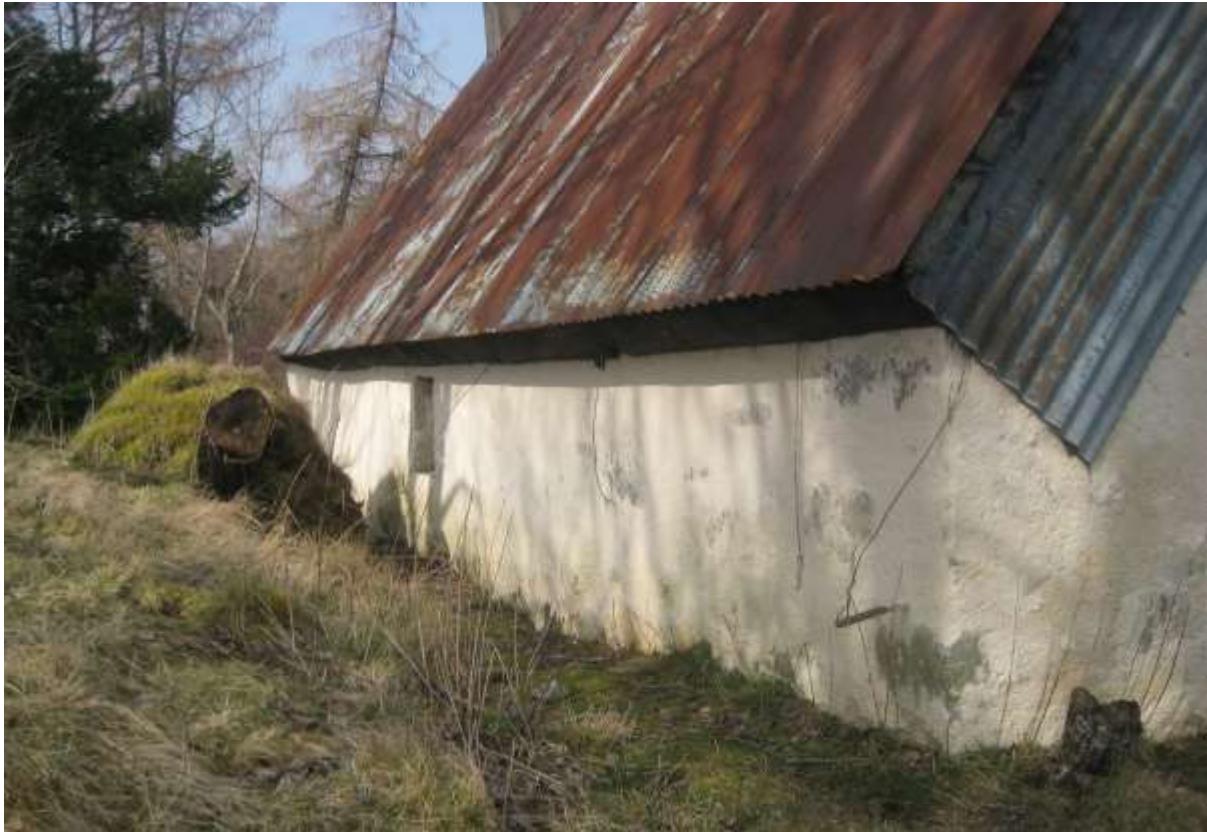
Figure 19. Completed limewash on the partly re-built south wall.

The repointed walls were protected with three coats of traditional lime wash, made up on site from quicklime and water (Figure 19). A small amount of tallow was added during the slaking to impart a degree of water resistance to the limewash.

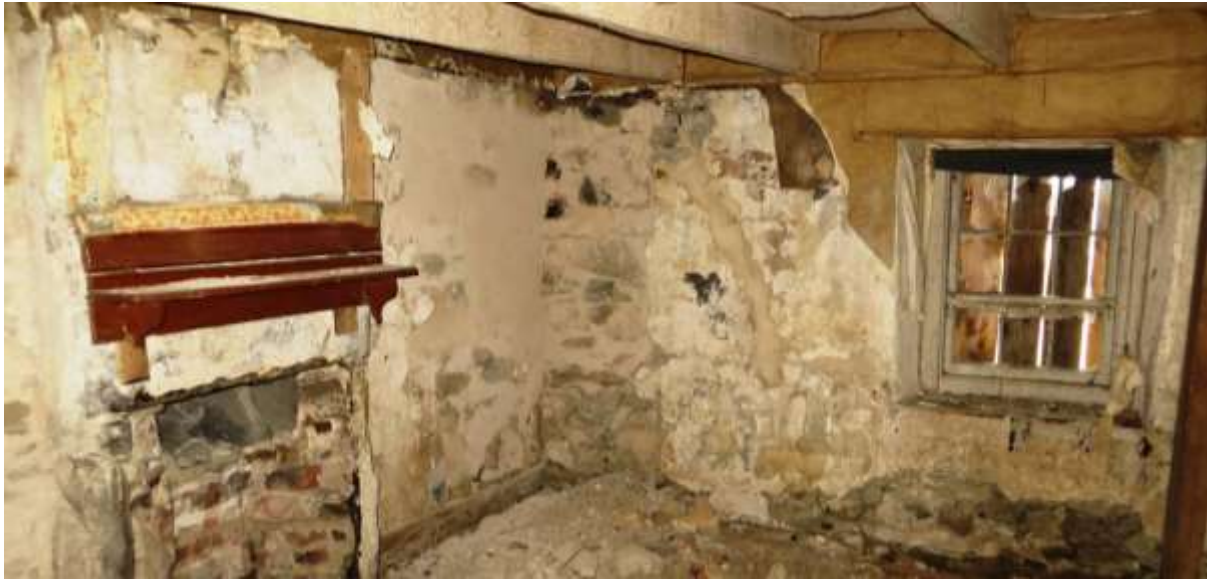
Internally, with the exception of the west bedroom, most walls were satisfactory, but in several places substantial re-pointing was needed due to leaching of lime mortar and settlement and displacement of individual stones. This was done first in order to consolidate the masonry prior to excavations into the floor for the under floor heating (Figure 20).

Figure 20. Completed re-pointing work in the parlour.

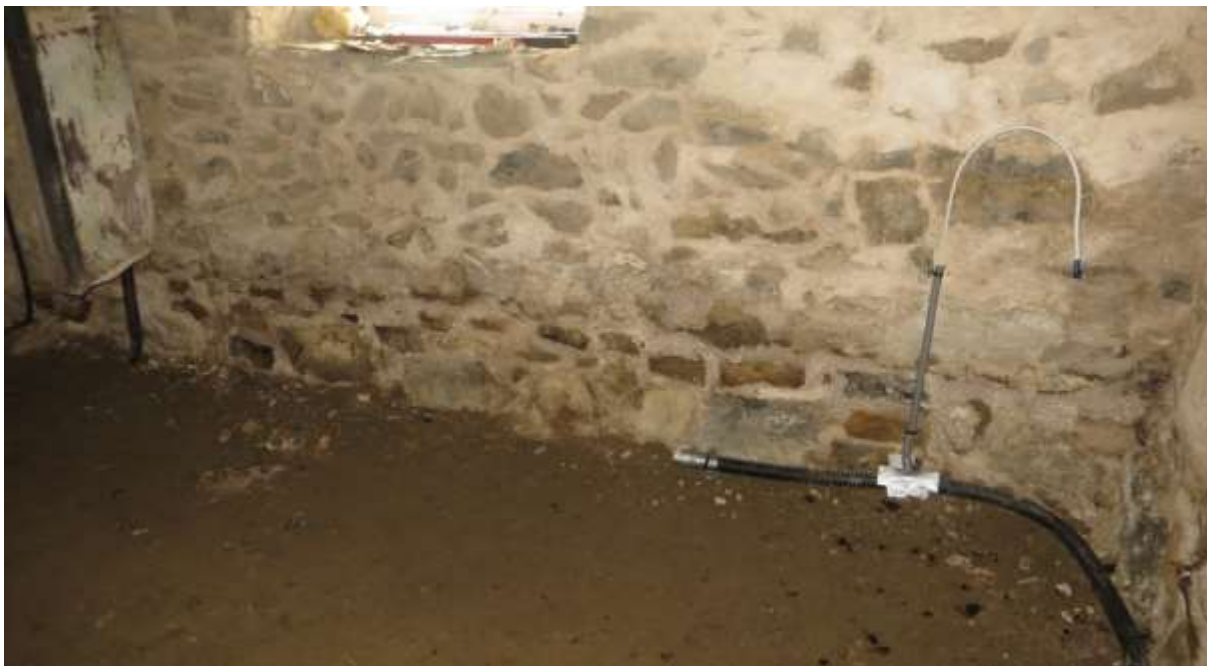
Figure 21. New masonry consolidation on the wall footings following the excavation of the floor.

An underfloor heating system supplied from a ground source heat pump was specified. This required the removal of the existing flagstones and the excavation of the floor, down to a depth of 400mm below the floor level. Part of this depth was required by the client to increase the room height. This was done by hand, and material was transported out in wheelbarrows. The depth of the excavation caused some apprehension for the contractor, fearing masonry movement due to removal of material at the base of the wall. In practice, for short periods (hours) exposing short lengths of wall in good condition on one side did not lead to issues. It was decided to excavate the floor in short sections (Figure 21), and additional masonry was built into the exposed footings of the wall.

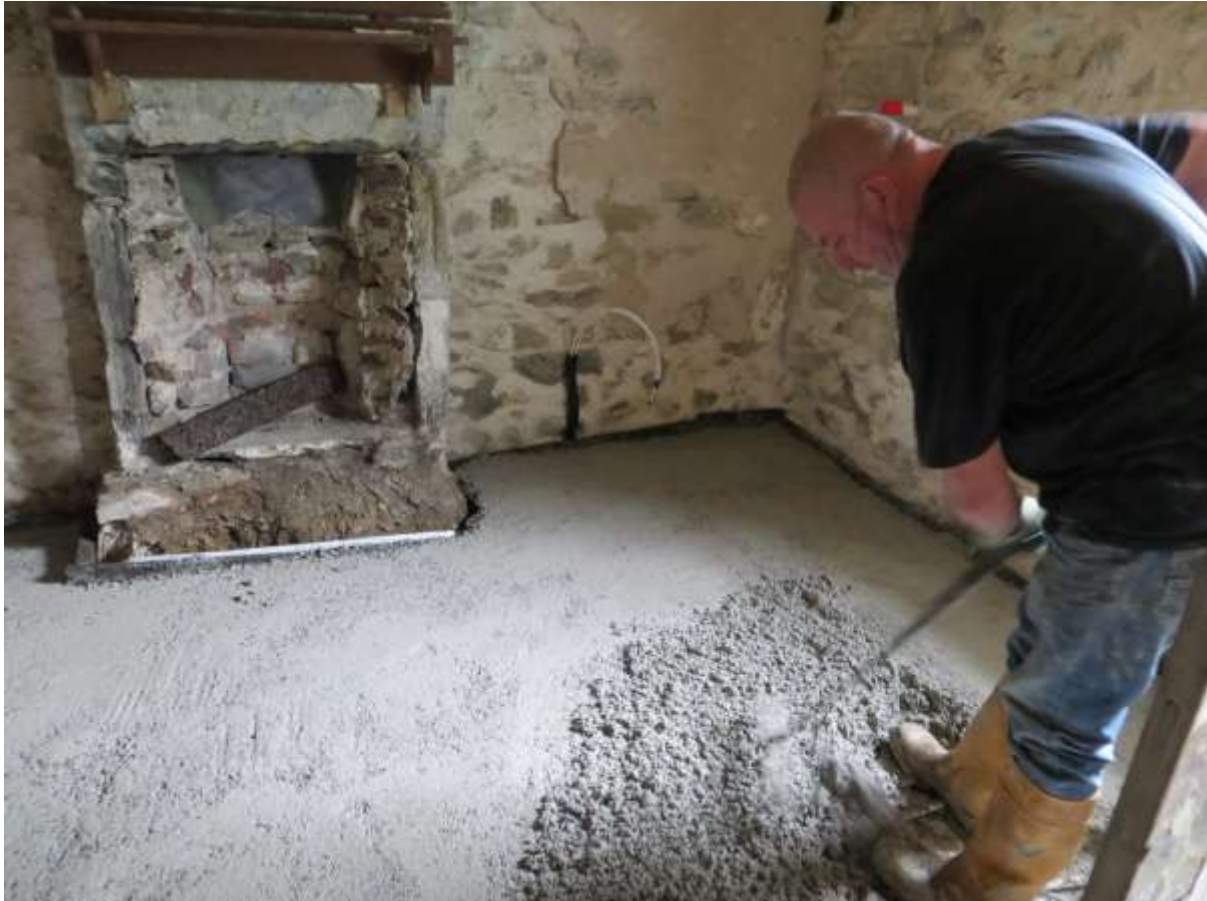
Figure 22. Laying the first lime concrete layer in the parlour. The final floor level was as the original at the height of the hearthstone.

An insulated lime concrete floor plate, designed for a heating loop, was laid in two layers to just below the final floor level (Figure 22). Level of the floor excavation was tapered up towards the walls to minimise excavation close to the wall foot. The floor consisted of an insulation layer of aggregate (expanded glass cobbles) overlaid with a geotextile membrane to provide a clean working surface, and enclosed with a 100mm lime concrete layer.

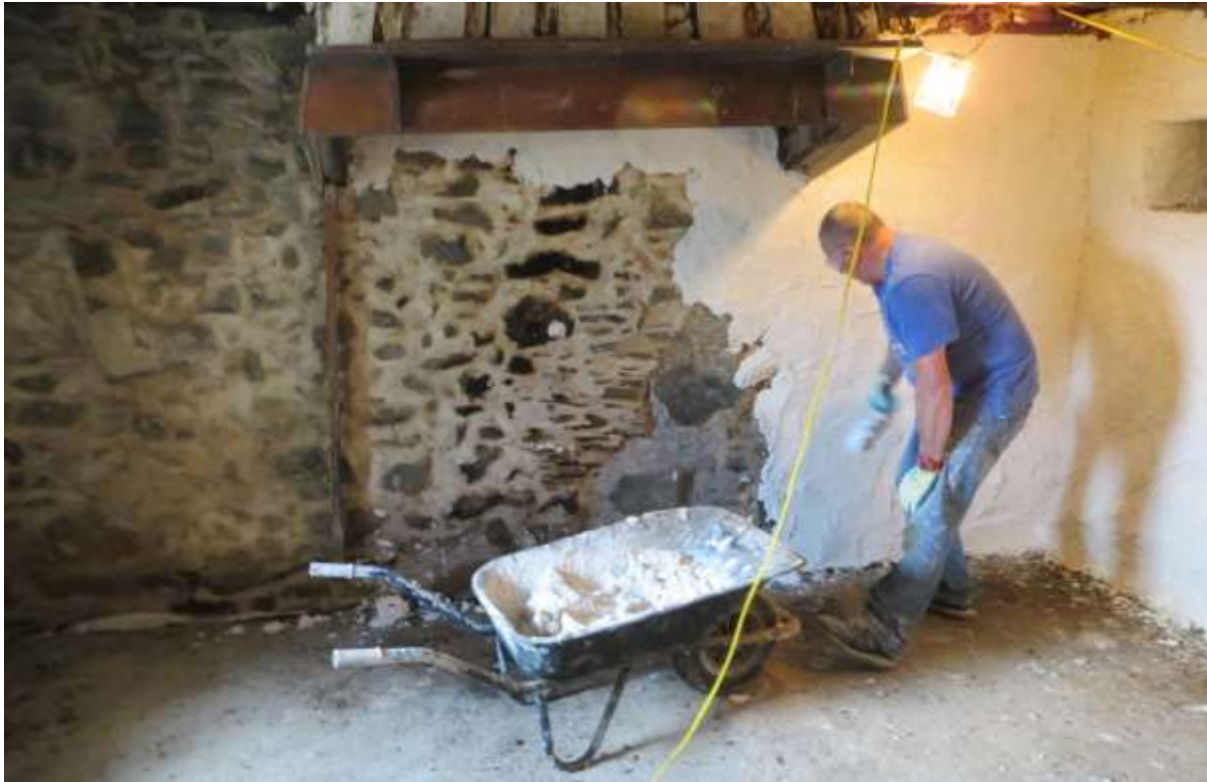
Figure 23. The first coat of insulated lime plaster being applied in the kitchen.

The building had originally been plastered on the hard; this plaster was in generally in poor condition, and on the rear wall it was entirely gone. The walls were re-plastered with an insulated lime plaster, applied in two coats to a thickness of around 60mm (Figure 23). This was intended to re-instate the original finish and provide improved insulation. Given the original thickness of about 35mm, an increase to a thickness of 60mm gave a very small reduction of internal volume. The vapour-open nature of the new plaster maintained the breathable construction of the traditional build.

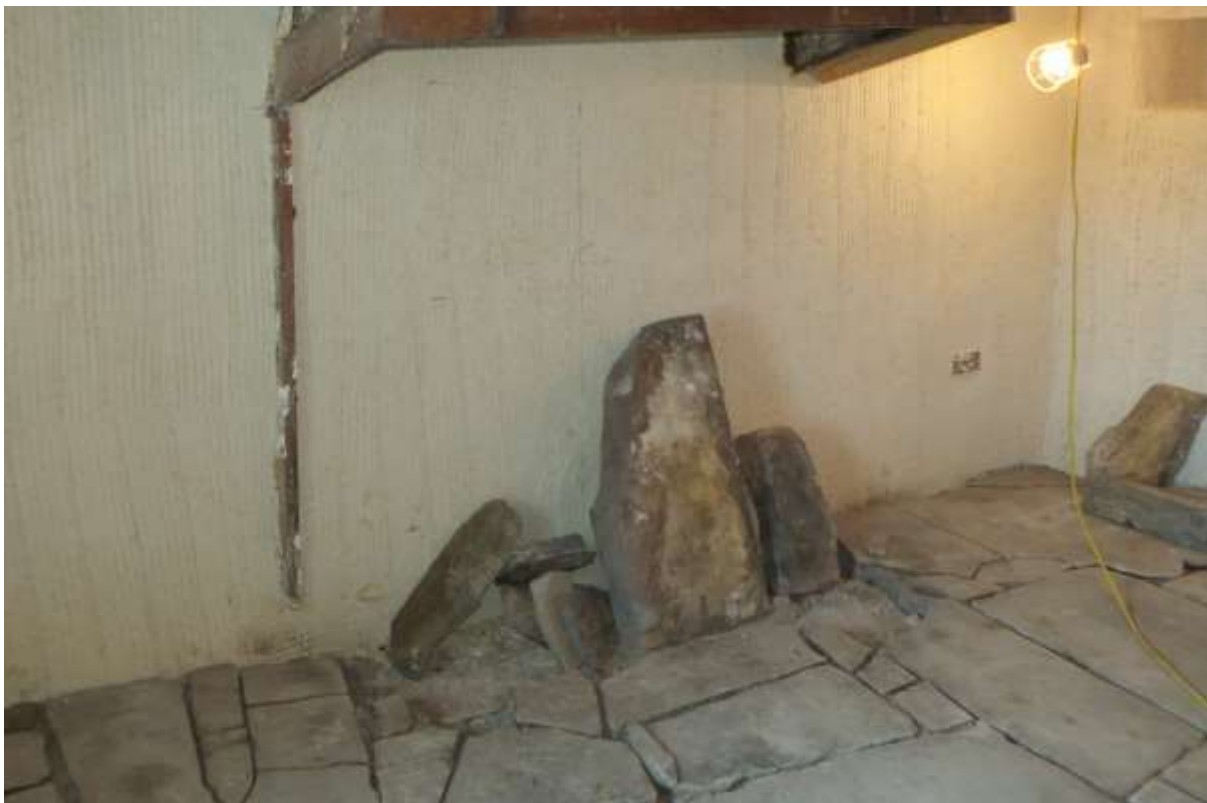
Figure 24. Re-laying the flagstones in the kitchen onto the insulated lime concrete.

The original flagstones had all been removed and numbered to allow their replacement in identical order and these were then relayed over the lime concrete slab, giving a floor finish much like the original (Figure 24)

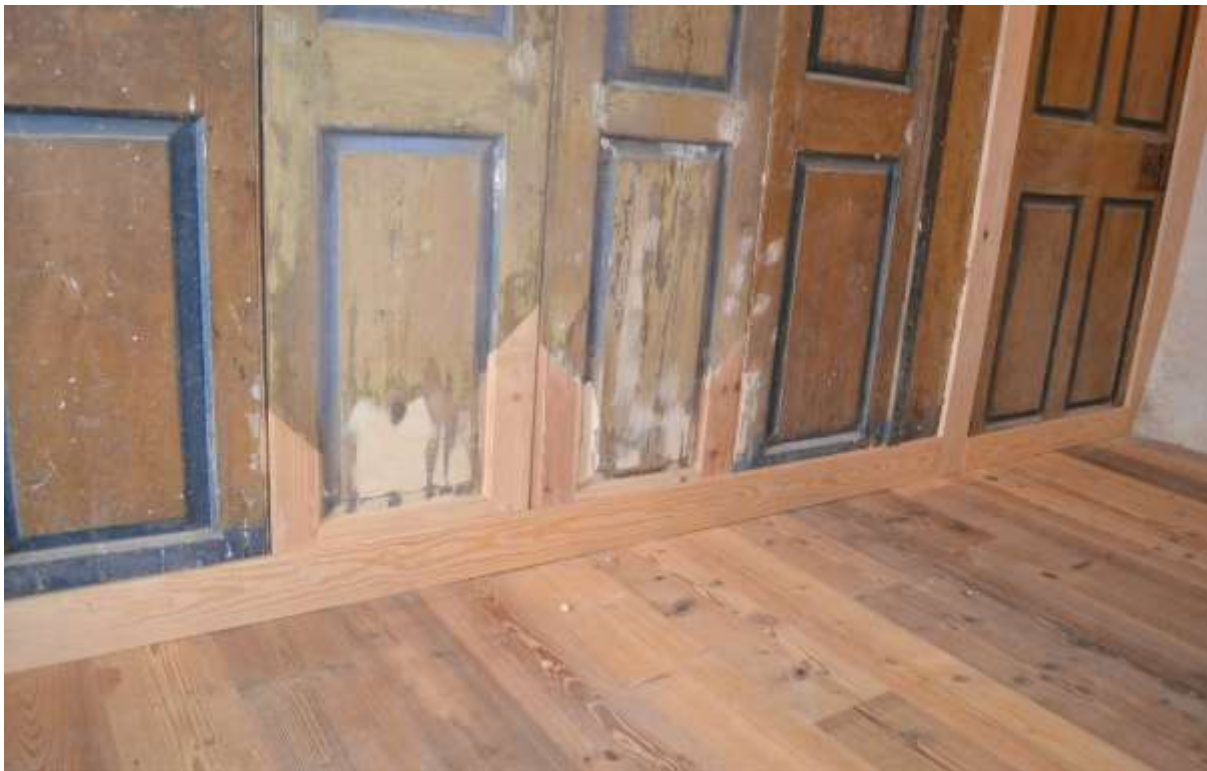
Figure 25. The new timber floor and the repaired box bed panelling in the west bedroom.

The original flagstone floor was only present in the kitchen and hallway, whilst the remainder of the ground floor had a timber floor, although as previously noted this had largely rotted away. In order to replicate the original floor finishes, the area of the previously timbered floors was made up with timber battens set into a lime concrete screed to allow fixing of replacement timber flooring. In order to ensure that the new timber flooring is unaffected by the underfloor heating, an engineered board was specified which comprised a softwood wearing-course bonded to a plywood tongue-and-grooved base which was fixed to the timber battens (Figure 25).

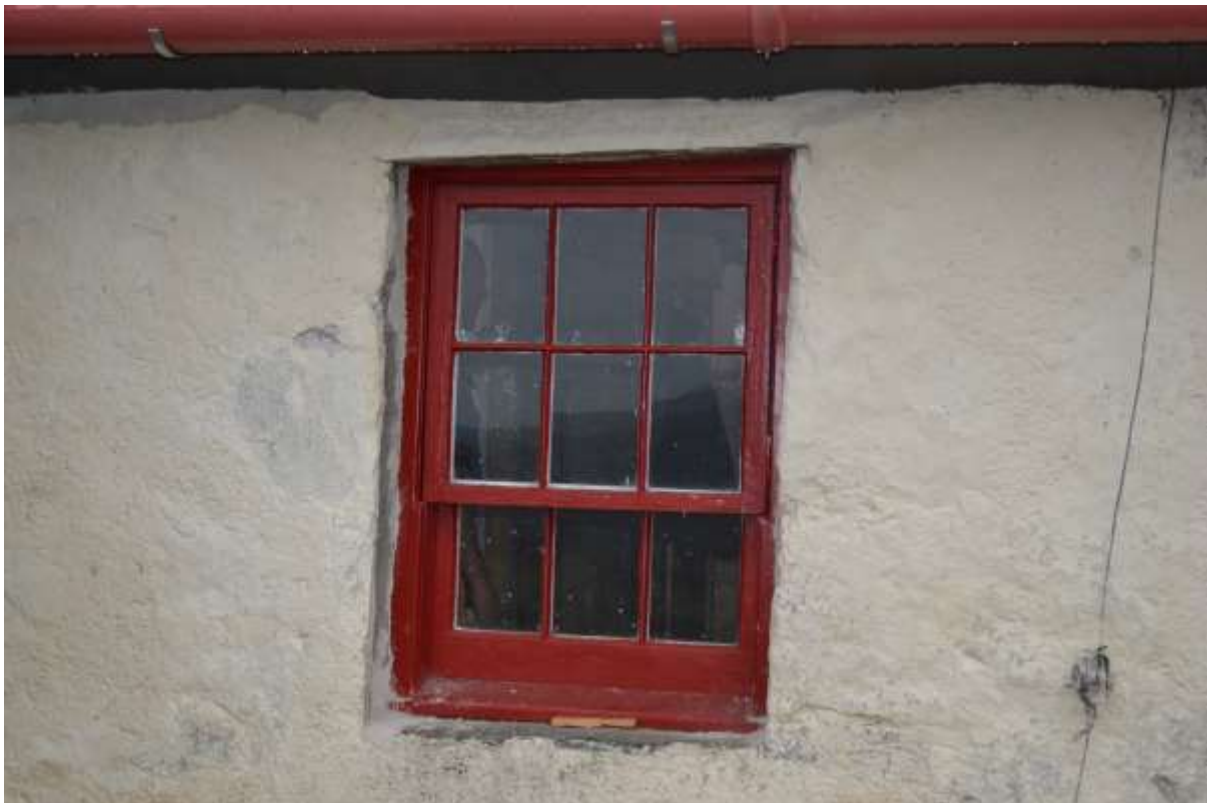
The two sash style windows appeared to be original and matched those pictured in the 19th century photographs. The upper sections were sound, but new cills and styles were required (Figure 27). Due to their small size, and their history, they were repaired like-for-like with no thermal improvement required by Building Control. There were no early glass panes remaining, nor the 'ancient knobble of glass' described by Nan Shepherd. Older glass, especially that from pre-1880 can be thin (down to 3mm), and it is likely to have been damaged at some point. Modern float glass, 6mm thick was used in repairing both sash windows.

Figure 27. The repaired parlour window, following adjustment for use as a fire escape.

In order to comply with Building Control requirements to ensure that the building could be evacuated via the windows in case of fire in the porch, the upper sashes had to be adapted to form casements; this require Listed Building Consent.

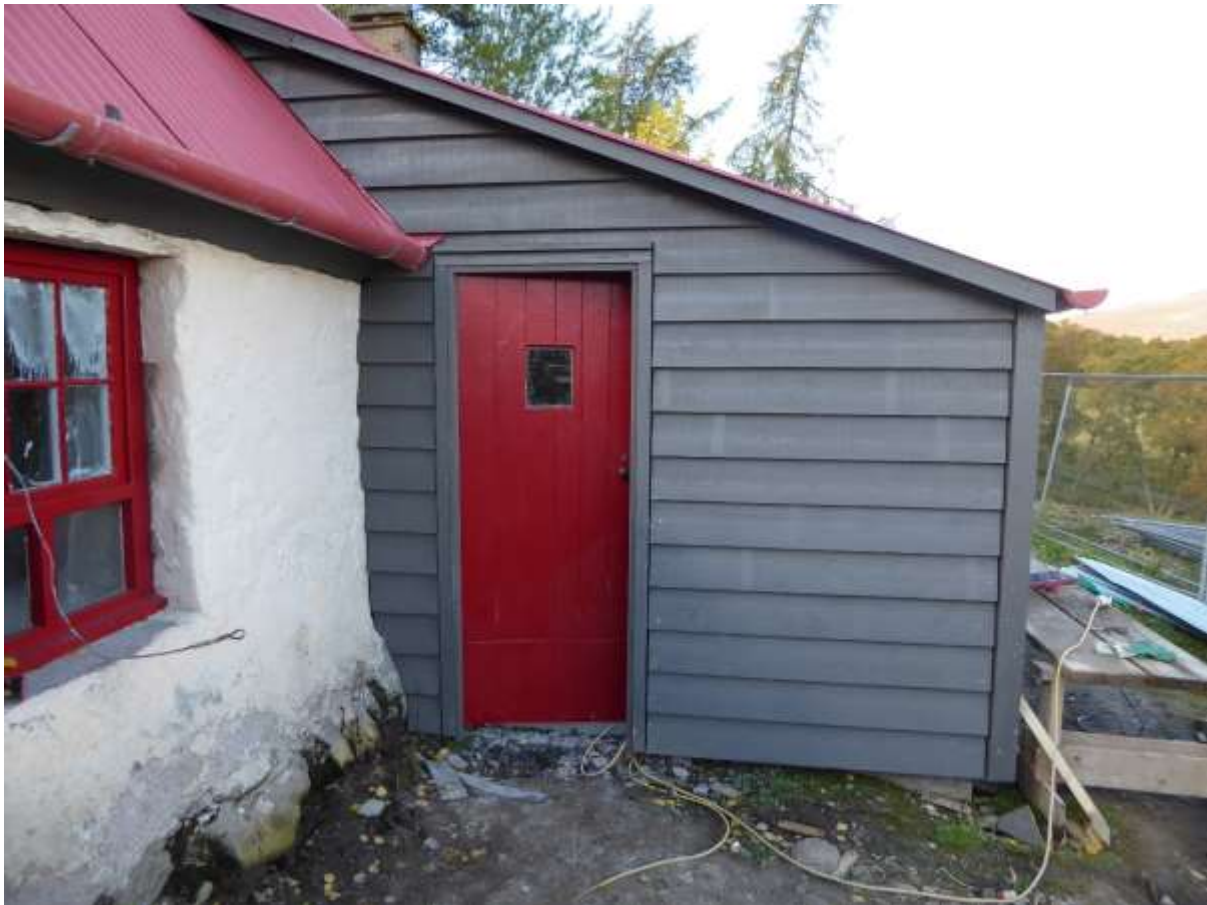
This additional feature, probably from the late-19th century, appeared sound but was found to have rotted considerably at ground level. While it was to be retained as part of the Listed Building Consent, it required additional work in order to be re-configured as a kitchen; it was therefore entirely rebuilt on a new foundation (Figure 28).

Figure 28. The rebuilt porch, on the original footings and to the same profile, which became the kitchen.

Wood fibre-board was fitted between the new framing to provide insulation, and new larch boarding was fastened to the exterior in the same manner as the original.
