Earlston

Conservation works to a mid-18th century terraced house

This publication should be quoted as:
Historic Environment Scotland
Refurbishment Case Study 18

Amy J Kennedy

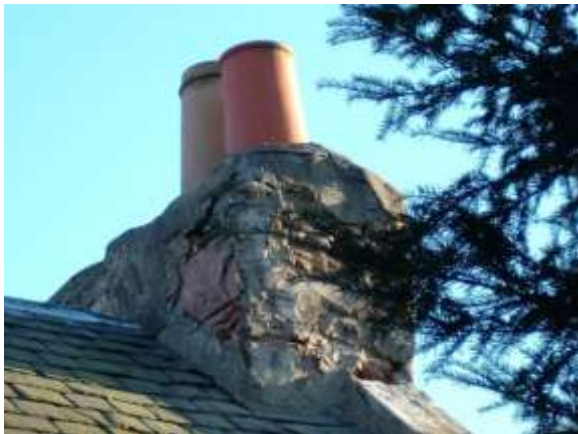
Through visual assessment there were no signs of cracking or movement in the exterior masonry walls; however issues were evident with the south-westerly chimney stack (*Fig. 4*). As chimneys are the most exposed element of a building, and by their nature typically hard to access, they are often neglected. Mortar joints had degraded and washed out over time, allowing water to penetrate the fabric and the establishment of vegetation. This compromised the structural integrity to a state of near collapse. Not only did this cause the chimney to be dangerous, it was admitting water to other areas of the property. Due to exposure to wind and rain, evidence of damp was found in the attic as a result (*Fig. 5*). There was also an area of rotten flooring and joists in the attic, towards the centre of the house, attributed to a roof leak which had subsequently been fixed.

Fig. 4: The west chimney prior to works; note the lack of a cope and poor pointing.

As previously stated, chimneys are generally the most exposed element of a building, and by their nature are typically hard to access. This often leads to their neglect, as was the case in Earlston. The westerly chimney stack was in such poor condition that, having been exposed to long periods of saturation and penetrating damp, the majority of the lime mortar joints had progressively washed out over time, resulting in a weakened structure. With only degraded and friable mortar remaining, the chimney was in a state of structural deformation, nearing collapse. Consequently, the chimney was taken down and rebuilt from ridge height.

Previously built using sandstone, the existing stone was in too poor a condition to be reused. Reclaimed colliery brick was used with a clay flue liner, in keeping with many other rebuilt chimneys in Earlston (*Fig. 10*).

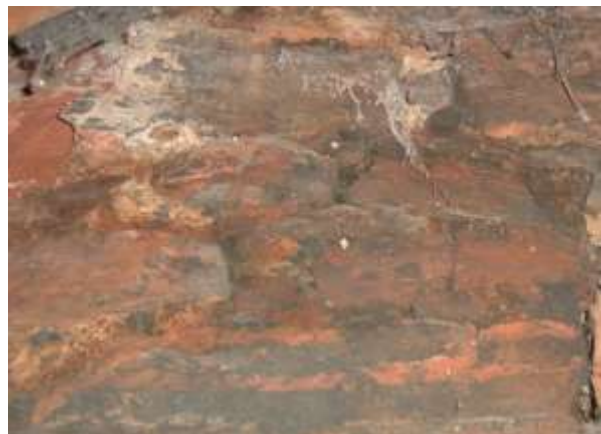
Fig. 5: Stained masonry and stone decay in the attic below chimney due to defective work above.

Due to the nature of the property, being a mid-terrace, it does not suffer greatly with levels of wind driven rain, having only two external walls. Dampness did however occur in the gable wall due to chimney defects, allowing water to be drawn in and become trapped. This issue was addressed through the re-building and repair of the chimney and the gable dried out. Correct detailing around the chimney allowed for the protection of the gable, whilst time and applied heat from the wood burning stove below subsequently helped dry out the wet gable.

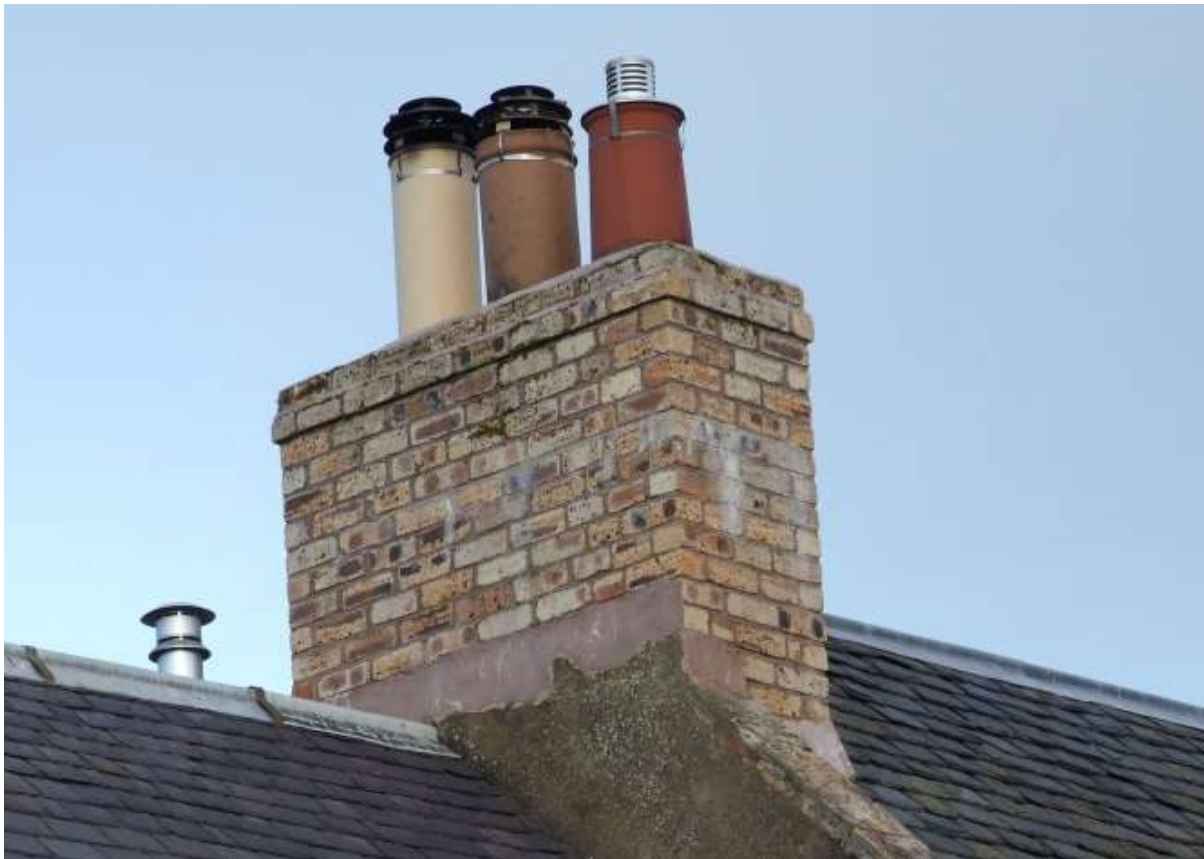
Fig. 10: New chimney stack built used reclaimed colliery brick.

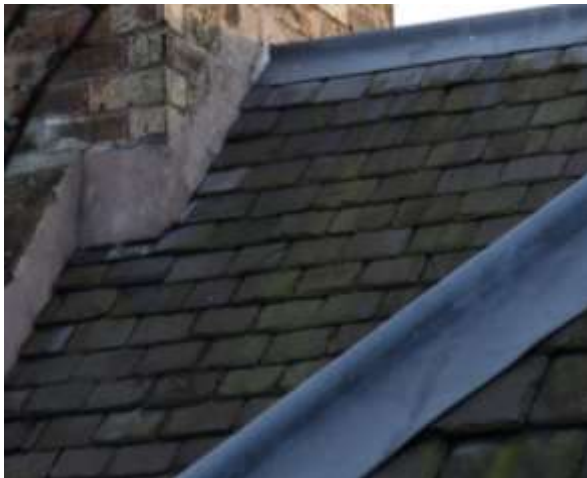
Fig. 11: Re-dressed, reinstated Welsh slate on the back pitch of the terrace, with replacement lead flashing.

Slates were then fastened with copper nails, which are more durable than ferrous metal or galvanised nails. Approximately 50% of the existing roof slate was redressed and reinstated on the back pitch (*Fig. 11*), while the remainder was replaced with reclaimed Scots slate on the front pitch. These were laid in the traditional manner with diminishing courses, utilising random lengths and widths, and overlapping each course with both headlap and sidelap. This arrangement is fundamental to the proper functioning of a slate roof to achieve weather tightness. In hindsight, the use of Scots slate was an indulgence of the owners and is now thought not to be in keeping with other properties in Earlston, due to different coursing and grading and where Welsh slate was the dominant slate used.

Replacement lead flashing was installed along the roof ridge (*Fig. 11*) and at the junction of the skew cope and the slates, replacing similar old lead flashing. These are important junctions which can be a point of weakness, particularly in terms of water penetration, which if uncovered or laid incorrectly can result in internal dampness.

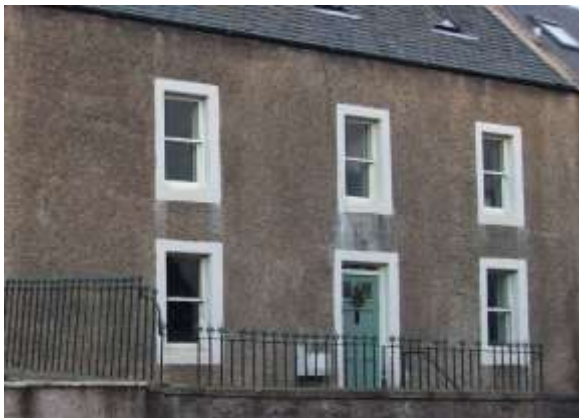
Fig. 12: Existing modern cement render.

Lime render finished with lime wash is often used as a protective layer on traditional masonry. Traditional lime harling reduces the incidence of hairline cracking, which can occur with cement render, while the open pore structure allows water vapour dispersal and prevents the build-up of moisture in a masonry wall. This is the most appropriate material when re-rendering any traditional structure. However, the Earlston property had been rendered in a modern cement based render, probably applied around the 1960's. As there were no obvious issues of damp it was decided to leave it in place (*Fig. 12*) but paint it with a mineral paint. Mineral paint bonds well with cement based substrates and allows a degree of vapour movement. The lighter colour much improves the aesthetics of the façade and it appears to be lasting well since application (*Fig. 13*).

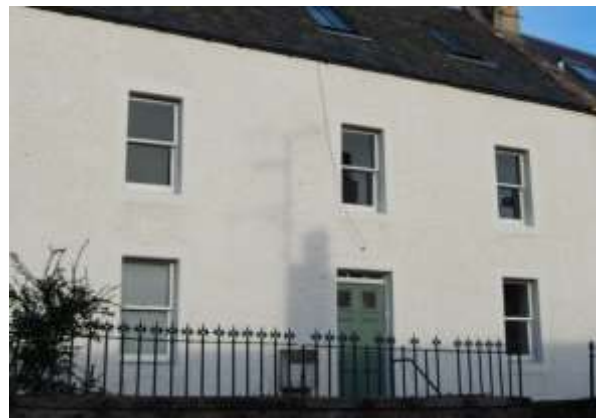
Fig. 13: Traditional mineral paint used on the principal façade.

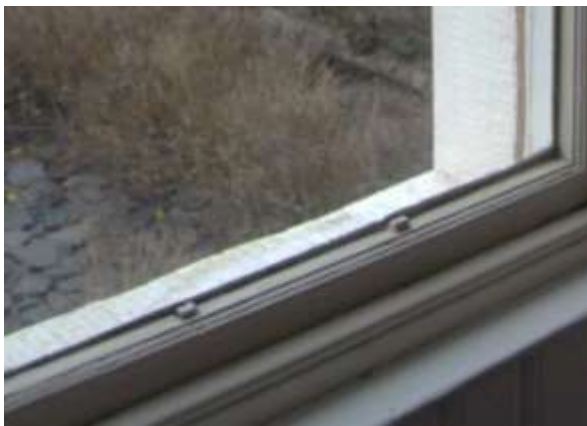
During the refurbishment, all of the existing single-glazed timber-frame sash and case windows were retained. These windows appeared to be original, showing a characteristic moulding pattern on the sashes. At some stage the astragals had been removed; stumps were still evident on the sashes, indicating they originally had six panes per sash (*Fig. 14*).

Fig. 14: Stumps of removed astragals showing the original 6 over 6 glazing arrangement.

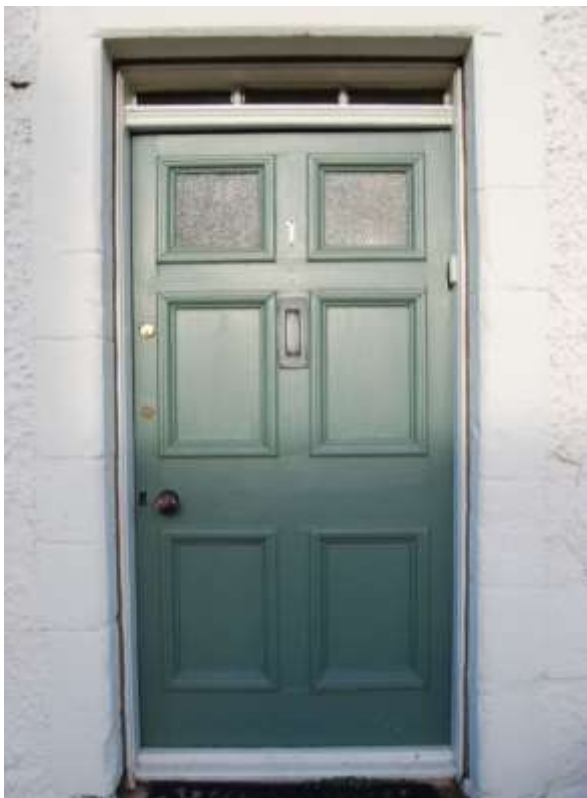
Fig. 16: External front door with wooden threshold to prevent driving wind and rain ingress at the periphery.

At the time of the refurbishment the external front door was in good condition. From the style, it was probably a late 19th century door with raised mouldings in the panels. As water was penetrating underneath the door, a new wooden threshold or sill was fitted to prevent driving rain and draughts breaching the door casing (*Fig. 16*). Now, some ten years later, the condition of the door is deteriorating. Consideration will need to be given whether to remove and replace the affected panel of the door or replace the entire door like-for-like.

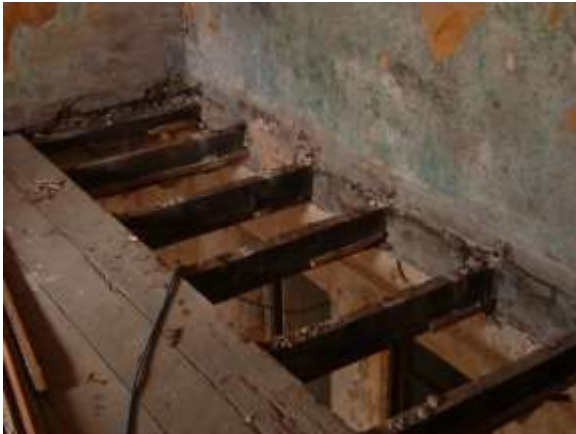
Defects were also noted internally; the intermediate timber floor joists appeared under-sized, resulting in movement or flexing within the floors. The barrel vaulted cellars to the rear were damp, due to being closed off with little to no ventilation and, with the addition of rainwater goods in the 19th century, water was draining from the roof into the cellars.

Fig. 17: Undersized timber floor joists resulting in movement across the floors.

Internal alterations and improvements commenced with work to the intermediate floors. Initial observation highlighted that the floor joists appeared undersized (*Fig. 17*), resulting in movement and deflection within the floors. The floor boards were lifted, and the existing joists were braced with additional new timbers. During this work, packed heather was found between the joists (*Fig. 18*); presumably installed as a form of sound insulation or deafening. This was nonetheless removed due to reservations about its fire risk.

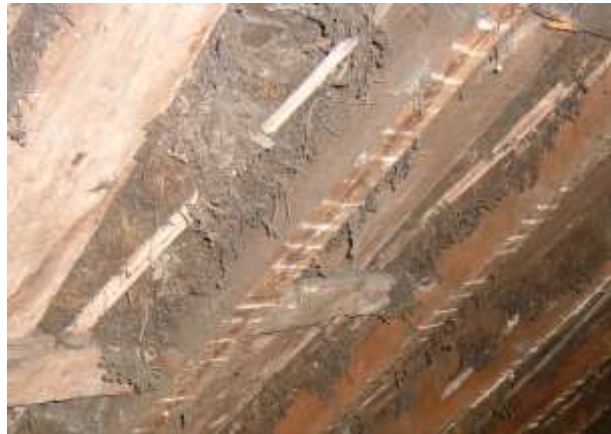
Fig. 18: Dried packed heather (grey colour) revealed in the floor zone.

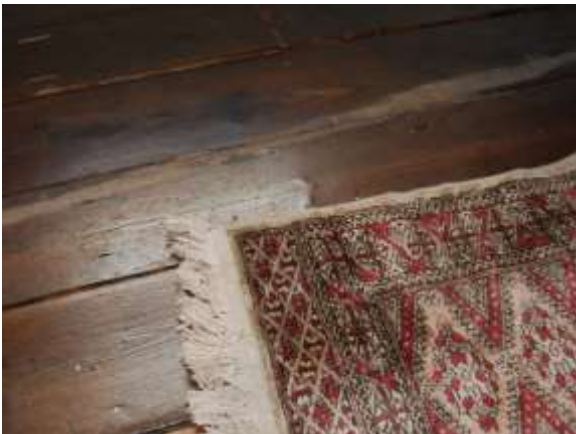
Fig. 19: Existing timber floor boards were re-laid.

Floor boards were reinstated where possible (*Fig. 19*) and where new ones were required these were cut to match the existing boards by a local sawmill (*Fig. 20*).

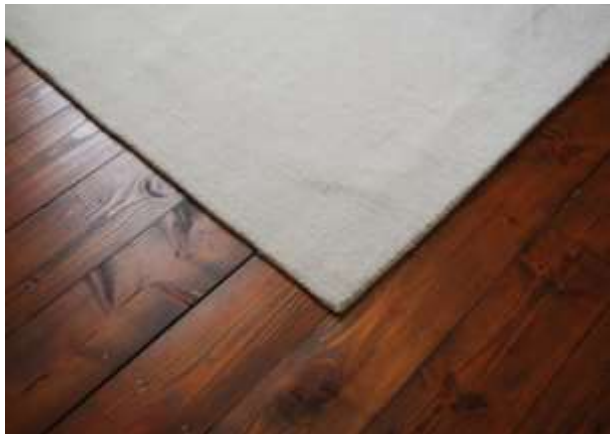
Fig. 20: New floor boards made by local sawmill, maintaining the width of the original boards.

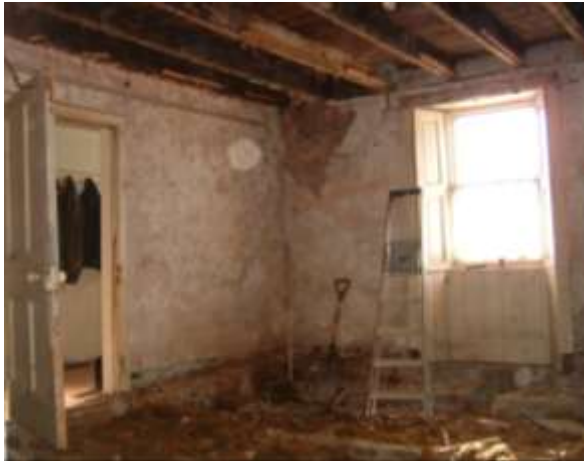
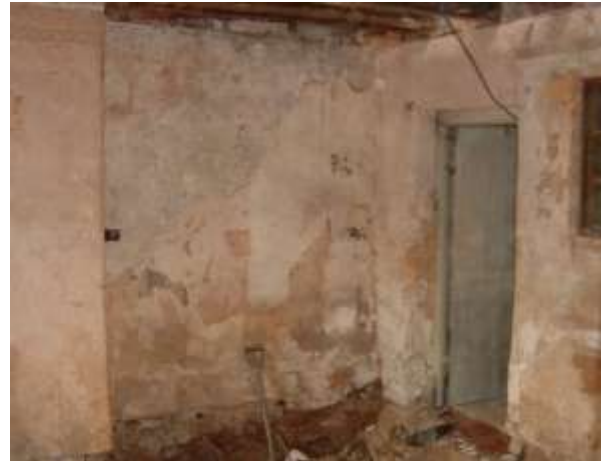
Fig. 25: Master bedroom works to re-plaster on the hard.

Fig. 26: Master bedroom works to re-plaster on the hard.

Most of the internal lime plaster was retained in the refurbishment, whilst areas in poor condition were repaired. Some areas were 'plastered on the hard', meaning that the plaster was applied directly onto the masonry. Areas in need of repair were largely found in the master bedroom (Fig. 25 and Fig. 26), the attics, and one of the cellars. The masonry in the other cellar was left un-plastered. Vapour-open lime plaster was used, as it allows a degree of air and moisture movement, which is compatible with traditional masonry walls.

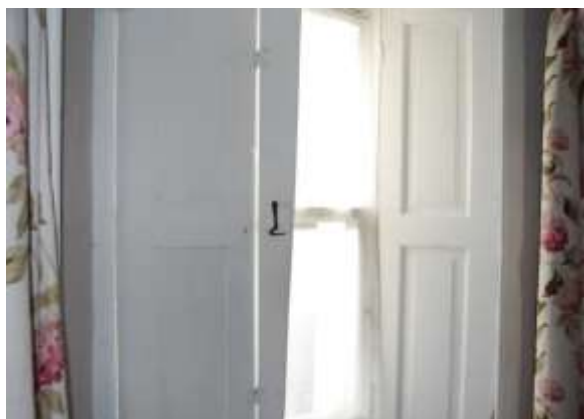
Fig. 27: Existing timber window shutters restored.

The vast majority of internal details, fixtures, features and finishes were retained, including internal finishes and ironmongery. The timber window shutters were retained and refurbished (Fig. 27), helping in the thermal performance of the property as well as privacy and security. The shutters were generally in good condition, and only required modest repairs. Dado rails were also restored where extant (Fig. 28), maintaining the character of the original design. Internal timber panelled doors were retained, and required minimum repair (Fig. 29). Plain boarded doors were also re-used (Fig. 30). Due to their condition and damage from earlier electrical work, the skirting boards were replaced.

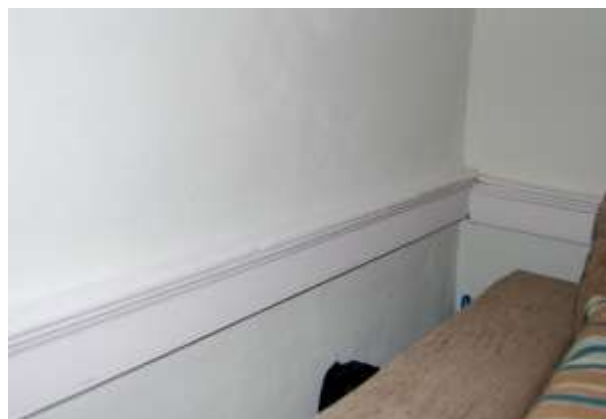
Fig. 28: Existing timber dado rails restored.
