REFURBISHMENT CASE STUDY 28

HOBKIRK CHURCH HAWICK

LIME POINTING WORKS AND OTHER REPAIRS

HOBKIRK CHURCH, HAWICK

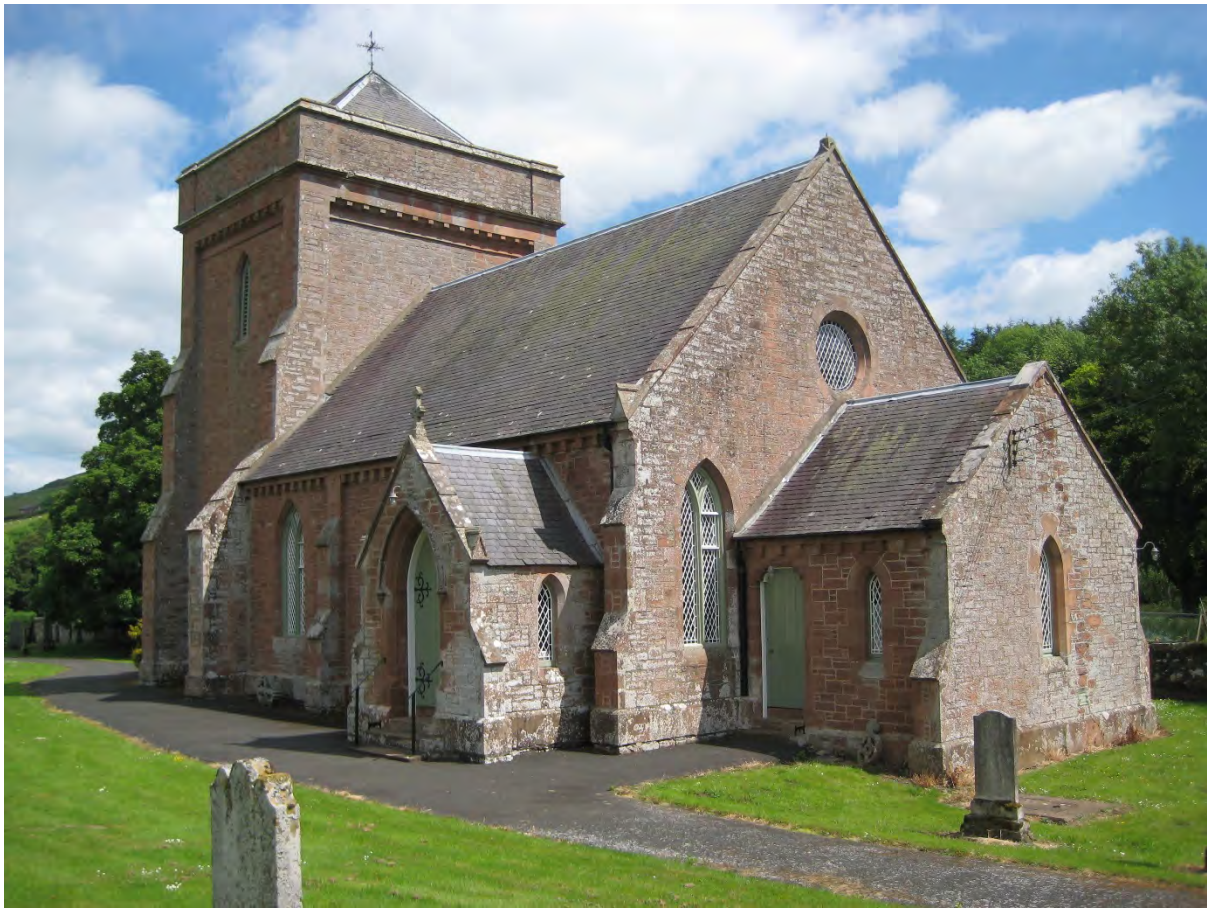
The condition of the external fabric was generally good, although failure of cement pointing on the vestry and nave gables had started to cause water ingress. The coursed rubble is a hard red sandstone, known geologically as 'Devonian Old Red Sandstone'. The stone dressings are of a similar hue, but softer in texture and showing signs of decay where there is persistent wetting and drying. Some areas of the walls had been repaired before, and it is believed that the last repair was re-pointing work to the gable of the nave and vestry in the late 1960s. This used a strong Portland cement mix which was pointed over the original lime-rich mortar. The new cement mortar was cracked in many places and had begun to come away from the

wall. In addition to failures in the pointing, open joints at the skew copes on the nave gable were letting in water. This high level work was addressed by the church at a later phase with re-pointing and new leadwork in 2016.

Figure 1. Hobkirk Church viewed from the southwest.

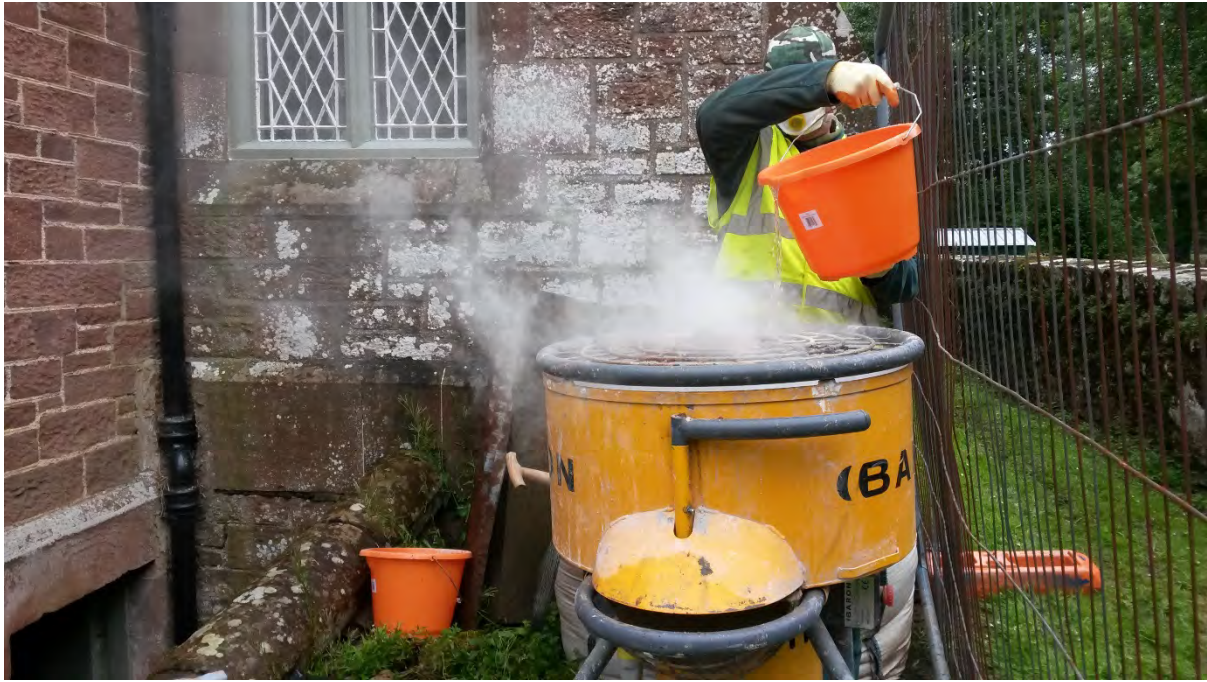
Figure 4. Addition of water during the batching of the pointing mortar.

For the first session in August 2013 the rubble pointing mix followed a 1:3 ratio of lime to sharp sand. The sand was sourced locally. The lime was 3/4 part quicklime and 1/4 of a part hydraulic lime (NHL 2). The mix was batched in a 20 litre forced action mixer (Figure 4). This type of mixer is sometimes preferred for limework as the lower water content in lime mortars (compared to cement mixing) does not allow free enough mixing in a bell type mixer. The sharp sand was supplied in a ton bag from the local builders' merchant and the quicklime from a specialist lime supplier.

The mixing sequence when using quicklime is important to ensure that the correct temperatures are maintained. On a more practical level, this can help to avoid mixer jams and mix saturation. The full measure of the sharp sand is added to the mixer first, followed by the kibbled quicklime; the action of the mixer combines the sand and the lime and a partial slake takes place from the water in the sand, breaking down the quicklime. The mix at this stage resembles a warm dry powder. Water is then added progressively to produce a soft porridge-like consistency. The quicklime slakes quickly from then on, with heat and water vapour generated. It is important to keep the mix fluid or plastic, but not too wet. The limeworker must judge the amount of water needed to produce the right consistency, depending on how dry the sand is. For this mix, per batch, it was around 1.5 buckets of water.

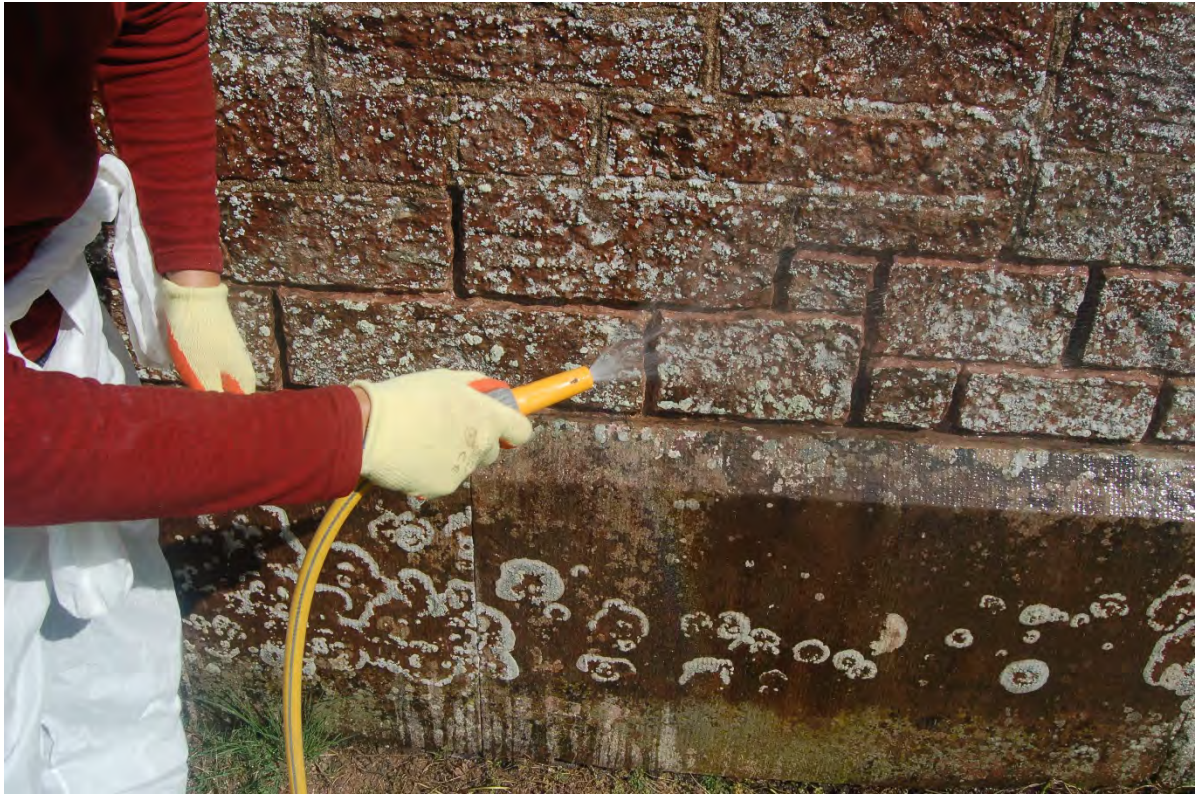
Figure 5. Cleaning the raked out joints prior to re-pointing.

The works at Hobkirk concentrated initially on re-pointing the coursed rubble and the fine ashlar joints of the sandstone dressings. For the 2013 work the volunteers began on the vestry gable, removing cement pointing from the late 1960s. This was done with hand tools, working along a joint, without attempting removal where mortar was found to still be strongly adhered. The joints were washed with a hose, which cleared any fines or debris, and also pre-wetted to prevent the mortar drying out from behind (Figure 5). Because the red sandstone rubble at Hobkirk is quite impermeable, only a modest amount of water was needed. The mortar was applied to the joints with a pointing key and was set just proud of the masonry surface so as to give a flush surface once scraped back (Figure 6).

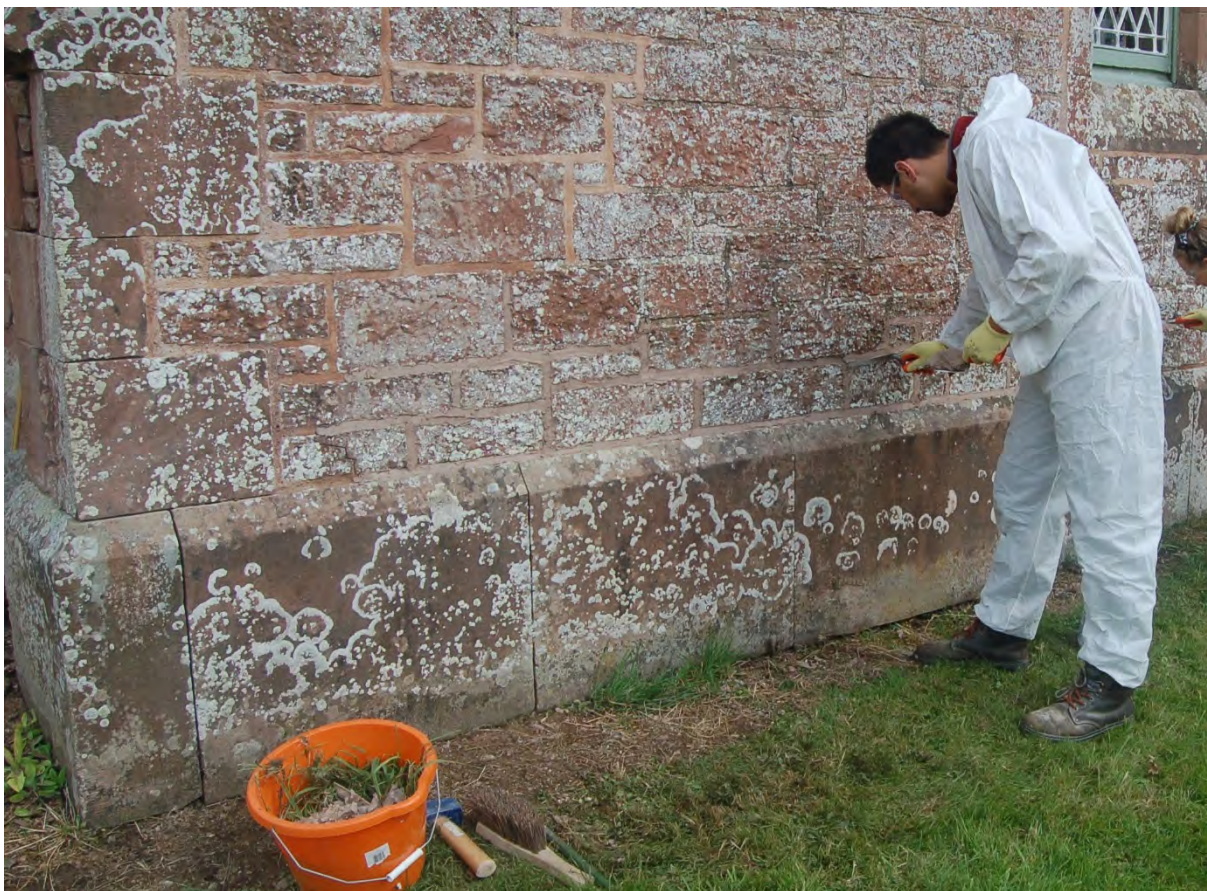
Figure 6. A volunteer re-pointing the vestry wall.

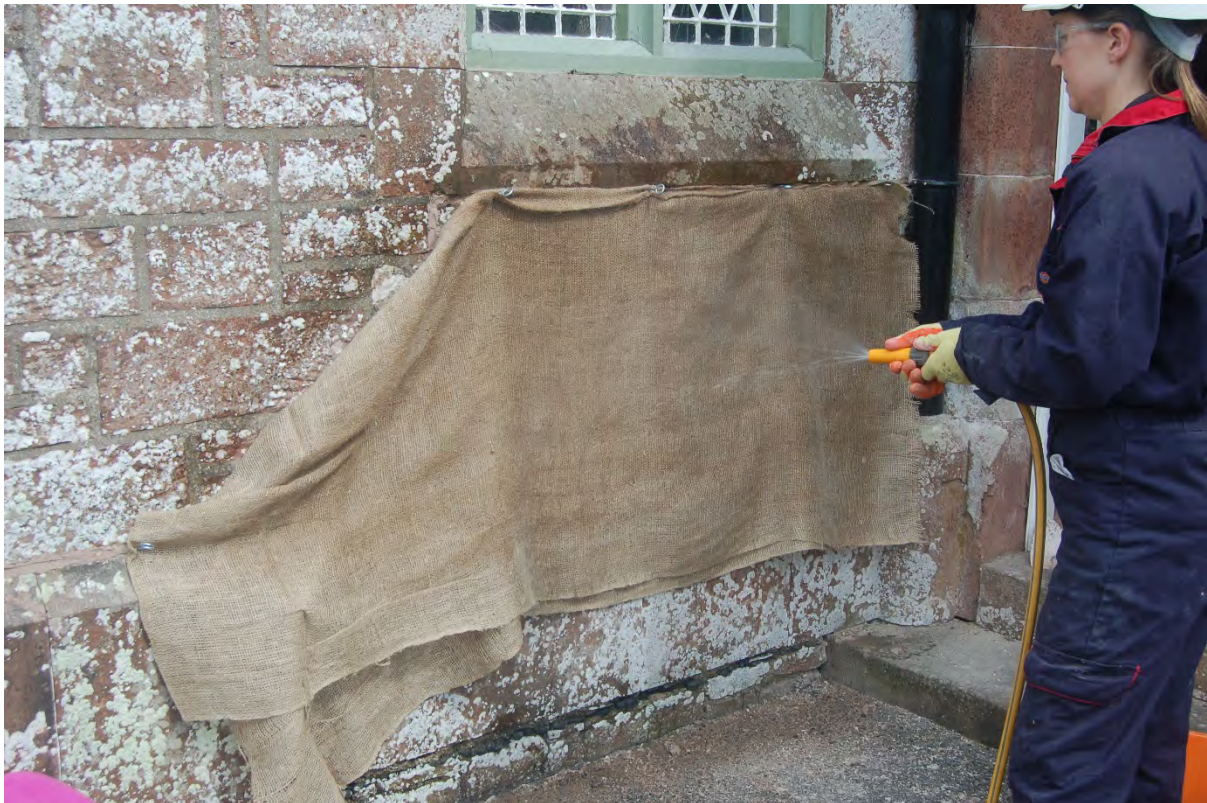
Figure 7. Finished pointing protected behind hessian. This needed wetting down for the first 24 hours while the initial set took place.

A few hours after the pointing, the joints were pressed back to close any cracks. Depending on the weather conditions, some wetting down of the wall was required. Afternoon sun on a recently pointed wall may cause the mortar to dry out too rapidly and inhibit curing. To prevent this, damp hessian was used to cover the repaired area for around 48 hours, and kept damp by lightly spraying with a hose (Figure 7). After two days the hessian was removed and the pointing continued to cure. By the end of the week the early work had set firm.

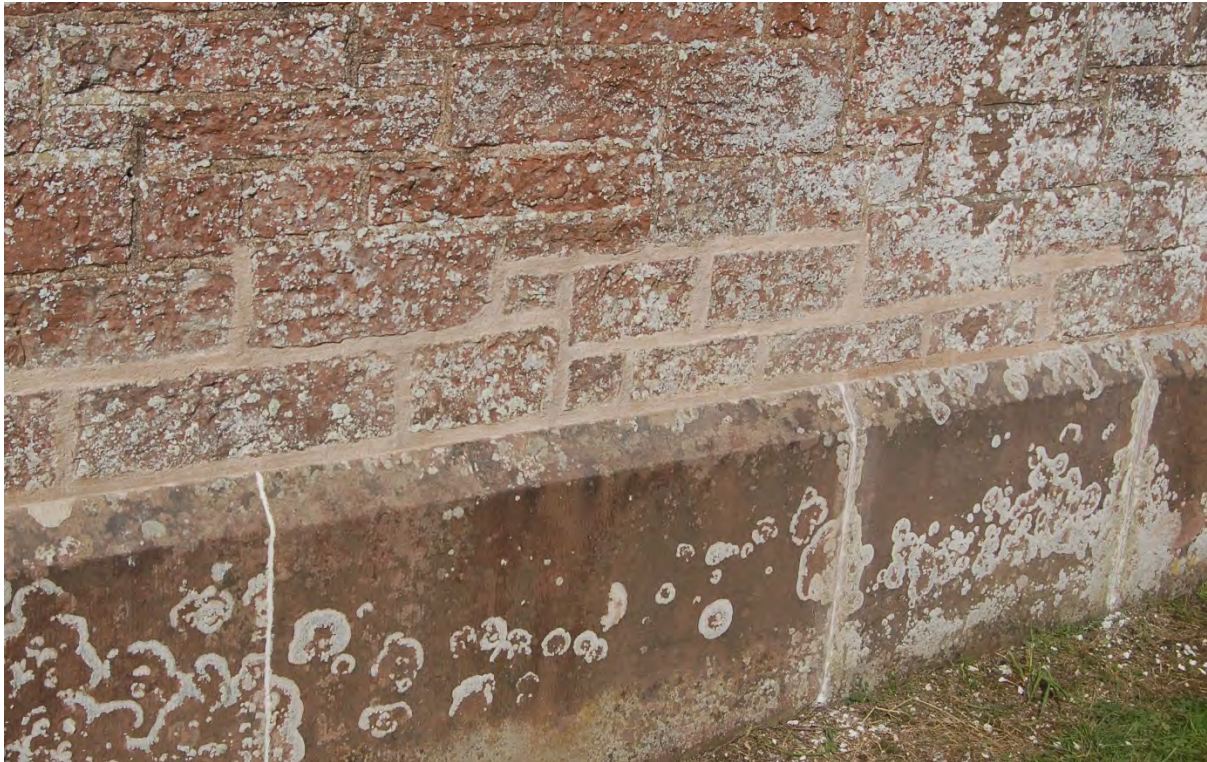
In the 2014 session more overcast and damp conditions permitted a more relaxed routine with the hessian. The mortar in the second session cured a creamy grey colour (Figure 8) and showed no signs of shrinkage or cracking.

Figure 8. The finished rubble joints from the 2014 working party.

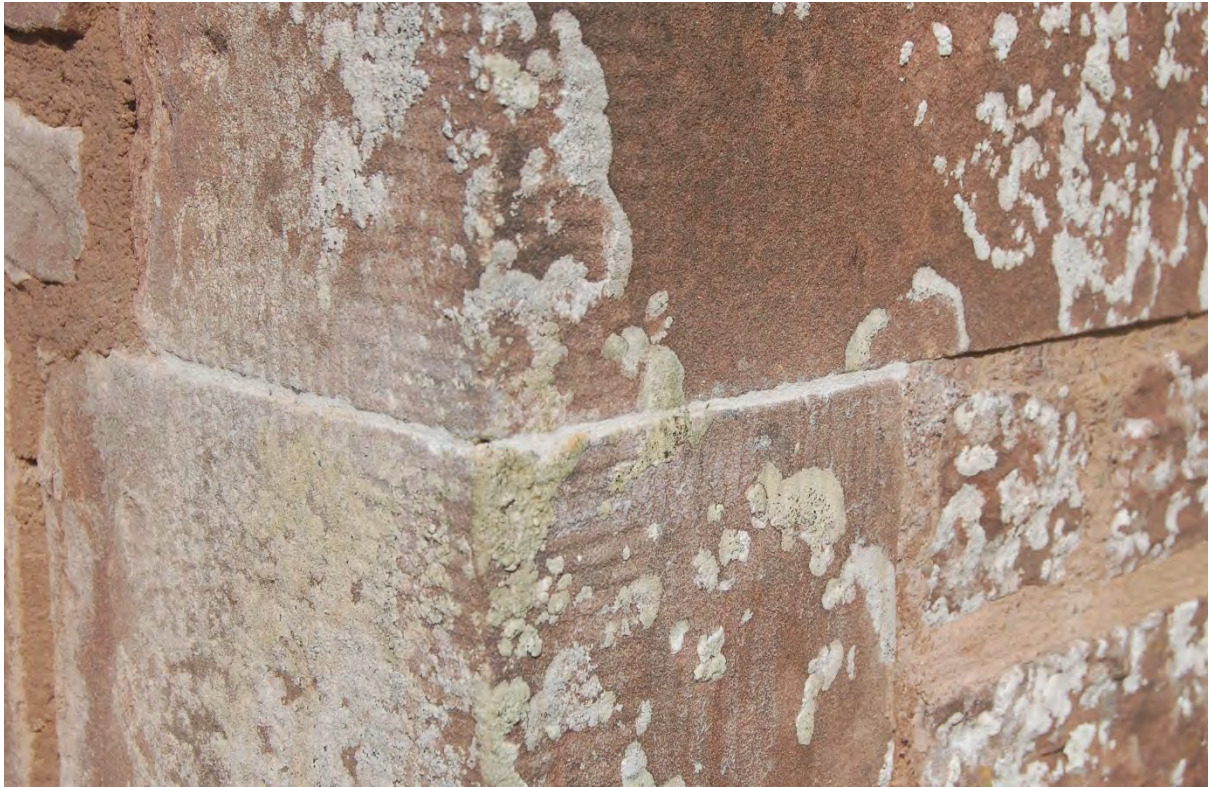
Although much of the stonework was in reasonable condition, in places the lime-rich pointing in the joints between the formal ashlar stones had been washed out, leaving an open joint. This was allowing water penetration into the stone below and behind, and frost and salt action were causing decay. Using fine tools and modified hacksaw blades, these joints were carefully raked out and prepared for re-pointing. The pointing mix for ashlar work differs considerably from that used in rubble pointing. As the width of the joint is so narrow, the mortar must have a very fine aggregate and be very pliable.

Figure 9. New ashlar pointing work on the narrow joints of the vestry gable quoins.

Opinions vary as to what constitutes the best ashlar pointing mix, but generally it is a lime putty with fine silica sand, mixed at 1:1. Chalk dust or whiting is sometimes used instead of the sand if a high degree of plasticity or 'squeeze' is needed, although normally only when bedding stones during initial construction. There is no quick method of ashlar pointing – it is a slow, careful process. Pre-wetting of the joint is needed, and wiping down the adjacent areas of stone to remove excess lime must be done promptly once the work is finished, to avoid staining the stone (Figure 9). Some contractors use masking tape adjacent to the joint to keep the stone clean.

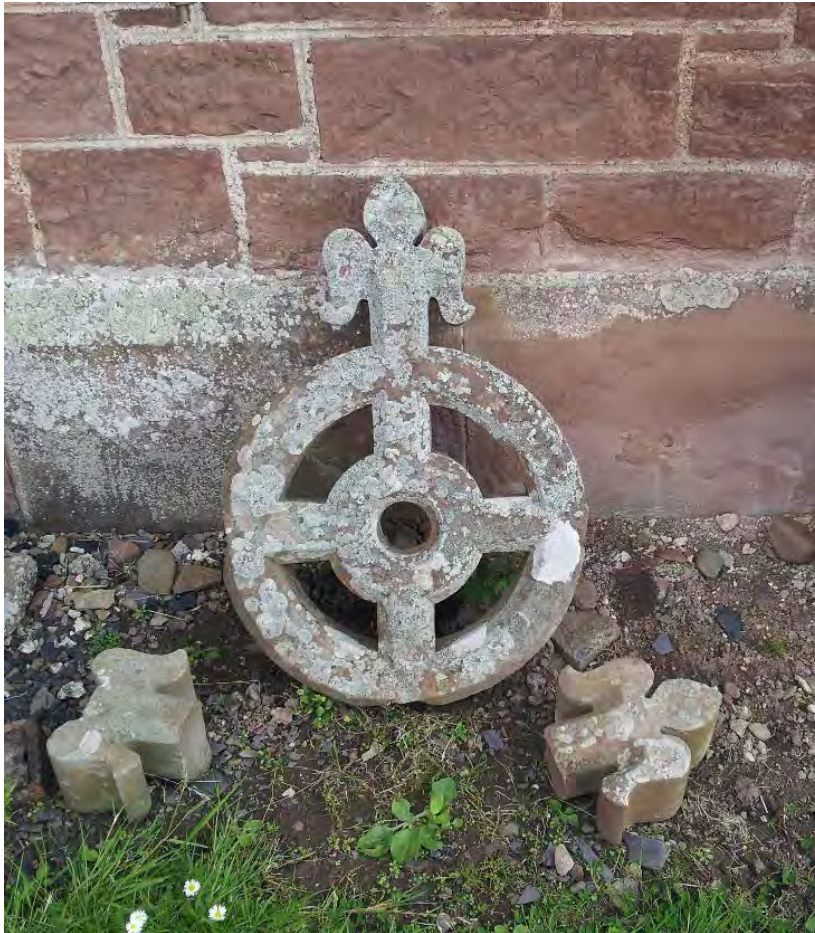
Figure 10. This decorative stone finial was carefully repaired by a stone conservator.

During the project the opportunity was taken to address other areas of damage in the church and its vicinity. Of increasing concern to the community was the condition of some of the headstones, grave markers and other memorials. A specialist HES stone conservator worked with another conservator from the SPAB and together they were able to refasten various broken stone fragments (Figure 10). Due to time constraints, repairs to only a few stones were completed, but it showed what was possible with the right expertise and equipment (Figure 11).

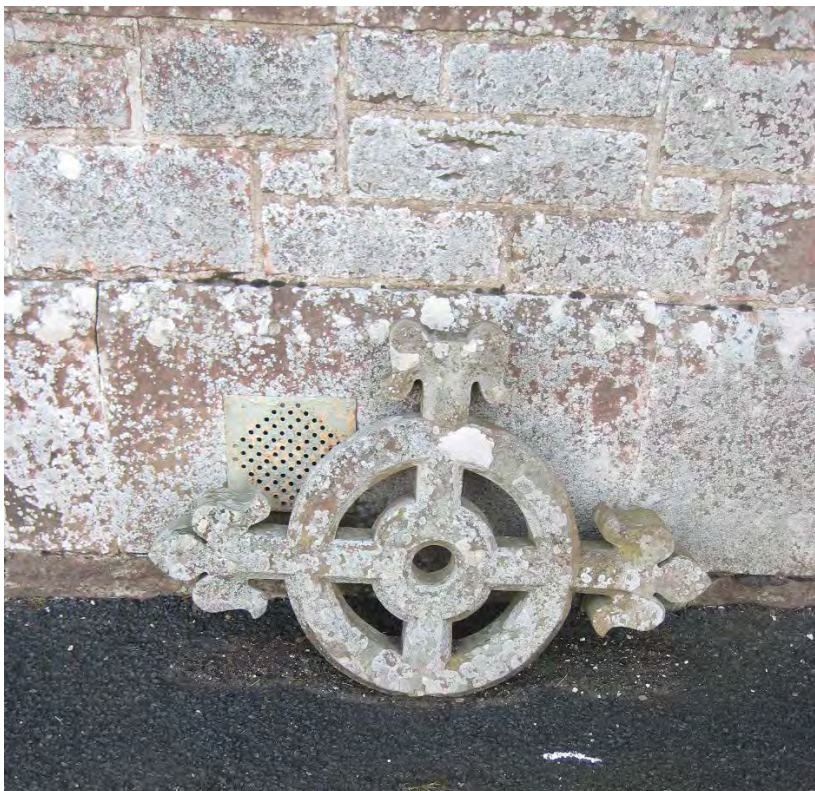
Figure 11. The finial after its repair.

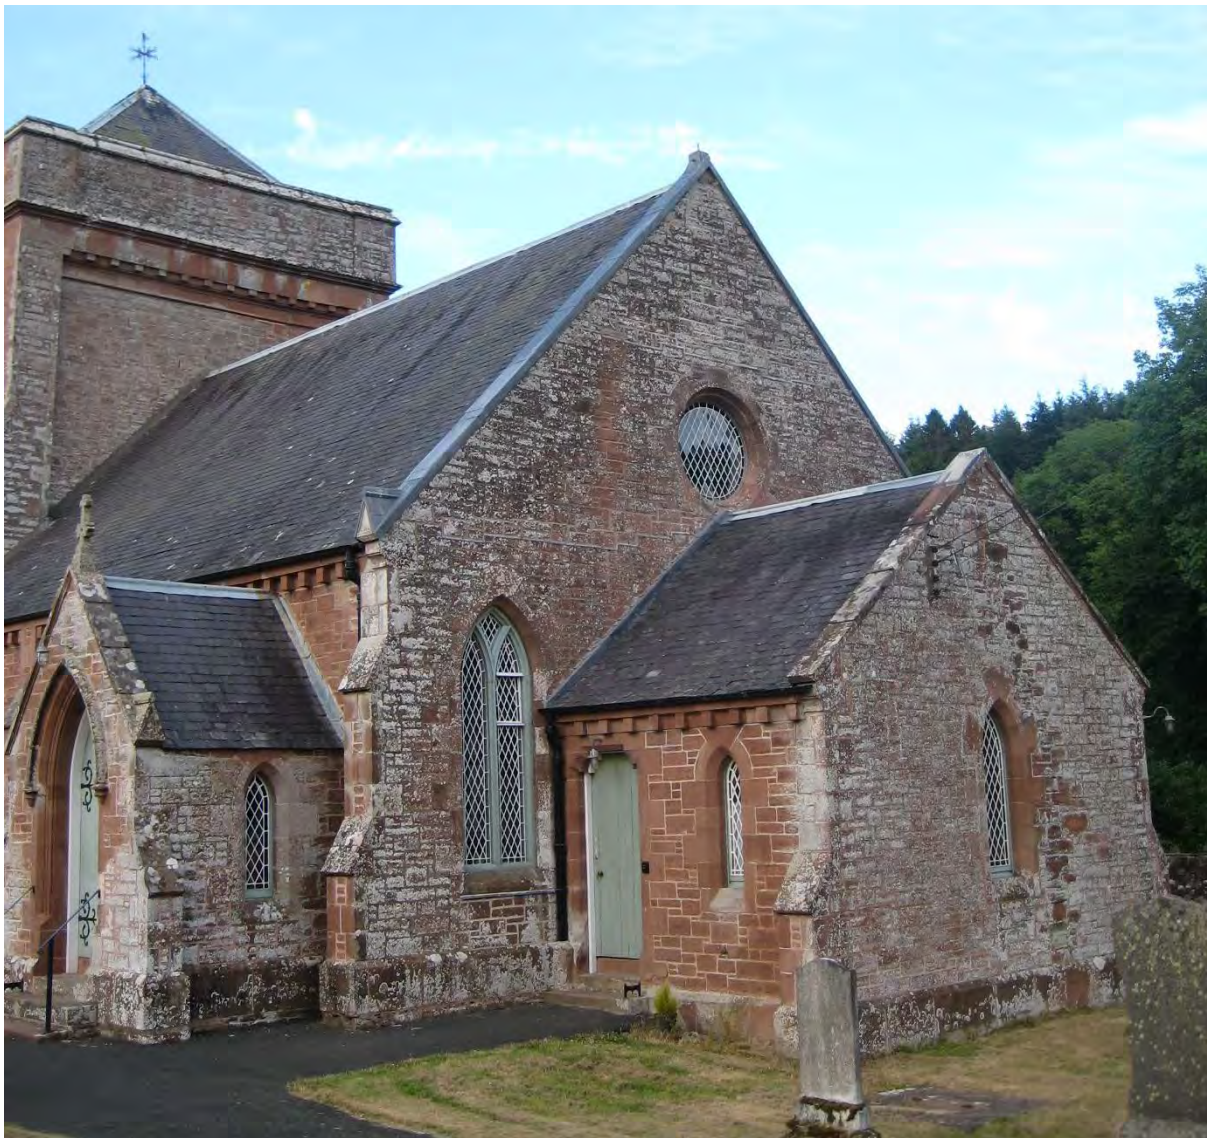
The two annual working parties achieved a considerable amount during the relatively short time available. The necessary re-pointing of a locally important 19th-century church was achieved using a traditional lime mortar, as well as successful temporary and permanent repairs to some memorials. The projects showed that with proper management a combination of skilled and unskilled individuals can deliver repairs of good quality. While all areas of the church could not be accessed, much was achieved that will be long lasting, and these areas did not need to be revisited during the main phase of repairs to gables and masonry that was subsequently carried out. The opportunity to observe how the limework fared over two winters has demonstrated that the hot-mixed mortar used is durable and lasting well in a relatively exposed location (Figure 14).

Figure 14. Hobkirk Church in 2018, demonstrating that the lime pointing work undertaken in 2013 and 2014 has held up well. Subsequent high level repairs and adaptations have also been carried out to help the building cope with increased rainfall due to a changing climate.
