Cove Harbour, Berwickshire

Pilot masonry repair and consolidation works

This publication should be quoted as:
Historic Environment Scotland
Refurbishment Case Study 23

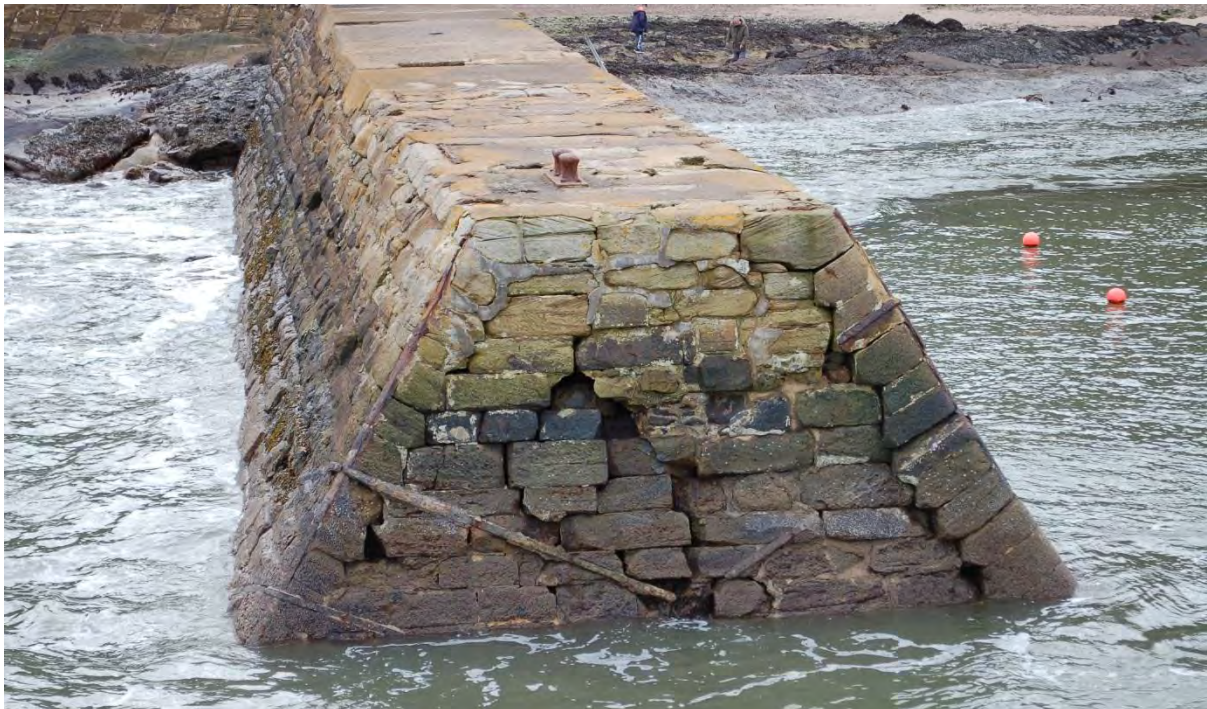
The investigations suggested two causes for the structural instability. Firstly a previous weakness of the foundation on the north-west corner, where adherence on the bedrock had not been achieved and it had been scoured away by water movement. This appears to have resulted in the slippage and cracking of the outer skin of masonry. Secondly, the washing out of the aggregate and fines from within the end of the pier, leading to internal collapse of the rubble masonry core and the outer skin of the north end of the pier collapsing inwards by about 300mm (Figure 3). The pier footings are surrounded by large amounts of aggregate and sand visible at low tide.

Figure 3. Masonry movement due to loss of core material can be clearly seen in this image of the north end of the Boyne Pier.

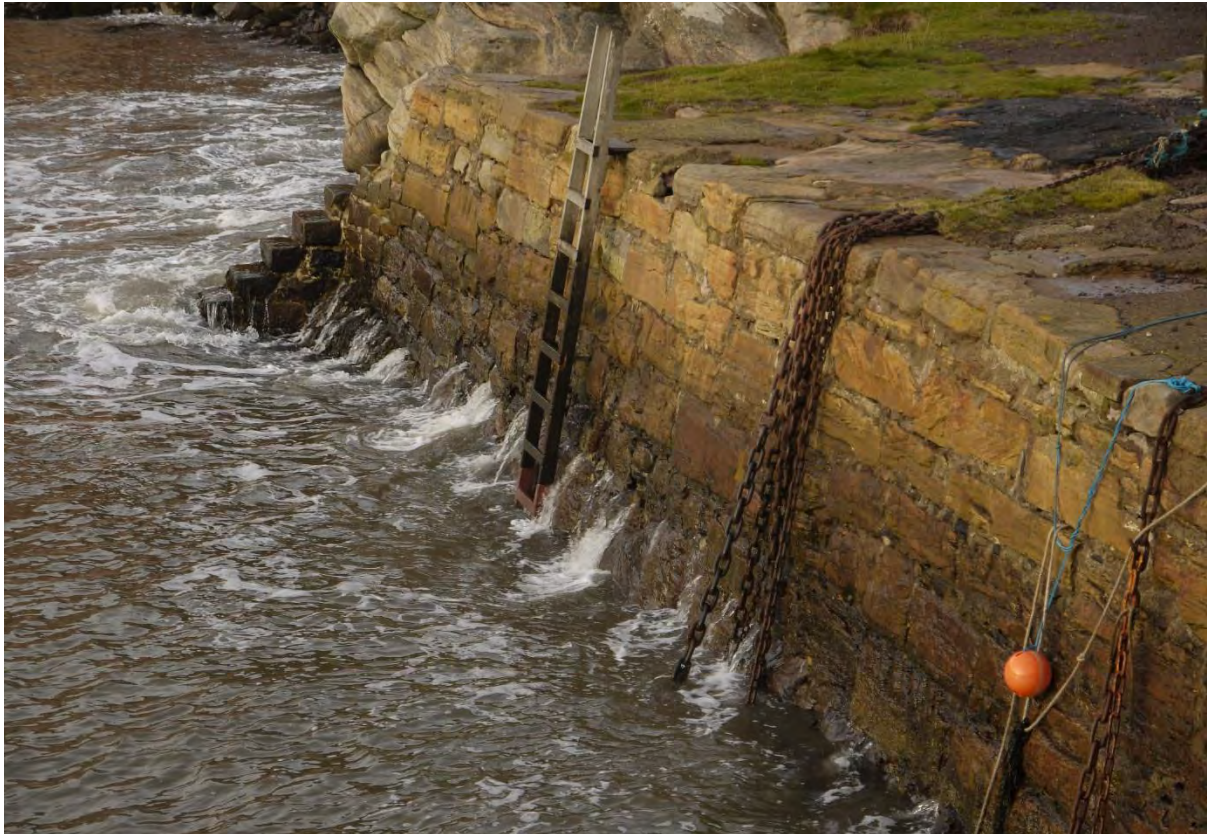
It was evident that the Main Pier was of the same construction. Evidence of the water washing through the pier could be seen in the spouts of water coming out from the base of the pier (Figure 4). In some traditional harbour structures, mainly those built from local rubble, the fabric is intentionally open for water to ingress and exit. The Cove Main Pier is more formally engineered construction with dressed stones and mortar, forming a solid face, and while a degree of water movement at the footings is likely, it was designed to be solid internally. The bulk movement of water as seen in Figure 4 is unintentional and is likely to be damaging.

Figure 4. Receding wave action revealing the presence of water in the voids of the Main Pier. The trial works were carried out in this area of the harbour.

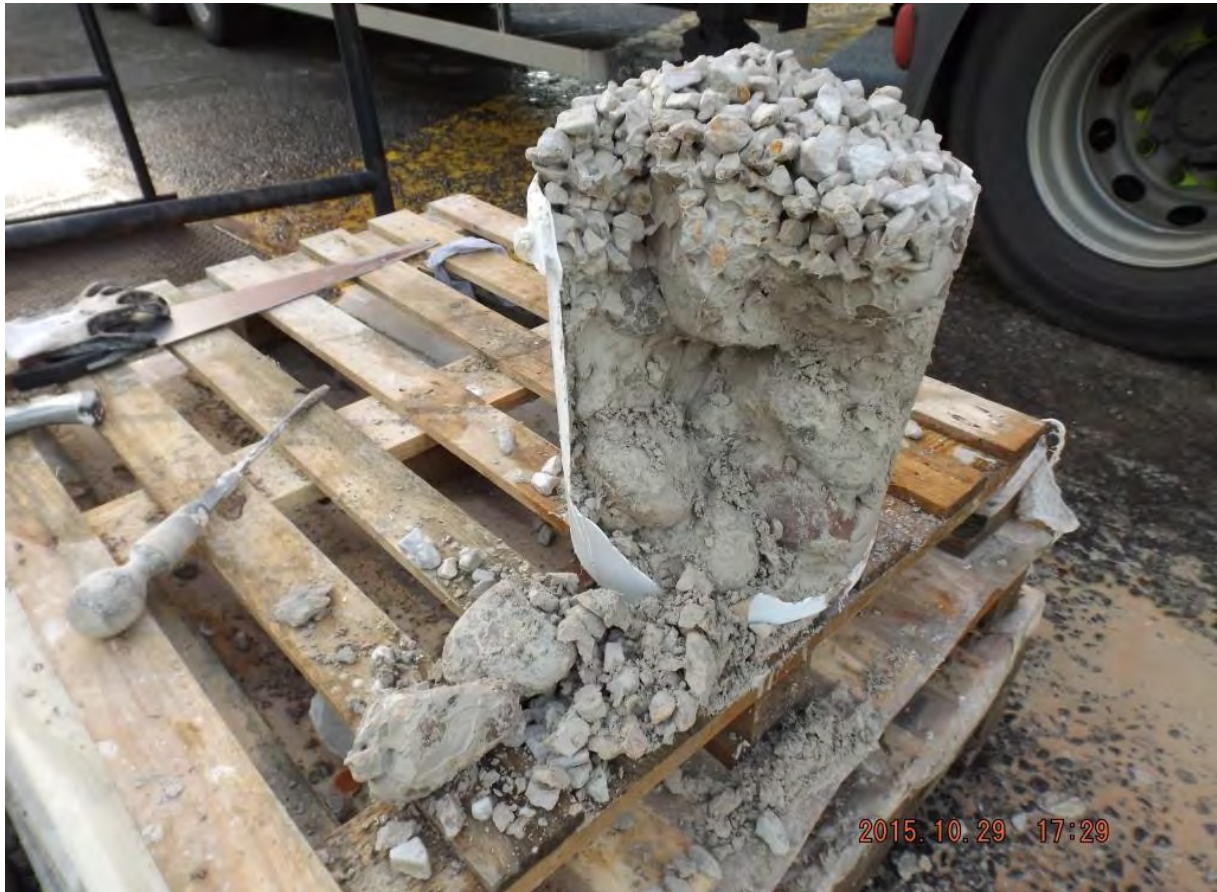
rounded pebbles (Figure 5). It immediately became apparent that the larger aggregate would not be carried by the basic grout: the larger pieces of aggregate locked together at constrictions between the pebbles and the remaining sand-filled grout merely passed through, filling up the voids between the pebbles and leaving the larger pieces sitting proud on the top of the trial unit.

Figure 5. One of the early off-site trials to establish if larger aggregate could be transported by the grout – a wall core mock up in a large plastic bucket.

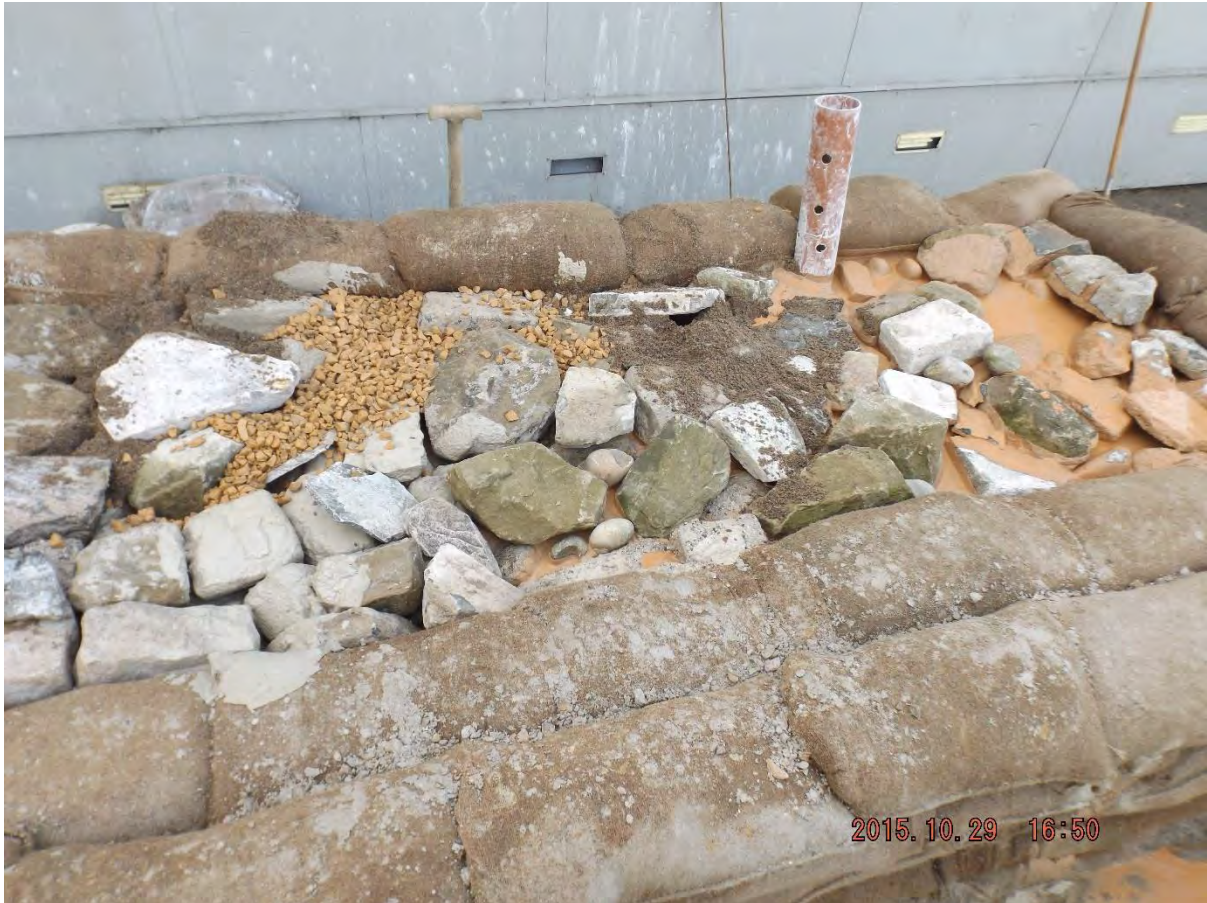
Figure 6. The trial grouting rig at the yard in Fife, prior to the pouring tests.

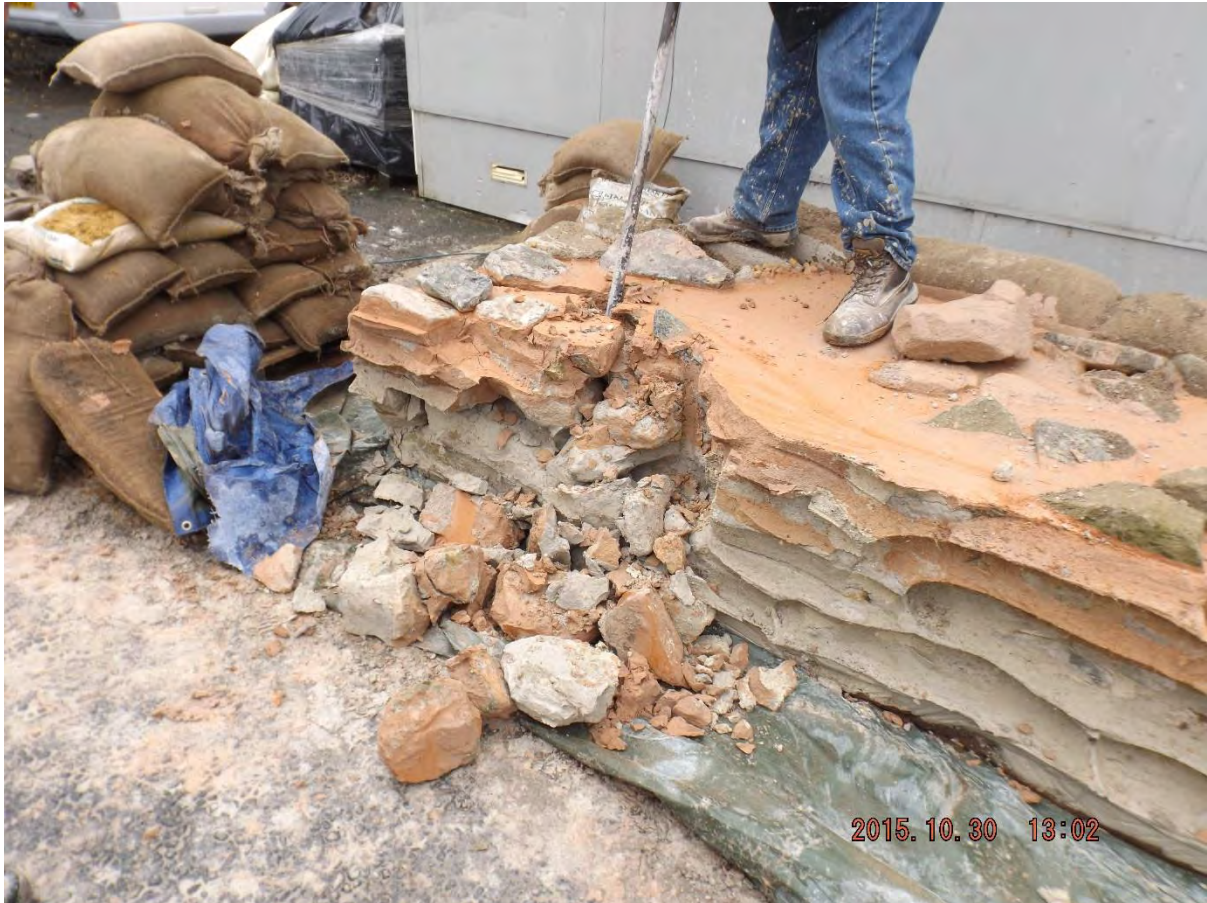
Figure 7. Opening up the grouting rig to assess penetration and the degree of set of the grout.

On opening up it was clear that the grout had penetrated all the voids and a reasonable set had been achieved. Following the yard trials it was estimated that the void ratio for the rig was approximately 30% voids. For many lime bonded walls this figure is much less, often around 10%.

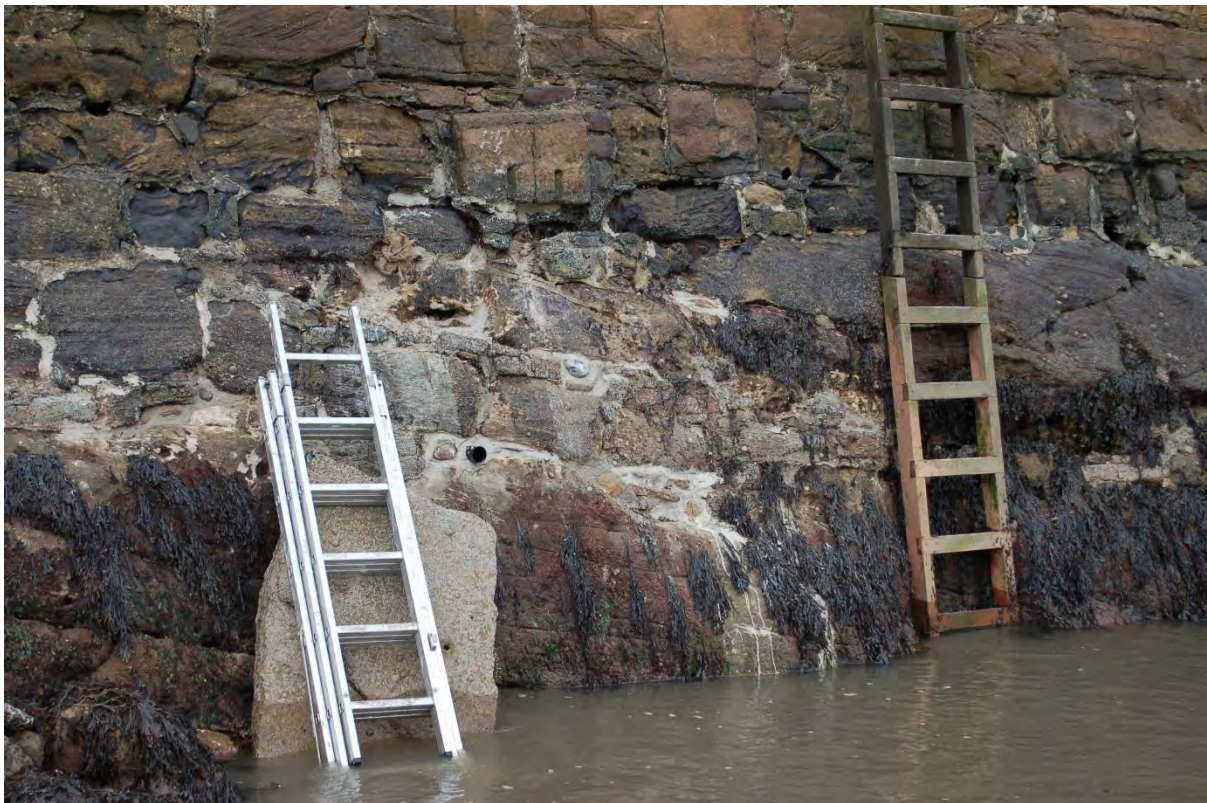
Figure 8. Partially completed pointing of the face of the main pier to the grouting trial.

To ensure that the grout entering the top of the pier could not run out through gaps in the bottom, the openings in the face would have to be pointed up. This was done using the designed mix from the supplier, selected to quickly set in salt water conditions. The repointing was done in the normal way, with lime mortar and pinning using small stones to reduce the volume of mortar in the joints (Figure 8). As with the trials in the yard, weep pipes were formed in the wall to assess the penetration and flow of the grouting mix.

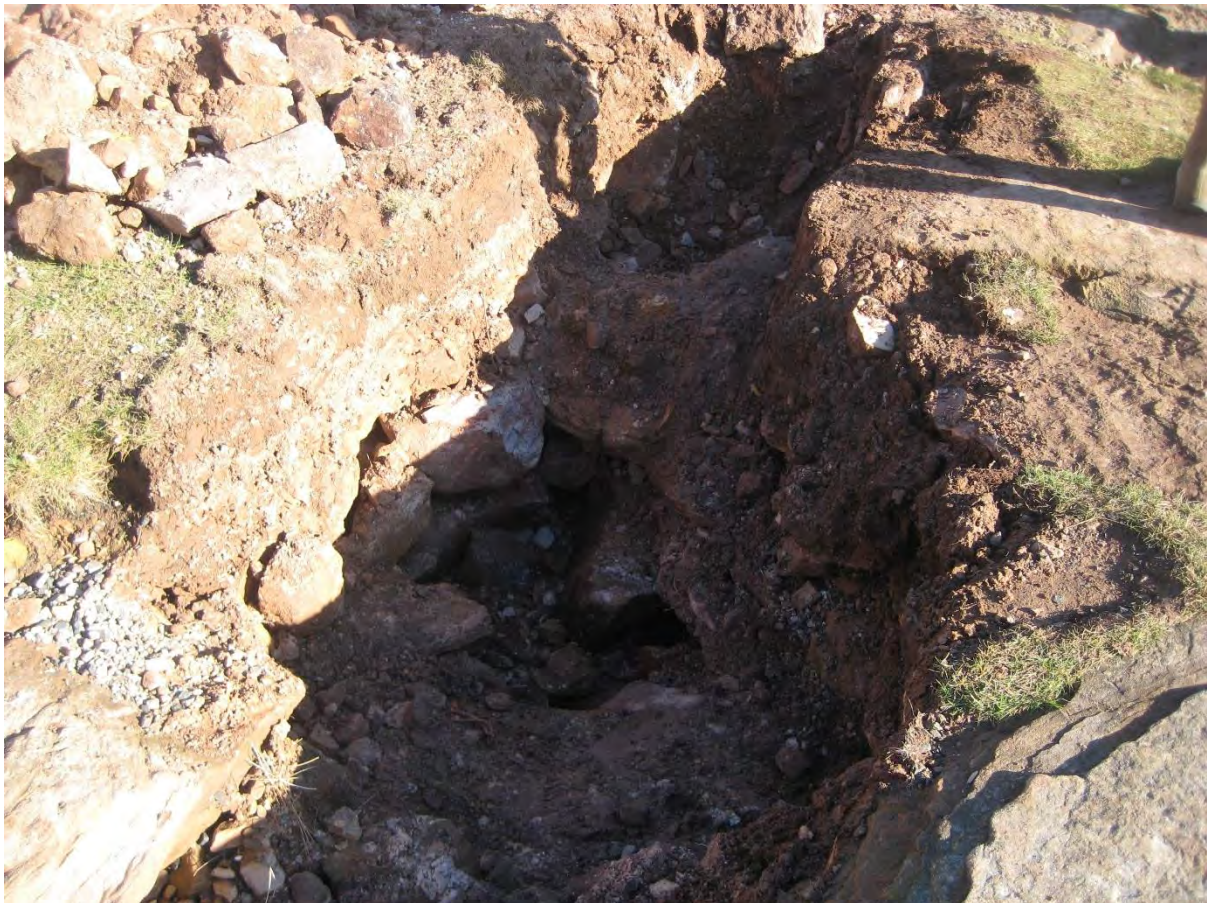
Figure 9. One of the pits opened up in the pier deck to expose the core beneath.

It was quickly obvious that there was an absence of smaller stones and larger aggregate. Even at a depth of only 750mm substantial voids were discovered. As this was at the sheltered end of the pier where wave action and suction is modest at lower levels, the likelihood was that the situation would be much worse in the more exposed sections further down the pier.

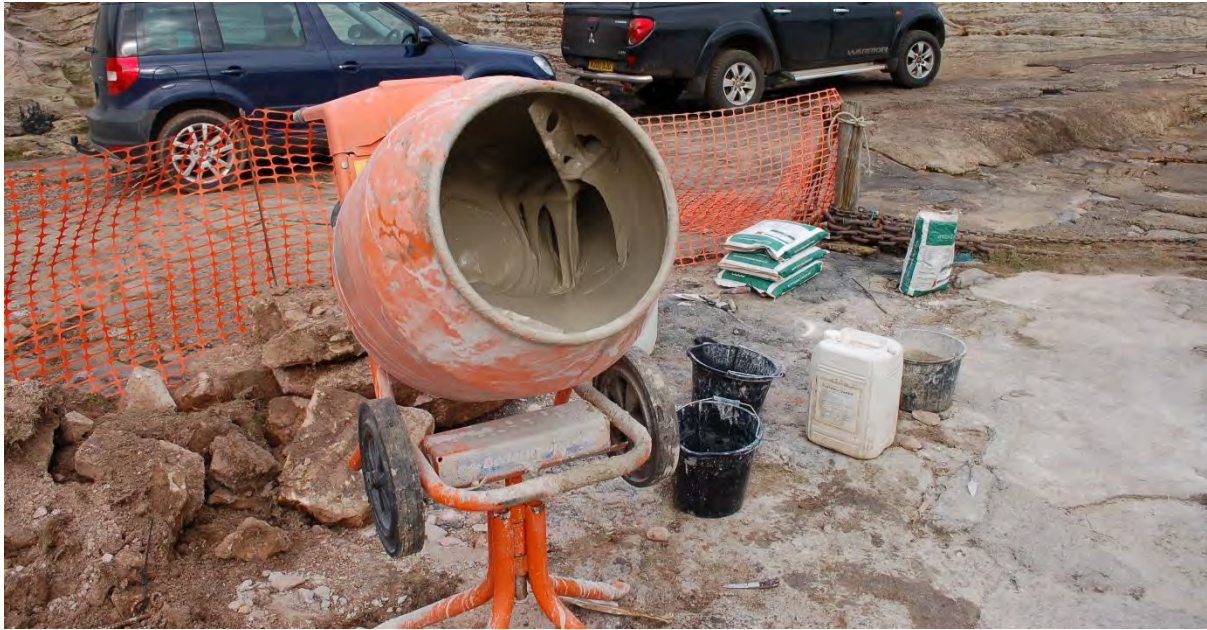
Figure 10. Mixing the grout in a small standard Belle type mixer.

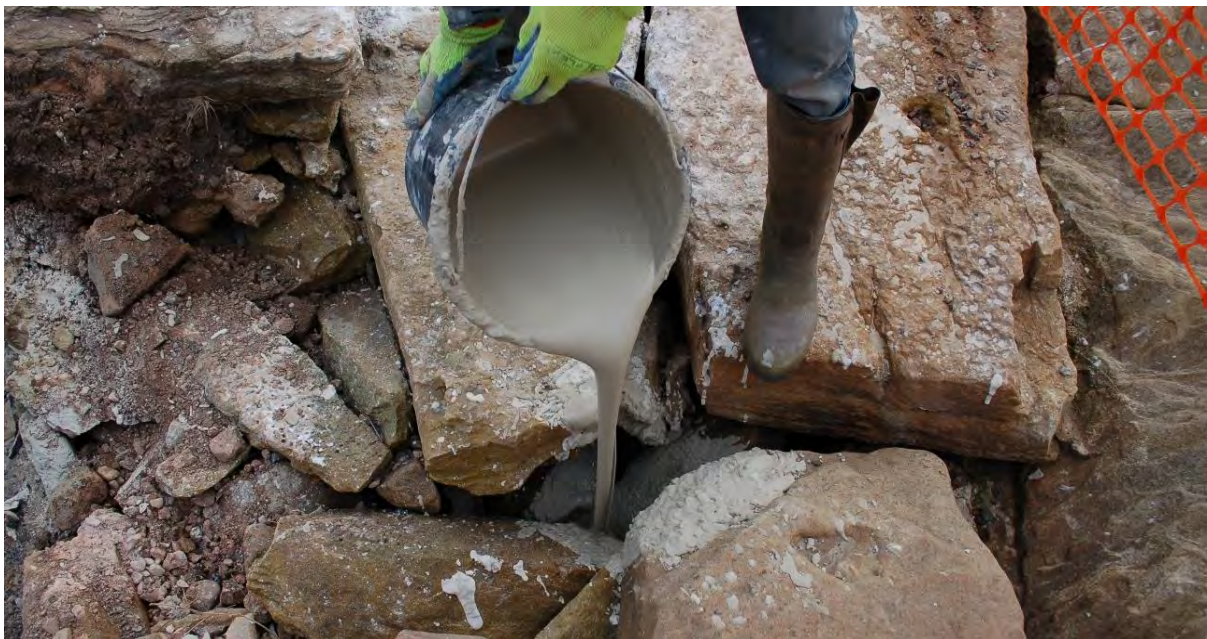
Figure 11. Pouring in the grout into the opened core with a builder's bucket.

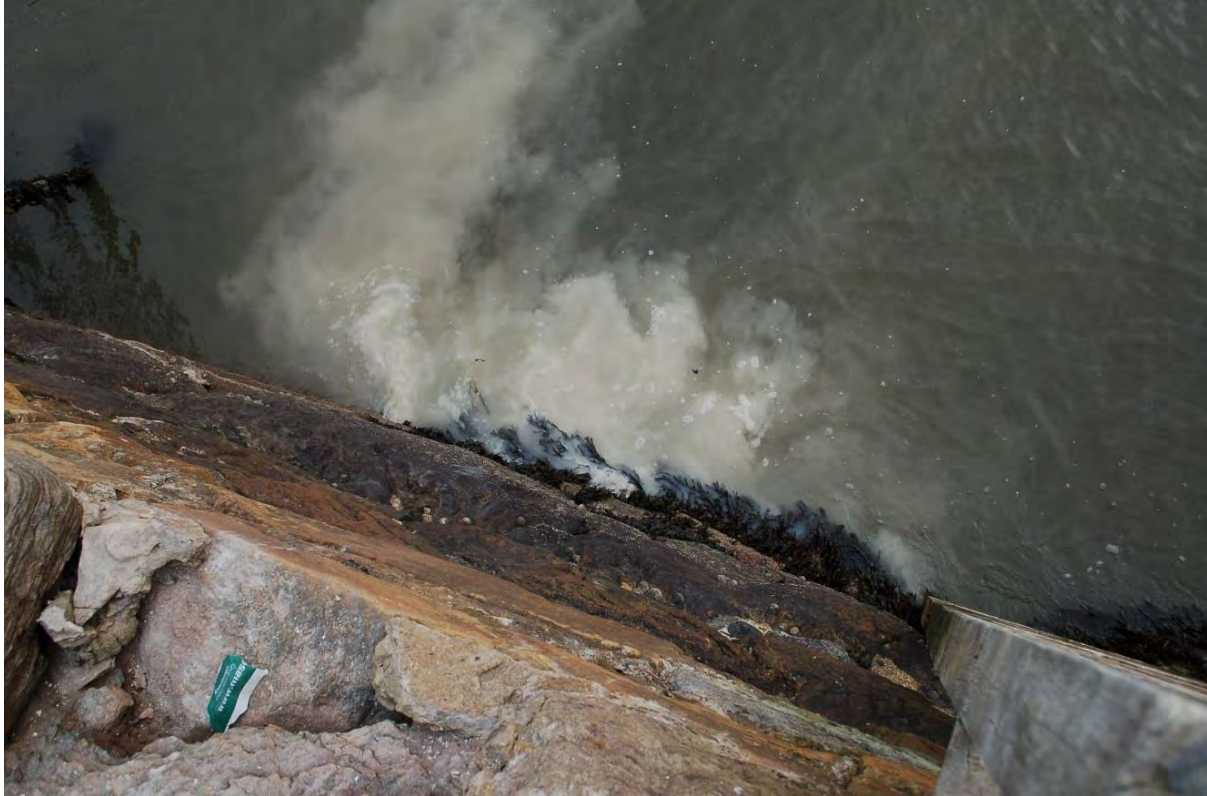
Figure 12. The grout was able to flow some distance within the structure and can be seen coming out of the pier face approximately 10 metres from the point of pouring.

This was not unexpected as there was underlying bedrock to the west and north of the pier structure preventing exit of the grout to anywhere else. While such penetration of the core by the grout was desirable in the context of a full repair (that of the whole of the Boyne Pier) it was less desirable in seeking to demonstrate consolidation to a more controlled narrow vertical section of the pier.

To address this problem a thicker mix with a quicker set time (10 minutes) was then used, whereby the grout would not be able to flow laterally so far; this was achieved by varying the moisture content of the grout. In terms of site workflow it was disruptive, as the grout pouring became intermittent, as time was required to allow the grout to set before the next pour.
