Kirkton of Coull, Aberdeenshire

Thermal Improvements to a 19th century farmhouse

Historic Scotland Refurbishment Case Study 16

Roger Curtis

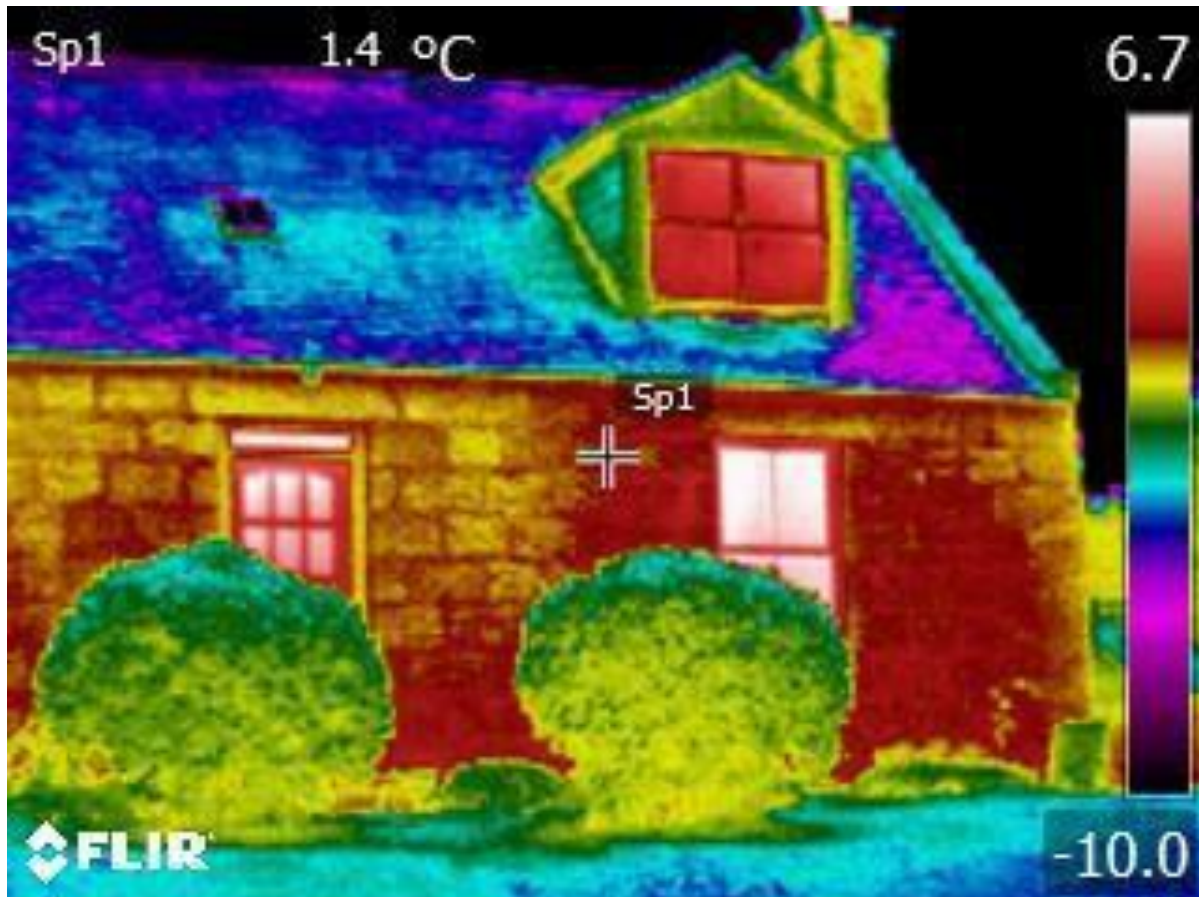
loss pathways showed up clearly. Care was taken to ensure that any solar gain on the fabric was not mistaken for a heat path. Even in the winter, low sun can warm roof elements and other surfaces. Areas that appeared to show high heat loss were the west gable at ground level, the dormers on the first floor, and areas of the roof and wall junction. Also of note was the finding that the roof slopes showed to be much cooler than expected, indicating a better thermal performance than anticipated (Fig. 5). This was confirmed by subsequent investigation, revealing that blown cellulose had previously been installed into the space between the internal lining and the sarking boards.

Figure 5: Thermal image of the front elevation, showing the better than expected performance of the roof. External air temperature 1.4°C

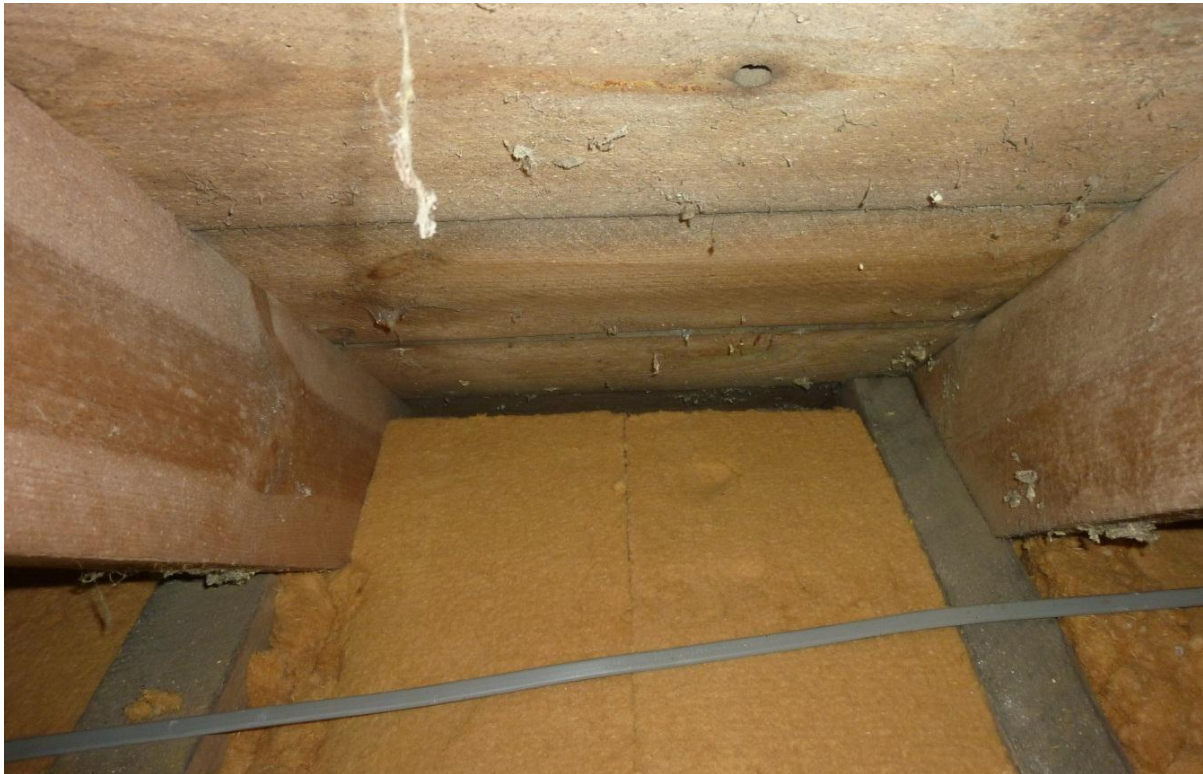
What was observed, however, was evidence of high humidity levels in the roof space above the first floor ceiling. This was in the form of white mould and evidence of active wood-boring insect damage. It is likely that the raised humidity levels were caused by a reduction in temperature from the legacy insulation work, and a reduction in fortuitous ventilation caused by the blown cellulose in the coombs.

Figure 7: *Wood fibre board insulation to the attic space, showing vented gap below the sarking*

As one of the objectives of the project was the use of wood fibre board to insulate a traditional coombed roof, and that the coverage and fill of the blown cellulose was varied, it was decided to remove the internal plasterboard linings in the first floor rooms and take out the cellulose fibre material. This was done with some ease; and again during removal there were no signs of condensation or any decay. This might well have been due to the vapour open nature of the cellulose material, the plasterboard, and the sarking boards.

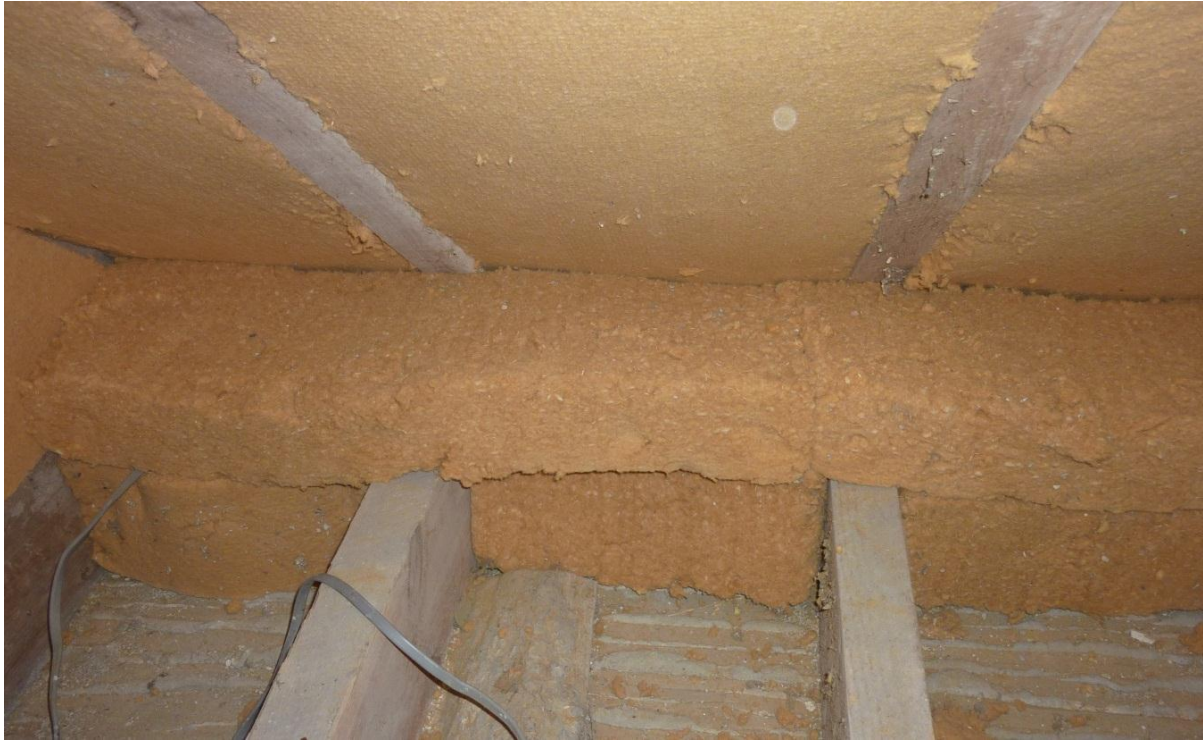
Figure 8: *Wood fibre board insulation at the junction of the roof and the wallhead.*

To insulate the roof slopes 80mm wood fibre board was cut to fit between the existing rafters. This was done outside with a table saw, and a snug push-fit was achieved. As this fitting operation was quite neat, and the board was to be further enclosed with new plasterboard, there was no requirement to fit any additional barriers, such as a vapour control layer; this function was provided by the wood fibre board itself. The rafters were of standard dimension for the period (150mm) giving space for a wood fibre board with a ventilation space between the underside of the sarking and the insulation board of 40mm. This insulation layer between the rafters was continued down to the wall heads; these were covered with off cuts of the insulation board (Fig. 8), and thus joining with the blown insulation in the room below.

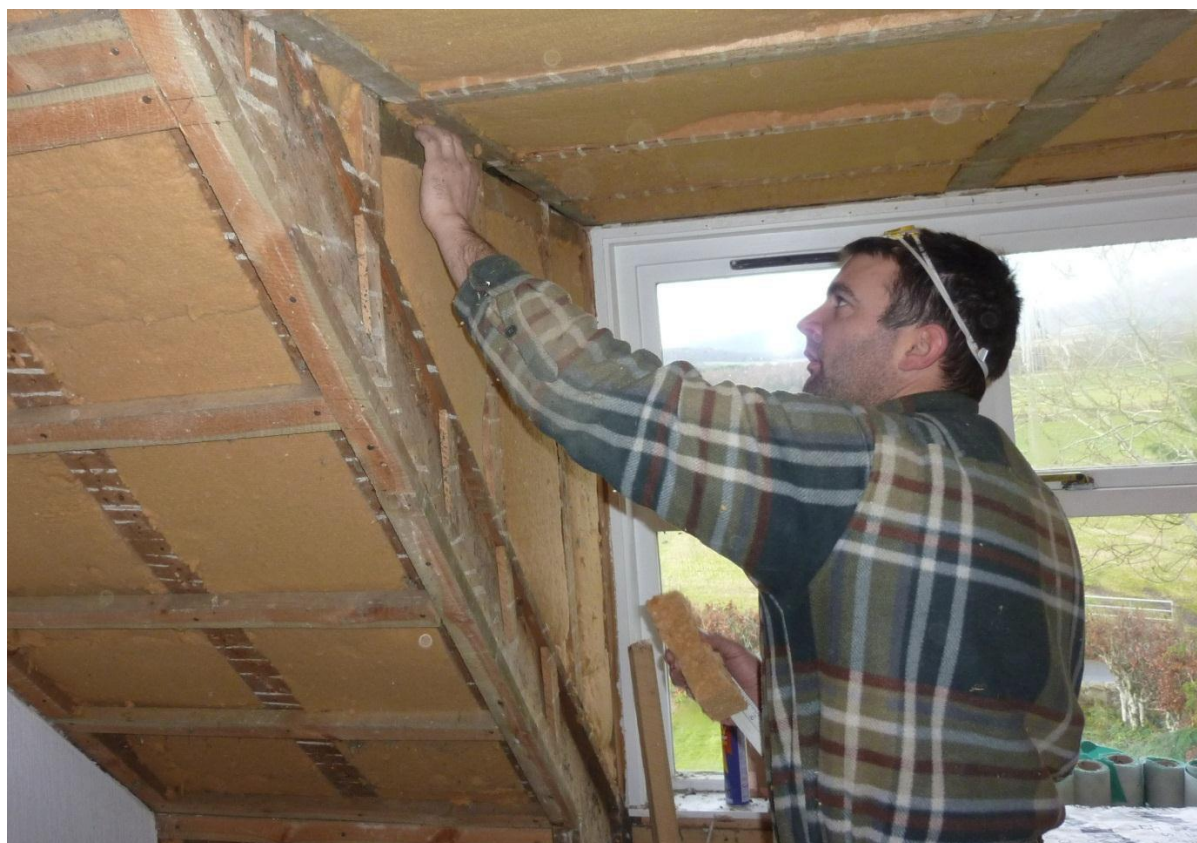
The pre-intervention U-value monitoring showed the relative effectiveness of the existing blown cellulose (Table 1). A failure in the post-intervention monitoring meant that no post intervention *in situ* readings were available and a calculated U-value had to be used. However, even noting the existing insulation, there was a reasonable improvement. Had there been no insulation prior to the work there would have been a more significant improvement.

Figure 9: Fitting wood fibre insulation to the dormers

Kirkton of Coull has two dormer windows, one in each of the bedrooms on the first floor. Dormer windows, while providing welcome natural light, can lose a lot of heat from the dormer sides and top, even when the glazed elements have good thermal performance. In this case the windows had previously been upgraded to double glazed units, but the framing of the sides that held them was un-insulated. As with the coomb ceilings, the plasterboard around the dormers was removed and wood fibre board sections, 80mm thick, were cut to fit between the structural timbers of the dormer cheeks and the ceiling (Fig. 9). New plasterboard was used to close in the panels; this was taped and lining paper was applied.

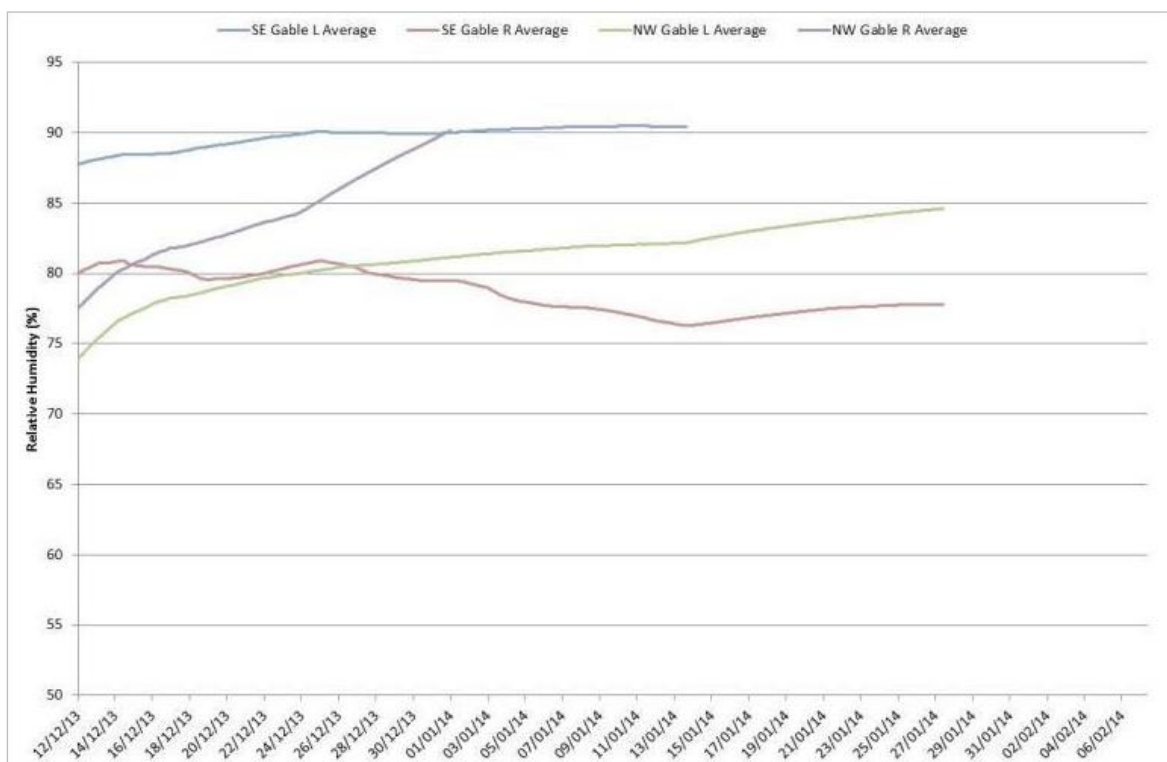
Figure 10: *Relative humidity in the first floor gable ends from December 2013 after the works in November. The increase in relative humidity reflects the reduced air movement.*

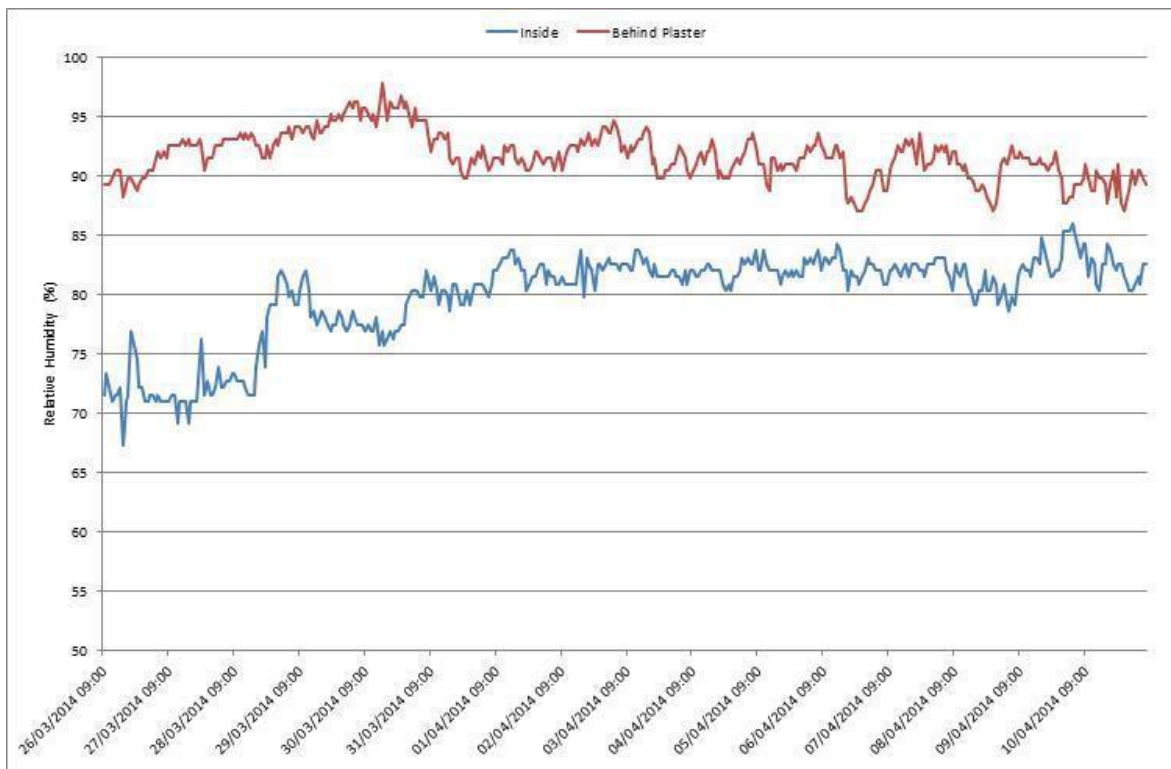
The monitoring of the relative humidity in the filled cavity indicated a very small increase in ambient levels, with readings around the 90% level (Fig. 11). This is likely to be due to the reduction in air leakage from the wall and floor insulation.

Figure 11: *Relative humidity readings in March and April 2014 from the internal and external face of the plasterboard in the ground floor bedroom after the insulation works to the walls*

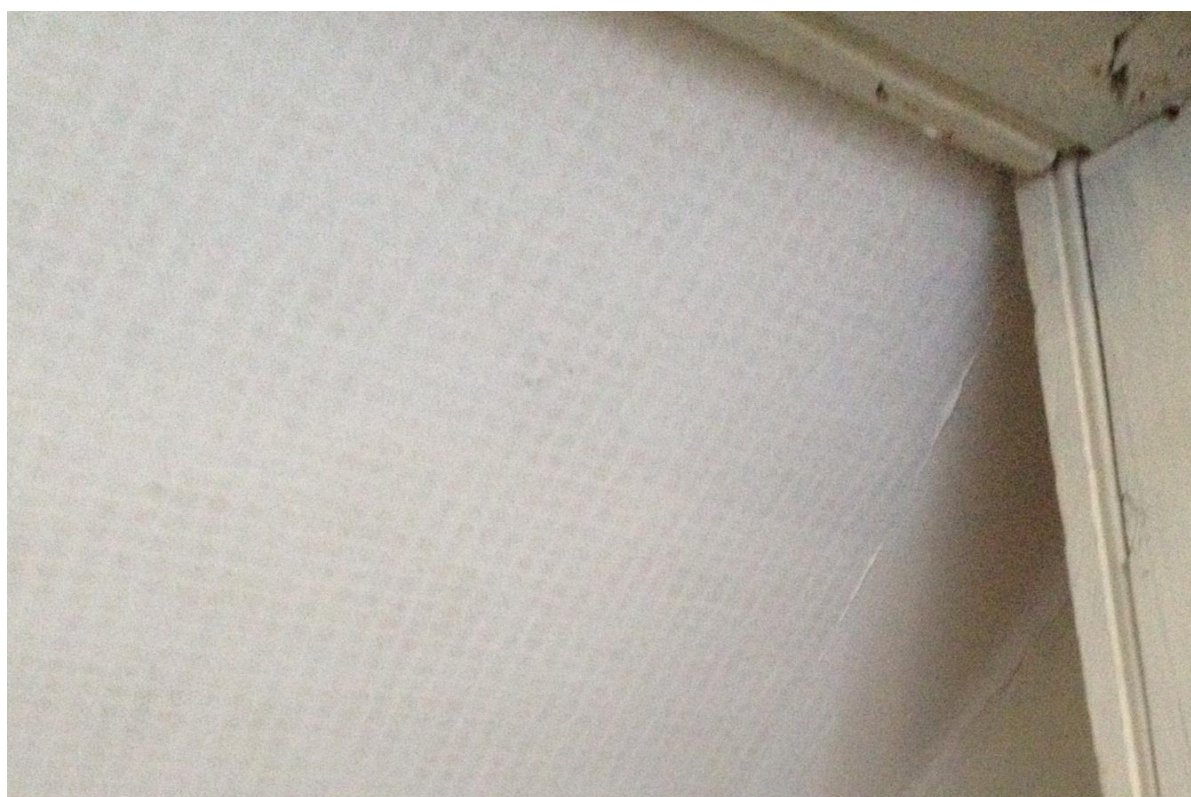
Figure 14: *The trial aerogel board following installation*

In order to trial newer types of insulation, an area of the stair cupboard (was lined with a new product; a thin aerogel based insulation board. This material, from a supplier in Scotland, was only 11mm thick, and could be mechanically fastened to the existing linings. The joints required to be taped and filled, but since it was the inside of the stair cupboard, the surface was not further finished (Fig. 14), although lining paper and a paint varnish would be suitable in a larger space. The U-value achieved by this measure was measured in two places as 0.27 and 0.37 W/m²K respectively (Table 4). This type of material may be suitable where it is not desirable to fill the space behind an internal lining. It also allows the retention of the existing lining and if required, it could be subsequently removed.

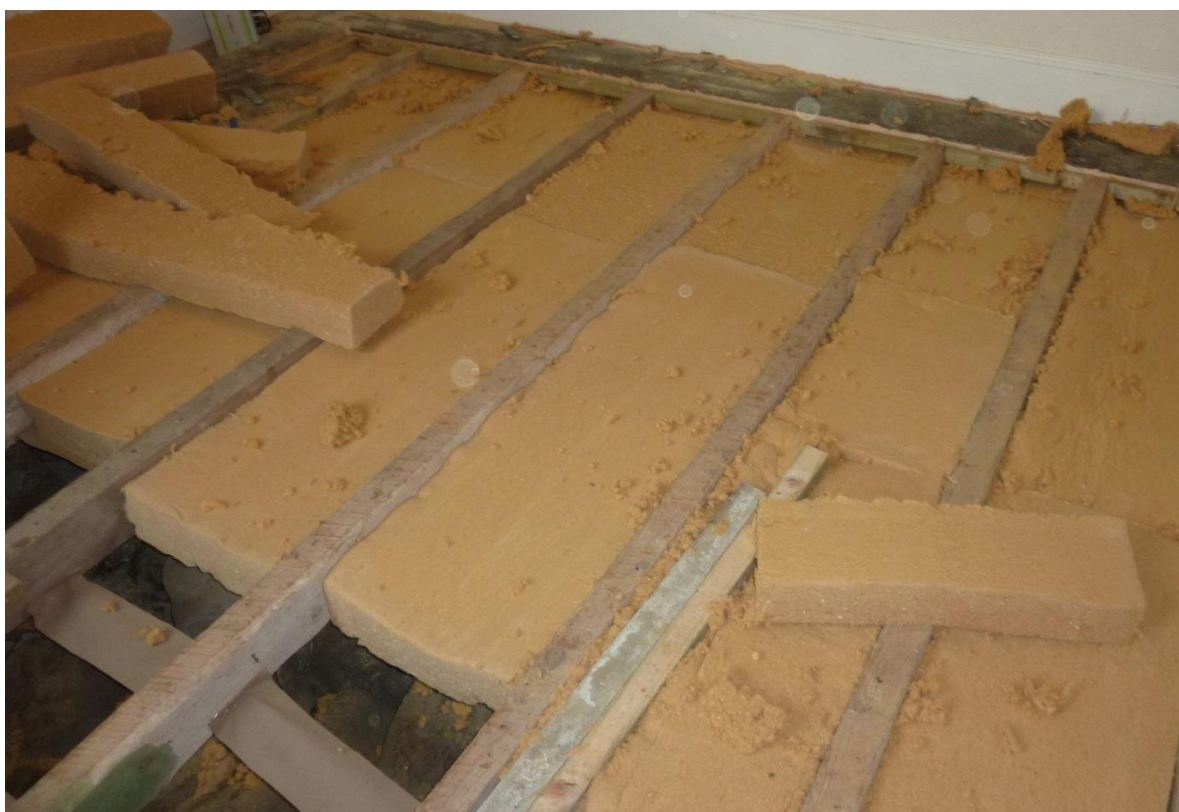
Figure 15: Floor opened up, showing the wood fibre board insulation in place

The floors in the hall and ground floor bedroom were suspended timber over a standard solum void. In these locations, floor timbers were lifted and wood fibre board insulation, 80mm thick was fitted between the floor joists, much as with the roof timbers. To maximise the thickness of insulation being used, woven tapes were fastened beneath the joists to hold the cut wood fibre boards (Fig. 15). Due to a misunderstanding on site, a compressed fibreboard flooring material was used to provide a new floor; although the re-use of the existing timber flooring (as demonstrated in Refurbishment Case Studies 7 and 20) would have been possible, and preferable. The improvement in U-value from the installation of the wood fibre boards was considerable (Table 5).

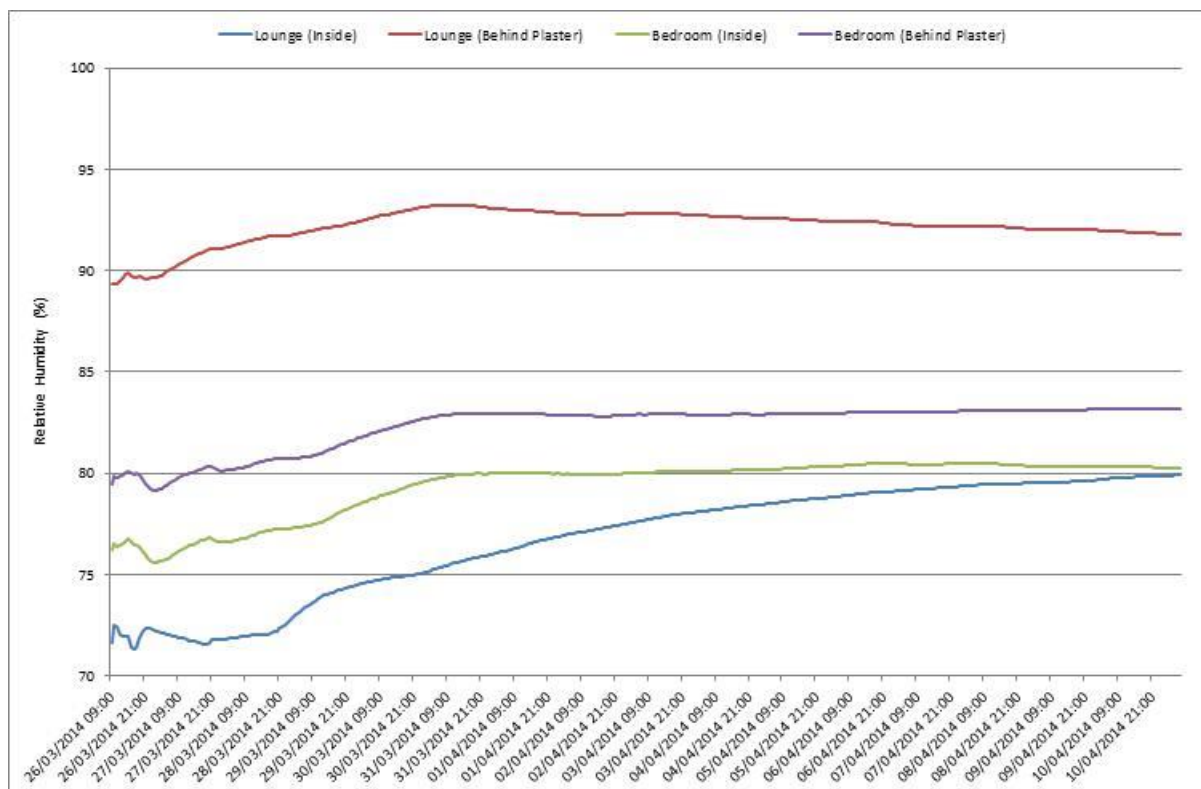
The monitoring of relative humidity provides an indication of the effects of the interventions on the building fabric, and enables an assessment to be made on their long term impacts. Allowing the built fabric to achieve moisture equilibrium across the building structure and linings was an important principle in the refurbishment. Initial monitoring in April 2014 showed a largely stable environment, but with some high readings (Fig. 18).

Figure 18: Smoothed relative humidity readings post-interventions

The RH readings for behind the plaster in the lounge are high, but the trend is downwards; and future monitoring will confirm if there remains a risk. The other fabric areas are within accepted limits, as long as the trend remains steady or downwards. Longer term monitoring will reveal such trends. The rising gradient of the blue line in Figure 18 is likely to reflect the increased water content of the air from a rising air temperature. Several techniques adopting similar solid wall insulation techniques have been adopted on other Historic Scotland projects several years ago, and have not given rise to any issues (*Refurbishment Case Study 1*). A further phase of monitoring will be programmed on completion of the final stage of works in summer 2015 to further investigate the effects of the wall insulation.
