THE
INVESTIGATION,
REPAIR AND
CONSERVATION
OF THE
DOULTON
FOUNTAIN,
GLASGOW GREEN

2 | Case
Study

TECHNICAL
CONSERVATION
GROUP

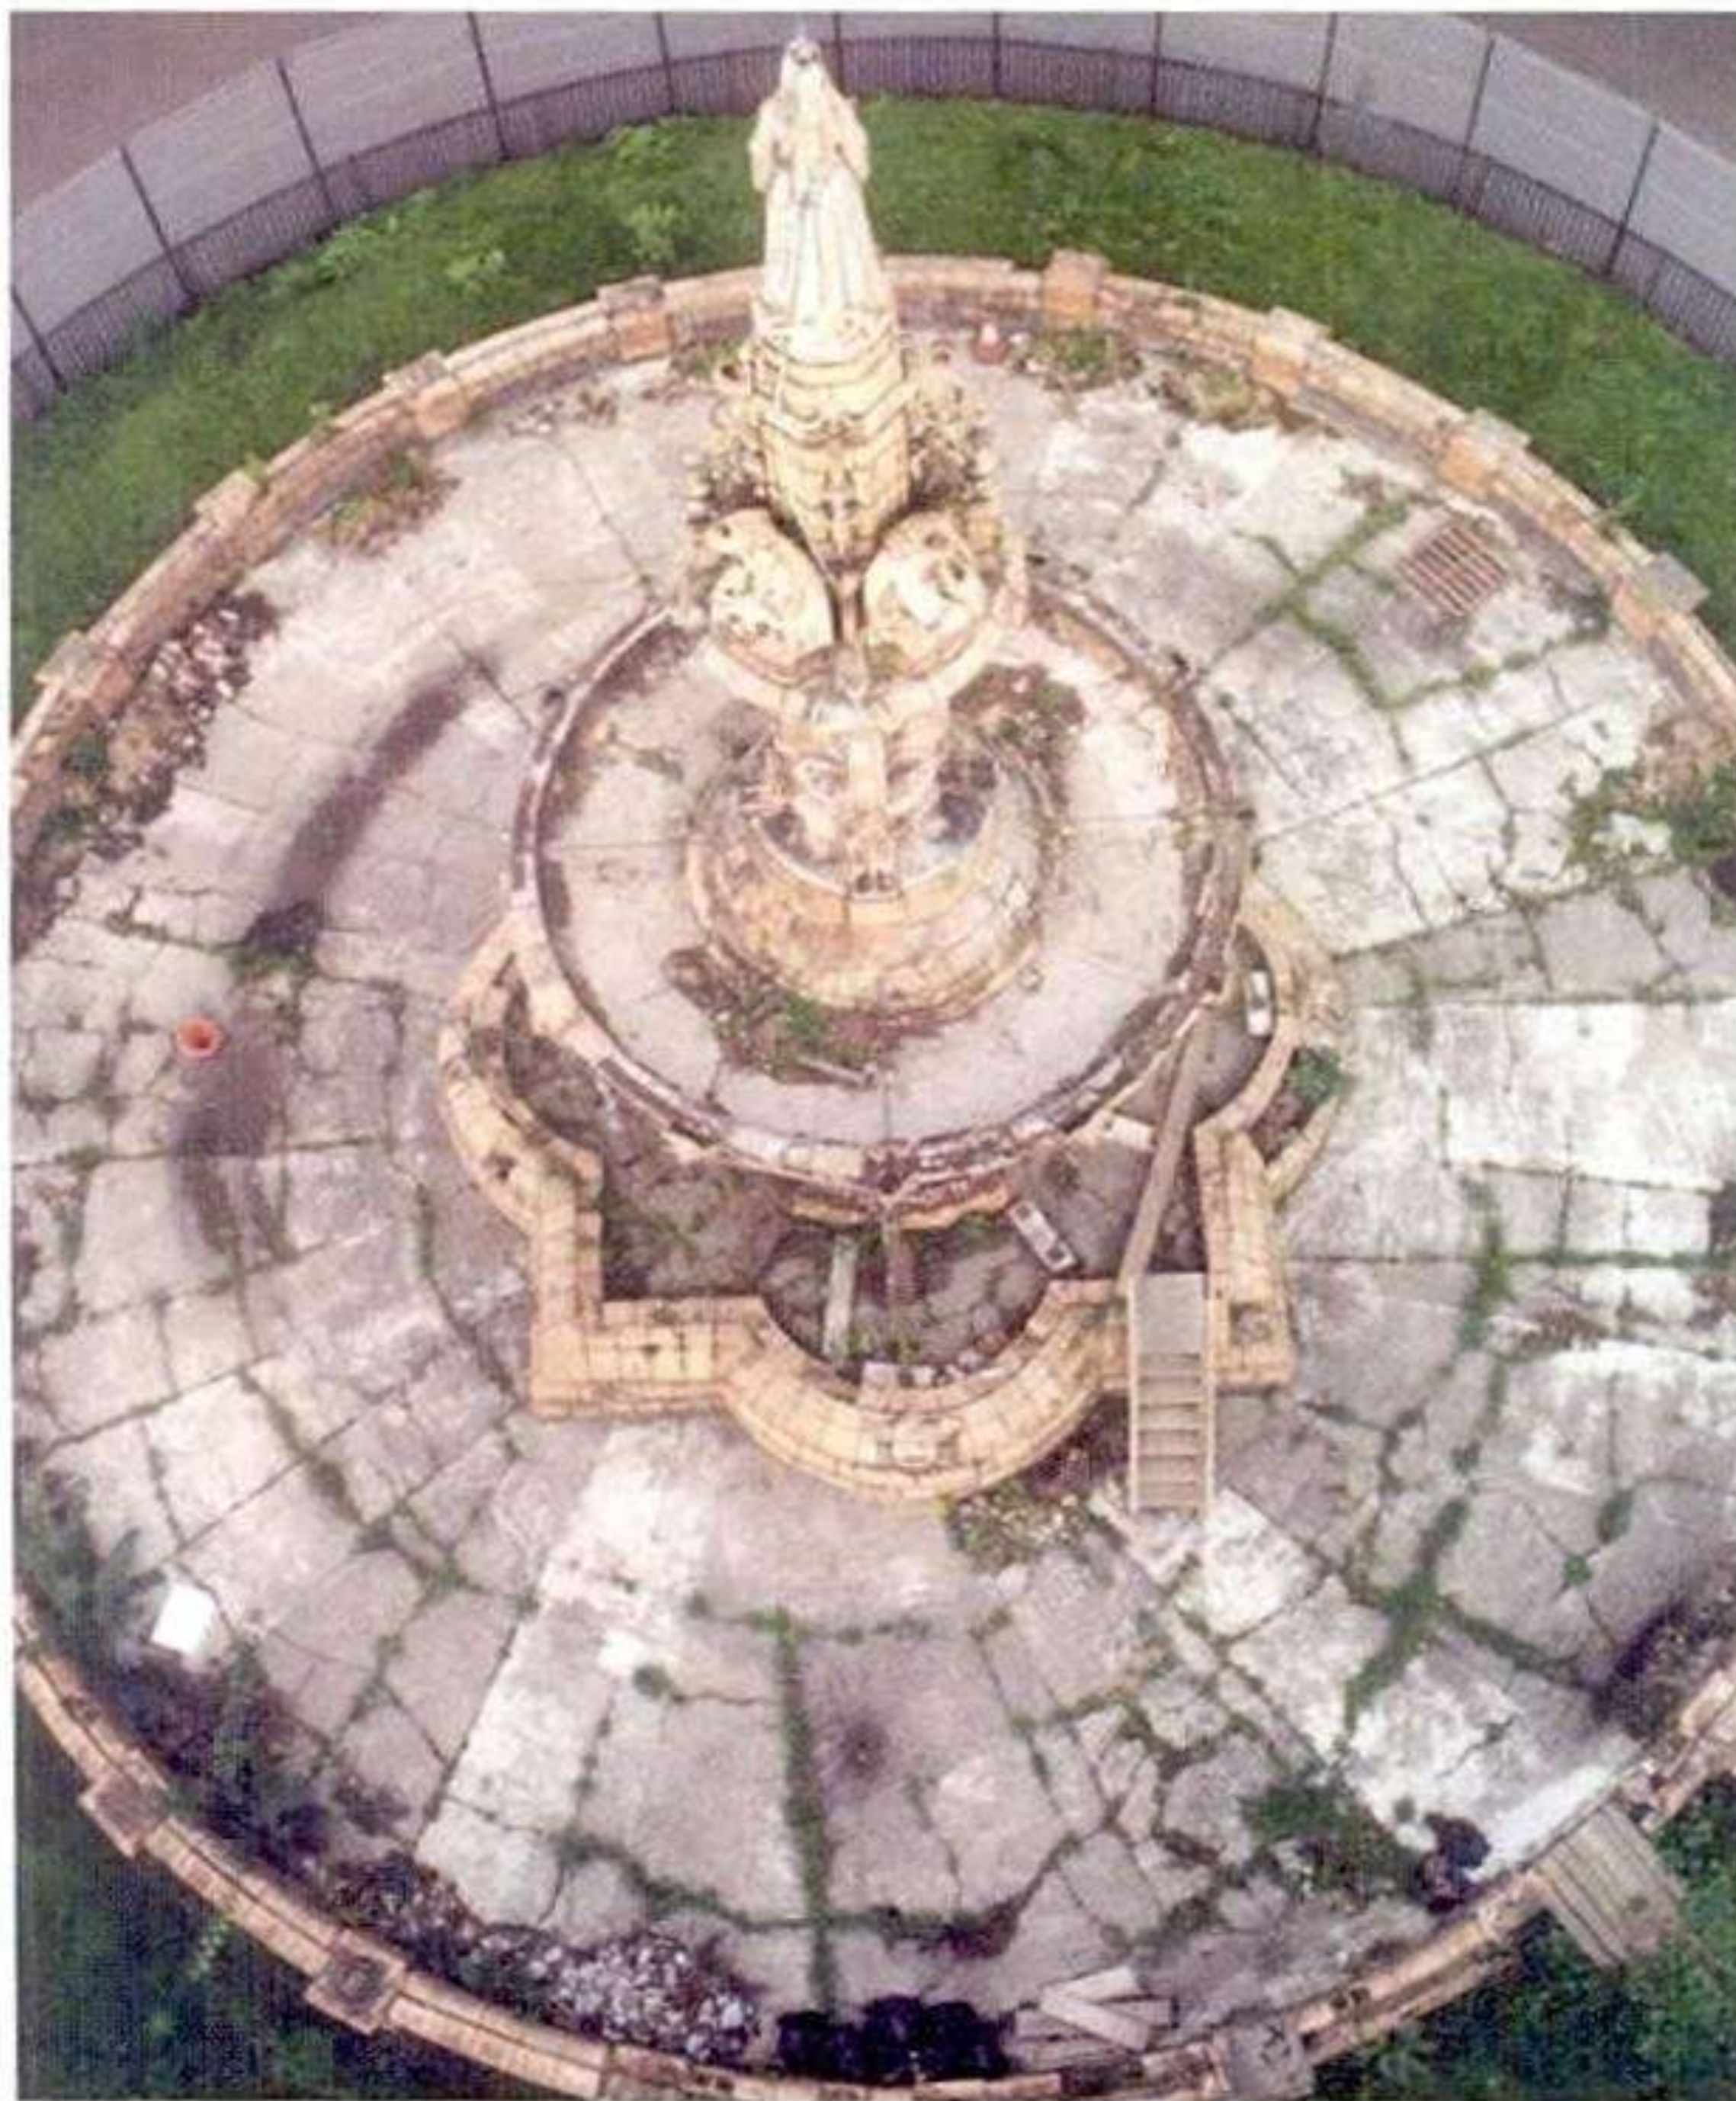
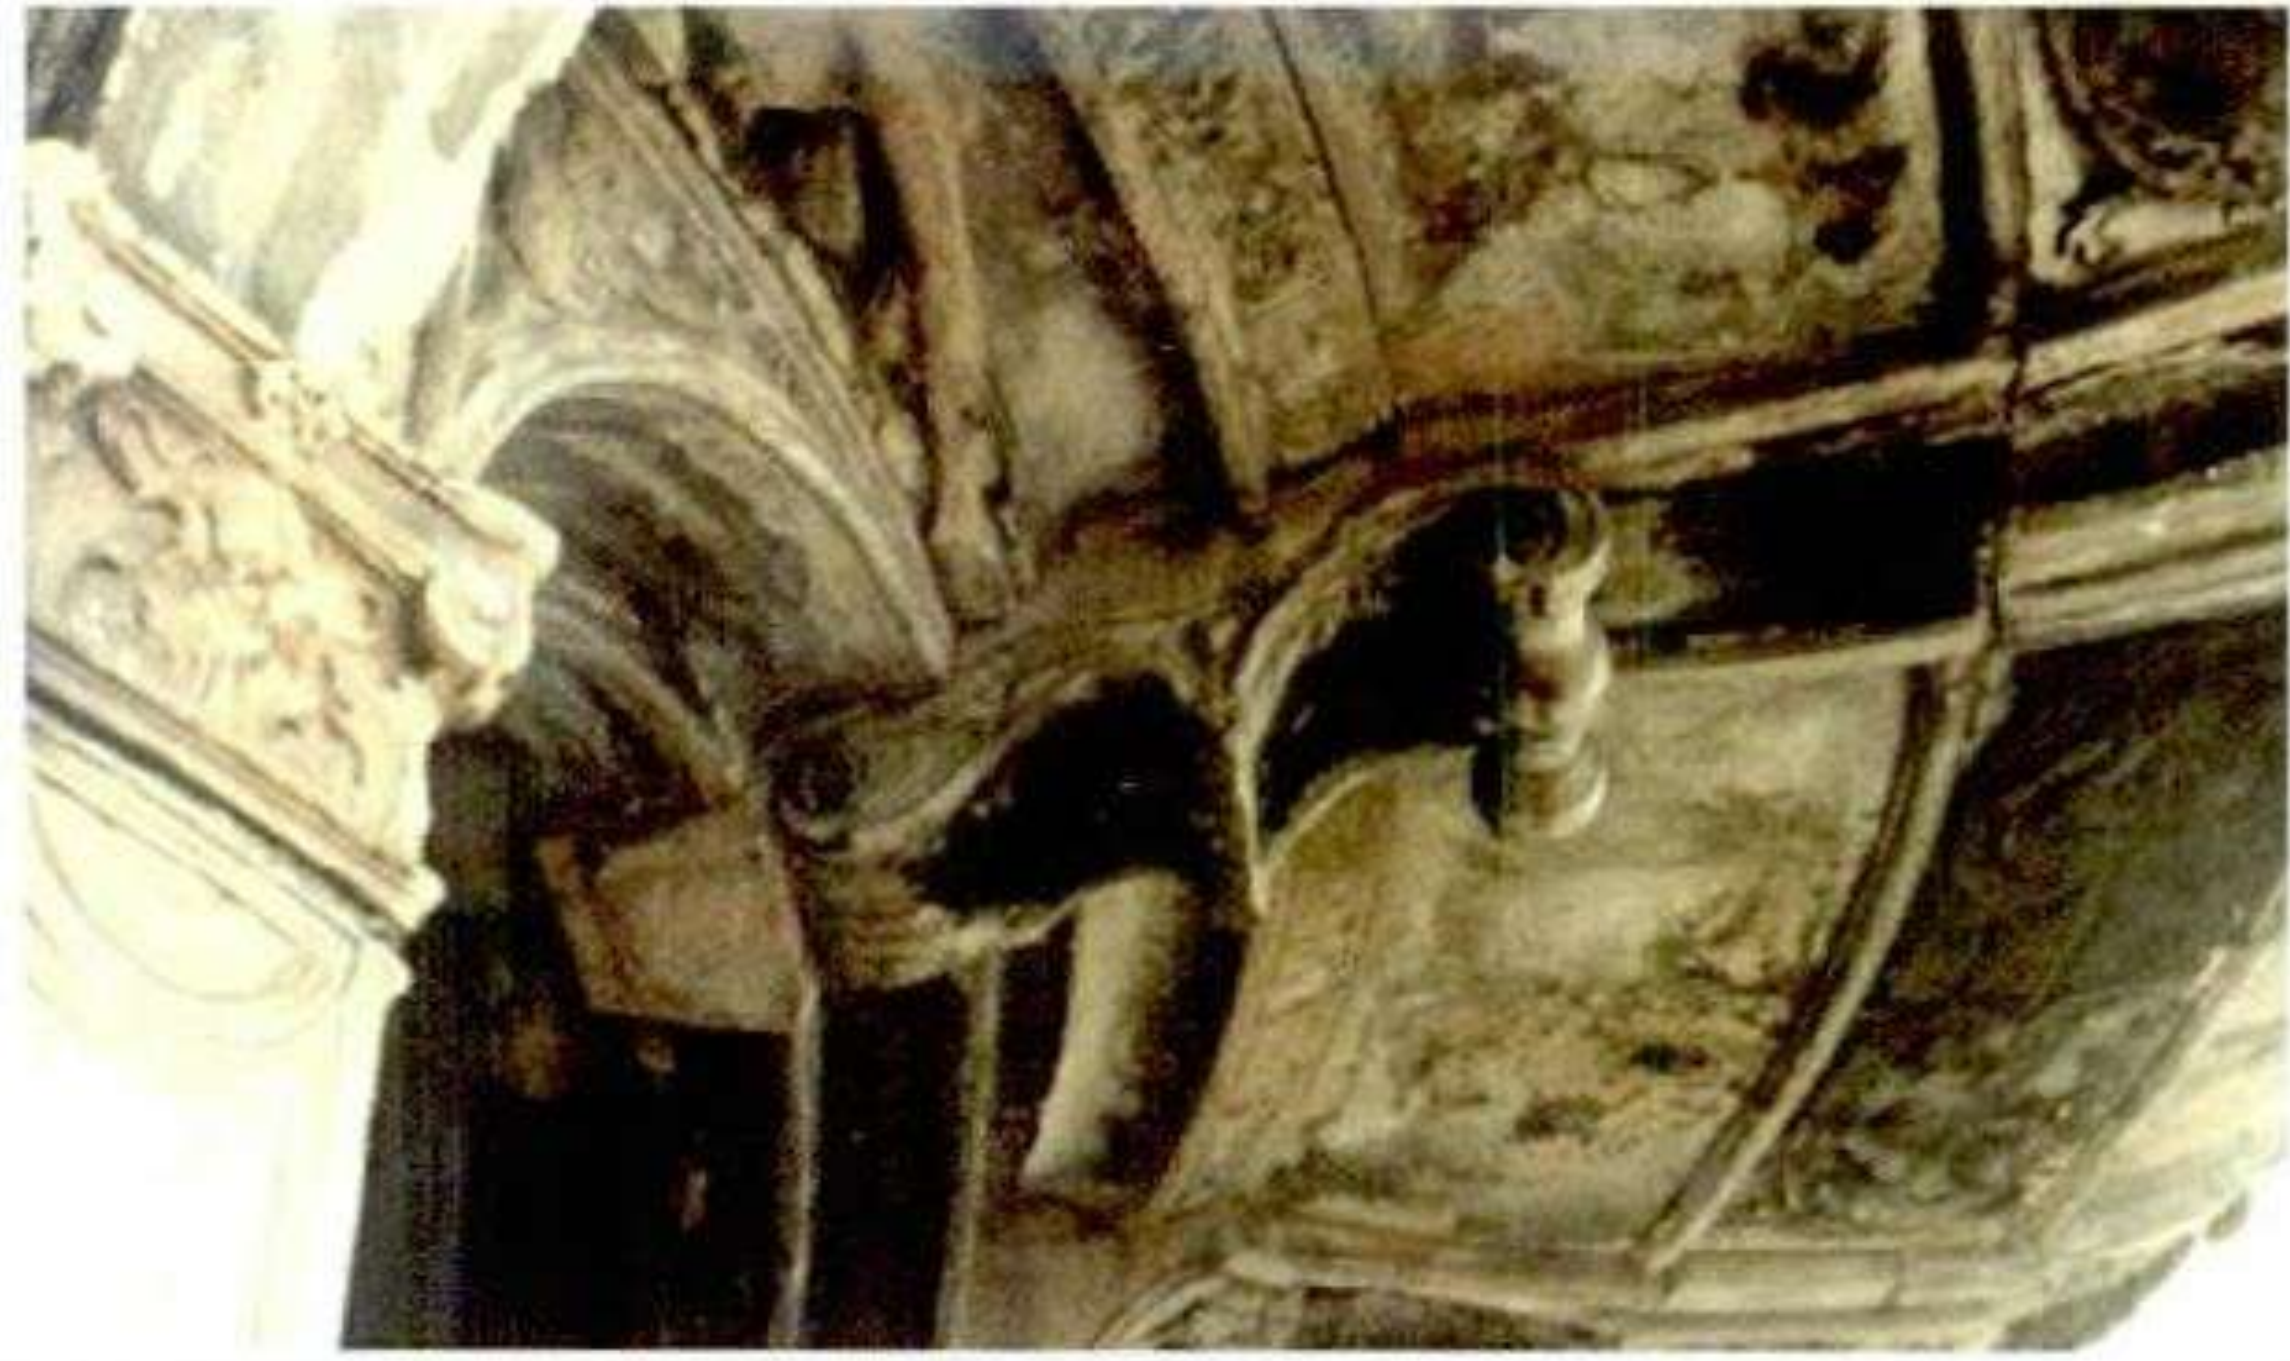
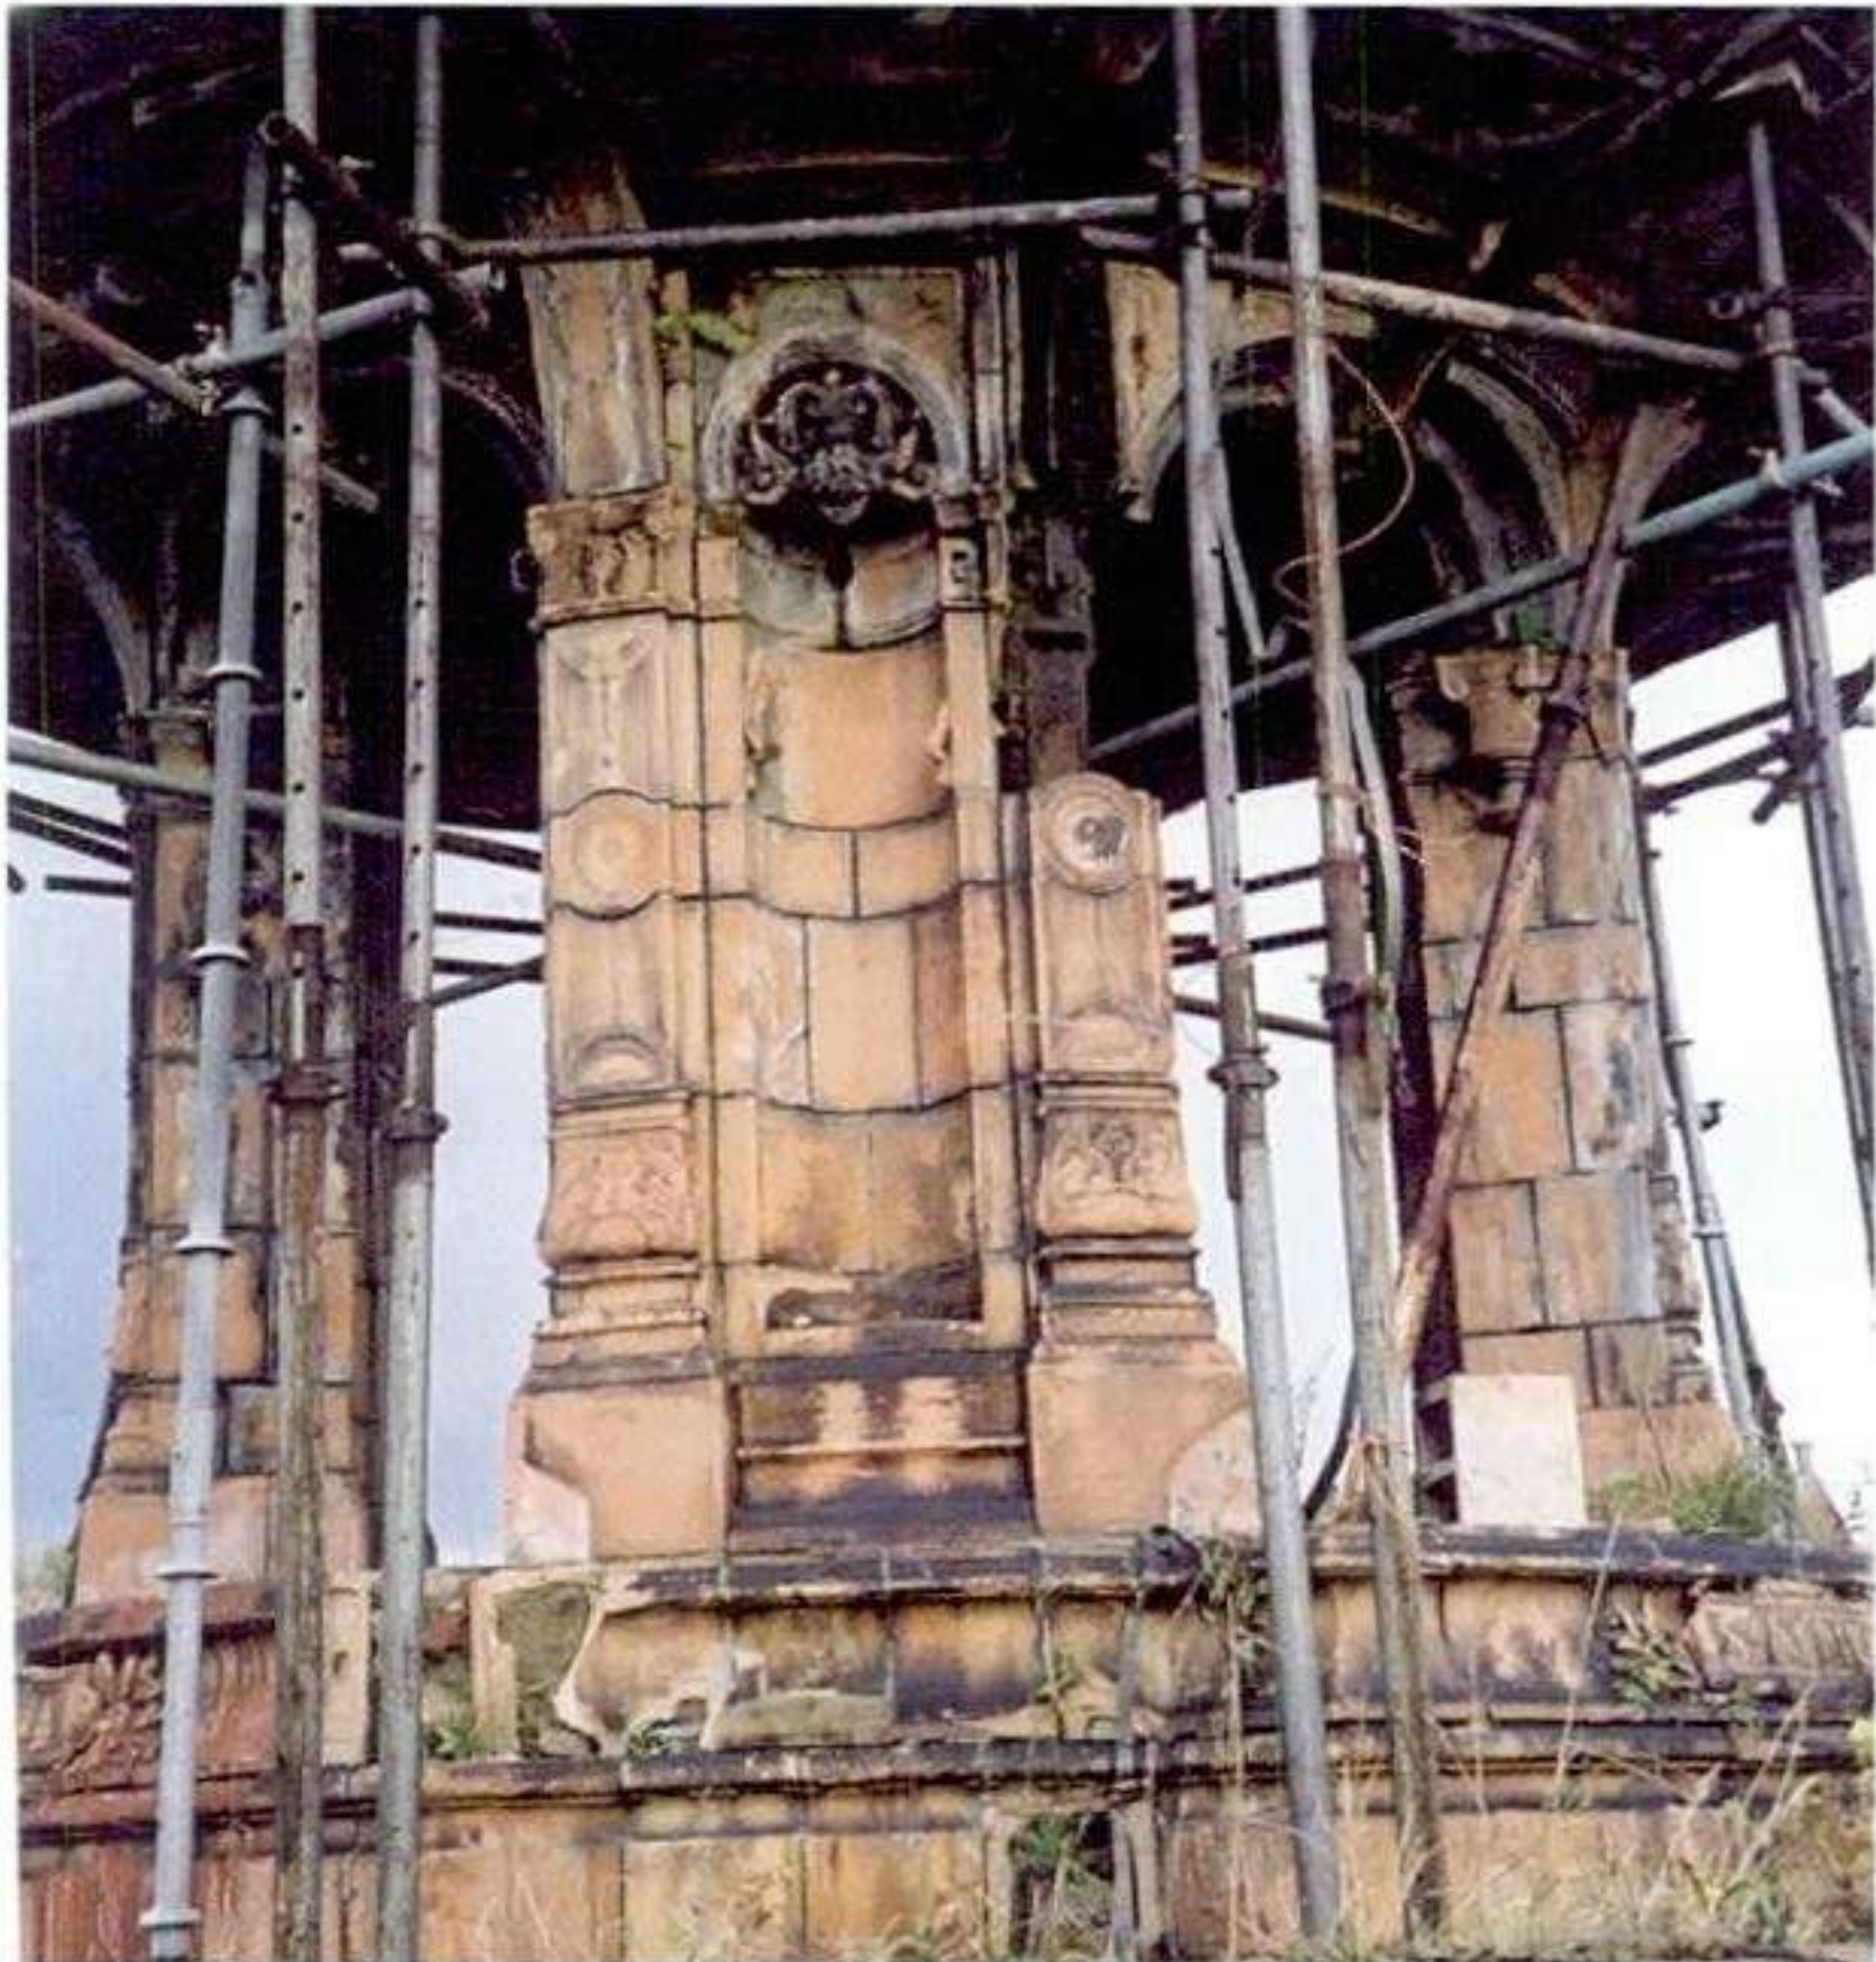
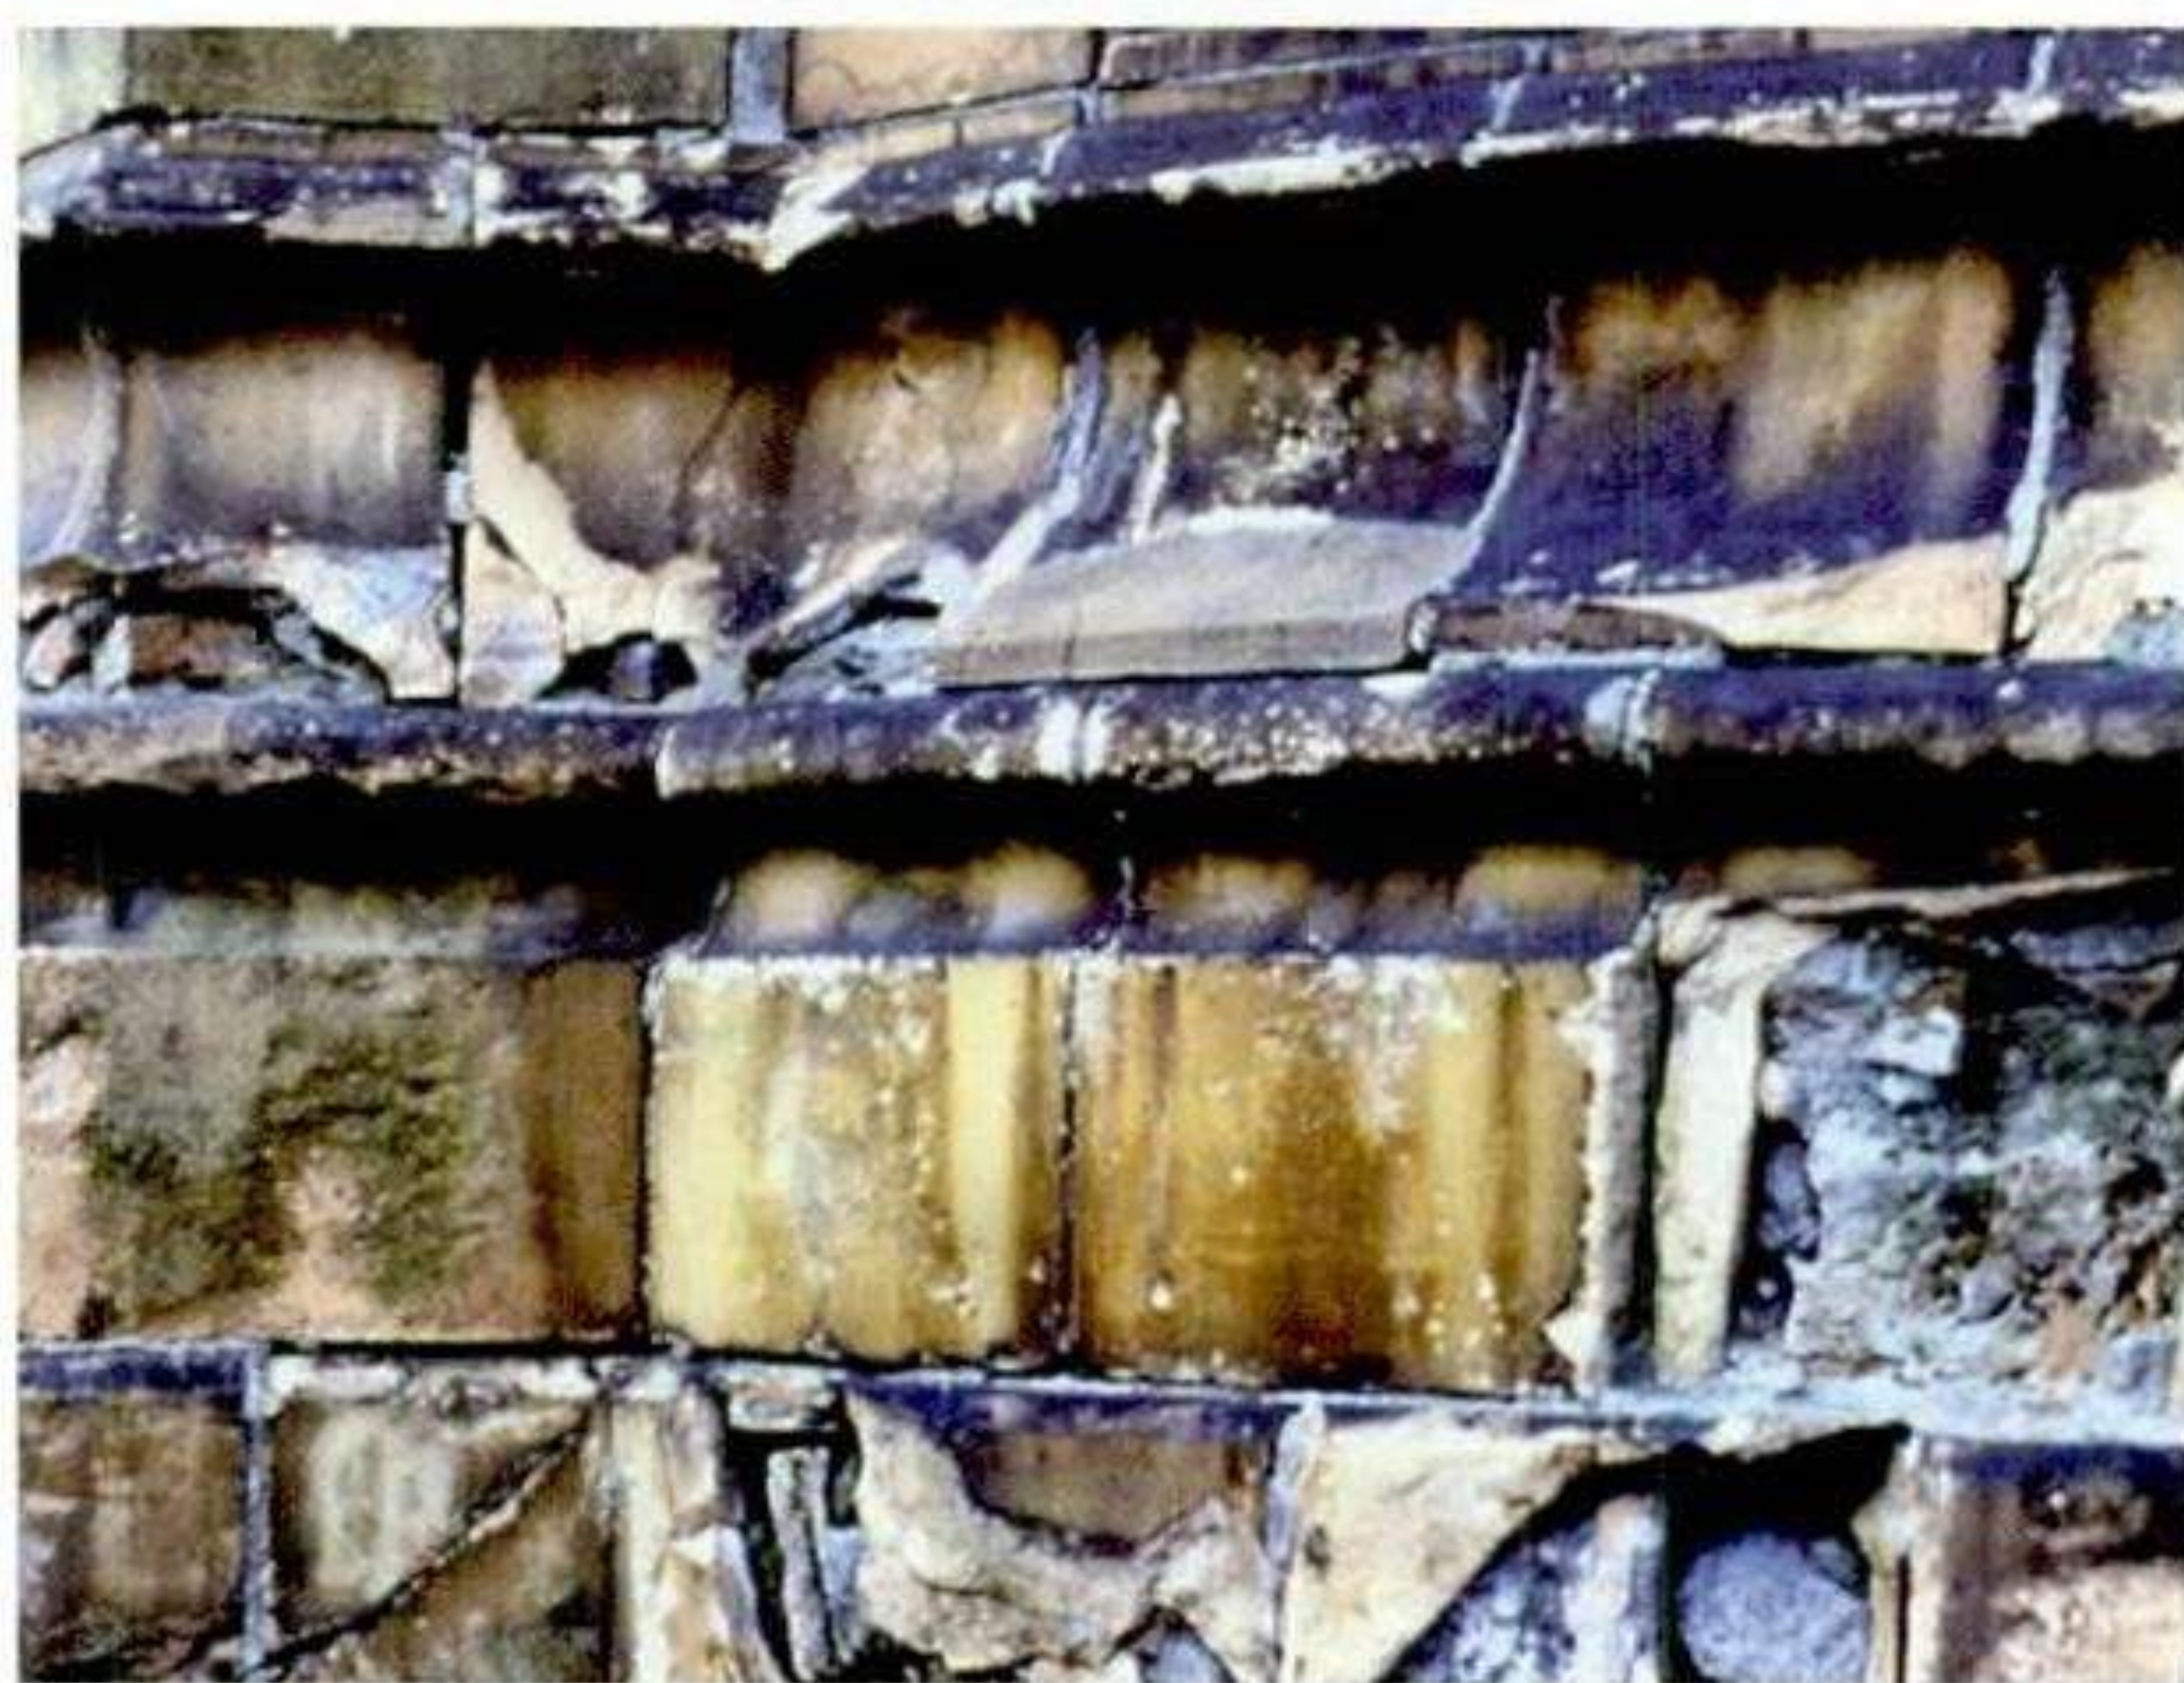
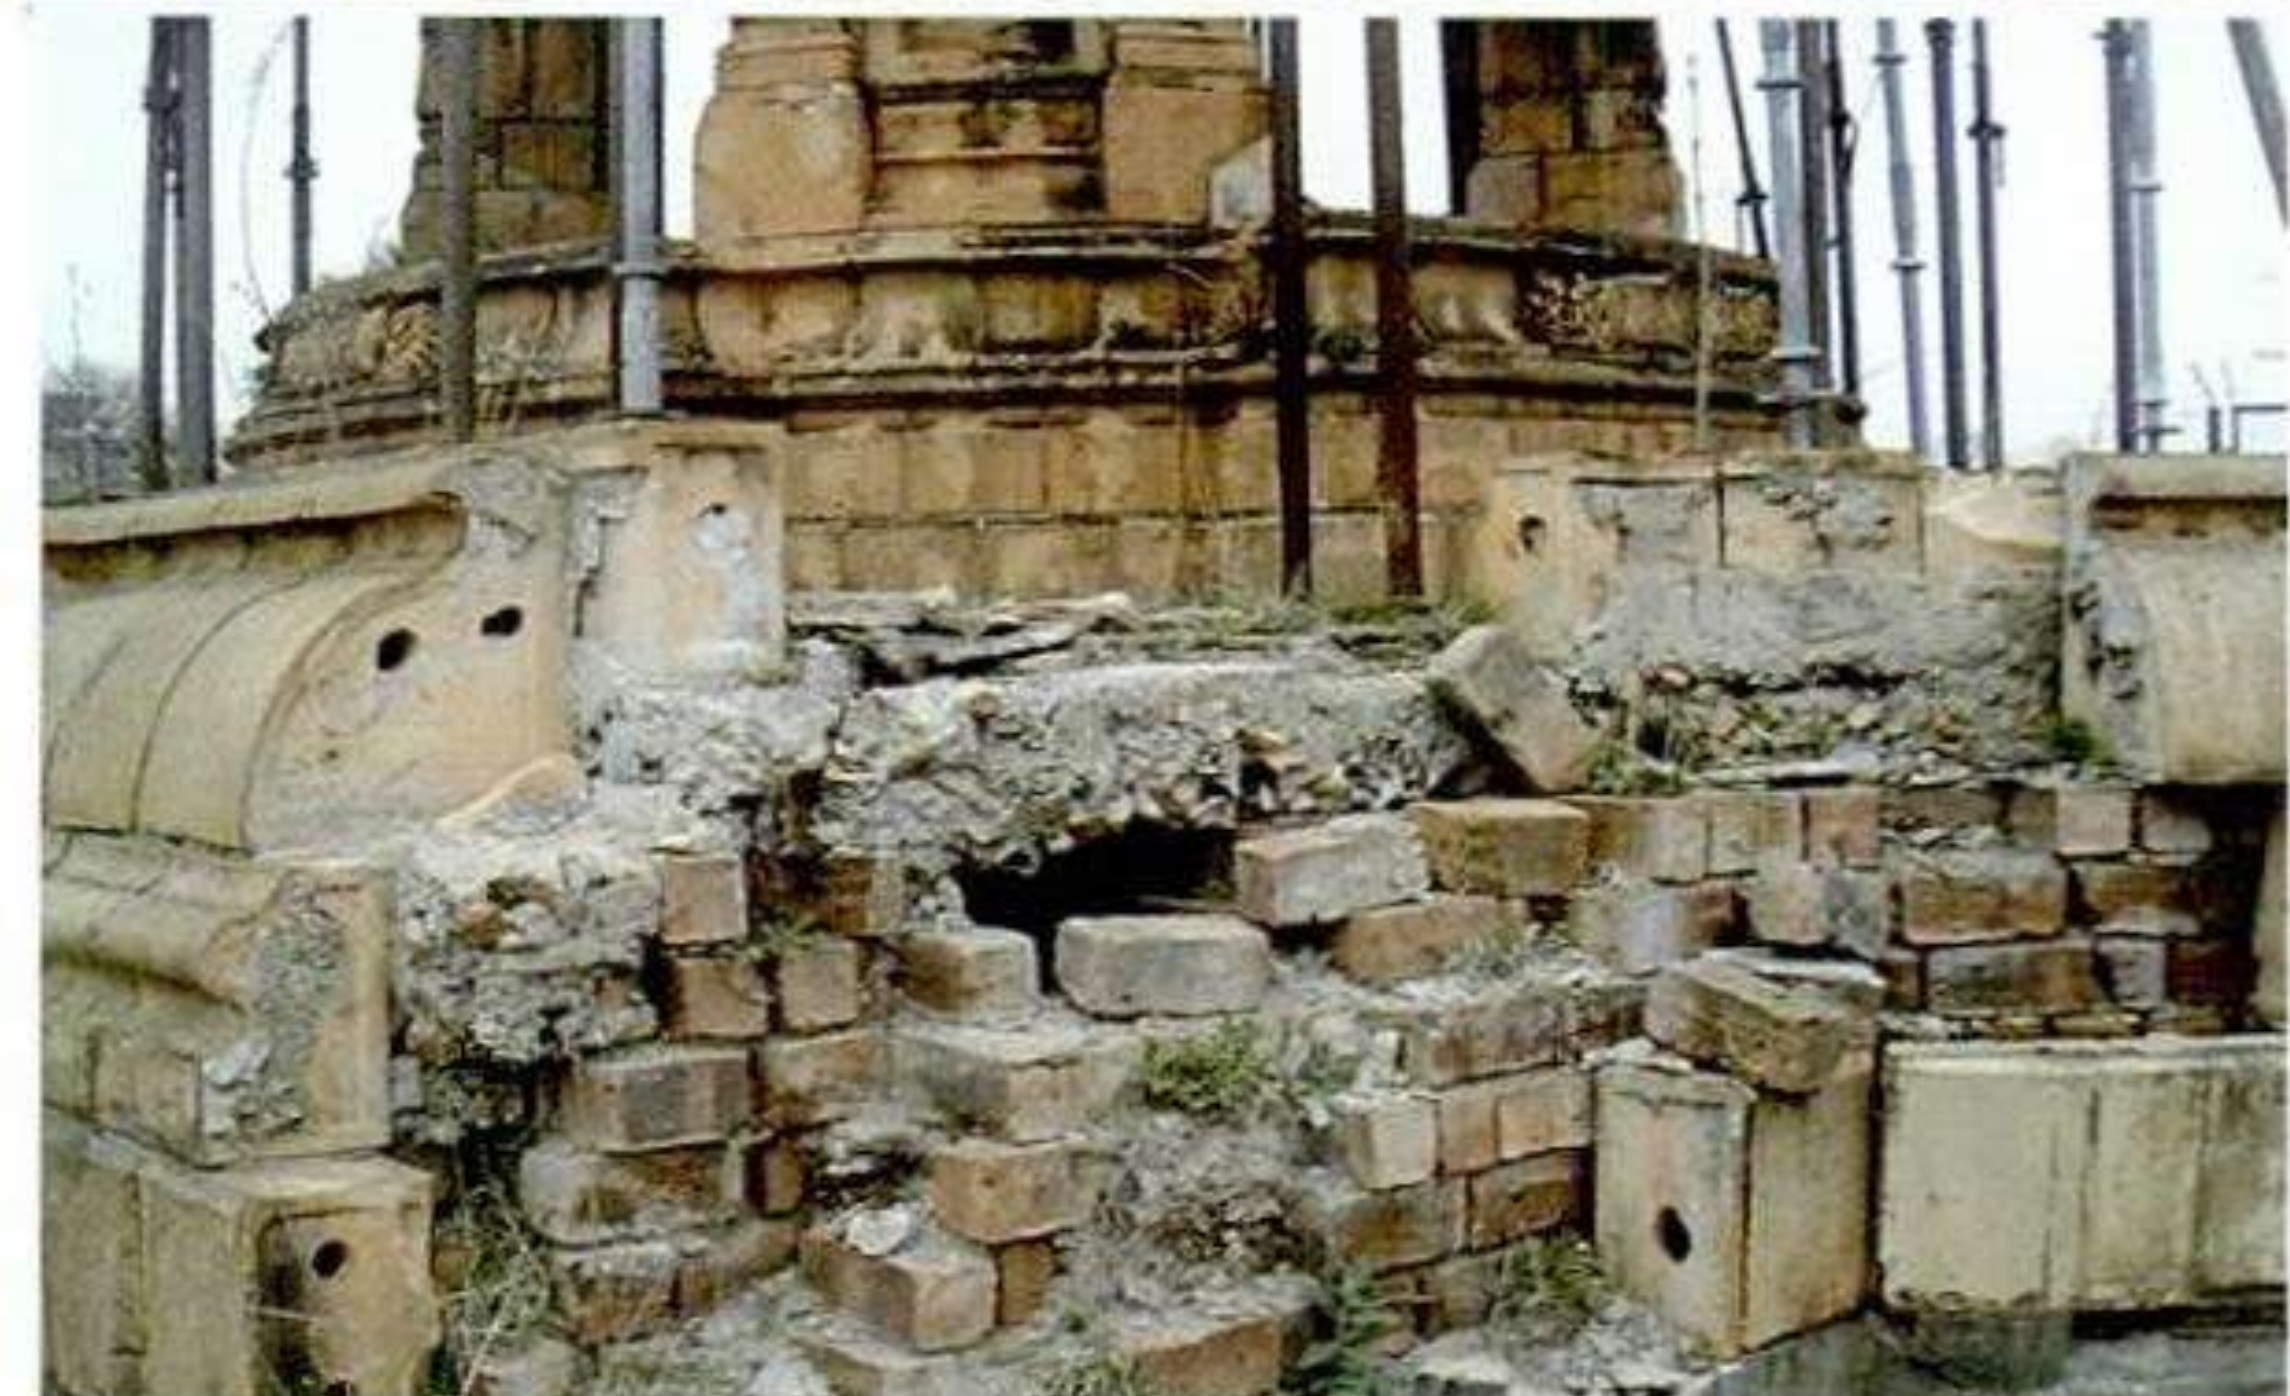
By 1999 the Doulton Fountain's condition had degenerated seriously. The principal causes of deterioration were weathering of under fired terracotta, frost, the expansive effect of corrosion of the embedded steel structure, lack of maintenance and vandalism.

Examples of the conditions found on the Doulton Fountain at the commencement of the restoration project.

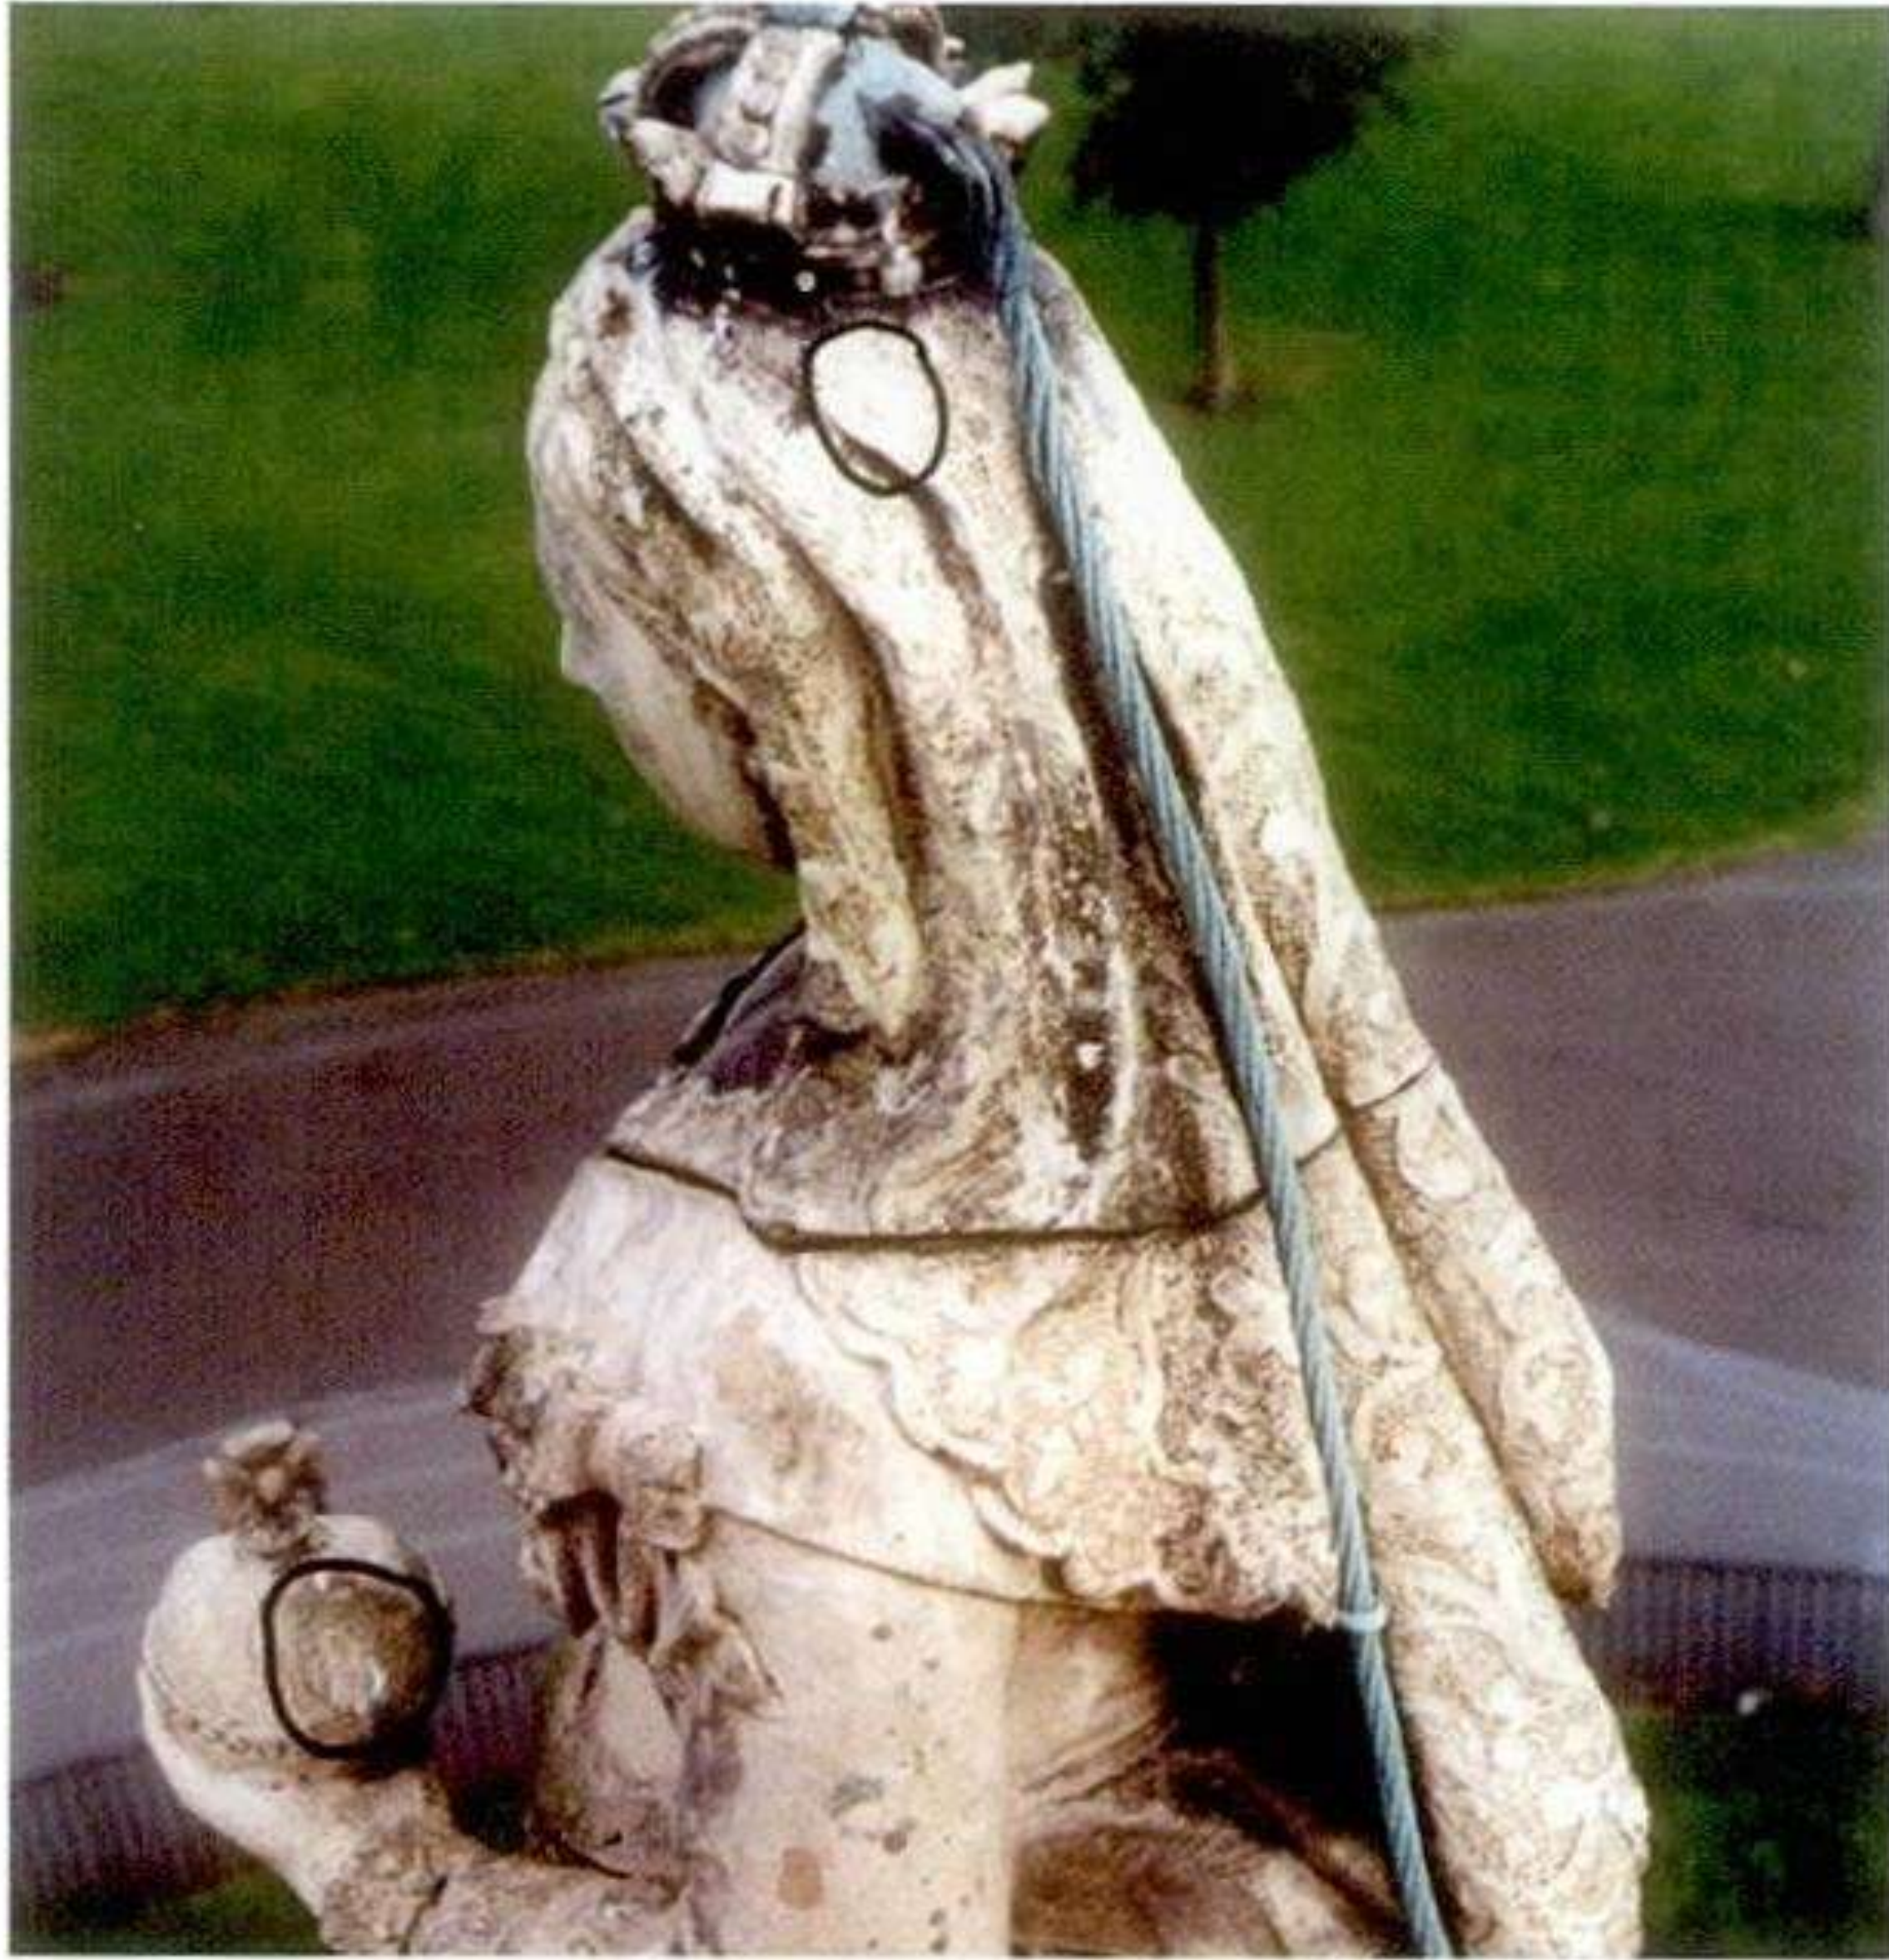
The sculpture of Victoria had suffered localised loss of details in exposed positions such as the top of her orb, shoulders and other sky-facing extremities. This had also caused a swathe of green staining down the back of the sculpture which had developed along the route of the copper conductor cable.
