THE
INVESTIGATION,
REPAIR AND
CONSERVATION
OF THE
DOULTON
FOUNTAIN,
GLASGOW GREEN

2 | Case
Study

TECHNICAL
CONSERVATION
GROUP

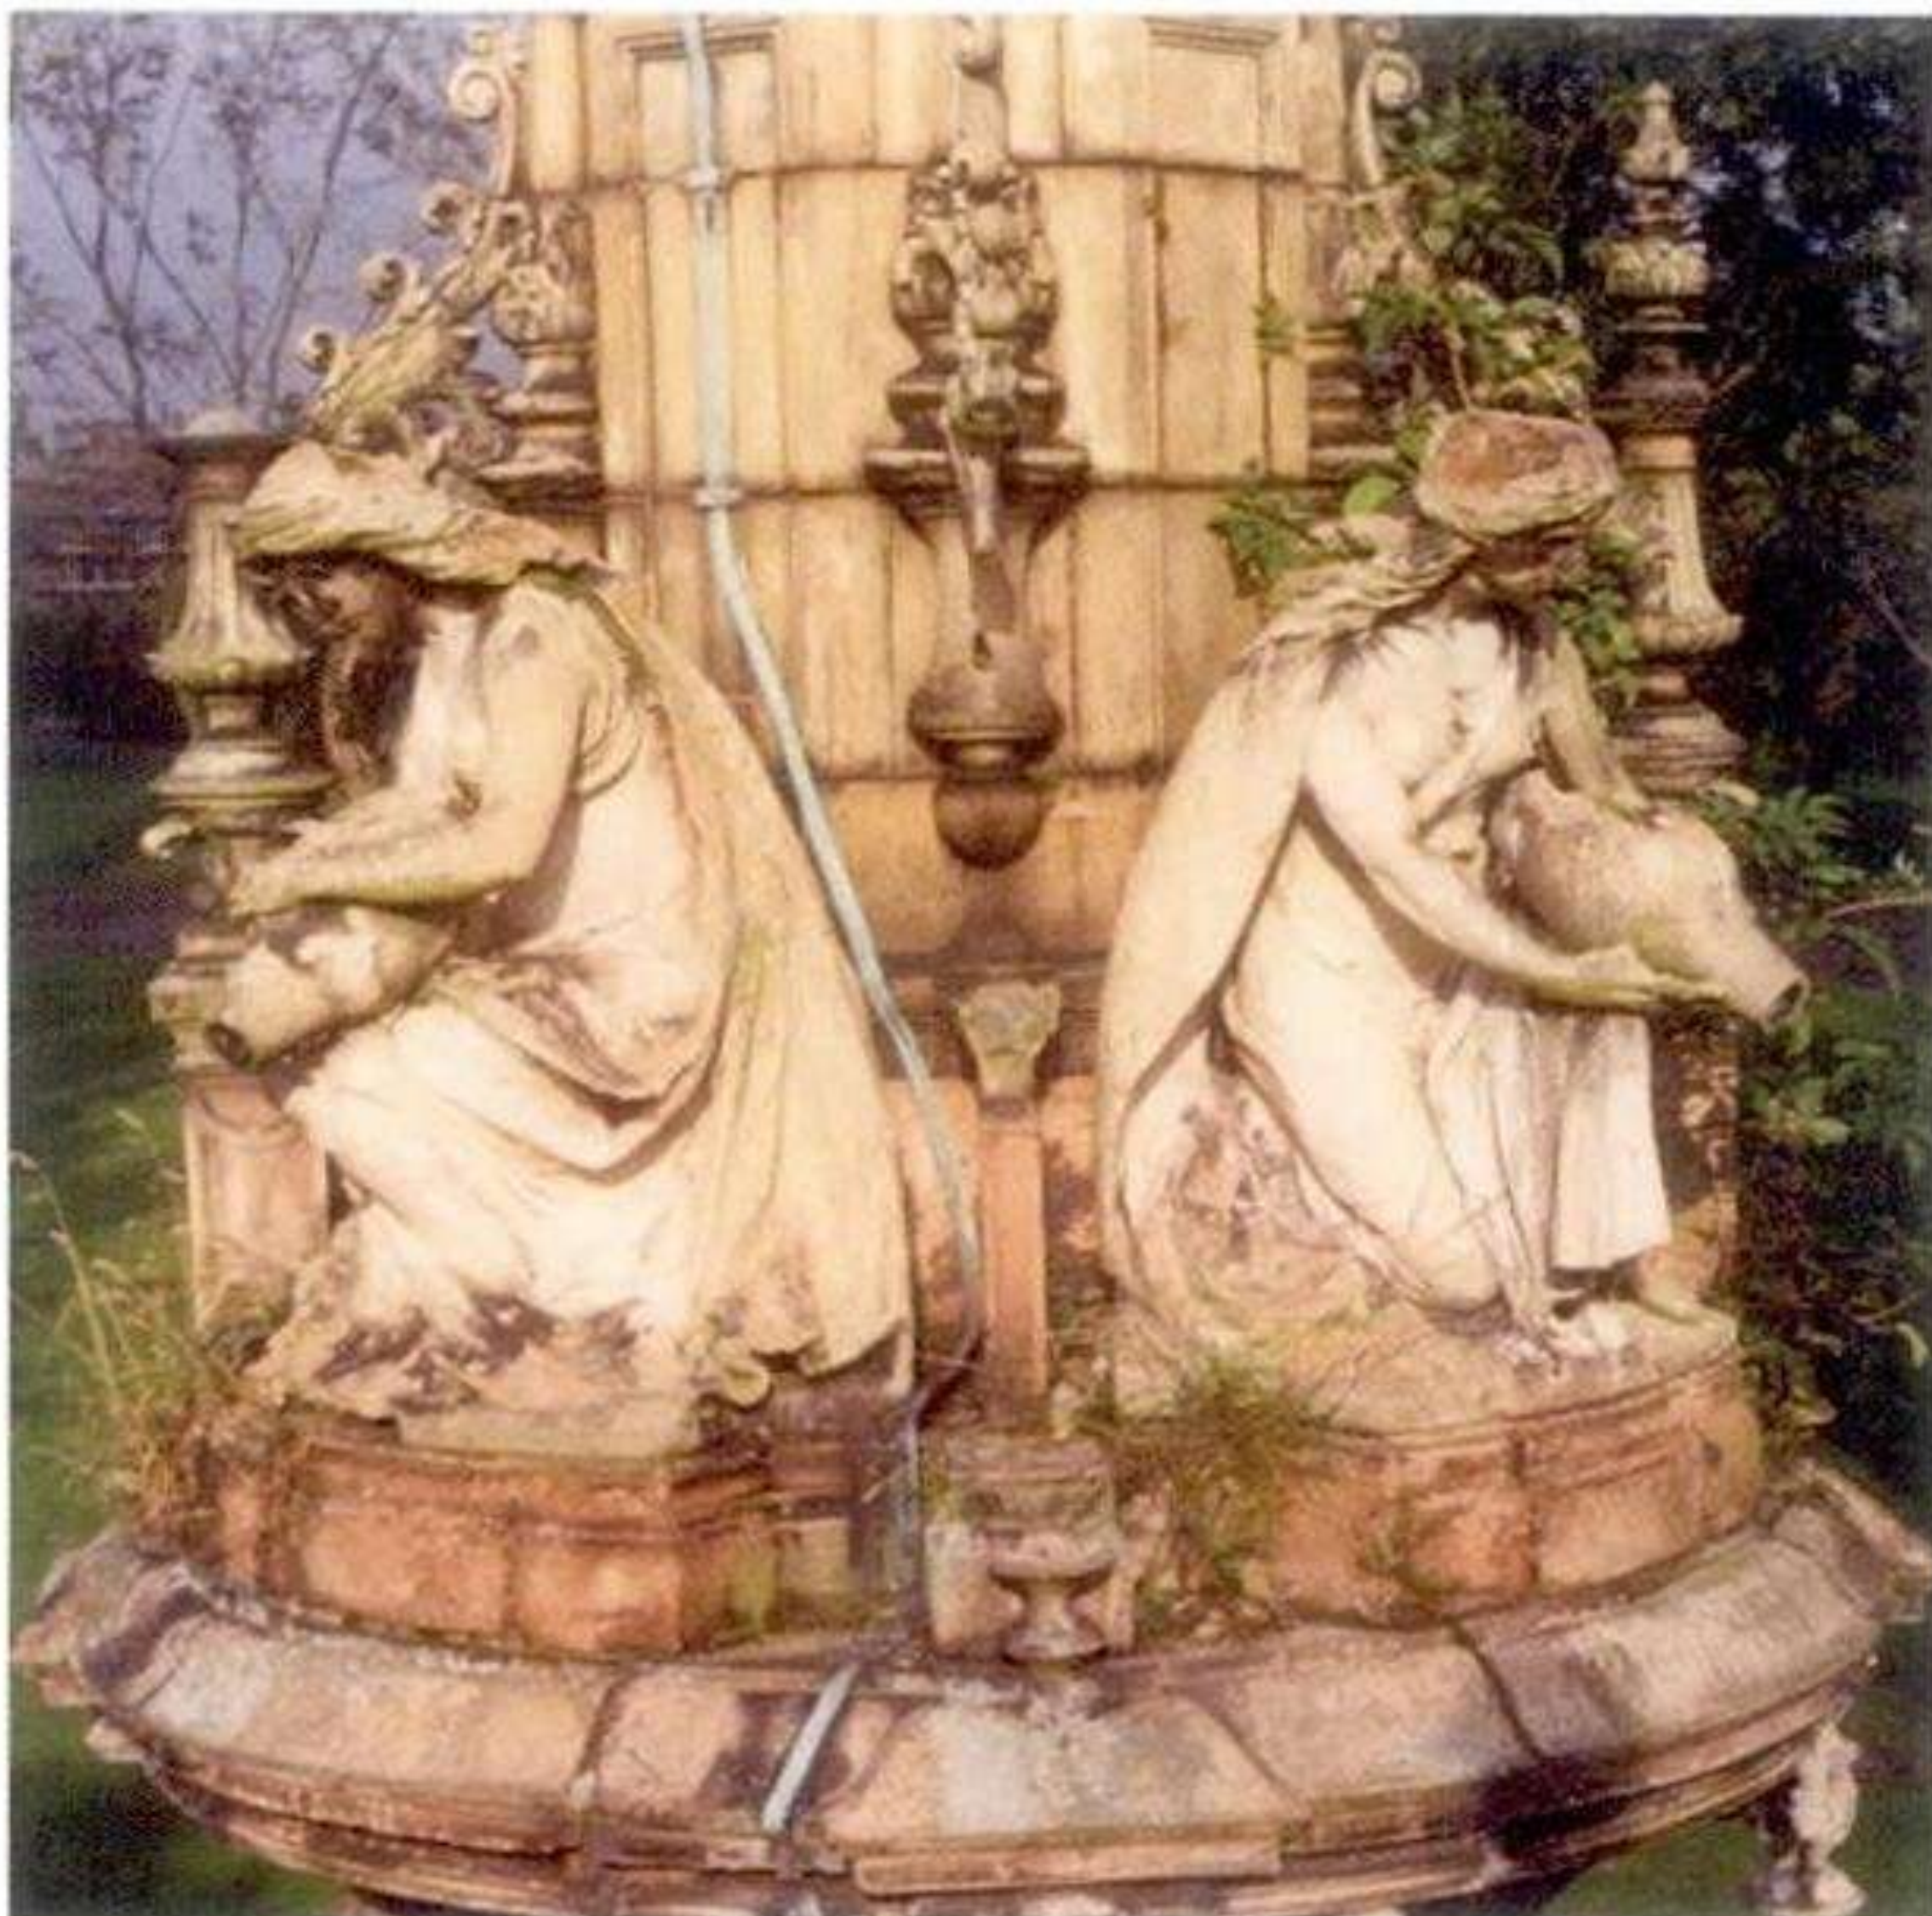
Most sky facing surfaces of the Water Bearers had been completely destroyed. Frost had affected most other surfaces leaving many of these in a deeply granulated, spalled or fractured state. The effect of the 1894 lightning strike had also taken its toll in the form of deep multiple layers of parallel spalling, and these had been exploited by the weathering.

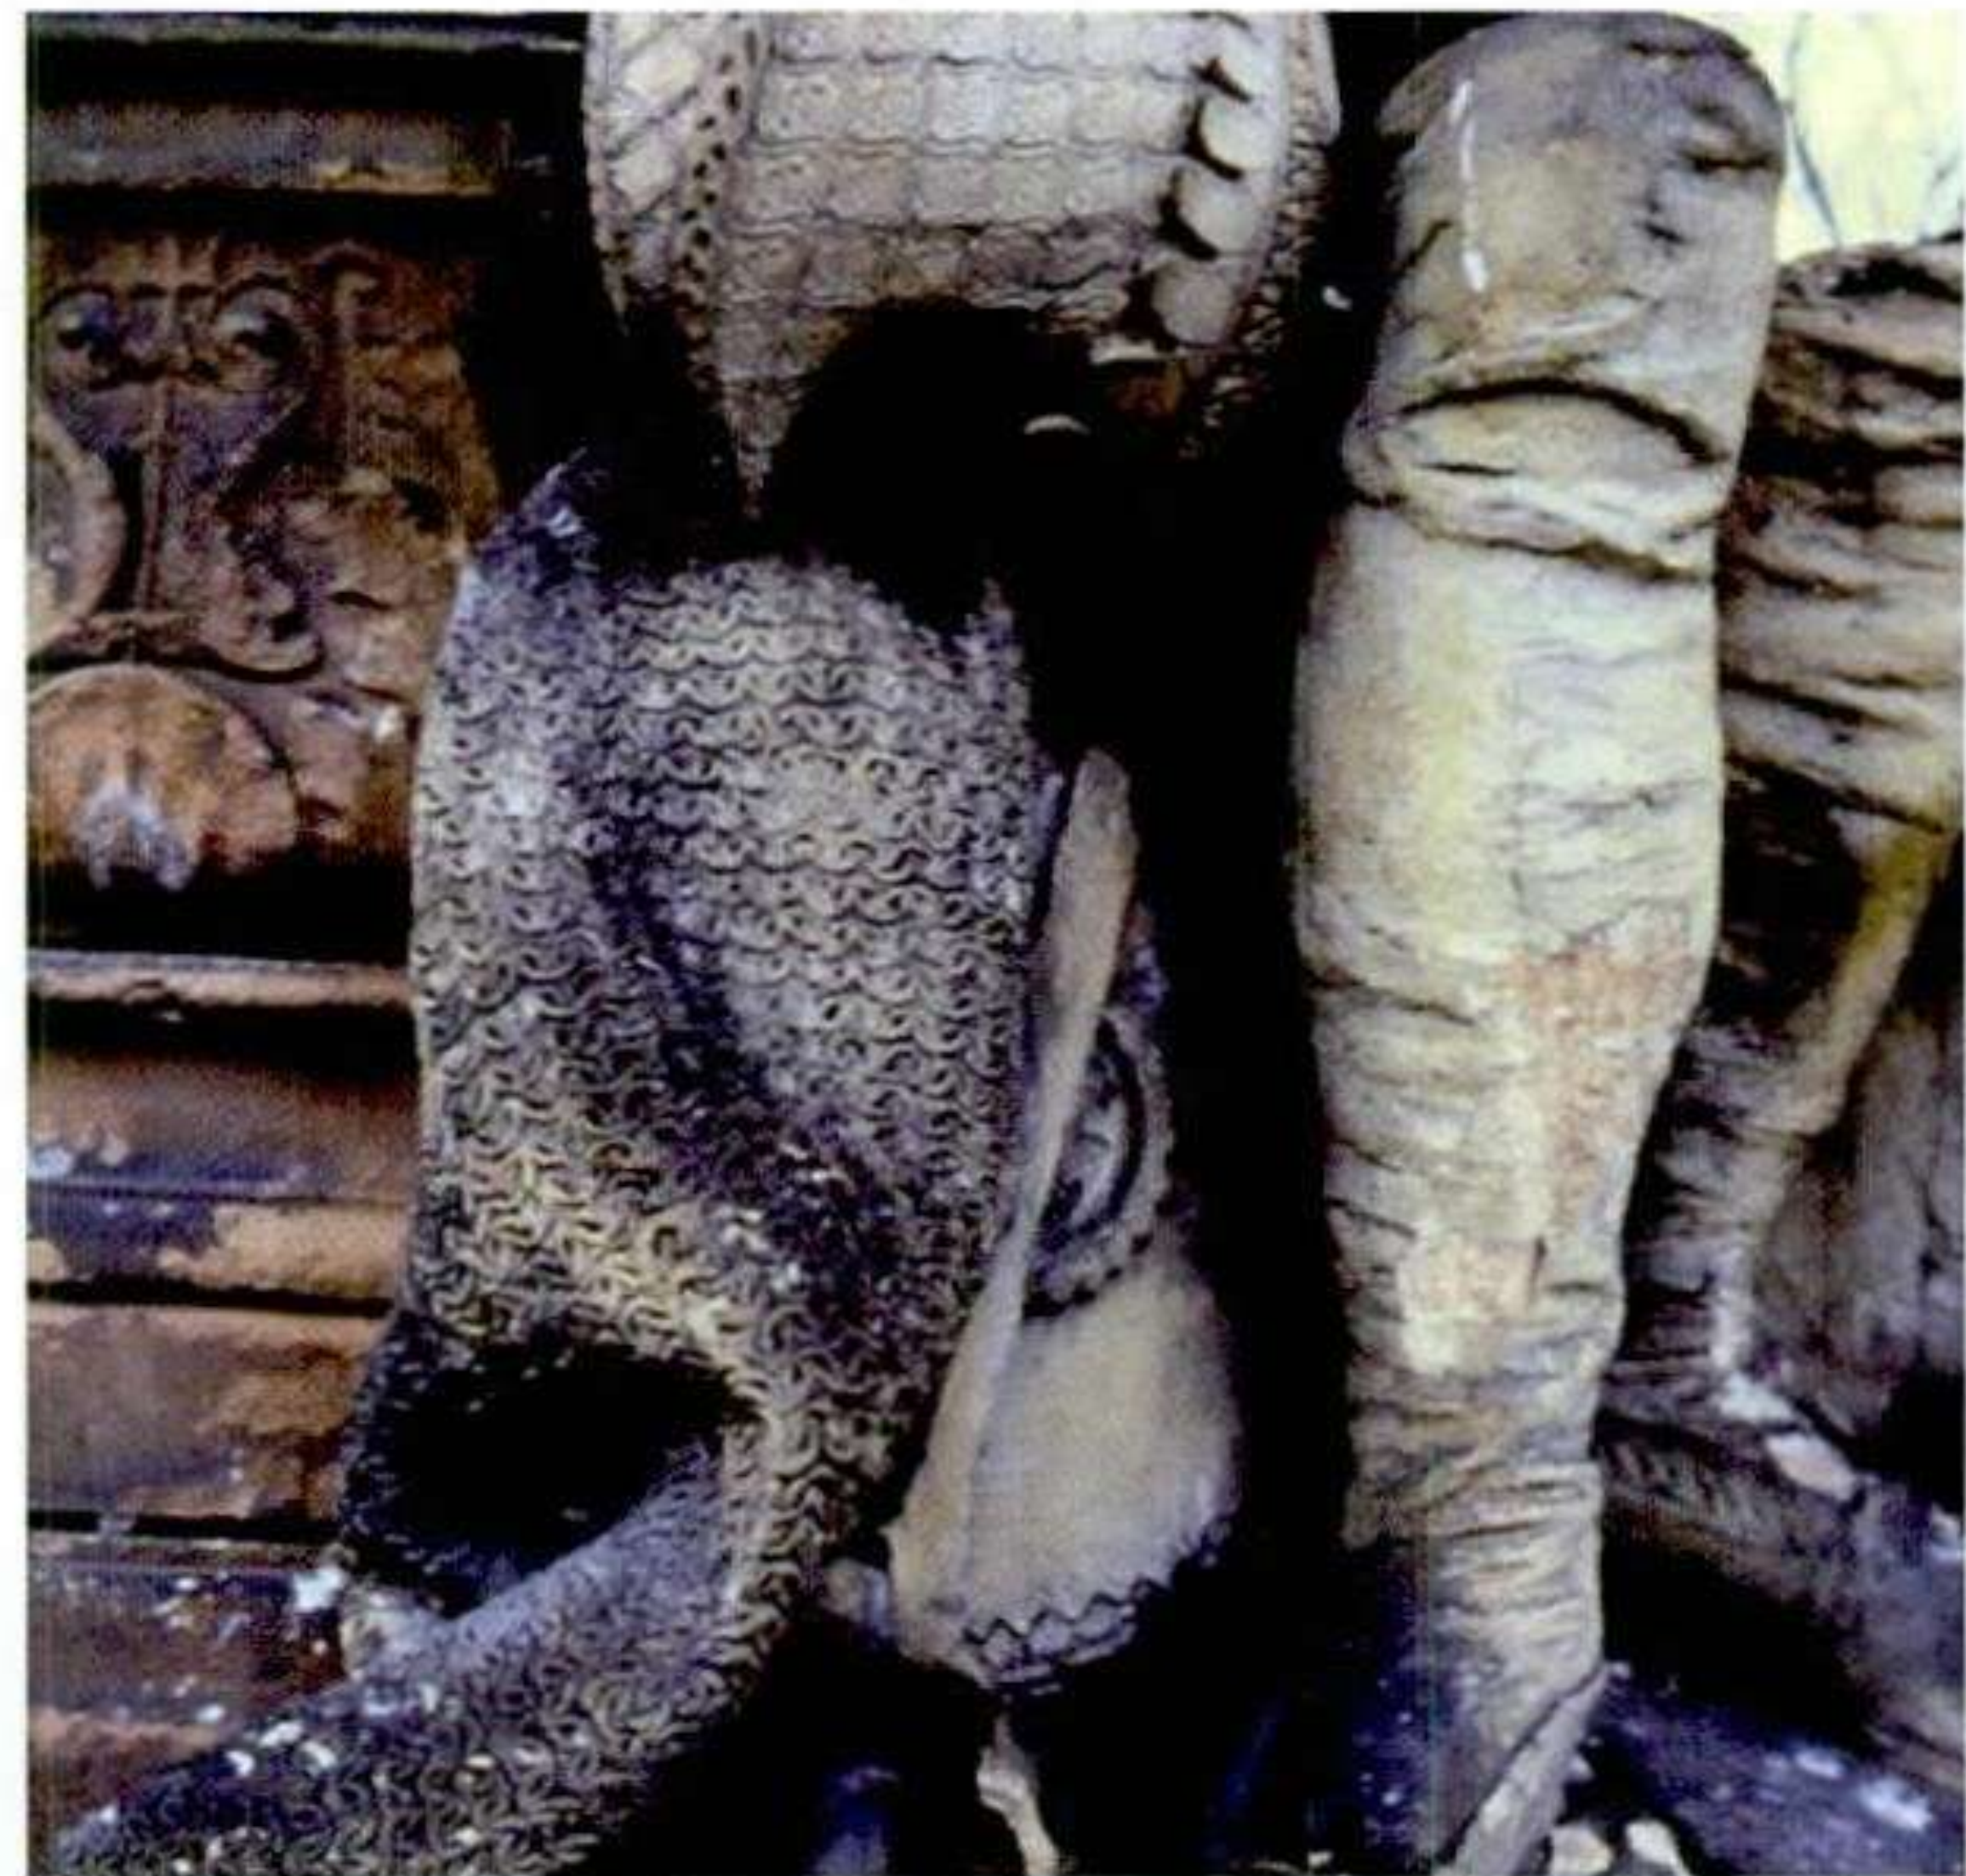
Probably the most heavily vandalised of the colonial groups, nearly all the pieces of India were either missing or severely damaged. Missing were the upper halves and heads of the male and female figures, the axe behind the man and the tree behind the female. Parts of the upper torso and arm of the woman were found in store along with fragments of the male tunic from the waist downwards and a few fragments of his left arm, some pieces of the plinth, including the female's right toes, the female's hand and a fragment of vase. The column with figures seated on horses which had sustained a lot of peripheral damage to the heads and upper torsos of the riders, was found in the sump of the external chamber.

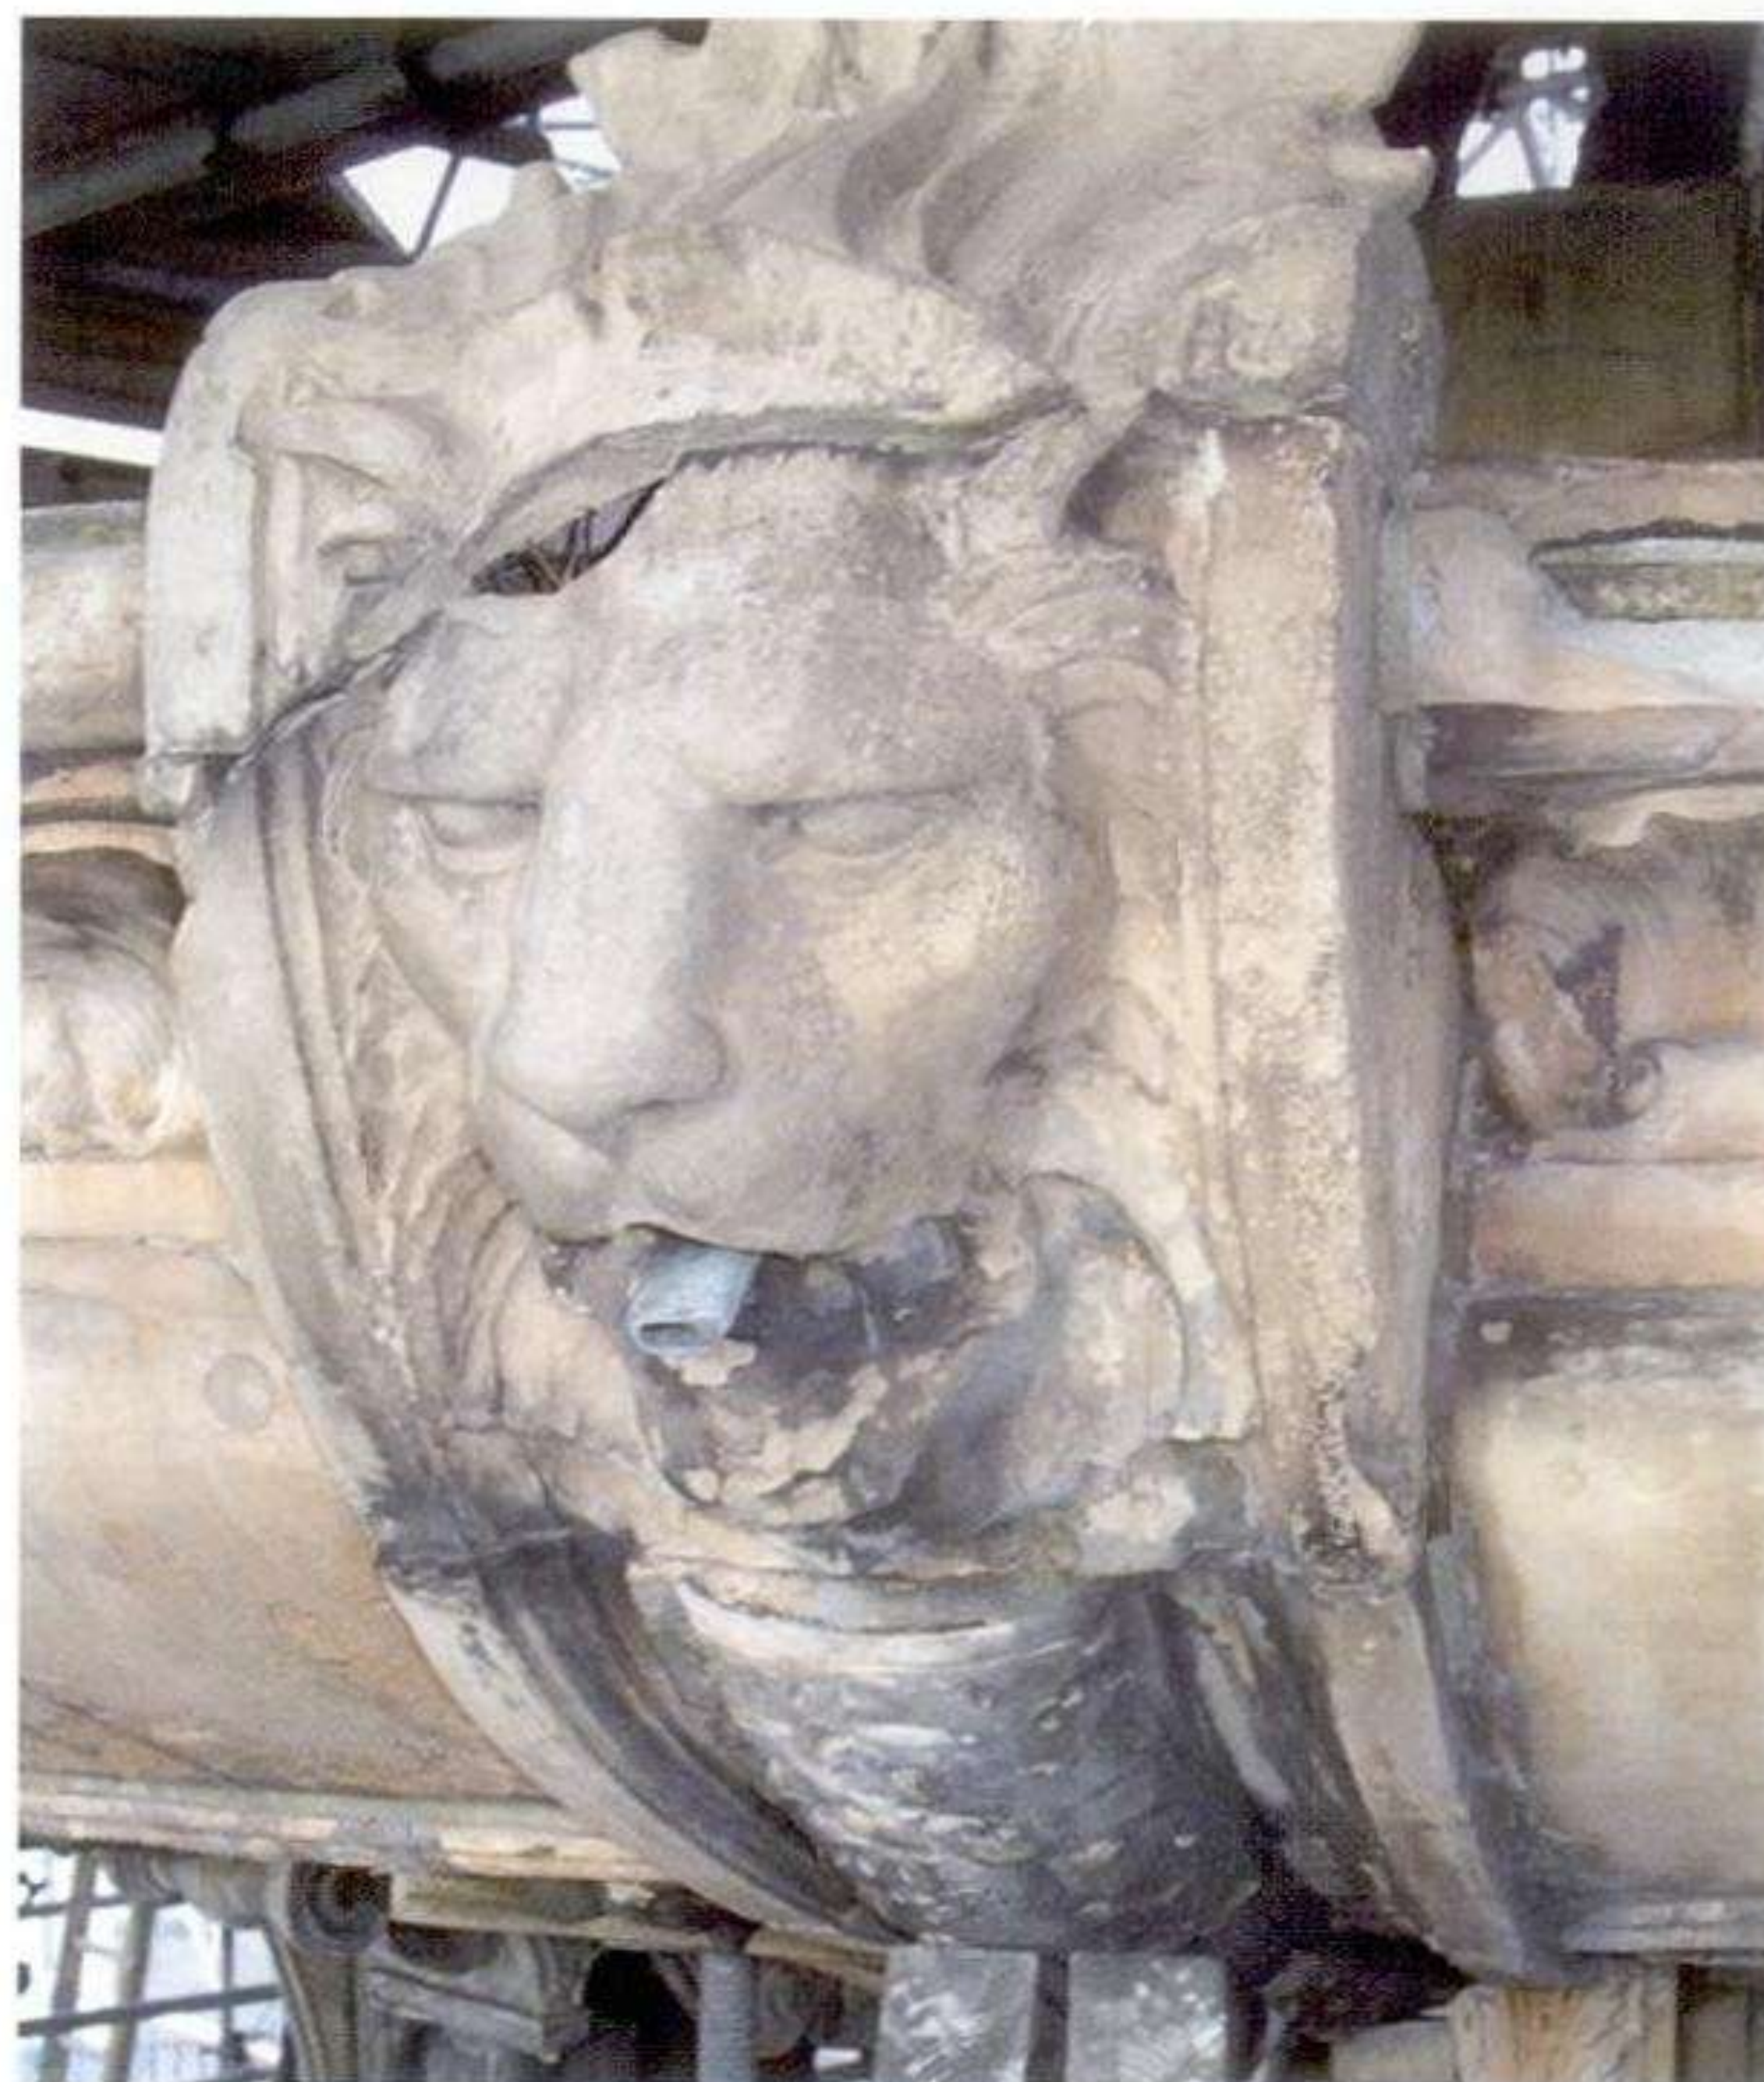
All the lion heads and associated moulded terracotta which clad the circular perimeter beam had fractured and many pieces had detached and fallen. All the pieces covering the ribs and supporting the infill panels had also fractured due to the corroding iron arms. The plain and decorative panels between the ribs had been affected in part by the corroding ribs but also had experienced granulation due to being insufficiently fired, frost and soluble salts.

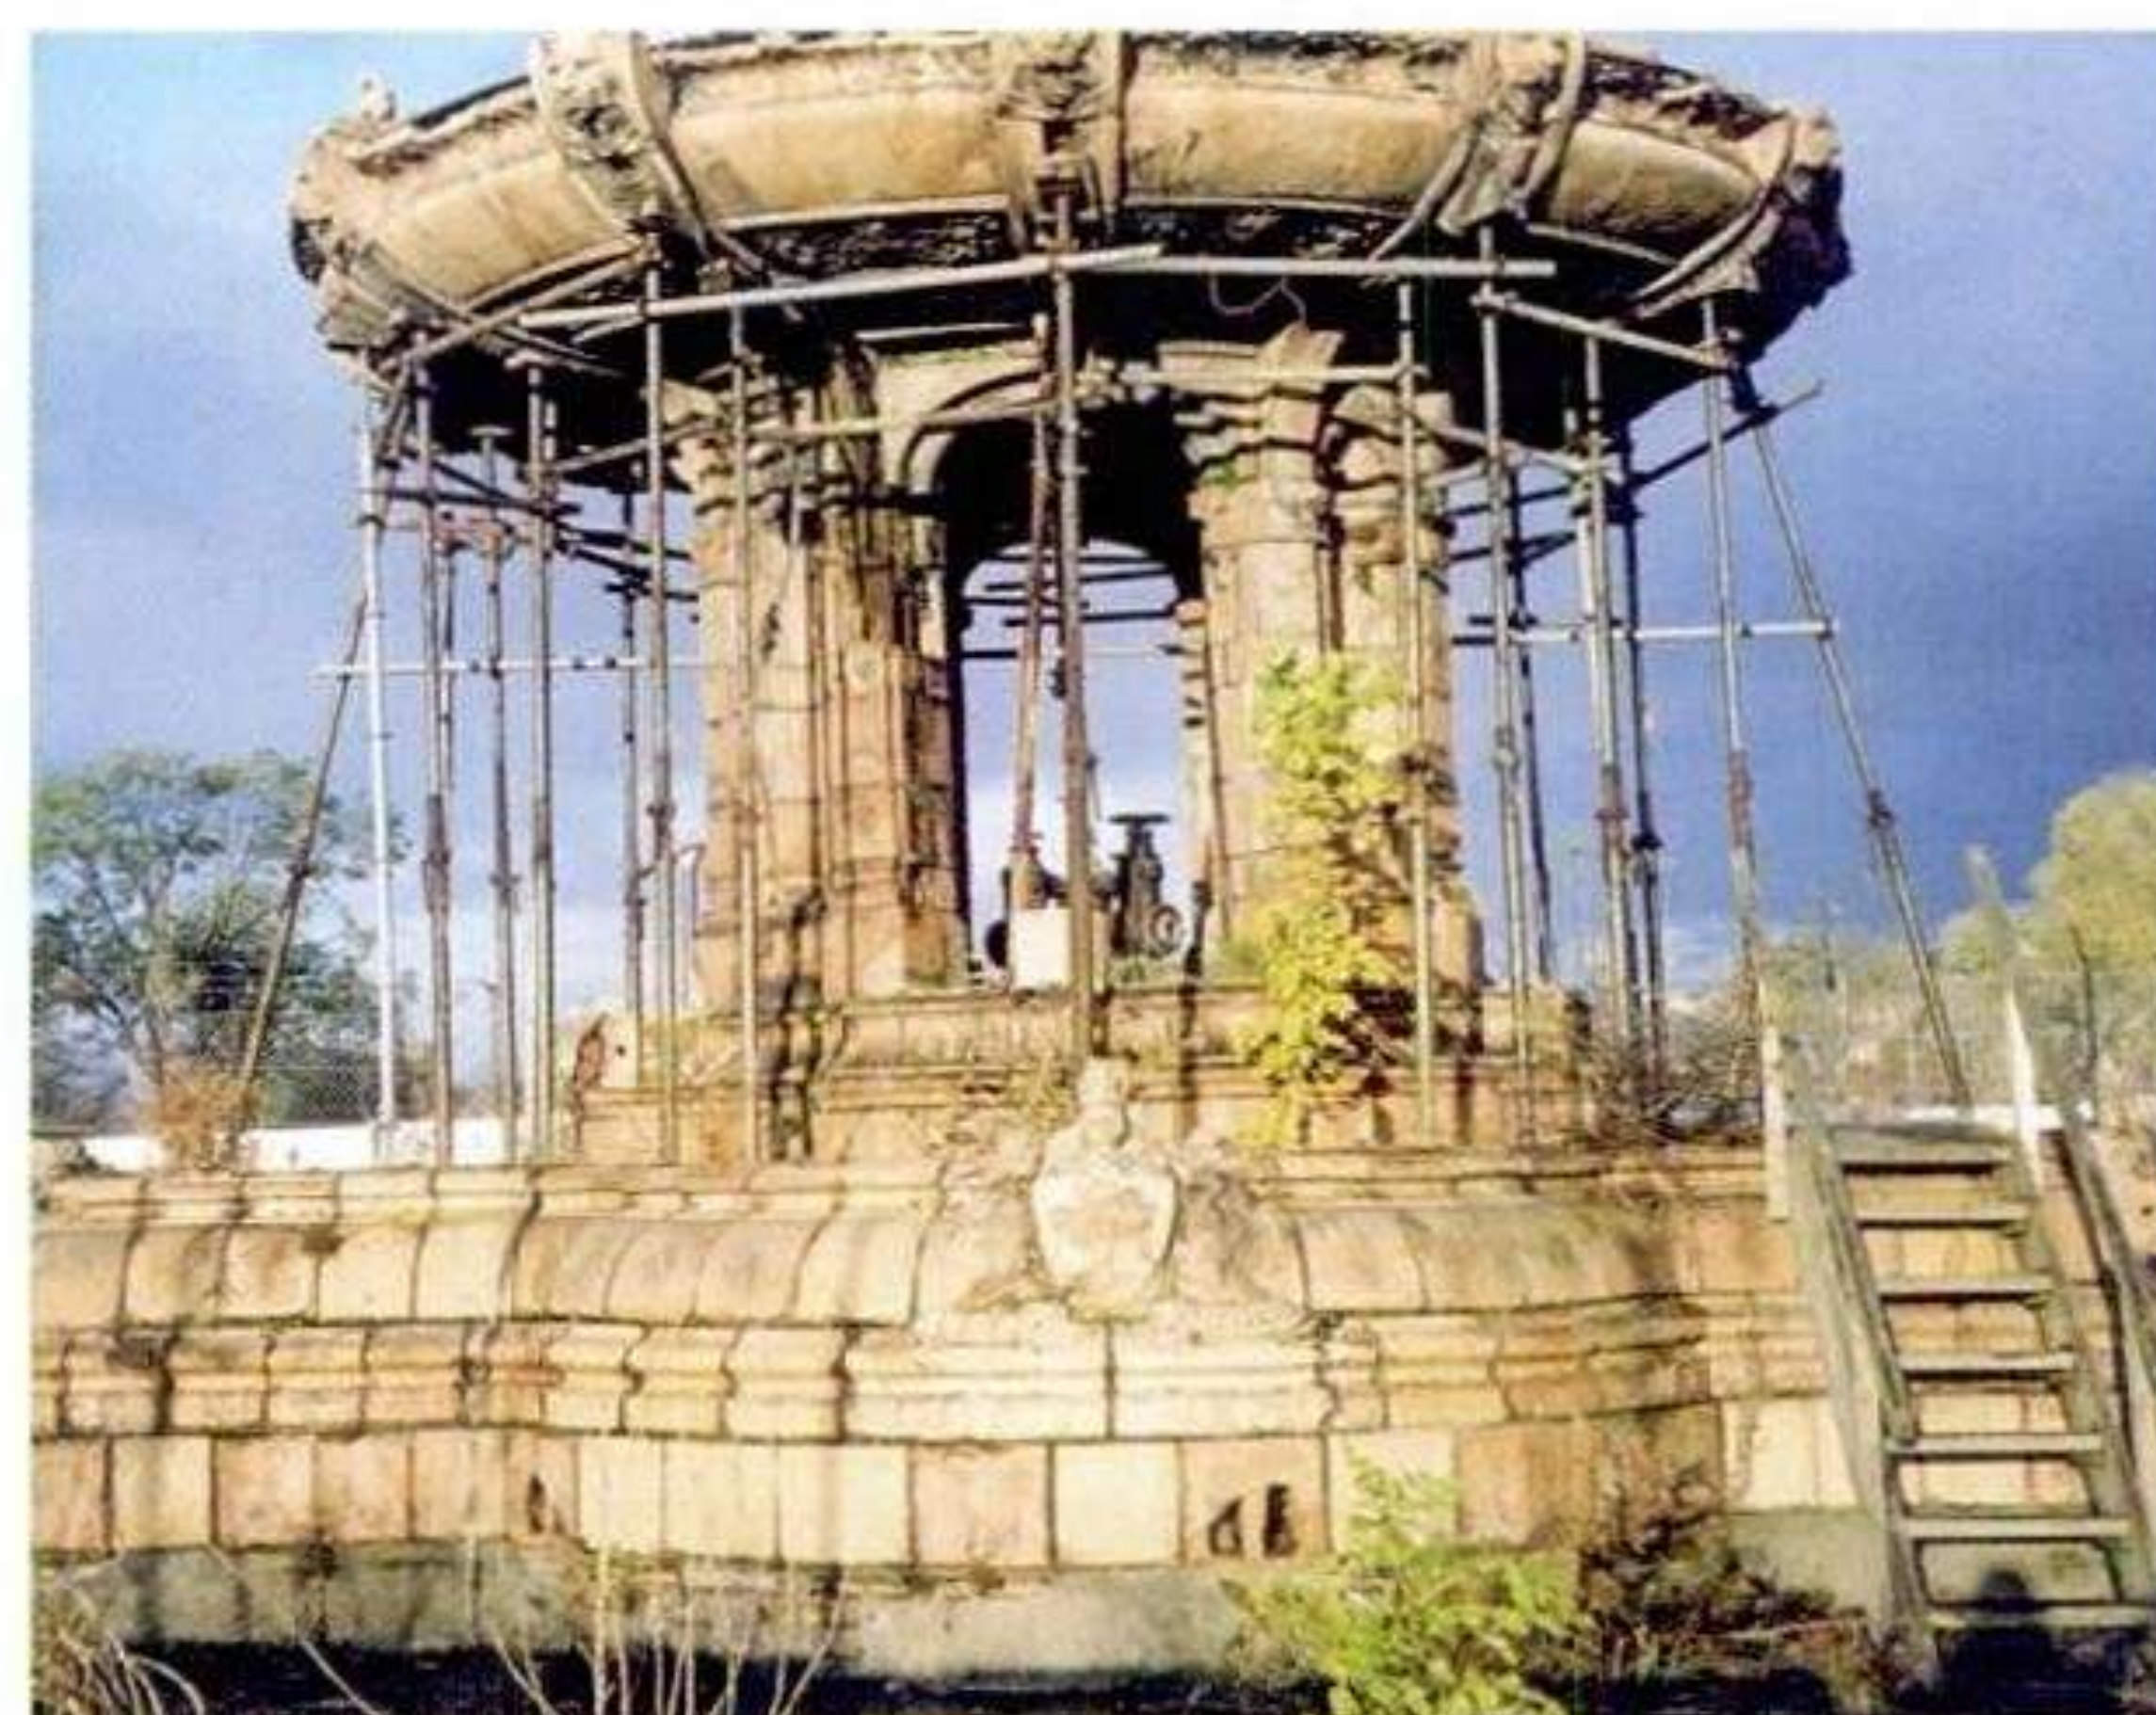
The Glasgow Coats of Arms situated beneath each colonial group had minor damages. All four torsos of the surmounting figure of St. Mungo had been damaged or removed. Archive photographs showed St. Mungo to have originally worn a Bishop's mitre, held a crosier in his left hand and to have his right hand held probably in a sign of peace.
