THE
INVESTIGATION,
REPAIR AND
CONSERVATION
OF THE
DOULTON
FOUNTAIN,
GLASGOW GREEN

2 | Case
Study

TECHNICAL
CONSERVATION
GROUP

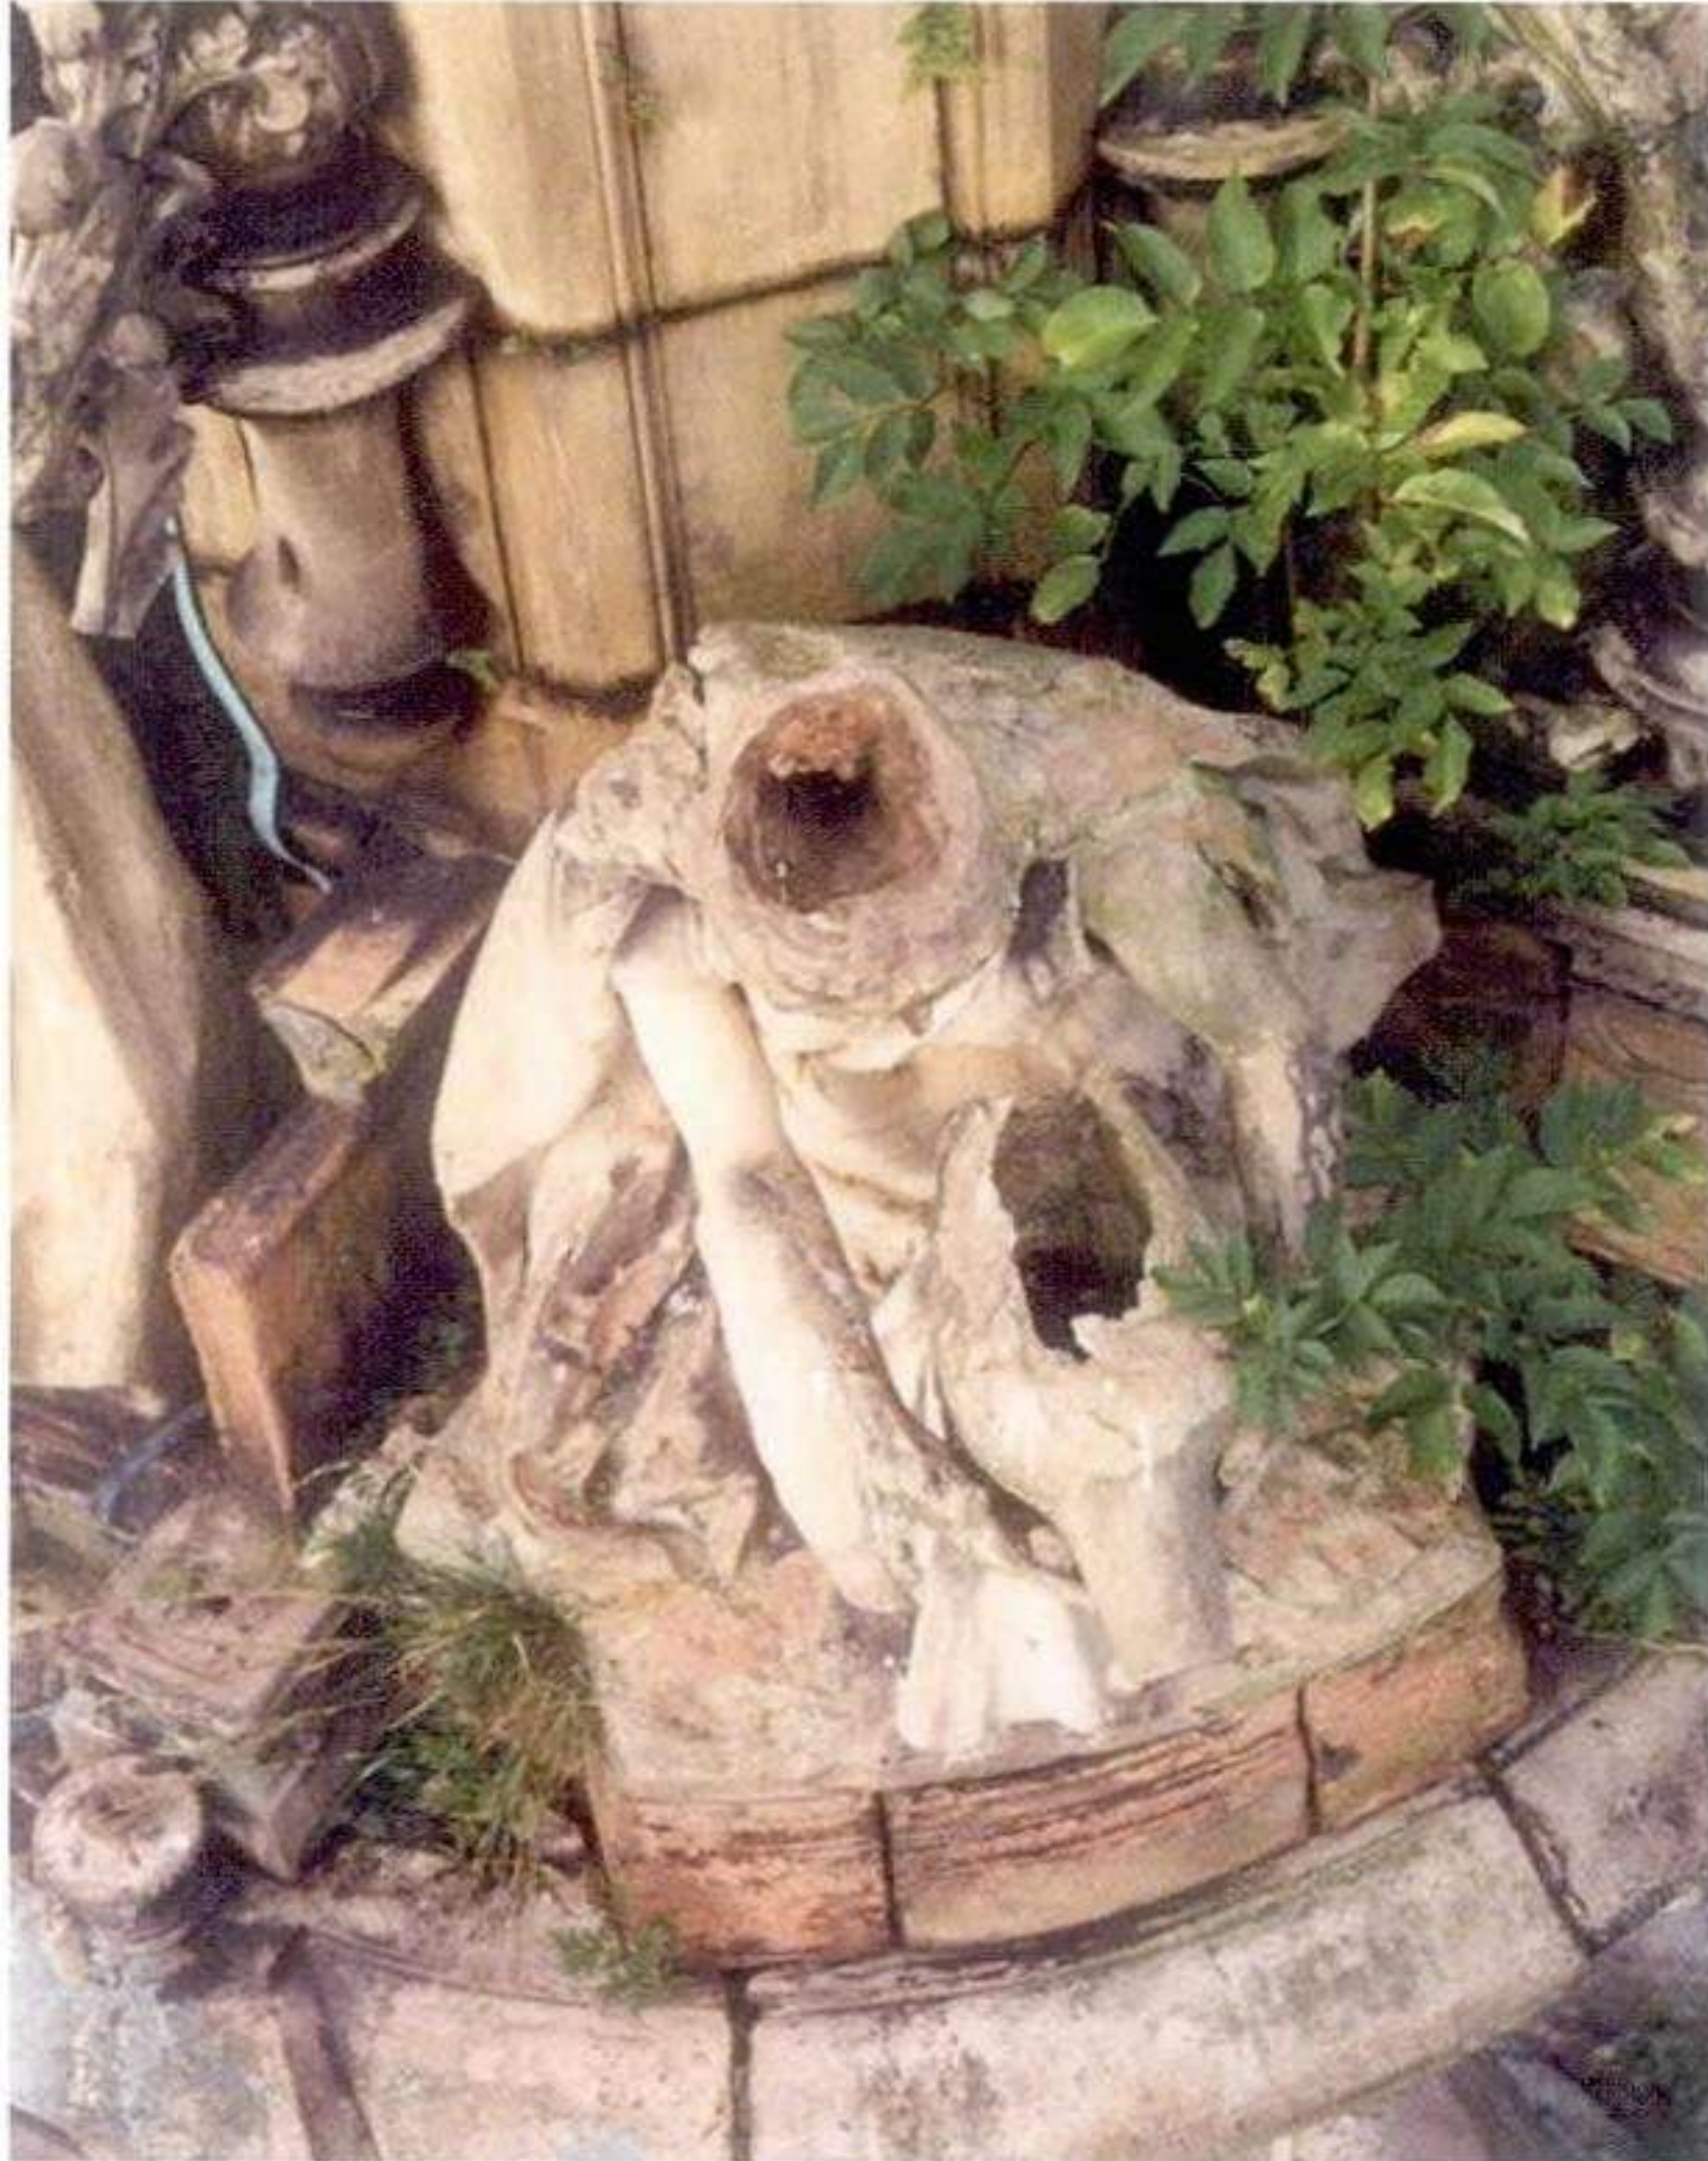
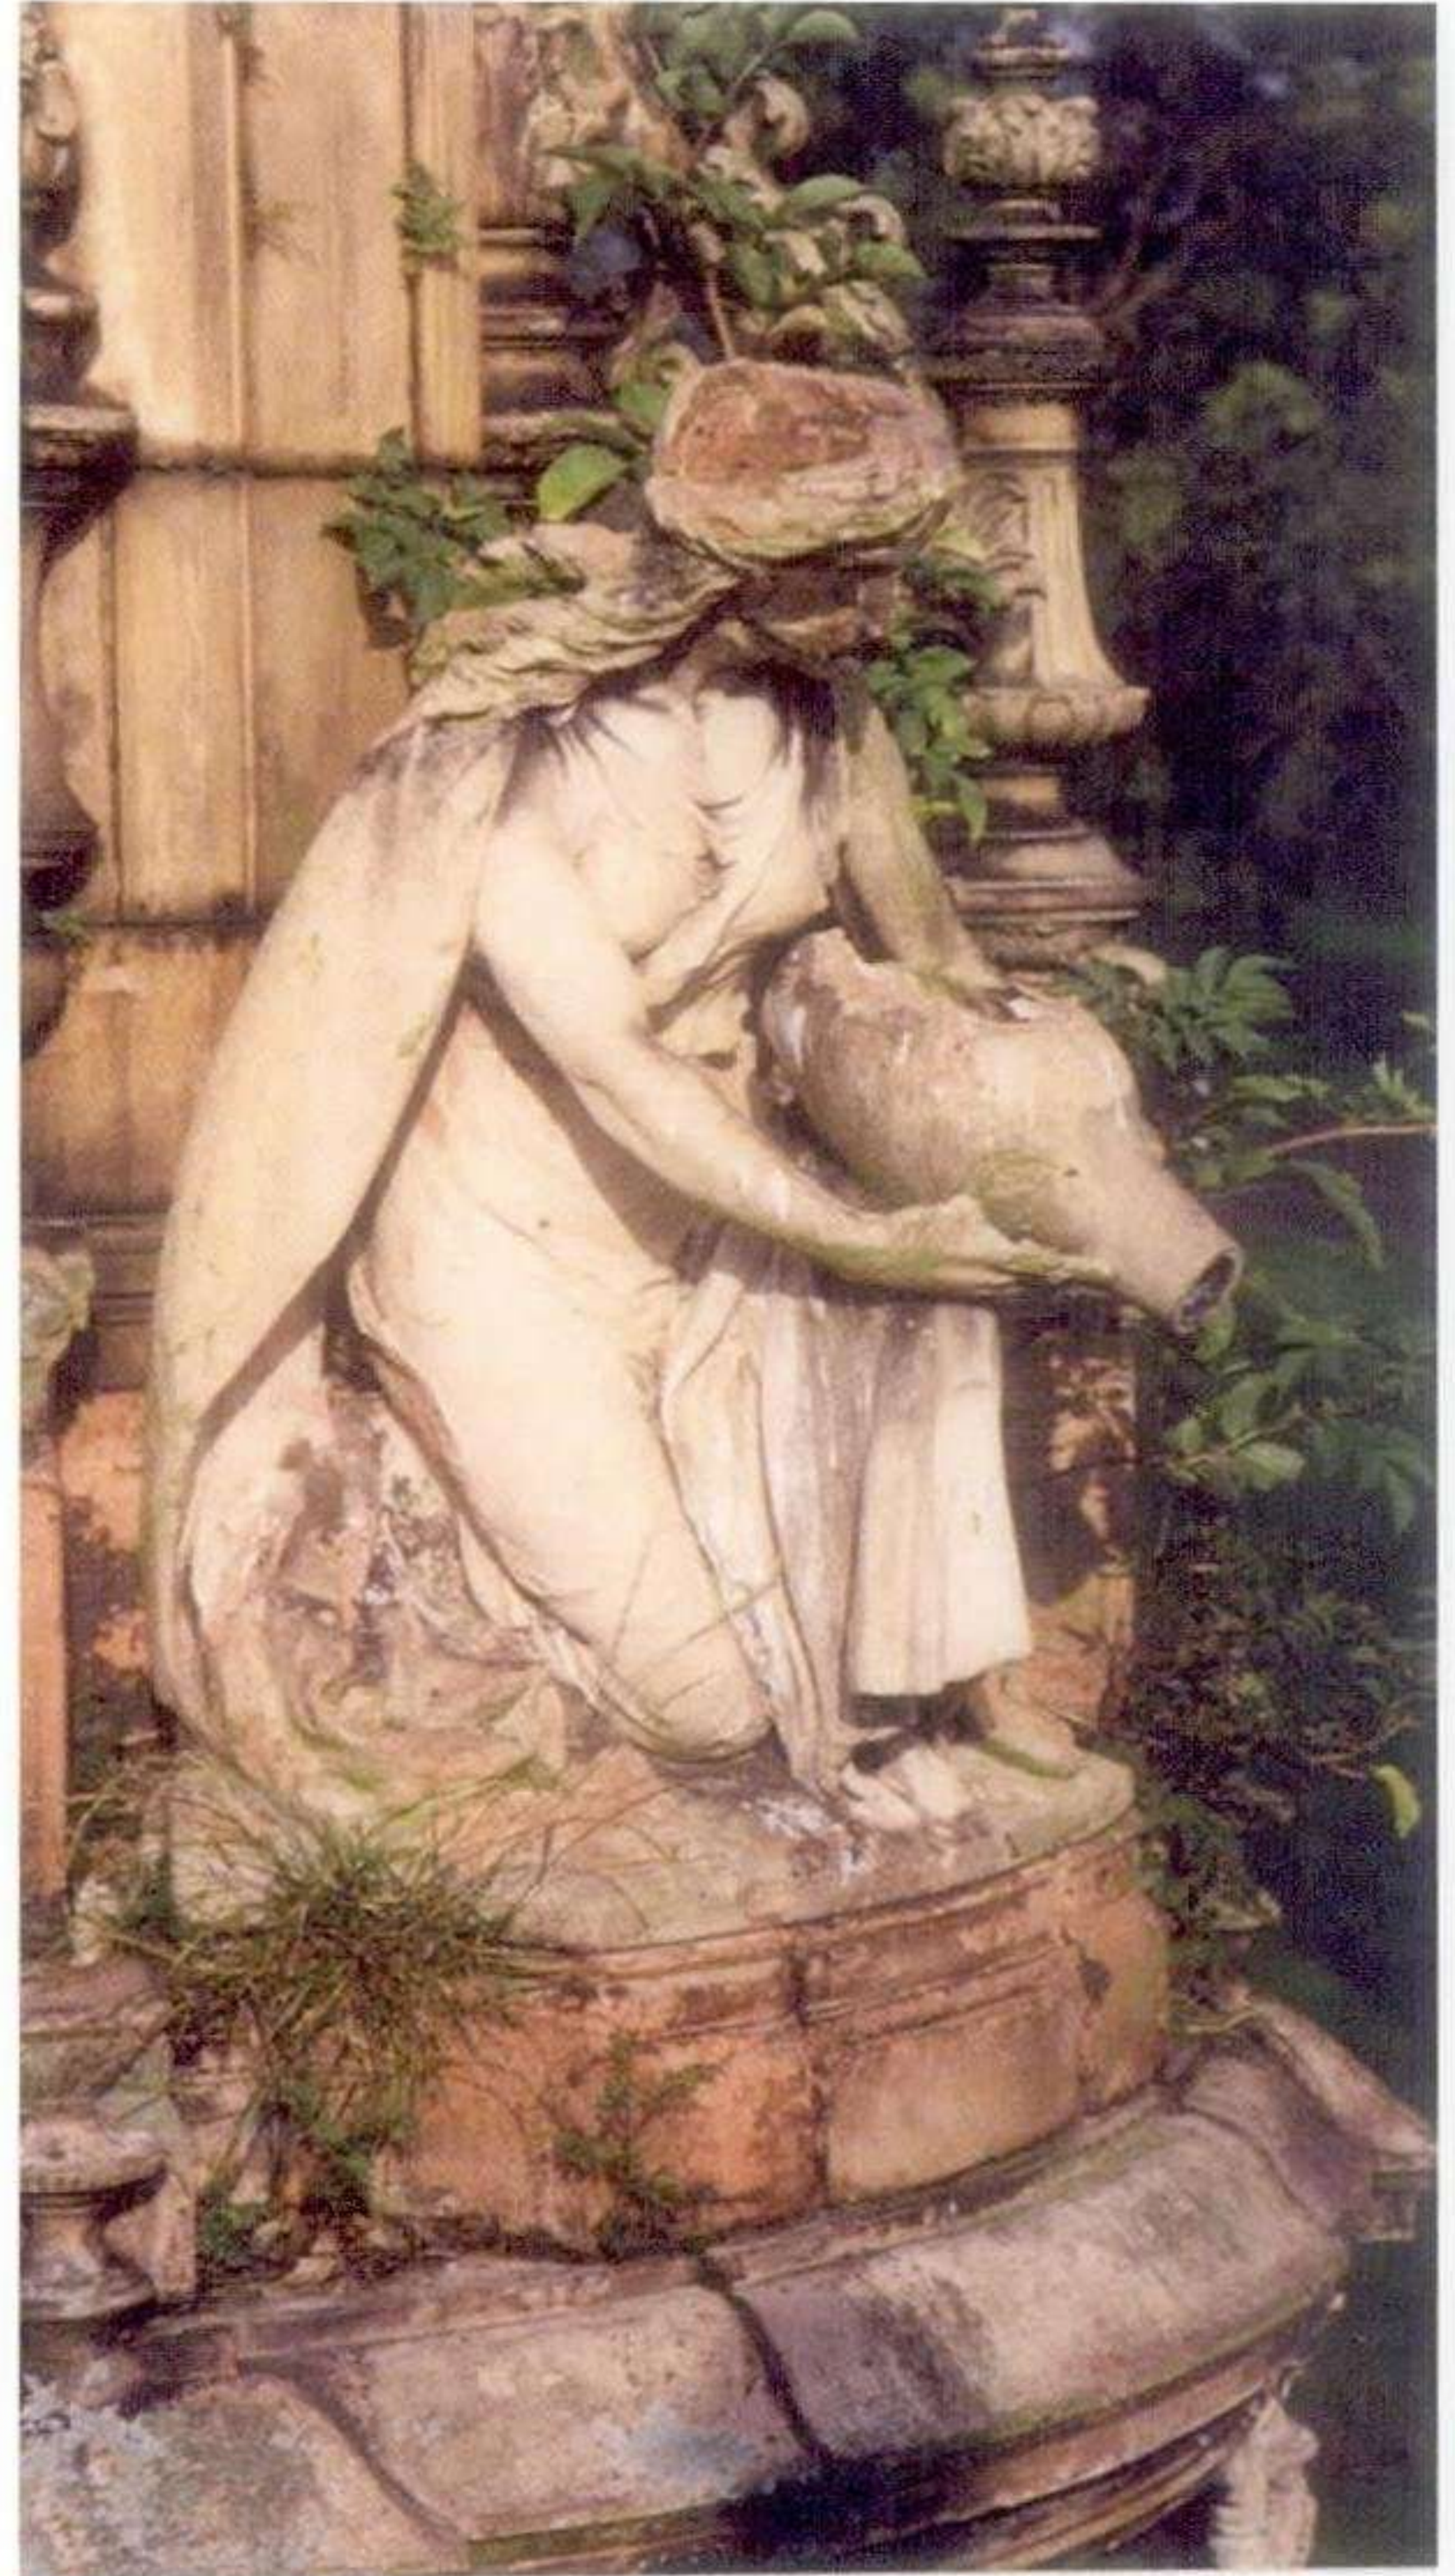
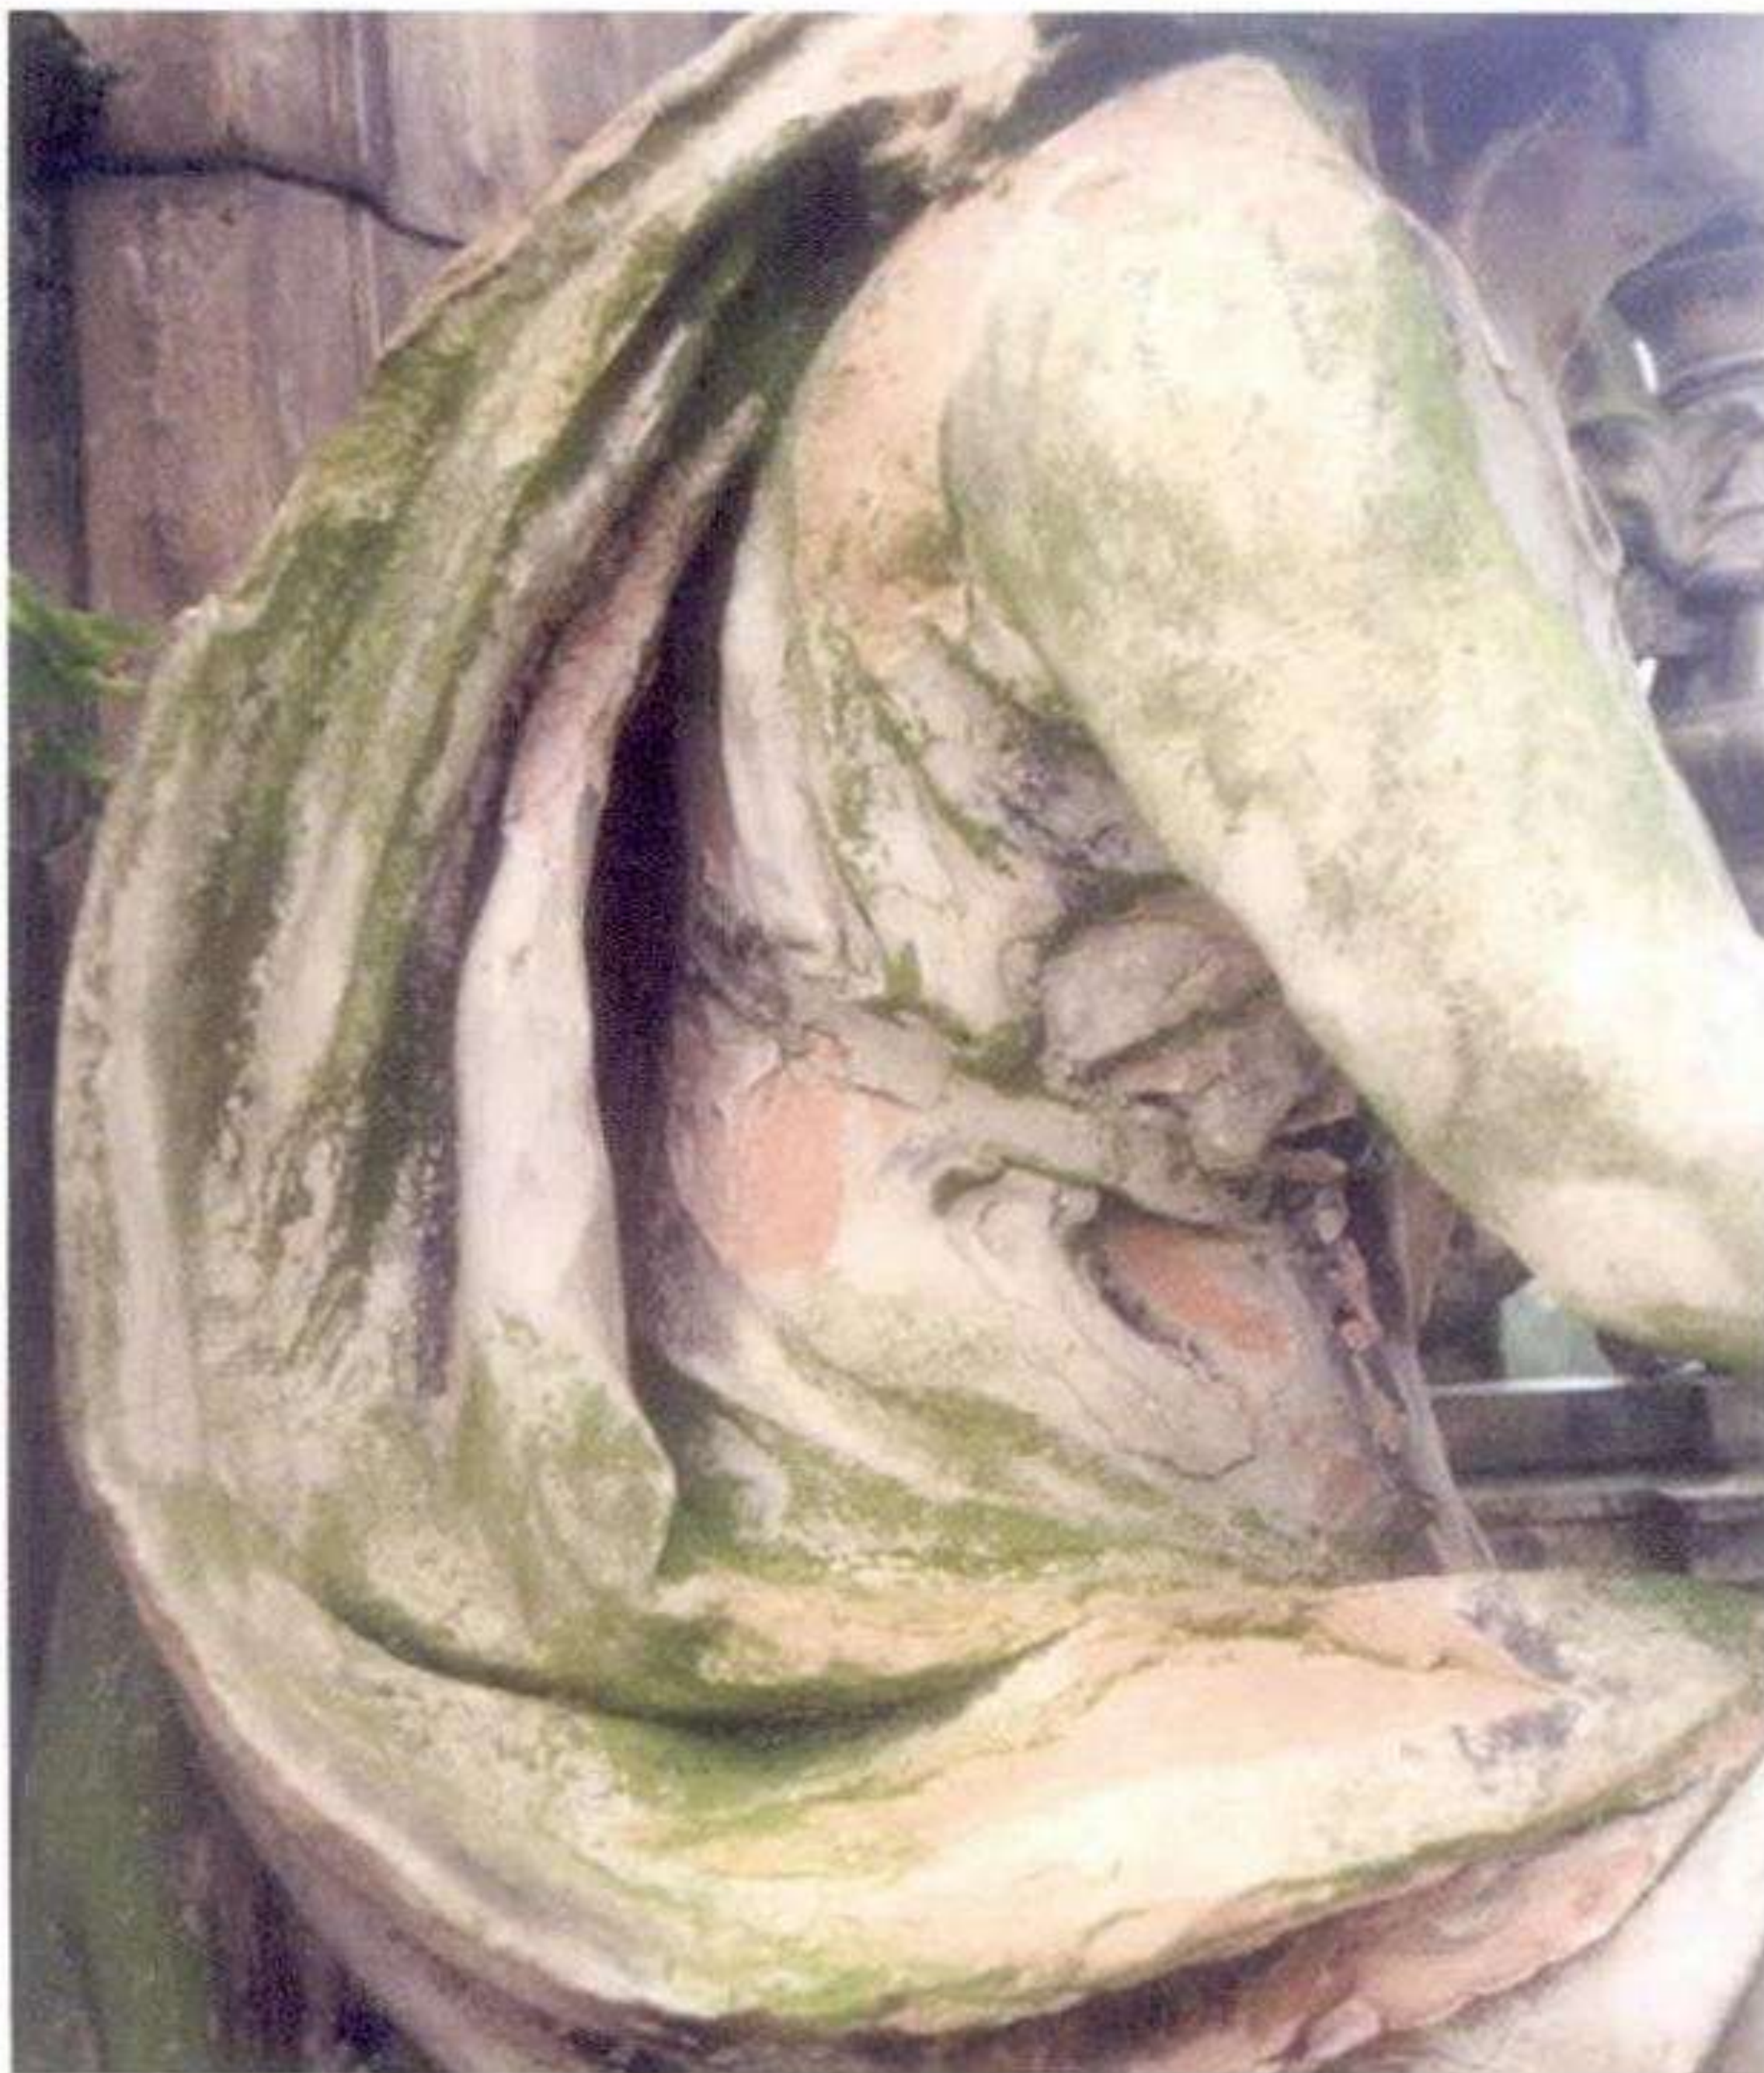
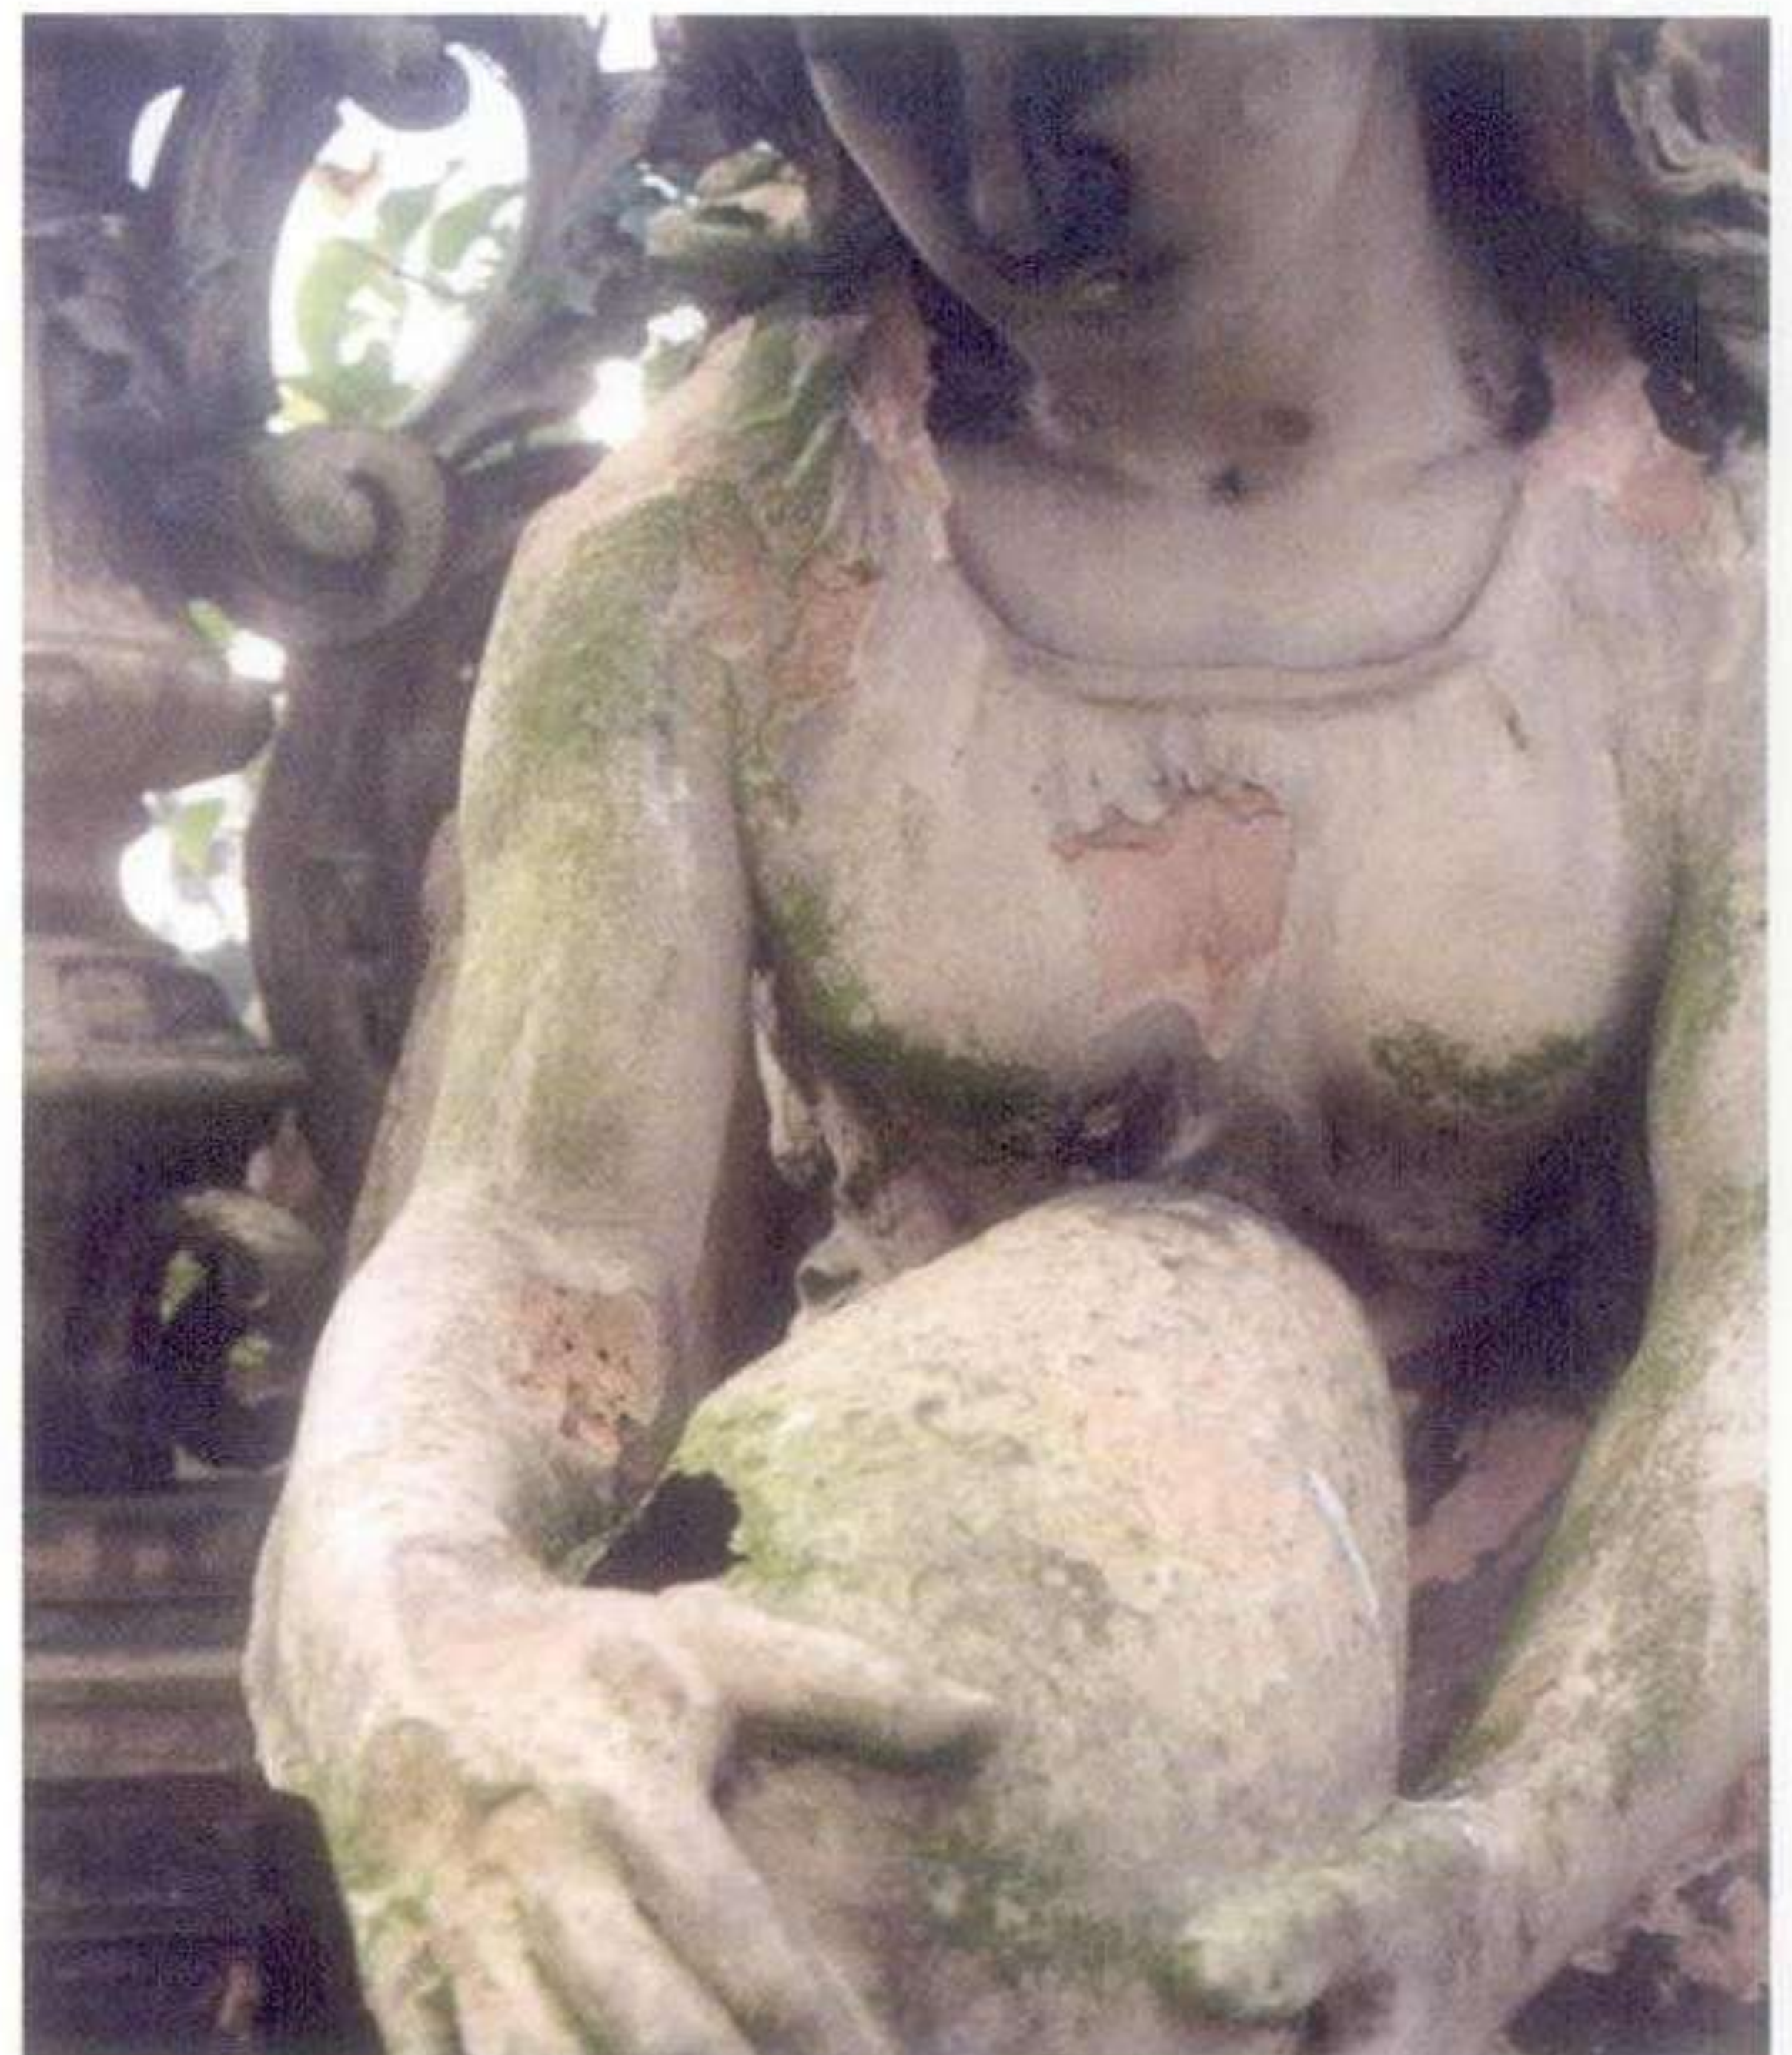
The fact the Doulton Fountain only operated originally during four of the warmer months of the year would have reduced the amount of damage caused due to frost action and water saturation of the terracotta. There is, never the less, widespread deterioration due to under firing alone.

Details of the deteriorated condition of the four Water Bearers. Fracturing, delamination, frost damage and surface granulation were widespread. (All: Nicola Ashurst)
