THE
INVESTIGATION,
REPAIR AND
CONSERVATION
OF THE
DOULTON
FOUNTAIN,
GLASGOW GREEN

2 | Case
Study

TECHNICAL
CONSERVATION
GROUP

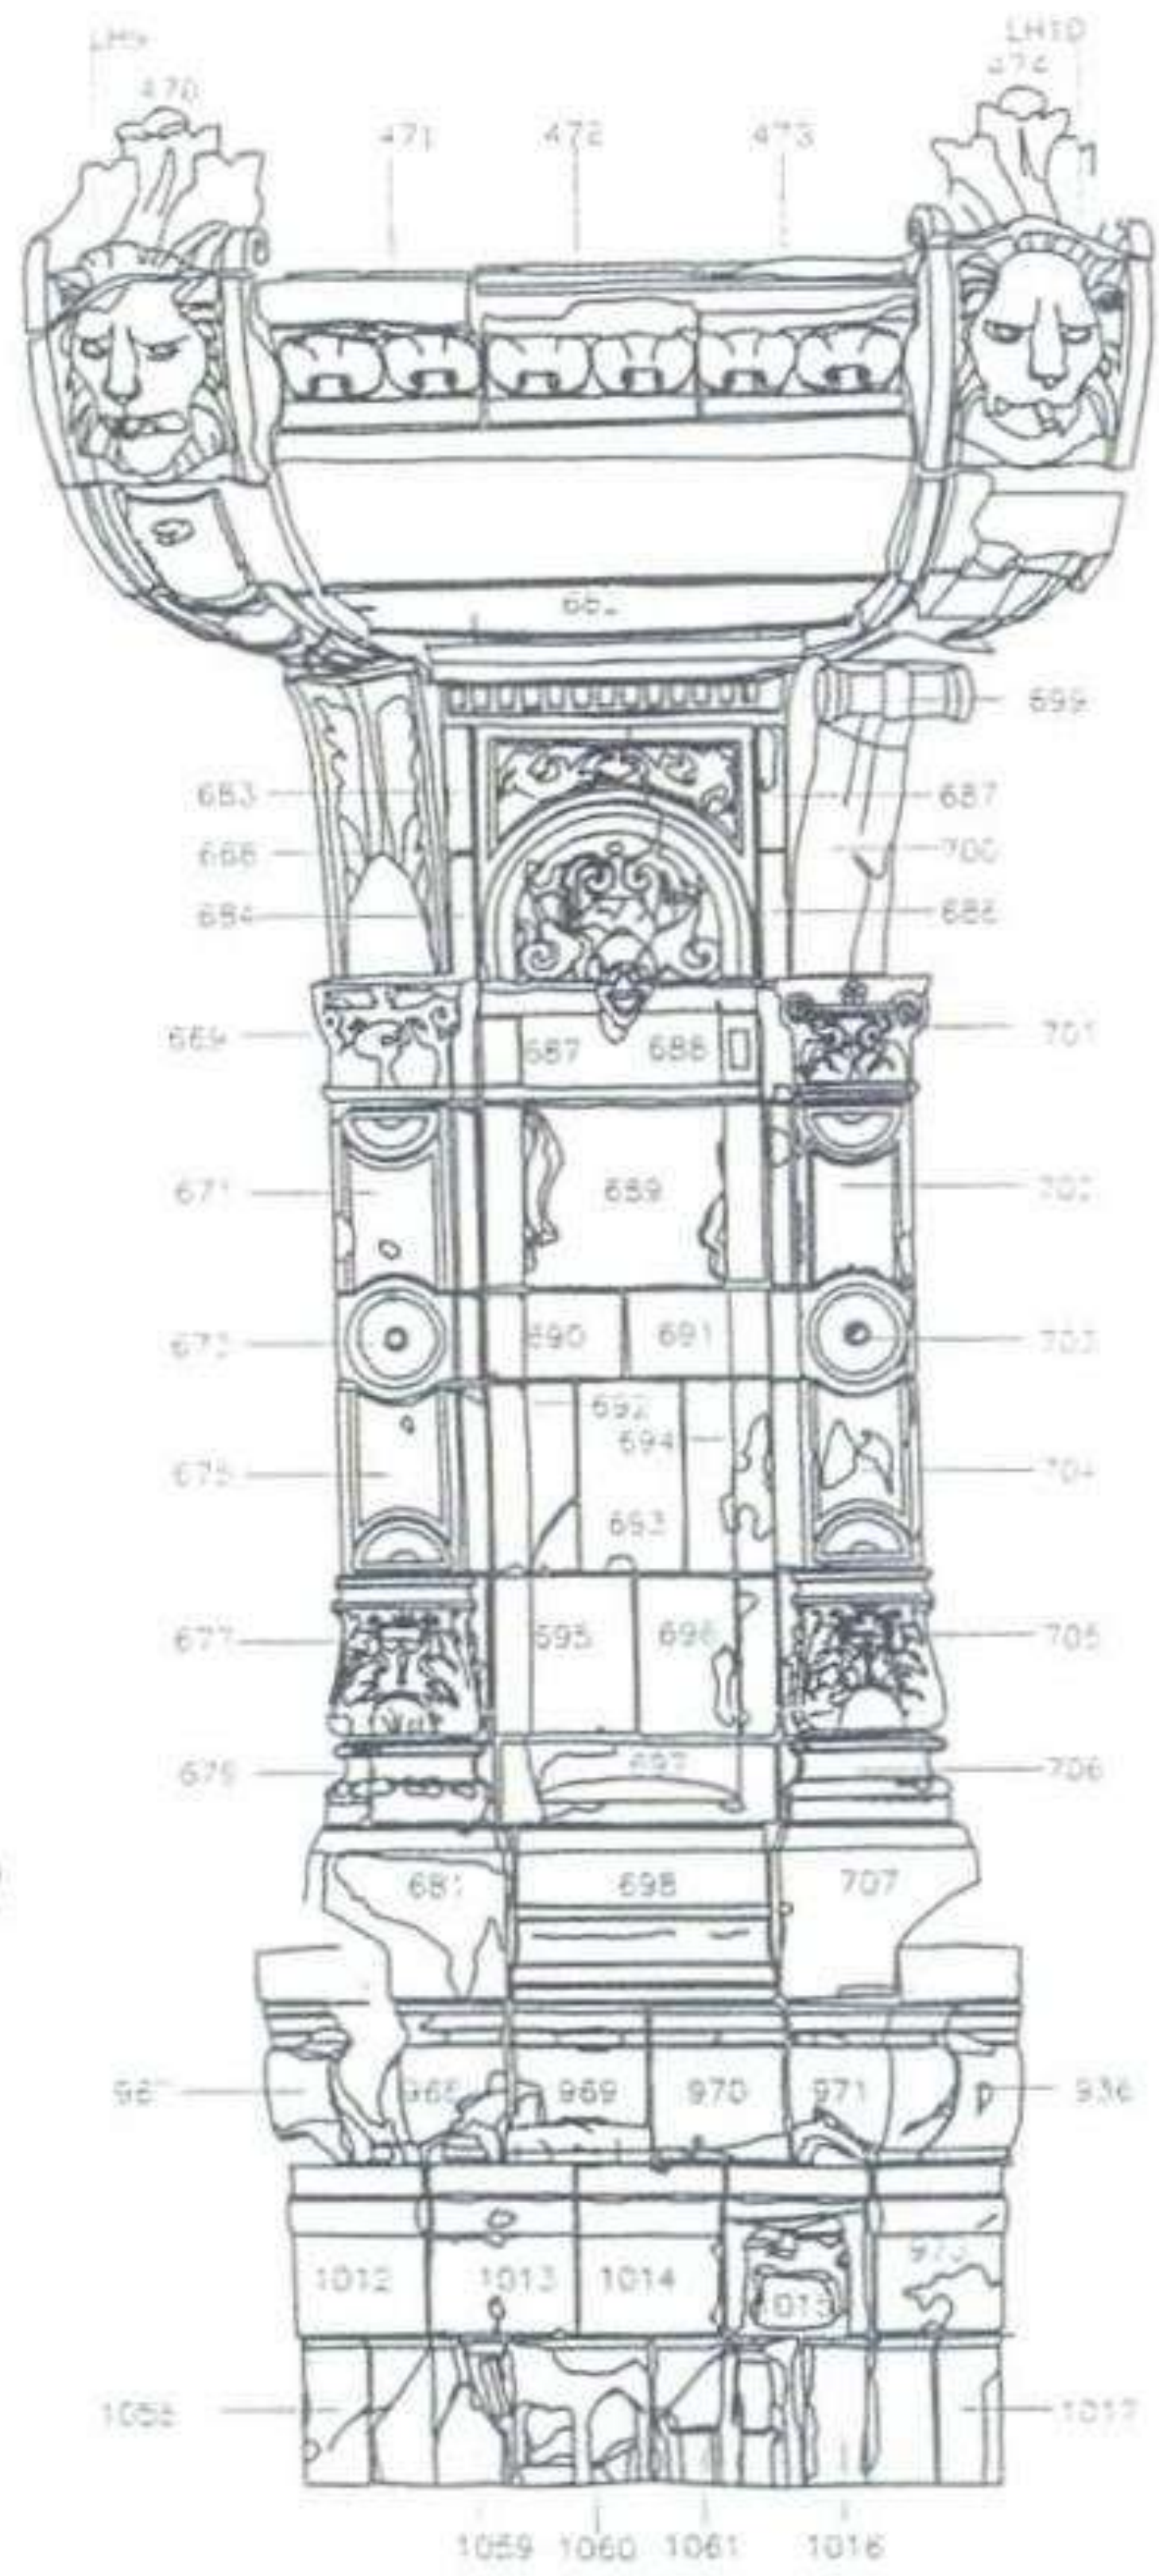
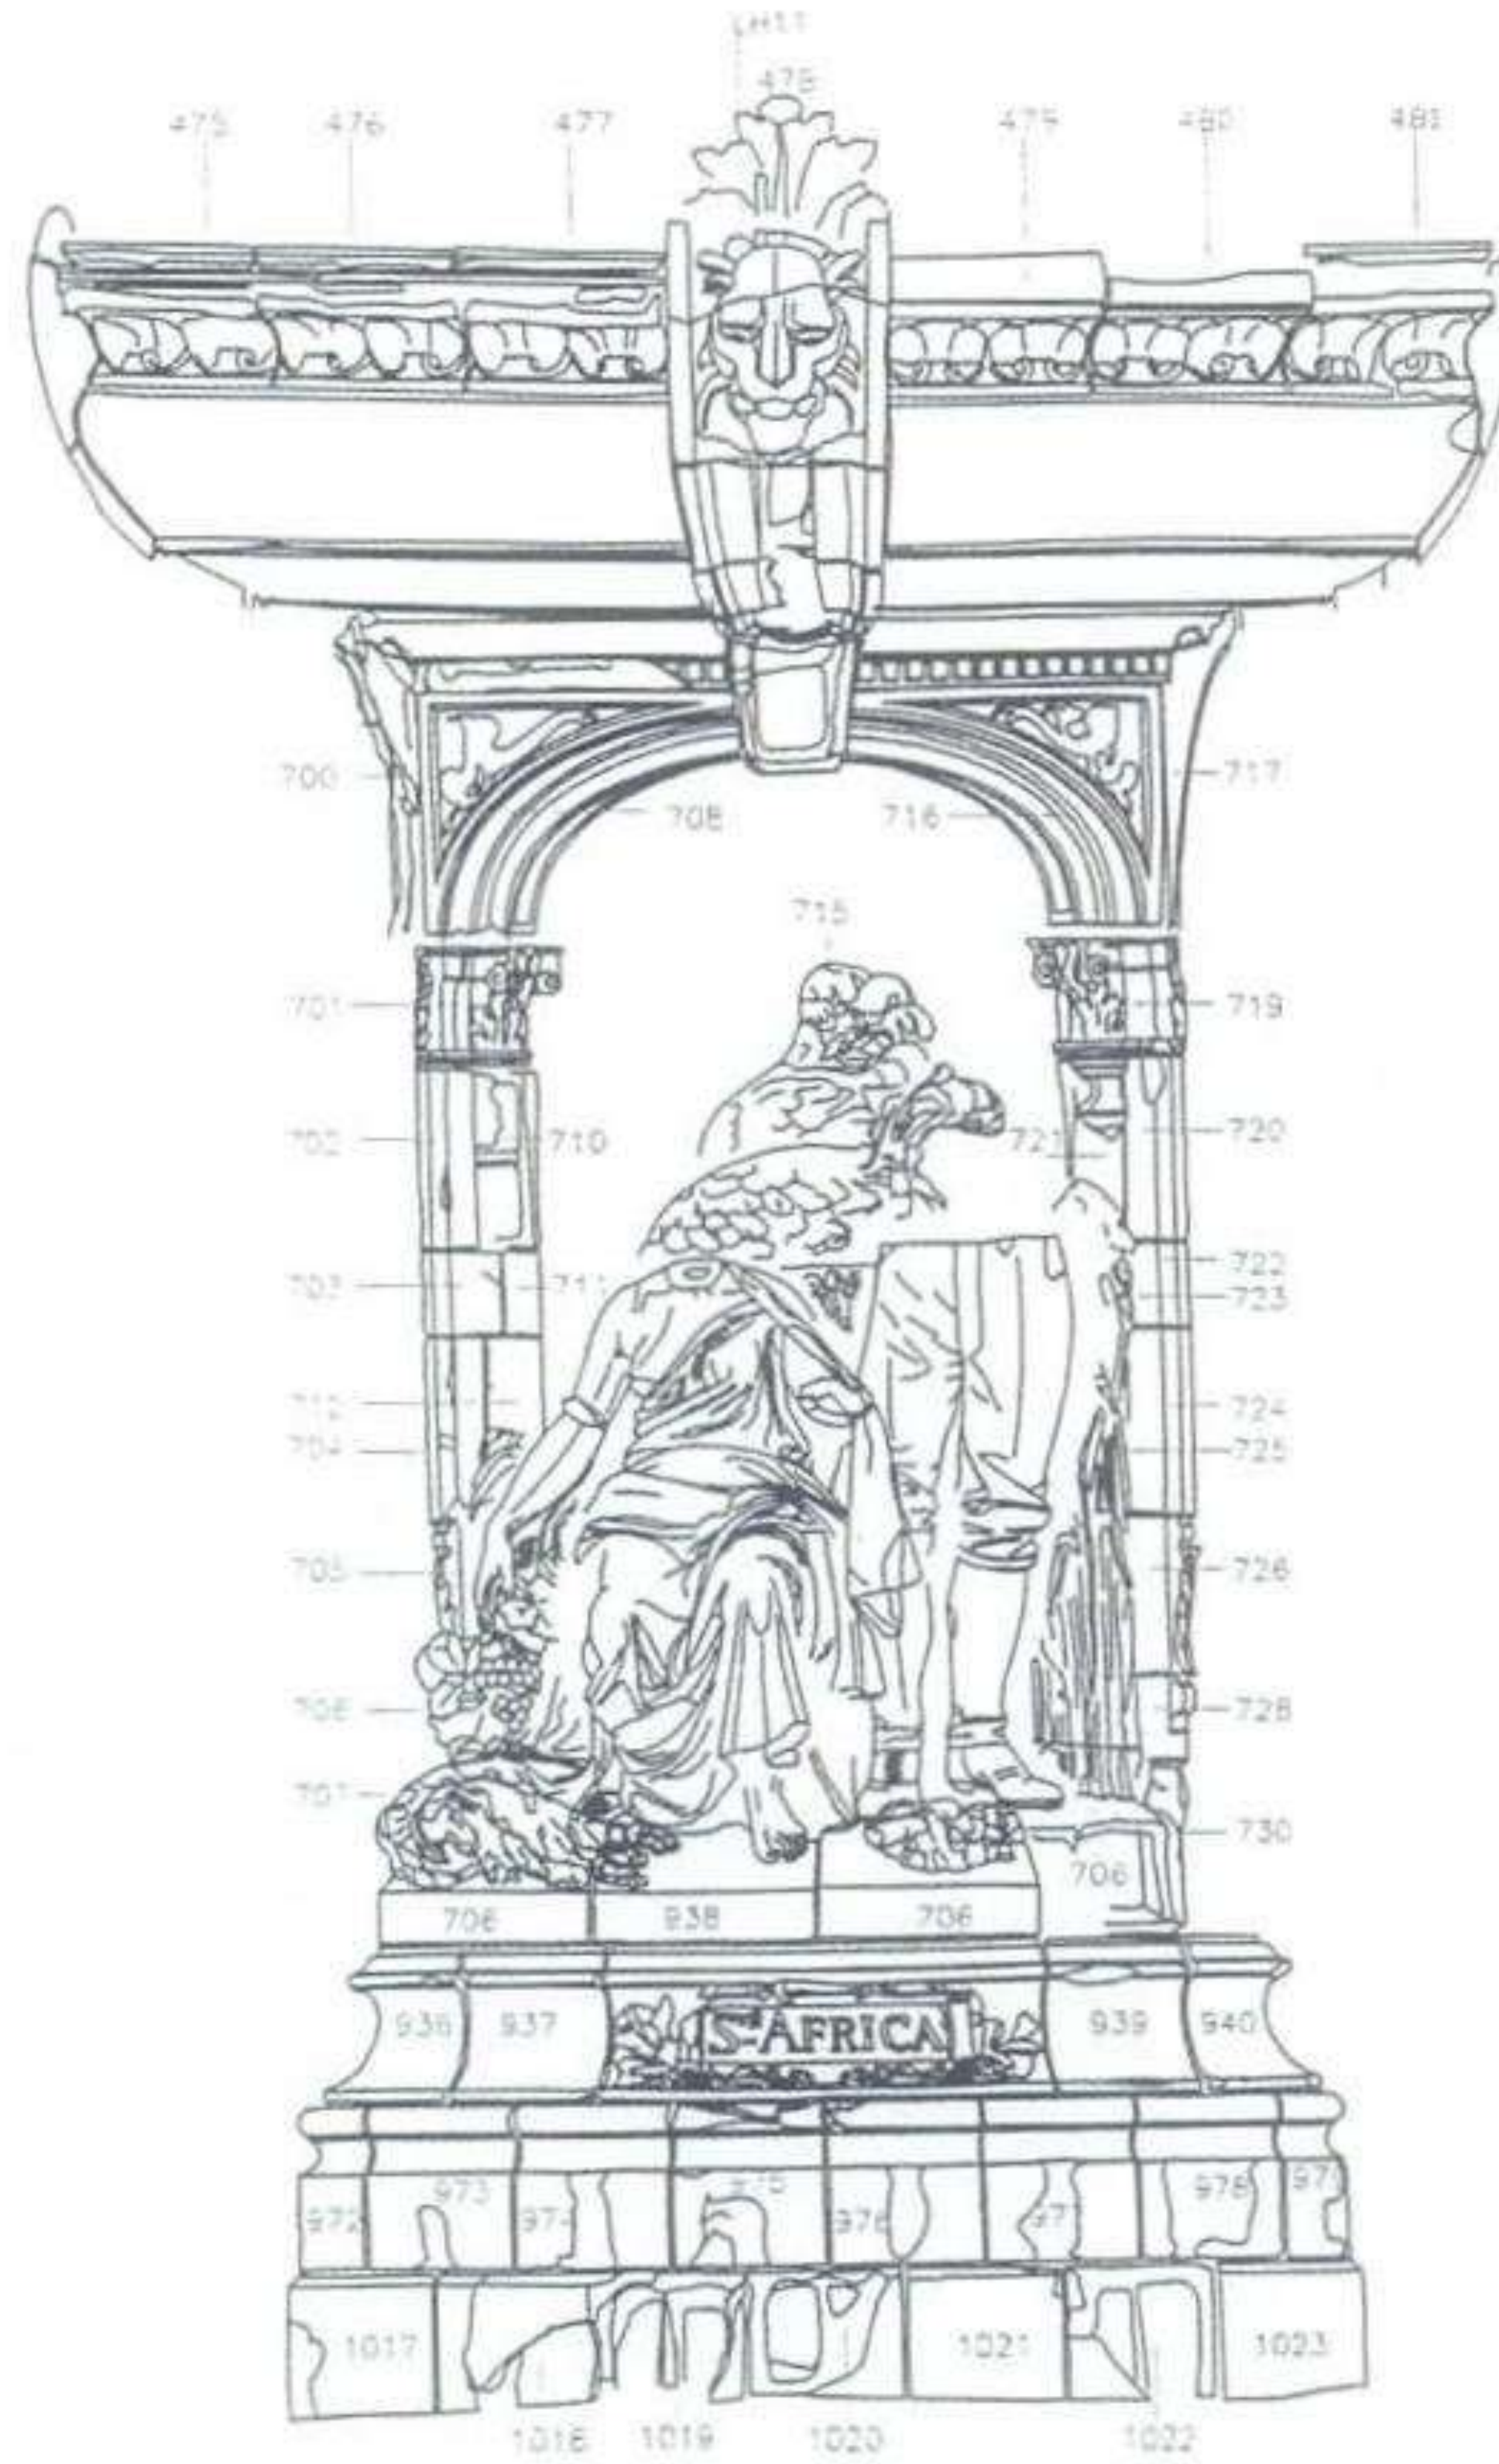
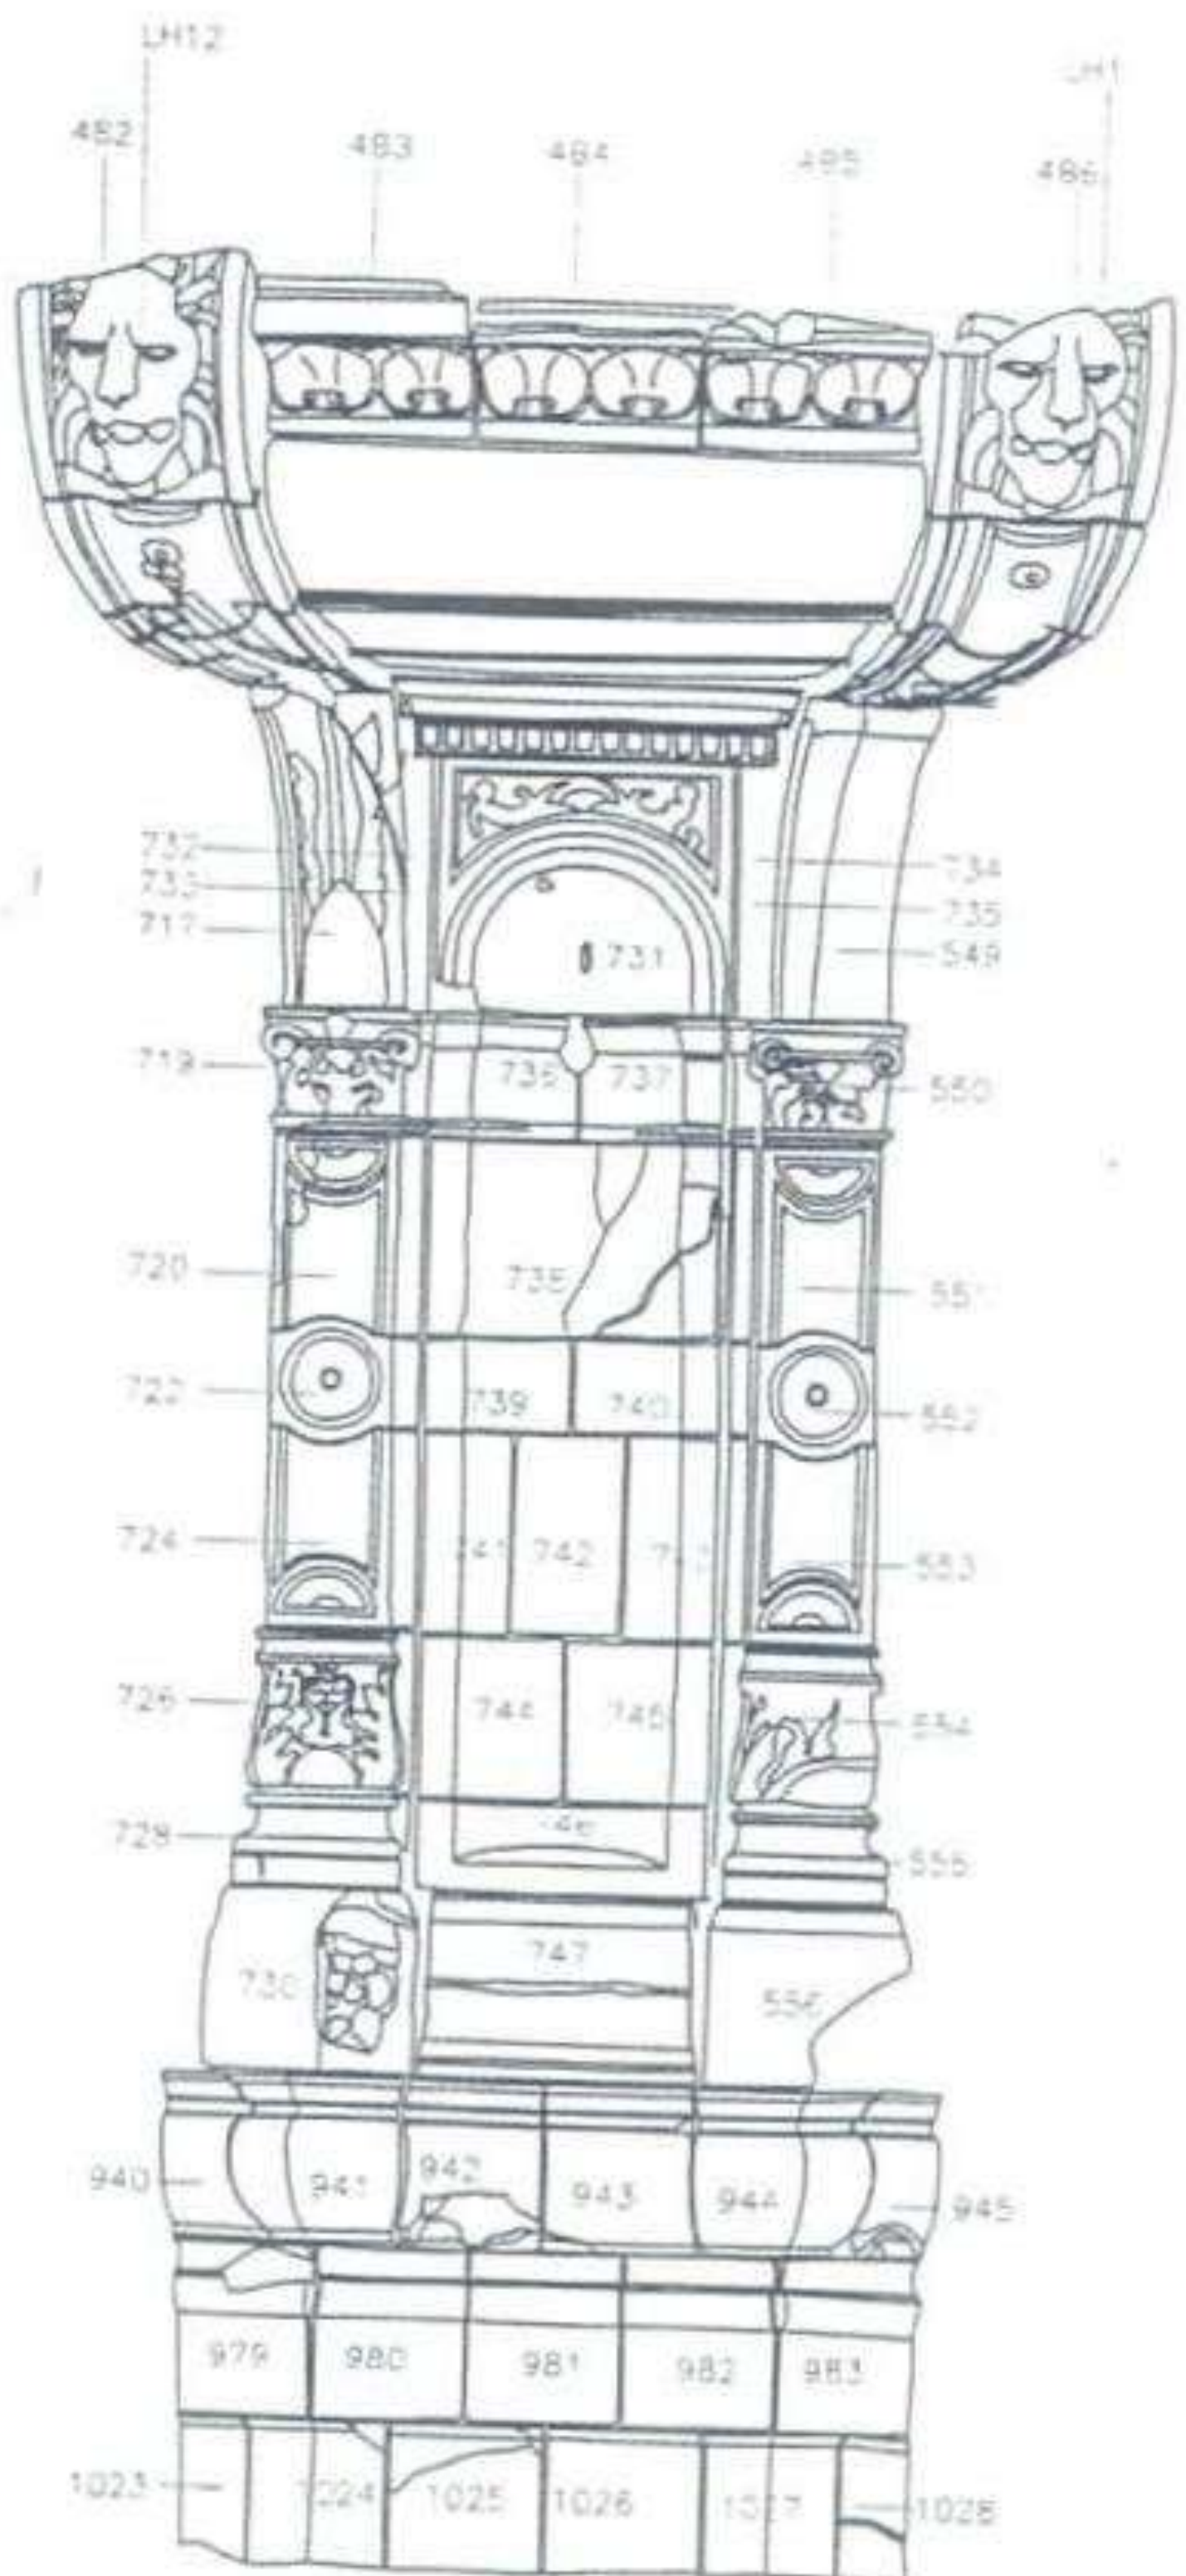
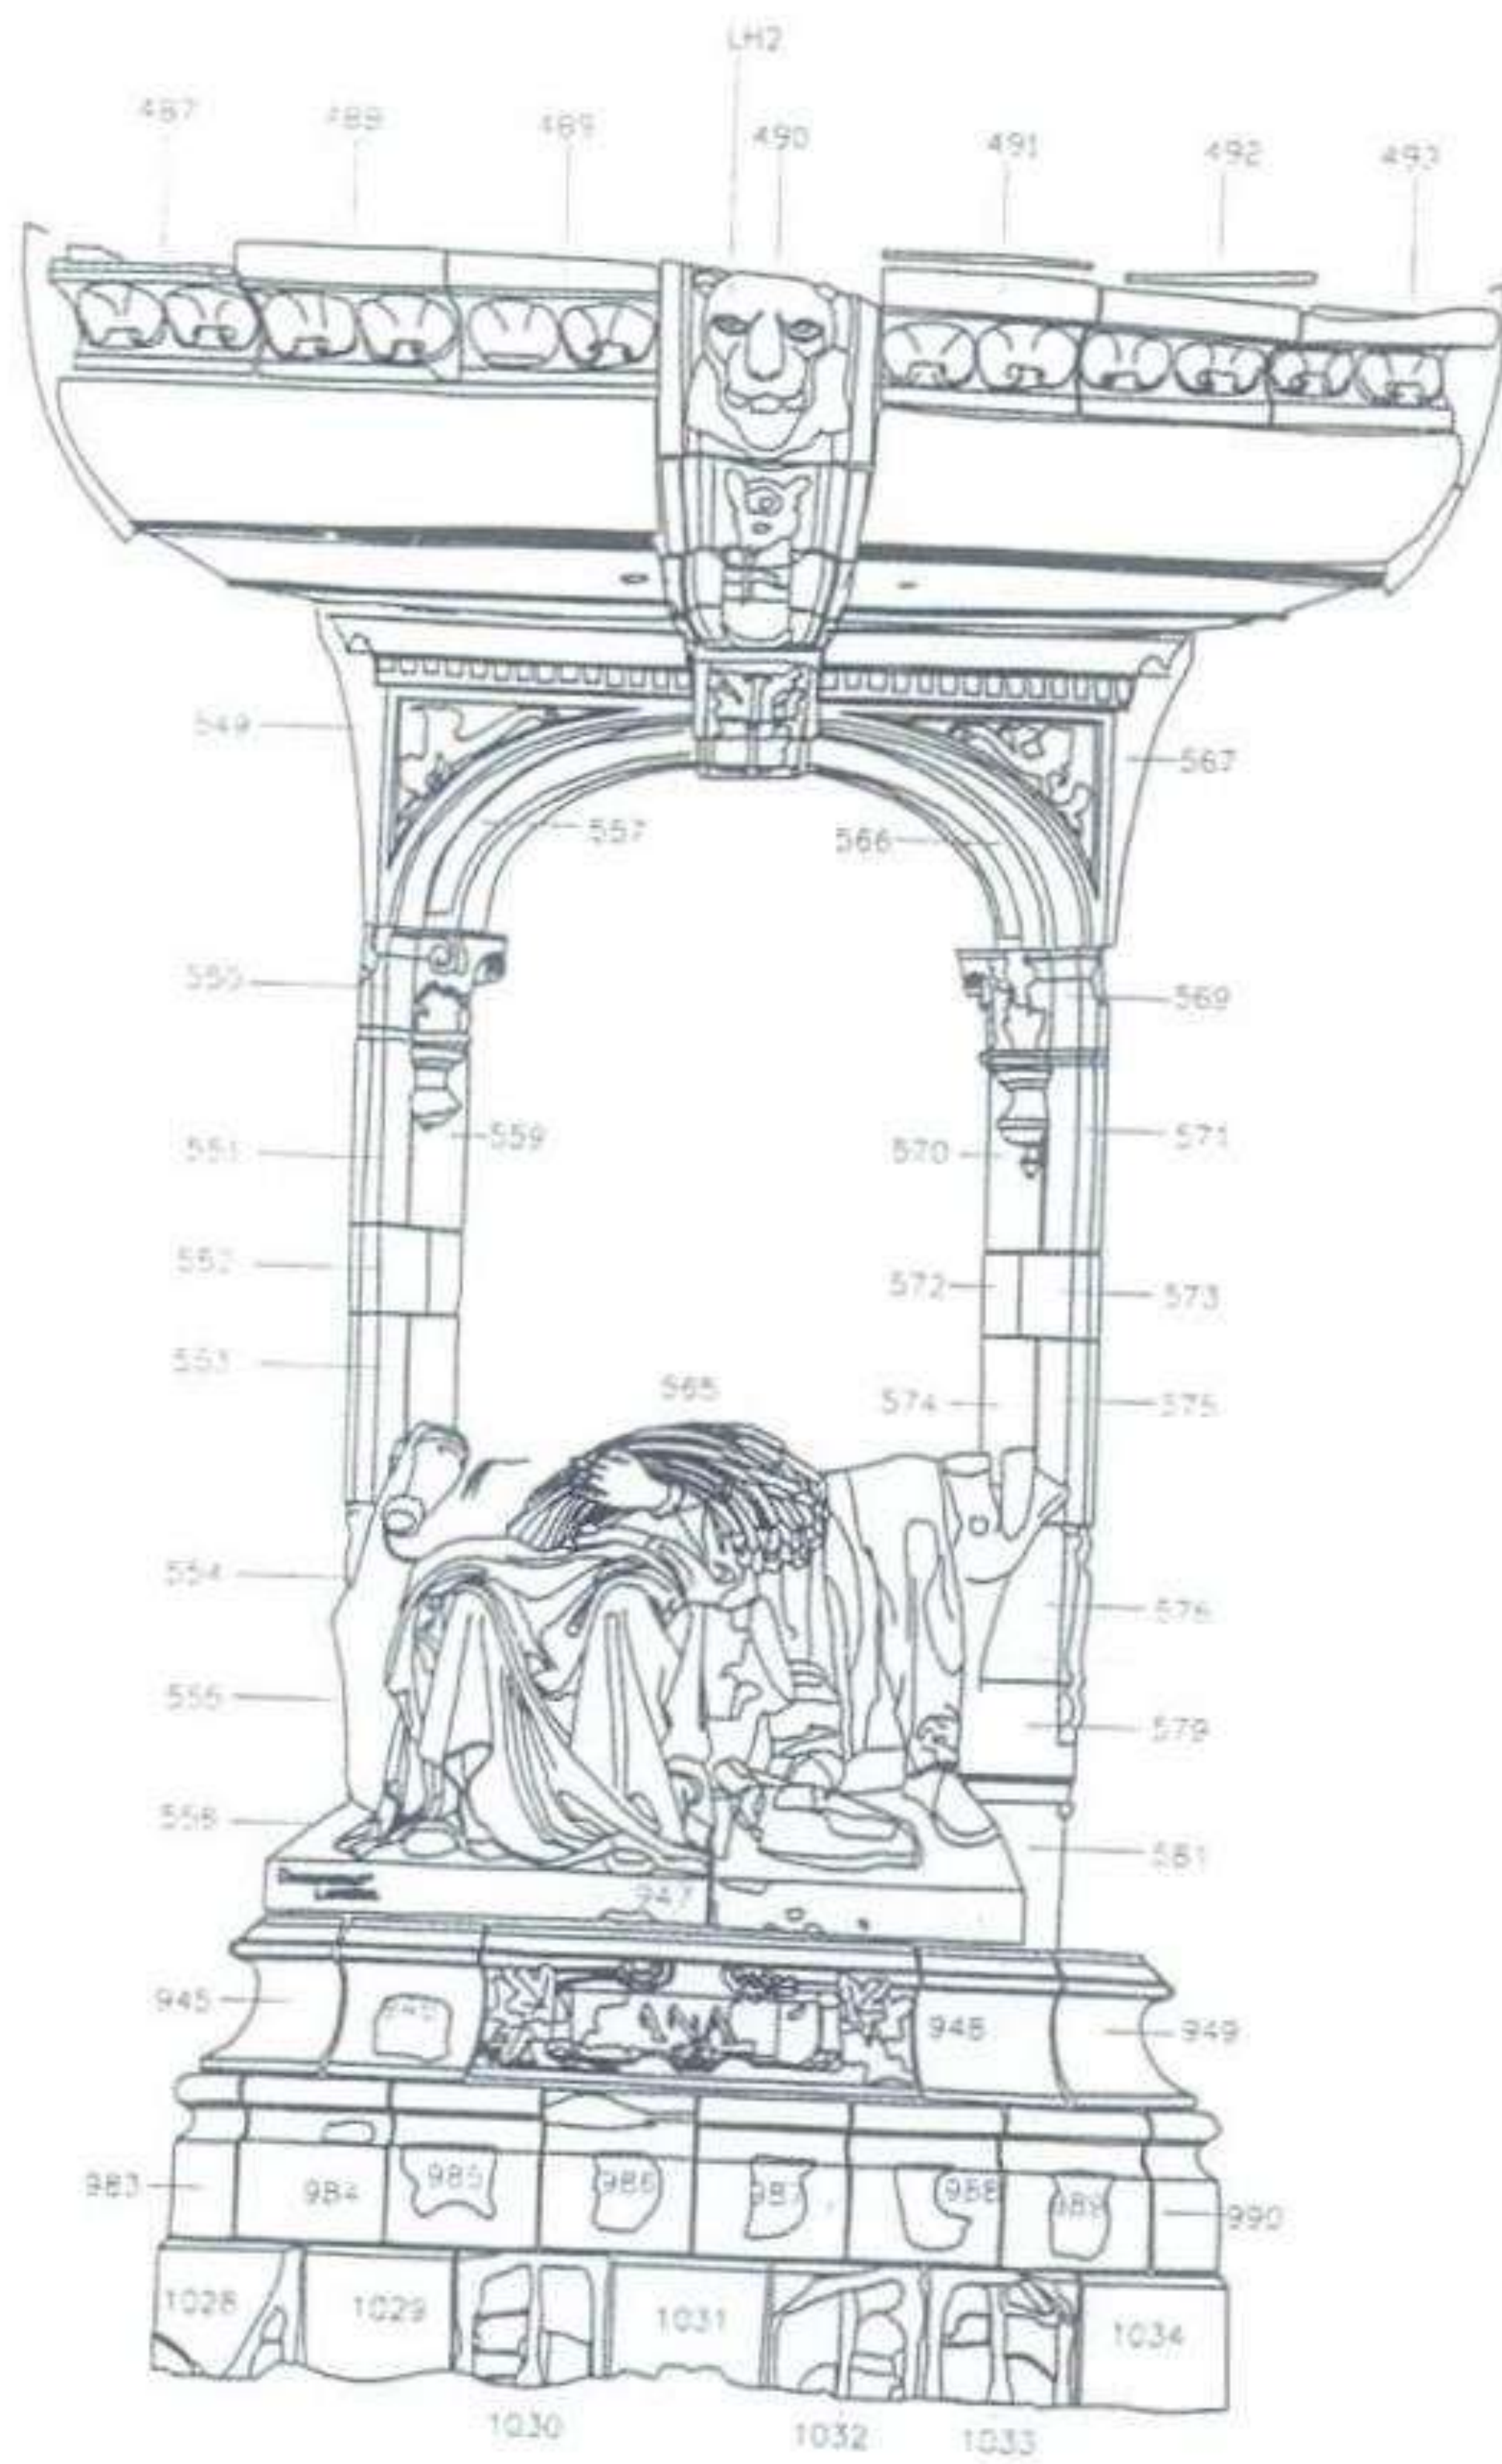
Architect's drawings of some of the block repairs scheduled for niches and piers between the colonial groups.

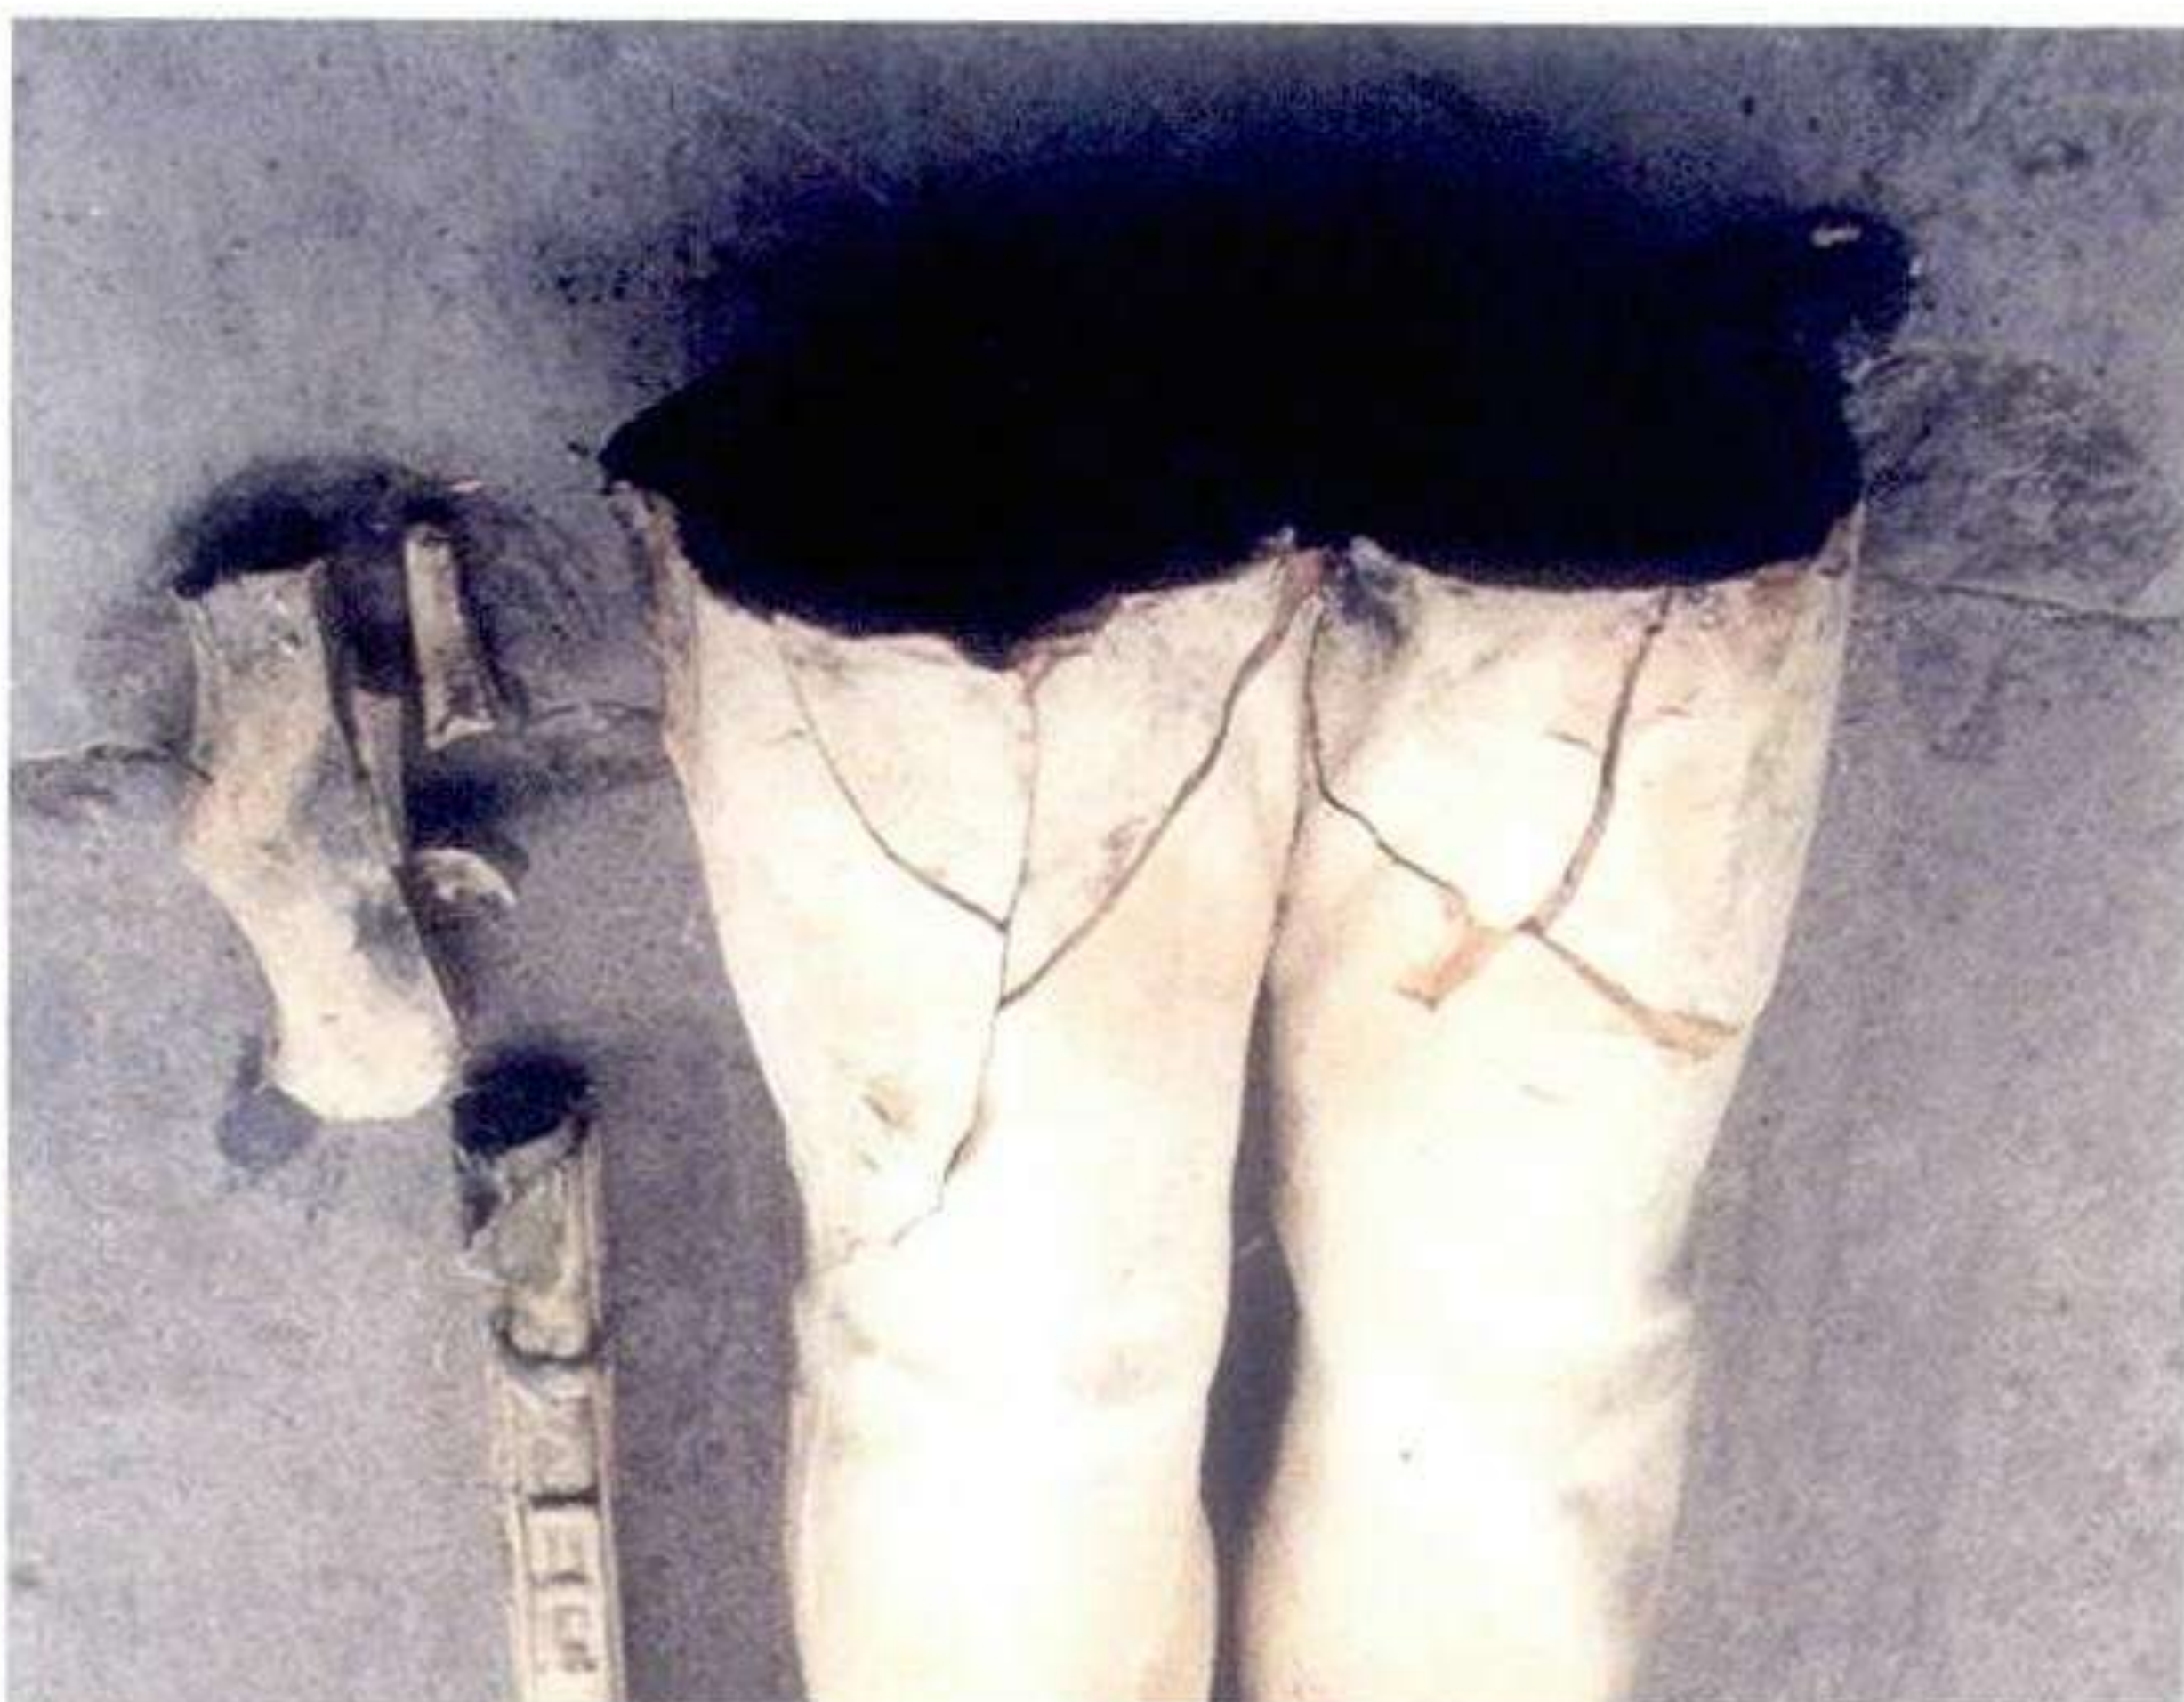
- The head of the Royal Irish Fusilier had been detached from his torso by vandals and could not be located. Localised weathering damage had taken place to his shoulders. The butt and bayonet off his gun were missing.

The damaged legs and gun of the Royal Irish Fusilier. (Nicola Ashurst)

- The Royal Irish Fusilier required a new head in terracotta, localised repairs to his torso, legs and base and replacement of the bayonet and other missing sections to his gun, in terracotta.
- The head, torso, legs and face of the Black Watch Highlander required localised repairs. His bayonet needed to be replaced in terracotta.

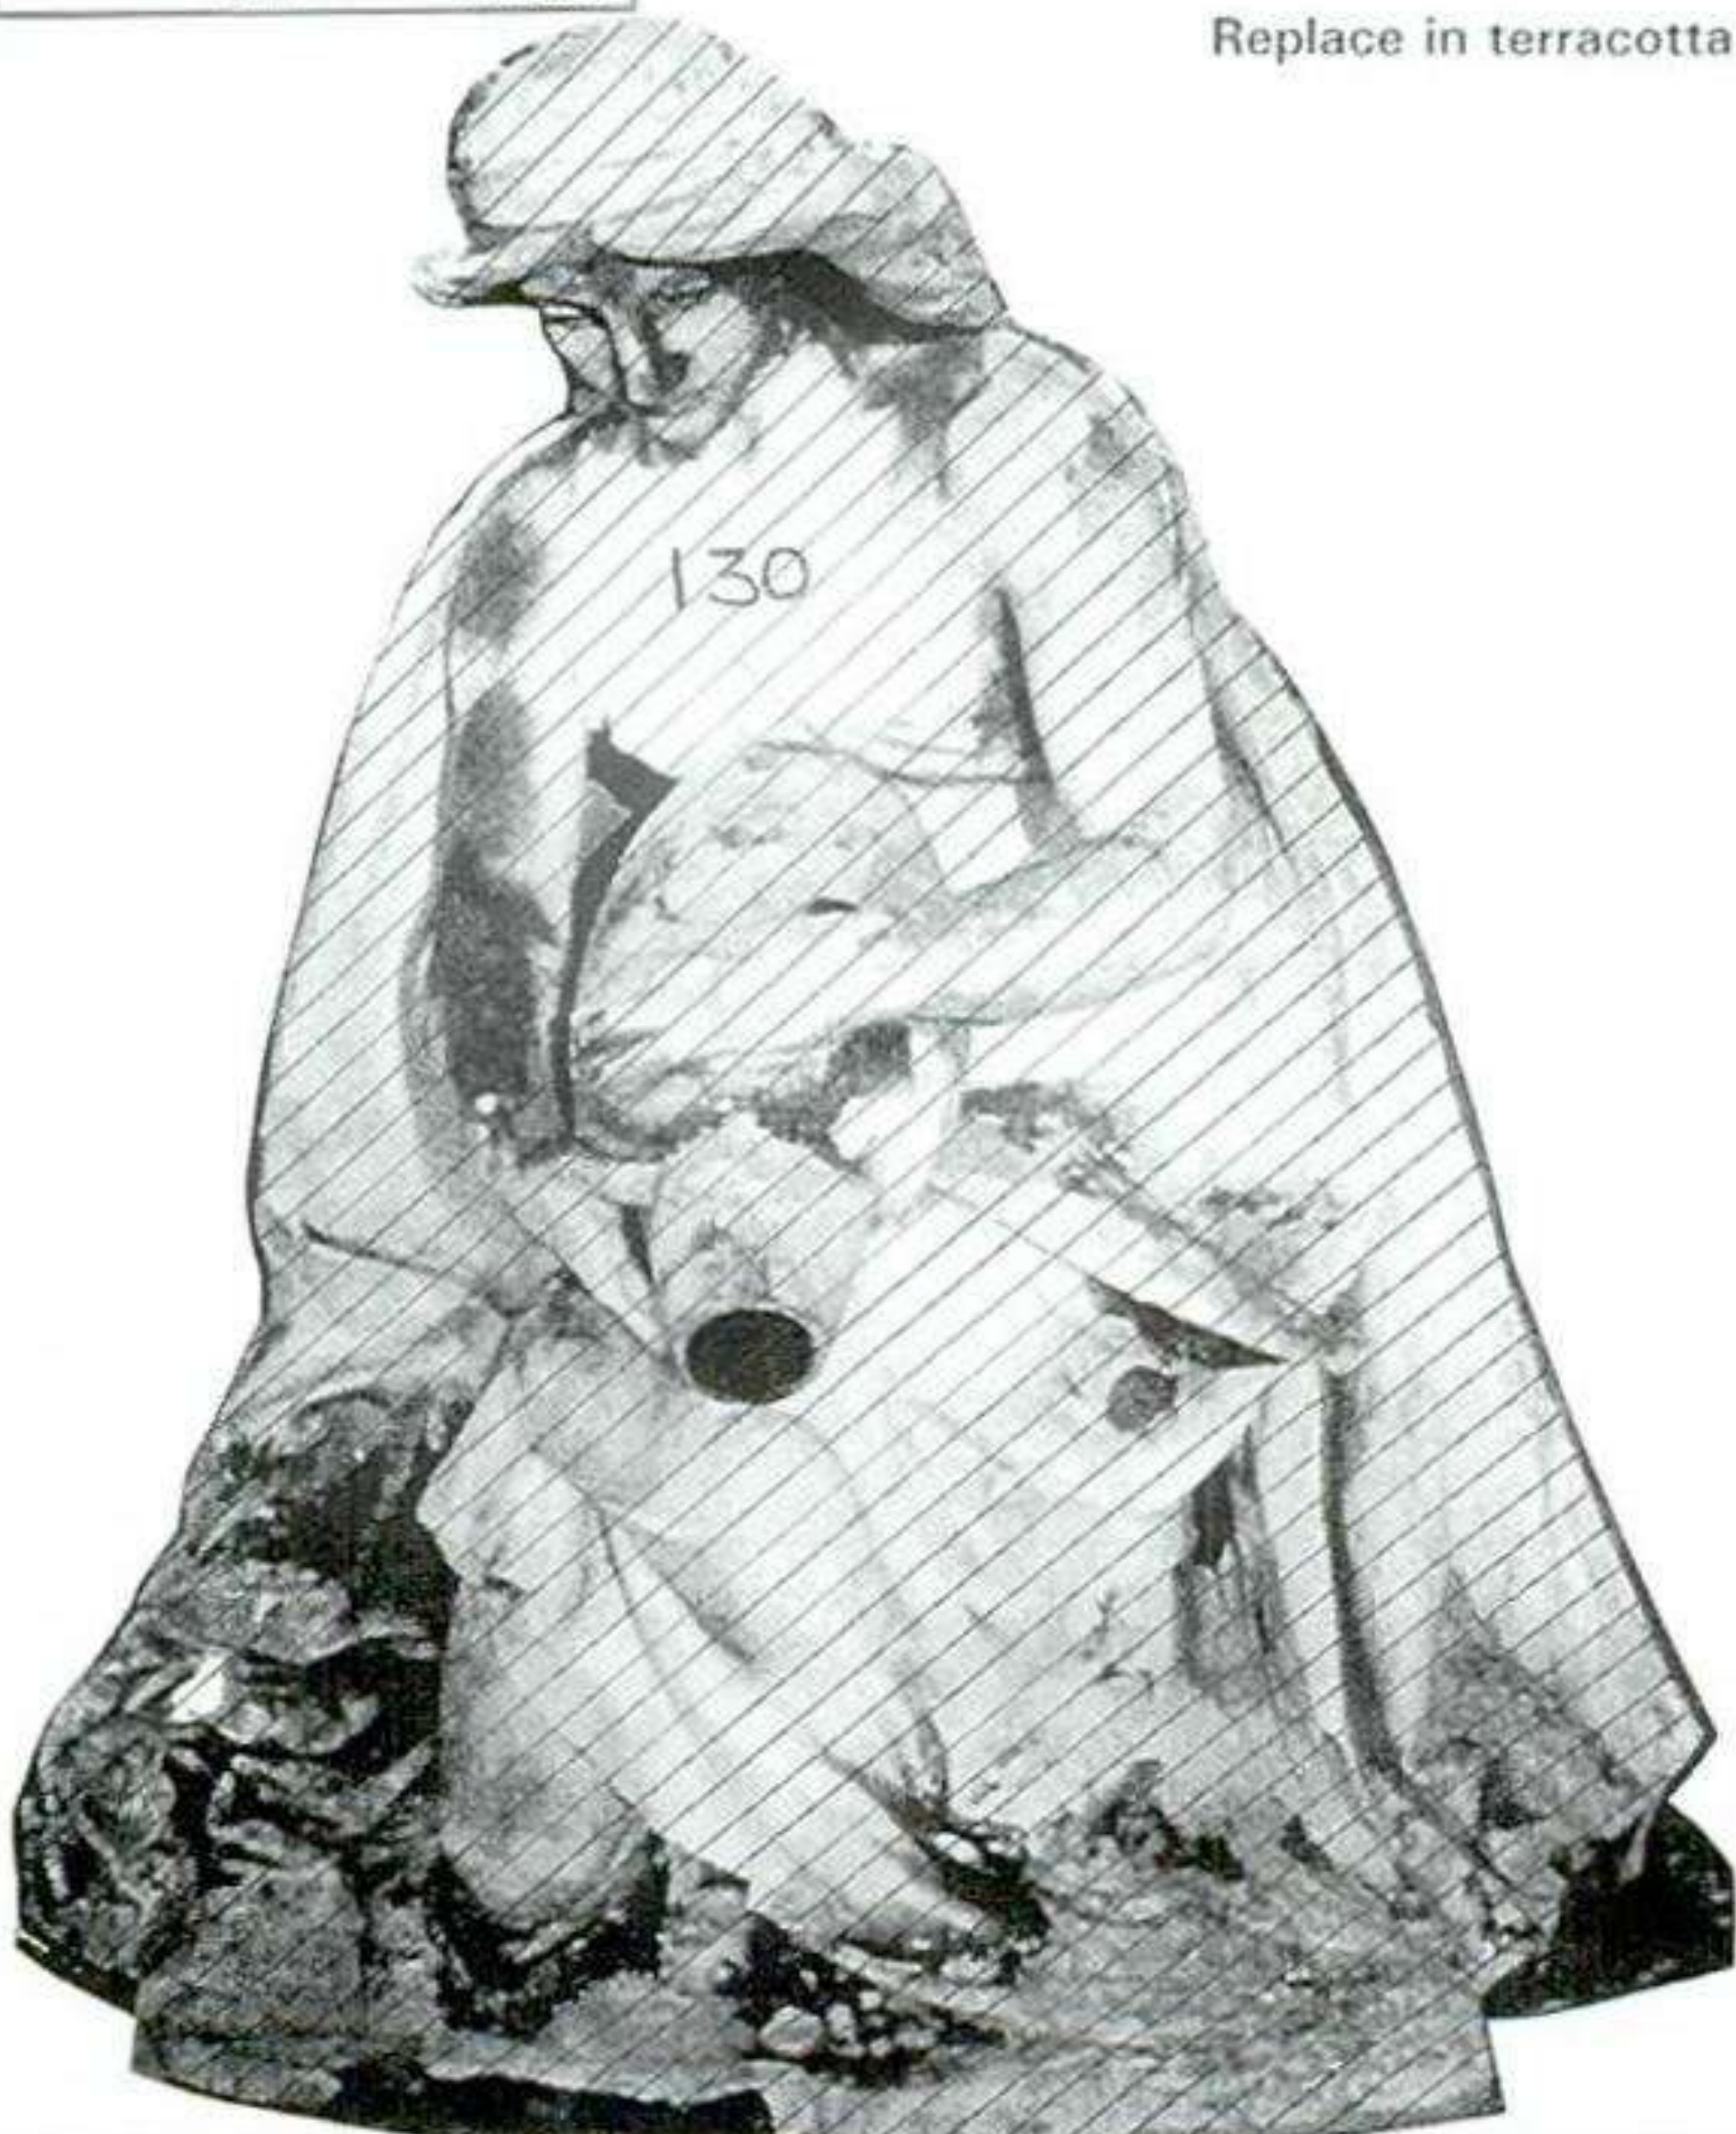
Conservation Strategies for the four Water Bearers. Their extremely poor condition meant they needed to be replaced. (Adriel Consultancy)
