THE
INVESTIGATION,
REPAIR AND
CONSERVATION
OF THE
DOULTON
FOUNTAIN,
GLASGOW GREEN

2 | Case
Study

TECHNICAL
CONSERVATION
GROUP

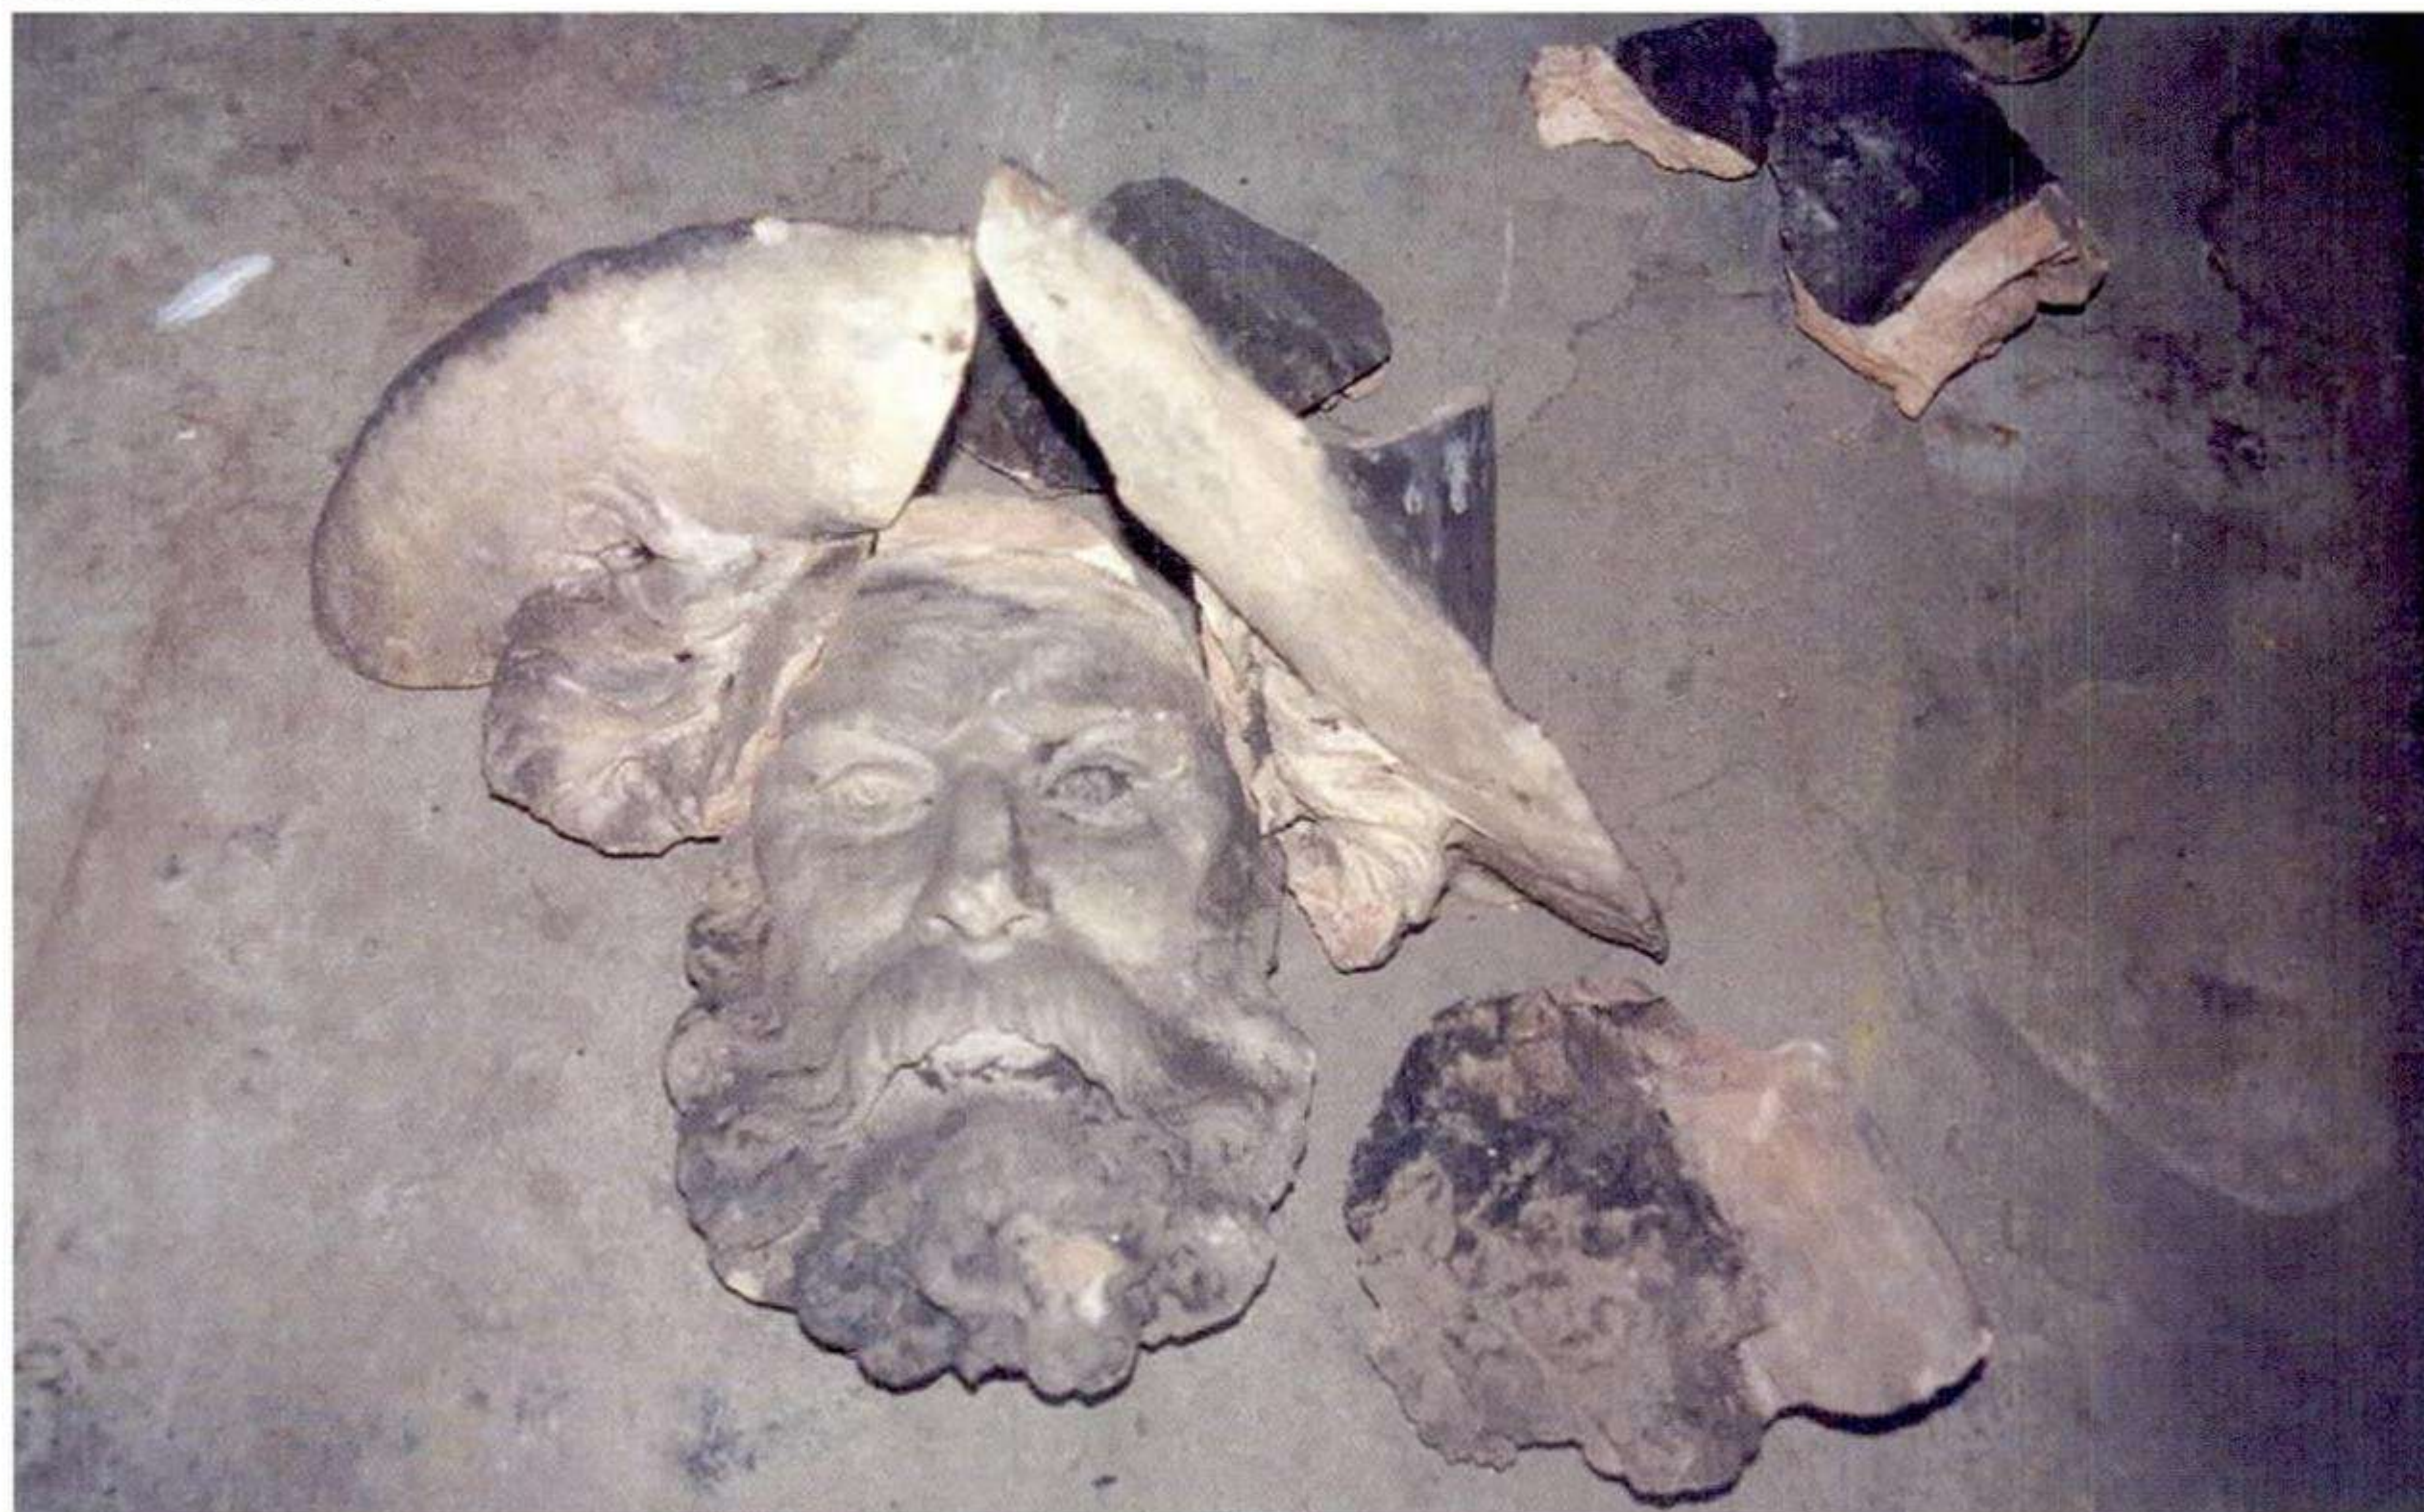
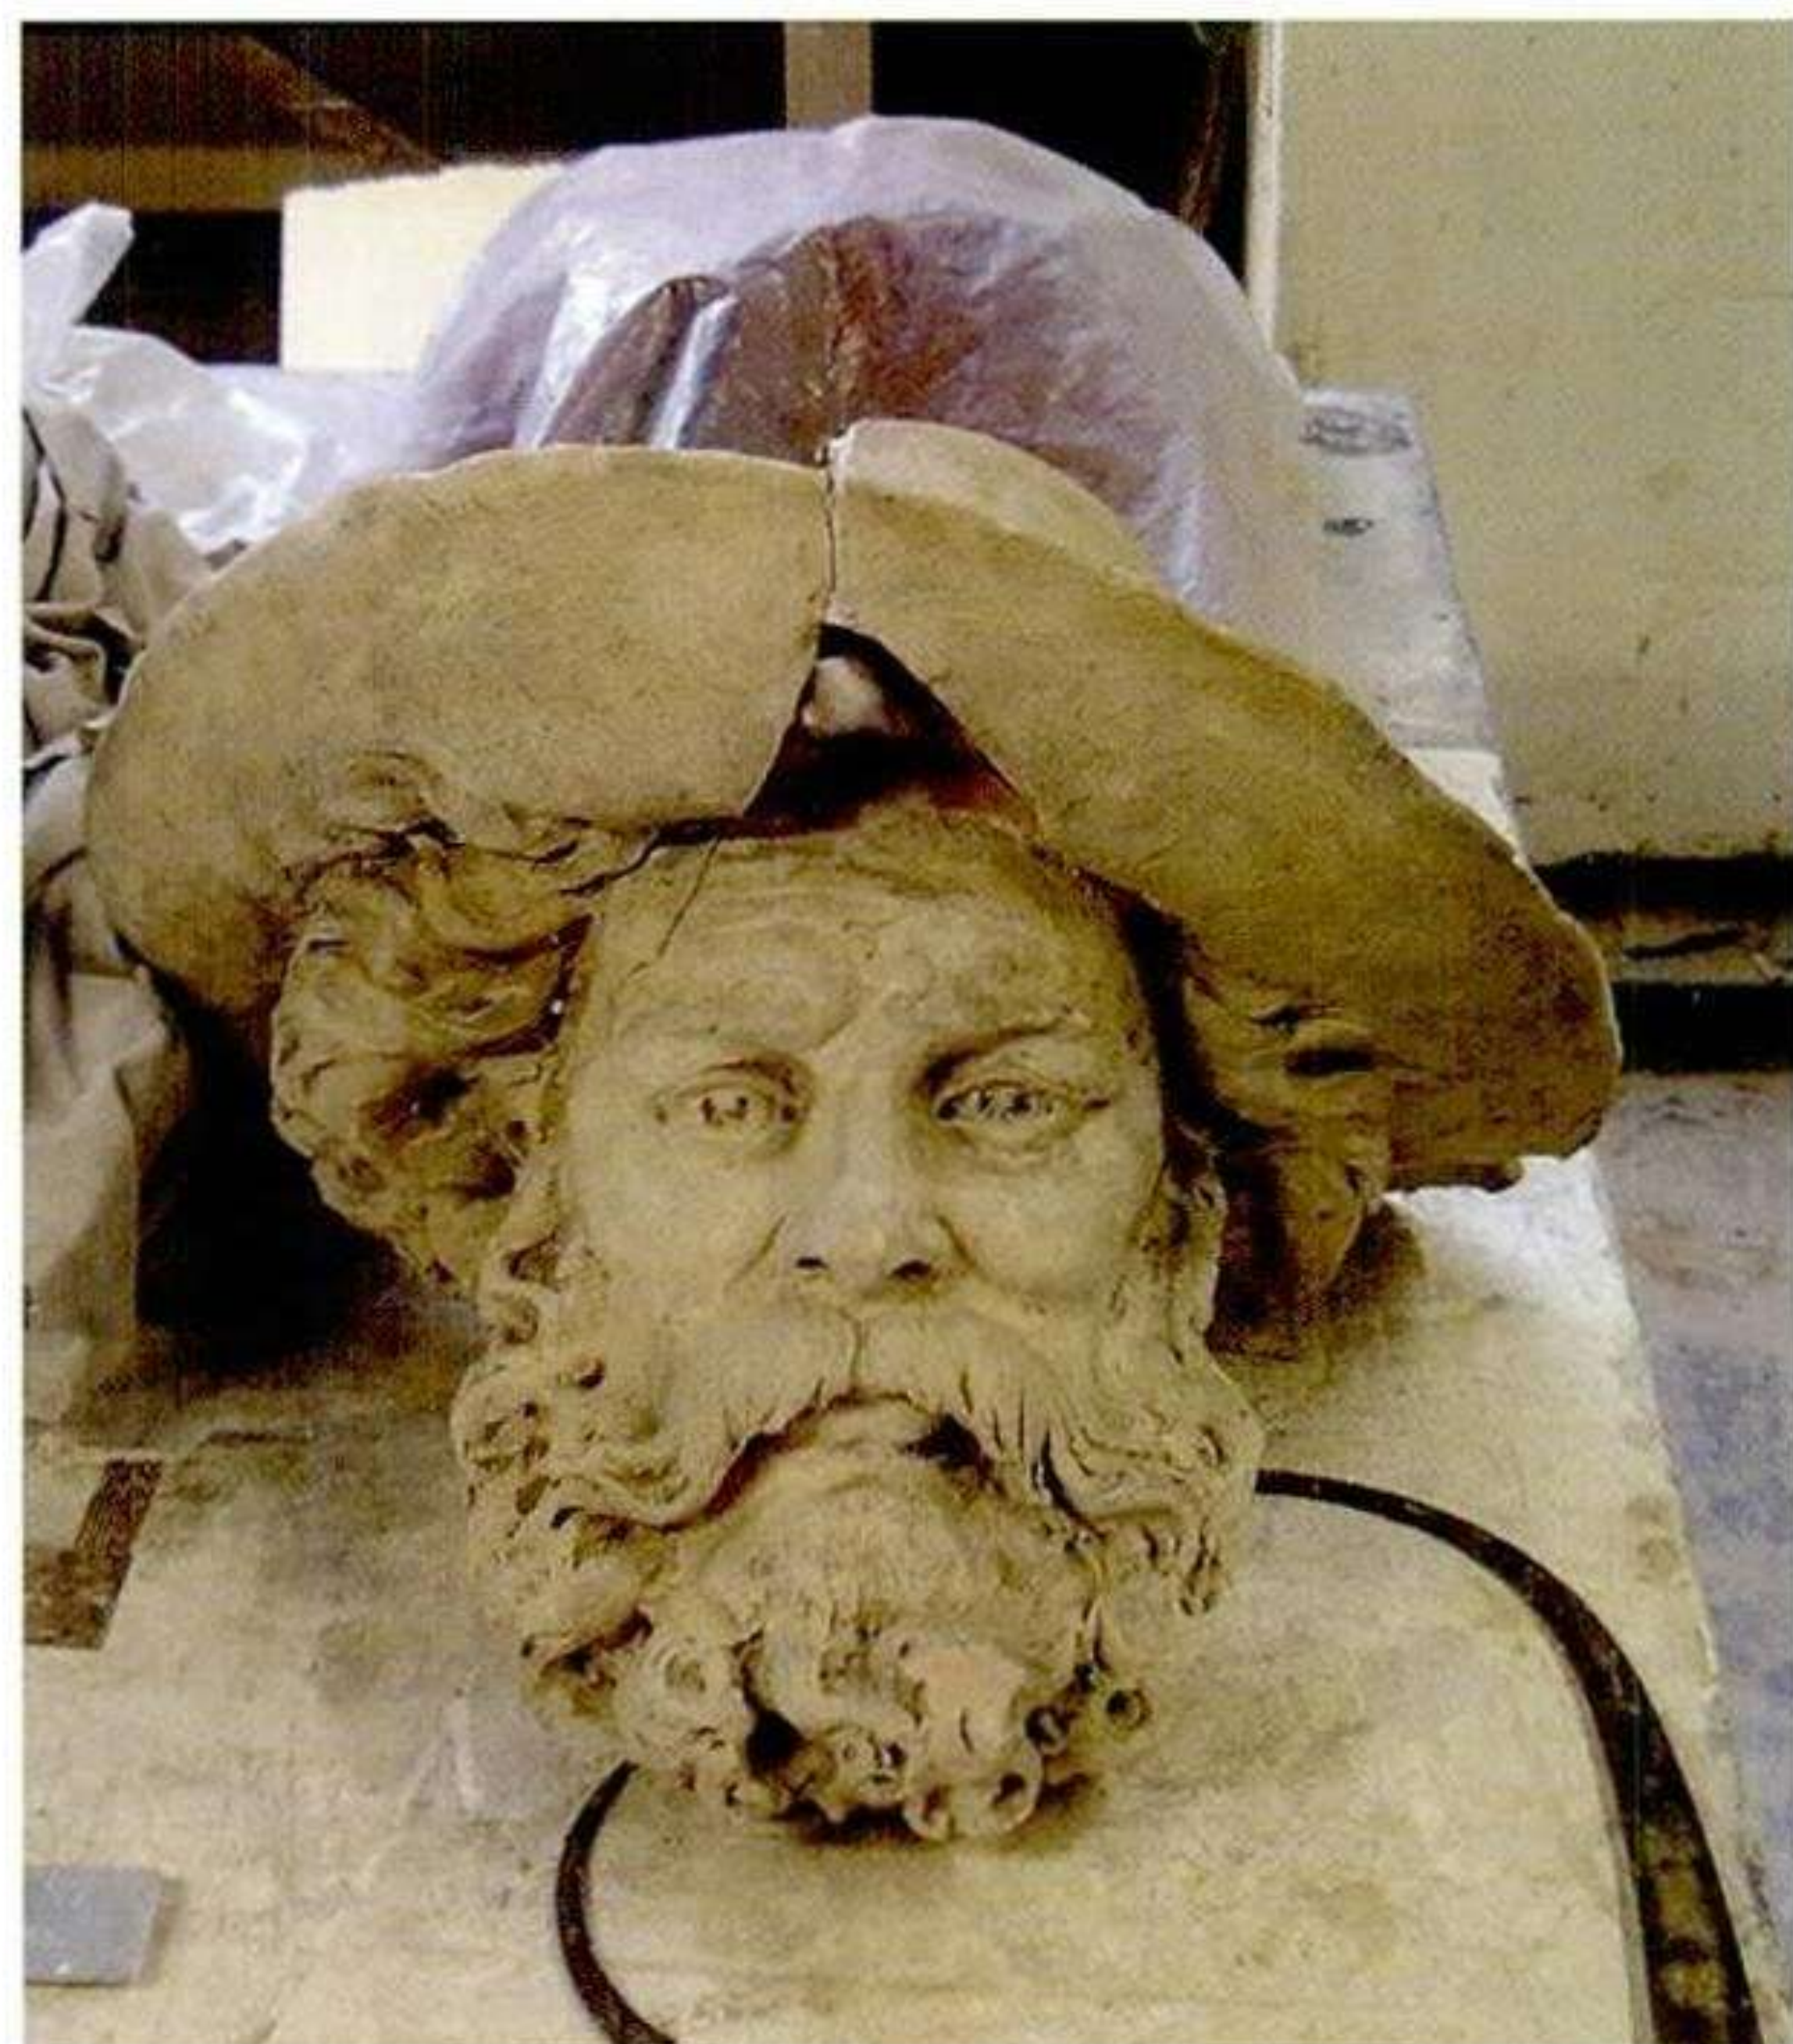
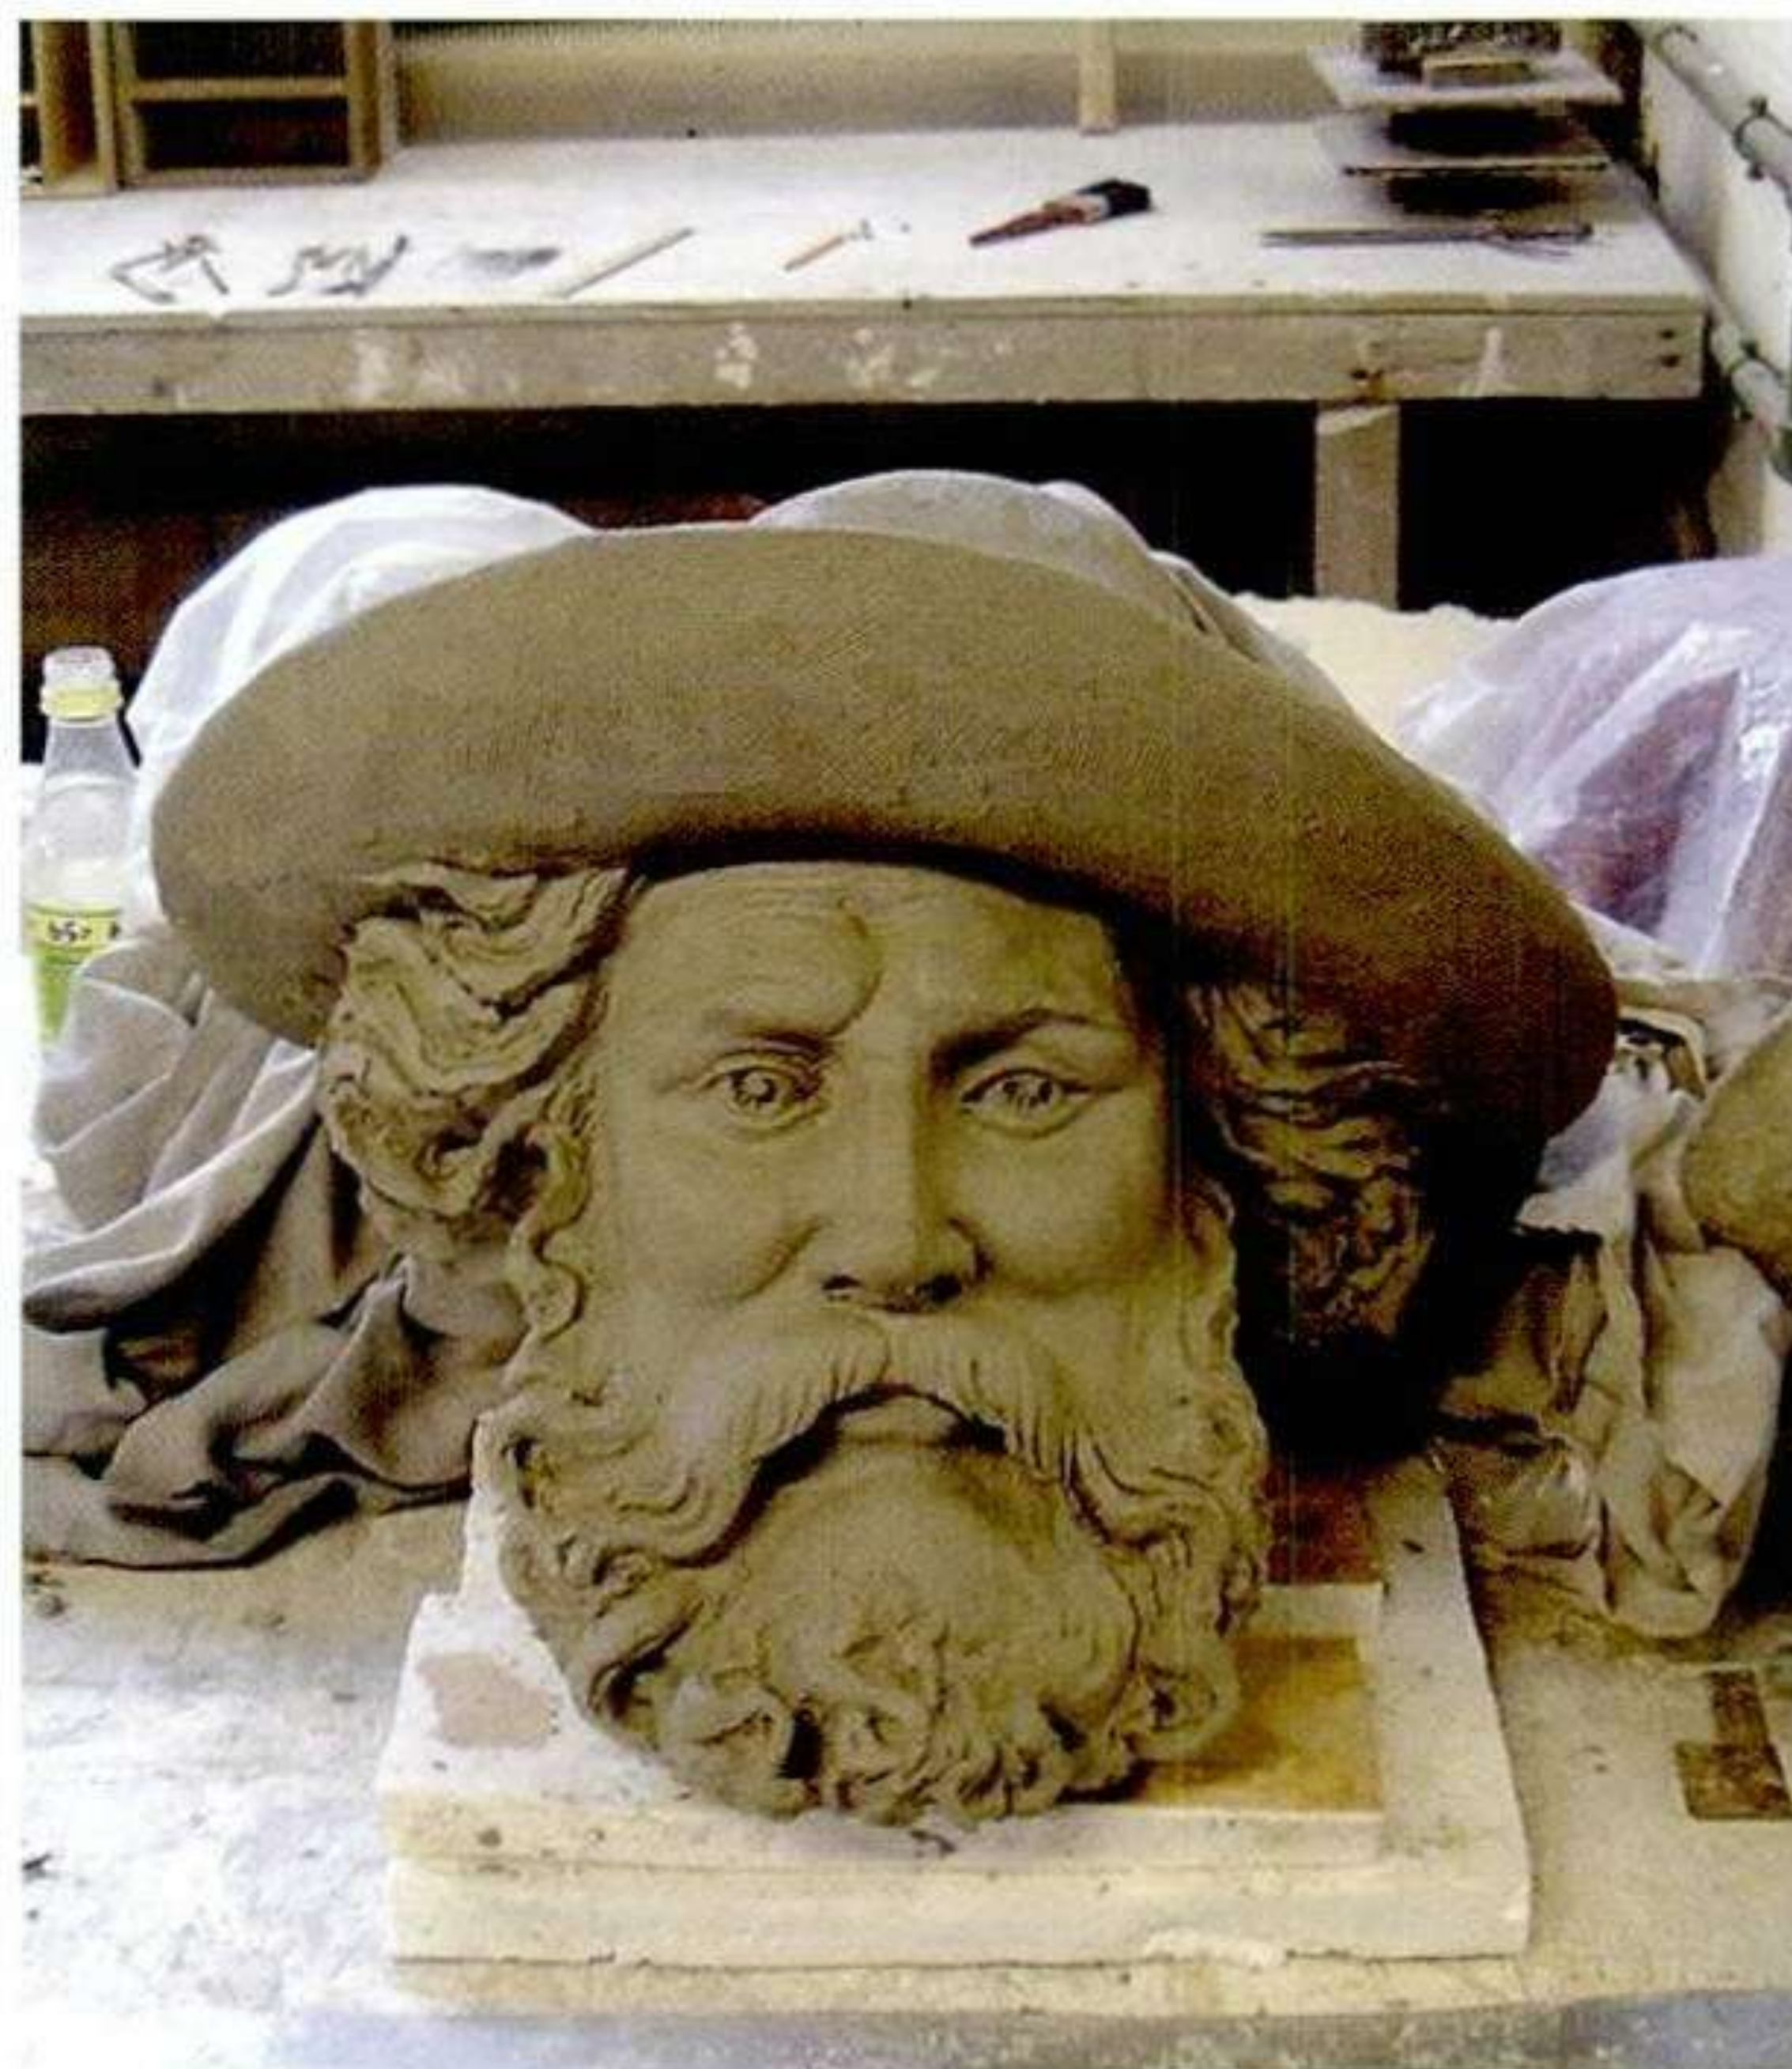
The Boer's head from the South African group: in pieces as found, reconstructed and the clay model of the successful sample piece.

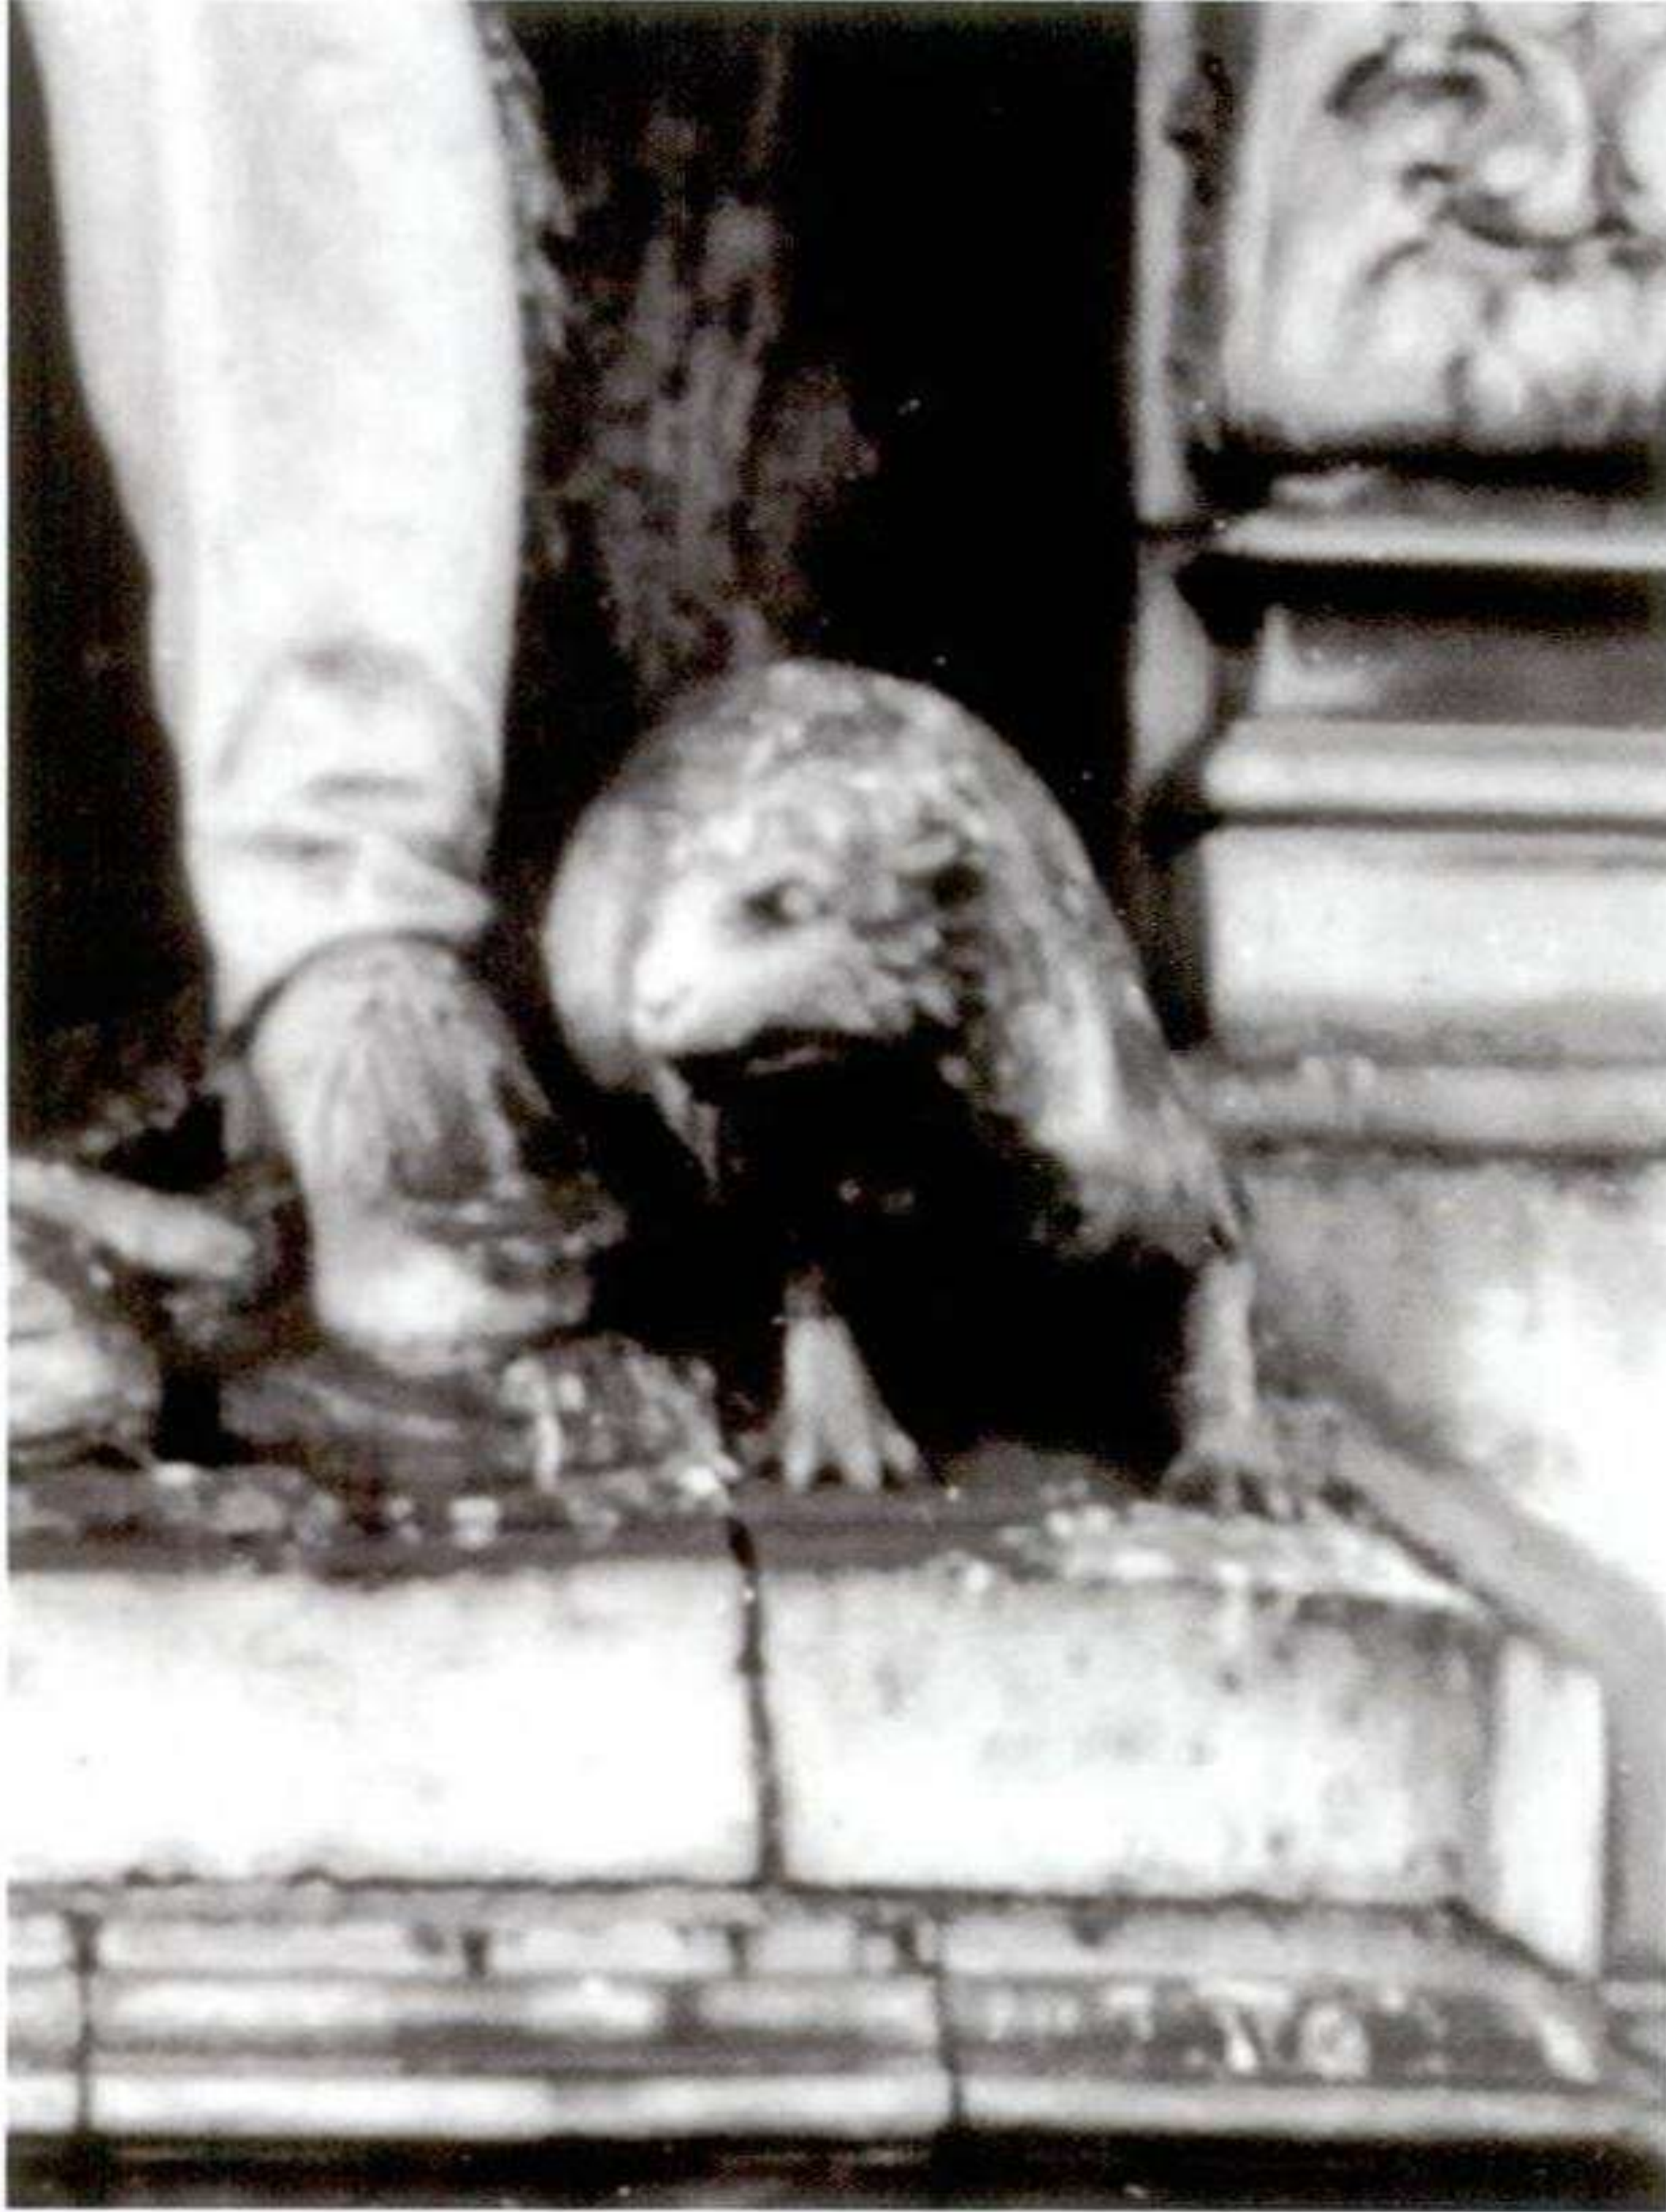
The corner base block to Canada was so weathered that recreation of the beaver could not rely on the original piece but had to concentrate on an early photograph and internet research on beavers.
