REFURBISHMENT CASE STUDY 30

GRAY HOUSE ERROL

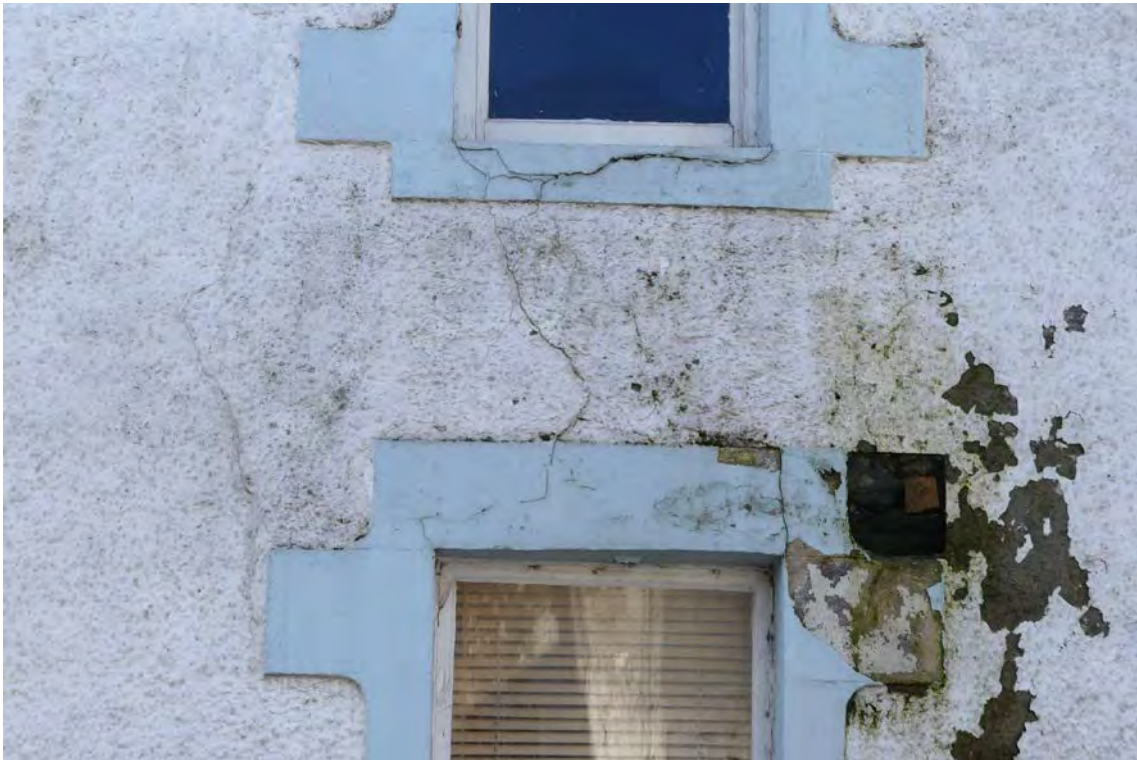
Figure 3: Cracks in the cement render

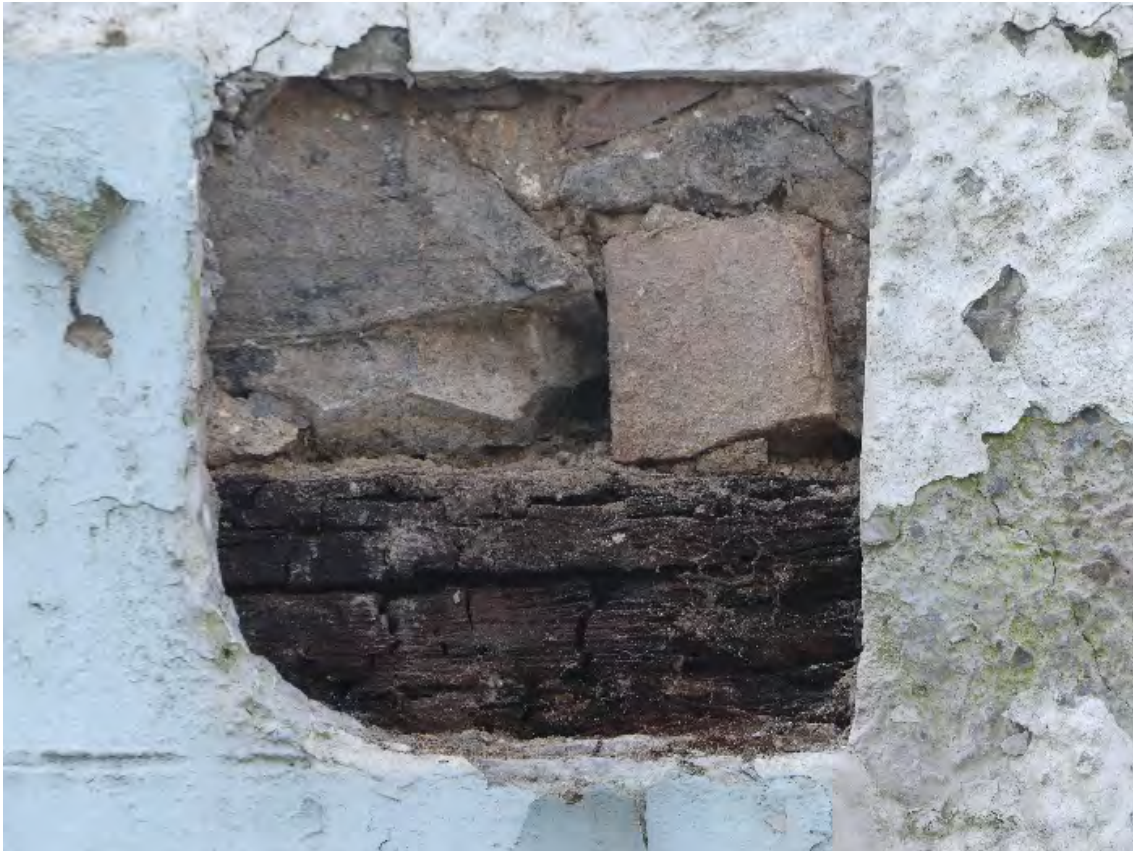
Figure 4: Inspection hole revealing a decayed timber lintel.

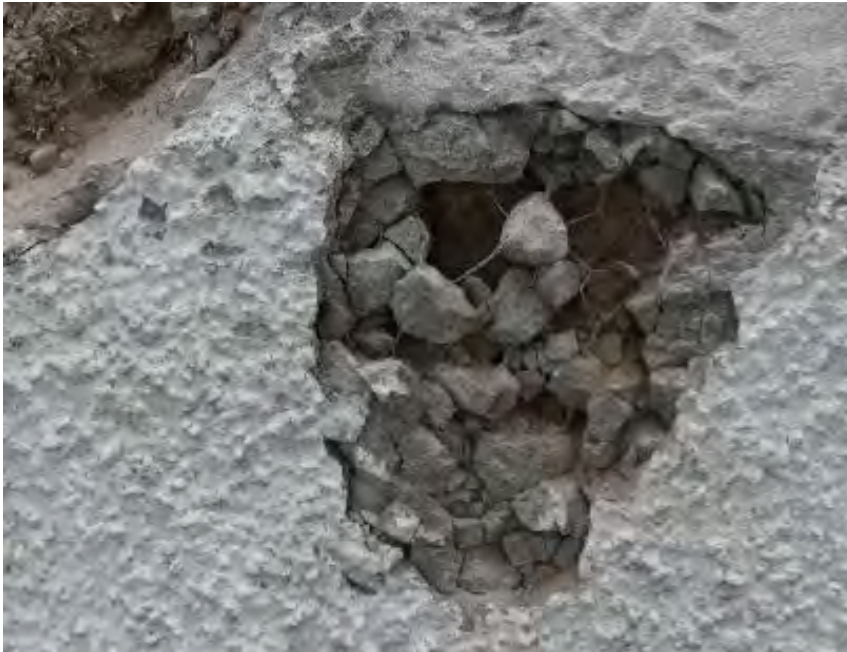
Figure 6: The cement render was reinforced with chicken wire.

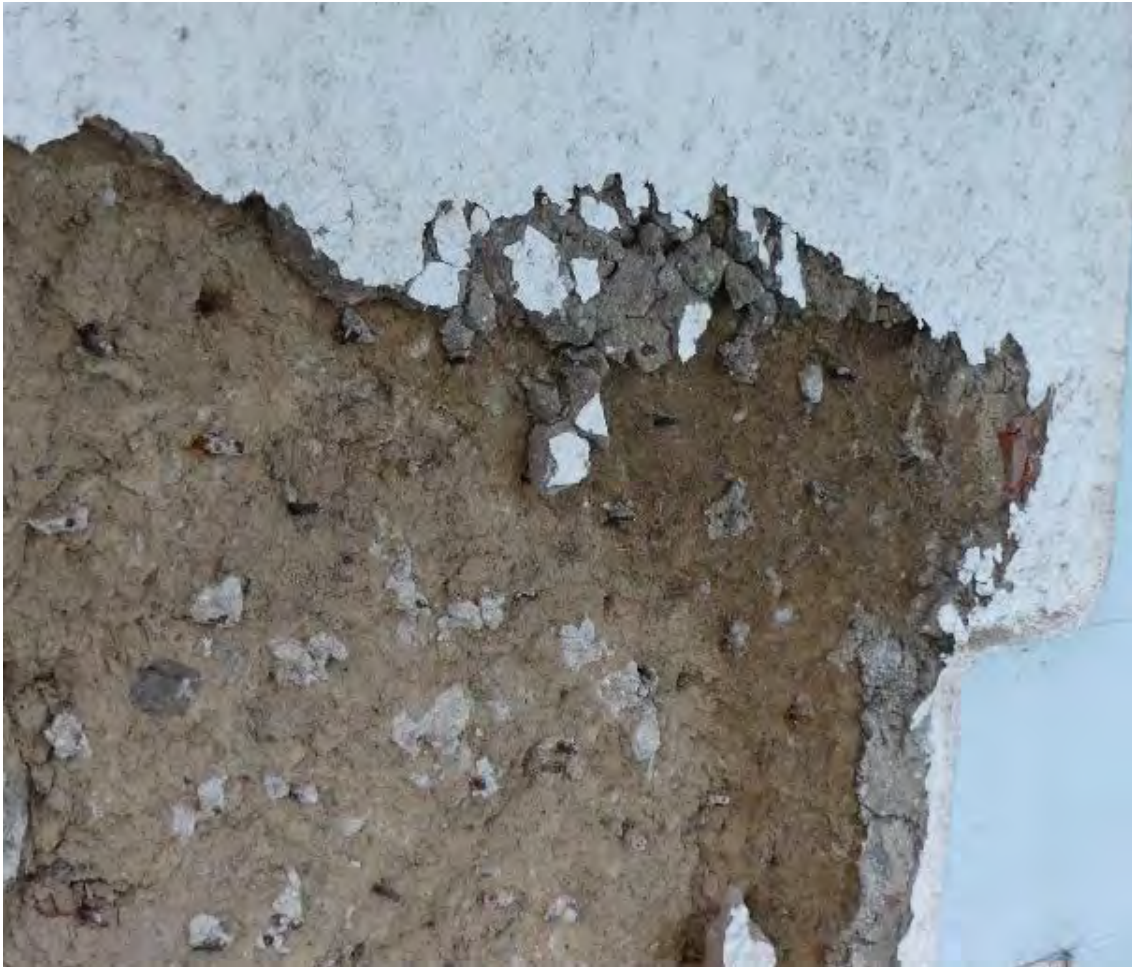
Figure 7: The darker area is damp mudwall, which lightened as it dried.

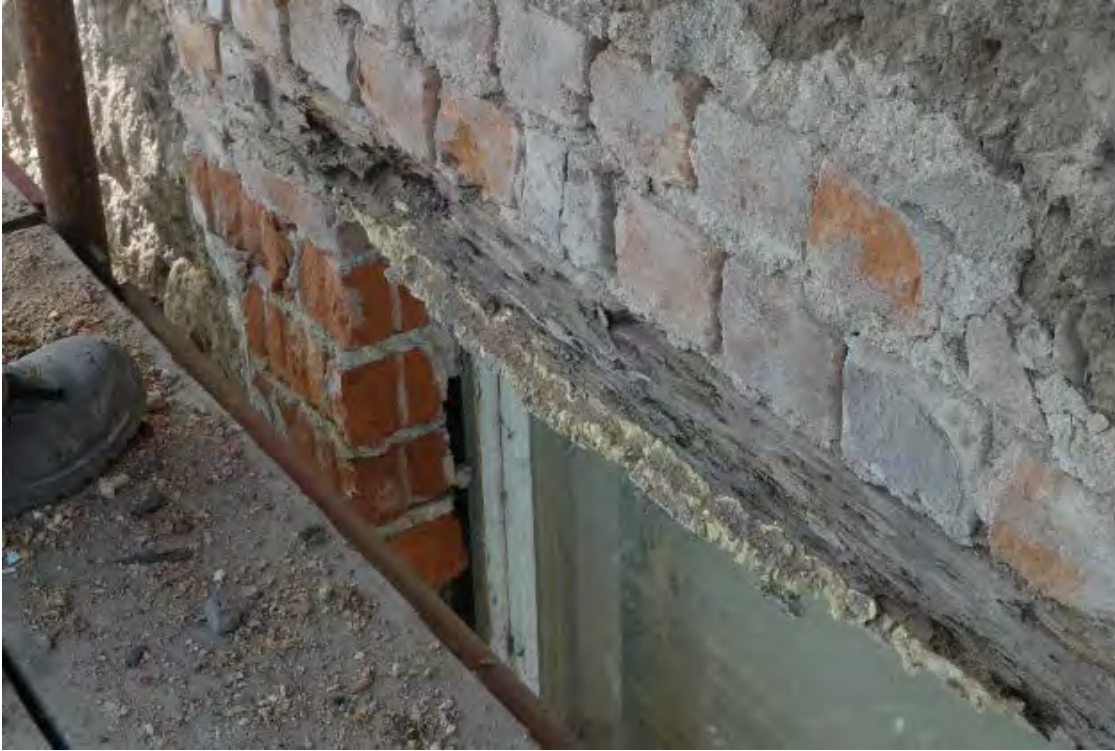
Figure 8: Removing the cement revealed rotten timber lintels supporting brick infill on slender brick facings.

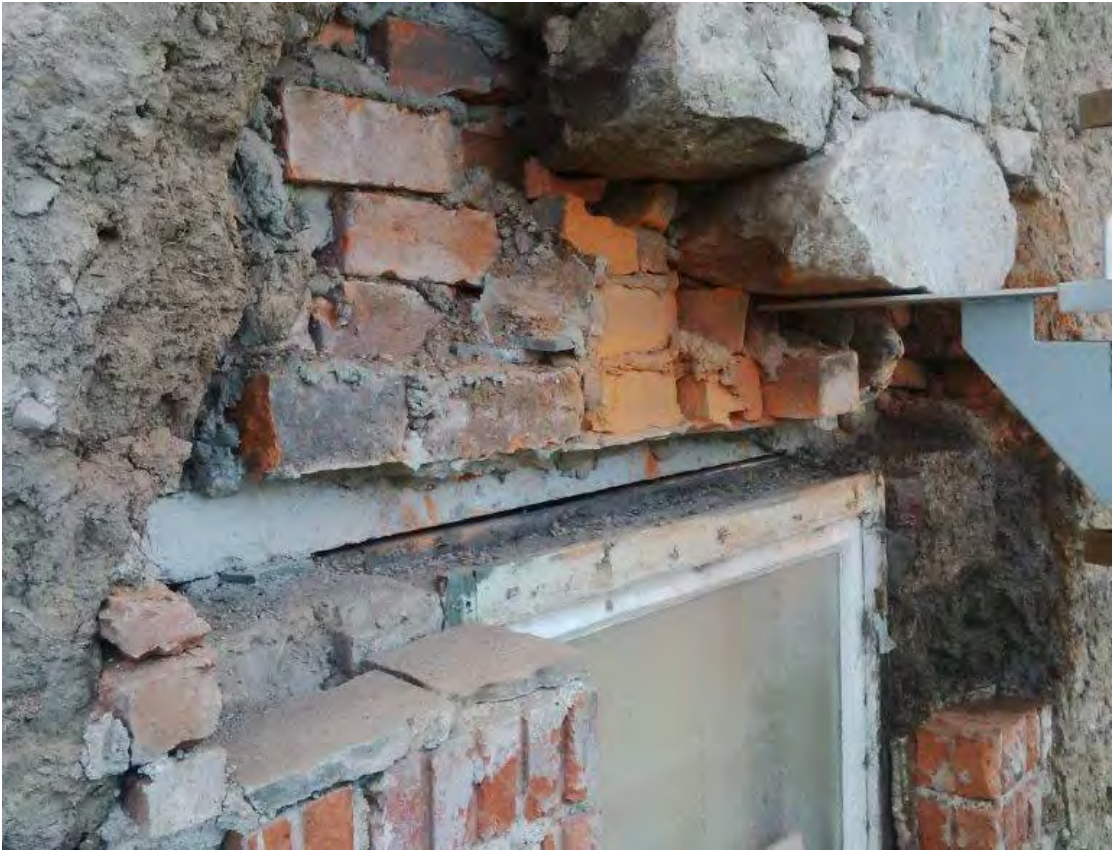
Figure 9: Temporary props allowed the lintels to be replaced in concrete and loose fill consolidated.

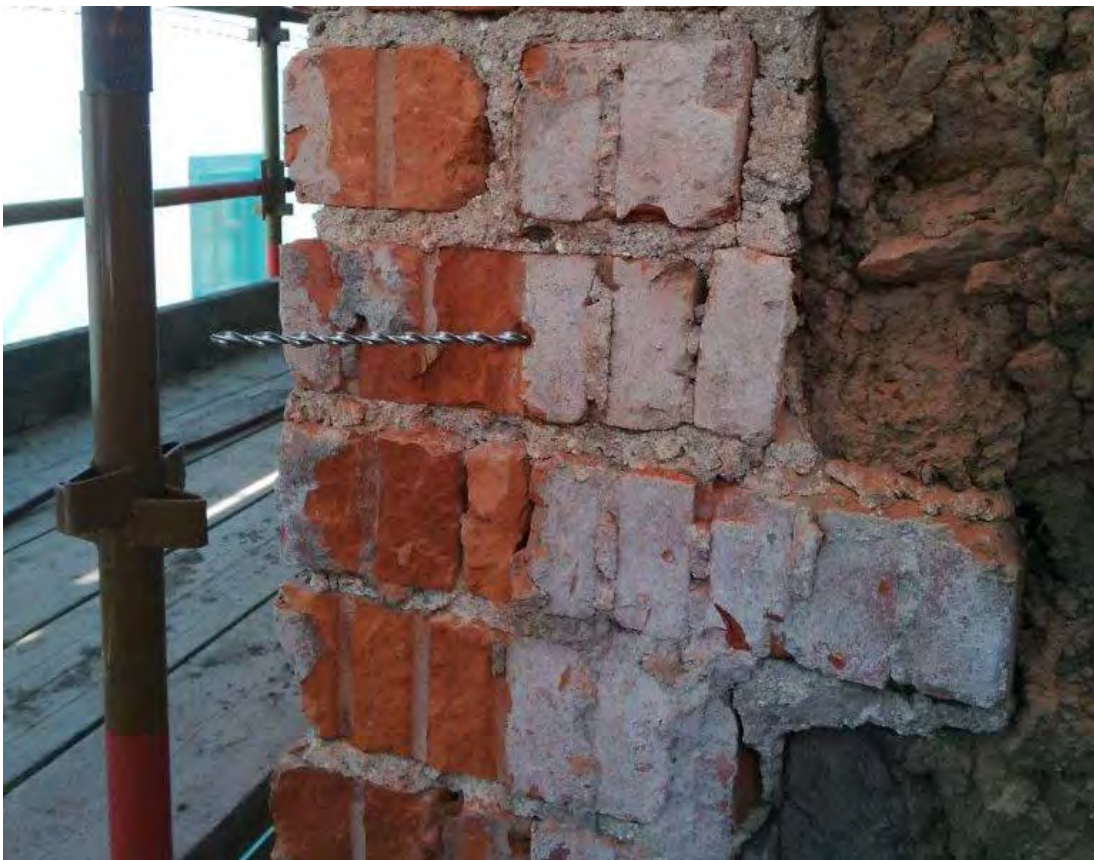
Figure 10: HeliBar being inserted to tie the corner brickwork to the main mudwall.

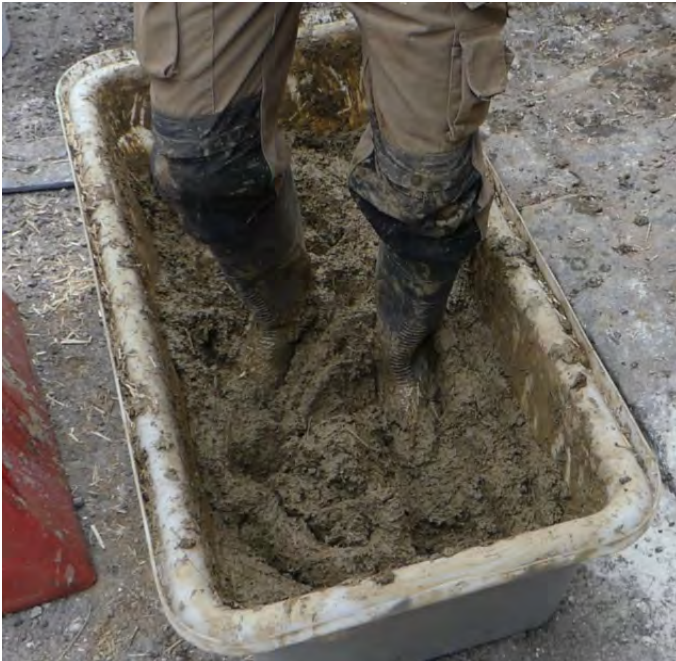
Figure 11: Clay being mixed with sand and straw by foot on site.

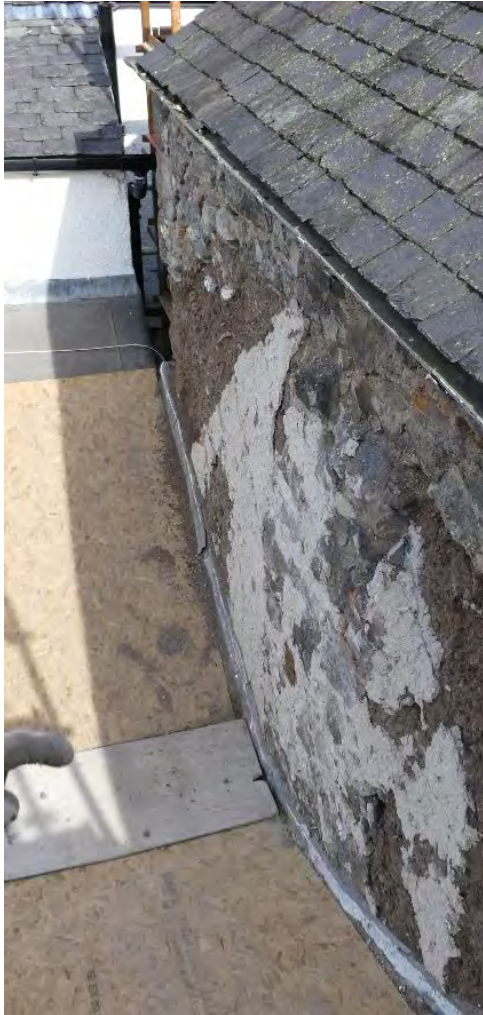
Figure 12: The surface included earth, stone, brick and areas of lime plaster or harl. Here the lime plaster is thought to be the internal plaster for an abutting pitched roof building, which was subsequently demolished.

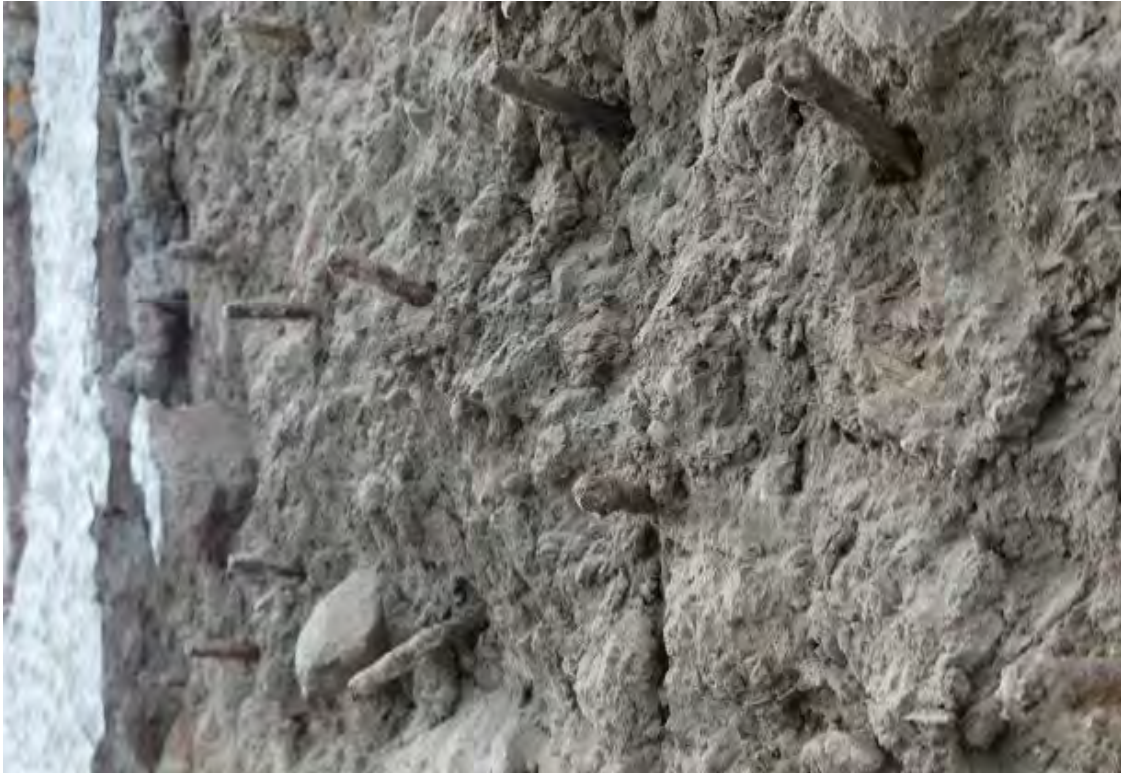
Figure 13: Some of the numerous rusted nails that had to be removed.

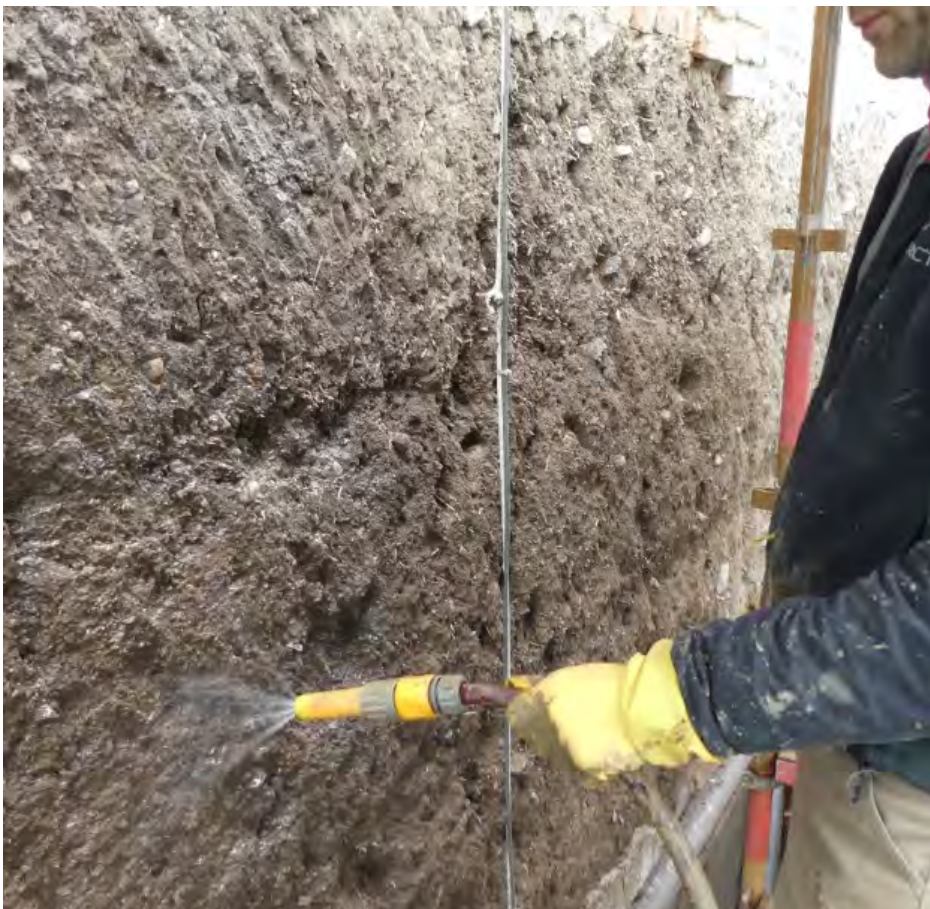
Figure 14: The mudwall was dampened before applying a clay slip. This picture shows the horizontal lift lines.

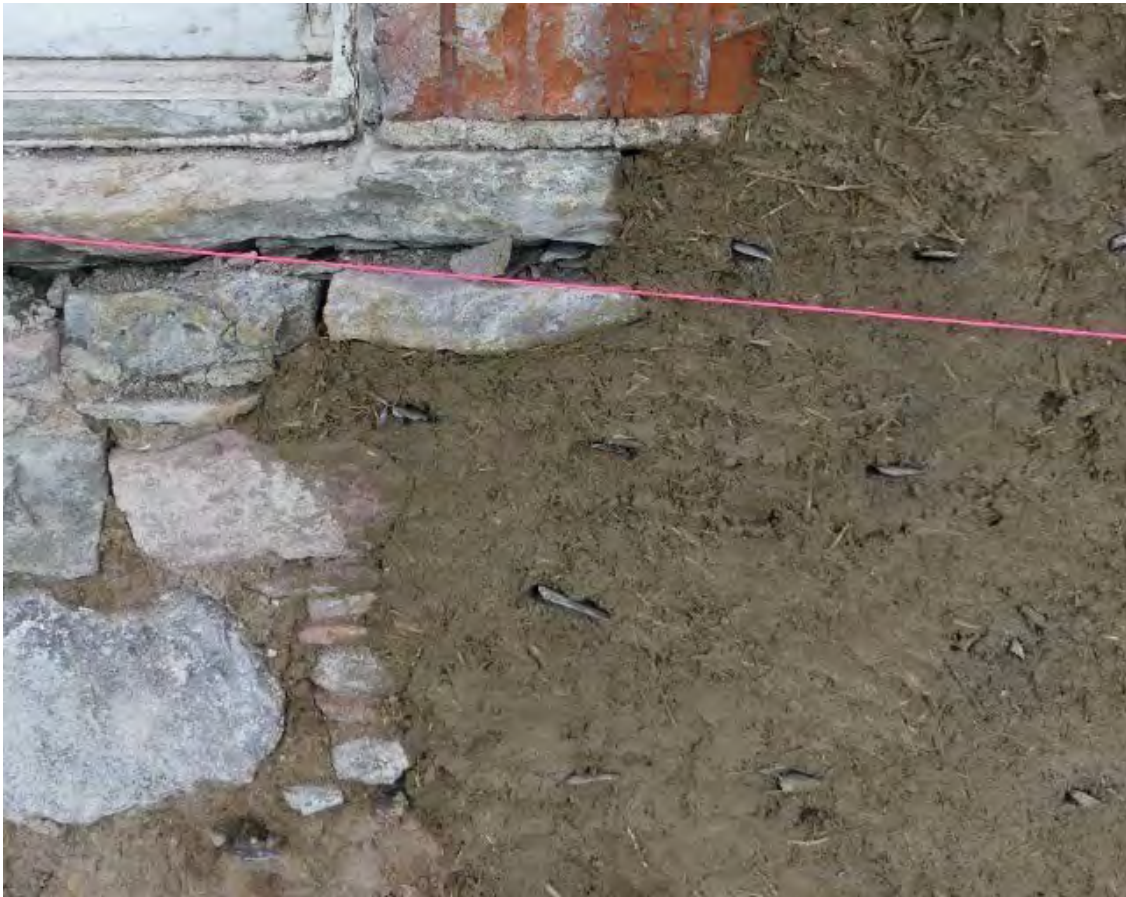
Figure 15: Slate hammered into the daub, with strings used to set a face line.

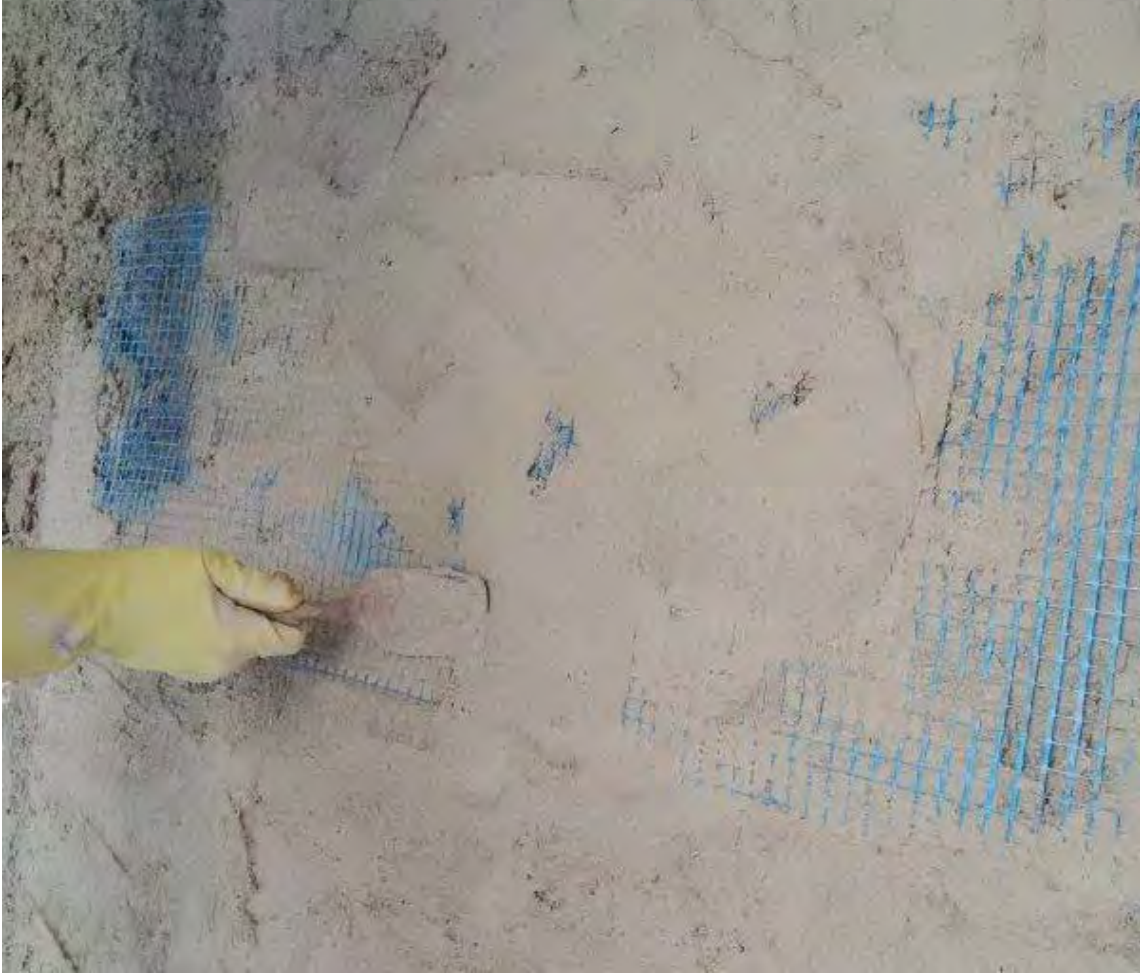
Figure 16: Plastic mesh reinforcement across substrate junctions to prevent cracking of the lime harl.

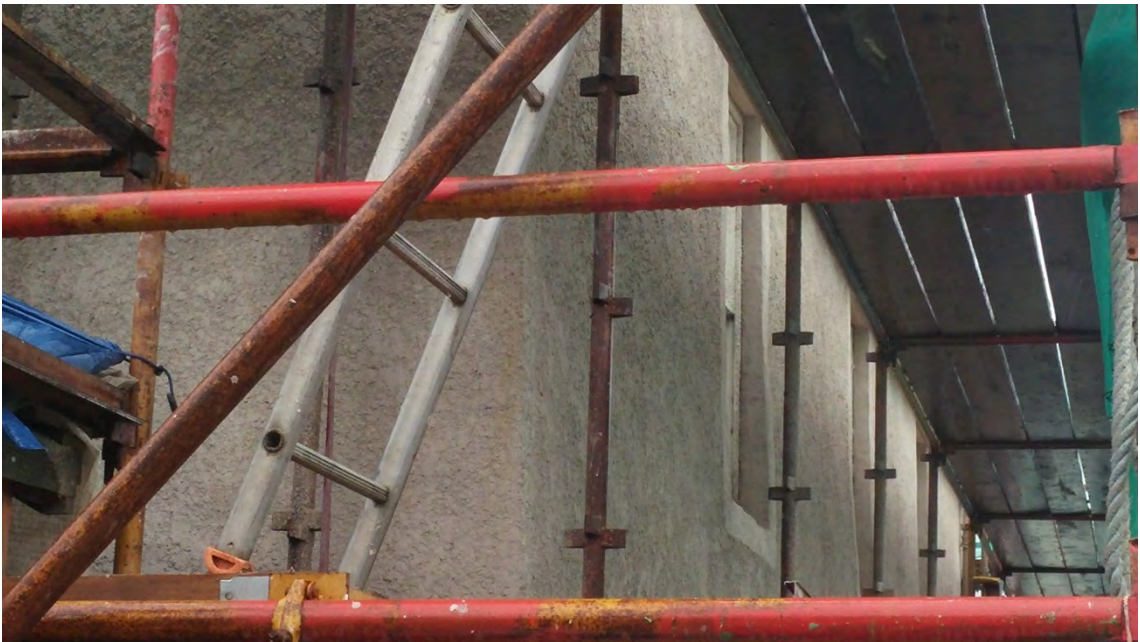
Figure 17: The harling was completed around the scaffold without visible lift lines.

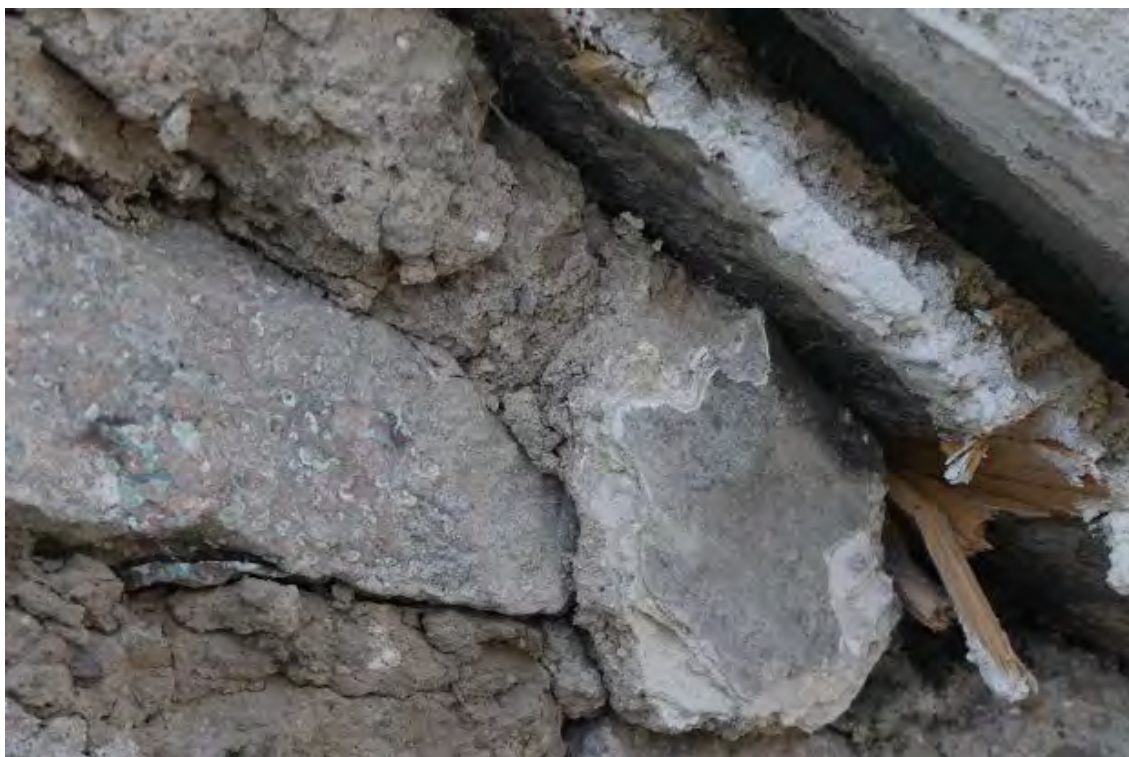
Figure 18: One fragment of original lime harl with limewash was found beneath the cement render.

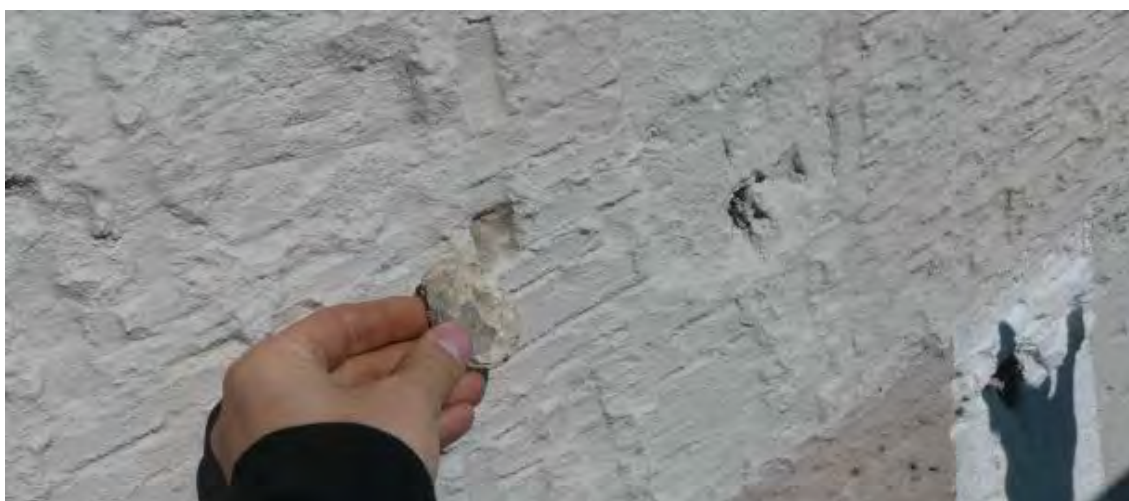
Figure 19: Fragment used to assess samples of limewash colour.

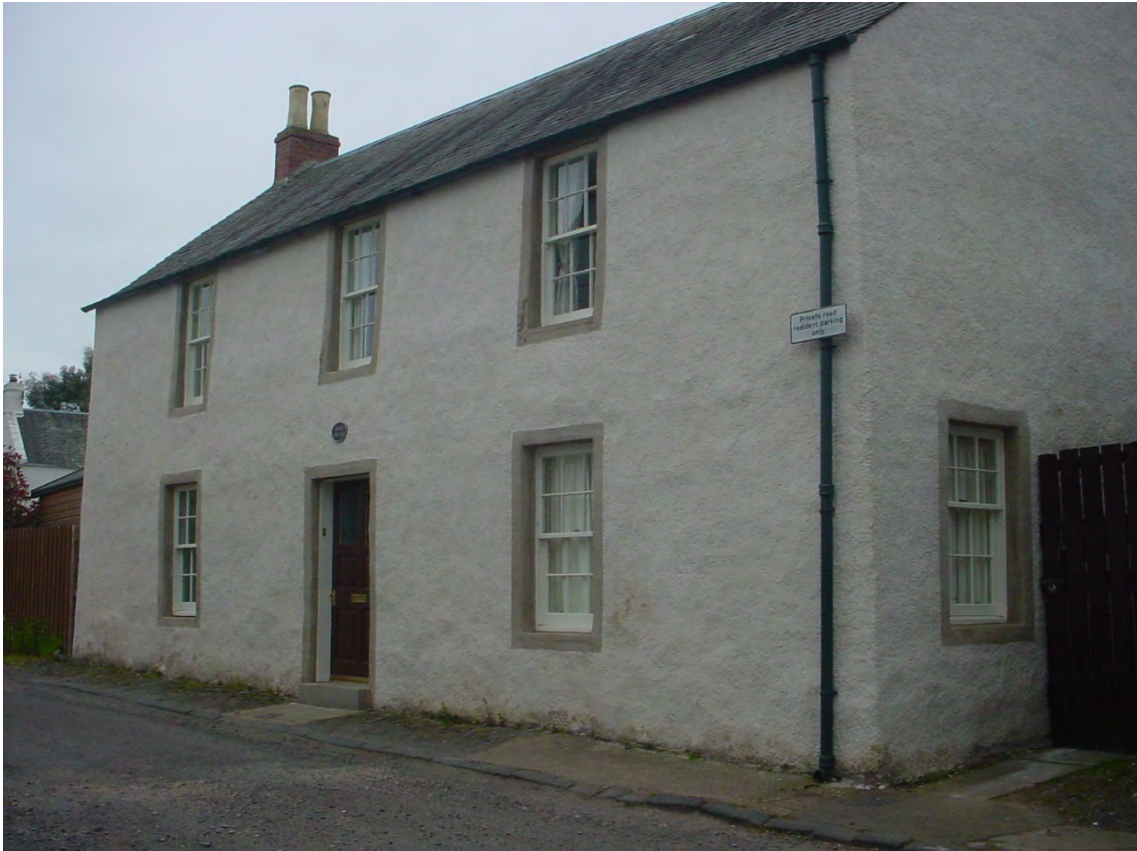
Figure 20: Gray House after the completion of works.
