HAA OF SAND, SHETLAND

HOT-MIXED MORTAR RE-HARLING AND ADAPTING A GABLE END WALL

This publication should be quoted as:
Historic Environment Scotland
Refurbishment Case Study 25

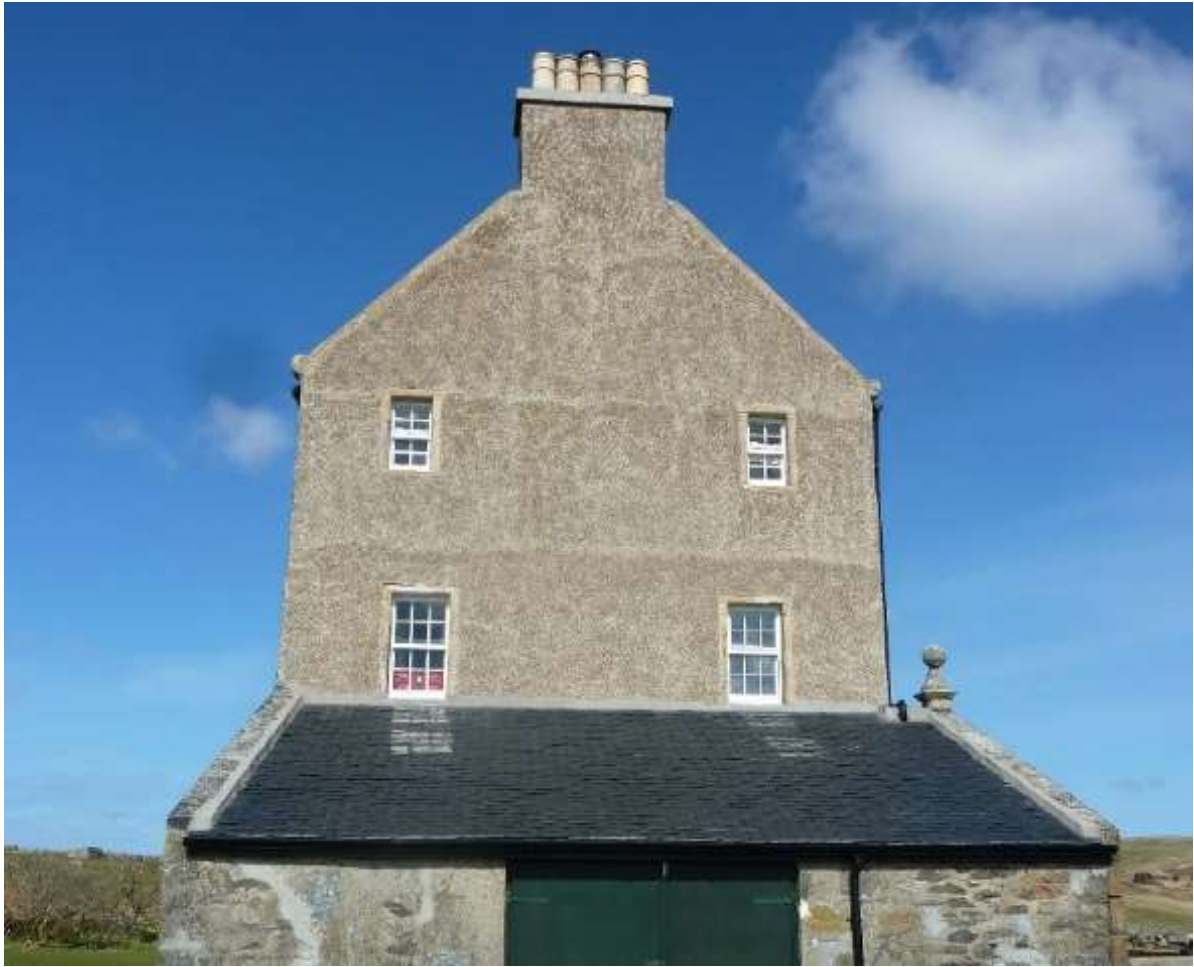
Figure 4: The exposed south east facing gable, prior to works.

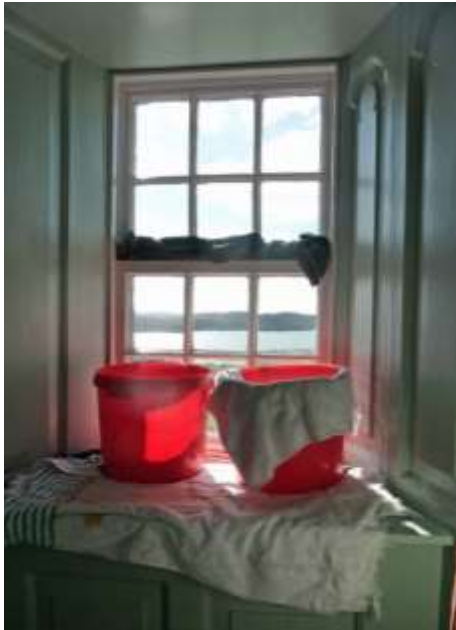
The owners of Haa of Sand sought advice in spring 2013 following a particularly harsh winter with constant south-easterly gales. They reported significant water ingress in various locations within the building, but most noticeably across the south gable at ground, first and second floor level. The water ingress was concentrated around the windows which were in poor condition (Figure 7), but also evident at higher level. The decorative timber panelling in the drawing room was becoming stained and warped in places, and water damage was visible in the cornicing in the bedrooms and at the window soffits (Figure 8 and 9). Water ingress was evident around the window reveals in several rooms as drips and leaks.

Figure 7: Water penetration around windows during bad weather (Photo: Redman Sutherland Architects).

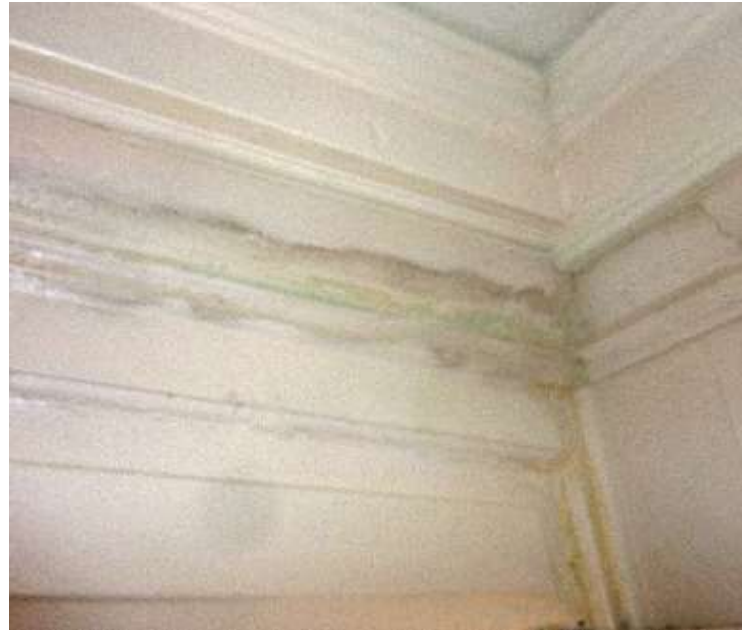
Figure 8: Water damage to panelling and cornice.

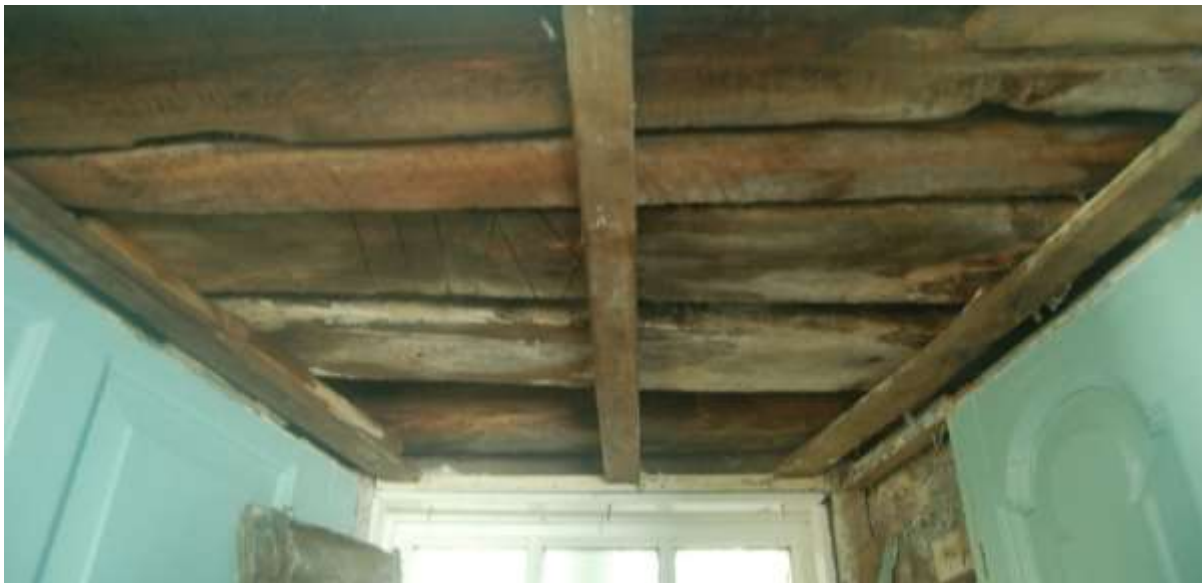
Figure 9: Water damage to window soffits.

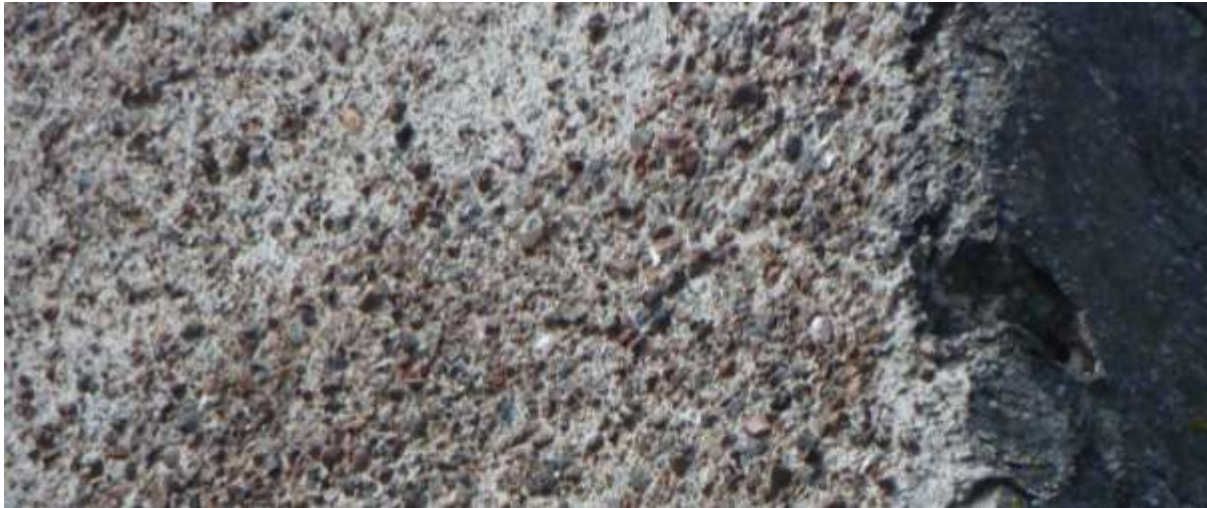
The roughcast to the south gable, which appeared to be a cement based mix, was cracked and bossed in several places. It had been patch repaired with a harder mix, and cracks filled with a silicone type sealant (Figure 10).

Figure 10: The existing cement-based roughcast was in poor condition.

The existing cement roughcast was carefully removed by hand, to avoid damage to the dressed stone finishes and underlying masonry. The cement came away relatively easily in this way, with some of the bossed areas readily coming away in sections. A number of sample panels were prepared for the replacement harled finish, and applied onto an exposed section of gable wall within the lean-to shed. A range of mixes were trialled with varying ratios and strengths of Natural Hydraulic Lime (NHL) and quick-lime, different lime suppliers and different aggregate sources. The first mix trialled was a gauged mix of Otterbein 3.5 with quicklime and crushed granite sand. This mix was slow to take a set, and a range of subsequent mixes were sampled, varying the proportions of the quicklime and hydraulic lime, the strength and supplier of NHL, and the method of mixing. Some poorly performing samples were attributed to excess water added during mixing and poorly graded aggregate.

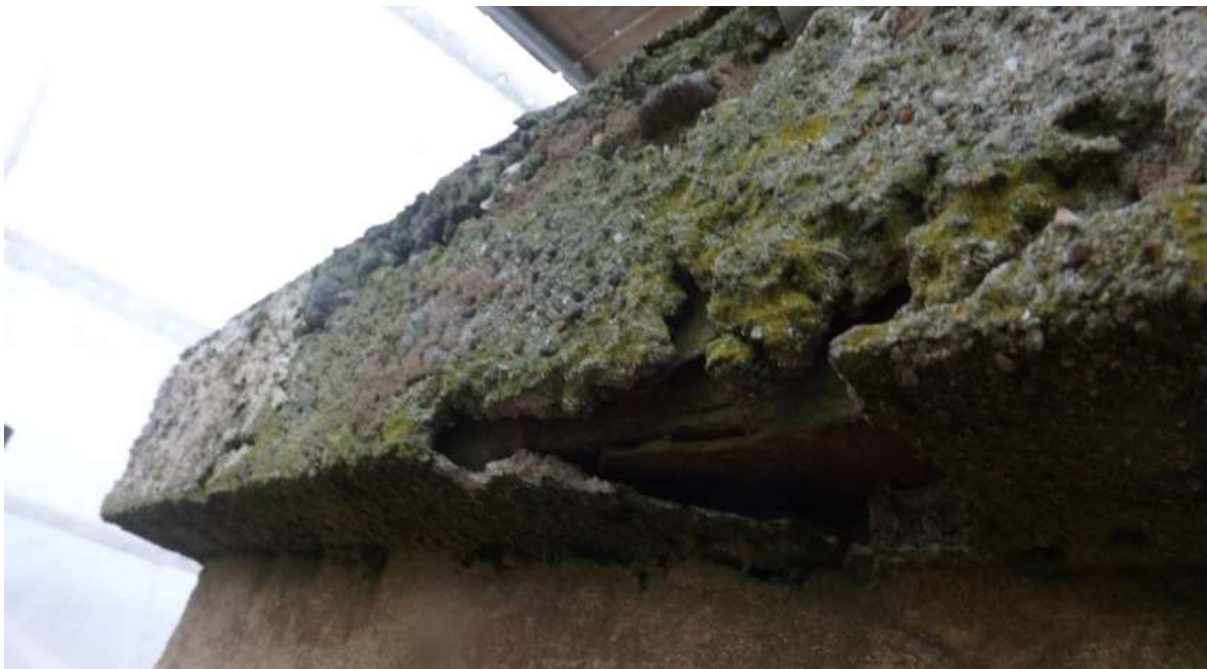
Only one flue remained in use in the south gable, servicing the open fire to the first floor drawing room. The other flues routed to uncapped chimneys, which were leaking and poorly ventilated. The chimney itself was in poor condition; the cope stone was constructed of rough concrete, which had degraded to expose a pebbly aggregate (Figure 11). The chimney pots were cracked and damaged in places, and the haunching around the chimney pots was detached or missing in places.

Figure 11: Degraded and defective concrete chimney cope.

Upon inspection of the chimney, it was noted that the chimney cope was constructed of rough cast concrete, with large pebbly aggregate. The concrete had begun to disaggregate, allowing water to penetrate. The copes were replaced with a new sandstone chimney cope, with improved weathering and drip details (Figure 19).

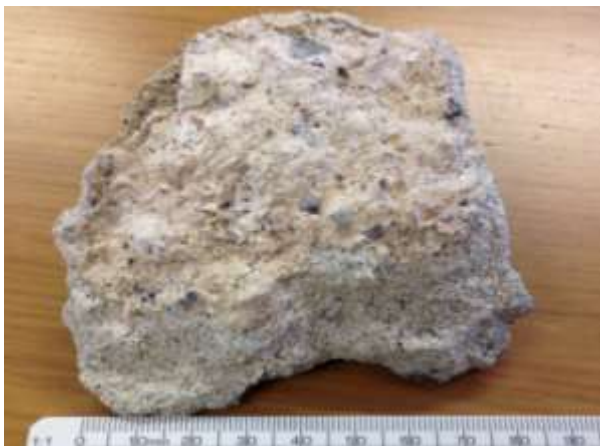
Figure 13: Traces of original lime-mortar finish attached to later roughcast.

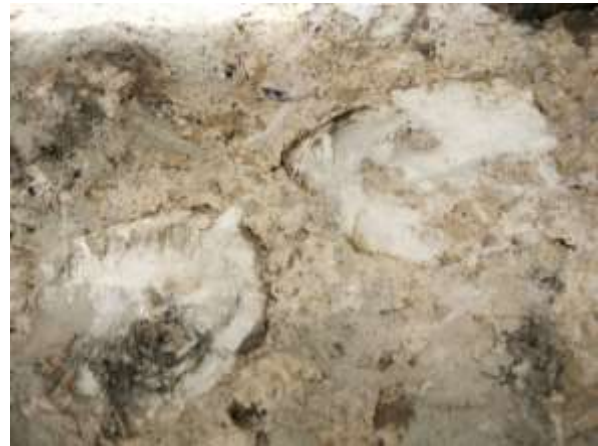
Figure 14: Oyster shell pinnings in the original underlying mortar mix.

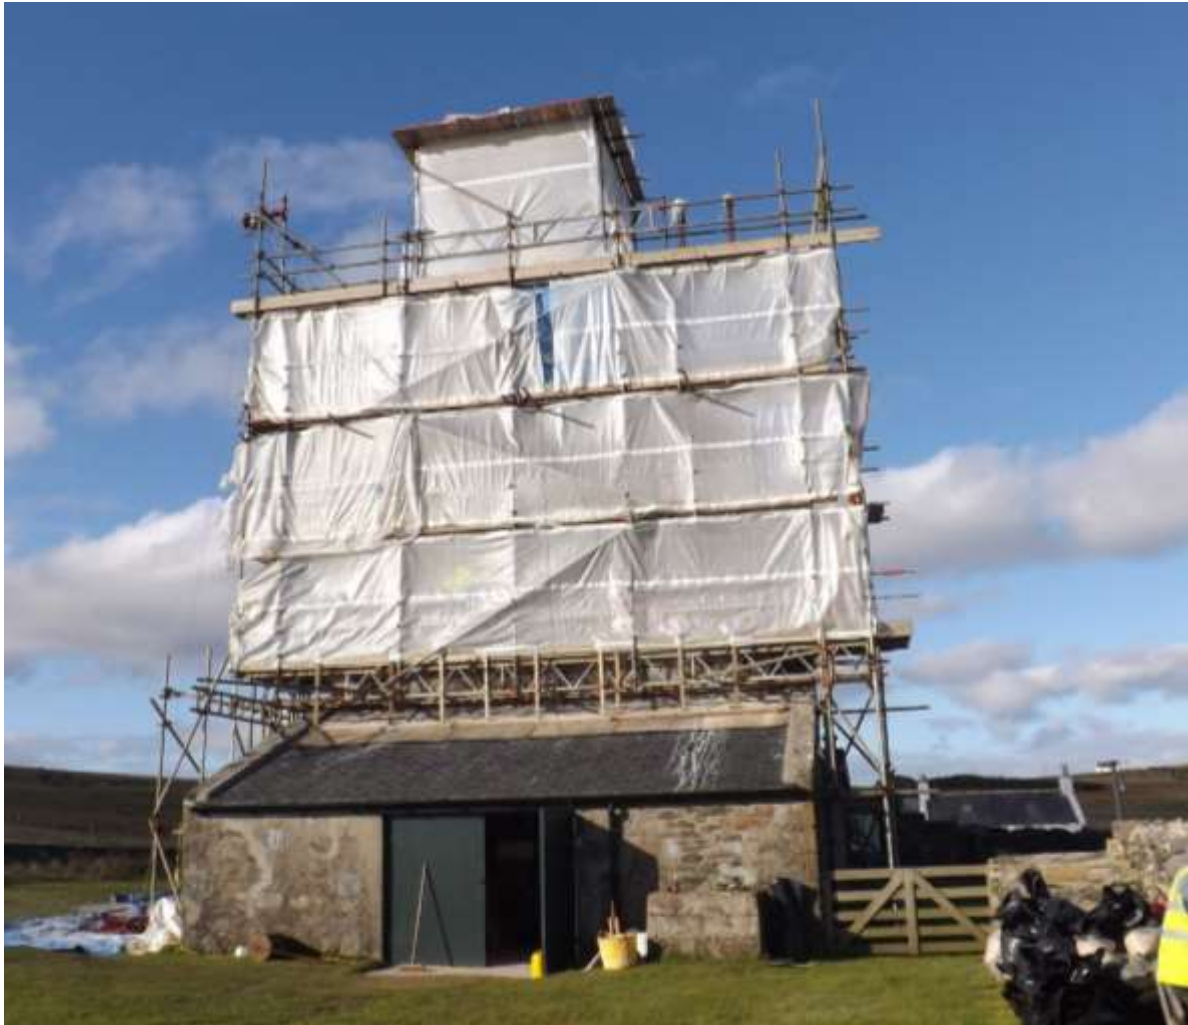
Figure 16: Work on site October 2014. The lime work was protected with plastic sheeting during works to prevent rapid drying.

The specification was to repair and flush point the wall using a 'hot-mix', with the mortar used well-mixed and slaked in a forced action mixer and hand cast (harled) while still warm. The wall was flush repointed and given a harled finish with one coat to an overall depth of around 10mm.

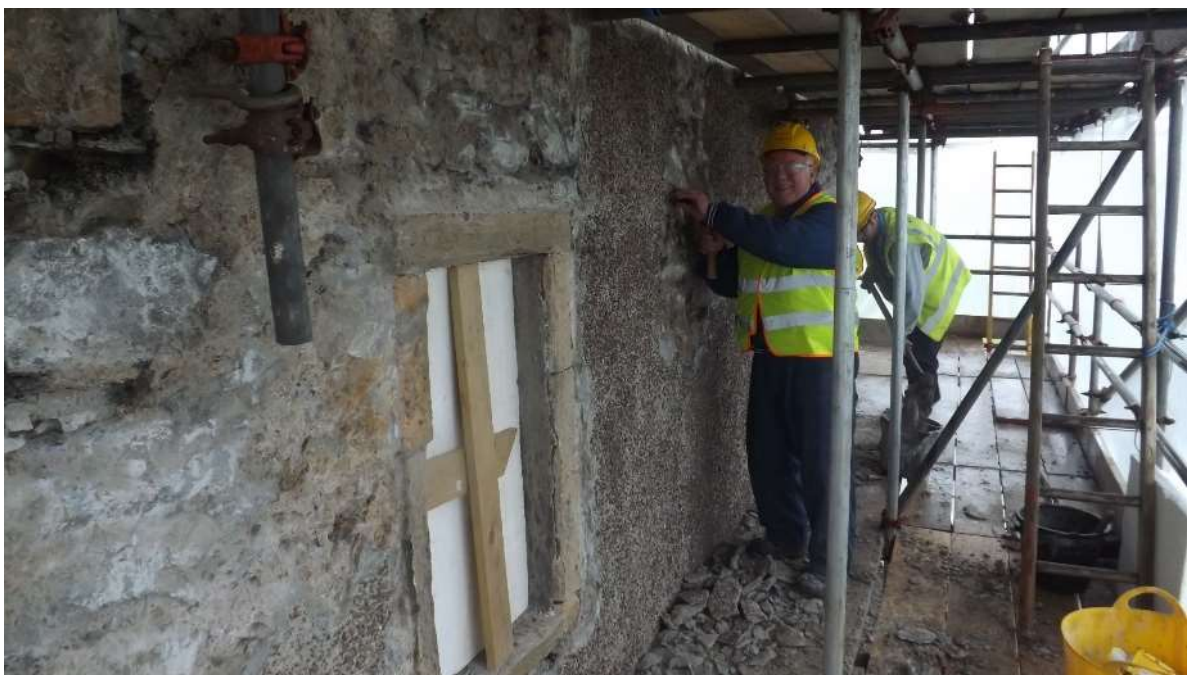
Figure 17: Removing the cement roughcast using hand-tools (Photo: Redman Sutherland Architects).

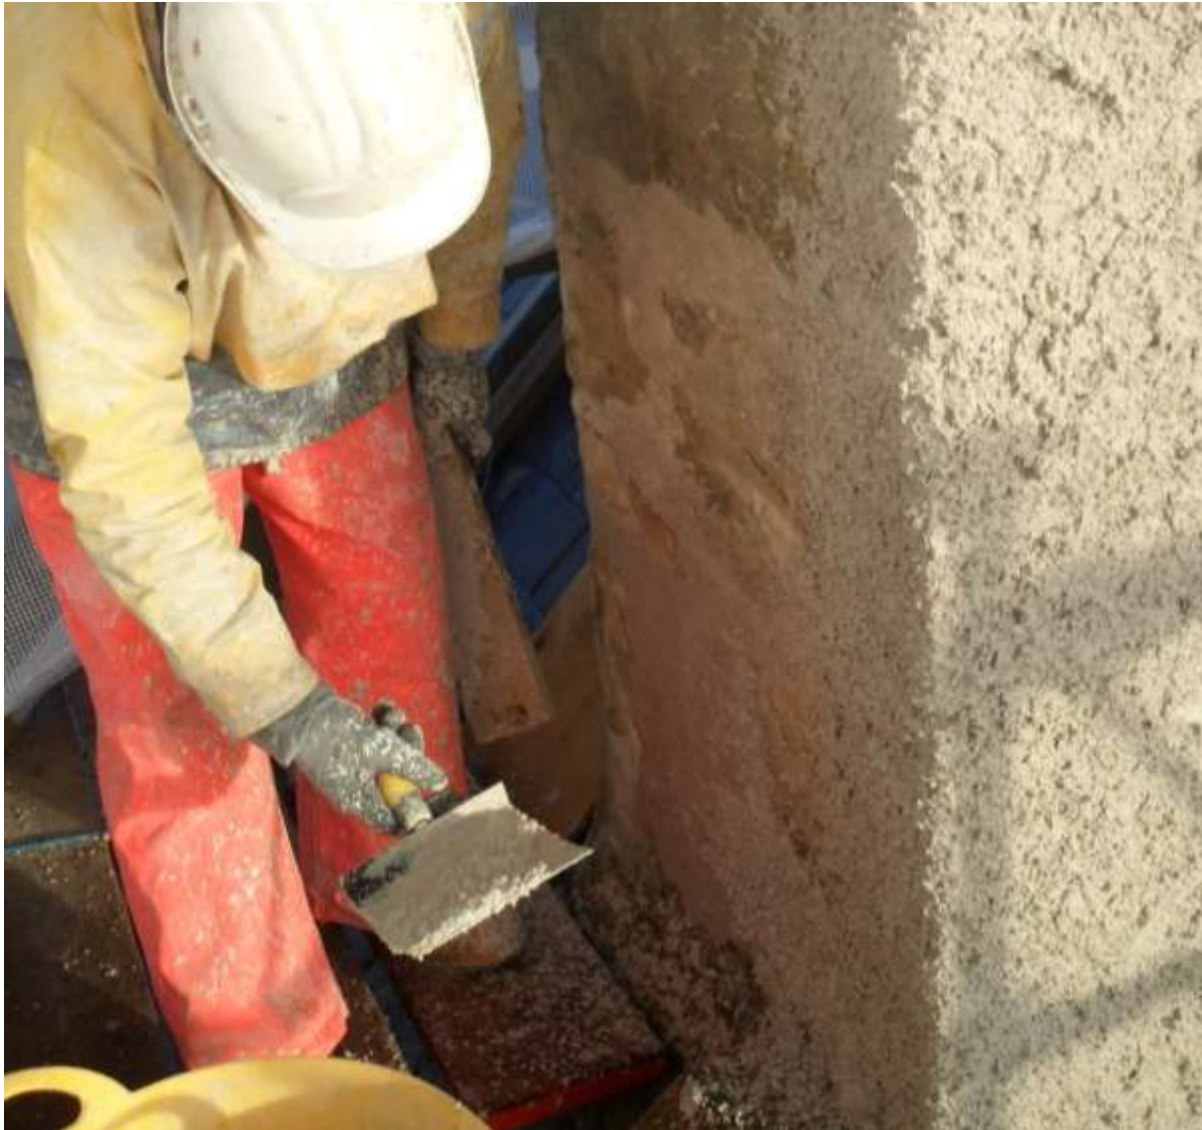
Figure 18. Re-harling the gable and chimney.

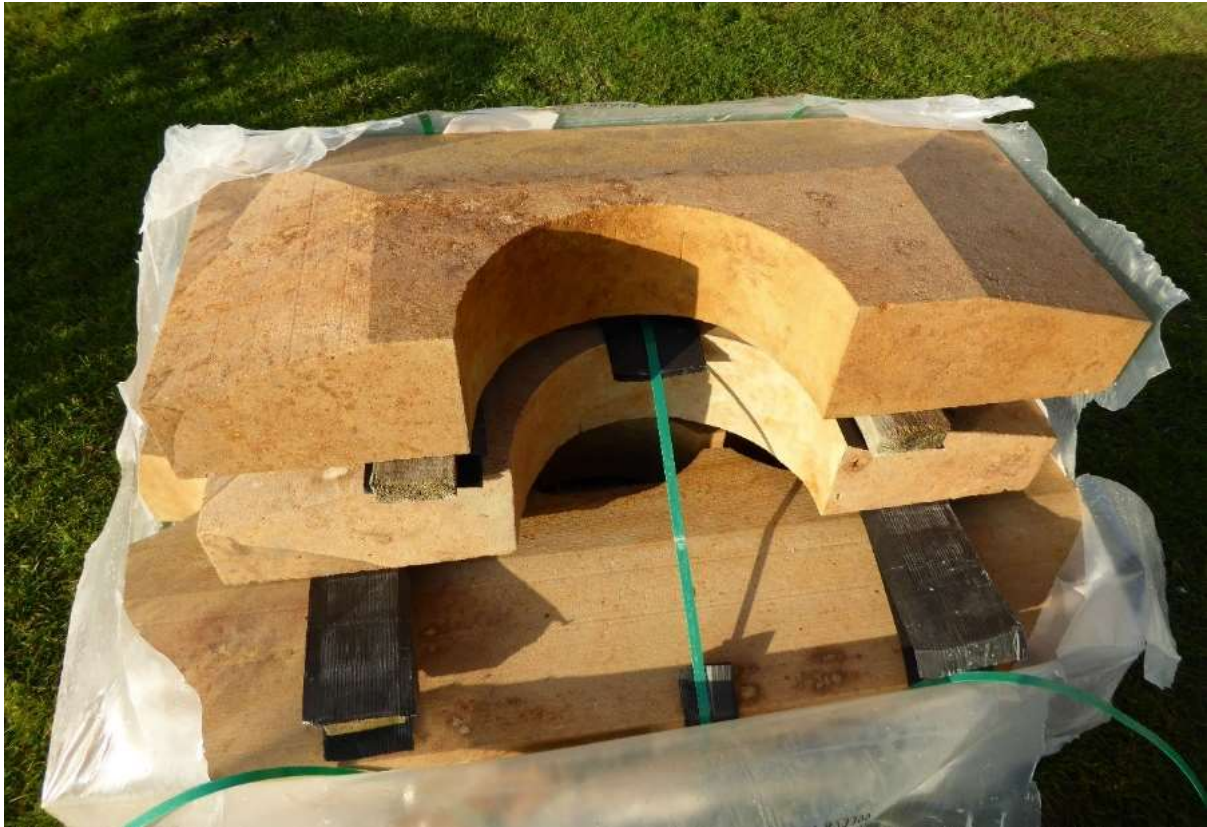
Figure 19: New stone chimney copes.

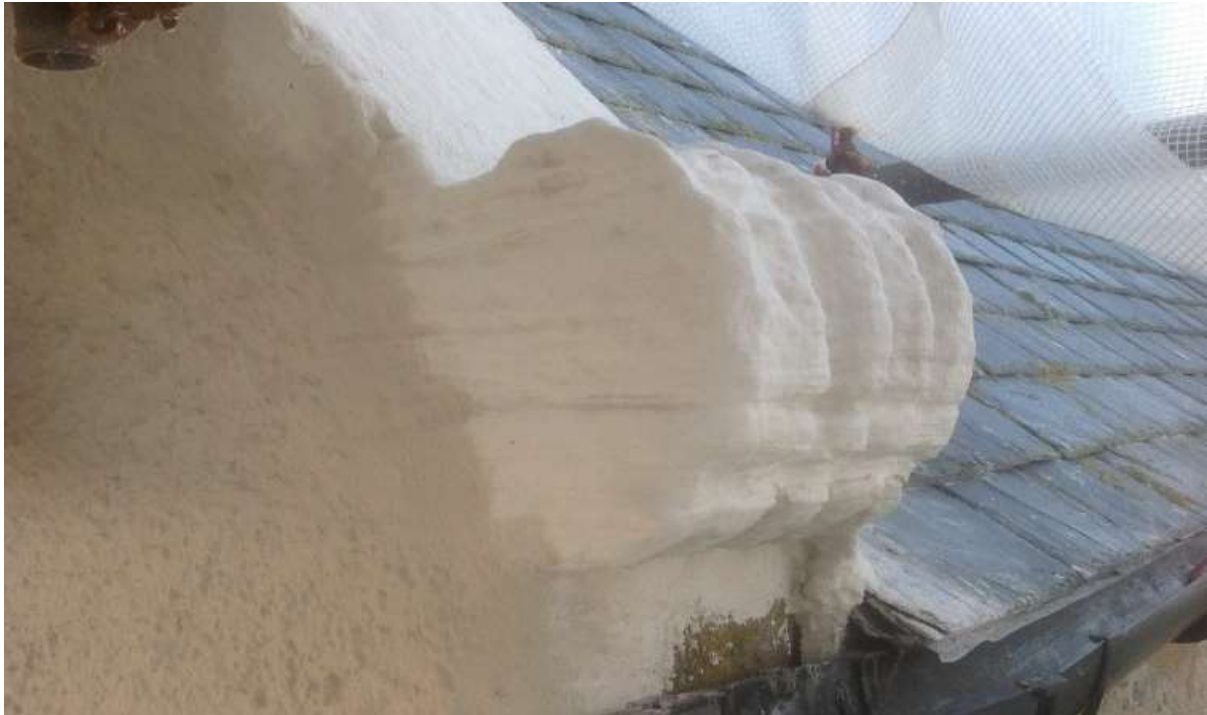
Figure 20: Limewashed decorative skewbutt detail.

The roof of Haa of Sand had been replaced, and is of relatively modern pitched slated construction, however the stone gables are contemporary with the earlier phase of the building, and had weathered considerably. The stone skew copes and decorative scrolled skewputts contribute significantly to the character of what is otherwise a relatively unadorned building externally, therefore alterations to this element were not desirable, despite the fact that the stone was heavily weathered. For this reason the skew copes were simply repointed with hot-mixed lime mortar and limewashed (Figure 20).

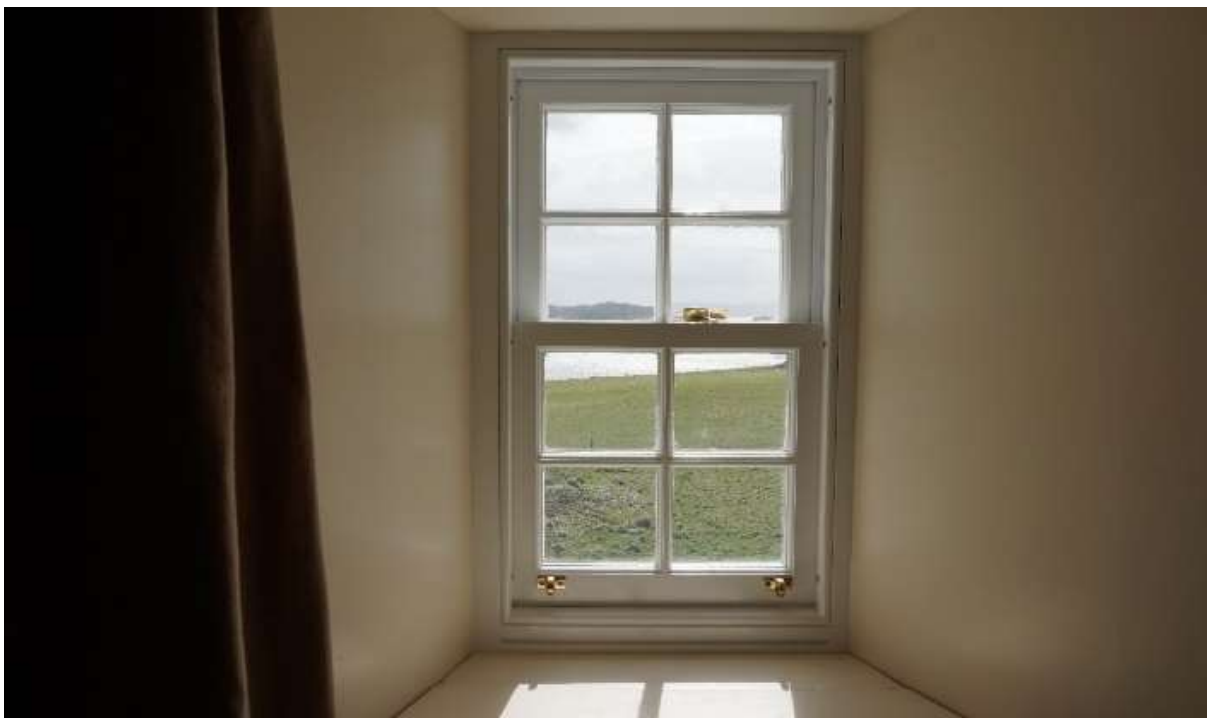
Figure 21: New slim profile double-glazed windows in situ.

The windows throughout the property were timber, single-glazed sash-and-case style, generally in poor condition. Some had been replaced in the 1980s and most of these were rotten in places and allowing water ingress. As a separate phase of the project, listed building consent was obtained for replacing the rotten windows with new timber-framed, slim profile double glazed sash and case units. This work was carried out as part of the overall project but was not funded as part of the research.

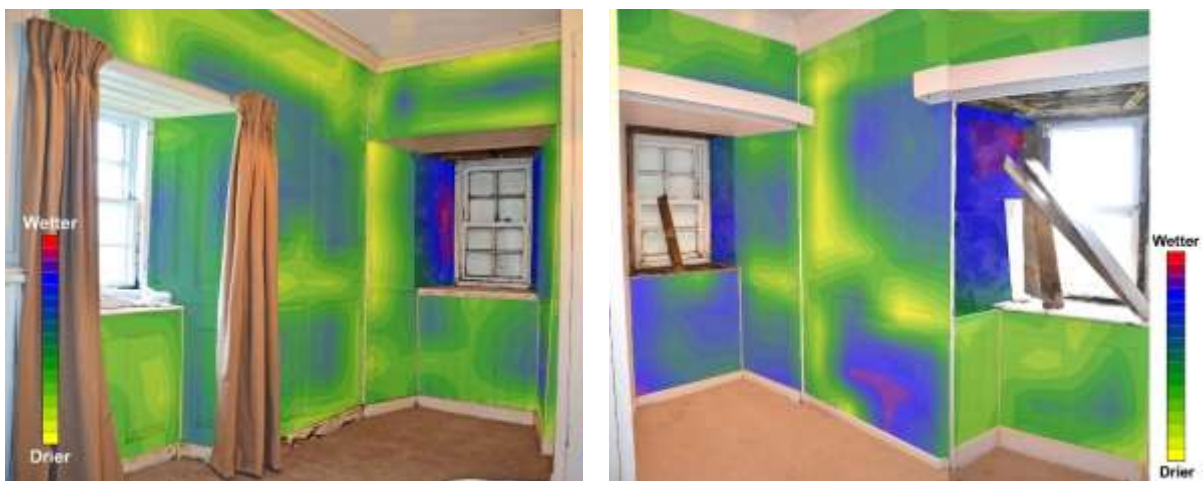
The walls were re-surveyed two years after the intervention; the interior finishes show no sign of dampness and the occupant reports that the gable wall rooms are dry with no evident issues of penetrating damp. However, moisture monitoring within the wall (at 3cm and 30cm depth) shows only modest improvements in moisture levels. This may be attributed to the length of time required to dry out saturated walls in an intermittently occupied building. The post intervention inspection nevertheless indicates that the gable wall is now coping adequately with the driving rain, in a way it previously was not. Monitoring is ongoing to determine the long-term impact and success of the interventions.

Figures 22 and 23: Pre-intervention moisture patterns within the gable at a depth of 30cm into the wall. The darker areas indicate high levels of damp.

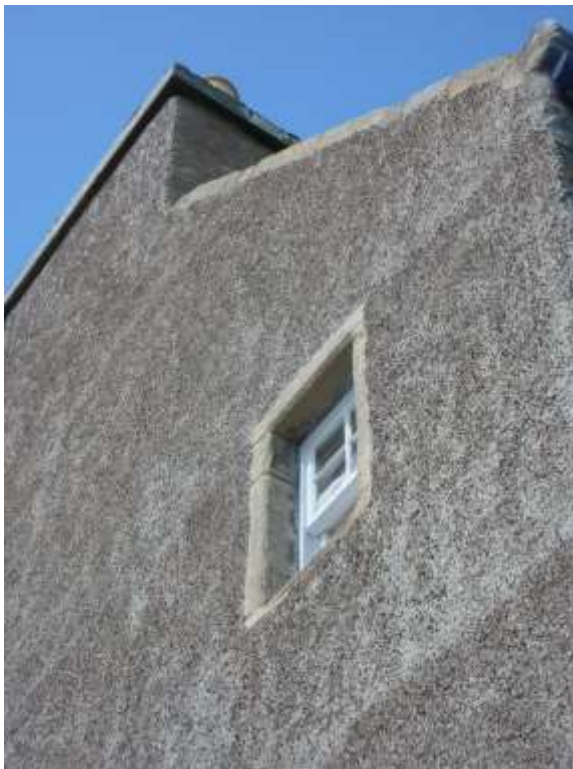
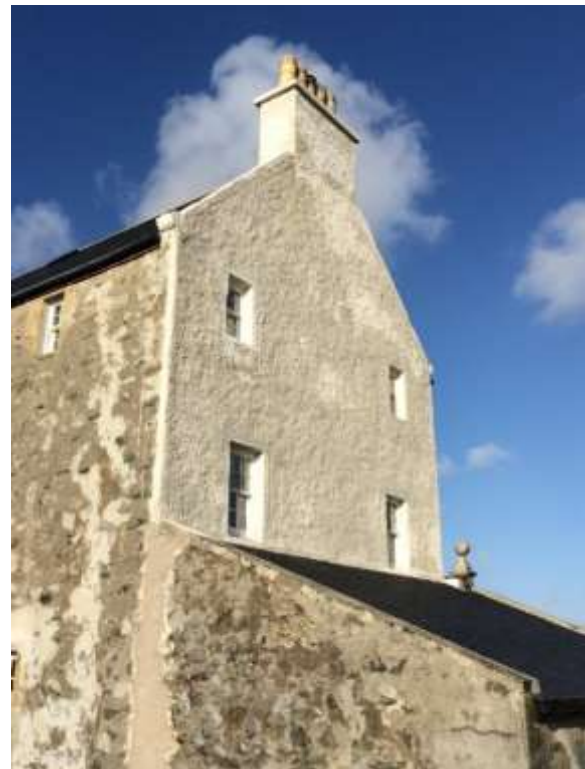
The work at Haa of Sand was carried out during October and November 2014. The site has been inspected since this date on a number of occasions, and most recently a high level inspection using a cherry-picker was undertaken in September 2016. The inspection showed that the harling was holding up extremely well after two years, showing no signs of degradation or detachment; with only one small area of limewash failure, at a vulnerable point below the SE skewputt.

Figures 24 and 25: The gable end before works (left) and after (right).
