REFURBISHMENT CASE STUDY 33

ST ATHERNASE CHURCH LEUCHARS

GROUND WORKS IN AN HISTORIC GRAVEYARD

ROGER CURTIS

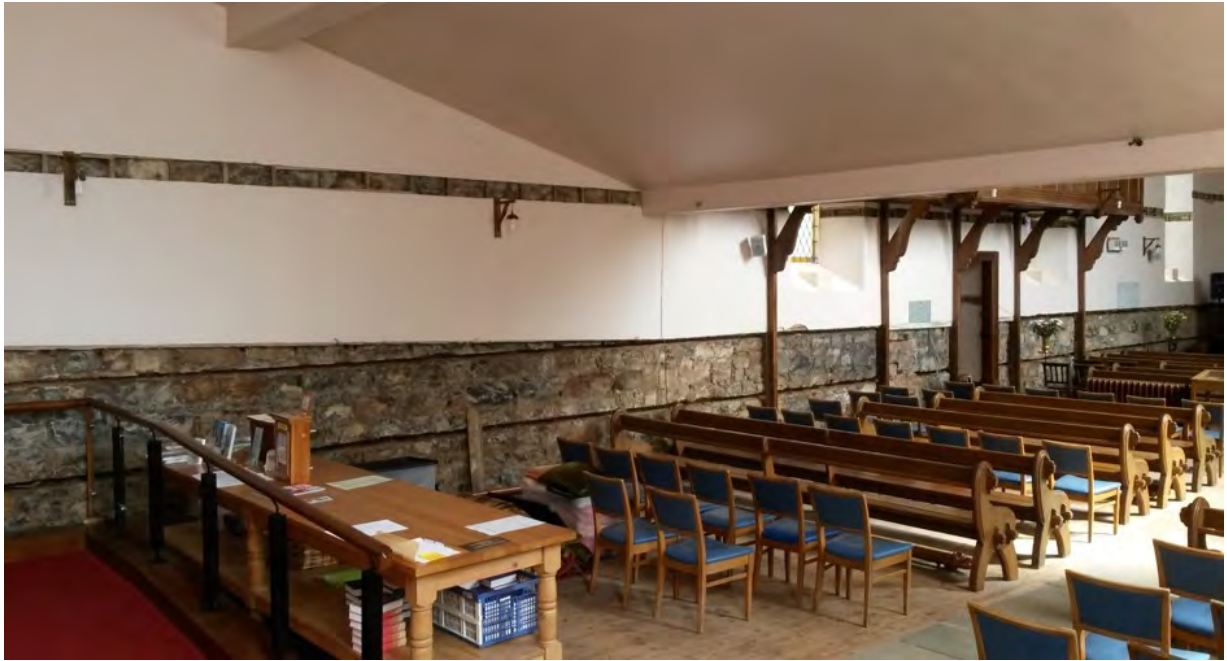
Possibly as a consequence of the high levels outside, the original timber floor in the nave had been removed in the past and a new timber floor laid over a base of concrete and compacted ash. Timber panelling had been installed below the dado rail in the nave, probably during the inter-war period. The panelling had decayed at the base of the walls and had been removed by the church in 2015 before the project started (Figure 5). This revealed the dampness of the masonry at the base of the walls. In some instances the walls were wet to the touch after rain. The water ingress was also creating extensive pattern staining to the flagstones in the historic apse (Figure 6).

Figure 5. The north side of the nave, showing the areas of stonework exposed by removal of the decayed panelling.

While the project focused on external works to address sources of water ingress, the damaged internal linings that had been removed as part of the earlier investigation works were also reinstated. A 1.5m high dado rail was reinstated along the inside faces to the north, west and south sides of the nave. Due to budget and programme constraints, re-instatement of the vertical timber lining was not possible. However, by agreement with the Committee on Church Art and Architecture (CARTA), the wall finishes above the level of the dado were replaced using traditional lath and plaster. As an interim measure and in anticipation of further regeneration works, the uncovered areas were lined with insulated moisture resistant plasterboard attached to timber framing with a ventilated air gap. This was set to give a finished surface, in line with the plane of the wall above, that would be resistant to the damp remaining in the walls. On completion, the interior of the nave was repainted.

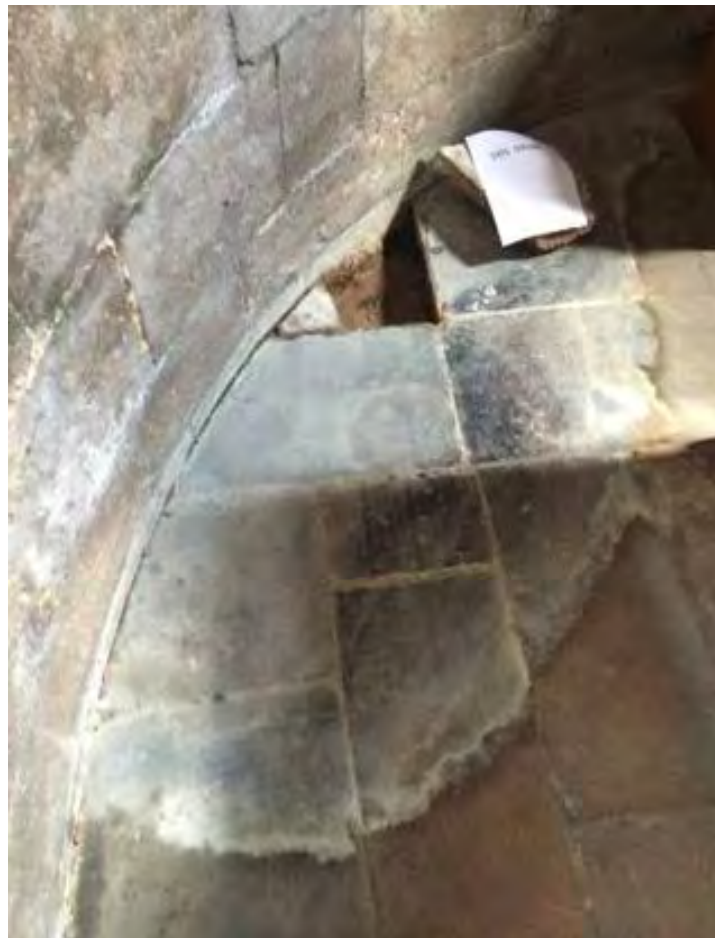
Figure 6. Damp and staining on the floor of the apse.

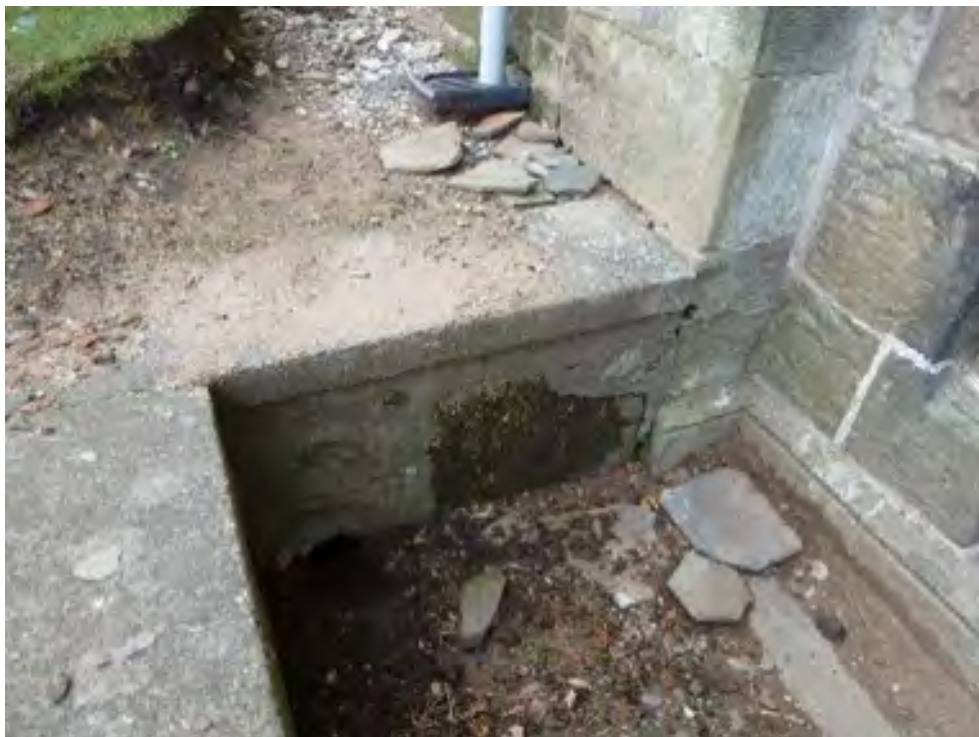
It was clear from the outset that there were issues resulting from the external ground levels. Works in the past had tried to address these in some places, including a lowered area created around the choir and the apse. However, the earth remained at high levels on the north and south side of the nave. It appeared that water from the nave roof was routed into this area (Figure 7) corresponding to the areas of damp visible internally in the apse.

Figure 7. The outlet point (the base of the downpipe) for water from the nave roof was effectively directing water into the lowered area around the choir and the apse.

climate. Rainwater goods were upgraded to a larger diameter, from 65mm to 75mm, and a rainwater downpipe was added on the north elevation. The new downpipes were also fitted with a rodding eye at low level to allow easy cleaning from the ground. An angled 'shoe' was fitted at the end of the downpipes to ensure the water passed into the belowground drainage via a horizontal grilled opening or 'gully trap' (Figure 19).

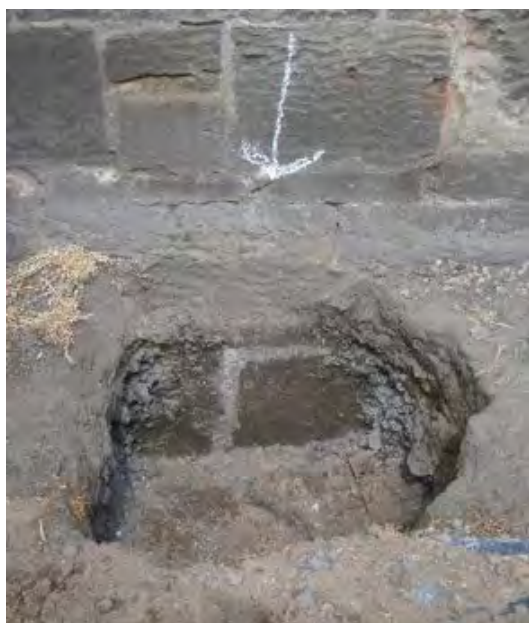
During the surveying work, trial pits to the north and south of the nave were made to check the levels of the foundations (Figure 8). These excavations produced several bone fragments (Figure 9). After taking advice from the minister, the bones were returned to the ground once survey works were complete. A further hole was dug at the southeast corner of the nave where the downpipe enters the ground at the junction with the chancel. The excavations confirmed that ground levels had risen considerably. In addition to drainage deficiencies, the wet earth in contact with the wall was causing damp to penetrate the building at low level.

Figure 8. One of the investigation pits dug on the south wall of the nave.

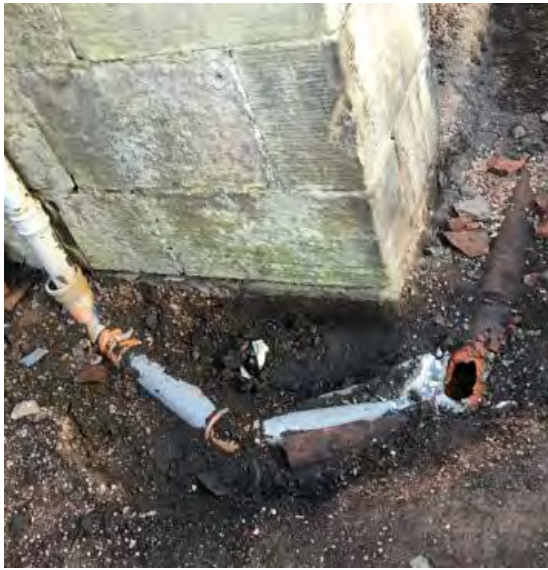
The investigations around the north side of the nave showed that surface water drainage was equally poor or non-existent, and the routes of the buried pipes in the graveyard could not be identified. Evidence of previous attempts to divert water away from the nave was also uncovered. Excavation work revealed poor drainage design and very basic attempts at

Figure 10. Long turns with no rodding facility resulted in blockages.

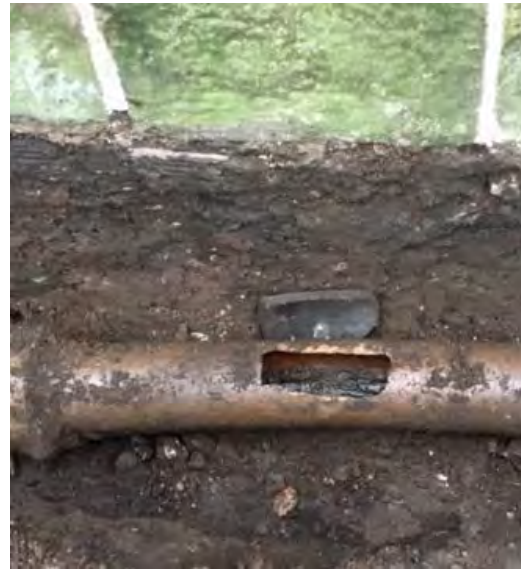
Figure 11. Fireclay drain adjacent to the nave wall, showing previous efforts to clear blockages.

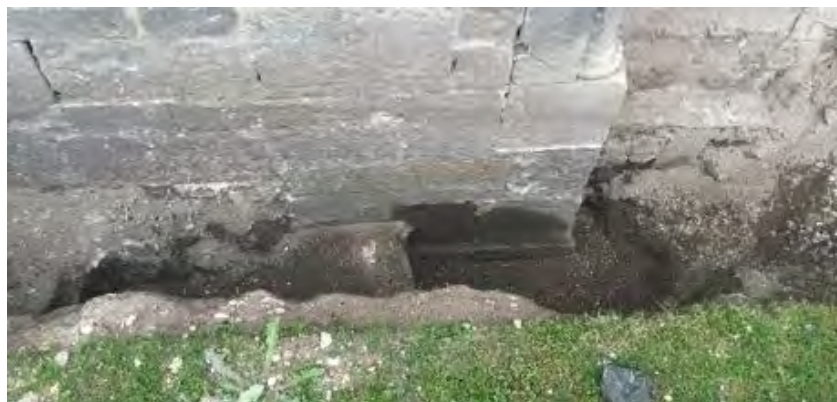
The differences in levels and the resulting damp problems were not a surprise. When the church was built, the interior floor level would have been the same or higher than the external ground level, but over time the outside earth level has risen. Figure 12 shows the base course of the nave wall which was uncovered during the investigations, some 300mm below the modern ground level. The ground level to the west of the nave in the slightly raised vestibule was more or less at the same level as the internal floor and was less of an issue. This gradual raising of external ground levels is common with many older structures, but particularly in churches with graveyards where there has been a history of burials over hundreds of years.

Figure 12. The base of the nave wall, now some 300mm below the present ground level.

The project team and the client agreed that the ground levels needed to be reduced on most elevations and that the belowground drainage arrangements should be redesigned. This would return the outside ground levels close to their original level and allow the masonry to dry out. Better belowground drainage would also reduce the amount of water in the soil, and keep the walls dry. Procedures for these works had to be agreed, with the following points considered:

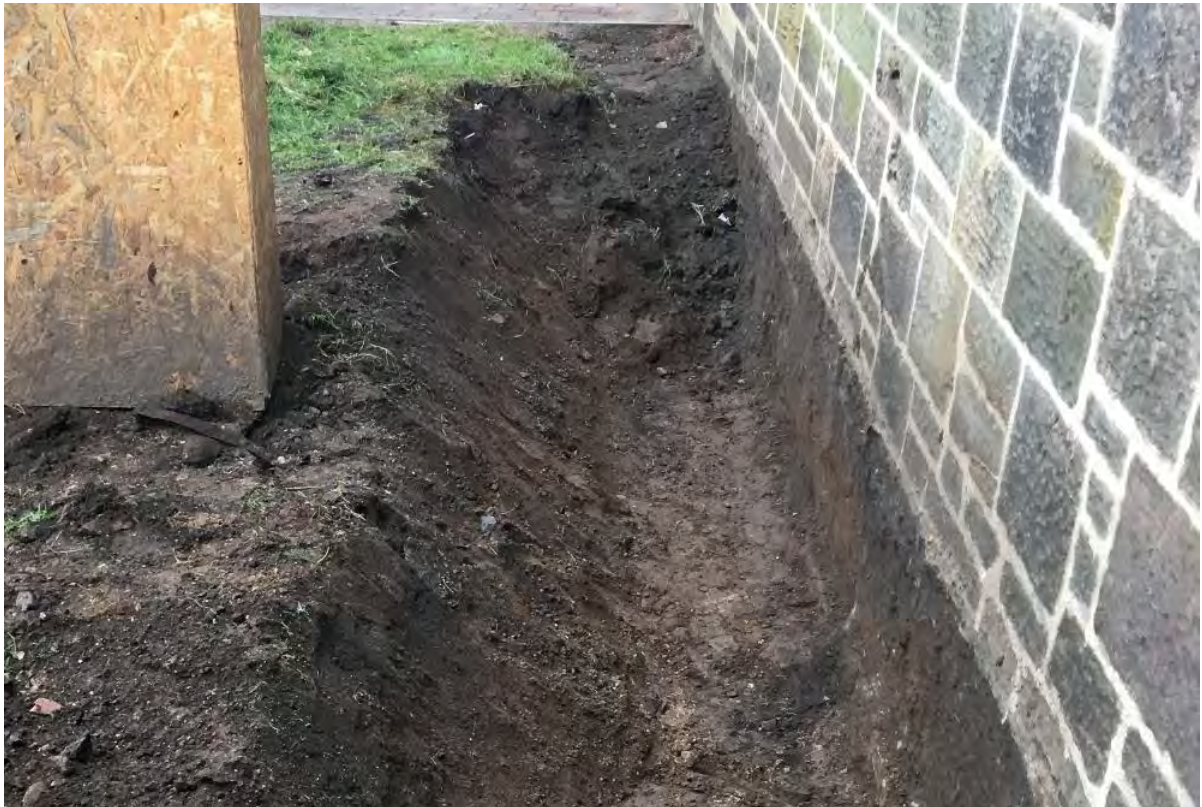
Figure 17. The newly dug trench along the south wall of the nave, where the base of an earlier wall can be seen. This restricted the depth of the excavation.

The excavation was originally intended to be carried out by hand. However, the volume of excavated earth and the requirement for it to be moved and laid out in spoil heaps in the graveyard, resulted in the contractor being allowed to use a small mechanical excavator. During the work to the south side of the nave, the footings of an earlier wall were uncovered which was probably the base of the wall of the 12th century nave. This restricted the depth to which the trench alongside the external face of the church walls could be excavated and where field drains could be located (Figure 17).

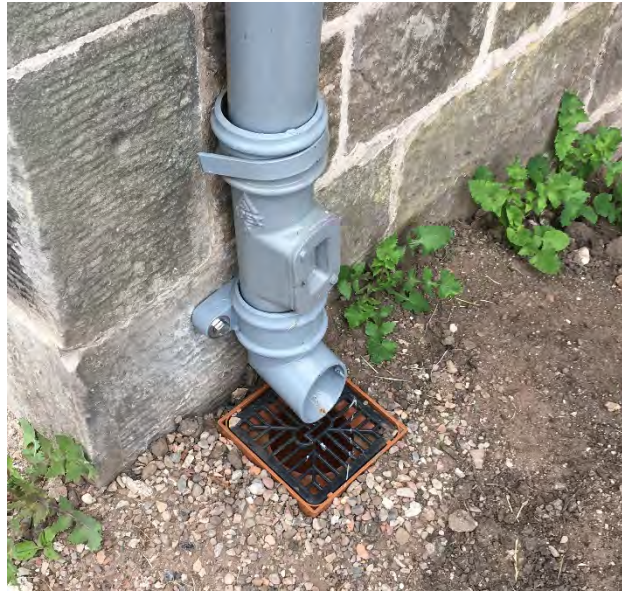
Figure 19. The new angled shoe directs water into the gully trap.

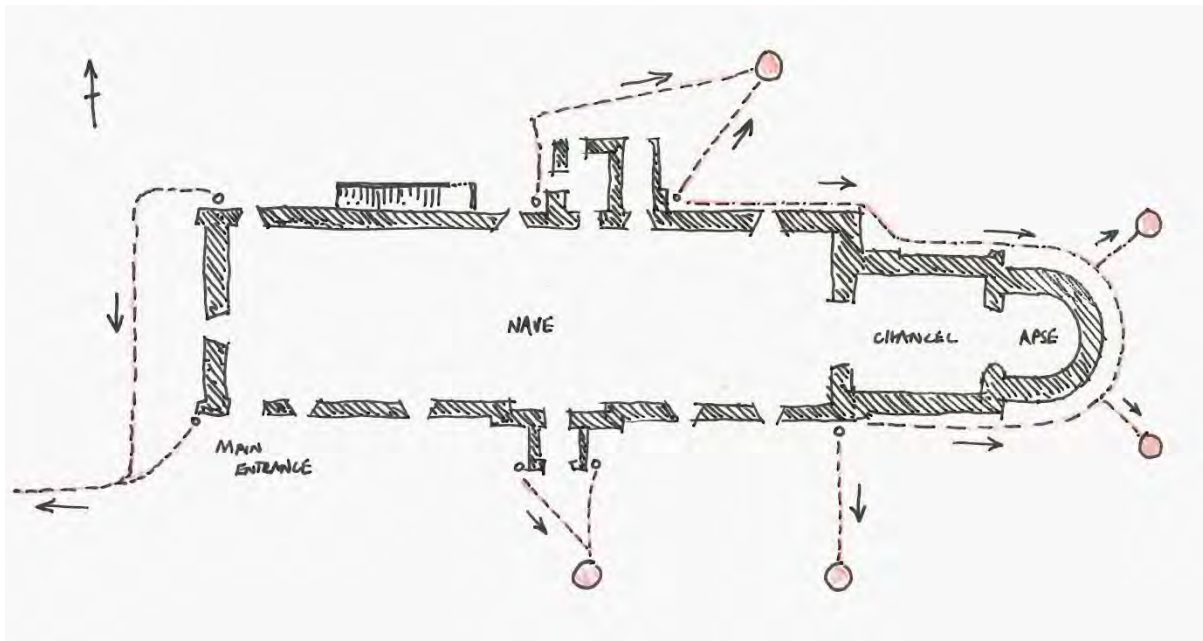
Figure 20. The new drainage layout for the church. The new soakaways to the north, east and south are marked as red circles.

Field drains made from buried perforated pipes were laid in pea gravel around the base of the walls around the apse and chancel as there were no downpipes and water had ponded. These pipes drained to two new soakaways to the southeast and northeast of the apse (Figure 20). This

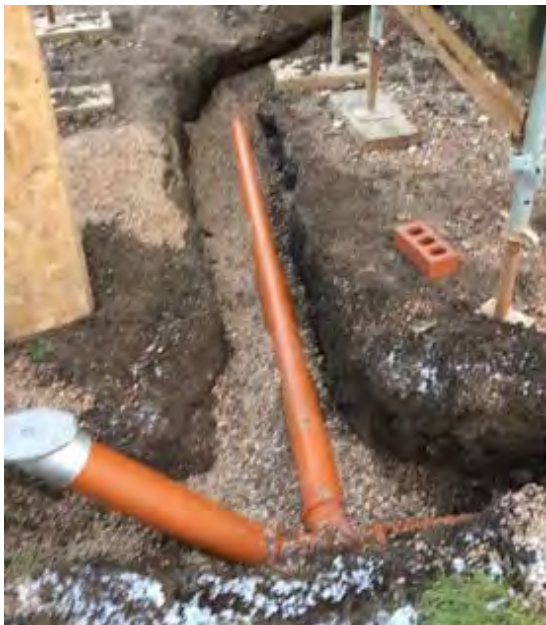
Figure 21. New drain route, note the rodding eye on the left for cleaning.

Drainage specification: The new drainage around the church comprises 100mm diameter PVCu pipes laid to fall in a granular pea bed. They have rodding eyes at ground level at every change of direction to facilitate future access and cleaning (Figure 21). The new drainage was photographed throughout the installation (Figure 22) and the locations recorded on a site plan.

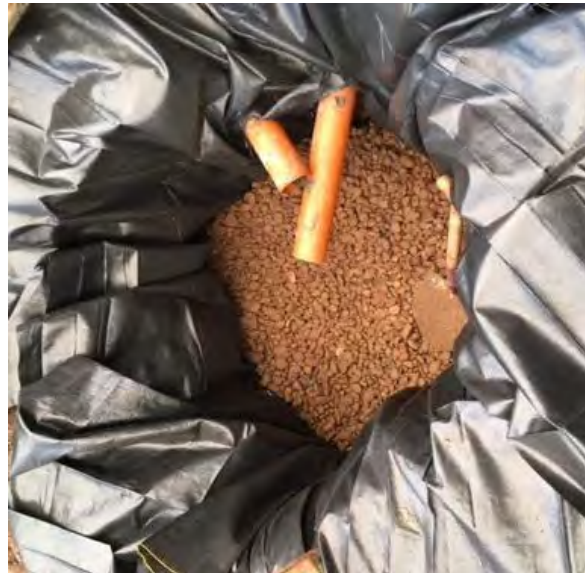
Figure 24. The soakaway pit lined and filled with gravel.

Soakaway design: The results of soil porosity tests determined that each of the five soakaways should be in the region of 1.5m square and 2.5m deep and be located at least 5m away from the church. The soakaway pits were lined with a permeable geotextile material and filled with gravel to the engineer's specifications (Figure 24).

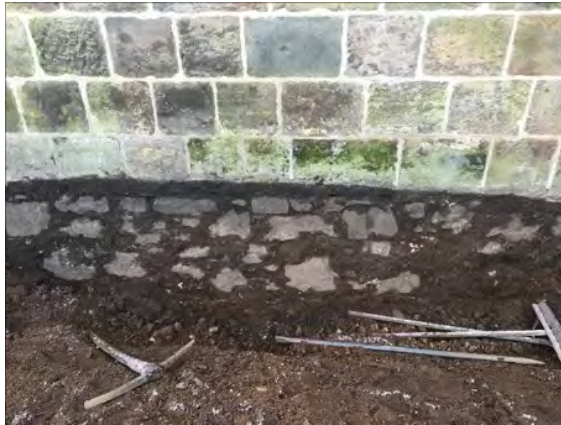
On the north side of the nave the lowered the ground levels exposed a rubble layer (Figure 29). The surface of this exposed stone was cleaned and re-pointed with a quicklime based mortar. This facilitated moisture movement, which also allows the walls to dry out quickly (Figure 30).

Figure 29. Newly exposed rubble on the north side of the nave.

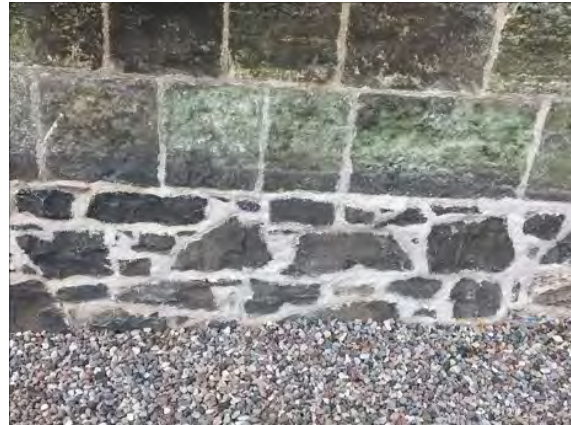
Figure 30. The masonry re-pointed using a quicklime based mortar.
