# ANGUS FLAGSTONE ROOFING – VOLUME I: LITERATURE REVIEW AND CASE STUDIES

HISTORIC  
ENVIRONMENT  
SCOTLAND

Principal Author: Sara Carruthers MCIOB, BSc (Hons), MA (Conservation, IoAAS), Certified Building Conservation Specialist (CIOB)

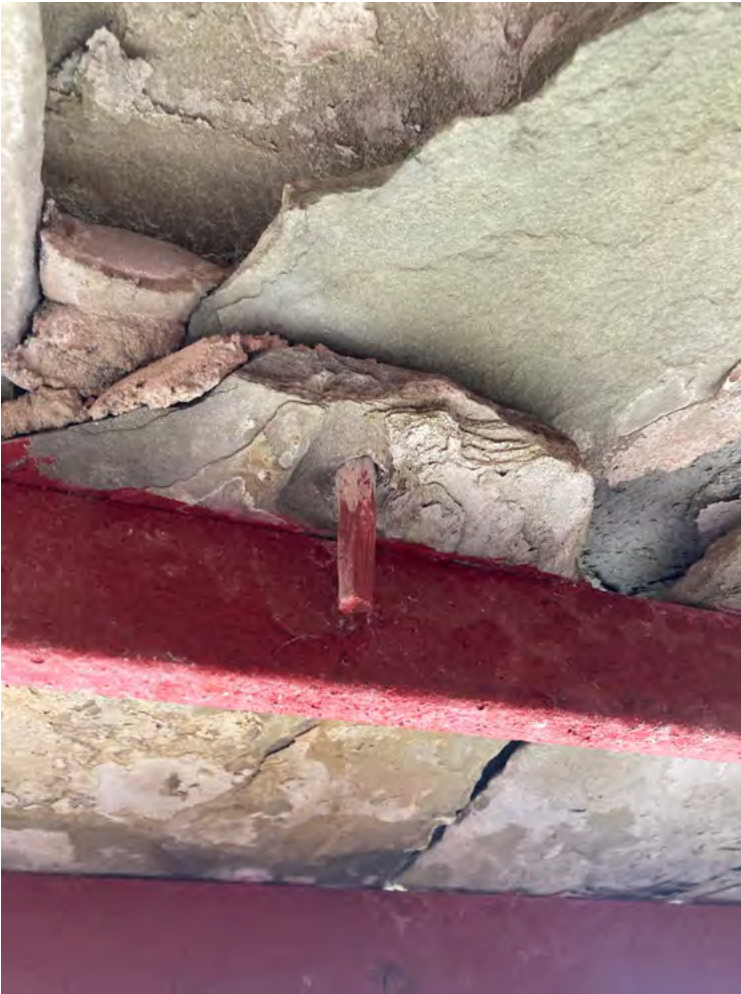
Figure 20: Batten and peg method of laying flagstone on a shelter at Arbroath Signal Station. Lime mortar bedding is still visible. © Graham Briggs.

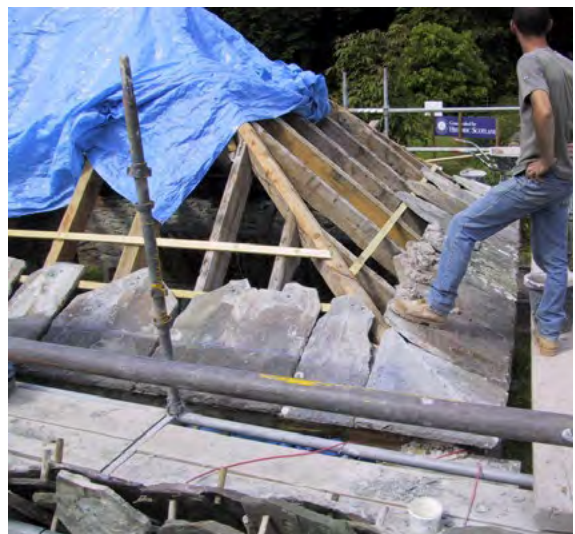
Figure 22: Roof repairs in progress at Pitmuies Estate, Angus, showing lime mortar bedding, pegged slates and battens. © Ian Cumming.

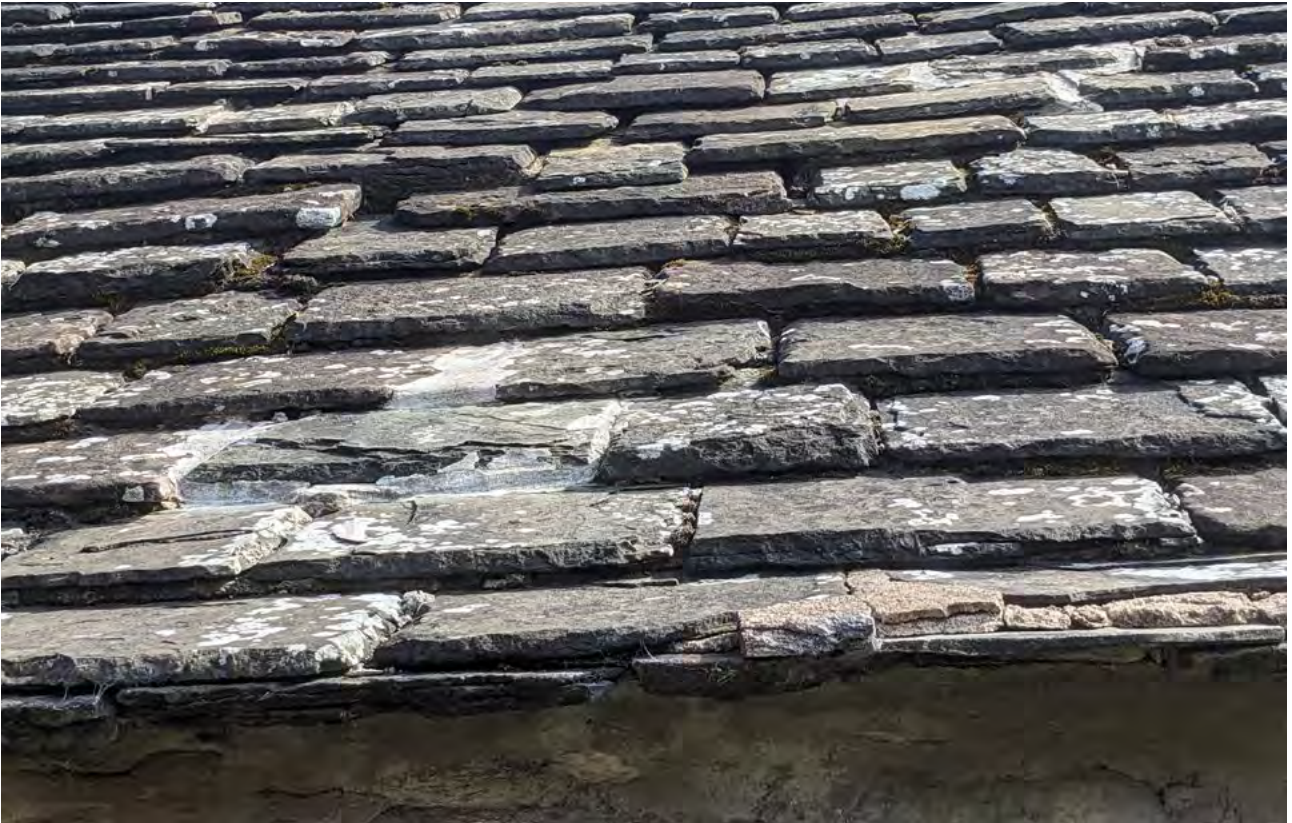
This is not a traditional detail and will adversely impact the performance and life expectancy of the roof. It will prevent water from draining between the double-lapped slates, as it was designed to do, and cause accelerated deterioration of the stone itself. Deterioration will be caused both by saturation and the use of a cement mortar with natural stone. Many flagstone roofs are observed to have a heavy moss covering, which indicates high water content.

Figure 35: An example of surface pointing of flagstone slates. While this can secure a broken slate, pointing under the tail will trap water within the roof and stone, promoting moss growth and frost damage. © Sara Carruthers.

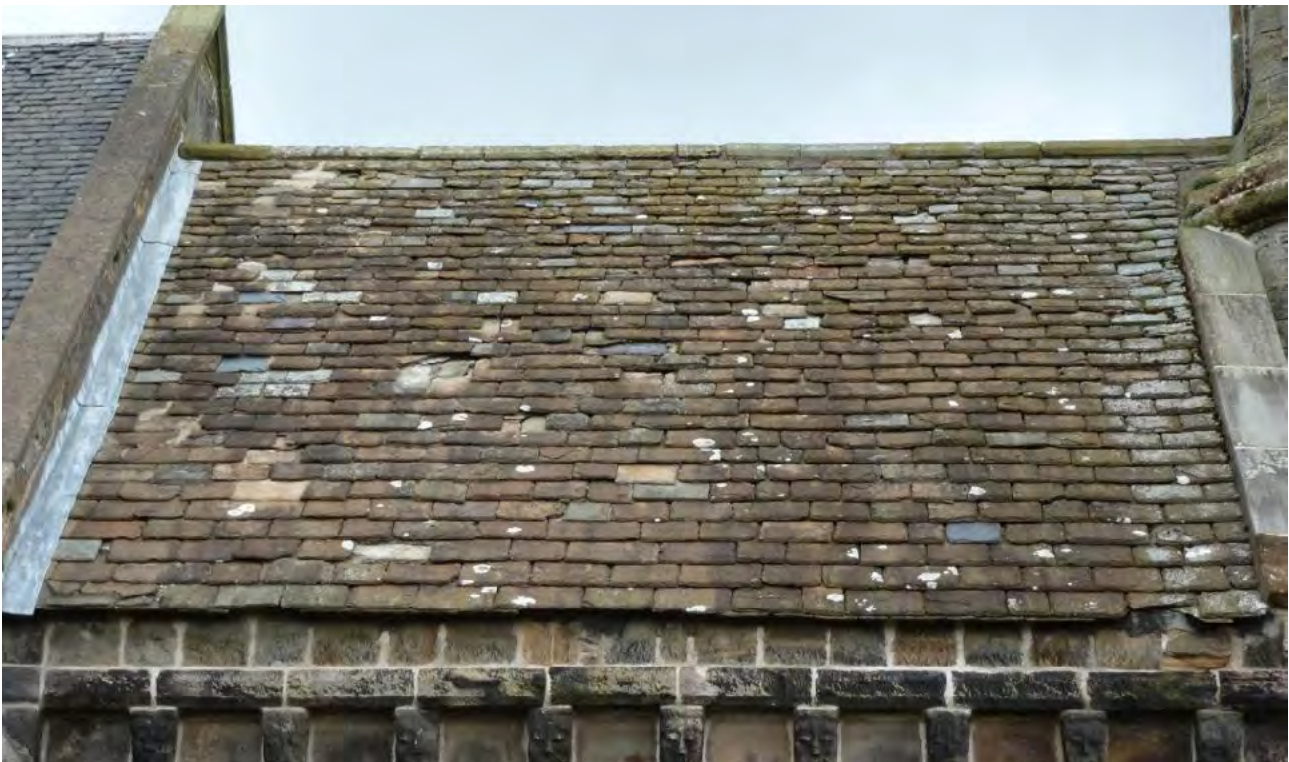
Figure 44: The south roof of the chancel at St Athernase, before repair. © Douglas Binnie.

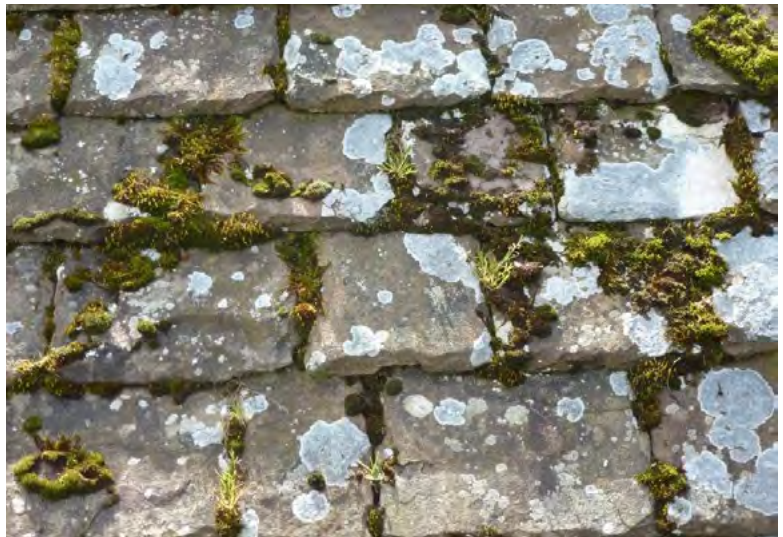
Figure 47: Part of St Athernase north roof, prior to repair. © Douglas Binnie.

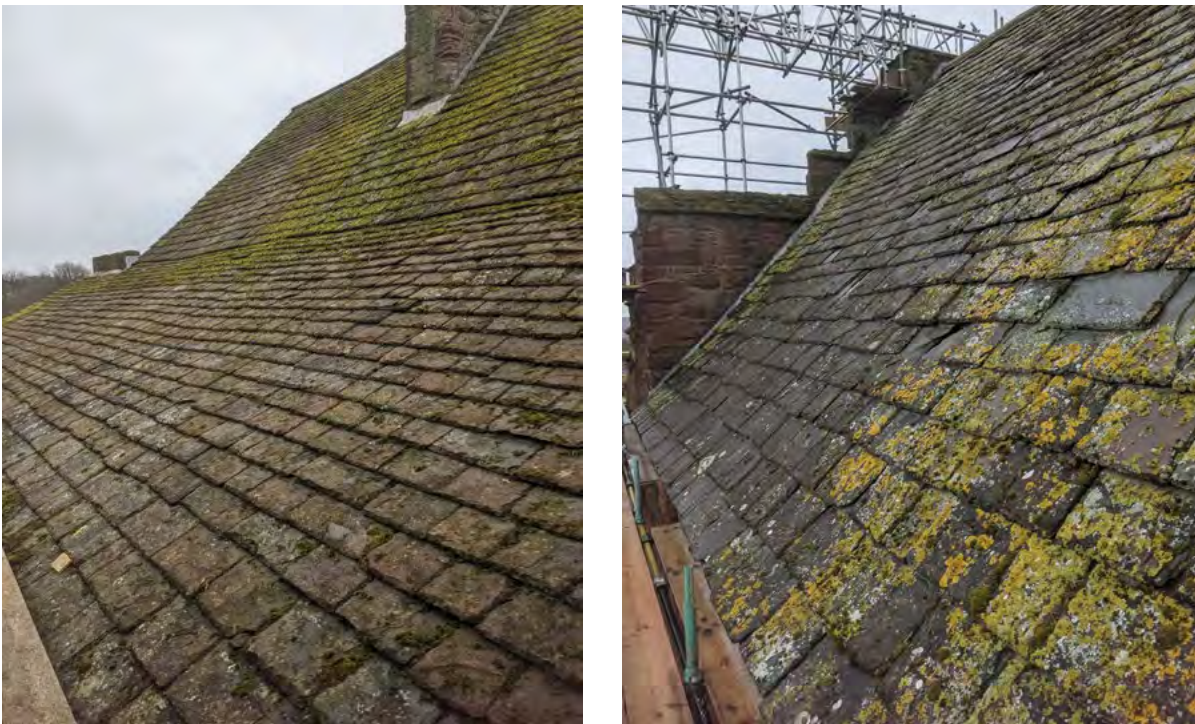
Figure 51a and b: The roof of the Abbot's House showing the north elevation (a) and south elevation, facing the sea (b). The south elevation is in poorer condition, with broken and delaminating flagstone. © Sara Carruthers.

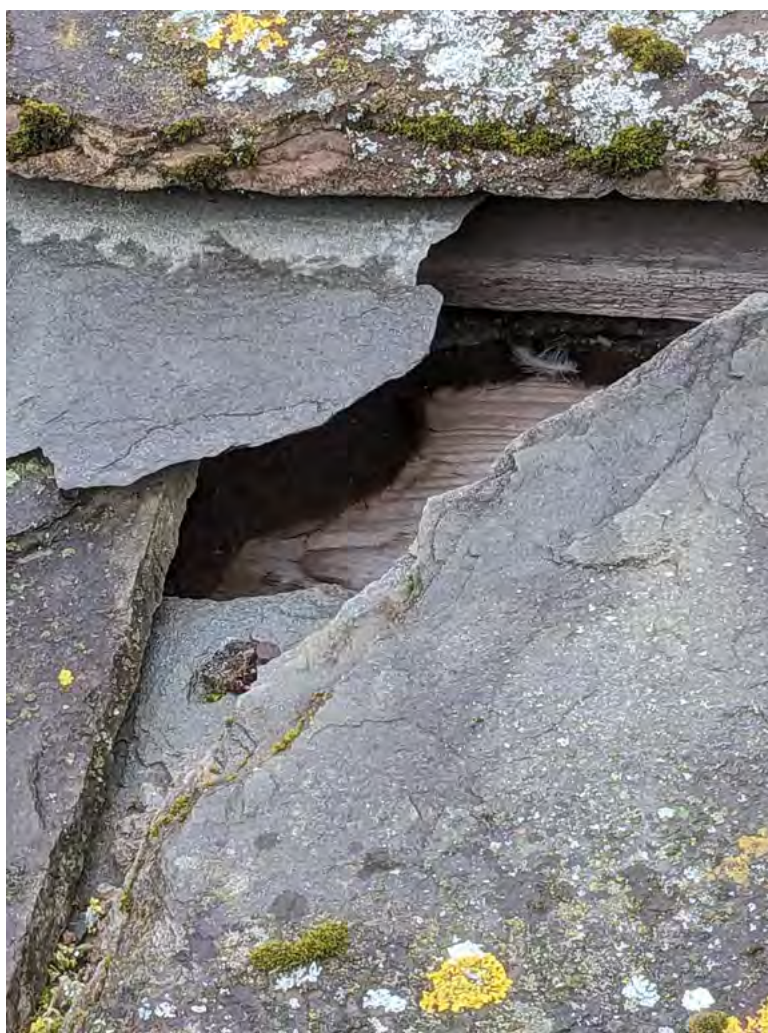
Figure 52: Close-up of a broken slate on the south elevation of the Abbot's House.  
© Sara Carruthers.

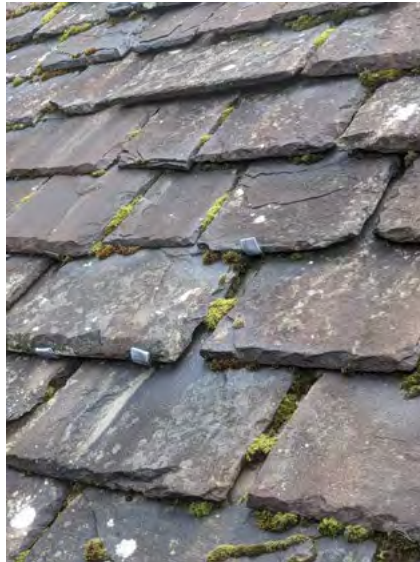
Figure 54: Replacement slates held in place with tingles, Falkland Palace. © Sara Carruthers.

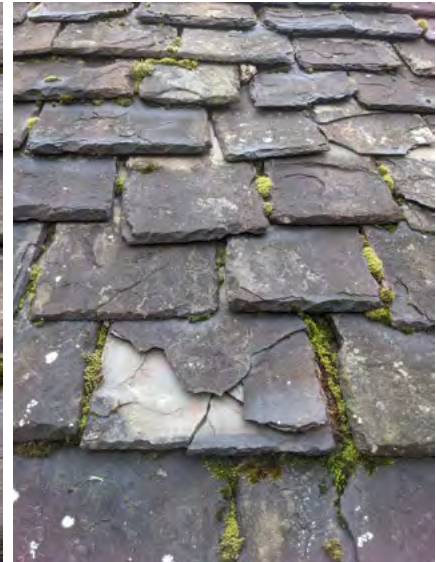
Figure 55: Examples of delamination and slippage from failed fixings, Falkland Palace. © Sara Carruthers.
