Callendar House Stable Block

Interim repairs to roof, rainwater goods and associated elements

Historic Scotland Refurbishment Case Study 15

Moses Jenkins

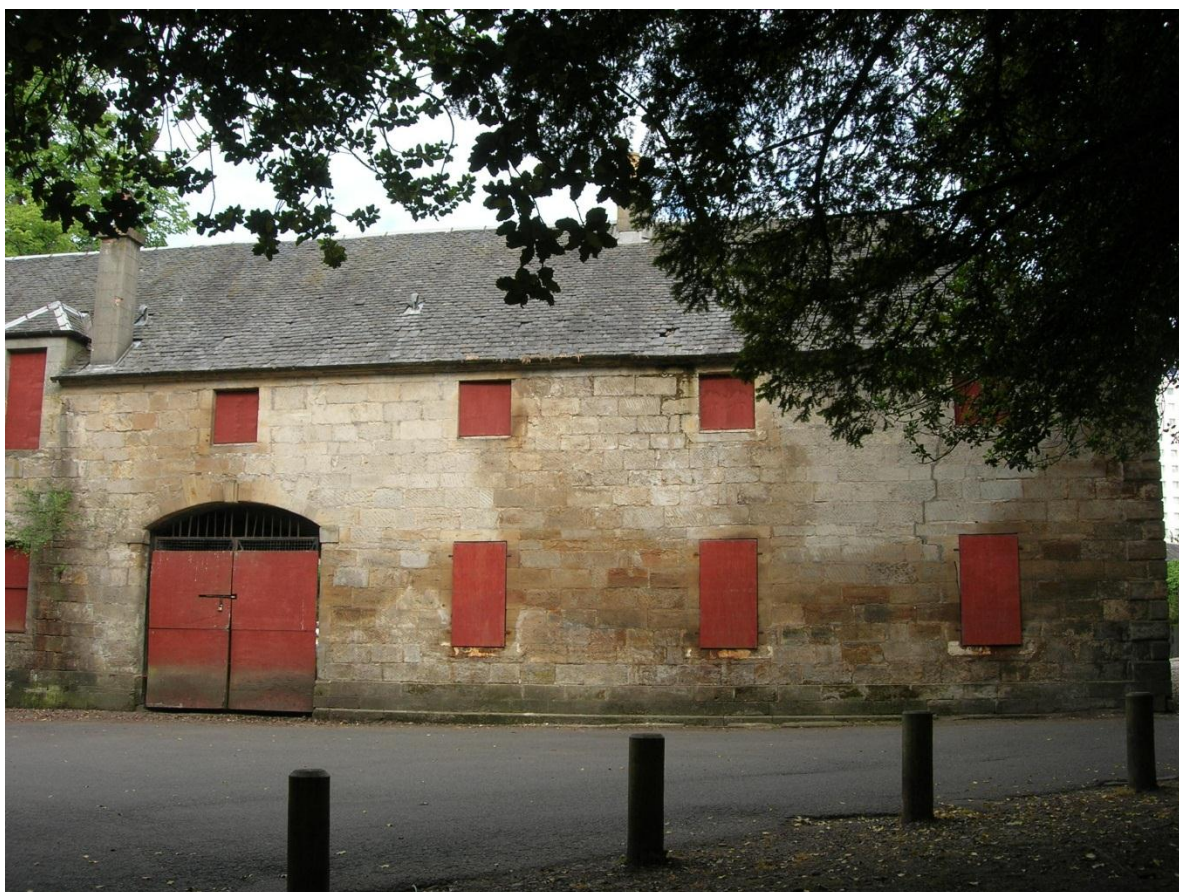
Prior to the implementation of the interim repairs, the building was rapidly falling into a state of serious disrepair. Many gutters and downpipes were blocked, cracked or missing, allowing large amounts of water to saturate the building fabric. Almost all glazing had been lost, with windows either boarded up or unsecured, leaving the building vulnerable to infestation by birds and vandalism. A large area of the internal pitch of the roof had lost its slates, leading to extensive rot in the timber structure beneath, and partial collapse. Finally, a chimney on one elevation had suffered severe stone decay leaving it in an unsafe condition.

Fig. 1. The west elevation of the stable block at Callendar House, Falkirk

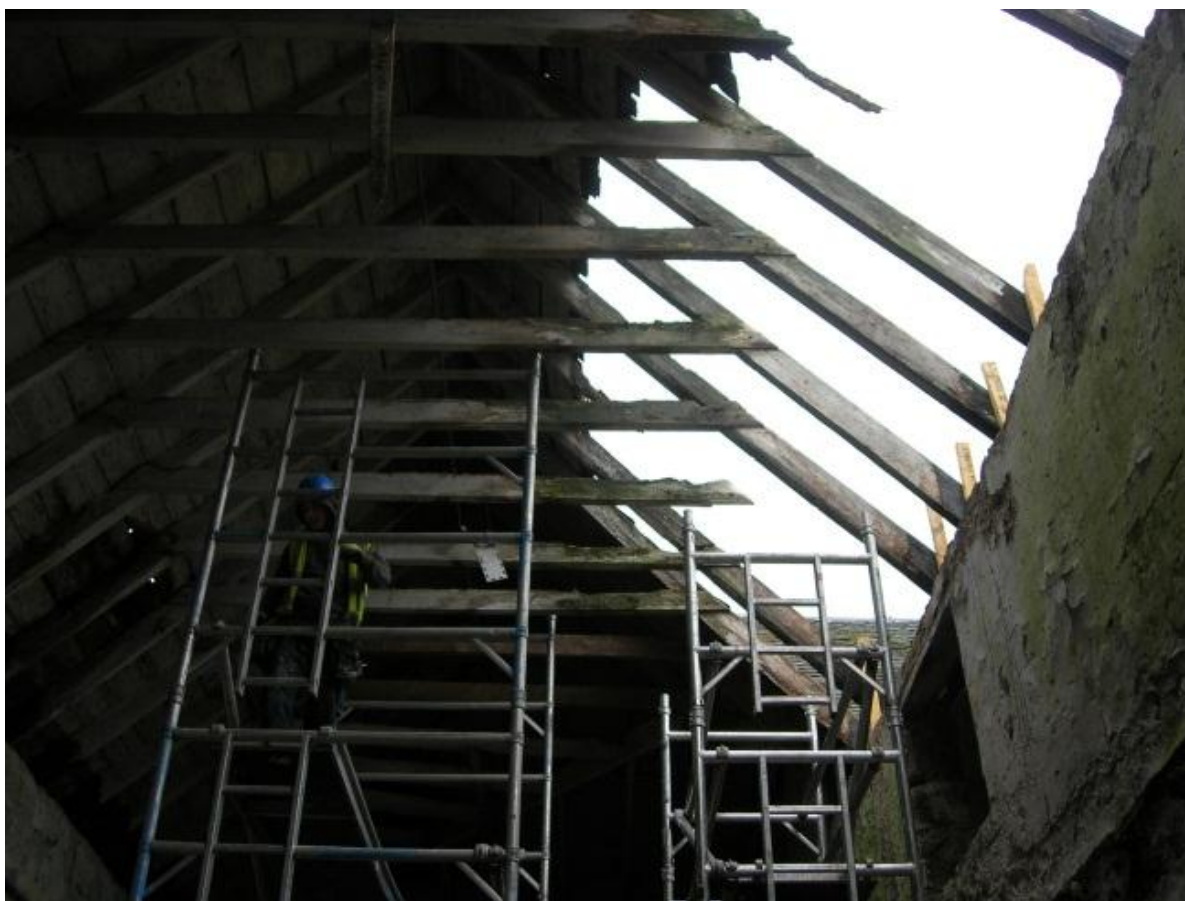
Fig. 2. Access to the damaged section of roof was via both an internal and external scaffold

When planning any scheme of construction work, safe access is an important consideration. At Callendar House Stables a range of access measures were required. For the repairs to the roof this was achieved through the use of scaffolding both externally and internally. To construct the internal scaffolding, a section of decayed floor had to be removed to allow the scaffold to rest on firm ground (Fig. 2). Although this may seem an extreme way of achieving access, the floor had decayed to such an extent that its removal would always have been necessary. Other repairs to gutters and downpipes were carried out using a cherry picker or smaller sections of scaffolding.

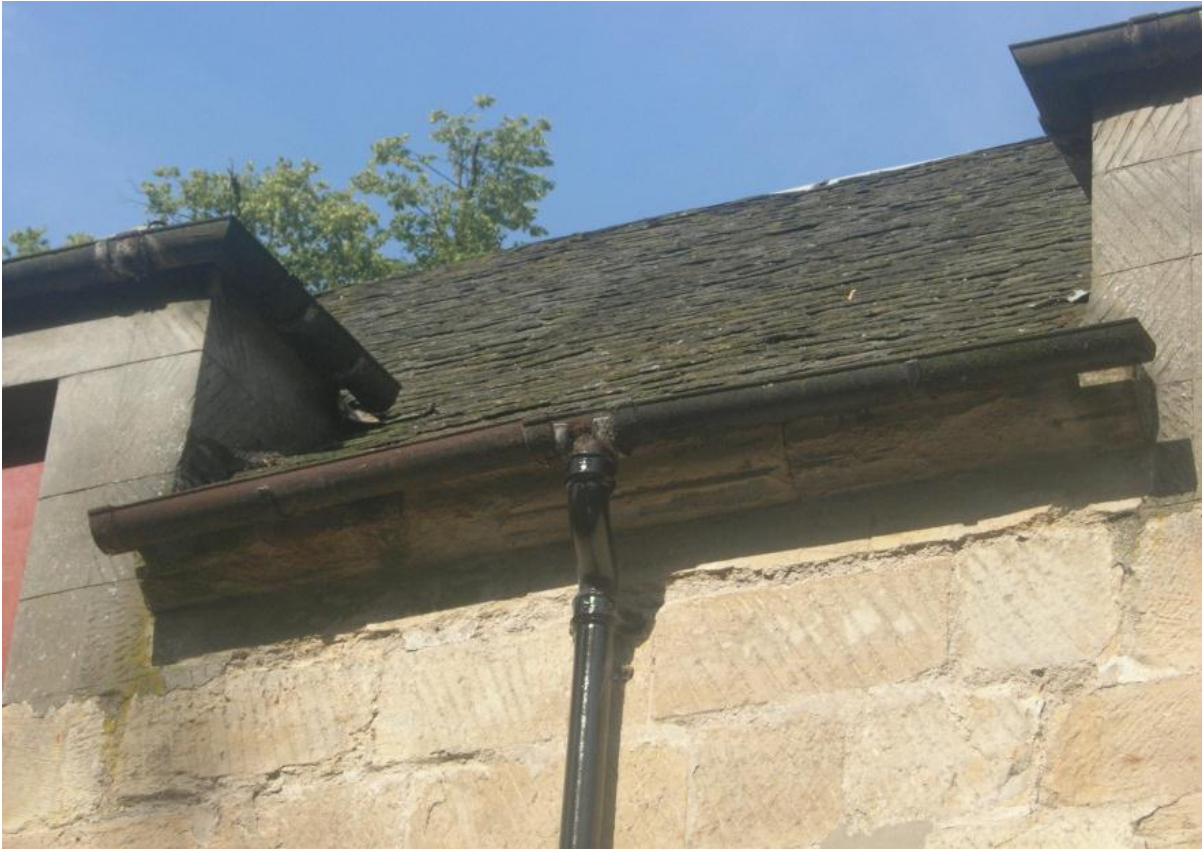
Fig. 3. Existing rhones were repaired and downpipes made good

At several points around the building, rainwater goods had been lost or were becoming detached. Their reinstatement was a priority to prevent the continued saturation of the masonry. Existing cast iron sections were re-used where intact, and made up by a small number of new pieces (Fig. 3). Due to financial constraints plastic rainwater goods were fitted as a temporary measure around the interior of the courtyard (Fig. 4), however their future reinstatement in cast iron was specified as part of the Listed Building Consent. A program of maintenance ensuring that rainwater goods remain free of blockages has been put in place to ensure problems do not recur. By re-instating a fully functioning rainwater disposal system, several areas of masonry which were becoming saturated and suffering decay will be much less vulnerable to further deterioration.

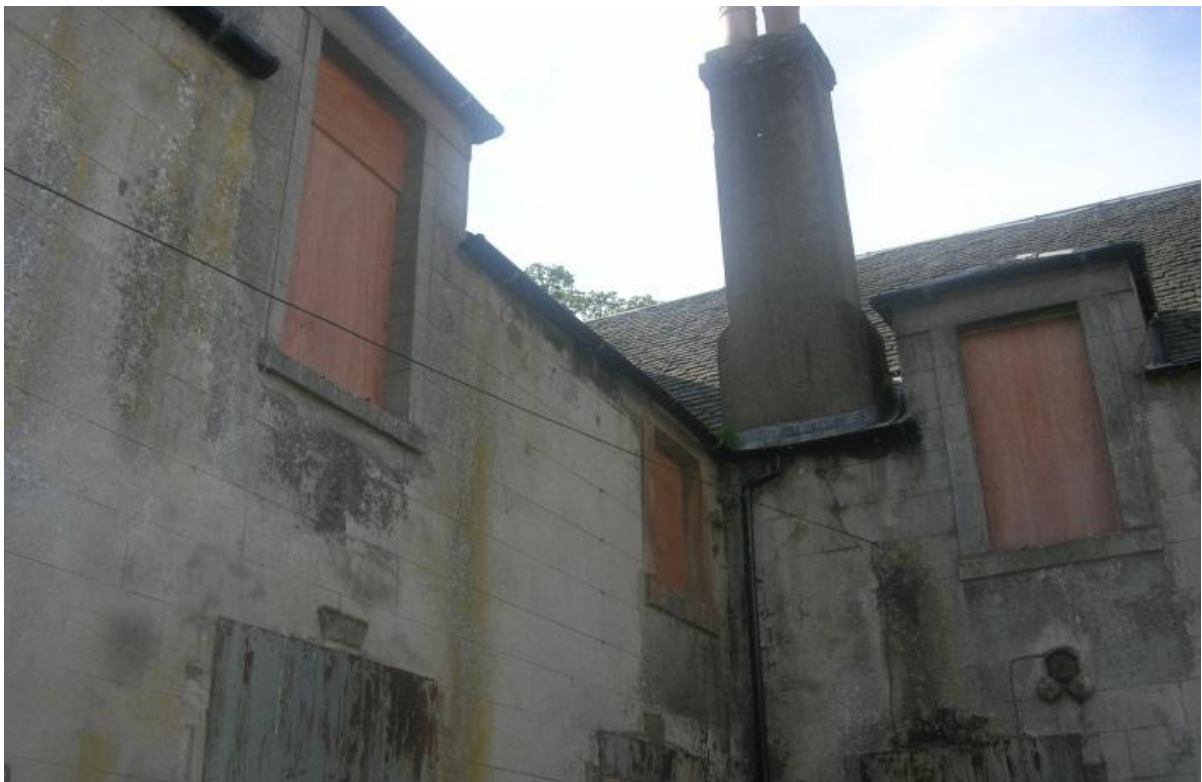
Fig. 4. Where the existing castwork was missing, new temporary plastic gutters were fitted to the courtyard elevations

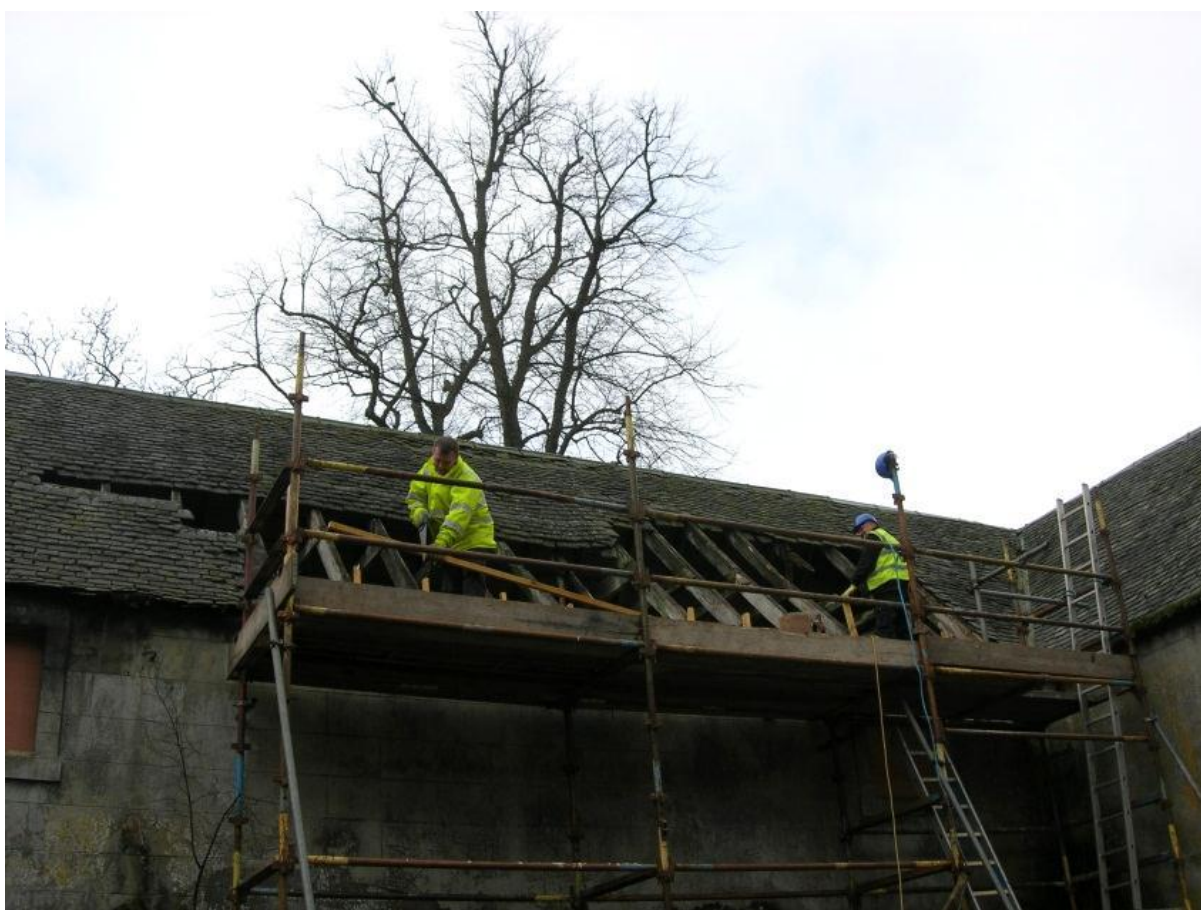
Significant failure had occurred to the roof covering and structural timbers below, on the internal pitch of the south elevation of the stable block. This was caused by an escalating series of slate slippages on the pitch, saturation and decay of the sarking boards and rotting of the rafter feet at wall head level. Following assessment it was found that twelve of the roof trusses had either cracked or suffered significant enough section loss to require replacement (Fig. 5). Given the extent of water penetration through the damaged roof covering, repair of the trusses by scarfing or other methods which would have retained some of the existing timber were not viable options. The sarking board had also suffered significant decay where a loss of roof covering had led to saturation. The wall plate was likewise entirely decayed in several places.

Fig. 5. The decayed section of roof being removed, in total twelve trusses required to be replaced during the interim repair measures

In carrying out the interim repair to the roof, the section of sarking which had rotted or been damaged was removed along with the slates and decayed trusses. Slates in good condition, or damaged larger sizes that could be re-dressed, were retained for reuse in a subsequent phase of more formal repair. The decayed sections of the wall

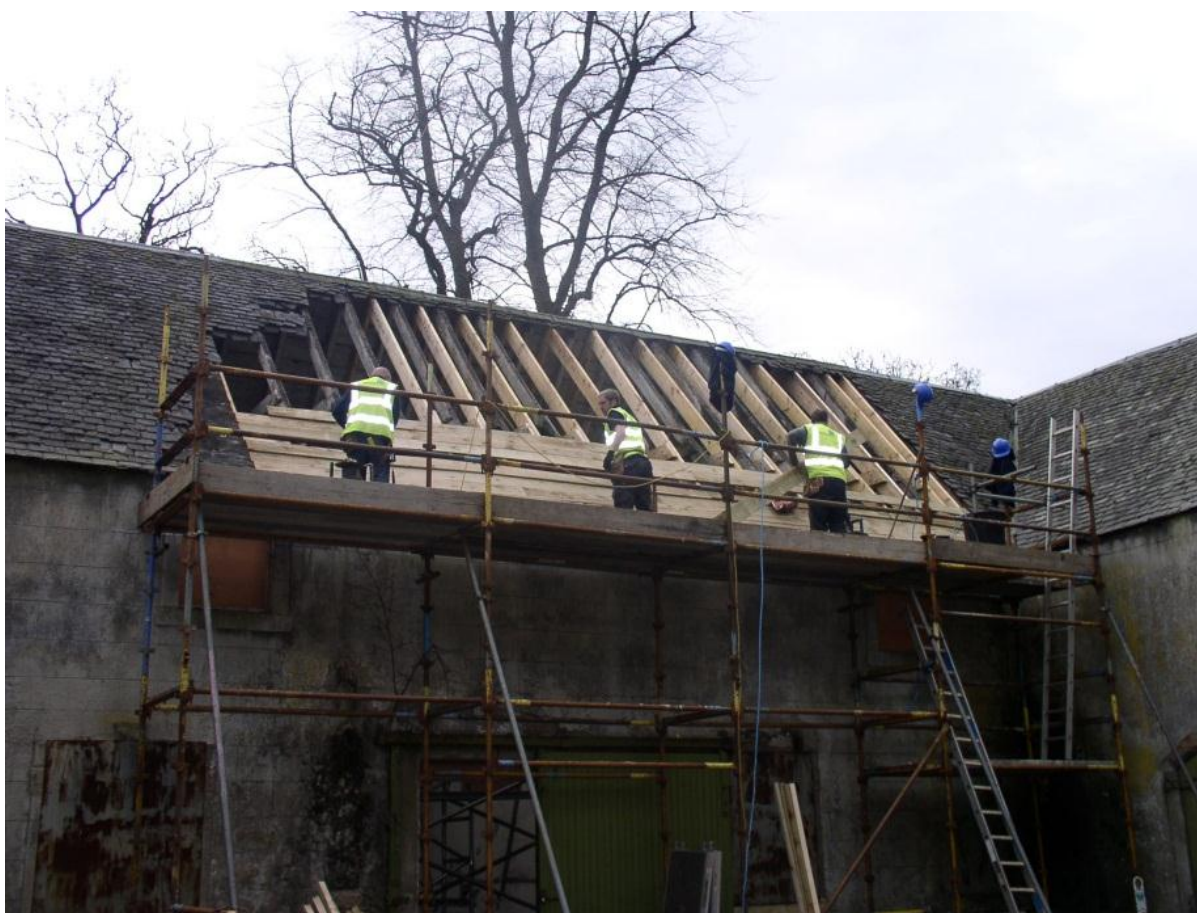
Fig. 6. Fixing the sarking boards onto the new trusses

plate were replaced like for like. New roof trusses of similar dimension to the originals were assembled, joining at the ridge with the sound timbers of the other pitch. Sarking board was reinstated to act both as a base for a roof covering and to provide lateral bracing to the new roof trusses (Fig. 6). These new structural elements, and the sarking, being essentially the same as the originals, would form a durable base onto which the slates could be fastened should a full repair scheme go ahead. It should be noted that while the works are described as interim, some elements could be done to the same standard as the original; the equivalent works using more temporary structural components would not have cost significantly less, and would not have suited a subsequent phase of work.

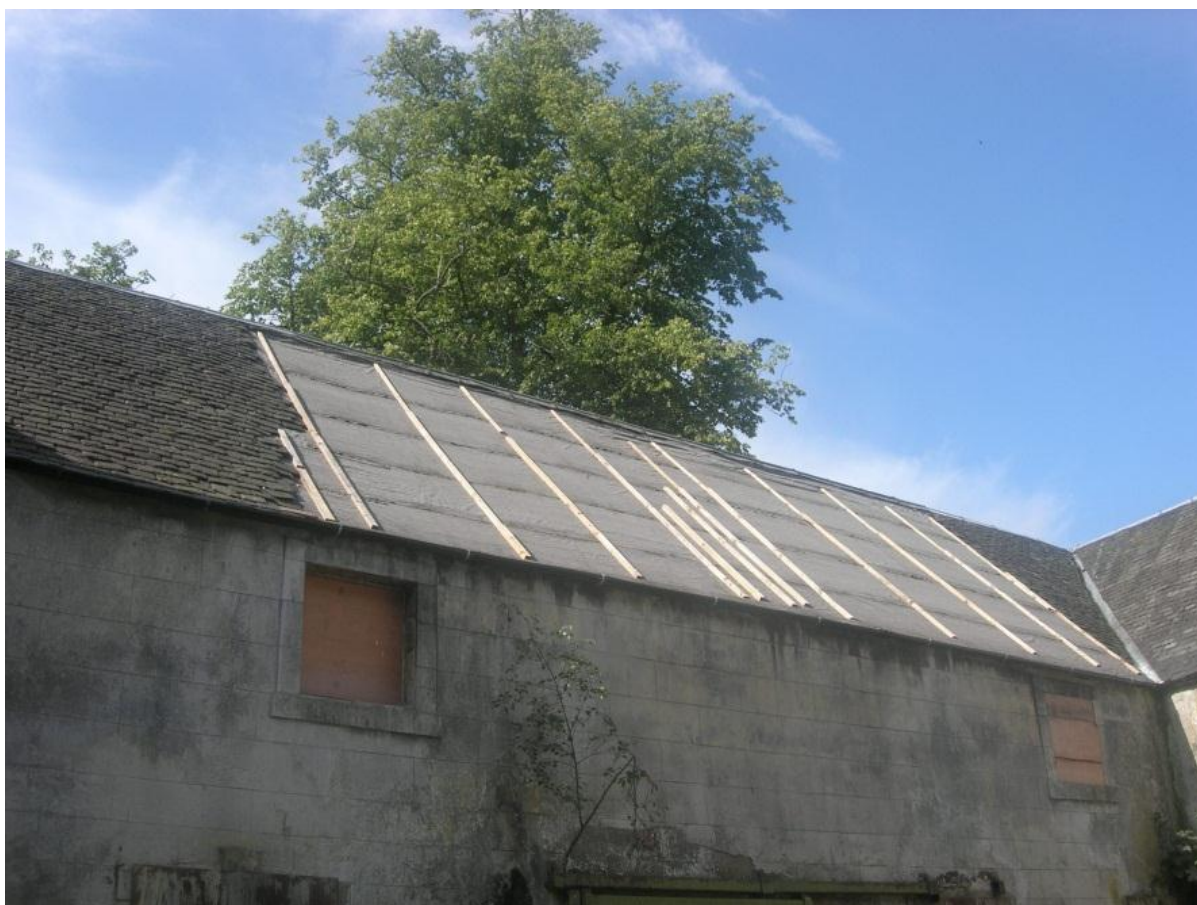
Fig. 7. The finished roof repair, showing the temporary felt covering and the battens

It was considered to be too expensive to reinstate the slated pitch, so it was decided to cover the new roof structure with bituminous felt. This material lends itself to temporary works as it is light, easily worked and can be quickly secured to the sarking boards or other substrate. While nailed at regular intervals along the horizontal joints, additional securing by means of timber battens is necessary to prevent wind lift (Fig. 7). The battens are fixed vertically down the line of the roof pitch to allow free drainage of water; when mounted horizontally they cause ponding

and consequent leakage. The product life of a single felt covering of this type is not long, probably five to ten years maximum. A further option would have been to apply several layers of felt, finished with a mineralised coating on the final layer, as employed at the Wauchope Mausoleum (Refurbishment Case Study 14). However, such an approach would have involved more work, and since the material would be melted together in layers onto the sarking, its removal may have presented a challenge when re-slating works commenced. The single layered covering as implemented has successfully made the building wind and water tight until a more long term and appropriate repair in slate can be carried out.

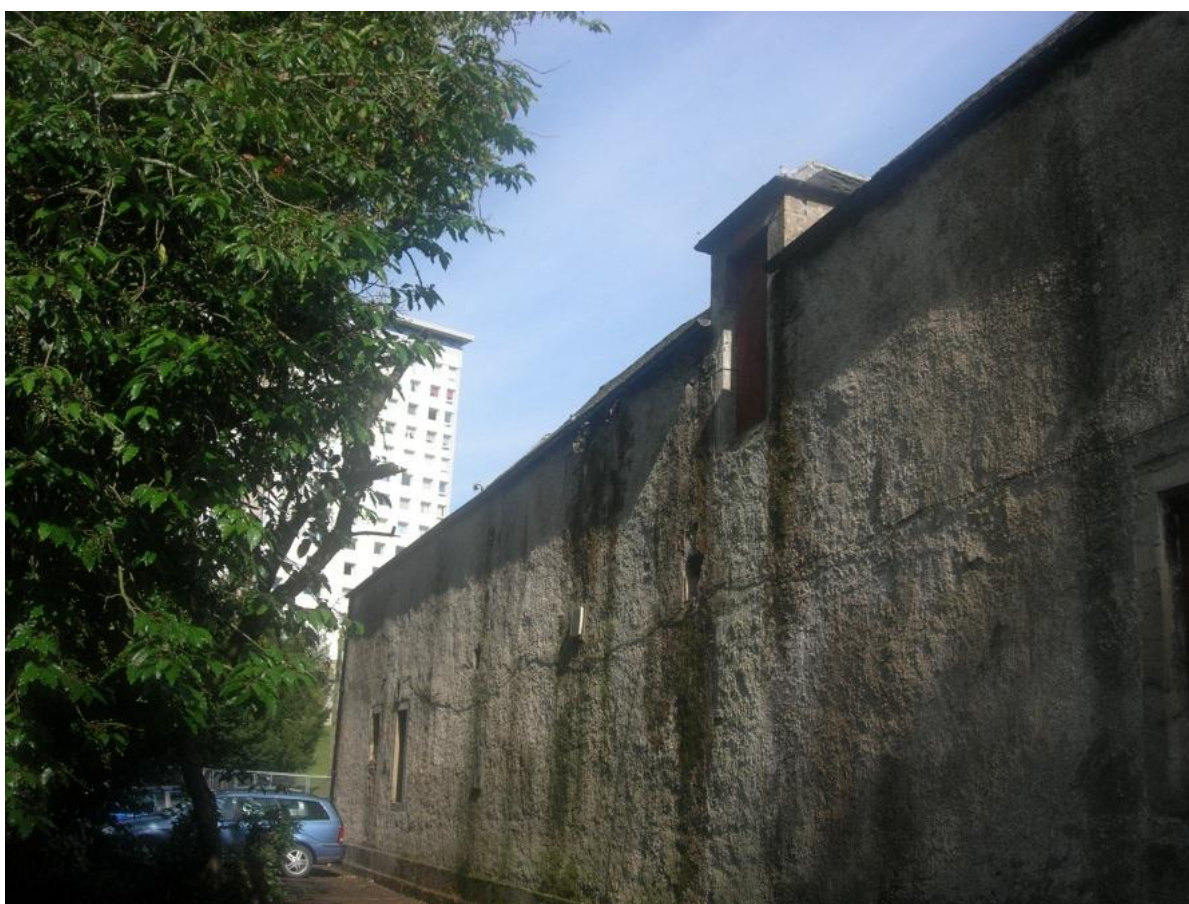
Fig. 8. Shrubs and trees were cut back to prevent physical damage and allow free air movement

At several points around the building, a lack of maintenance and consequent water ingress had allowed vegetation to establish and spread. The roots were well established in the damp masonry, and the growth was starting to force apart the joints. The vegetation was therefore cut back and the roots removed where possible. Where roots were deeper and removal was not straightforward, the cut ends were poisoned with a proprietary brushwood killer. In a more formal repair programme the masonry would have been lifted to remove larger root sections. More substantial repairs will be made in the future when budgets allow. Around the external perimeter of the building, shrubs and trees had been allowed to freely encroach on the masonry; this was causing physical damage and restricting air movement around the walls, preventing the dispersal of water from the fabric. The shrubs were cut back to a distance of four metres from the walls (Fig. 8).

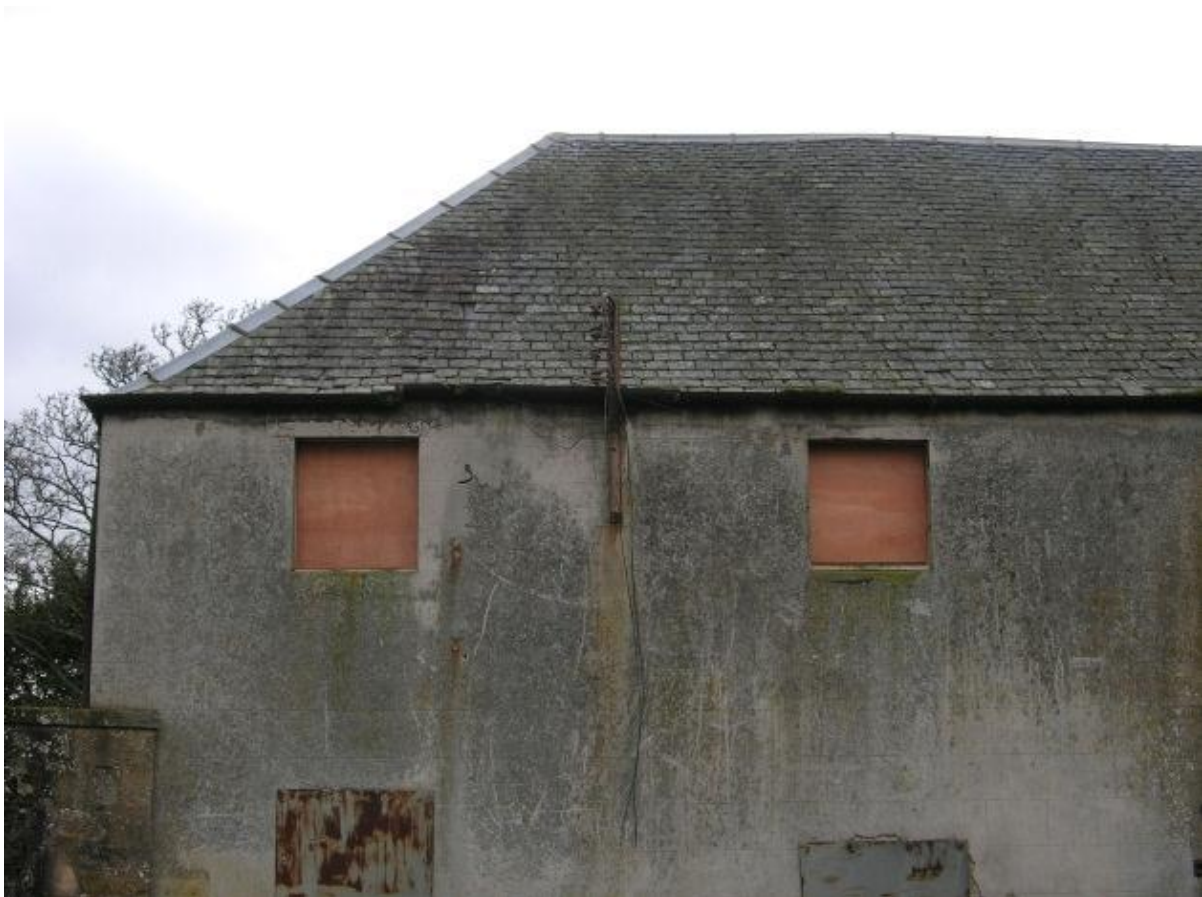
Fig. 9. Windows were boarded up to prevent re-infestation by birds and other unauthorised access

Although a number of windows had been secured with steel plates in the past, at several points these were missing, most notably in the upper floor windows and skylights. These openings were re-secured with composite timber boards to prevent access by pigeons and other birds (Fig. 9). The securing of window and other openings is also an important part of prevention of unauthorised access, reducing the risk of vandalism, arson or other activities to which empty buildings can be prone. Small gaps were left at the margins to allow a degree of ventilation. The boards were then painted to harmonise the presentation of the elevations and improve the overall appearance.
