REFURBISHMENT CASE STUDY 34

SOUDEN KIRK SOUTHDEAN PARISH

INTERIM REPAIRS

INTERIM REPAIR WORKS AT SOUDEN KIRK

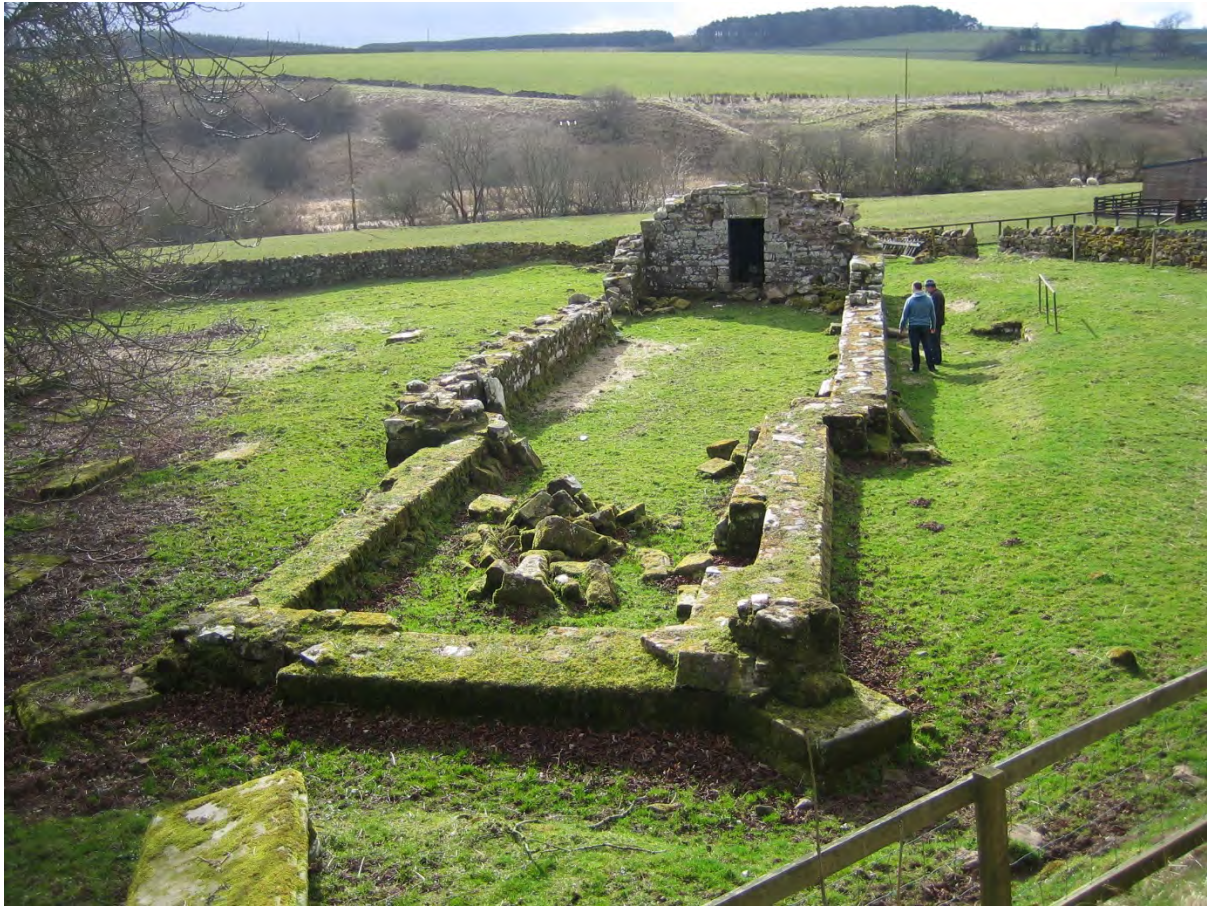
Over many years, the concrete flat roof and its drain to take water away had failed. In 2005, a large ash tree - itself many years old - fell over onto the tower, dislodging the facing masonry on the northeastern face of the tower, causing considerable damage. While the timber debris was cleared shortly afterwards, a large number of samplings became established in the tower wallheads. The growth of these and weather action entirely broke up the cement pointing and capping of the wall head, and a split in the concrete roof was letting in considerable volumes of water. In a curious attempt to address water ingress, the external walls of the tower had been pointed with a strong sand and cement mortar at some time in the past. This compounded the dampness by preventing any drying of the walls through the mortar joints. The site and the graveyard are now grazed by sheep, which keeps down the grass and nettles (Figure 3).

Figure 3. Souden Kirk viewed from the north east; the choir in the middle foreground, with the nave and the rebuilt tower in the middle right.

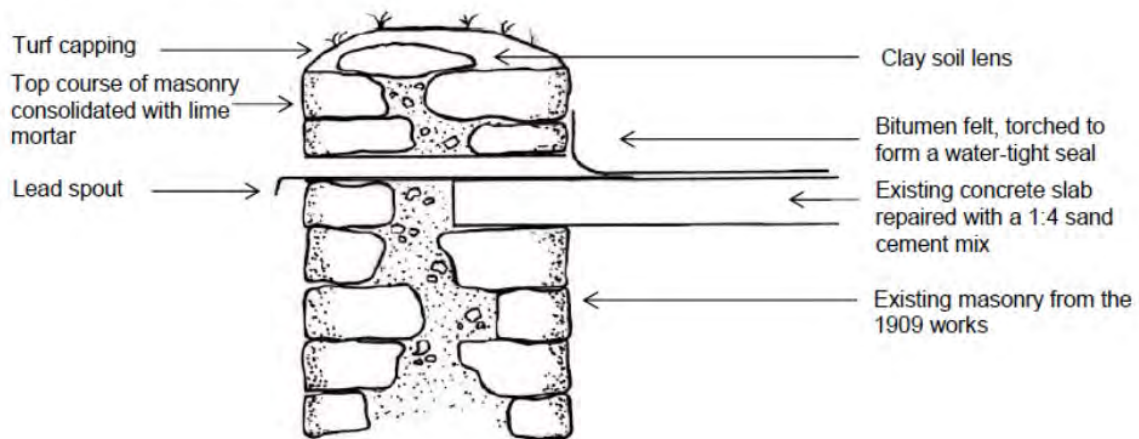
Figure 4. Detailed section through the wallhead showing the proposals, as part of the SMC application

It was agreed that the cement capping to the wall heads would be removed and replaced by a 'soft cap' of clay and turf. The upper course of masonry would be re-set in a lime mortar. To reduce water ingress, a layer of bitumous felt would be set onto the masonry, and covered with a layer of clay and turf. The edges would be set or bound with new stones at the sides. The purpose of the soft cap was less to shed water in the traditional sense, but to absorb or buffer rain fall and prevent it running into the walls and interior of the tower. This turf layer would then dry out and the cycle repeated during the next rain. The concrete flat roof with its central join line letting in water would be made more waterproof with the application of two layers of torch on mineral felt. The upstands would be torched onto the vertical masonry and the run of the deck would connect to a new drain through the wall and out via a new lead spout. The details of this were recorded in drawings to accompany the SMC application (Figure 4).

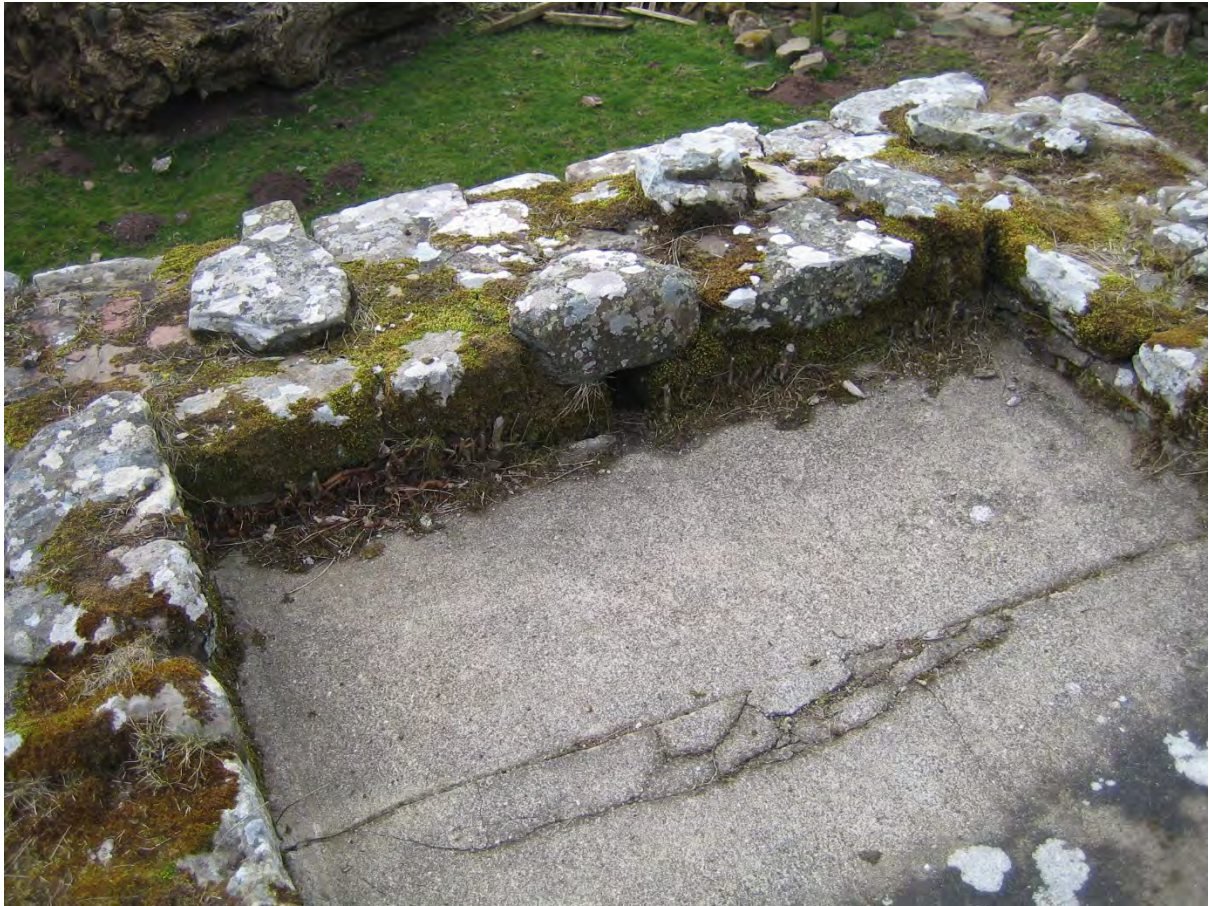
Figure 5. The roof of the tower following cleaning. The sapling stumps and the cracked concrete roof can be seen.

A degree of pre-work was required, and in the summer of 2014, the saplings on the roof of the tower were cut back and the stumps poisoned. When the project began in the late summer of 2015, the woody stumps could then be removed, confident that growth had been killed off. The initial work was the clearing and cleaning of the concrete roof and the adjacent masonry to allow for a better assessment of the wall head condition and the concrete roof (Figure 5).

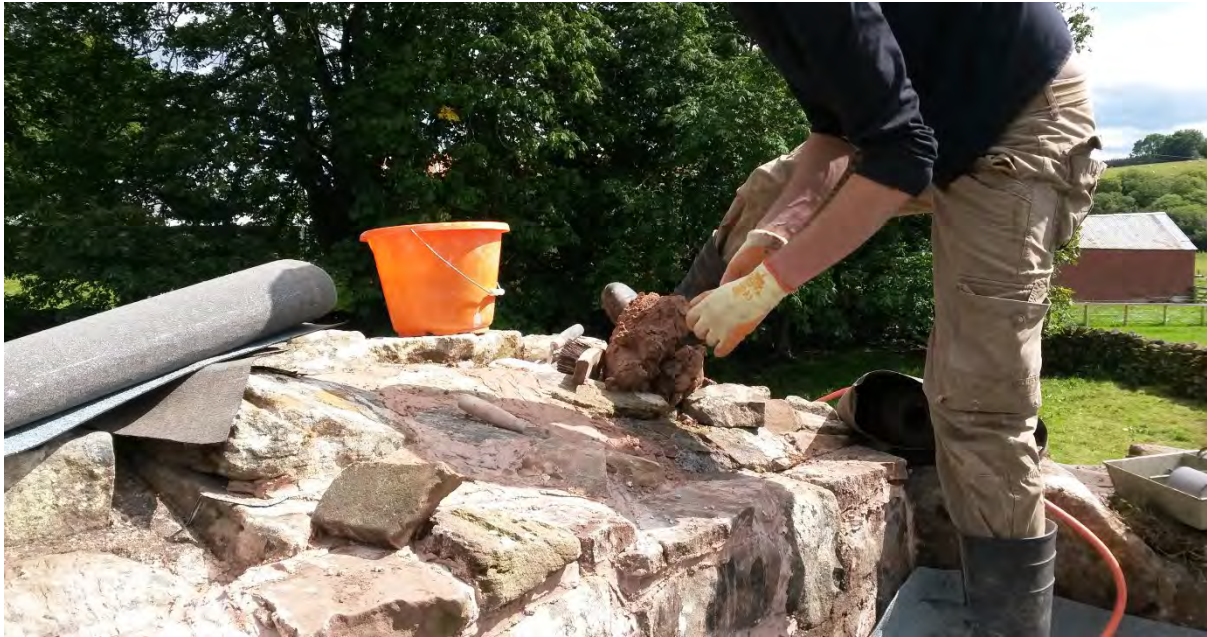
The top course of masonry was largely loose and the cement had entirely come away, admitting water freely to the wall structure below. The cement fragments were removed along with any vegetation and the top course of masonry was re-bedded in a hot mixed lime mortar, delivered from the site at Hobkirk Church (Figure 6). This mortar was given two days to stiffen up before the next layer was added. Once the mortar had set, the next layer, the bituminous felt, was cut and laid. Frequent adjustments were required to accommodate the changes in levels and profiles across the wall heads.

Figure 6. Re-bedding the masonry of the tower wall heads prior to the application of the soft capping.

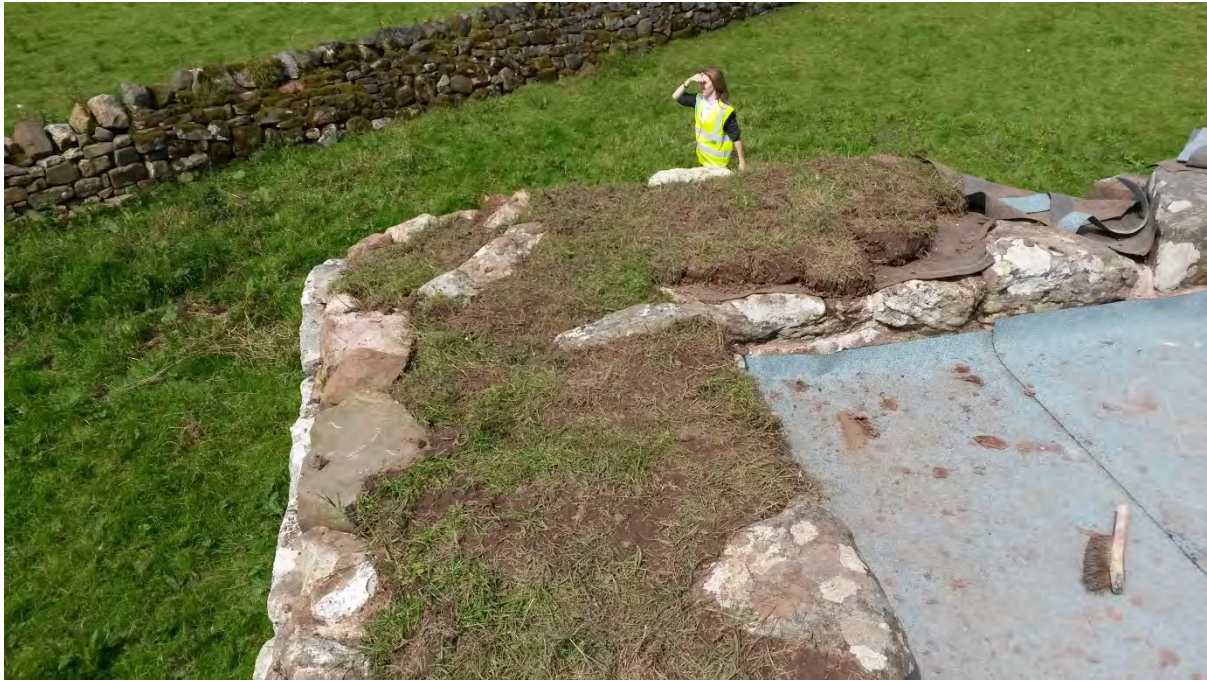
Figure 7. The new turf forming the soft capping on the tower wallheads during laying. Due to the exposed nature of the site from the southwest, the turf was edged with masonry. The application of the new mineral felt covering to the flat concrete roof is underway, seen to the right.

Investigation in the field adjacent to the monument, and discussion with the landowner, identified an area of clay rich soil with a strong growth of grass. The soil was sufficiently rich in clay to not need a clay layer below. While the areas of the wall head were modest, and the quantities required were small, time was short and the weather window for completion of the tower interim works narrow. To achieve the soft capping task quickly, two members of staff worked on the wall heads and a chain of six volunteers passed the turf squares from the field up to the tower. The turf and its clay rich soil were pressed onto the bitumen felt to give a layer approximately 200mm in thickness (Figure 7). This allowed the capping to be substantially complete within 2 hours. The clay and turf layer was edged on the windward side with edging stones to prevent wind scour and wind driven rain washing out the soil from the turf and breaking down the clay.

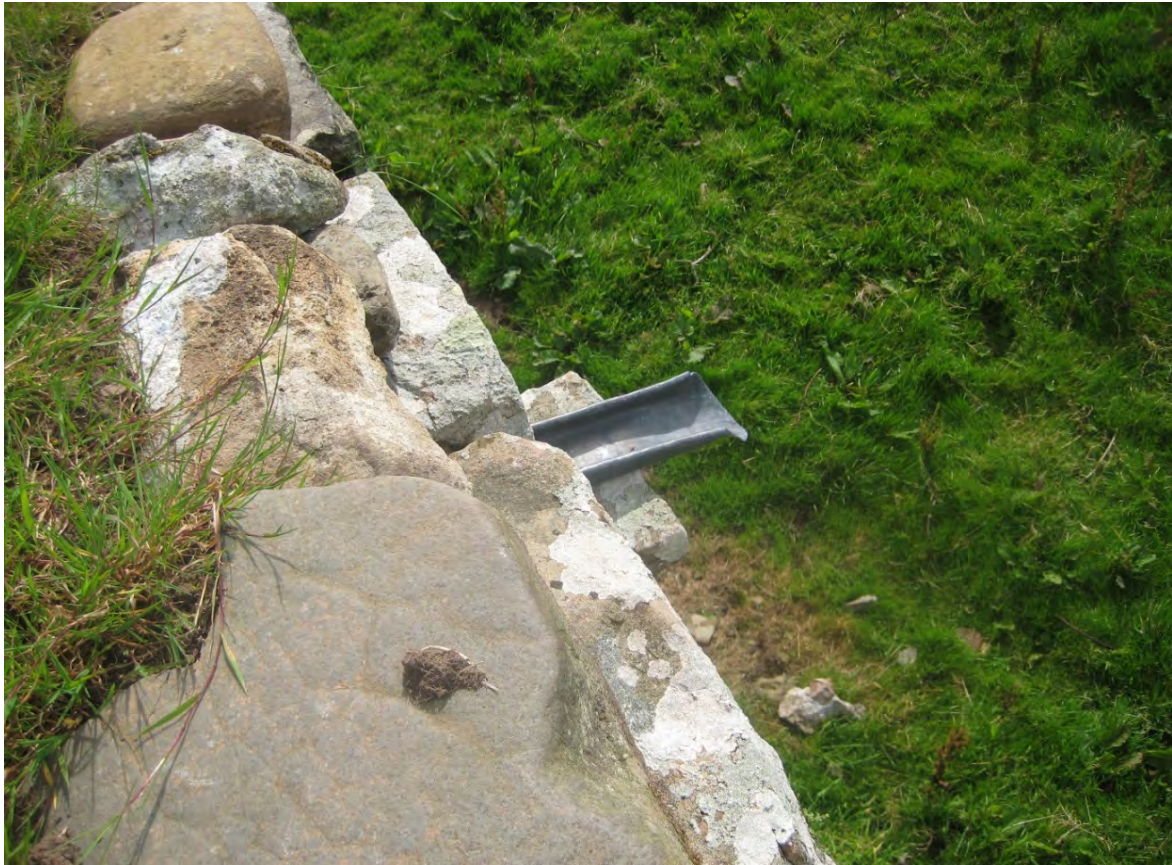
While there had been provision for water to run off the concrete roof, the channel through the wall head had become cracked and broken, leaving water to percolate through the masonry. A new spout was worked from a sheet of code 8 lead, and mounted within the existing channel to take water off the tower roof (Figure 8).

Figure 8. The new lead spout inserted in the existing stone opening to take water off the roof.

Inspection of the roof at intervals following the works showed that this was an area of potential blockage through the accumulation of organic debris and washed out clay. While satisfactory regular cleaning was required, as with any roof water disposal arrangement. The junction between the felt roof covering and the lead of the spout failed on two occasions and had to be re-torched.

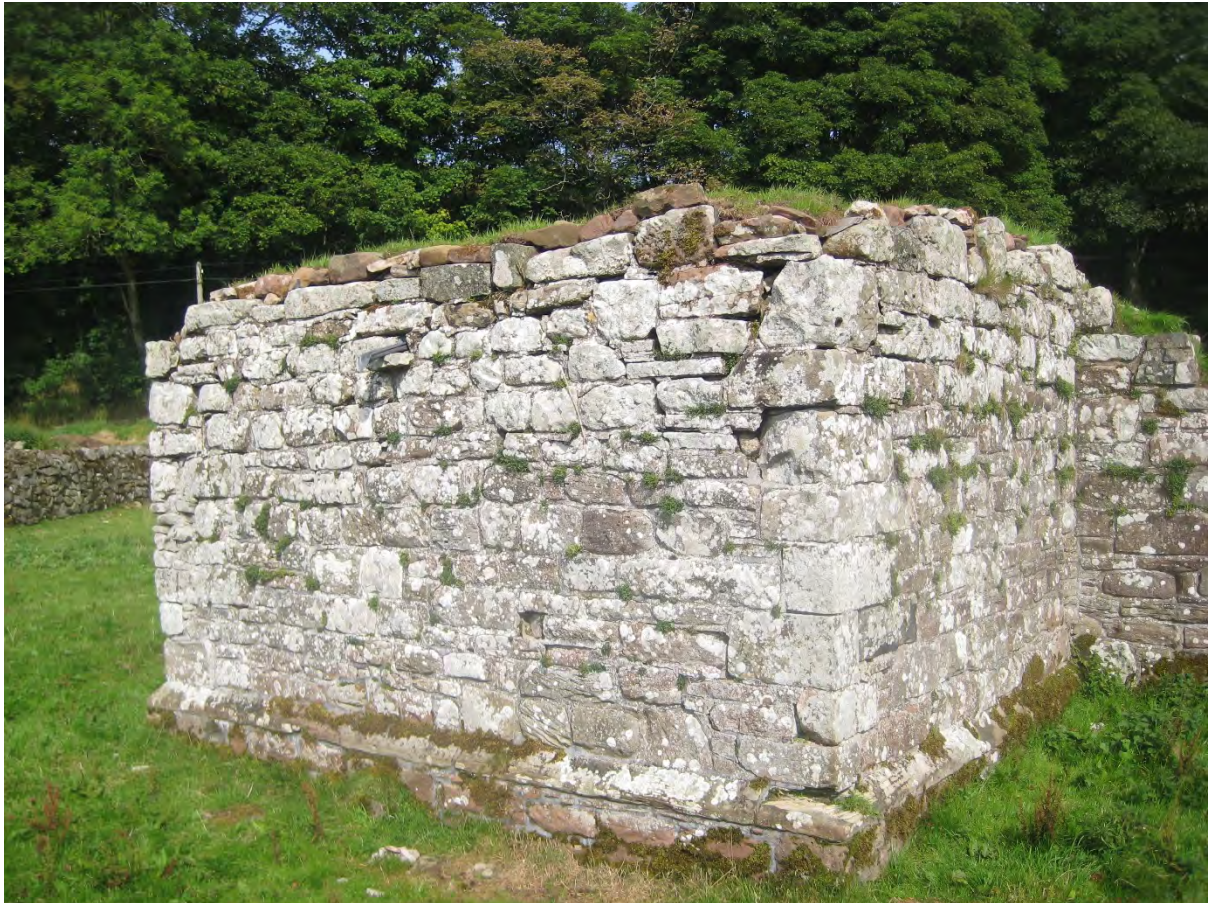
When viewed from the ground, the soft capping layer is very discrete and will give a more durable and appropriate protection to the wall heads (Figure 9). There was not enough time in the project to address the removal of the hard cement pointing on the outside of the tower, although this may be possible under a separate project.

Figure 9. The tower viewed from the south west. The turf and grass of the soft capping is just visible. The grey cement pointing from earlier works is very evident on the lower courses.

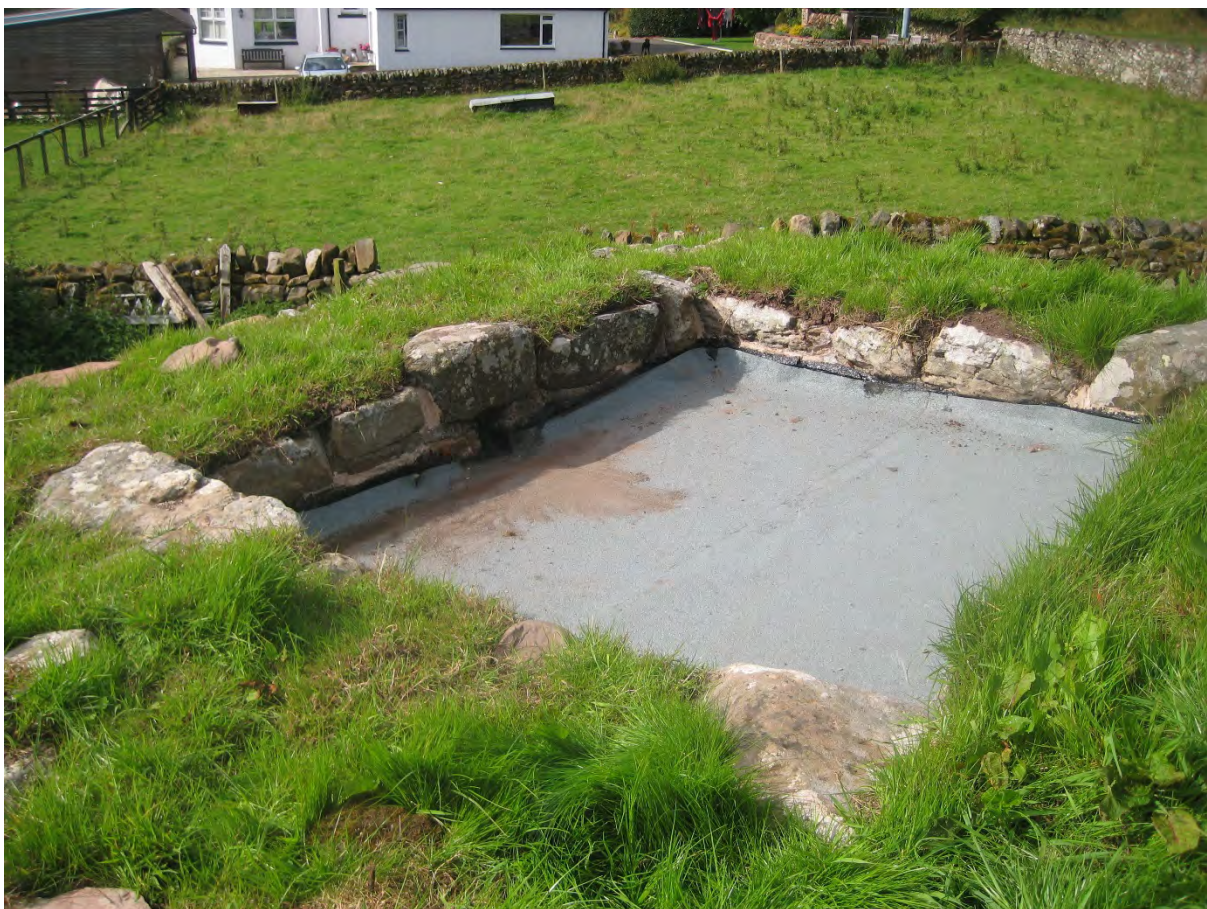
Souden Kirk has been visited annually since 2015, and the condition of the turf and the clay is generally good. There has been a small amount of wind scour on the south west corner, and on the nave side the turf is weathering back, allowing the clay to be washed out, but in most areas the turf is well established (Figure 10). Some docks and other weeds were removed, and it seems that occasional grazing by lambs has helped keep the turf tight. The mineral felt covering to the concrete roof is working well, although the bond to the stones with the felt up stand is failing in some places. Re-growth of the ash saplings appears to have been arrested. The drain area into the spout does need regular cleaning out.

Figure 10. The roof and soft capping photographed in 2016.
