Leighton Library

Installation of loft insulation

This publication should be quoted as:
Historic Scotland Refurbishment Case Study 9

Moses Jenkins

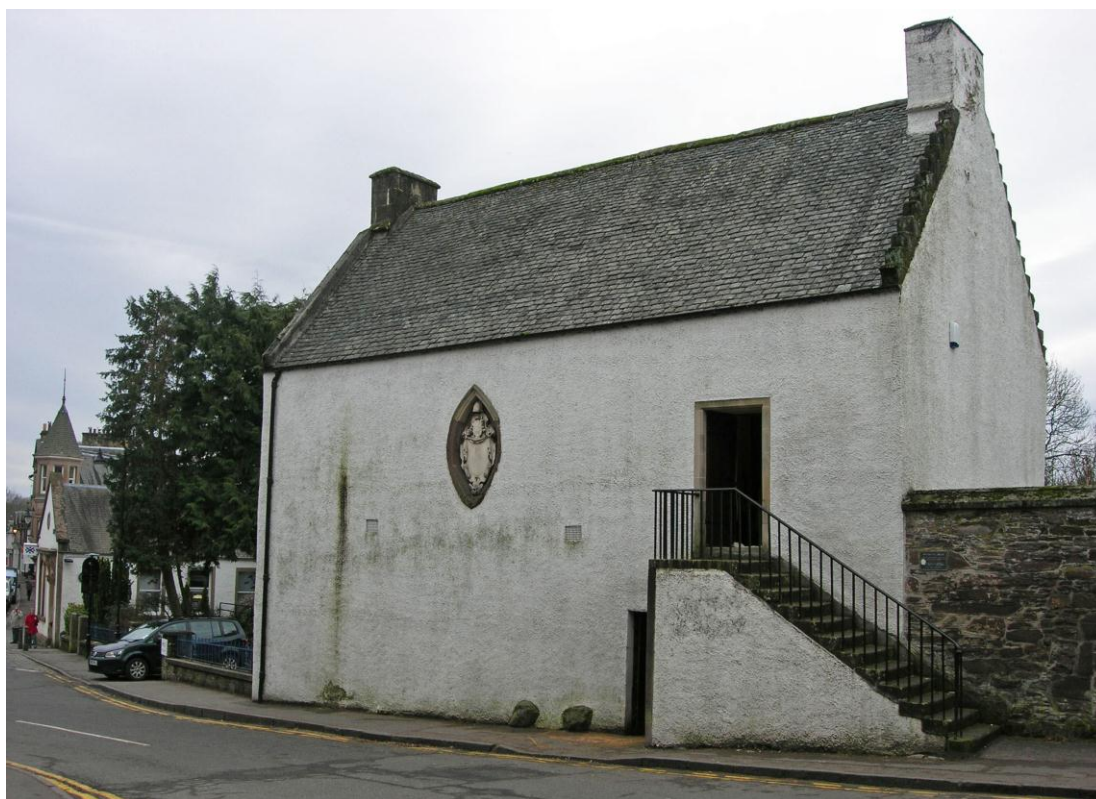
Fig. 1. View of the library from the north-east

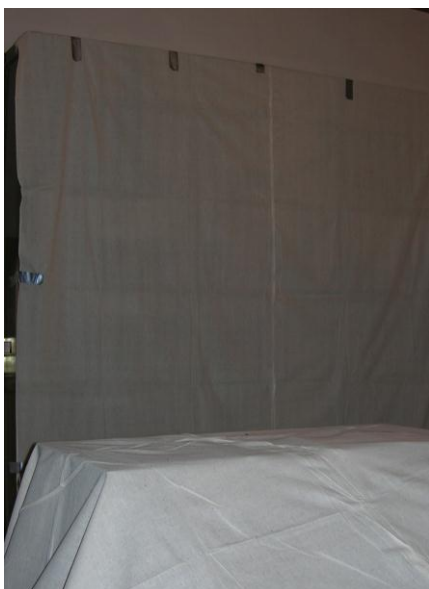
Fig. 2. Protection measures in the library

It was necessary when carrying out this work to take measures to ensure that the contents of the library were protected from damage. Prior to the commencement of the work the bookcases were covered in dust sheets (Fig. 2). To minimise dust the insulation was stored in the ground floor and all cutting took place outside.

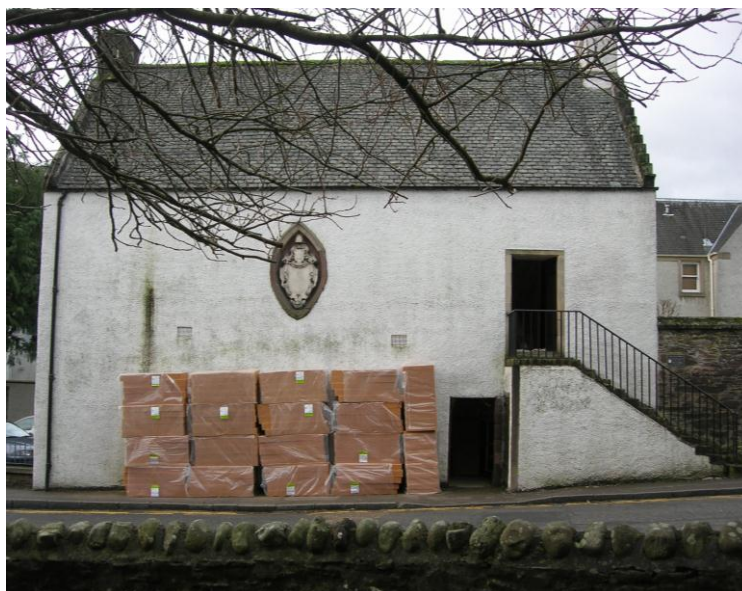
Fig. 3. Insulation arrives on site during the improvement works

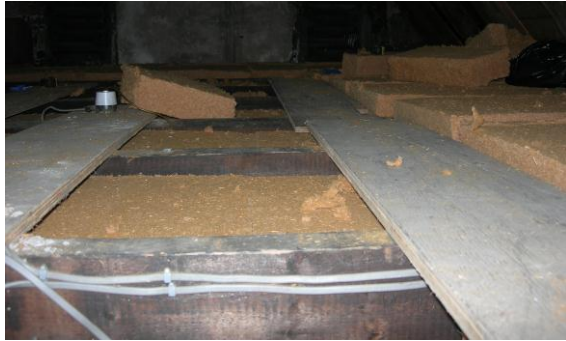
Fig 4. The wood fibre board fitted between the ceiling joists

The insulation was cut to fit snugly between the existing ceiling joists and laid in two layers, giving a combined thickness of 200 mm (Fig. 4). Extensive use was made of crawl boards to facilitate access during the work. The final level of the insulation was just proud of the ceiling joists (Fig. 5).

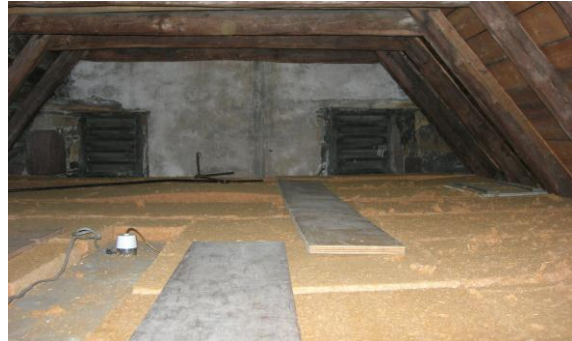
Fig 5. Wood fibre boards fitted with no gaps

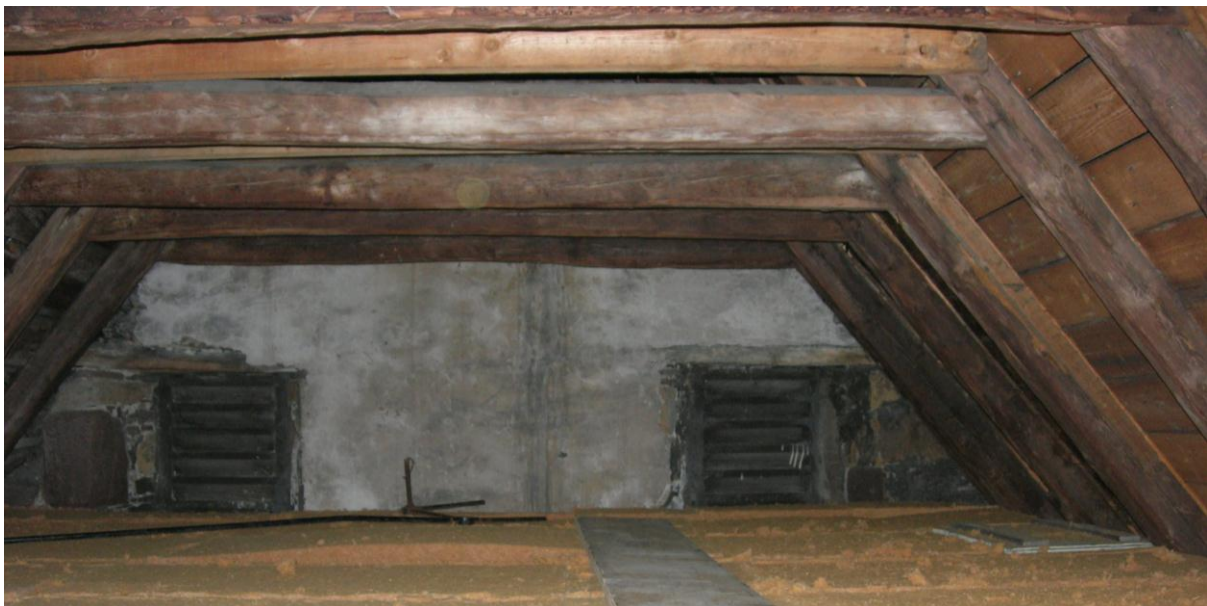
The installation of loft insulation at ceiling level creates a ‘cold roof’ space above, as the roof space now sits out with the insulation. Because of the lowered temperatures, the roof space must be adequately ventilated to mitigate potential condensation, due to the lowered dew point in the now colder space. In a traditional slate roof there is usually no roofing felt or barrier present between the sarking boards and slates and thus a degree of ventilation occurs through the roof fabric; this is often considered adequate ventilation for a ‘cold roof’ space. However, the Leighton Library underwent a restoration in the mid 1980s and it is understood that a bituminous roofing felt was installed under the slates, thus preventing ventilation through the roof fabric. This is often the case with buildings constructed or restored after 1945. Roofs with bituminous roofing felt in place typically require other methods of ventilation, such as roof vents, or venting at the ridge and eaves.

Fig. 6. Existing vents retained for ventilation

In the case of the library the previous means of ventilating this roof space was through two large louvered vents on the south-east gable. These had been partially closed off, but were re-opened, ensuring an adequate degree of ventilation into the roof space (Fig. 6).

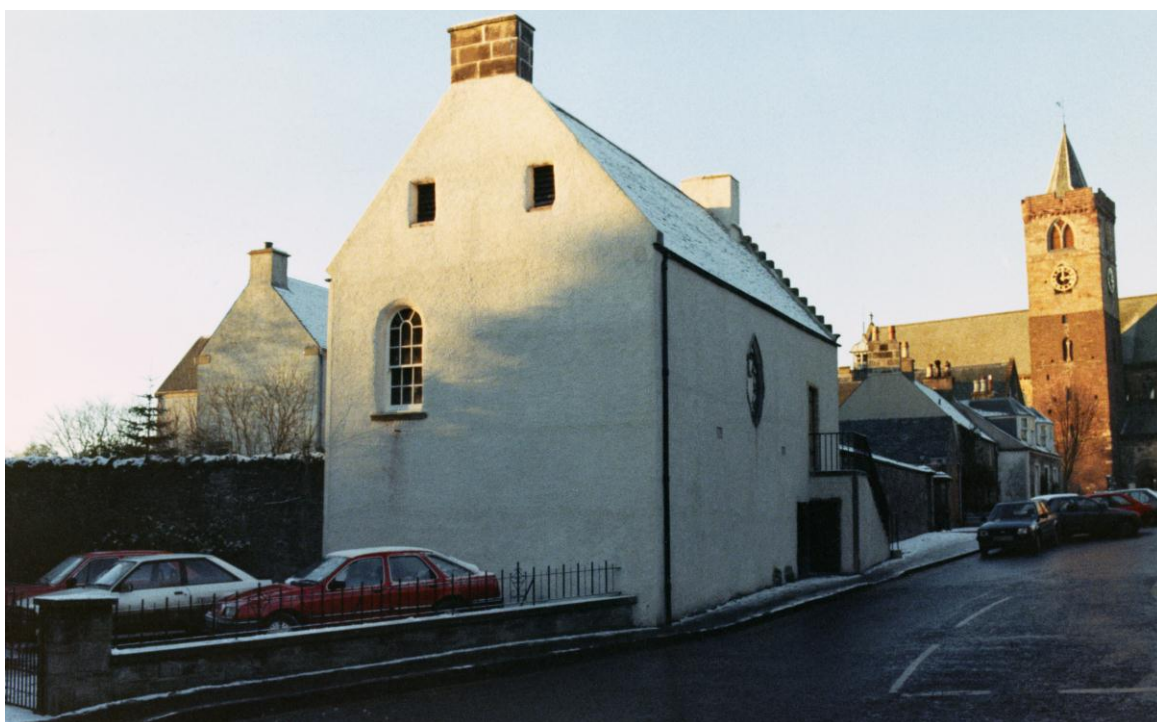
Fig. 7. South-east gable of library showing the two loft vents at upper level. © Newsquest (Herald & Times). Licensor www.scran.ac.uk
