# THE STONE OF DESTINY

CONDITION ASSESSMENT, SCIENTIFIC ANALYSIS AND **DIGITAL DOCUMENTATION** 2023

HISTORIC SCOTLAND

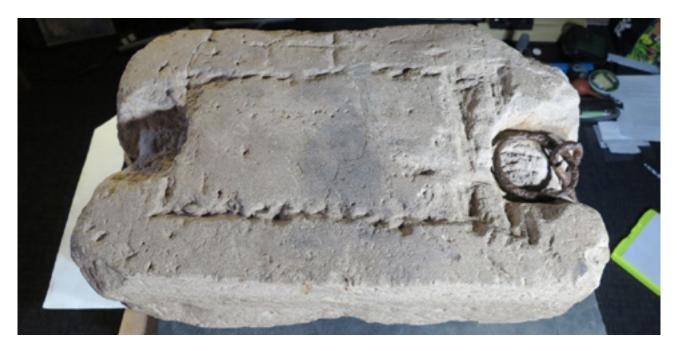
The condition of the top surface is stable (Figs 2–6). There are no signs of any active disintegration (Fig 2) nor any new **iron oxide** spots, which is to be expected as the Stone has been displayed in a controlled and stable environment.

Fig 2. General photo of the top face of the Stone (2023).

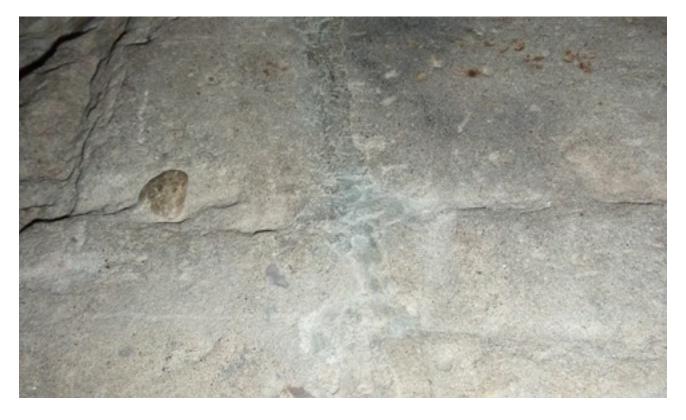
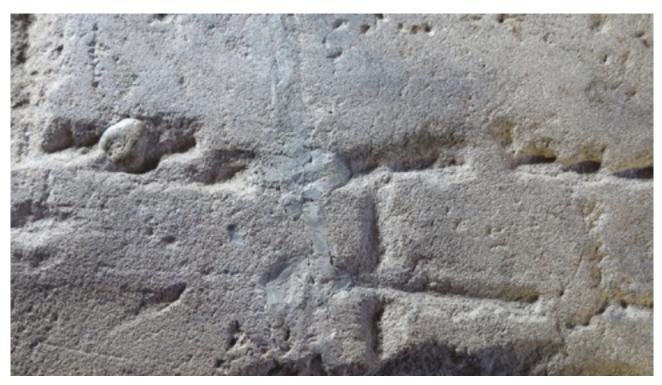
Fig 3. Close up photo of the top face (2016).

Fig 4. Same area as seen in Fig 3, photographed in 2023.

The condition assessment also identified areas with old hairline cracks in pointing repairs from the 1950s (see Figs 3 and 4), which are stable, have not expanded and do not appear to be opening up. Through condition checks like this one, these areas will continue to be monitored for any changes, which could indicate structural movement or failure of the internal fixings.

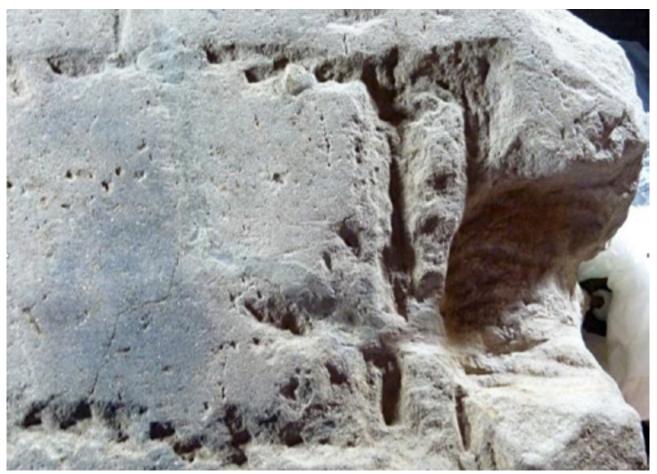
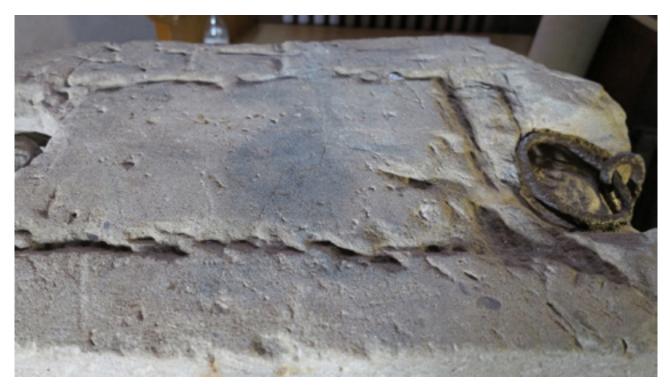
No expansion or intensification of the dark staining covering much of the central part of the upper face has been observed since it was photographed in 1996 (Figs 5 and 6).<sup>2</sup> It was thought that the staining might relate to the Stone's previous location at Westminster Abbey or was due to its possible burial during the Second World War.<sup>3</sup> Recent scientific analysis has shown the dark stained area is richer in zinc. The source of the zinc is not known.<sup>4</sup> It may have been through direct contact with a metallic object or from absorption of a zinc-contaminated solution, even in a burial scenario. As a result, the staining may still be related to the burial of the larger section in 'open country',<sup>5</sup> as the staining is only noticeable in the larger fragment of fractured stone.

Fig 5. The top surface with a noticeable fine crack and dark staining in the middle of the Stone, photographed in 2016.

Fig 6. The same area as seen in Fig 5, recorded in 2023.

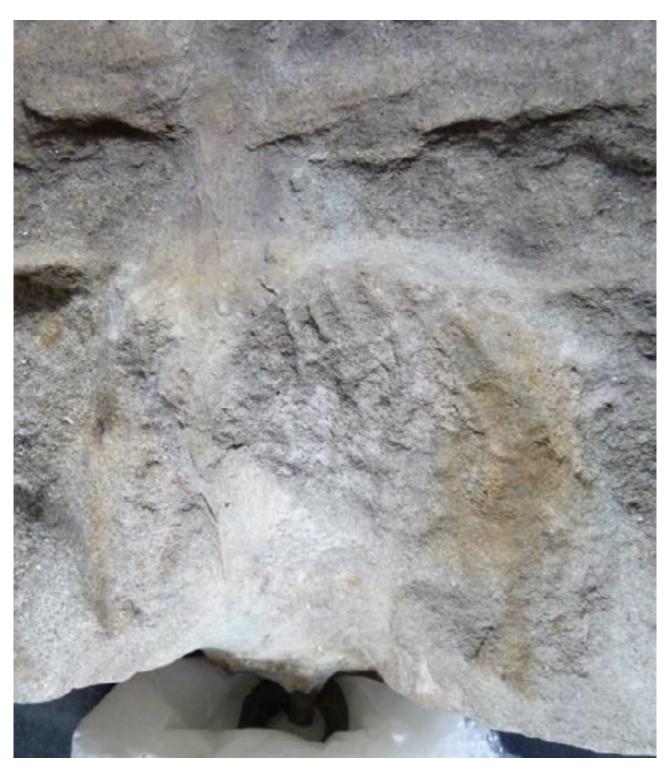
The staining in the circular sockets for the iron rings, already noted in 2016, has neither expanded nor intensified, suggesting that there is no active corrosion happening to the iron elements (Figs 7–10).

Fig 9. Sinister face socket (2016).

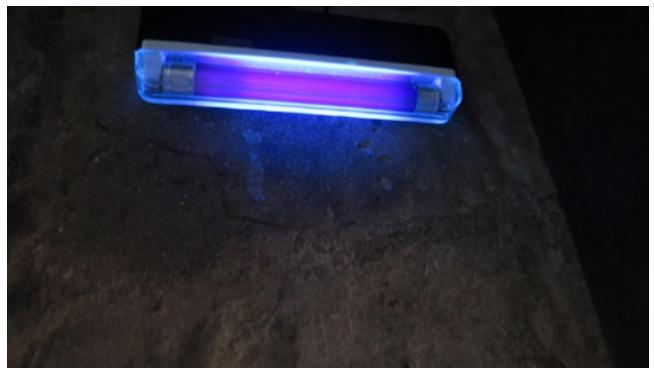
Additionally, the area was observed under UV light, revealing staining of a different nature, which is visible in daylight when looking at the stone surface from an angle (Figs 11 and 12). The staining forms a shiny streak and a spot. The origin of this is unknown. However, staining of a similar shape and in a similar location can be seen on a photo of the Stone from the past (dated latest 2012). The staining visible on this older photograph resembles a drip from melted wax or silicone (Fig 13).

Fig 11. Newly identified staining under UV light (2023).

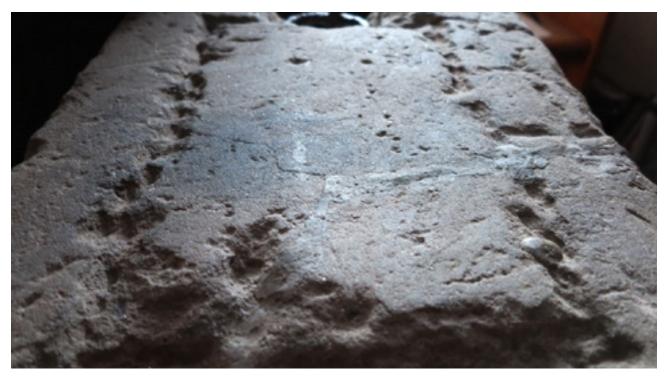
Fig 12. The same area in daylight (2023).

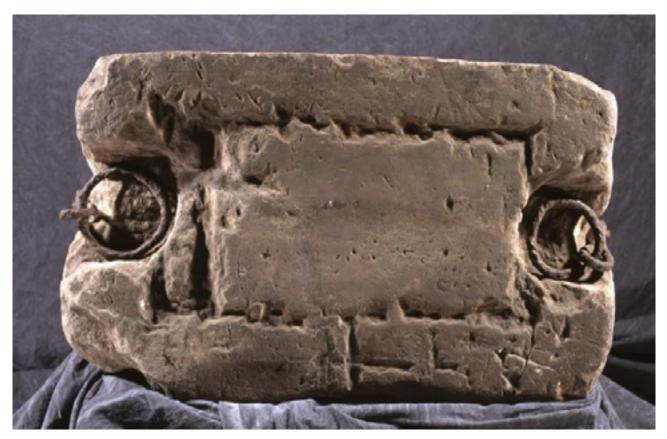
Fig 13. Staining identified on the Stone's top surface in 2023 and already visible on an older photo of the Stone from no later than 2012.

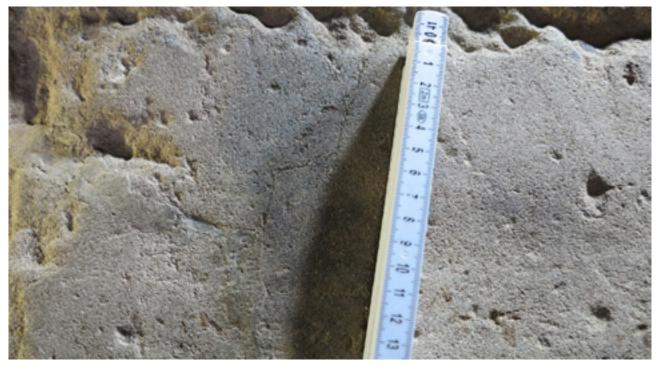
A hairline fissure, extending from the joint corner in the centre of the top surface towards the front edge, is similarly stable (Fig 14). It is possible that an inherent geological weakness in the Stone (a fissure or 'dry') determined the way the Stone has broken in the past. Some sources reveal that there was a crack already visible in photographs dated pre-1950, which would confirm this hypothesis.<sup>6</sup> This feature of the Stone should be monitored closely.

Fig 14. Close-up of a hairline fissure (2023).

- 1. The fine crack on the top of the Stone was injected with a 2.5% solution of Paraloid B-72 acrylic resin in acetone/IMS (50/50) (Fig 14).
- 2. The fine crack and area slightly prone to flaking near the lead fixing in the sinister end face of the Stone were injected with 2.5% of B-72 in acetone/IMS (50/50) as well as filled and edge-pointed with acrylic-based mortar repair (5% B-72 in acetone/IMS mixed with a stone dust and sand) (Figs 52 and 53).

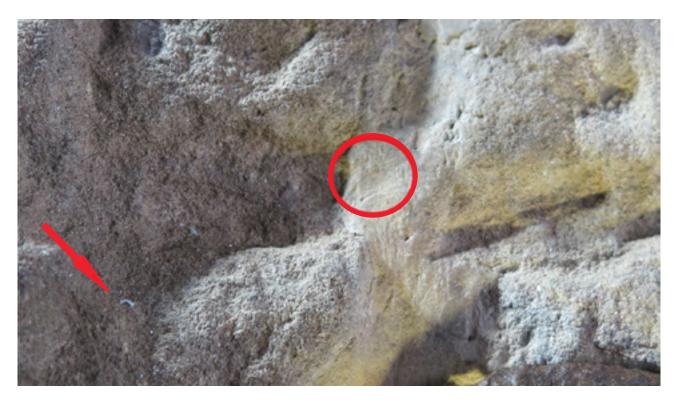
At the time of the condition assessment, the top surface was covered with white elongated flecks of what looked like a waxy substance, similar to silicone sealant (Fig 15). These flecks don't seem to have adhered to or affected the stone surface, and they were removed with a soft, dry brush. Although unconfirmed as the cause, a review of the silicon rubber seals in the glass display case was undertaken to check for any deterioration that may require their renewal.

The **cementitious** repair applied to the Stone in 1950–51 contains fibrous material, which glowed under UV light.<sup>7</sup> This could be identified under a portable microscope as small pieces of wood or brush bristles; probably used to finish or work over the applied repair (Figs 15–17).

Fig 15. The circled area (top) shows a repair joint with visible fibrous material incorporated into mortar (2023). The area indicated by an arrow (left) shows visible white flecks of a silicone-like substance deposited on the stone surface.

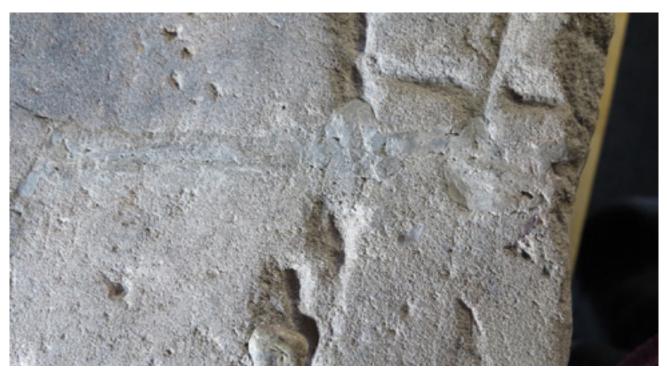
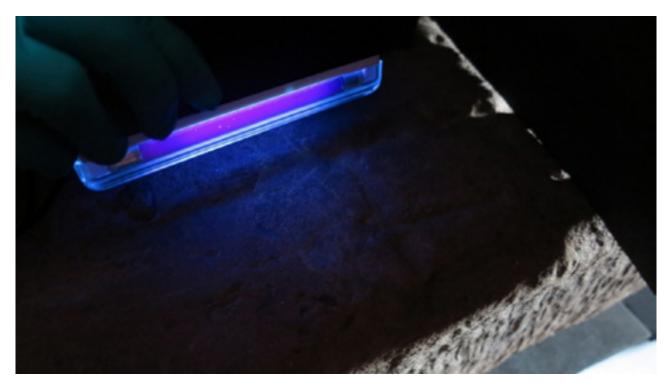
Fig 16. Close-up of the area with visible fibrous material within the cementitious repair (2023).

Fig 17. The same area as Fig 16 under UV light. Note the slightly glowing visible line.

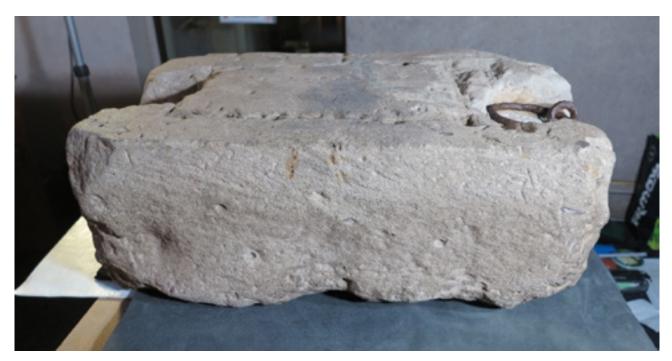
- iron staining.
- shiny surface **accretion** in the low area of the front face (which seems to be greasy in nature and attracts cloth and paper fibres).
- minute blue paint traces (most likely from tools used for movement at some point during the 20th century) (Fig 18).

Fig 18. General photo of the front face (2023).

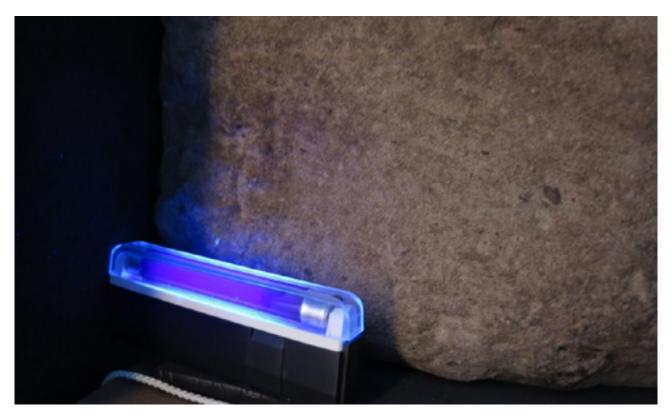
A small, resinous, semi-transparent yellow-white residue was spotted on the lower left corner of the front face (Fig 19). It was also visible as a glowing spot under UV light (Fig 20). The nature and location of the residue may suggest a **deposit** of substances used for decorating or protecting the wooden Coronation Chair (eg varnish), which could have been grazed during previous de-installations of the Stone from the chair. Westminster conservators informed the team of the presence of 'orpiment', a hazardous substance previously used on the chair that required PPE and risk management procedures when handling. The potential for this substance leaving residue on the Stone should be considered not only for condition assessment and conservation purposes, but for health and safety reasons for any future interactions with the Stone.

Fig 20. Lower left corner of the front face. The resinous residue visible in UV light (2023).

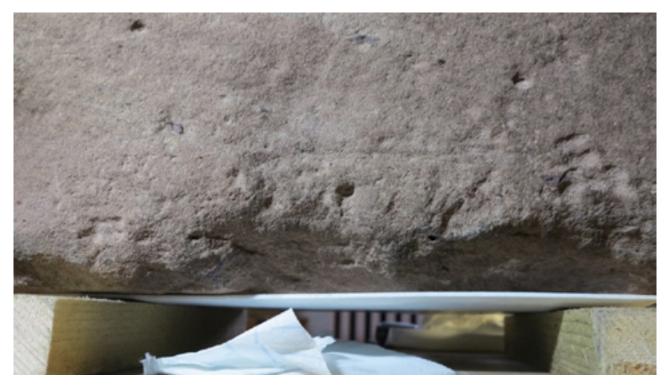
The condition assessment was able to identify areas that required attention to ensure the good condition of the Stone. This included a fine fissure and a flake slightly separating from the underside of the front face, which was noticed during the check (Fig 21), and could therefore be addressed in the next phase of conservation work (see the Remedial Treatments section of this condition assessment report for more details).

Fig 21. Lower edge of the front face. Visible fine fissure and a stone flake (2023).

- 3. The open crack above the stone flake in the lower edge of the front face was injected with 2.5% B-72 in acetone/IMS (50/50) (Fig 21).
- 4. The acrylic mortar used to fill the drilled hole was dissolved with an application of acetone in a syringe, then removed. The hole, which still contains the empty lead container, was then deep-filled with a properly colour-matched fill of the same material at 5% B-72 in acetone/IMS (50/50) (Figs 27 and 28).

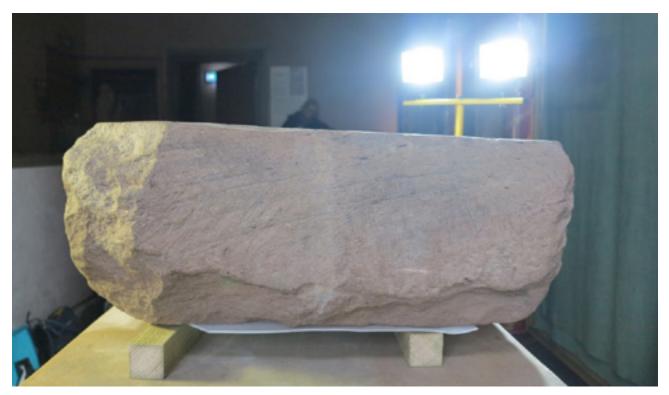
The condition of the back surface is stable (Fig 22). Traces of mineral adherences, most probably **gypsum**,<sup>8</sup> do not show any changes and seem to be intact (Figs 25 and 26).

Fig 22. General view of the back face (2023).

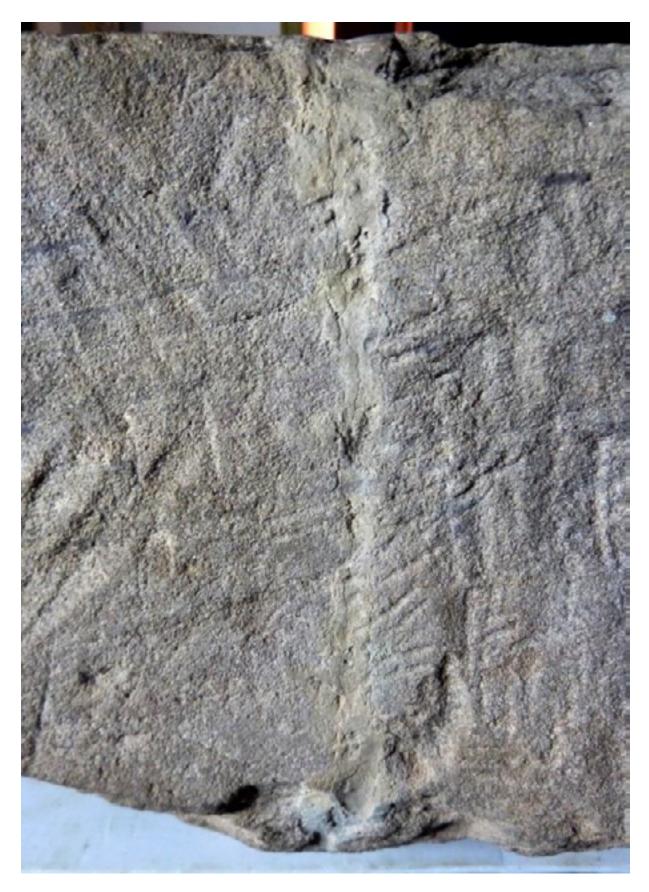
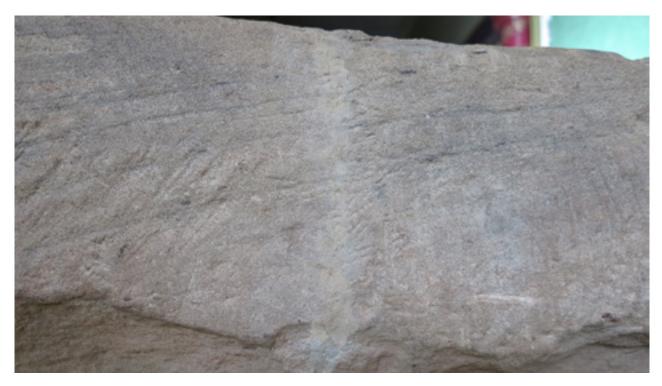
The cementitious pointing applied around the 1950 repair joint in this location does not show any signs of dislodging, and the fine cracks noted in 2016 have neither expanded nor opened up (Figs 23 and 24).

Fig 23. Condition of the joint over the repair (2016).

Fig 24. The same area as in Fig 23, photographed in 2023.

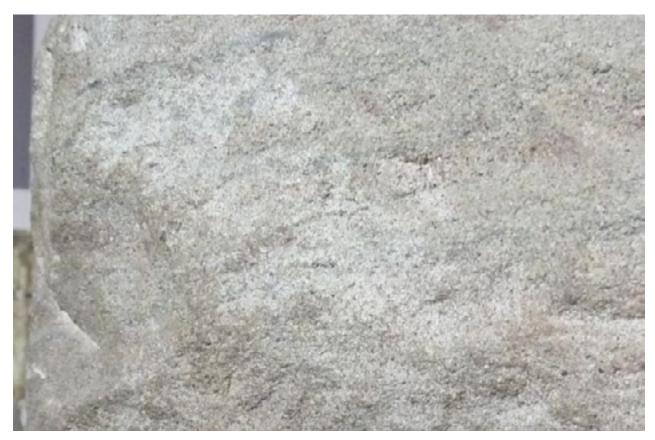
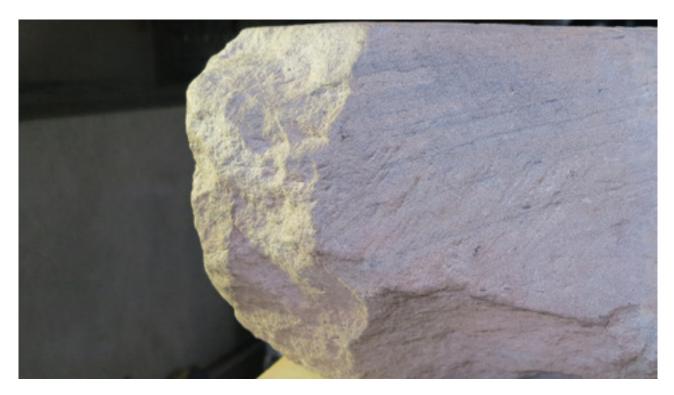
Fig 25. Photo record of the mineral mortar residue (2016).

Fig 26. The same area as in Fig 25, photographed in 2023, with no discernible change.

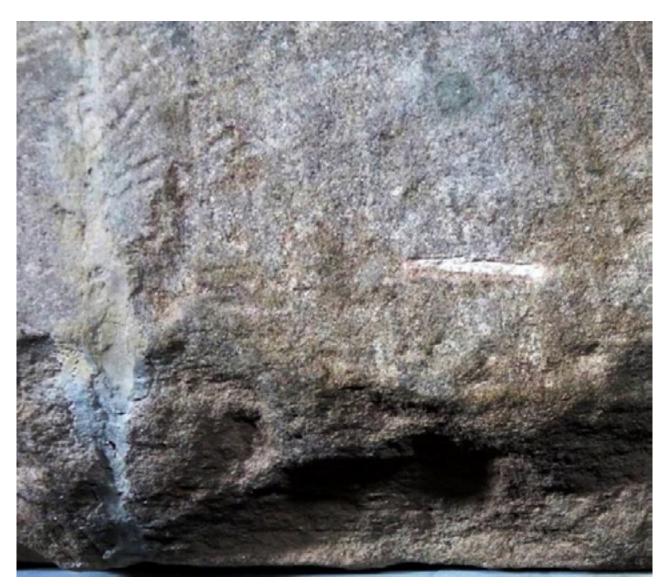
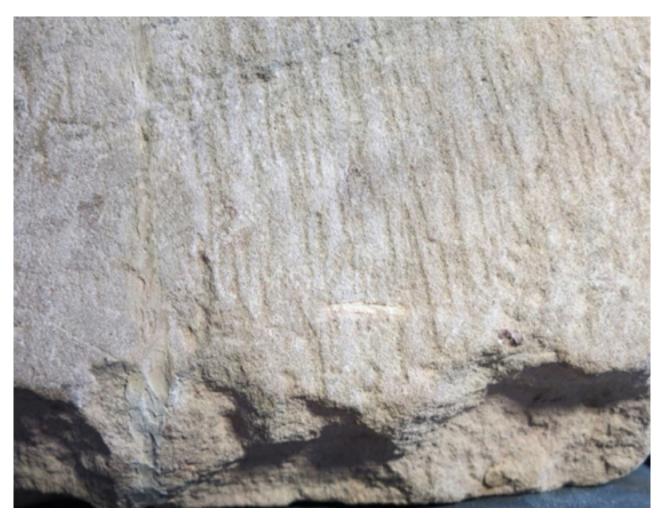
A hole repair, found in 1996 and filled with an **acrylic** mortar, was slightly off the colour of the Stone and required replacement (Figs 27 and 28). The drilled hole had previously held a small lead tube containing an offcut from a 1970s authentication document (accession no. E6120) and had been covered with a wax seal.

Fig 27. Visible acrylic mortar-fill not matching the stone colour anymore and requiring replacing (2016).

Fig 28. The same area as Fig. 27 after the replacement of the fill in 2023.

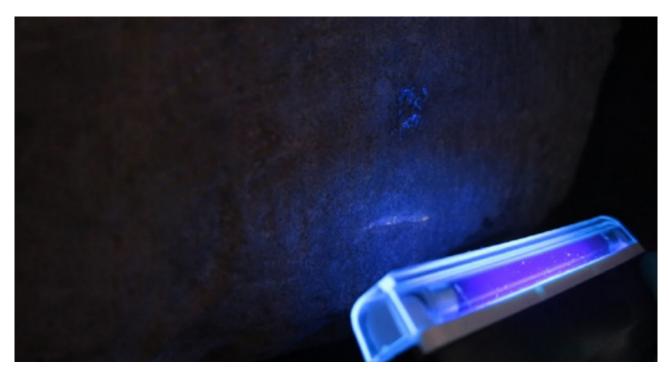
The edges of the hole repair also showed fluorescence in UV light. The thread-like appearance of the glowing substance indicated the presence of some fibres, perhaps gauze or paper, most probably used during repairs (Fig 29).

One area of a scratched white inclusion in the Stone glowed under UV light, suggesting the presence of a mineral inherent to the Stone fluorescing in UV, or traces of substance glowing in the UV (Fig 29).

Fig 29. Lower right corner of the back face under UV light (2023).

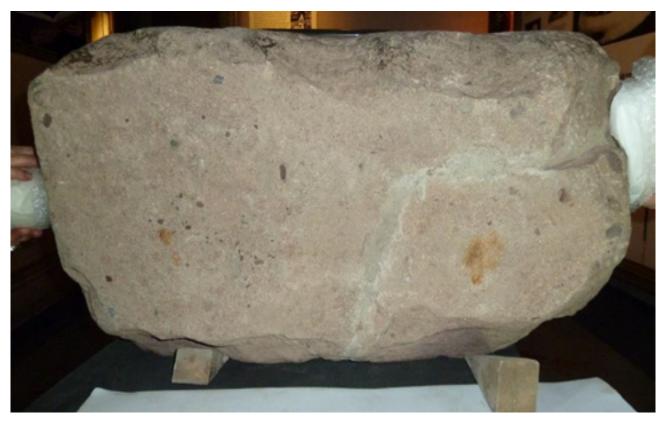
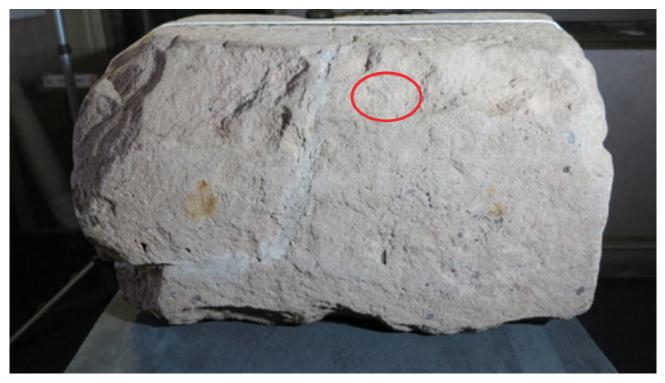
The rust staining already noted in 2016, and probably related to the presence of the two transverse supportive iron bars added to the chair construction in 1821,<sup>9</sup> has not intensified or expanded (Figs 30 and 31).

Fig 30. General view of the bottom face, with the Stone laid on the back face (2016).

Fig 31. General view of the bottom face, with the Stone laid on the front face (2023).

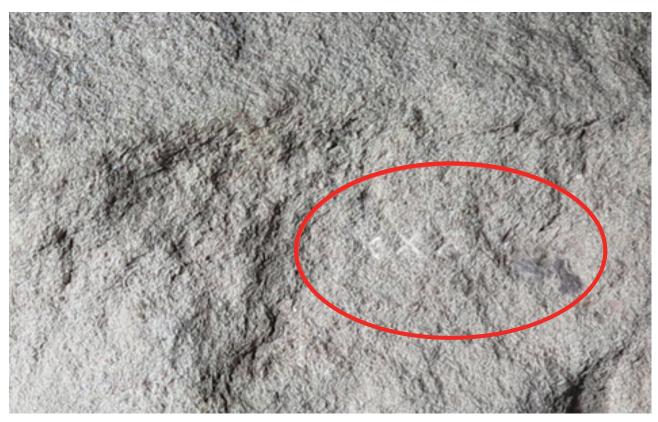
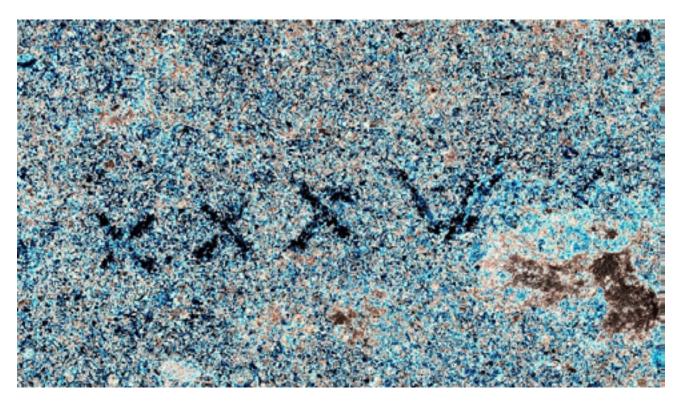
Near the edge, between the bottom face and the back face, a previously undocumented earlier incised inscription has been noticed. The sharply incised inscription represents Roman numbers or letters: XXXV or XXXVX,<sup>10</sup> with the last X being slightly shallower (Figs 32a, b and c). The inscription appears to be relatively modern, possibly 20th century, and though there is no record of its purpose, it is conceivable that the marking may have been added to help identify the Stone or a part of it. The two occasions which seem most likely are: (1) during the Second World War when the Stone is thought to have been concealed for its safekeeping, or (2) in the 1970s when concerns were heightened following a second (failed) attempt to remove the Stone from Westminster Abbey. The visible number could possibly be part of an **accession system**.

Fig 32a. Close-up of the incised numbers/letters.

Fig 32c. Close-up of the incised numbers. Macro photo modified on Photoshop to extract the lines (2023). Figs 32b and 32c provided by the Digital Documentation Team.

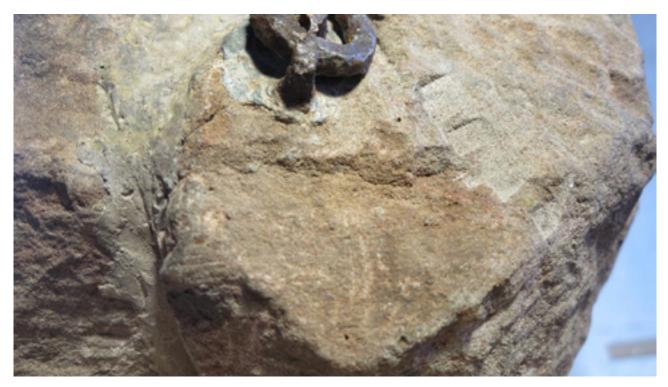
However, the condition assessment also found some areas on the face that will require continued monitoring to keep the Stone in good condition, including: a fine diagonal crack radiating from the lead plug towards the repair joint; a noticeable area slightly prone to flaking under the lead plug (Fig 36); and a fine crack in the repair area located in the socket for the metal elements (Fig 37).

Fig 36. The sinister end face showing a visible fine crack and the area prone to flaking (2023).

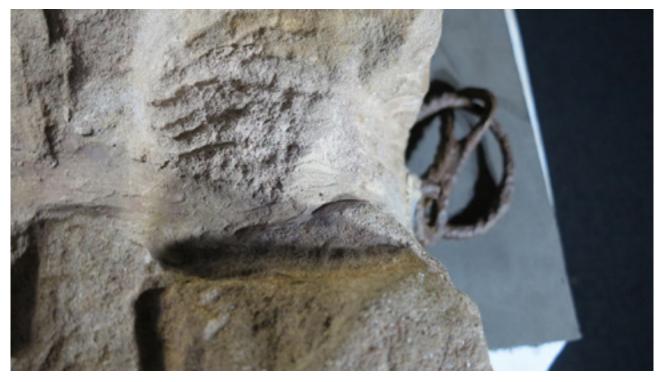
Fig 37. The repair area in the socket for the metal elements (2023).

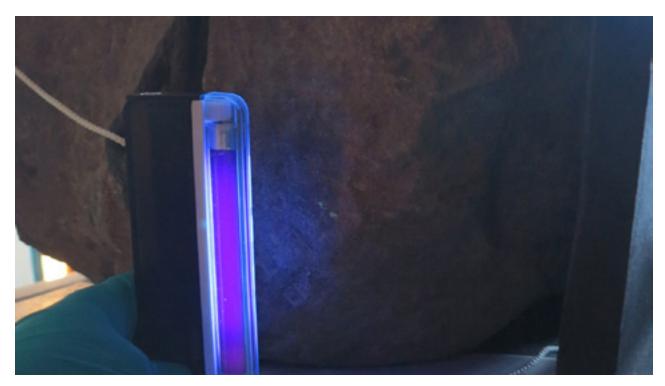
Three areas on the Stone's face showed fluorescence under the UV light (Fig 38). Two of them (top) were of a resinous residue and the one below appeared to be a mineral inherent to the Stone.

Fig 38. The sinister end face under UV light and the three fluorescing areas visible (2023).

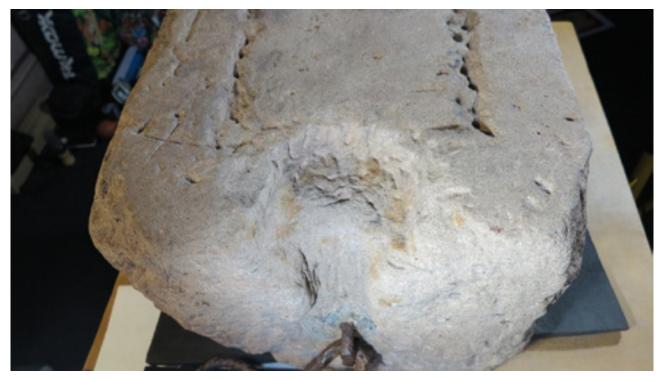
The condition of the surface of the dexter end of the Stone is stable (Fig 40). The iron staining, already identified in 2016, caused by the corrosion of iron elements located in the socket dedicated to them has neither intensified nor expanded (Figs 39 and 41). Similar observations were made of the iron staining inherent to the Stone and present on the right lower corner of the left end face (Figs 42 and 43).

Fig 41. Visible staining in the socket for the iron ring (2023).

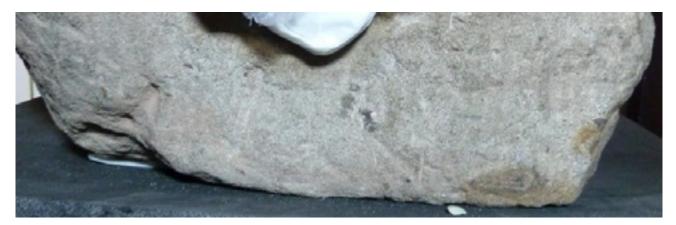
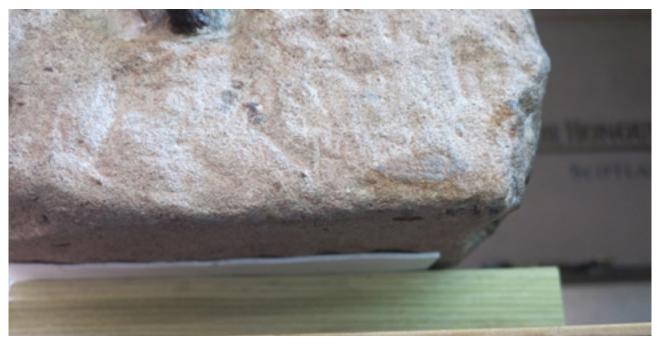
Fig 42. Visible iron staining inherent to the Stone and residues of the brown matter (2016).

Fig 43. Same area as Fig 42, photographed in 2023.

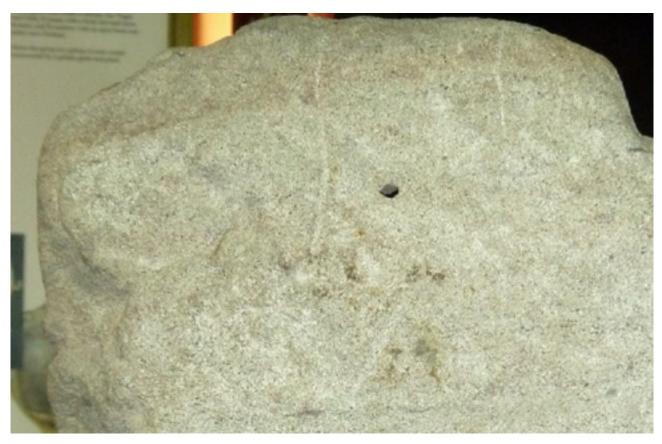
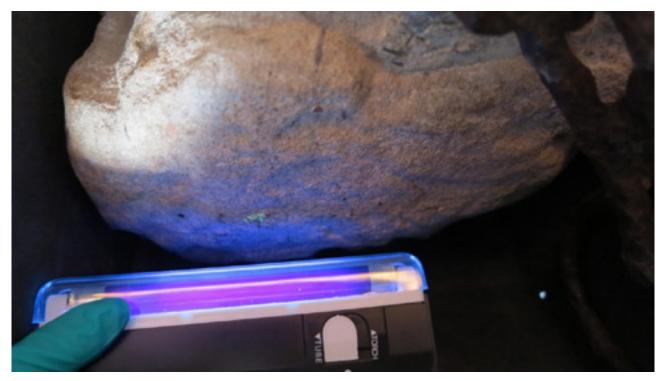
The resinous, semi-transparent yellow-brown substance is most probably organic, deposited onto the area under the two lines incised on the left top corner of the left end face. It was observed under UV light (Figs 44-46). The residue showed fluorescence of similar colour and intensity as the deposit on the left lower corner of the front face of the Stone (Fig 20).

Fig 44. Two visible carved/incised lines, and below, a brown substance of organic nature (2016).

Fig 46. The same area as in Figs 44 and 45, observed under UV light.

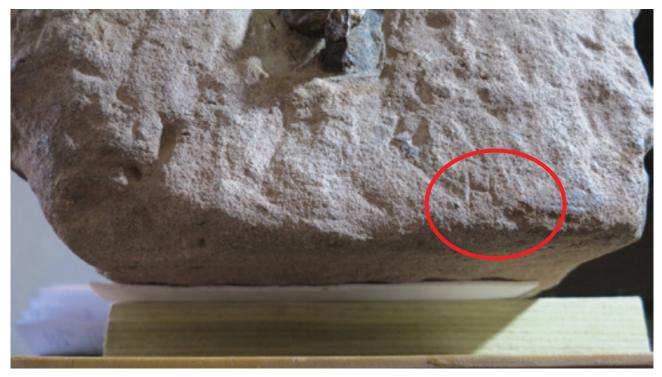
In addition to the observations from 2016, an area of scratched or incised pattern was identified during the recent assessment (Fig 47). It is located in the lower right corner and the pattern resembles a letter H.

Fig 47. Incised pattern resembling letter H.

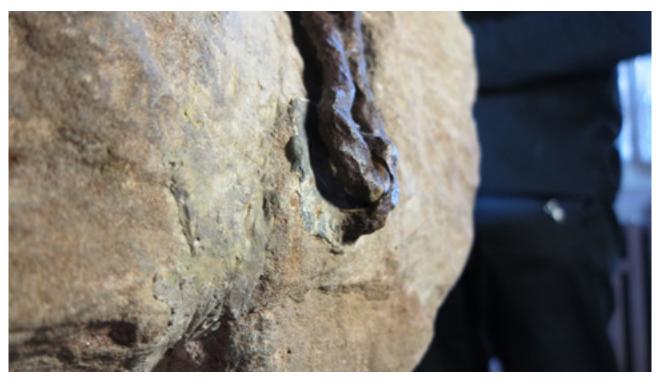
The condition assessment also revealed small areas of flaking iron corrosion and a previously undocumented crack in the staple on the dexter side of the Stone. Overall, the fragile nature of the iron staples makes them the most vulnerable to damage of all elements of the Stone. In case of any examination or movement of the Stone, these must be carefully protected (Figs 49 and 51).

Fig 49. Close-up of the sinister face showing the thinness of the staple and its fragility and vulnerability to mechanical damage (2023).

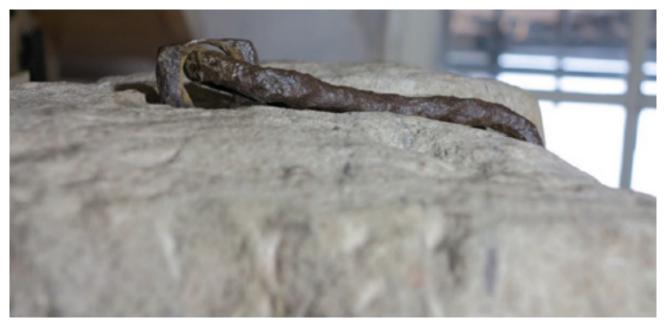
Fig 51. Close-up of the dexter face showing the fragility of the ironwork and its vulnerability to mechanical damage (2023).

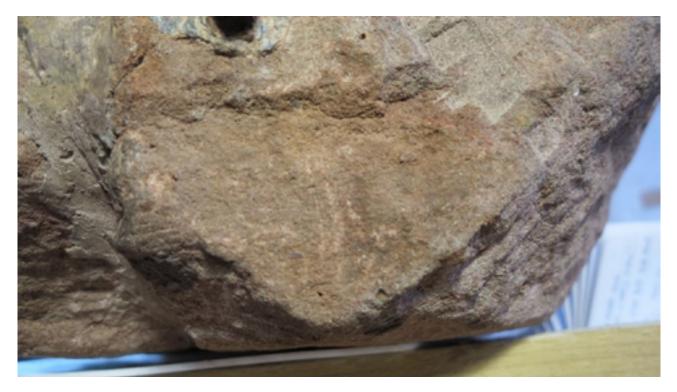
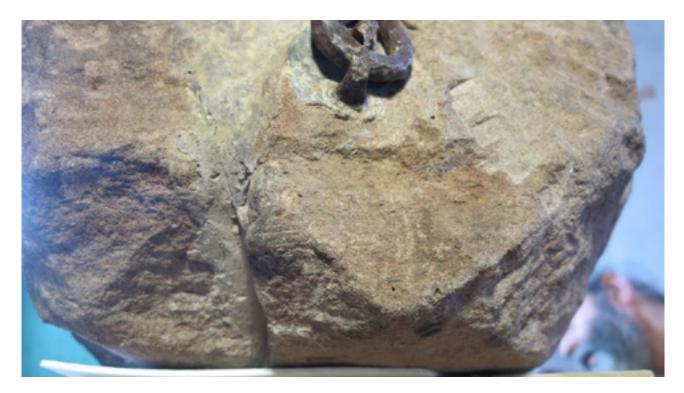
Fig 52. Fine crack and area slightly prone to flaking in the right (sinister) face before any treatments.

Fig 53. The same area shown in Fig 52 after injection and filling with acrylic resin mortar repairs.

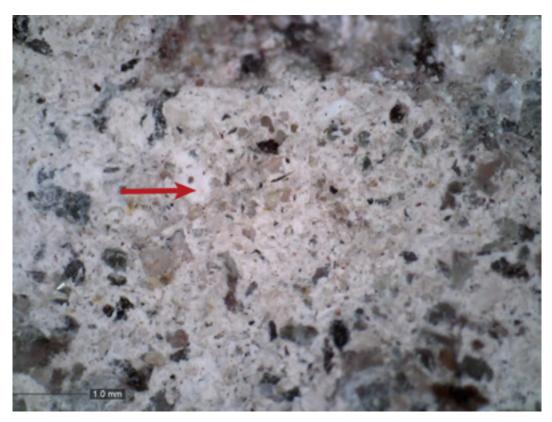
The highest concentration of gypsum (~36%) was detected on the top surface in the recess of one of the lifting rings (Figs 3 and 4a). Smoother areas of the top surface had relatively low levels of gypsum (Fig 4b). Variable amounts were observed on the other surfaces examined (Fig 5). Overall, samples analysed on the top and front surfaces had lower sulphate concentrations and samples from the base, back, sinister and dexter surfaces had higher sulphate concentrations. The cause of these differences is not known.

Fig 4a. Sample area 500. Magnified image of an area of white deposited material on the top surface. Lump of unmixed gypsum highlighted by red arrow.

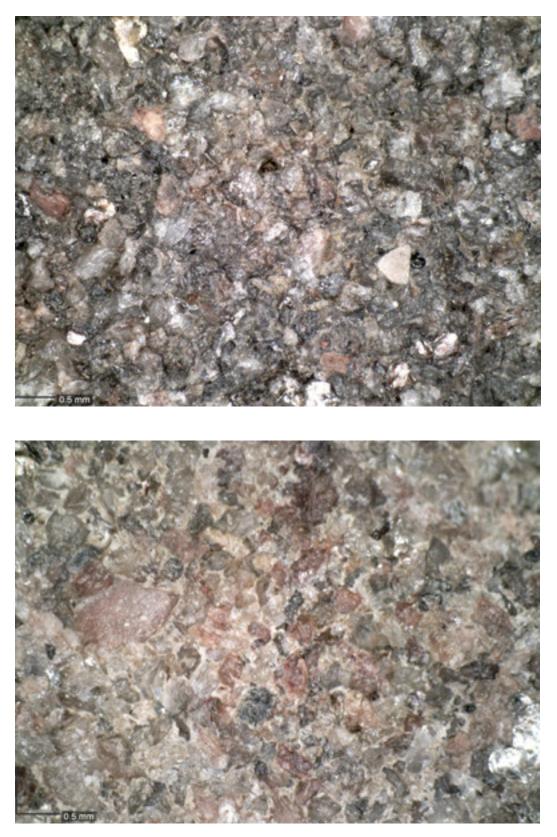
Fig 6. Difference in appearance between dark 'heart' shaped patch and an area of unstained stone on the top surface of the Stone of Destiny. Above: Sample area 1160 – dark surface staining on grains. Below: Sample area 1169 – clean open mineral texture on an adjacent area of non-stained stone.
