REFURBISHMENT CASE STUDY 35

LAURISTON TERRACE EDINBURGH

INSULATION WORK TO A 19TH
CENTURY TENEMENT

ROGER CURTIS

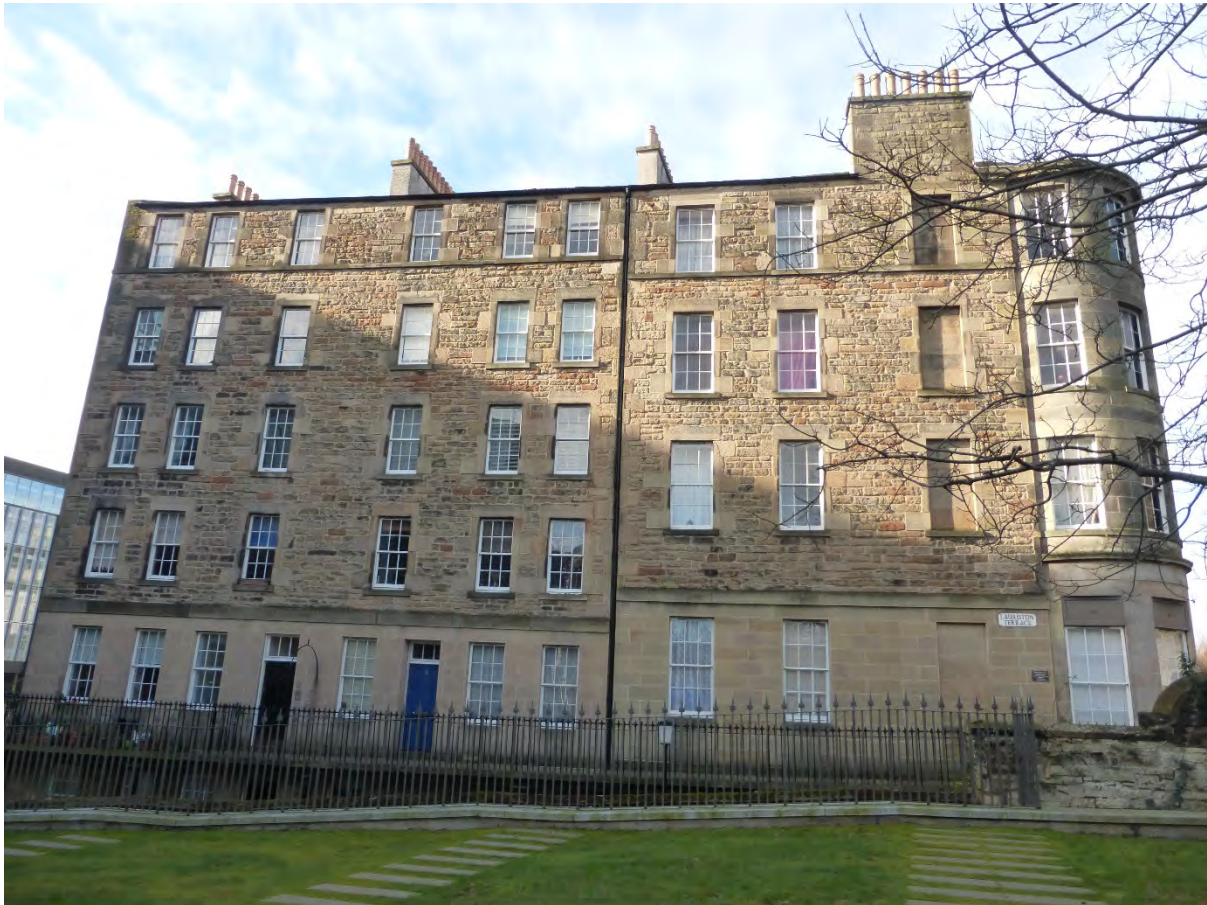
Figure 1: Front elevation of Lauriston Terrace. The flats where work was carried out are the farthest tenements on the left.

The south gable wall is random rubble construction, and the east and the west façades are ashlar faced. A condition assessment showed that the external masonry was in good condition and dry. The chimney and skew copes of the gable had been well maintained and were in good condition. All rainwater goods functioned properly. The interior of the tenement block changed extensively as part of the works in the 1990s. All original lath and plaster linings were removed, and the walls were strapped and lined with

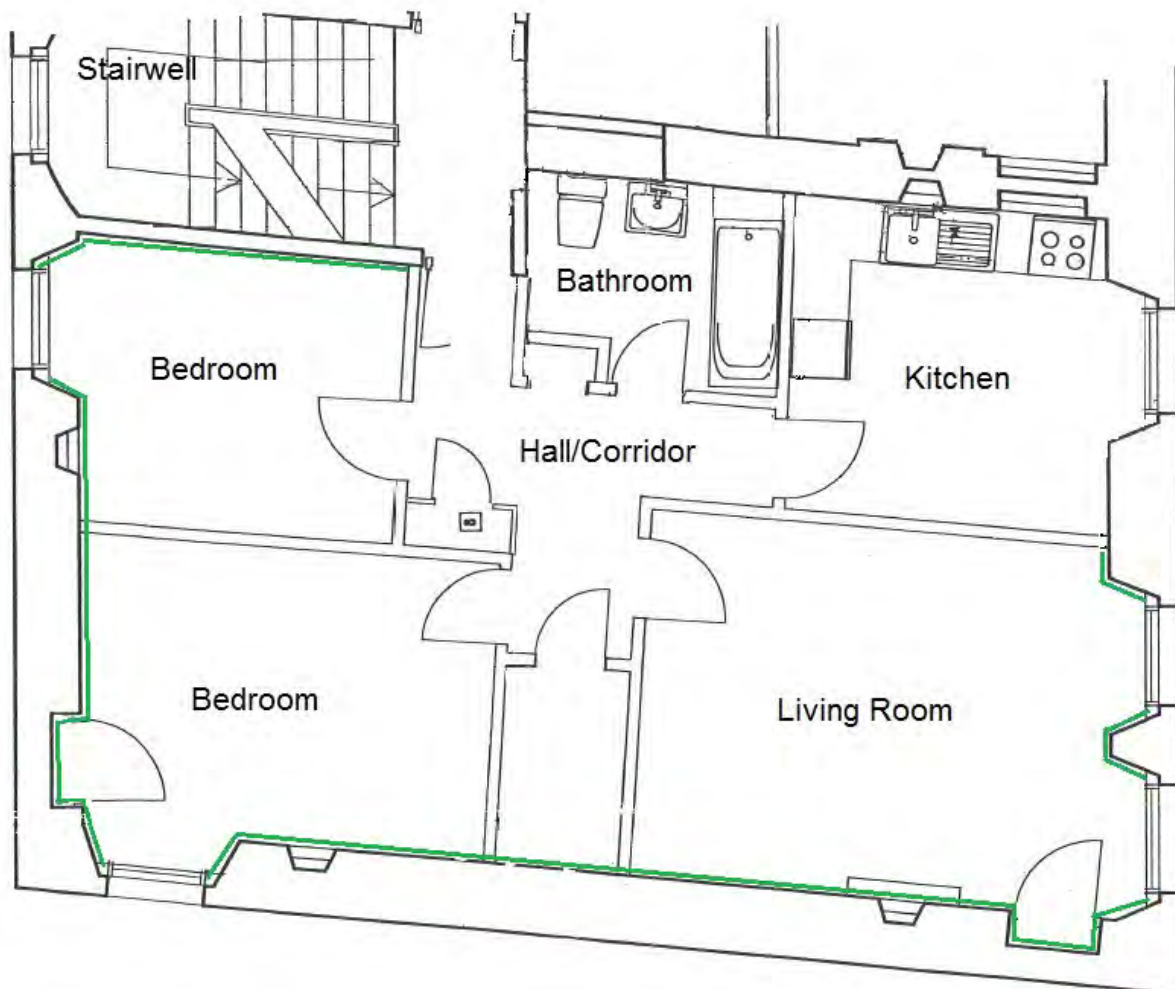
In addition to the flat's exterior wall areas, the polystyrene bead was injected into other voids, such as behind the press cupboards and window reveals. The areas identified for insulation are shown in Figure 2.

Figure 2. Plan of monitored flat in Lauriston Terrace (not to scale). The areas insulated with polystyrene bead are shown in green.

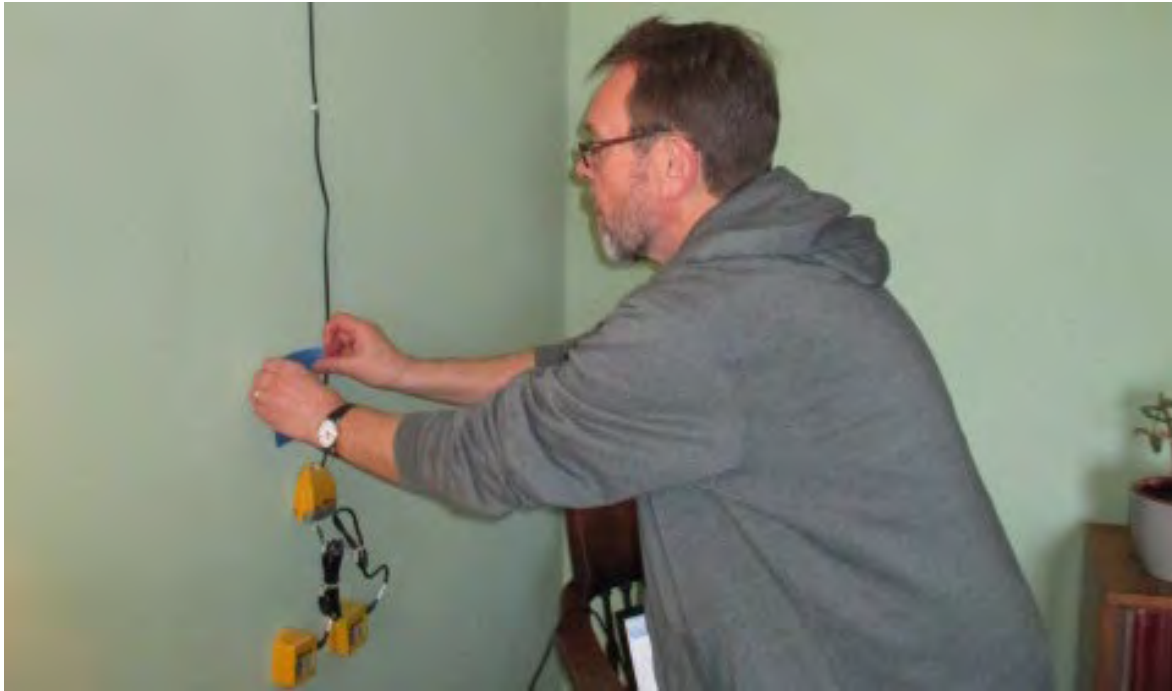
The in-situ U-value measurements for the walls were carried out in three locations on the gable wall. A heat flux plate was fastened to the wall and cables routed discreetly to a central logger box, from which data could be readily extracted. This monitoring required approximately three weeks of data, with a temperature difference of 10°C or more between the internal and external environment. Monitoring was carried out during November 2013. The heat flux plates are shown being installed in Figure 3.

Figure 3. Installation of one of the heat flux plates.

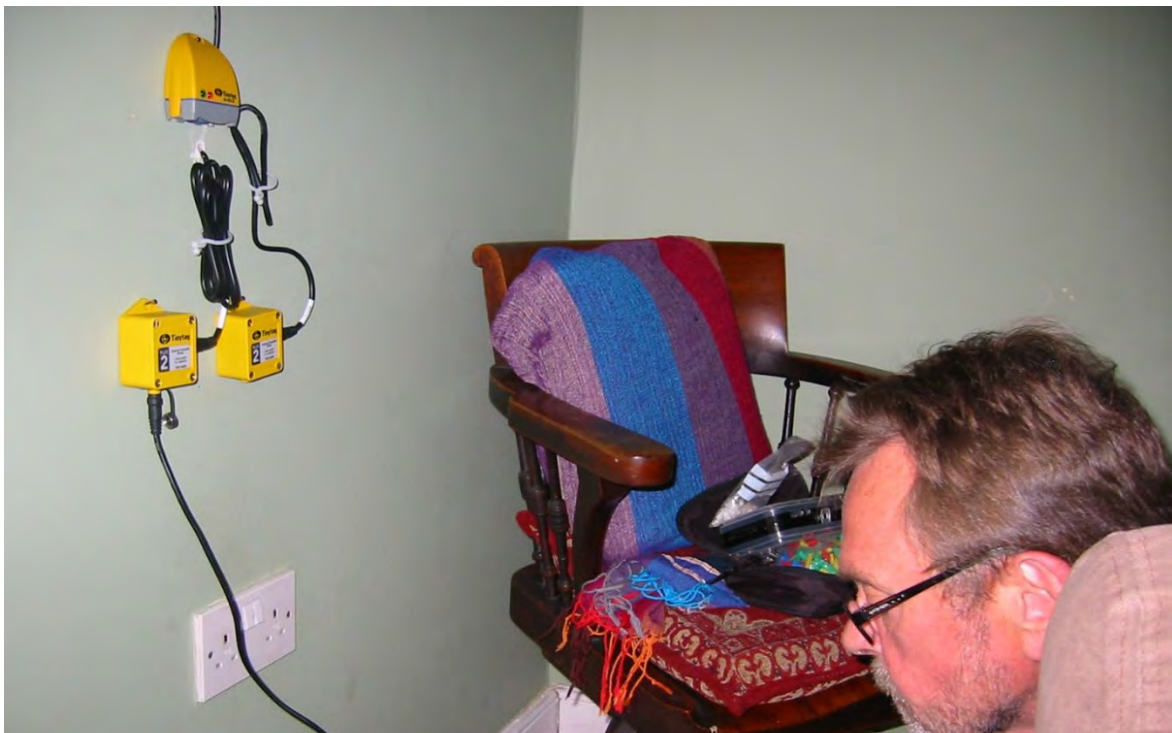
To assess the conditions inside the flat, relative humidity and temperature data loggers were placed on the gable wall in the living room, the main bedroom wall, and the wall in the small bedroom adjacent to the staircase. Figure 4 shows the monitor in situ on the wall.

Figure 4. Installation of one of the humidity and temperature sensors.

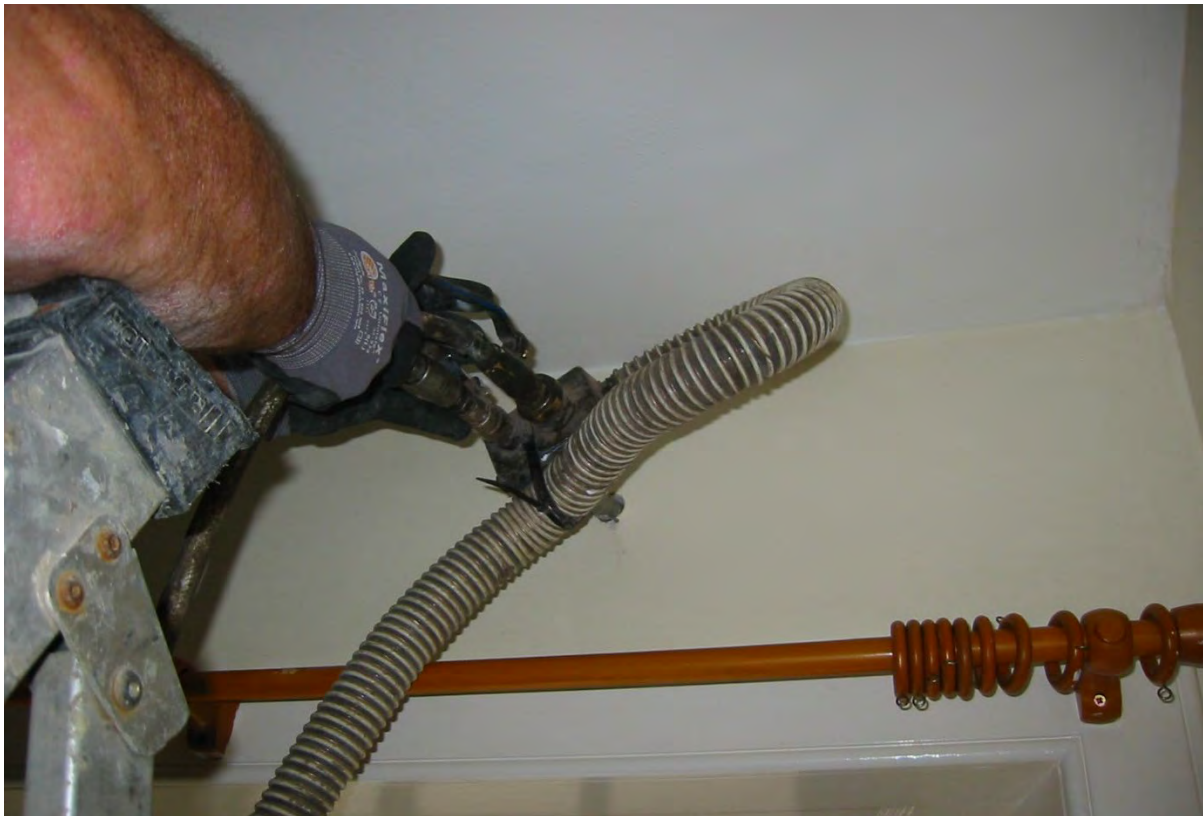
In the past, there have been concerns that polystyrene bead insulation could damage PVC wiring cables. A change in the bonding agent used for the insulation, however, removed this risk and the contractor advised that it was safe to proceed with the work. To inject the material, 25mm diameter holes were drilled into the plasterboard at regular intervals. The actual installation was relatively straightforward (Figure 5), though it did require several holes to also be drilled across the top of each wall.

Figure 5. Blowing in the insulation.

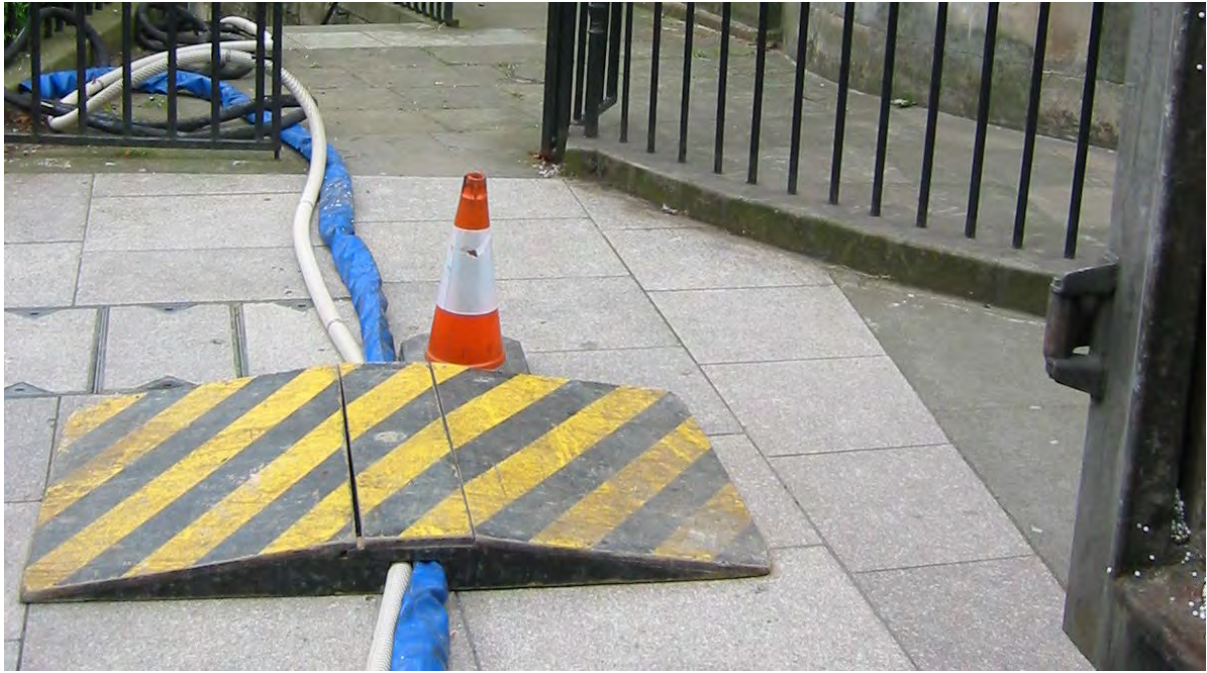
Routes for the hoses carrying the insulation from the compressor, and a material supply vehicle, needed to be considered, especially as to where the vehicle could park. In this case, due to the orientation of the building, routes for the pipes to deliver the polystyrene bead were quite long and had to cross a pavement (Figure 6). Therefore, a parking permit had to be sought from the City of Edinburgh Council.

Figure 6. The pipes for the insulation crossing the pavement into Lauriston Terrace.

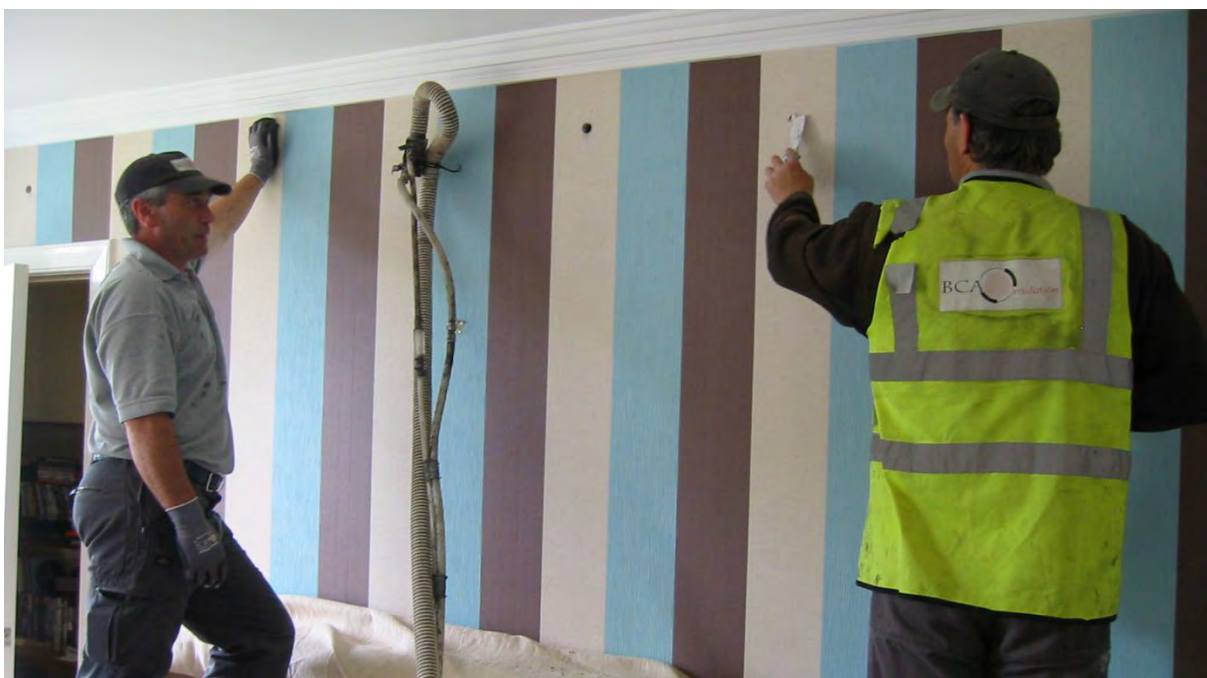
The pressure in the delivery hose was adjusted to ensure the material filled the void, and an infrared camera was used to check that the bonded bead had spread evenly. Once the material had set, the holes were patched over by the installers (Figure 7). This saved time for the decorators who came in shortly afterwards, with the initial filler already cured in the holes. It was estimated that the installation of the insulation would take four hours per flat to complete (doing two flats in a day). However, in reality, it took approximately six hours per flat.

Figure 7. Filling the holes following the injection of the bonded bead. Note the bead delivery nozzle, middle left.

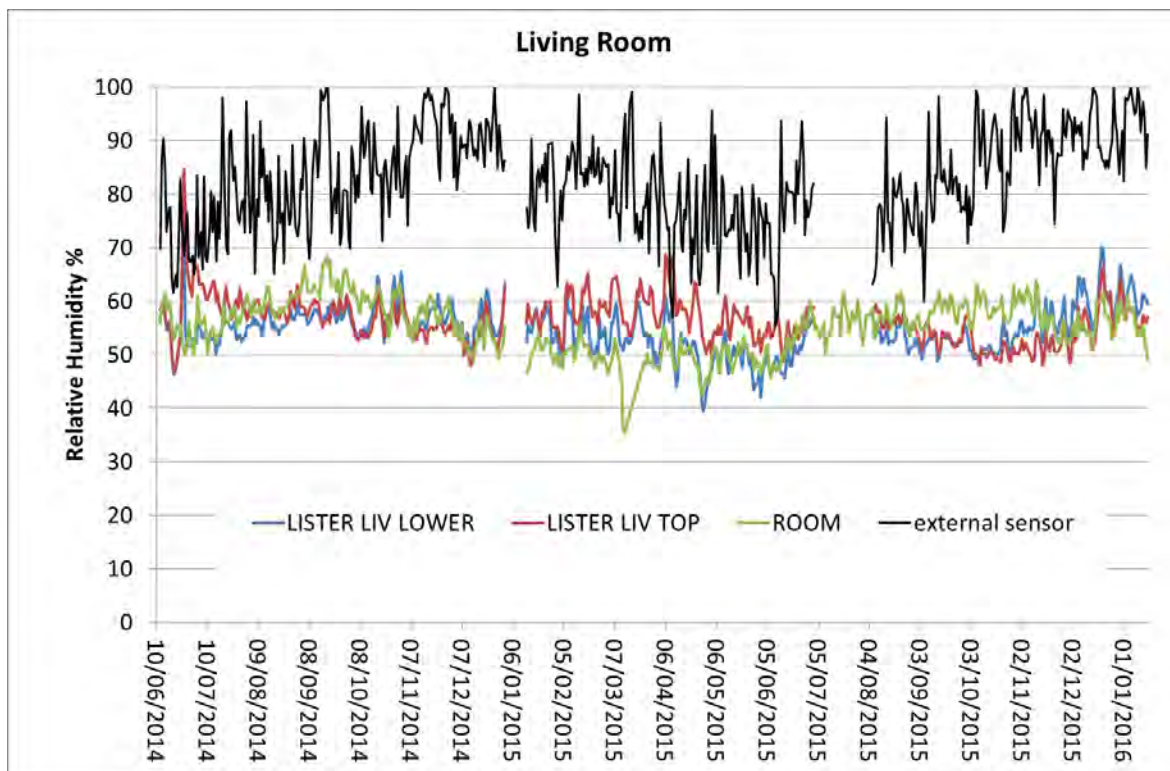
The humidity in the filled cavity behind the plasterboard was also monitored using temperature and relative humidity probes behind the existing plaster lining, over an 18-month period (from June 2014 to January 2016). This assessed how the wall conditions might have changed following the works and the standard level of humidity. Over the monitoring period,

the conditions within the walls at the interface between the insulation and the original masonry indicated no interstitial condensation, and the relative humidity remained below acceptable standards (Figure 8).

Figure 8. Monitoring of relative humidity within the wall of the living room.
