REFURBISHMENT CASE STUDY 37

HOLYROOD PARK LODGE EDINBURGH

THERMAL UPGRADE WORKS TO A 19TH CENTURY
LODGE HOUSE

HISTORIC
ENVIRONMENT
SCOTLAND

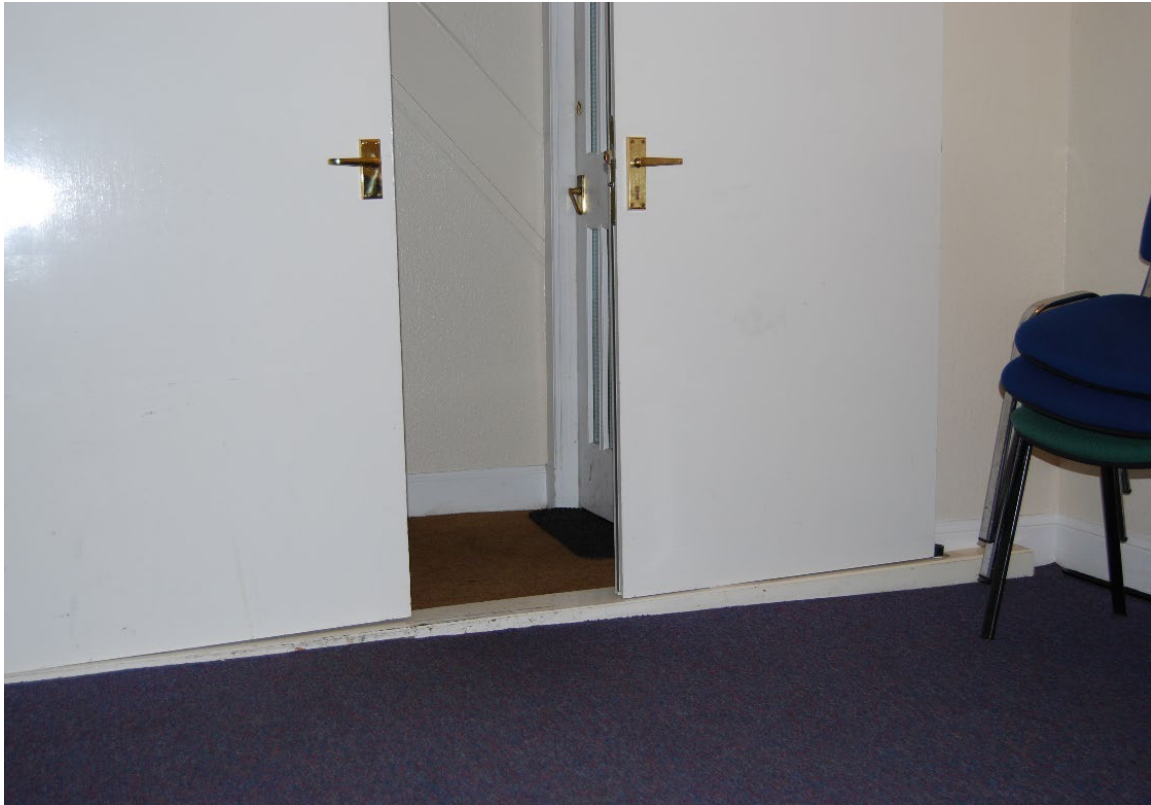
(single-glazed casements) were installed (Figure 3). However, the internal work was more conventional, with modern decorative finishes and details. The floors were covered in a hardwearing commercial carpet; the original timber floorboards remained underneath and in reasonably good condition, although the ground floor room to the east had dropped by several inches in one corner (Figure 4).

Figure 4. The downstairs meeting room showing the modern finishes and the settlement of the timber floor.

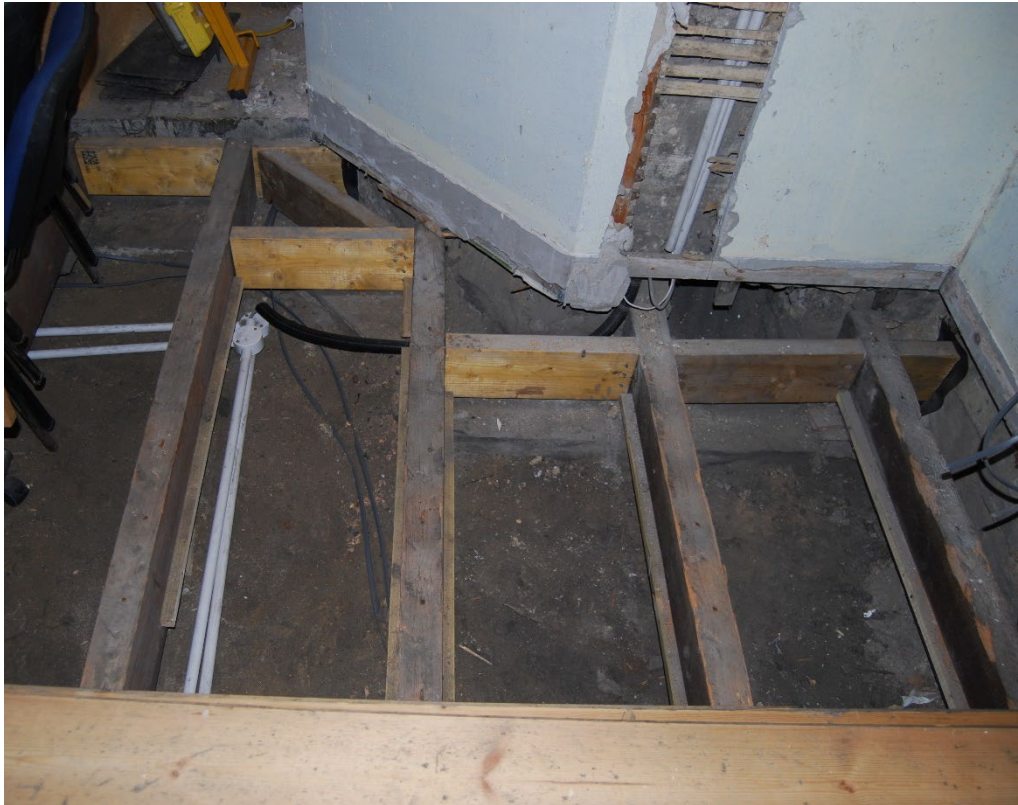
The ground floor of the lodge has suspended timber floors throughout. In the south east room where there had been building settlement, the floor sloped and was uneven; repair and remedial work was required. The floor covering was removed, and floorboards carefully lifted and set aside for re-use. Some joists were off the level by some 40mm, apparently the result of a partial collapse of two dwarf walls that ran across the room. In addition, the joists ends were not well bedded or packed into the external walls. New supports were built up to carry the joists. A new level was established using the hearth stones in each room as a datum. Despite the building settlement, the existing floor joists were in good condition and only required minor repairs. The joists were levelled with timber packers and slate pieces. To give additional lateral stiffness, additional braces or 'dwangs' were fastened at right angles to the joists (Figure 12) at regular intervals. In the north east room, sections of the floorboards were also lifted to check the floor's condition and route new power and data conduit and cabling for the shop.

Figure 12. The additional stiffening put into the ground floor joists using 'dwangs'.

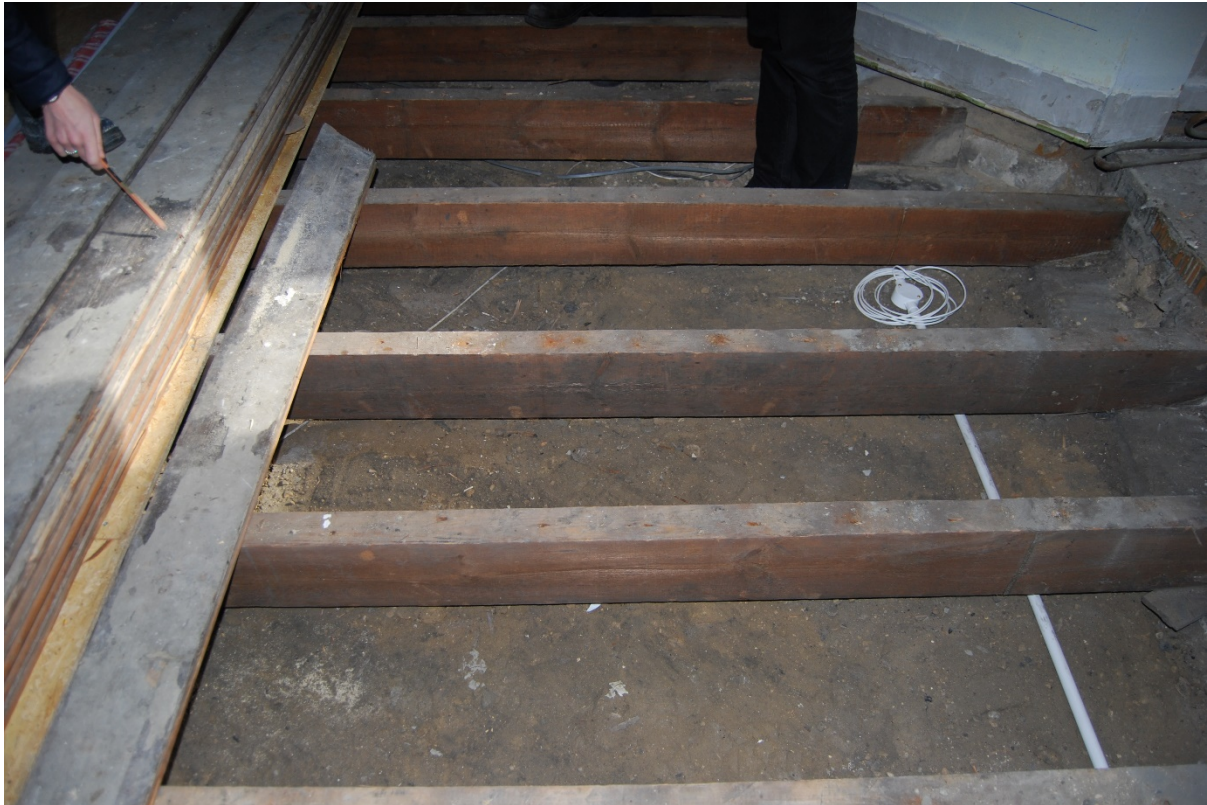
While the location of the lodge is low-lying and the ground around is prone to water run-off from the modern hard landscaping to the south west, the underfloor void (solum) appeared dry. There were some small areas of wet rot on the underside of the joists, close to the wall junction, where at some point the floor void had been damp. The dry state of the floor void may be due to improvements in surface drainage in the garden area, as part of the 1990's works. It is common with some approaches to refurbishment to lay a concrete floor after removal of a suspended timber floor. This is not suitable for traditional buildings, as the moisture in the ground is prevented from evaporating; this means the solum becomes damper and water rises up the masonry of the walls and partitions, exacerbating the very dampness the intervention seeks to exclude. A considerable amount of loose masonry material and other debris was removed from the floor void on the ground floor (this amounted to about 40 rubble bags) reducing the solum level below the floorboards by about 40mm. This is expected to have improved the air flow in the floor void considerably (Figure 13). Externally, the iron grilles in the masonry walls that allow outside air into the solum were cleaned to ensure full air movement into the insulated space (Figure 14).

Figure 13. The cleaned-out floor void prior to the insulation being fitted.

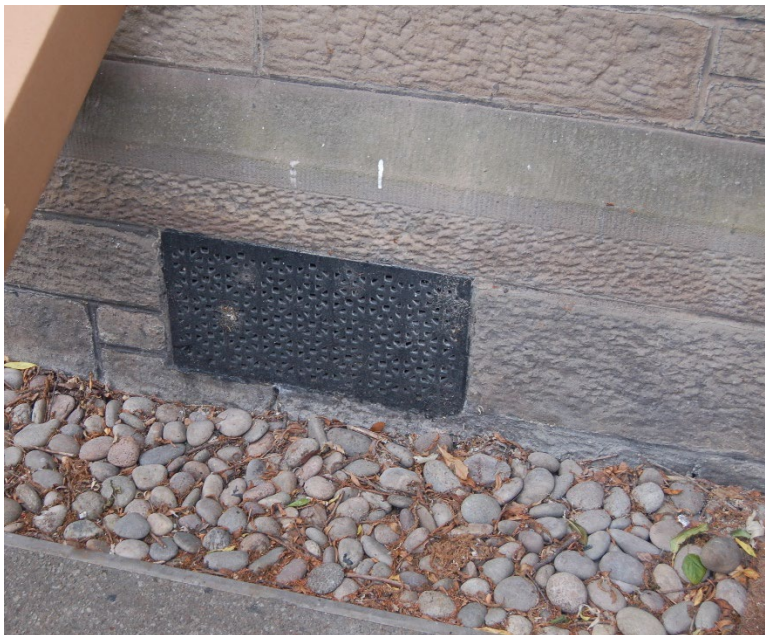
Figure 14. The external ventilation grilles to the floor void. These were cleaned to ensure full air movement.

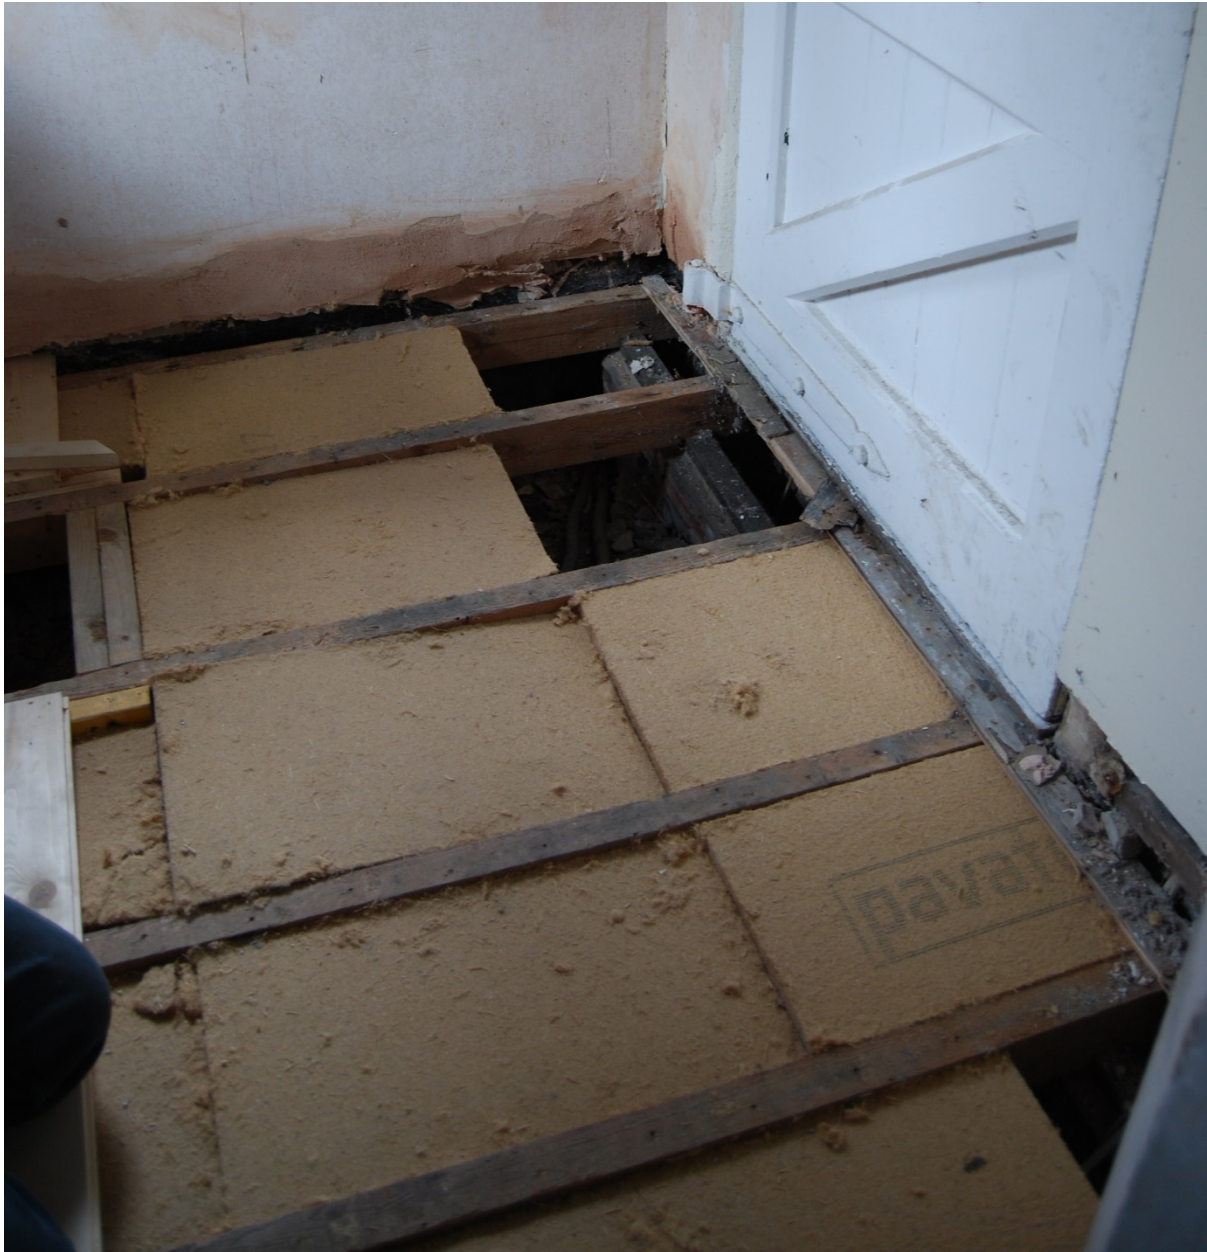
The cut batts were mounted on timber runners fastened to the lower edge of the floor joists. The tolerance in cutting gave a snug fit between the joists; the runners giving some closure on any gaps. However, absolute air tightness was not desired either, as some air movement was considered desirable. Due to the thickness of the insulation at 100mm, the finished level of the insulation was approximately 10mm below the level of the top of the joist (Figure 17).

Figure 17. The floor insulation in place between the joists in the hall prior to the boards being laid.

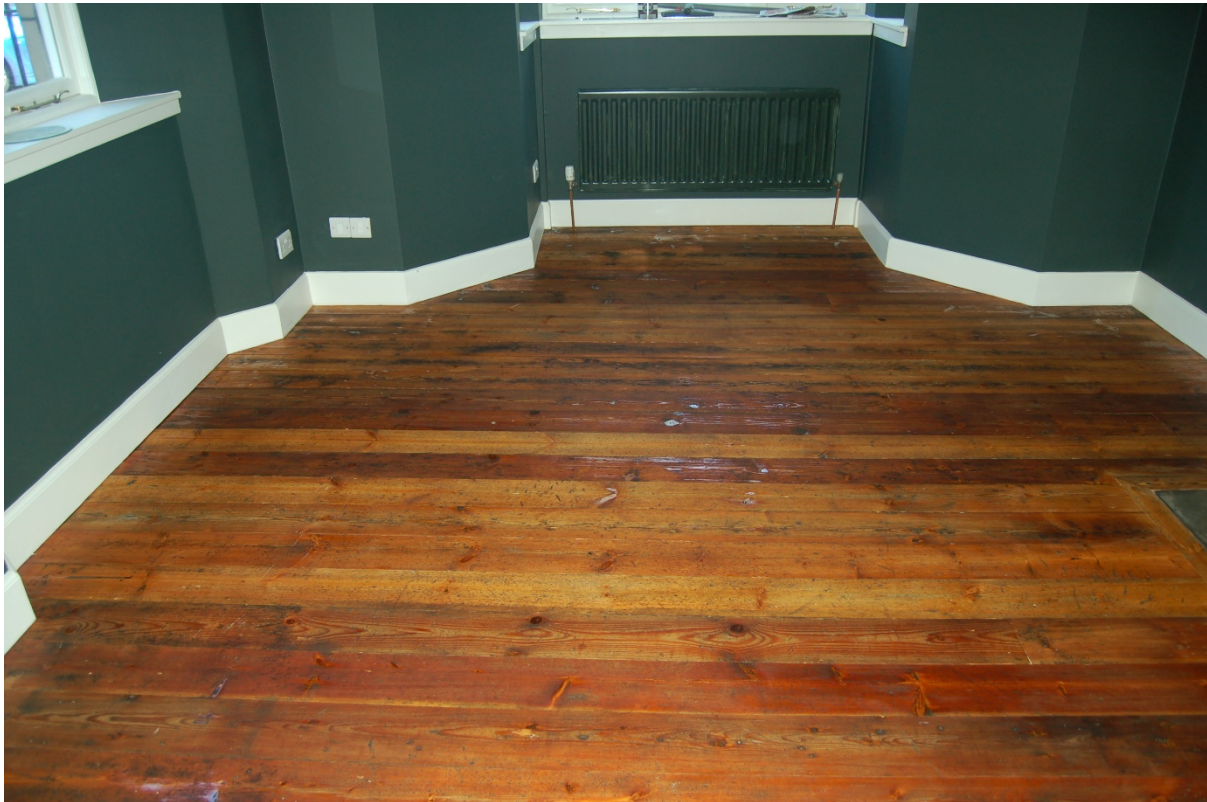
Following the insulation work, as many as possible of the floorboards were re-laid. Due care was taken when lifting the floorboards, but about 50% of the floorboards from the ground floor were unsuitable for reuse, due to deterioration and damage from service installations. A decision was therefore taken to relay the floor in the exhibition room with the original floorboard timbers, making up the shortfall with salvaged boards from the other areas, and fit new timber tongue and groove floorboards in the shop and corridor areas. Care was taken to ensure that the floor was re-laid around the hearth stones in the traditional way (Figure 18). The original flooring was sanded in the workshop before laying and finished with two coats of water-based varnish. The quality of the original timber flooring became very obvious to see when compared to the new flooring in the

shop and corridor. While the new timber was of acceptable quality, it was much paler in colour due to less resin and faster growth, and was also slightly softer, making it susceptible to marks and dents from foot traffic and when moving materials and equipment. The floorboards on the first floor were not lifted as they were in good condition and the thermal upgrade did not require intermediate floors to be insulated.

Figure 18. The re-laid floor in the exhibition room, note the rich colour of the historic timber and the mitred edging around the hearthstone on the right of the image.

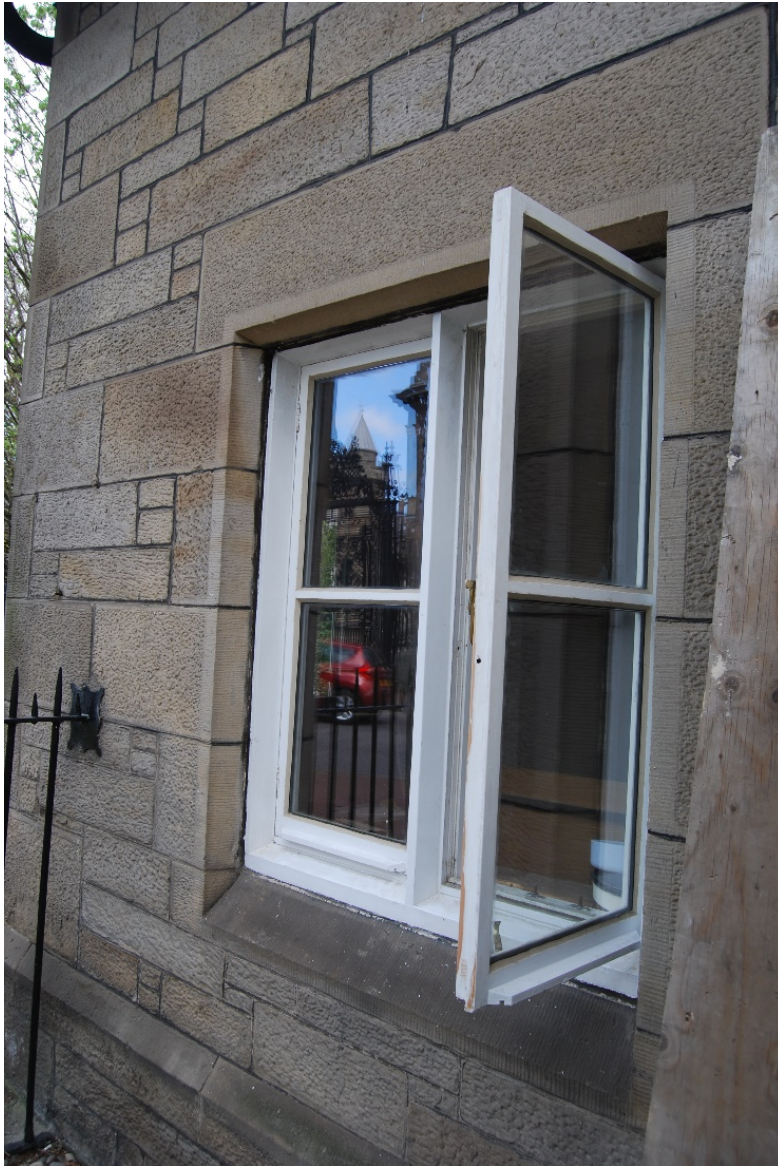
The existing windows in the lodge were all single-glazed casement type windows of varying dates, with most having been fitted as part of the 1995 repair works. The casements in the shop corridor and main hall were fitted into original frames, with traces of the once common green paint in the lower layers. All frames and casements were in good condition, so the decision was taken to keep them and upgrade the glass with slim profile double glazed units from a Scottish supplier. For this work, the casements were removed to the contractor's workshop to fit new higher performance glass units, overhaul the hinges and stays, and check over that they are functional and operable before re-installing into the building frames (Figure 20).

Figure 20. The new double-glazed units set into the existing casements.

All the new insulated glass units (IGU's) units were bedded in traditional linseed oil putty; to separate the linseed oil from the window edge seals, silicone was used on the edges. Some industry guidance indicates that linseed oil may damage the edge seals of double-glazed units. To assess these possible effects, two fixed casements in the interpretation room were only bedded with linseed oil putty, with no barrier between the unit and the putty. The condition of this double-glazed unit will be monitored. (At the time of writing of this document there have been no visual changes to the window assembly.) In addition to the improved glass, draught strips were rebated into the casement edges to reduce air infiltration (Figure 21). This worked well on the smaller windows but, where there had been building settlement or a poorly fitting frame, the gap was too much for the cushion strip to make up and an air gap remained. This was especially noticeable in the first-floor meeting room where the window opening on the gable wall was distorted by the building settlement. Following the main project work, silicone beading was applied to cover the remaining air gap.

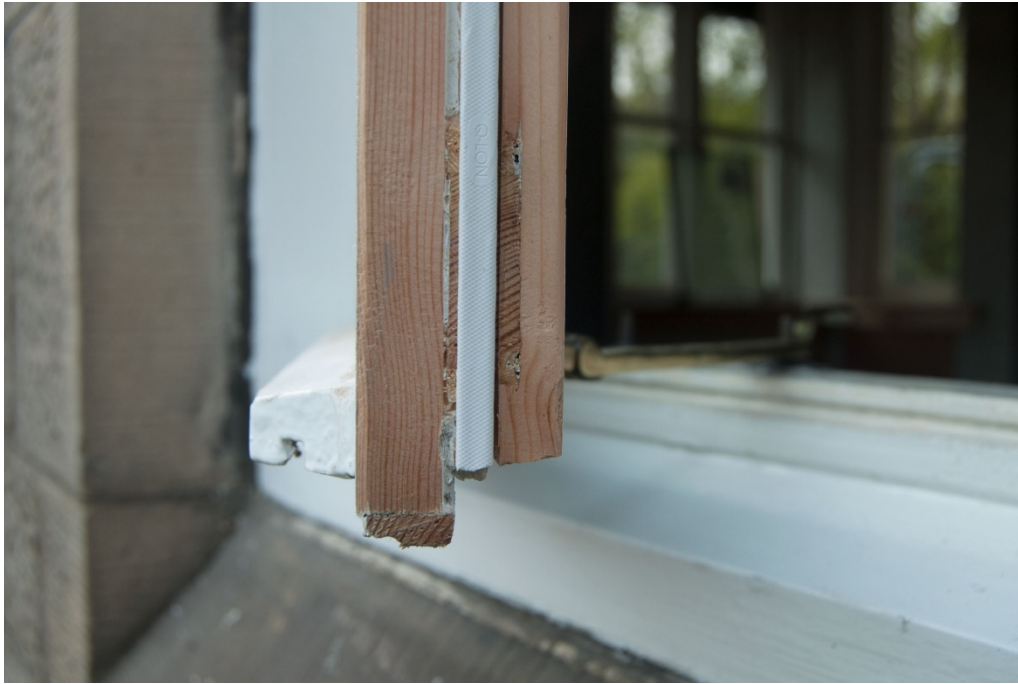
Figure 21. The cushion-type draught strip fitted to the casements.

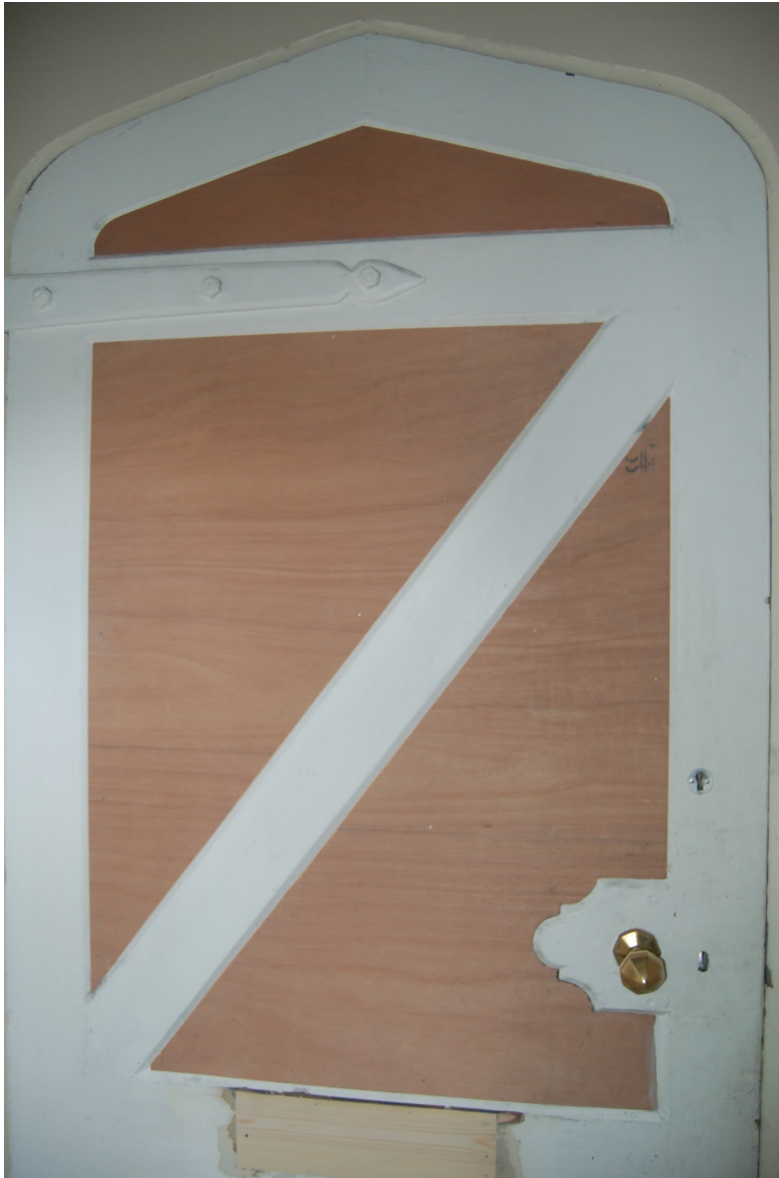
Panelled and similar traditionally made door types often have slimmer components to create their distinctive appearance. Modern insulation materials such as aerogel-based products can offer a good solution for increasing the thermal performance of traditional door types where the panels are thin and for retaining the existing doors within the building door frames. At Holyrood Park Lodge, aerogel board was therefore added to improve the thermal performance of both external doors. It was decided to leave the timber beading and door mouldings in place around the inset panels and to directly apply the aerogel blanket (5mm thick) to the fielded panels on the inside of the door, then cover with a thin plywood panel (6mm thick), all cut to size for a good fit (Fig. 22). All existing hardware was retained.

Figure 22. One of the ledged and braced doors at the lodge before being redecorated, showing the plywood panel on top of the aerogel board.

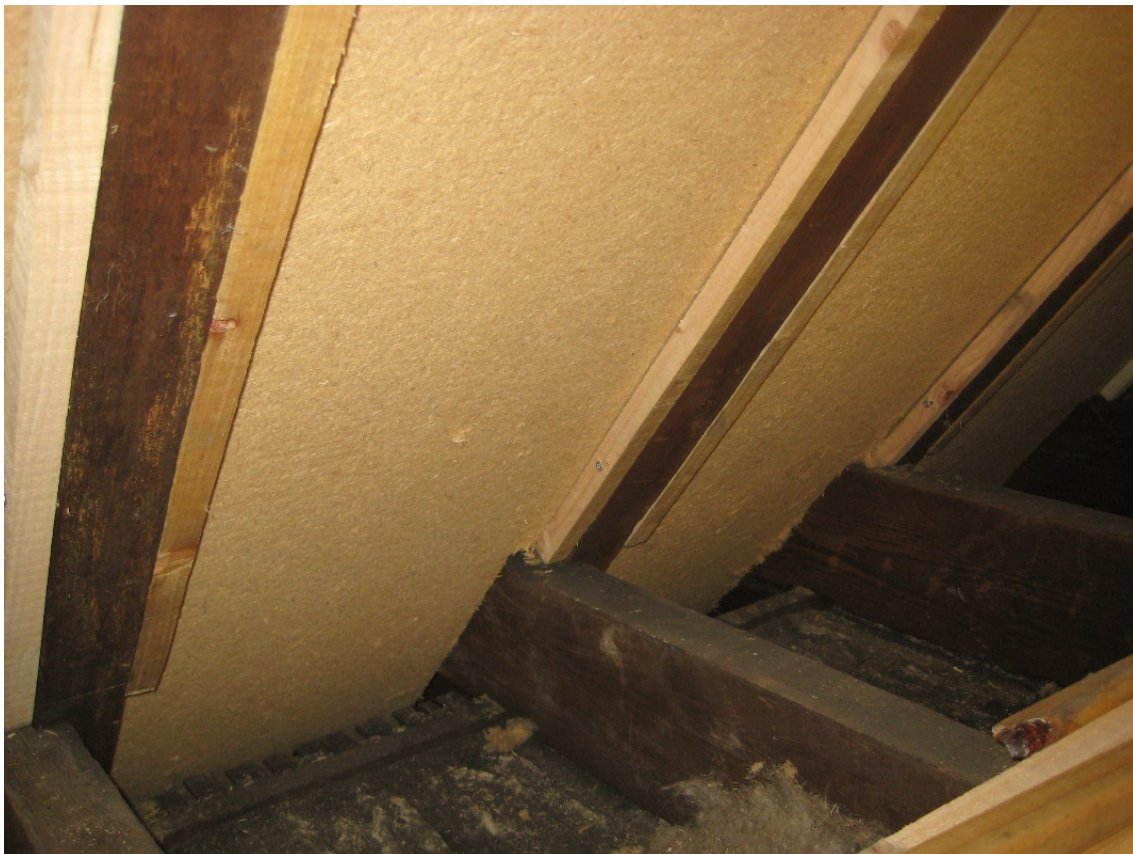
The roof to the upper floor of Holyrood Park Lodge has two attic spaces separated by the masonry of the chimney breast. To access each of the attics the ceiling hatches were enlarged to give more space and improve safe working access into these areas. Proprietary ceiling access panels with drop down ladder steps were fitted in the first-floor meeting room and the staff room. This allows easier access for inspections and for visitors to see the works undertaken. Wood-fibre was selected for insulation, since it absorbs and releases water vapour as internal conditions change with temperature. Any condensation from changes in dew point will be absorbed into the wood fibres and will not bead up and run down the insulation, which can happen with some materials. One roof space area, the south facing gable, was fitted with wood-fibre board fastened between the rafters, much as was done on the timber floor. This gave what is termed a 'warm roof' (Figure 23).

Figure 23. The wood-fibre insulation in the south gable space; a 'warm roof'. Note the insulation continuing down in the coom.

During the installation work, it was questioned if the wood-fibre batts should be tight up against the sarking, giving a single roof layer, or leave a 30mm gap. Conventional practice recommends a ventilation gap, and this was adhered to for most of the roof slope. To assess the effects of having no air gap, two insulation boards - covering the width between three rafters - were reset close against the sarking. In-situ humidity monitoring equipment was installed in both areas to allow assessment of any difference in the condition of the insulation and sarking timbers. The monitoring was set in place in the Autumn of 2017 and was conducted over the following two winters. Initial results suggest that there is only a minor difference in relative humidity between the ventilated space and the unventilated wood-fibre insulation. Monitoring is continuing in this area until winter 2020.

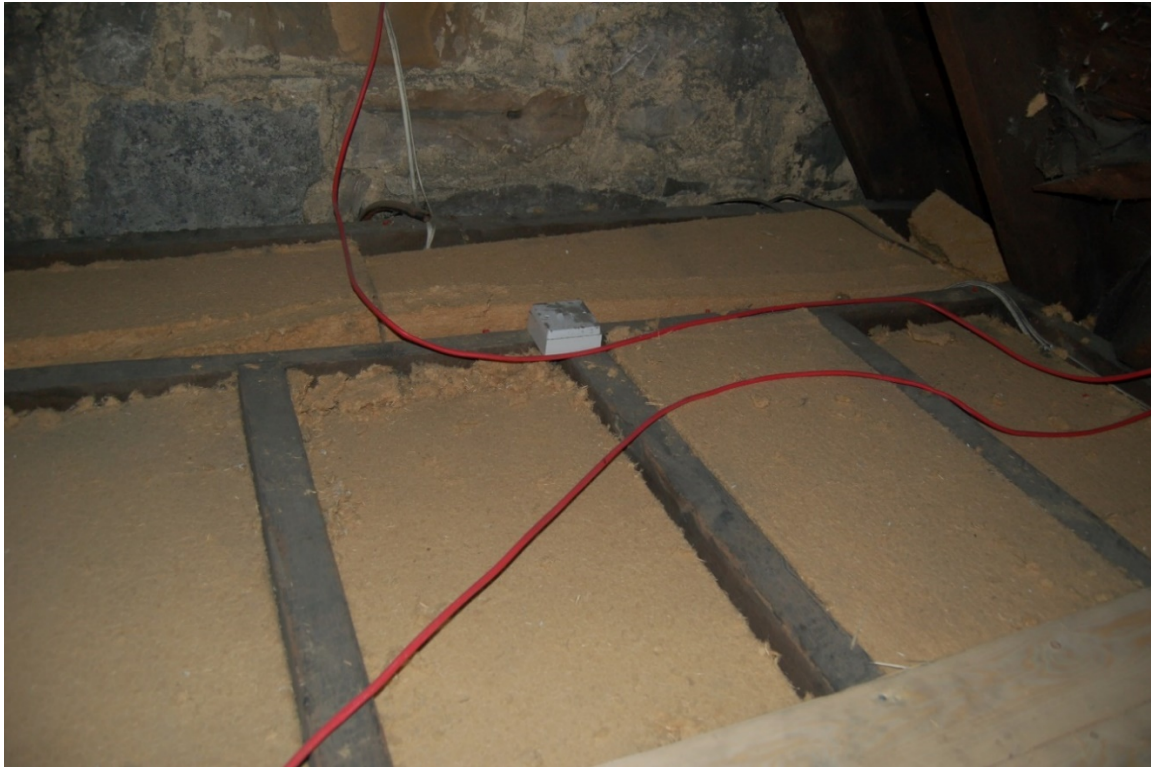
Figure 24. The wood-fibre insulation batts laid flat between the ceiling joists to give a 'cold roof'.

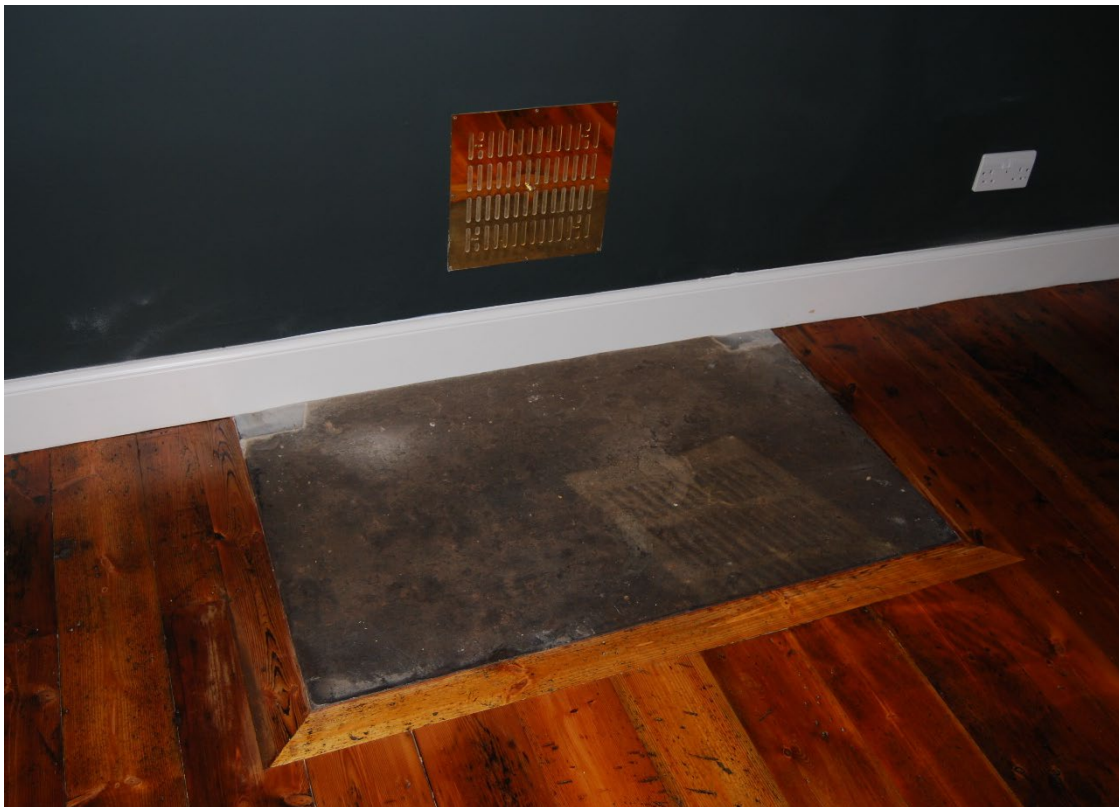
should generally be kept open to allow dispersal of water vapour from walls. At the lodge, all hearths had been closed off as part of the 1990s work. To progress thinking on the ventilation benefits of open flues and to improve the natural ventilation of the meeting room, where there might be up to ten people, it was decided to re-instate the hearth and mantelpiece in the meeting room to allow full air movement through the flue. In addition, a larger vent plate would be put into the former hearth opening in the interpretation room and shop (Figure 27). Both these interventions would allow the re-instatement of air movement in the flue and a degree of passive ventilation to both rooms.

Figure 27. The new ventilation grille in the former hearth in the interpretation room.

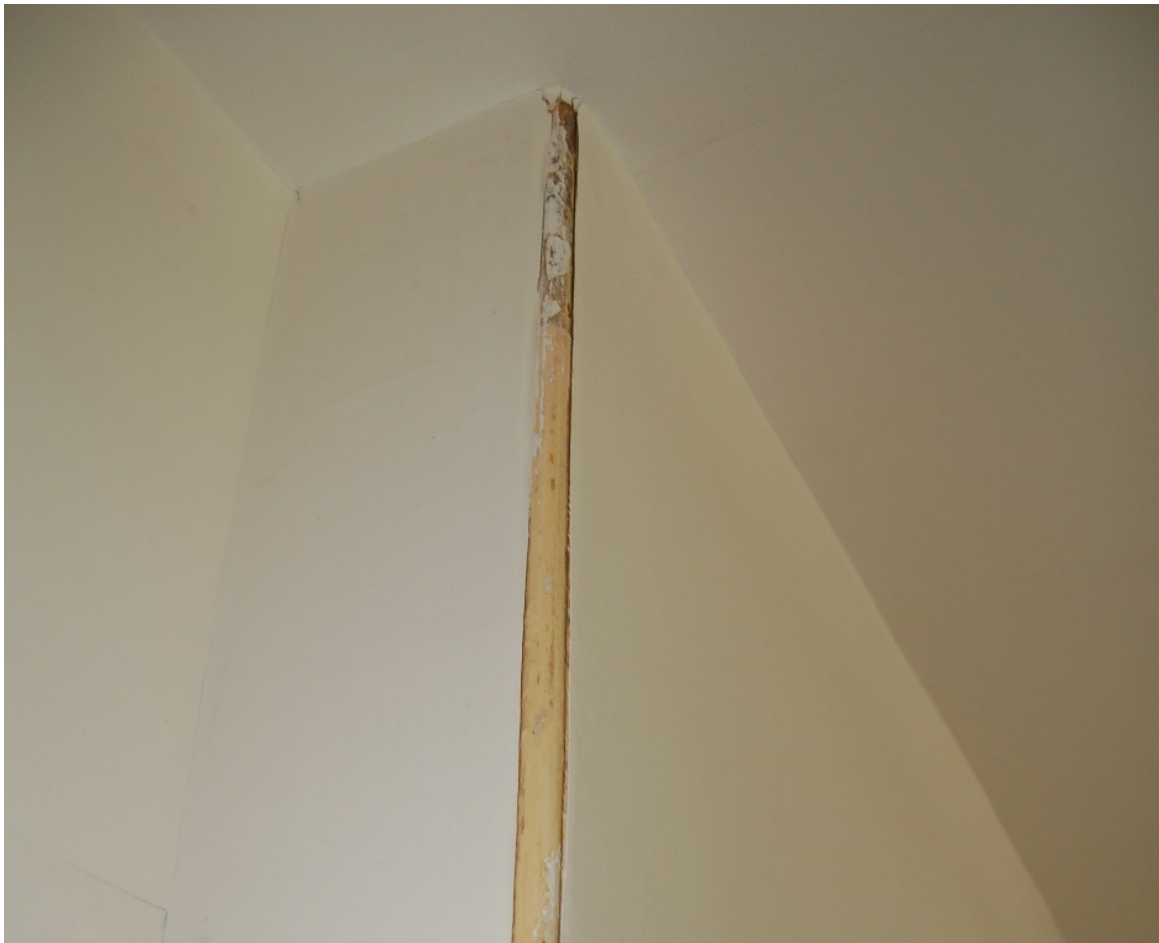
On the corners or 'arrases' of plastered areas, the timber bead was returned to its original finish with the plaster edge strips uncovered; in Scotland this detail is called a 'quirk' (Figure 30) and softens the edges of corners and other terminations.

Figure 30. During the redecoration, the configuration of the timber corner detail, called a 'quirk', was re-instated.

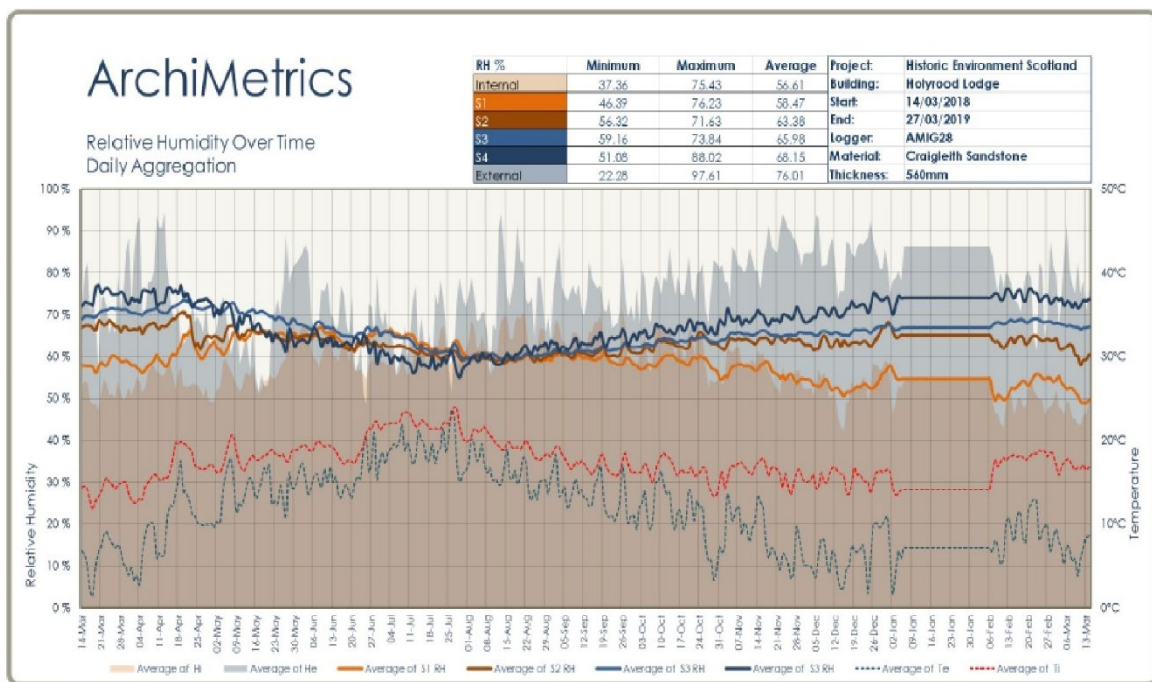
The works were completed in July 2017 and building monitoring was resumed in February 2018. The first year of post-intervention monitoring was limited in scope to two areas: wall insulation assessment and measuring of relative humidity on the west facing elevation. Before intervention, relative humidity values varied significantly, mainly due to the building being underheated, however, monitoring has shown that, post-refurbishment, the west wall behaves much as traditional walls behave in heated buildings, with a much lower relative humidity level. These relative humidity levels are an improvement to both the internal environment and the wall conditions, showing that the insulation had indeed a positive impact. A representative graph of humidity through the wall section,

Figure 33. Post-refurbishment humidity levels over time through the section of the west wall.

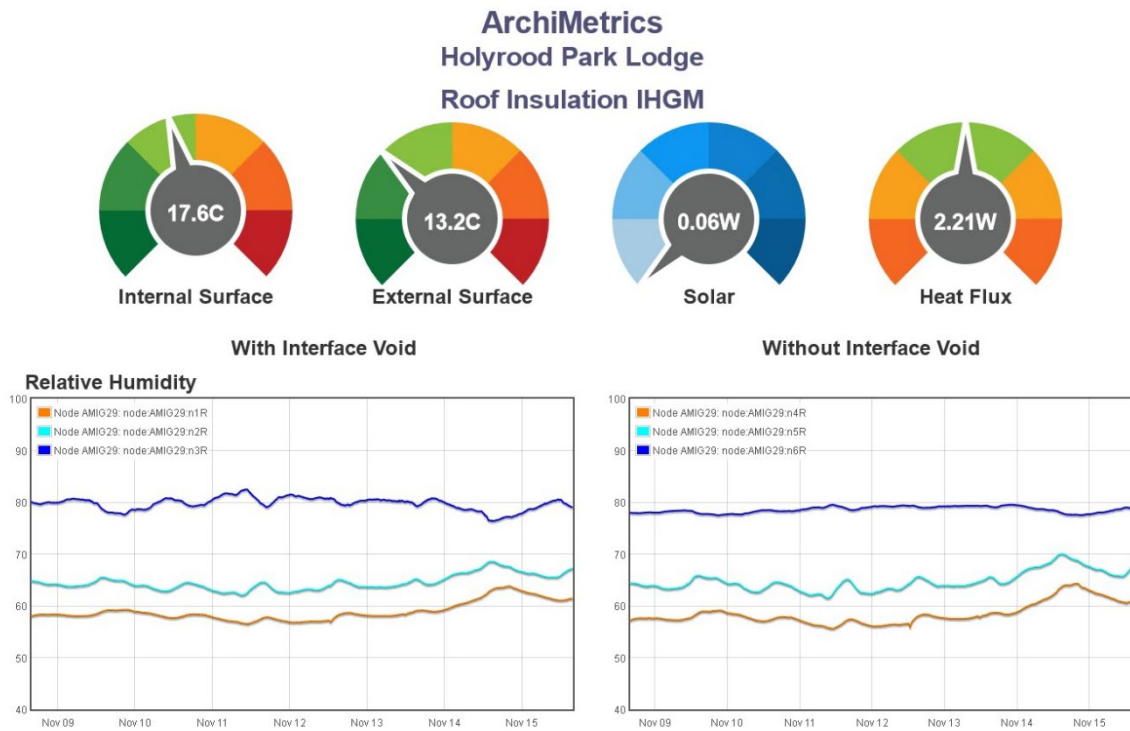
In the winter of 2018/2019, additional monitoring was carried out focussing on the conditions in the warm roof at the interface of the insulation and the sarking, as well as within the insulation material. During the monitoring period, a dashboard type display was developed to allow an at-a-glance assessment of the conditions in the roof insulation. A screen grab of this display is shown below (Figure 34). The results so far are indicating that the effectiveness of the improvements is generally as expected. The

specific area of the roof where the insulation was pressed up against the sarking, described as ‘without interface void’ in Figure 34, shows no significant difference in conditions at the junction when compared to the one ‘with interface void’. This supports the theory that where vapour and capillary active materials are used for insulation, internal humidity is controlled, and the roof is wind and watertight, moisture does not build up.

Figure 34. The online dashboard showing the humidity in the roof insulation in the warm roof during November 2018, as well as the average internal and external temperature.

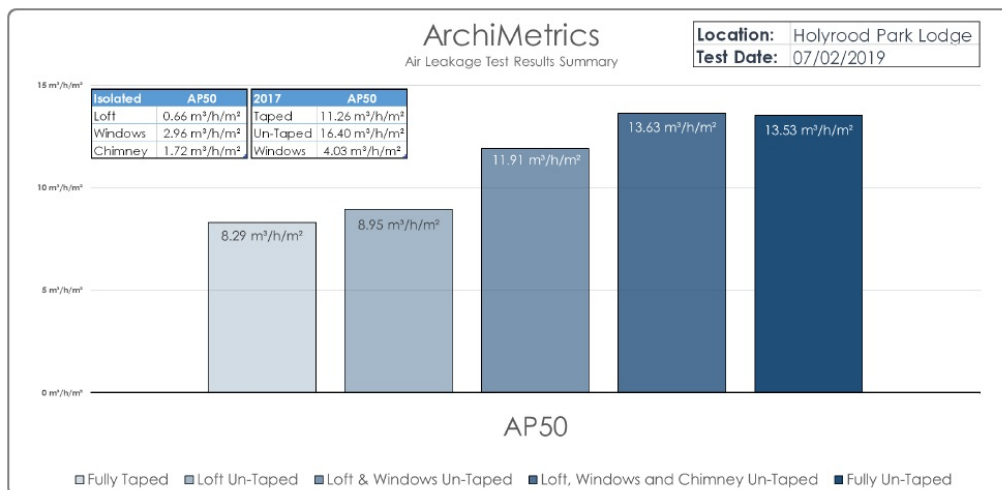
Air pressure tests were carried out on the refurbished building in February 2019, which included, but not limited to, the standard test methodology. The overall air leakage was an average of 11.25 m³/h/m²; an improvement of 26% from the pre-intervention figure of average 15.29 m³/h/m² measured in January 2017 (Figure 35). During the testing, it was clear that there was still air leaking from the windows and the assessors judged that further window draught proofing would give a still better figure. (By way of comparison, the Scottish Building Standards recommend a maximum air infiltration for new build and conversions of 10m³/h.m² @ 50 Pa.)

Figure 35. The air pressure test results from February 2019.

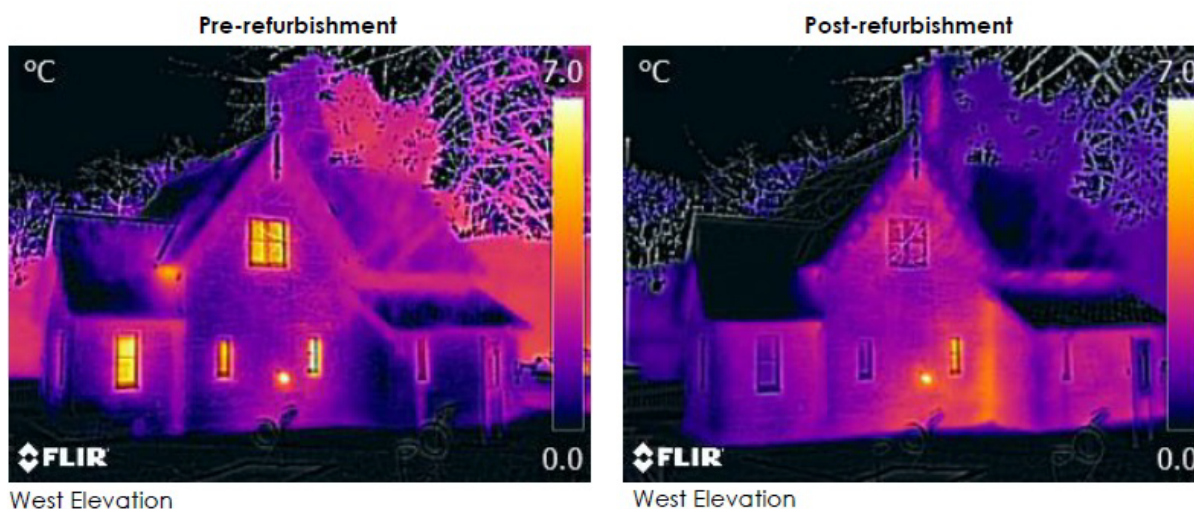
Figure 36. Thermograms of the Lodge pre- and post-refurbishment. There is a clear improvement in the glazing performance.
