GARDEN BOTHY, CUMNOCK

UPGRADES TO WALLS, FLOORS, WINDOWS & DOOR

Historic Scotland Refurbishment Case Study 8

MOSES JENKINS

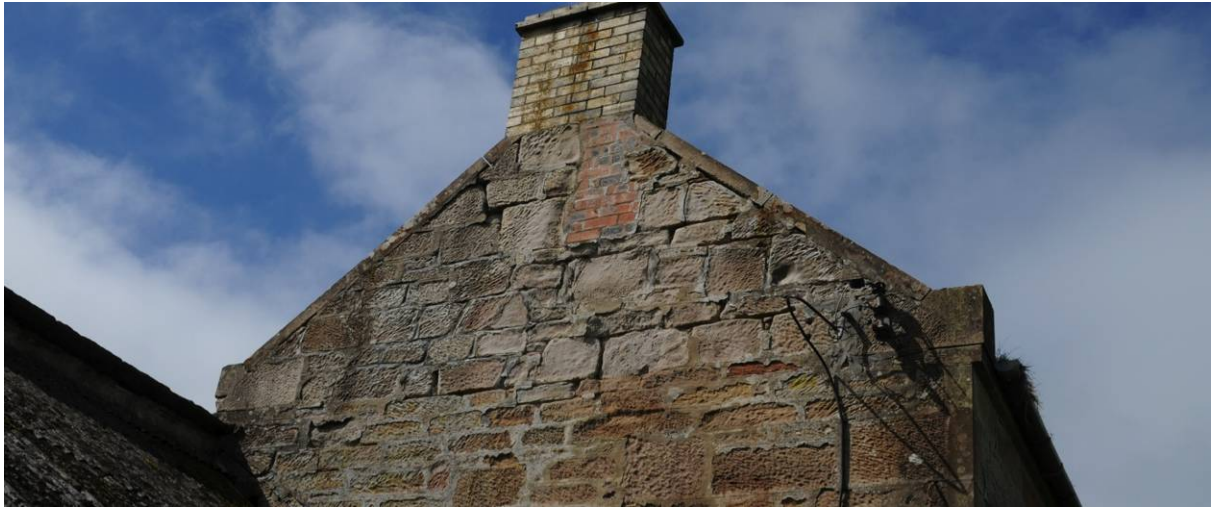
Fig. 2. The east gable end of the Garden Bothy, prior to enabling works

Masonry repairs were carried out to all external walls (Fig. 2). This involved repointing with lime mortar and, on the rear elevation, the insertion of reinforcement to cracked areas of brickwork. The repointing work was executed using an NHL 3.5 mortar and covered an area of approximately 14 square meters (Fig. 3). Additionally, an area of wall adjacent to the front door was required to be made sound using reinforcing ties and limited repointing.

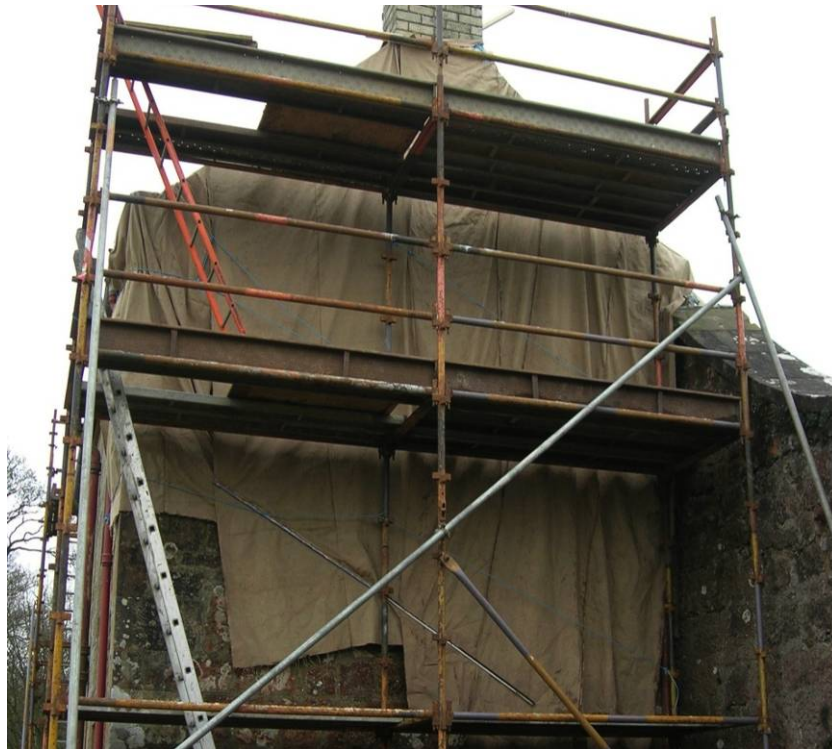
Fig. 3. Repointing masonry to prevent water ingress was a key part of the enabling works for the project which had to take place before any thermal improvement work could be undertaken

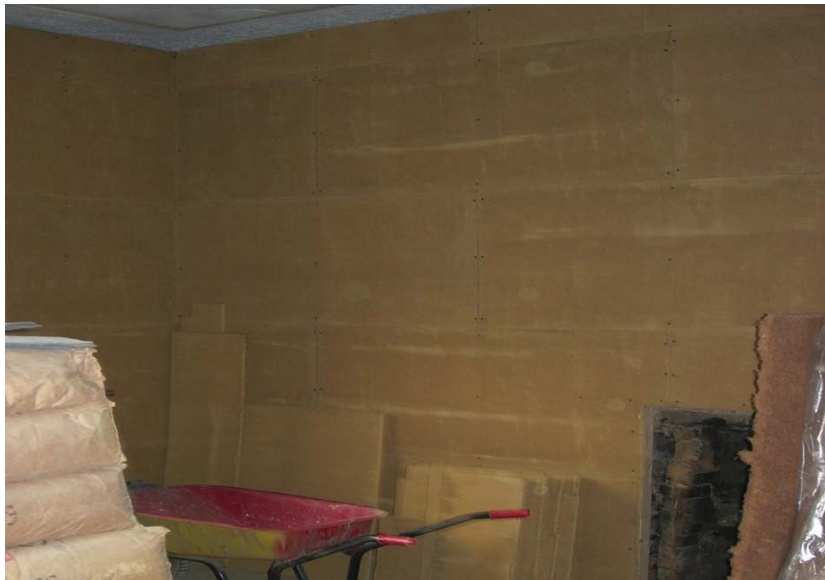
Fig. 4. Clay board in place over hemp board insulation ready to take clay plaster skim coat finish

In one ground floor room the original wall linings had been removed in previous refurbishments and replaced with plasterboard. This lining, along with all fixings, was removed and the walls were taken back to the stone masonry. The wall was then framed out and 50 mm of hemp board was applied between the timbers. Rather than applying plasterboard or a plaster skim coat over the hemp a more vapour permeable option was applied using clay board finished with a clay plaster. This was achieved by fixing 25 mm thick clay board to the timber and then applying two coats of clay plaster on top (Fig. 4). Finally, clay paint was used as a decorative finish. By using natural, vapour permeable materials for the insulation of the walls, humidity regulation would be improved humidity both internally and within the fabric of the walls, thus avoiding the risk of condensation and damaging moisture concentrations which may have resulted had impermeable materials been employed.

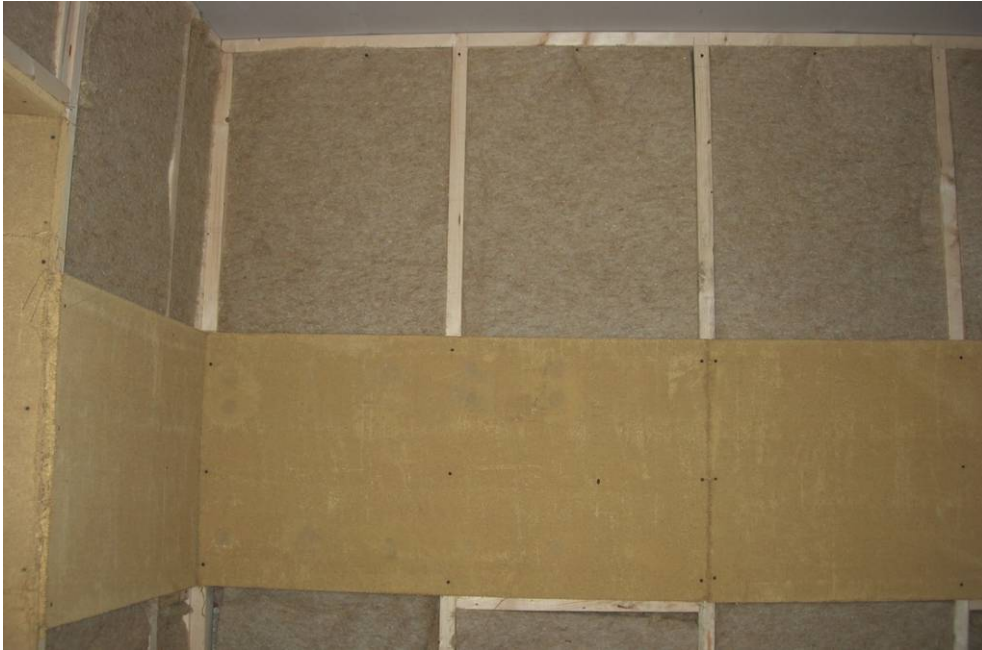
Fig. 5. Wood fibre insulation applied between timber straps with clay board being applied on top of this

As with other rooms on the ground room floor, the kitchen also had no original wall linings. For the upgrade the existing modern linings were stripped away and the walls framed out and filled using 80 mm wood fibre insulation (Fig. 5). The finishing process again included clay board, plaster and paint, as above (Fig. 6).

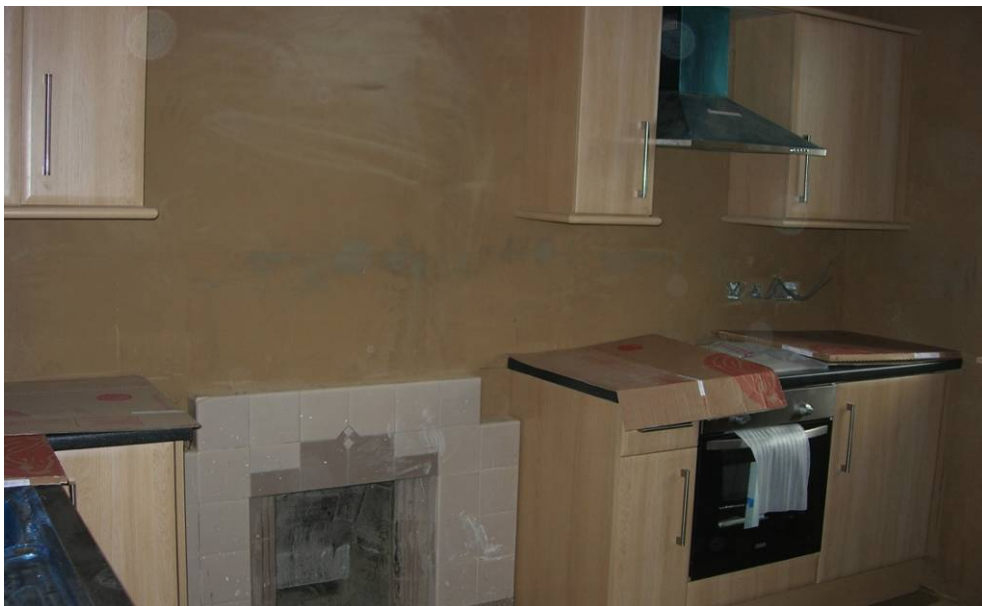
Fig. 6. The clay plastered walls with kitchen units in place

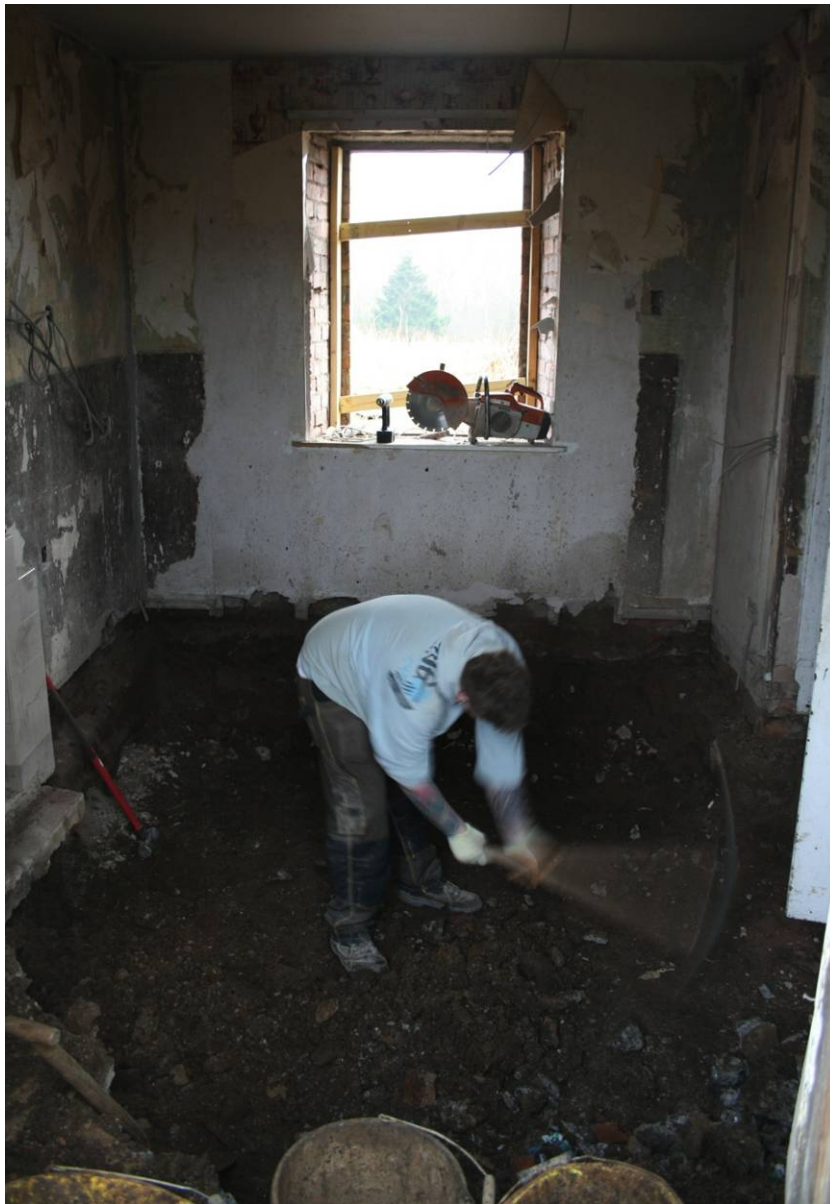
Fig. 7. Excavating the floor in preparation for the insulation layer being put down

In one ground floor room and the hall area the original floor had been removed and replaced by four inch thick un-insulated concrete. It is likely that the floor would have a poor thermal performance and it was therefore decided that this should be removed and replaced with insulated lime concrete.

The first stage was to excavate the concrete slab and subsoil (Fig. 7). This was a large job with around 16-18 tonnes of material excavated. A batter was maintained where the excavation reached the walls to ensure these were not undermined. As the concrete floor was being excavated it became apparent that its foundations were more

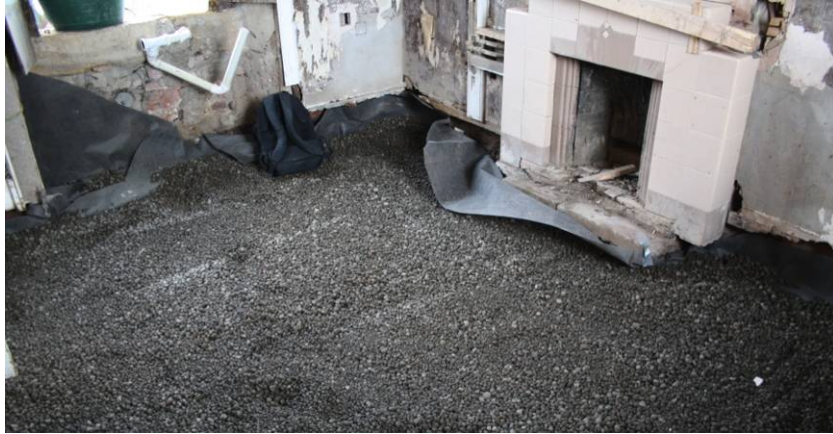
Fig. 8. The loose LECA laid down over a layer of geotextile

The next stage was to lay a substantial layer (c.500 mm depth) of loose LECA, with an aggregate size of around 10-20 mm (Fig. 8). A second layer of geotextile was placed on top of this. On top of the loose LECA, a 100 mm layer of lime concrete formed of LECA, aggregate size 0-20 mm, bound with NHL5 lime was laid (Figs. 9, 10 & 11). Finally, sandstone flags from a quarry in the North of England (Fig. 12) were laid as a finished surface on a lime mortar bed, and given three coats of wax to protect the surface from spillages.

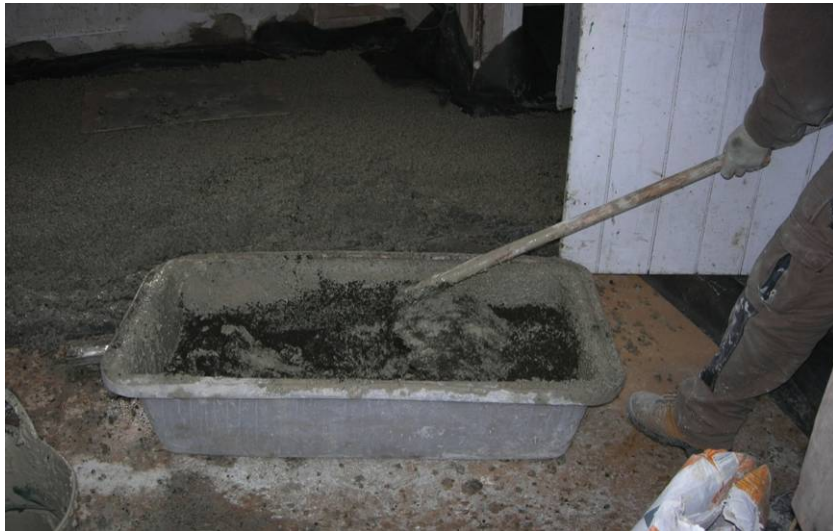
Fig. 9. The lime concrete being mixed using a traditional larry

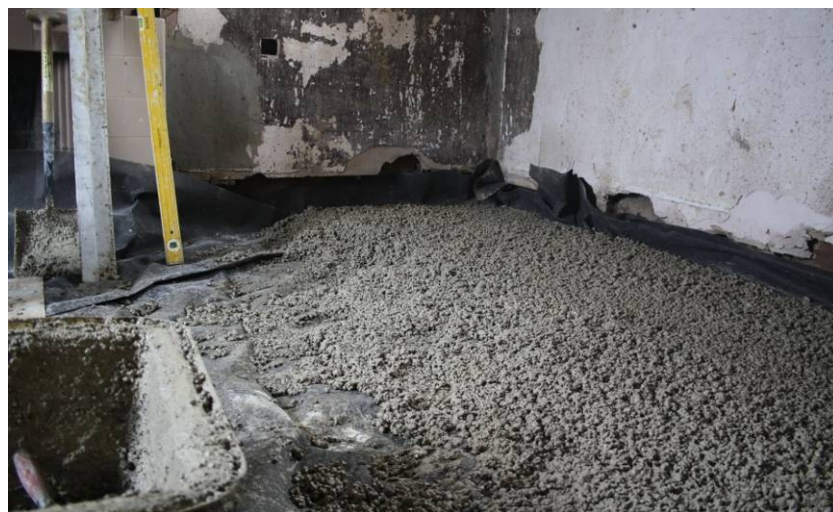
Fig. 10. The lime concrete screed being laid

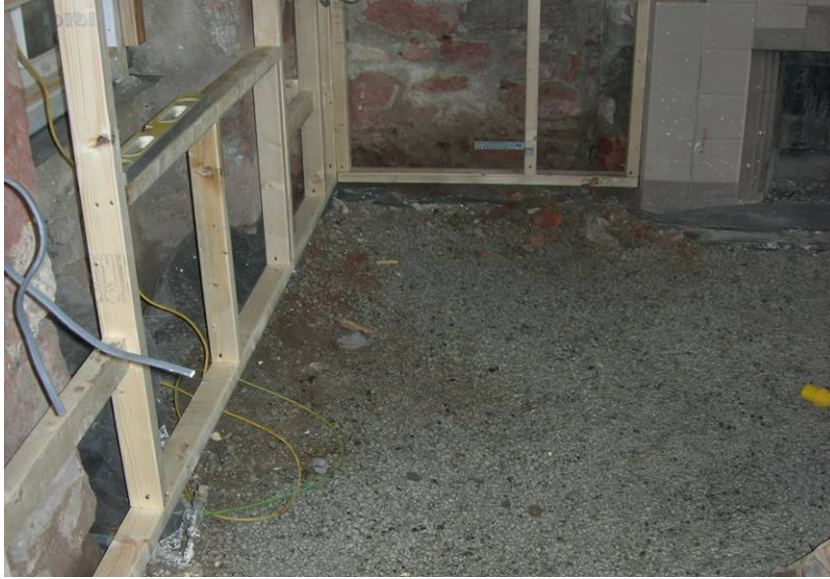
Fig. 11. The lime concrete layer in situ

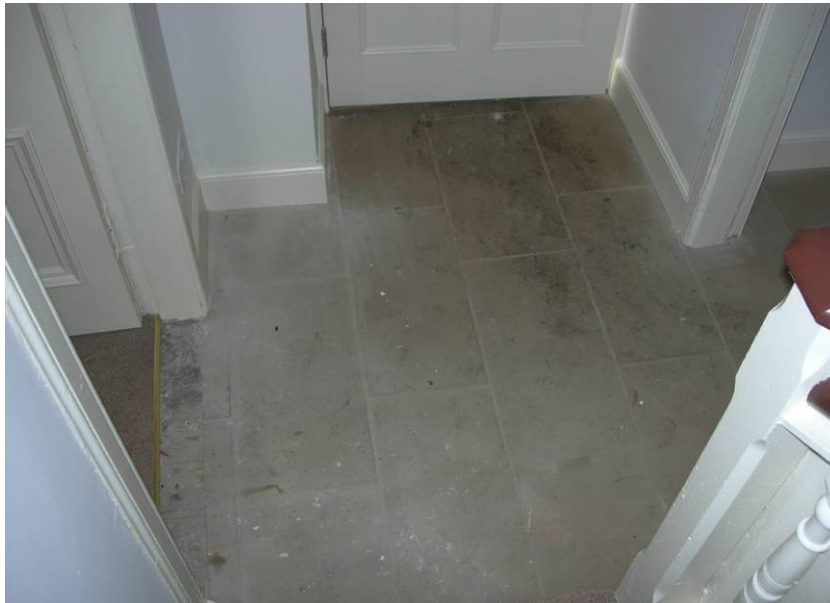
Fig. 12. British sandstone flagstones laid as a finish to the lime concrete floor

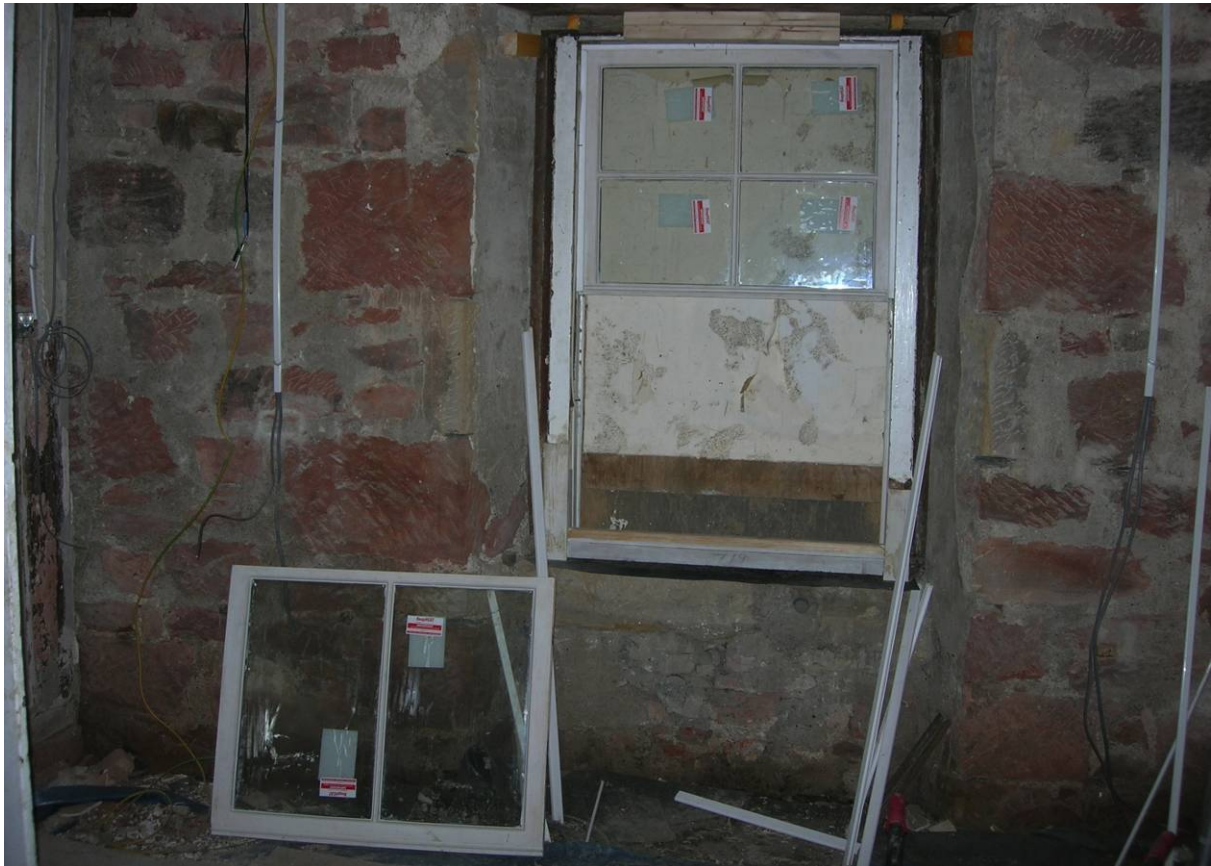
It was decided to upgrade the windows to double glazing. At the outset of the project the windows were in varying states of disrepair. In accordance with the aim of retaining as much original fabric as possible it was therefore decided to repair and upgrade those windows which could be saved, and to have new windows manufactured to the original profile where this was not possible (Fig. 13).

Fig. 13. Original sashes with new double glazed units being installed in repaired cases

Where windows were repaired this involved new timber being used to replace any sections which were rotten. The original glazing was removed, the checks altered and bevelled glazing beads fitted to take the new double glazed units which were 12.5 mm in thickness. These units were manufactured locally in Glasgow. All batten rods and parting beads were required to be renewed. The assembled windows were then painted and re-hung with new sash cords and weights to allow them to be fully operable and therefore contribute to the passive ventilation of the house when required. During these works all windows were draught stripped.

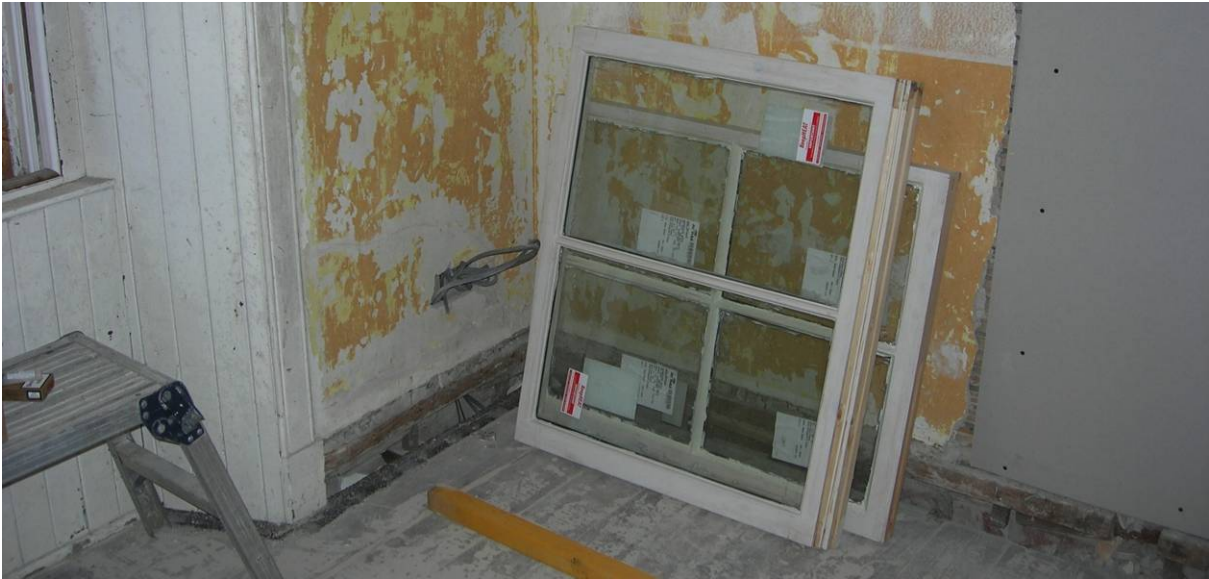
Fig. 14. New double glazed sash windows awaiting hanging

In some instances poor maintenance had led to such excessive decay that repair was impractical and new timber windows were manufactured by the joiner who performed the upgrade work (Fig. 14). Replacement was required for two complete window sets in the rear elevation, and one top sash, four bottom sashes and to a case sill in the front elevation. The same new double glazed units were used throughout and all windows brought back to full working order. The pane size and layout of the replacement windows was matched to the originals to ensure visual integrity.

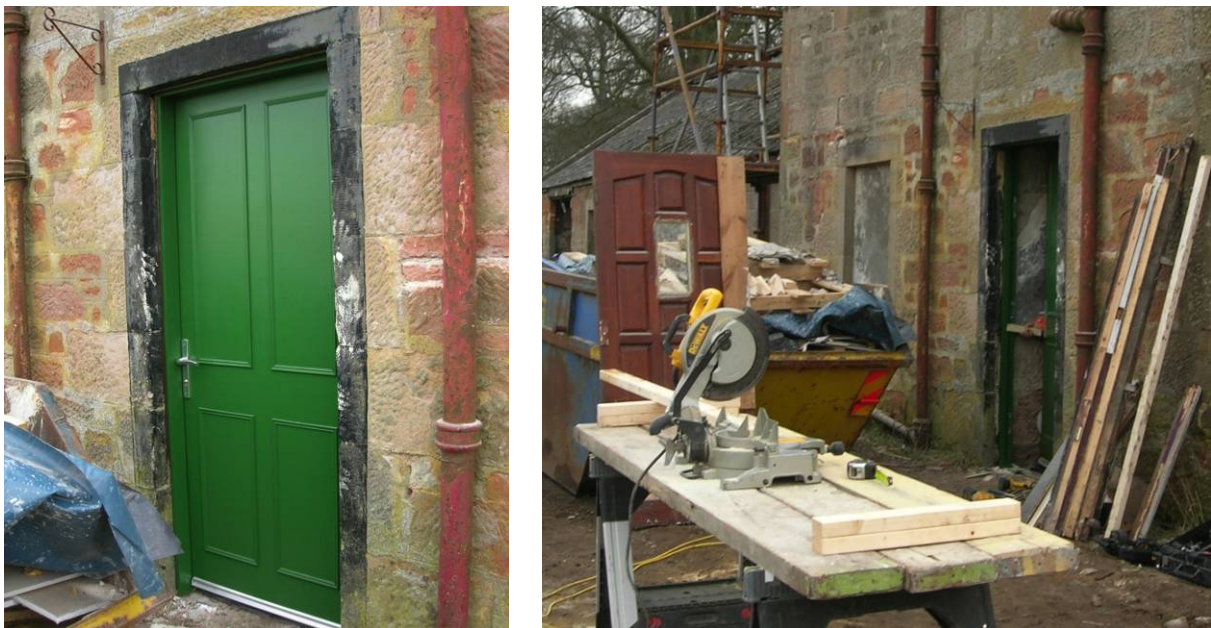
Fig. 15. The new insulated replacement front door, the only external door to the bothy

The only external door in the property was a modern replacement which was visually inappropriate and poorly insulated. It was decided to replace this with a highly insulated alternative with an appearance more compatible with the building (Fig. 15). The new door was manufactured to incorporate an aerogel insulation blanket, providing a U-value of $0.62 \text{ W/m}^2\text{K}$ for the door blade. The internal doors were all sound and no works were required to these.

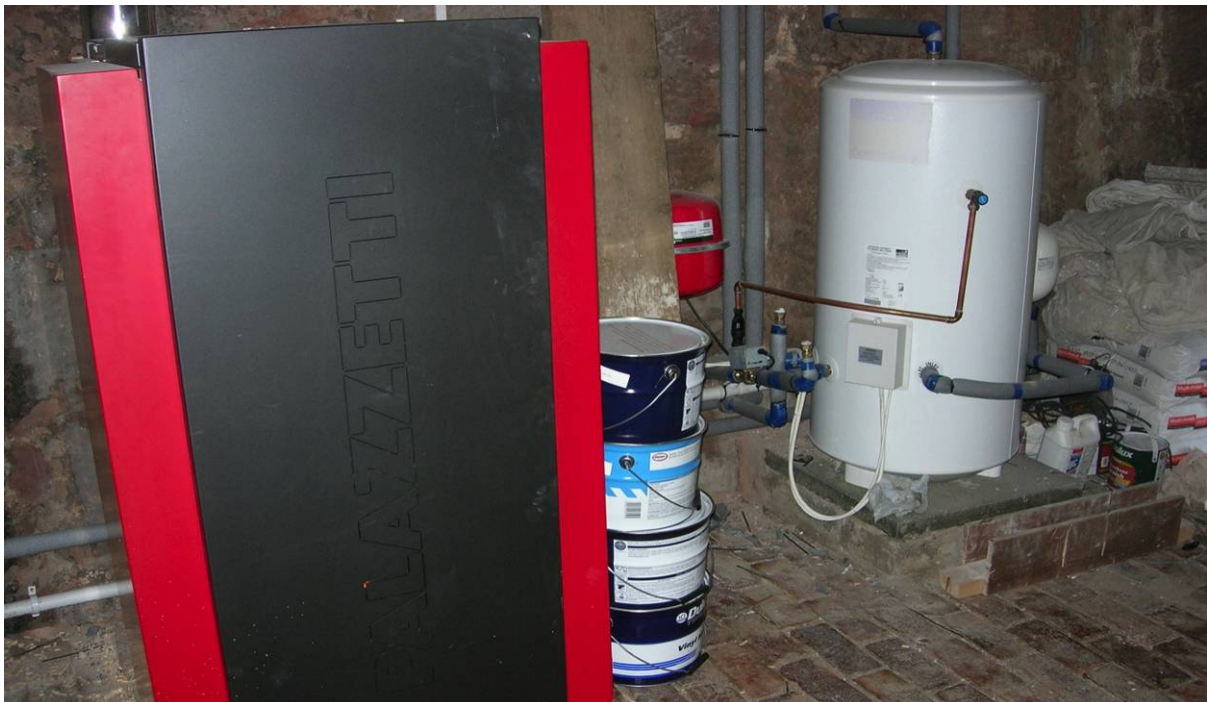
Fig. 16. The pellet fuelled biomass boiler and hot water tank

It was decided to install a micro renewable heating system in the form of a pellet-fuelled biomass boiler. This decision was influenced by a number of factors, including the use of biomass on the surrounding estate and the presence of outbuildings to house the boiler system and provide dry storage for the fuel pellets.

The boiler heats four radiators, one in each of the main rooms of the house, and also provides hot water. There is sufficient heat load capacity to heat the outbuildings in future.

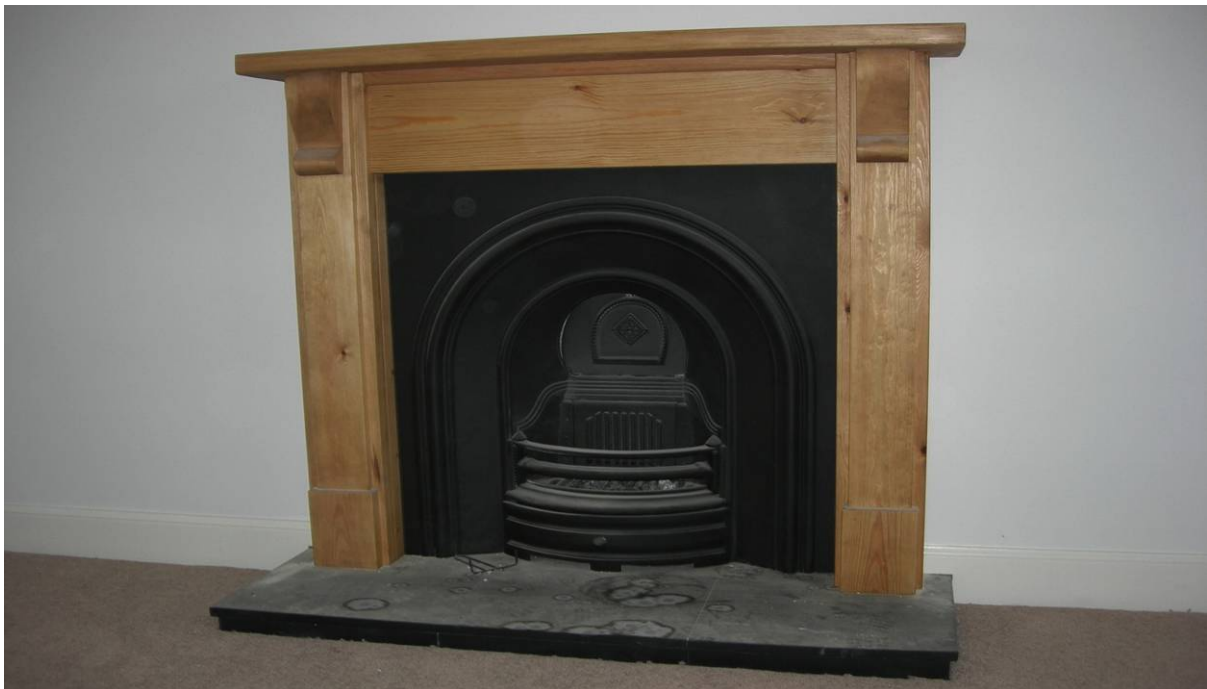
Fig. 17. The hearth and flue in the sitting room, finished with a plain wooden surround

The existing hearth and flue in the main ground floor room were retained and a refurbished late 19th century grate was installed, finished with a plain wooden surround. The grate featured a closable baffle to allow the control of natural ventilation via the flue (Fig. 17). As part of the window refurbishment only basic draught stripping was carried out, in order to ensure an appropriate level of ventilation (to approximate that supplied by trickle vents), necessary in a domestic context.

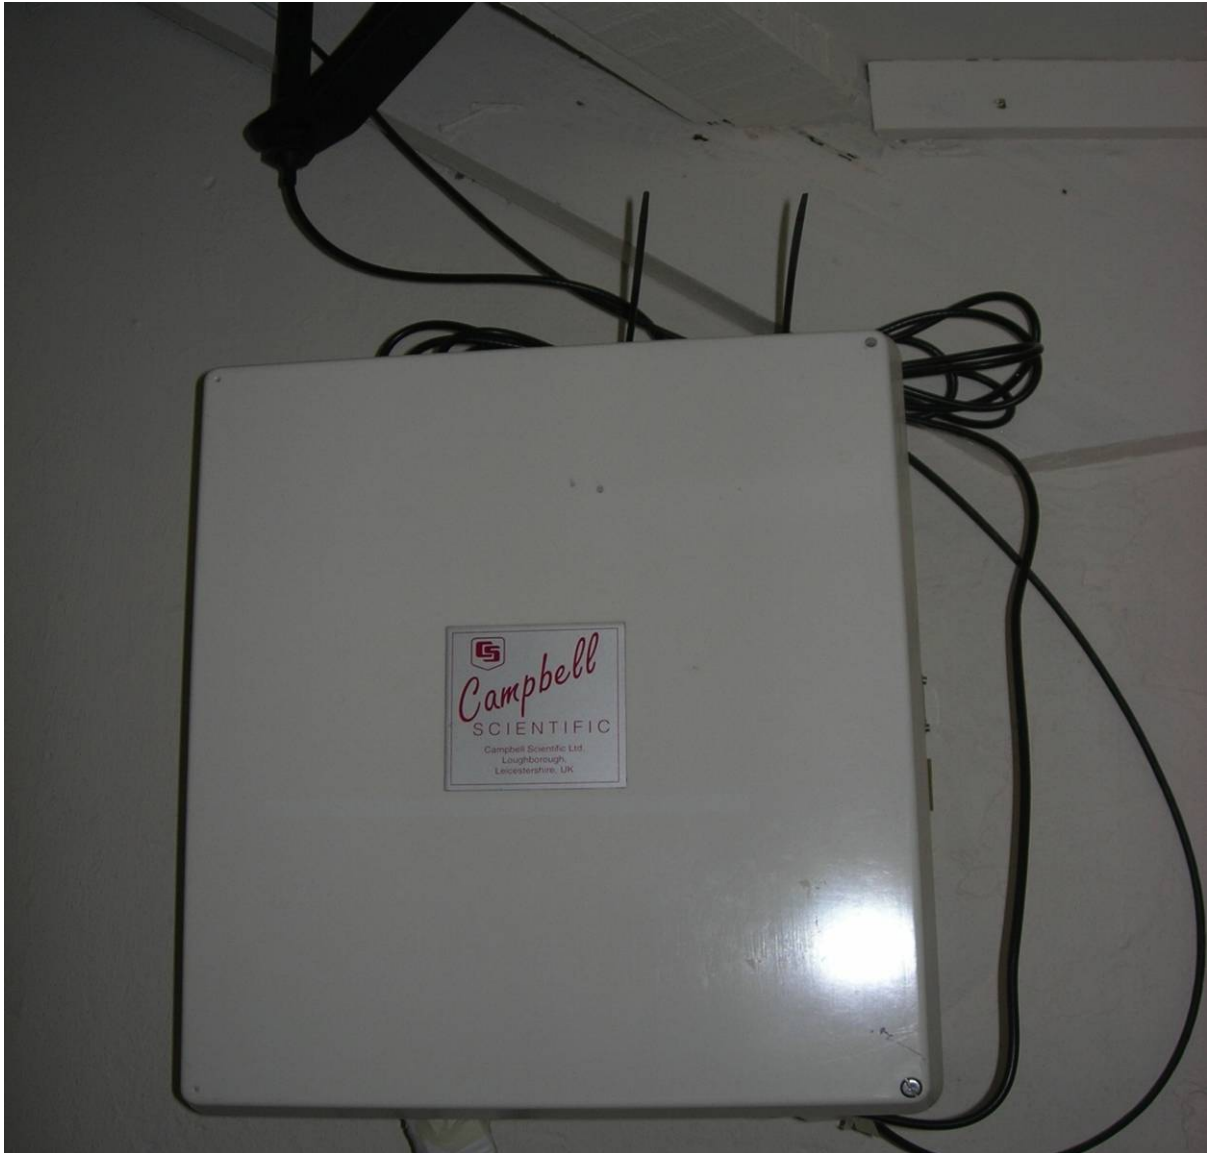
Fig. 18. Remote logging equipment for long term monitoring of hygrothermal performance
