SCOTSTARVIT TOWER COTTAGE, CUPAR

THERMAL UPGRADES & INSTALLATION OF RADIANT HEATING

This publication should be quoted as:
Historic Scotland Refurbishment Case Study 7

JESSICA SNOW

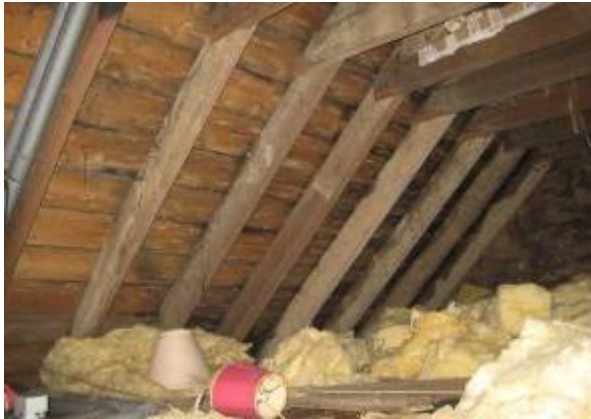
Fig. 4. Attic filled with variable depths of mineral wool and other discarded items, prior to the improvement works

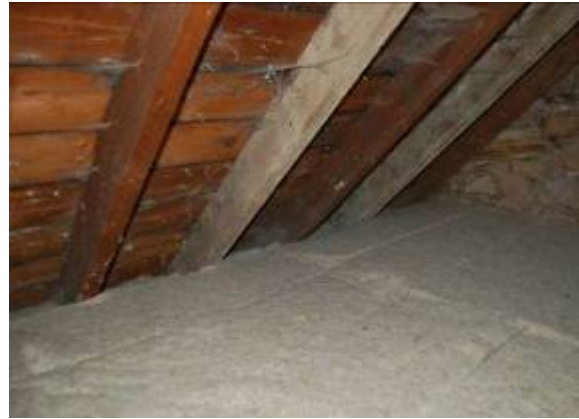
Fig. 5. Attic insulated with 270 mm flexible hemp batts

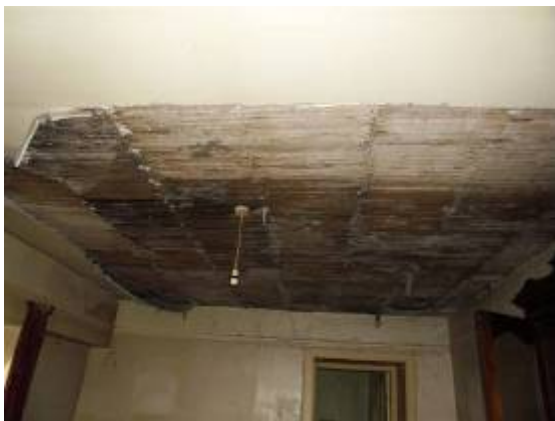
Fig. 6. Lath and plaster ceiling damaged by water leak

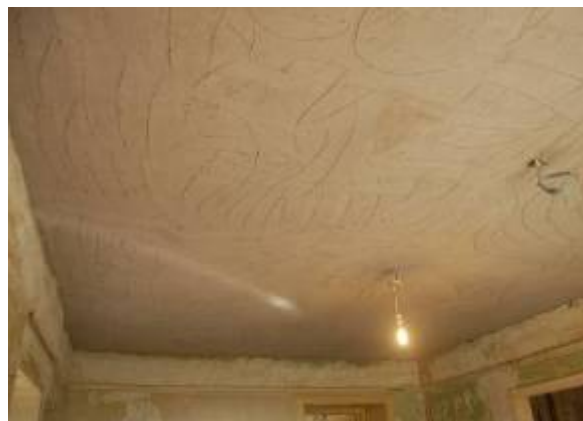
Fig. 7. The ceiling was repaired using haired lime plaster on lath

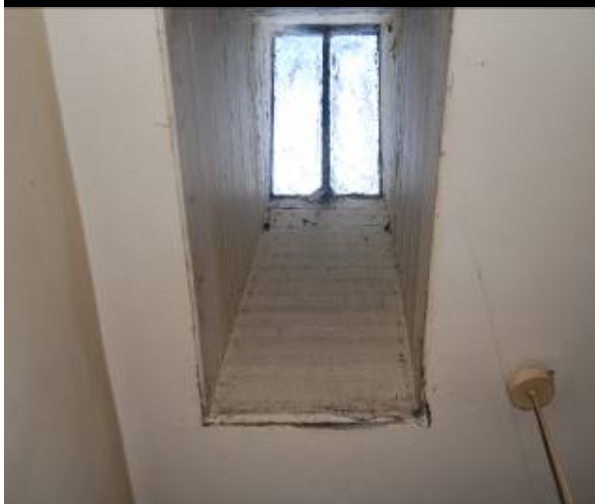
Fig. 8. The original iron rooflight was retained, but the glazing was replaced

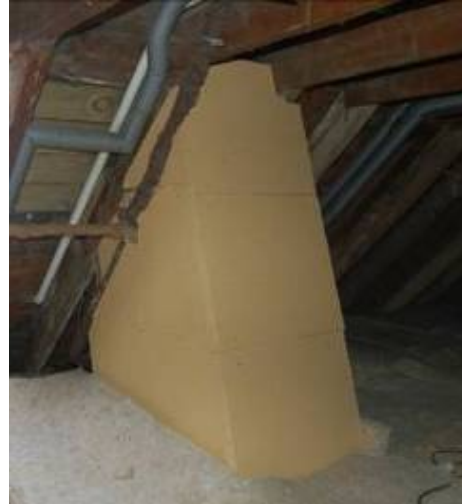
Fig. 9. The lightwell was insulated with wood fibreboard

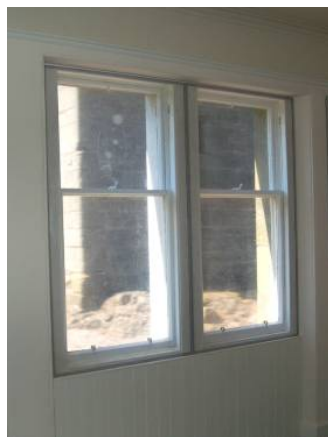
Fig. 10. The windows were fitted with polycarbonate secondary glazing

The advantages of this type of secondary glazing are that it is relatively cheap, at around £100 a square metre; it is easy to install and it is seasonal, so it can be removed during the summer months when not required. It also requires minimal fixings or damage to the fabric. Its disadvantages are that when it is not in use it requires storage space; it can be unwieldy to lift off or replace and it can become scratched and soiled over time. In addition, there were a number of incidents where the glazing was unexpectedly 'blown' off by air pressure changes, which was potentially hazardous. To resolve this issue, additional fixings had to be made to secure the glazing to the window frame.

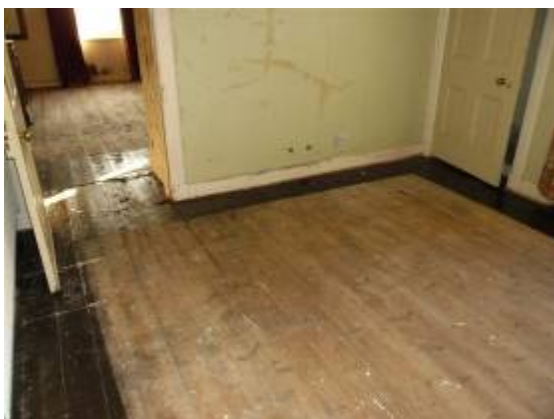
Fig. 11. Suspended timber floor showing 19th century staining at edges

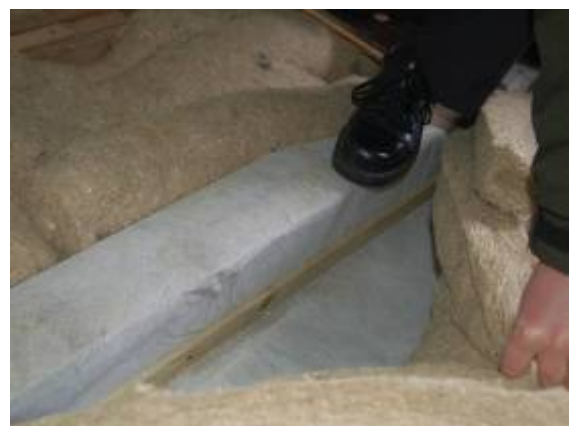
Fig. 12. The hemp batts were supported with a breather membrane

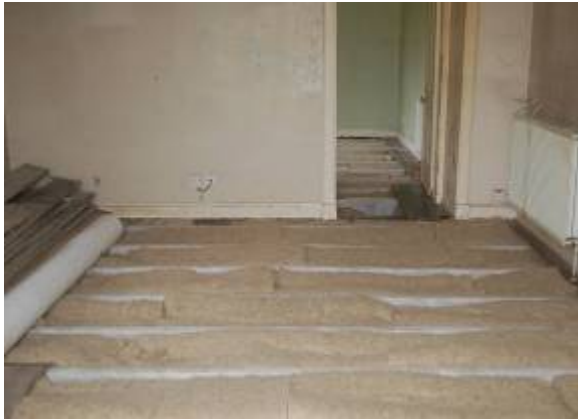
Fig. 13. Hemp insulation prior to re-laying floorboards

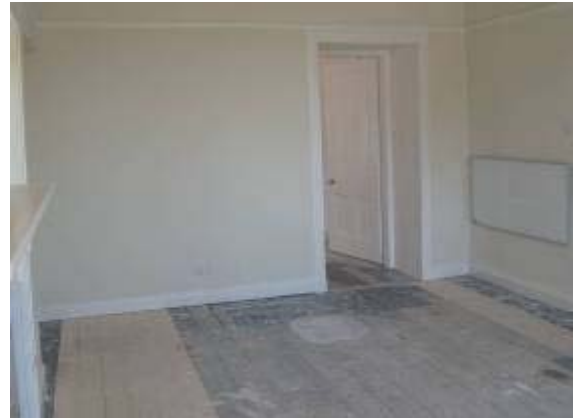
Fig. 14. Floor re-laid following insulation, showing areas of repair

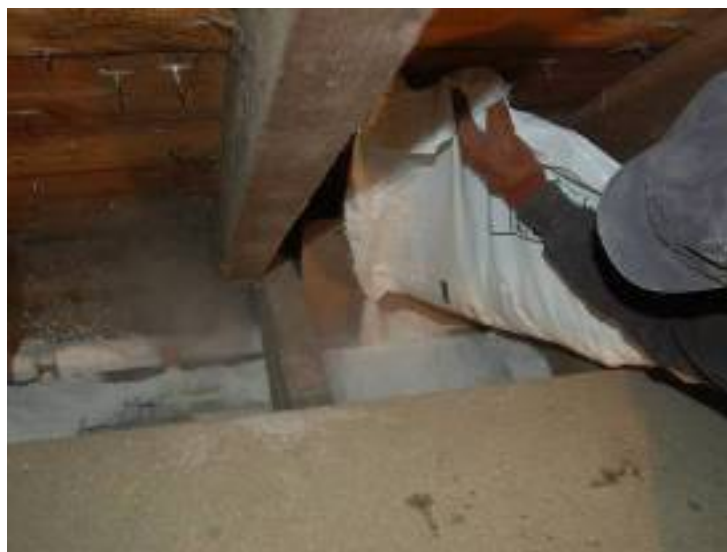
Fig. 15. Perlite insulation poured into wall voids from the attic space

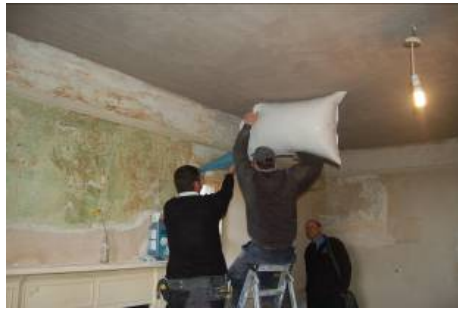
Fig. 16. Insulation being poured into the window reveals

Whilst the benefit of the perlite was its free-flow characteristic, this also proved to be a problem as it was subsequently discovered that the insulation material had run into the window sash boxes and filled up the casings, causing an obstruction to the window opening. This meant that where the insulation had been installed, the window linings had to be removed in order to access and clear the sash boxes. The space around them was then blocked up using hemp-fibre to prevent the same thing happening again. Some of the window reveals were lath and plaster and some were plasterboard, but all were replaced with lath and haired lime plaster.

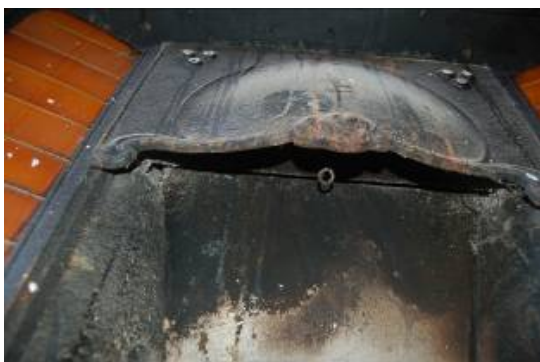
During the pre-intervention air-tightness testing it was found the chimney was accounting for approximately 7% of the air leakage from the property (Fig. 17), and, probably more importantly, was missing its pot and allowing water ingress into the chimney (Fig. 18). A Chinese lantern chimney pot was installed, allowing sufficient ventilation but preventing excessive draughts and air leakage.

Fig. 17. The adjustable baffle allowing chimney ventilation to be controlled

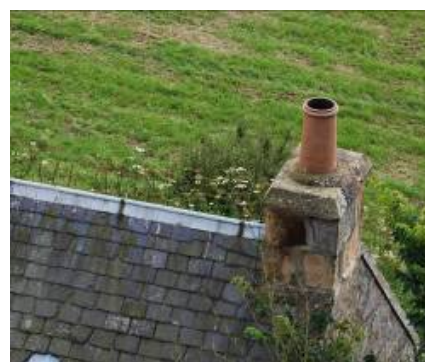
Fig. 18. The open chimney pot before refurbishment works

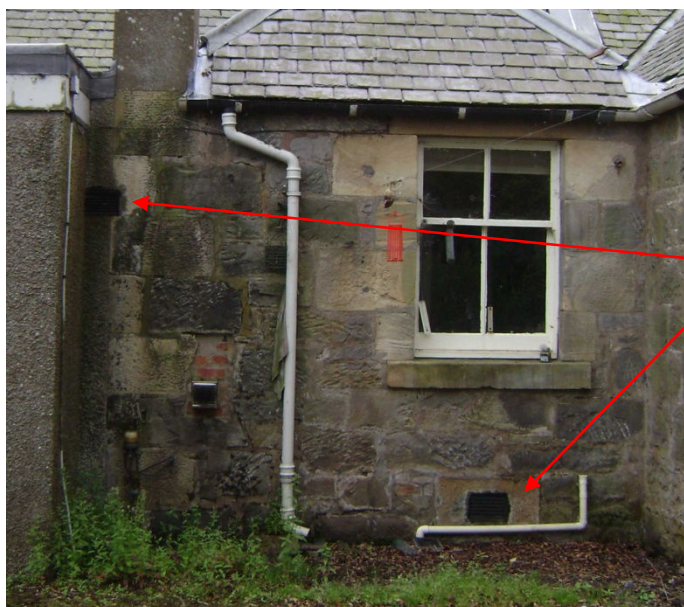
There are two vents in the external wall of the kitchen (shown in photograph) - one to the LHS of the chimney and the other vent under the window. There was no obvious evidence of any vents inside the kitchen, but a large amount of the wall area is currently obscured by kitchen units.

One vent was assumed to be related to the old flue and the other to ventilate the cavity behind the lining. Both of these were taped up from the outside as a precautionary measure as most of this wall had kitchen units fitted. On completion of the test, the tape had been displaced on both, indicating air flow through this route during the test (the tape on the boiler exhaust remained undisturbed).

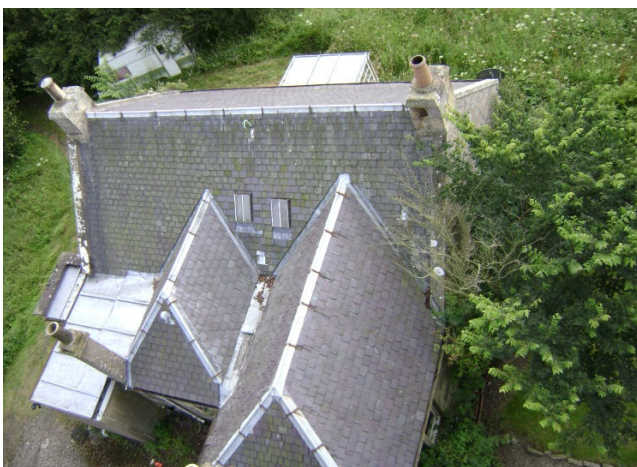
Under the standard test procedure, chimneys and flues in the dwelling are excluded from the results. During the pre-refurbishment test, when the fireplace in the living room was uncovered an increase in air flow of $343 \text{ m}^3\text{h}^{-1}$ @ 50Pa was noted with the damper in place. However, during the post-refurbishment test, an additional air flow of only $112 \text{ m}^3\text{h}^{-1}$ @ 50Pa was recorded when the damper was in place and $134 \text{ m}^3\text{h}^{-1}$ @ 50Pa with the fireplace fully open. Subsequent investigation identified the flue has been capped (shown in photographs).

Photograph taken at time of 2011 pre-refurbishment air permeability testing showing open chimney pot to living room

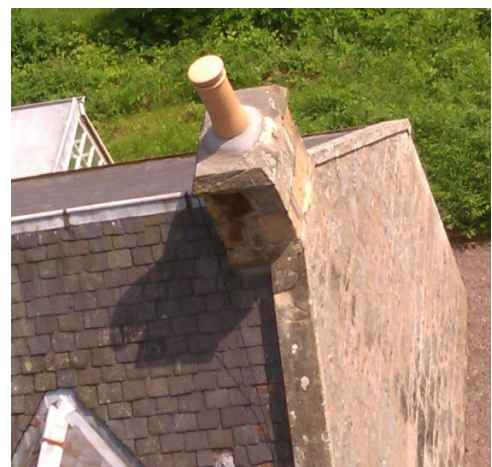
Photograph taken 26 June 2012, showing capping to flue from living room
