WELLS O' WEARIE, EDINBURGH

THERMAL UPGRADES TO WALLS, ROOF, FLOORS & GLAZING

Historic Scotland Refurbishment Case Study 2

ROGER CURTIS

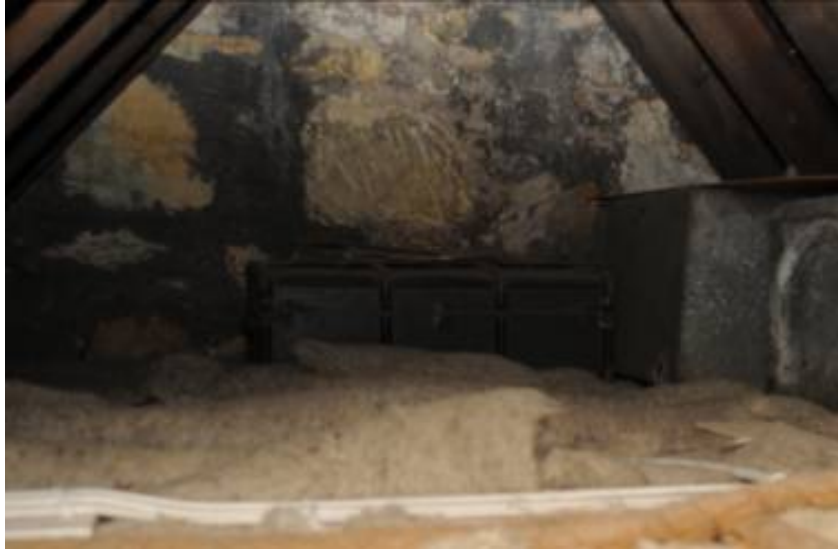
Fig. 5. The sheep's wool insulation laid in the attic space

The ceiling consisted of lath and plaster with a later polystyrene coving. There was a modest amount of mineral wool in the loft space, which had been fitted some time ago and had slumped in areas. It was decided to replace the mineral wool with a sheep's wool product to a depth of 280 mm (Fig. 5), the standard depth for loft work. As there was no storage requirement, additional height was not necessary for the ceiling joists (Fig. 5), although this could be implemented if required. When insulating such roof spaces, and in effect turning a warm attic space into a cold one, additional roof ventilation is sometimes required. However, in this case, the slates are fixed directly onto the sarking, with no roofing or under-slate felt, and the ventilation to the roof space was considered sufficient. This is in contrast to more modern roofs, where if there is a non-breathable layer in place (such as under-slate bitumous felt) then slate vents might be required.

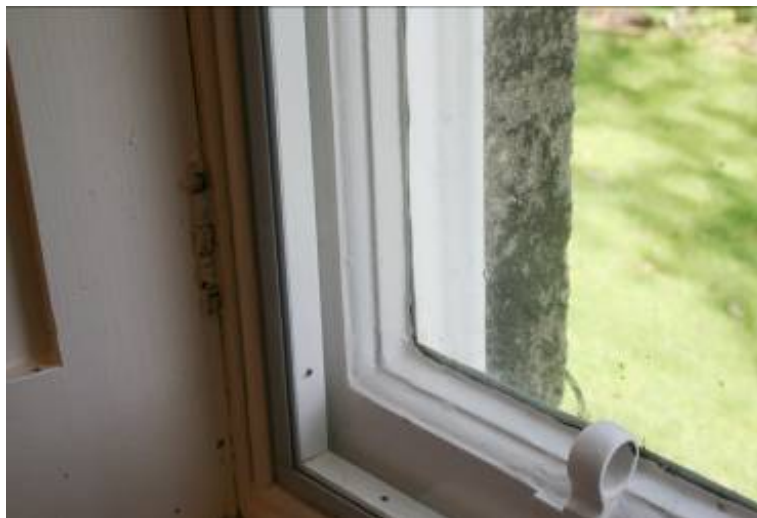
Fig. 6. Polycarbonate secondary glazing in place; note the shutter is free to close

The existing windows were of traditional sash and case pattern, in good condition with working shutters. As the sashes were '6 over 6' (six panes in each sash), the cost of inserting double glazed units into the existing sashes would have been considerable for such a small glazed area. Conventional secondary glazing would likewise have been expensive, so an alternative polycarbonate system was used – this is essentially a single sheet cut to size and applied with magnetic strips onto timber bearers within the staff beads (Fig. 6). This glazing arrangement allowed the shutters to continue to function, addressed thermal heat losses and air leakage and, while not to the standards of more mainstream options, it nevertheless made a significant difference.

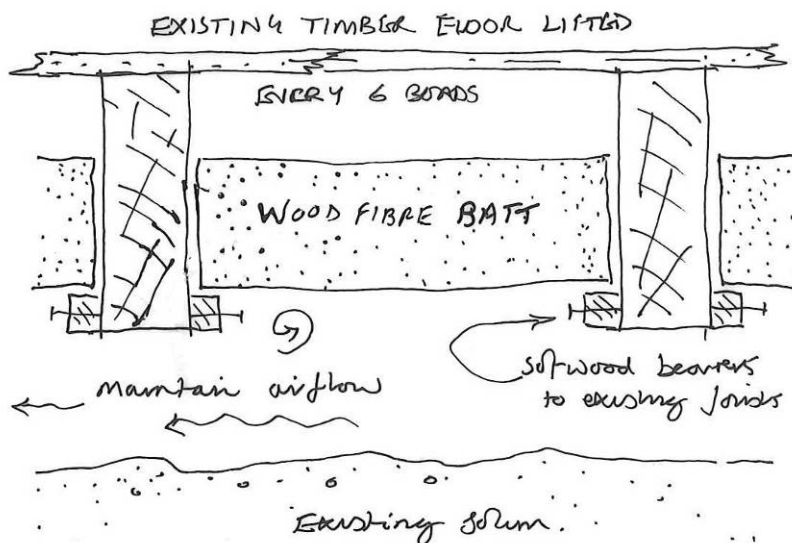
Fig. 7. Indicative detail for the floor insulation

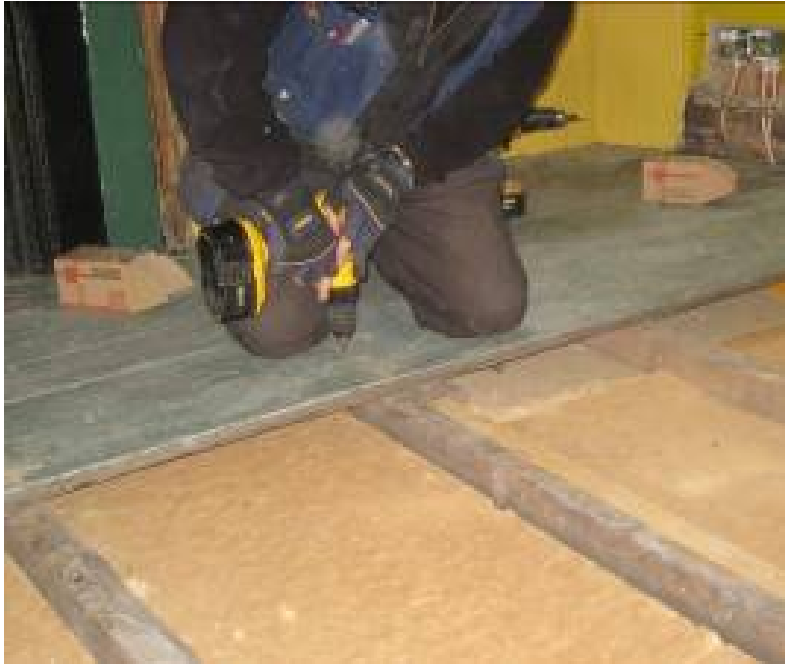
Fig. 8. Floor being fixed down over wood fibre bats

It was found that in many areas only selected floorboards needed to be lifted (every sixth board) to gain access for the work, depending on the reach and skill of the joiner. In order to minimise damage to the boards when lifting, the feathers of the boards were cut with a 'skill saw' to allow easy prising up. Once the condition of the joists was confirmed as being sound, timber rails were fastened to the lower edge of each joist using ring shank nails (Fig. 7). By minimising the number of boards lifted, disruption was kept to a minimum although the skirting boards were removed. Proprietary wood fibreboard, 80 mm thick, was cut into bats to fit between the joists. This was initially done by hand, but cutting such composite materials with a handsaw proved difficult and led to a lot of dust; it was quickly decided to cut the material in the workshop with a bandsaw, which proved to be a much better solution. The bats were then eased into the space between the joists and held in place by the fixed rail. The floorboards were then replaced (Fig. 8).

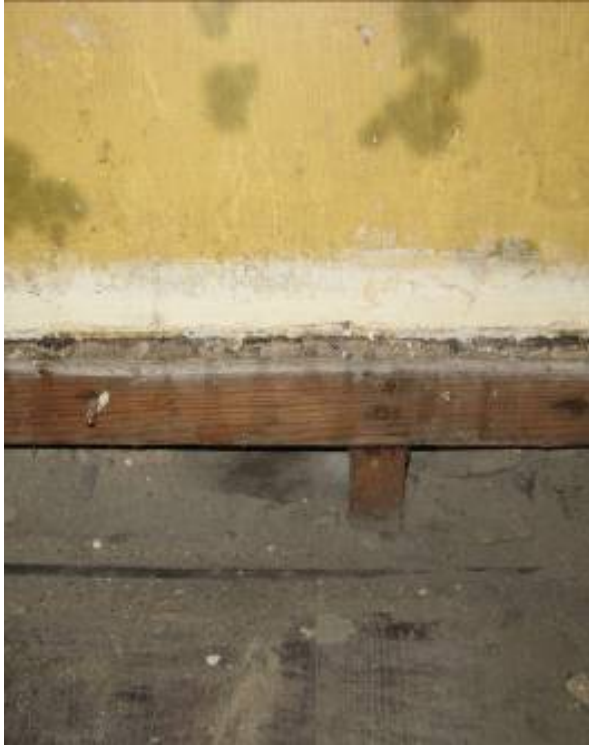
Fig. 9. Skirting boards removed to check wall and floor junction

Prior to the works, all decorative coverings were removed and defective plaster made good. This was required not just for the subsequent decoration works, but to ensure that the surface of the plaster was able to handle moisture for reasons described above. The skirting boards had already been removed as part of the floor works, and this allowed us to check that the floorboards were tight against the masonry (Fig. 9), preventing any loss of material down into the solum space.

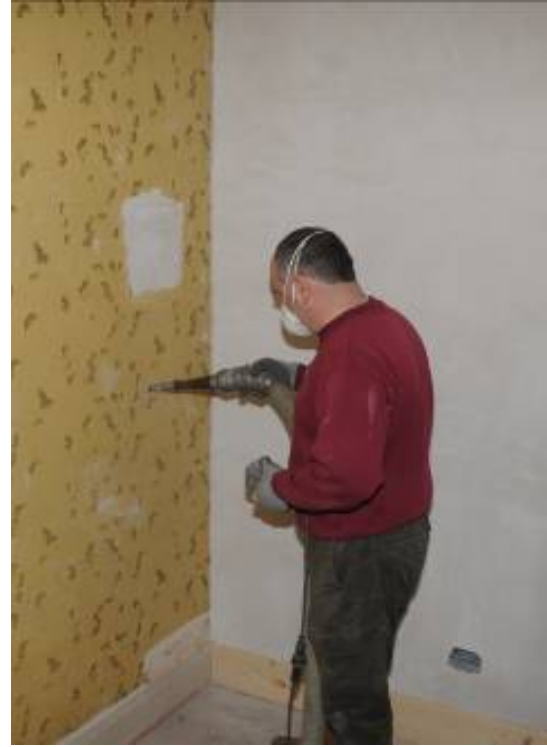
Fig. 10. Blowing in the cellulose fibre

A series of holes, approximately 25 mm in diameter, were drilled at 1 m centres across the face of the wall. A long hose was used to deliver the product, tailing back to a vehicle containing the blowing equipment. While parking was not an issue in this case, in some urban locations this could be a significant limitation on site works. The material was then blown into the void, working upwards from the lowest holes (Fig. 10). By the change in the audio tone around the nozzle, the operatives were able to detect when the cellulose had reached the level of the hole, and move on to the next opening. The wall was completed in approximately 30 minutes.

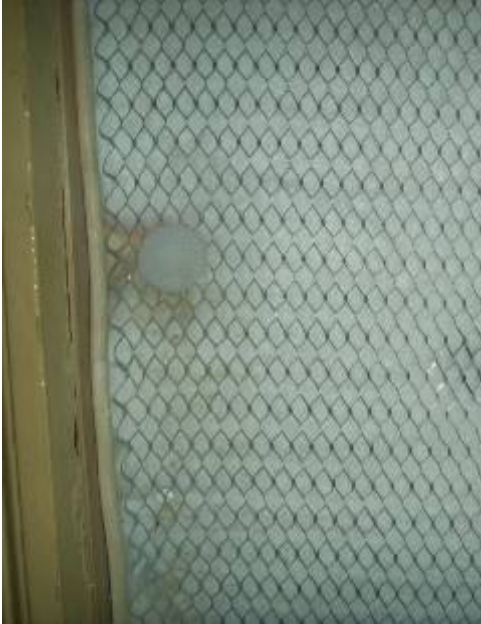
Fig. 11. Aerogel blanket held behind mesh

Where there are concerns with wind driven water penetration into mass walls (and it has to be accepted that this does happen in some situations) then the infilling of the void behind the linings should not be attempted, as the ventilated void plays an important role in water dispersal. Instead, an insulation material can be applied to the surface of the existing linings. In this trial a 10 mm layer of aerogel blanket was used, secured to the wall behind an expanded mesh sheet and fastened with thermally decoupled fixings (Fig. 11). To allow proper coverage of the wall, the skirting boards and facings were removed and two coats of renovating plaster were then applied to finish (Fig. 12).

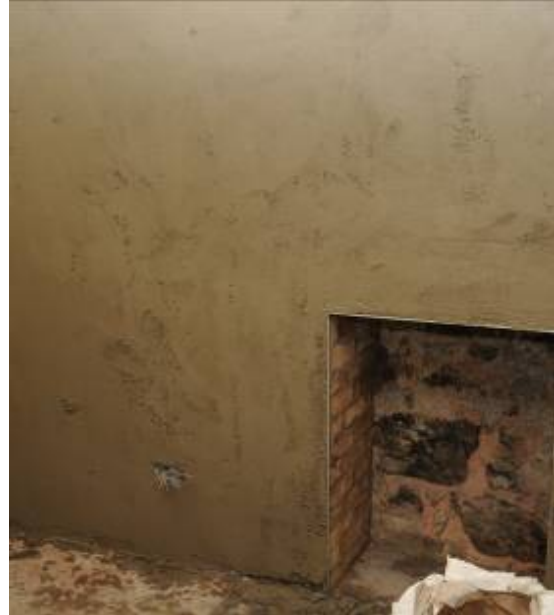
Fig. 12. First coat of plaster on top of the mesh/insulation layer

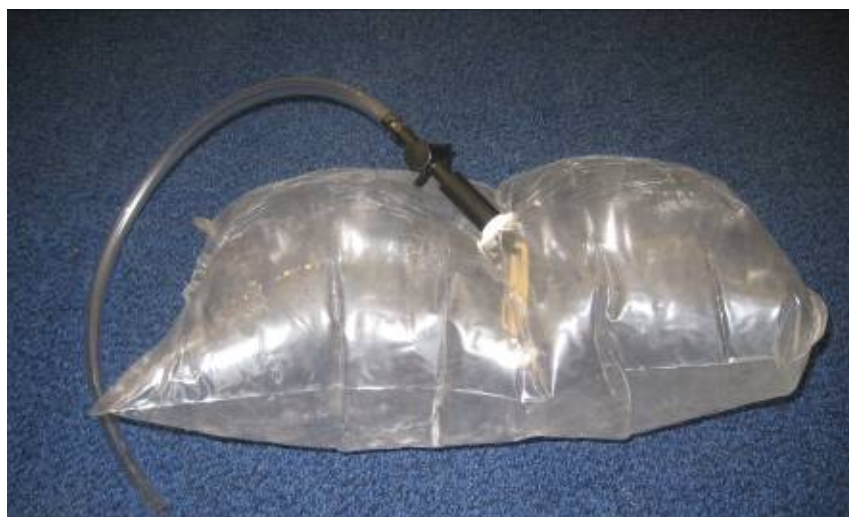
Fig. 13. Chimney balloon used to temporarily close off the flue

The room had one chimney with a wood burning boiler / stove of obsolete design in the hearth. In many energy efficiency upgrade works, flues are closed off and stacks are dismantled. This is effective in reducing air leakage and advection heat loss but also removes an important means of ventilation. In addition, the chimneystacks are often a defining feature of traditional structures and its retention was considered important. In this case, as other areas of air infiltration had been addressed (from the floor and window), it was felt important not only to keep the stack, but also to keep the flue open, allowing passive ventilation of the room. As an alternative to permanent closure, a chimney balloon (Fig. 13) was fitted into the flue just above the grate to restrict air movement in winter and during times of high winds. The balloon can be removed when ventilation is required, such as during the summer and other warm months. Given recent changes in Scotland's weather, resulting in a shorter winter heating season and higher temperatures overall, the risks of overheating in well-insulated buildings are becoming also increasingly relevant. It is thus likely that traditional passive ventilation features such as chimneys may become increasingly important in keeping occupants cool in buildings of all types.
