Wauchope Mausoleum, Edinburgh

Interim Roofing Repairs

Historic Scotland Refurbishment Case Study 14

Interim roofing repairs

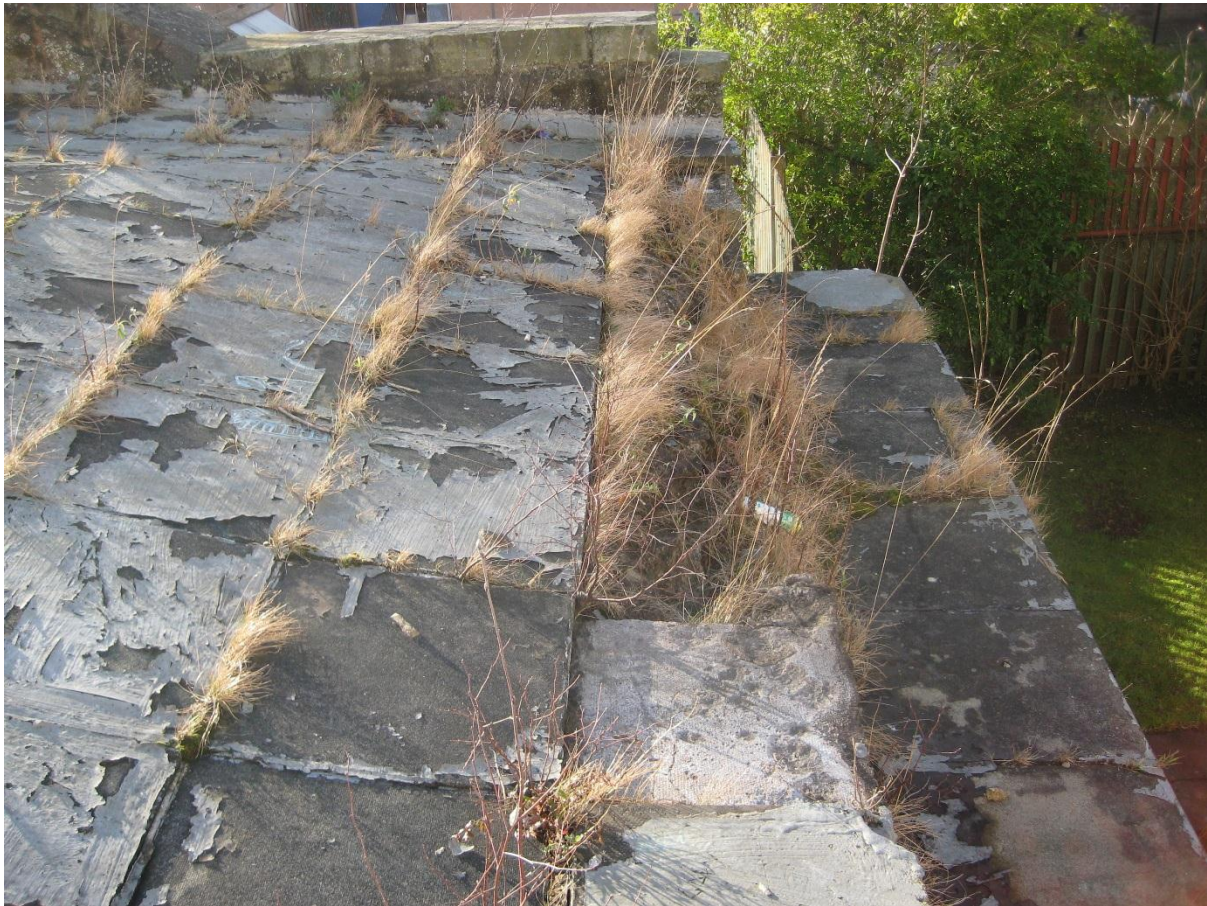
Following the redevelopment of the site in the 1950s it appears that the mausoleum has gone through several cycles of repair, the most recent being its adaptation as an emergency generator house for the adjacent housing estate. This function resulted in the formation of a roof over the vault consisting of concrete paving slabs and sealed with a 'painted on' single ply roofing membrane. While this may have proved effective in the early years, damage from UV light, vandalism and self-seeded vegetation growth have resulted in its degradation, leaving an ineffective and permeable roof covering. The monument structure below has become saturated, resulting in substantial visible leaching of lime binder from the walls and the vault. The cement pointing to the rubble external faces compounds the problem by trapping moisture within the walls.

Fig. 2. The condition of the roof covering prior to the 2014 works

considering what might be possible. It was decided that a new roofing layer, formed of three layers of bituminous roofing felt, would be the most suitable material to secure the roof. Additional masonry repairs to the slabs as well as the removal of woody shrub growth would also be required.

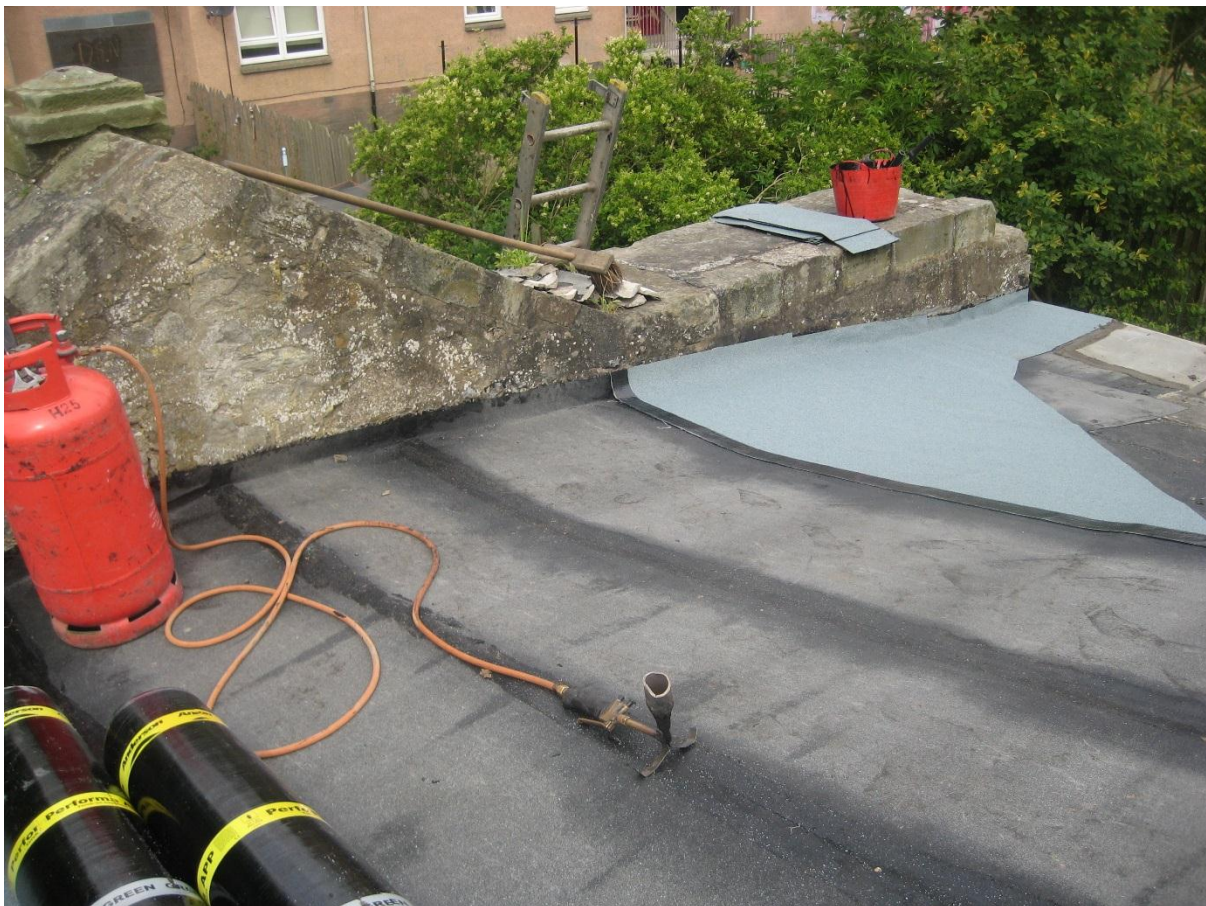
Fig. 3. The application of the bitumen felt covering

1. Removal of vegetation and poisoning of roots
2. Repairing and re-bedding the existing roof slabs including installation of new slabs where required
3. Applying the new roof covering and completing the edge detailing (Fig. 3)

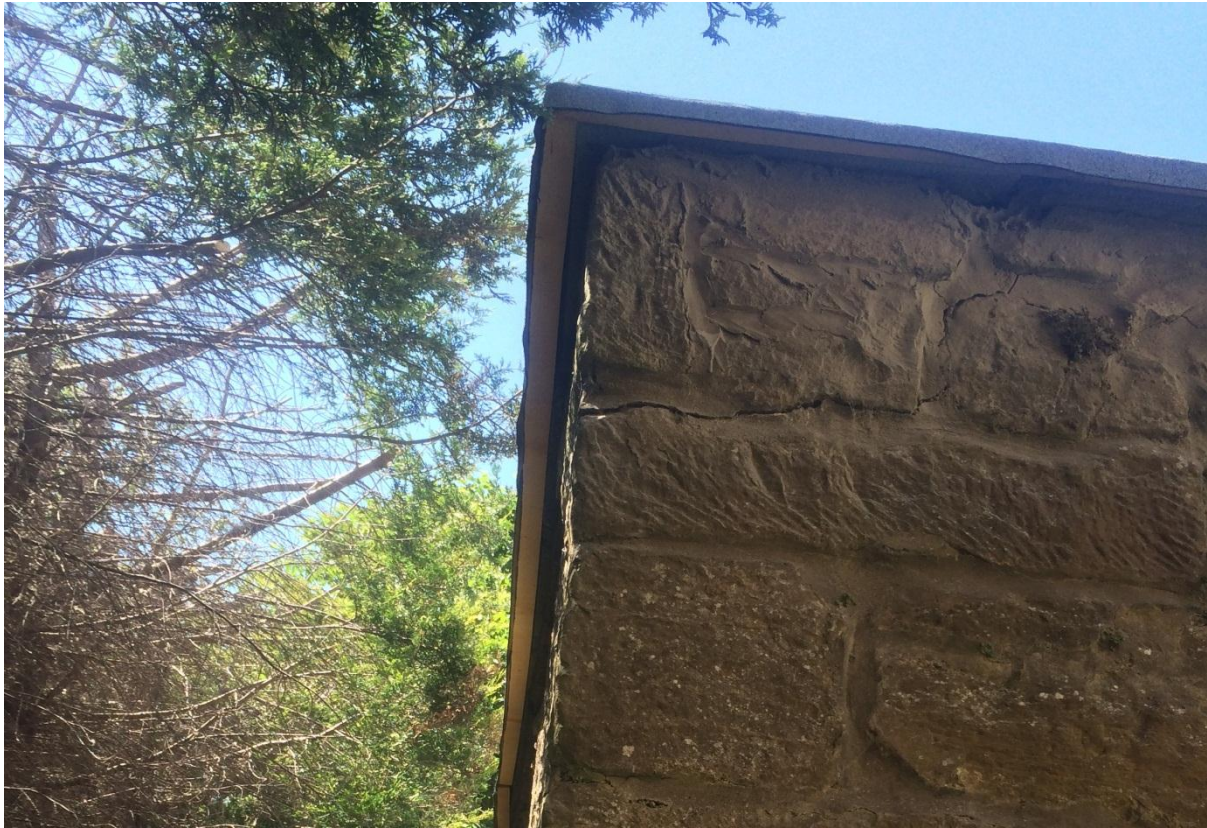
Fig. 4. The finished edge detailing

Stage 3, the application of the roof covering, was completed in the last week of June, with the new edge detailing and final works being completed in the first week of July. Site visits by the Client and Historic Scotland during each of these stages allowed review of the details and occasional adjustments to the formal plan; for example a final version of the edge detail was suggested by the site charge hand, and

subsequently implemented as the confirmed finish (Fig. 4). This revised detail consisted of the addition of an angled piece of timber, mechanically fastened to the concrete paving slabs forming the roof deck. This allowed the formation of a drip edge with the mineral felt, and an additional 40mm of projection away from the vertical of the wall. This feature will keep the water from the roof run-off away from the upper part of the wall, assisting in keeping it dry.

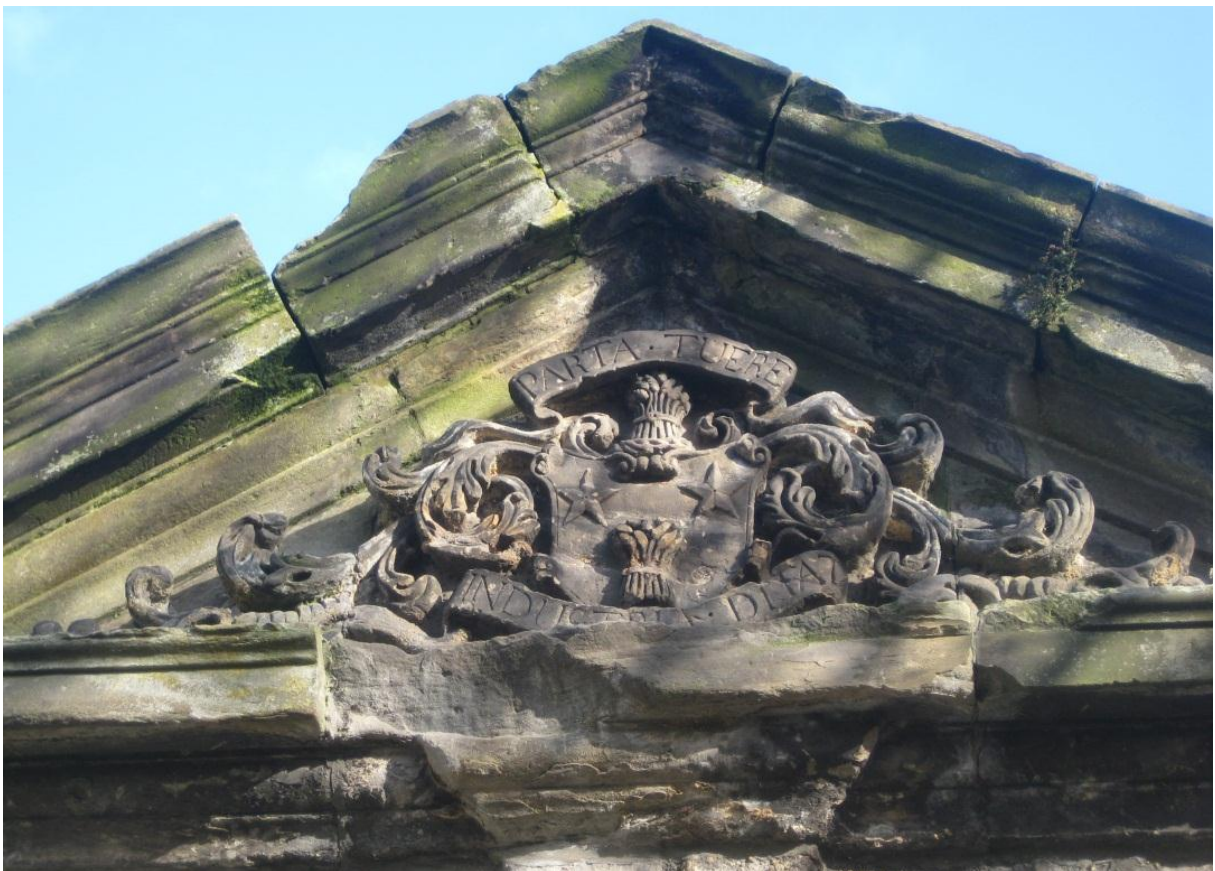
The priority for most interim repairs is keeping water out of the building, and therefore the repairs of summer 2014 were concerned only with the main roof structure. However, the fine ashlarwork of the principal elevation and the carved adornment in the cartouche within the central pediment has great architectural merit and historical importance. Water ingress through open ashlar joints and missing parts of the cornice and pediment has resulted in staining and decay to masonry in the vicinity (Fig. 5). A separate scheme of work will be planned and costed to address these areas of damage and inhibit further decay.

Fig. 5. Staining on the carved stonework from open ashlar joints and damaged cornice

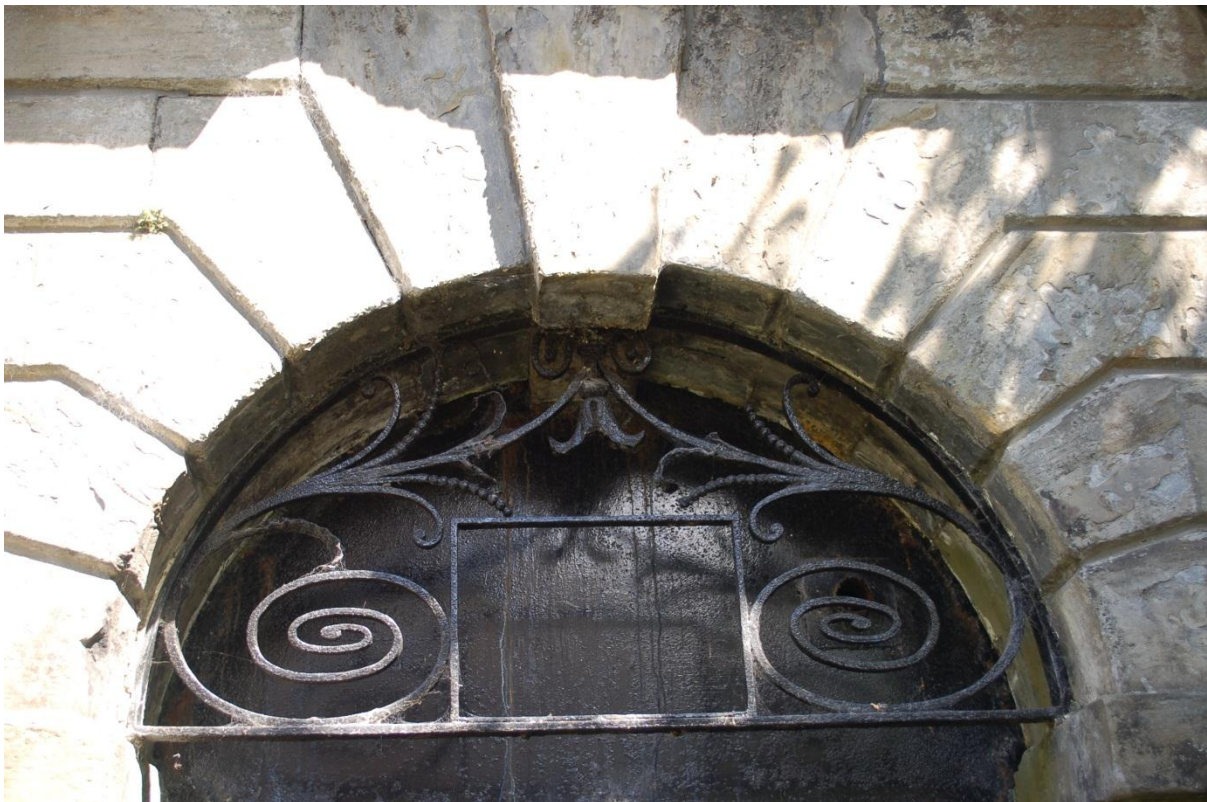
The almost total saturation of the monument means that drying out is likely to take a long time. Following water ingress, heated masonry structures can take many months or even years to dry out; this structure - unheated and with no windows - is likely to dry slowly. The current steel door, installed as part of the generator facility, does not allow adequate ventilation and also detracts from the fine ironwork beneath the arch (Fig. 6.). A door of more sympathetic design, that allows better advection of moisture, would permit quicker drying out and on-going air movement and ventilation.

Fig. 6. Original wrought iron screen in front of the modern steel door
