# REFURBISHMENT CASE STUDY 26

## BLACK BULL CLOSE DUNBAR

HOT-MIXED LIME MORTAR TRIALS

HISTORIC  
ENVIRONMENT  
SCOTLAND

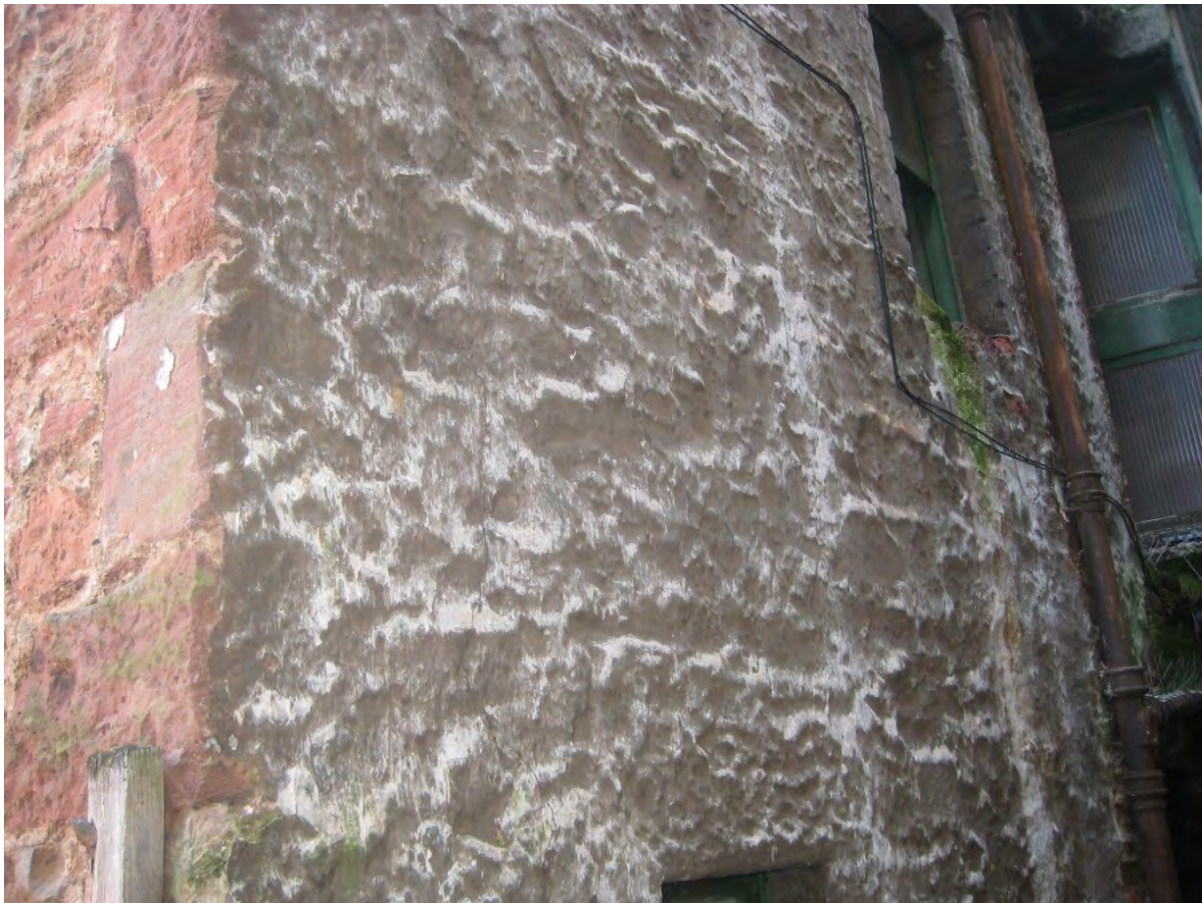
Figure 2. Surviving historic harling finished with limewash in Black Bull Close, Dunbar.

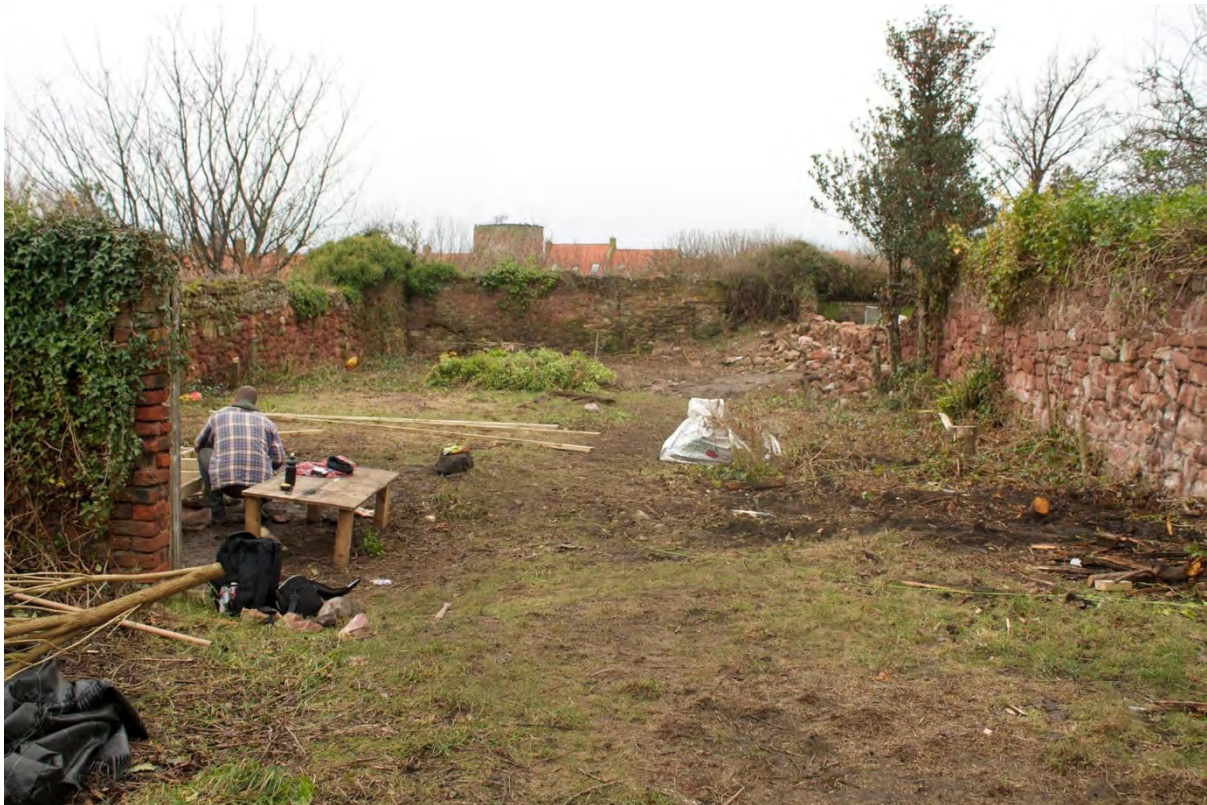
aggregates; the site is only a few hundred metres from the coast. Various repairs at different times had resulted in a heterogeneous mixture of masonry styles. In some areas on the south-west wall entire sections had been taken down and the stone removed. The Ridge wished to rebuild these sections to restore the garden boundary and provide support for the growing of fruit. The growth of ivy has caused structural instability in some areas of upstanding walls at the street end of the plot, which will be addressed in a future programme of works.

Figure 3. View of the garden plot and the boundary wall before the works. Phase 1 started with rebuilding the collapsed section on the far right.

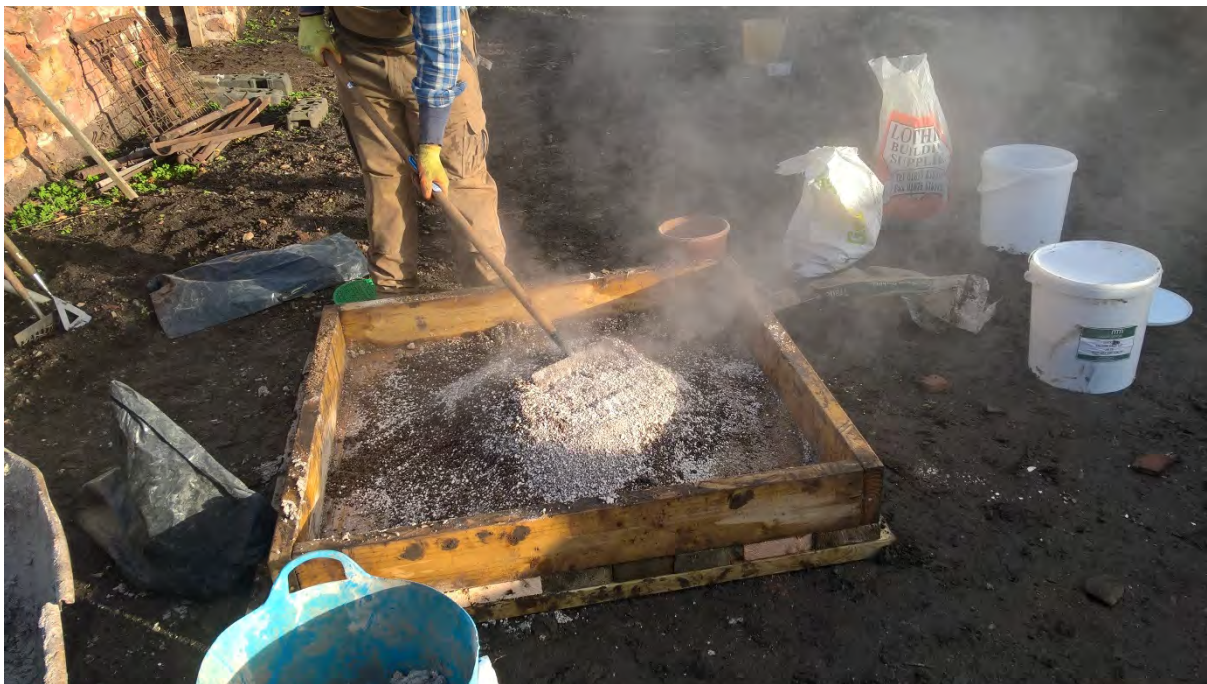
Figure 4. Hand-batching the sand and quicklime. This mortar bath was used to prepare the mortar for the test mortar and the rest of the project.

At project inception the hiring of a forced action mixer was considered, but issues of cost, storage and provision of electrical power meant that this would have been impractical. Therefore a traditional mortar trough was constructed from scaffold battens and 4 inch nails (Figure 4) and was used for all mortar preparation during the project. Although basic, it proved ideal for use by the volunteers, who enjoyed the direct contact with the materials, and easily produced the mortar needed by the two stonemasons engaged in the rubble building (see section on health and safety below). While hand-batching is suitable for smaller projects, for larger work a forced action mixer is generally recommended for best results.

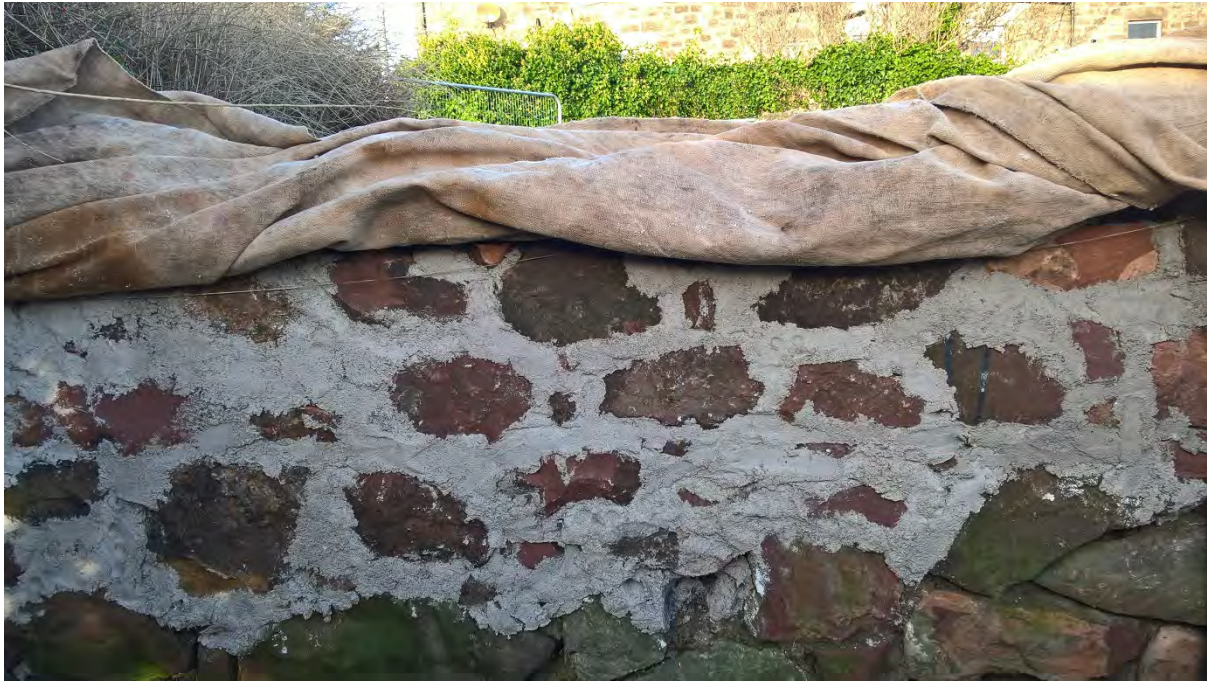
Figure 5. The wall head protection in place at the end of Phase 1 in December 2016. This mortar has yet to take a set and be scraped back.

concluding in mid-December. This period was characterised by low temperatures but generally dry weather. The rubble work was taken up in 12 inch lifts, extending in a more or less horizontal line. Care was taken to ensure that the wall core was through bonded with stones. The mortar was batched fairly stiff, but just wet enough to allow easy positioning of the stones, and the mortar was left slightly proud of the wall (Figure 5).

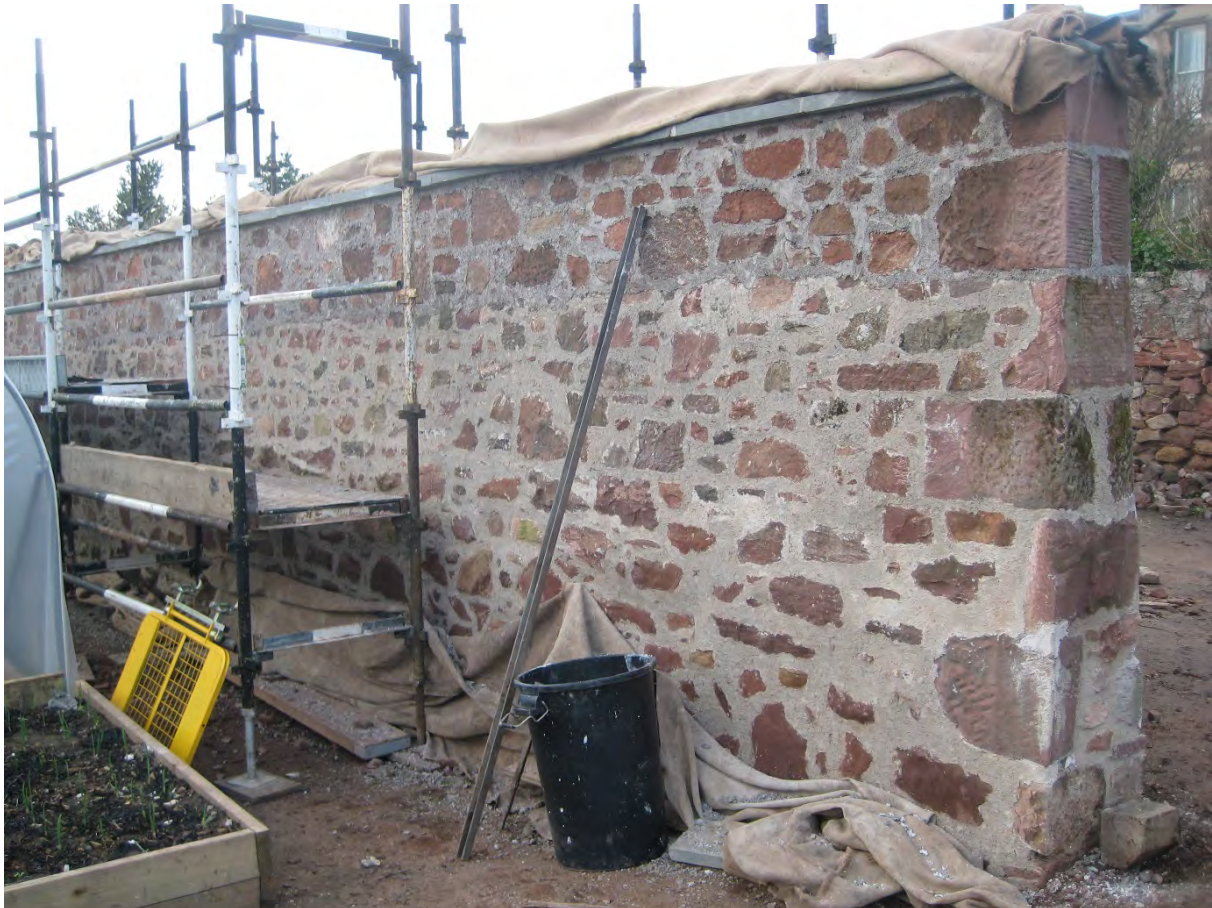
During Phase 2 the sharp sand content of the standard mix was increased to 3 parts, and the building sand component was removed. This was to simplify batching and determine if removing the finer aggregate made any difference. This simplified mix was functional, but more difficult to work, and was described as 'too sticky'. When cured it had a lighter colour than the standard mix, which was noticeable at the south-west end of the wall, which was shaded. It was concluded that the original standard mix containing building sand produced better results. The concrete slabs, selected as the cope, were also bedded in.

Figure 6. The rebuilt boundary wall at the end of Phase 2 in March 2017, with the flush pointing finish clear. The upper quarter of the wall has yet to take a set and be scraped back.

The second period of work, beginning in February 2017, took the south-west length of the wall up to full height by March 2017 (Figure 6). As the wall rose in height a single lift system scaffold was required to give a more effective working height, especially when handling heavy stones. The mortar from Phase 1 was scraped back just proud of the faces of the stones, giving a generally smooth surface.

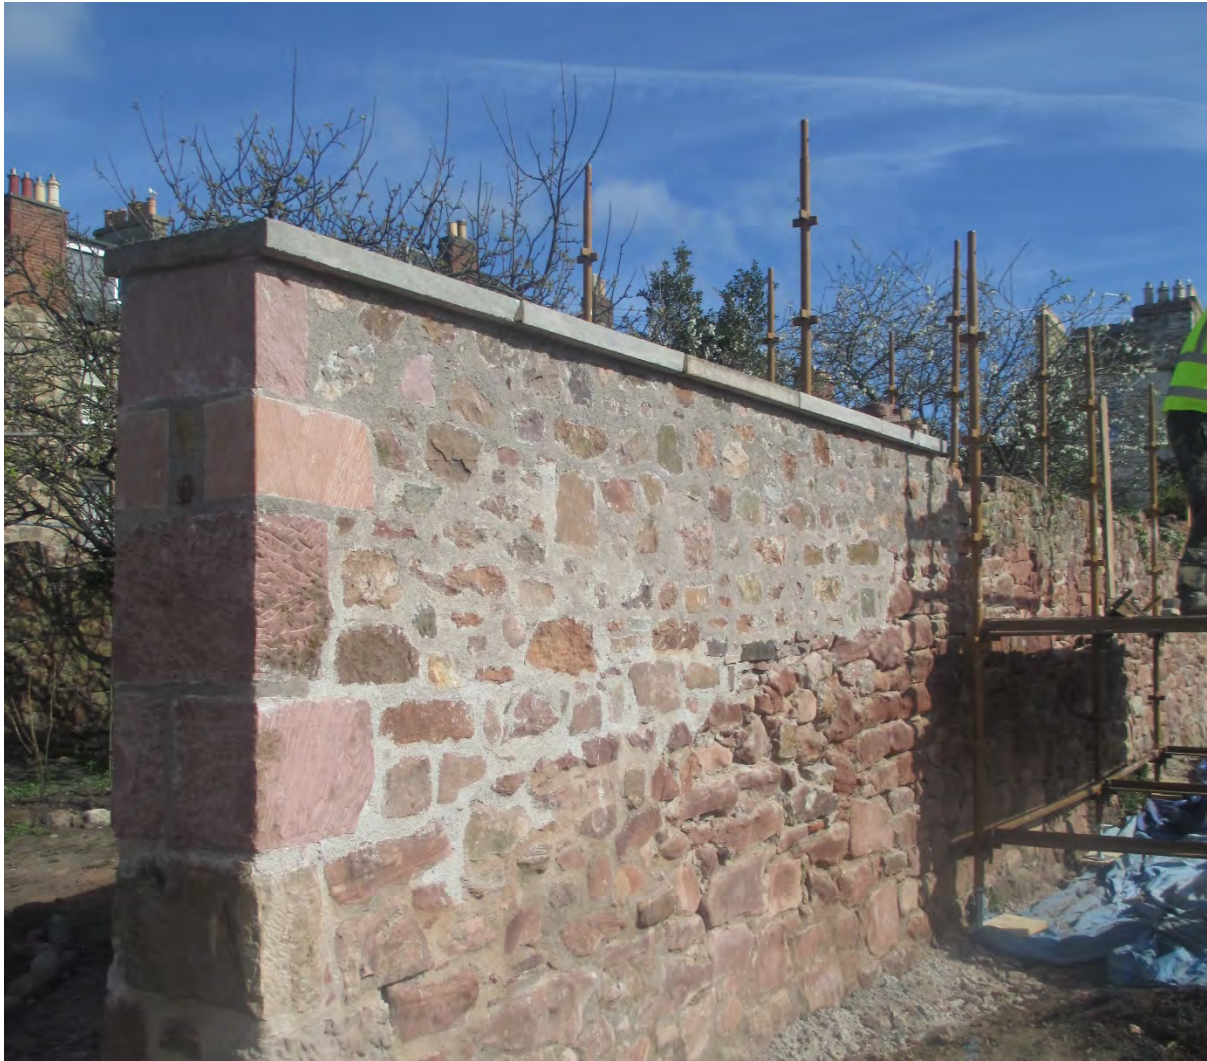
Figure 7. The rebuilt middle section of the boundary wall following scraping back towards the end of Phase 3 in April 2017.

The final stage of the project began in April 2017 and completed the middle section of the north wall. As Phase 3 progressed, it was decided to set up a cover over the scaffold to allow work to progress during periods of rain. This significantly improved site availability and the working conditions for the masons. The mortar in Phase 3 cured much quicker than in earlier phases, and was ready to be scraped back after only three days (Figure 7). This quicker set was due to higher ambient temperatures as the spring progressed. For all phases, the wall head was protected during and after the works with hessian and polythene until the mortar had fully cured. Misting and re-hydrating the finished mortar was not required due to the quantity of water within the wall from the new mortar and the generally slow drying.

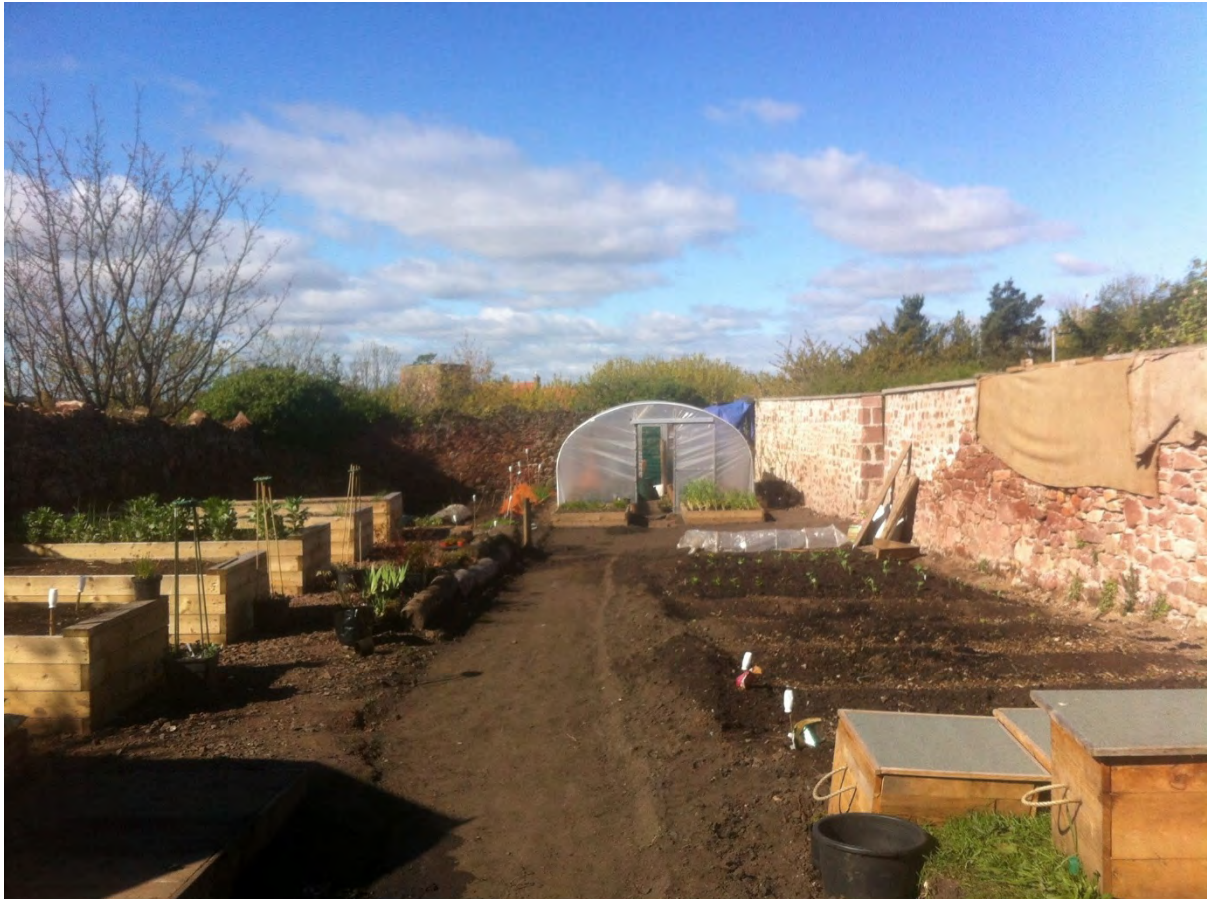
Only one small area of mortar failure was noticed, occurring where the new work met the existing wall at the south-west end. In this location the existing historic mortar, being very absorptive, drew the water from the new mortar. This caused drying, rather than the desired curing or carbonation, of the lime binder. It resulted in a whitish bright and friable mortar, visually different from the cured mortar elsewhere. This failed mortar was removed and replaced; careful dampening down resulted in a proper cure with the repaired section.

Figure 9. The finished walls from Phases 1 to 3 can be seen middle-right. The hessian protection is still covering the repaired upper masonry and new copes on the right.
