A Survey of Thatched Buildings in Scotland

Thatch Survey of Scotland
2014-15

A photographic survey of thatched buildings in Scotland, surveyed between May 2014 and August 2015 by Zoe Herbert (SPAB Scotland Officer), on behalf of the Society for the Protection of Ancient Buildings.

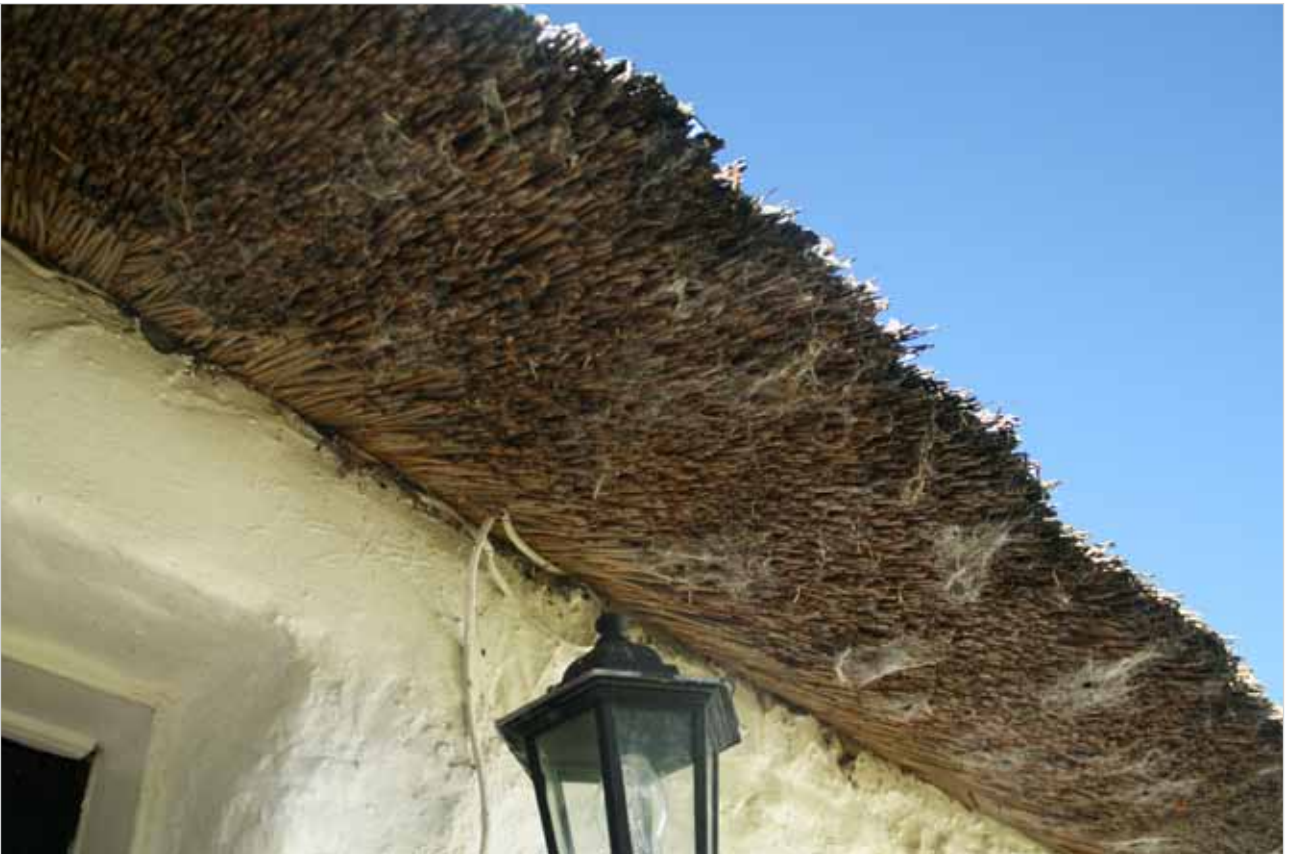
left around the sides. The thatch has deteriorated slightly in places; there are a few loose reeds throughout and the thatch has sunk away from the ridge at the top and at the concrete skews, though this could be partly due to deterioration of the ridge at the same time. Part of a group of thatched cottages of the same period (see surveys 059 and 061-064).

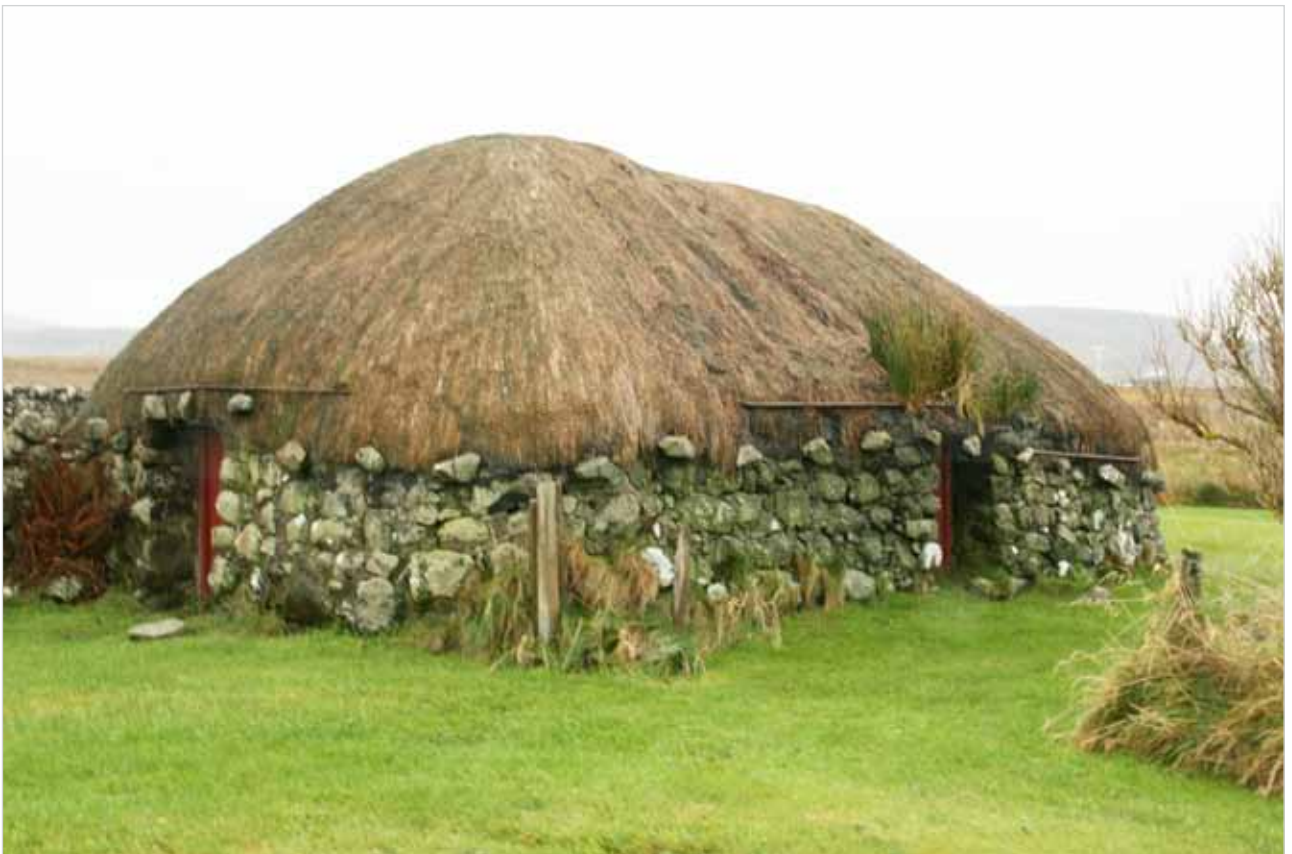
ridge, is entirely netted. The netting is weighted just above the eaves and around the chimney stacks at either end with stones that have been secured to the netting with wire. There is a small amount of algae-like growth across the surface of the thatch, but this is minimal. N.B. Thatch was repaired in July 2015.

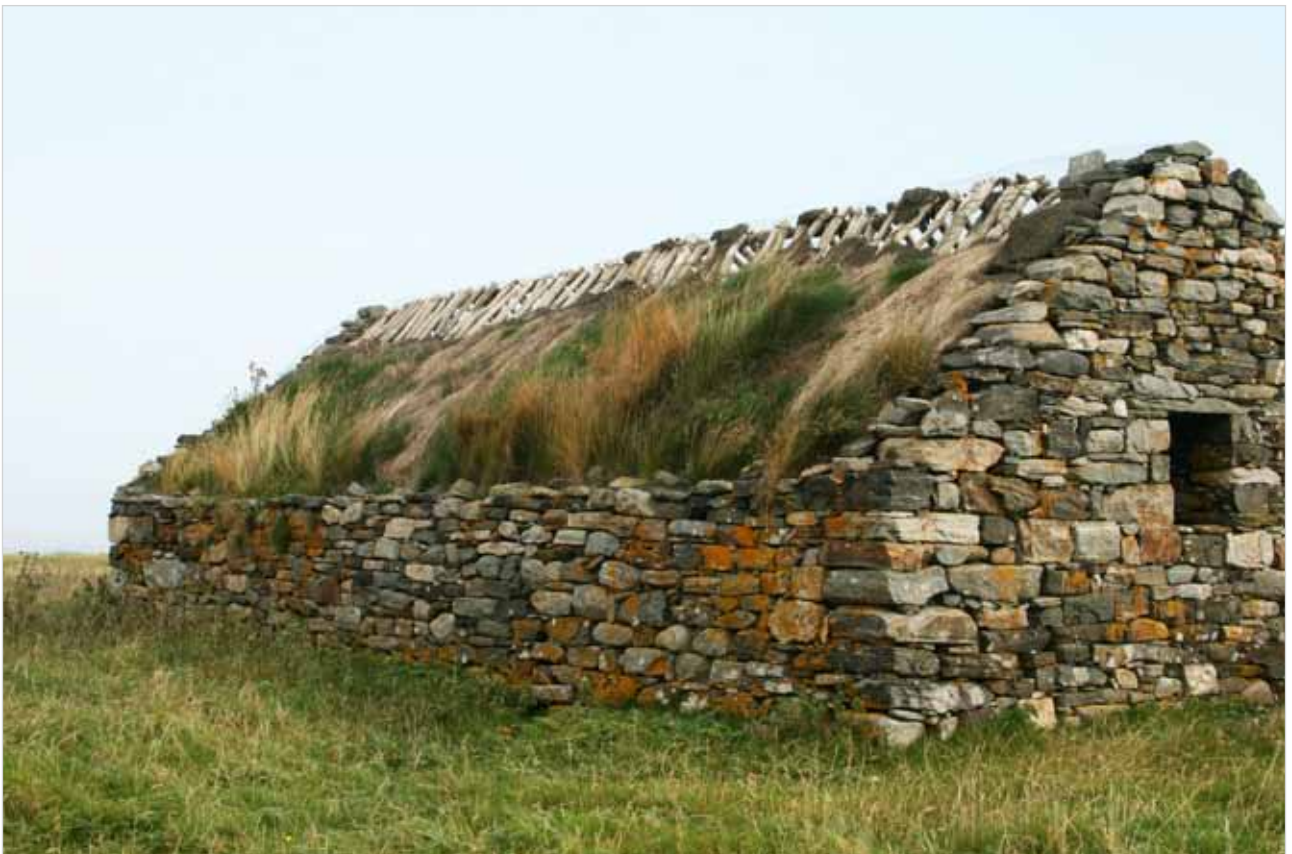
and the turf underlay is exposed in many places. The roof remains netted, held in place by stones that are secured to the netting by string along the wallhead and skews. The building is located next to a thatched byre under the same listing (survey number 248). The barn has been on the Buildings at Risk Register since 2009 (BAR reference number 3744).
