# The Pleasance, Edinburgh

Insulation of coom ceiling, attic space & lightwell

This publication should be quoted as:  
Historic Scotland Refurbishment Case Study 5

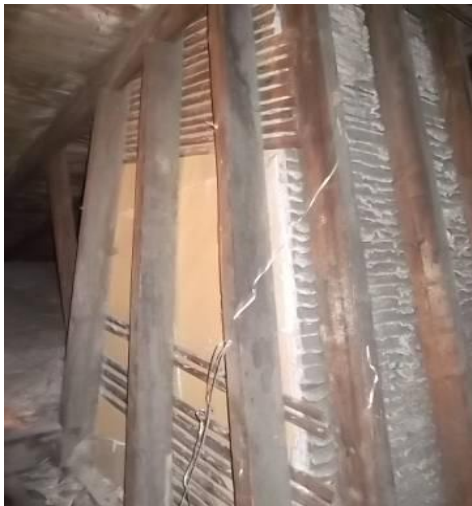
Within the attic space there are two light wells from the roof line down to ceiling level, one of which remains in use providing natural daylight into the hall below; the other is redundant and closed off. The shafts are lined with lime plaster on timber lath nailed directly on to timber framing, with some areas of plaster replaced with plasterboard (Fig. 2). The inside faces of the light wells are finished in a textured coating. The functioning light shafts were insulated on the attic side with 100 mm glass fibre insulation, held in place with nylon bands (Fig. 3).

Fig. 2. Un-insulated lightwell within the attic space. Image by Adam Dudley Architects

All existing insulation was removed from between the truss ties and from the light shaft walls (Fig. 12). Following the removal of all debris, 180 mm sheep's wool insulation was laid between the truss ties, and 100 mm insulation above, across the ties, overlapping with the bonded bead which filled the coom, to provide a completely insulated envelope (Fig. 13 and Fig. 14). Sheep's wool insulation, 180 mm in thickness, was installed between the timber uprights to the roof light shafts, wrapped at the corners, and secured with nylon banding (Fig. 15). The cold-water tanks and copper pipework were all also insulated using proprietary materials and installation methods.

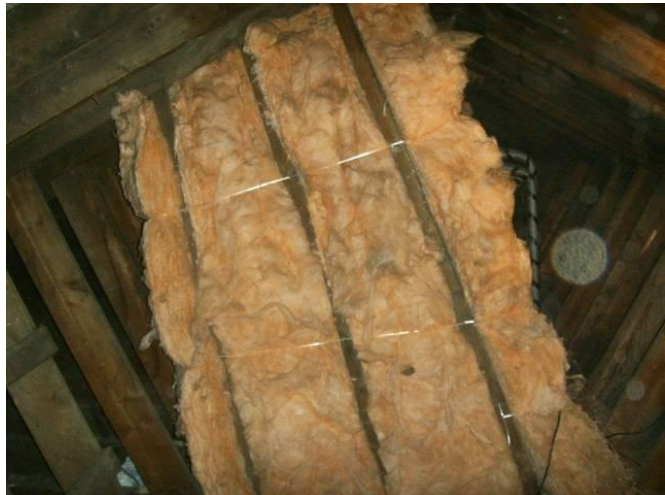
Fig. 3. Old glass fibre insulation to lightwell. Image by Adam Dudley Architects

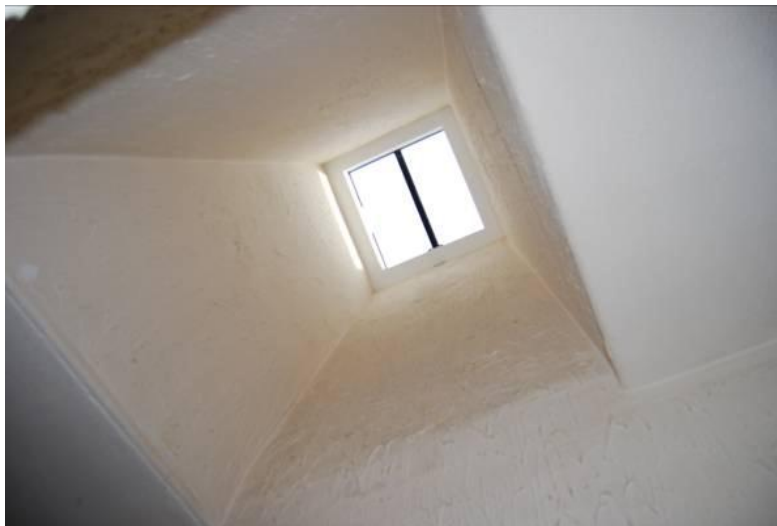
Fig. 10. New double glazed mechanized roof light

The existing roof light was removed and replaced with a double glazed roof light (Fig. 10) with a motorised opening mechanism (Fig. 11). This was to allow cooling of the building during the summer months and controlled ventilation throughout the year. As the building fronts onto a busy road, and the rear faces the Pleasance Courtyard (a principal Edinburgh Fringe venue), noise pollution was an issue, so providing ventilation without opening the front and rear windows improved the internal conditions.

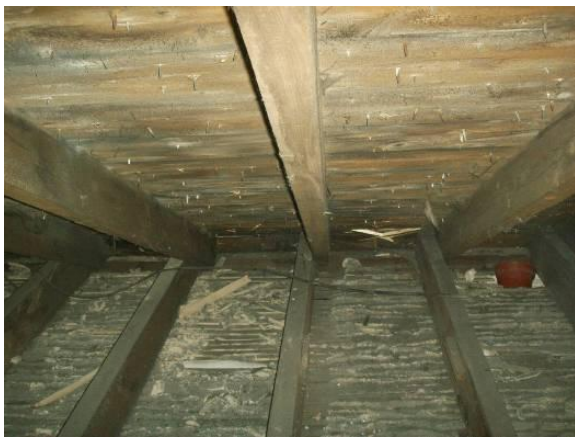
Fig. 12. Existing roof insulation was removed. Image by Adam Dudley Architects

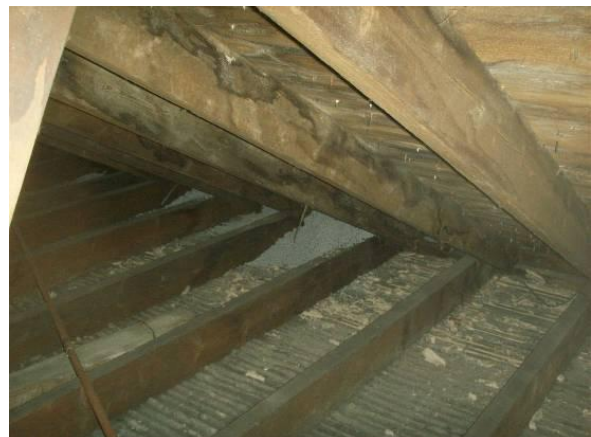
Fig. 13. Blown bead showing at the top of the filled cavity. Image by Adam Dudley Architects

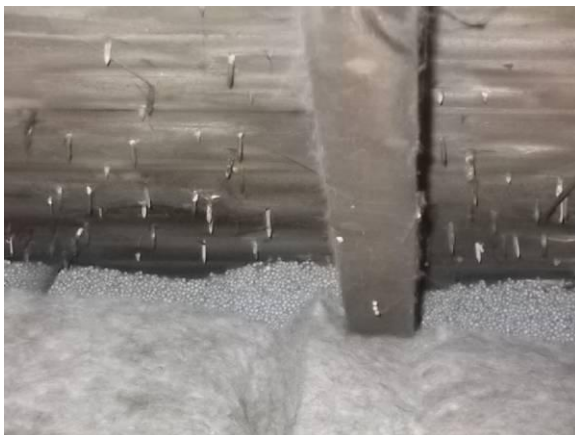
Fig. 14. The blown bead and the sheep's wool overlap to provide a fully insulated roof. Image by Adam Dudley Architects

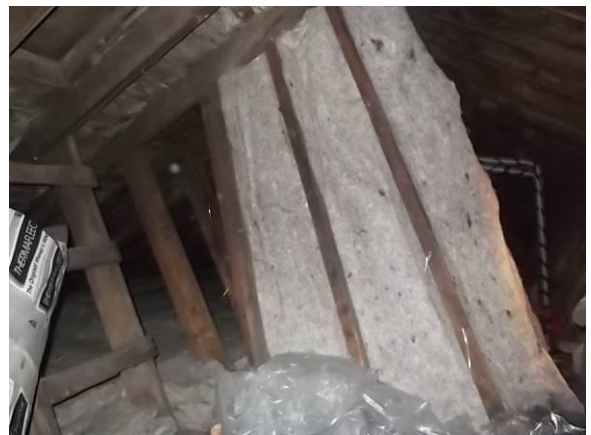
Fig. 15. Light well, insulated with sheep's wool. Image by Adam Dudley Architects

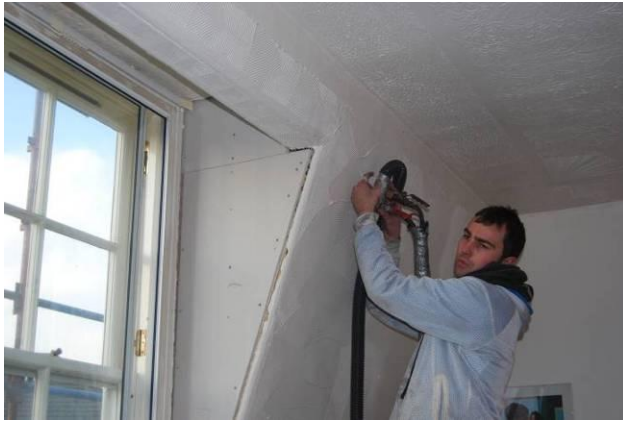
Fig. 16. Bonded polystyrene bead being pumped into the void

Holes were drilled through the lath and plaster at the top of the sloping walls, directly below the roof truss beams between every rafter, and below each windowsill between every upright. Polystyrene bead insulation was blown in through these holes, where they filled the voids at the eaves, behind the dwarf wall partitions, and between the lath and plaster and the underside of the sarking of the coom ceiling (Figs. 16 -19). This bead product was coated on entry with a PVA glue that, once in place, holds the beads together in a solid open-celled matrix.

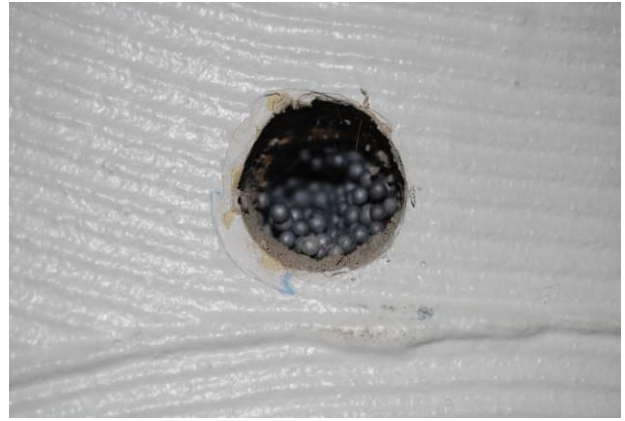
Fig. 17. The polystyrene bead insulation is pumped through holes approximately 30 mm in diameter

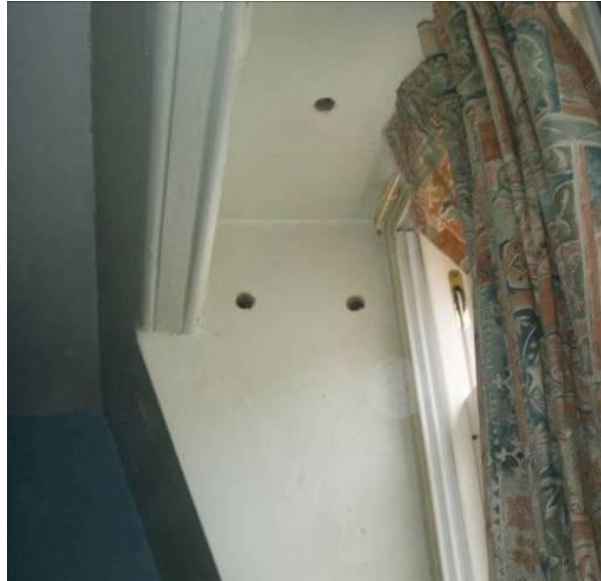
Fig. 20. Dormer cheek, drilled prior to injection of the bead. Image by Adam Dudley Architects

To establish the construction detailing, the linings to the dormer cheeks in the rear bedroom dormer and kitchen were removed, leaving the original lath and plaster linings, to the living room and other rear bedroom, in place. Using the information obtained through the opening-up works, 22 mm diameter holes were drilled through the lath and plaster at the head of the dormer cheeks in the living room and rear bedroom, each side of the central upright, and blown bead insulation was installed (Fig. 20).

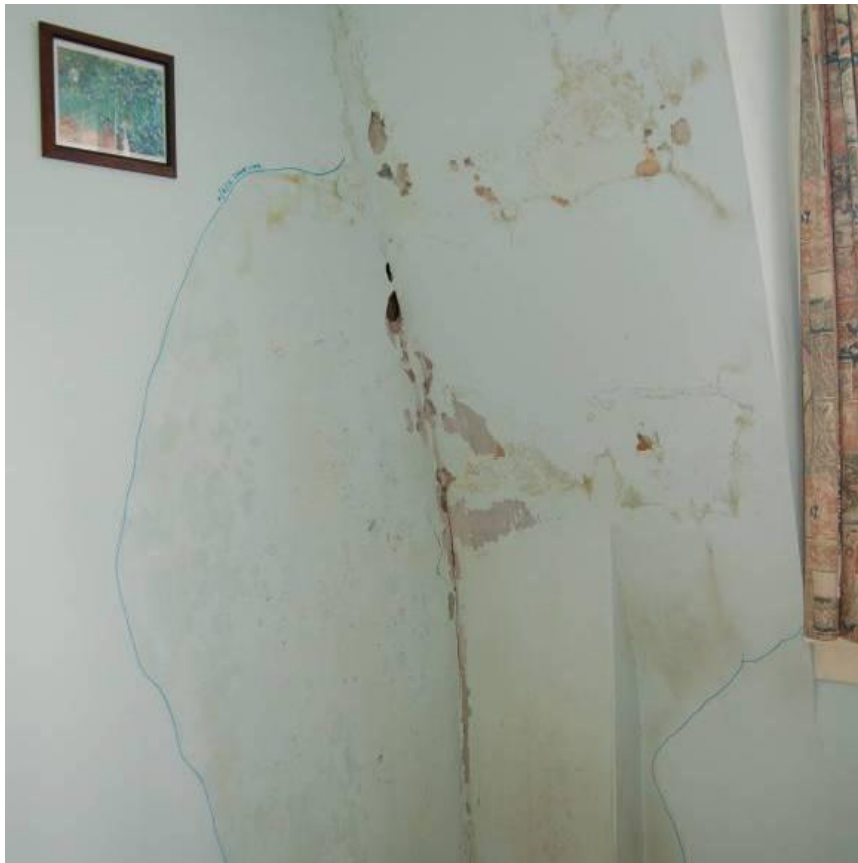
Following completion of the work at The Pleasance, an incident occurred which caused water damage to the insulated areas. This came about due to an overflow pipe from the water tank in the loft becoming damaged during the refurbishment works. When the tank subsequently overflowed, the water was released into the roof space rather than being discharged out of the building at roof level. The overflow was of sufficient quantity to percolate through the insulation and into the internal linings of the coom and flat ceilings, causing localised damage (Fig. 22).

Fig. 22. Water damage to the coom ceiling from damaged pipe in the water tank

It should be emphasised that water ingress itself does not always cause extensive damage; it is usually the added weight that causes plaster to fall. Timber is not always damaged by water, although smaller sections can distort if only wet for a short period of time. It is prolonged saturation, or prolonged levels of high humidity that cause decay. In properly ventilated roof structures water should be able to dissipate freely. In this case the damage was exacerbated by the fact that the situation was not fully addressed for some time and drying of the plaster was inhibited by surface finishes that did not allow the free movement of water vapour. However, when the areas were fully uncovered, it was observed that the bonded bead remained largely unaffected although the bonding agent in the beads (a water-based glue) had partially broken down and the beads were effectively loose (Fig. 23).

The fabric did however effectively dry out, and the presence of the bonded bead did not prevent timely drying. Humidity monitors have been installed to monitor the relative humidity at the depth of the sarking and just behind the internal lining. Results from this monitoring will show how quickly and effectively the wall is drying out to appropriate levels.

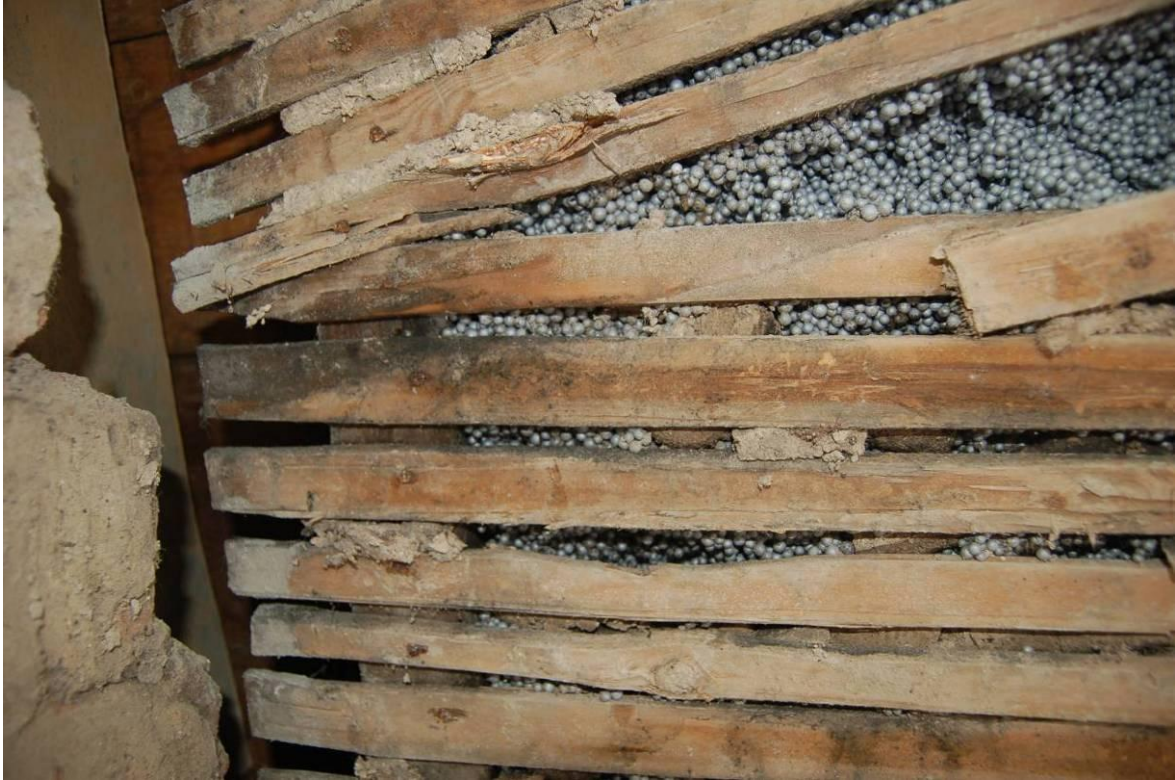
Figure. 23. Bonded bead following the water damage
