# KILDONAN, SOUTH UIST

## INSULATION TO WALLS, ROOF, WINDOWS & DOOR

This publication should be quoted as:  
Historic Scotland Refurbishment Case Study 6

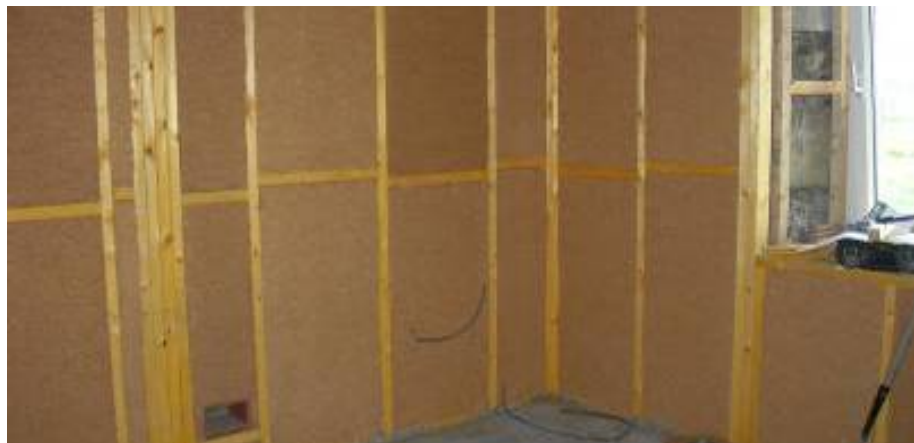
Fig. 2. Wood fibreboard between timber straps prior to application of plasterboard

As previous wall linings had decayed to such an extent as to make their retention impractical, three of the four external walls on the ground floor of the building were insulated using wood fibreboard. This was fitted between timber strapping to a thickness of 100 mm and fixed directly onto the masonry (Fig. 2).

Plasterboard (without any vapour barrier) was applied over the wood fibreboard, taped and filled, and painted with clay paint to finish. These materials achieved the aim of making the insulation measure entirely vapour permeable.

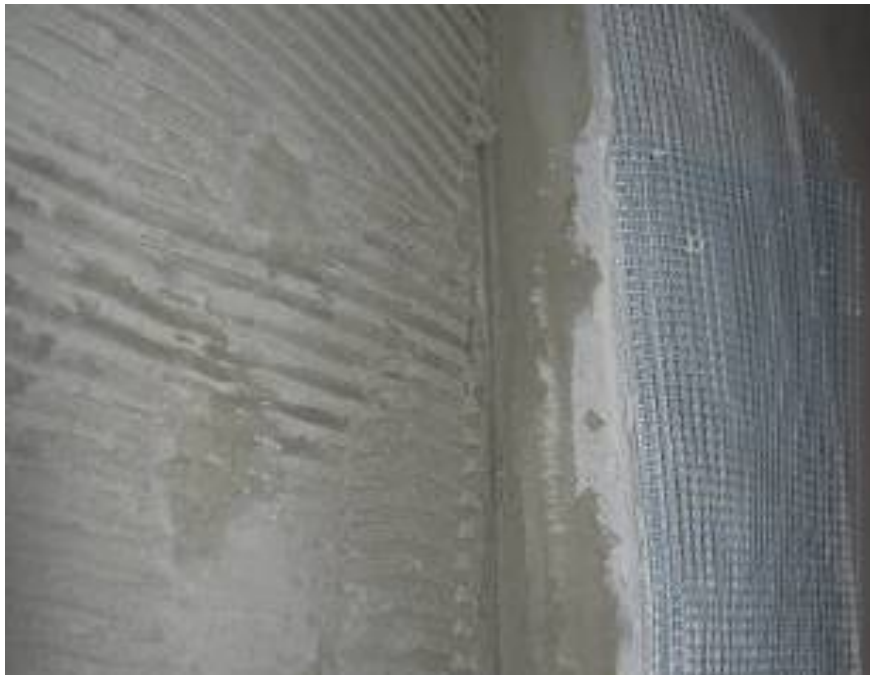
Fig. 3. Solid wall insulation using calcium silicate board, left open to show the layers

The fourth wall of the ground floor, which had previously been plastered 'on the hard', was insulated using calcium silicate board 50 mm in thickness (Fig. 3). This was applied directly to the masonry using a moisture permeable adhesive mortar and mesh reinforcement was then fitted over this to allow a two-coat plaster system to be applied as a finish. This was finished with a clay paint to ensure full vapour permeability.

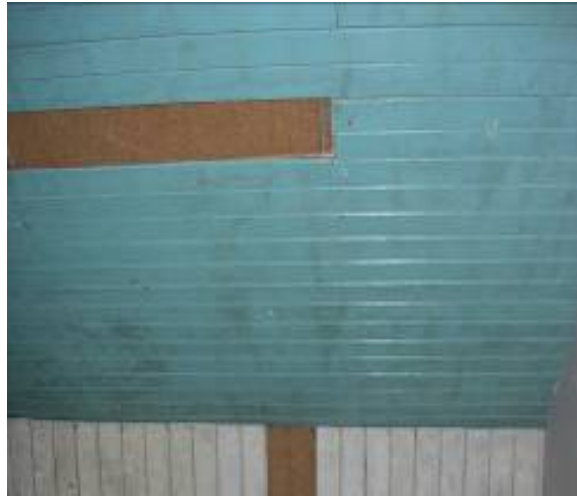
Fig. 4. Wood fibre insulation to the coom, showing re-fixed timber linings

In the upper floor, the coom ceiling was insulated with the same wood fibreboard used on the ground floor walls. Rather than fitting between new timber framing, here the same material was inserted behind the existing v-groove timber wall lining, to a thickness of 50 mm. This was achieved by removing some of the boards to allow the insulation to be inserted (Fig. 4) and refastening the existing boards. By using the correct thickness of wood fibreboard, a void was left (about 10 mm) to allow air circulation between the top of the insulation and the underside of the sarking board. This ensured the free ventilation of the void space and ensures dispersal of any water ingress from rain being driven under the slates in extreme conditions. The small area of flat ceiling below the roof apex was also insulated using 100 mm thick wood fibreboard.

The 50 mm thick wood fibreboard used behind the existing v-groove timber lining in the coom ceiling gave a U-value improvement from 1.6 to 0.8. The small area of flat ceiling, insulated using 100 mm of wood fibreboard, was improved from 1.9 to 0.4. These results are significant as they show that a good level of improvement can be achieved in a coom ceiling, an area of a building often considered difficult to treat.

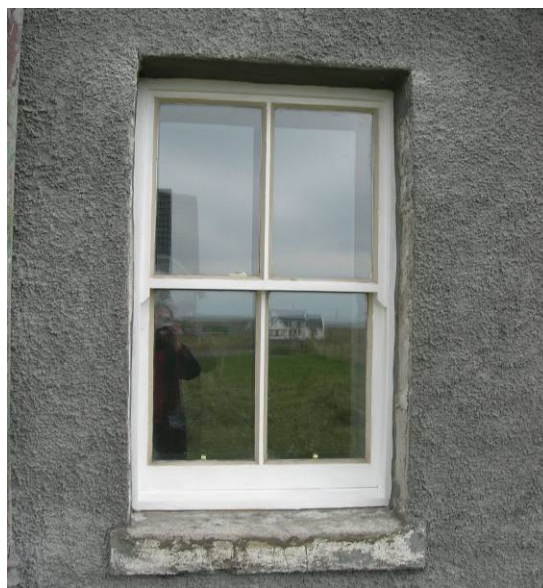
The existing windows at the property were UPVC replacements which, as well as being aesthetically displeasing, had started to fail. The decision was taken to replace these with new timber double glazed sash and case windows. Due to constraints of funding and time, only one trial window could be manufactured and installed. A pattern from similar buildings of the same date was used to inform pane configuration. In order to retain and develop local trade skills, this was manufactured by a contractor on the island. Had UPVC replacements been procured, there would have been no contribution to the local economy or such development of local skills. The trial double glazed sash and case window was manufactured and fitted successfully (Fig. 5).

Fig. 5. The new timber double glazed window

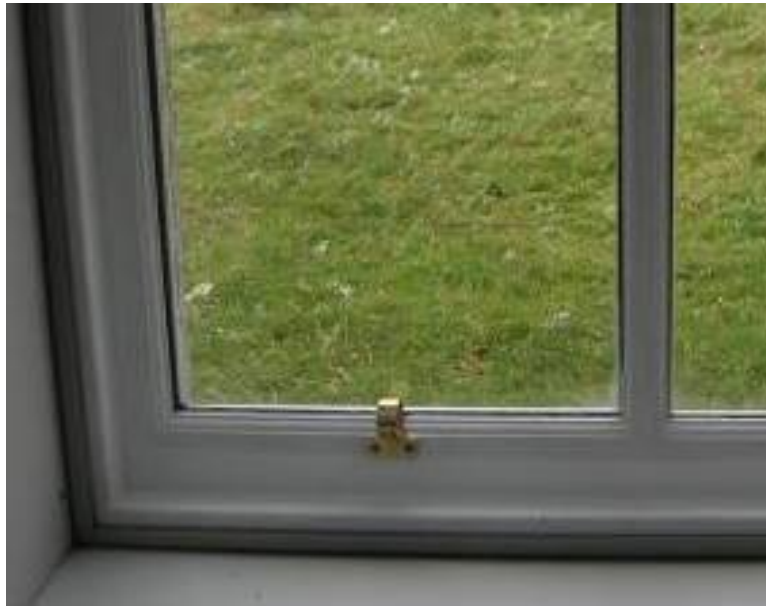
Fig. 6. New double glazed window with polycarbonate secondary glazing in place

As a trial improvement with relevance to buildings in exposed locations, secondary glazing was fitted. This was a proprietary product consisting of polycarbonate sheet fixed to the internal side of the window frame using magnetic strips. These strips held the panel firmly in place, but can be removed by the occupants (Fig. 6) for cleaning etc as required.

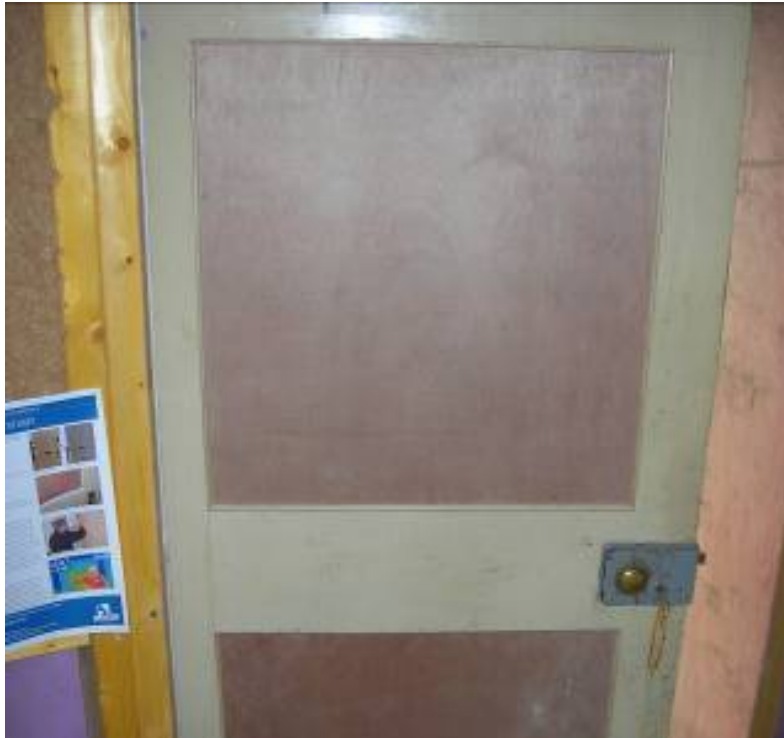
Fig. 7. The insulated door prior to painting

The existing door was a two-panel timber door of standard construction, with thin infill panels 6 mm thick. The technique for upgrading such a door is relatively straightforward using thin insulation set onto the panels. The frame of the door (the styles and rails) are of reasonable thickness and thus do not need improvement. In this case the thermal performance of the panels was improved with 10 mm thick aerogel held behind a new 6 mm plywood sheet. The edges were finished with new mouldings to make a neat junction with the rails and styles (Fig. 7) and then painted.
