TECHNICAL PAPER 29

REVIEW OF HOT-MIXED EXTERNAL LIME
COATINGS IN SCOTLAND 1997-2016

HISTORIC
ENVIRONMENT
SCOTLAND

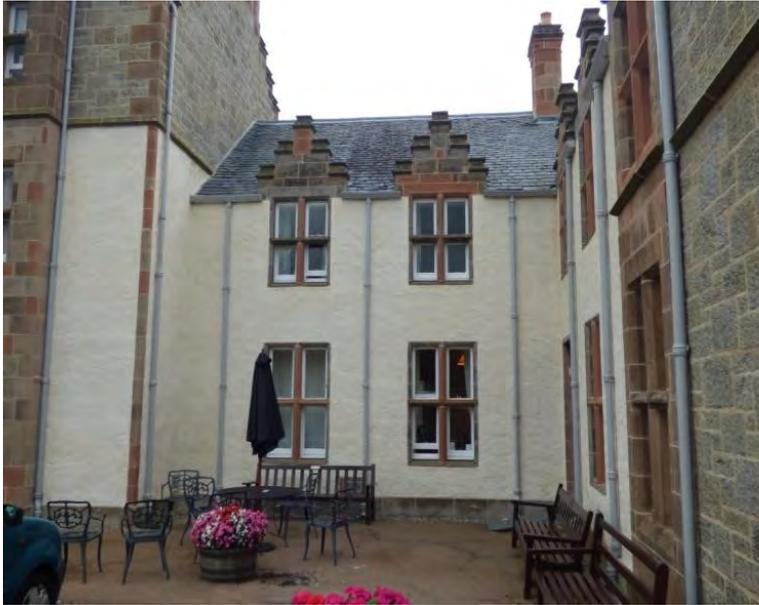
Figure 1.2. Harling to the front elevation, east side of the tower. The harl and limewash all appear to be uniform and in a sound condition.

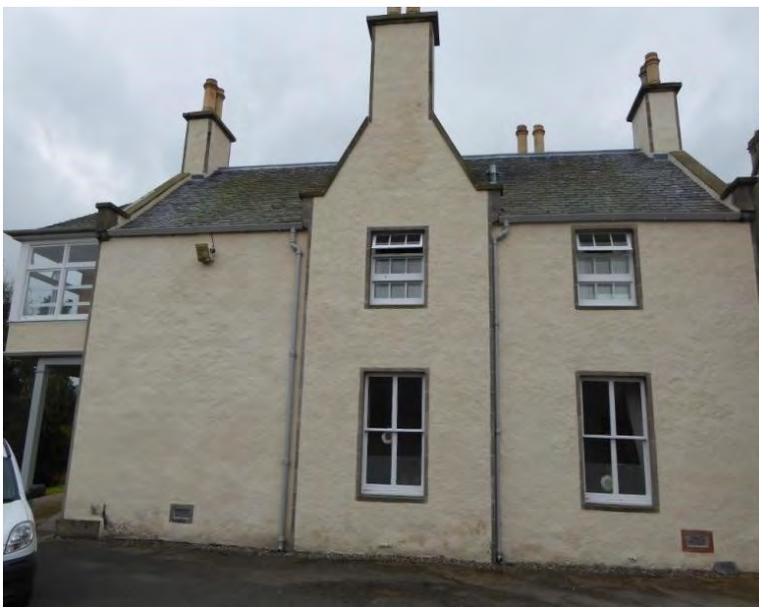
Figure 1.3 Rear elevation, the harl and limewash all sound, with the exception of rising damp and some mechanical damage at ground level.

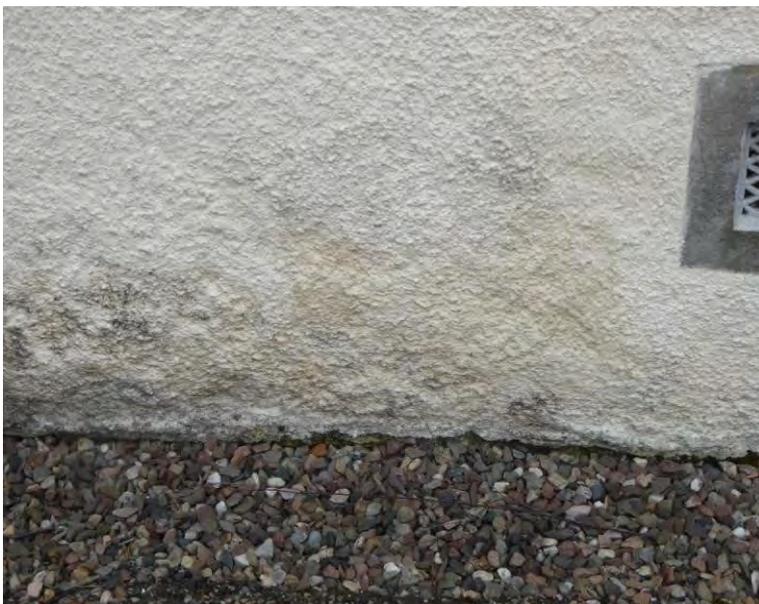
Figure 1.4 The harl at ground level on the rear elevation, showing some staining from rising damp, however, it remains well bonded.

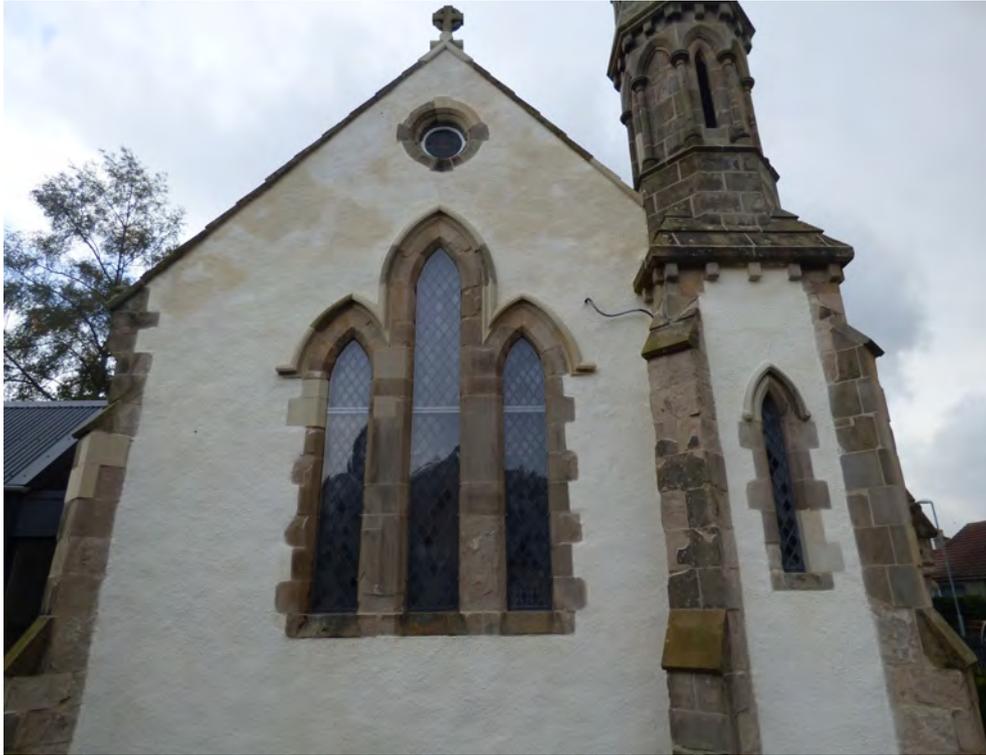
Figure 2.2 View of the west gable with bell tower. The harl and limewash are well finished and appear sound at this time. The limewash at upper levels shows the effect of wetting drying cycles.

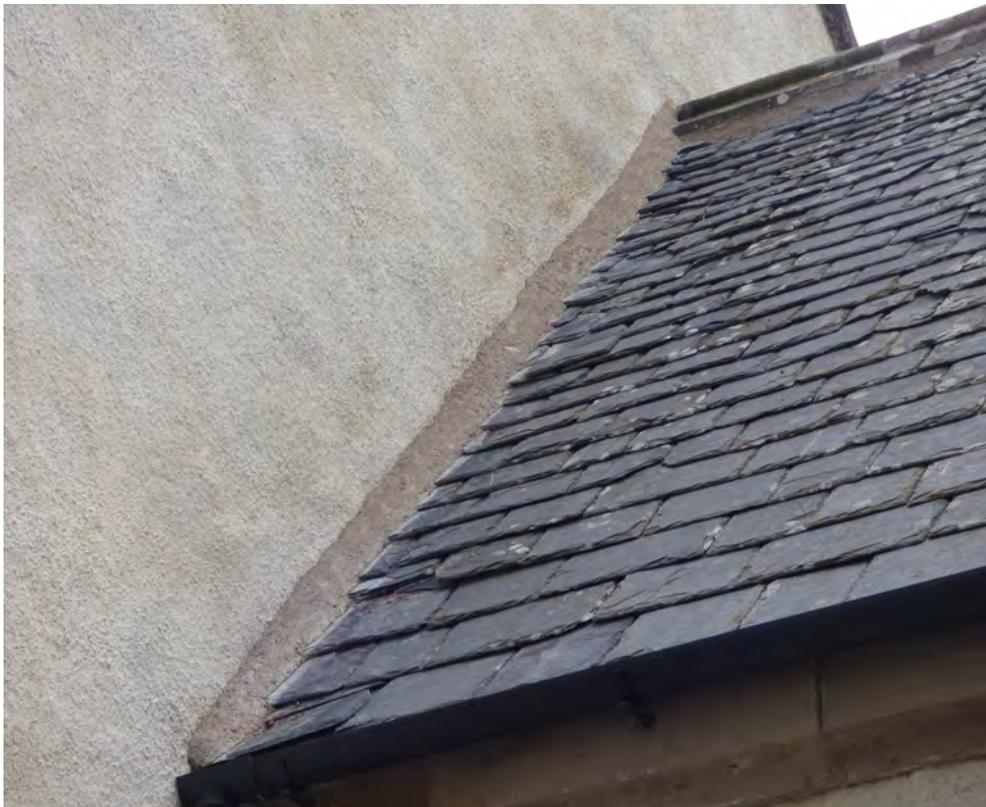
Figure 2.3 Slight patchiness was observed on the east gable, which is not uncommon in limewashed harl, particularly following periods of rainfall and subsequent drying.

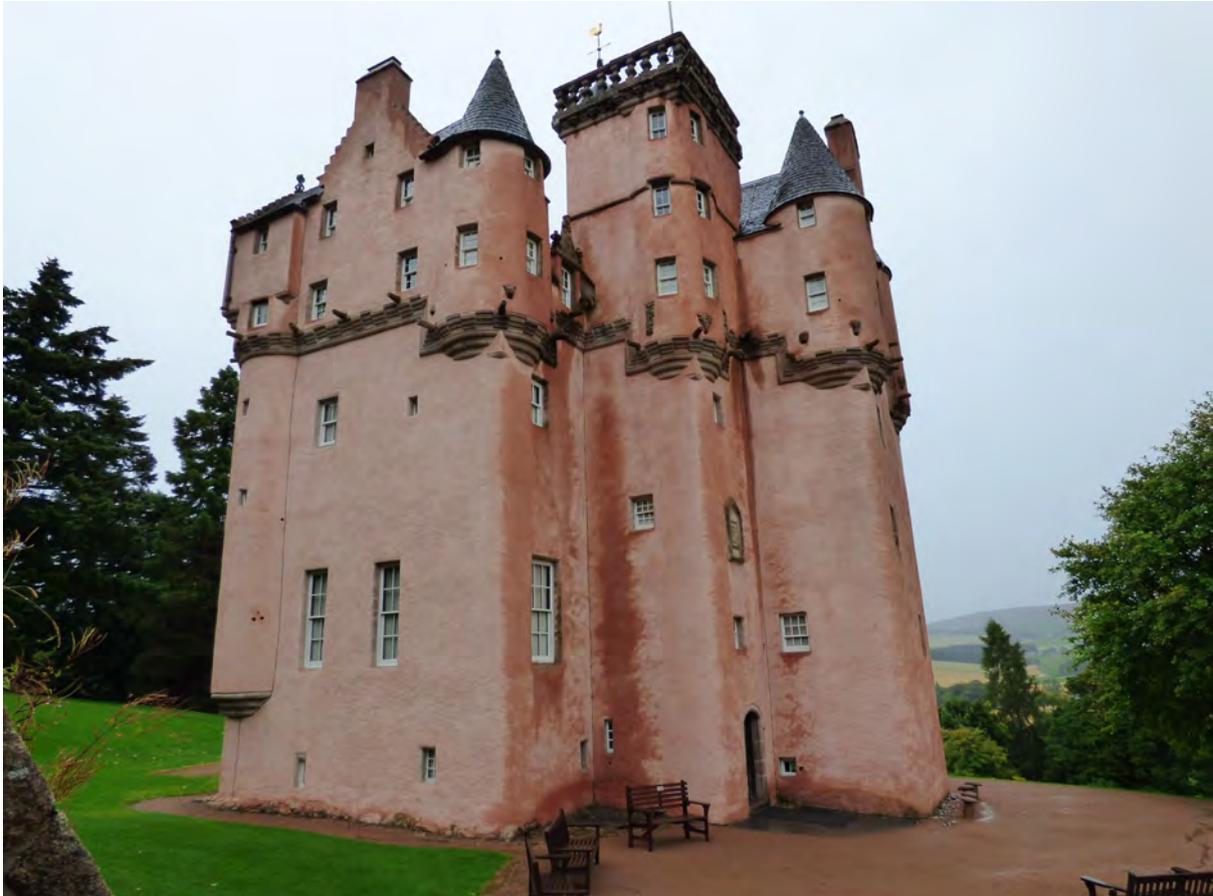
Figure 3.1 View from the south after a period of heavy rainfall.

The harl appears generally sound as confirmed, where accessible, by tapping. In addition to the wetting of the walls by windblown spray, water shed from high level spouts is landing close to the base of the wall with splash back damage observed on the low level limewash.

Localised patch repairs and re-limewashing were observed at ground level. In an attempt to address erosion and pitting of the ground surface, granite sets have been laid. These have resulted in splash back affecting the harl at ground level.

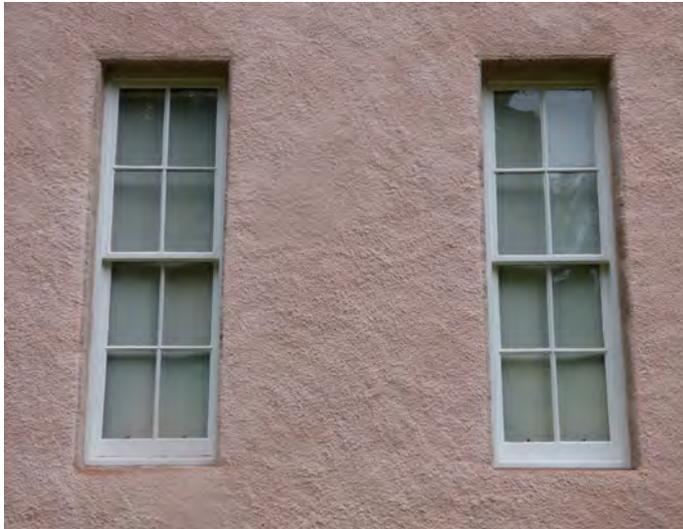
Figure 3.2 View of an area of wall, at first floor level on the west elevation, where the harl and limewash appear sound. No discolouration or erosion was detected at the cills, as is common below large windows where water sheds faster.

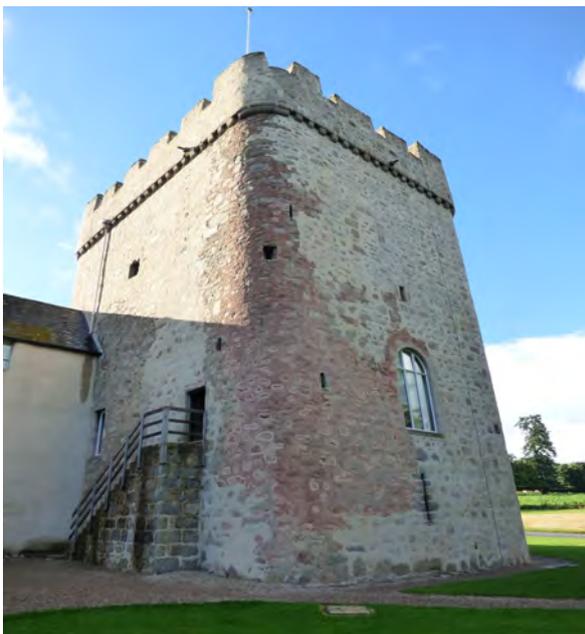
The pink area in Figure 4.2 is not a plume of damp but surviving areas of a 19th-century sneck harl. This exposed corner shows indications of retained moisture, leaching and spalling due to frost attack. There are also areas of retained cementitious pointing overlying and adjacent to the areas of disrupted pointing. It may be that its retention is contributing to the degree of saturation indicated at the areas of disrupted pointing.

Figure 4.2 View of the south-west faces of the tower, affected by localised cracking and spalling of the mortar.

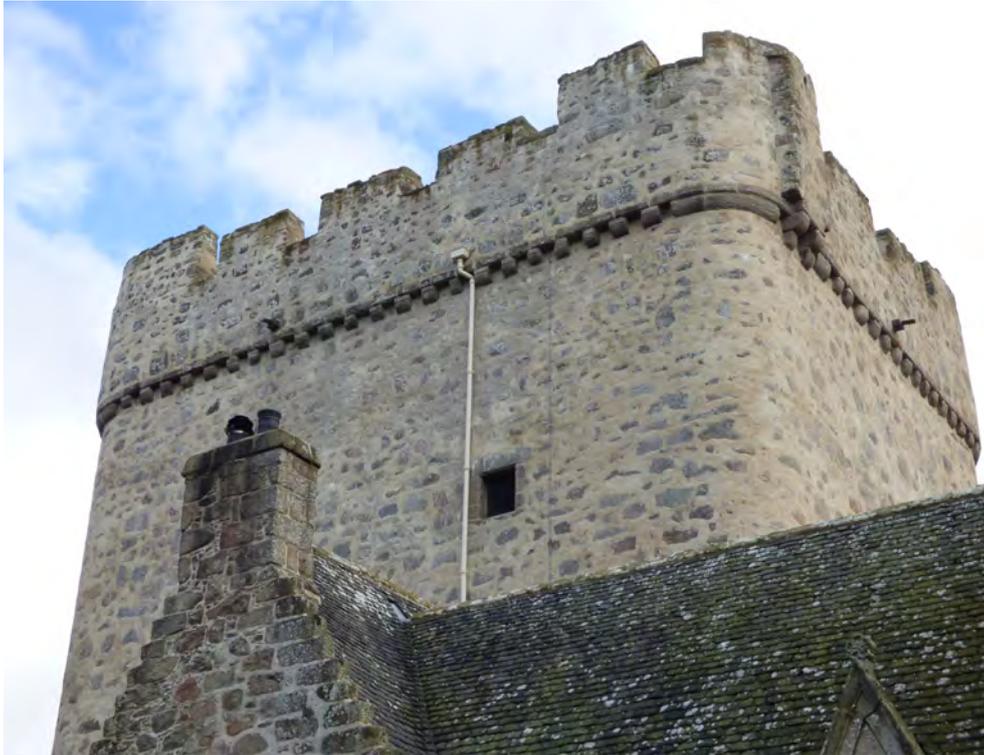
Figure 4.3 The east elevation of the tower, where the pointing appears to be performing well.

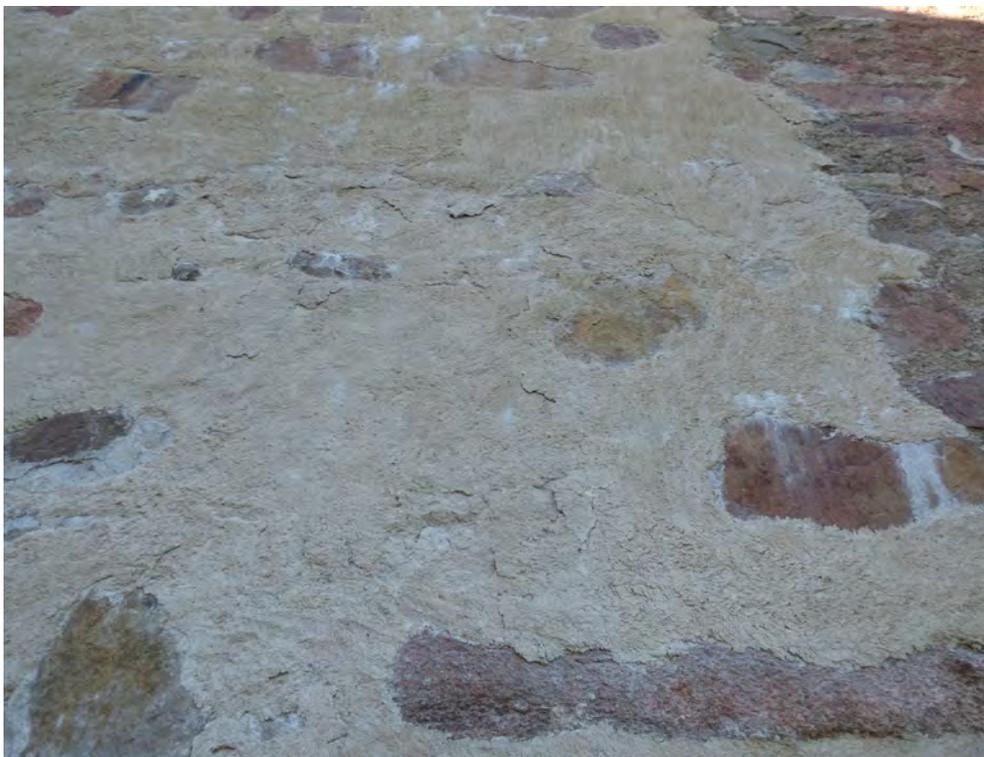
Part of the west wall has all the typical features of wet mortar affected by frost damage, causing failure. The leaching shows that the wall is still wet. This may be a consequence of poor parapet drainage or water being played down the wall from the spouts above.

Figure 4.4 Section of pointing on the west wall, where scaling mortar and leaching of lime were observed. This example is directly below one of the parapet water spouts and adjacent to a large section of retained cement based pointing work.

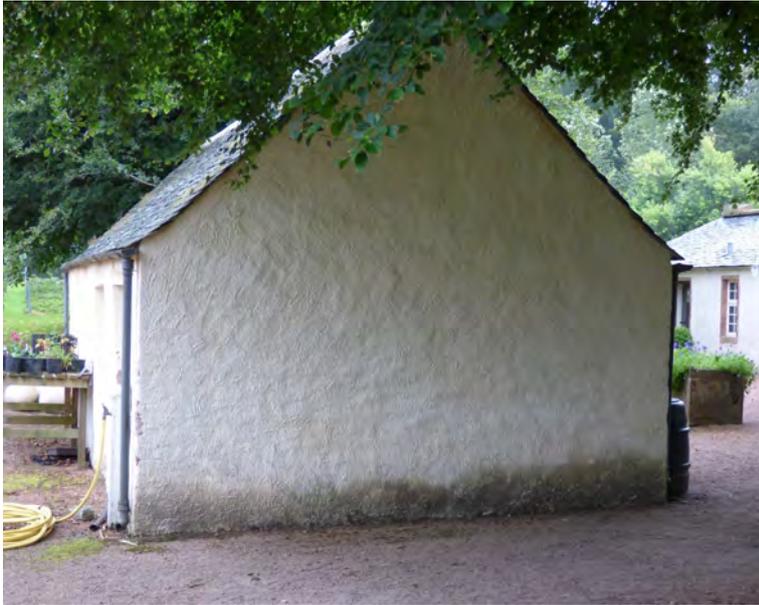
Figure 5.2 West gable, with the limewash and harling over most of the wall area in good condition. The exception is at ground level which is marked by soiling and wetting due to long term splash back from rainwater dripping from the roof.

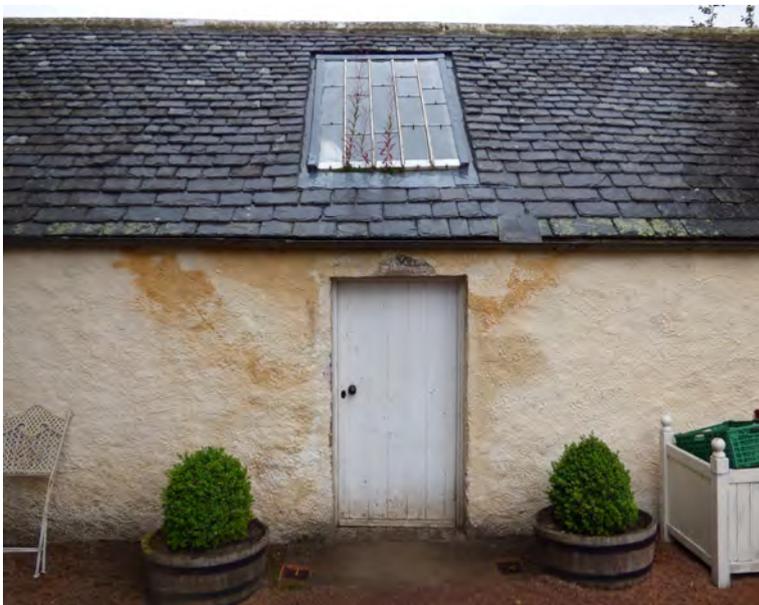
Figure 5.3 Rear elevation, with discolouration and some spalling from water damage. This is possibly caused by rainwater overtopping the gutters below the large rooflight.

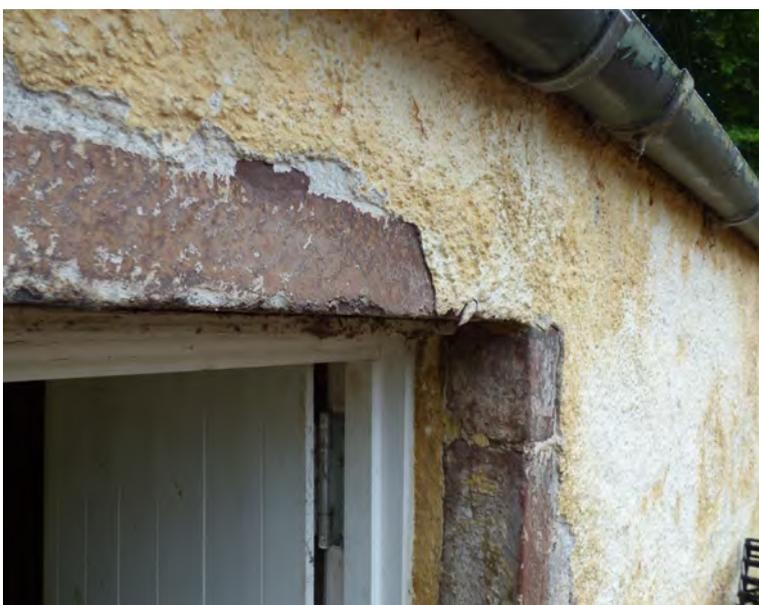
The loss of harl appears to have occurred where the harl was applied over the top of sandstone dressings at door surrounds and window lintels; in these cases the harl is typically less than 5mm in thickness. Where the harl was applied at a greater thickness over stone dressings it is still mostly attached. Discolouration of the limewash was observed, particularly where water run-off from the roof and cills was apparent. The building has not been re-limewashed since the date of the works.

The loss of harl over the doorway may be due to the nature of the stone. It is smooth with various paint coatings still adhered which may have prevented the harl bonding with the stone.

Figure 5.4 Loss of harl from the lintel and the sandstone dressings to the ingo at the east doorway on the front elevation.

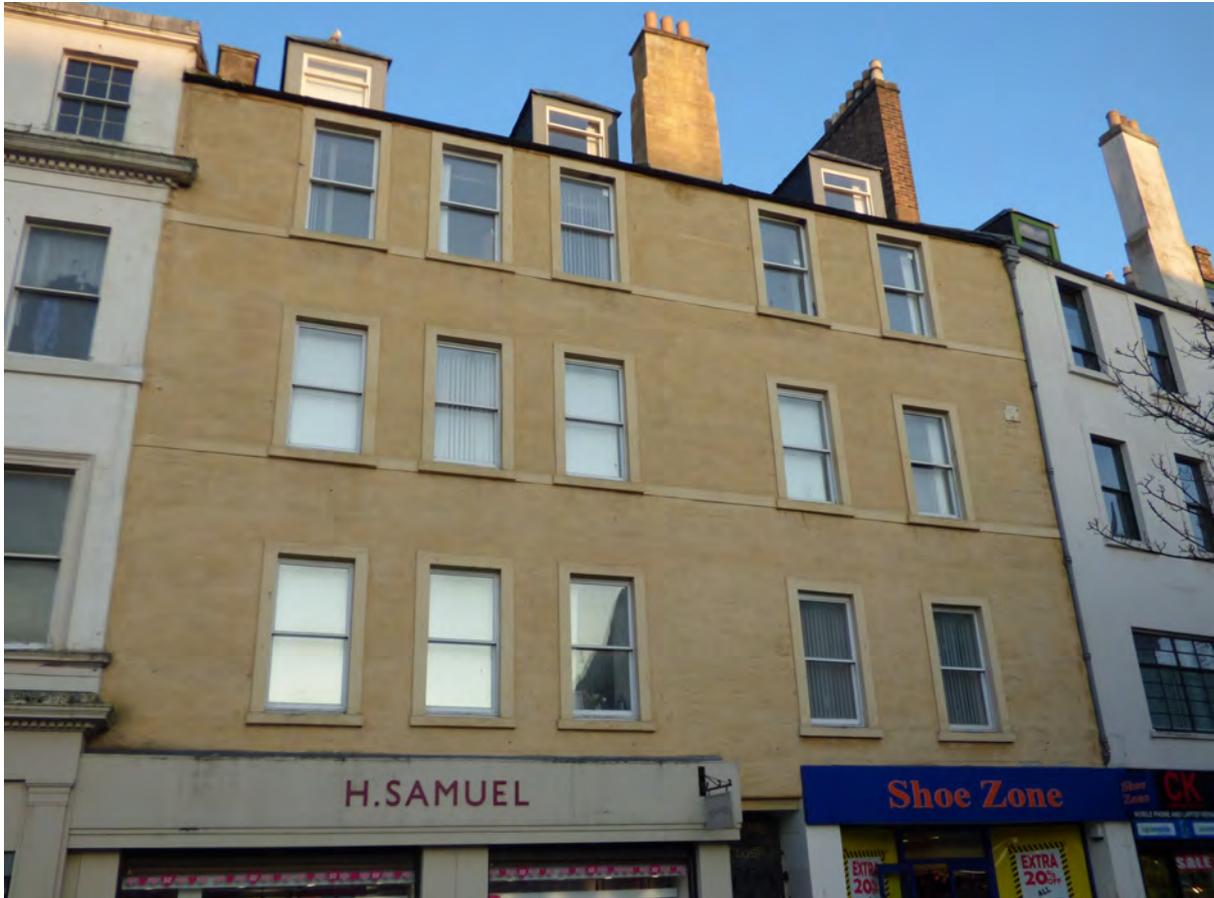
Figure 6.1 Front elevation showing the generally good condition of the harling.

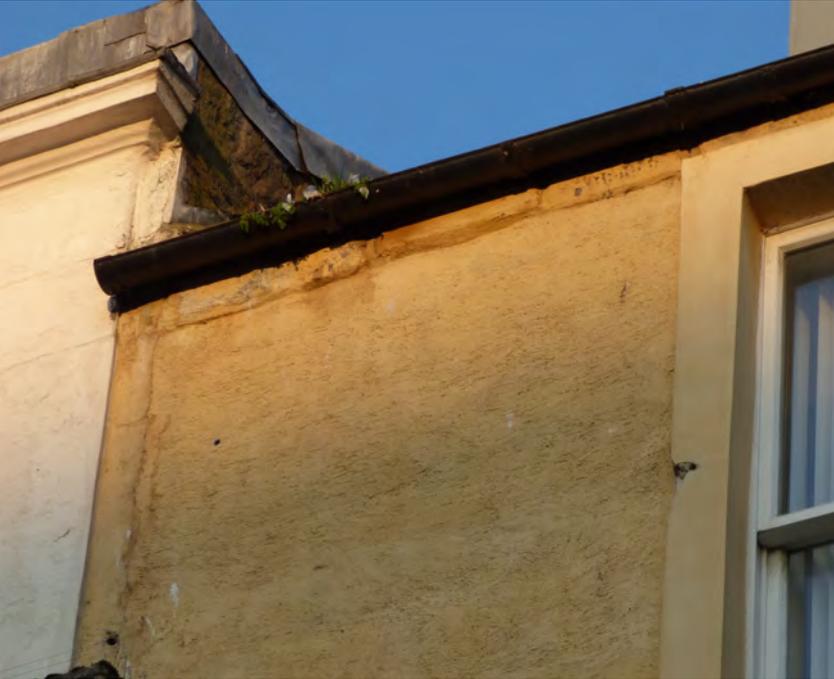
Figure 6.2 West side of elevation at roof level, showing some localised disruption of the harl from running water due to a blocked rhone.

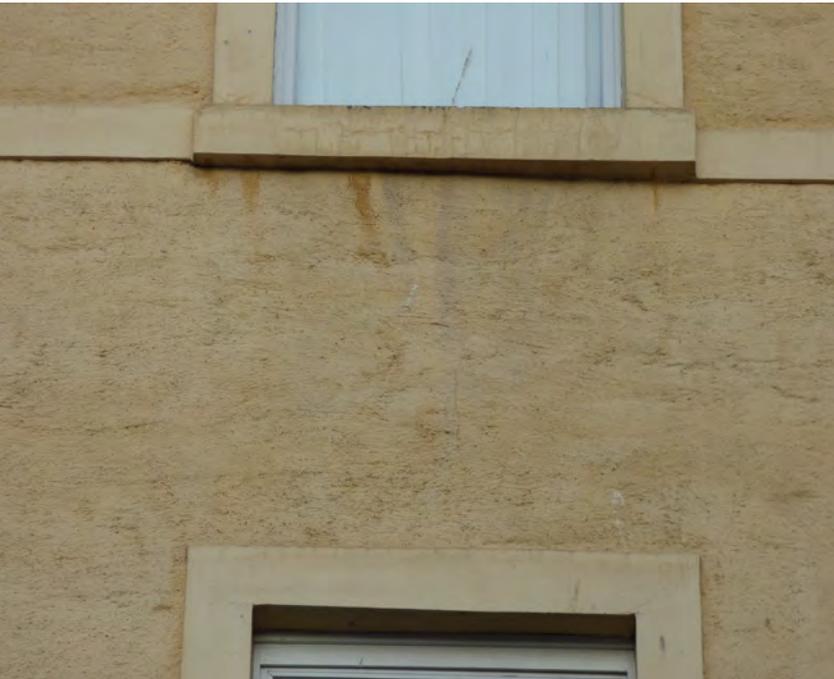
Figure 6.3 View of harl just above a first floor window, some faint horizontal cracking and discolouration of the limewash below the cill can be seen due to water draining over the cill.

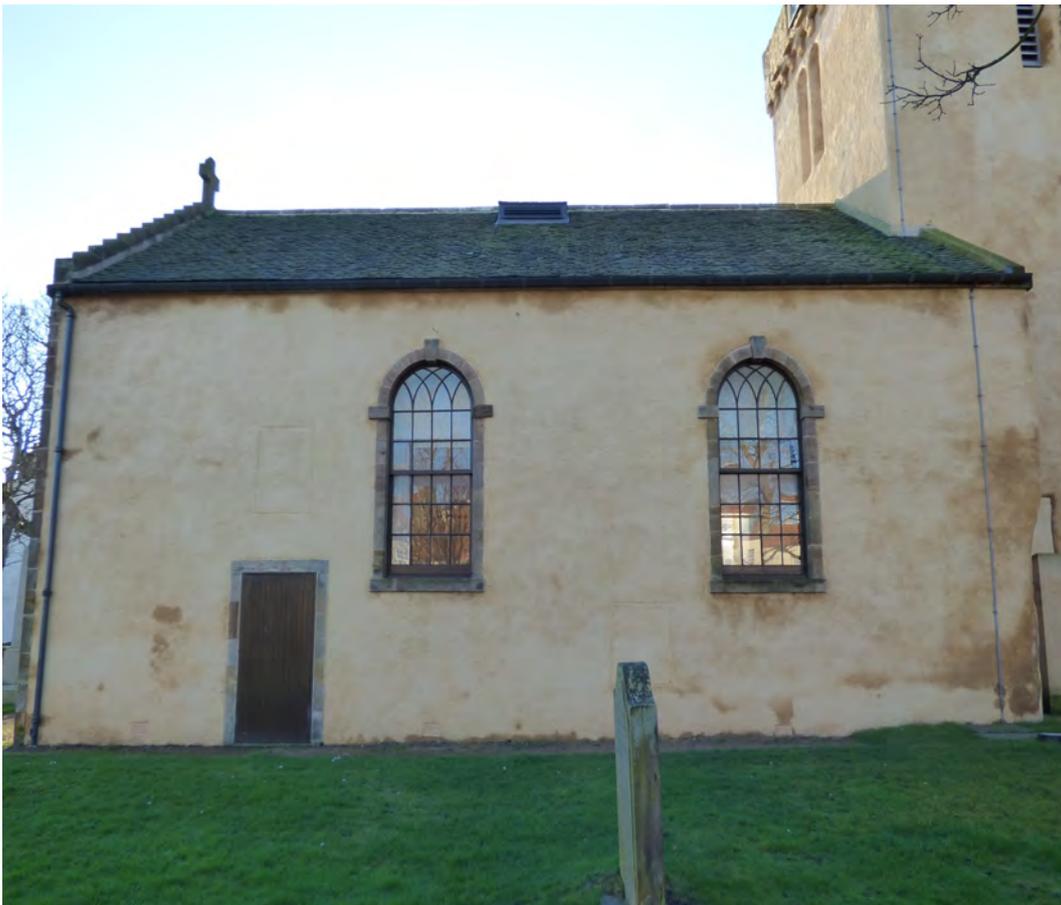
Figure 7.2 North elevation, where the harl appears sound and well bonded. Localised discolouration seems to be due to water run-off and from drying of the previously saturated walls.

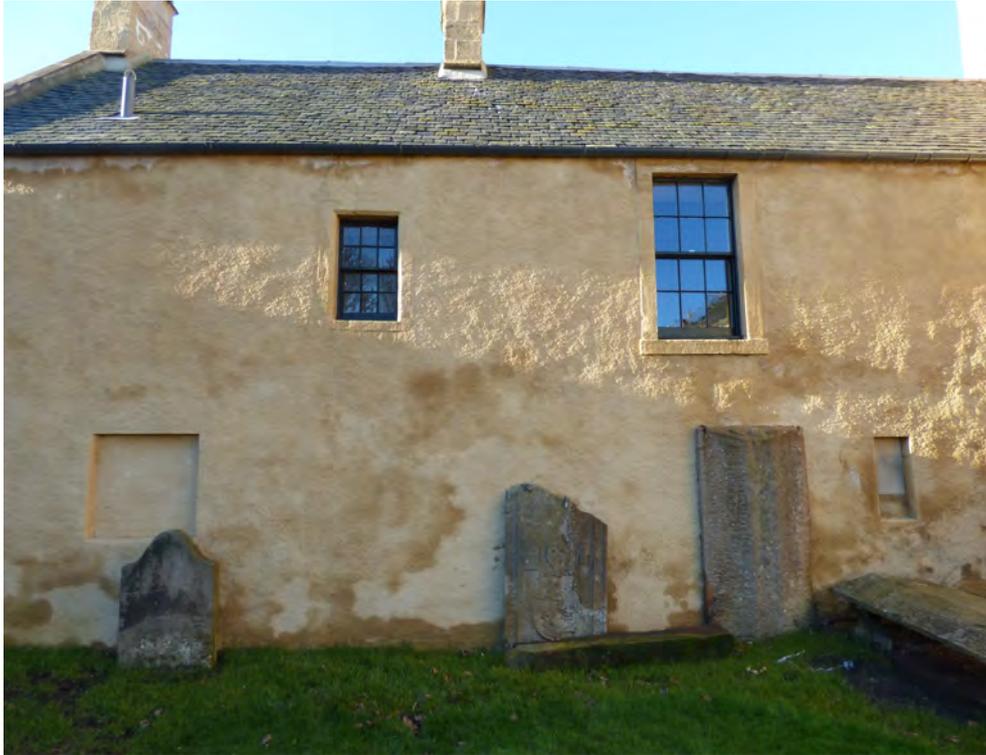
Figure 7.3 East elevation, which is generally in a sound condition, with localised discolouration of the harl, again due to both rising and draining dampness and the drying of the wall fabric below.

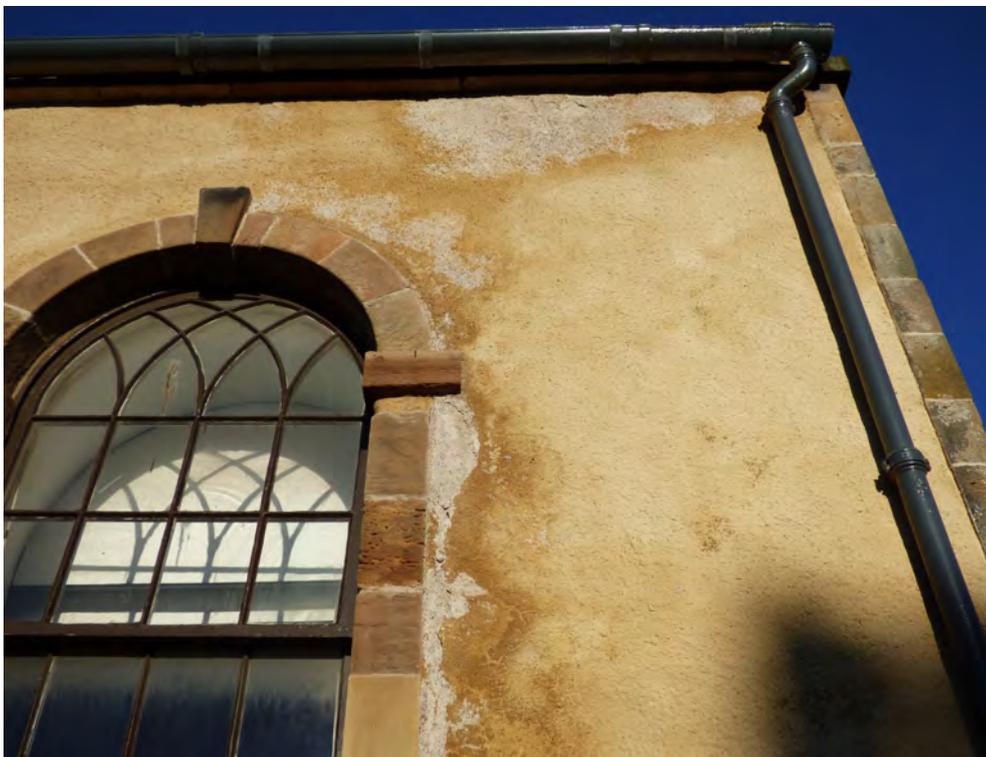
The harling and limewash on the south elevation (east end) of the church is suffering from a previous defect with the roof gutters. Channelled water flow down the wall face has resulted in erosion and damage to the harling. A similar pattern, but with a lesser degree of damage to the harling, can be seen to the west end of this elevation. However, the rainwater goods on this elevation appear to have been modified, possibly resolving the problem.

Figure 7.4 Close-up of the erosion damage at the east side of the south elevation, caused by blocked or poorly configured rainwater goods above, now rectified.

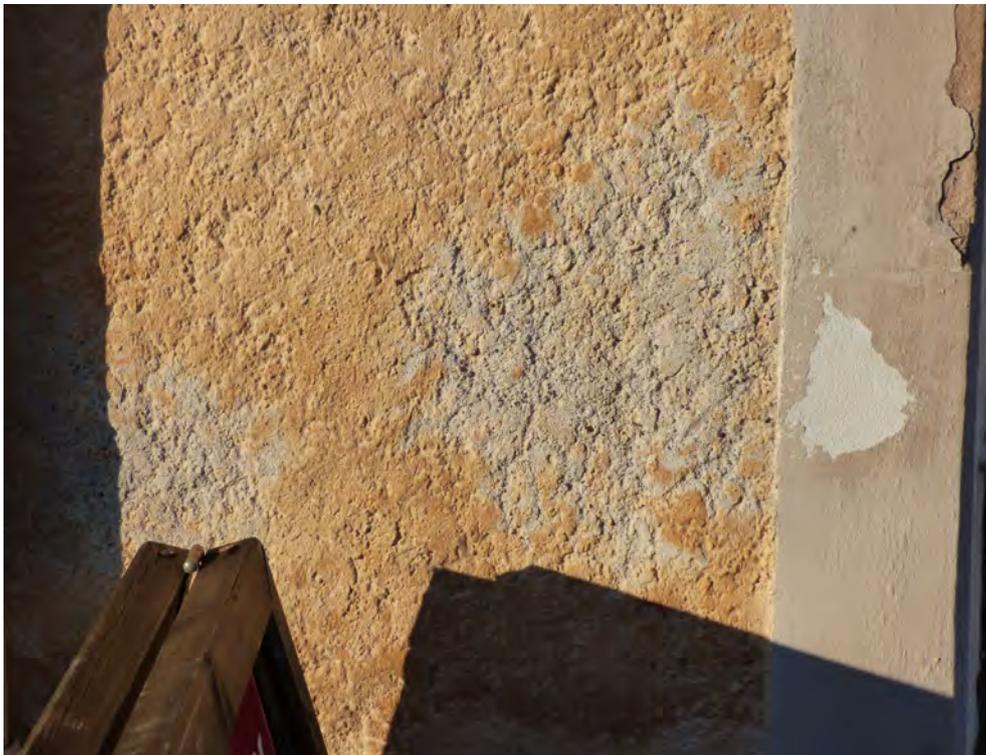
Figure 8.3. West side of the facade, at low level, where damage to the surface is evident. There has also been localised loss of the finish coat and limewash to the window dressing of the westernmost window.

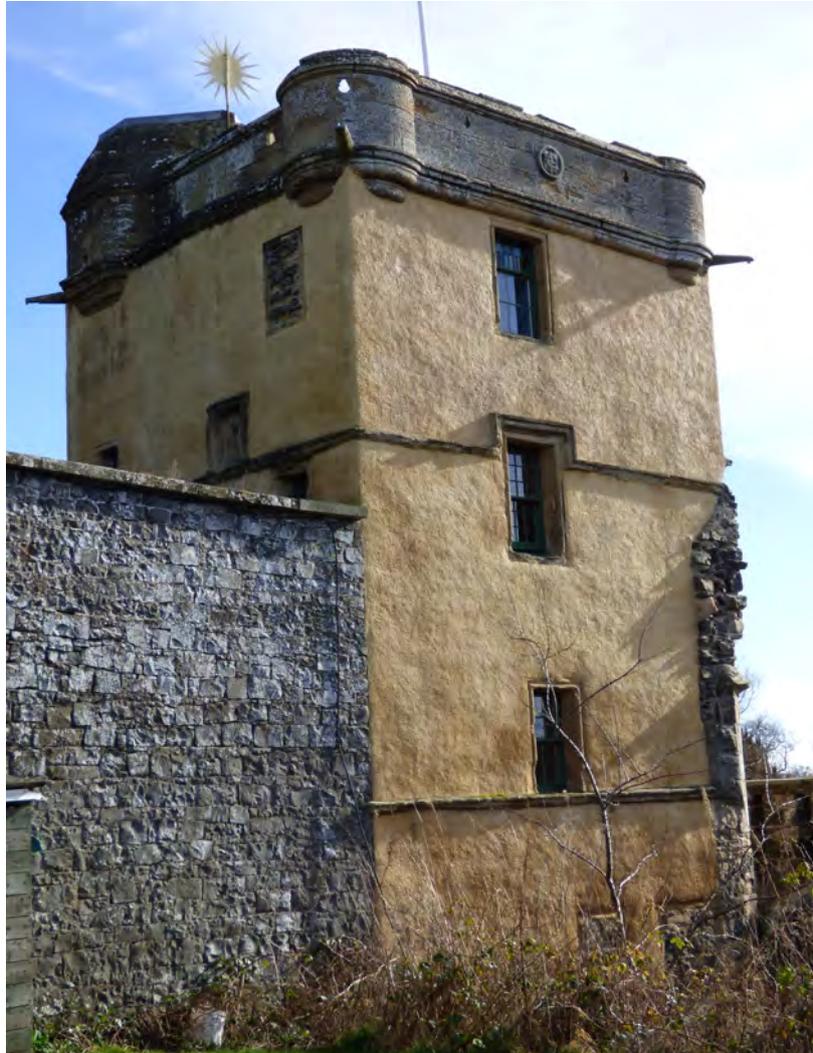
Figure 9.1 View of the west elevation of the tower, from the north-west, showing the slight colour variation in the limewash.

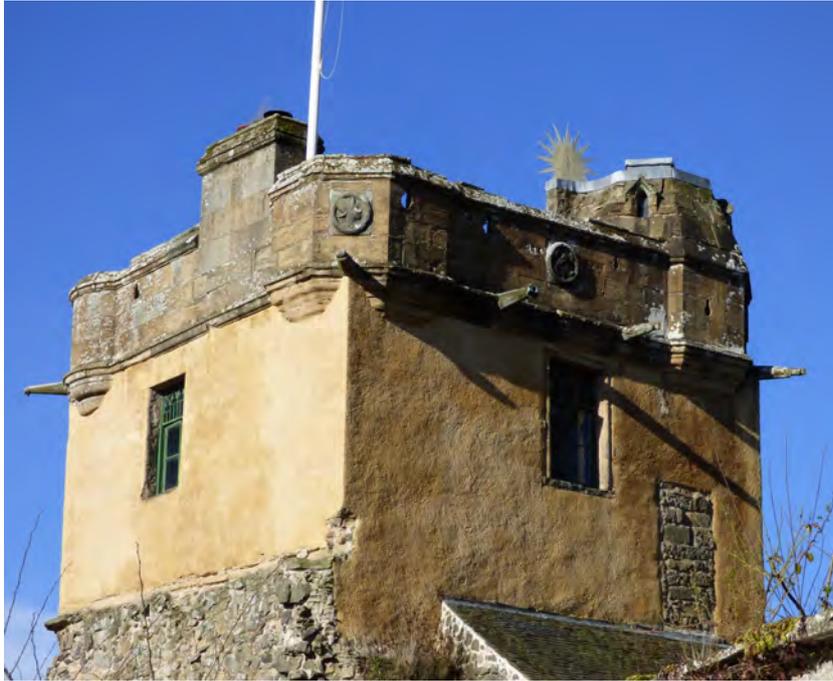
Figure 9.2 View of the south-east corner, with the localised area of disrupted harling apparent just below the string course on the north side of the east elevation.

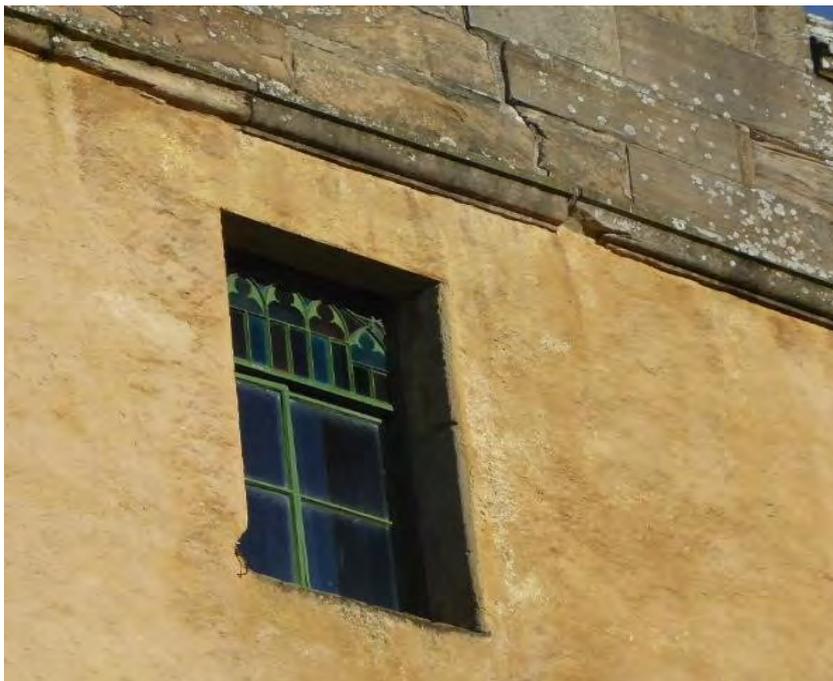
Figure 9.3 A close up of the upper part of the tower on the south elevation where a crack was observed below the chimney. Note the additional weathering below the open joint in the string course.

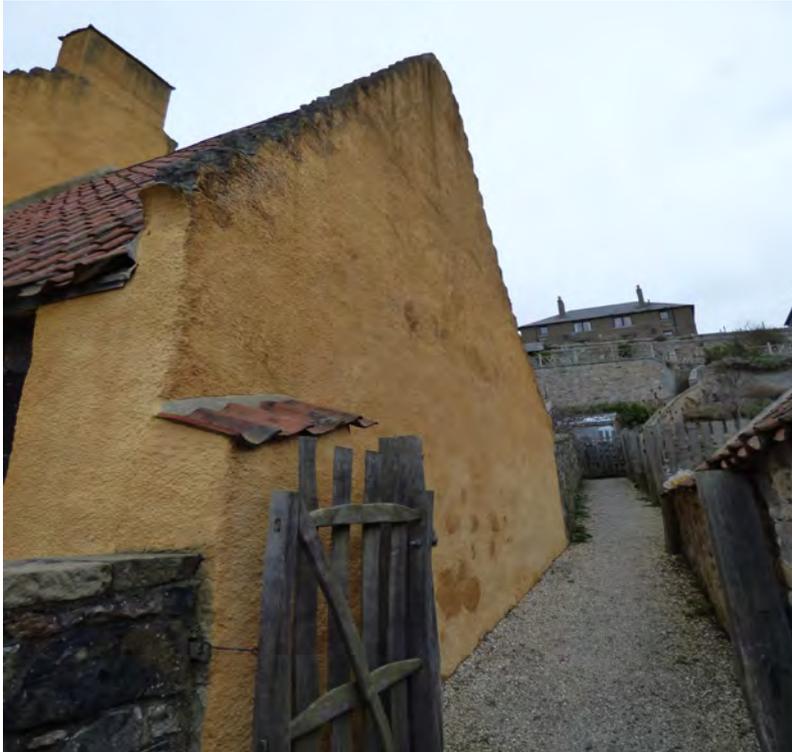
Figure 10.2 View of the east gable of the east extension. Staining at the crow steps is clear, as is blotching from salts within the wall lower down.

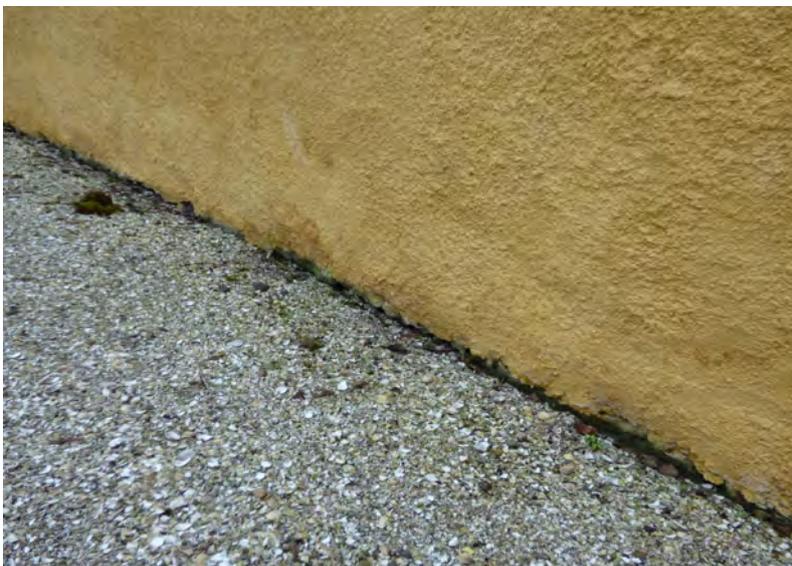
Figure 10.3 View of harl close to ground level. The harl has been terminated just above ground level to minimise wicking.

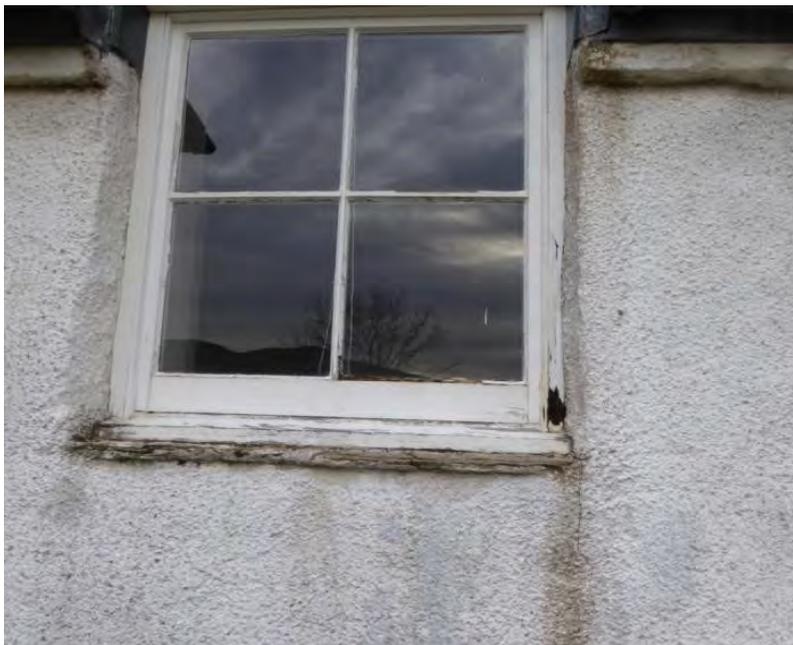
Figure 12.2 Window on the south elevation. The flaggy stone cill is deteriorating, as are all cills on this elevation, with a crack on the east side of window. Although there is evidence of channelled water flow over the cill, the underlying harl is sound and the limewash in relatively good condition.

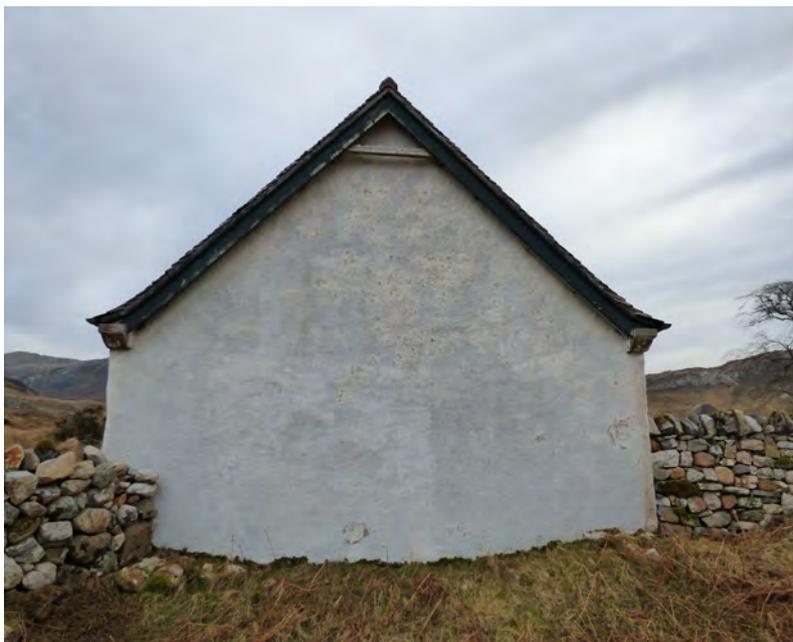
Figure 12.3 The lime harling on the very exposed west gable remains in good condition. There is some loss of limewash, which is to be expected due to the exposed nature of the site.

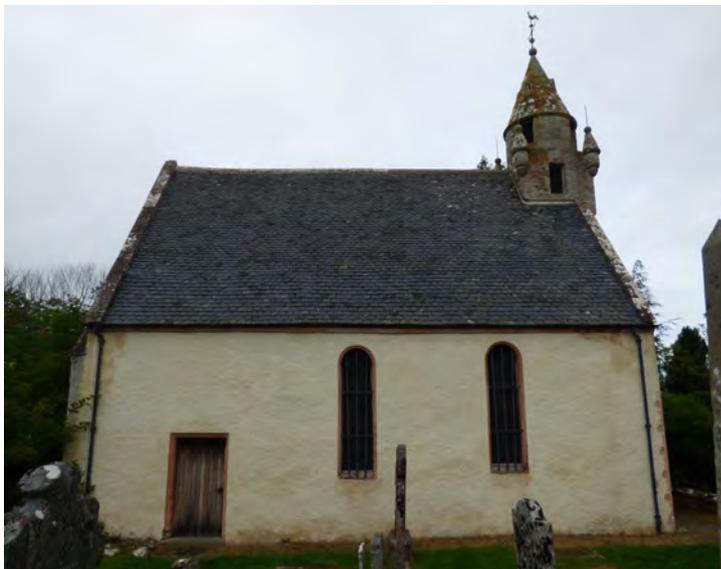
Figure 15.2 South elevation, showing the staining from water run-off below the cills and the damage from the overflowing of the rhones at the wall head.

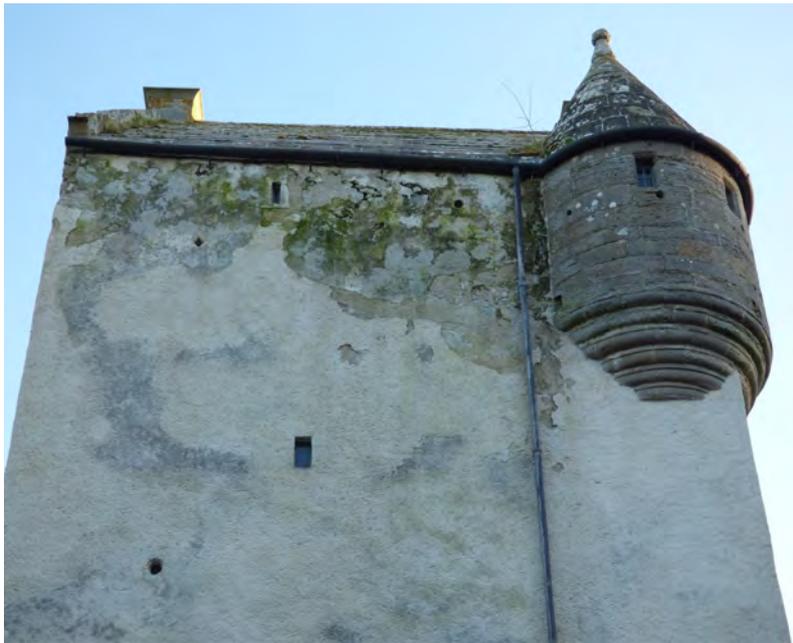
Figure 16.2 Extensive failure of the harling on the upper part of the north-west elevation, where there is total saturation of the wall head, probably due to poorly detailed rhones and a blocked downpipe.

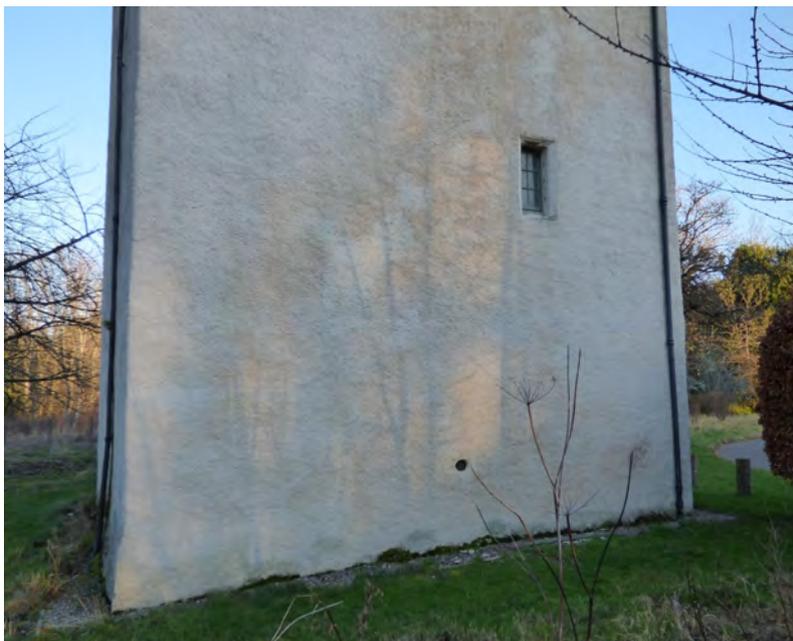
Figure 16.3 Base of the south-west elevation showing the harling and limewash to be in good condition.

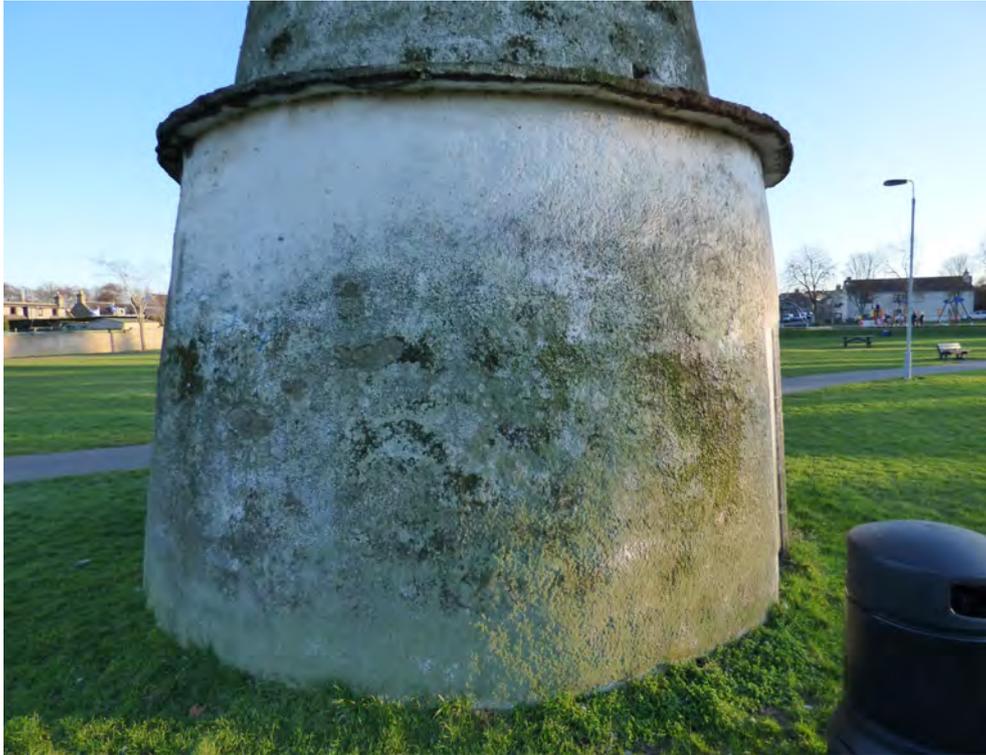
Figure 17.2 North side of the doocot showing the generally sound condition of the harl.

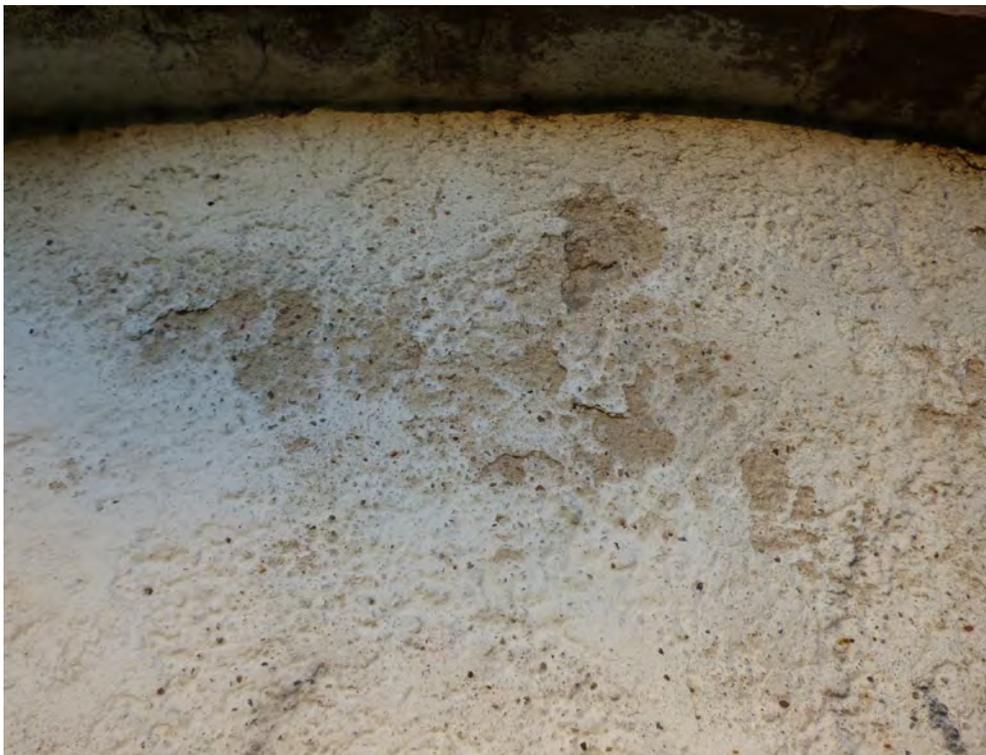
Figure 17.3 Localised erosion of the surface just below the lower stone rat ledge on the west side.

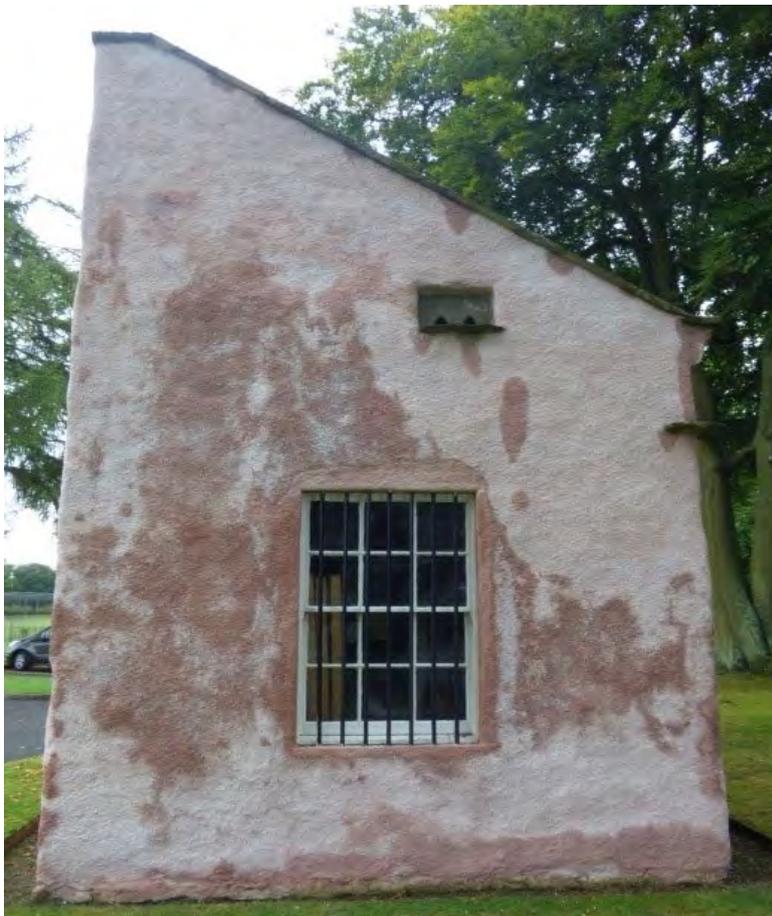
Figure 18.2 View of the west gable, showing extensive discolouration. This is mostly due to insufficient overhang on the skew cope above, and wind driven rain having recently played on the surface.
