TECHNICAL PAPER 29

REVIEW OF HOT-MIXED EXTERNAL LIME
COATINGS IN SCOTLAND 1997-2016

HISTORIC
ENVIRONMENT
SCOTLAND

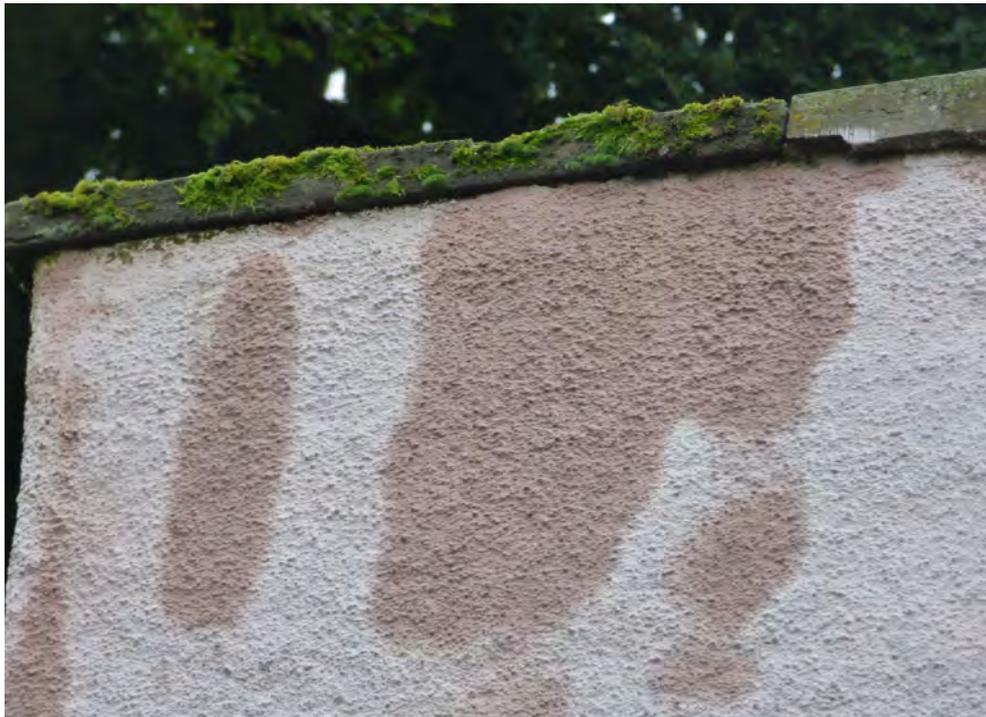
Figure 18.4 Close-up of the copes on the north elevation, east side, supporting moss and algae, demonstrating that they are holding moisture. The affected copes also display localised loss of fabric. An open joint can be seen in the cope, shown in the upper right side of the image. Water is draining through the open joint, flowing along the wall head below the cope and draining down over the harl below. There is the additional possibility that moisture is accessing the wall head at this location and wetting the wall behind the harl.

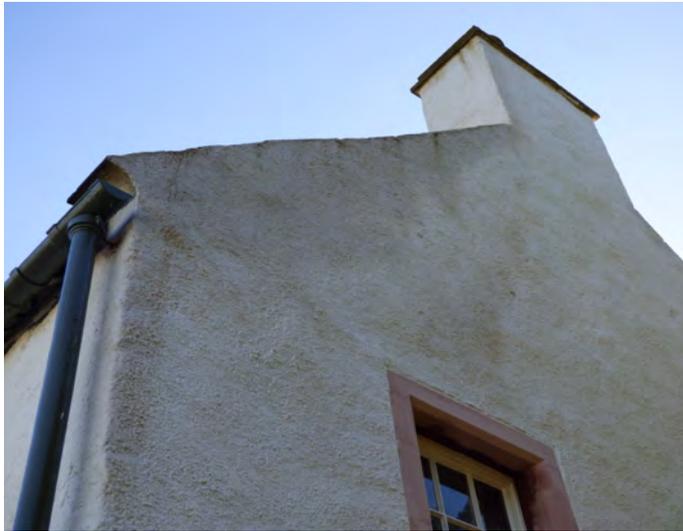
Figure 19.2 Evidence of rainwater wetting the wall below the north skew on the west gable, where water is running off the skew copes onto the gable.

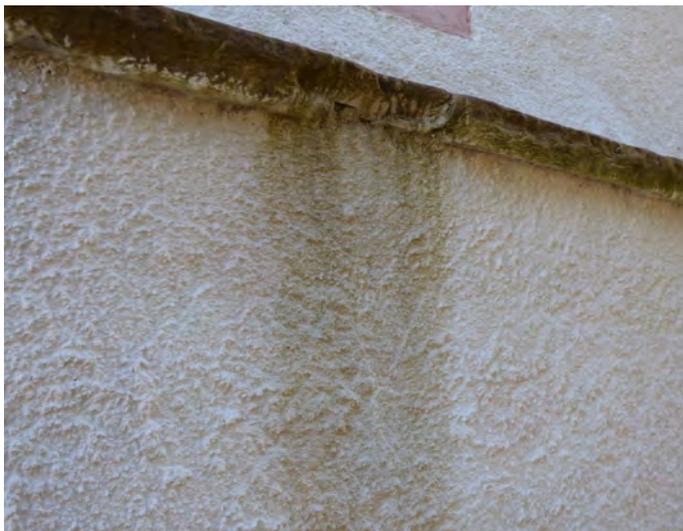
Figure 19.3 Staining of the harl of the stepped extension on the west gable, where the drip detailing is damaged or insufficient.

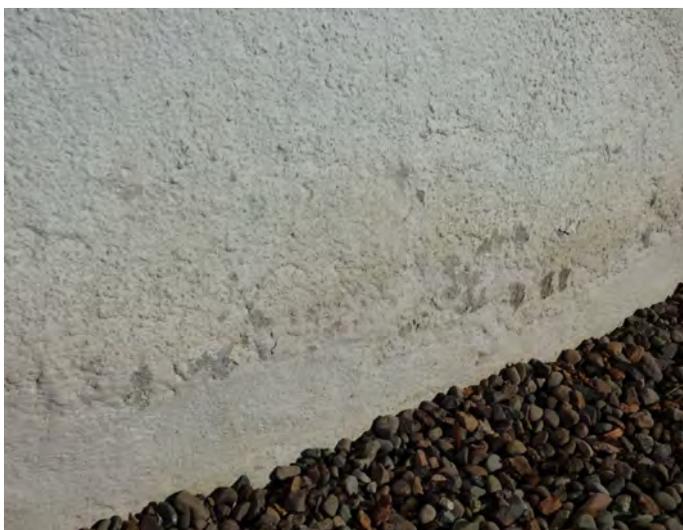
Figure 19.4 Localised spalling at low level in this area of repair.

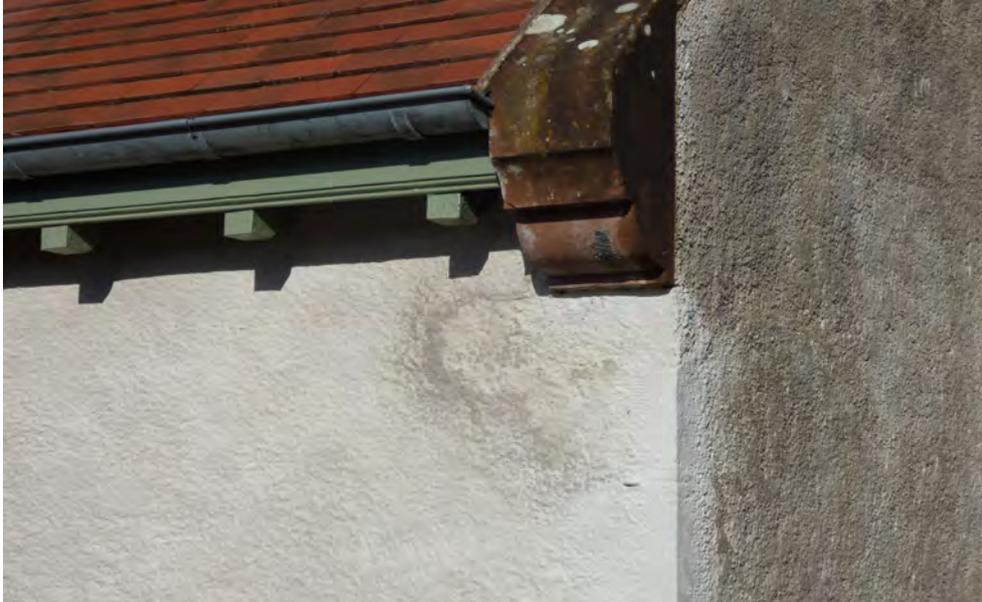
Figure 20.2 View of the skew putt on the south-east corner, which shows some minor staining of the limewash due to water run-off from the skew putt.

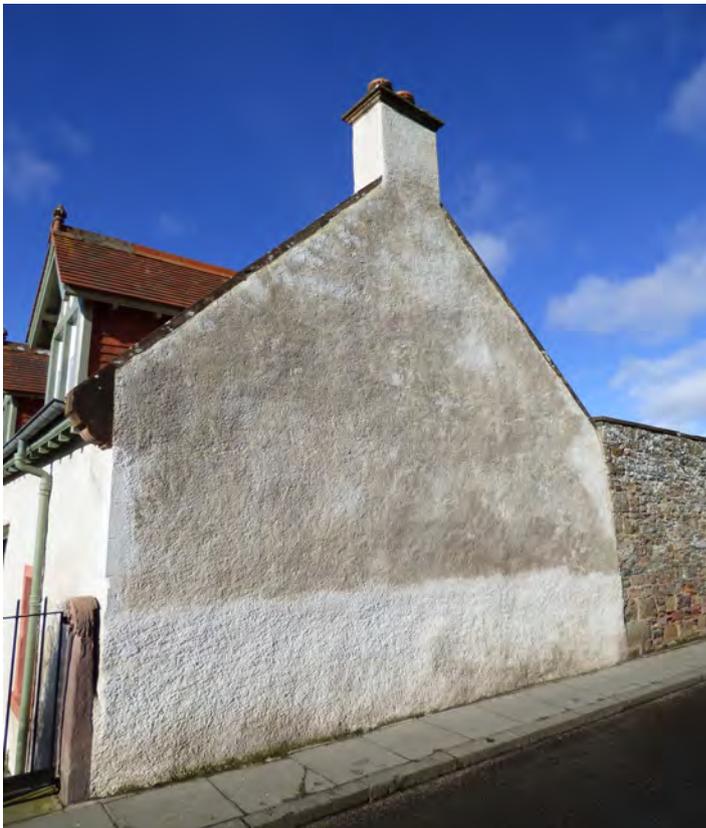
Figure 20.3 View of the east gable, showing the effects of a recent wall coating at lower levels.

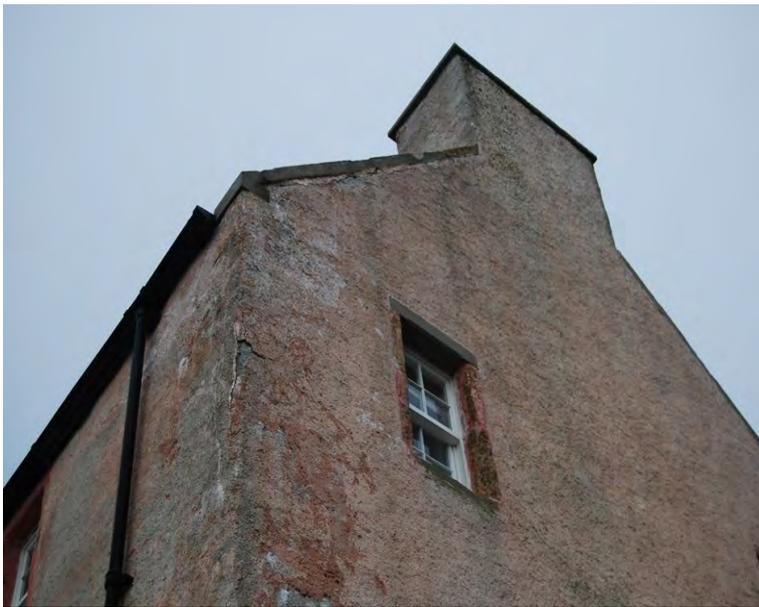
Figure 22.2 South-west corner illustrating a number of defects to the harling; cracking and localised detachment of harl, localised lime leaching and partial loss of limewash.

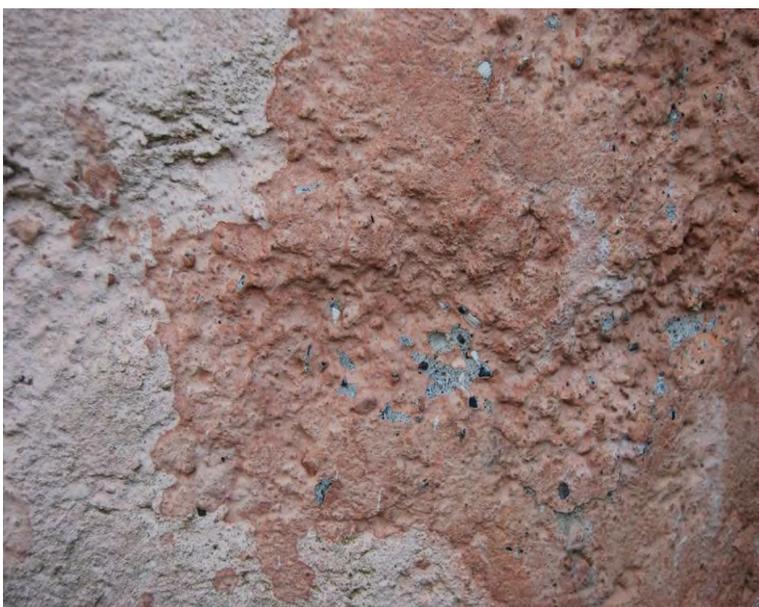
Figure 22.3 Detail of harling and limewash, with localised area of weathering/decay exposing underlying harl. The shell fragments can be seen in the harl finish.

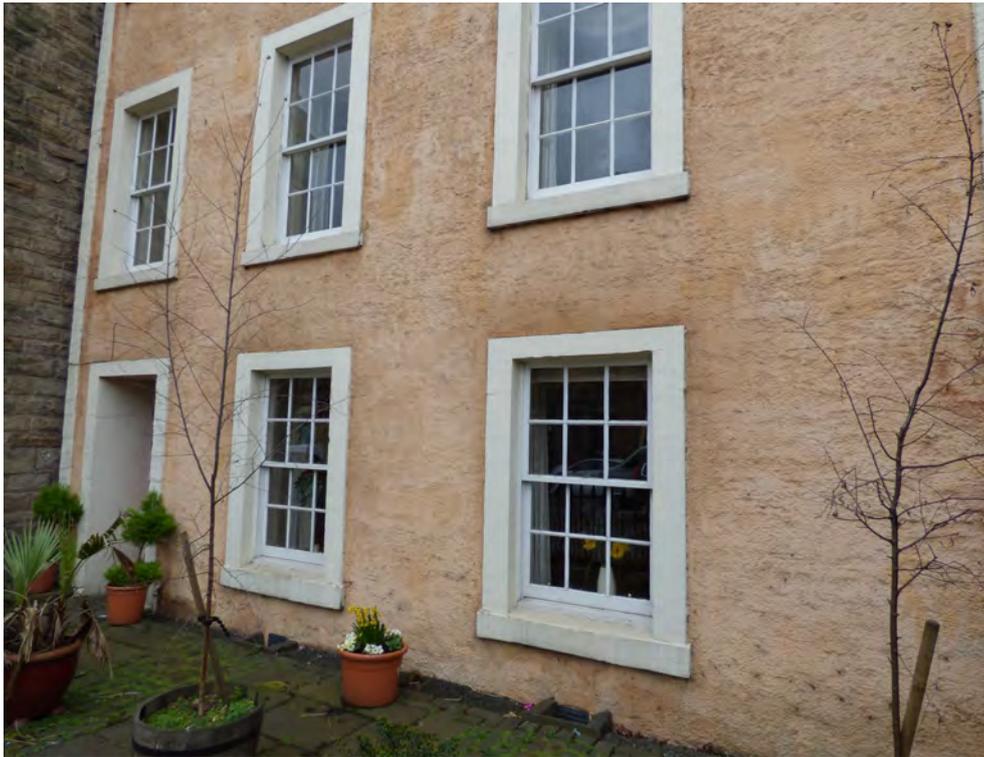
Figure 23.2 General view of the ground floor elevation, showing intact harl.

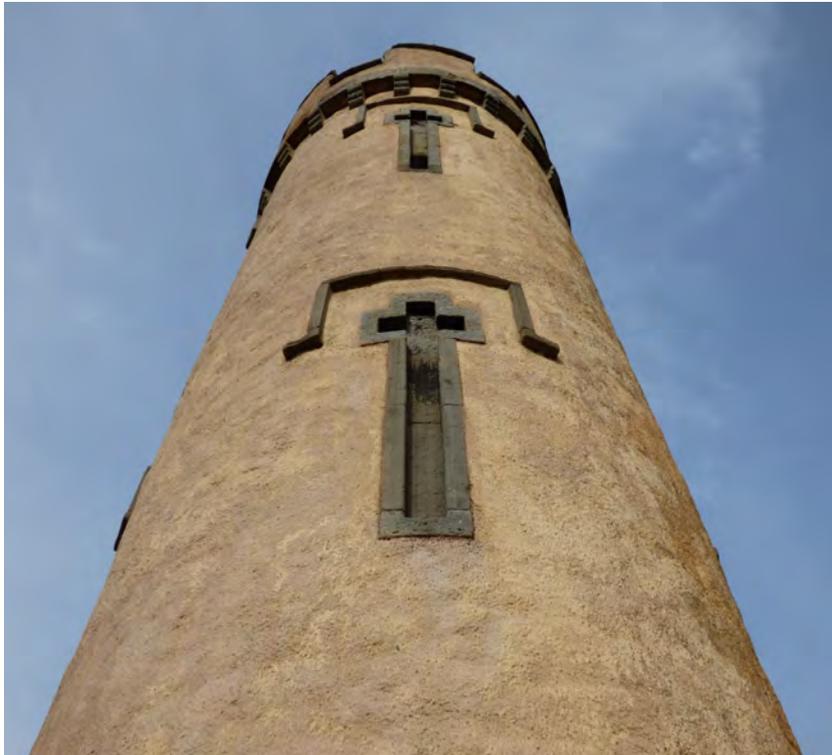
Figure 24.2 View of the upper part of the east elevation showing the weathering and the discolouration of the limewash on the north (right) side of the tower. This side has the most colour variation.
