REFURBISHMENT CASE STUDY 29

FALKLAND HOUSE STABLES FIFE

MAINTENANCE AND ADAPTION WORKS

MAINTENANCE AND ADAPTATION WORKS

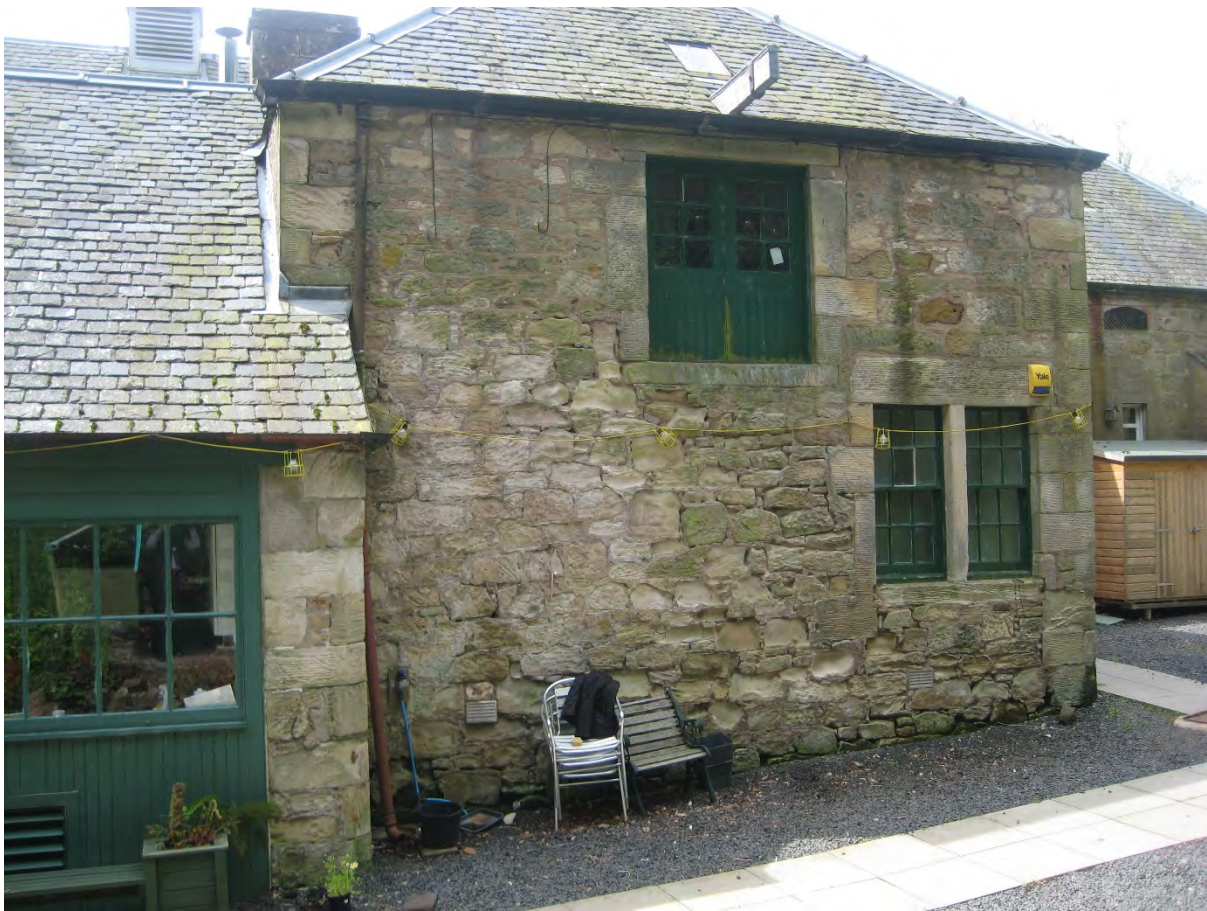
Figure 1. View of the north elevation of the stable block where the works took place. Note the poor condition of the stonework at lower levels.

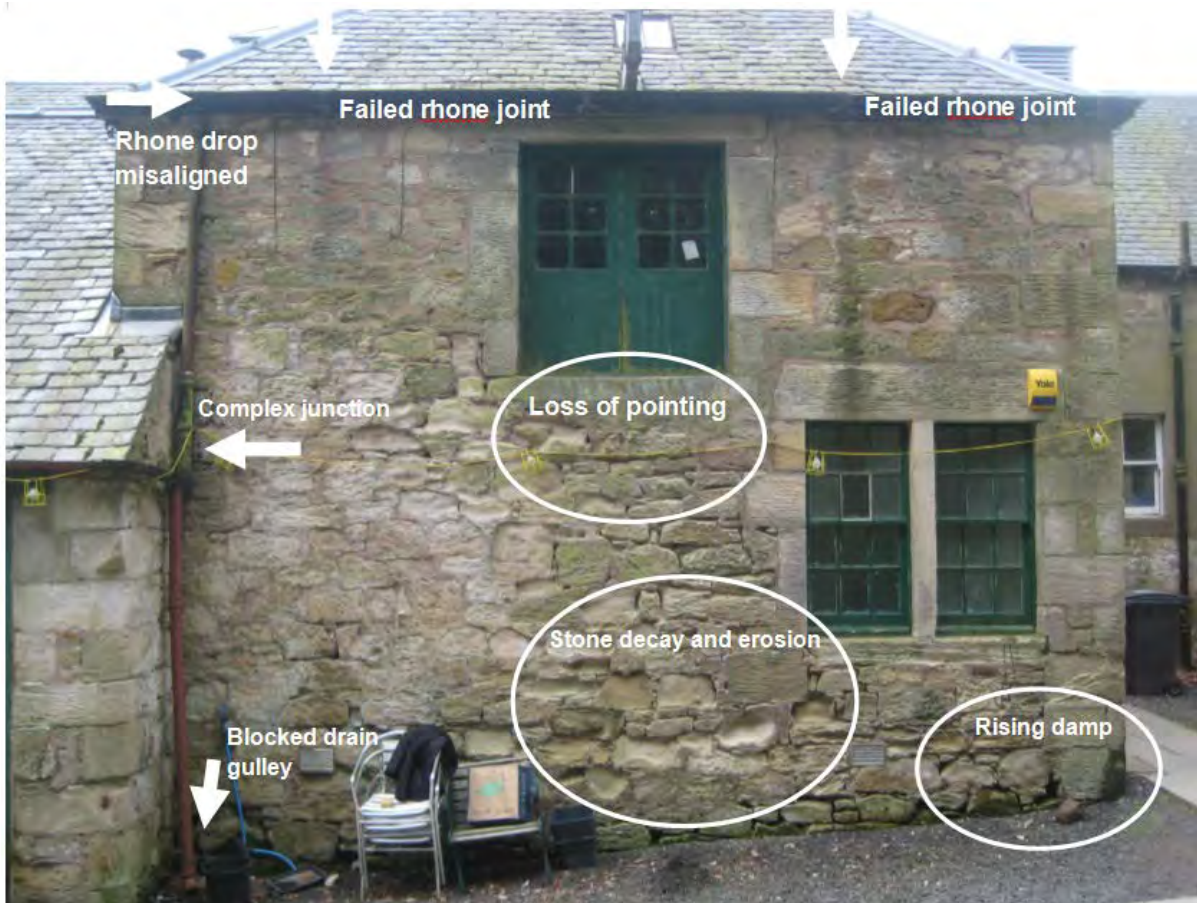
The works of 2009 included work to the profiled cast iron rhones but these were leaking at the joints. The run, or 'fall,' that governs the direction of water flow was inconsistent, while the connection with the downpipe was undersized and did not meet the downpipe. These defects (Figure 2) meant that the wall masonry was saturated for extended periods following rainfall. The rainwater disposal arrangements had evolved in a haphazard fashion and resulted in a complex series of junctions of various sized cast work. A single downpipe was taking run-off from both the stable roof to the right, but also from the workshop roof to the left - a considerable volume of water. The outflow discharged arbitrarily, missing the entry point for the below ground drainage.

A former hayloft entrance had been renewed in timber to a good standard, but water run-off from the timber and glazed areas was causing damage to the masonry below. This was exacerbated by the additional water from the leaking joints in the rhones. The masonry needed to be protected from this run-off by a new lead drip, chased into the joint below the stone cill of the hayloft opening.

Figure 2. The stable block elevation - key defects from water overflow and leakage are marked in white.

The profiled cast rhone had been replaced in the 2009 works, but it appeared that the joints had either failed quickly or had not been installed correctly. Inspection by staff highlighted that the jointing compound, a linseed oil putty, had deteriorated. Cast iron rhones are subject to thermal movement and therefore a flexible jointing compound, or 'plumbers mait,' was selected as a better material to absorb this movement. The defective junction with the downpipe was repaired with a larger lead sleeve. The workshop roof was given a new downpipe on the left hand side, removing the need for the complex junction with the stable roof downpipe, and reducing the intake to the existing downpipe.

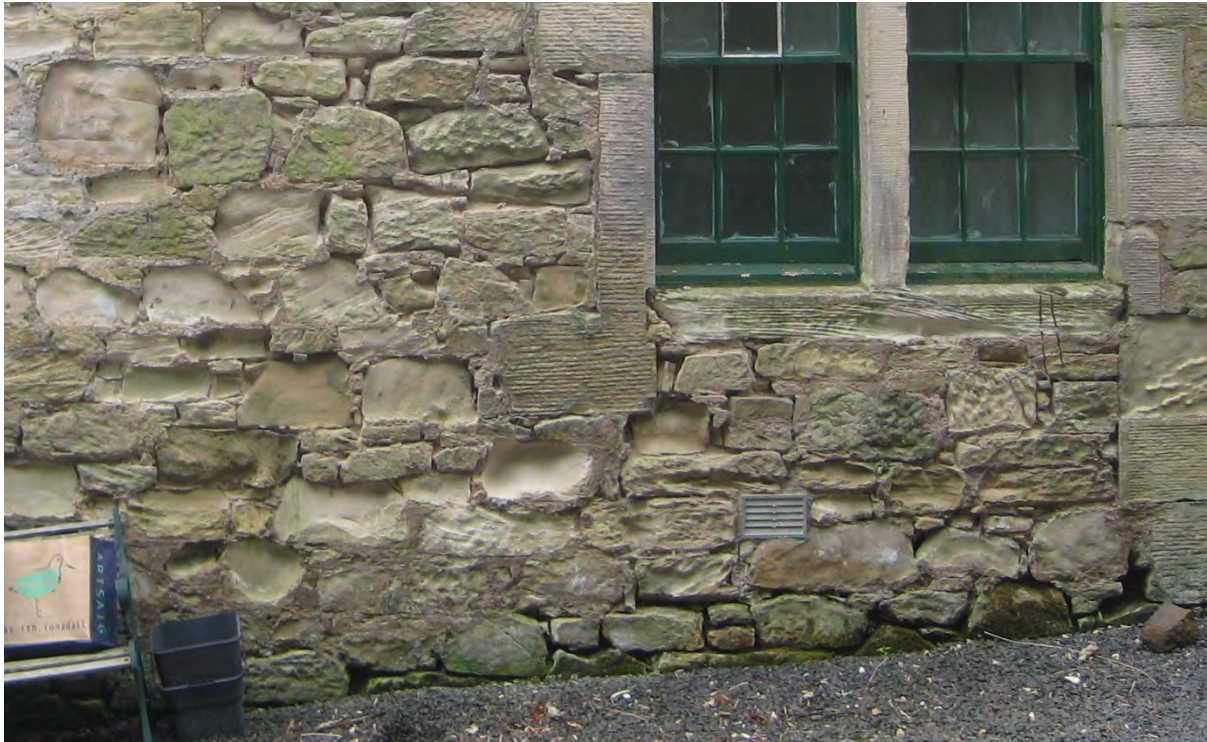
There was extensive loss of the mortar pointing, and erosion of the sandstone masonry (Figure 3). All materials will suffer if subjected to increased water saturation and in this case the relatively soft sandstone is showing such effects. The cause of the deterioration had been much deliberated in the past, with complex and costly masonry repairs proposed. However, without first identifying and rectifying the root cause of the problem it is inevitable that any repair works would be unsuccessful and at risk of early failure.

Figure 3. Extensive stone decay at the lower part of the wall. Greening of the masonry due to damp at the base of the wall can be seen bottom right.

The lime mortar of the wall core was damp to touch and areas of the surface mortar supported moss and algal growth (Figure 3). This can indicate continuously wet masonry and sometimes a high nitrate content.

The reasons for the damp were likely caused by a combination of factors. The re-worked ground had been raised a few inches and covered with a non-woven geotextile layer (permeable membrane), which had trapped a layer of fine sediment or soil on the upper side. This hindered the natural drying of the ground. Secondly, a new internal concrete floor did not allow vapour dispersal across the whole floor area, resulting in concentrations of moisture in the wall footings. The presence of green algae and moss in the joints also suggested that the moisture coming through may have had a higher than normal nitrate content. This might indicate drain water coming from a leak in a grey or sewage water pipe, the subject of recent works, or nitrate salts leaching from the soil.

The criteria for stone replacement was based on if the stone had weathered back more than 25% of its depth and if the stone was not considered robust enough to last until the next major maintenance cycle. Using this criteria, only two eroded stones were removed and new sandstone from the Estate stocks were cut and dressed to fit.

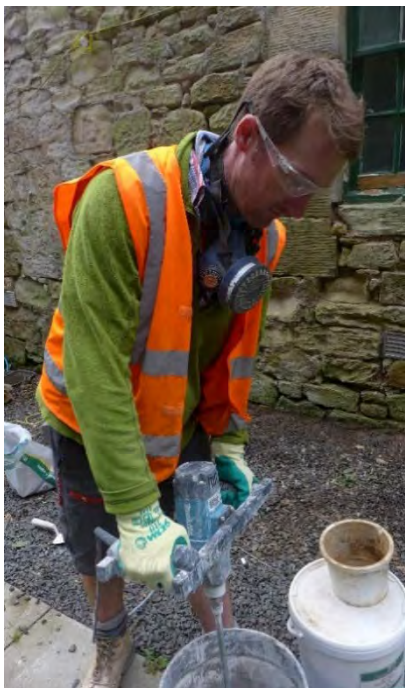
Figure 4. Trial mixes being prepared using a hand-held mixer.

It was decided early on to test various additives in a hot-mixed lime mortar to achieve the best visual and performance match. A hot-mixed mortar is prepared by mixing quicklime with aggregate and water, which produces heat. A mortar analysis was not carried out as the existing mortar was not believed to be original and one of the objectives of the trial was to empower the contractor to make an informed judgement on the mix whilst guided by HES. Trial mixes were based on one part quicklime to three parts sharp sand, with the addition of brick dust (trial 1) and crushed shell (trial

2) made in small test batches using a hand-held mixer (Figure 4). From visual analysis of other original mortars throughout the Estate, this was considered to be fit for purpose, both technically and aesthetically. The methodology for the repair of the pointing sought to replicate a flush point in the style and finish of the existing work, including the use of pinnings (small stones used to pack out the joints). This style is common in Scotland and examples are found in other parts of the Estate. The sharp sand was supplied in a ton bag from the local builders' merchant. The quicklime, crushed brick and shell came from a specialist lime supplier.

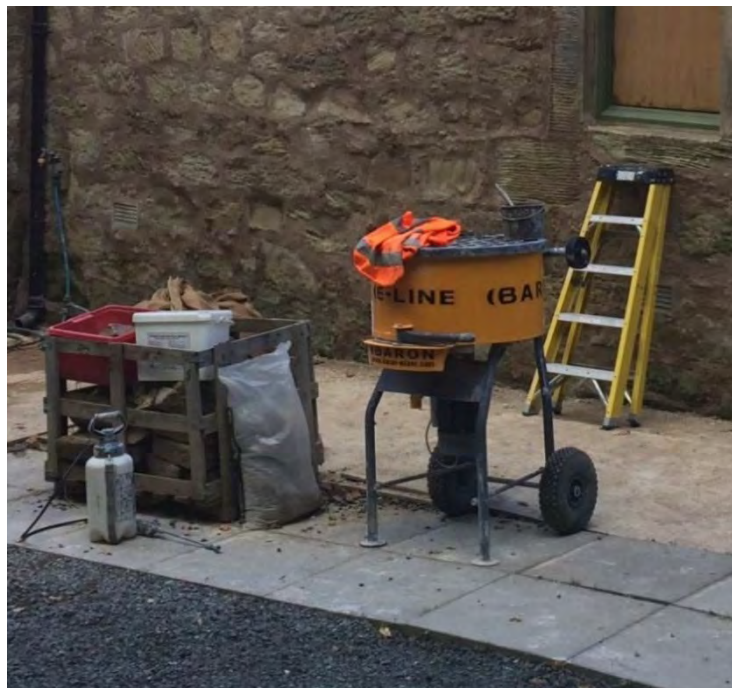
Figure 5. The small forced action mixer used for the preparing the hot-mixed lime mortar.

The contractor was familiar with lime mortars but not experienced with hot-mixed lime mortars, and was given instruction by HES staff before the pointing work began. The instructions given can be found in Annex A. Batching of the bulk of the mortar was done with a small (20 litre) electric forced action mixer (Figure 5). The contractor was quickly able to judge water content and produce good, consistent mortar.

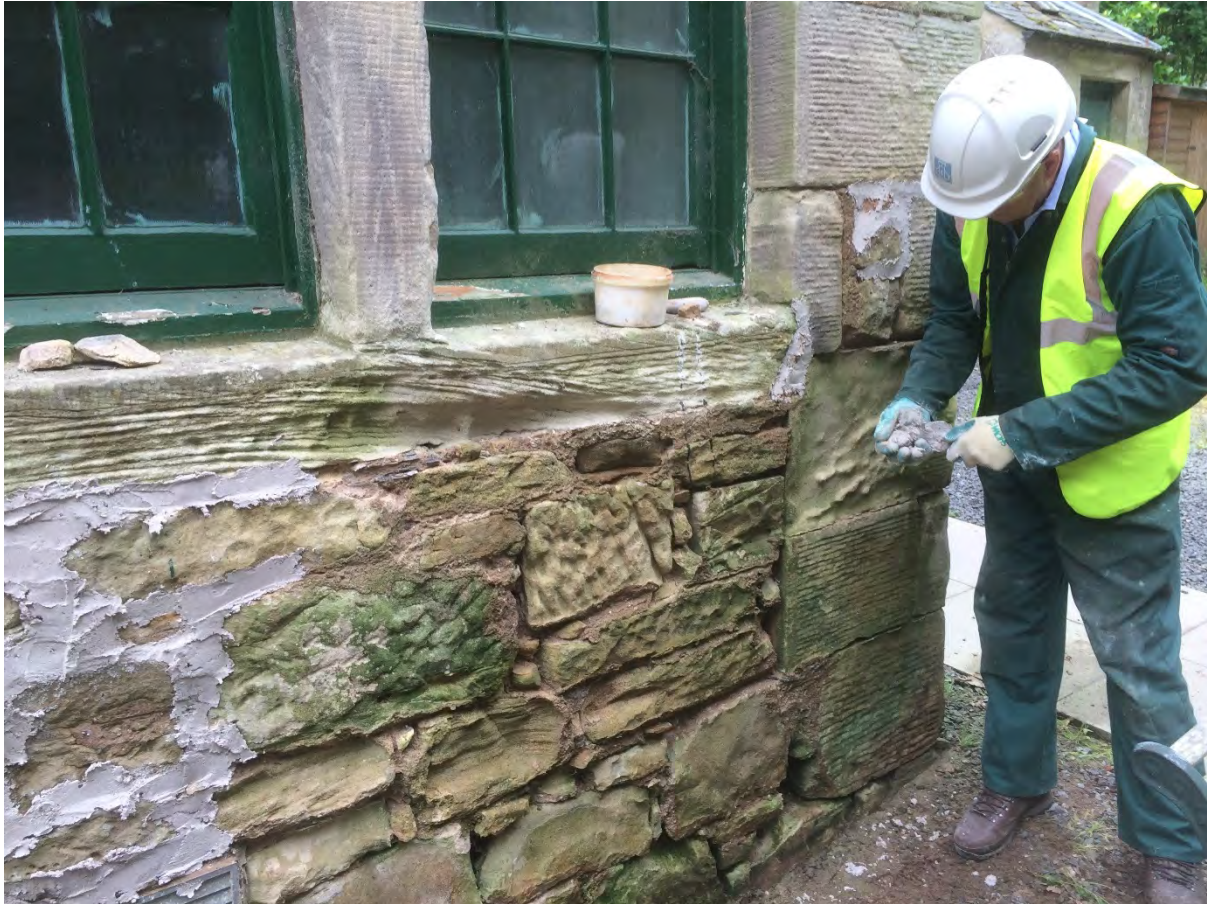
Figure 6. Re-pointing the wall with hot-mixed lime mortar.

Previous areas of cement pointing were removed and the wall brushed down before being re-pointed (Figure 6). The trial mortars with different additives were applied first, with two small areas below the window selected for testing. The first trial mortar had brick dust added at 10% and the second had crushed shell at 15%.

Brick dust and crushed shell are both traditional additives for lime mortars, probably used historically to initiate a quicker set. Both mixes took an initial set after four or five hours, and were pressed back to close any shrinkage cracks. The brick dust had little apparent effect on the curing time, which was not really discernible in site conditions¹. The crushed oyster shell, however, gave a good texture and final appearance to the mortar. It also seemed to give a slight improvement in setting time and the stiffness of the initial set. Therefore, it was agreed that the shell mix would be used for the remainder of the work.

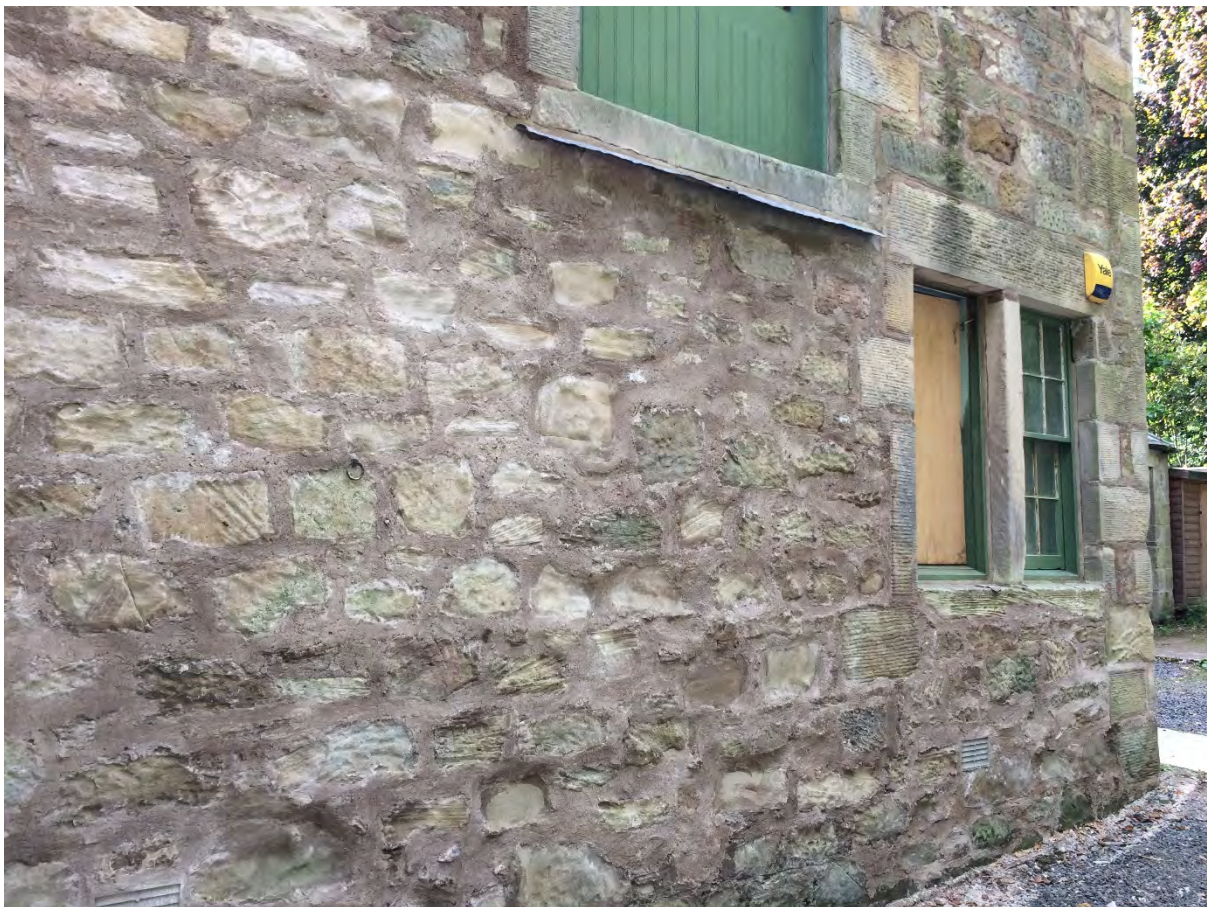
Figure 7. The replaced stones and the finished lime mortar surface following the final scrape back of the mortar.

The new mortar was finished by scraping the mortar with the back of a trowel, work normally carried out the following morning. This finish textured the surface of the mortar and increased vapour release, assisting the carbonation process through a more open surface. Where stones had

The main re-pointing work took place in late summer, during reasonable temperatures of around 15°C. Care was needed in the management of the curing, to prevent rapid drying. Hessian protection was used, along with spraying with water twice daily following the initial cure. After three days the wall mortar was left to cure without further intervention (Figure 7). As the mortar cured and dried it took on a creamy grey colour. Typically a properly cured lime mortar will be a grey or off-white cream, however, this can be affected by the fines (fine aggregate and dust) within the aggregate and any other additives. Bright white lime mortars normally indicate a mortar that has dried quickly and not properly cured.

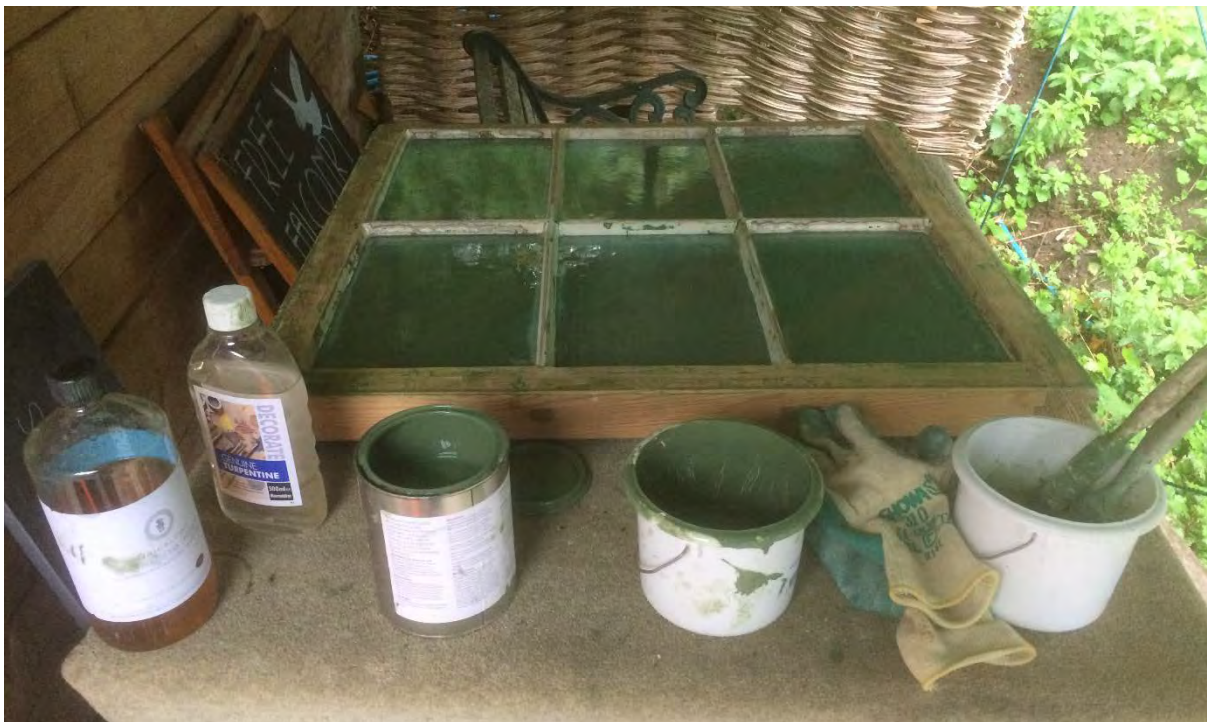
Figure 8. The sash removed ready for painting with the linseed oil paint. All previous layers of paint had been removed down to bare wood.

The bulk of the work was in the preparation. All layers of previous paint were removed down to bare timber using a hot air gun and a hook scraper. A record was taken of the lower layers to understand how the colours used in the painting of the stable external woodwork had evolved. In this case the base layers were a dark forest green colour, which had been replaced with a brighter lighter green. Therefore, the opportunity was taken to revert to a darker green, in keeping with the original paint scheme. Once the sash was stripped to bare wood (Figure 8), two coats of plain boiled linseed oil undercoat were applied, with a few days between each coat to allow the layers to cure.

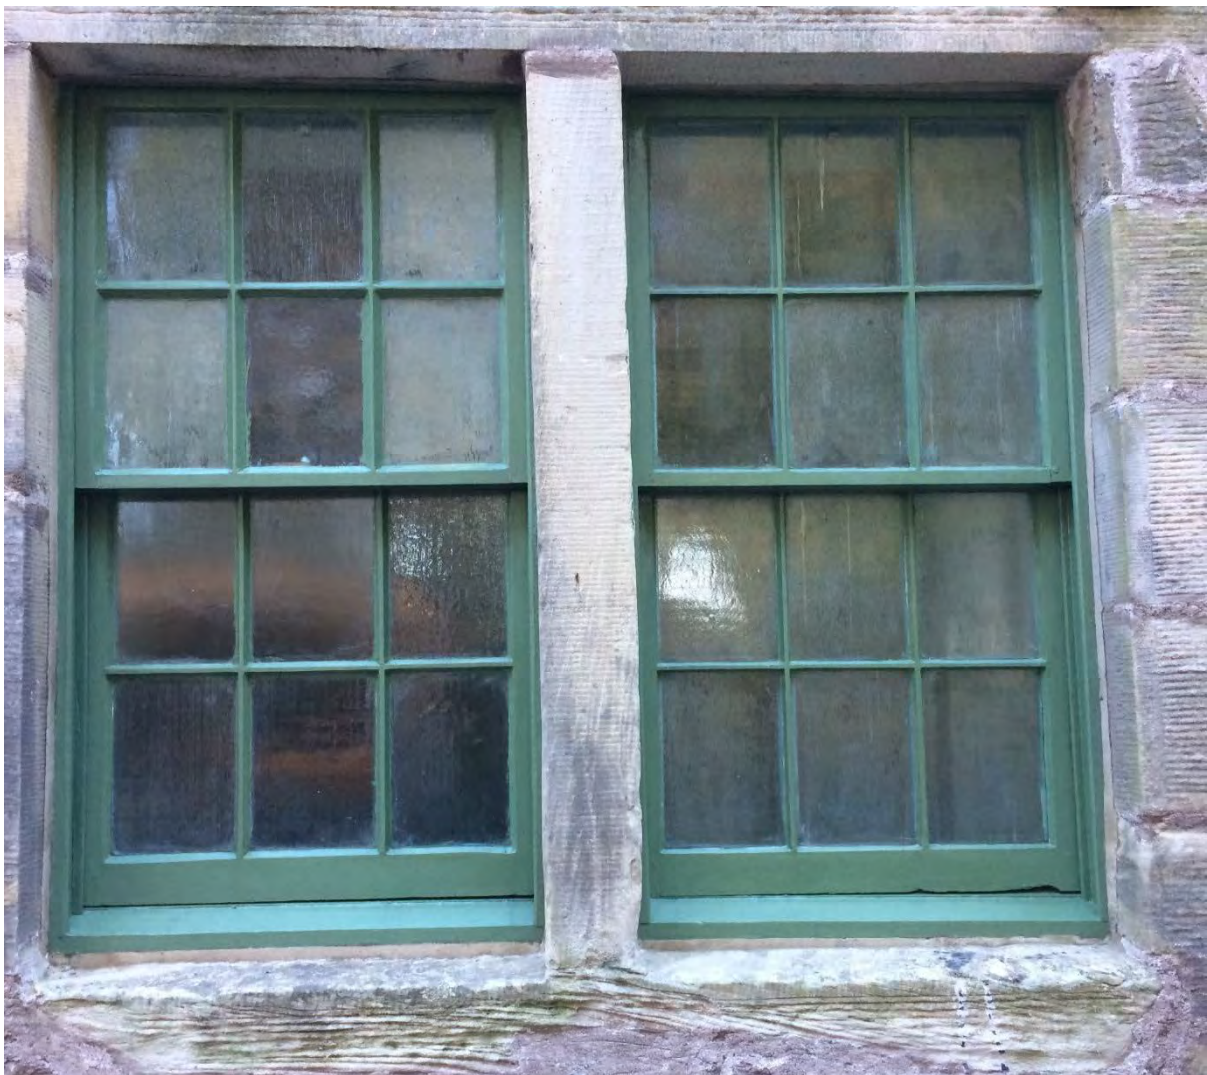
paints, and although it has considerable depth and cover (due to its high pigment content) if the layers are not kept thin it will 'run' and leave 'tears' of excess paint. A linseed oil paint can take quite a high sheen and this was evident on the finished sashes (Figure 9). The finish will progressively become more matt in appearance over several years.

Figure 9. The lower windows of the stable block windows painted with linseed oil paint.

The lesson from this part of the trial is that linseed oil paint work needs to be undertaken in reasonably warm conditions. This could be achieved by taking the sashes to the workshop for painting, or by enclosing the window case behind protection, with some form of heating. Some practitioners use an ultra violet lamp to speed up the curing.

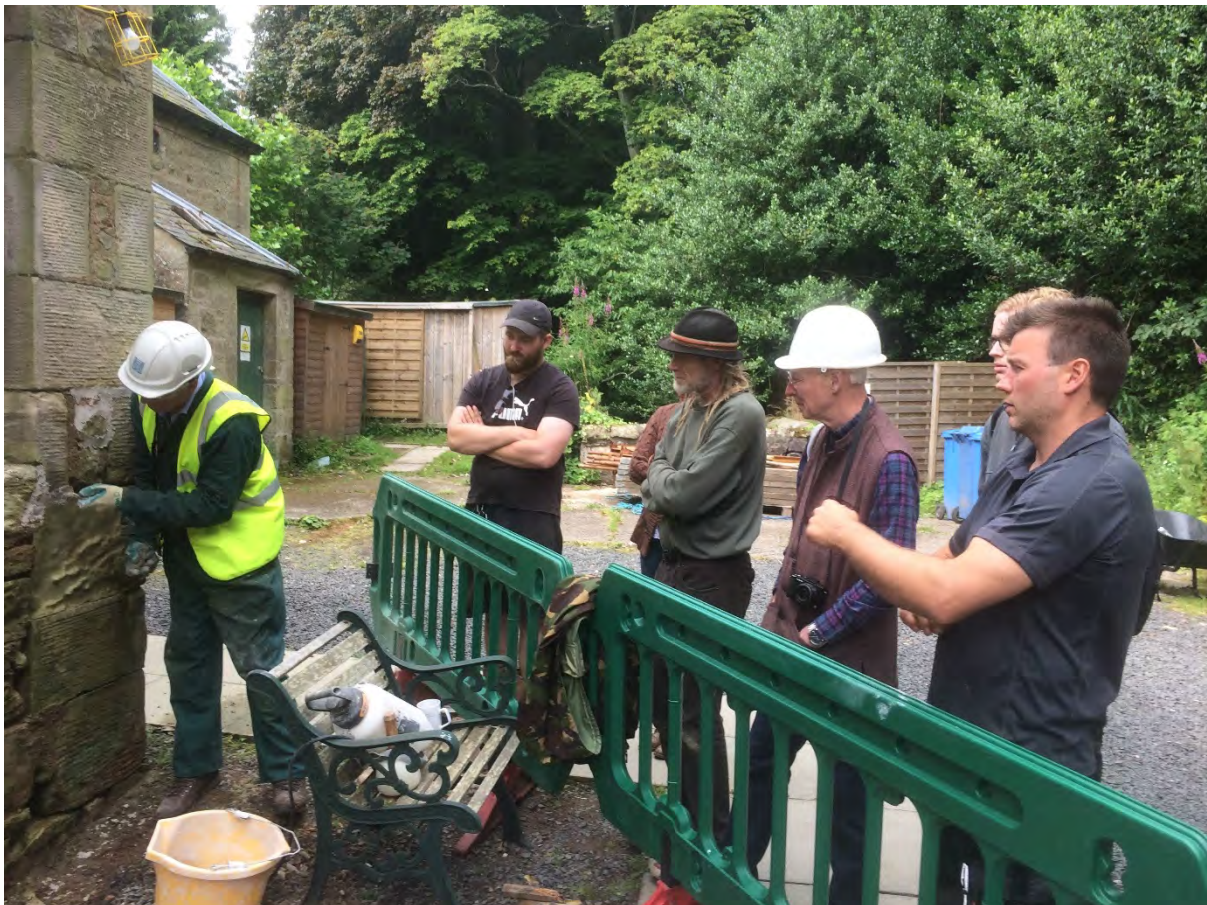
Figure 10. Pointing demonstration during the half-day training session at the start of the project.

Community partners and other stakeholders were invited to participate for a half-day session in the preparation and the application of the hot-mixed lime mortar. This included Trustees, Estate staff and other volunteers who wanted to acquire masonry and lime skills (Figure 10). This turned out to be successful not only in explaining what was happening to the stable wall, but also in demonstrating the practical process of re-pointing, showing that reasonably skilled or even inexperienced people could do good work with the right training. Importantly, it ensured that the community was included in the process and therefore able to assist on subsequent phases of re-pointing work. This involvement was especially relevant as a hot-mixed lime mortar was used. This is a method of mortar preparation that has been largely overlooked by the wider conservation sector, despite evidence for it being commonly used for traditional and historic mortars.
