Newtongrange

Installation of roof and coom insulation and secondary glazing

This publication should be quoted as:
Historic Scotland Refurbishment Case Study 11

Jessica Snow

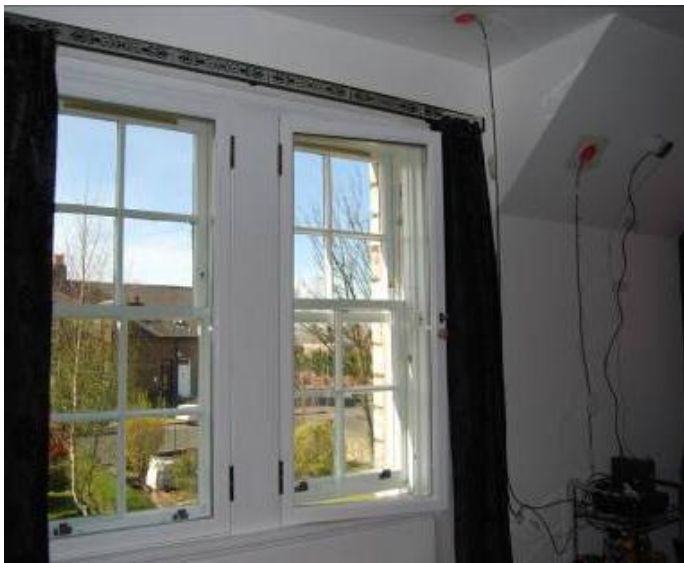
Fig. 2. The timber double-glazed secondary glazing. Testing equipment from Napier University also seen on right.

The architect designed a bespoke timber double glazed secondary glazing unit to suit the existing glazing arrangements. It was fabricated in the contractors workshop using standard joinery equipment and skills. The existing timber beads pinned to the inside facings of the window cases (sides, head, and cill) were removed so that the new units could be fastened directly to the window case without having to disturb the linings. The new units were side hung, with releasable restrictor stays, and included lift-off hinges so that the slender frames could be readily squared-up and fixed to the window case in advance of hanging the sashes. Small timber cover beads were pinned around the perimeter of the units and painted to match (Fig. 2).

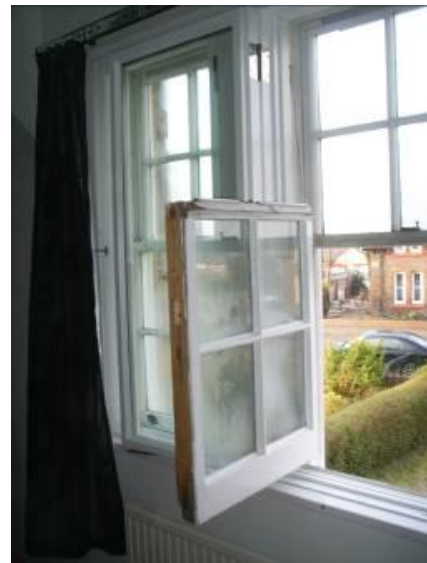
Fig. 3. Access to original windows for cleaning was maintained

The existing draught-stripping on the original windows, which was in poor condition, was removed in order to increase the passive ventilation and prevent condensation forming on the inside face of the external glazing. The secondary glazed units had integral trickle ventilation. The existing sash and case windows were also fitted with cord clutches and eyelets, removable batten rods and simplex hinges, to allow safe cleaning of the windows on both sides, from the inside (Fig. 3).

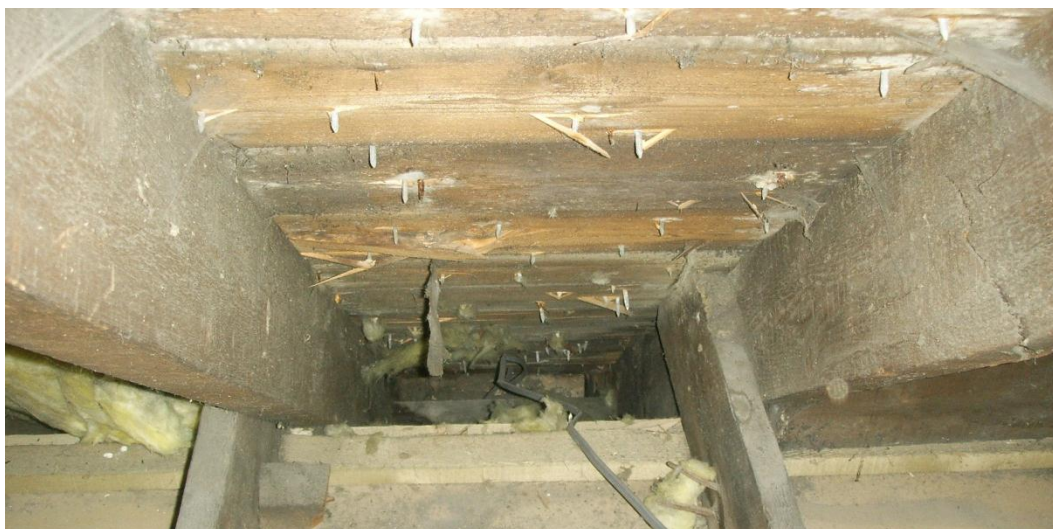
Fig. 4. Access to voids in coom ceiling via attic space

The existing insulation was removed from between the truss ties, with a focus on removing any surplus which had been pushed down in between the timbers to the coom ceilings. This work was carried out with some care due to the slate nails projecting through the underside of the sarking (Fig. 4).

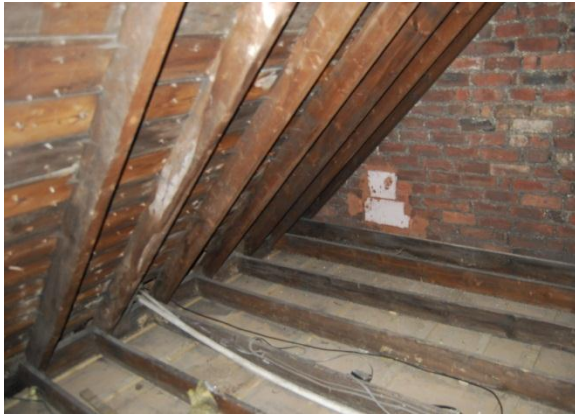
Fig. 5. Ceiling space prior to insertion of insulation

Following the removal of all debris (Fig. 5), bonded polystyrene bead insulation was installed between the rafters of the coom ceilings, via the open voids from within the roof space, so as to avoid any disturbance to the coom linings and decoration of the rooms below (Fig. 6). The insulation was mechanically blown in by the insulation contractor. The blowing equipment is mounted in a small lorry, and as such ensuring parking was available on the street was important.

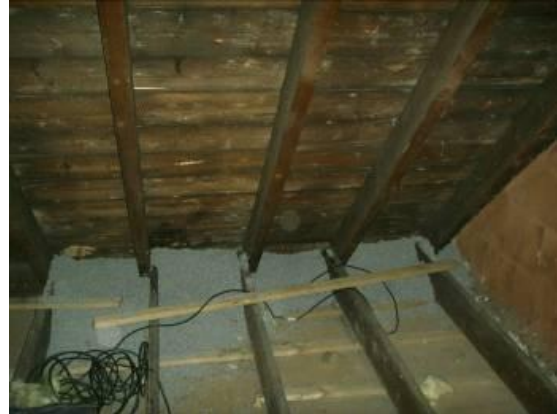
Fig. 6. The bonded bead insulation installed in the cooms

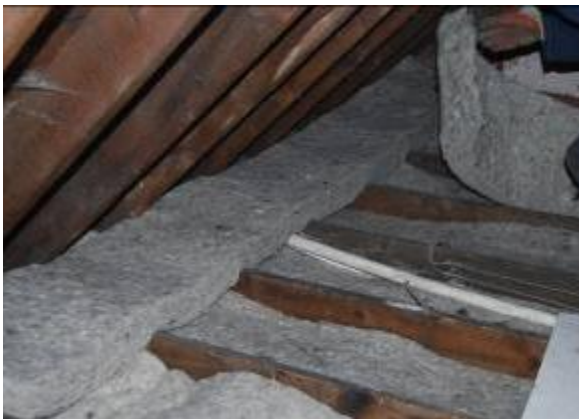
Fig. 7. Insulation between and over joists

After insertion of the blown bead insulation, 140 mm sheep's wool insulation was laid between the main roof ties and dormer roof ties, with 100 mm insulation above, across the ties (Fig. 7).

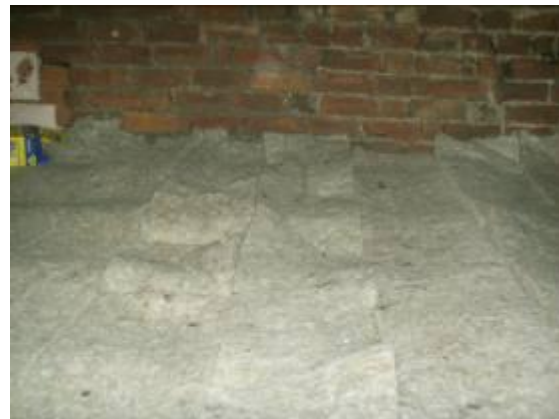
Fig. 8. Sheep's Wool Insulation

Whilst the building had some degraded mineral wool insulation *in situ*, the replacement with sheep's wool was considered an improvement. As well as increasing the depth of insulation, the more 'breathable' characteristics of the sheep's wool were considered to be desirable as a humidity buffer. In addition, it is more pleasant to handle than synthetic alternatives and is a more sustainable material overall. Fig. 8 shows the insulation post-installation.

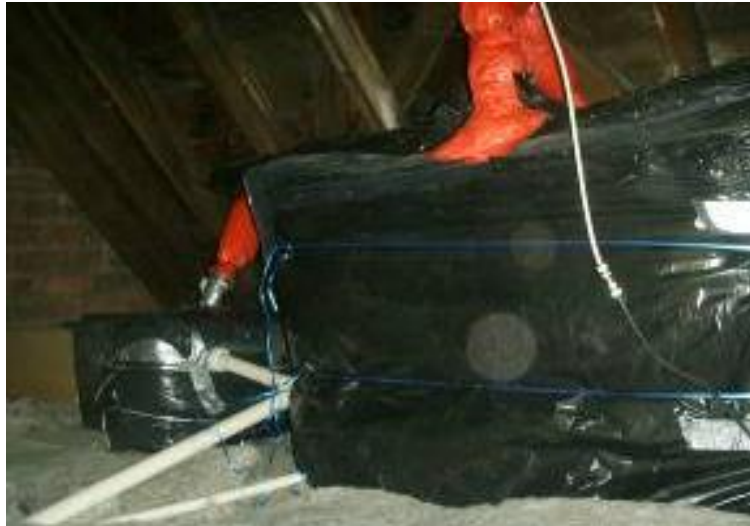
Fig. 9. The water tank and pipes were insulated top prevent freezing.

The cold water tanks, copper pipework, and ceiling hatch were all also insulated using proprietary materials and installation methods (Fig. 9). This is to prevent the water in the tank and pipes freezing during cold spells, which is a risk when loft insulation is increased.

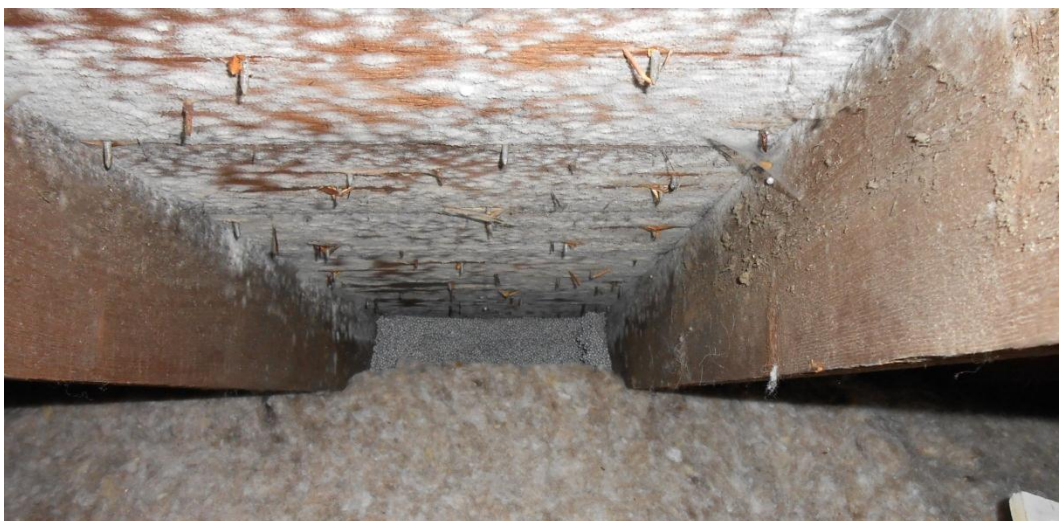
The works were completed in the Autumn of 2011, and the tenant reported an improvement in temperatures in the upstairs bedrooms. However, in December 2012, the tenant noticed white mould on the underside of the sarking board at all levels of the roof. Investigations by the Architect and Historic Scotland confirmed that this was white mould, growing due to high relative humidity levels in the roof space (Fig. 10). It was immediately apparent that the roof space ventilation was insufficient, resulting in high relative humidity levels; the condensation resulting from the changes in dew point (as a consequence of the reduced attic temperatures) were giving suitable conditions for mould growth. During the inspection it was also noticed that there were droplets of water on the end of the nail heads protruding from the sarking, also an indicator of excessive relative humidity. The sheep's wool insulation on the ceiling joists was not affected.

Fig. 10. White mould on the roof slope, caused by insufficient ventilation

checked. On closer inspection it transpired that while the mineral wool from previous interventions had been largely removed, a tight plug of material remained at the base of the coom, and there was no ventilated pathway to the eaves. The junction between the wall head and the roof slope had not allowed the anticipated ventilation levels. After removal of the blown bead insulation in February 2013, additional monitors were installed by Napier University, to assess the situation over several months. According to BS EN 13788 (2012)¹, BS 5250 (2011)² and CIBSE Guide A (2006)³ internal relative humidity levels of >80% provide a condition conducive for mould growth in building timbers. Mould can continue to grow in relative humidity levels >70% if such humidity spikes occur over prolonged periods of time. Fig. 11 shows the relative humidity levels taken in the roof during 2013. While at times the levels reached over 70% and even 80% it was never for a prolonged period of time after February 2013.

It was obvious that remedial work was required. To check for further hidden defects the blown bead insulation was removed from the cooms and the air path down the coom was

By December 2013 sufficient data had been collected to determine that the relative humidity readings were at acceptable levels within the attic. No further mould growth or condensation activity was noted, and the tenant did not experience any further disruption. At present the roof coom is without insulation. In Spring 2014 wood fibre board insulation will be installed, with a 30mm space below the sarking, running all the way down to the junction of the coom and the wall. The improvements to the windows did not present any issues.

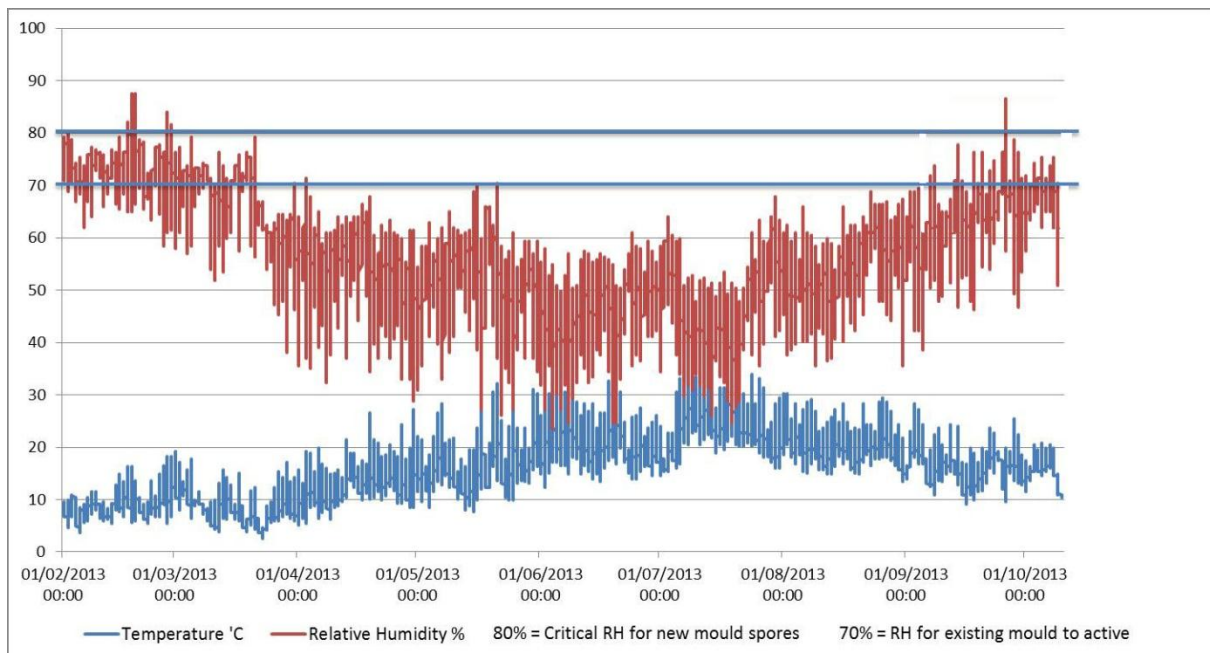
Fig. 11. Temperature and Relative humidity recorded in the attic space of 41 Main Street from February to October 2013. Showing the occurrences when the RH levels in the attic space reached above 70 and 80% during 8 months of 2013.
