FIVE TENEMENT FLATS, EDINBURGH

WALL & WINDOW UPGRADES

This publication should be quoted as:
Historic Scotland Refurbishment Case Study 1

Historic Scotland Refurbishment Case Study 1

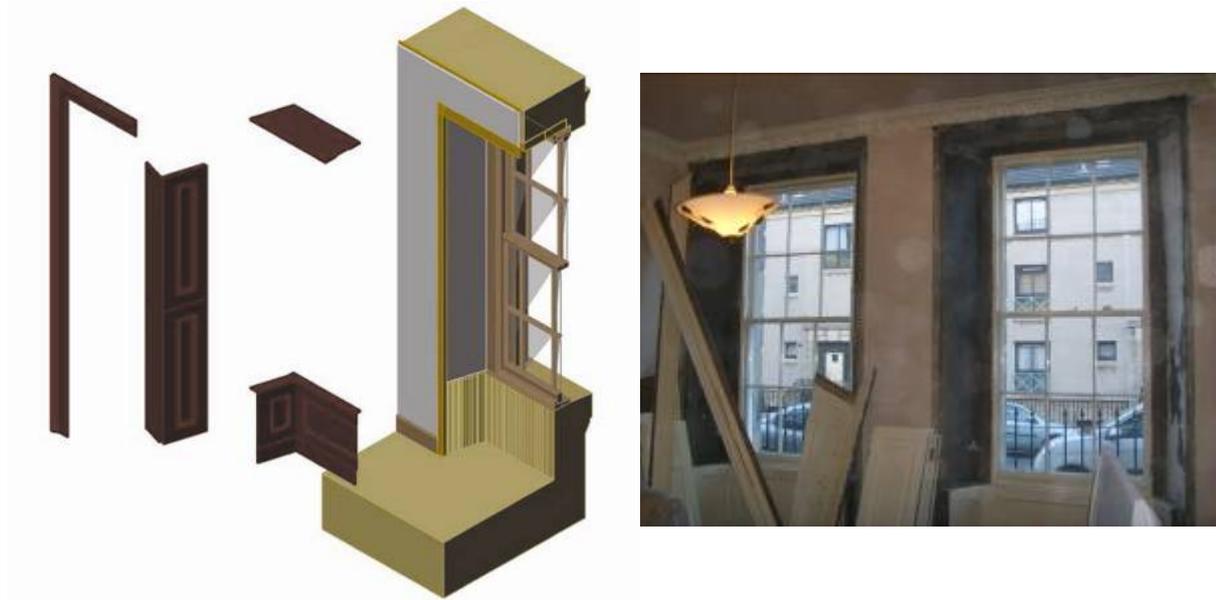
Fig. 2. Diagram and photograph showing dismantling of the window sets

- The shutters in this property were found to be nailed shut, with the backs bonded to the pocket lining. As the shutters were opened up, the plaster to the pocket fell away, leaving the random rubble stonework to the reveals exposed
- Architraves and skirting blocks were carefully prised away from timber grounds, taking care not to disturb the decoration or plasterwork
- Soffit panels were prised away from timber packers / timber safe lintels, exposing the cavity at the head of the window opening

- Window elbows and backs were removed in one piece, exposing the cavities between the architrave / lath ground each side of opening, below cill level. (The cavities above cill level were also exposed as a result of the plaster linings to the shutter pockets coming away)

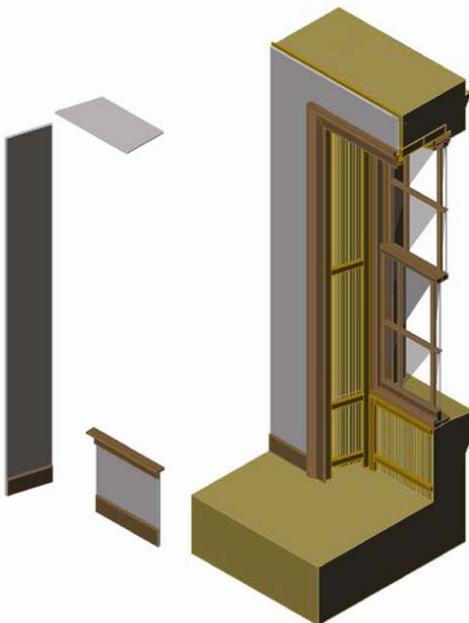
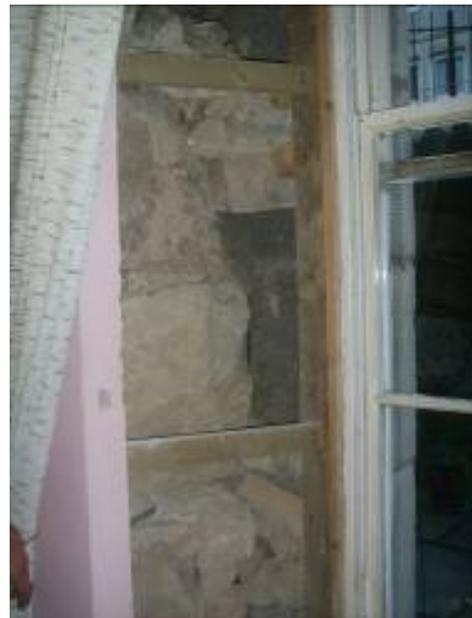
Fig. 5. Drawing and photograph showing soffit and panel insulation

- Existing skirting, window cill board, and apron, removed and set aside
- The plasterboard linings to the window reveals and back, fixed to timber framing, were removed, leaving the cavity around the opening exposed in places. The removal of the linings exposed large, structurally unsound voids in the inside face of the stonework to the base of the reveals and window back, which had to be made good

- The leading edges of the window reveals / soffit were formed with a galvanized plasterers bead and plaster skim coat, and the plasterboard was cut short at the edge, so as not to disturb the bead
- The plasterboard soffit was removed from the timber framing, exposing the cavity at the head of the window opening. The original timber safe lintels had been replaced with concrete lintels
- The open cavities in the walls were packed with mineral wool, and bonded polystyrene bead was blown in behind the plasterboard to fully fill the cavity (approx. 70 – 80 mm deep)
- The window opening was fitted with an aluminium, double glazed, tilt and turn secondary glazed unit
- Rigid insulation was cut and tightly fitted between the new framing to the window back and the existing framing to the reveals and soffit: 100 mm thick to window back, 50 mm thick to reveals, 35 mm thick to soffit

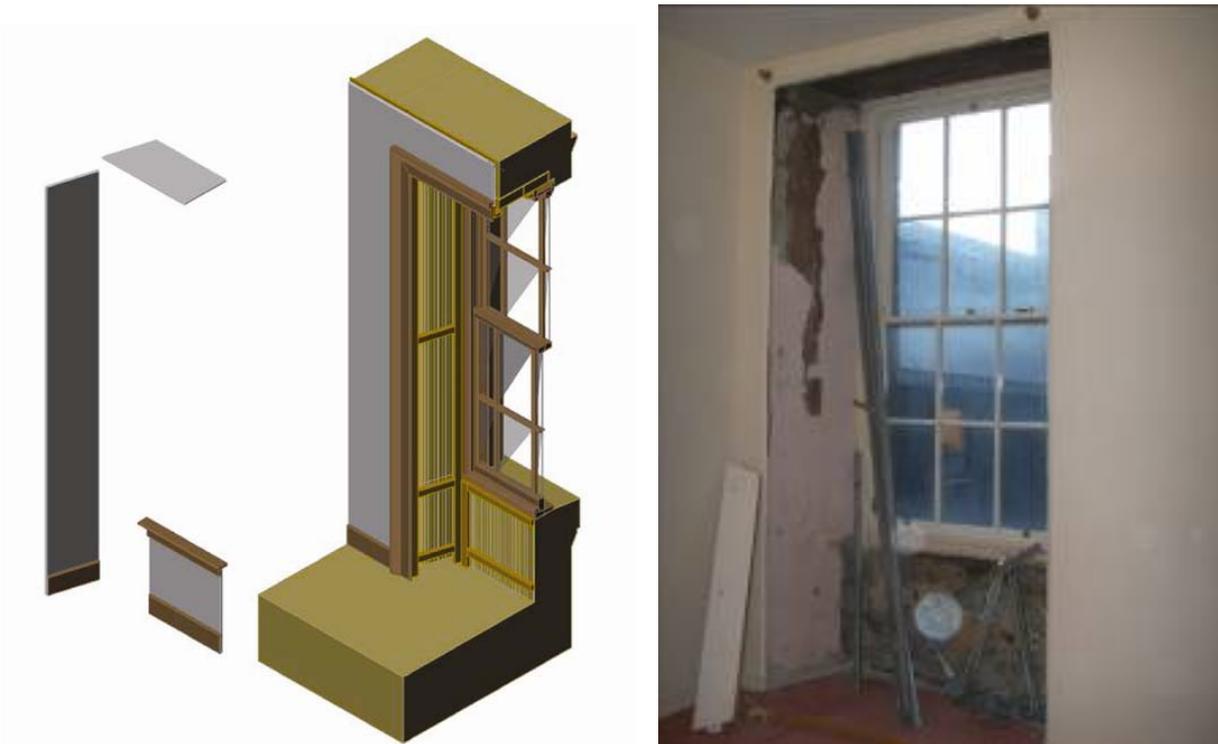
Fig. 12. Diagram and photograph showing downtakings

- The plasterboard linings to the window reveals and back, fixed to metal framing, were removed, leaving the cavity around the opening fully exposed. The linings to the reveals were screwed to poorly fixed metal framing, which came away as the plasterboard was removed
- The leading edges of the window reveals / soffit were formed with taped corner strips, which were cut to allow the release of the plasterboard
- The plasterboard soffit was removed from the timber framing, exposing the cavity at the head of the window opening. The original timber safe lintels had been replaced with RSJ's, fixed tight to the head of the window

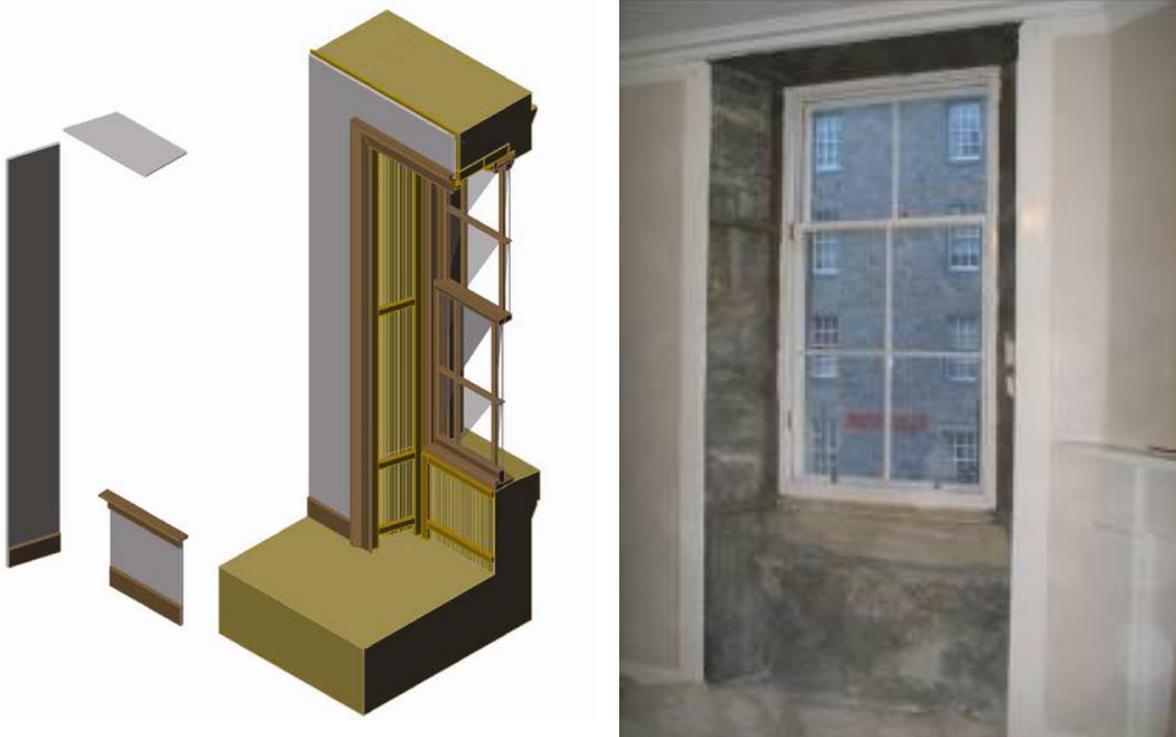
Fig. 16. Diagram and photograph showing downtakings

- Where the timber window wedges were loose, additional packers were to be fitted to keep the sash and case window in place until the new framing was installed

- Any obsolete / defective timber dooks set into the stonework were removed and disposed of

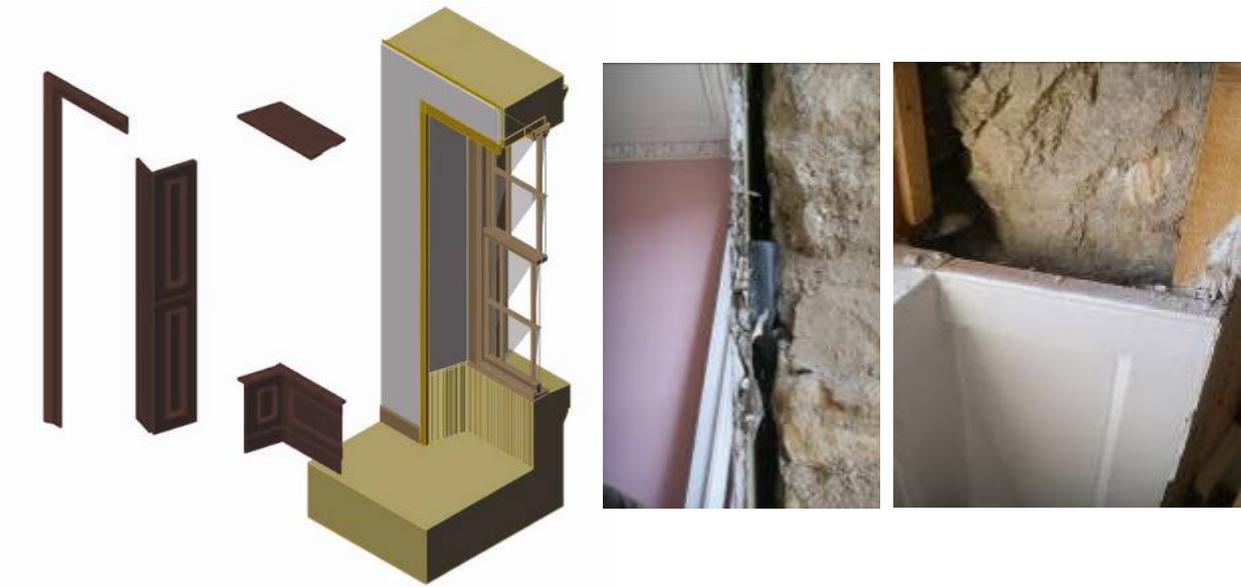
Fig. 29. Diagram and photographs showing dismantlings and exposed elements

- Architraves and skirting blocks were carefully prised away from timber grounds
- The wall linings had previously been replaced in plasterboard on timber battens. The shutters pockets had been framed out, and the shutters were nailed shut, with the plasterboard nailed to the leading edges. The entire wall lining was structurally unsound, and came away as the shutters were carefully opened up, leaving the original stonework fully exposed

- Soffit panels were prised away from timber packers / timber safe lintels, exposing the cavity at the head of the window opening
- Window elbows and backs were removed in one piece

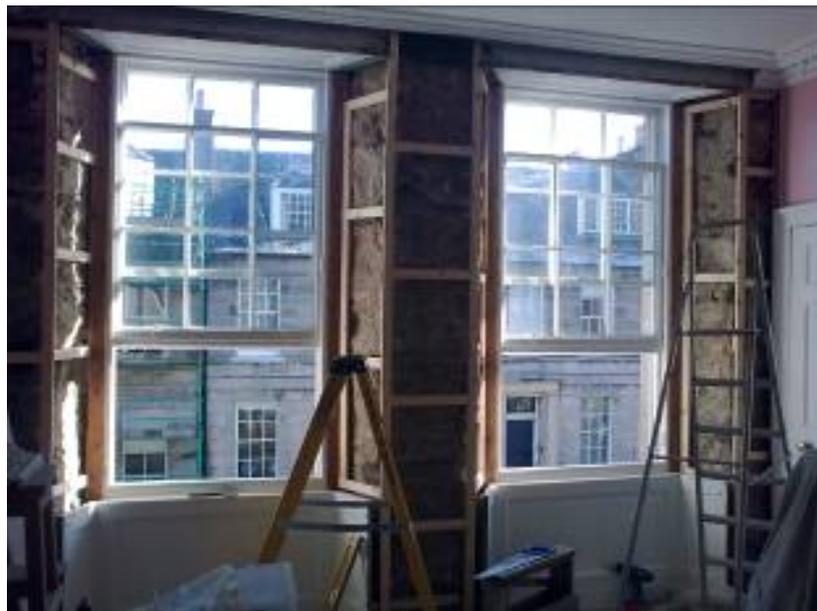
Fig. 30. Reframing and wall upgrade work

- Wall to front, north east elevation of apartment comprising broached ashlar, with droved margins to window surrounds. Overall masonry thickness approx. 650 mm
- Wall lining in plasterboard, on inadequate timber framing, with the plasterboard largely nailed into the edges of the window shutters, which were, in turn, permanently fixed back into the pockets. Decorative cornice, with sections over the window heads missing, and ogee skirting.
- 2 no. 6 over 6 pane sash and case windows with fixed shutters with panelled elbows soffit and back. Moulded architraves with skirting blocks
- Living room – 2 no. windows to north east side
- Wall lining plasterboard, with 40 – 50 mm cavity

- The entire wall lining directly below the existing cornice was re-built in 50 x 25 mm timber framing, held clear from the masonry, with 25 mm rigid insulation, and 12.5 mm plasterboard, taped and filled

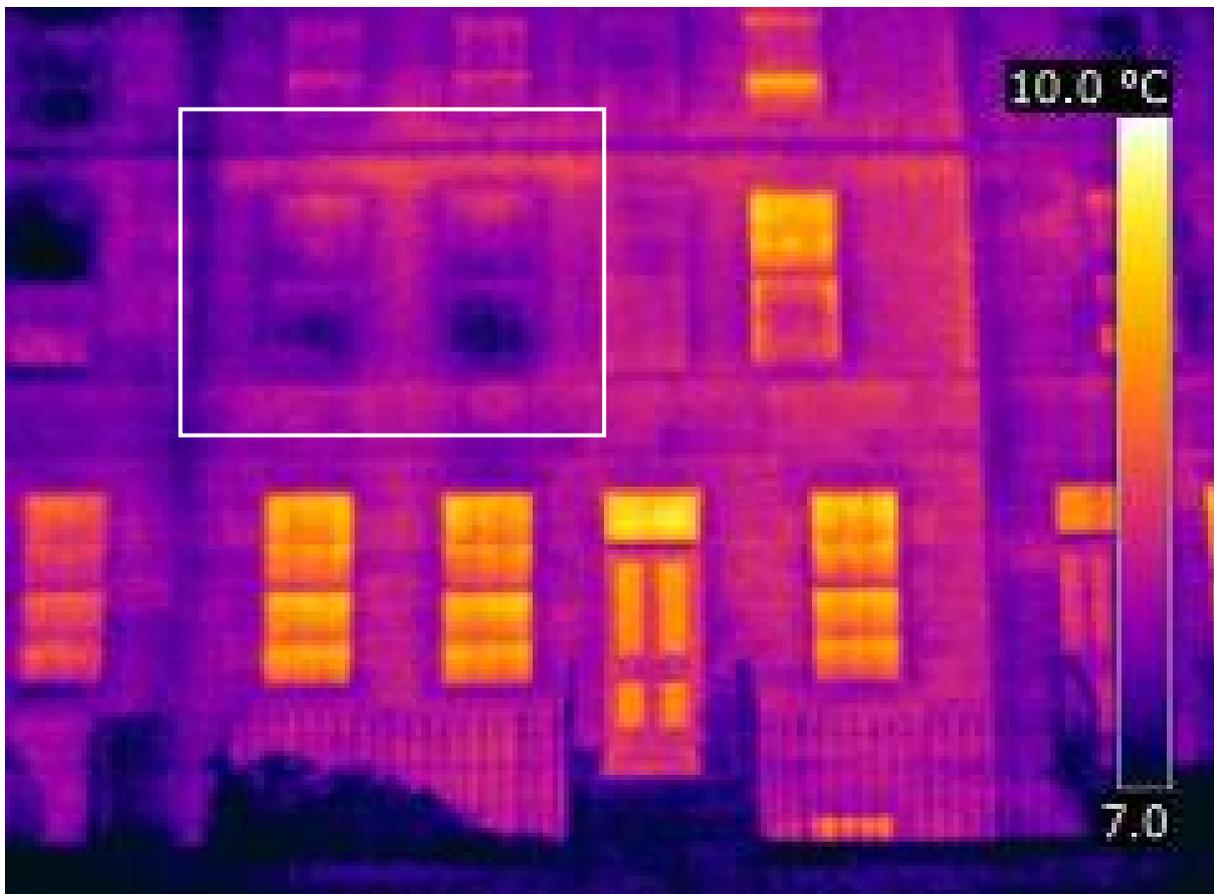
Prior to the works, this property had single glazed timber sash windows, which have a poor thermal performance. After being fitted with single-glazed secondary glazing, the U-value decreased from 5.2 to 1.5 W/m²K, an improvement of more than 70%. One set of window shutters were upgraded using a 10 mm aerogel quilt, which reduced the U-value down to 0.4 W/m²K with the shutters closed. This pre and post-intervention infra-red image was taken with the shutters shut. It demonstrates the reduction in heat loss from the improved windows and walls, indicated by the darker areas.

Fig. 34. Thermographic image of property E, showing the improved glazing
 © Scottish Energy Centre, Edinburgh Napier University

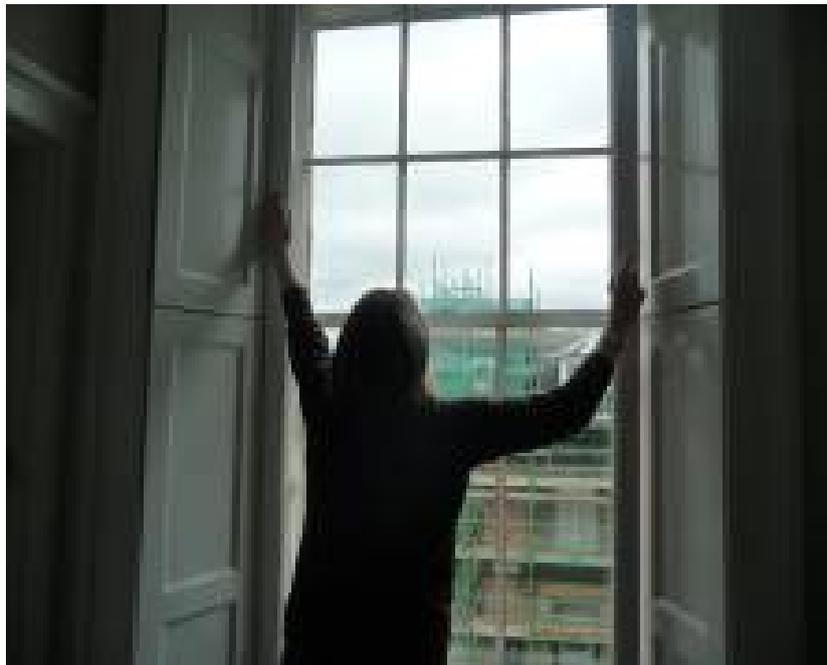
Post-completion feedback indicated that the outcome is seen as beneficial by the tenants, although there were a number of issues raised. As the specification was non-standard, and some elements were experimental, the level of site supervision required was beyond that of a normal window replacement contract. The duration of works was a major concern and all tenants would have preferred that the work could have been coordinated more tightly.

Fig. 36. Tenants pointed out that “you have to stretch both your arms wide and push hard to close the window from the tilt position. Not easy unless you are tall and strong”.
