MONUMENTS IN MONUMENTS

CONFERENCE PROCEEDINGS

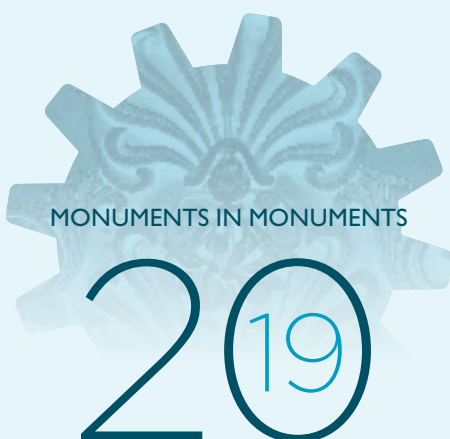
Paul Barham	227
REVEALED BY FIRE: HISTORIC GRAFFITI AT BIRKHILL HOUSE, COALBURN	
Alessandro Cini	243
COLOURS IN ROMANESQUE SCULPTURE: POLYCHROMY FOUND IN A 12TH CENTURY BAS RELIEF IN PAVIA, ITALY	
Ariana McSweeney, Gus Fraser	253
LAYERS OF COMMEMORATION IN MOUNT AUBURN CEMETERY'S GARDNER TOMB	
Meghan King	263
HOLDING LOSS AT ITS CENTRE: LOOK OF AGE AT MISSIONS CONCEPCIÓN AND SAN JOSÉ

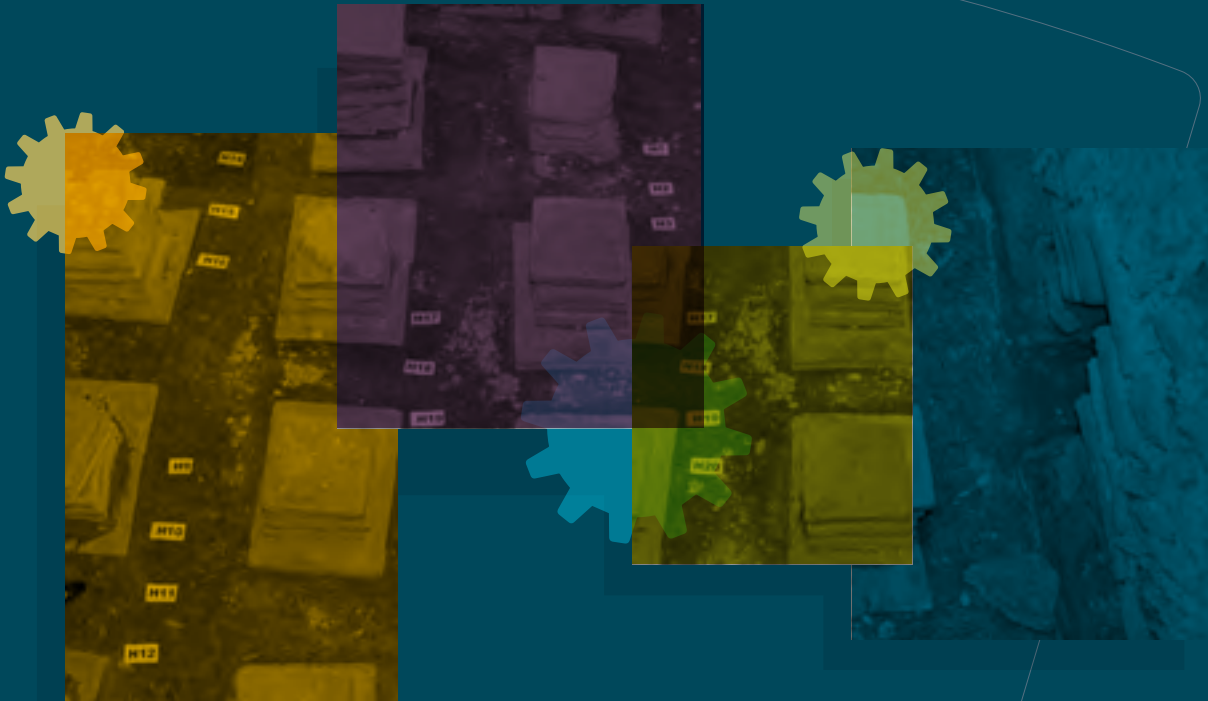
EVOLVING COLLABORATION BETWEEN ACADEMICS AND CONSERVATORS: ILLUSTRATION USING NDTs TO MAP AND MONITOR DECAY OF CERAMIC TESSERAE AND EARTHEN FLOORS

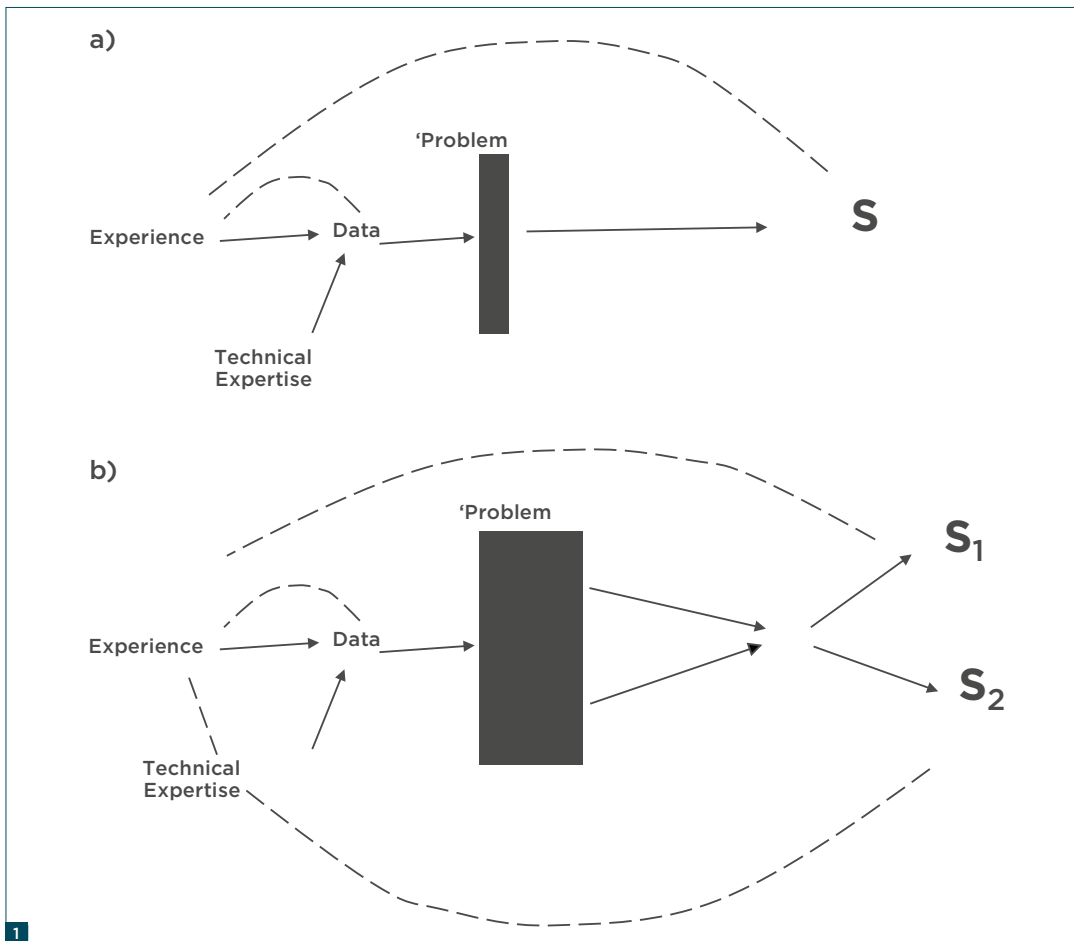
Figure 1:
a) Model of collaboration between academics and conservators where academics provide technical expertise only.
b) Model of collaboration between academics and conservators where there is a collaborative development the problem space and solutions.

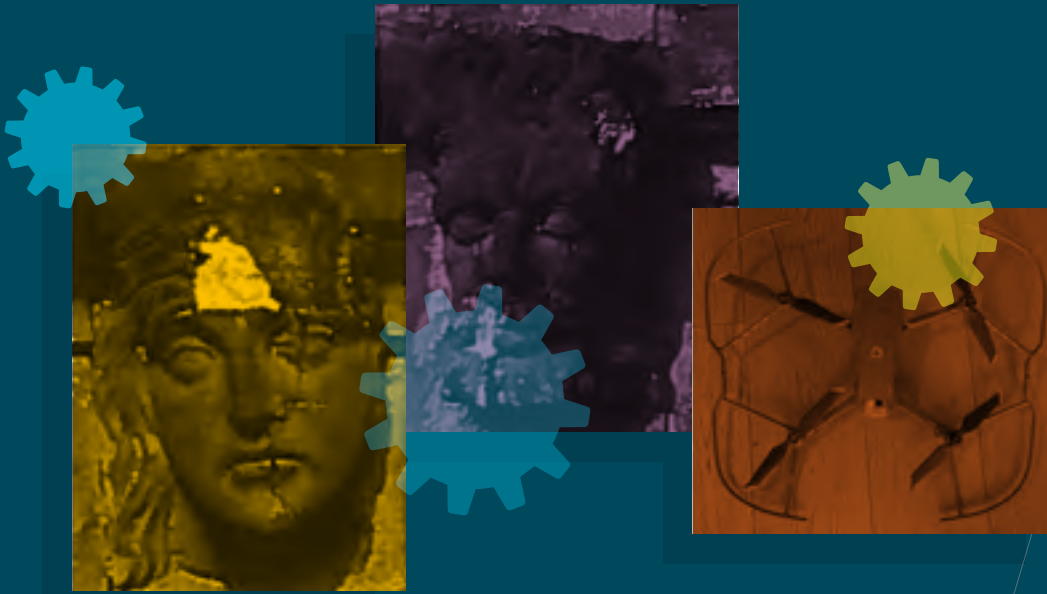
BRINGING THE OUTSIDE INSIDE: INSPECTING THE CONDITION OF CARVINGS ON FORMERLY EXTERIOR FEATURE WALLS

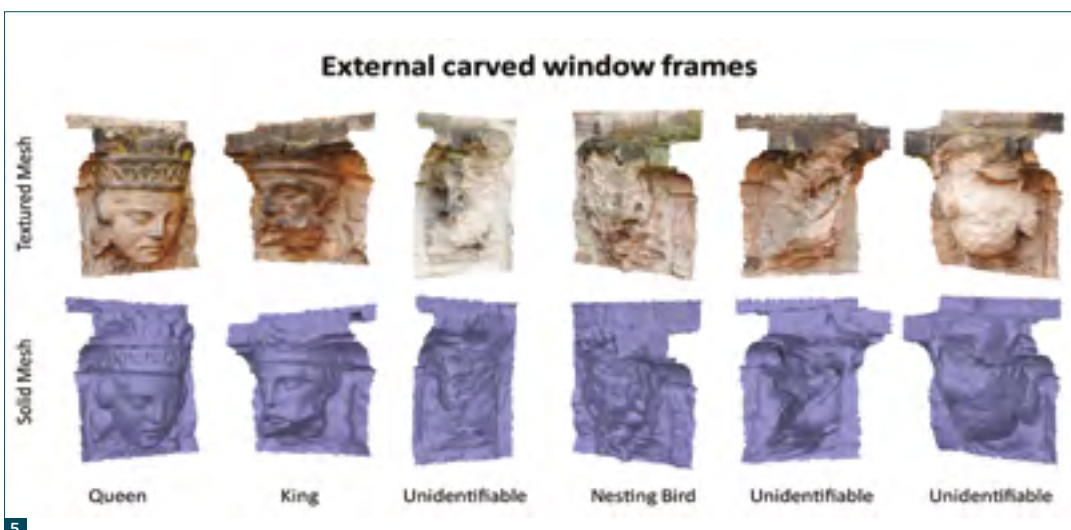
Figure 5:
Output 3D models of
the exterior carvings.

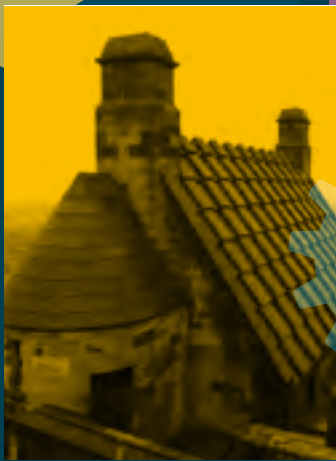
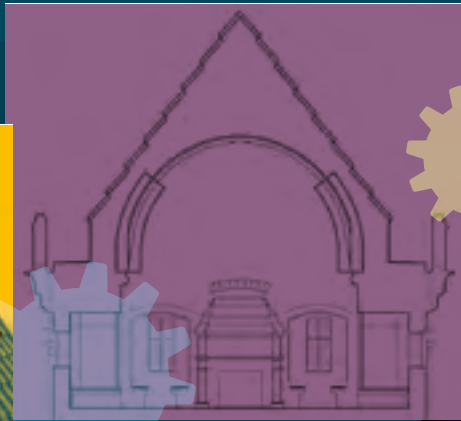
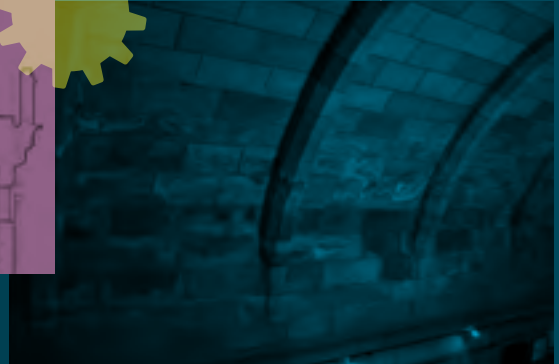
USING MULTI-SENSOR MOISTURE MEASUREMENT IN CONSERVATION THROUGH 'BUILDING PATHOLOGY INDICES' AND 3D DIGITAL DOCUMENTATION

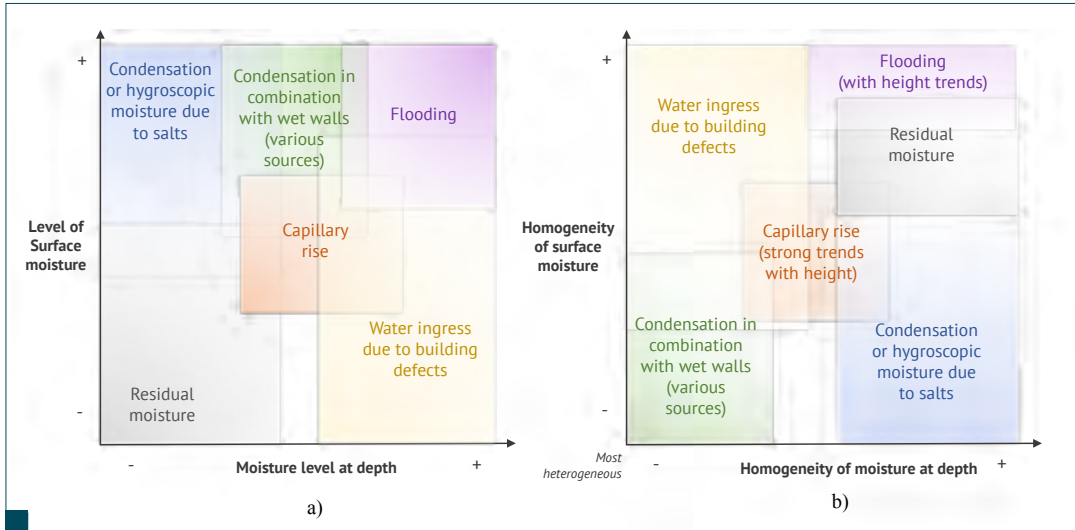
Figure 1: A two-dimensional visualisation of using comparison between surface moisture and moisture at depth a) and homogeneity of surface moisture and moisture at depth b) to infer potential sources of moisture ingress in buildings. Adapted from Göller (n.d.).

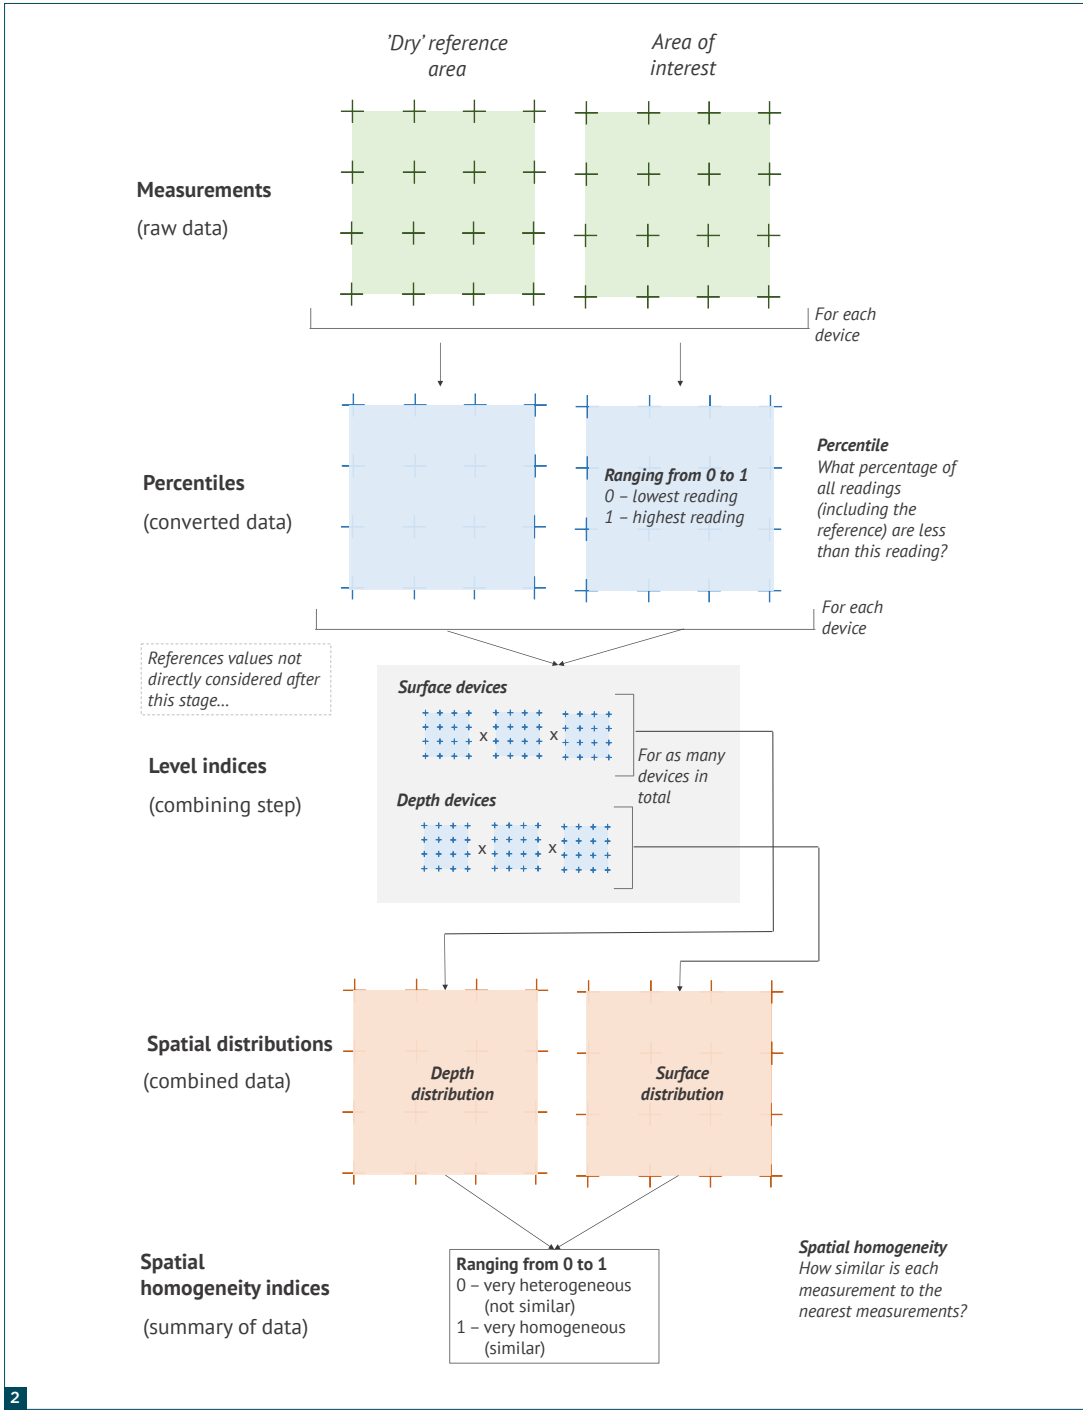
Figure 2:
A visualisation of the calculation procedure for the building pathology indices.

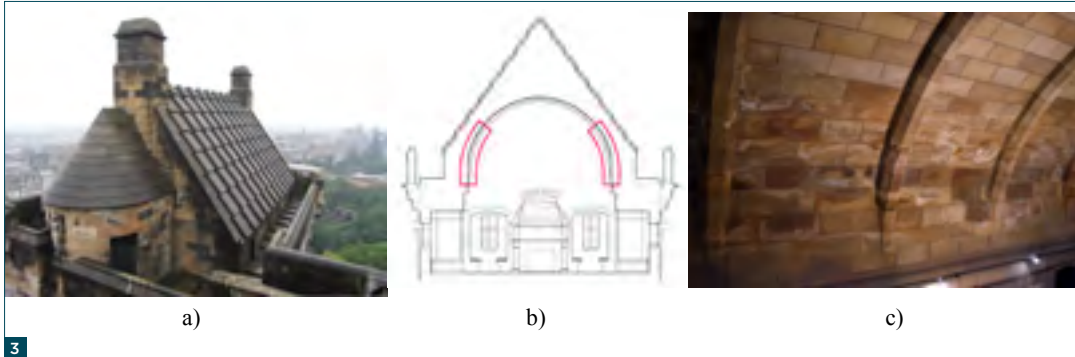
Figure 3:
a) The exterior and context of Argyle Tower, Edinburgh Castle;
b) a cross-section of the construction with the area of interest (location of bays) in red; and
c) an interior view of the deterioration in the bays at the intersection of the vault and the vertical wall.
Image in (a) CC-BY-SA 2.0 Gareth James.

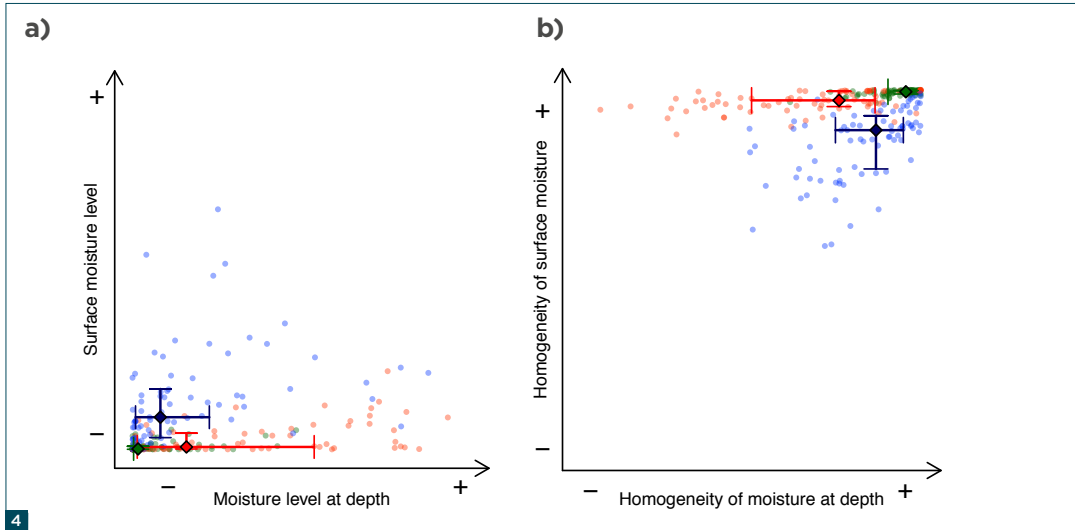
Figure 4: The level a) and homogeneity b) indices for the bays plotted onto the framework presented in Figure 1: Bay A (red), Bay B (blue), and the reference measurement grid (green). Smaller circles represent individual grid points, while the large squares are the median (the index value which is greater than half of those within the grid) that are presented with the inter-quartile range as whiskers (a range in which 50% of the data centred around the median lie).

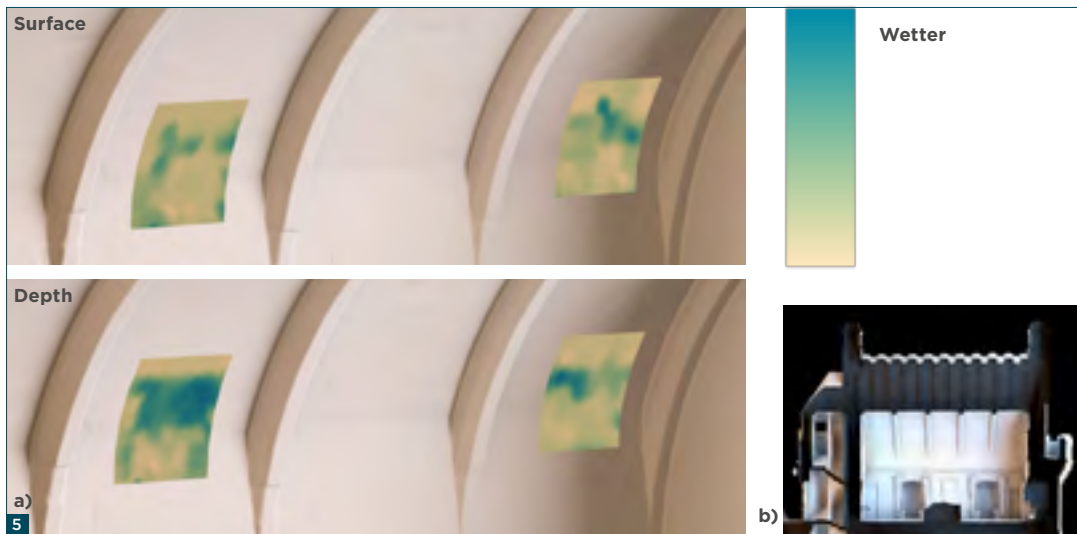
Figure 5:
a) Surface and depth level indices for Bay A (left) and Bay B (right);
b) A 3D cross-section of Argyle Tower, in which the box indicates the measurement locations.

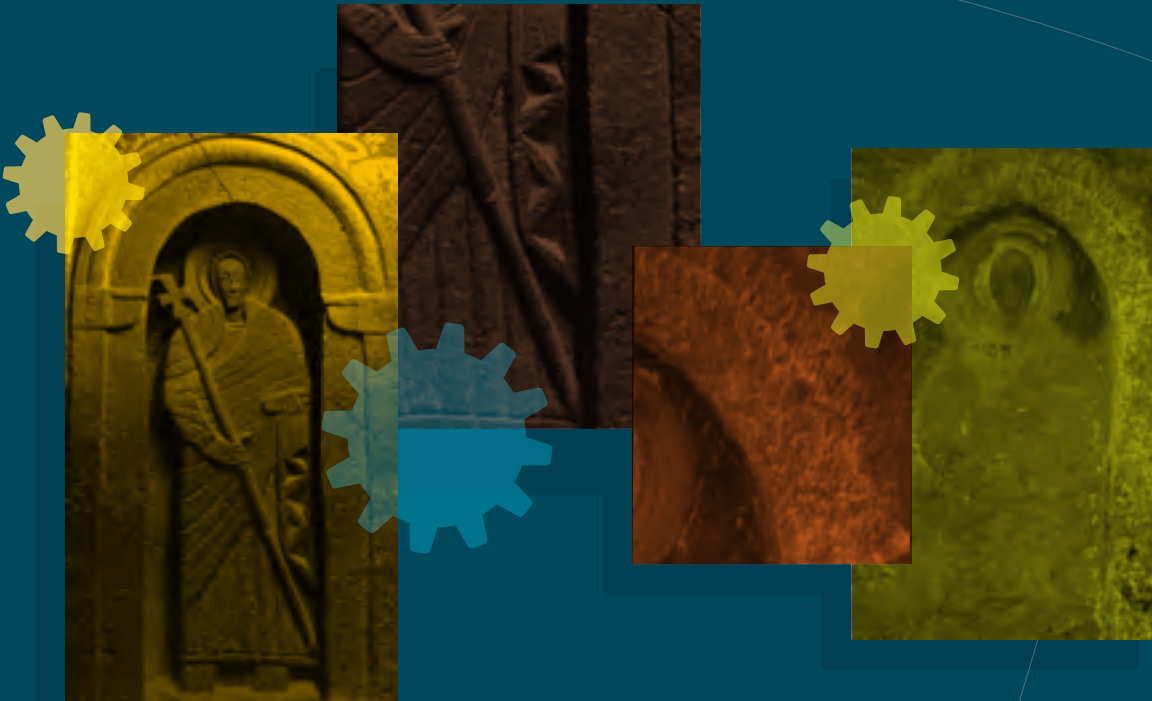
USING PORTABLE MOISTURE METERS AND PAPER PULP POULTICE TO INVESTIGATE MOISTURE AND SALT DISTRIBUTION IN ROCK-HEWN BAS-RELIEFS IN BETE GOLGOTHA, LALIBELA, ETHIOPIA

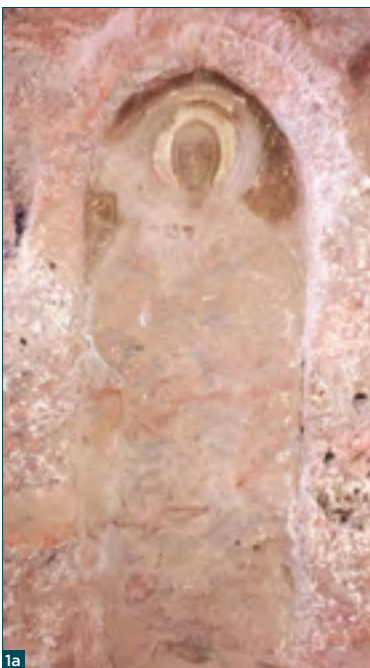
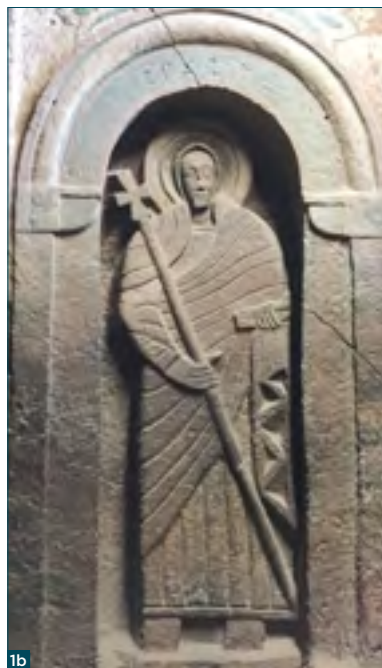
Figure 1:
Bas-reliefs in
Bete Golgotha:
a) N1 and b) S1.

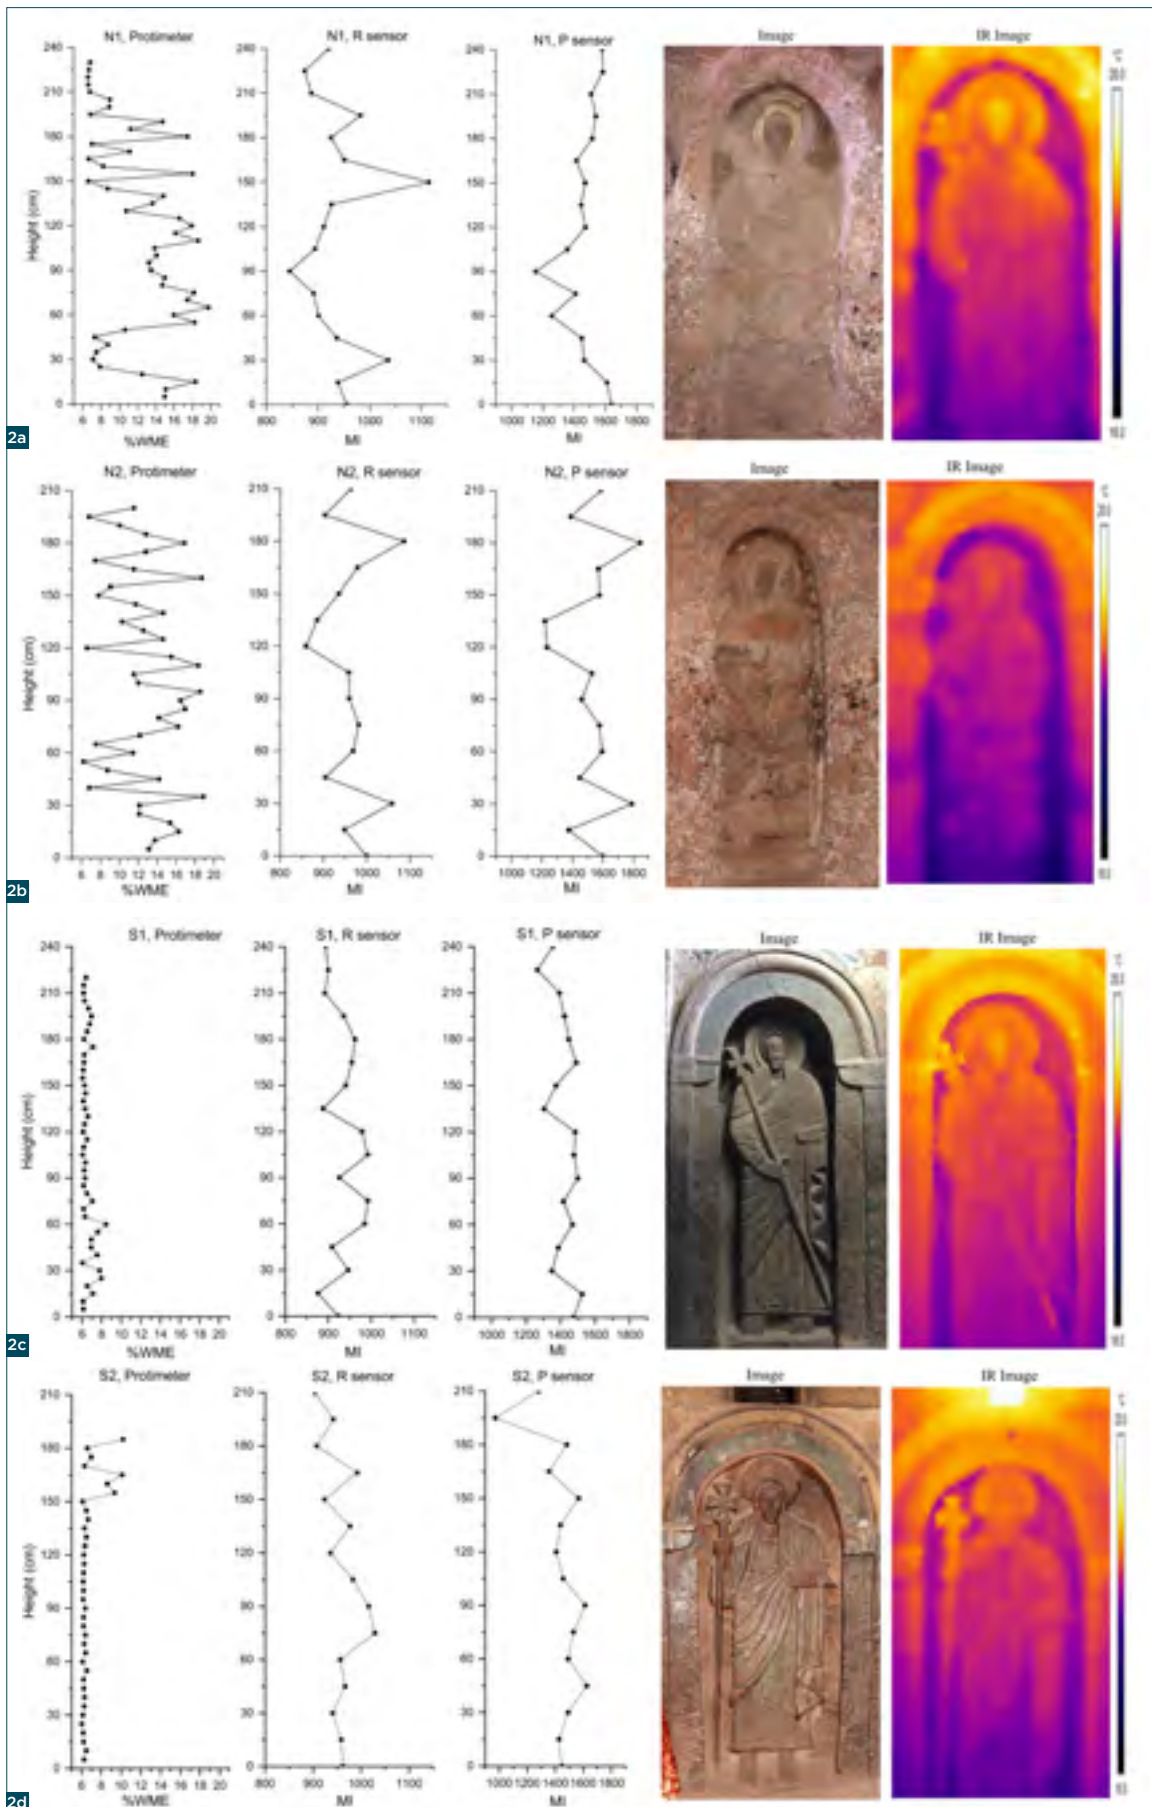
Figure 2: Moisture measurement results of bas-reliefs (from left) Protimeter, R sensor, P sensor, Image and IR images of a) N1; b) N2; c) S1; and d) S2.

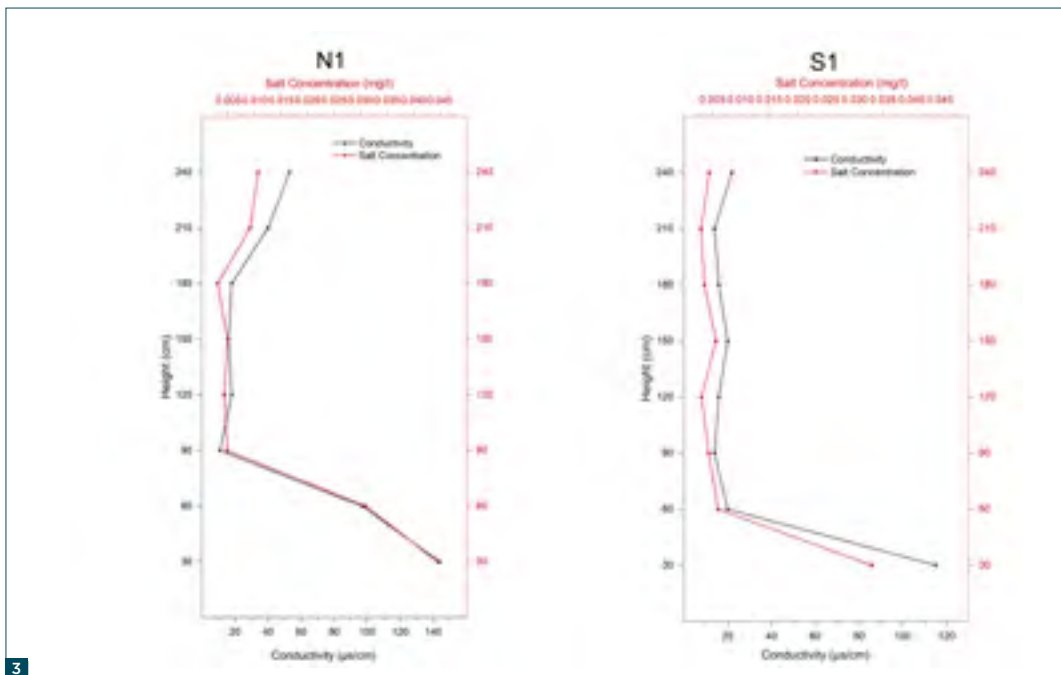
Figure 3: Correlation of conductivity ($\mu\text{s}/\text{cm}$) and salt concentration (mg/l) of poultice sample solutions of: a) N1 ($R^2= 0.988$) and b) S1 ($R^2= 0.997$).

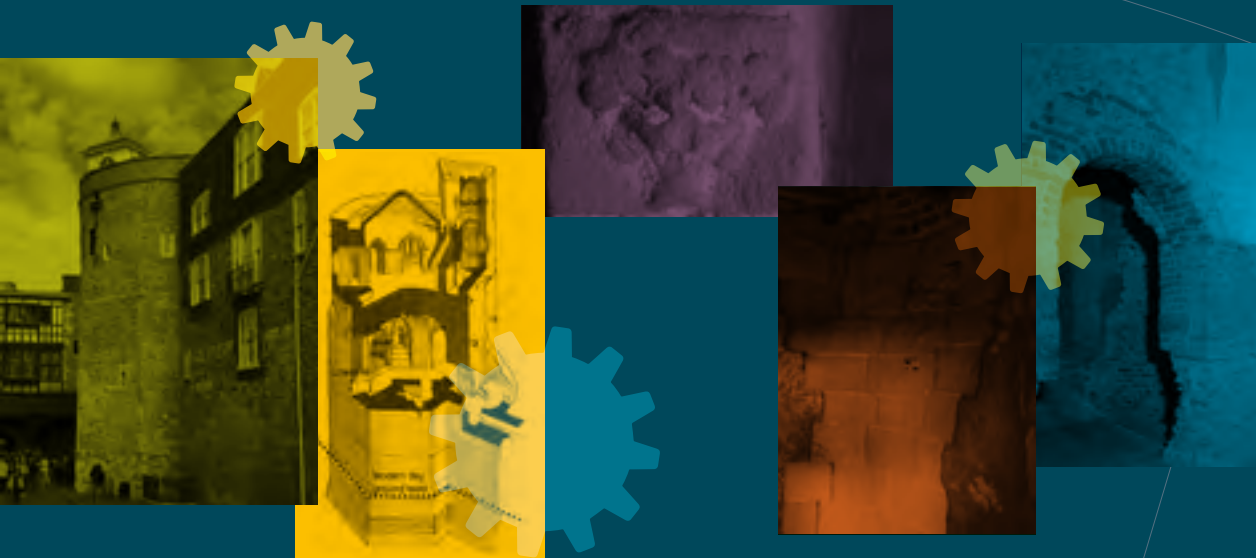
BELLWEATHERED: REIGATE STONE DECAY MECHANISMS AT THE BELL TOWER, TOWER OF LONDON

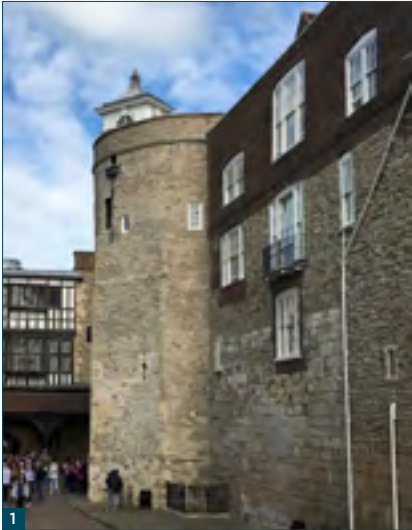
Figure 1:
Bell Tower from
south-east.

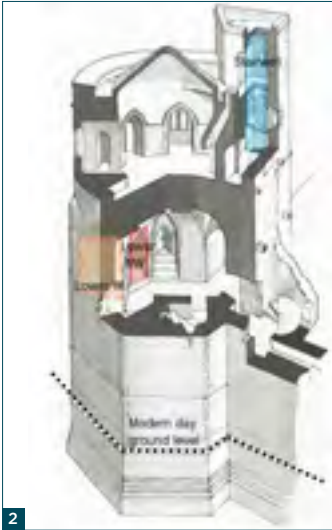
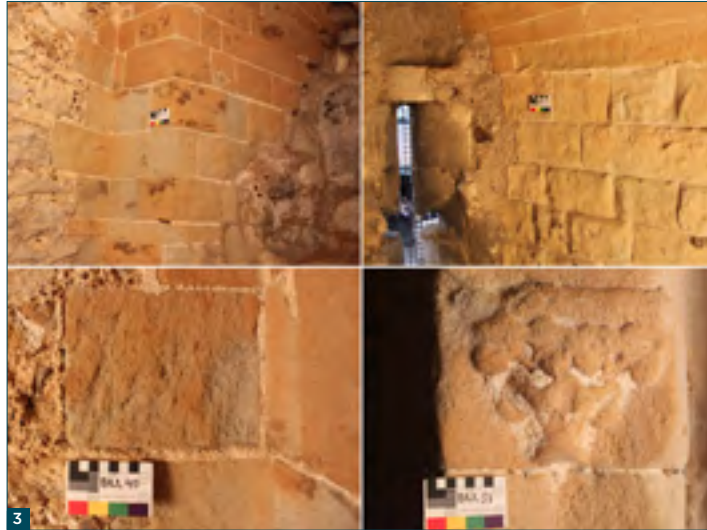
Figure 2: Axonometric of Bell Tower from south, showing locations in this study (modified from a drawing by Terry Bell).

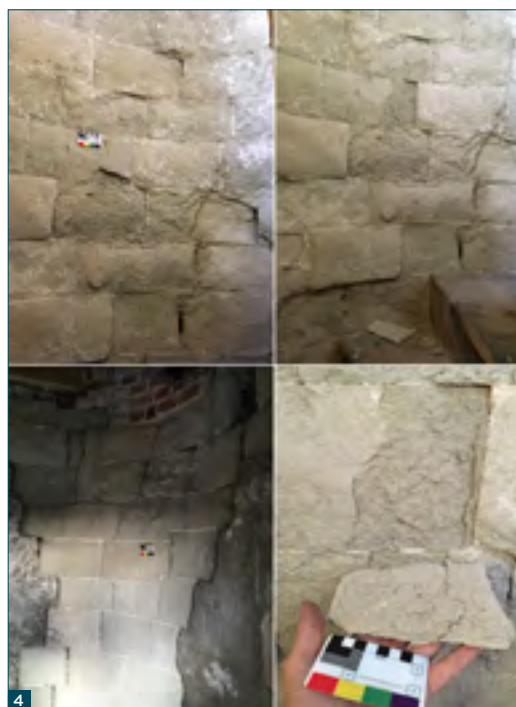
Figure 4: Reigate masonry in stairwell. Top left: flaking decay on west flank (Jan. 2018); Top right: west flank following detachment episode (Aug. 2018); Bottom left: east flank; Bottom right: typical detached material and fresh subsurface.

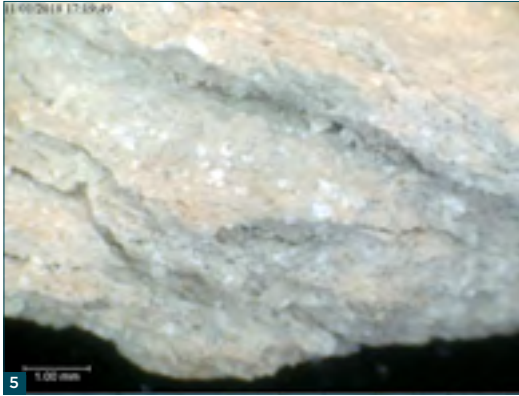
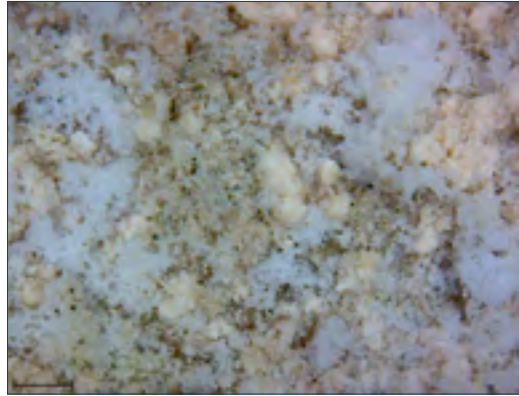
Figure 5: Micrographs of detached flake (left) and powdering surface (right) showing salt contamination (scale bars 1mm).

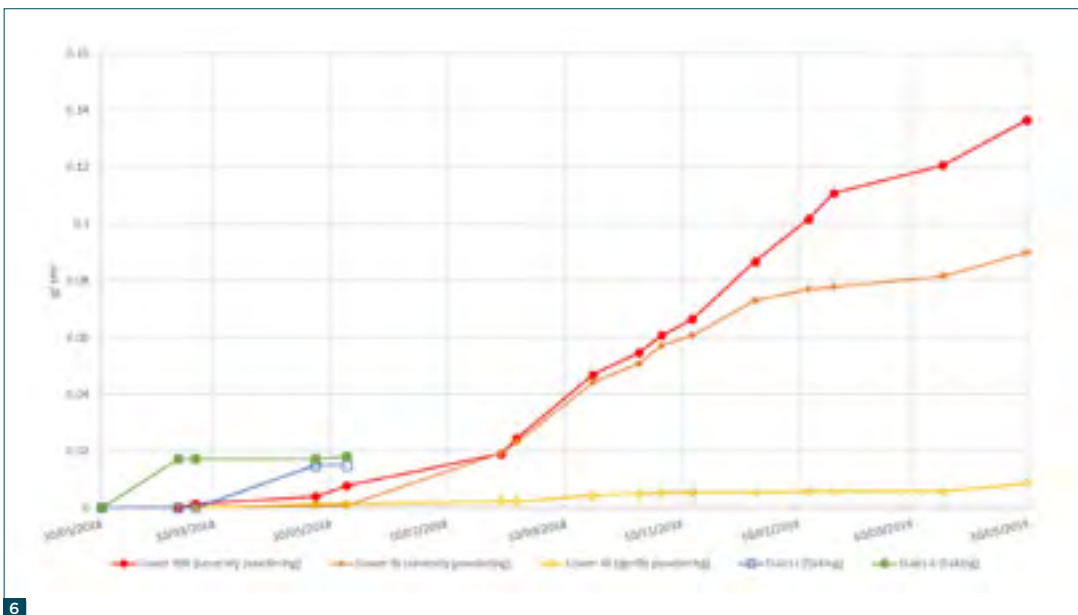
Figure 6: Cumulative mass of material collected in trays at base of decaying masonry.

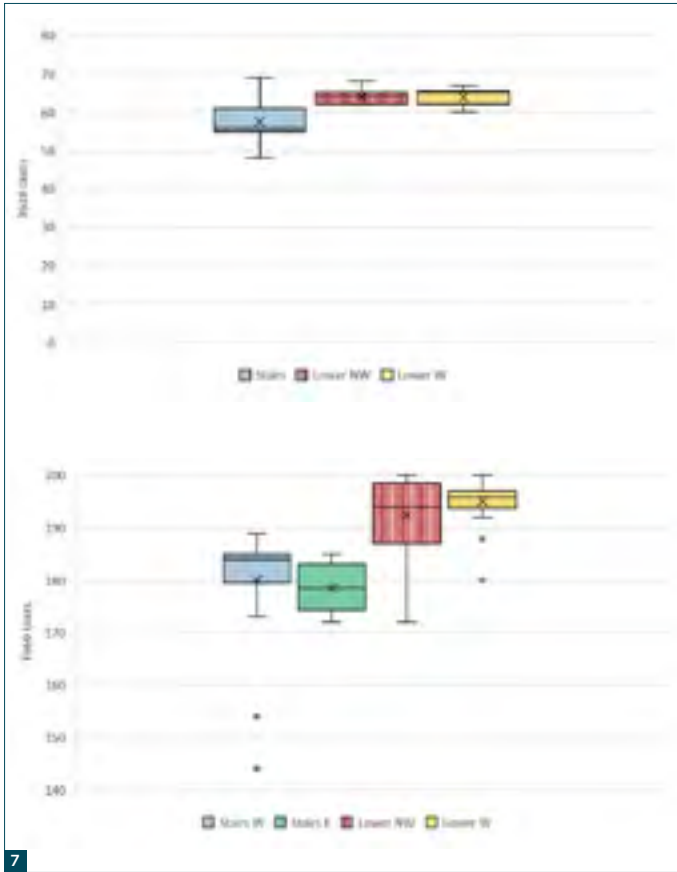
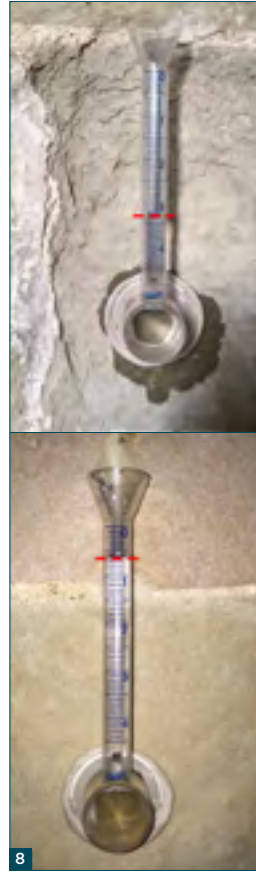
Figure 7: Boxplots of readings taken with moisture meters, showing mean (x), median (middle line), interquartile range (box), range (whiskers) and outliers (i.e. datapoints over 1.5 times above or below IQR). Results for T660 near surface readings above, results for T610 sub-surface readings below.

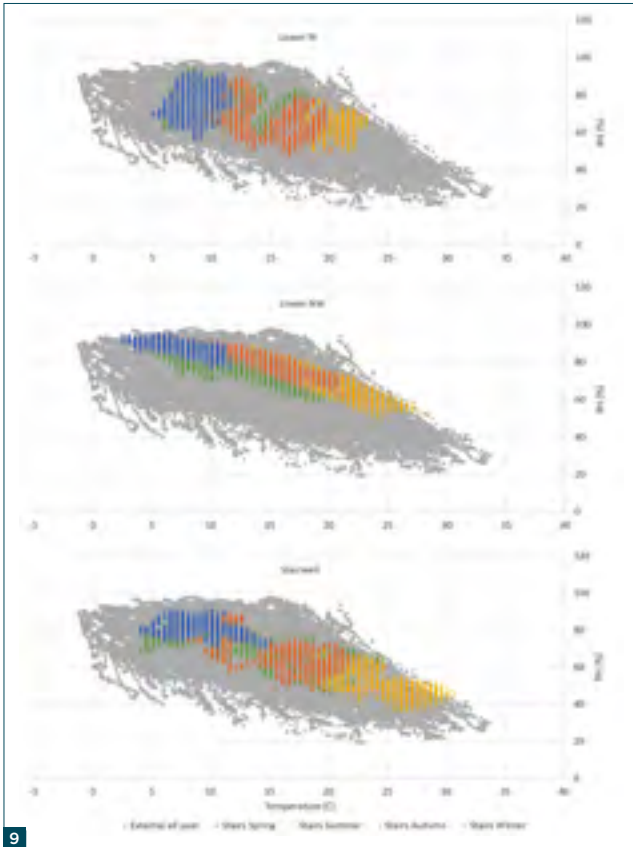
Figure 9: Scatterplots showing seasonal distribution of temperature and RH at surveyed locations (March 2018 - February 2019).

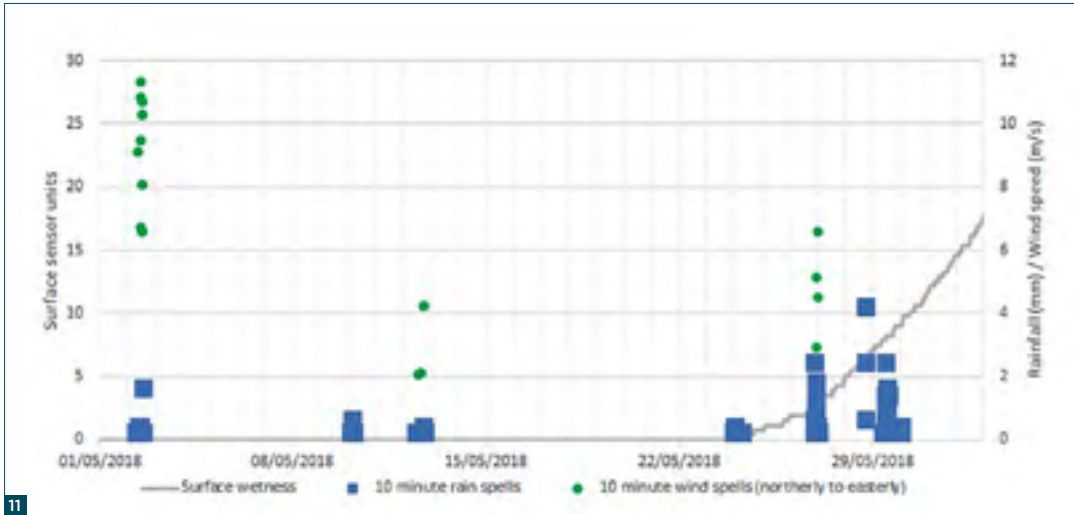
Figure 11: Five-week period showing correlation between surface-wetness sensor sealed against Reigate Stone in north-west alcove and wind-driven rainfall.

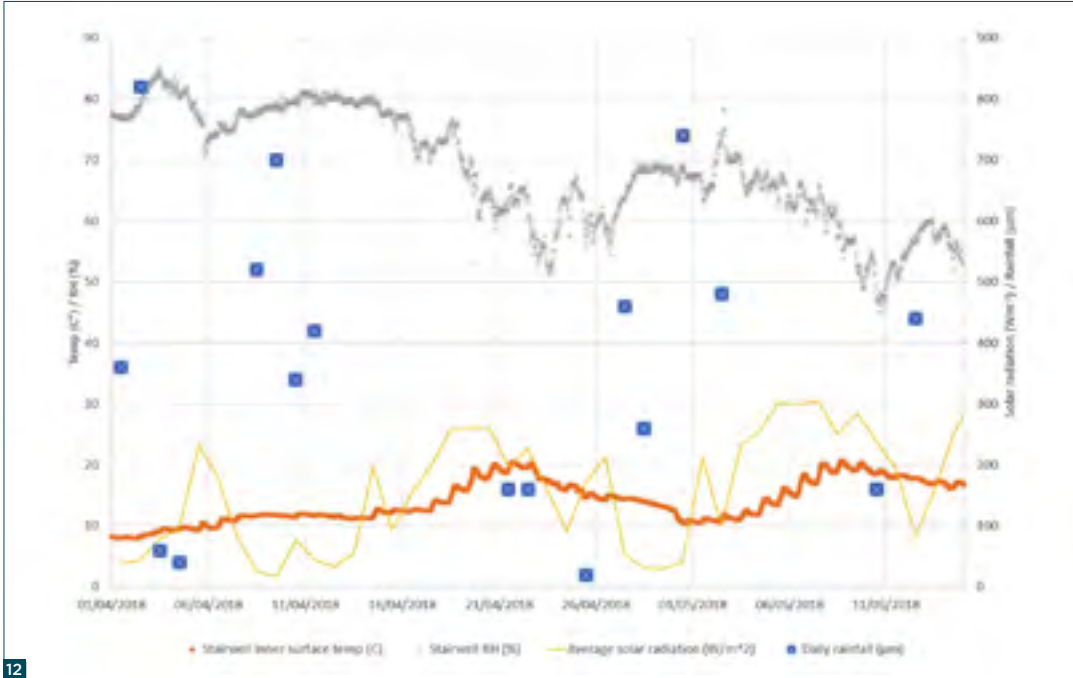
Figure 12: Six-week period in spring 2018, showing correlation of solar radiation and rainfall with RH and Reigate surface temperature in stairwell.

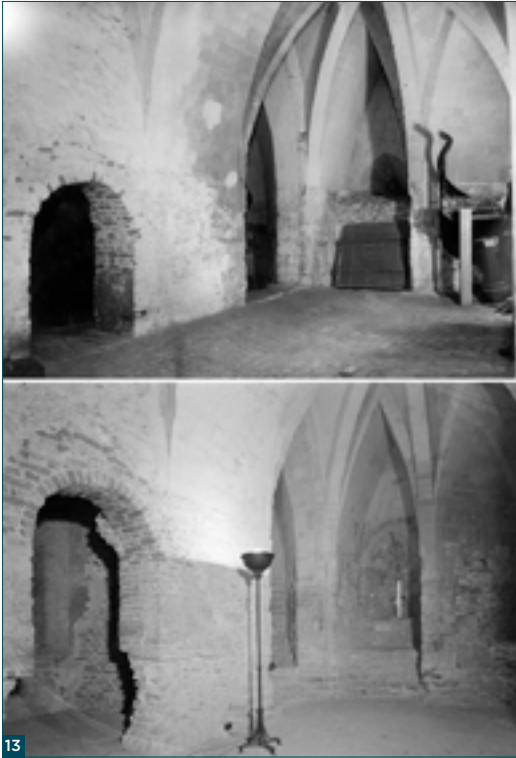
Photos of the lower chamber taken in 1945 and 1958 highlight the significance of contingency when considering the emergence of decay patterns (Figure 13). Rubble can be seen blocking the western alcove, the line of which closely matches the differential erosion visible today. The photos also show changes to the dressed masonry; what appears to be a thick limewash or plaster coat applied to

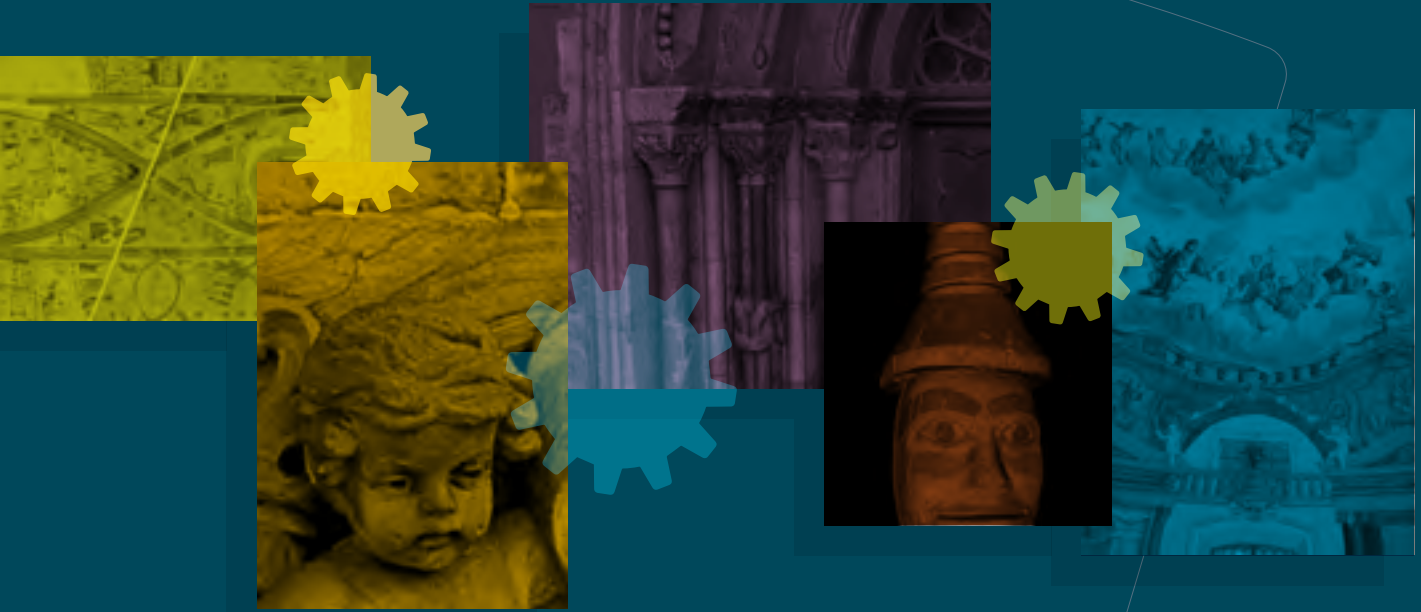
3D DOCUMENTATION OF MURAL PAINTINGS AND 3D MAPPING

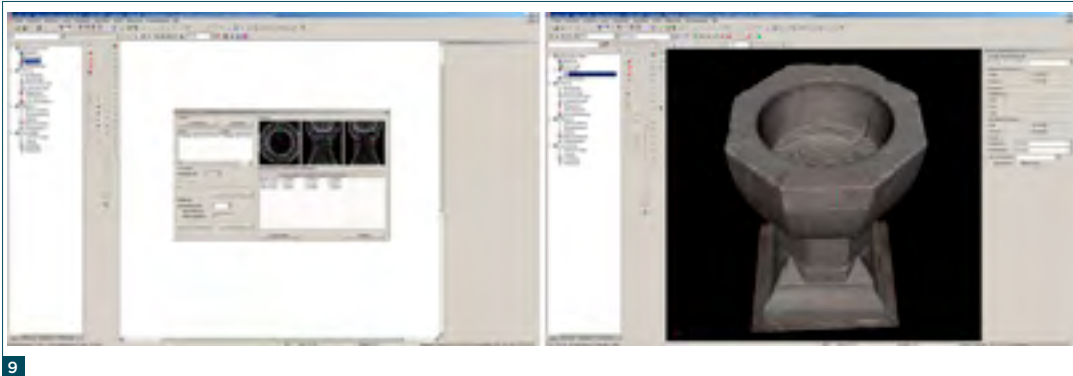
Figure 9:
Left: Import window for surface model in STL-, VRML- and OBJ-files with insertion of scaling factor and unit;
Right: 3D display of textured surface model.

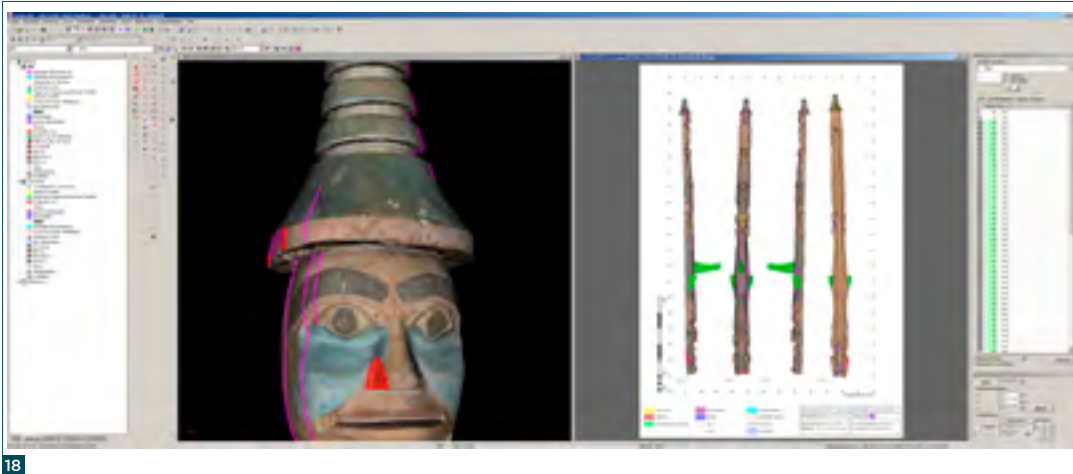
Figure 18: Left: 3D display of textured surface model of the totem pole with mapping; Right: true-to-scale outside unwrapping of 4 model views with orthogonal projection, mapping and group legend.

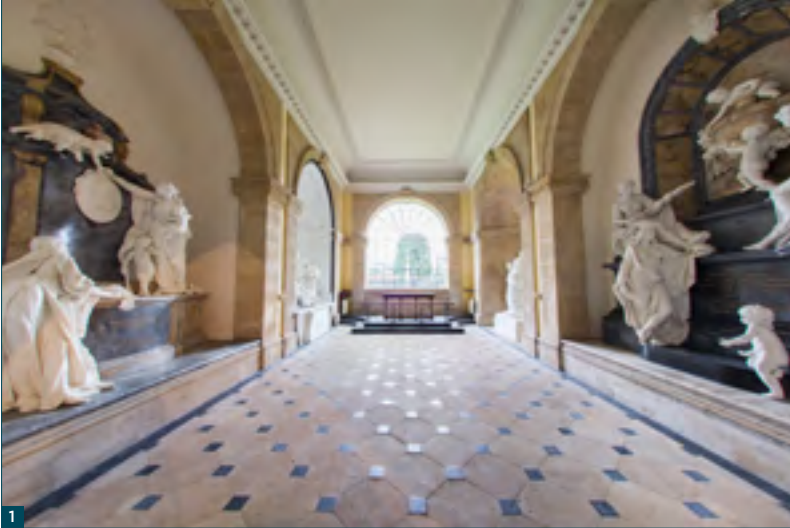
Figure 1:
Image by kind
permission of Buccleuch
Living Heritage
Trust: Photography
by Tom Arber.

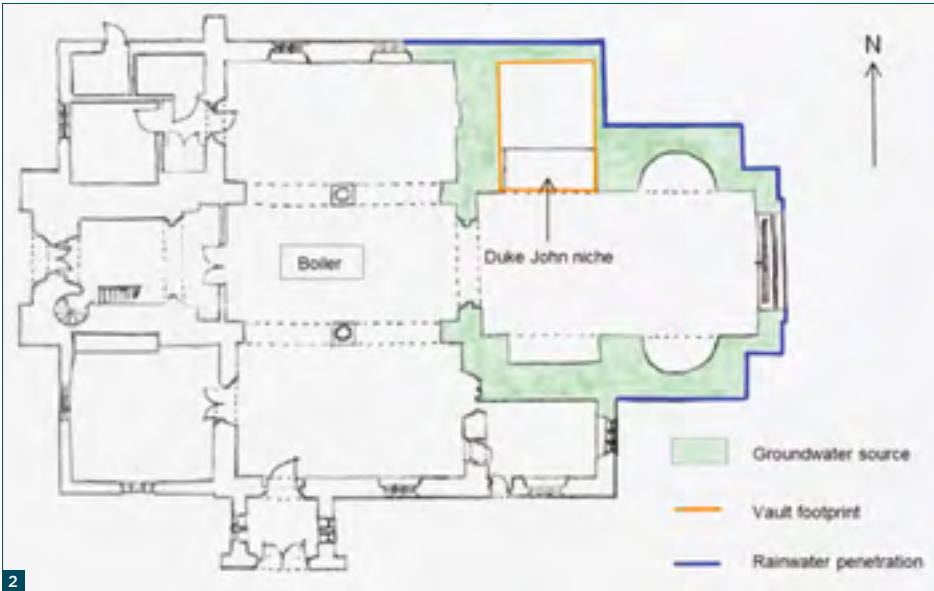
Figure 2:
Plan of church.

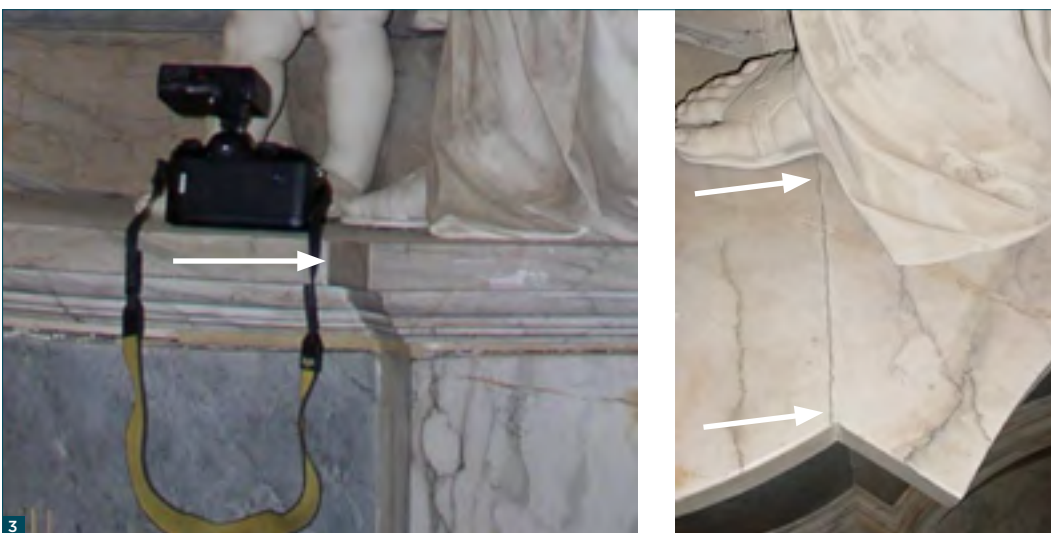
Figure 3:
Images from 2008 and 2013. The fracture in the shelf radiating from the angle of the moulding and terminating below Charity. Images courtesy of Skillington Workshop Ltd.

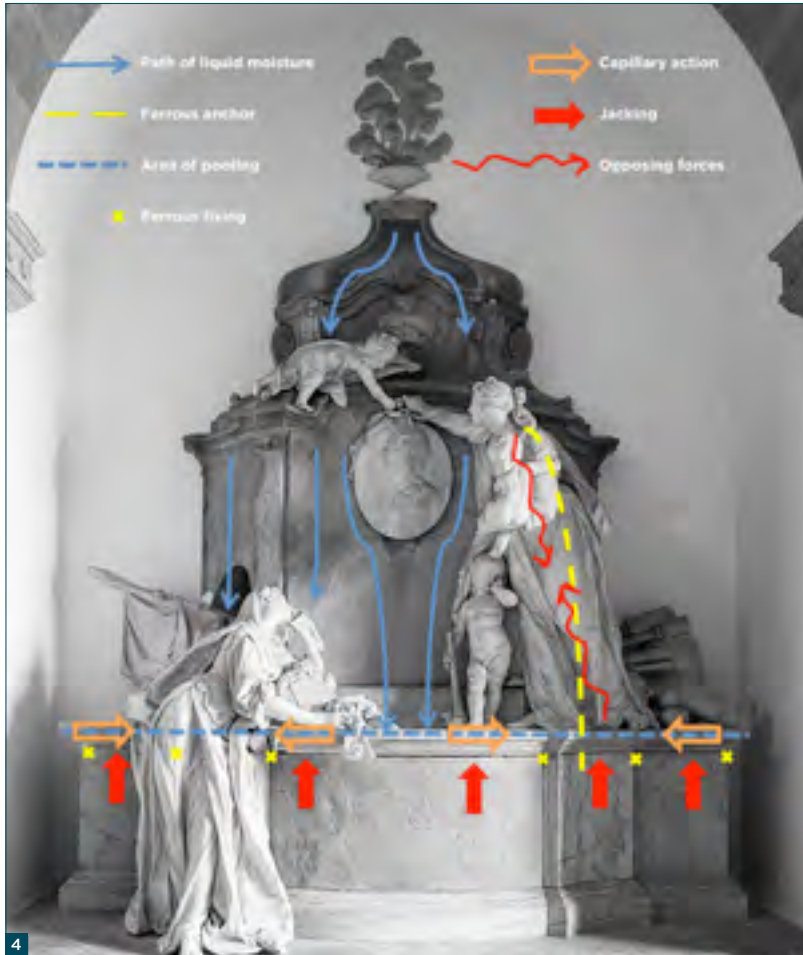
Figure 4:
Image by kind
permission of Buccleuch
Living Heritage
Trust: Photography
by Tom Arber.
