MONUMENTS IN MONUMENTS

CONFERENCE PROCEEDINGS

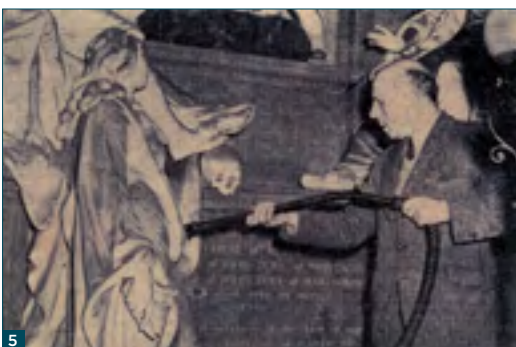
Figure 5: Mr Sinnett, agent to the Duke of Buccleuch before the monument of Mary, Duchess of Montagu. Note the soiling to upper surfaces. From the Kettering Evening Telegraph, 1948.

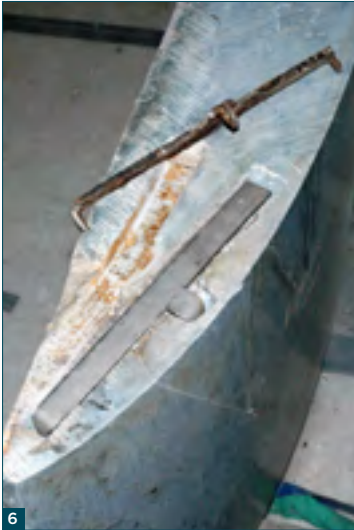
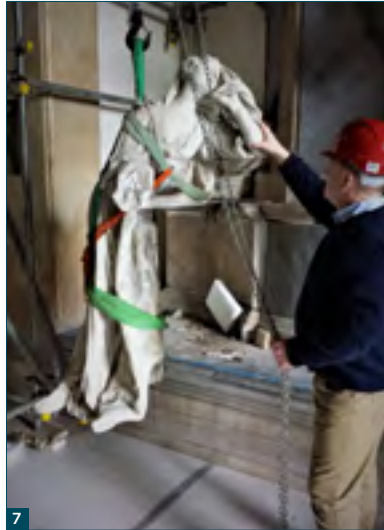
Figure 6:
An original ferrous
clamp to the
inscription block and
its stainless steel
replacement. Image
courtesy of Skillington
Workshop Ltd.

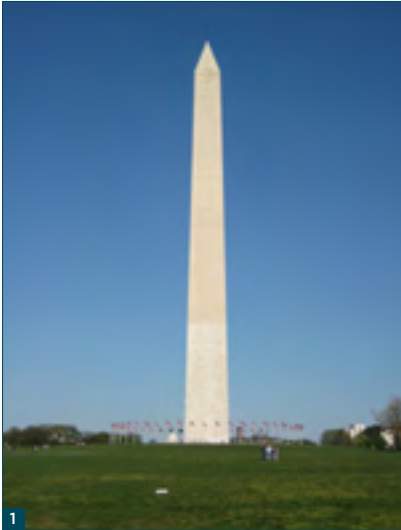
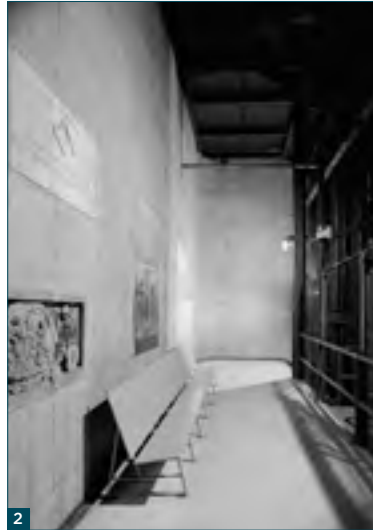
Figure 1:
Washington Monument.
All photos courtesy of the NPS unless otherwise noted.

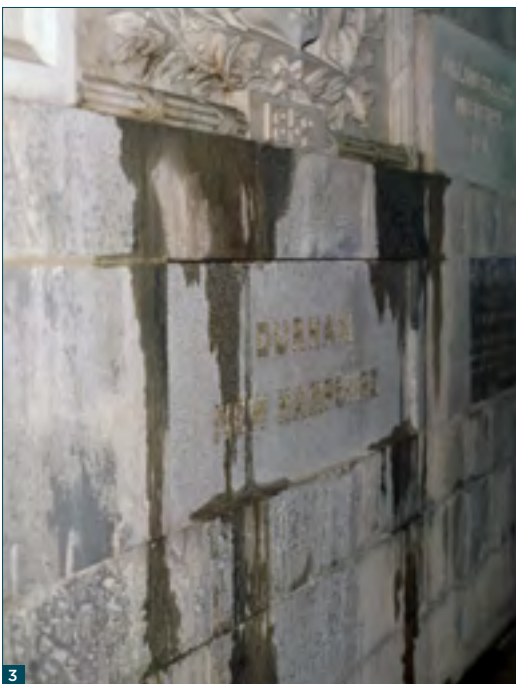
In the upper part of the monument, seeping or pouring rainwater – and condensation – has caused the rusting of iron wedges with associated cracks, spalls, and stains in the stones. Rainwater has also caused the rusting of the steel brackets and ‘toe boards’ of landings and large drip trails of iron-oxide particles on walls. During periods of drying, salts from cement grouts have caused disaggregation and flaking of stone surfaces.

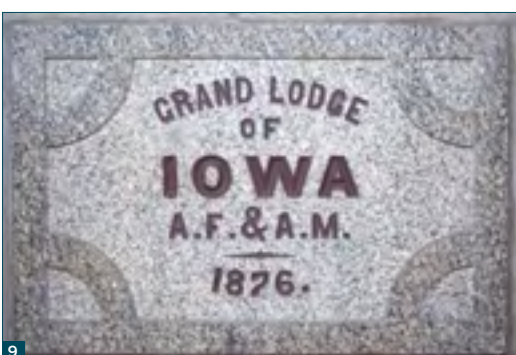
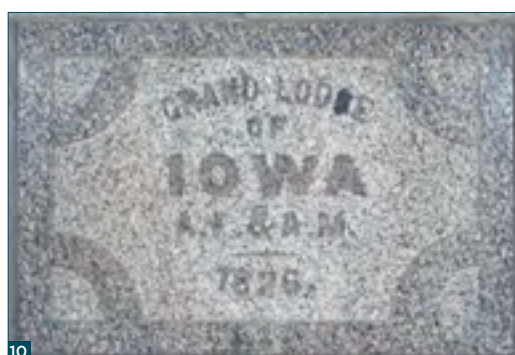
Figure 9:
Masons, Grand Lodge
of Iowa (2' 8" x 3' 11"),
donated in 1876 and
installed in 1885, 210ft
level, before treatment,
1998. Note: black mark
in the 'G' of 'Lodge' is an
inclusion in the stone.

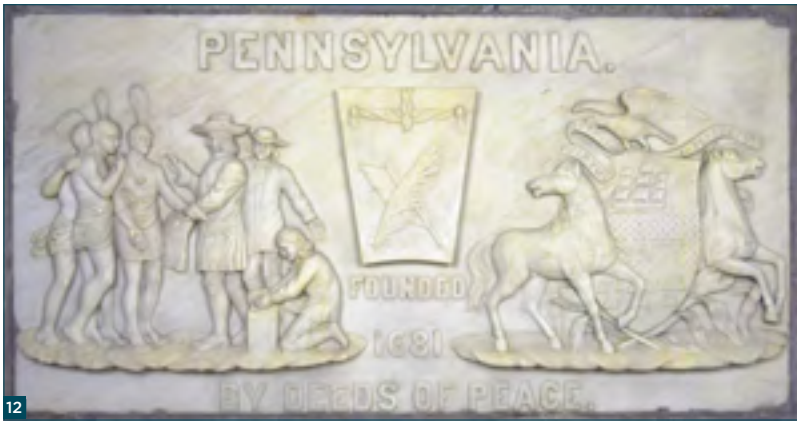
Figure 12:
Pennsylvania, after
treatment, 2000.

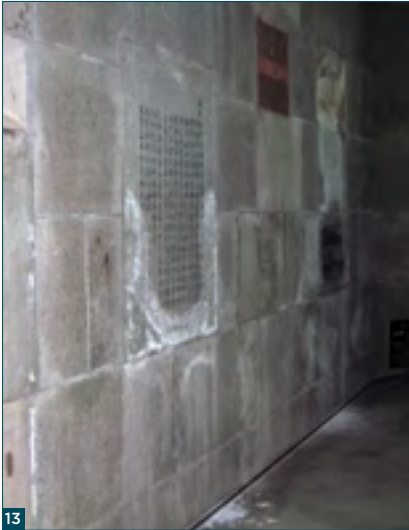
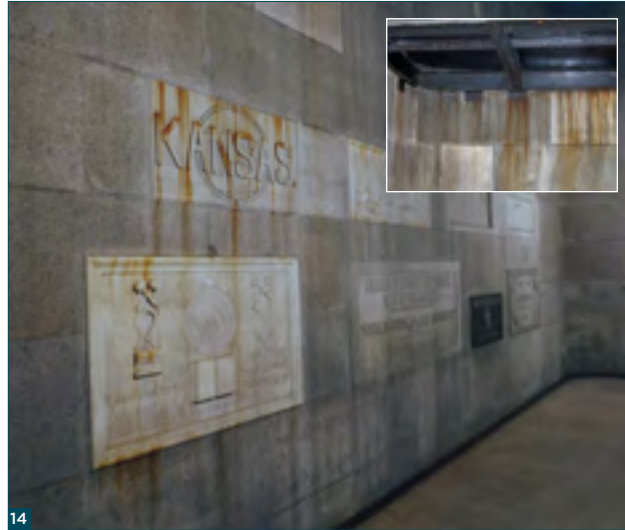
Figure 13:
220ft level following a period of drying; salts from cement grout behind stones, 2009.

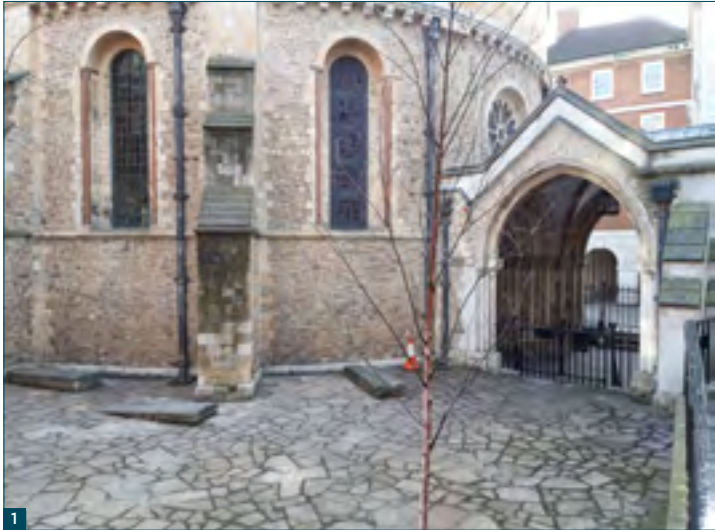
Figure 1:
View of doorway and porch (© Purcell).

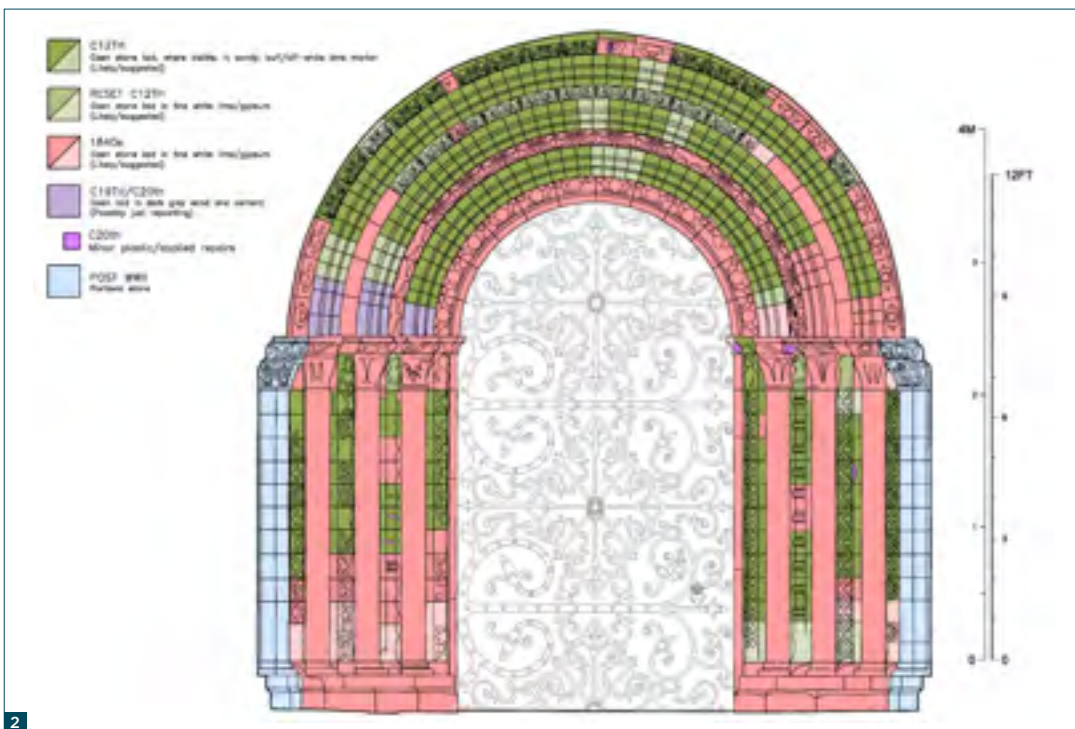
Figure 2: Image showing age of stones (© CAT).

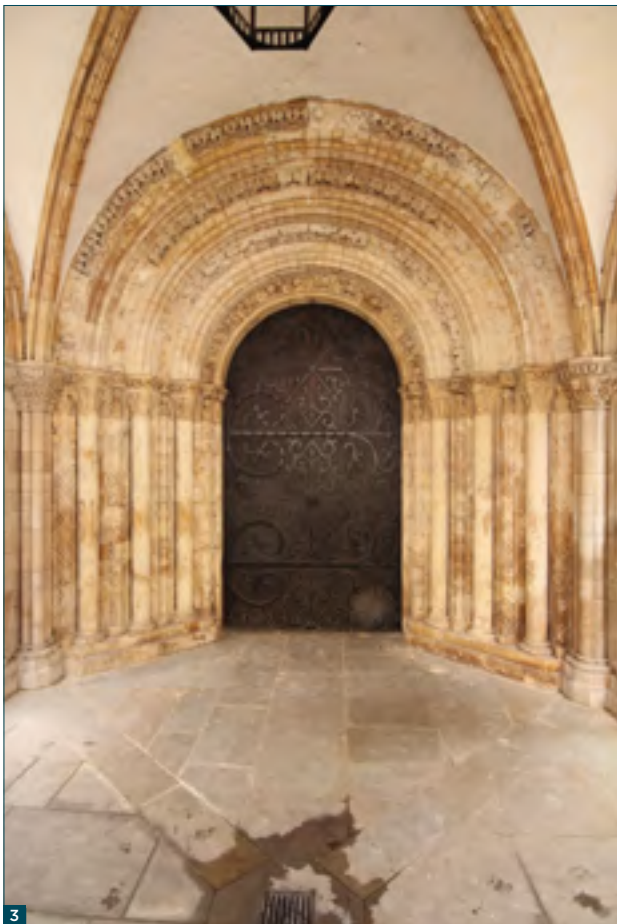
Figure 3:
Condition of doorway
in 2017 (© CAT).

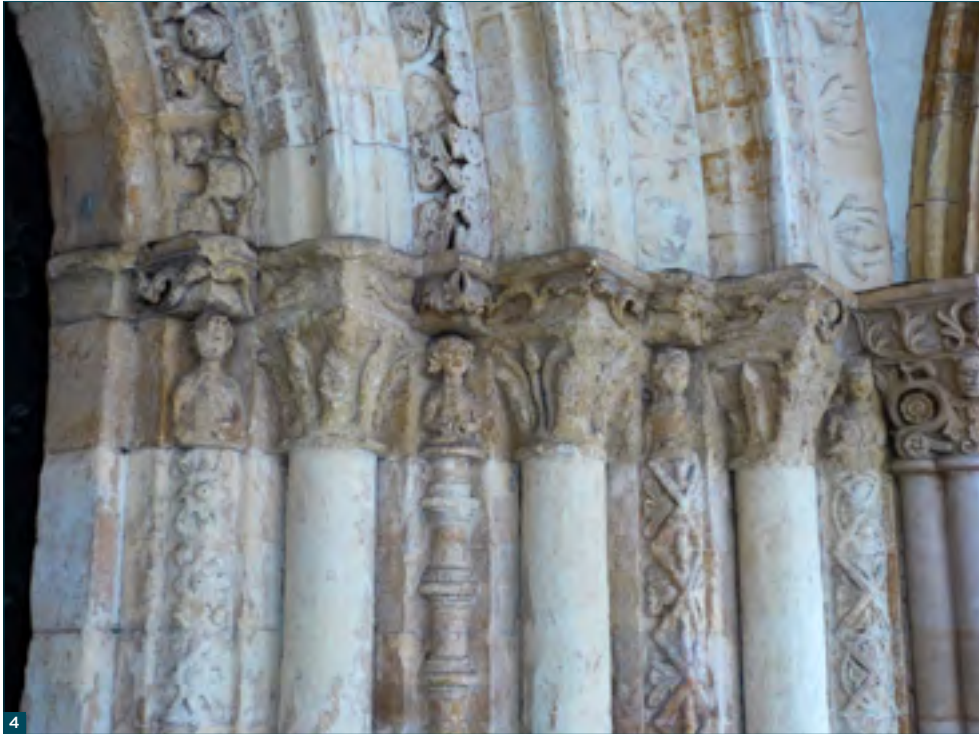
Figure 4:
Detail of south side
showing variable
surfaces (© OCC).

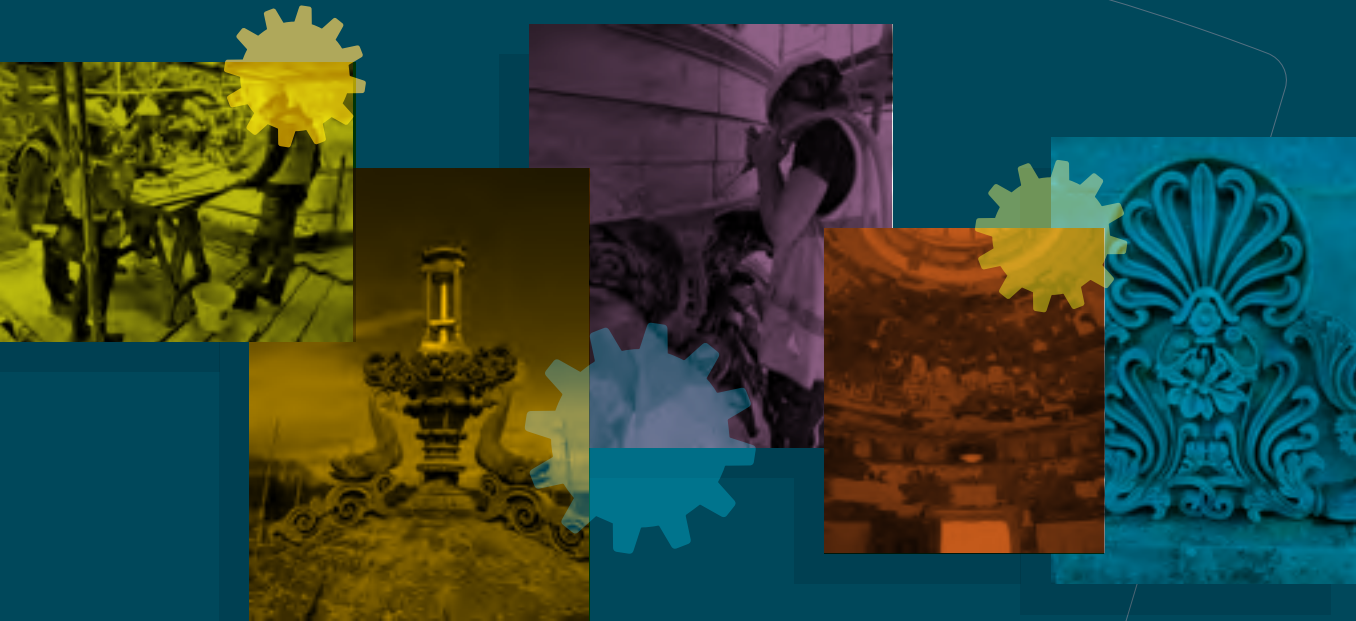
**MICRO-GROUTING OF BURNS
MONUMENT, ALLOWAY, AYRSHIRE:
A SYNTHESIS OF TRADITION AND
INNOVATION IN BUILDING CONSERVATION**

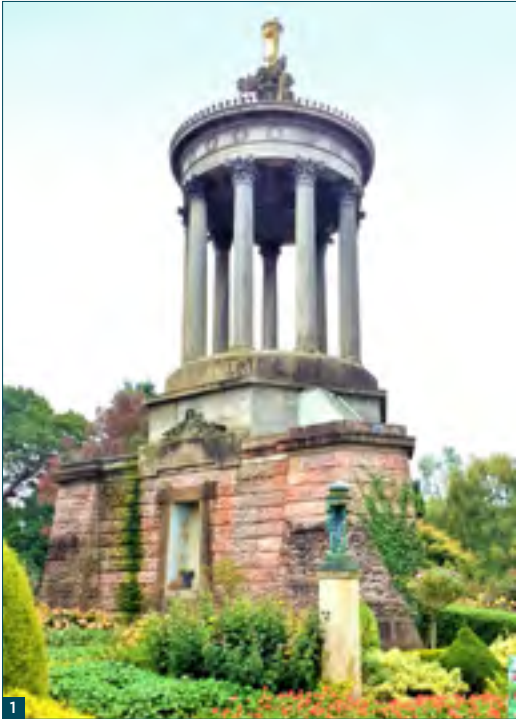
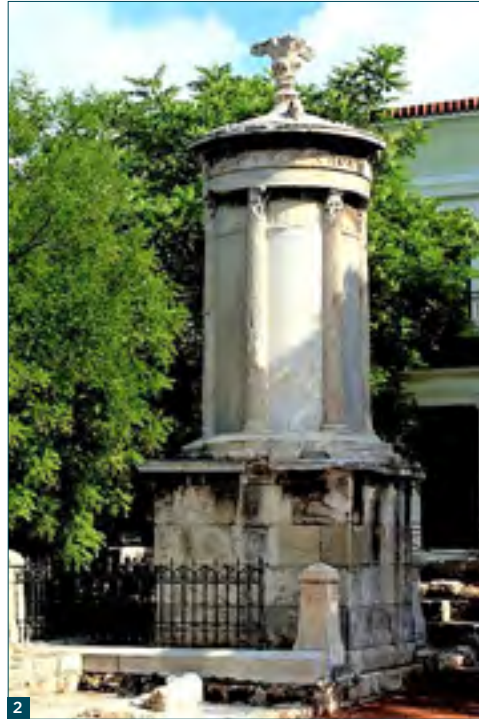
Figure 1:
Burns Monument,
2016 before
conservation work.

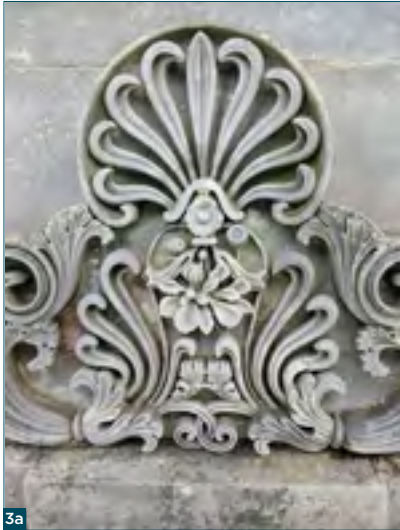
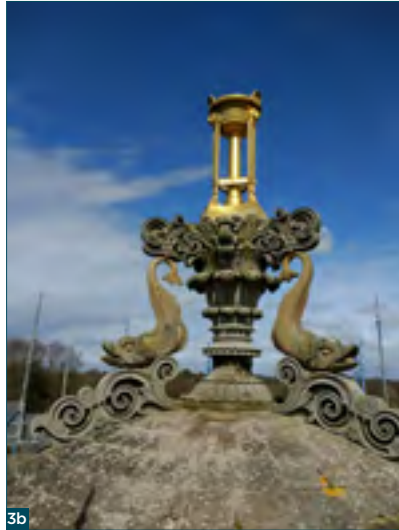
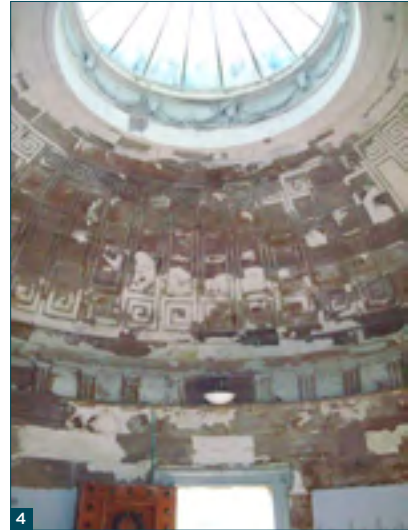
Its construction is outstanding: built using the finest Scottish sandstone available and constructed in the best ashlar stonemasonry traditions of the time (Figure 3). Almost two centuries on, however, the exposed masonry is suffering from extensive water penetration leading to progressive, irreversible damage and disfigurement of the finely wrought ashlar interior.

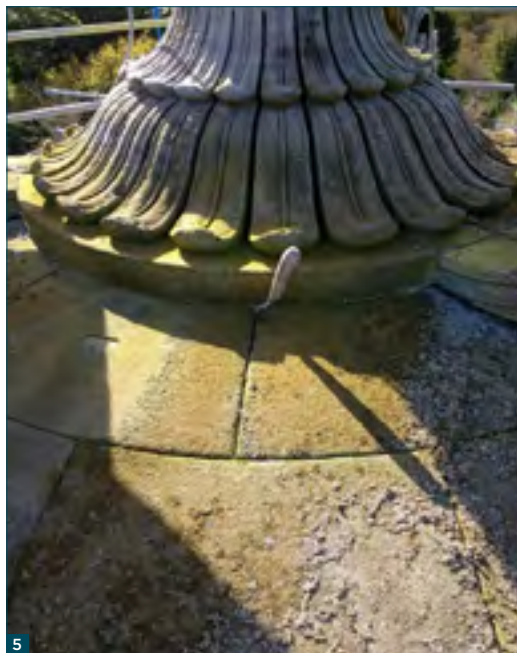
2. SURVEY AND INVESTIGATION

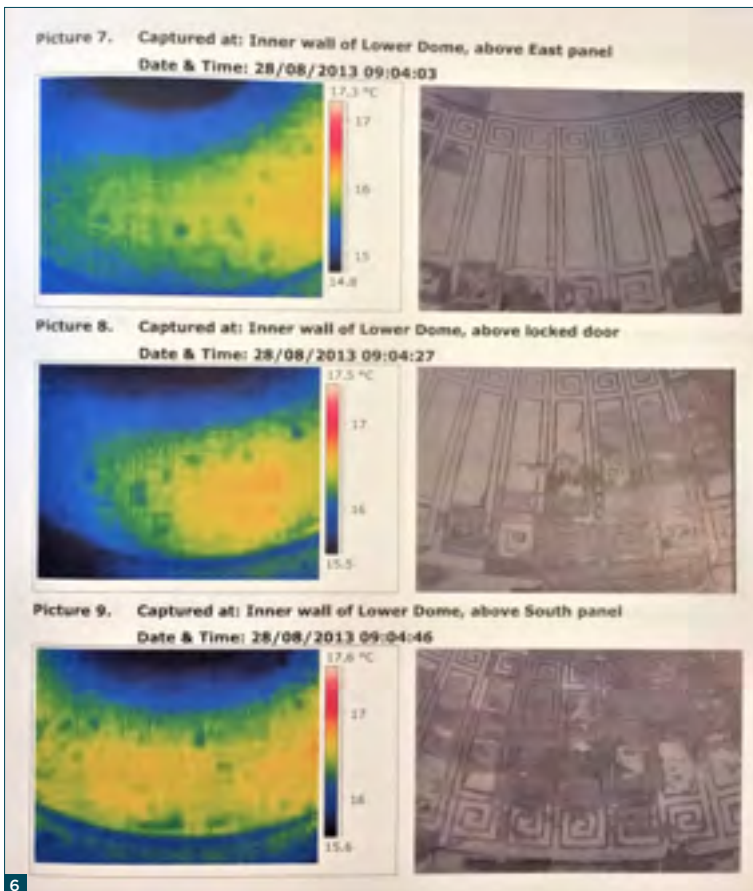
Figure 6:
Infra-red thermography
report extract.

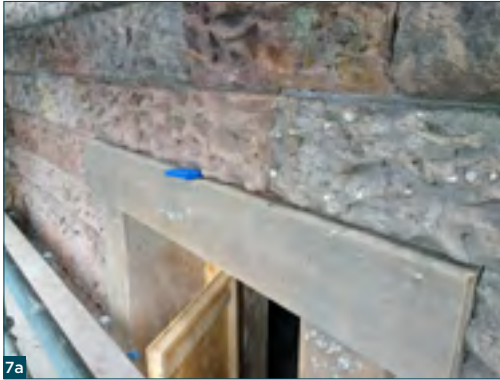
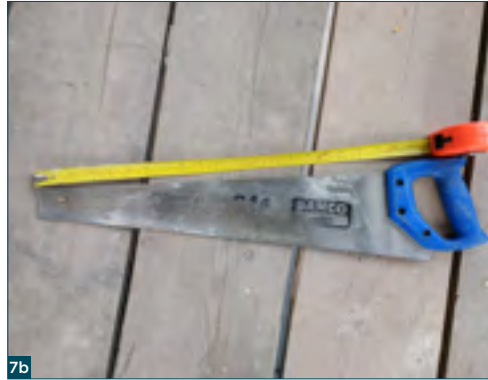
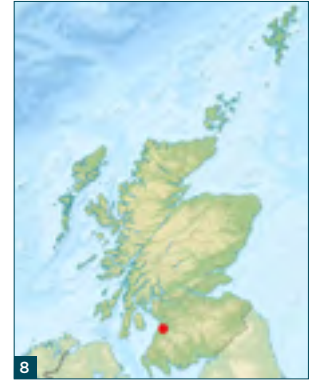
and levelling of stone units during the construction process. Unfortunately now, these voided beds, some measuring up to 1100mm deep (Figure 7) create effective primary pathways for water ingress into the core.

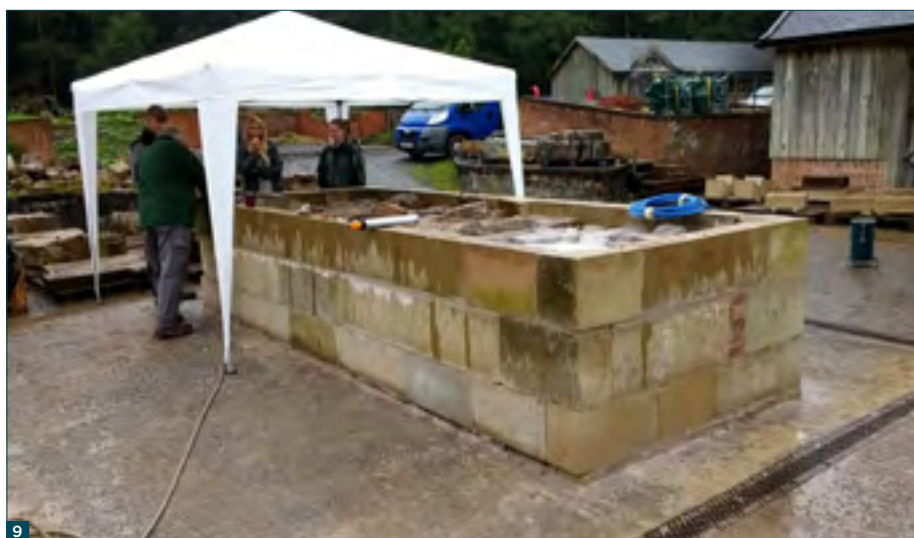
Figure 9:
Test rig ashlar wall and rubble core for micro-grouting trials at Culzean Castle 2017.

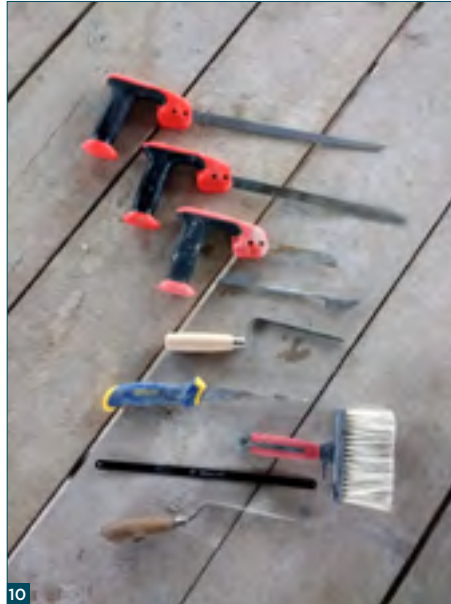
Figure 10:
A selection of tools used for raking defective mortar out of ashlar mortar joints.

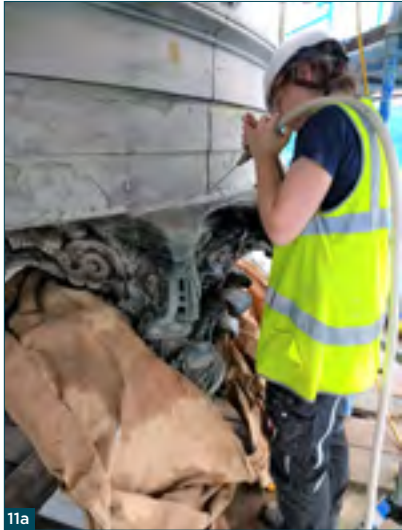
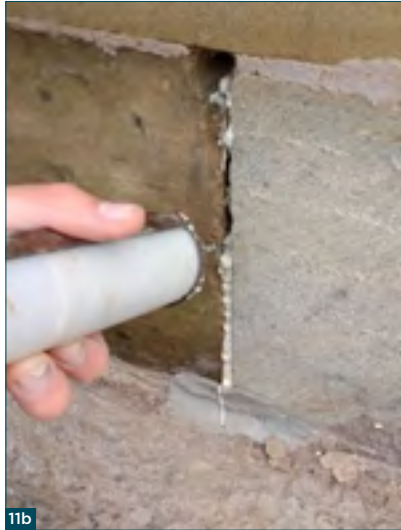
Figure 11:
a) Micro-grouting capital top bed using fully fluid lime grout.
b) Pointing an open joint using restricted flow lime grout.

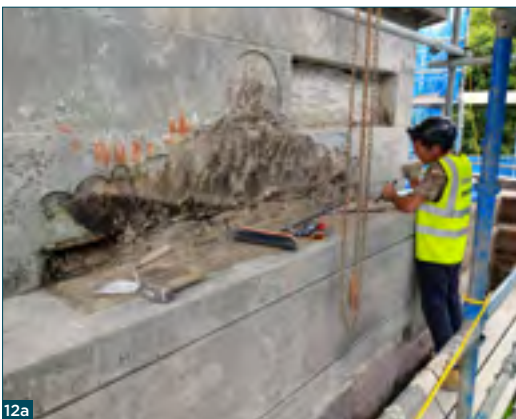
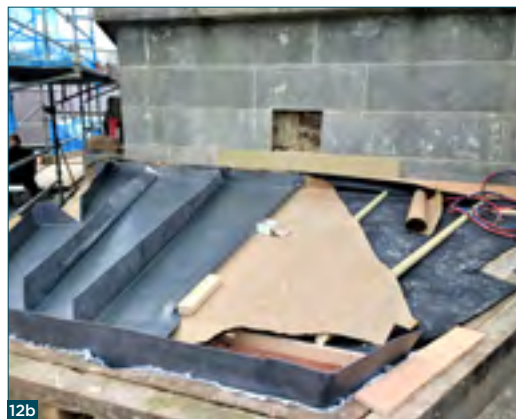
Figure 12:
a) Monument conservation works in-progress, 2018.
b) Replacement lead flat roof coverings in-progress, 2019.

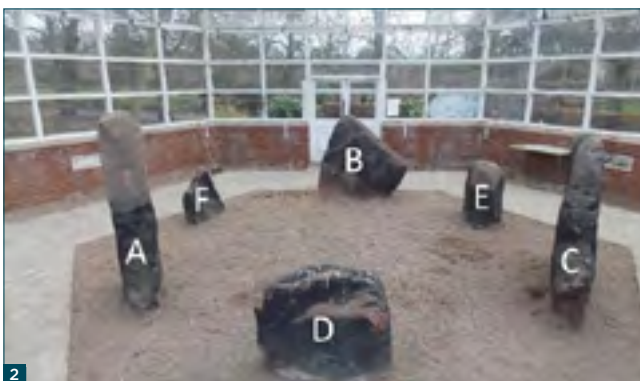
Figure 2:
The Calder Stones in
the Harthill Vestibule.
The identification of
the stones follows the
convention developed
by Forde-Johnston.

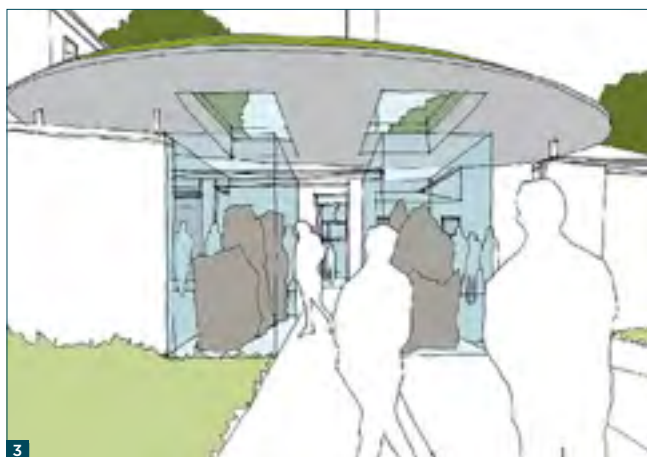
Figure 3:
Visual of architects' initial design.

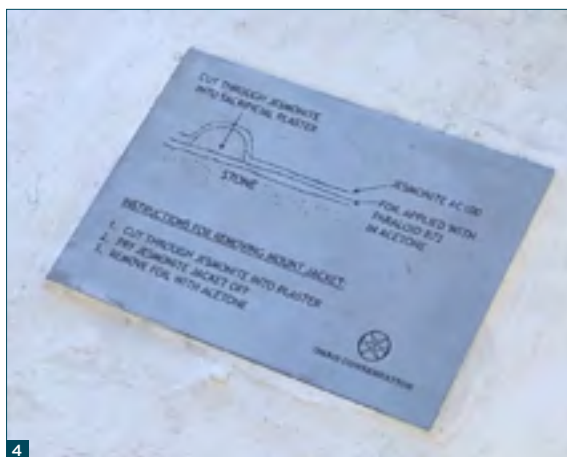
Figure 4: Steel plate showing how to remove jacket, embedded in the mount jacket itself.

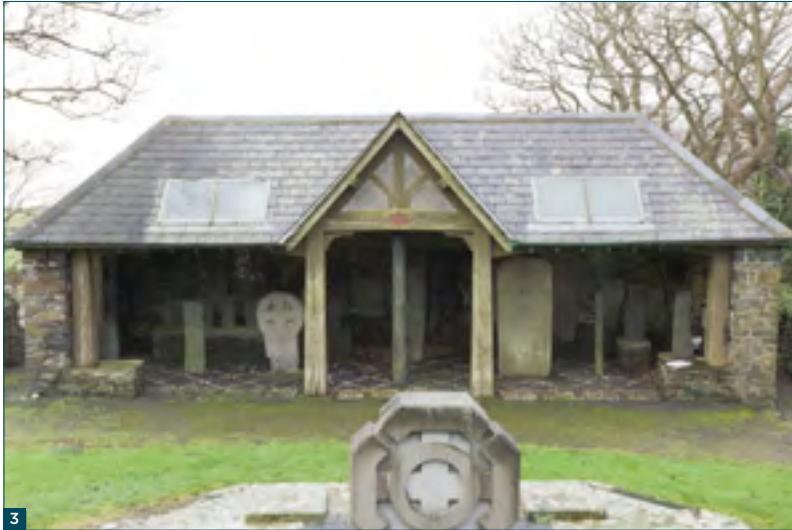
Figure 3:
Maughold Cross
Shelter (1906).

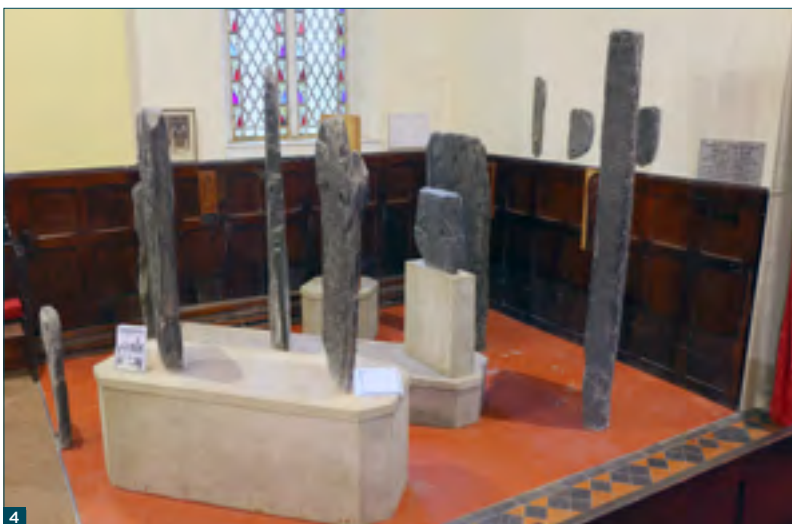
Figure 4:
Manx Crosses at
St Michael and All
Angels, Kirk Michael.

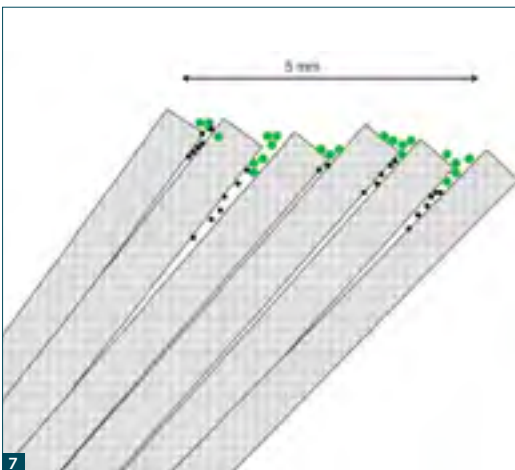
Figure 7:
Possible role of algae and fungi (smaller dots) in the decay of Manx Series stones.

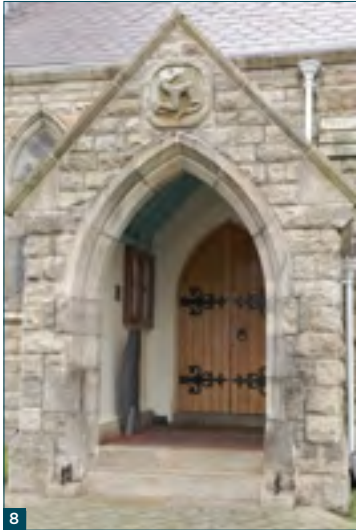
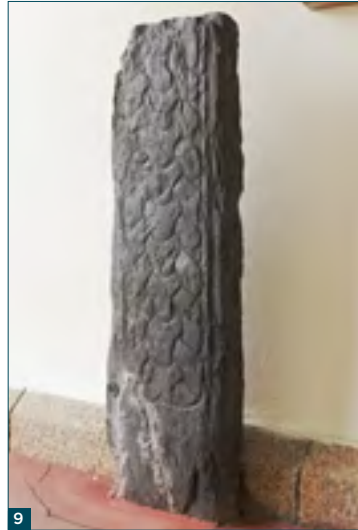
Figure 8:
Osruth's Cross (MC107)
in the porch, St John's.

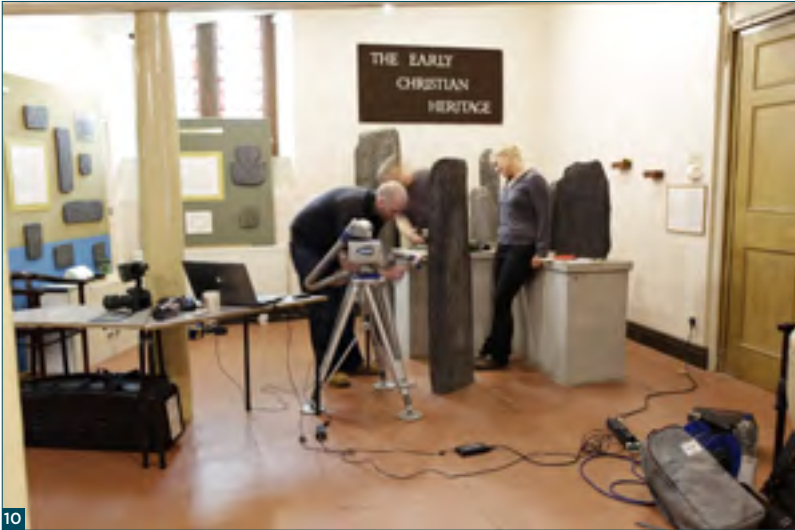
Figure 10:
Dr James Miles and
Gianna Gandossi from
Archaeovision at
Andreas Church.

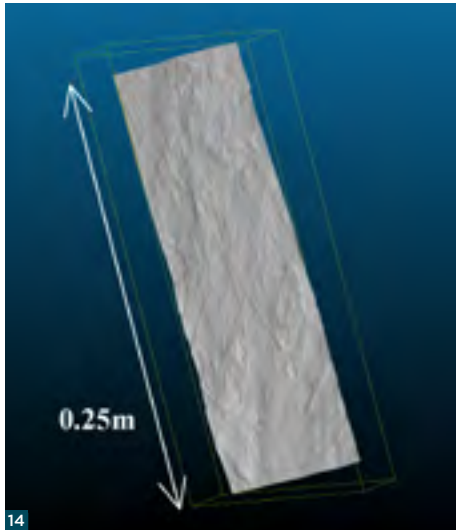
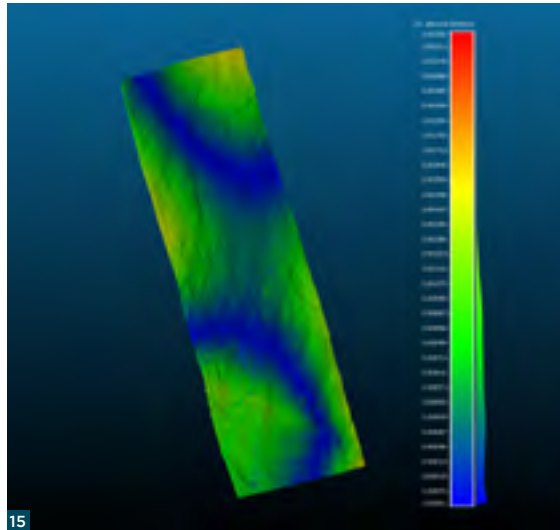
Figure 14:
Part of the aligned
clouds of MC42 and its
1905 plaster mould.

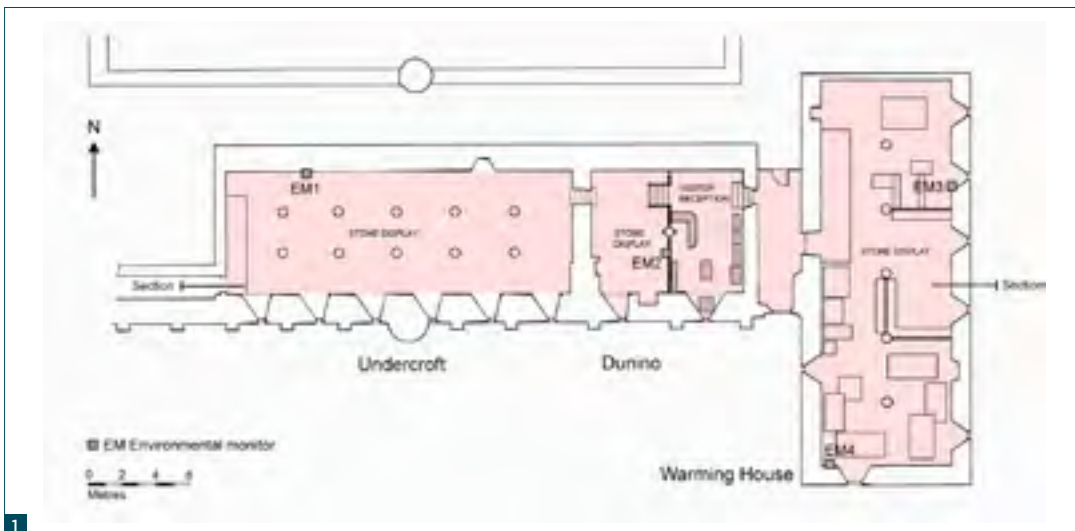
Figure 1:
Floor plan of St Andrews
Cathedral Museum.

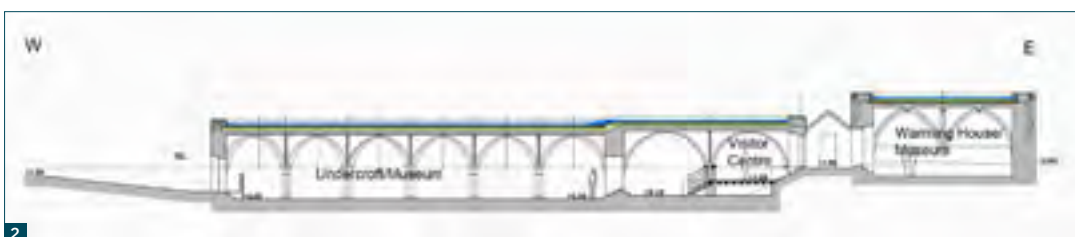
Figure 2:
Cross section
through St Andrews
Cathedral Museum.

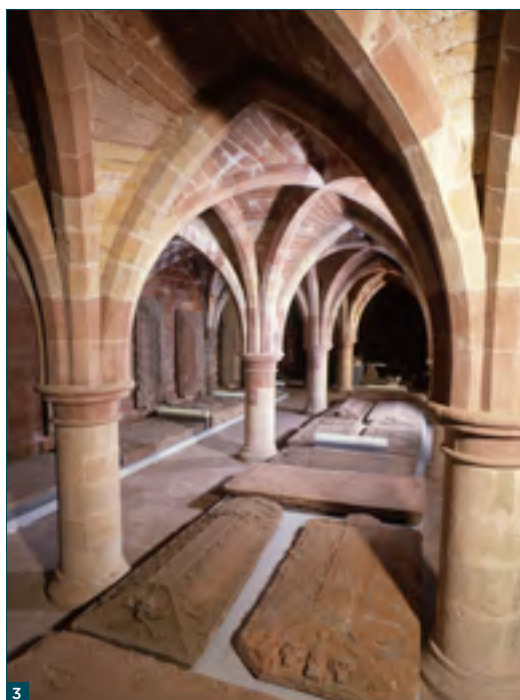
Figure 3:
Stone displays in the Undercroft, St Andrews Cathedral Museum, © Crown Copyright HES.

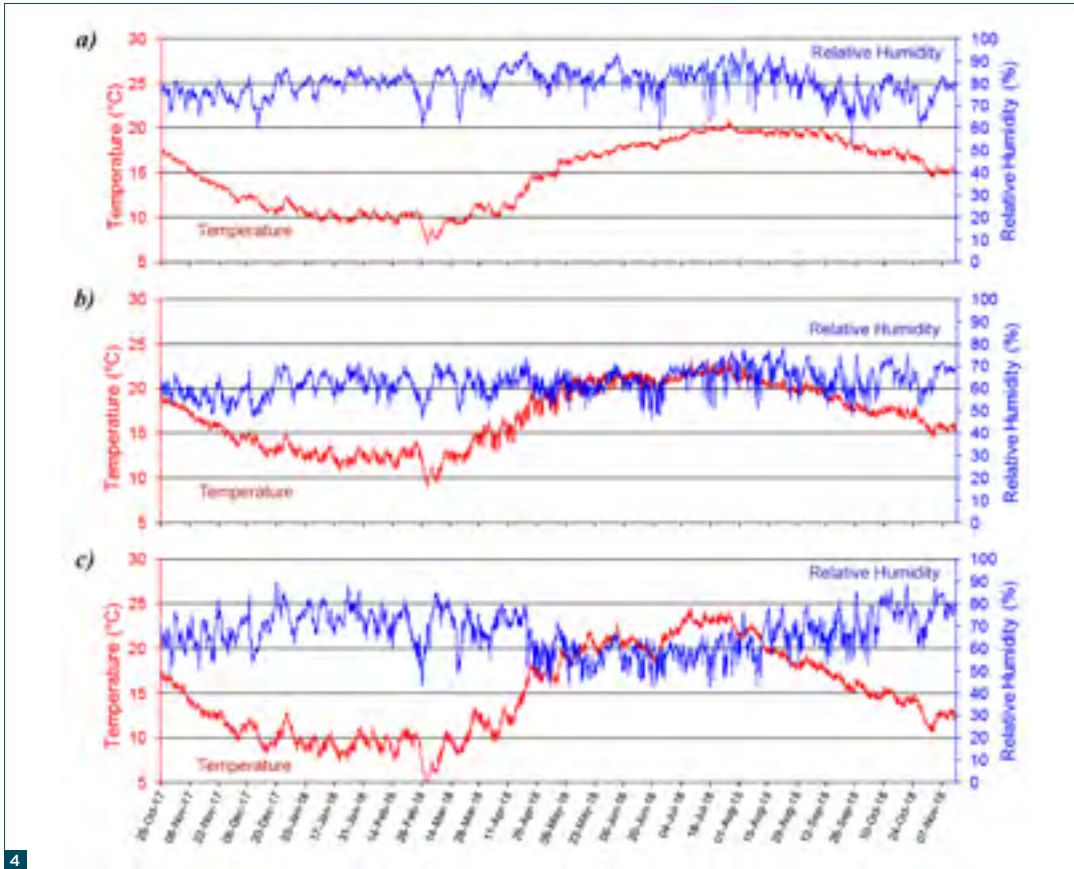
Figure 4: Variations in temperature and relative humidity, 24 Oct 2017–13 Nov 2018, a) Undercroft, b) Dunino, c) Warming House (SW).

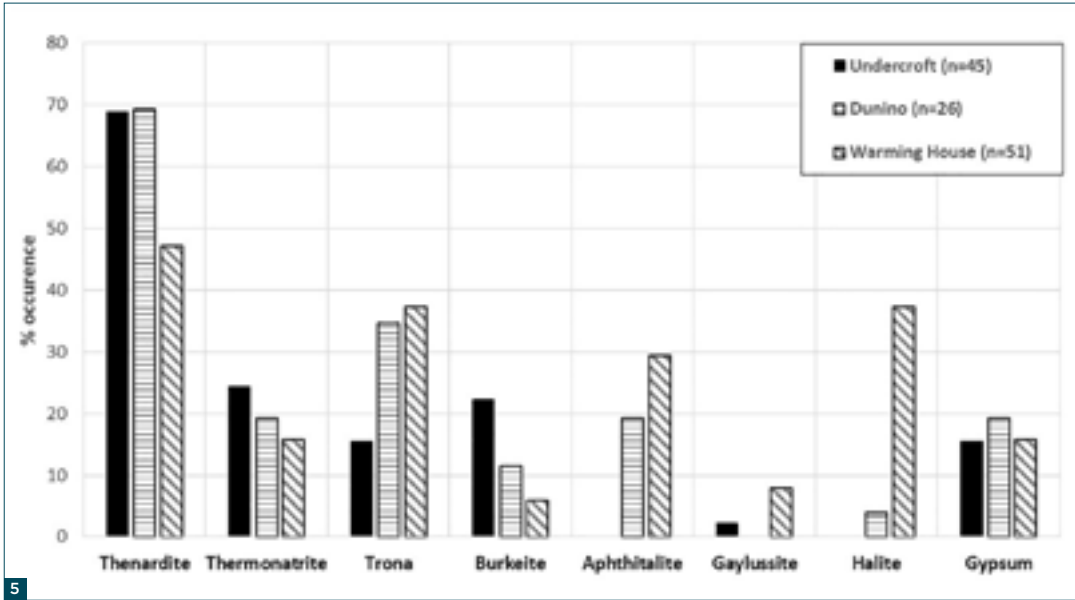
Figure 5: Distribution of identified salts by museum room (% breakdown by presence in sample only).

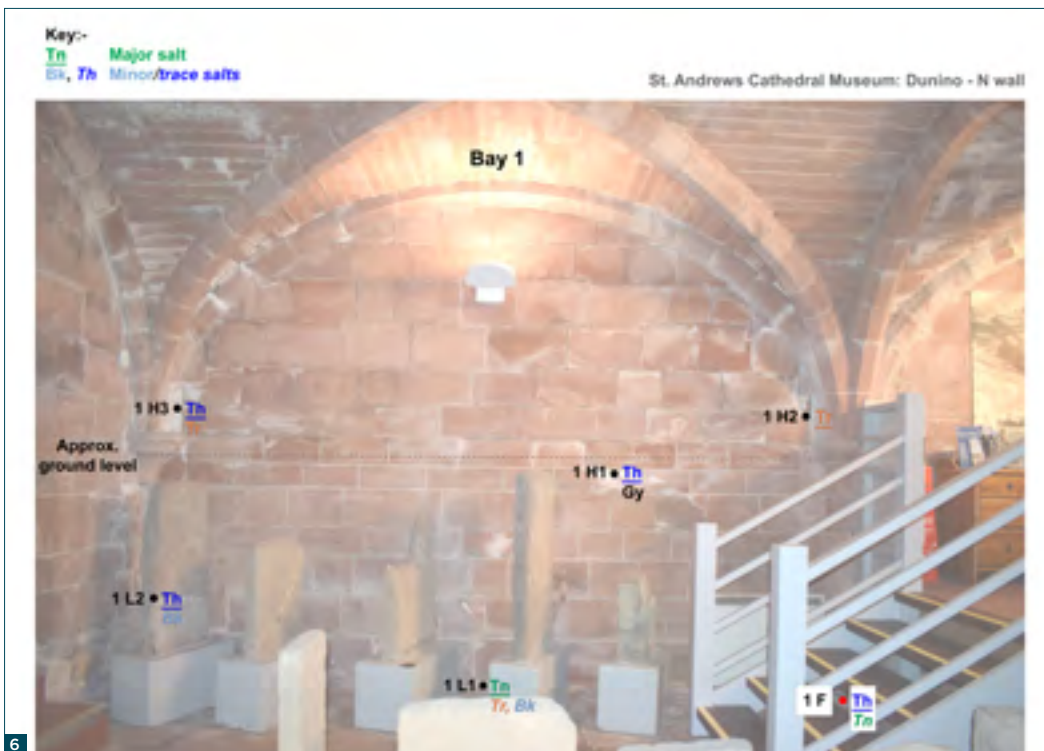
Figure 6: Salt analysis results for Dunino, N wall, October 2017 (Th=thenardite, Tn=theronatrite, Tr=trona, Bk=burkeite, Gy=gypsum).

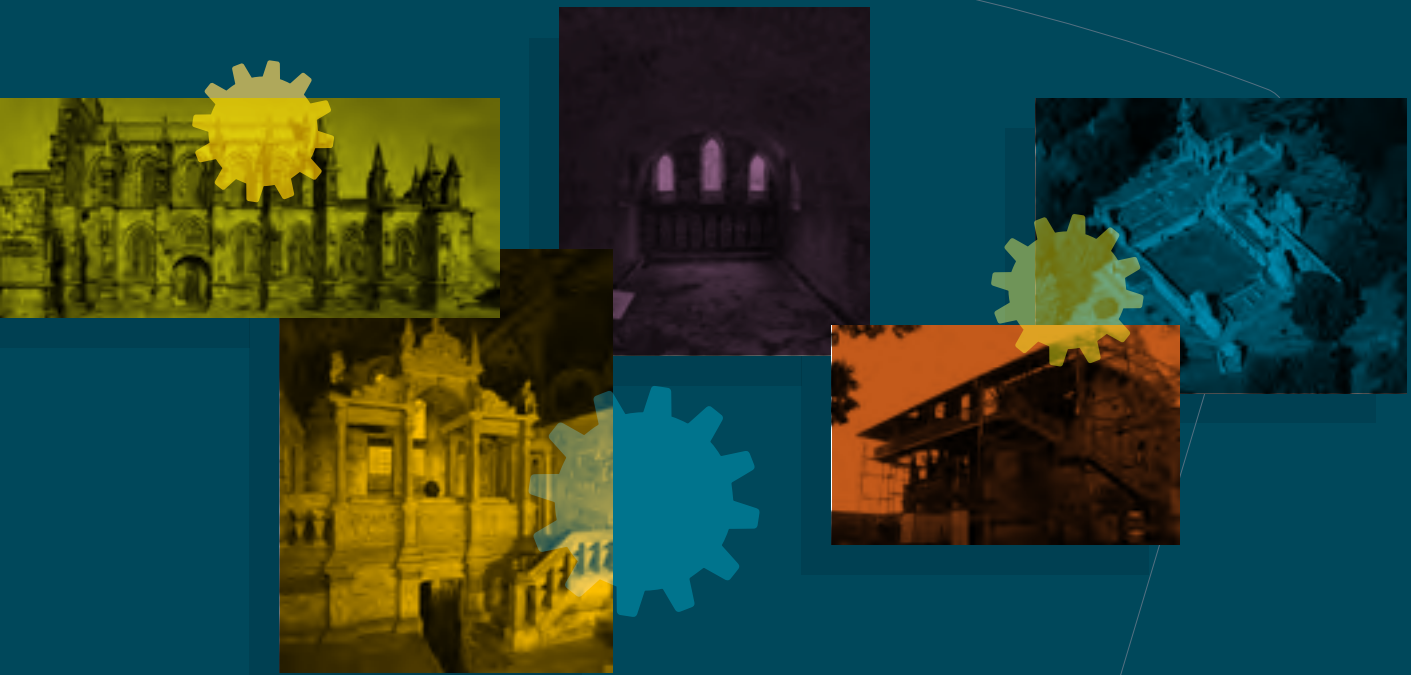
**PREVENTIVE CONSERVATION
FOR MONUMENTS:
MONITORING AND ADAPTING THE
ENVIRONMENT WITHIN A BUILDING**

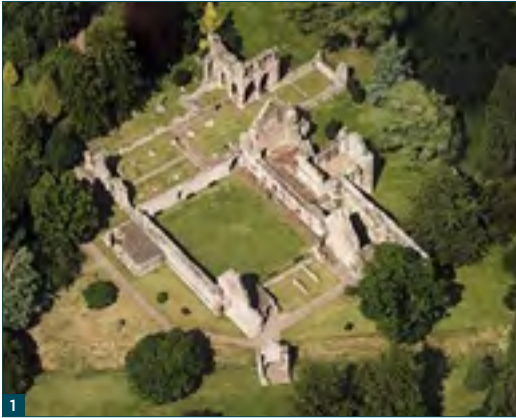
relative humidity, environmental monitoring, salts, preventive conservation

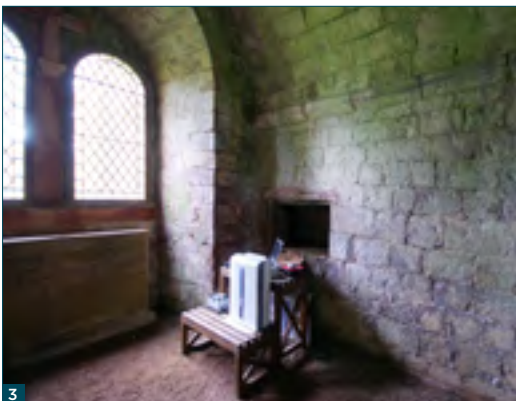
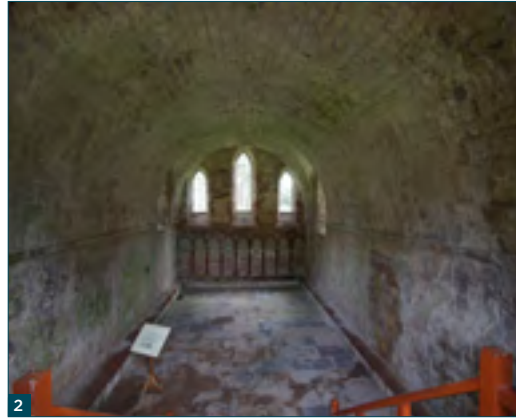
2. DRYBURGH ABBEY: CHAPTER HOUSE AND PARLOUR

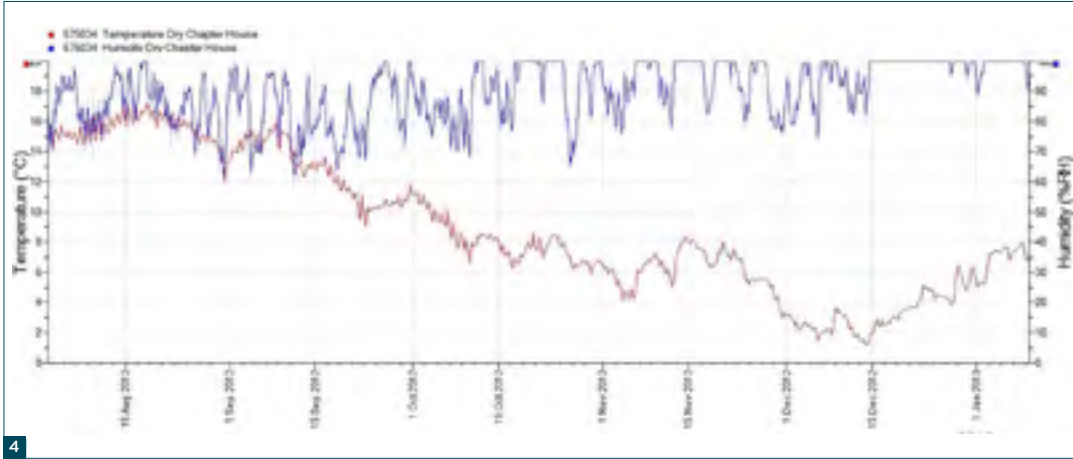
Figure 4:
Chapter House
temperature and
relative humidity.

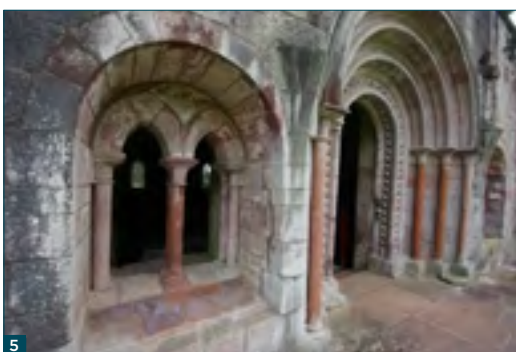
However, there were aesthetic concerns raised by the Historic Environment Scotland Cultural Resources Advisor

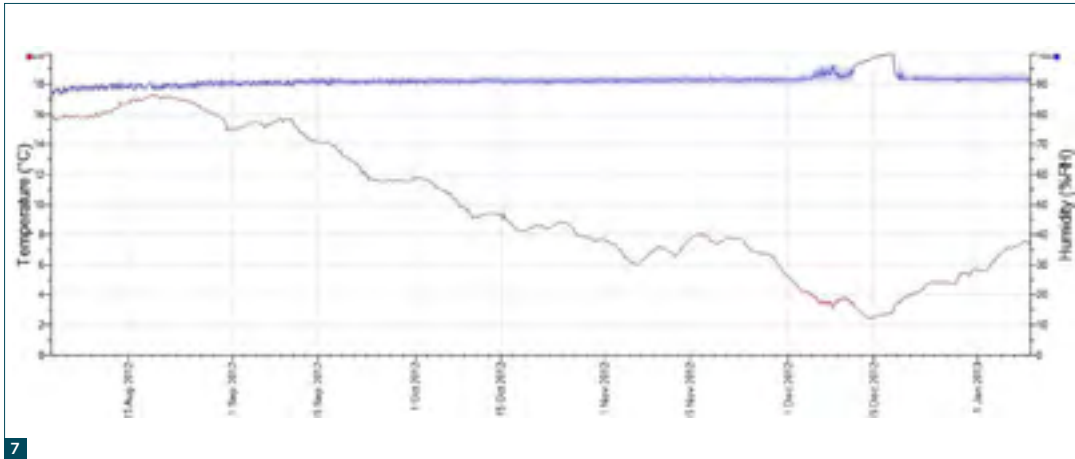
Figure 7:
Chapter House with dehumidification.

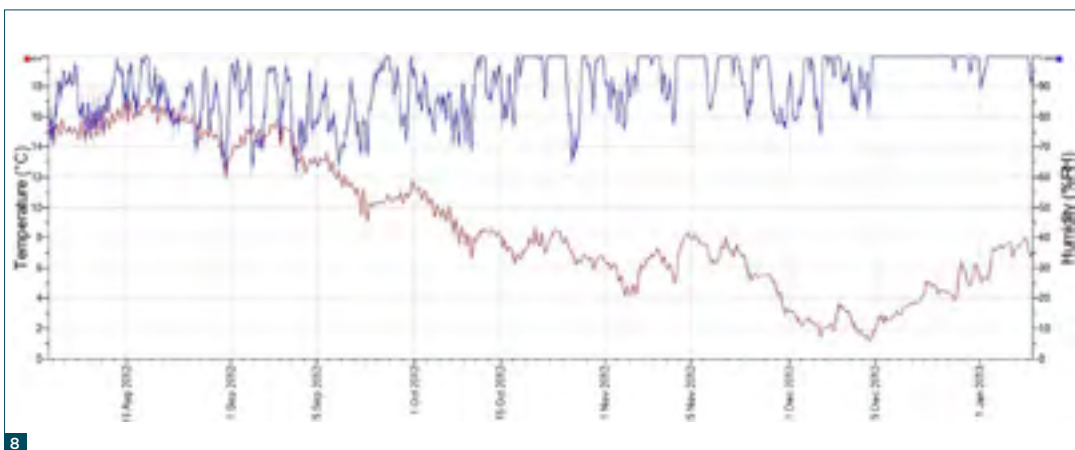
Figure 8:
Chapter House without dehumidification.

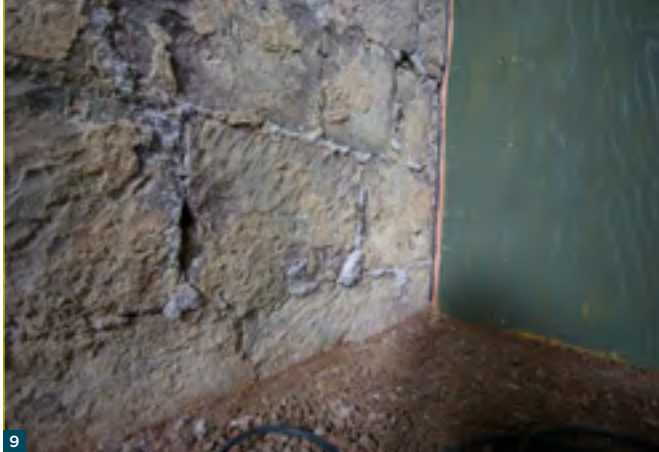
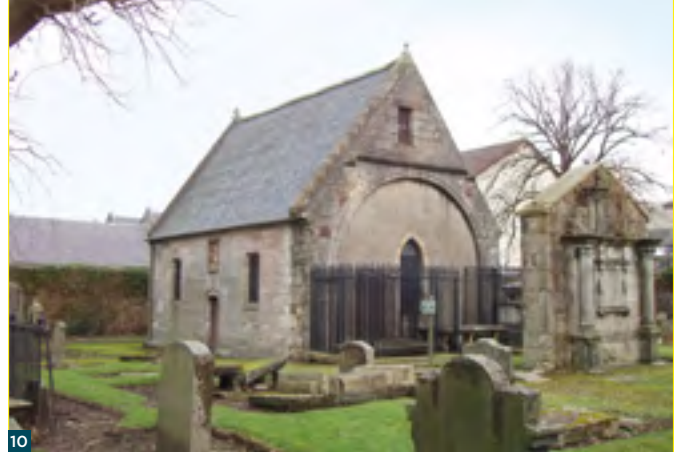
green sheen of microbiological growth on the masonry inside the partition, compared to outside where the environment was uncontrolled.

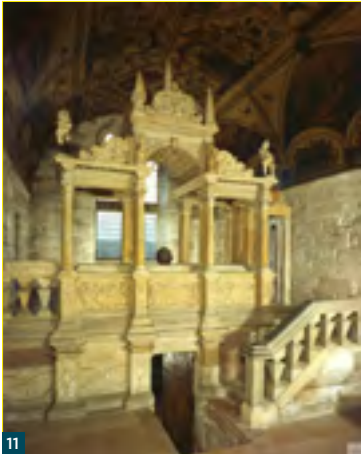
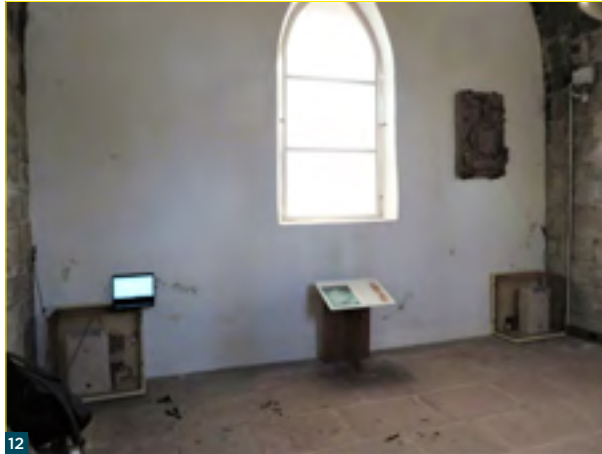
Figure 11:
Montgomery Monument
and ceiling.
