MONUMENTS IN MONUMENTS

CONFERENCE PROCEEDINGS

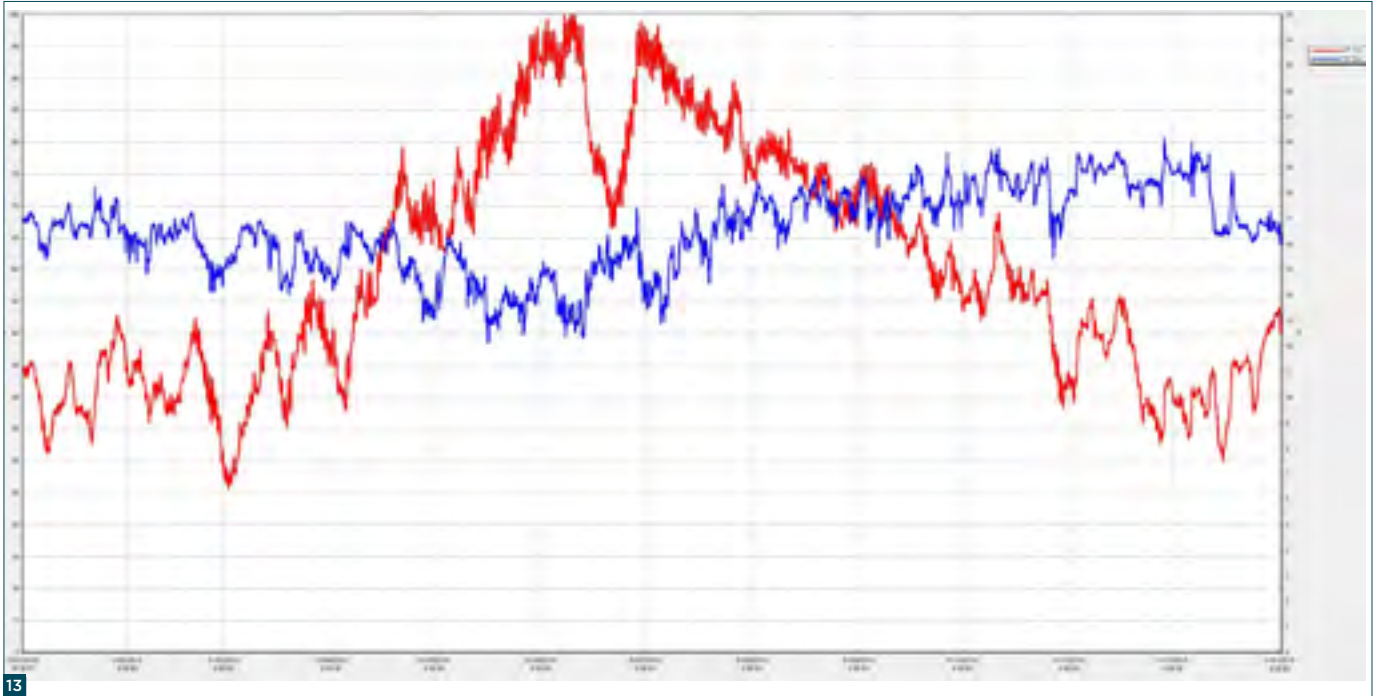
Figure 13:
Environment in 2018.

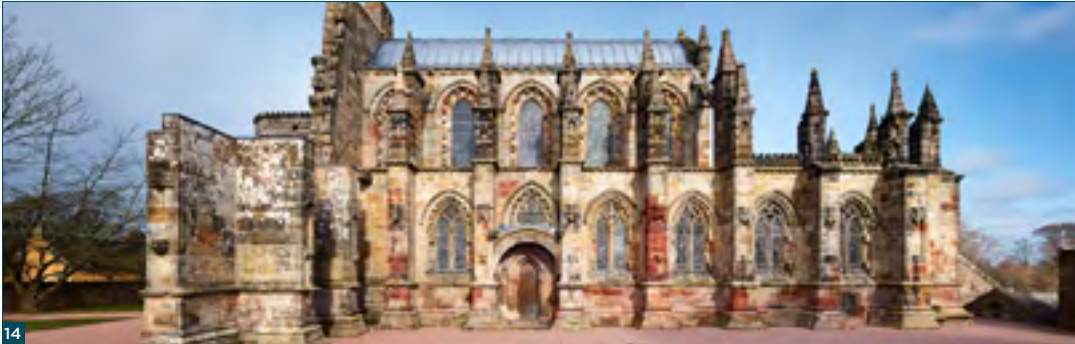
Figure 14:
Rosslyn Chapel.

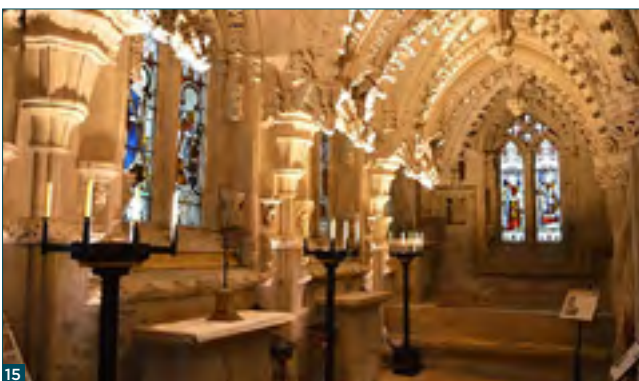
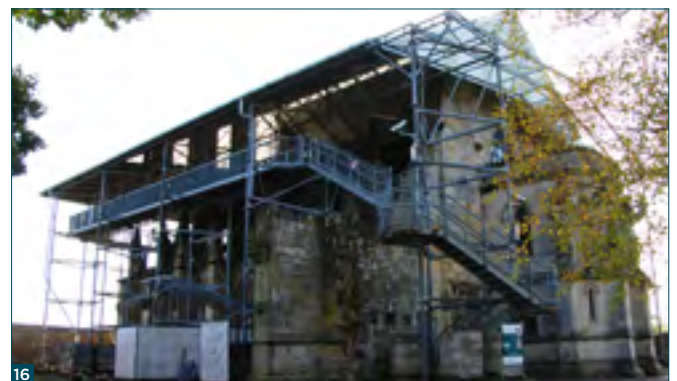
and anemometers to assist the stained-glass conservators with the design of a protective glazing scheme. The environmental monitoring system was designed to answer the following questions:

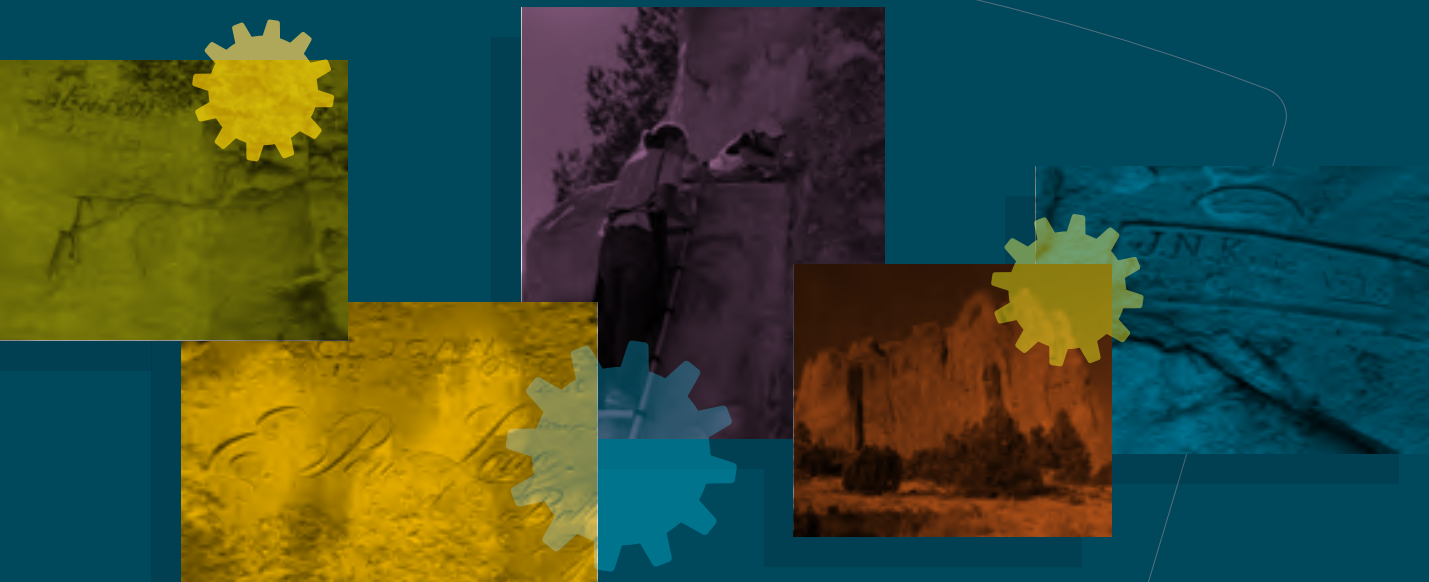
PRESERVATION OF THE HISTORIC INSCRIPTIONS AT EL MORRO NATIONAL MONUMENT, NEW MEXICO

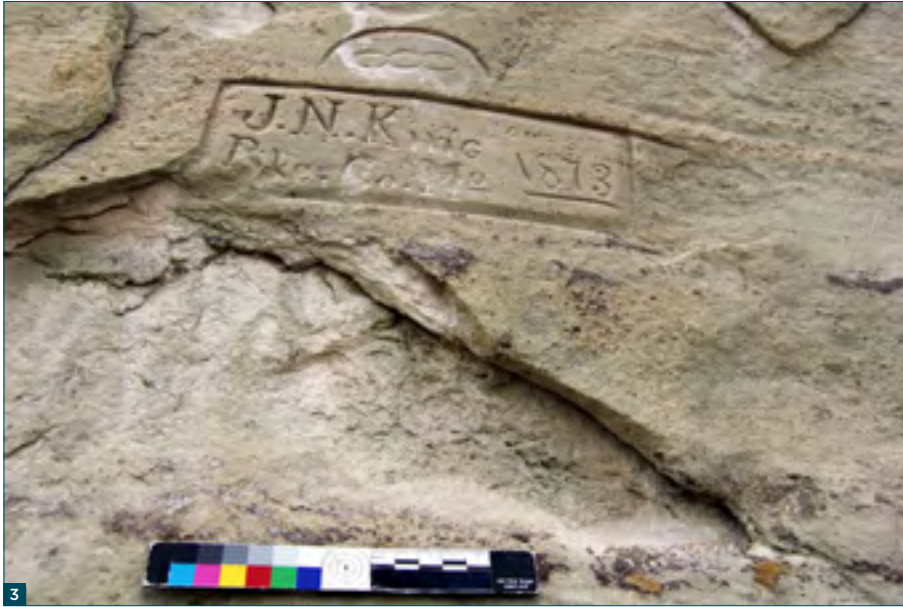
Figure 3:
Example of slab
detachment and
undercutting of panel
XX2. Photo: UNM.

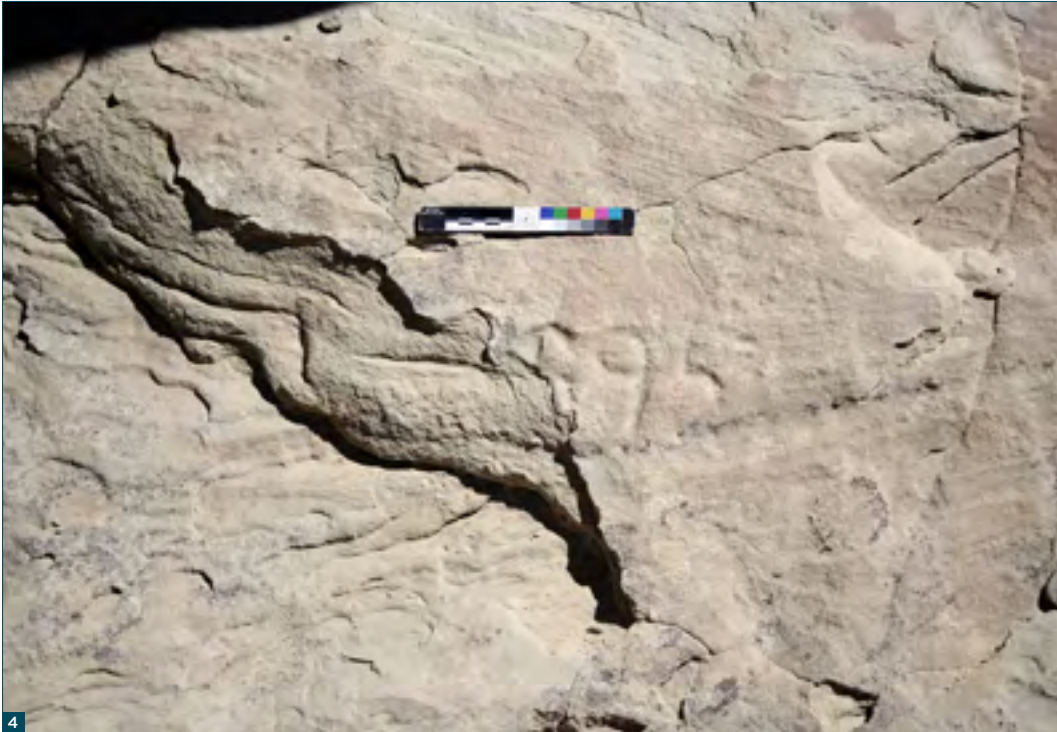
Figure 4:
Example of rock erosion,
panel T8. Photo: UNM.

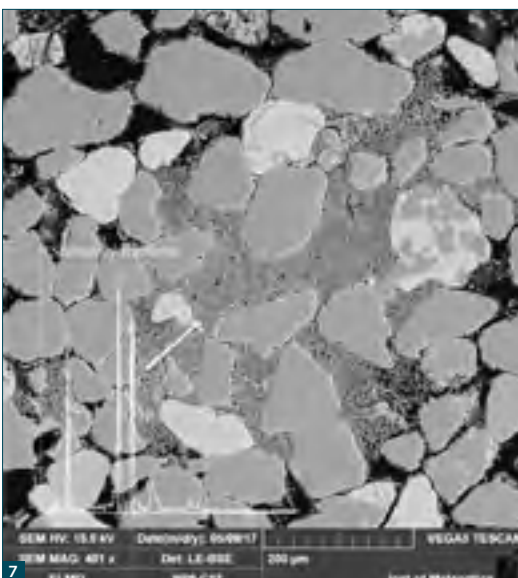
Figure 7: EDS-BSE of secondary kaolinite precipitated in the near-surface pore space (sample NP, taken along the main Inscription Trail in Cross' subunit 17). (scale bar = 200 microns). Photo: UNM.

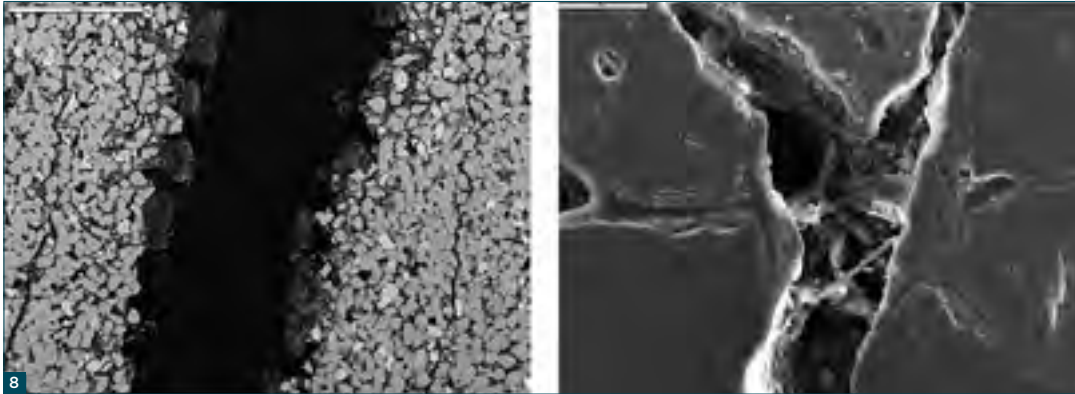
Figure 8: BSE of cracks parallel to the lichen-covered surface (left), and microfungi filaments binding the detached surface to the bedrock (right) (scale bars = 1 millimeter (left); 20 microns (right); sample NW2L, collected along the main Inscription Trail).

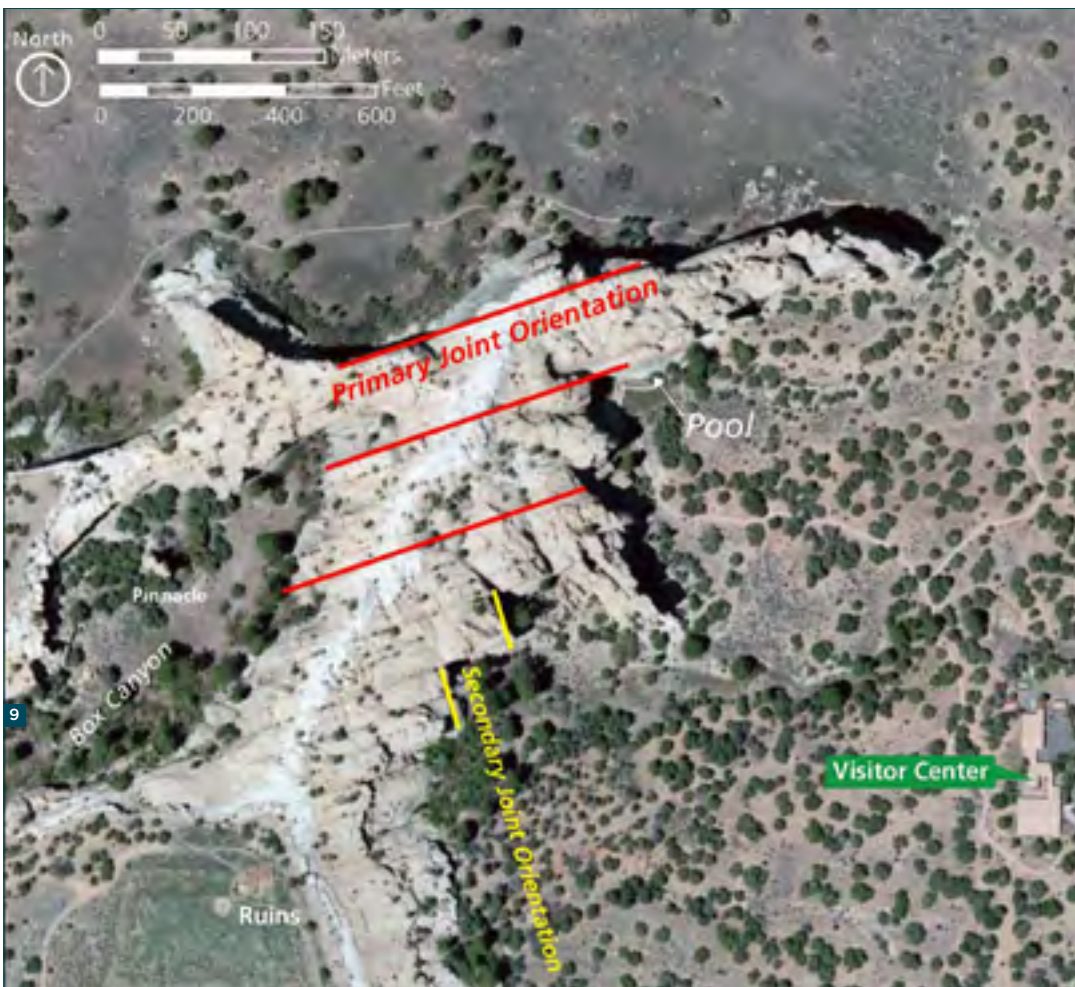
Figure 9: Aerial photograph of Inscription Rock at El Morro National Monument, showing the location of North Point and the primary and secondary joint orientations. Graphics by Talon Newton.

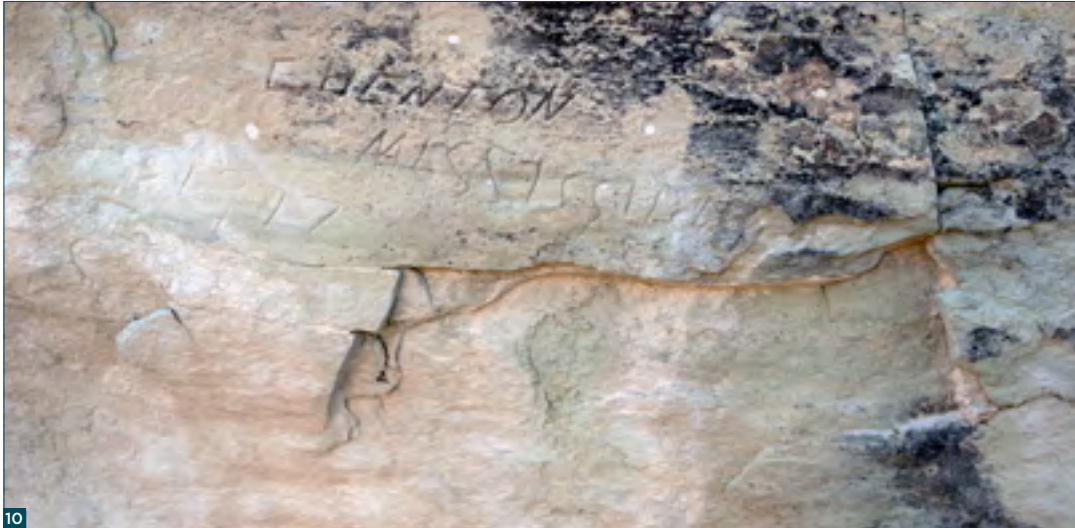
Figure 10:
Example of previous
treatment: pinning and
edging, panel WW5.
Pins are concealed
with a natural hydraulic
lime fill, which can
be seen as white
circles. Photo: UNM.

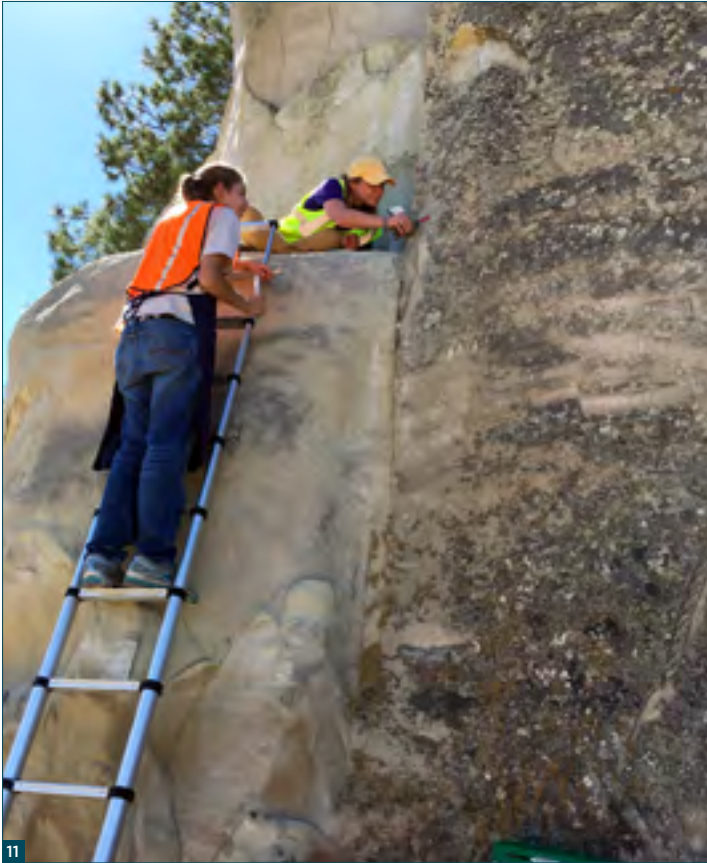
Figure 11: Conservation treatment (grouting and filling) of detachment at North Point, panel BB8. Note pronounced preferential growth of lichens and other microflora on right. Photo: UNM.

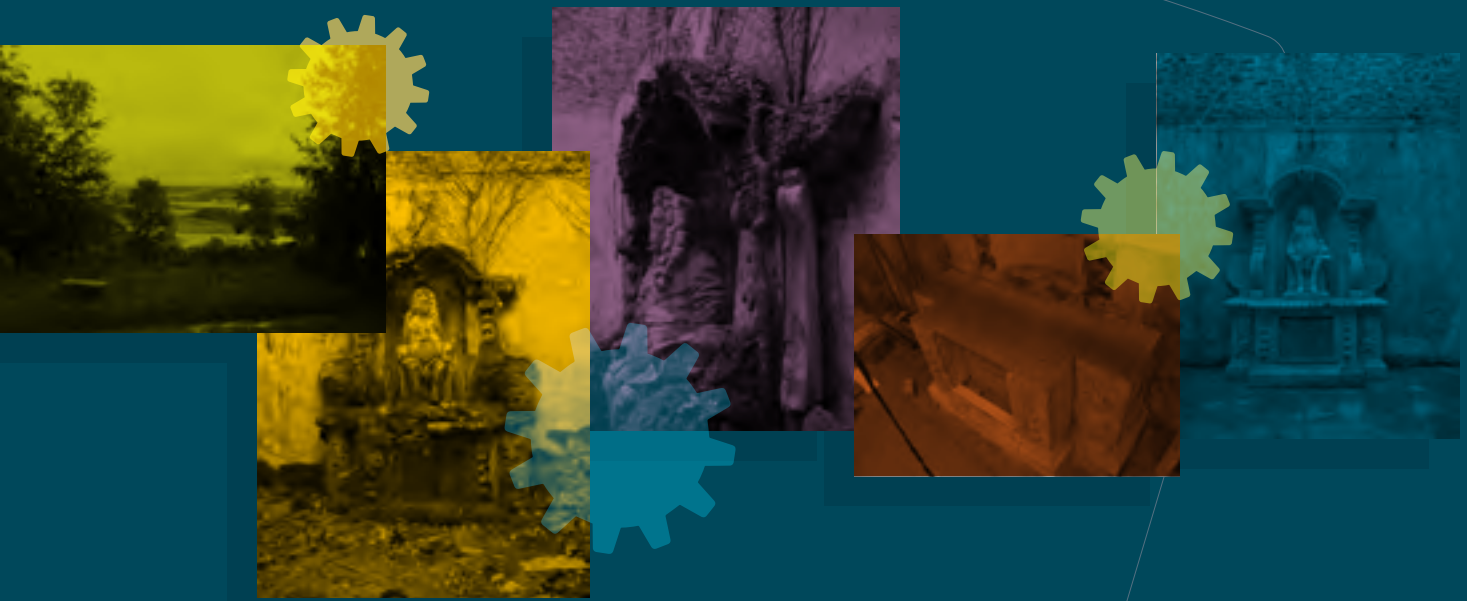
THE SIR JAMES TILLIE MONUMENT – PENTILLIE CASTLE, CORNWALL: THE REPAIR OF A MONUMENT AND THE DISCOVERY OF A BODY

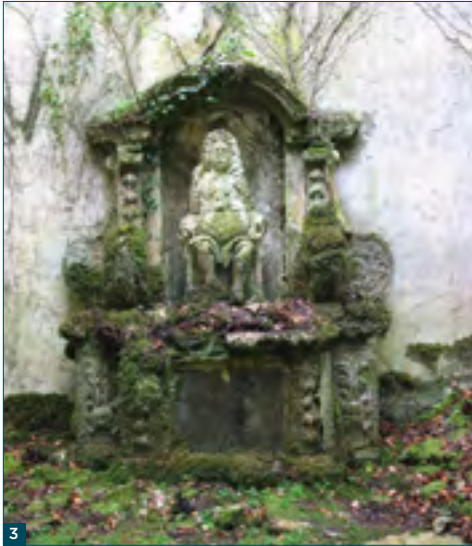
During the early assessment it appeared that weathering and the possible expansion of hidden ferrous fixings had forced elements apart, opening joints and weakening the structure. As the evaluation continued, it became apparent that there was no rust staining and only limited

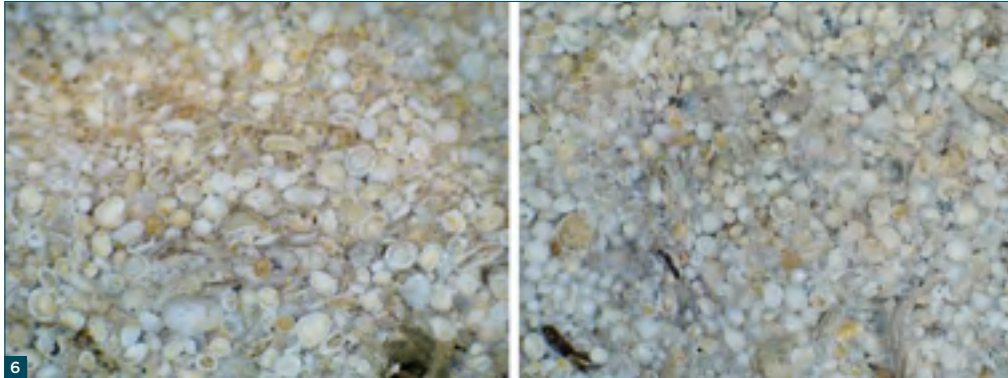
Figure 6:
USB microscope
image, magnification x
200, left sample from
gadrooned table-
top, right of Hartham
Park Bath stone.

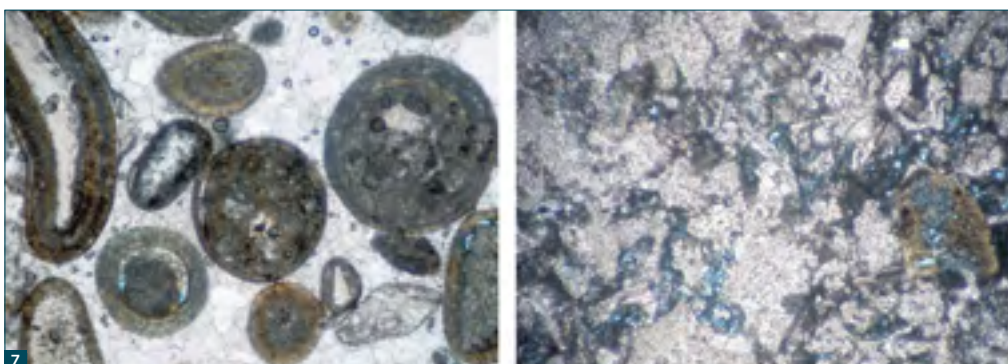
Figure 7:
Geologists’
photomicrographs.
Left; Bath stone
oosparite grainstone
Right, Beerstone
biomicrite packstone.
Both samples width
2.2mm, open pores
filled with blue resin.

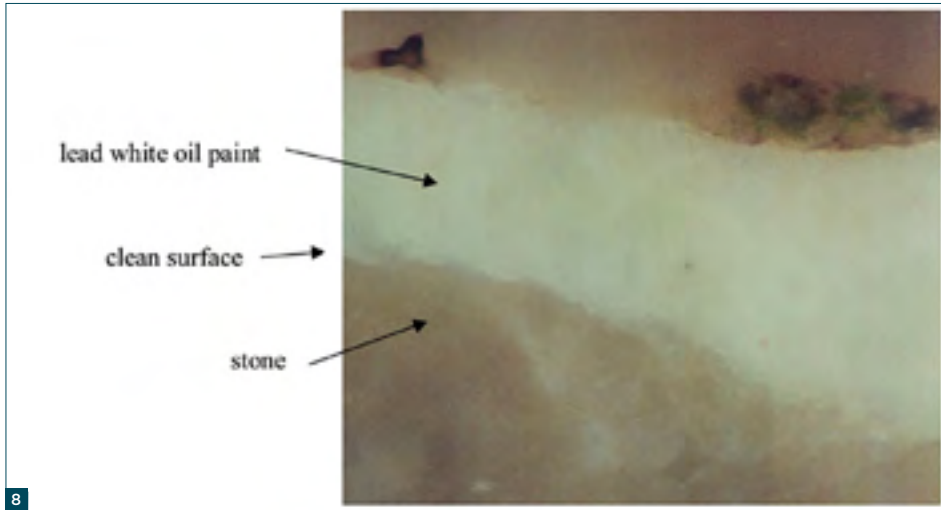
Figure 8:
Cross sectional analysis
of paint sample.

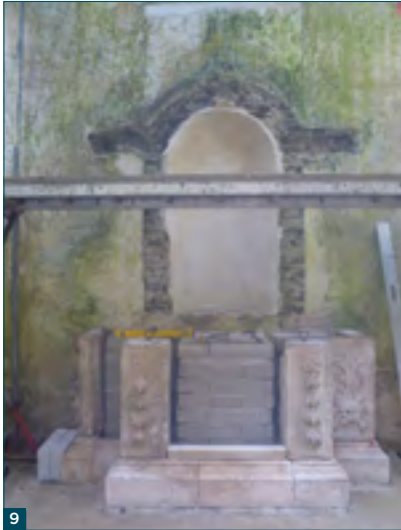
Figure 9:
Reconstruction
in progress.

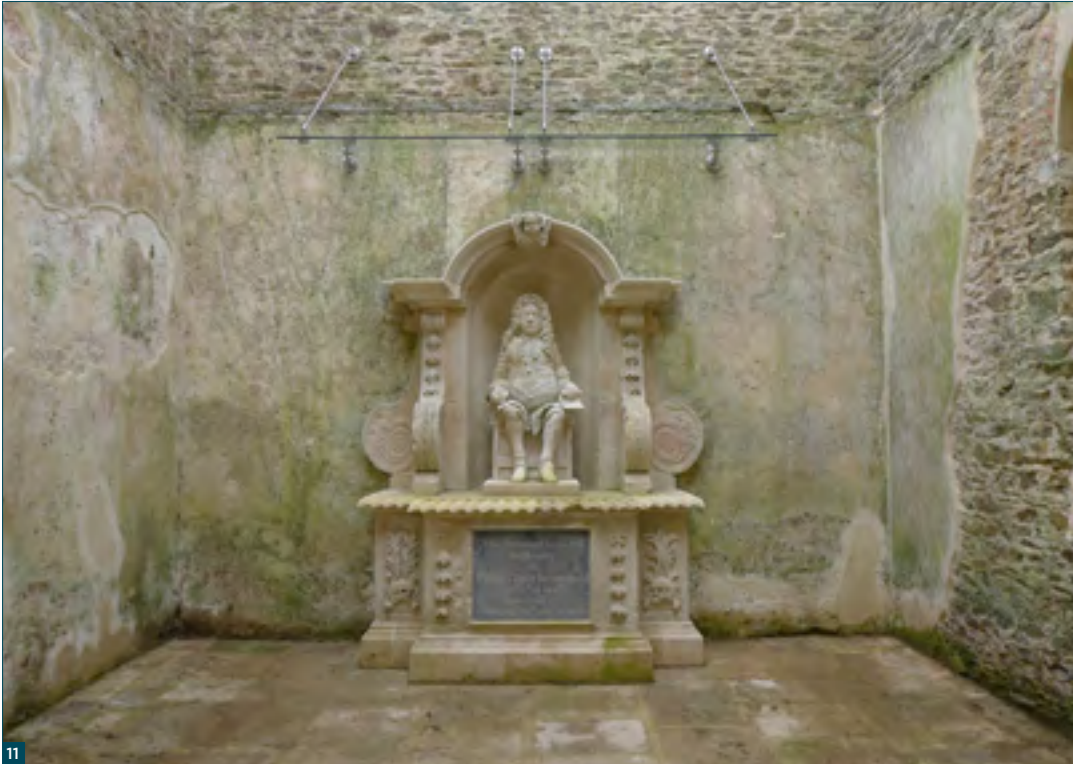
Figure 11:
Monument completed
with canopy in place.

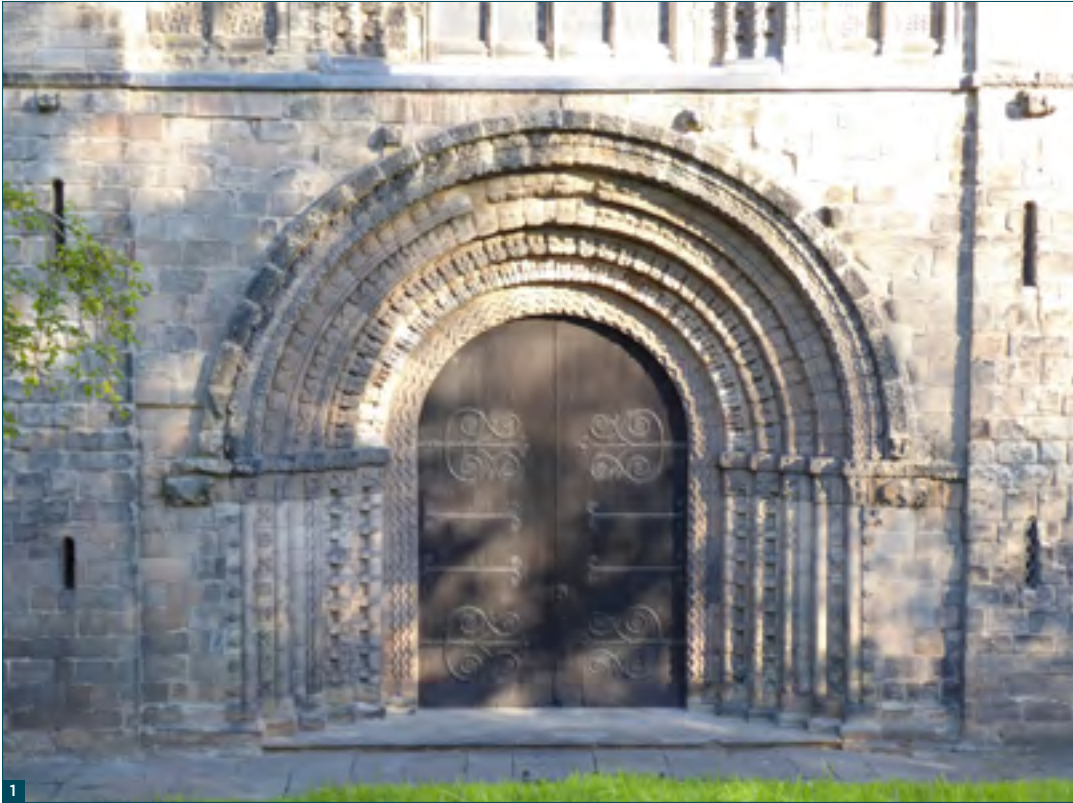
Figure 1:
The doorway.

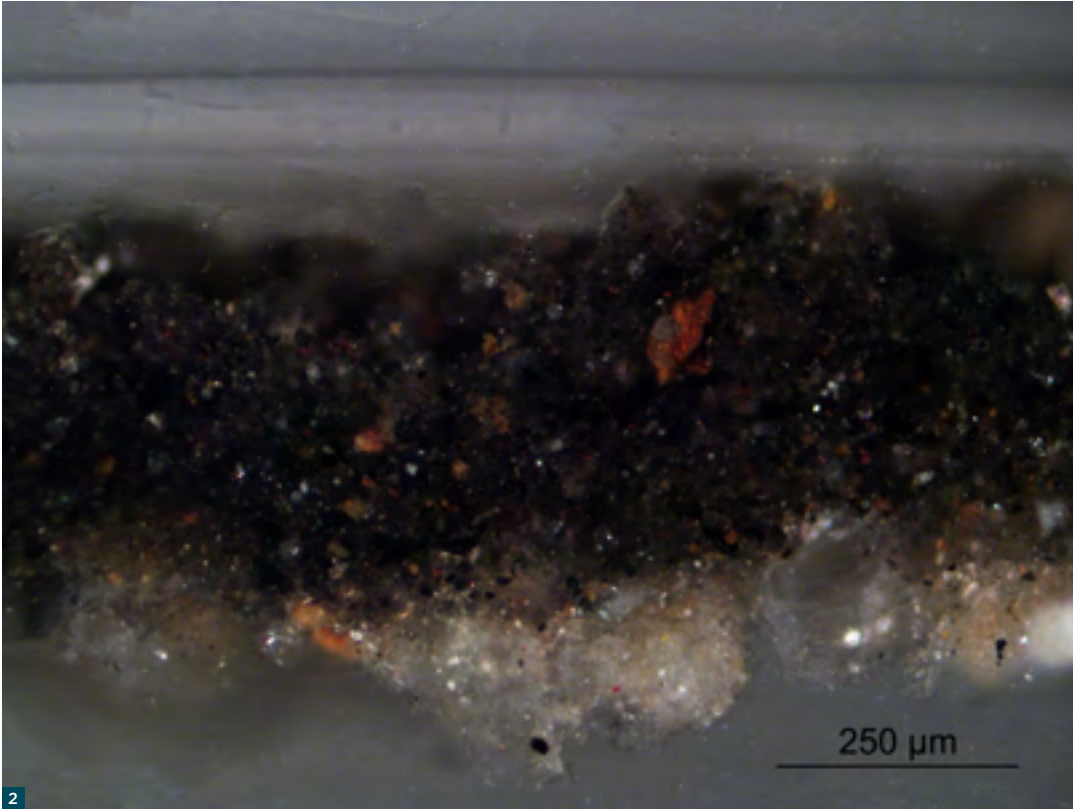
Figure 2:
Cross-section of the
gypsum crust.

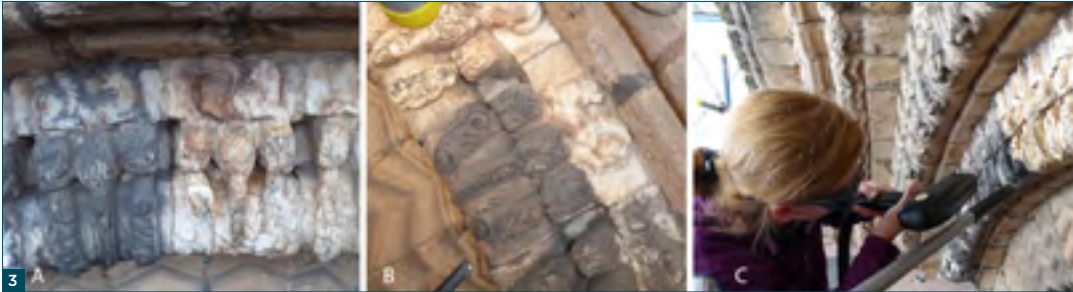
Figure 3: Laser cleaning, stone to the left before and to the right after (A), upper section of stone cleaned (B), cleaning in progress (C).

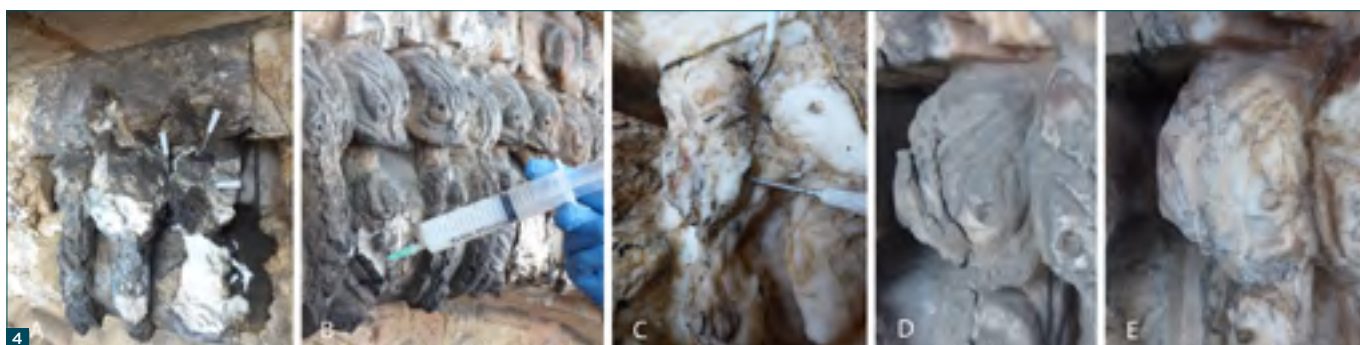
Detaching, minor stone fragments (mostly in the form of thin scales) were either secured by the injection of small amounts of acrylic resin or removed, the void and the reverse side cleaned and fixed back into position by spot-fixing with acrylic resin of high viscosity (30–35% Paraloid B72 in Acetone).

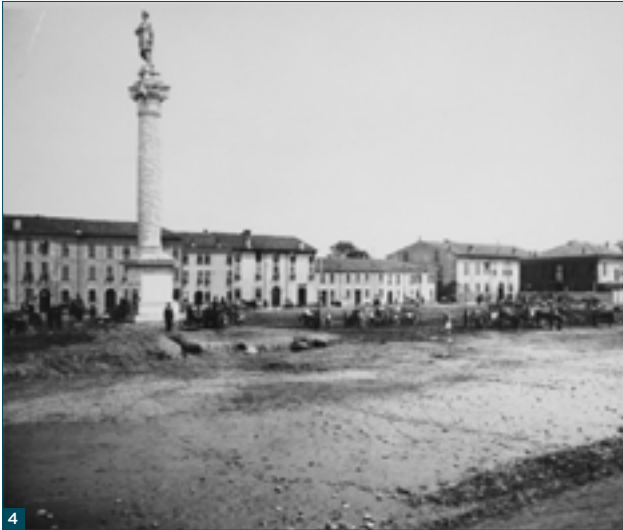
Figure 4:
 Historical photograph,
 Municipal Historical
 Archive of Ferrara,
 Carteggio XIX
 secolo, roads and
 buildings, b.17, 1935.

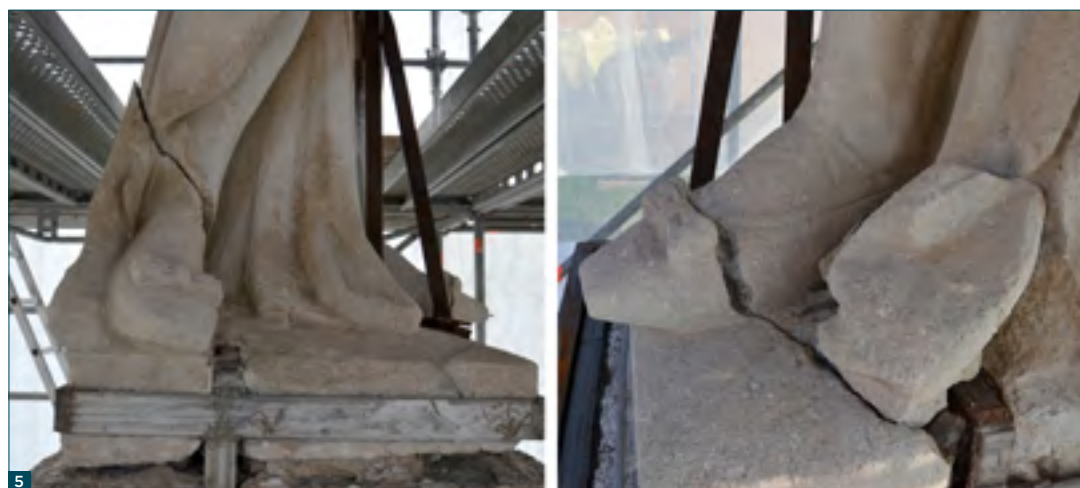
Figure 5:
Statue of Ariosto
disconnected
at the base.

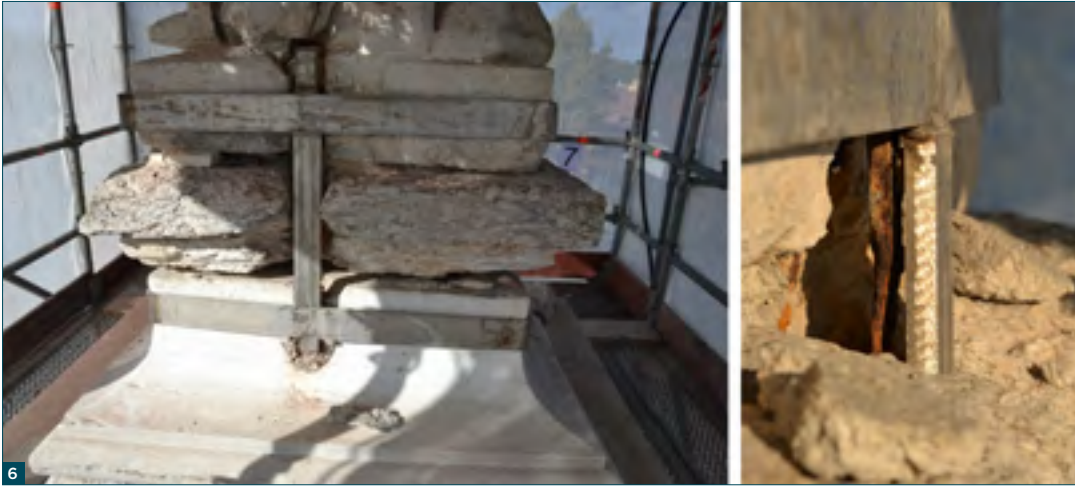
Figure 6:
Podium of the statue.
The external metal support ring in stainless steel has been welded to the damaged parts, accelerating oxidation.

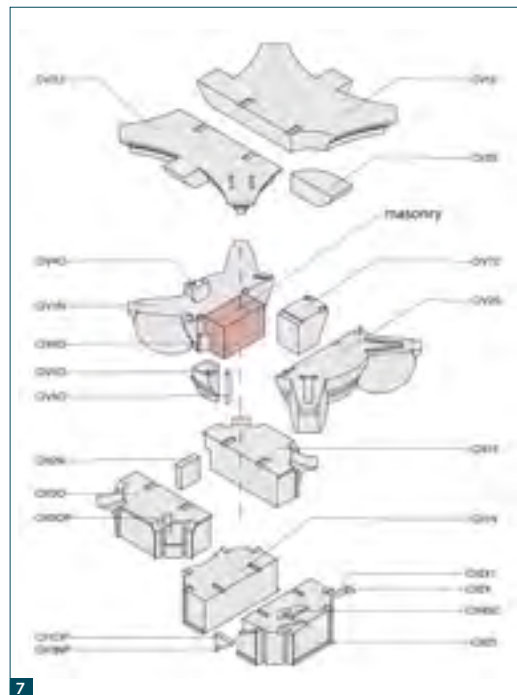
Figure 7:
Exploded axonometric view of the capital drawn up following the dismantling of the various elements and preparation for their repositioning.

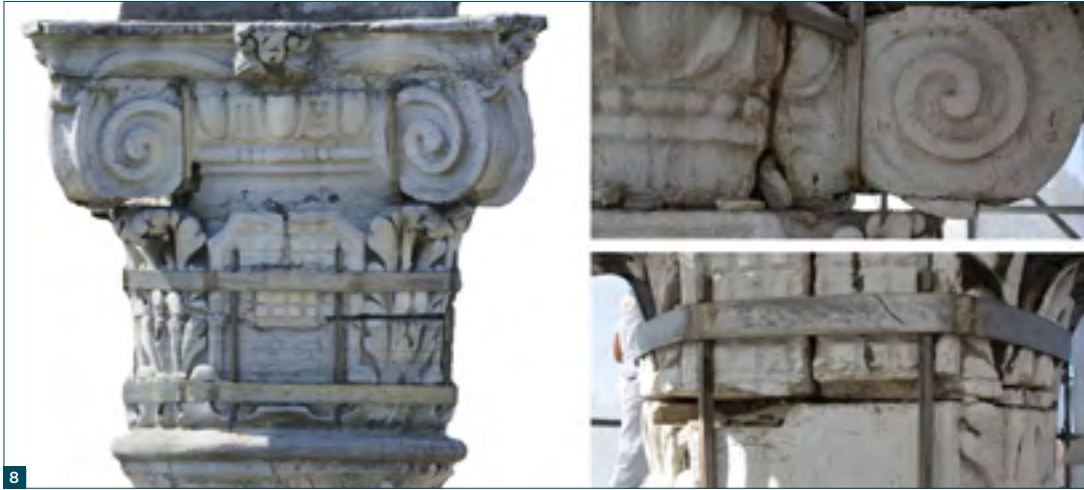
Figure 8:
Capital of the column before the restoration works and the dismantling of each stone element.

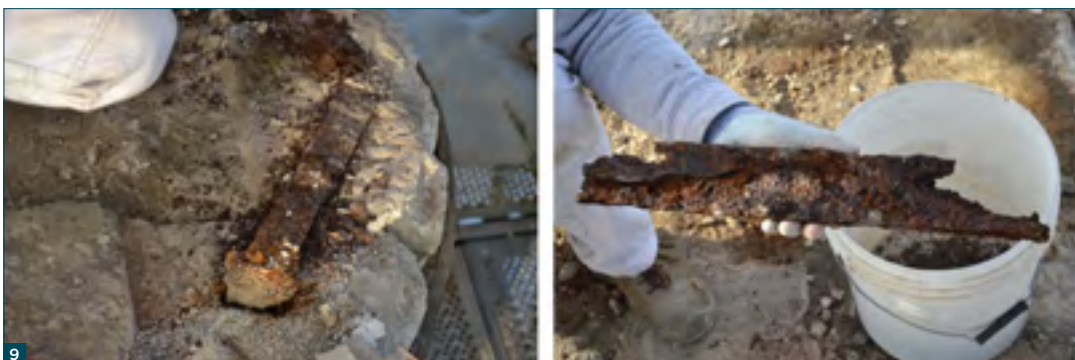
Figure 9:
Oxidation of the internal fixtures between the parts which define the individual stone elements of the capital.

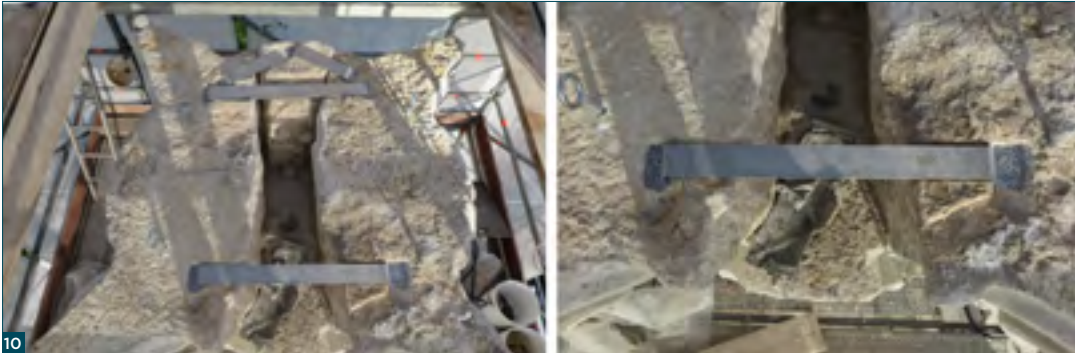
Figure 10:
New cramps in duplex stainless steel connecting the various elements of the capital.

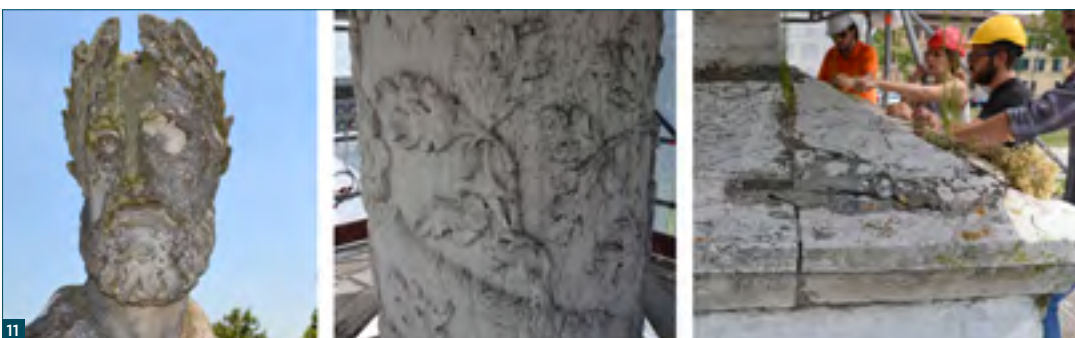
Figure 11:
Deterioration of the surfaces of the statue, shaft and pedestal.

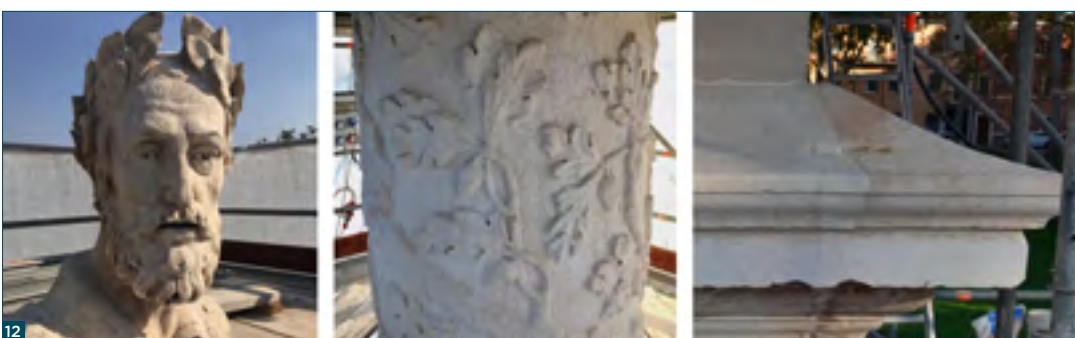
Figure 12:
Operations to clean the surfaces of the statue, shaft and pedestal.

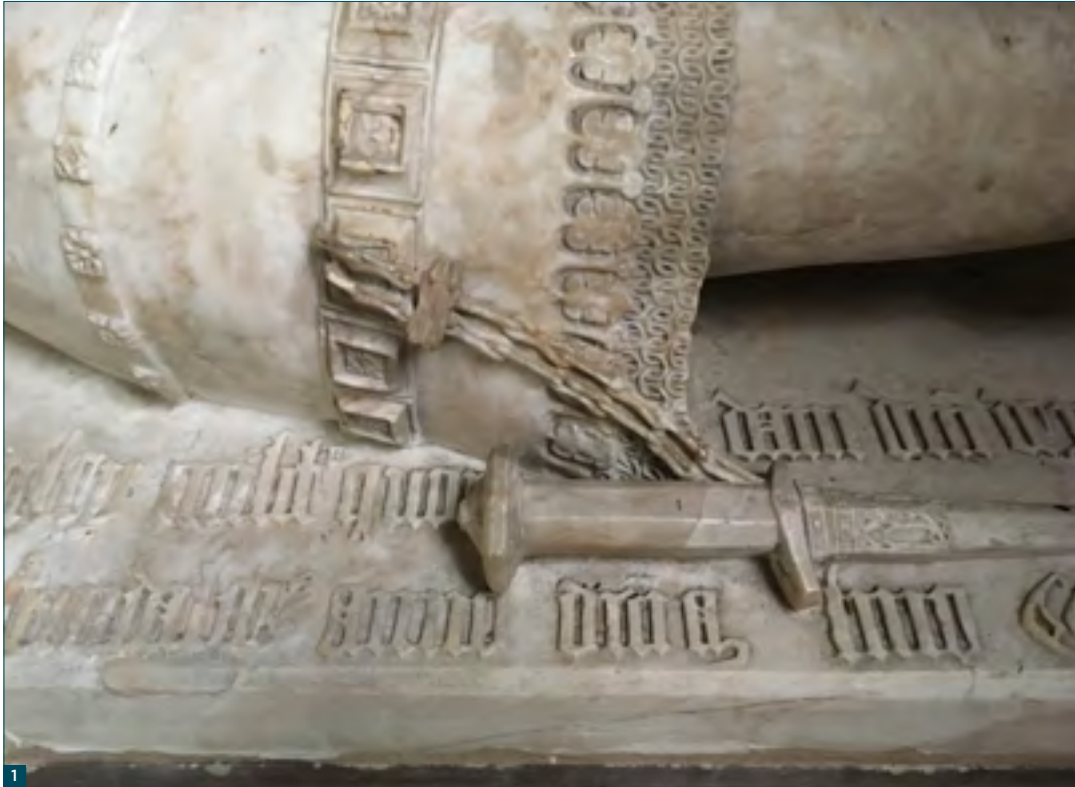
Figure 1: Detail of a knight of c. 1410 from Elford (Staffordshire), showing intricately carved alabaster indent restoration by Richardson. The inscription is an addition probably of c. 1540, when the monument was 're-used'. The monument was most recently conserved in 1996.

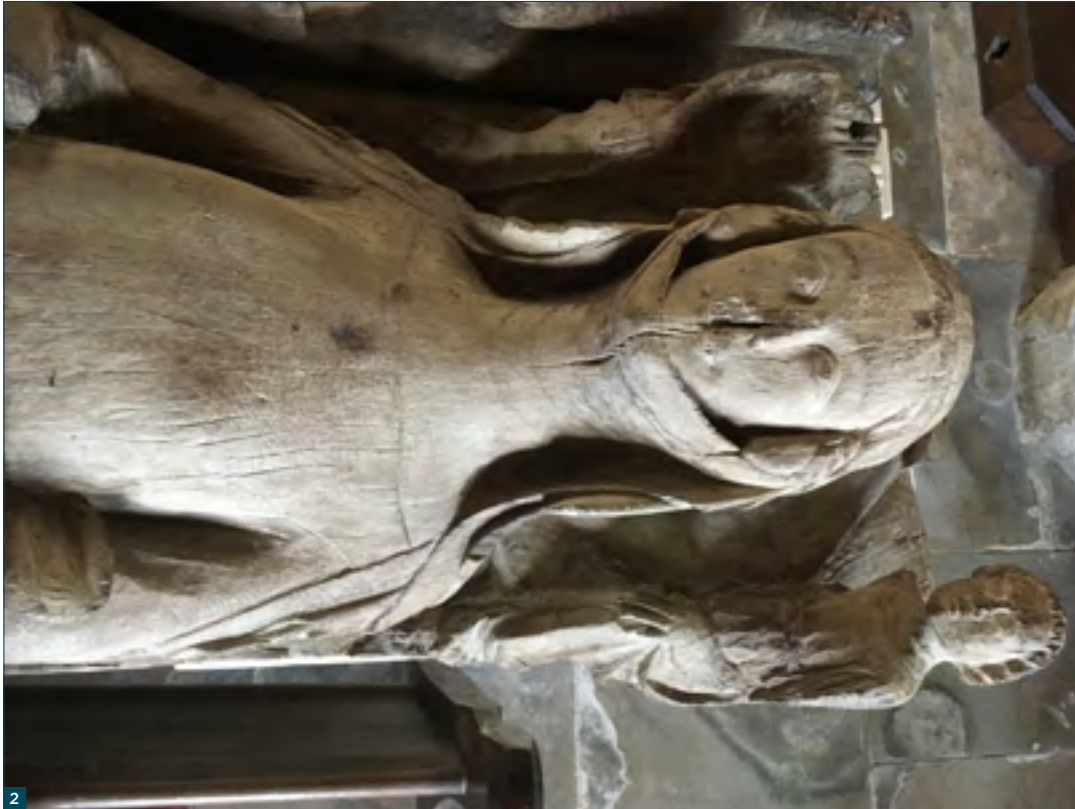
Figure 2: The oak effigy of a lady, mid-14th century, at Paulerspury (Northamptonshire), conserved by Crossley in about 1920. No attempt was made to restore missing features such as the hands.

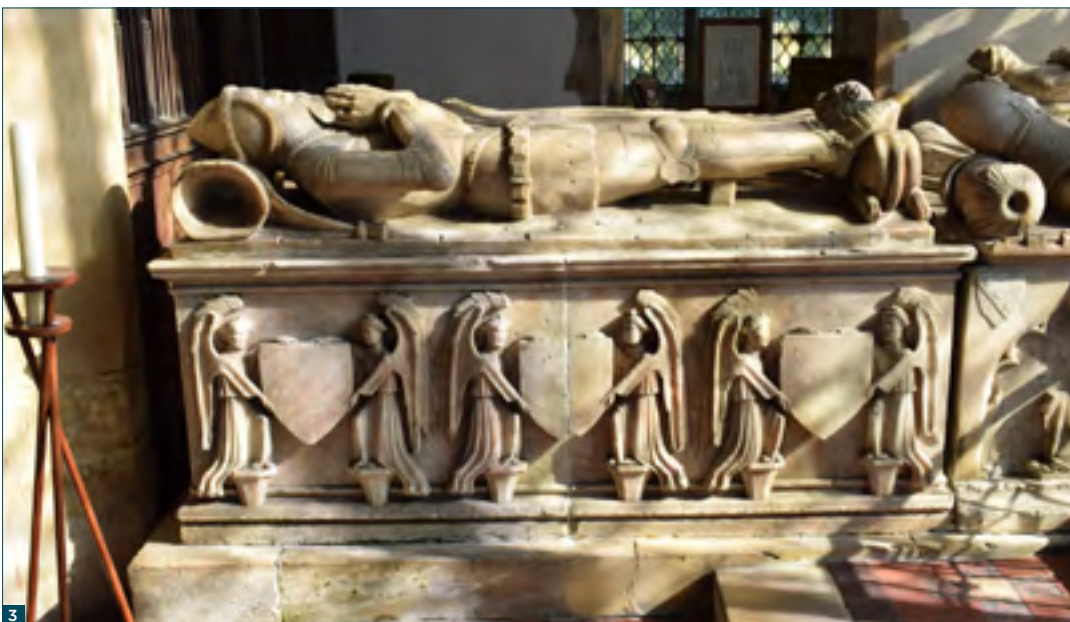
Figure 3: Alabaster tomb chest with effigies of a knight and lady of c. 1410 at Swine (East Yorkshire), conserved in the 1930s with an early attempt at isolating from damp with a membrane.

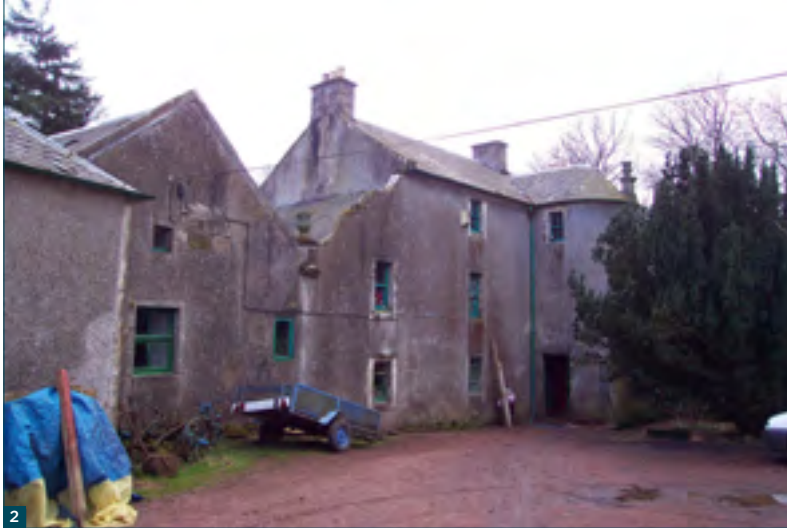
Figure 2:
Birkill House in
the year 2000.

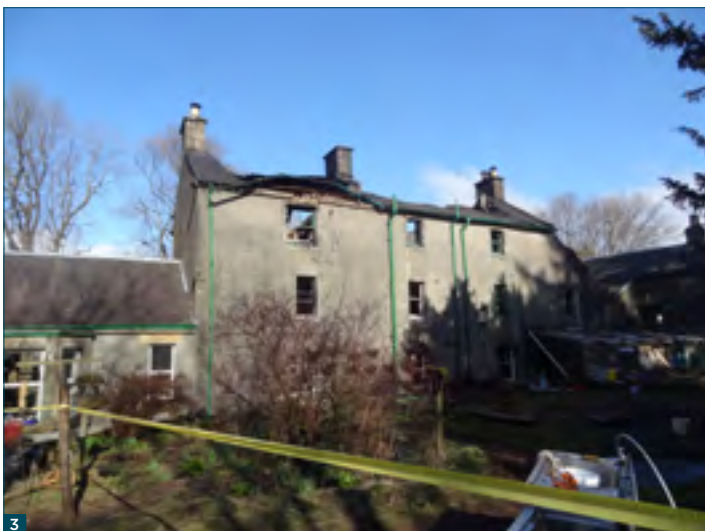
Figure 3:
Extent of fire damage,
March 2016.

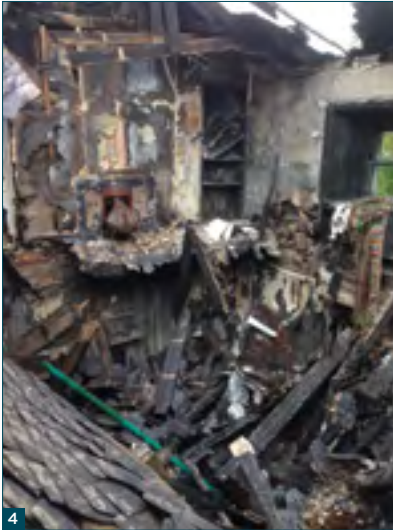
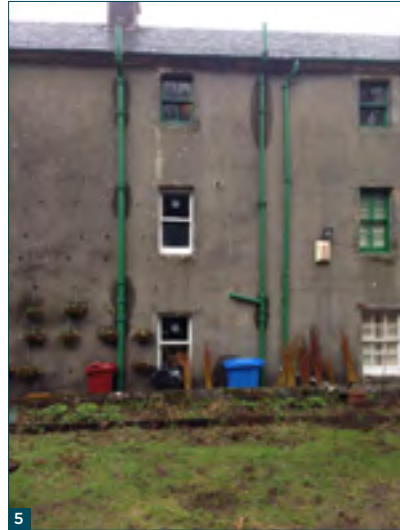
Figure 4:
Beneath the debris,
some of the panelling
still appeared to
be salvageable.

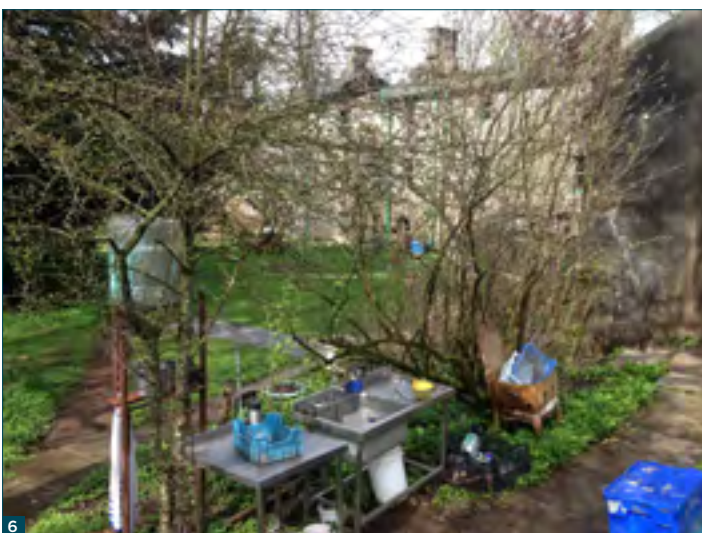
Figure 6:
Temporary field
kitchen - life goes on
at the housing co-op.

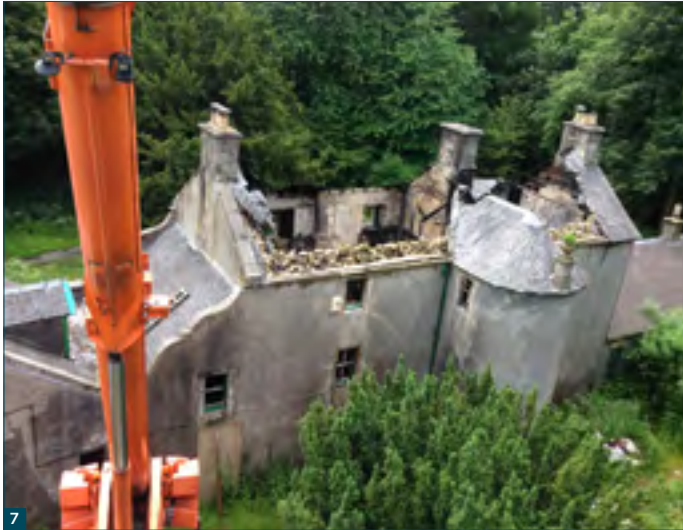
Figure 7:
Inspecting the damage from the 'man-basket'.

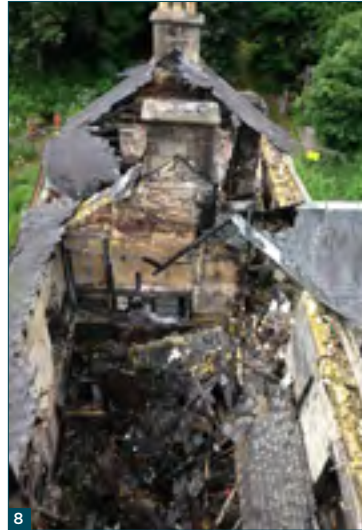
Figure 8:
Assessing the requirements for the strip-out and stabilisation.

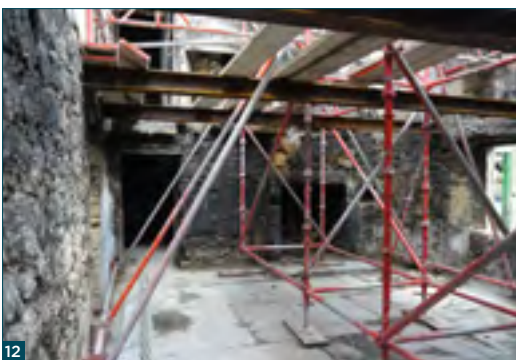
Figure 12:
Temporary works
in progress.

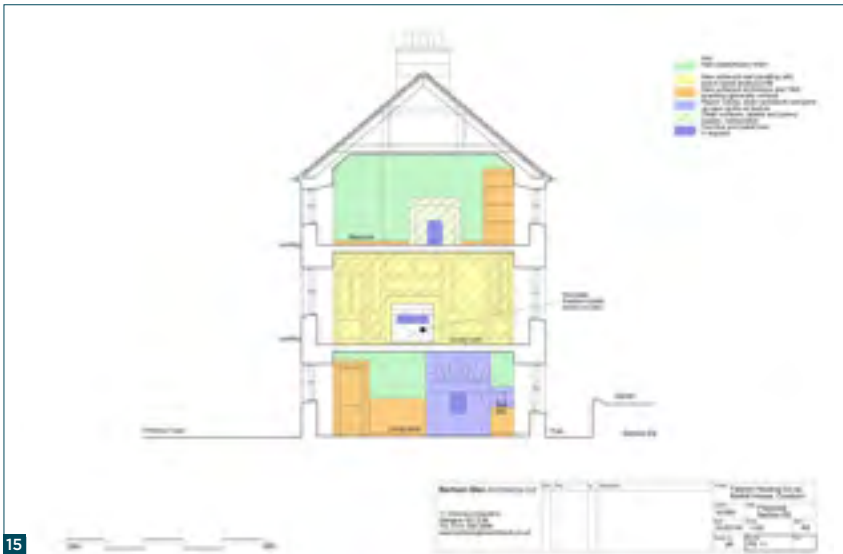
Figure 15:
East gable section
repairs - the
reinstatement of
panelling was taken
out as a saving.
