MONUMENTS IN MONUMENTS

CONFERENCE PROCEEDINGS

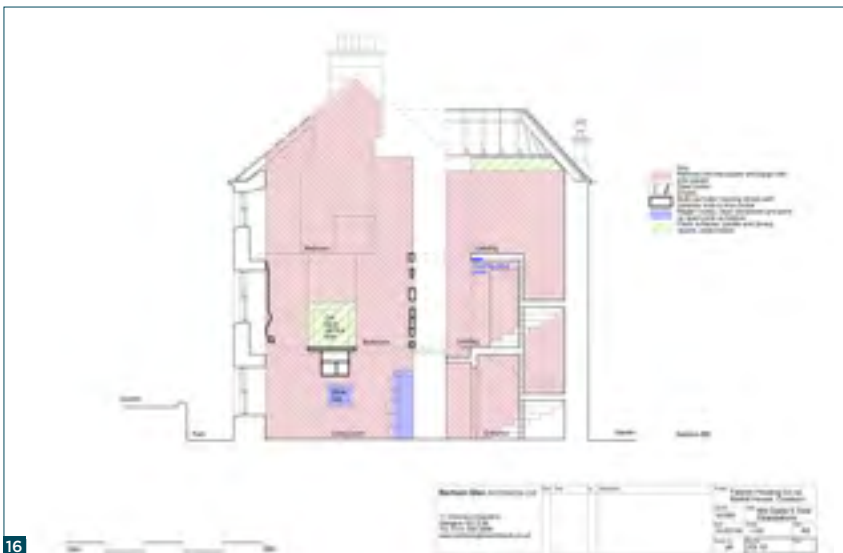
Figure 16:
Mid gable dilapidations.

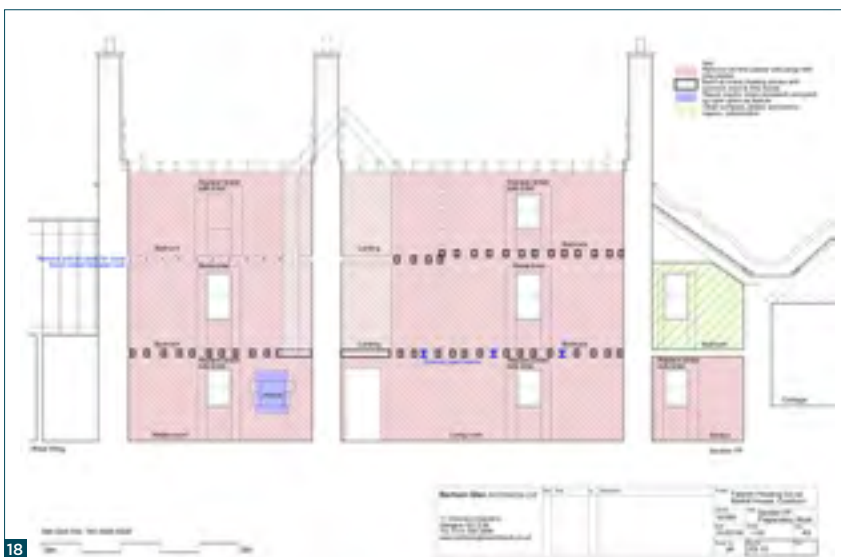
Figure 17:
Mid gable section
repairs.

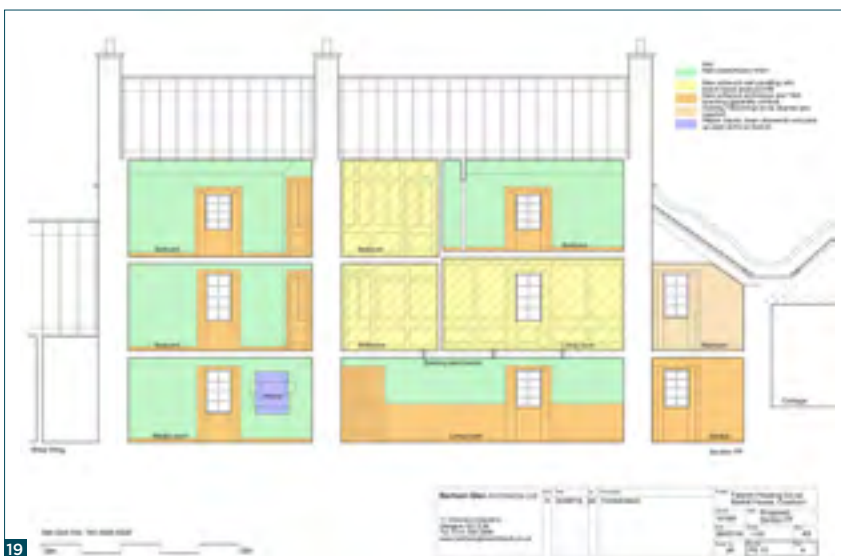
Figure 18:
North wall dilapidations.

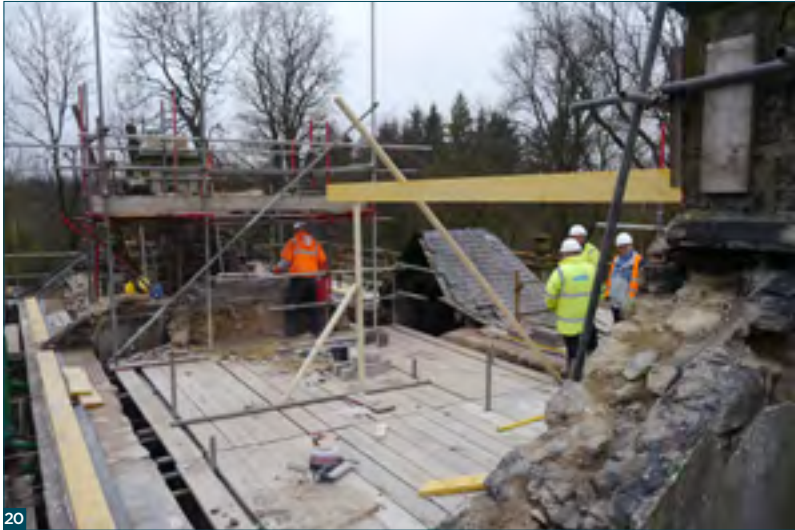
Figure 20:
Progress on site.

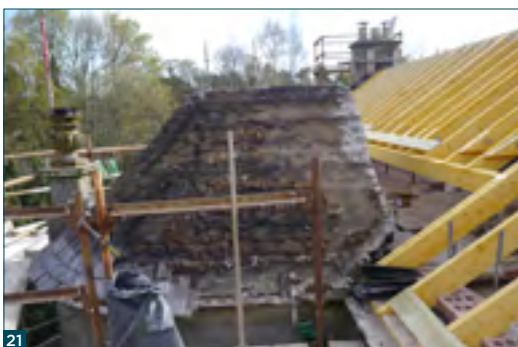
Figure 21:
Replacing the roof was the first priority.

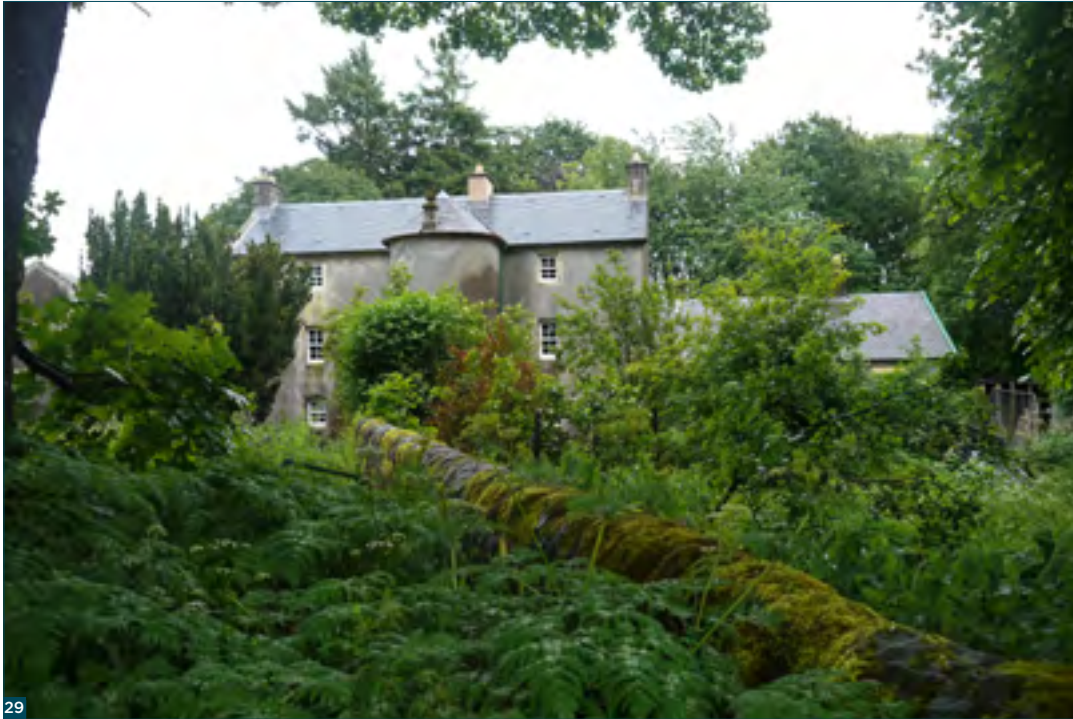
Figure 29:
Birkhill House restored.

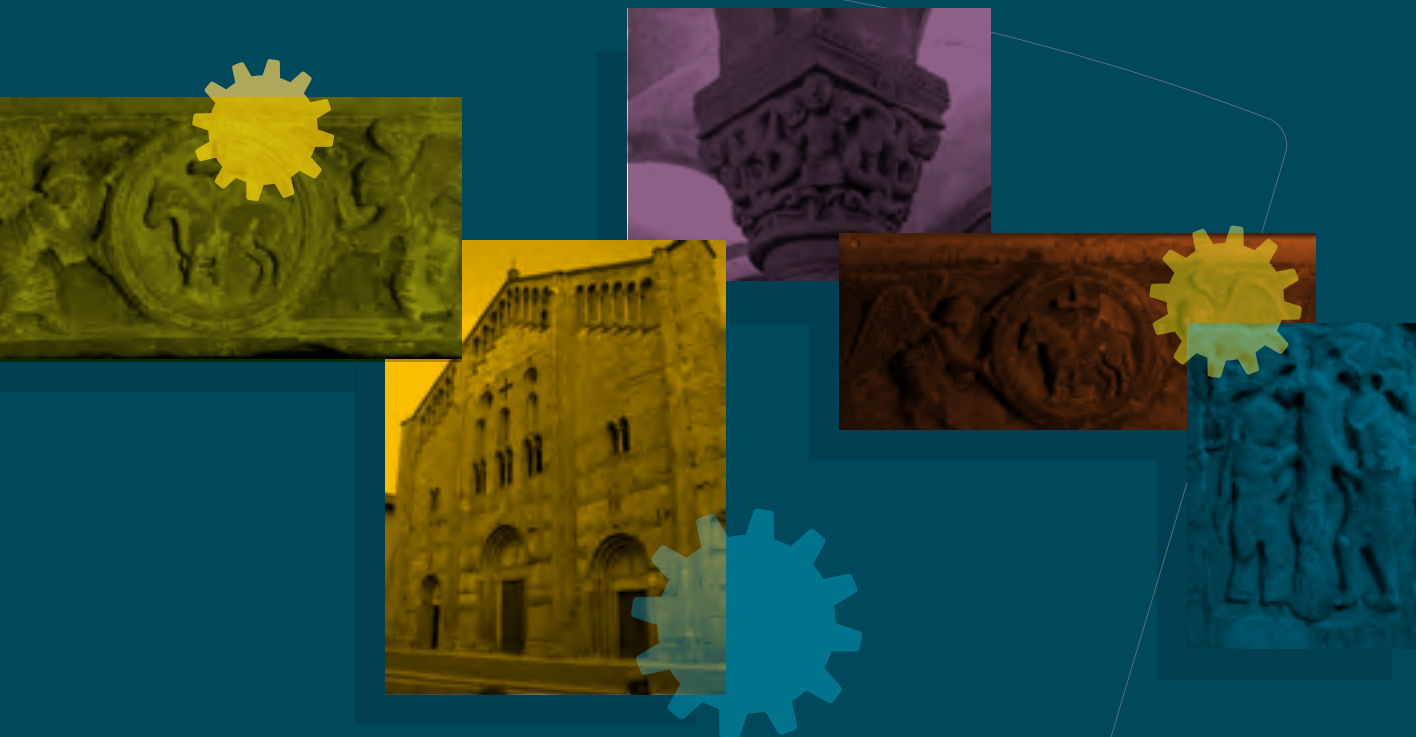
COLOURS IN ROMANESQUE SCULPTURE:
POLYCHROMY FOUND IN A 12TH
CENTURY BAS RELIEF IN PAVIA, ITALY

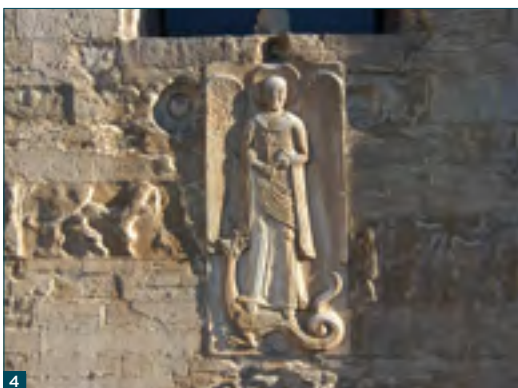
Figure 4:
St Michael Archangel.

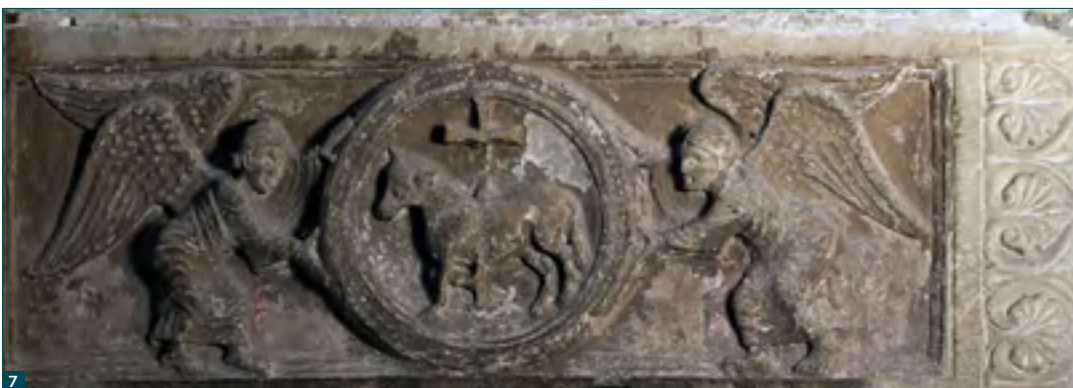
Figure 6:
Exterior carving
showing signs of
deterioration.

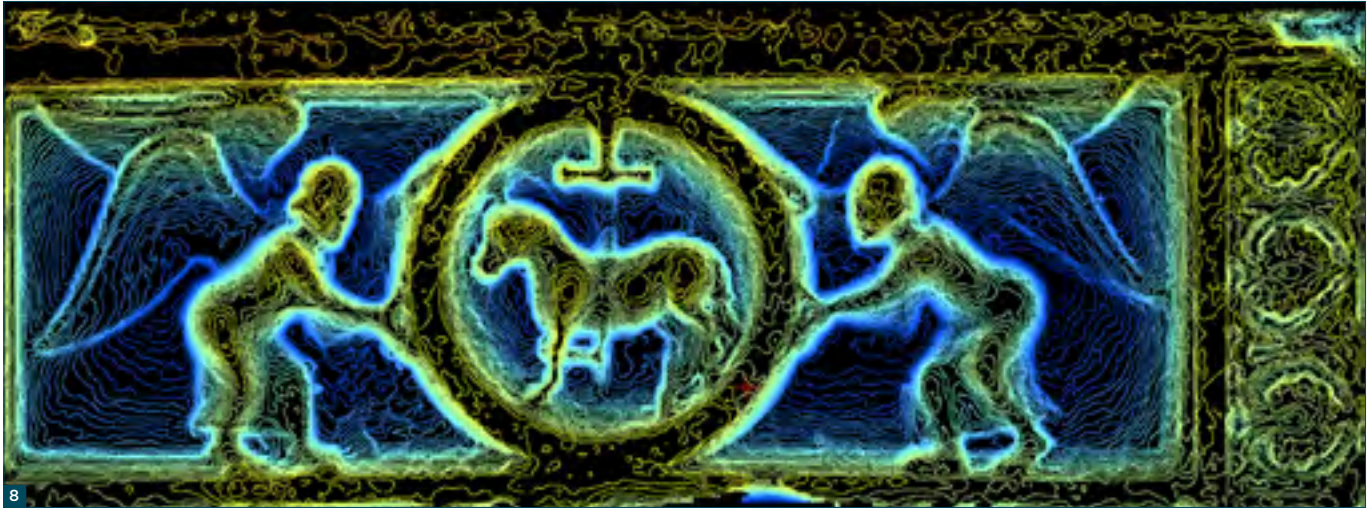
Figure 8:
Point cloud of laser scanning carried out by architects Peverelli and Colombo.

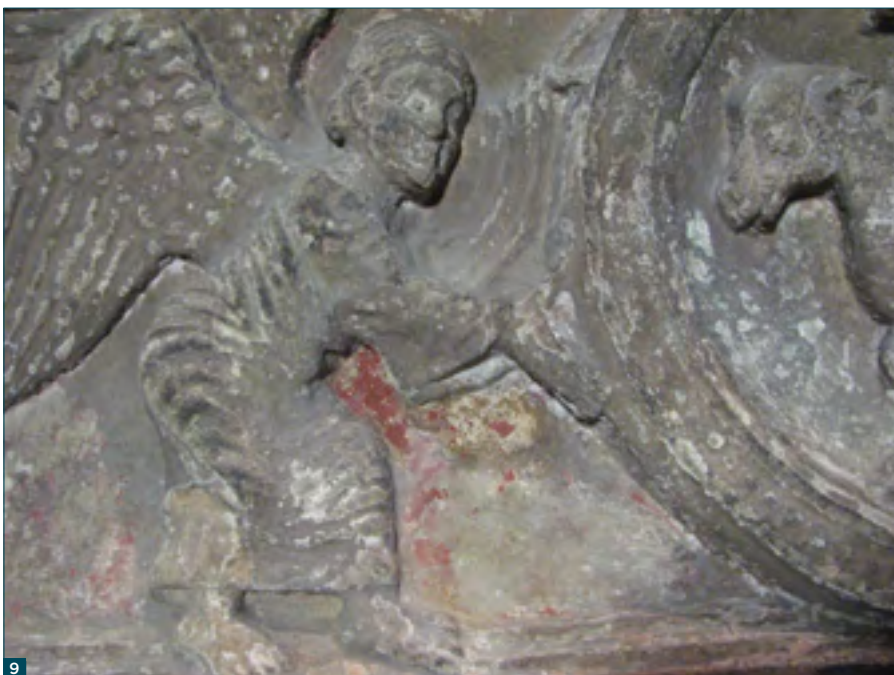
Figure 9:
Survey revealed the presence of a painted layer.

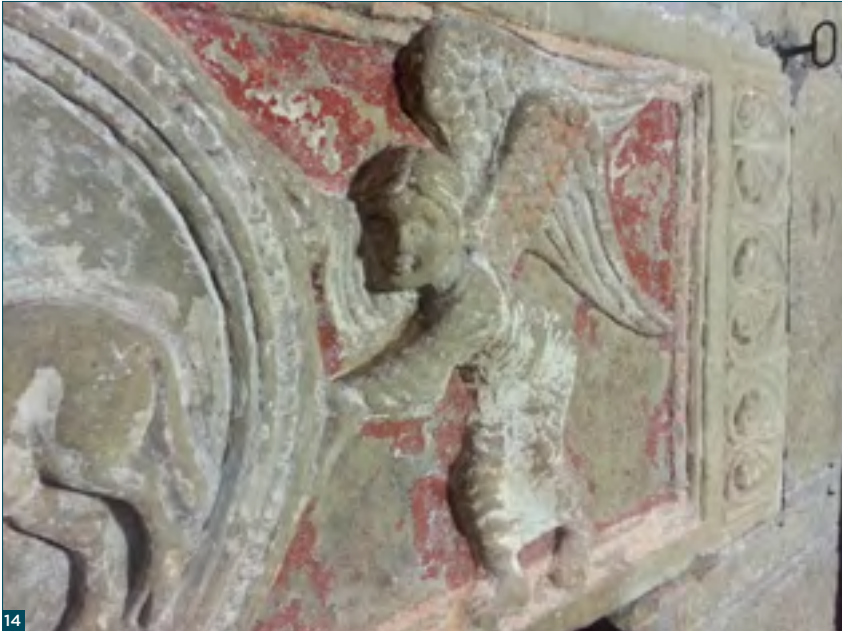
Figure 14:
The newly discovered polychromatic layer changed the perception of the interior decoration of the church.

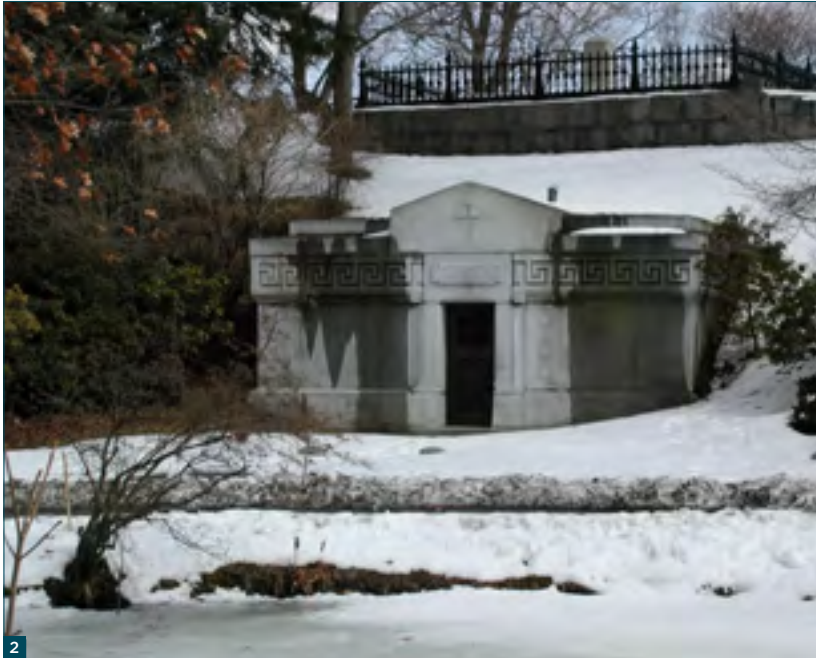
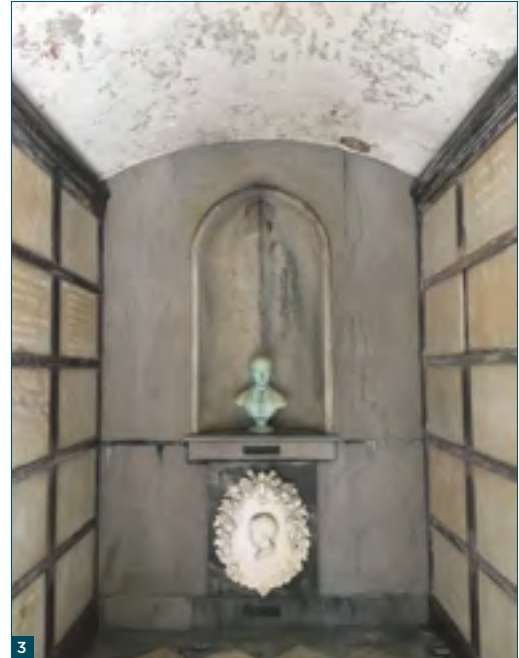
Figure 2:
Gardner family tomb.

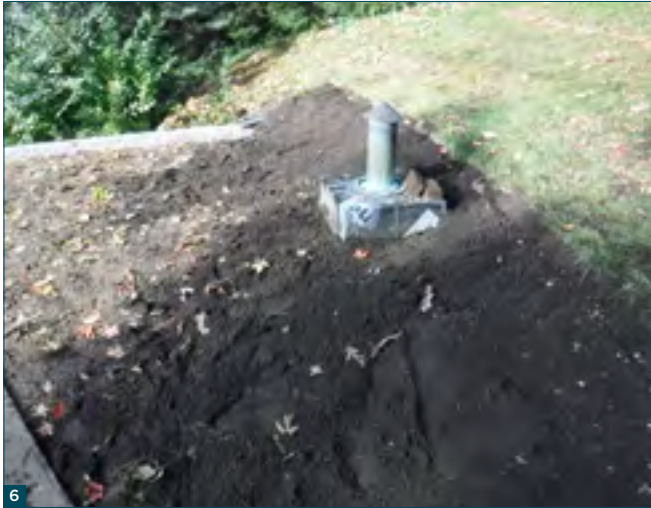
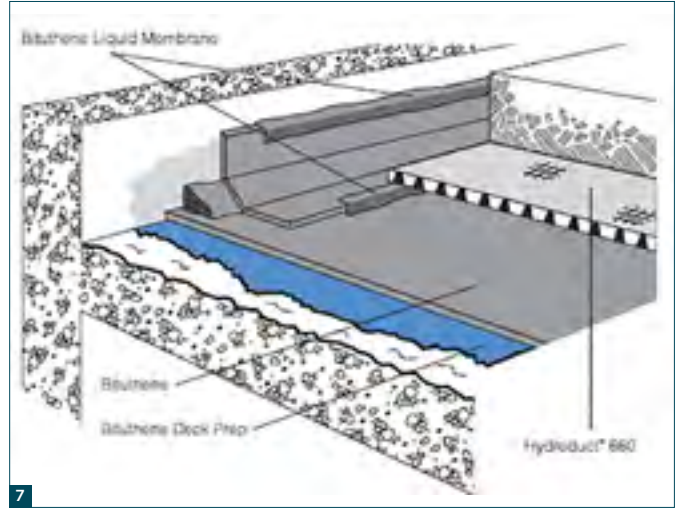
The ventilator pipe cap had also come off, but it was replaced quickly (Figure 6).

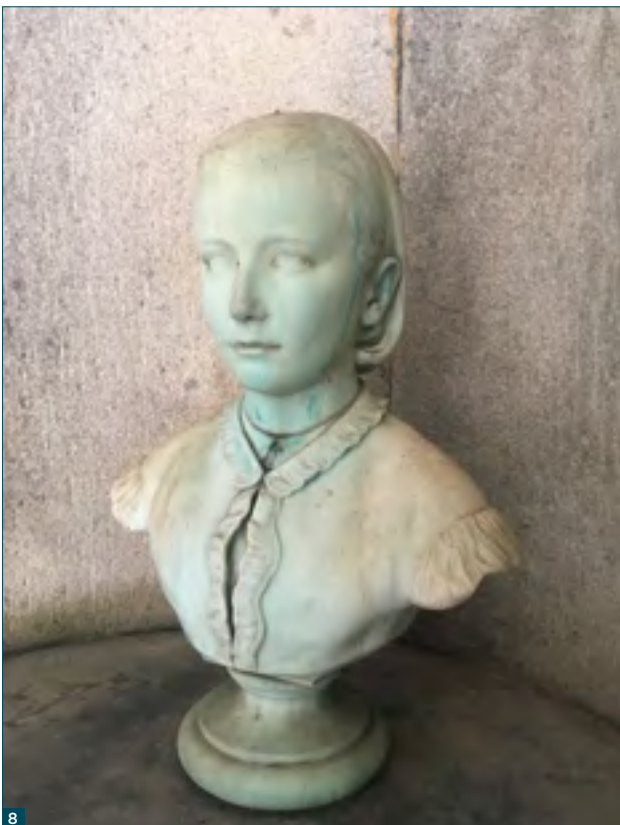
Figure 8:
Close up of bust in situ.

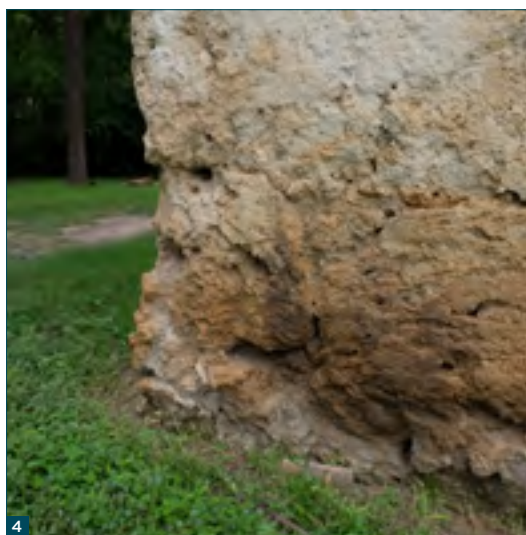
Figure 4:
North-west corner of the church of Concepción.
