MONITORING THERMAL UPGRADES TO TEN TRADITIONAL PROPERTIES

JOHN CURRIE, JULIO BROS WILLIAMSON & JON STINSON

This Technical Paper should be quoted as:
Historic Scotland Technical Paper 19

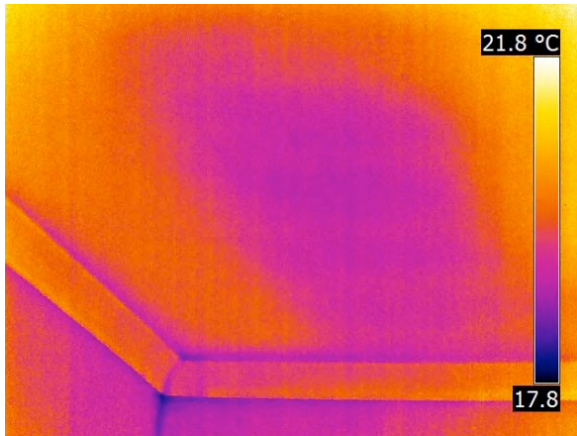
Fig. 5 Example of a infra-red image, showing temperature differential across a ceiling before intervention

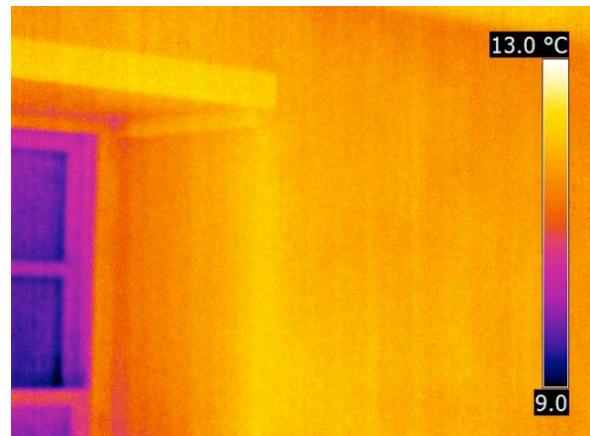
Fig. 6 Infra-red image showing a homogeneous temperature gradient across a wall after intervention

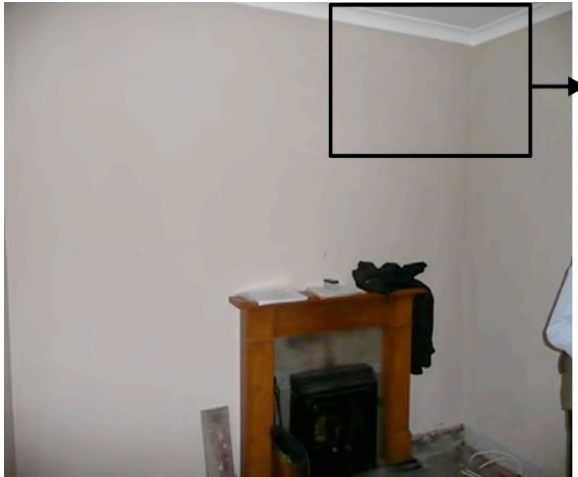
During the pre-intervention monitoring phase, a thermographic survey was conducted to identify locations of anomalies in the internal fabric and to provide an indication of the thermal profile across the surface of various elements (Fig. 14 and Fig. 15). The latter figure shows the temperature gradient as captured by the infra-red camera. The bluer and darker areas indicate zones of lower surface temperature, representing a higher rate of heat loss through the building element, whereas the yellow through to red areas depict higher surface temperatures. The qualitative analysis of the thermograms captured during the pre-intervention testing shows a varying temperature gradient across the internal surface of the walls, ceiling and floor, with heat loss across the elements and at junctions.

Fig. 14 Photograph of the east wall pre-intervention, showing the junction between the east wall and ceiling

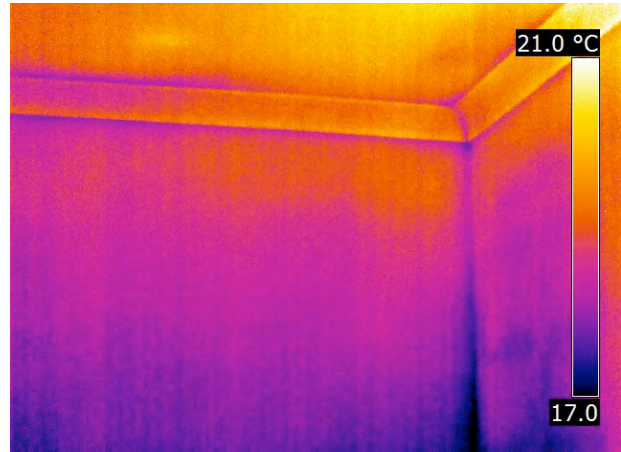
Fig. 15 Thermogram of the junction between the corner of the east wall and ceiling

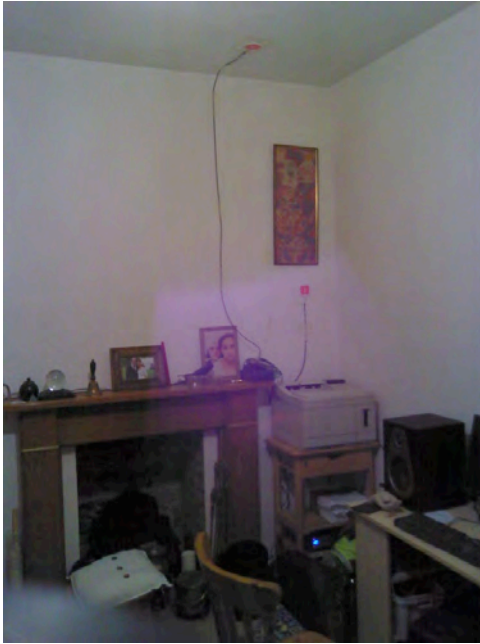
Fig. 16 Photograph of the east wall post-intervention, showing the junction between the south east wall and the ceiling

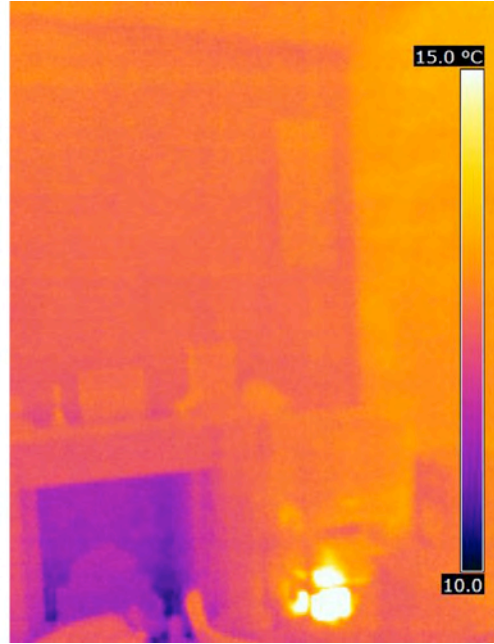
Fig. 17 Thermographic image of the junction between the corner of the east wall and ceiling

In comparison to Fig. 14, the pre-intervention image in Fig. 17 shows a more homogeneous colour profile across the surface of the walls and ceiling, which indicates the continuity of insulation across the building elements that were treated with additional insulation. Fig. 17 is representative of the images of the other walls and floor in the study. The thermographic results revealed no obvious cold spots or areas of contrasting temperature difference on the surfaces treated as part of the thermal upgrade project.

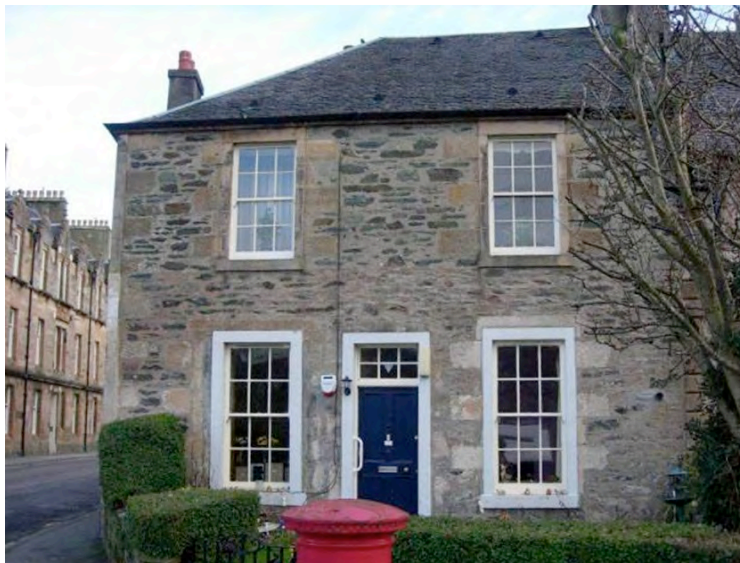
This trial involved testing the thermal performance of an external timber door before and after insulation retrofit works had been carried out (Fig. 27 and Fig. 28). The recessed panel door and frame were made of timber with high thermal transmittance, and air infiltration occurred around the edges and at meeting points between door and frames.

Fig. 27 External view of the door at Colbeck Place

Pre-intervention testing took place over 14 days in January 2011, during which time the average recorded external temperature was 4 °C and the average external relative humidity was 95 %. The recorded internal environment averaged at 18 °C and 45 % relative humidity. The door was then insulated with 10 mm thick aerogel blankets over the internal side of the door and fitted with strips of seals and brushes around the frame to reduce air leakage.

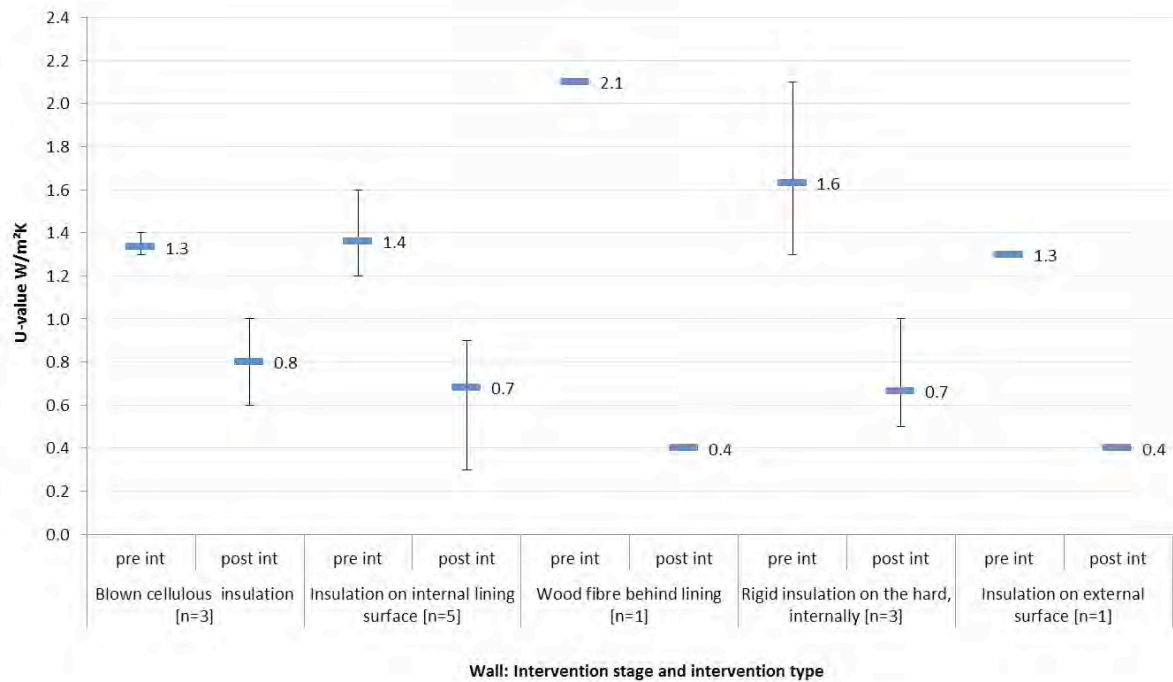
Fig. 38 Stone walls: Range bar chart of average, upper and lower U-value (recorded pre- and post-intervention) for all the walls monitored in the report (n= number of elements tested)

The intervention method of using blown cellulose insulation, aerogel insulation on internal lining surface, and rigid insulation ‘on the hard’, provided enough samples to produce range bars. The range bar results recorded from the walls where blown cellulose insulation was used is relatively small, indicating that the values from the sample are closely grouped. Usually this result would imply that, if blown cellulose insulation was used in a different location with the same wall type, the improved U-value would be circa 0.8 W/(m² K).

However, as these results came from the same property (Wells o’ Wearie), a degree of caution must be exercised in making wider assumptions. The U-values measured from the walls with insulation on the internal lining, i.e. aerogel blanket, ranged between an upper limit of 0.9 W/(m² K) in the Wee Causeway cottage, down to a lower limit of 0.3 W/(m² K) in the property at Whitevale Street. This value range may be the result of workmanship, but more likely, it may be the result of the air cavity behind the lath and plaster and whether it was ventilated to the external environment.

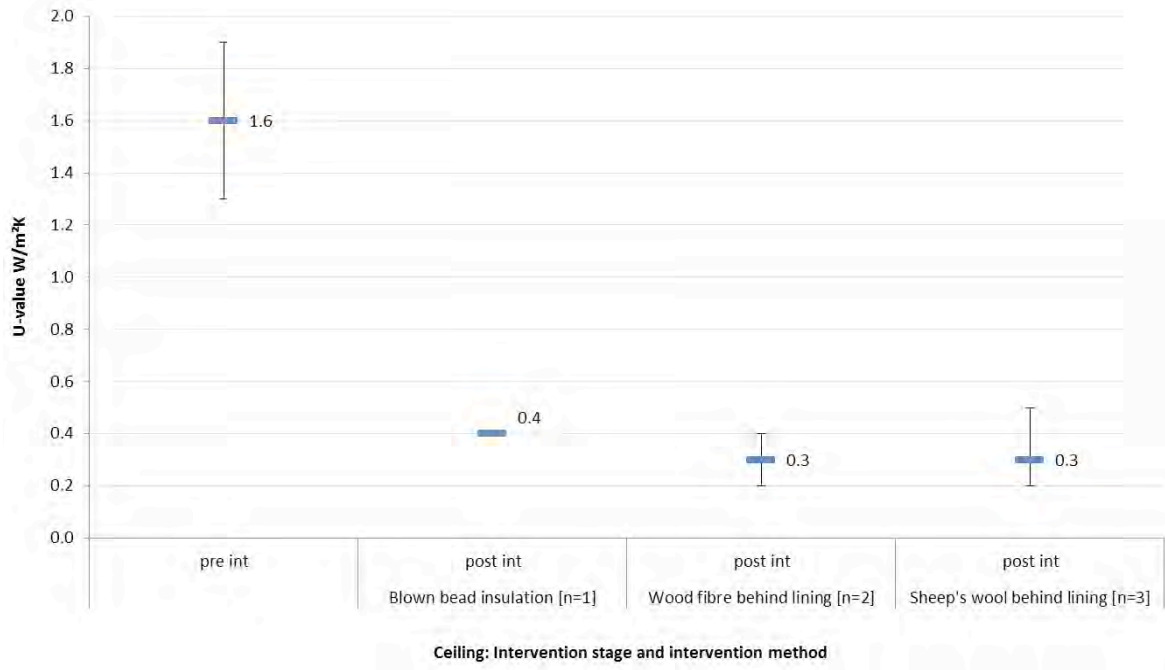
Fig. 39 Ceilings: Range bar chart of average pre- and post-intervention U-value results for all the ceilings monitored in the report

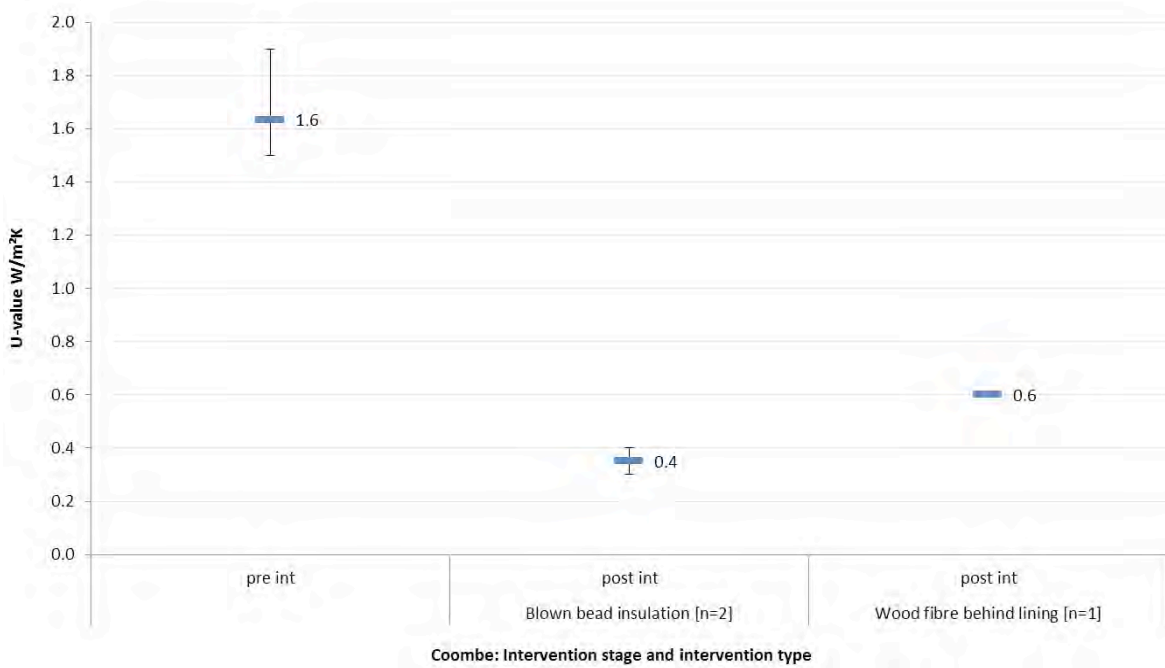
Fig. 40 Coomb ceilings: Range bar chart of average pre- and post-intervention U-value results for the coomb ceilings monitored in the report

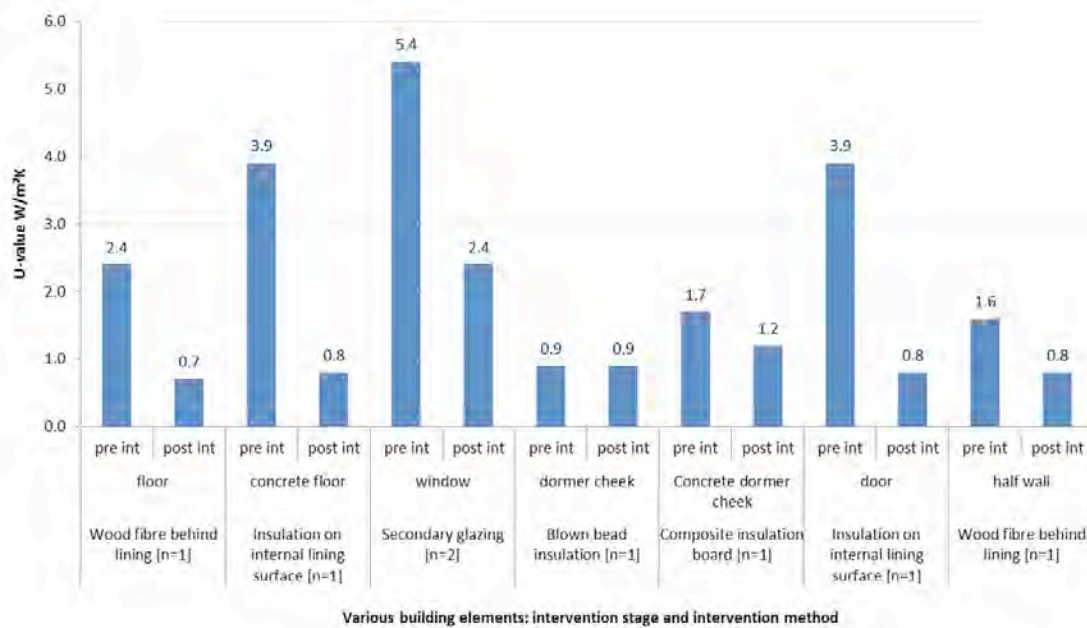
Fig. 41 Bar chart of average pre- and post-intervention U-values for various building elements
