ST PETER'S SEMINARY Cardross

CONSERVATION ASSESSMENT

Main Report

FEBRUARY 2008

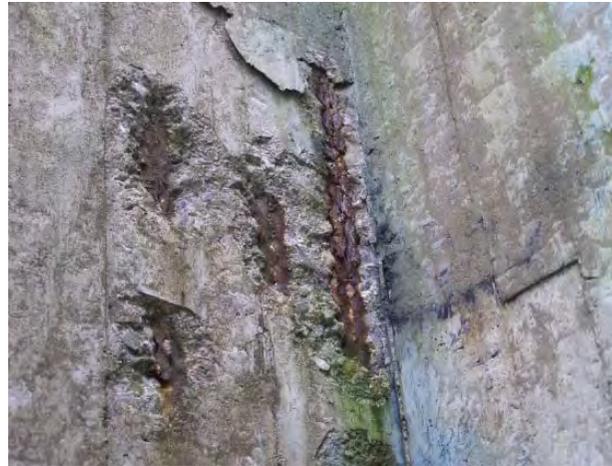
Exposed corroded reinforcement

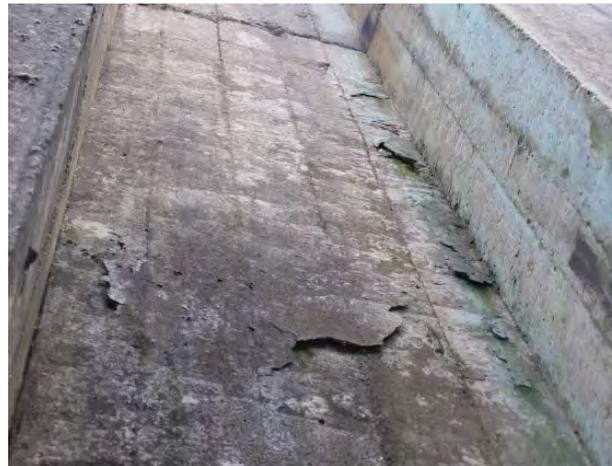
Delamination of concrete surface

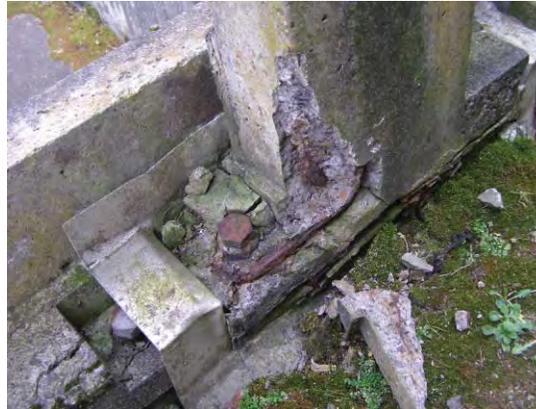
Corroded bolt fixings at base of concrete posts

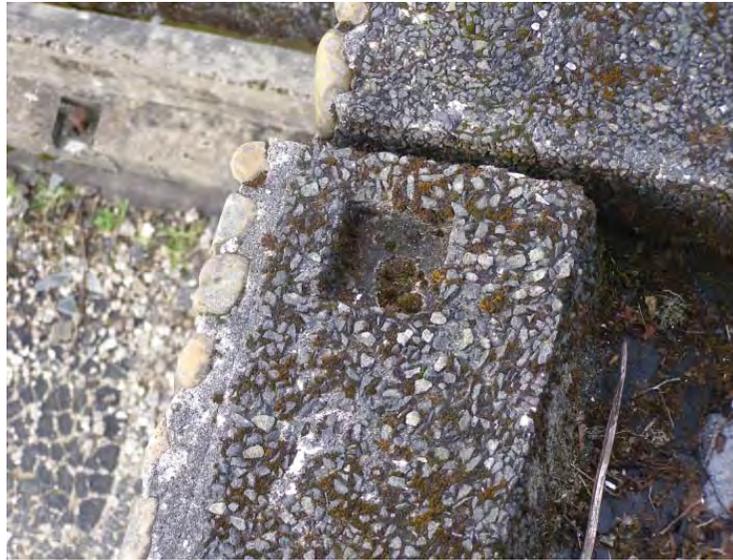
Displacement of corner handrail post

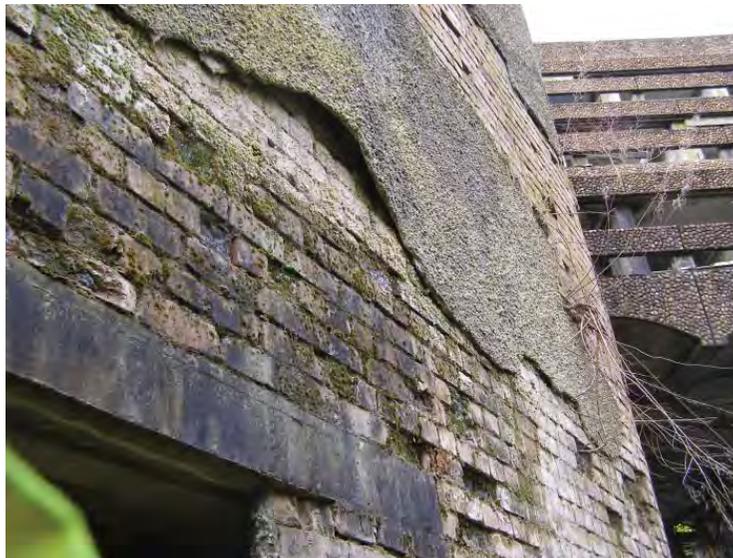
Lost and delaminating render with consequential brick damage

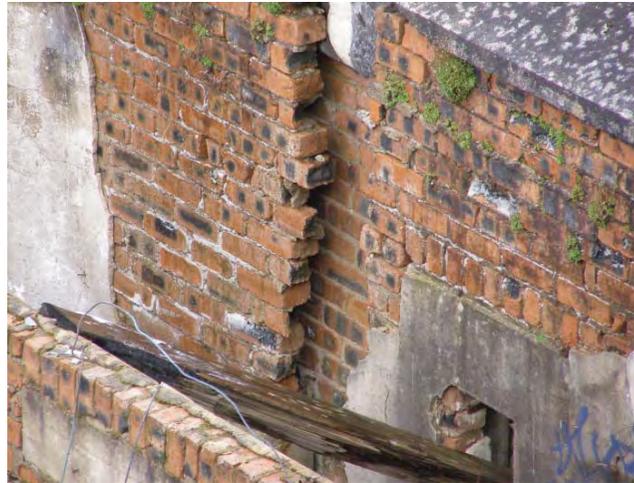
Corrosion of wall ties

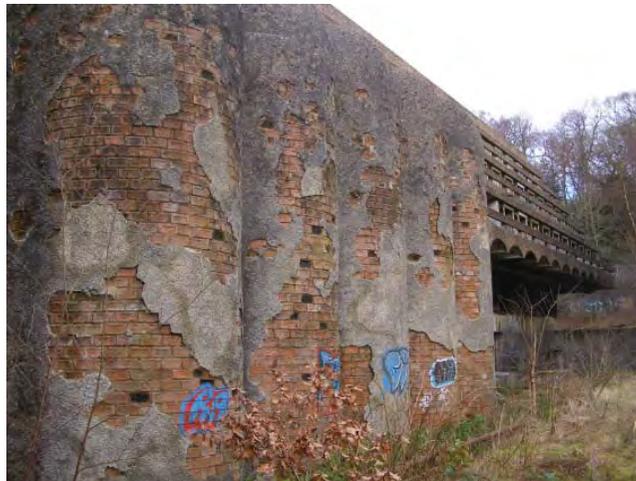
Delaminating/missing render from brick silo shaped chapels

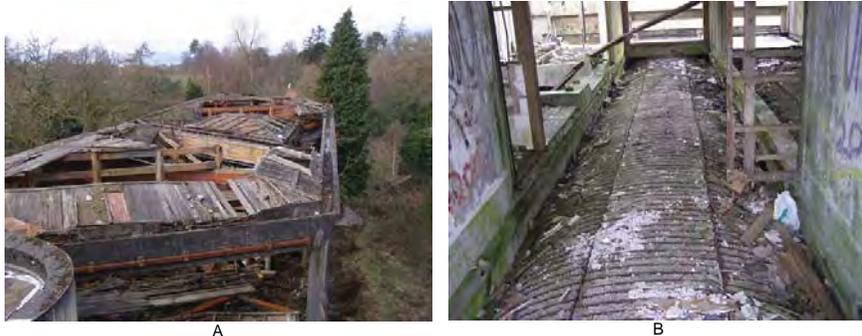
Plates T2: Unsafe, rotten and partially collapsed roofs.

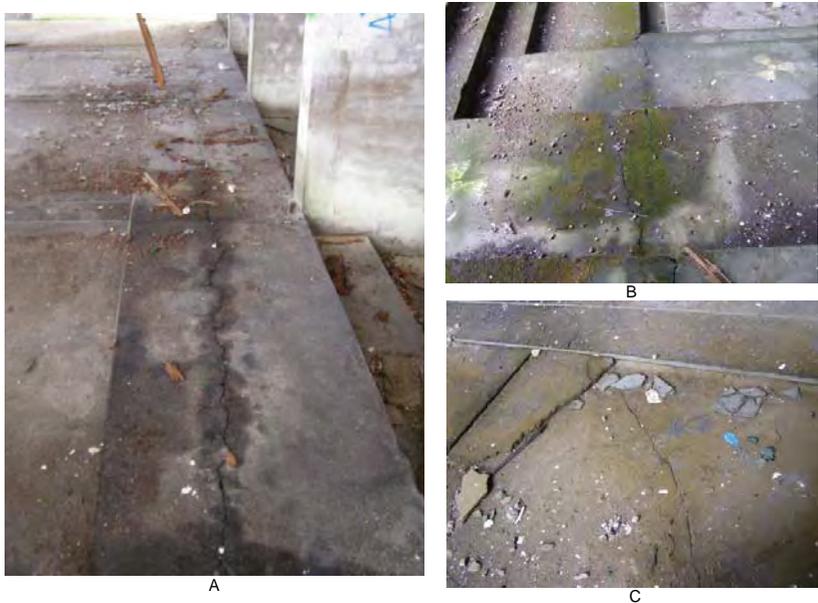
Plates T10: Cracking through the suspended floor to the main building, possibly reflecting hidden structural details and / or relative movement/s of the structure.

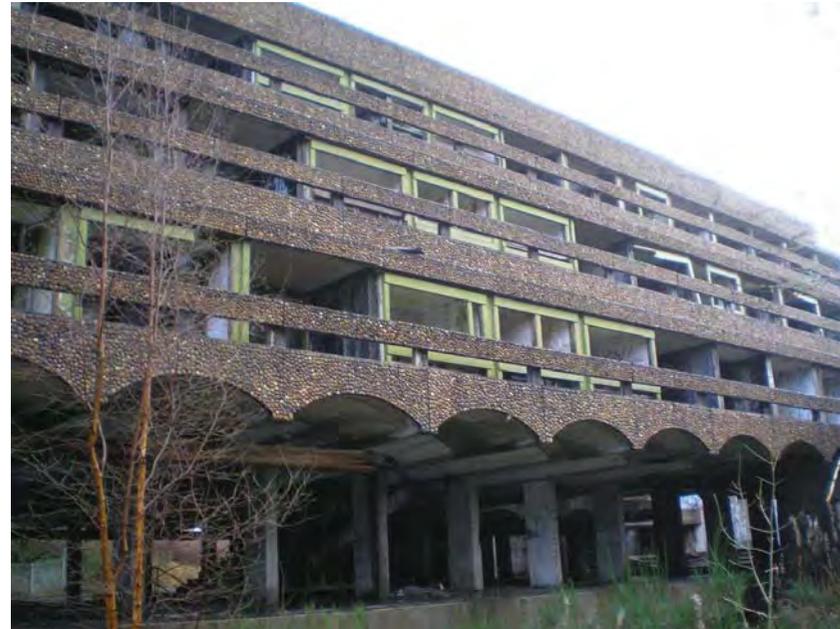
Plate T12: General, typical external view showing the panels in good visual condition. See also Plate T13, below.

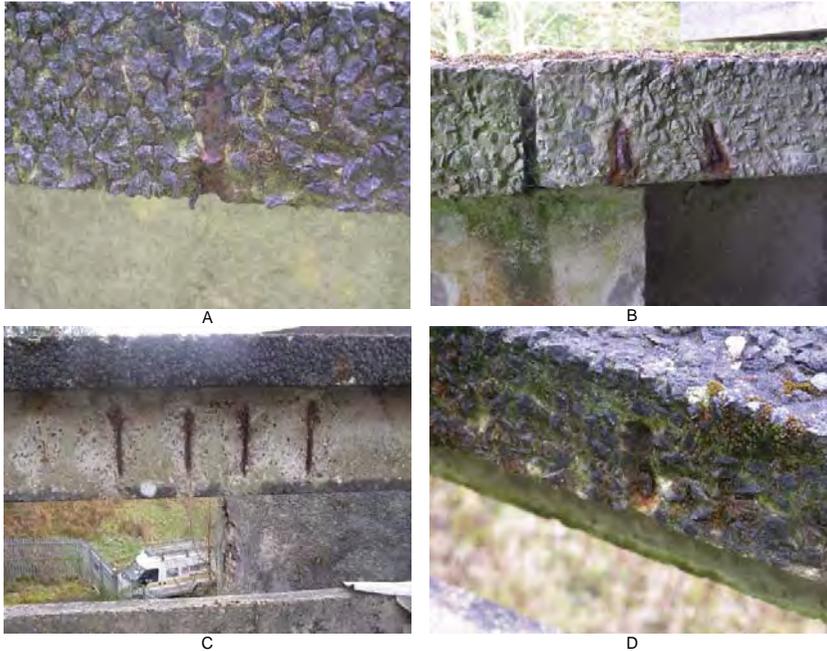
Plates T14: Exposed reinforcement and surface spalling associated with corroded reinforcement on the hidden and less obvious surfaces of the pre-cast panels.

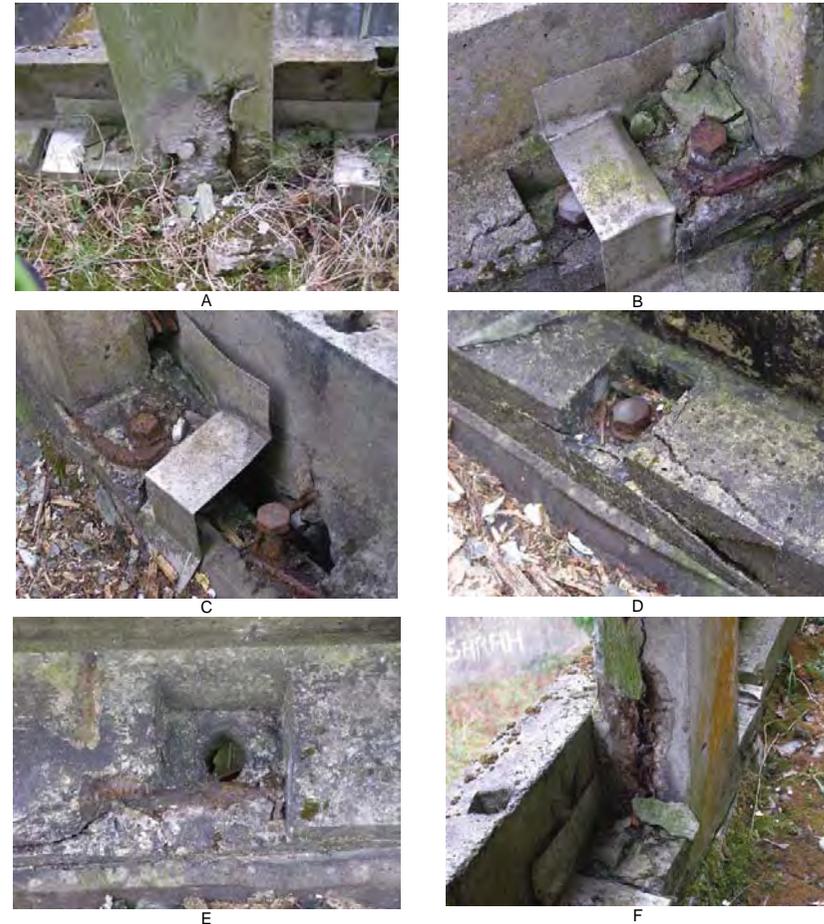
Plates T17: Deterioration and distress associated with the lower panel and stub column fixings.

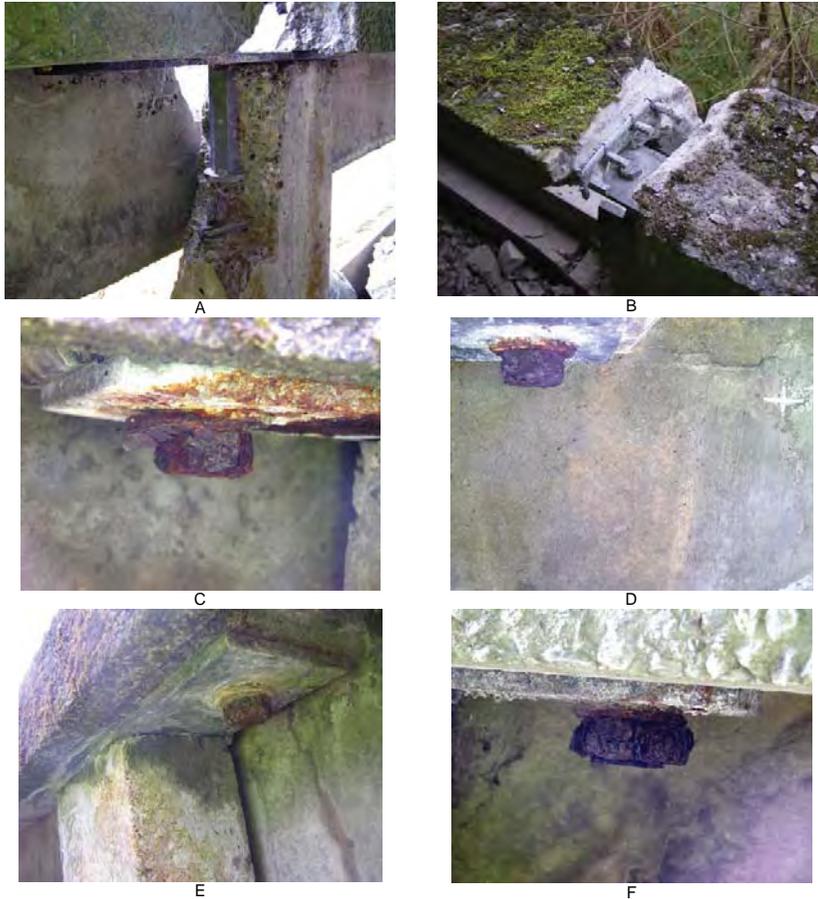
Plates T18: The stub columns and pre-cast handrail units had been cast with threaded steel sockets at fixing positions. Steel plates had been bolted onto the tops of the stub columns, with further bolts through the steel plates and up into the backs of the handrail units. The steel elements had been galvanised, but in some locations the galvanising had deteriorated and corrosion was apparent.

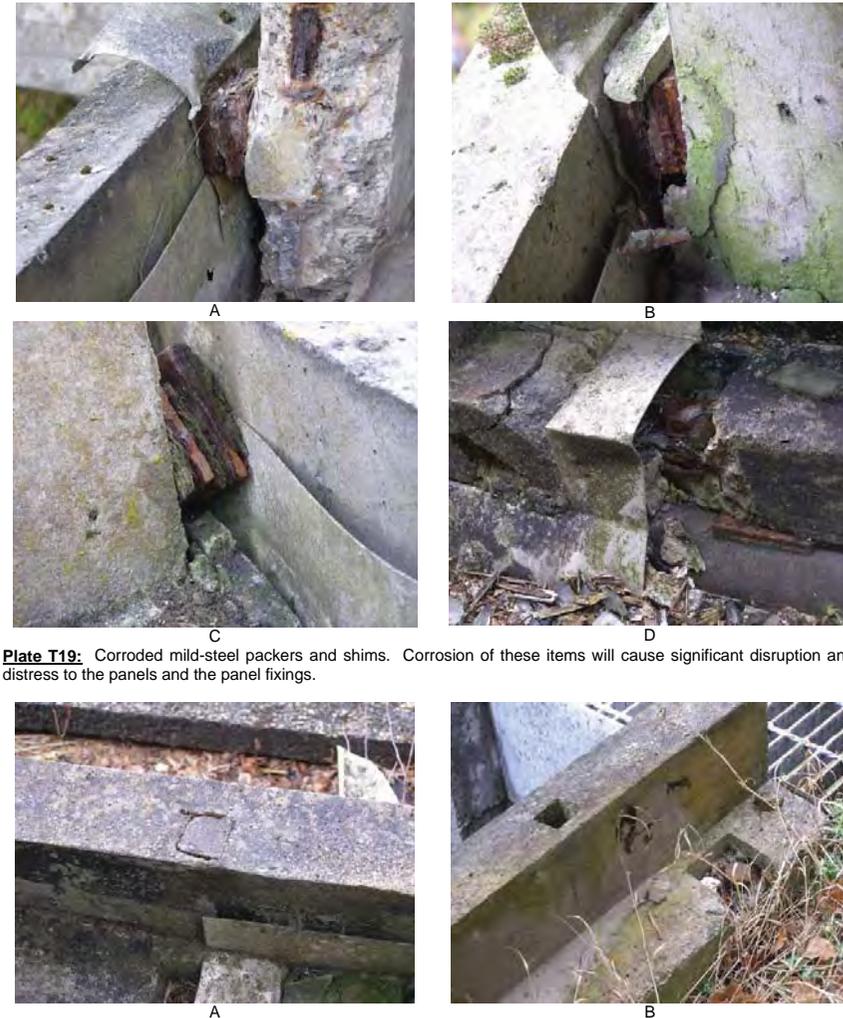
Plate T19: Corroded mild-steel packers and shims. Corrosion of these items will cause significant disruption and distress to the panels and the panel fixings.
