TECHNICAL PAPER 33

MASONRY POINTING AND JOINT FINISHING

PART 2 - GAZETTEER

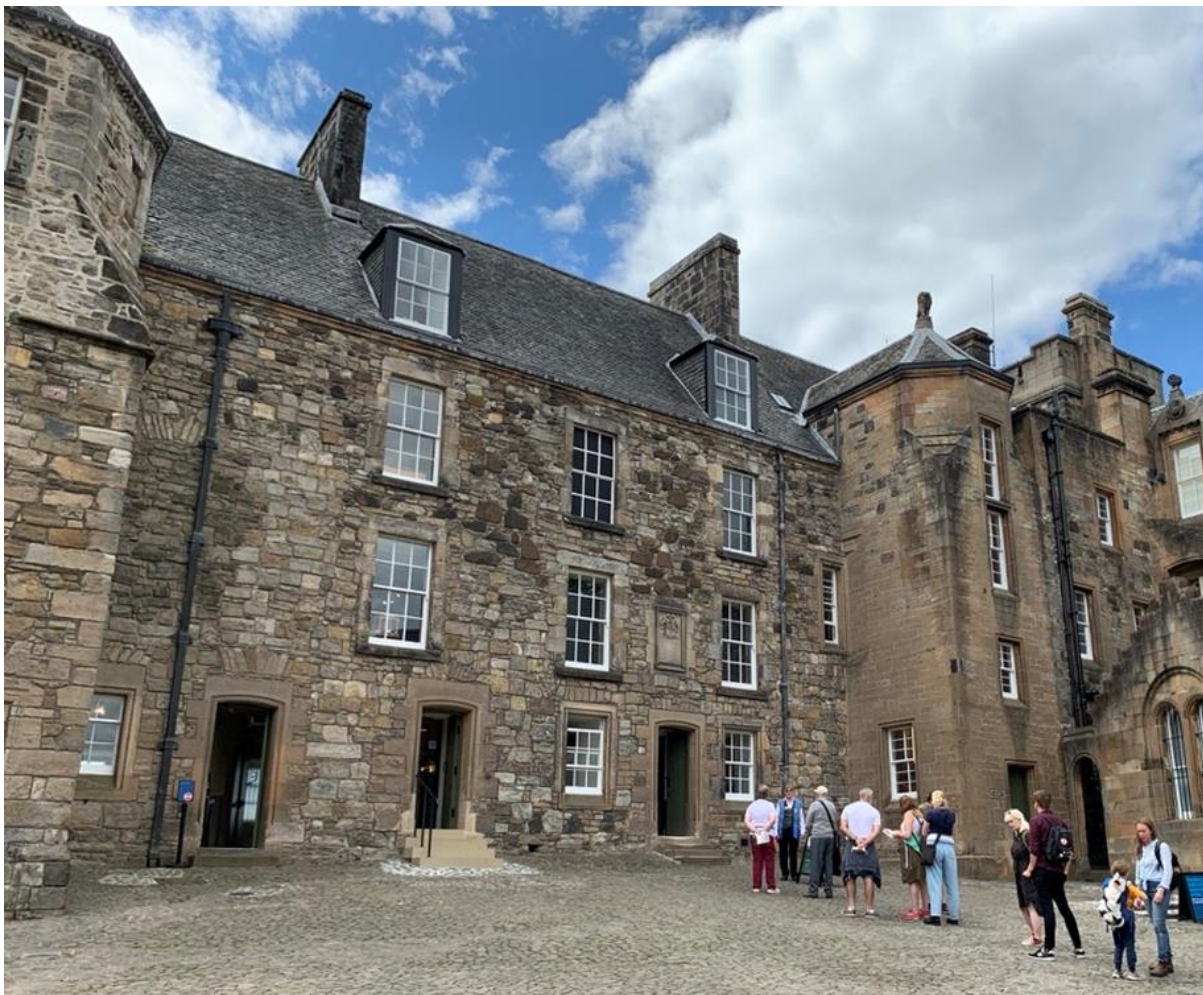
Figure 001.1. The Kings Old Building, Stirling Castle. To the right is the 19th century repair work.

The King's Old Building, (Figure 001.1) was built for James the IV in around 1497 as part of the Royal Complex at Stirling Castle. Masonry work in the 20th century now presents a bare stone façade with a heavily recessed cement joint between the blocks of masonry. However, upon scrutiny of masonry lower down, there are traces of lime harl in some areas (Figure 001.2). Archive images from the 19th century show that the finish was a lined out flush point, and it is likely that the original harl was removed as part of this work. This lined out pointing may have been associated with the repair works after the fire and the rebuilding of the Officers Mess by Robert Billings in 1857. Later activity by the Ministry of Works resulted in the recessed pointing style (Figure 001.3) seen today.

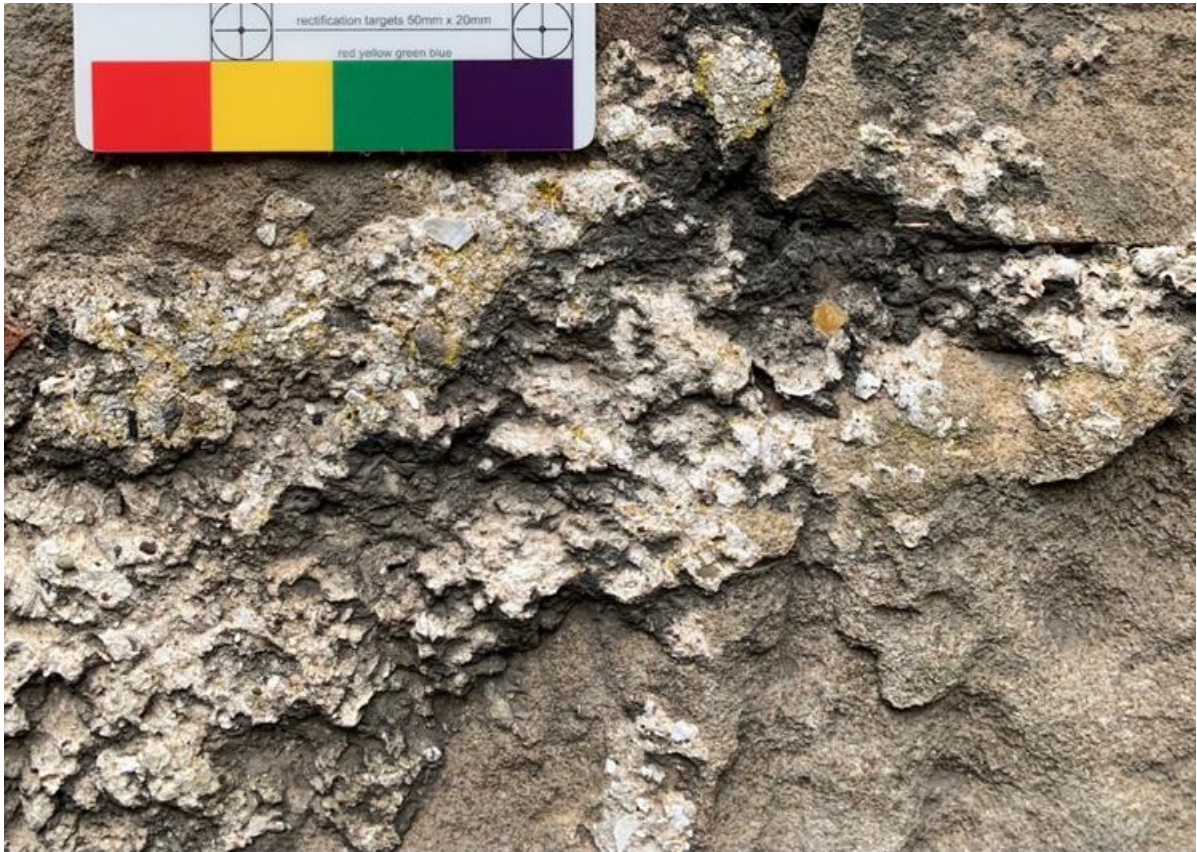
Figure 001.2. Surviving harl on the walls of the Kings Old Building. Despite many interventions there are still areas of early lime harl on the building.

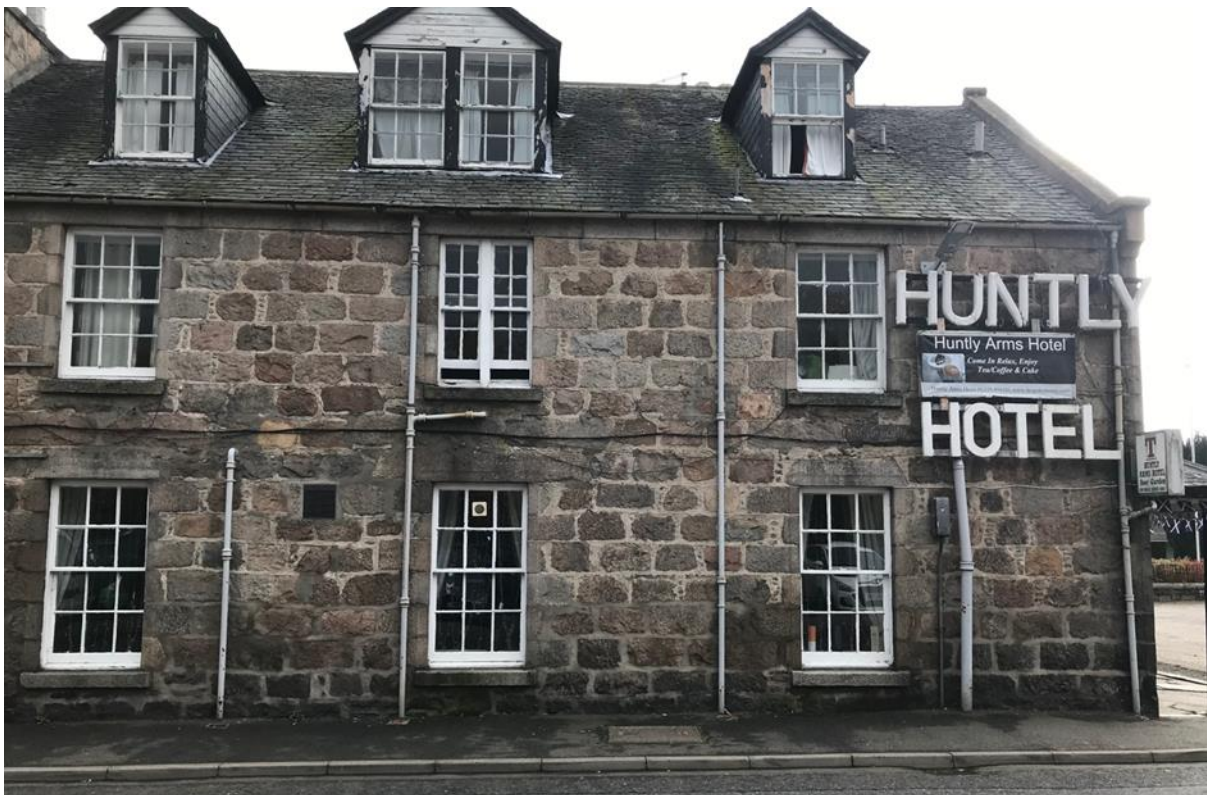
Figure 009.1. The North elevation of the Huntly Arms Hotel, Aboyne.

A three bay two and a half storey building (Figure 009.1). The pointing is fully flush finish and has a raised band measuring 20mm applied to both the horizontal and perpendicular joints (Figures 009.2). The sand and aggregates are sharp and well graded with no sign of inclusions. The most likely source of lime for the mortar would be Parkmore at Portsoy. The extant finish is generally intact though worn in some areas, resulting in the raised band becoming faint. In other areas, repairs have been made with a cement mortar (Figure 009.3). Other buildings in the area demonstrate a similar pointing tradition. It is possible that mortar was applied liberally over the whole joint and then flattened with the back of a trowel. Two parallel lines might have been struck using rod or level and the lines made by using something similar to a carving fork. Once the lines were struck, the mortar on the outer edges of marks could be teased away, leaving the raised band prominent of the wider surface. There are no indications of limewash.

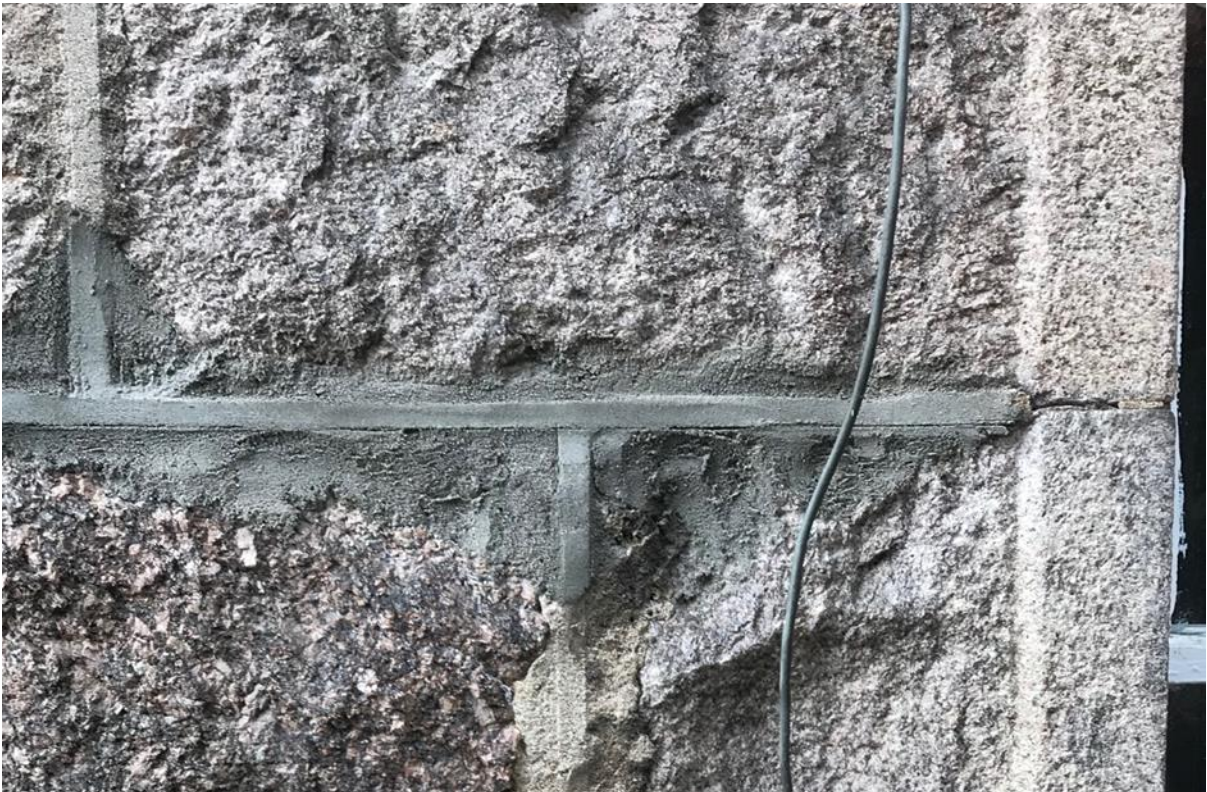
Figure 009.3. Raised band repairs in cement mortar.

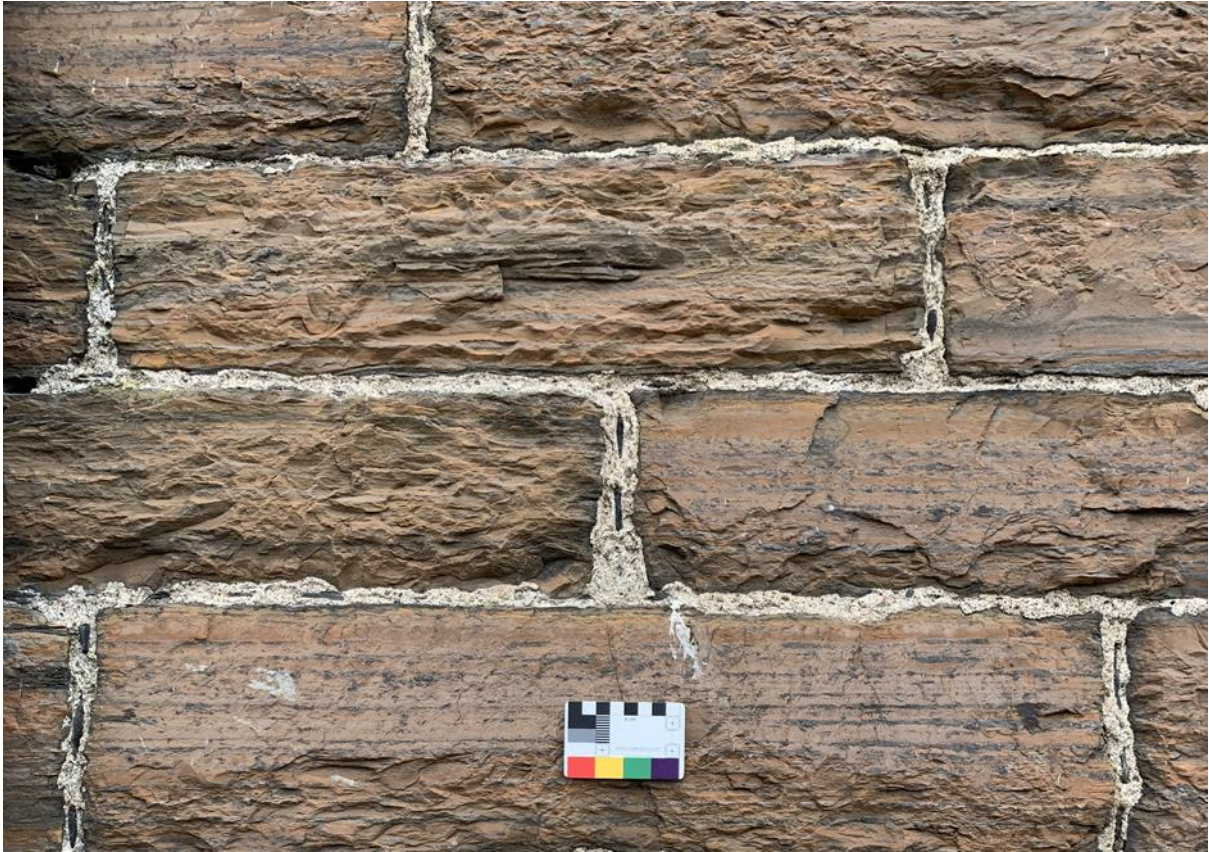
Figure 016.2. Cherry cocking of the joint with slate pieces, a feature done in lieu of the more common lining out seen in many other buildings in this study.

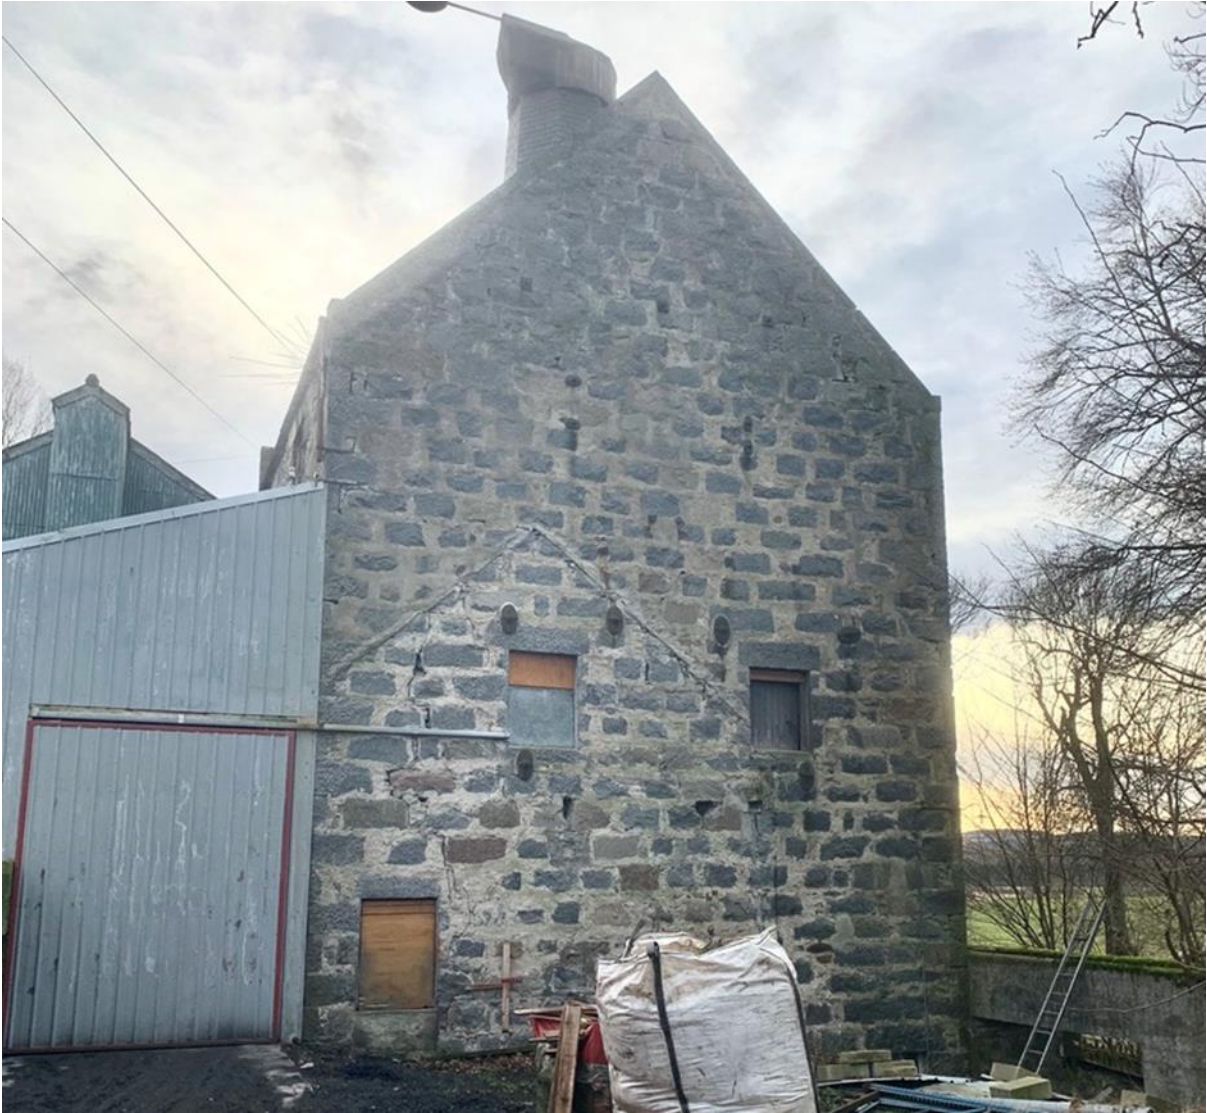
Figure 022.2. Sneck harled granite/gritstone on the northeast gable.

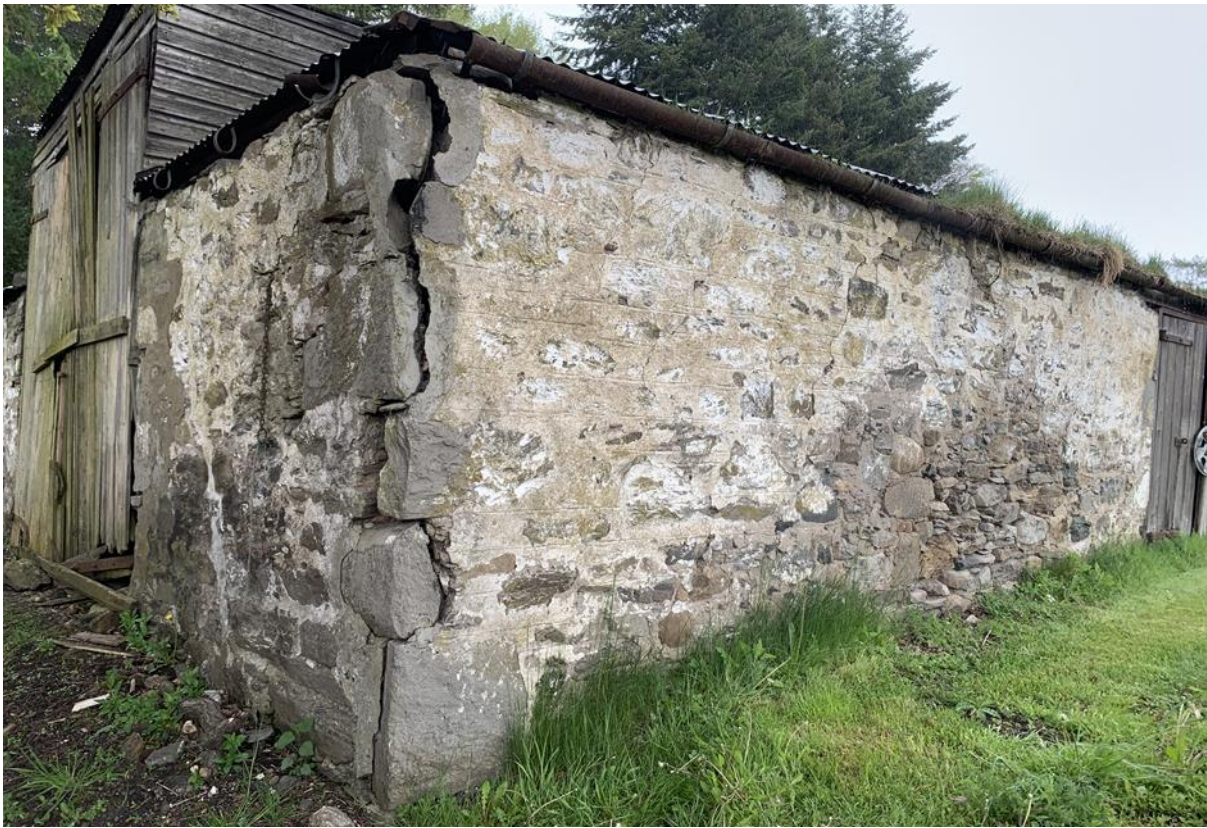
Figure 026.1. The steading building showing the flush pointed ruled out masonry and limewash.

This appears to be an early 19th century steading associated with Ballechin Farm. The roof arrangement has been altered and there are various modern configurations of roofing materials (Figure 026.1). The rubble masonry of the walls however shows a flush point and informal ruling out with limewash (Figure 026.2). The limewash, as might be expected, survives well in areas free of water from defective roof drainage.

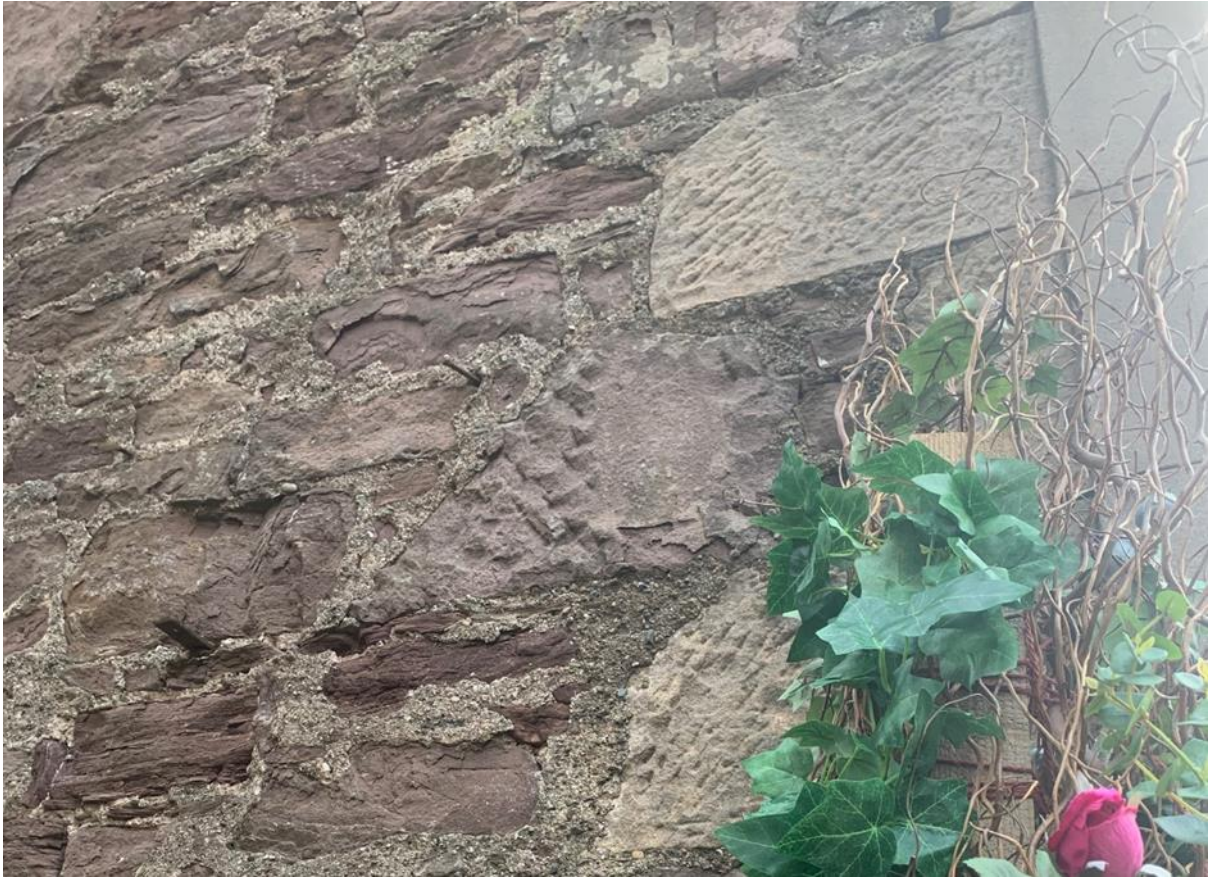
Figure 030.2. Finish on the north gable; this may be the remains of a flush point.

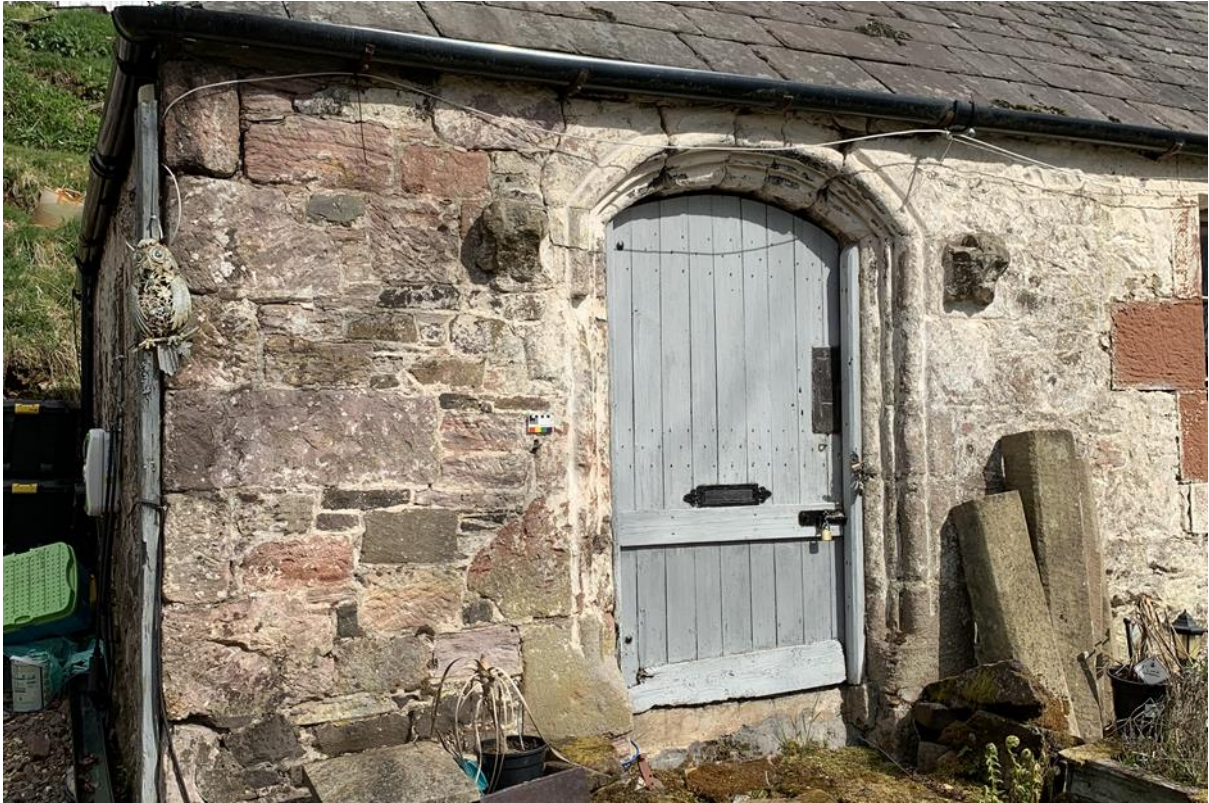
Figure 037.2. The re-used door surround; flush pointing and limewash surviving on the right-hand side.

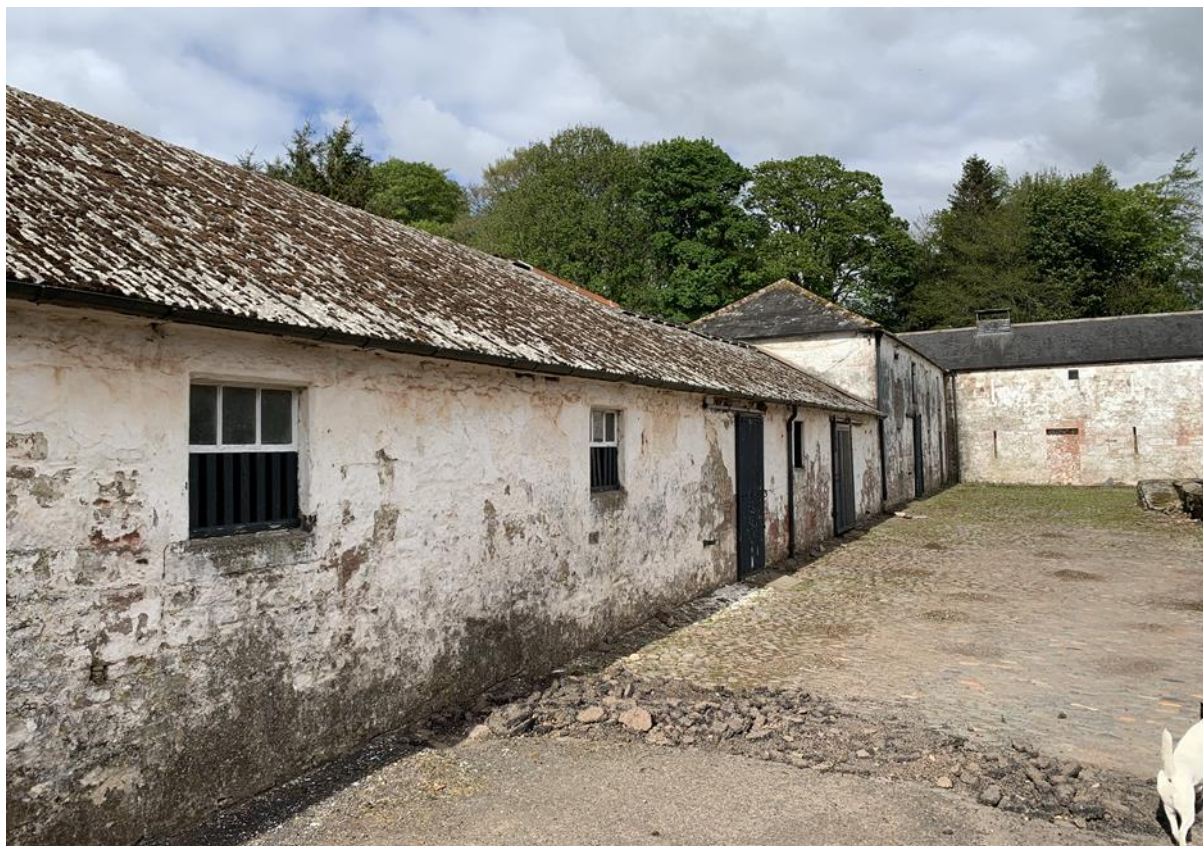
Figure 038.1. View of the North West range of the Coshogle steading where large areas of original finish survive.

The Coshogle farm steading is believed to have been designed along with the farmhouse by the architect Walter Newall around 1830 and is Category B Listed (Figure 038.1). The complex represents a multi-period development with differing pointing styles and limewash coats. The survival of such an extent of limewash is a significant contribution to the study and shows the durability of traditional finishes when buildings are maintained in good condition, however, wear is evident in some areas due to splash back or mechanical damage (Figure 038.2). Two pointing styles are evident; ruled flush finished and limewashed (Figure 038.3), and flush pointed and limewashed (Figure 038.4). In places the limewash is multi-layered and survives well.

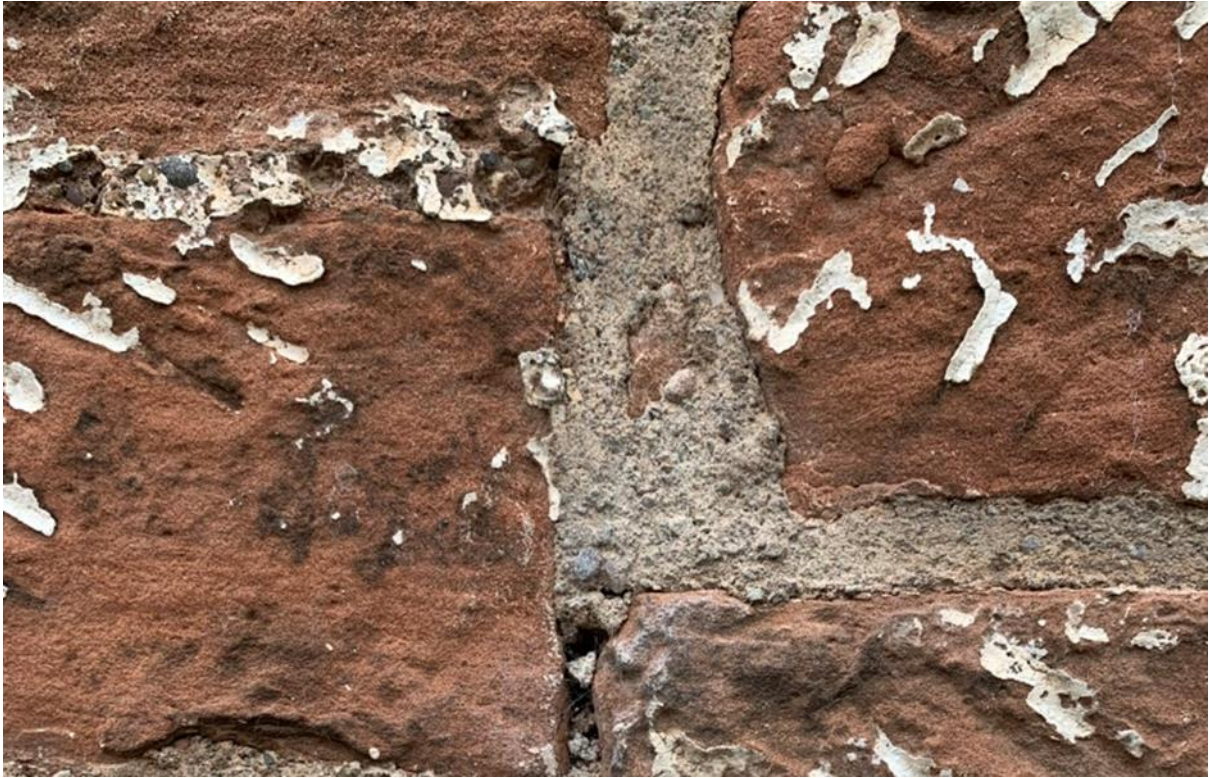
Figure 040.2. Later pointing from 2007 alongside historic evidence for limewash and a flush point.

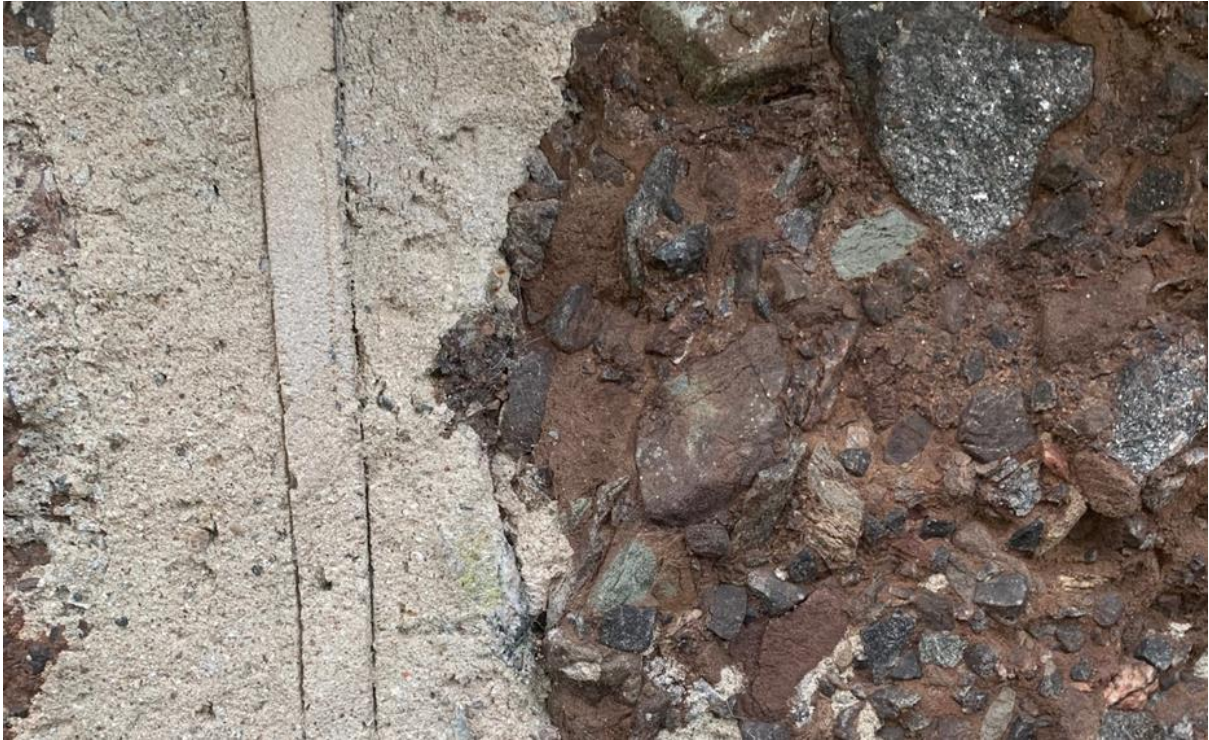
Figure 042.2. Poor quality local agglomerate stone with traces of irregular vertical and horizontal ribbon pointing. Traces of what maybe c.1816 harl in the deeper recesses of the agglomerate stone with overlaying ribbon pointing from the 1879 work.

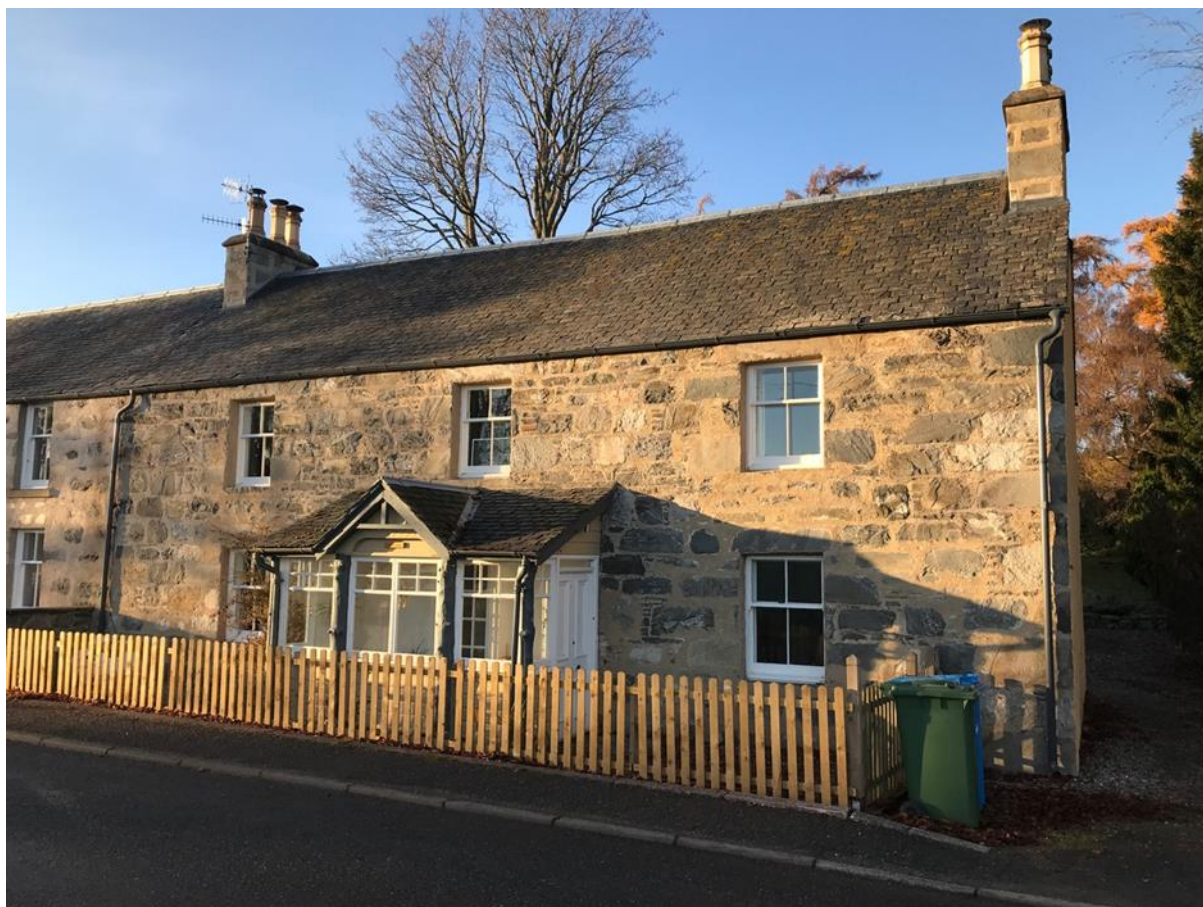
Figure 043.1. The cottage, with recently repaired ruled sneck harl.

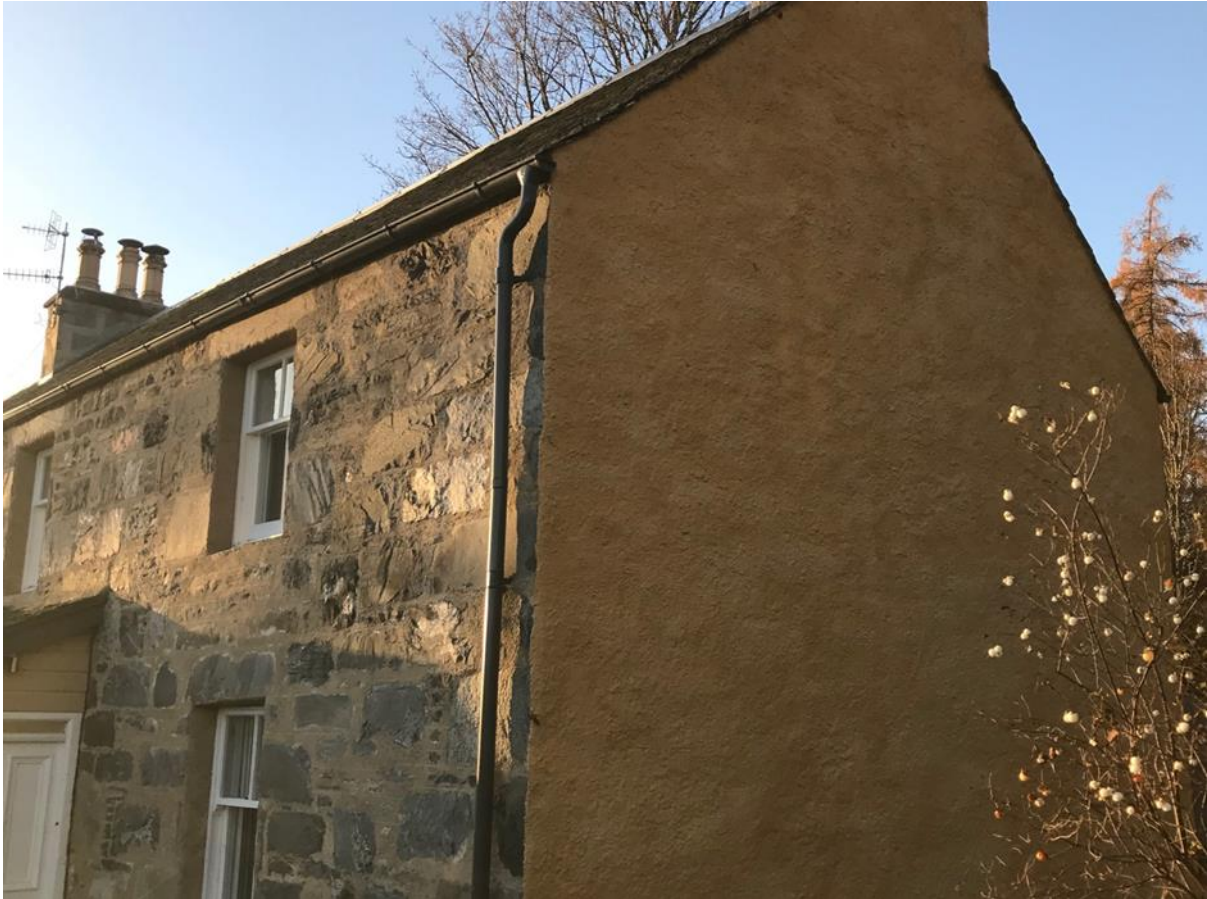
Figure 043.2. Ruled semi-formal front and repaired and limewashed gable and rear elevation.

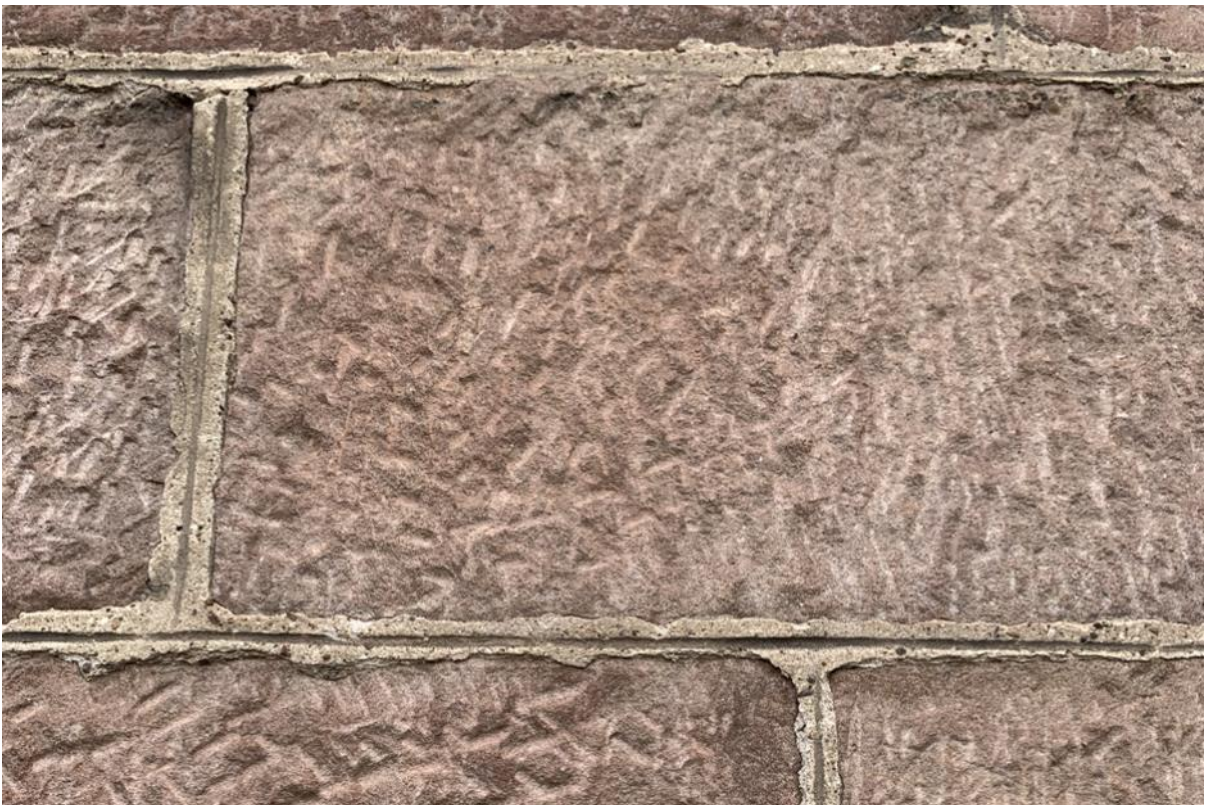
Figure 050.3. Multi directional tooling of the masonry blocks on the principal elevation. Crisp lined out flush pointing still in good condition.

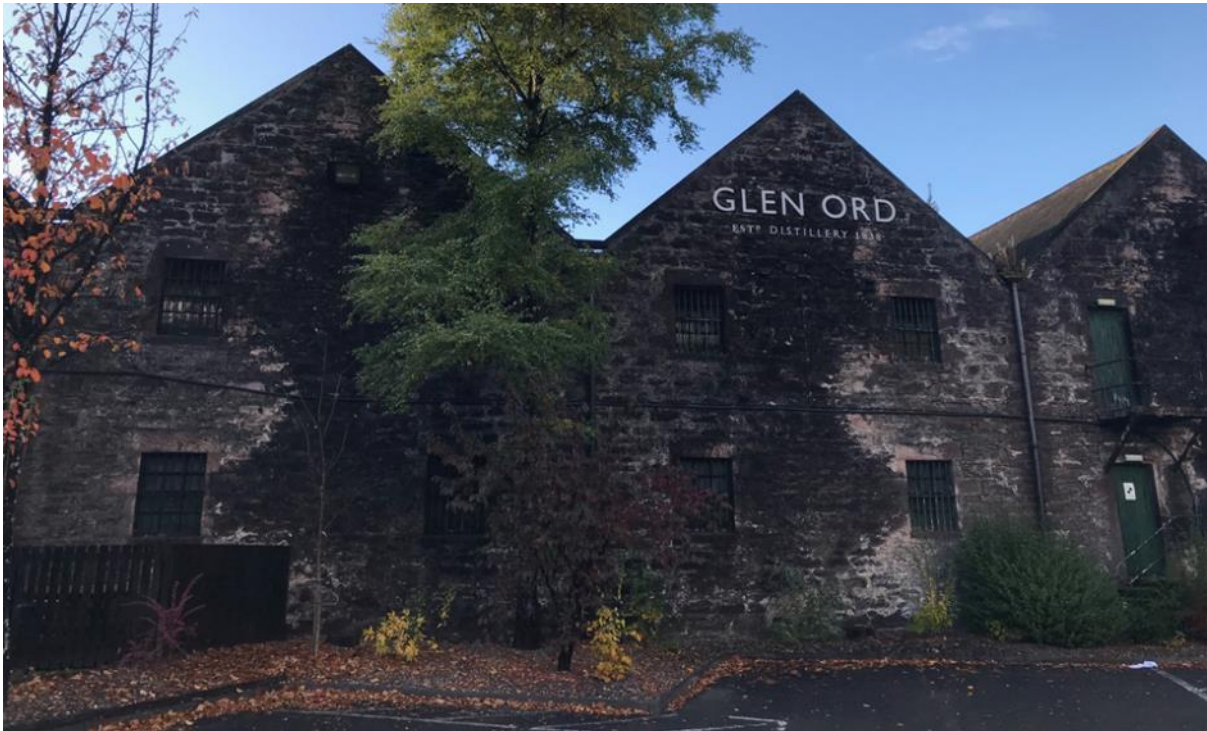
Figure 052.1. Glen Ord Distillery covered in lime finish but obscured by sac fungus.

A large range of sandstone buildings used to distil, store and sell whisky. At first glance, any finish is difficult to observe because the whole building is covered in a sac fungus (*Baudoinia Compniacensis*) (Figure 052.1). The ethanol from the distilling process provides the food source for the growth of the fungus. On closer observation there are two types of finish present. The first (Figure 052.2), is either a complete harl or 'sneck' point. Given the covering of fungus and some areas of decay, it is difficult to tell whether a full harl has graded away or if the original was the now attenuated extant finish. The second sample is clearly a sneck harl and has been ruled horizontally ruled out (Figure 052.3). Given its location close to the ground and the clear evidence of salt damage, it would appear that this is a secondary application.

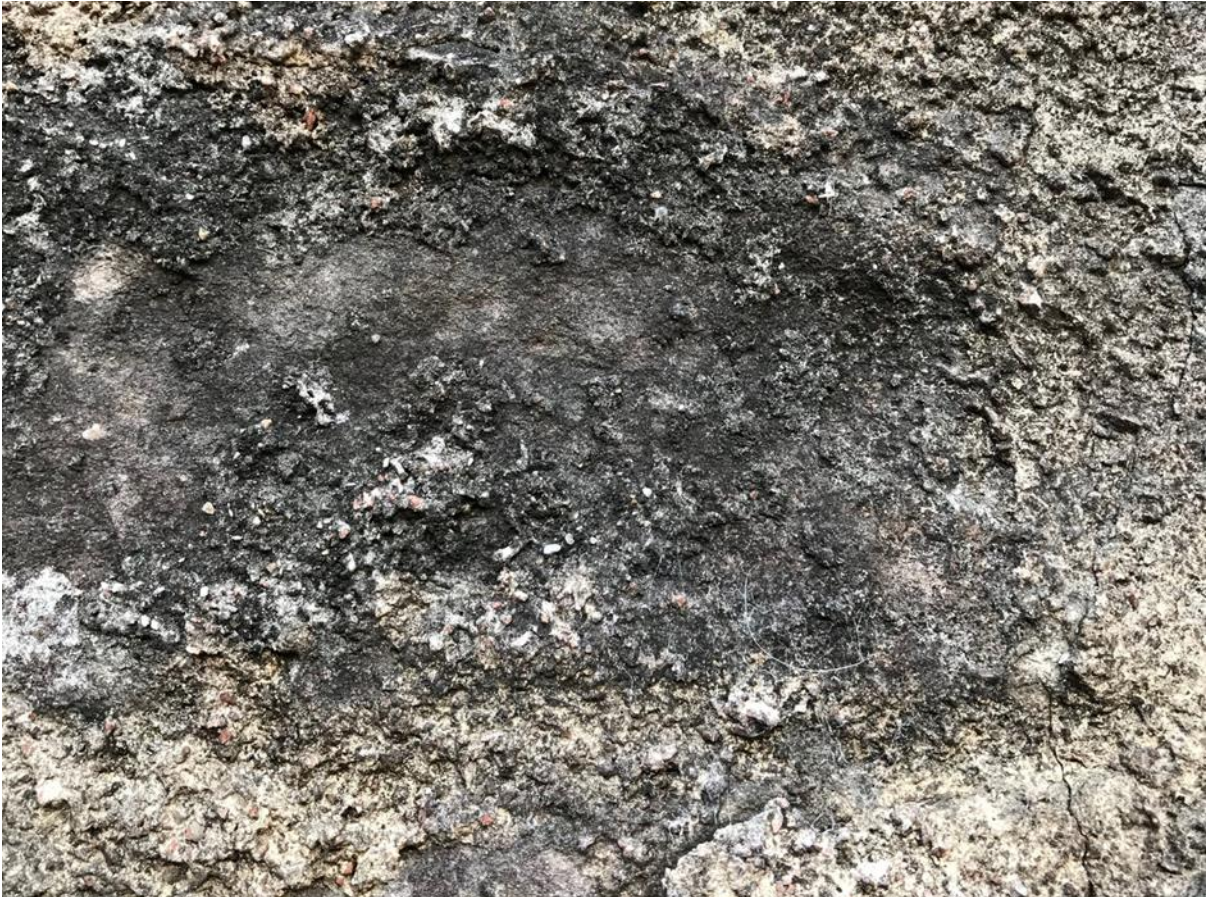
Figure 052.2. Sneck harl or possibly graded away full harl.

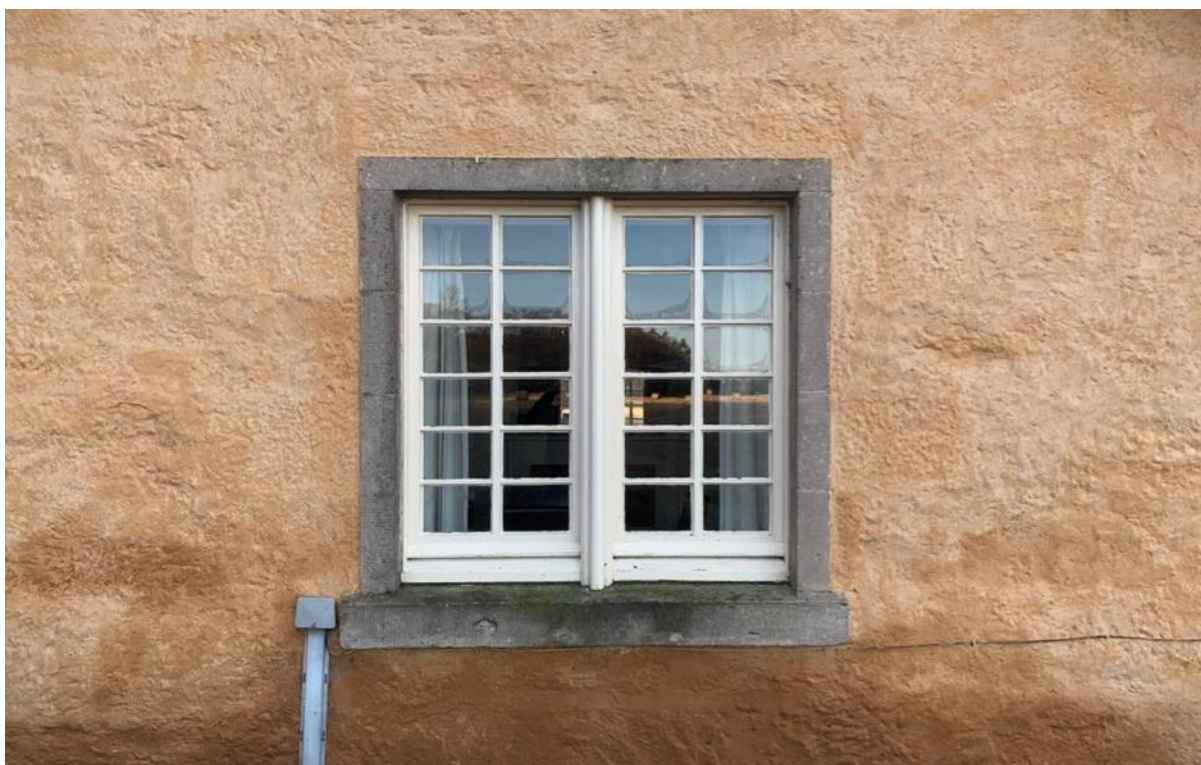
Figure 057.2. Limewashed sneck harl.

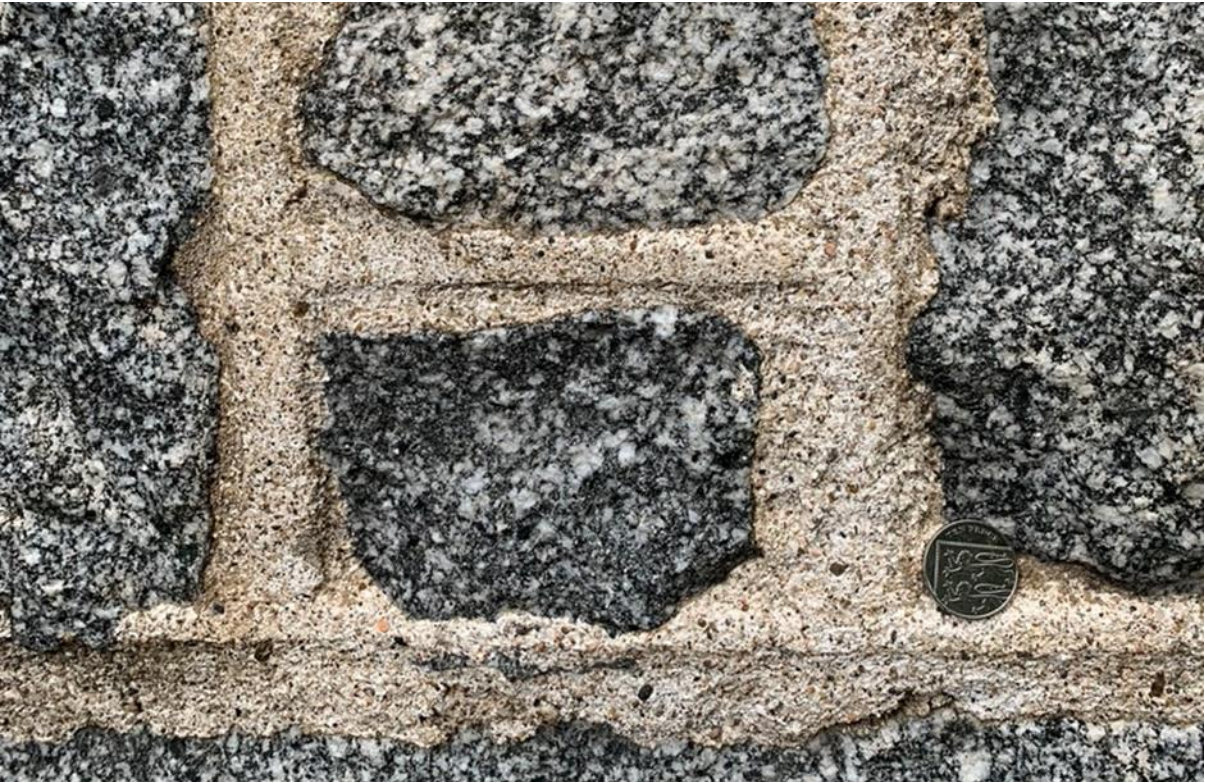
Figure 059.2. Lime mortar ribbon pointing with fine sharp angular aggregates.

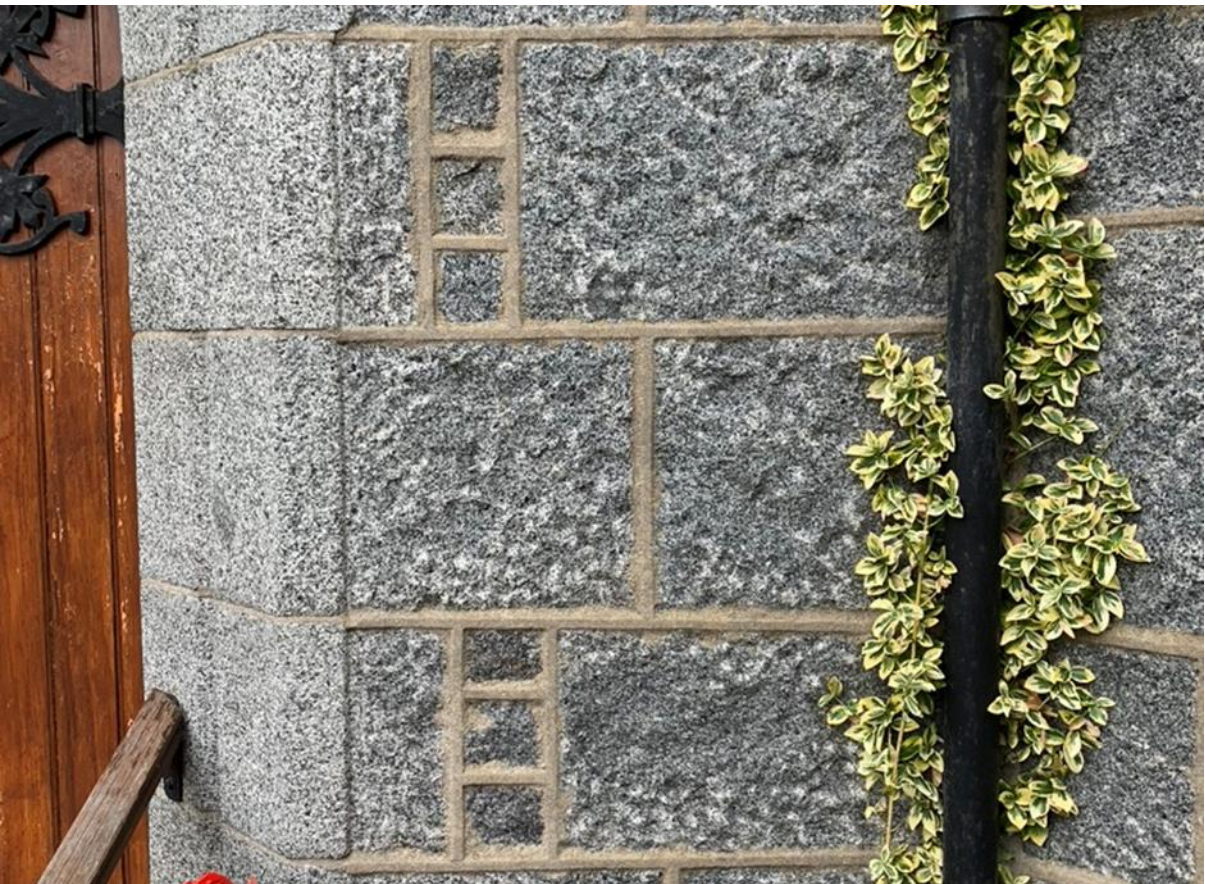
Figure 059.3. Cement mortar repairs to the tower. The repairs, though lacking in understanding of materials the work does recognize local vernacular building practice.

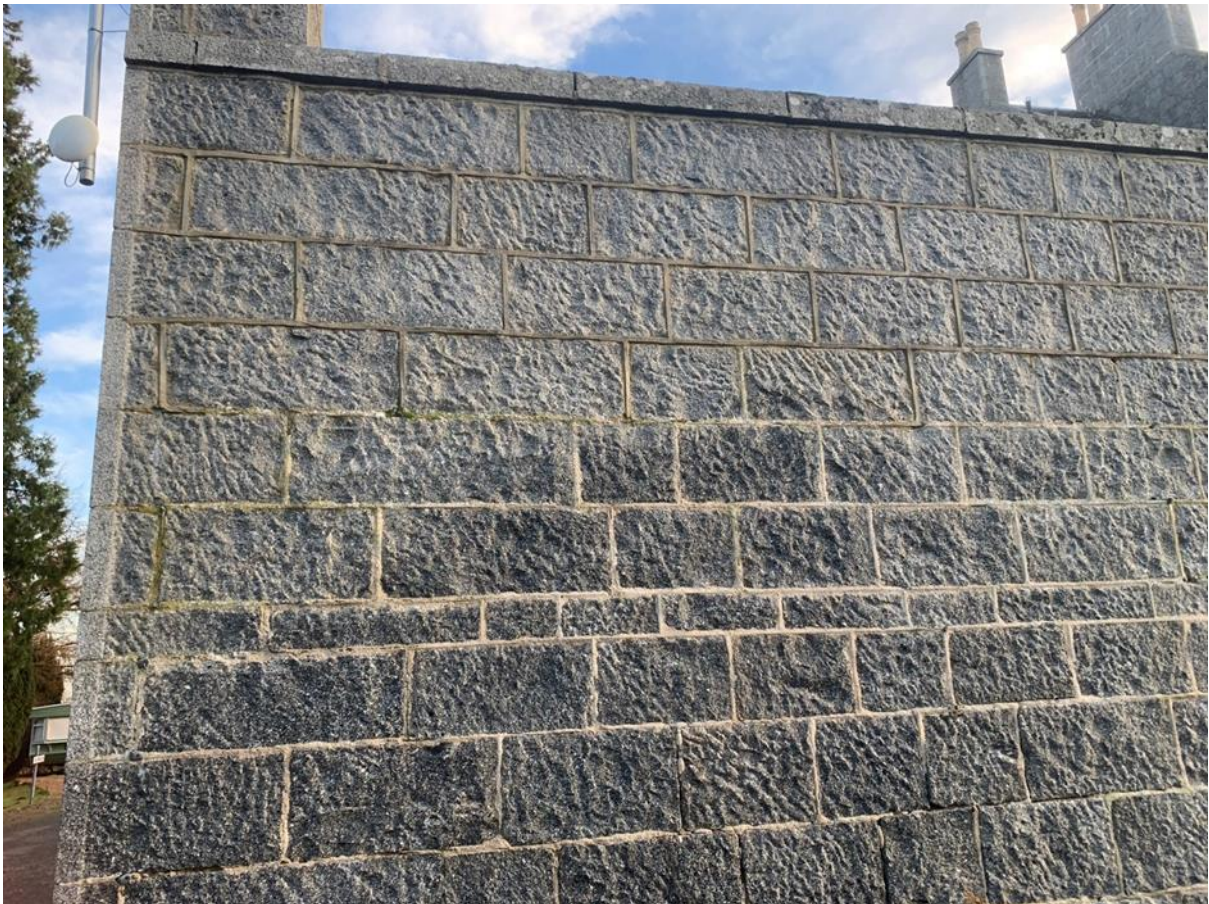
Figure O61.3. The upper half of the wall has a later cement replacement while the lower half retains the finer lime pointing.
