TECHNICAL PAPER 33

MASONRY POINTING AND JOINT FINISHING

PART 2 - GAZETTEER

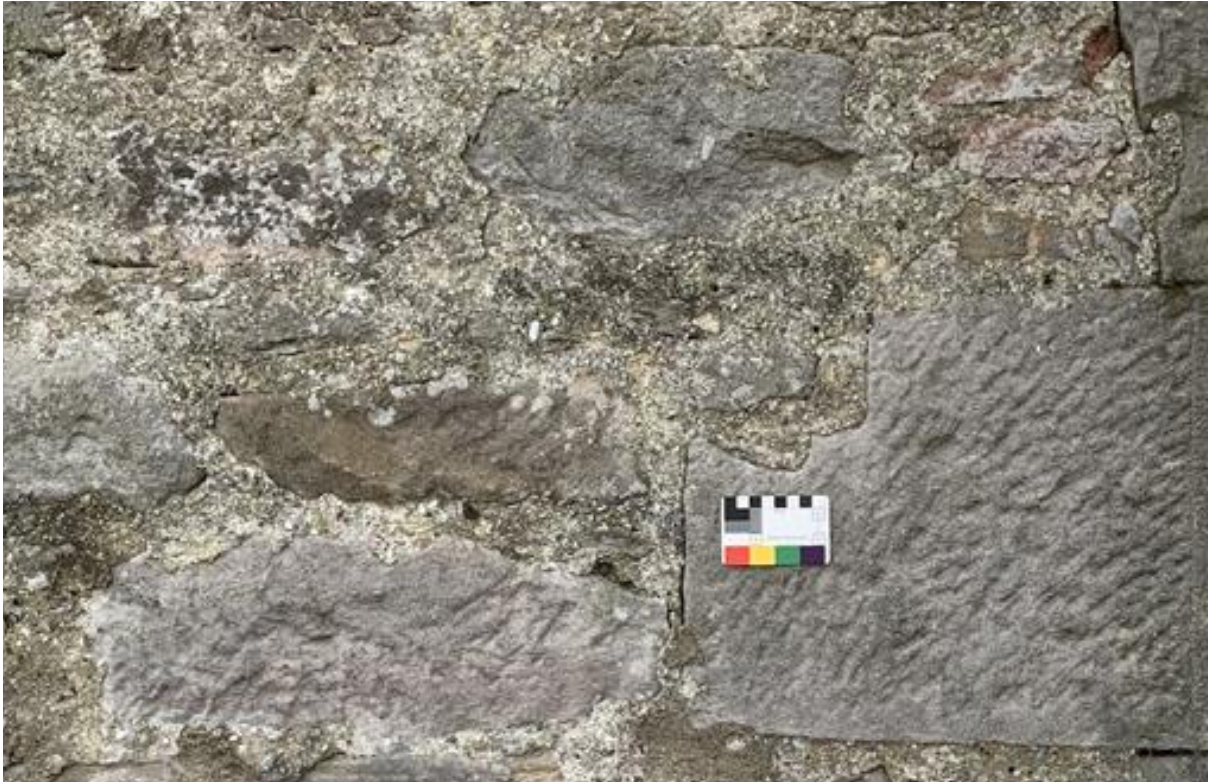
Figure 077.2. Sneck pointed gable.

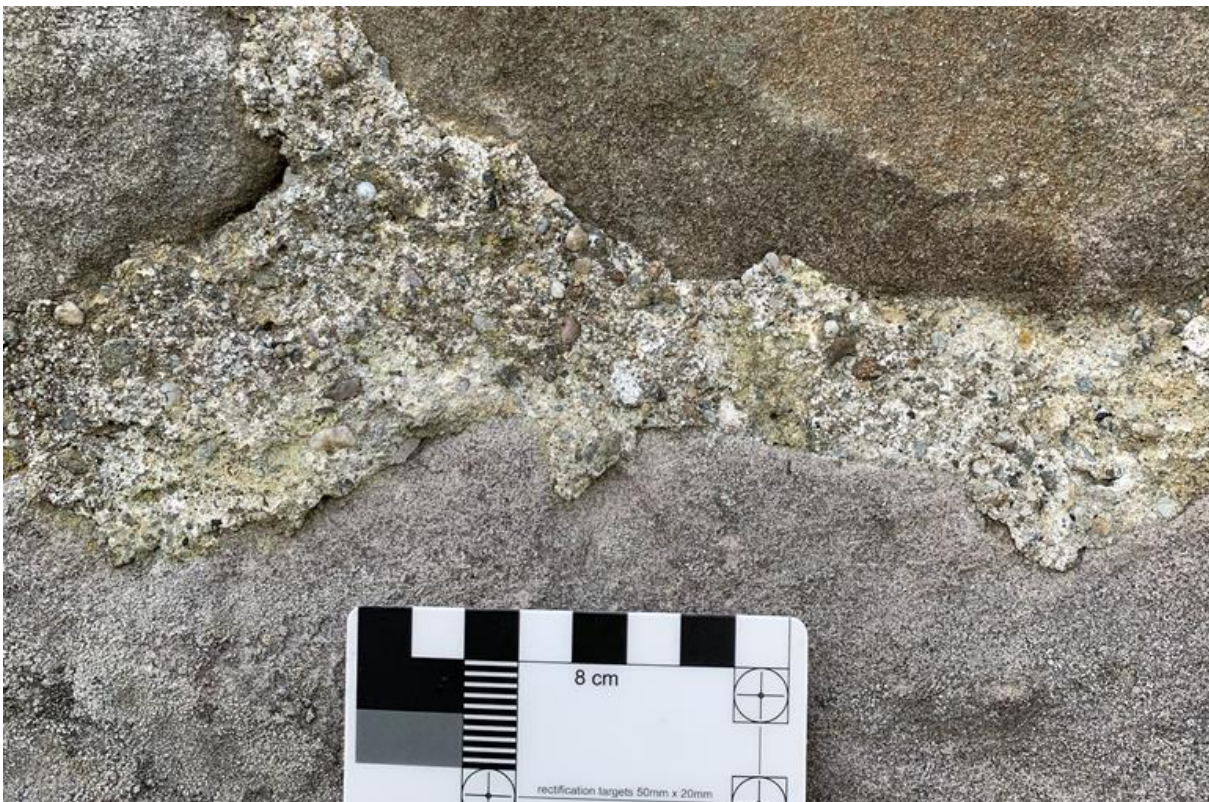
Figure 077.3. Worn sneck pointing with coarse rounded aggregates and lime inclusions.

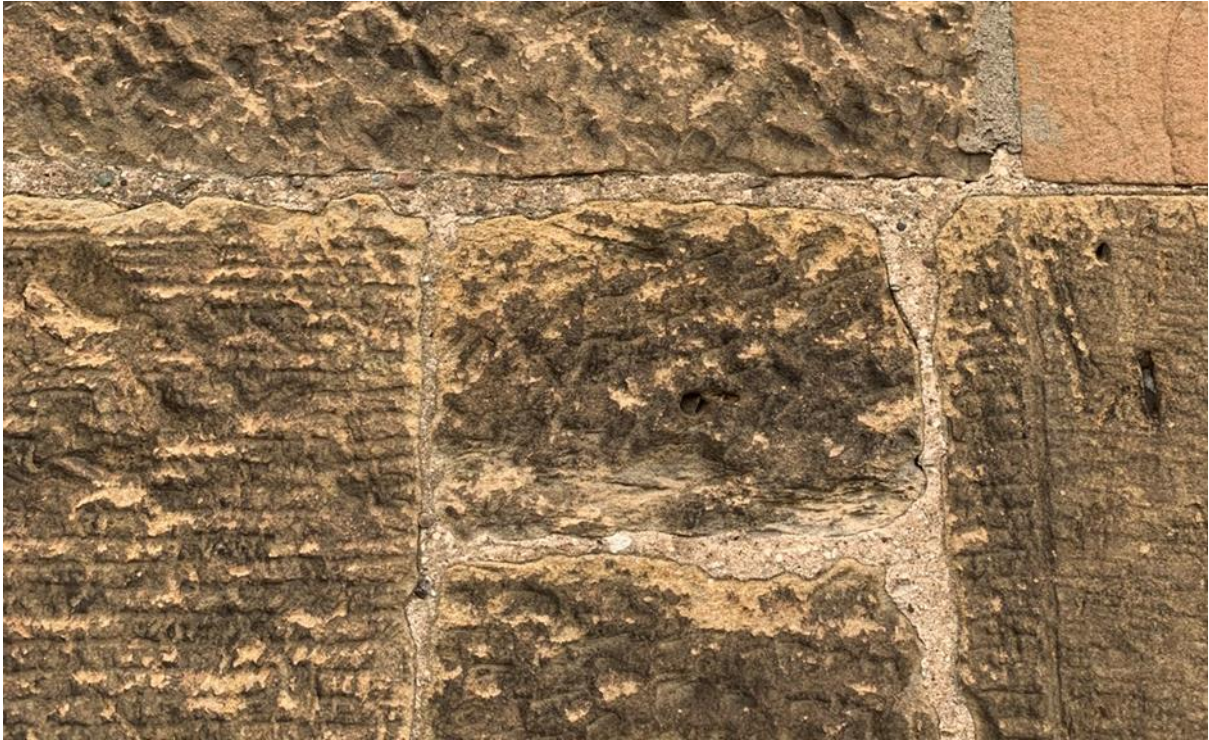
Figure 080.2. Relatively wide flush finish.

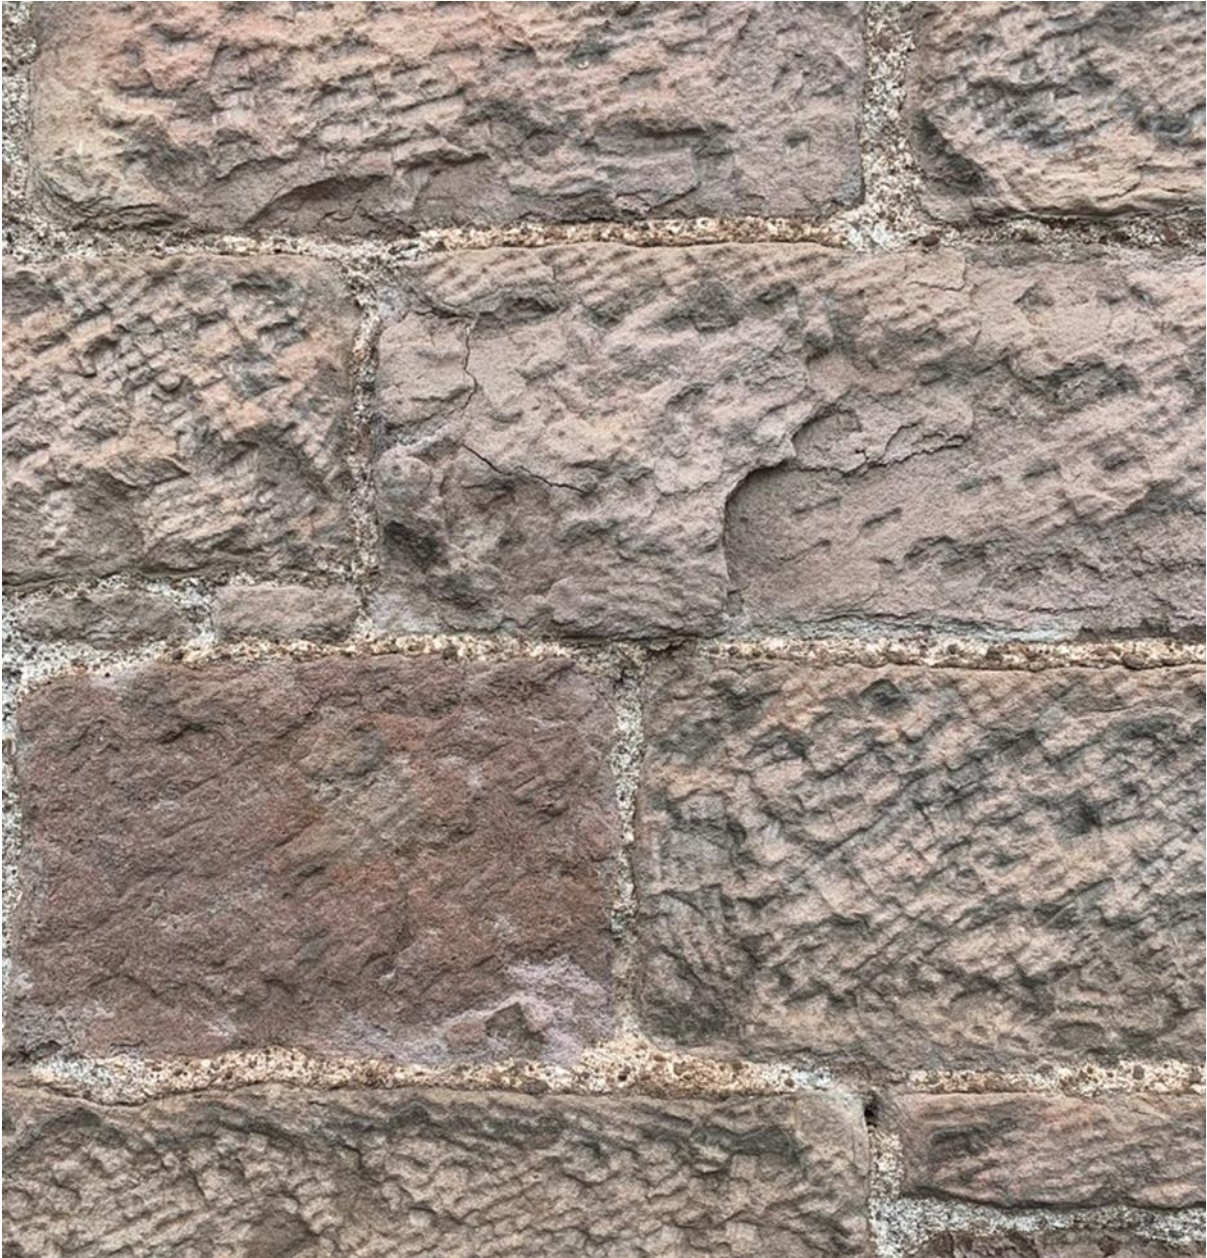
A three-storey house with squared sandstone blocks (Figure 084.1). The joints are flush finished with a convex and rounded profile (Figure 084.2). It is worth noting the decay of the sandstone even when flush finished with a lime mortar.

Figure 084.2. Joints with convex and rounded profile.

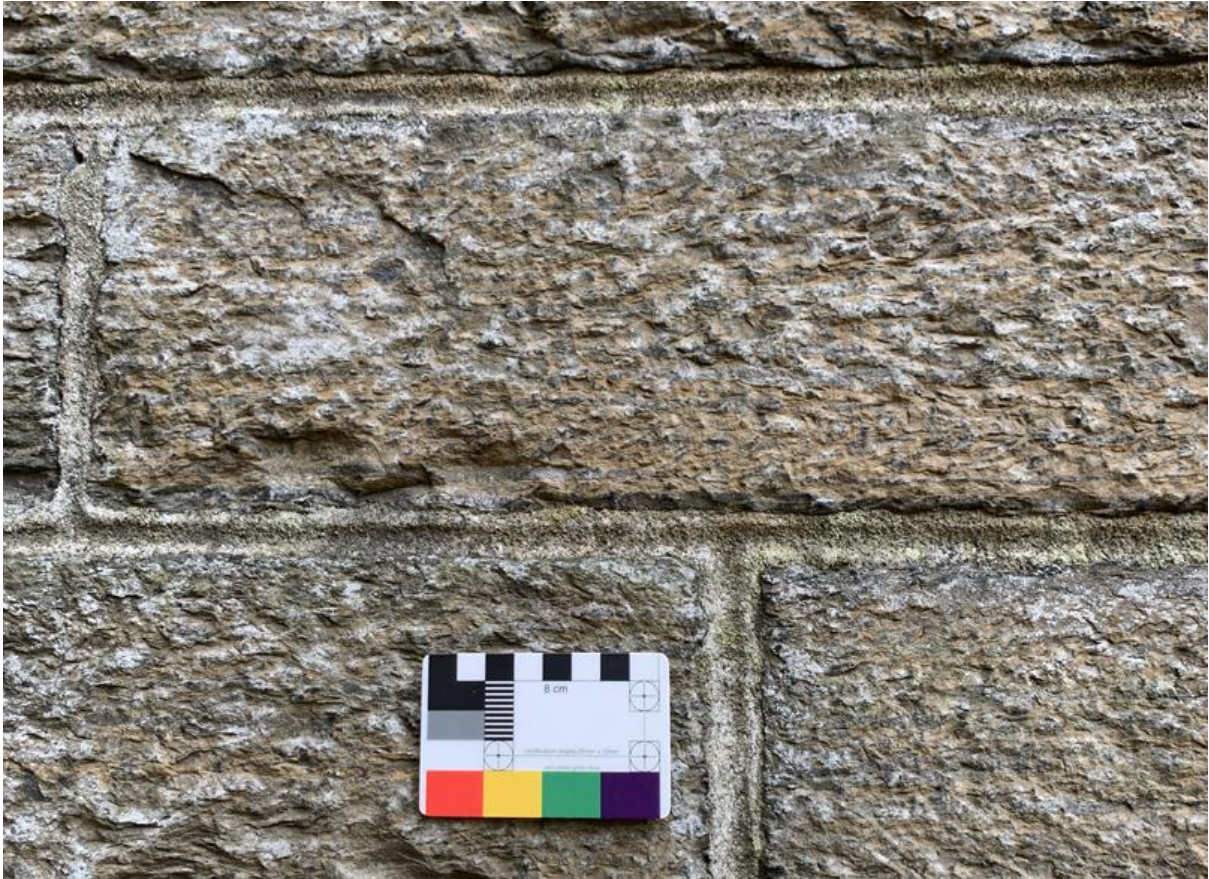
Figure 099.2. Mortar with horizontal and vertical ruling out and crisp joints.

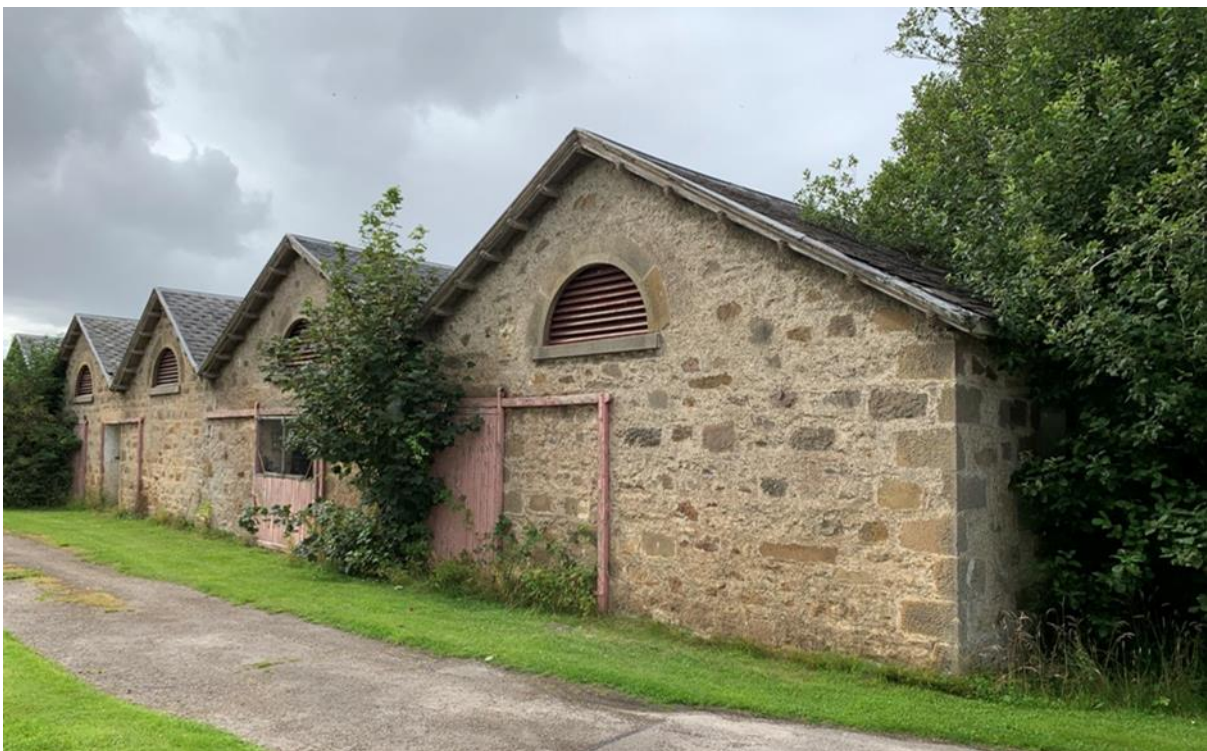
The sides and rear of the complex (Figure 100.3) are harled random rubble with a mix of stone types. The masonry has been cherry - cocked, and the harl survives well generally but especially in the sheltered areas under the overhanging eaves.

Figure 100.3. The rear, harled elevation of the steading, material wearing away with the best preserved remaining under the eaves.

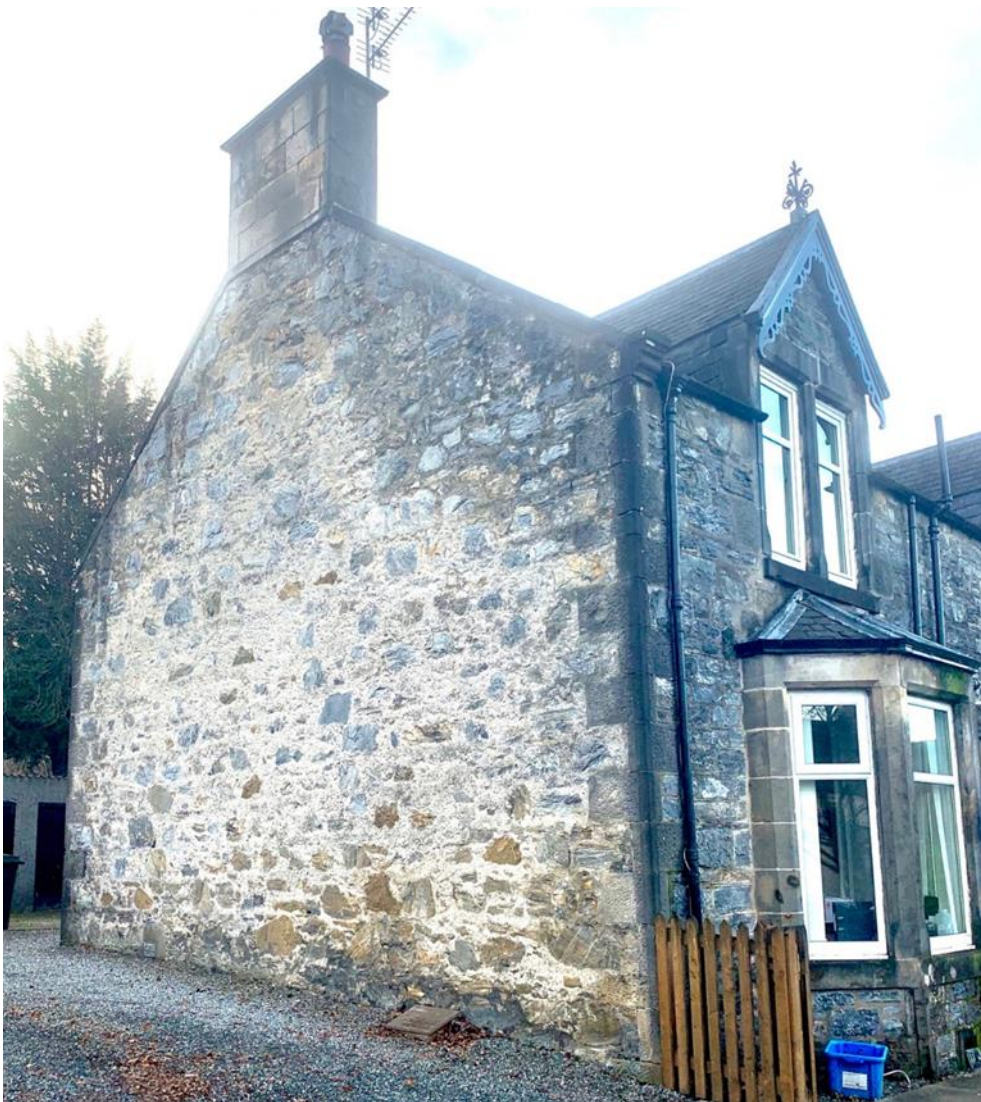
Figure 110.1. Gable elevation showing sac fungus.

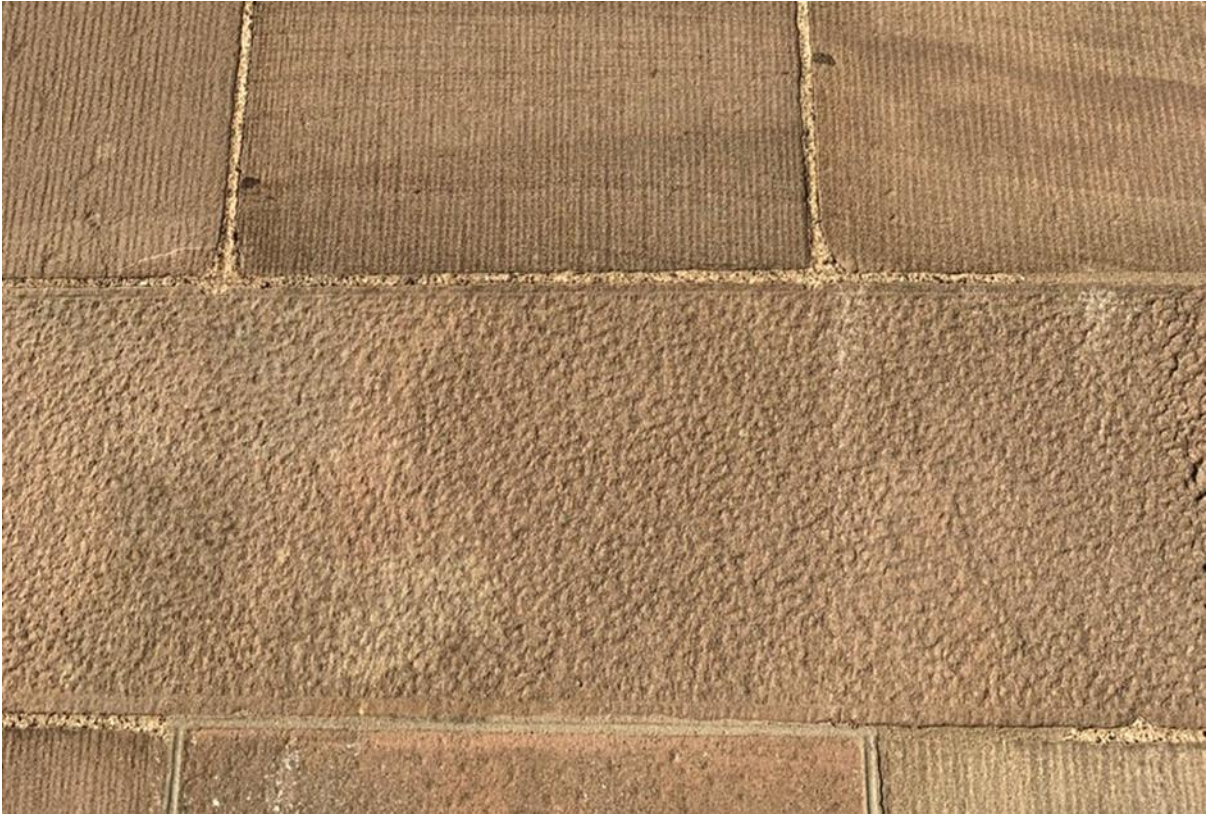
Figure 114.2. The ashlar work with traces of a lined out joint.

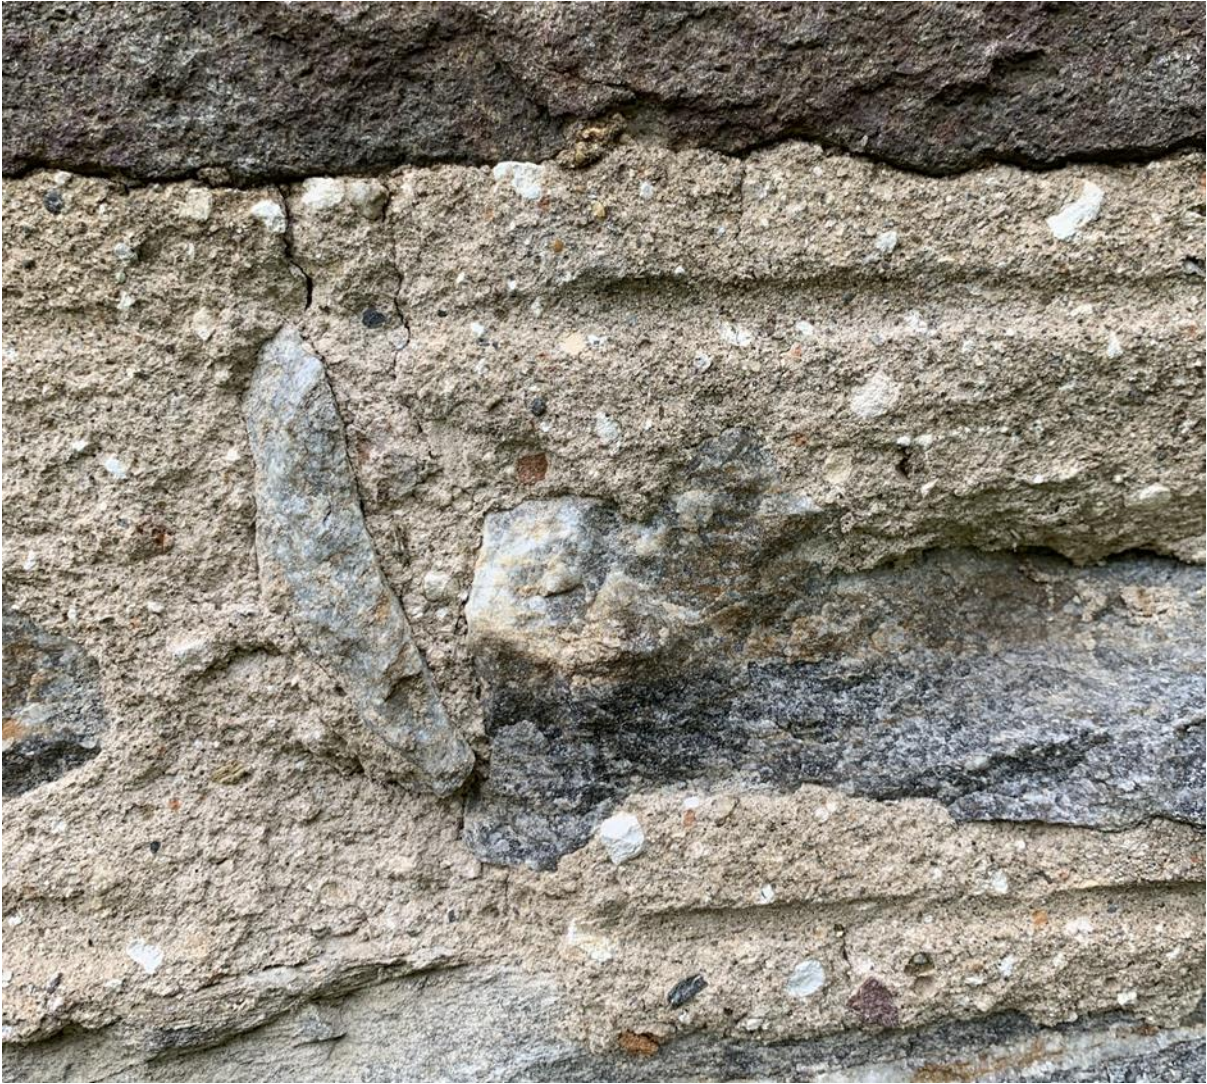
Figure 118.2. A close-up view of the flush point pointing, showing the horizontal ruling out.

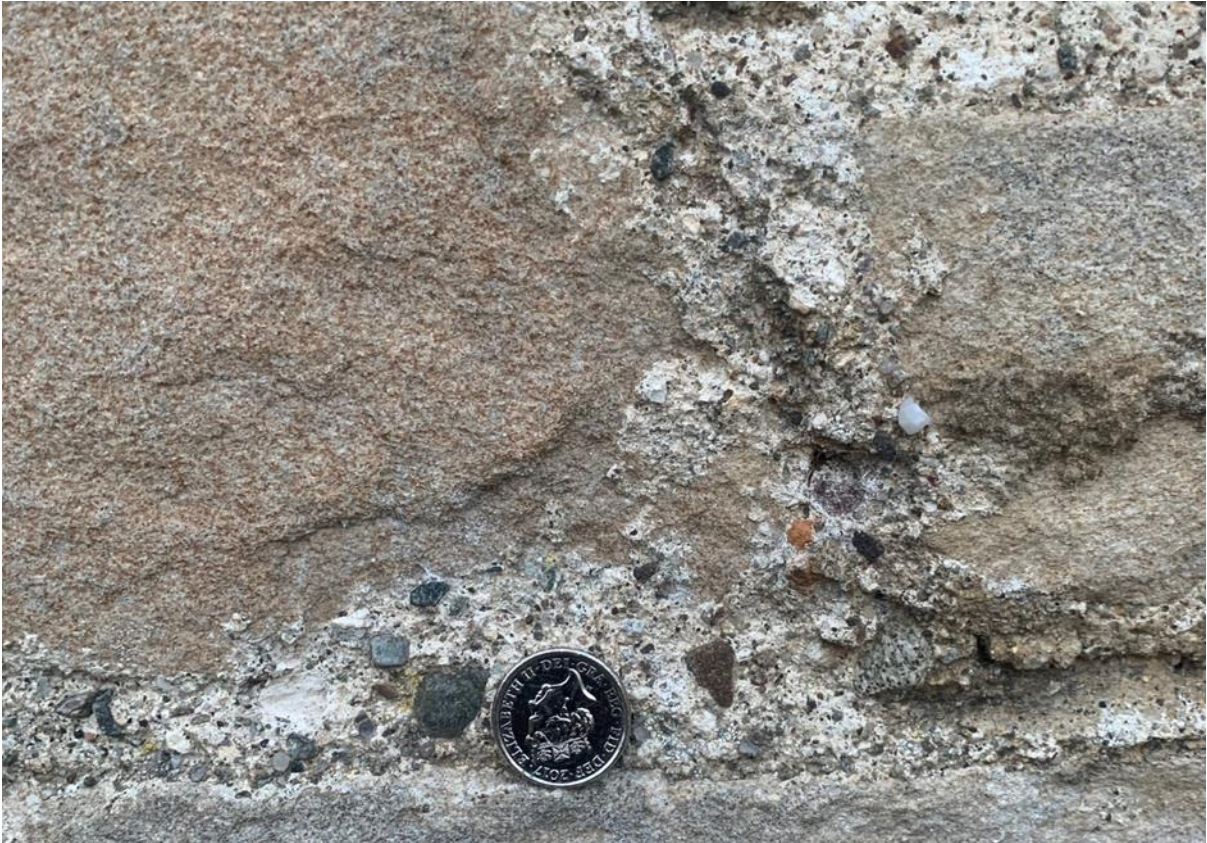
Figure 121.2. Very coarse mortar used for bedding and finishing.

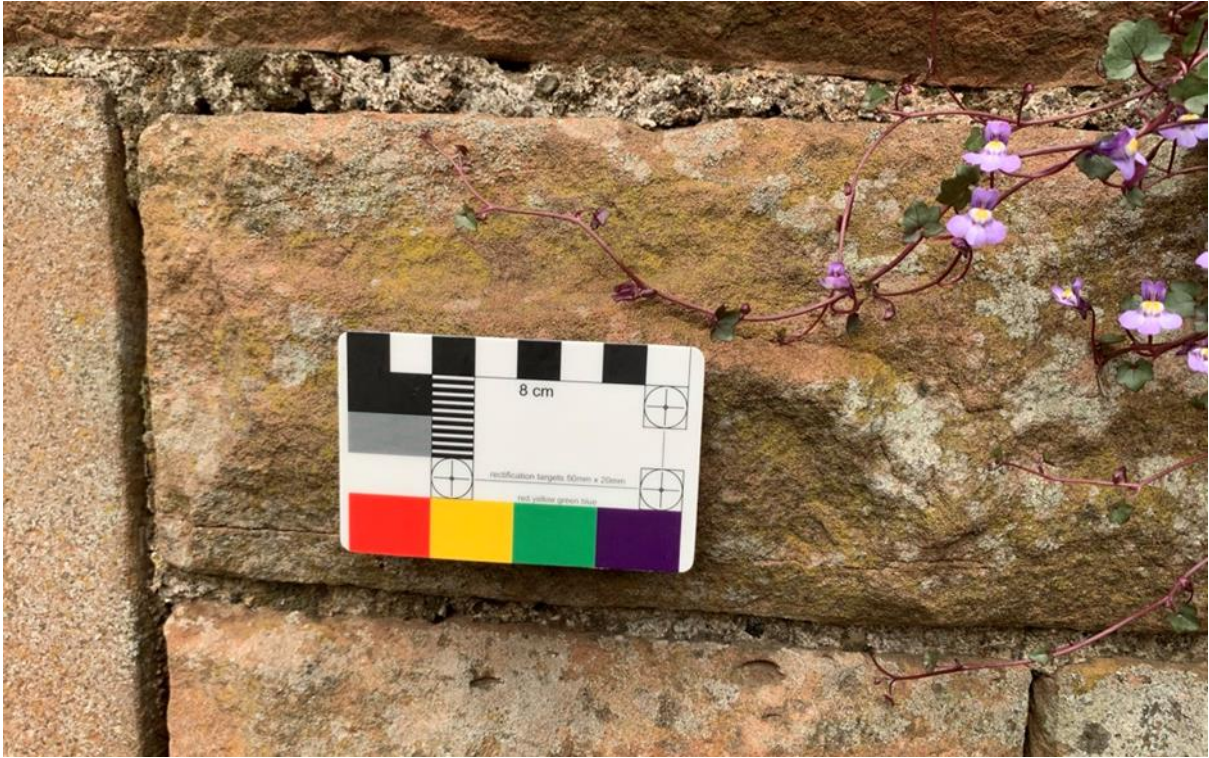
Figure 128.2. Weathered and eroded joins in the original mortar.
