# Rothesay

## Installation of insulation and secondary glazing

Historic Scotland Refurbishment Case Study 10

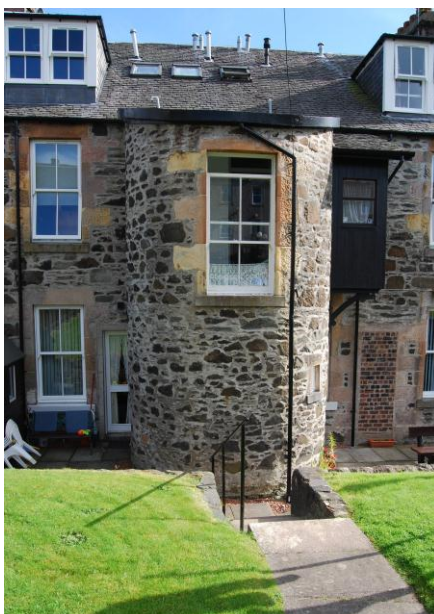
This late 19<sup>th</sup> century, category C-listed two storey tenement is constructed of lime bonded whinstone with sandstone dressings. It has been repointed with a cement/sand mix in the past which is in satisfactory condition. There are four flats within the tenement block, all of which are accessed from an external stair tower to the rear of the property (Fig. 1). The property retains traditional timber glazing on the ground and first floor although most other internal features have been lost. In terms of energy efficiency improvements only the loft of the tenement had been insulated. The landlord, Fyne Homes, wished to improve the thermal comfort of the tenants with a programme of trial insulation works. As the stone stair stood proud of the building line, and was consistently cold during the winter months, it was considered that this area should be upgraded first. This was to comprise internal wall insulation and glazing upgrades to the stair windows. An additional benefit of this work was that the living spaces of the tenements would be unaffected as the work was restricted to the stairwell.

Fig 1: Rear stairwall at Columshill Street

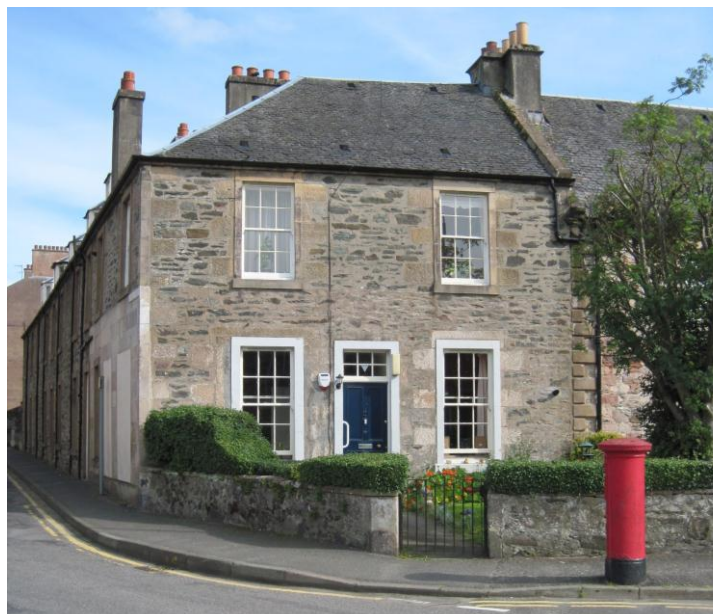
Fig 2: Front elevation of Russell Street

The second site is a mid 19<sup>th</sup> century, category C-listed two story tenement constructed of lime bonded whinstone rubble with sandstone dressings (Fig. 2). The building had formerly been a single dwelling, and in the post war period it had been divided into two flats. The glazing on both floors was single glazed sash type, dating from the late 19<sup>th</sup> century, and possibly original to the building. The front door was a 4 section fielded panel door, also believed to be of the late 19<sup>th</sup> century. While there were some gaps in the sashes and the door frame, both these elements were in good condition, with no signs of timber decay. As such, both these elements were considered an important aspect of the character of the building and the local amenity, and a premise of the upgrade was the retention and thermal improvement of these original elements.

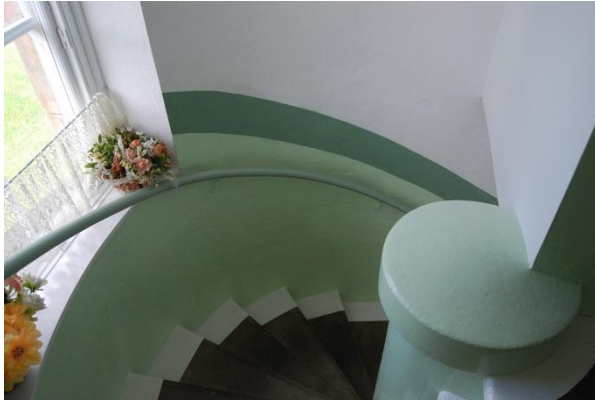
*Fig. 3: The stairwell post intervention - aerogel blanket with lime plaster and clay paint finish. The secondary glazing is also visible on the window.*

The finish to the stairwell before work started was a plaster direct onto the masonry (termed “on the hard”) and finished with gloss paint. In order to ensure that water vapour in the walls was able to disperse, and especially since the external masonry was pointed in a cement mortar, the paint was removed. A flexible aerogel blanket, 10 mm in thickness was then fastened to the wall behind an expanded steel mesh with thermally decoupled fasteners (a “mushroom type”) in order to prevent cold bridging. The aerogel was then enclosed with 2 coats of lime plaster, following the curve of the stair. The plaster was painted with a vapour open clay paint to maximise vapour dissipation. Aerogel blanket is a relatively new insulation material, which while expensive (currently approx £50.00 per square metre) it was technically suitable as it is vapour open, and so compatible with traditional structures. The addition of new insulation and plaster required the removal and relocation of several light fixtures and the stair handrail.

The aerogel blanket proved very suitable for use within the stairwell, particularly in terms of workability on site, as it was easy to install on the curved wall. Board based insulation would have been more difficult to work with on the curved form (Fig. 3).

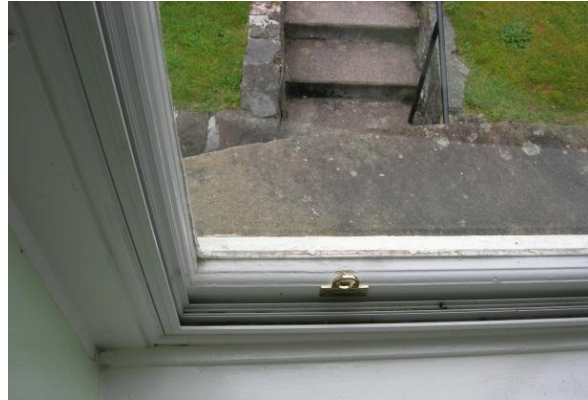
*Fig. 4: Secondary glazing added to the interior side of the existing window in the stairwell*

The single glazed window in the stairwell was also upgraded with the addition of secondary glazing to the interior side (Fig. 4). A slim, aluminium framed secondary glazing unit with an operable lower sliding sash was selected. It can be removed for cleaning if required.

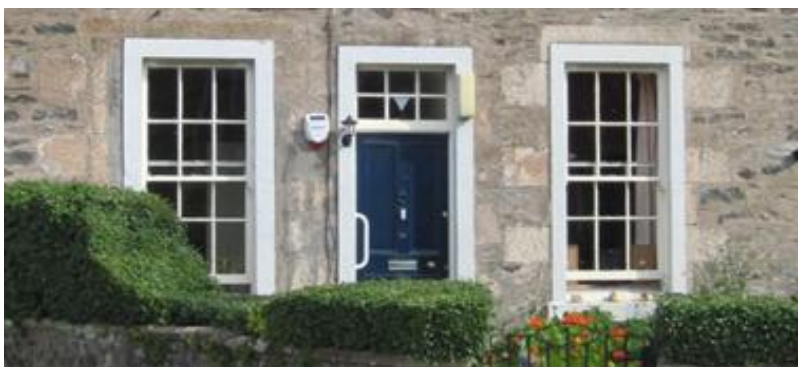
*Fig 5: Windows and door upgraded, with secondary glazing and aerogel board applied to door panels*

The walls at Russell Street had been relined in the 1990's, and although the work was carried out to today's standards the surfaces were in good condition with some mineral wool insulation behind plasterboard. The tenant was elderly and did not want any disruption to the property – this limited improvements to the timber windows and the front door. It was therefore determined that the most beneficial intervention would be the addition of secondary glazing to the interior side of three of the largest windows in the flat, two on the front elevation and one on the side elevation. The existing windows, single-glazed timber sash and case, were in good condition and needed minimal repair and painting. The secondary glazing needed to be operable for ventilation and, as with Columshill Street, a sliding sash system that allowed the raising of the lower secondary sash was selected. Fig. 5 shows the secondary glazing and the external sash open for ventilation.

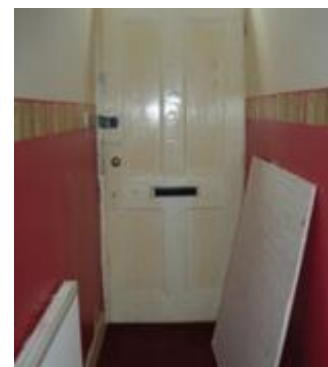
*Fig 6: Interior side of front door prior to application of aerogel board*

The second aspect of the upgrade work at Russell Street was the thermal improvement of the front door (Fig. 6). The existing timber door was retained, and sections of 10 mm aerogel blanket were applied to the internal face of the panels. The blanket was held in place, thin plywood was then applied over it and fastened with a timber bead. This held the plywood flat against the insulation, and also maintained the fielded panel design of the inside face. The door was then repainted.
