TECHNICAL PAPER 24

HISTORIC ENVIRONMENT SCOTLAND
REFURBISHMENT CASE STUDIES:
REVIEW OF ENERGY EFFICIENCY PROJECTS

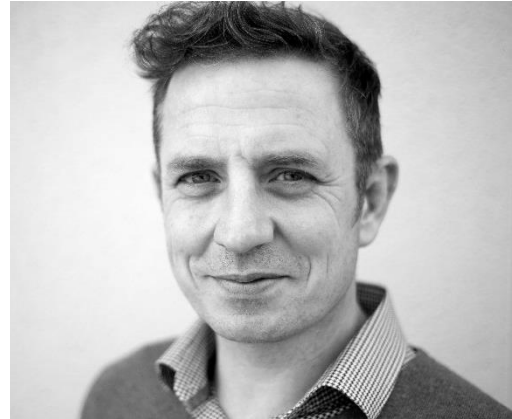
postgraduate conservation fellowship with Historic Scotland before he took up a post at the Scottish Lime Centre Trust. Formally he was a Lead Surveyor at the National Trust for Scotland, managing a team of surveyors in the repair and maintenance of some of Scotland's most significant buildings. He is now a Director with Adams Napier Partnership, a Chartered Building Surveying Practice specialising in building conservation, research and training. William has contributed to the publication of several technical advice notes and short guides and is a regular speaker at conferences and CPD events on a wide range of conservation subjects.

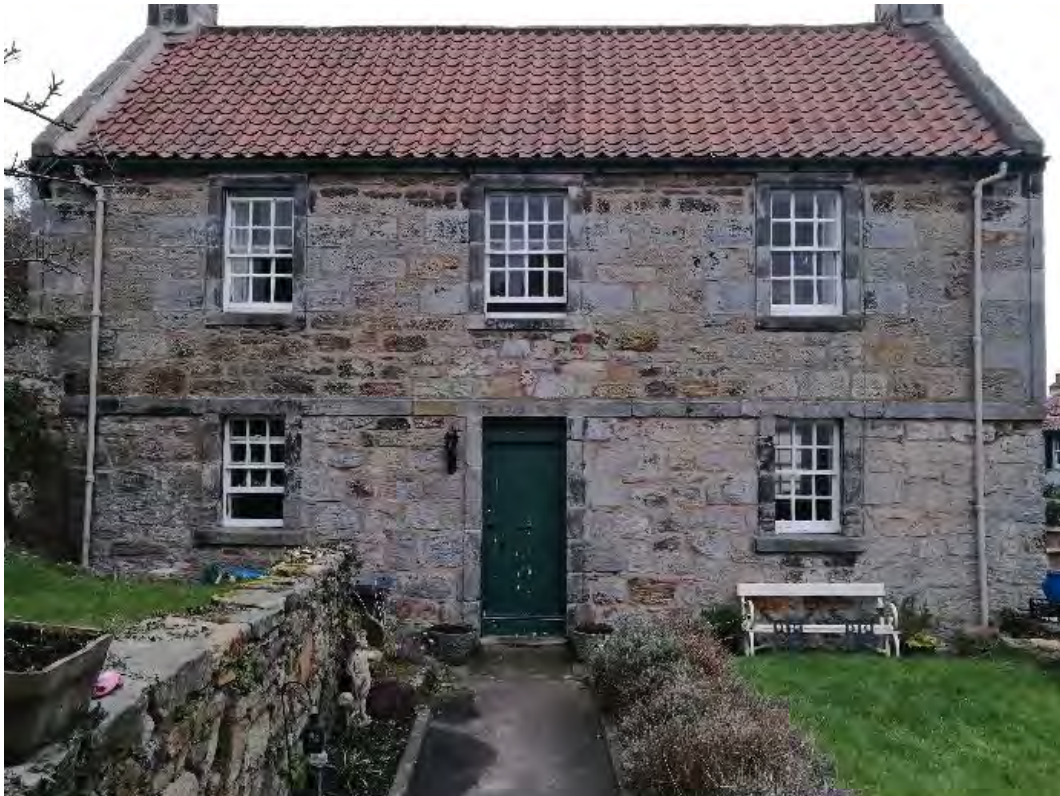
Figure 1: Domestic buildings such as Wee Causeway, described in Refurbishment Case Study 3, were included in the project review.

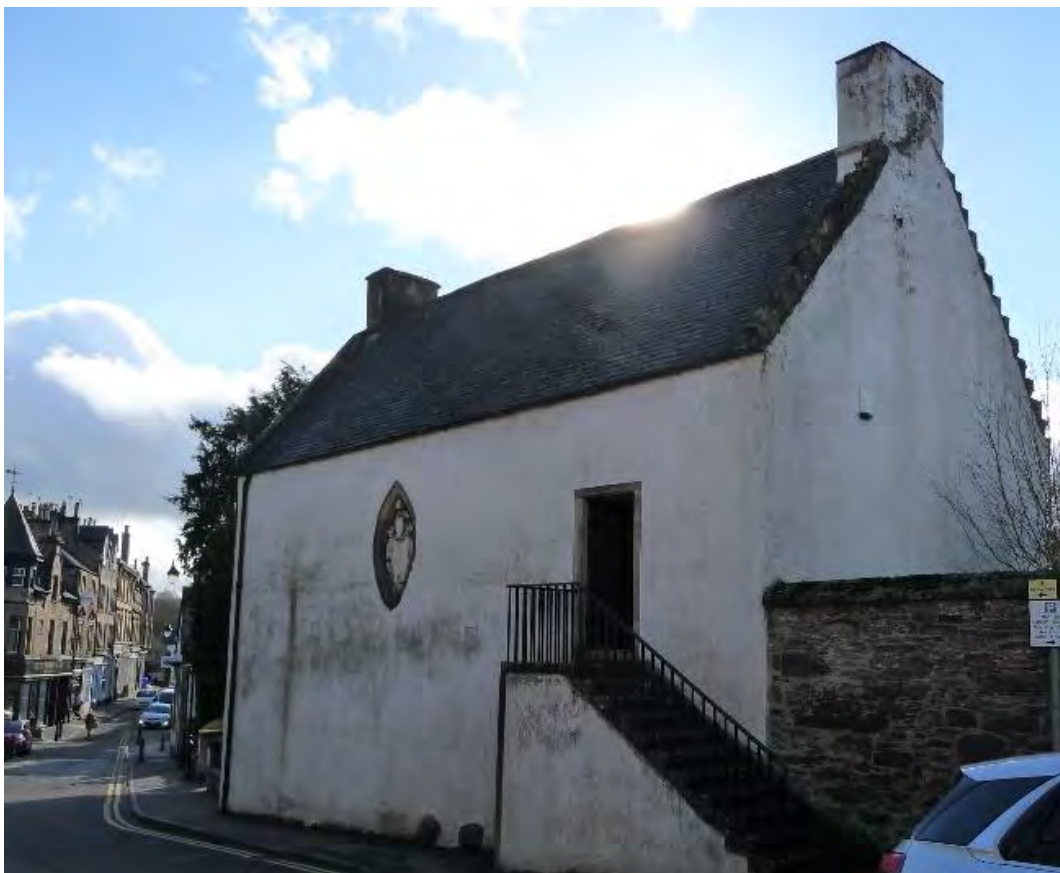
Figure 2: Non-domestic buildings, such as Leighton Library, were also included in the project review. This Refurbishment Case Study is pending publication.

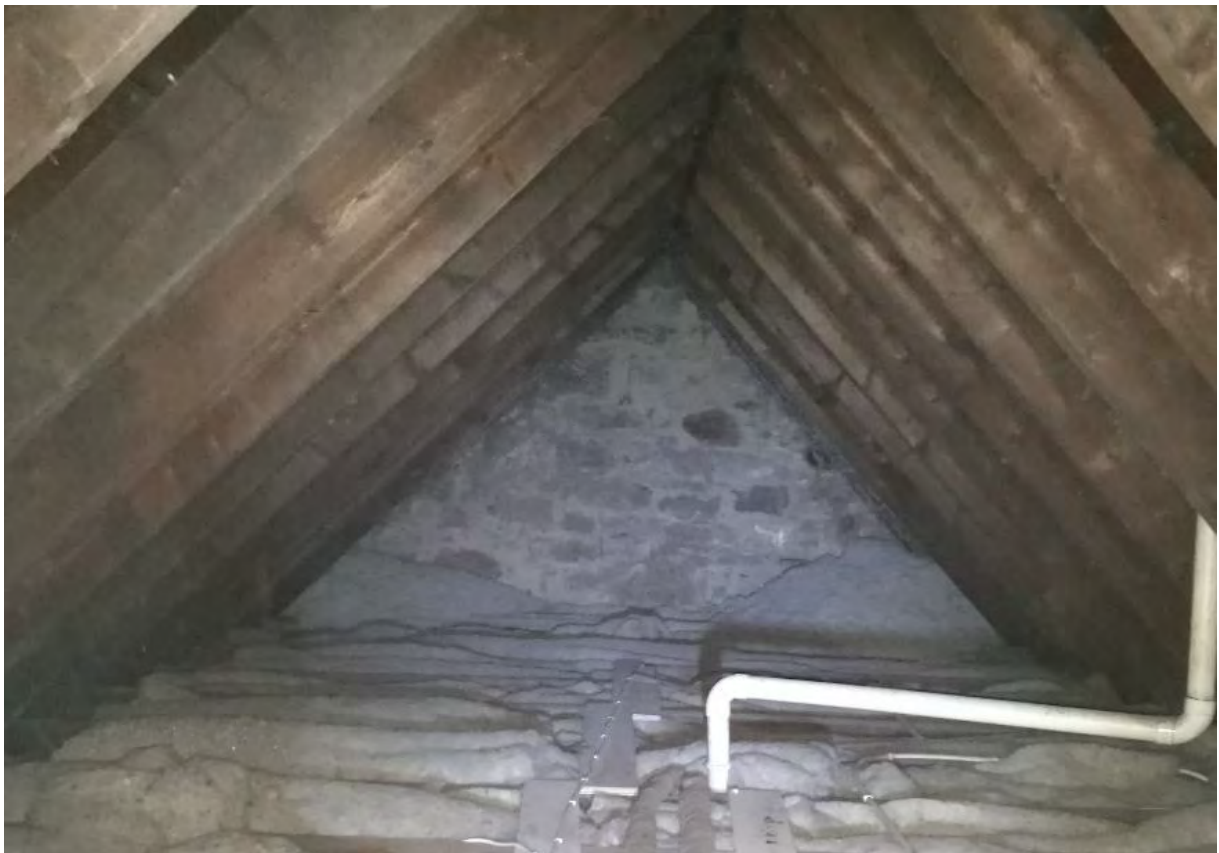
Figure 7: Blown cellulose insulation deposited in the attic space at Wells o' Wearie.

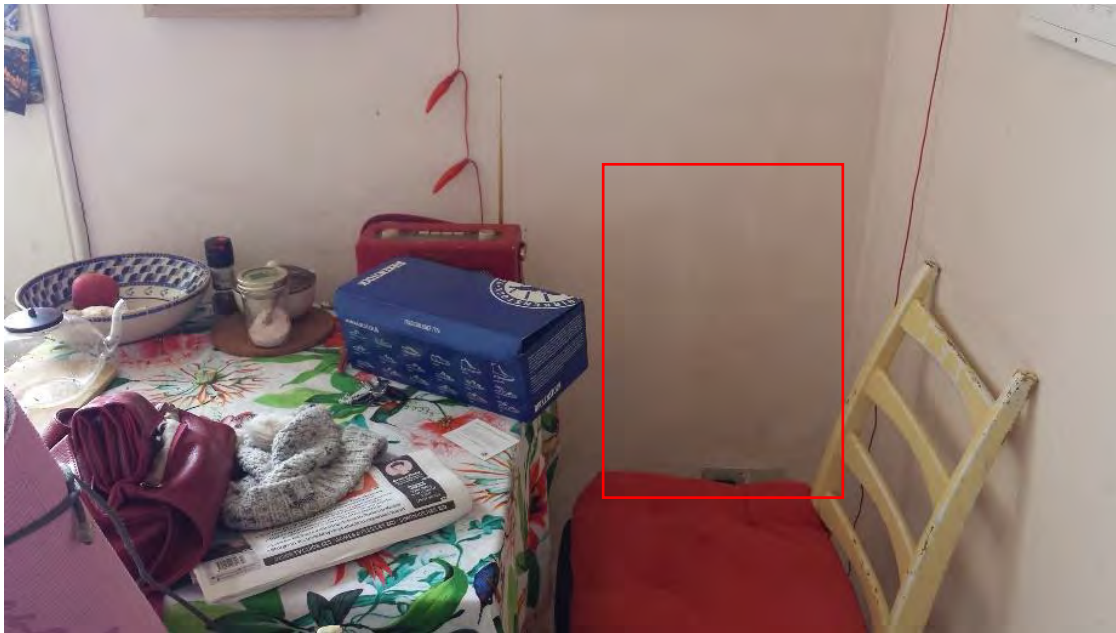
Figure 8: Mould growth (outlined in red) on the wall at Roxburgh Street, Edinburgh.

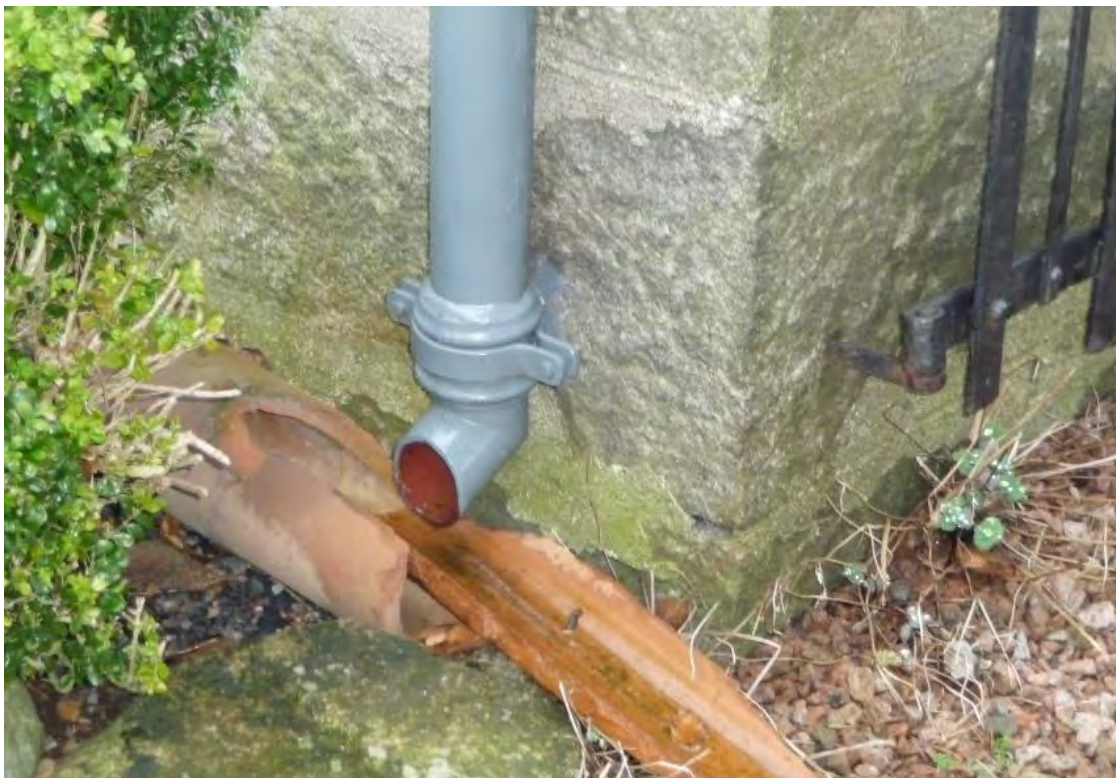
Figure 9: Poor rainwater management in south-east corner of Kirkton of Coull corresponding with area on dampness noted internally in living room.

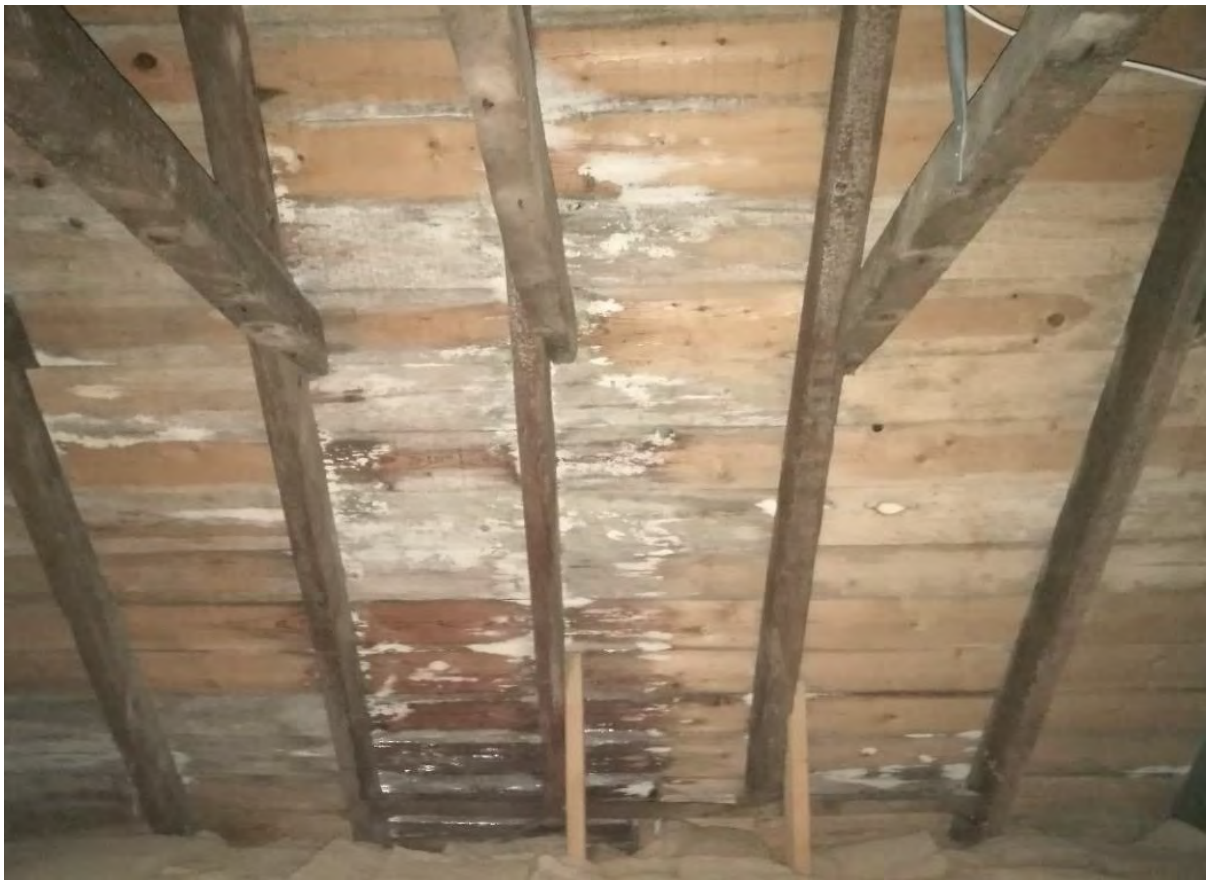
Figure 12: Mould visible on underside of sarking boards in an unventilated roof space following installation of insulation at Wee Causeway.

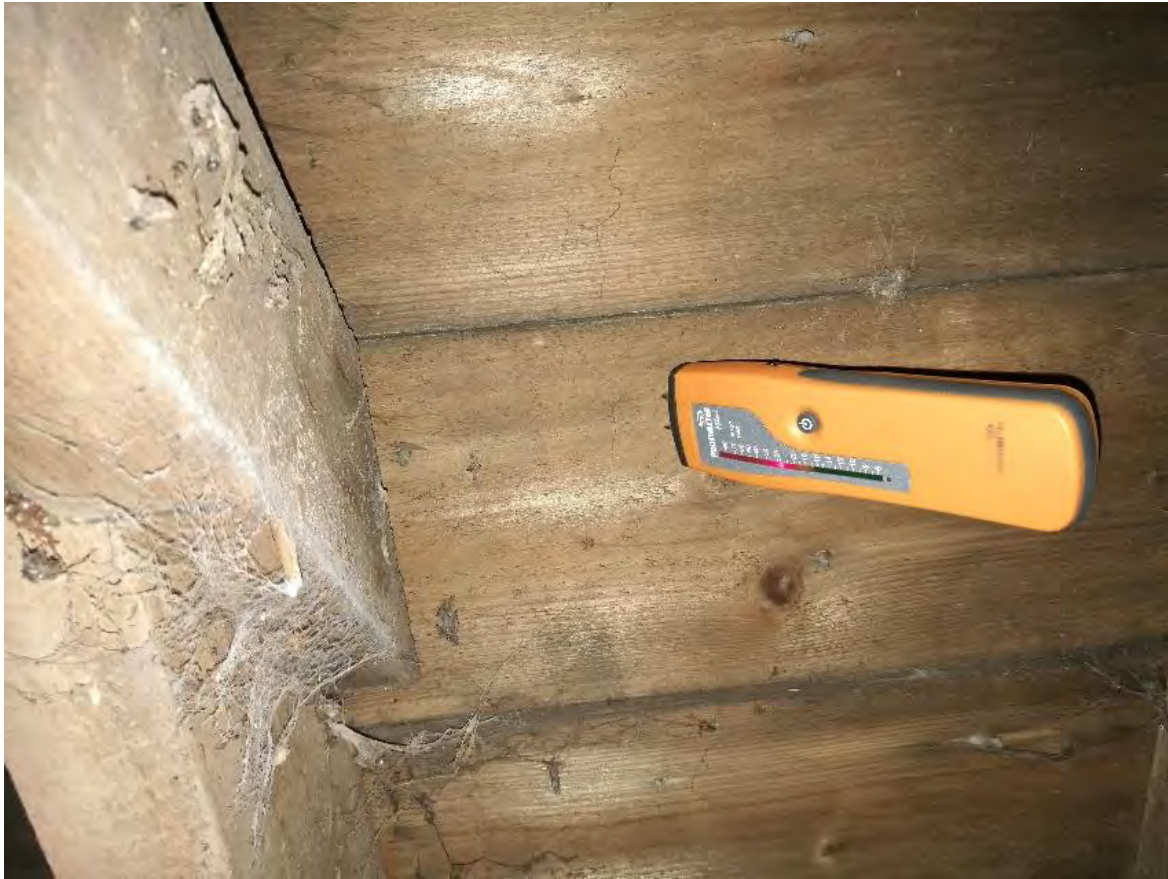
Figure 13: Higher moisture levels recorded on the underside of the sarking boards in the area over the shower room at the Garden Bothy.

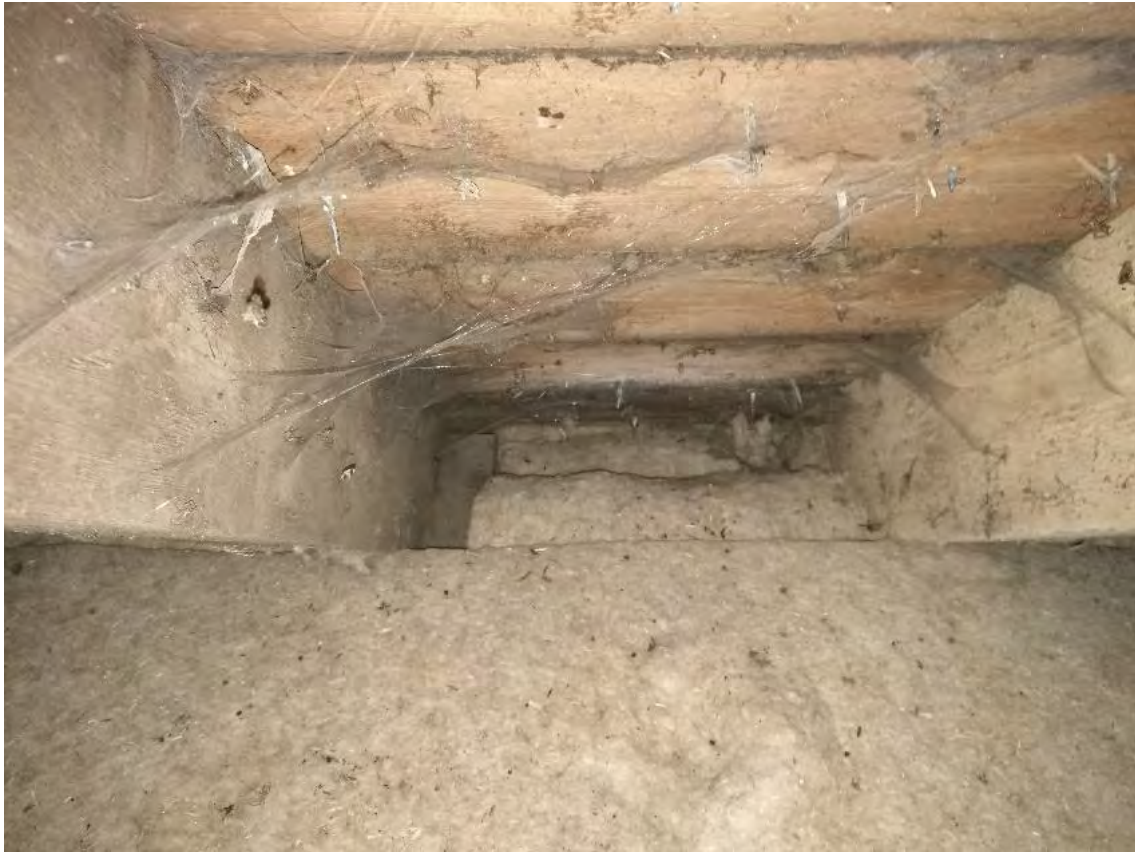
Figure 14: At Scotstarvit Cottage there did not appear to be any air gaps at eaves level to encourage ventilation in the roof space.

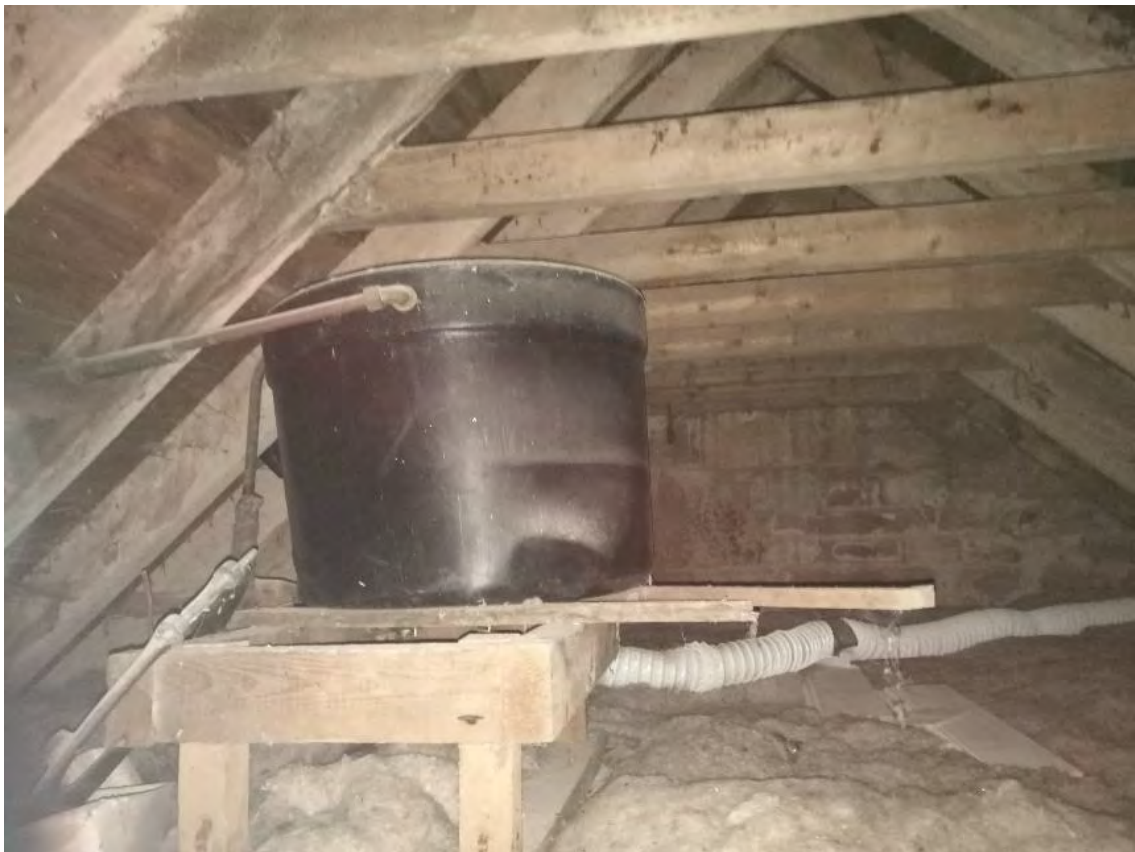
Figure 15: Uninsulated cold water storage tank and associated pipework at the Garden Bothy, which could cause problems if subjected to freezing temperatures.

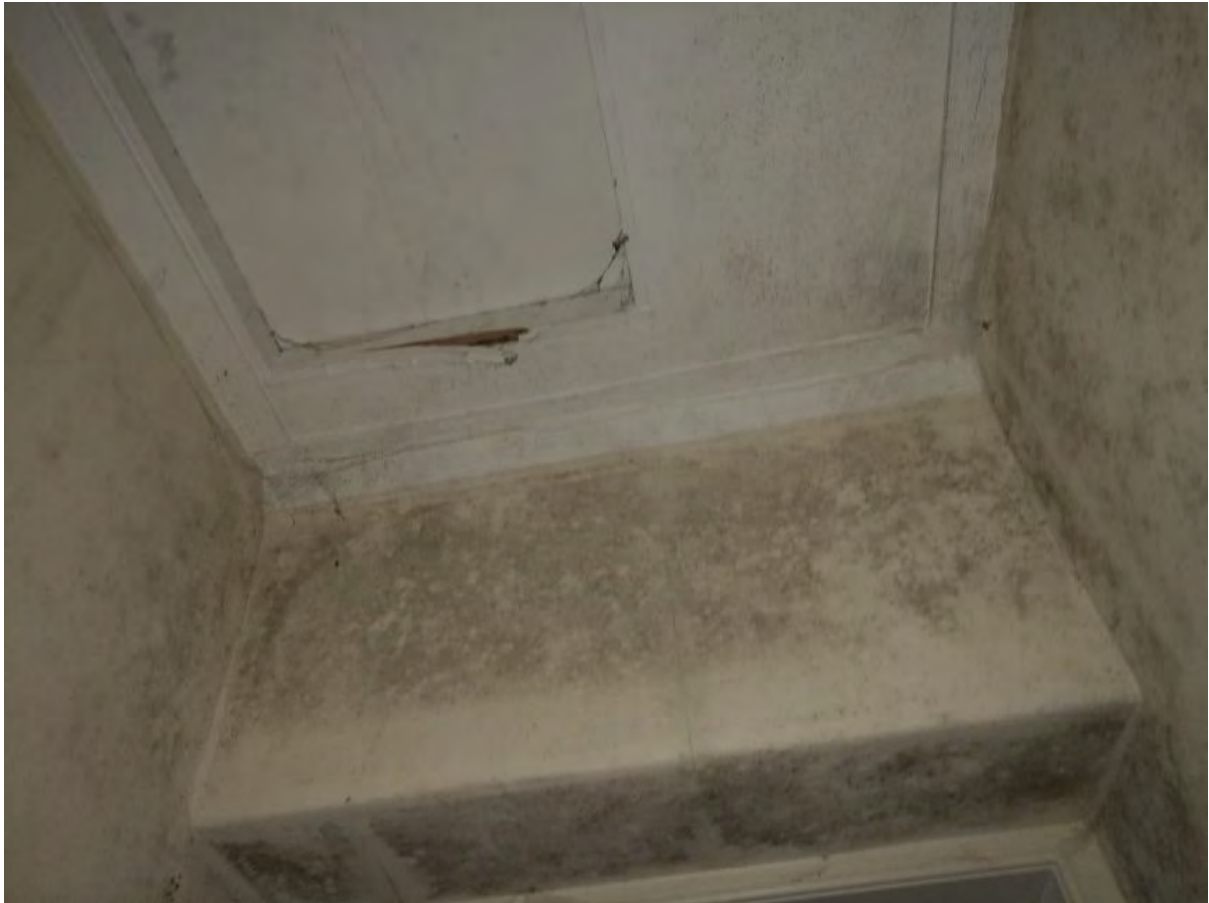
Figure 16: Surface mould in the hallway around the uninsulated loft hatch cover at Wells o' Wearie.

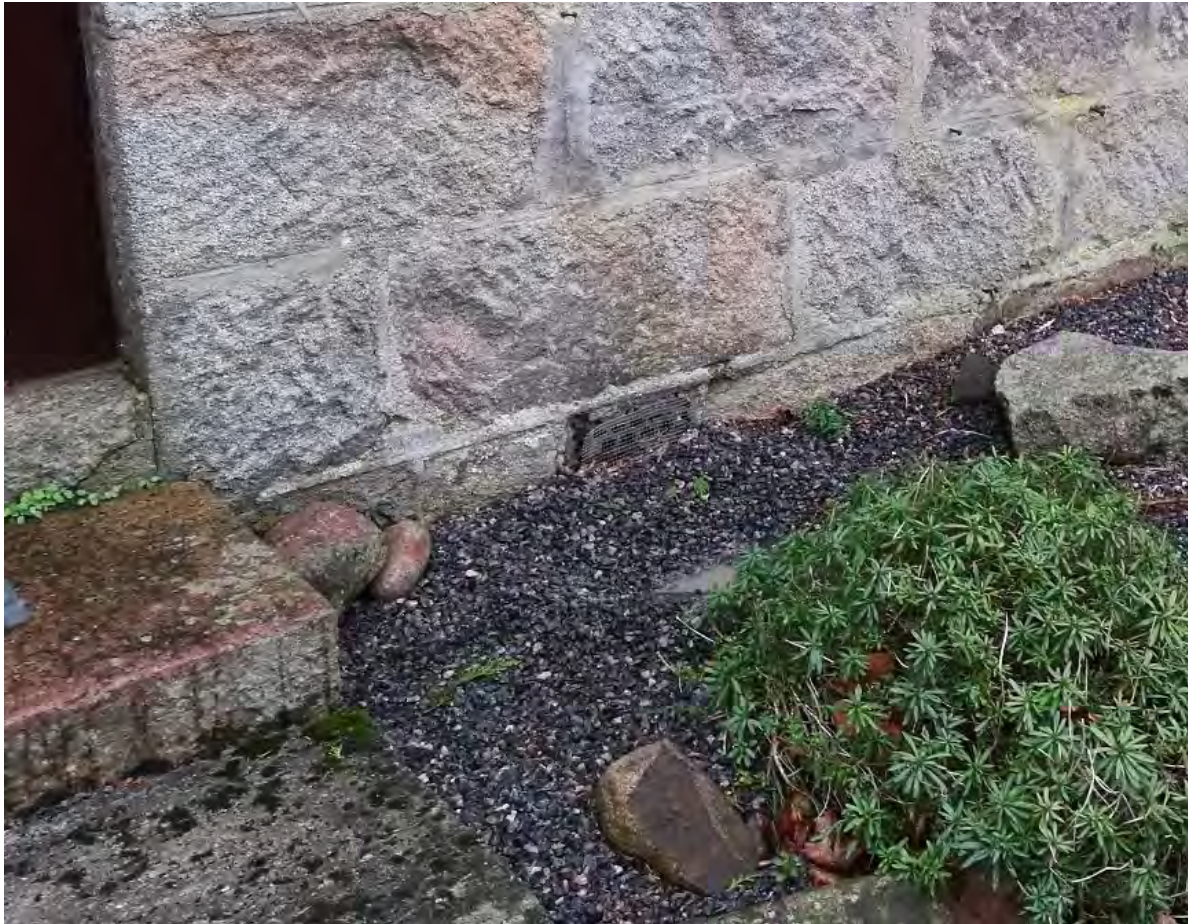
Figure 19: Raised external ground levels and partially blocked underfloor ventilation, as identified at Kirktoon of Coul, can compromise natural airflow into the underfloor space which increases the risk of damp related problems such as condensation and timber decay.

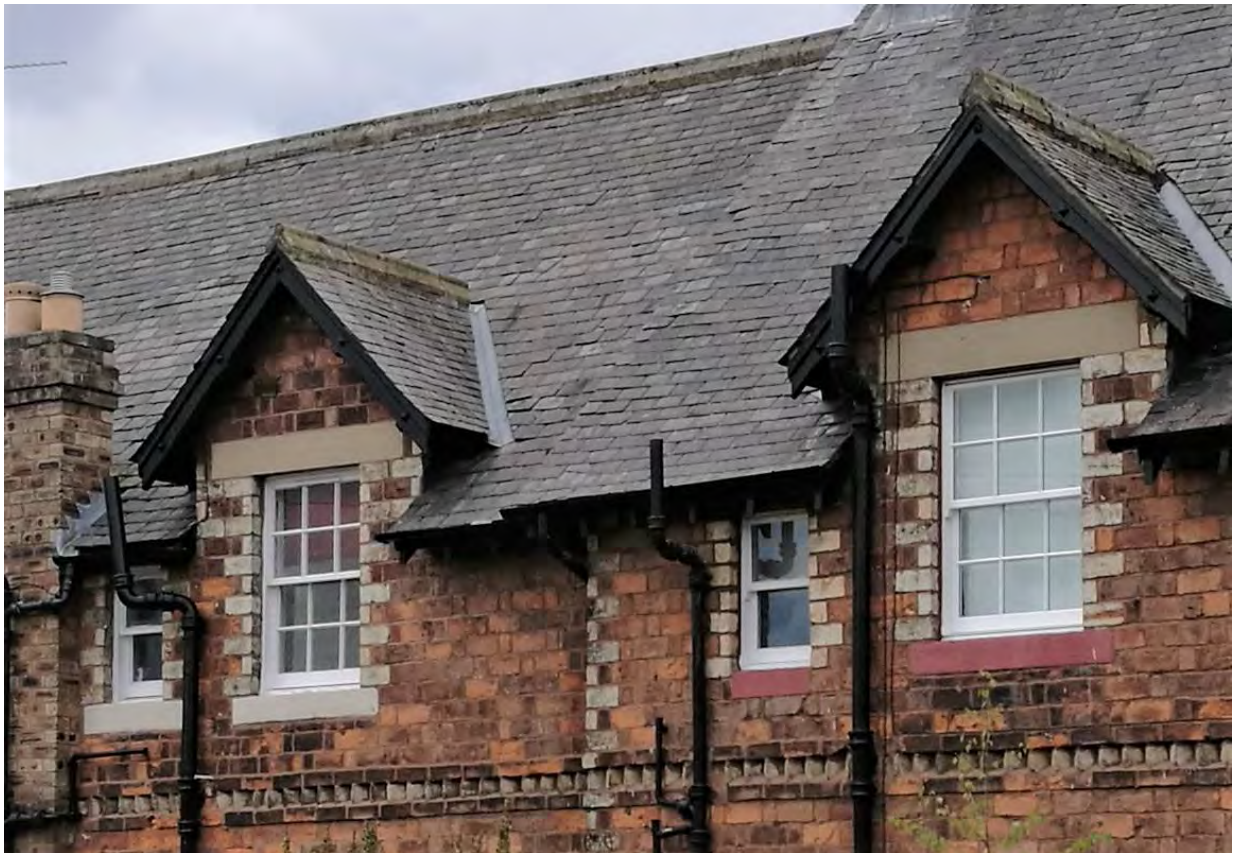
Figure 21: On the right, new timber sash and case double glazed windows installed at Newtongrange. Although broadly similar to the original windows, they are not an exact match.

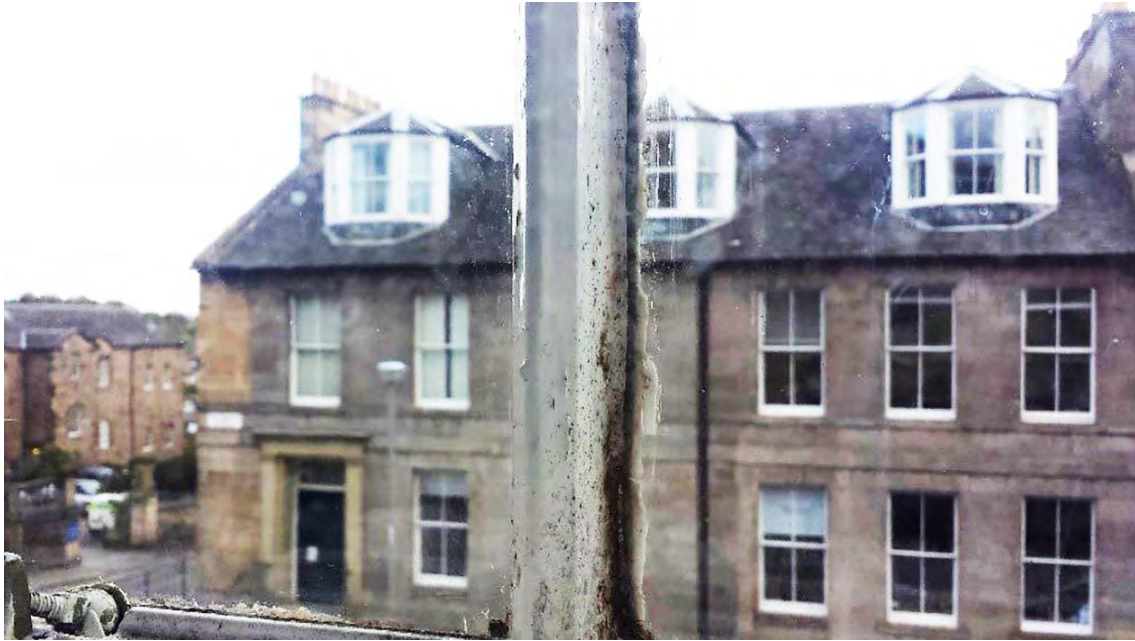
Figure 22: Mould growth on the windows of one of the tenement flats upgraded in Edinburgh, likely due to a lack of ventilation.

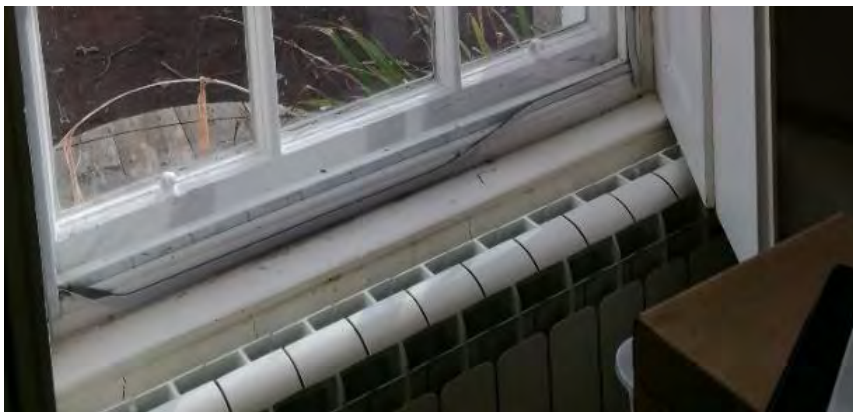
Figure 23: Failing magnetic strips on bottom sash rail around the secondary glazing at Wells o' Wearie.

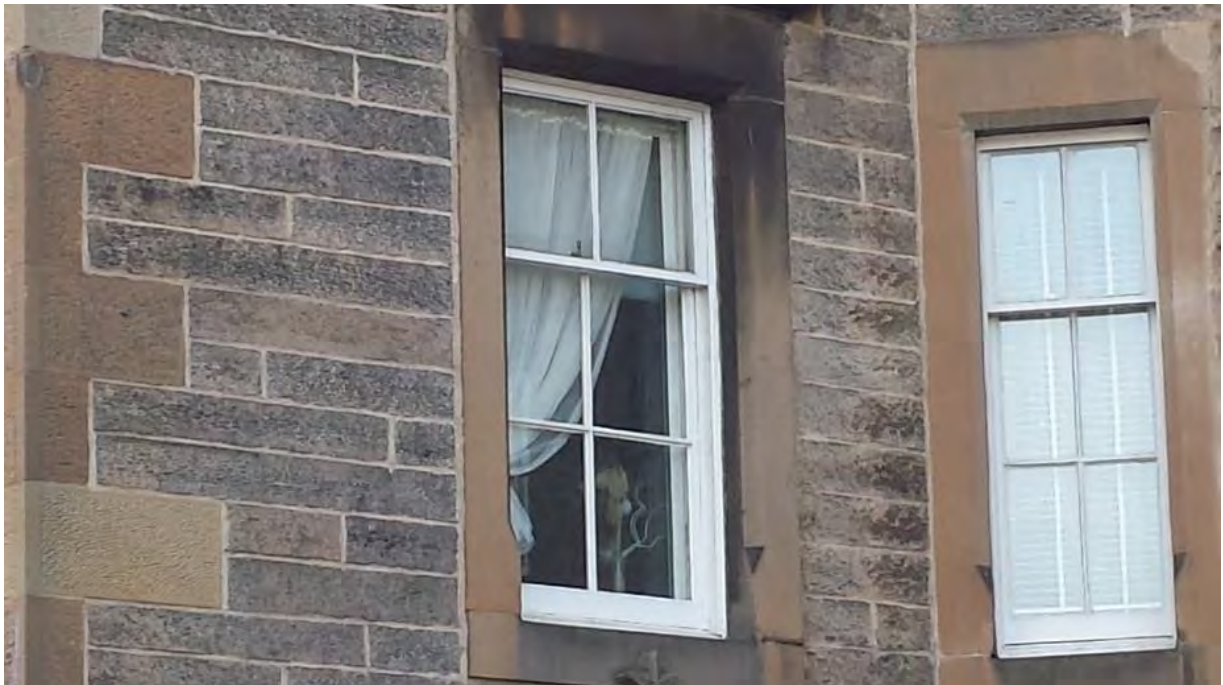
Figure 24: Bespoke secondary glazing in the Edinburgh tenement flats, which is almost imperceptible from ground level.

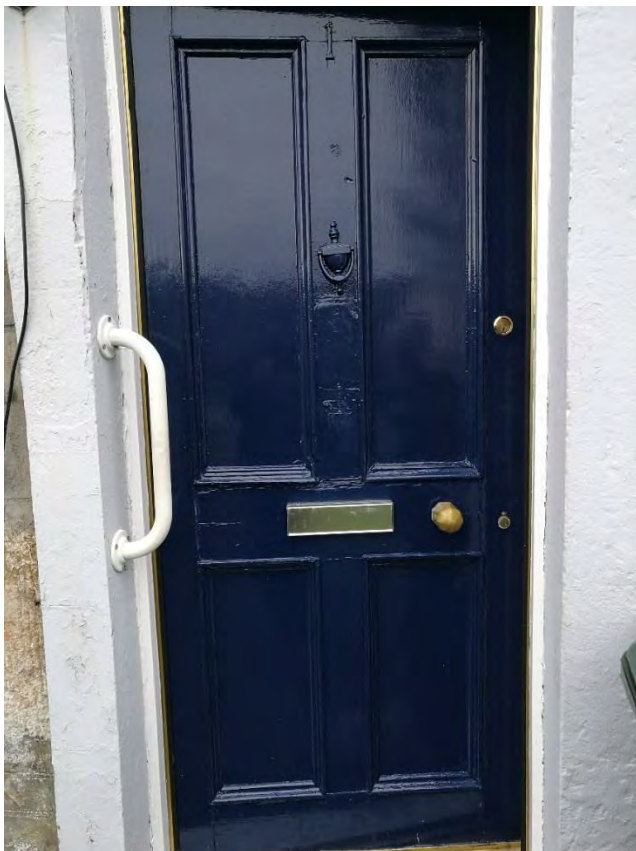
Figure 26: Russell Street, Rothesay. Despite recent re-decoration, the front door is in poor condition, with rot, damaged mouldings and poor preparation. The door remains draughty at the threshold.

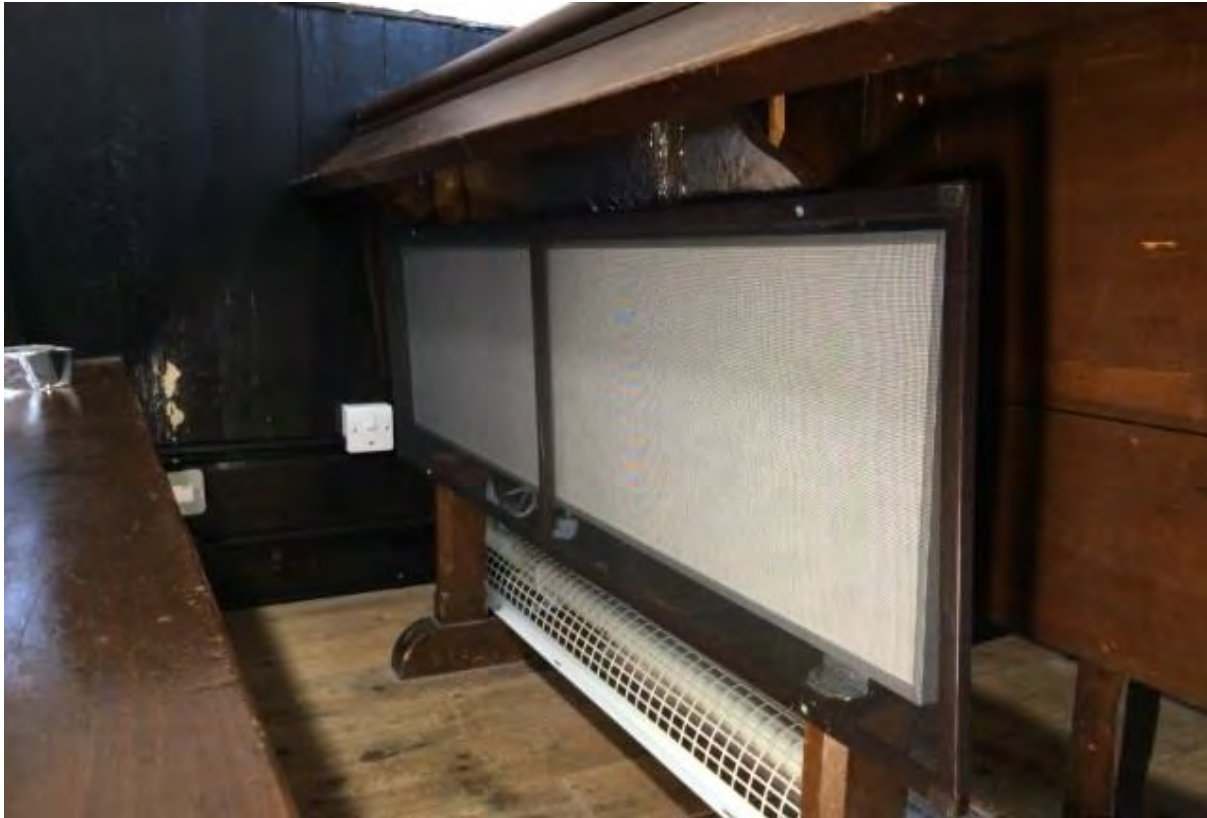
Figure 28: Kilmelford Parish Church, where a range of heaters, including oil filled, air source and radiant panels, were installed as part of trials which aimed to improve the quality of heating for the building and its occupants while reducing energy consumption. However, the visual impact is considerable and gives rise to a cluttered appearance.

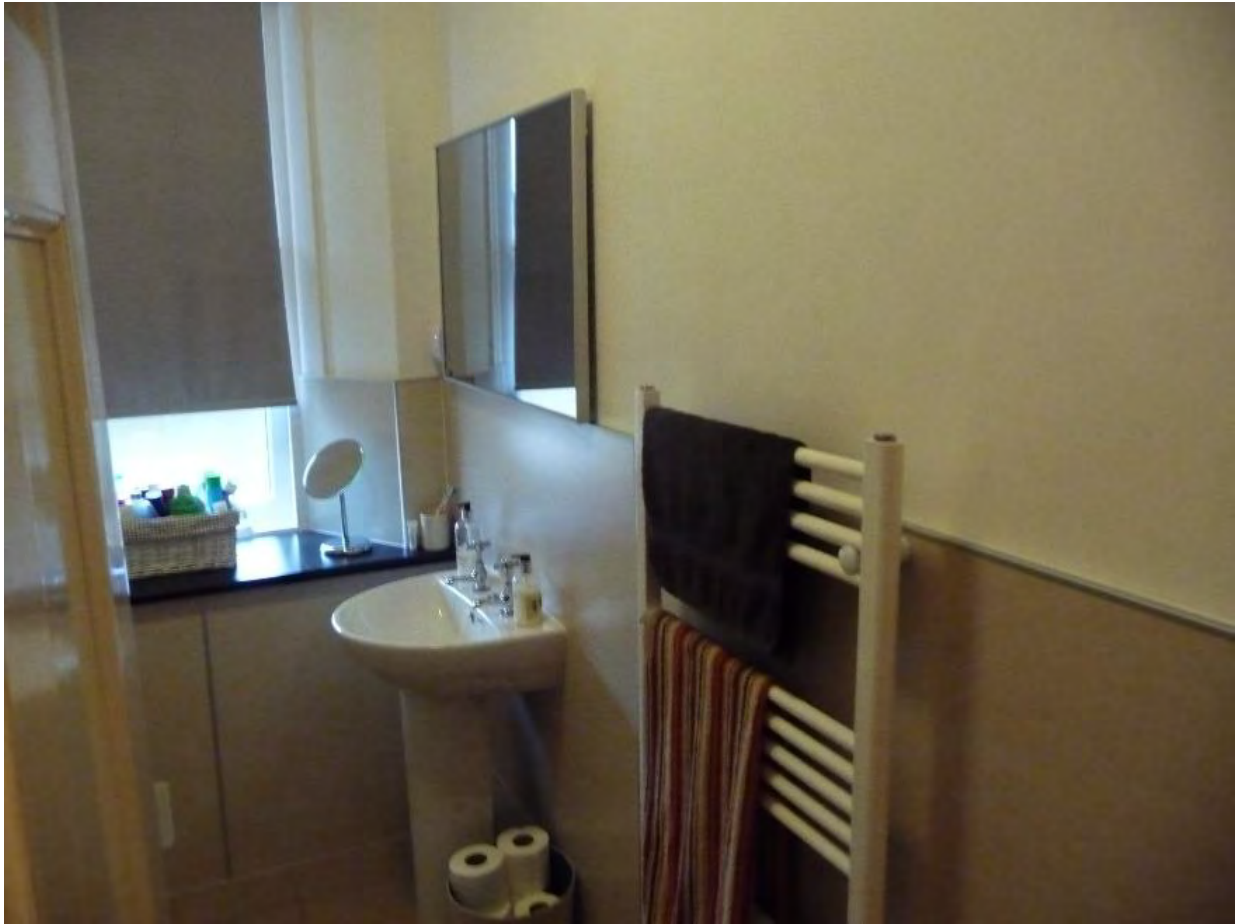
Figure 29: The radiant panel mirror installed in the bathroom at Annat Road.

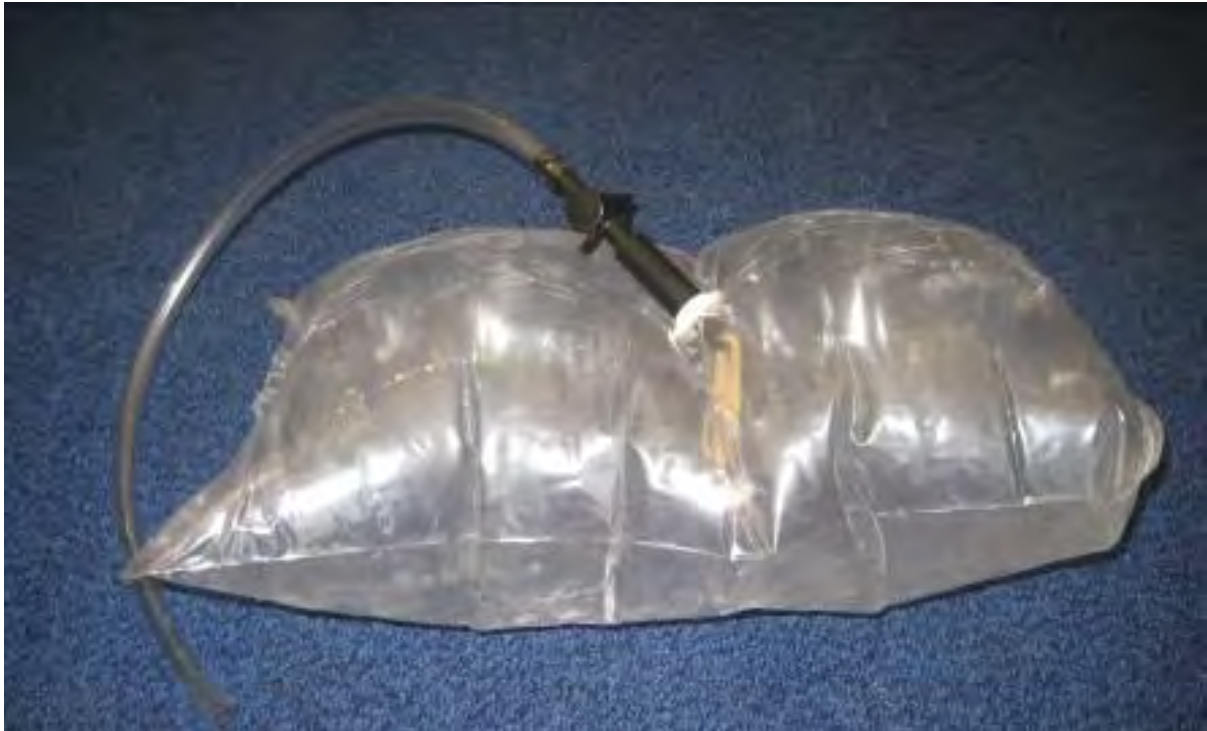
Figure 30: The chimney balloon used at Wells o' Wearie to help with down-draughts in the winter.

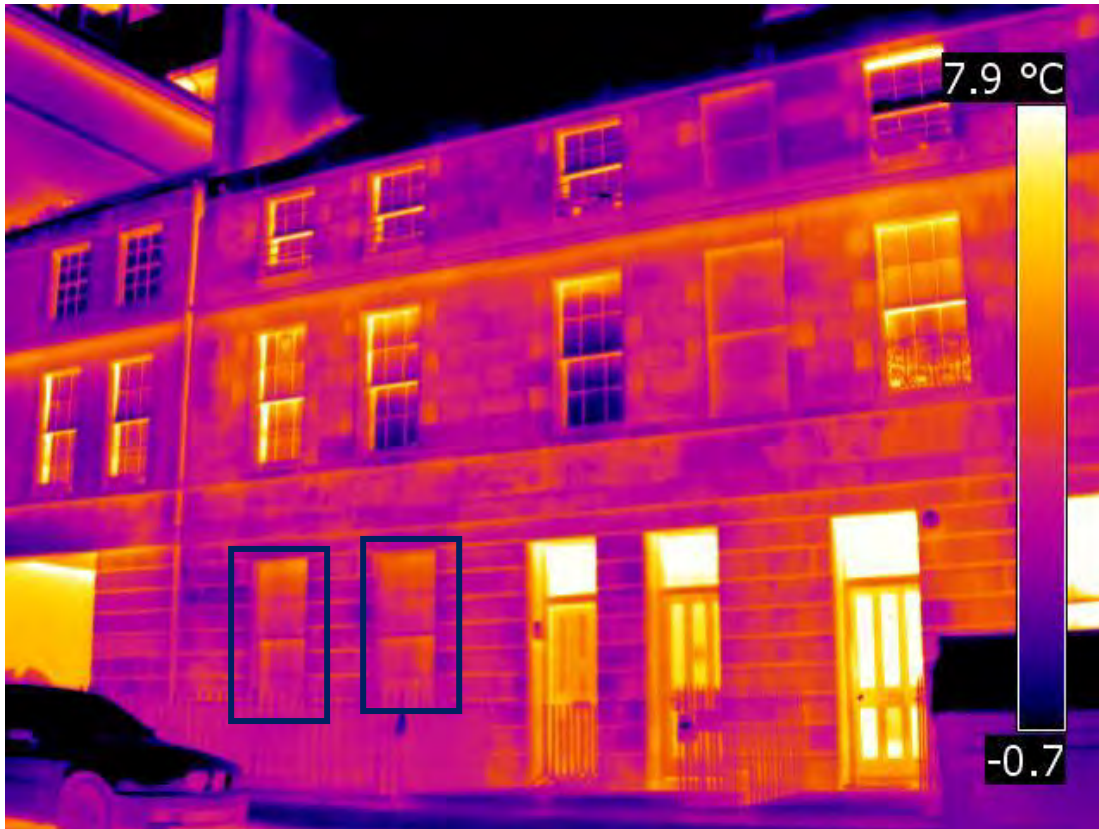
Figure 31: The reduction of heat loss through the newly upgraded windows at Roxburgh Street, Edinburgh (marked in black) with unimproved windows on neighbouring properties.

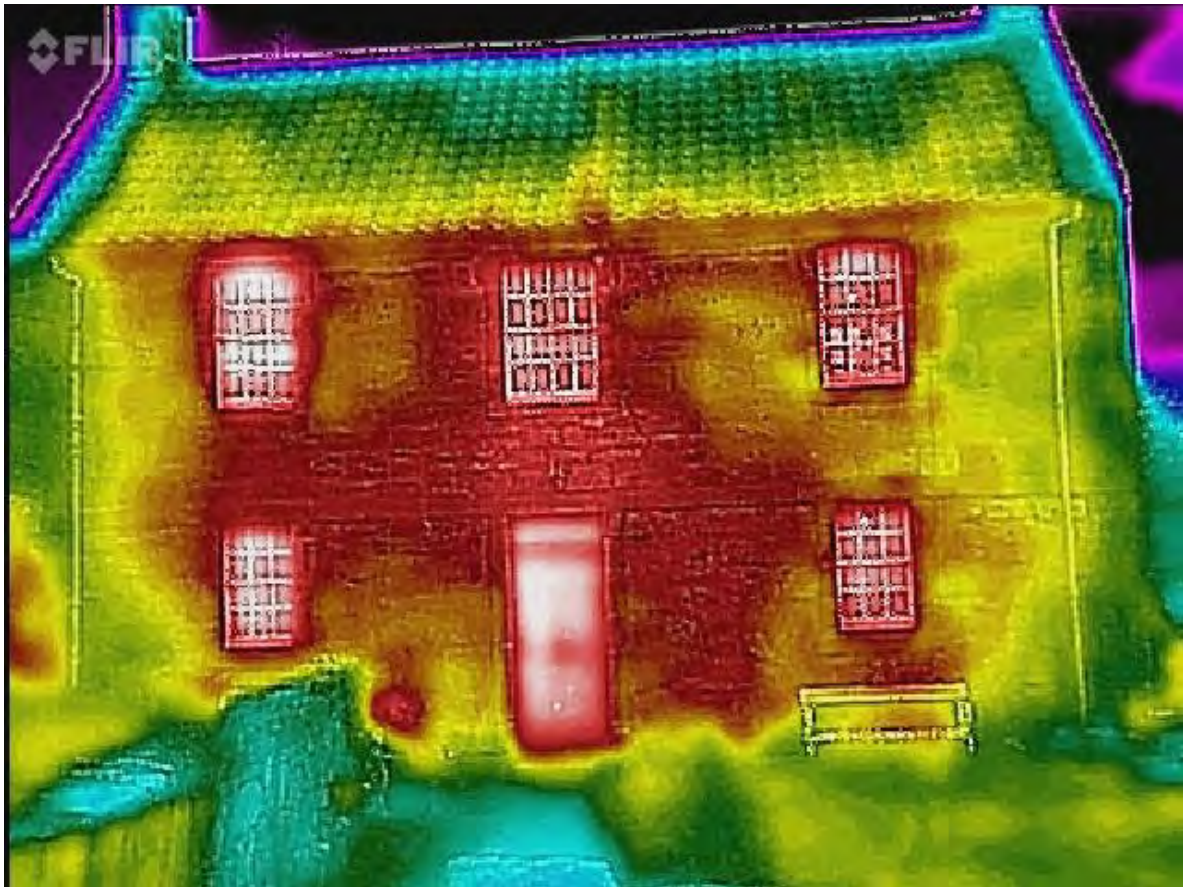
Figure 32: Wee Causeway, Culross, thermal anomalies indicate potential areas of heat loss particularly around windows and doors.

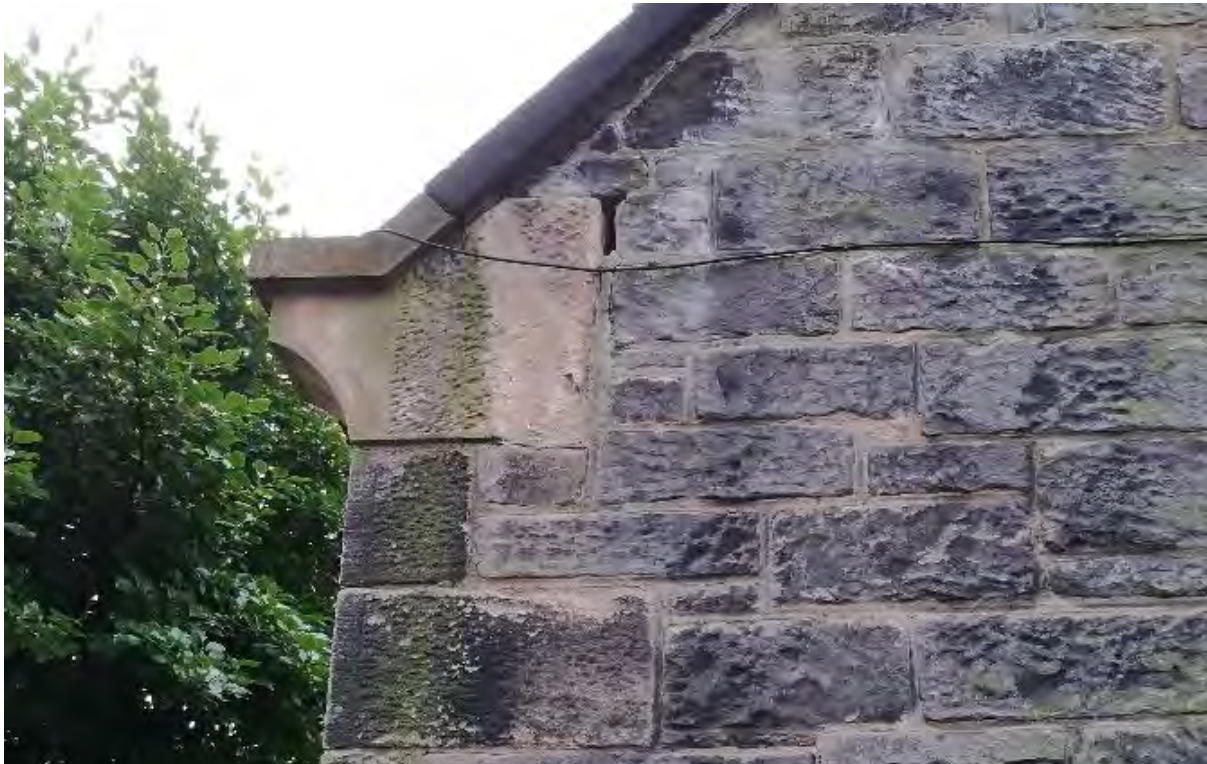
Figure 33: External masonry at Wells o' Wearie. The performance of the new wall insulation is being compromised by poor maintenance and inappropriate repairs resulting in damp walls which are less thermally efficient.

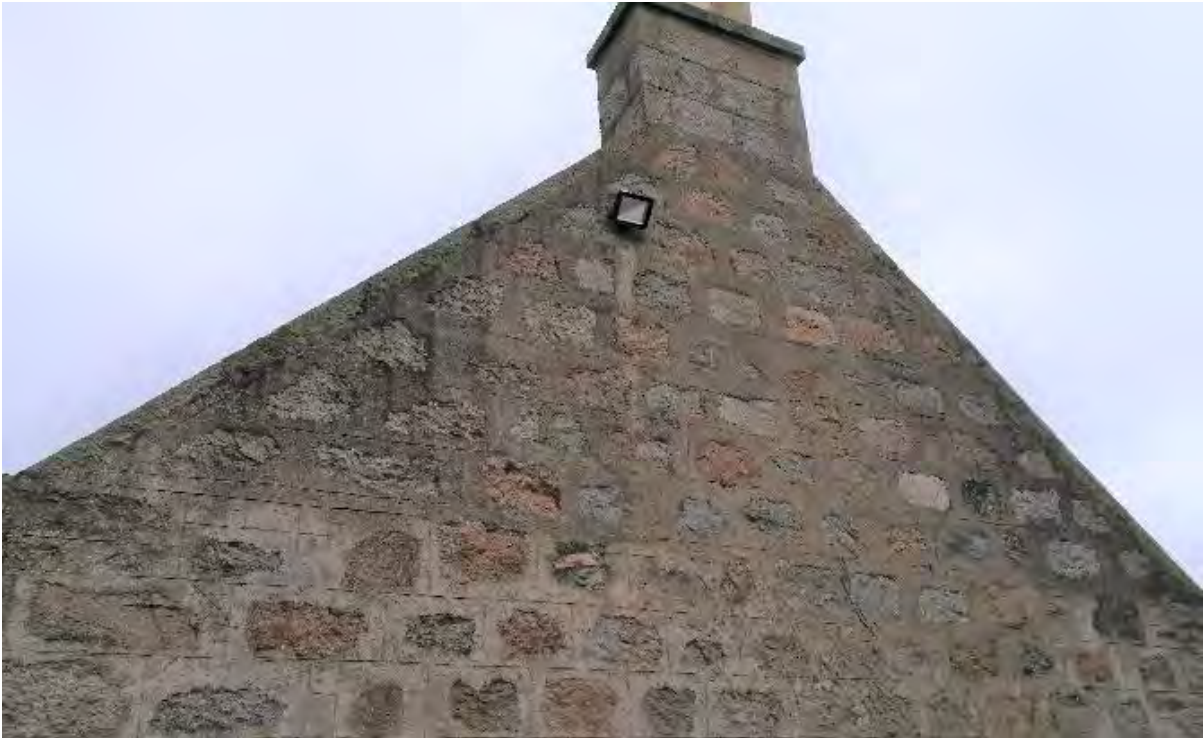
Figure 34: The masonry at Kirkton of Coull. As with Wells o' Wearie, damp masonry is compromising the performance of the new wall insulation. In this case the damp is likely to be exacerbated by the use of cement based pointing.
