### SOFT CAPPING IN SCOTLAND

The context and potential of using plants to protect masonry

> Volume 2 Case Studies

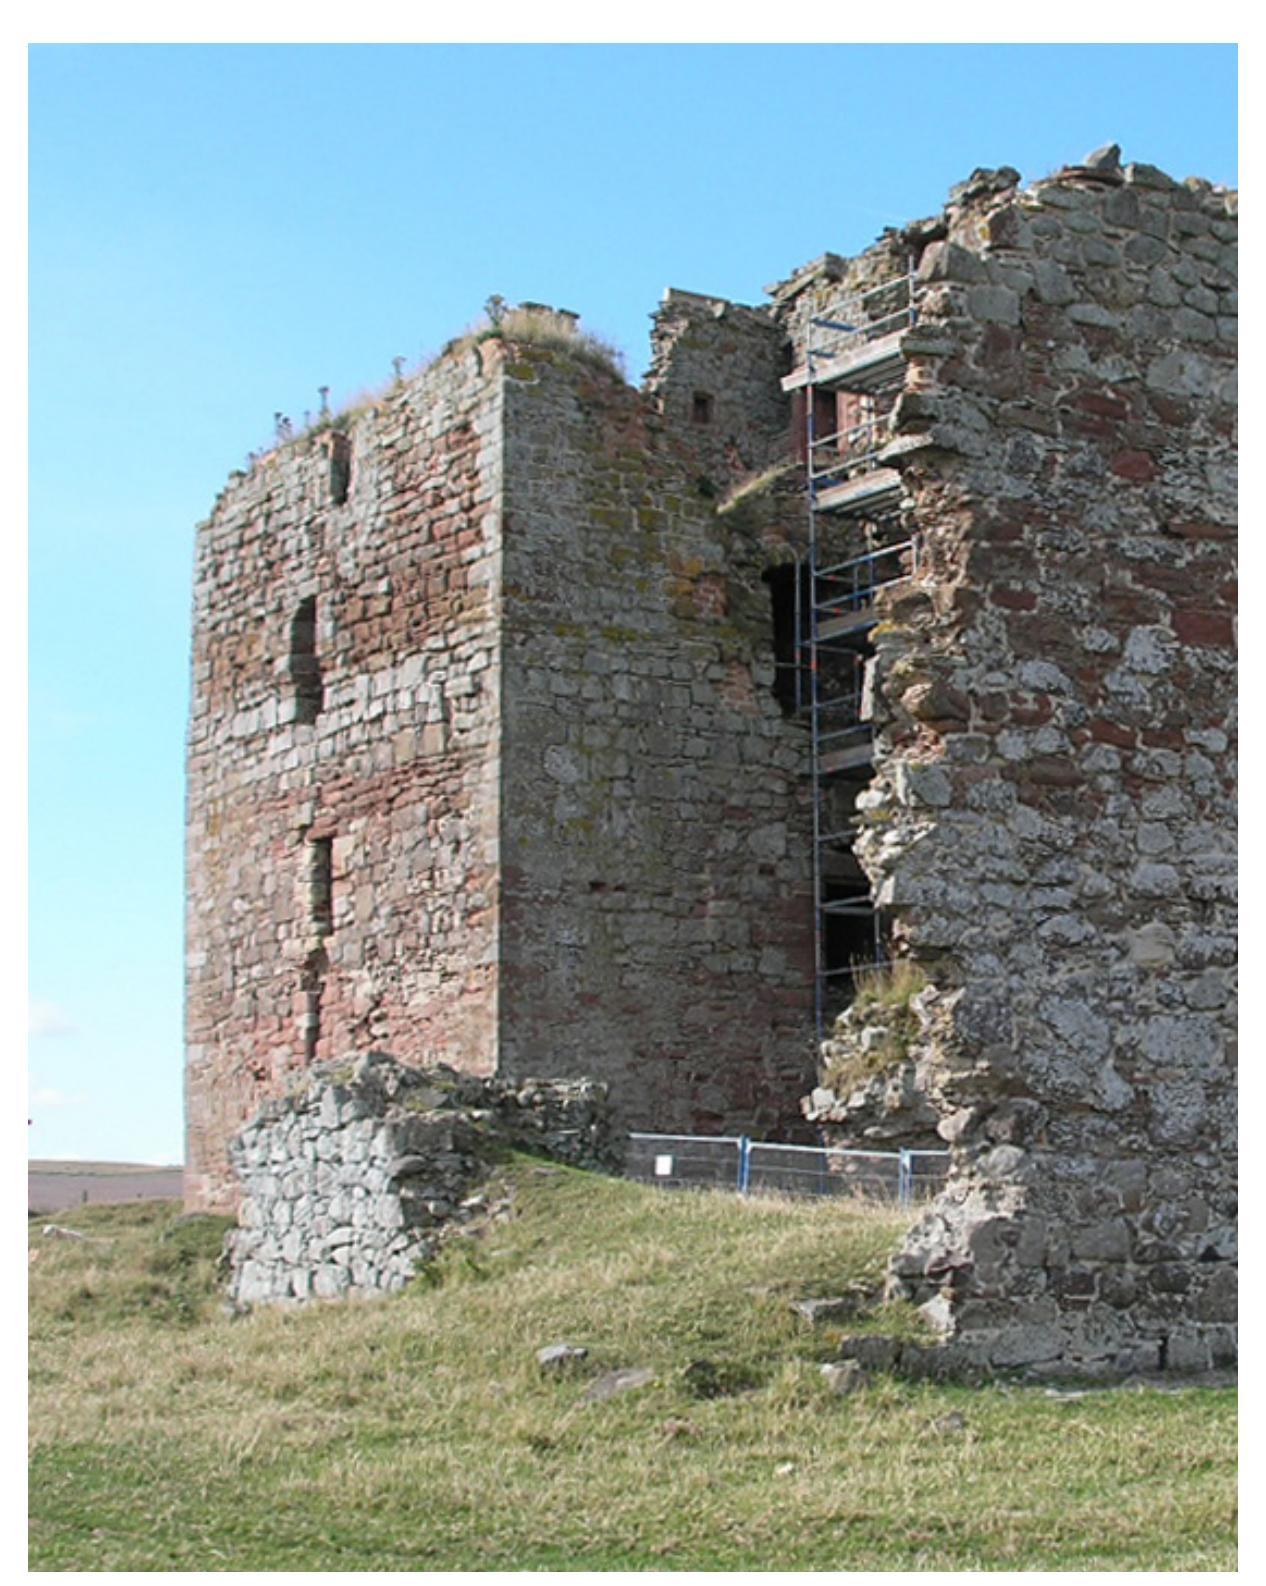
Fig. 2.1: A view of Cessford Castle ruin after the masonry repairs which kept most of the historic natural cappings.

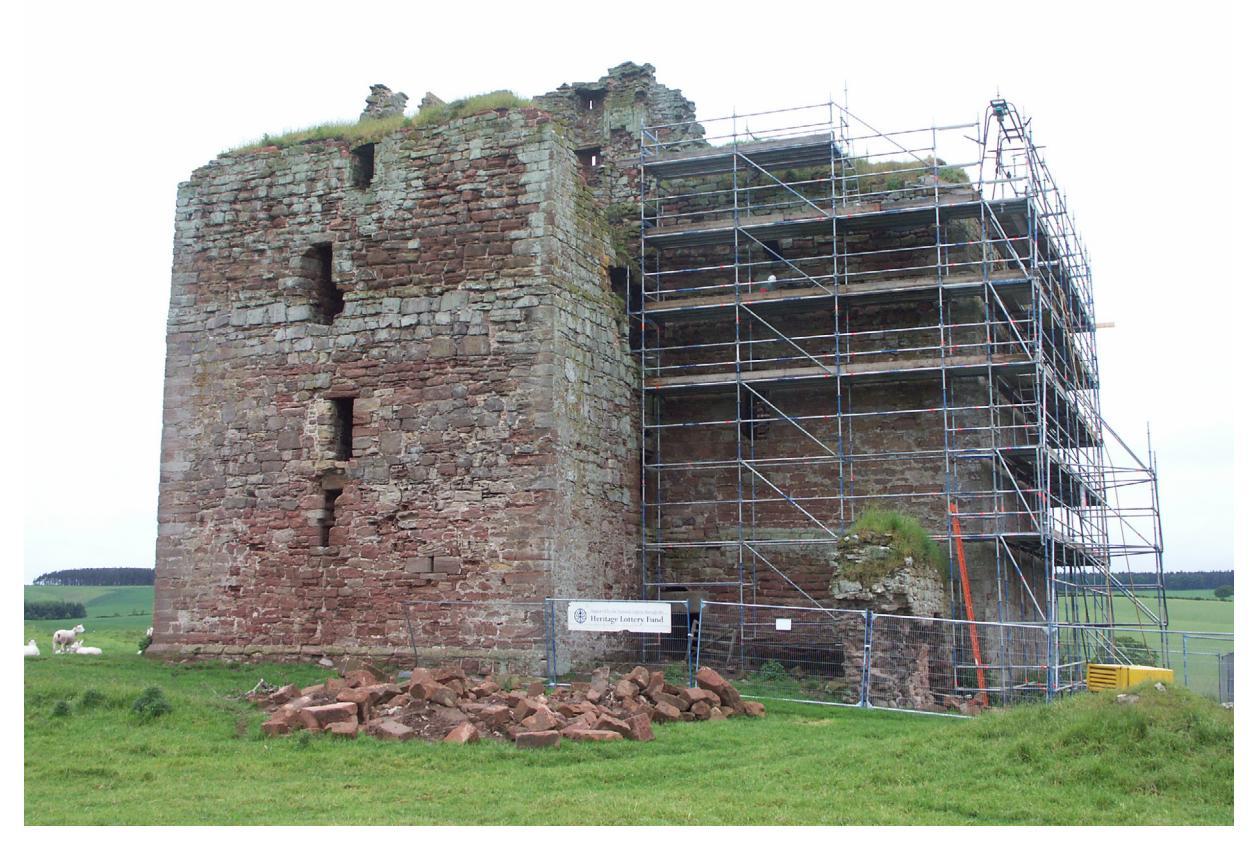
Fig. 2.3: West view, 2005. The wallhead on the left had been repaired the previous year.

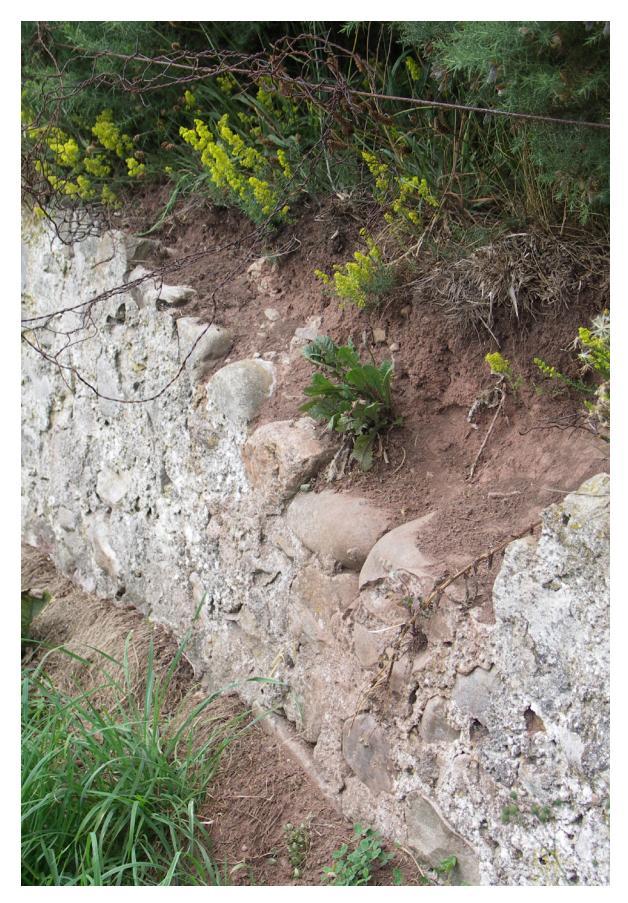
*Fig. 4.16: Wall 3, damage by animals establishing a regular path over the retaining section of wall.*

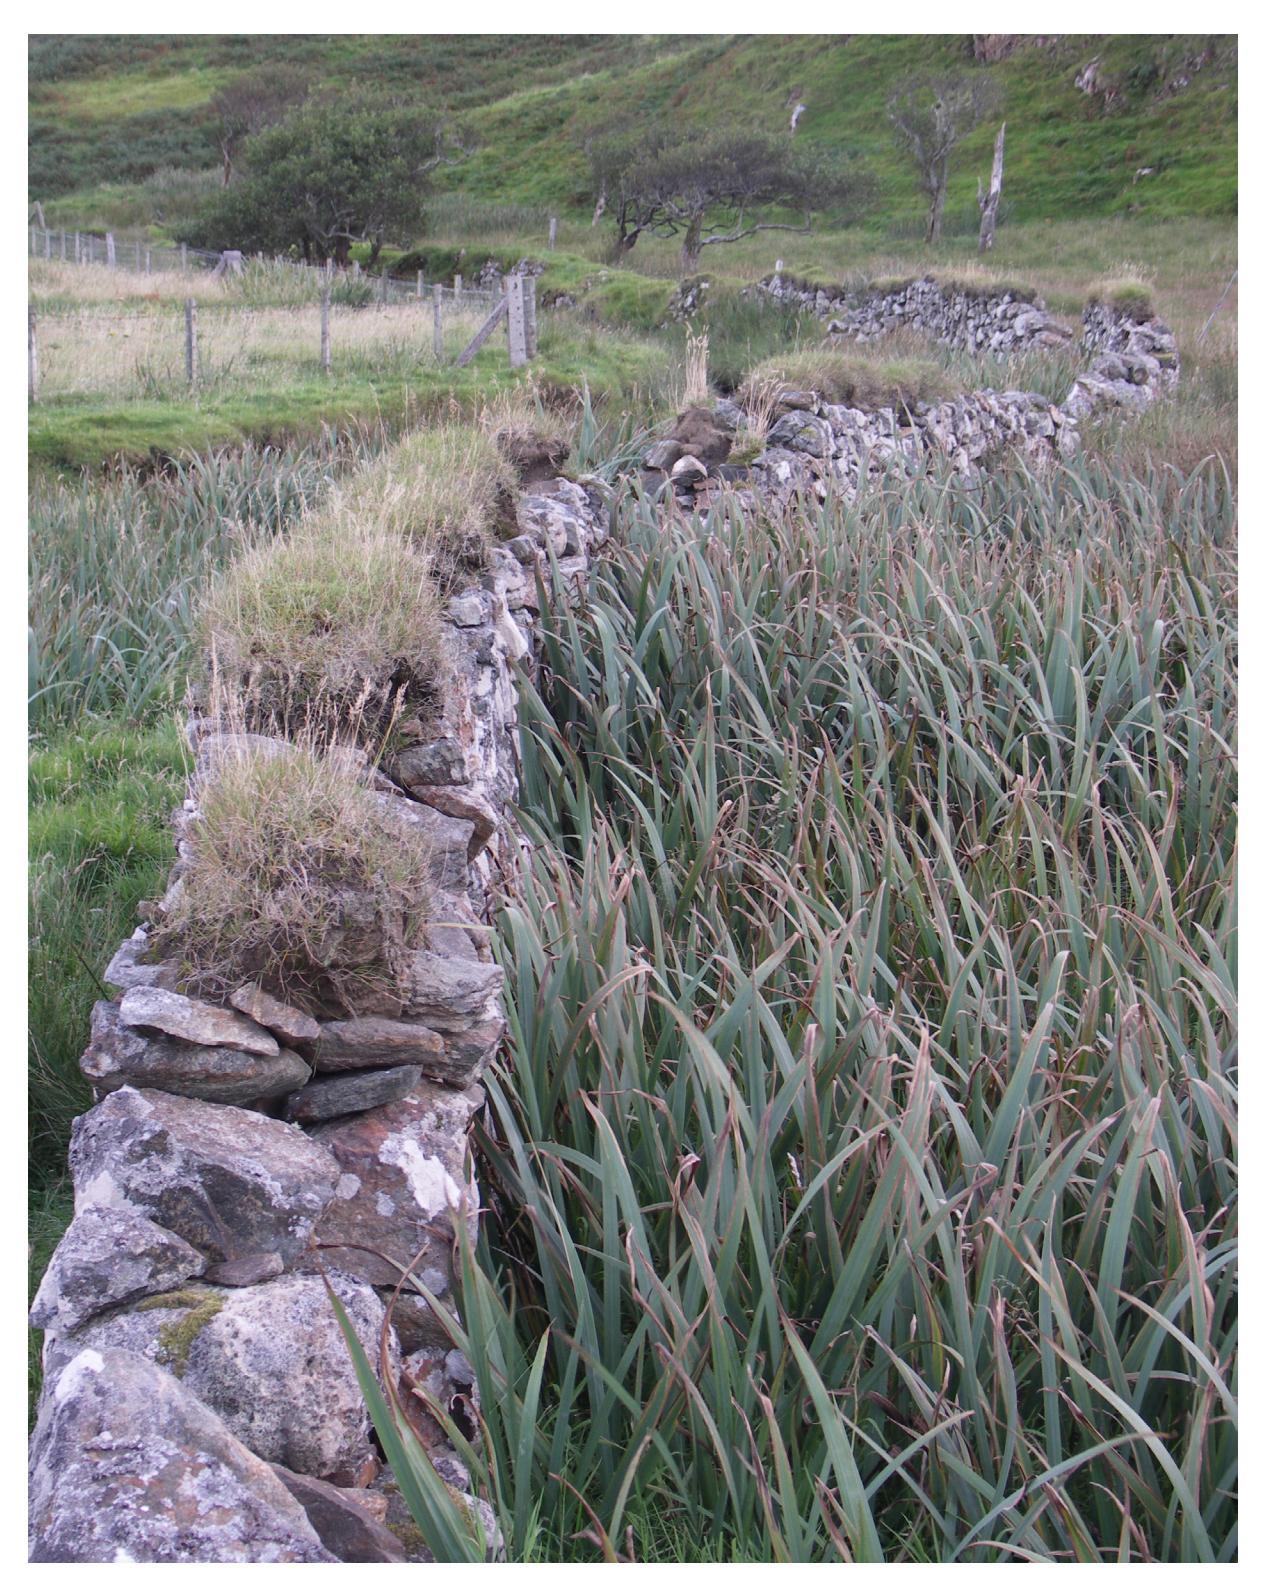
Fig 5.1. Field Enclosure Walls, Roghadal. View of wall running across wet ground. The amount of fallen wall may relate to weak foundation conditions.

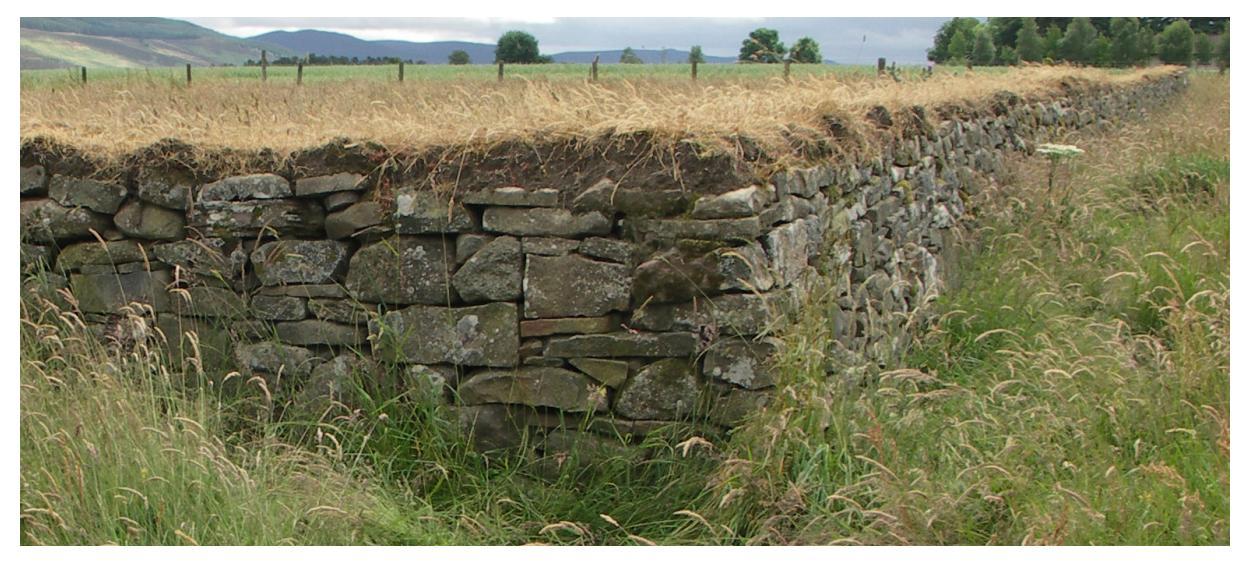
*Fig. 6.11: The turf capped drystone dyke is more vulnerable to drought, which means it can support much fewer species than the turf dyke and experiences progressive edge decay.*

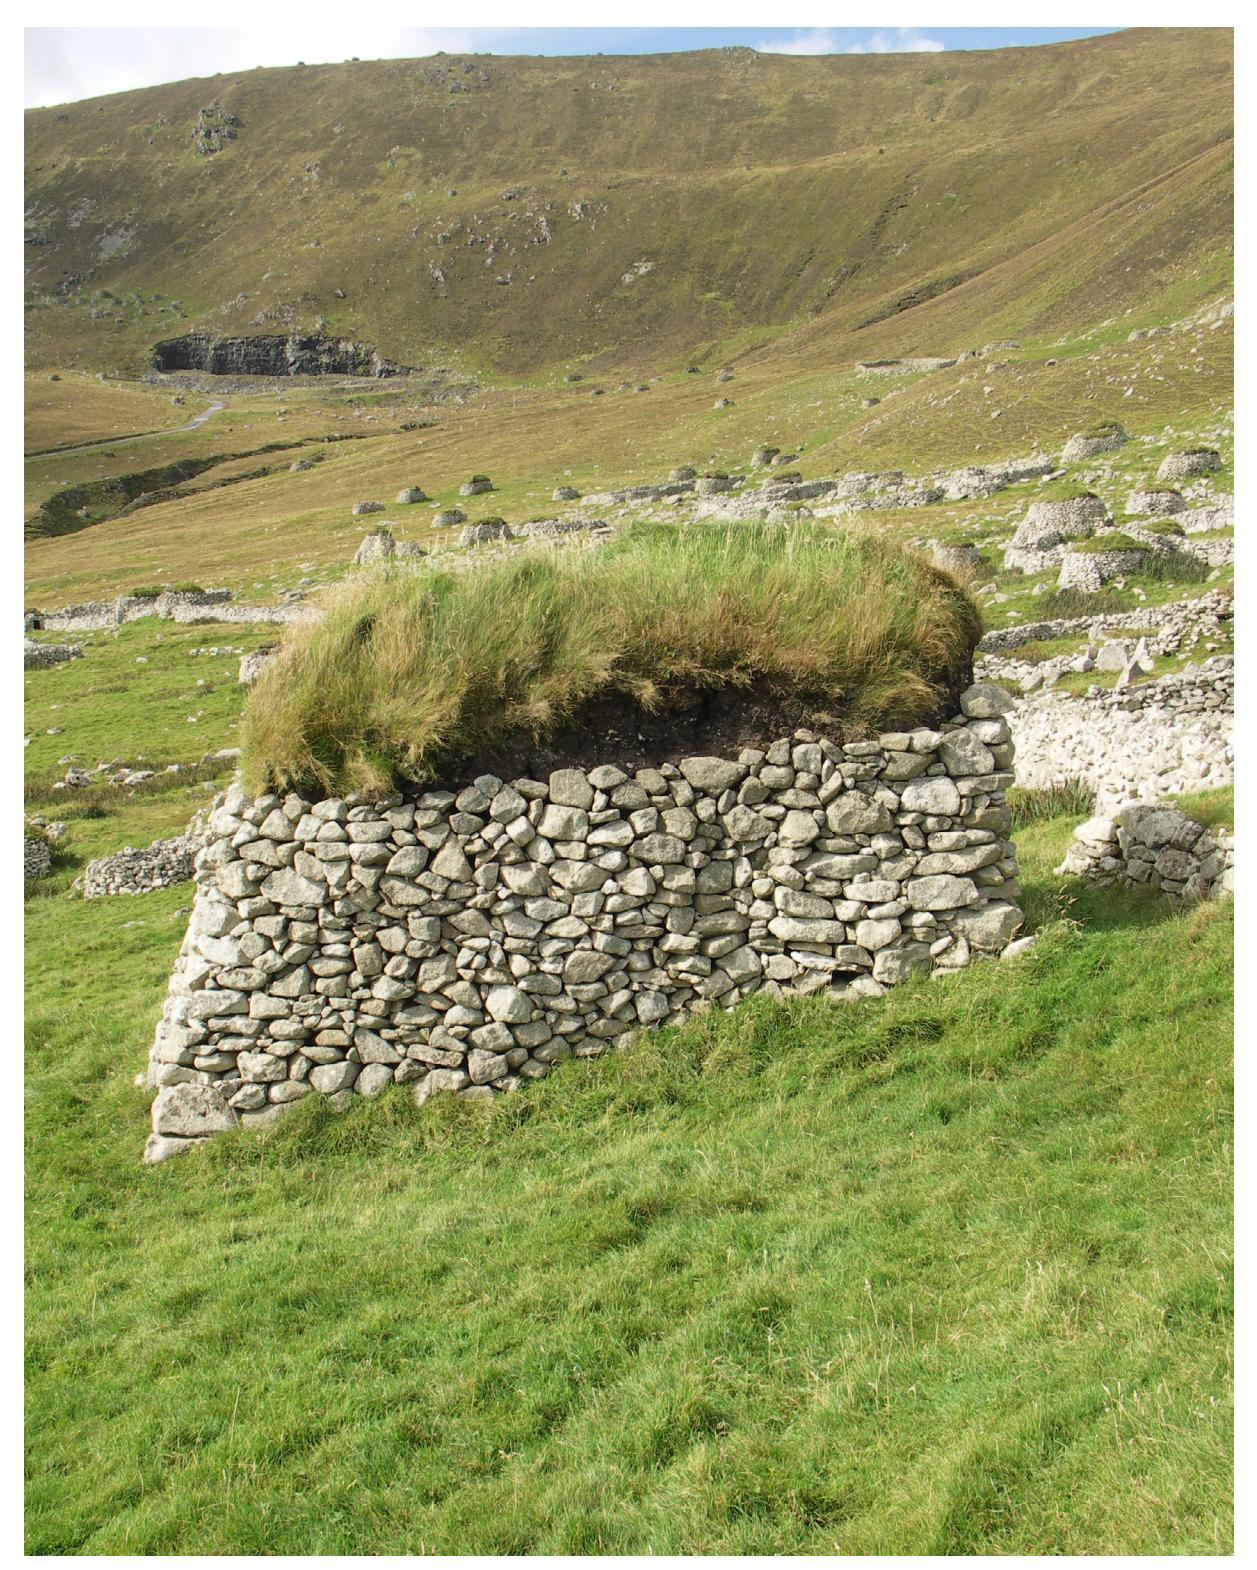
Fig. 7.1: A general view near the village, showing one of the tallest turf cappings, with some edge decay.

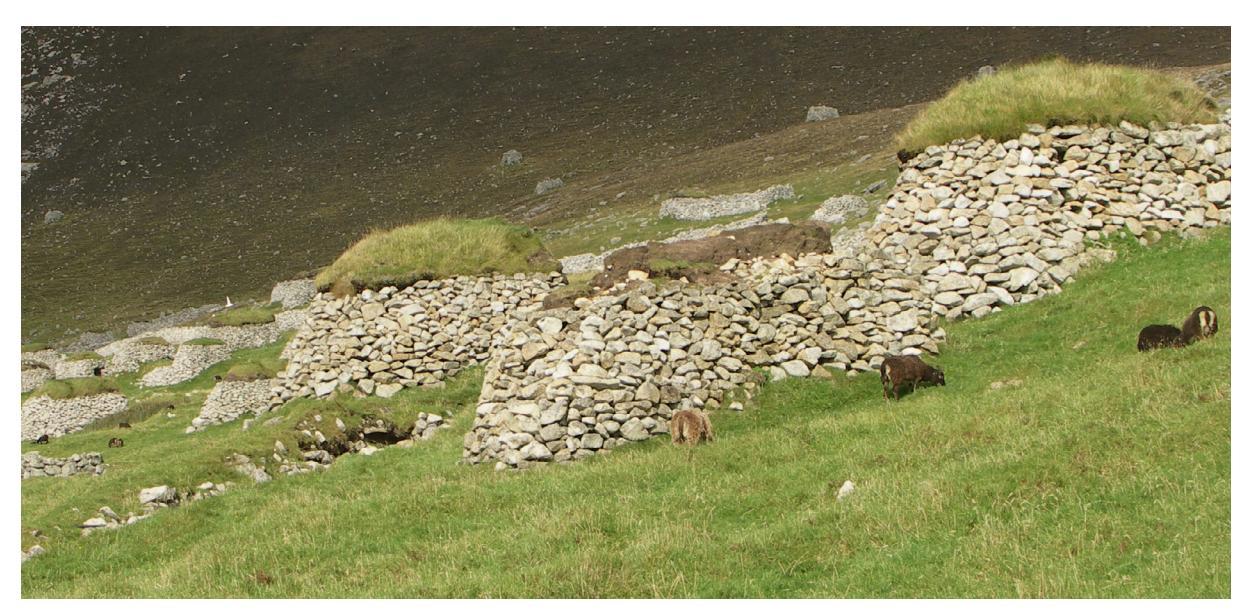
*Fig. 7.12. Cleitean within the head dyke. The condition of individual cappings can dramatically differ from apparently comparable ones nearby.*

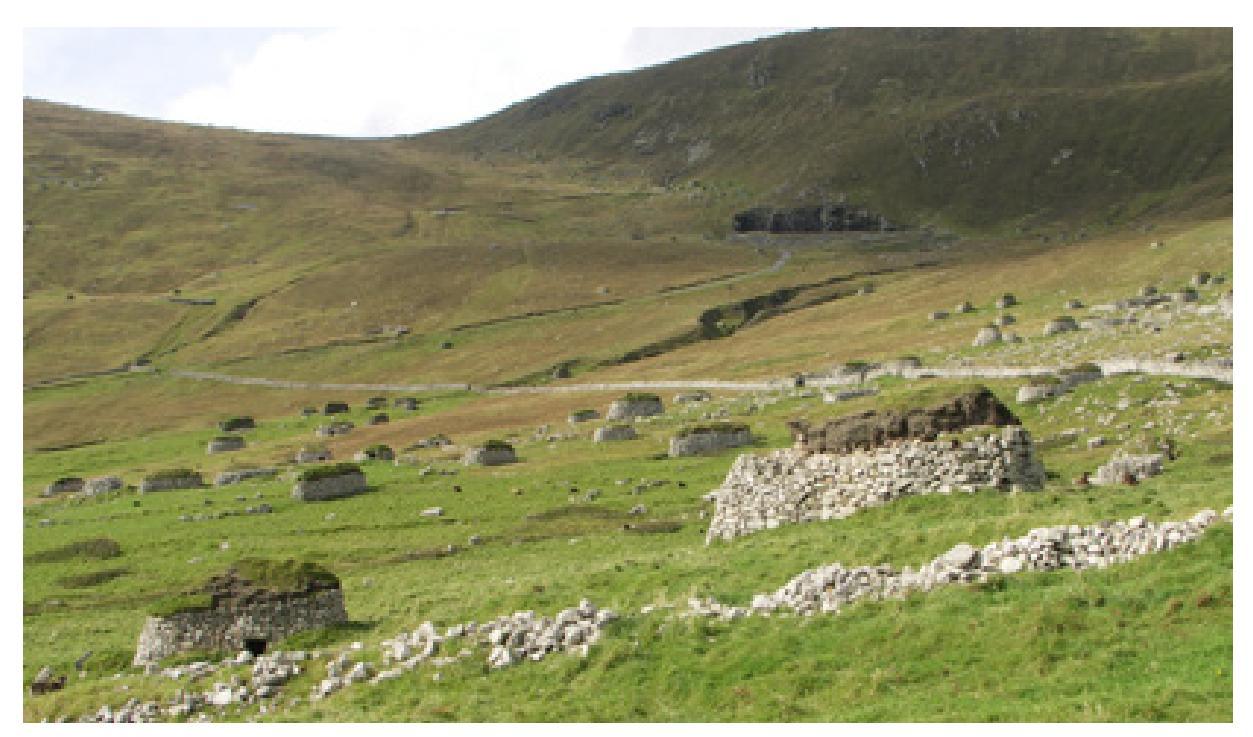
Fig. 7.21: General view showing two cleit roofs where repairs are failing.

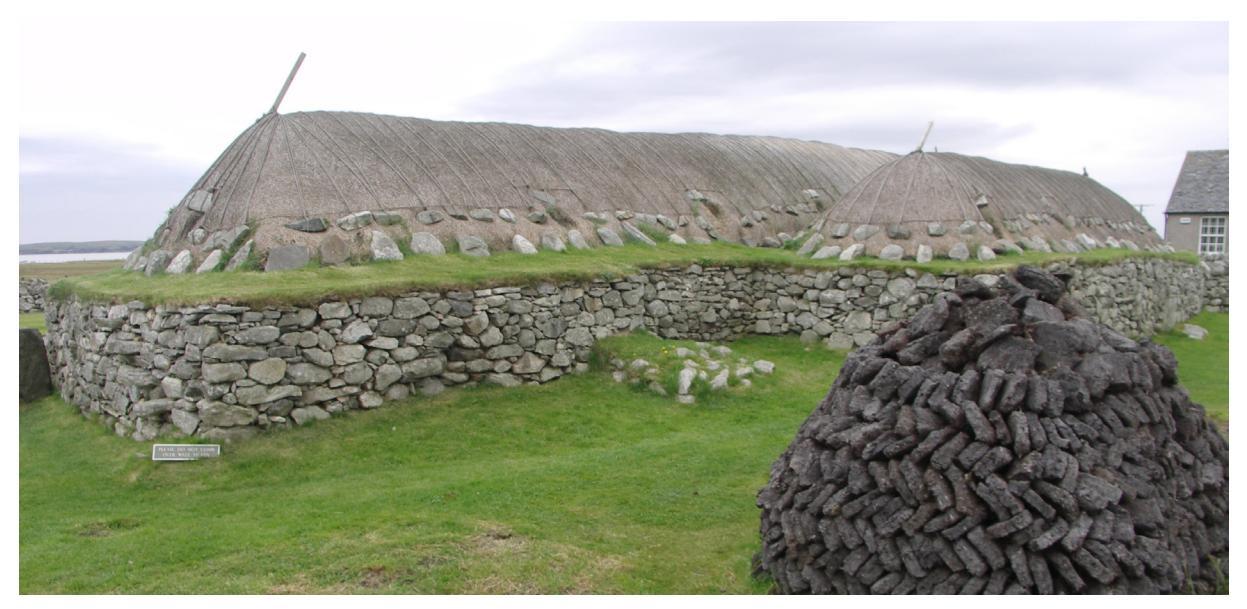
Fig. 9.4: East view. Grass tends to infiltrate the thatch edge where it is difficult to strim. Note the projecting stone steps on the left to access the wallhead.

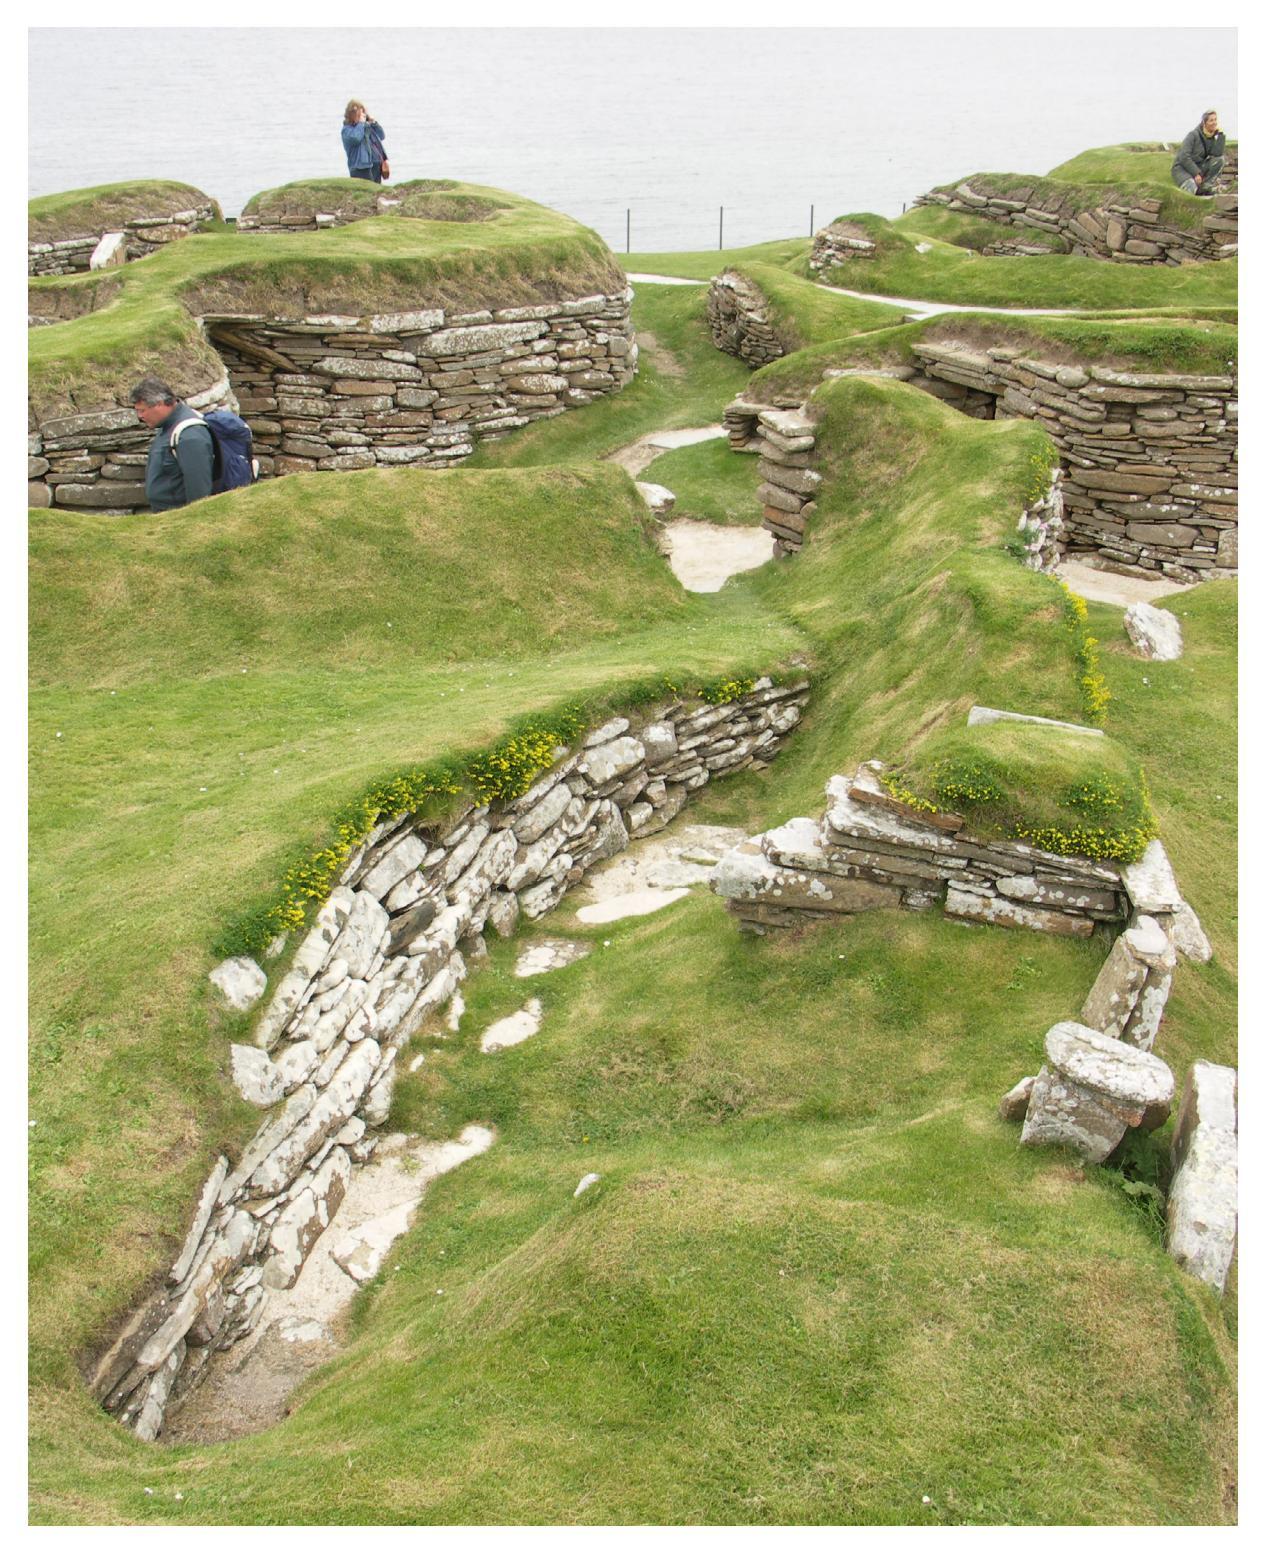
*Fig. 10.1: Skara Brae, Orkney. In summer the site attracts large number of visitors. Despite being maintained to a very high standard the failure of some turf edges detracts from the presentation of the monument.*

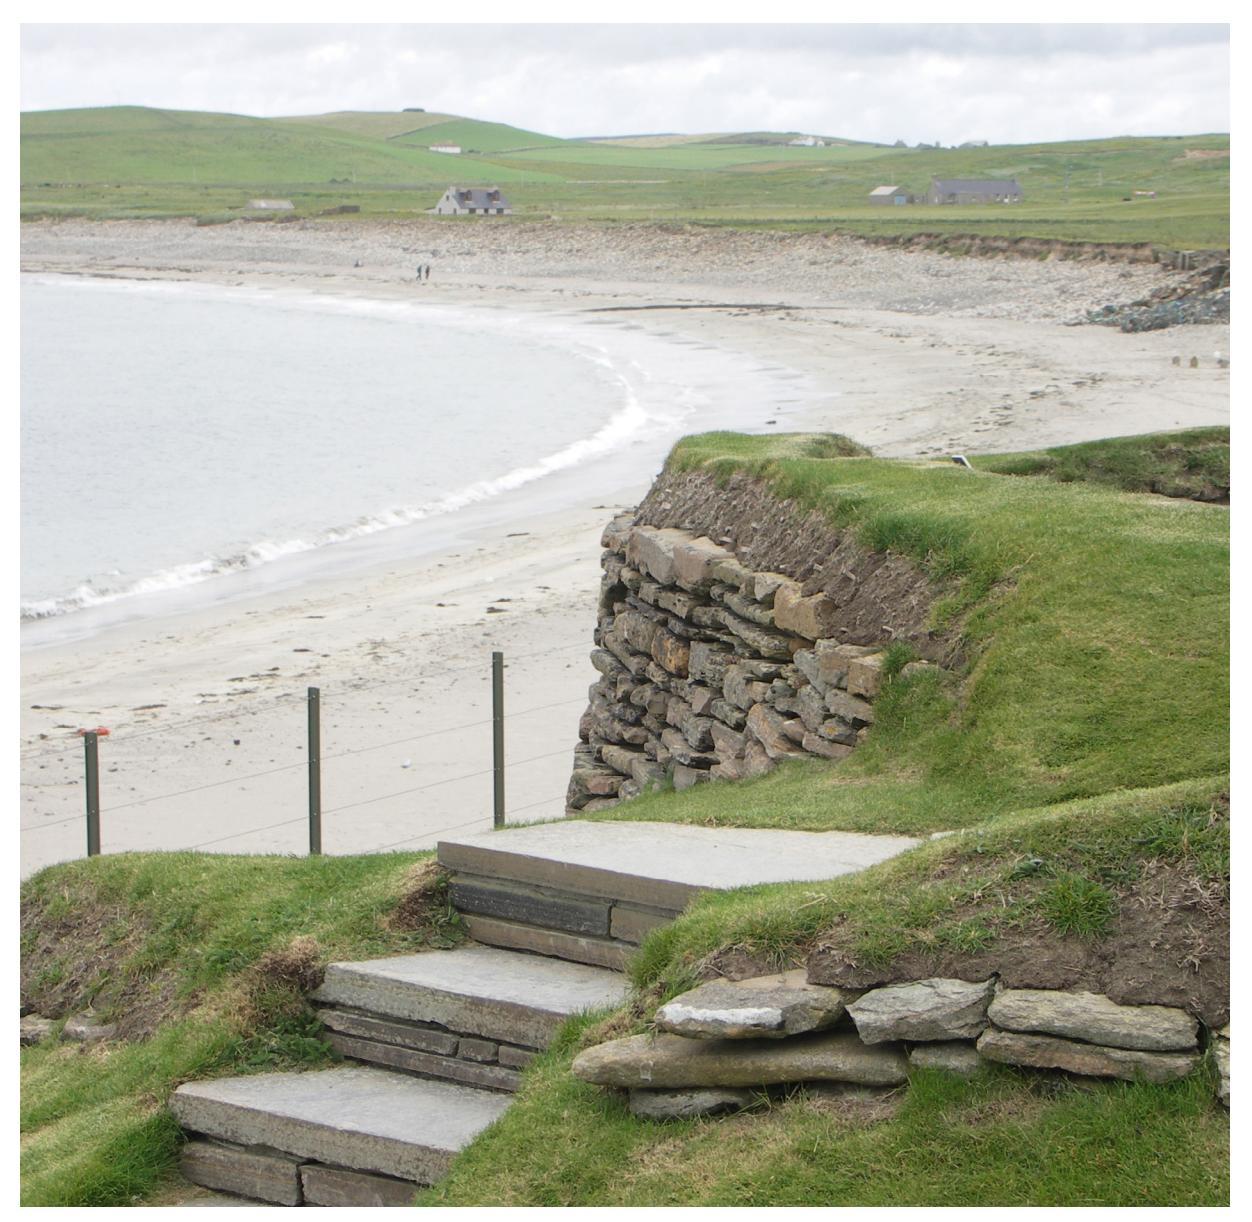
Fig. 10.9: Both original turf (foreground) and subsequent repairs (background) fare worse on the exposed seaward faces.

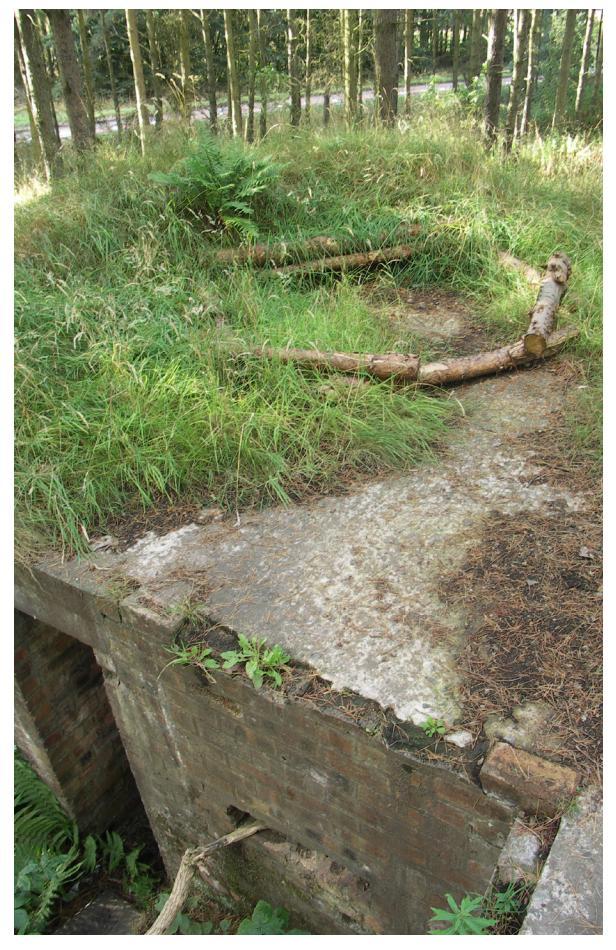
*Fig. 12.6: Decay of the brick facing head is associated with loss of the turf capping and to climbing by people.*

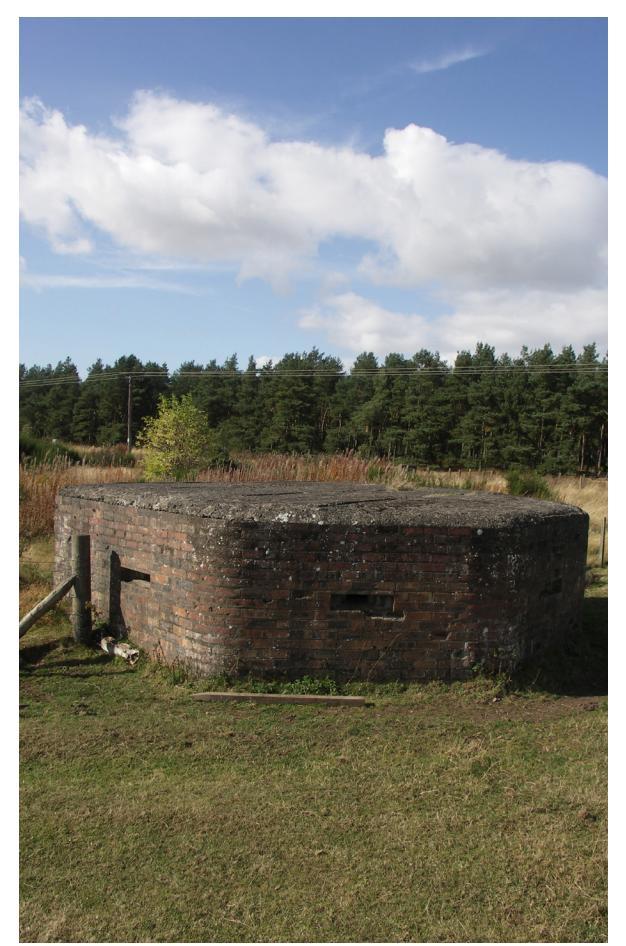
*Fig. 12.7: A nearby comparable pillbox, where the capping has not survived in the open exposure and dry climate.*

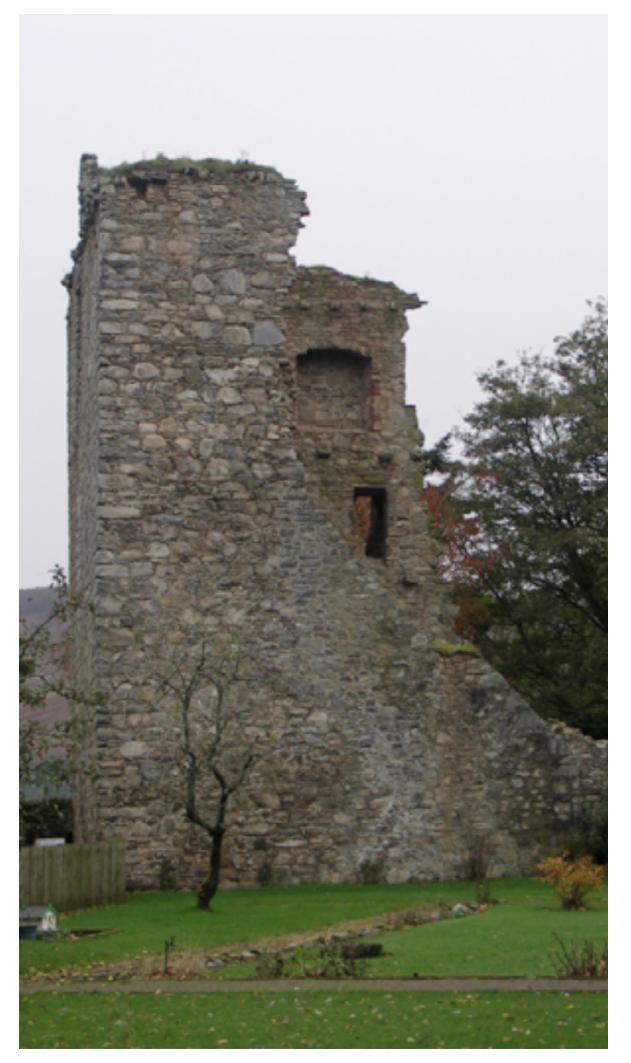
*Fig. 16.3: West view. The visual impact of the cappings is subtle, though brown clay staining is quite apparent.*

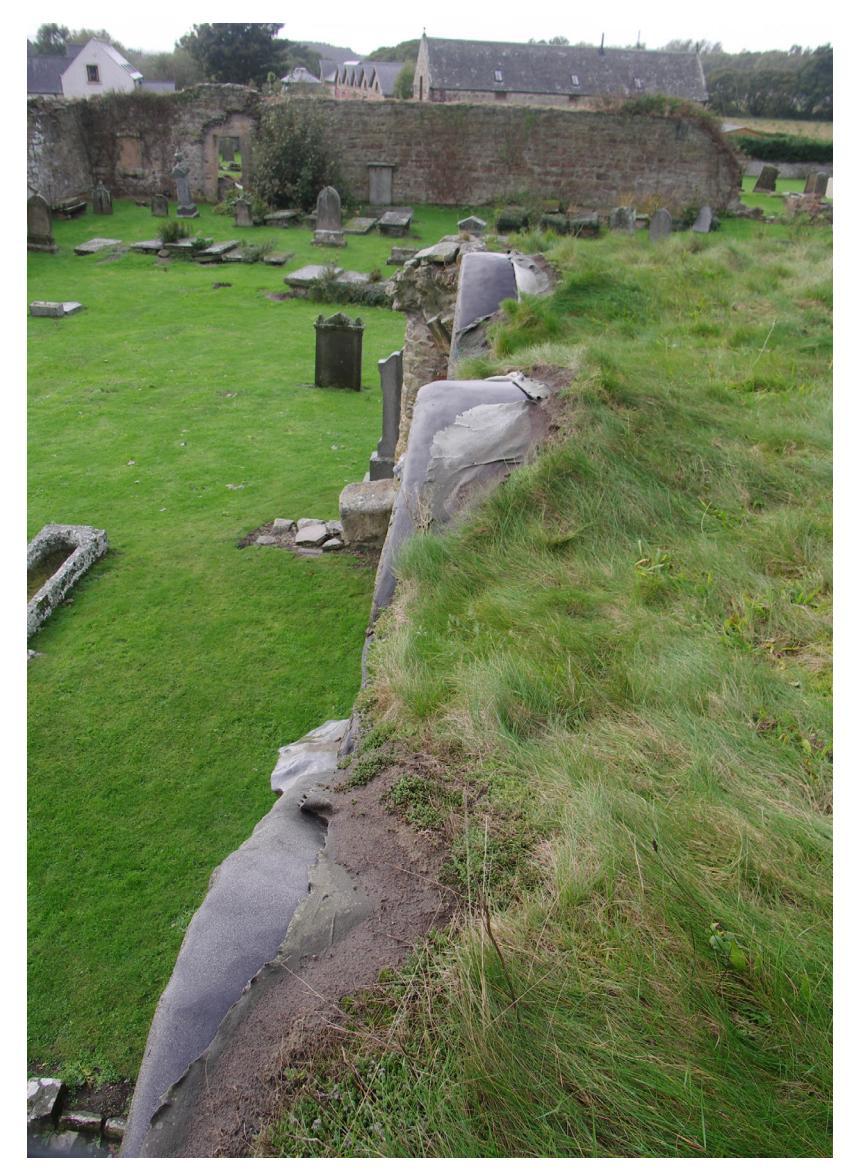
*Fig. 24.2: The south edge of the main roof capping. There is some local stabilisation, especially by sedum.*

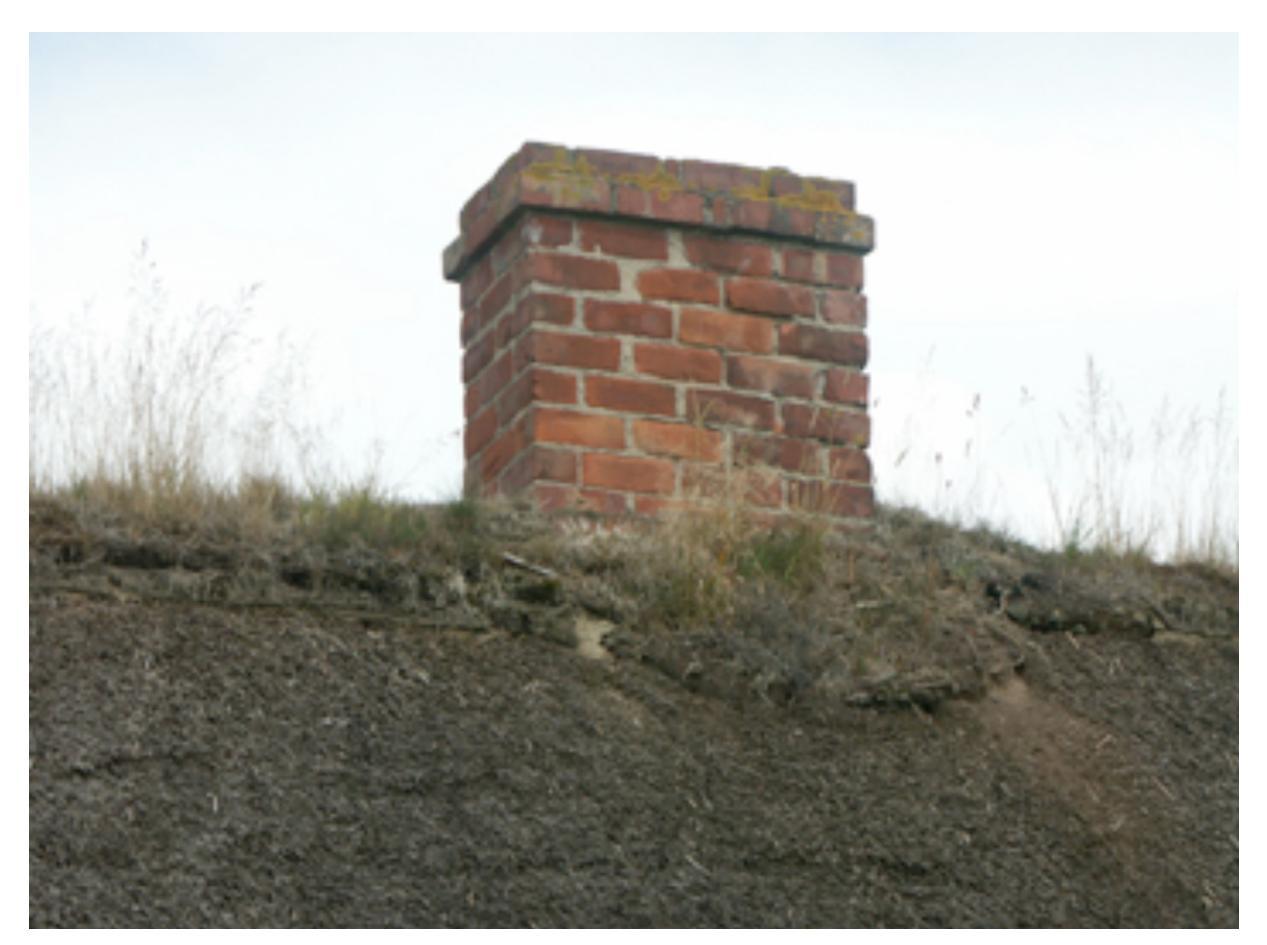
*Fig. 32.6: The south side of the schoolhouse clay/turf ridge capping. Despite repairs and a better quality turf, the ridge is still vulnerable to dieback and decay, though the north side fares better. This ridge has since been re-done in 2008.*

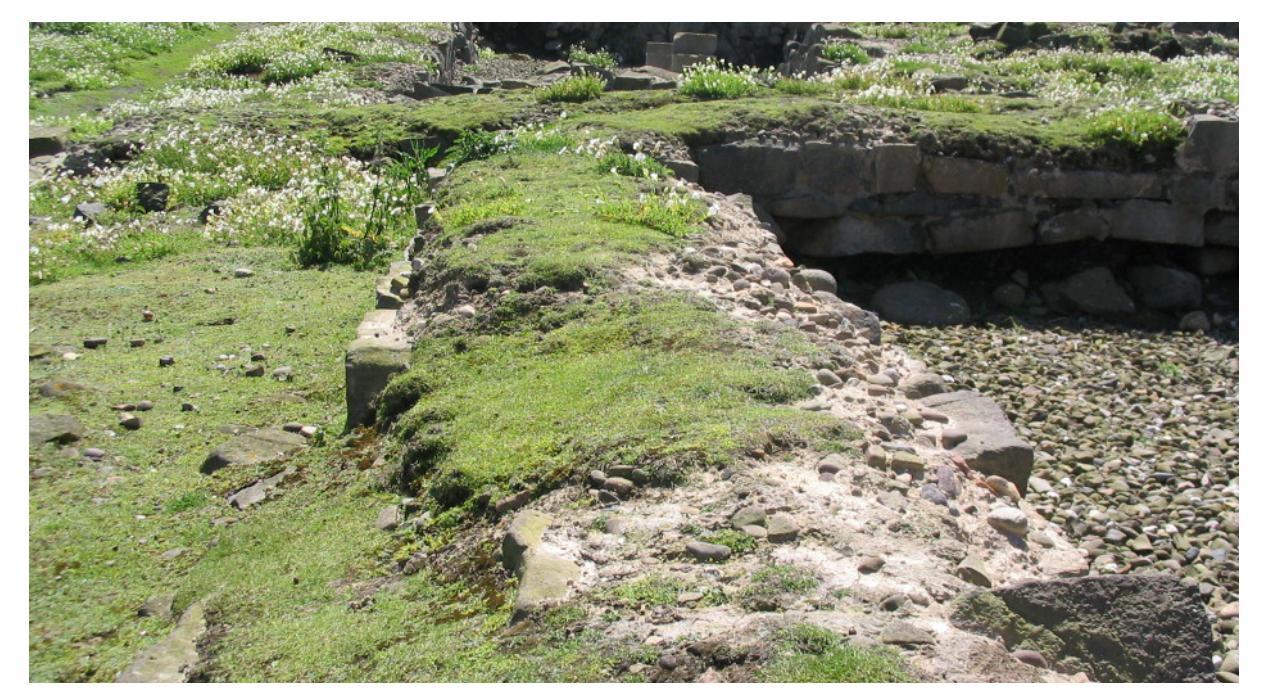
Fig. 36.10: Failure on sections of the low-lying walls. The surviving cap condition is comparable to the surrounding area.

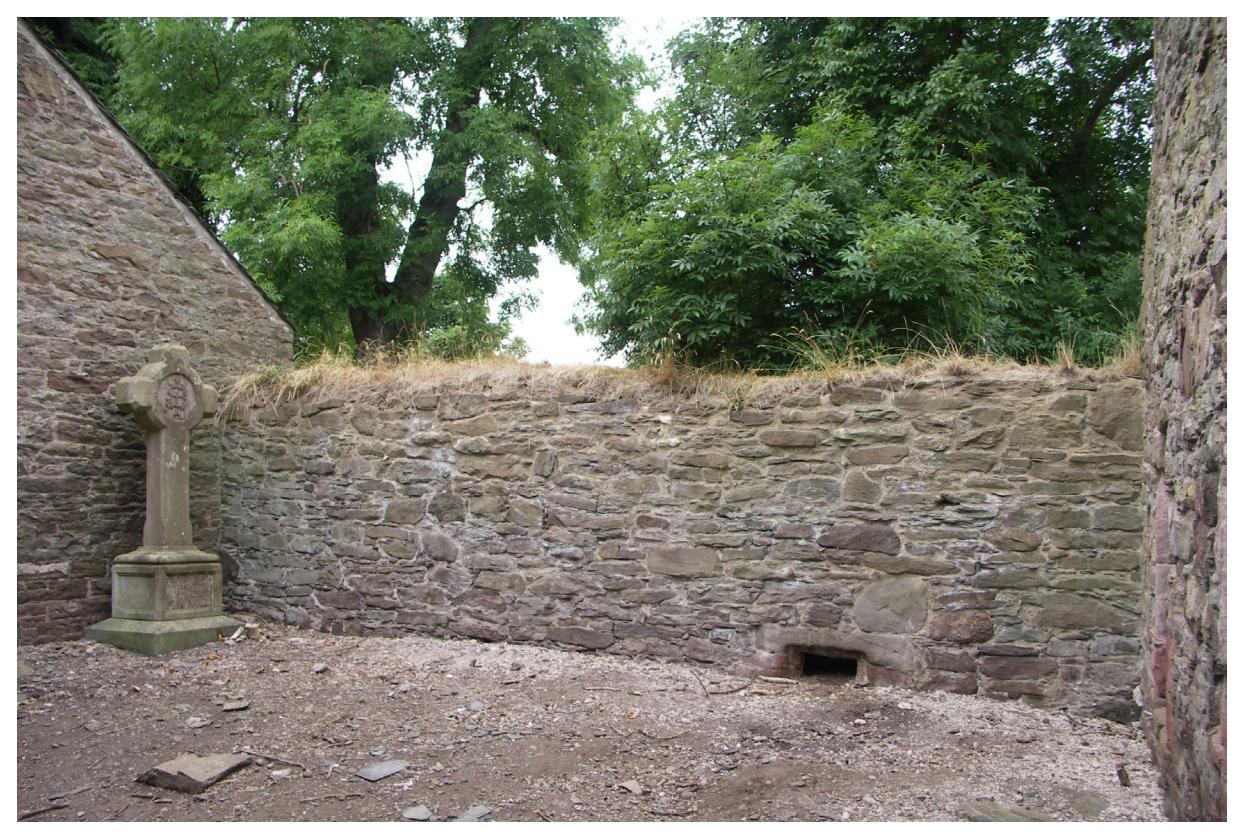
Fig. 38.2: The south side, with the capping in unattractive summer condition.

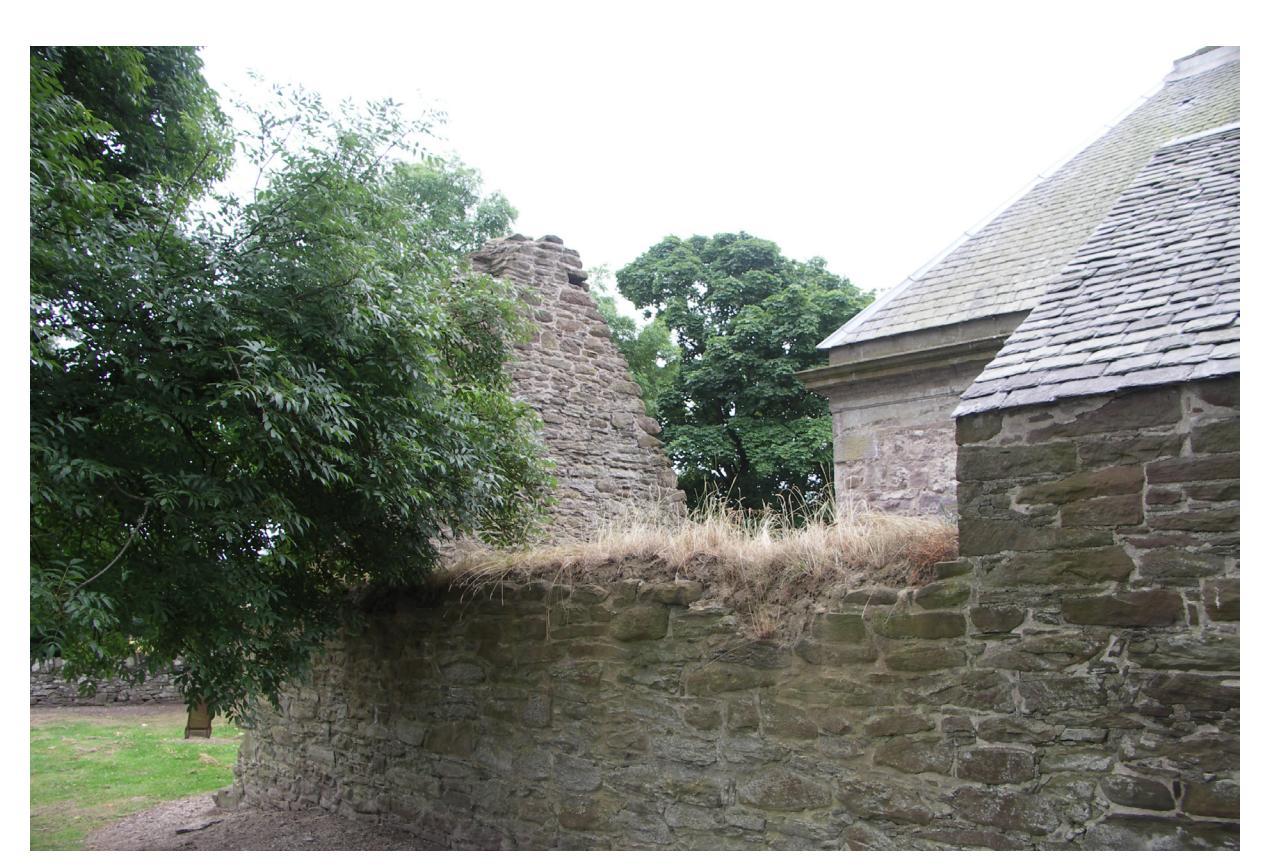
Fig 38.3: North side. Abrasion by the tree, blown in the wind, may be an additional factor in decay of the capping.

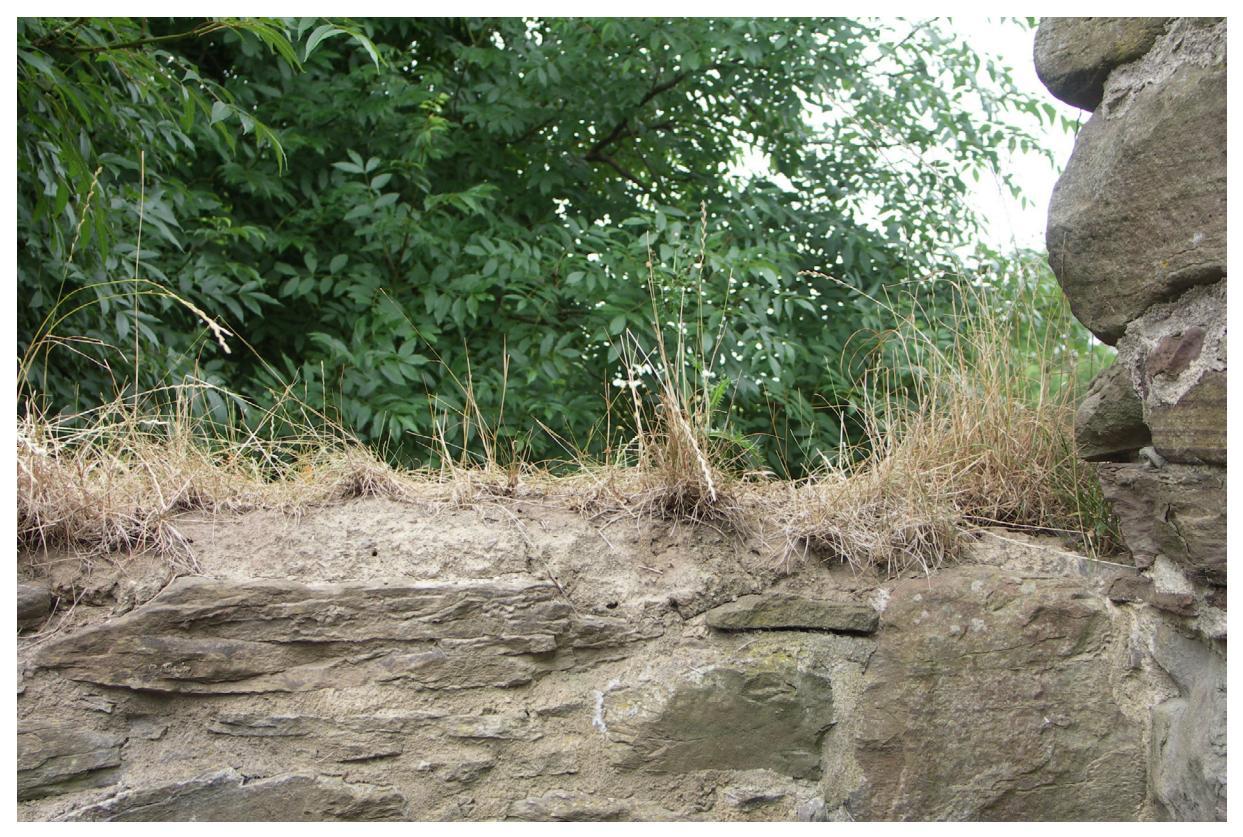
Fig. 38.4: The east section, with greatest dieback and soil staining, but some green grass adjacent to the gable.
