### SOFT CAPPING IN SCOTLAND

The context and potential of using plants to protect masonry

> Volume 2 Case Studies

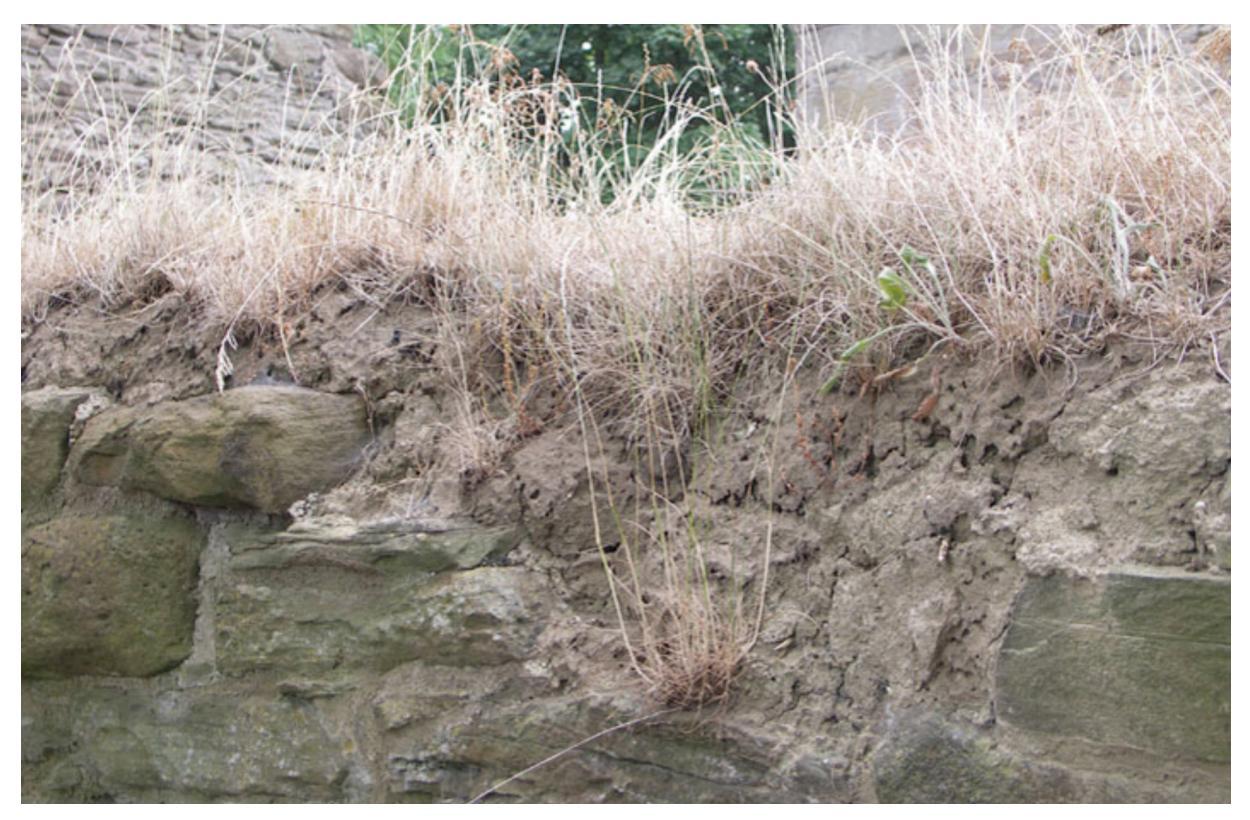
*Fig.* 38.5: The north face, with progressive decay of the exposed soil and clay layers, but also some secondary growth of mosses and grass. It may be the cap is simply in long-term transition to more suitable species.
