TECHNICAL
ADVICE
NOTE

CORROSION IN
MASONRY CLAD
EARLY 20TH
CENTURY STEEL
FRAMED
BUILDINGS

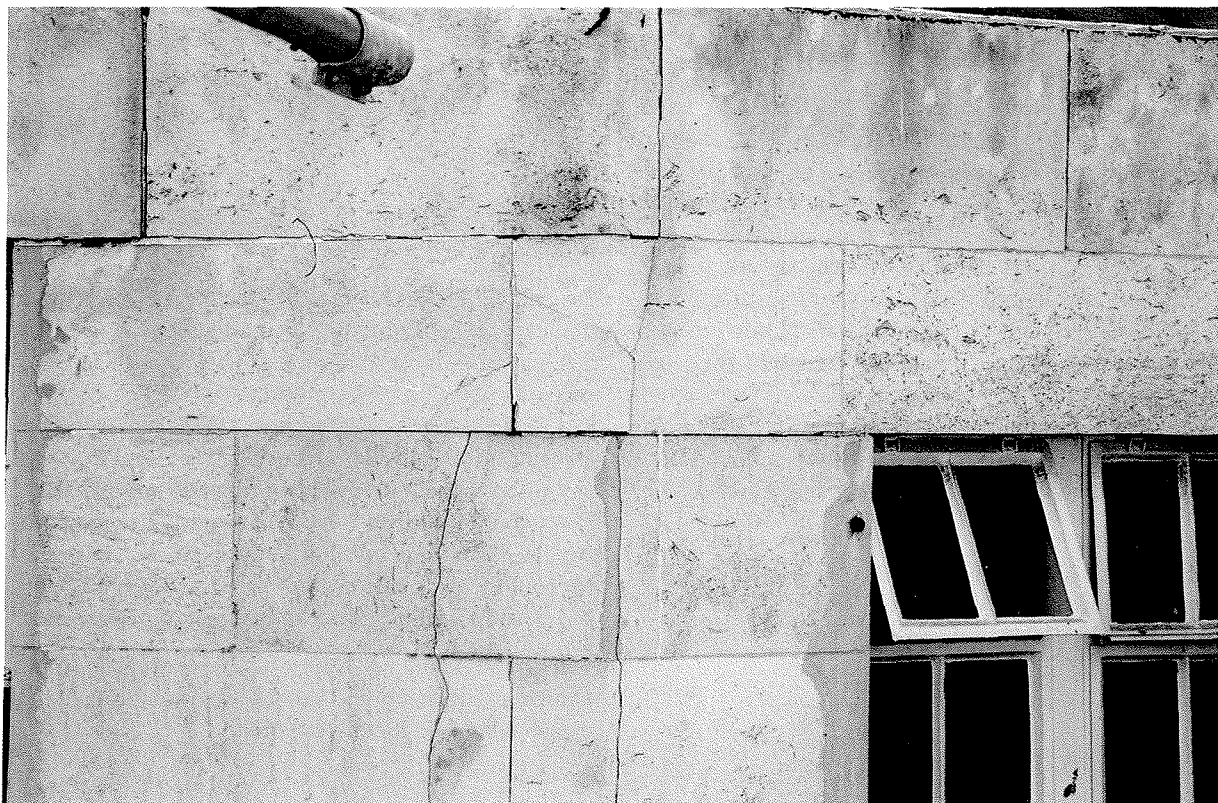
Figure 1. Cracking and stonework displacement due to corrosion of the underlying steel column.

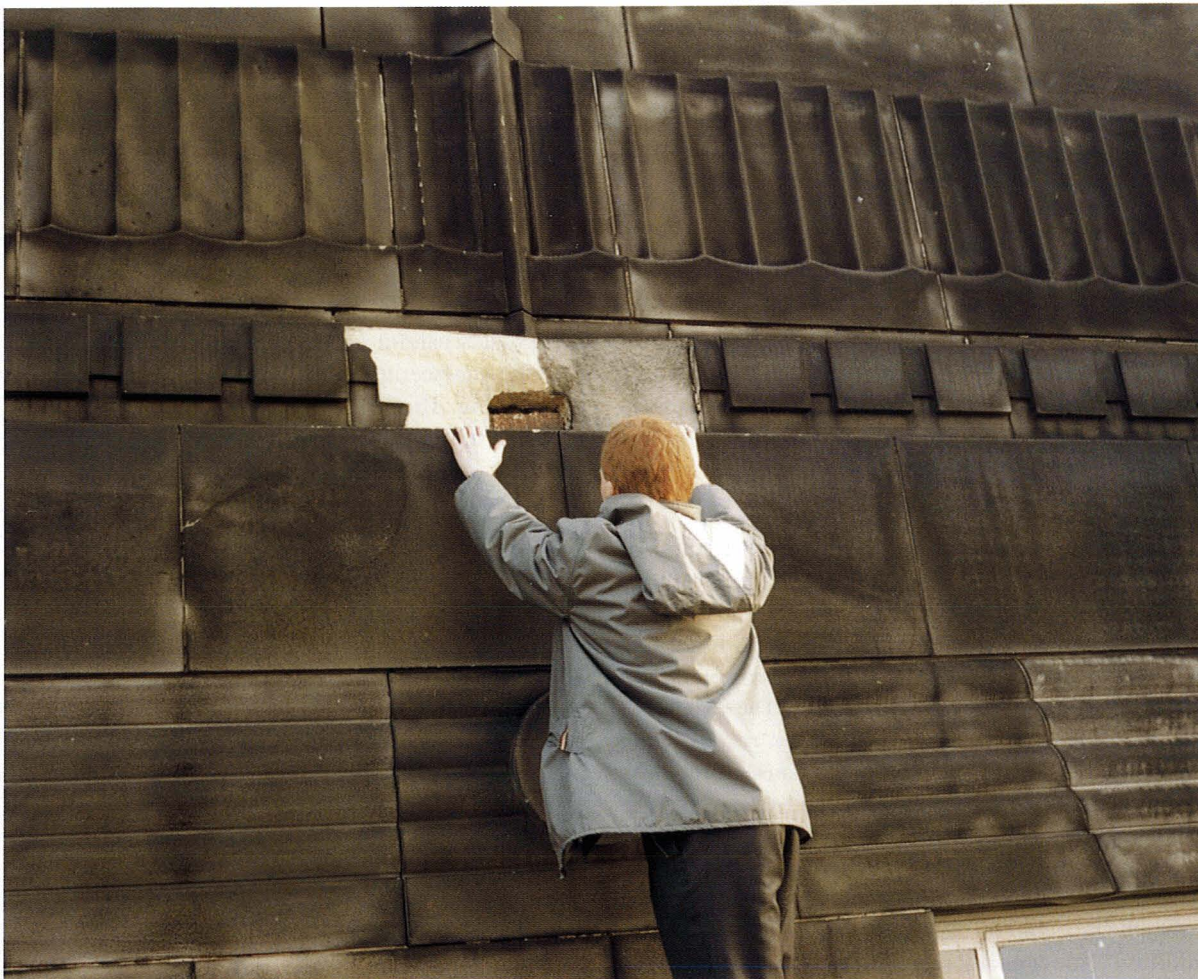
Figure 2. Large stone spall due to corrosion of the steel column. Cases such as these are clearly a potential safety problem and detailed investigations and remedial actions are required to prevent reoccurrence.

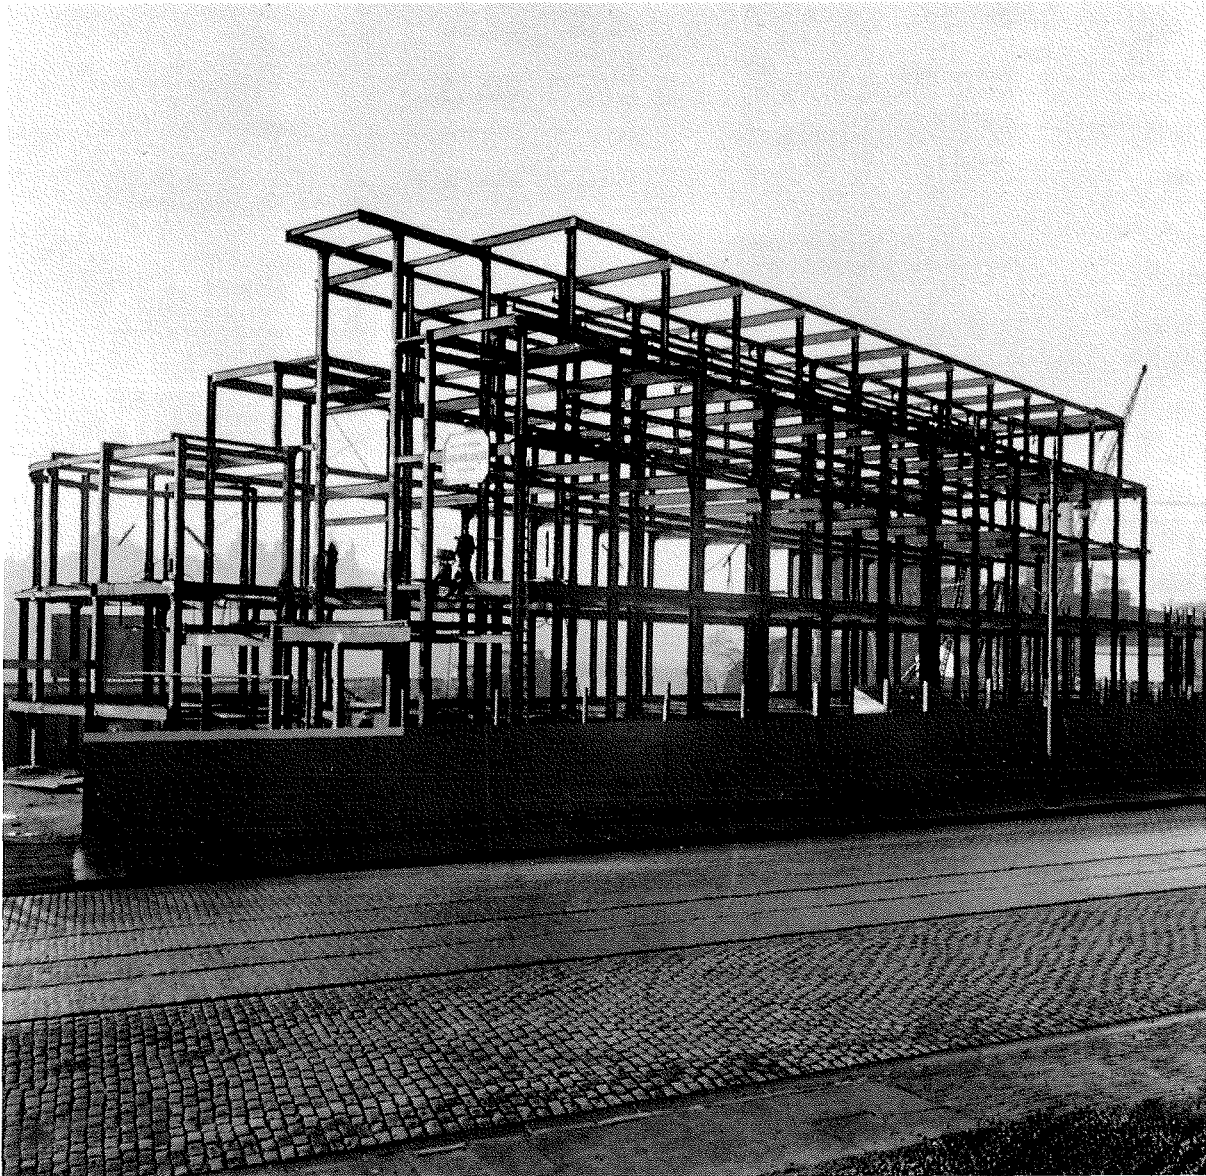
Figure 3. The structural steel skeleton frame typical of buildings constructed between 1909 and 1939.

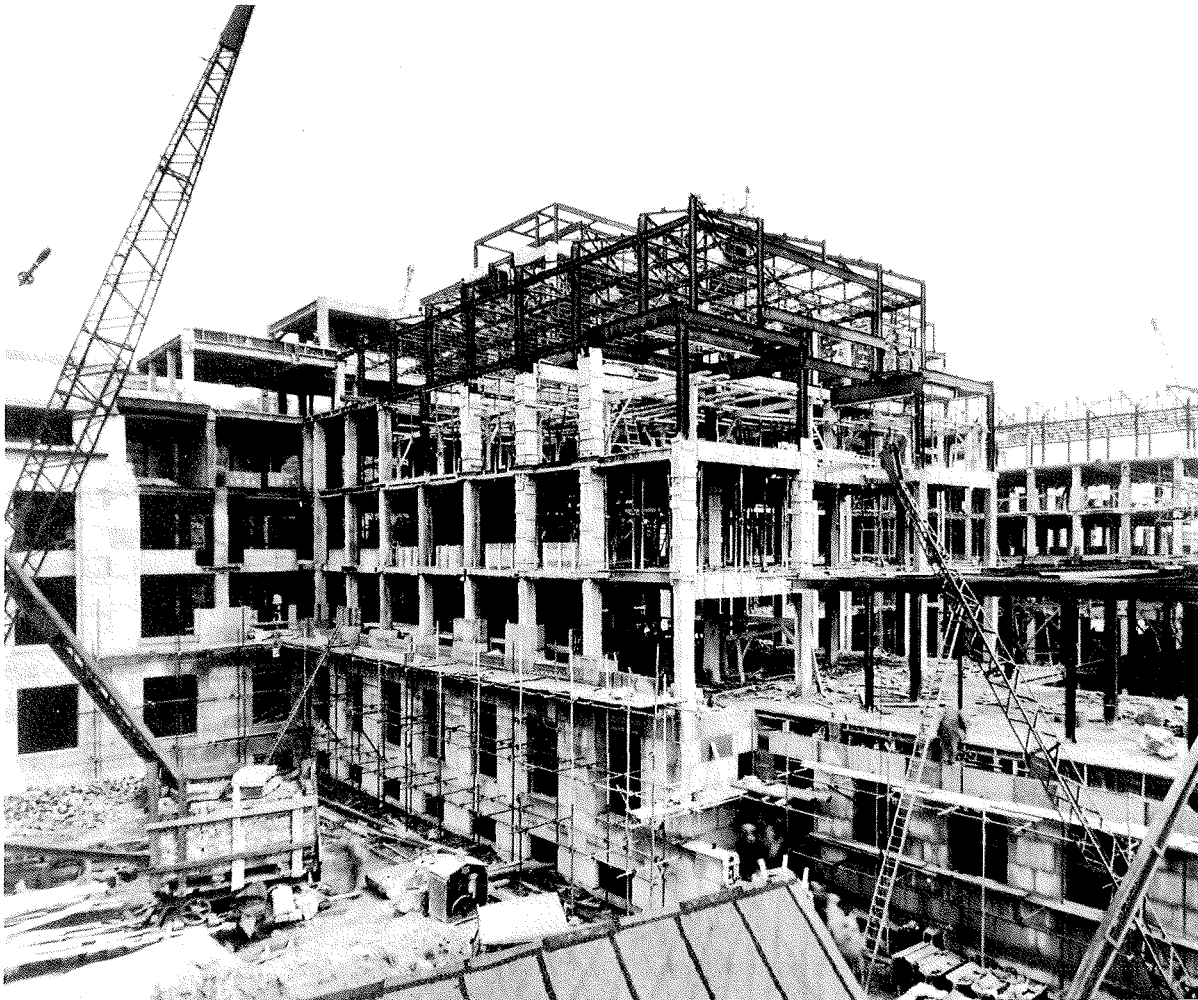
Figure 4. The construction of St Andrews House, Edinburgh. The steel frame, concrete encasement of the steelwork and the addition of stonework can be identified as construction progresses.

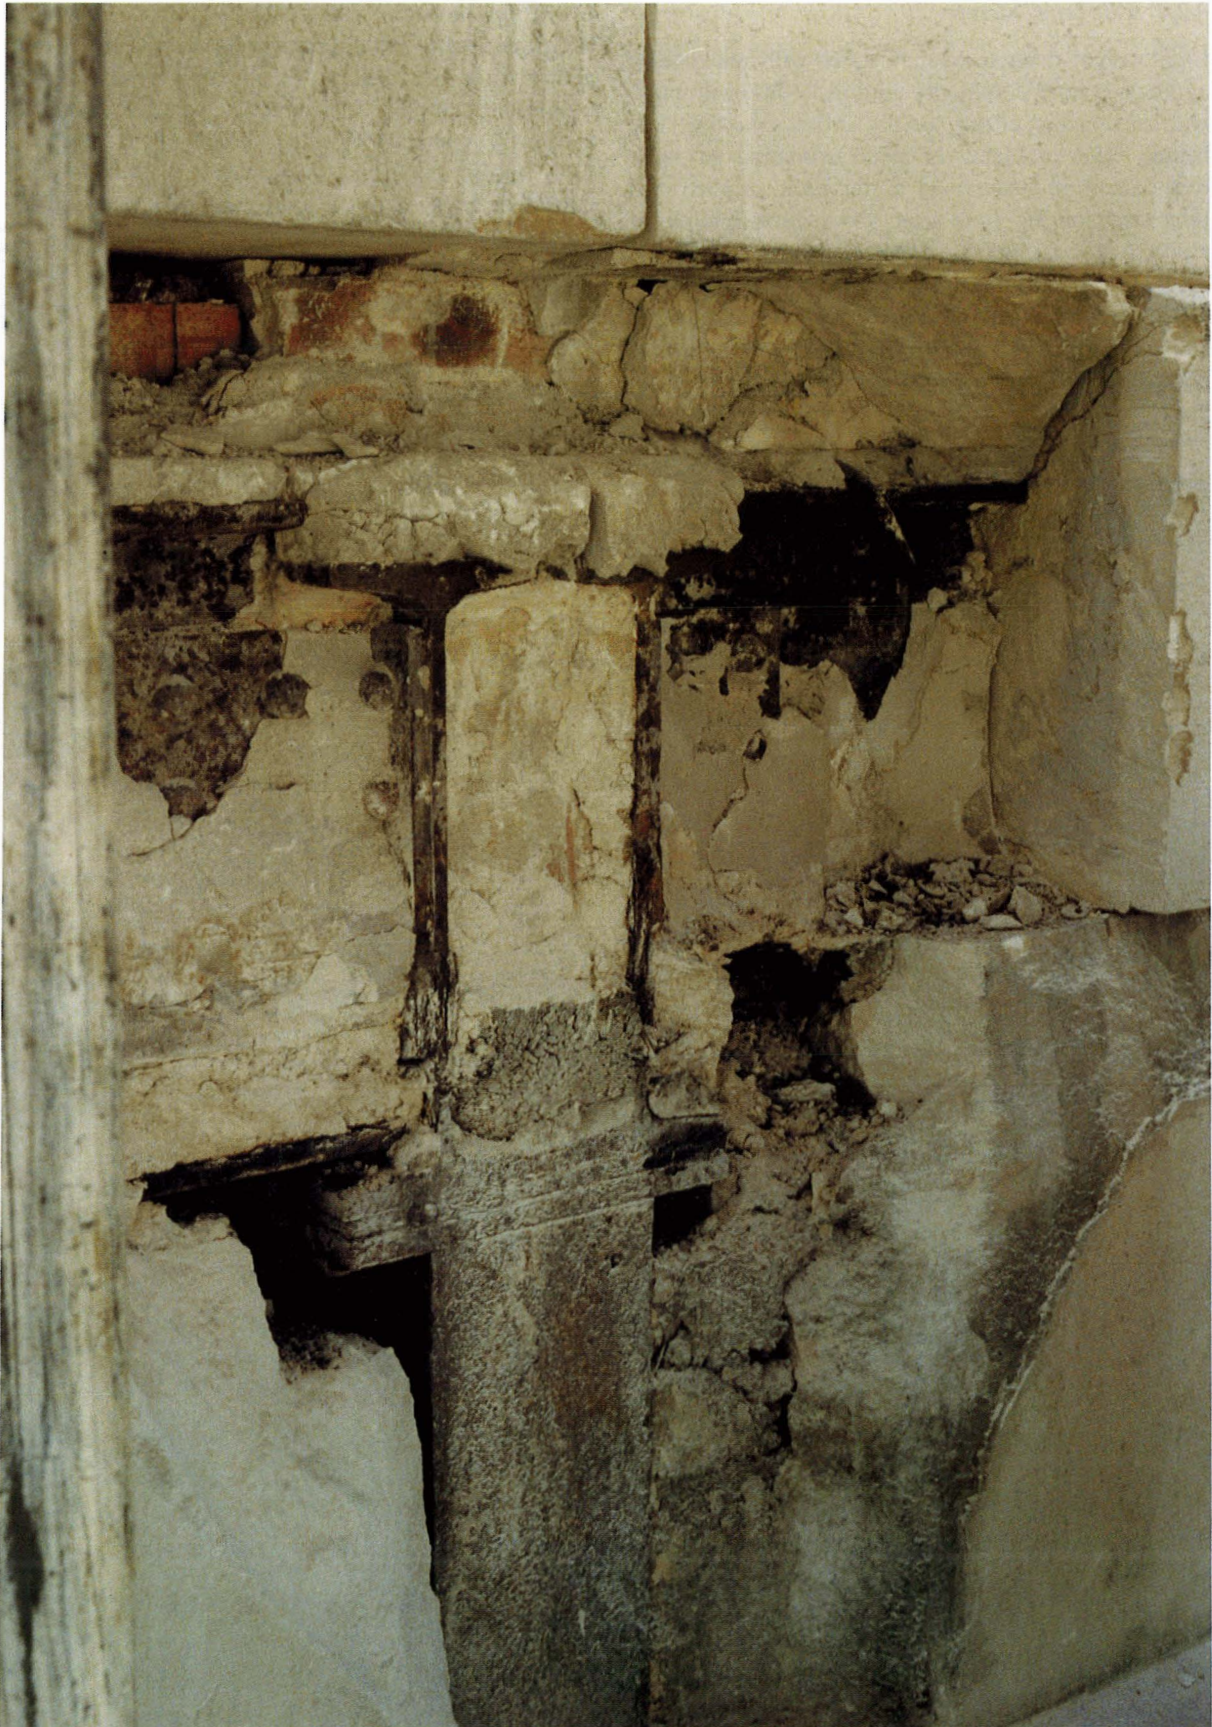
Figure 6. Mortar infilling and notched stonework around steel columns and beams. Note the large void at the plated connection due to difficulty in in-filling at the time of construction.

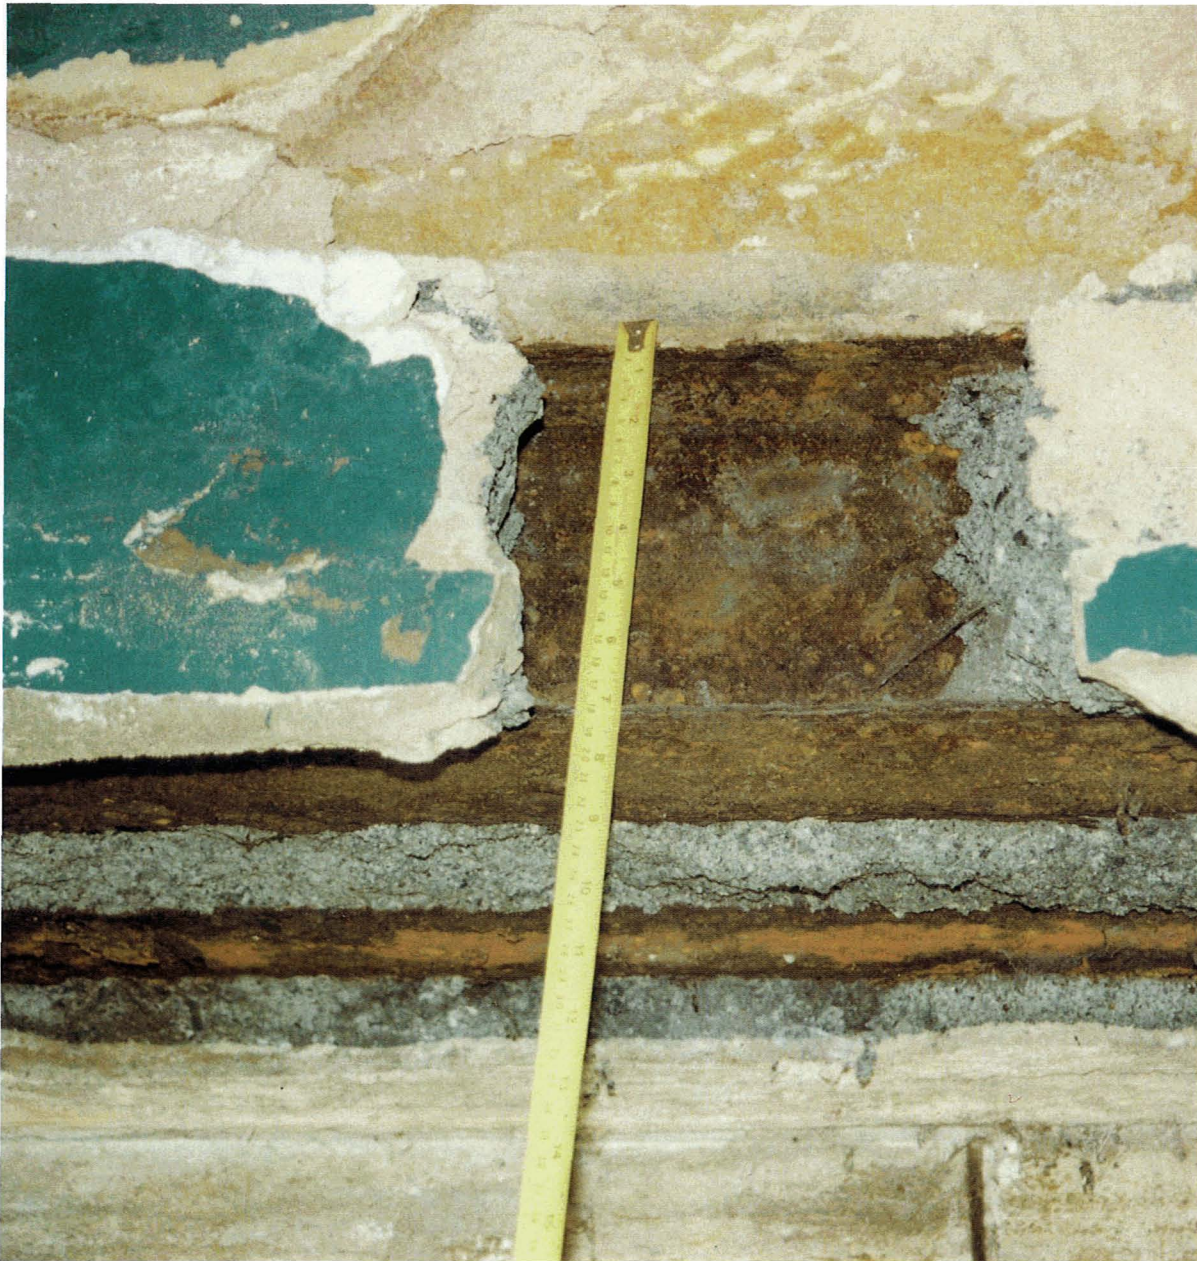
Figure 7. Severe corrosion of this double 'I' section encased in clinker concrete resulted in internal spalling of the concrete and plaster.

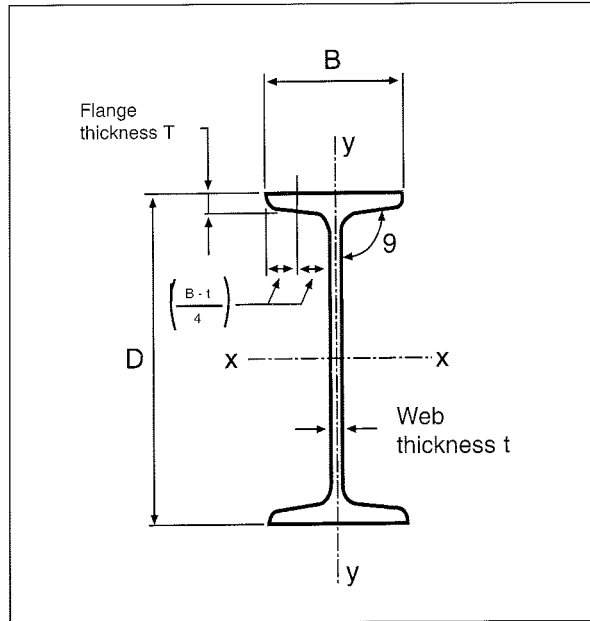
Figure 8. The standard BS4 section.

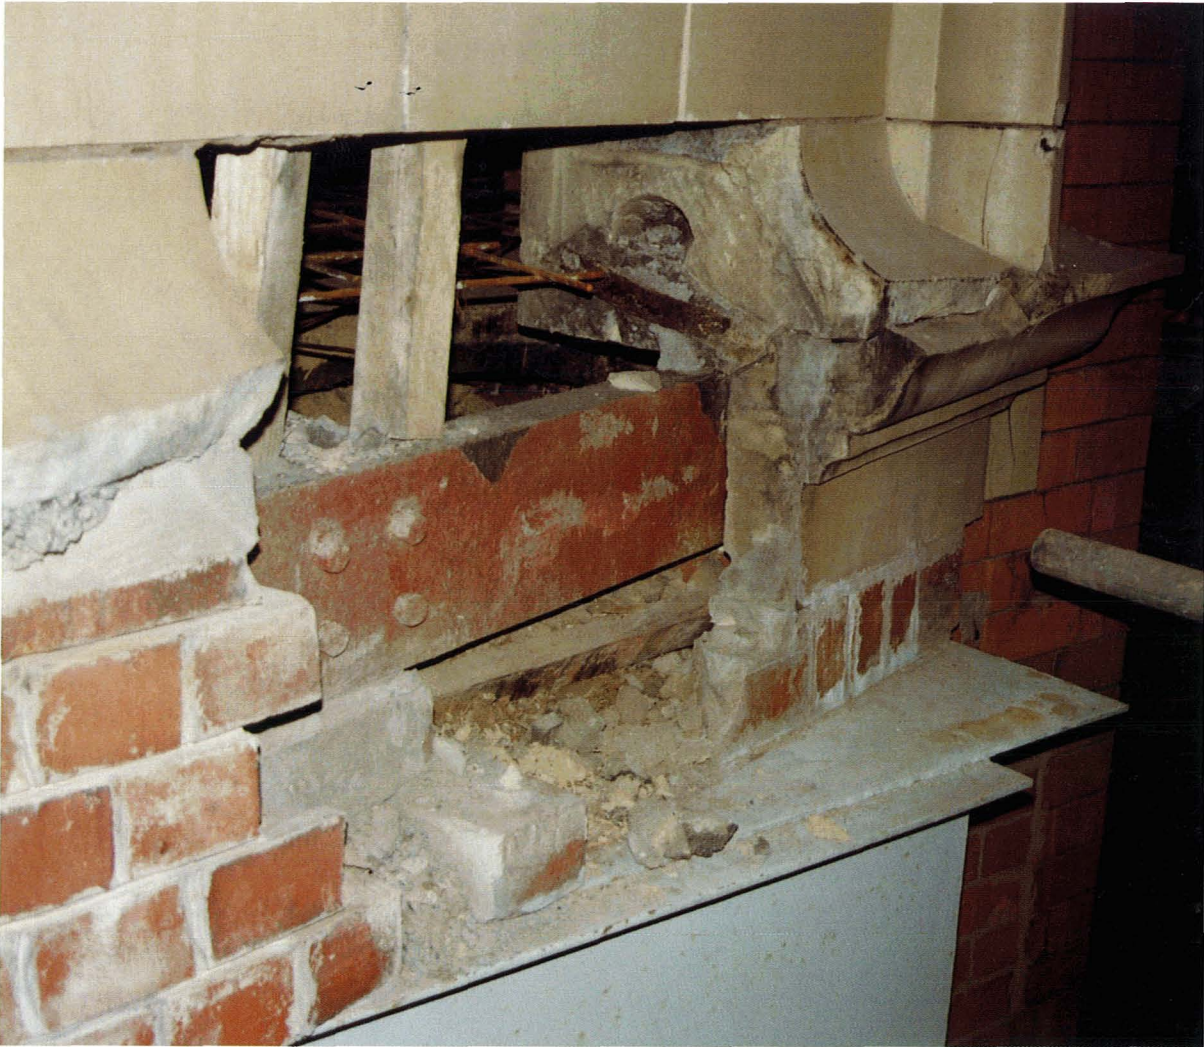
Figure 9. 'Red Lead' paint systems as shown are generally rare in steel framed buildings. However, where used some corrosion protection is provided, especially in locations with voidage. In cases where a mortar connection exists between the frame and cladding corrosion protection is minimal and many such buildings now suffer corrosion problems.

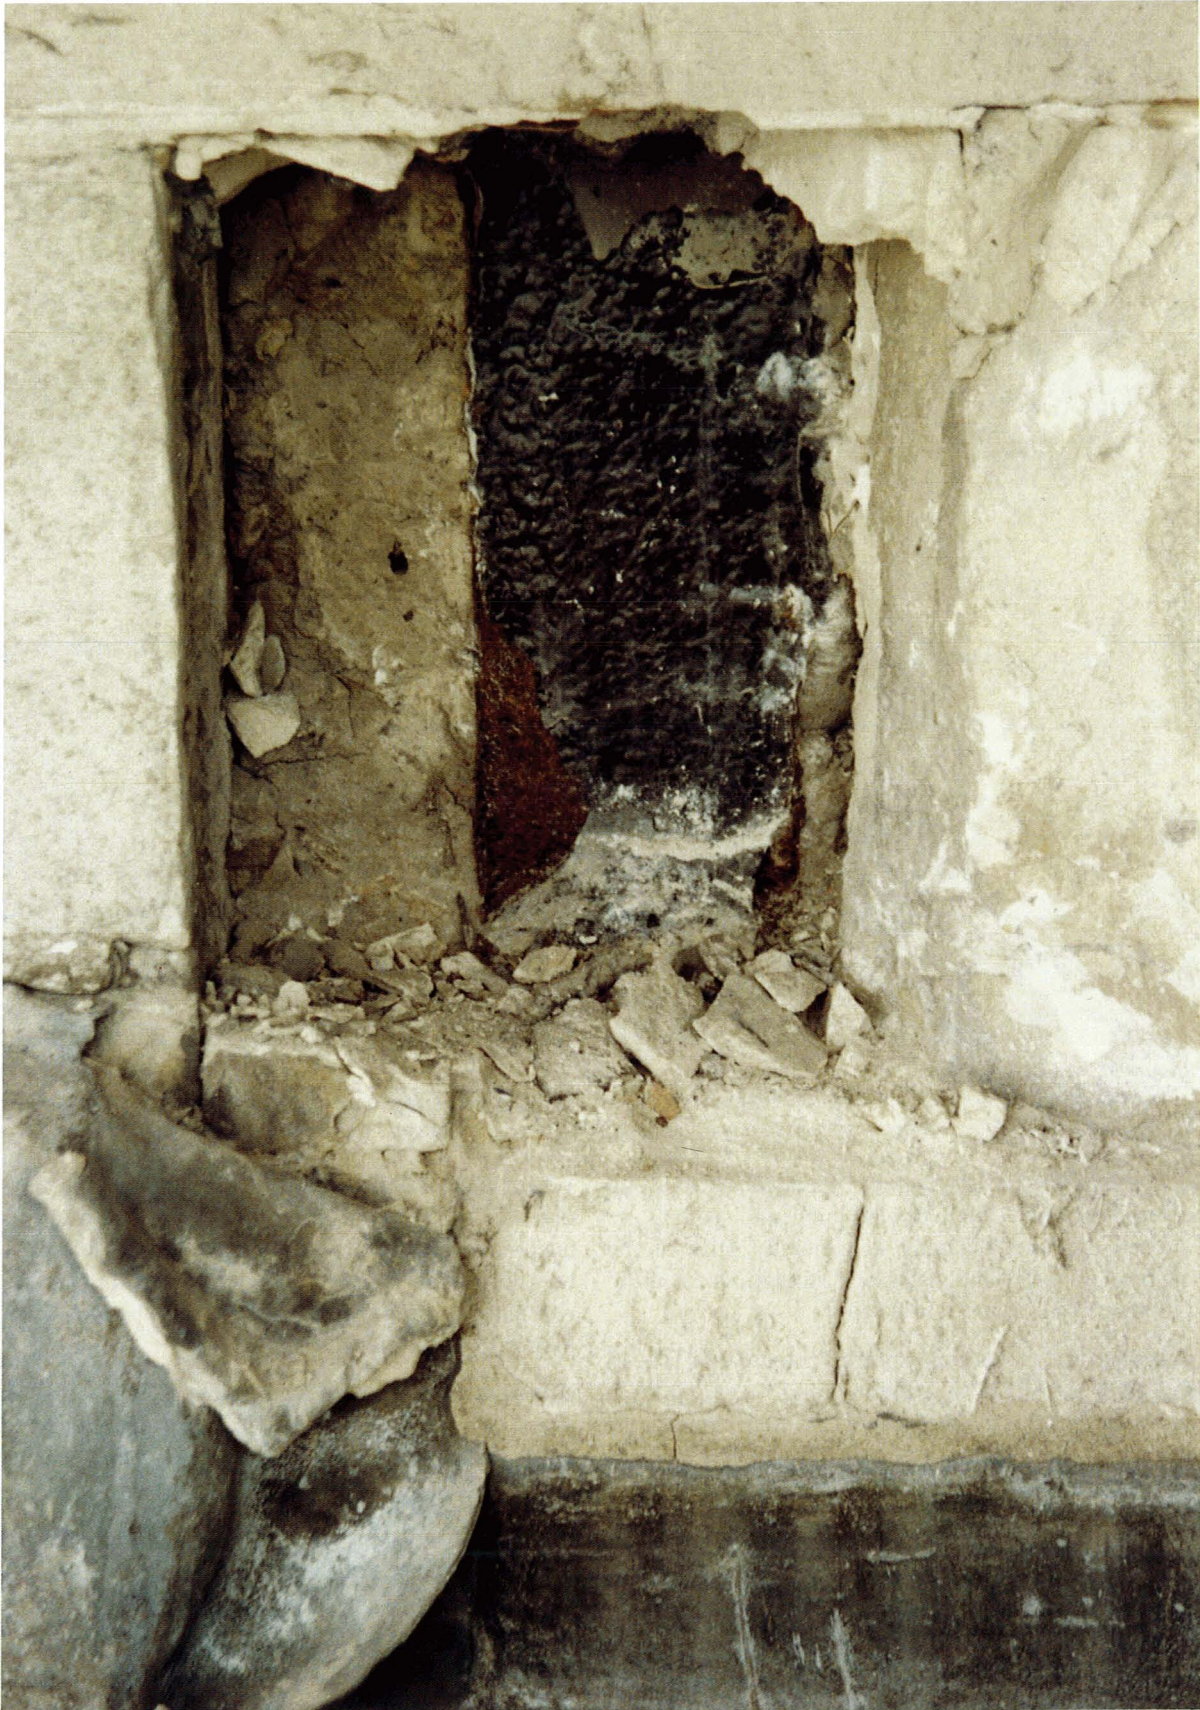
Figure 10. Bituminous paint systems such as these are rare in steel framed buildings and provide little corrosion protection.

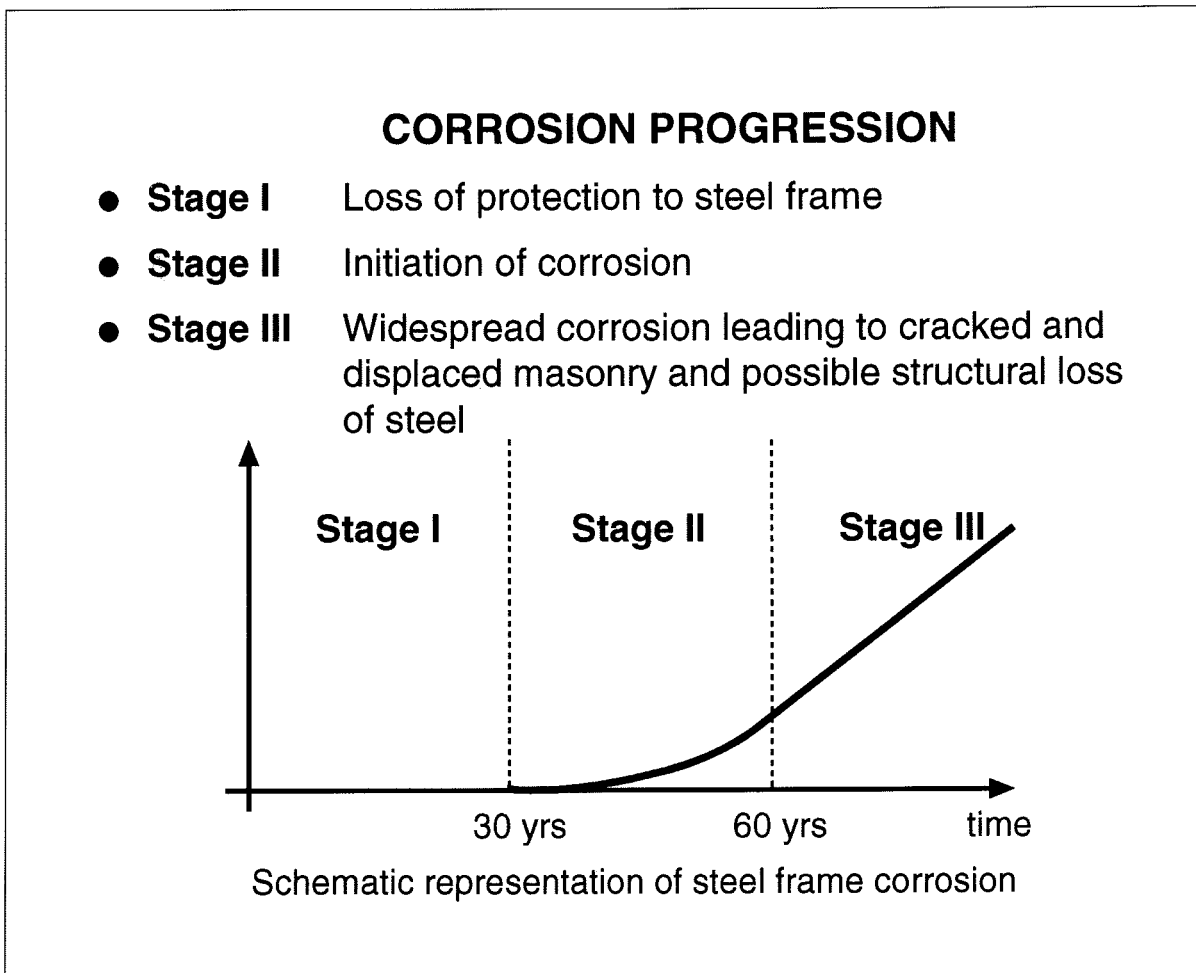
Figure 11. Time to corrosion.

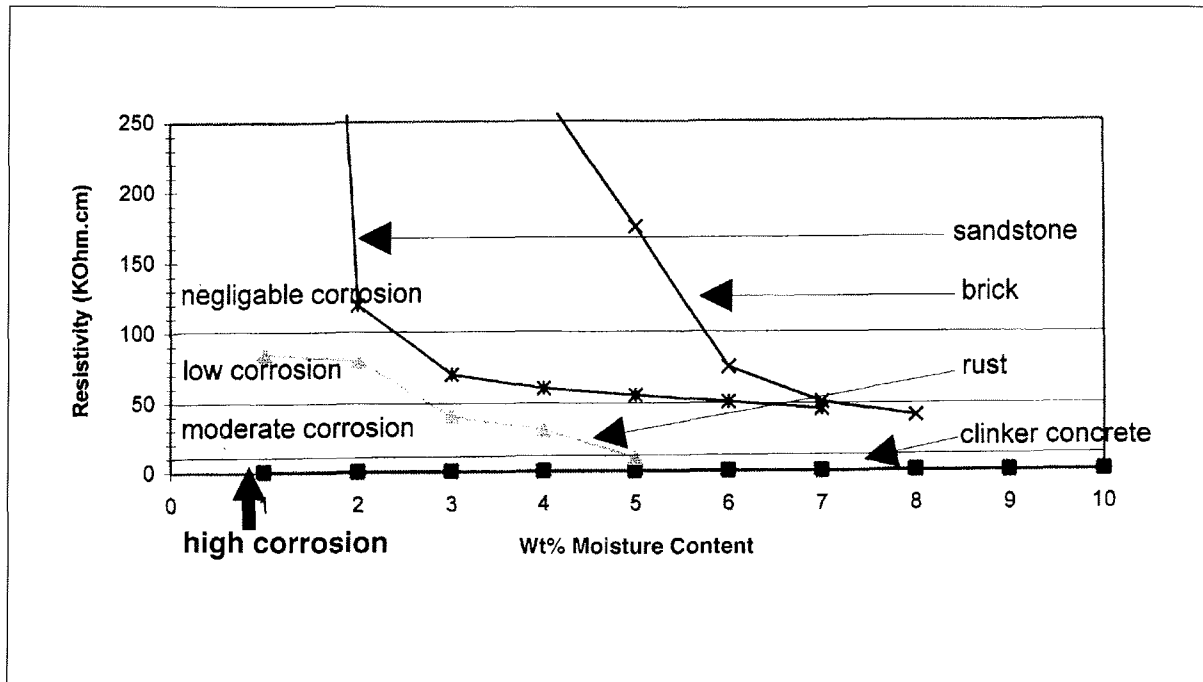
Figure 12. Graph of resistivity vs moisture content for common materials.

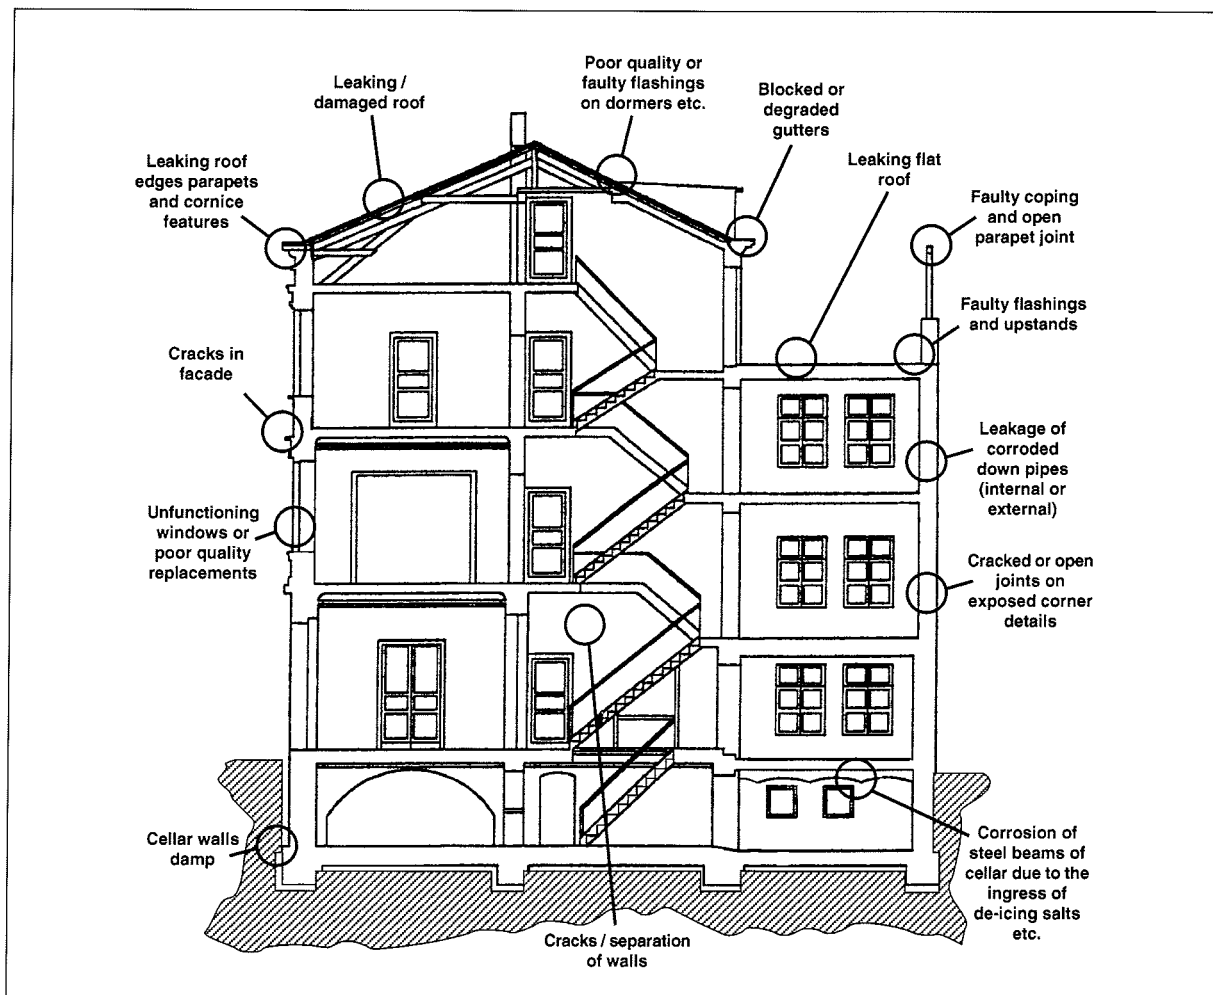
Figure 13. Typical areas of a building where faults lead to the initiation of corrosion. (Adapted from Abb2.8, "Dritter Bericht über Schäden an Gebäuden"; Bundesministerium für Raumordnung, Bauwesen und Städtebau, Bonn; 1996).

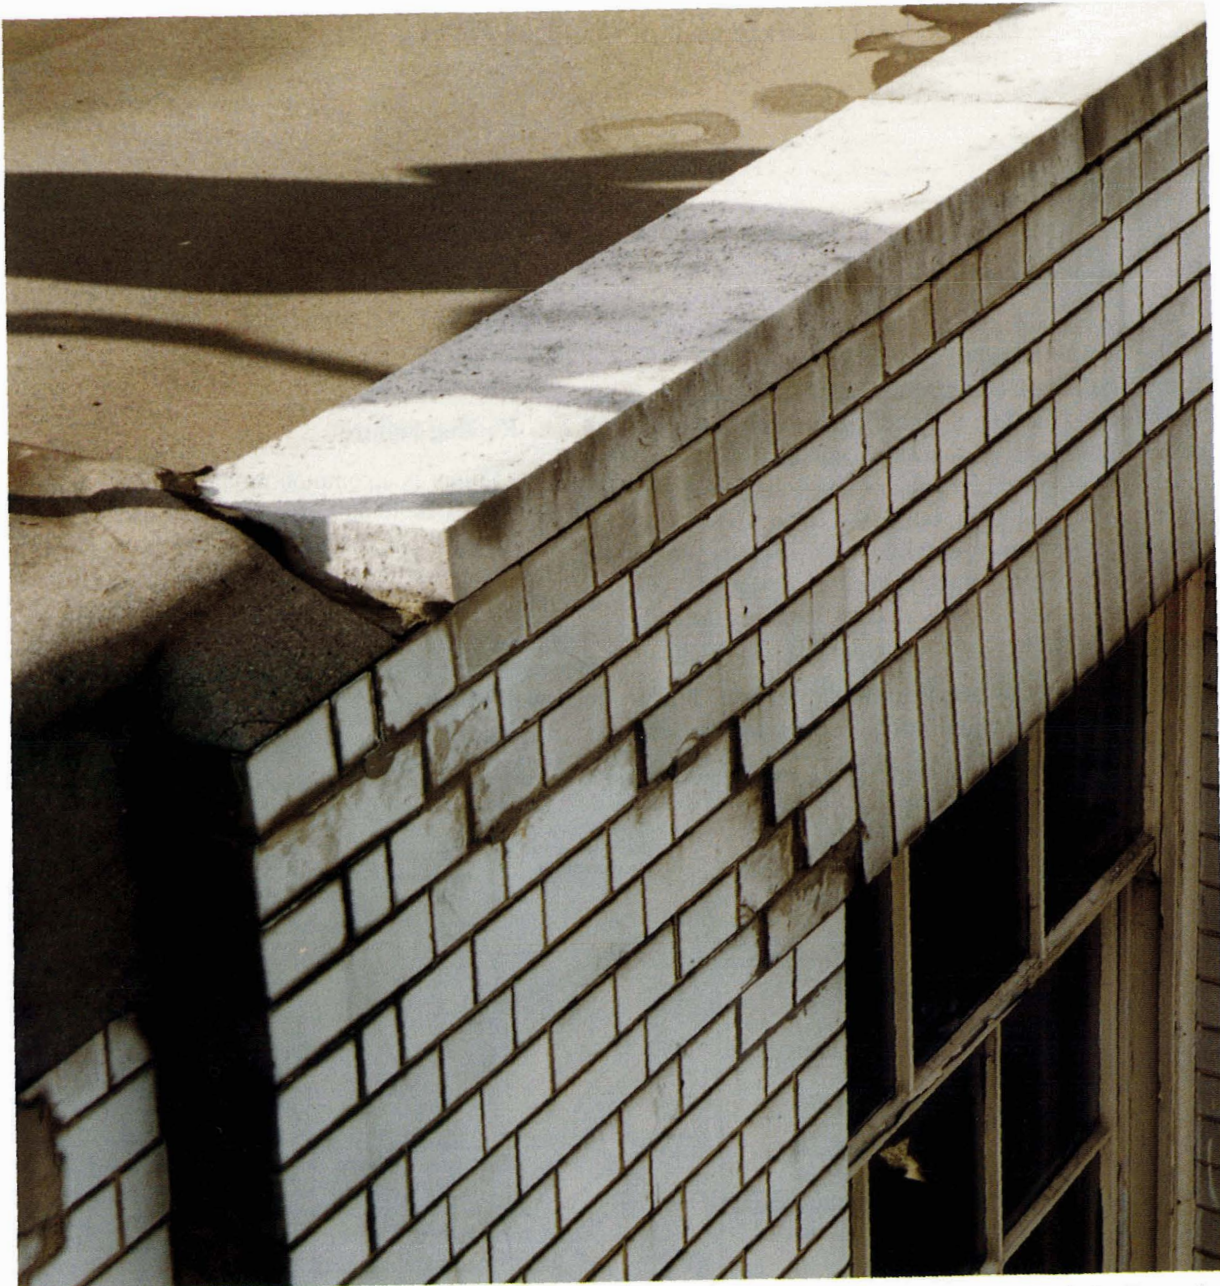
Figure 14. Severe corrosion jacking above a glazed brick window head due to water penetration through a faulty flat roof.

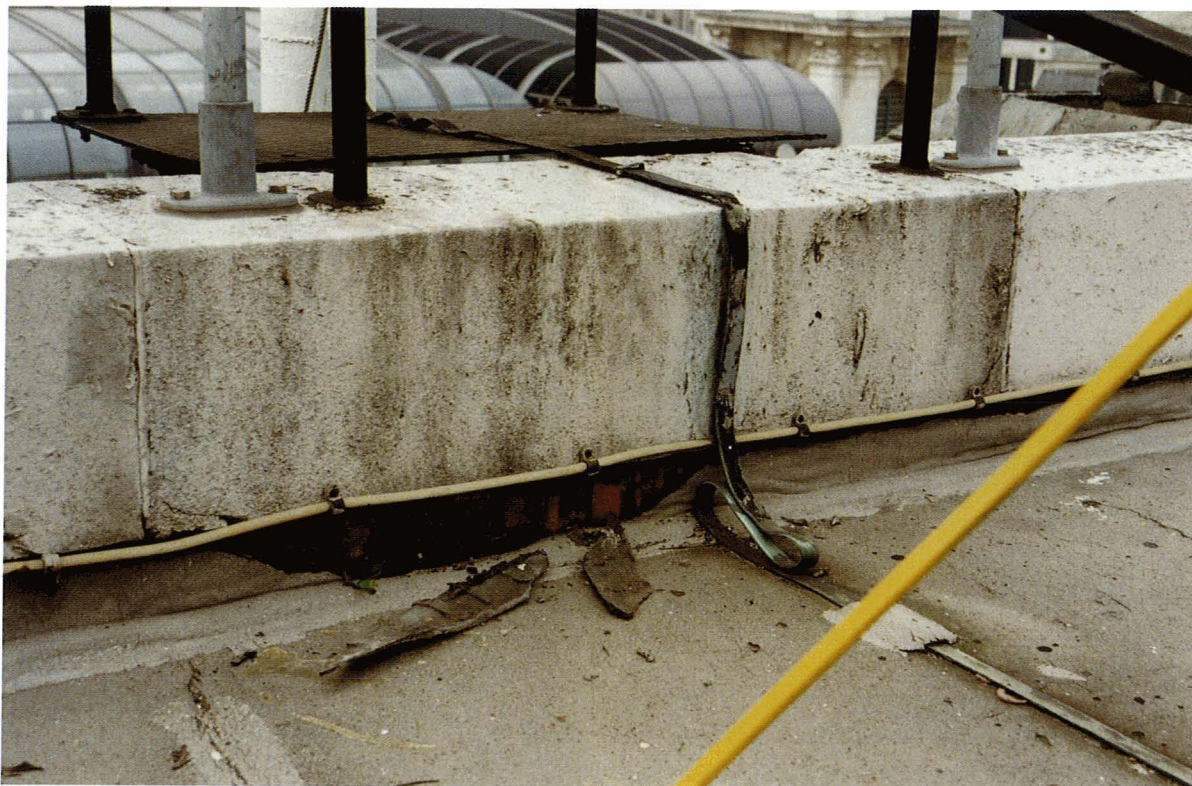
Figure 15. Failed upstand and cracked asphalt on flat roof.

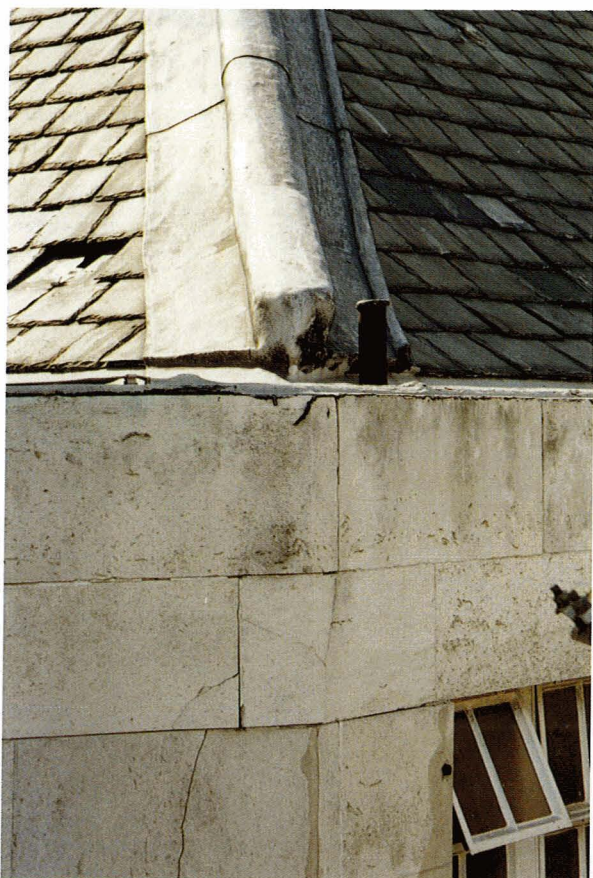
Figure 16. Cracked and displaced masonry due to corrosion resulting from poorly maintained roof.

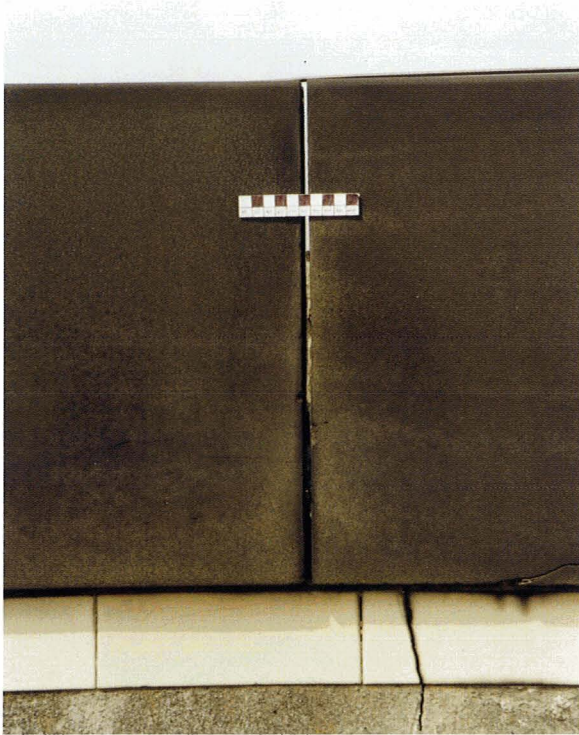
Figure 17. Open joint and cracking in an ashlar sandstone parapet due to thermal cycling. Complete mortar loss has occurred following opening of the joint to twice its original width (each square = 10mm on scale).

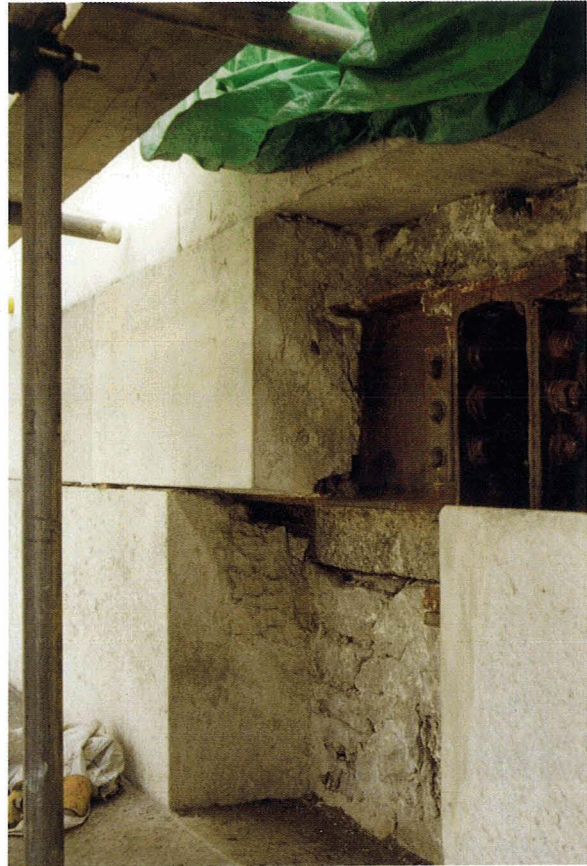
Figure 19. Moisture diffusion through the parapet stone work results in corrosion of steel work. In this case corrosion has resulted in enlargement of the joint adjacent to the lower flange.

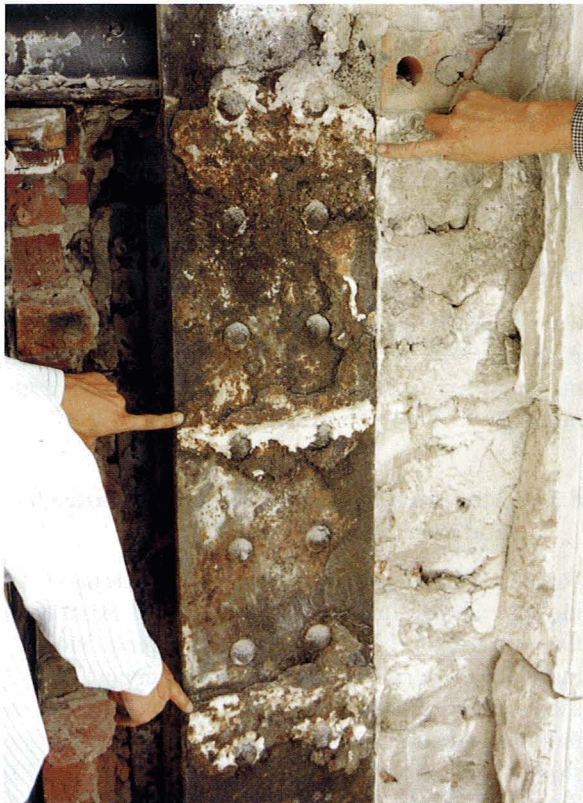
Figure 18. Opening up of a column reveals corrosion problems due to moisture ingress through cracked ashlar jointing. Note the additional corrosion product at the joint locations.

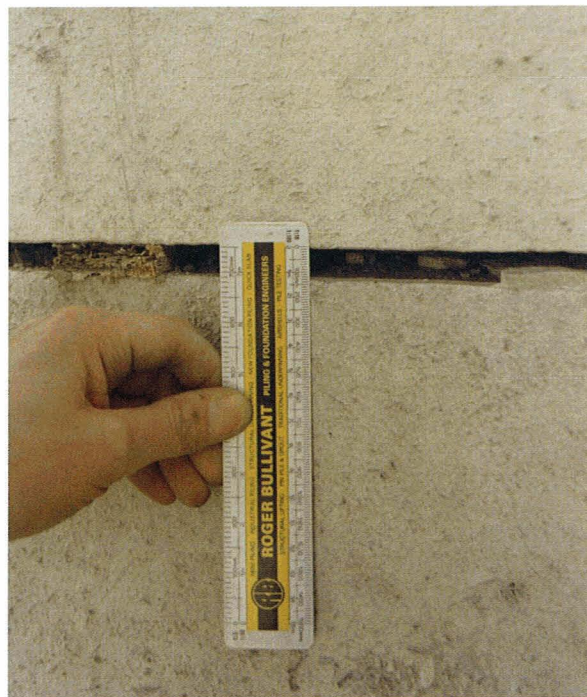
Figure 20. Closer inspection of the parapet stone work of Figure 19 shows corrosion of the lower flange has resulted in opening of the joint from 5mm to 12mm. Problems such as these are typical in corroding steel frame buildings.

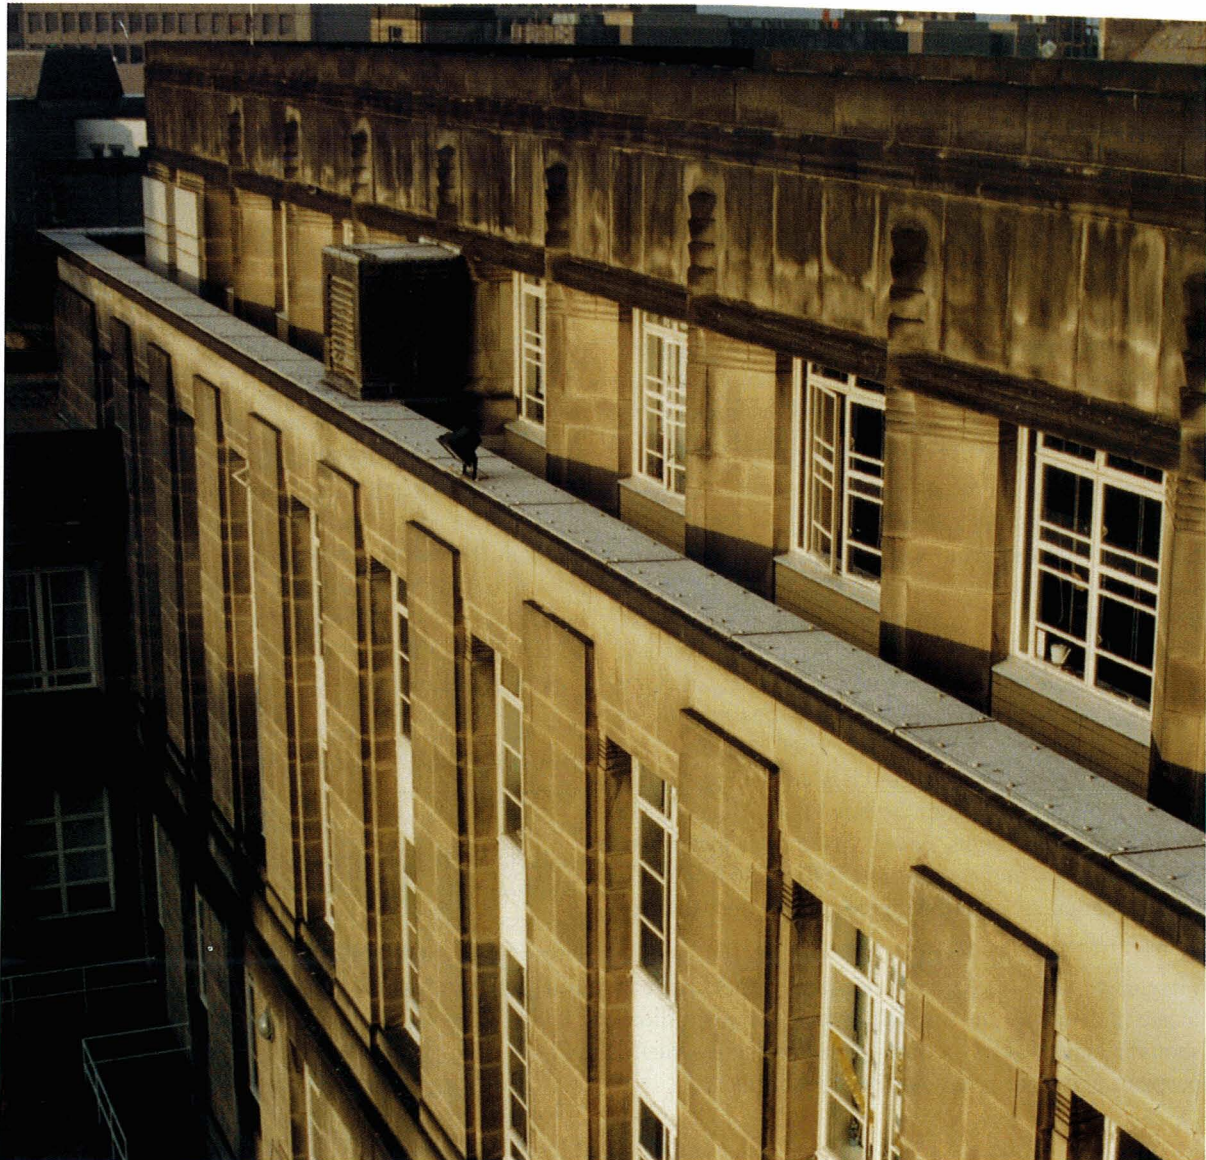
Figure 21. The early addition of a capping to a parapet wall coping in a sandstone clad building to prevent water penetration into the building.
