TECHNICAL
ADVICE
NOTE

CORROSION IN
MASONRY CLAD
EARLY 20TH
CENTURY STEEL
FRAMED
BUILDINGS

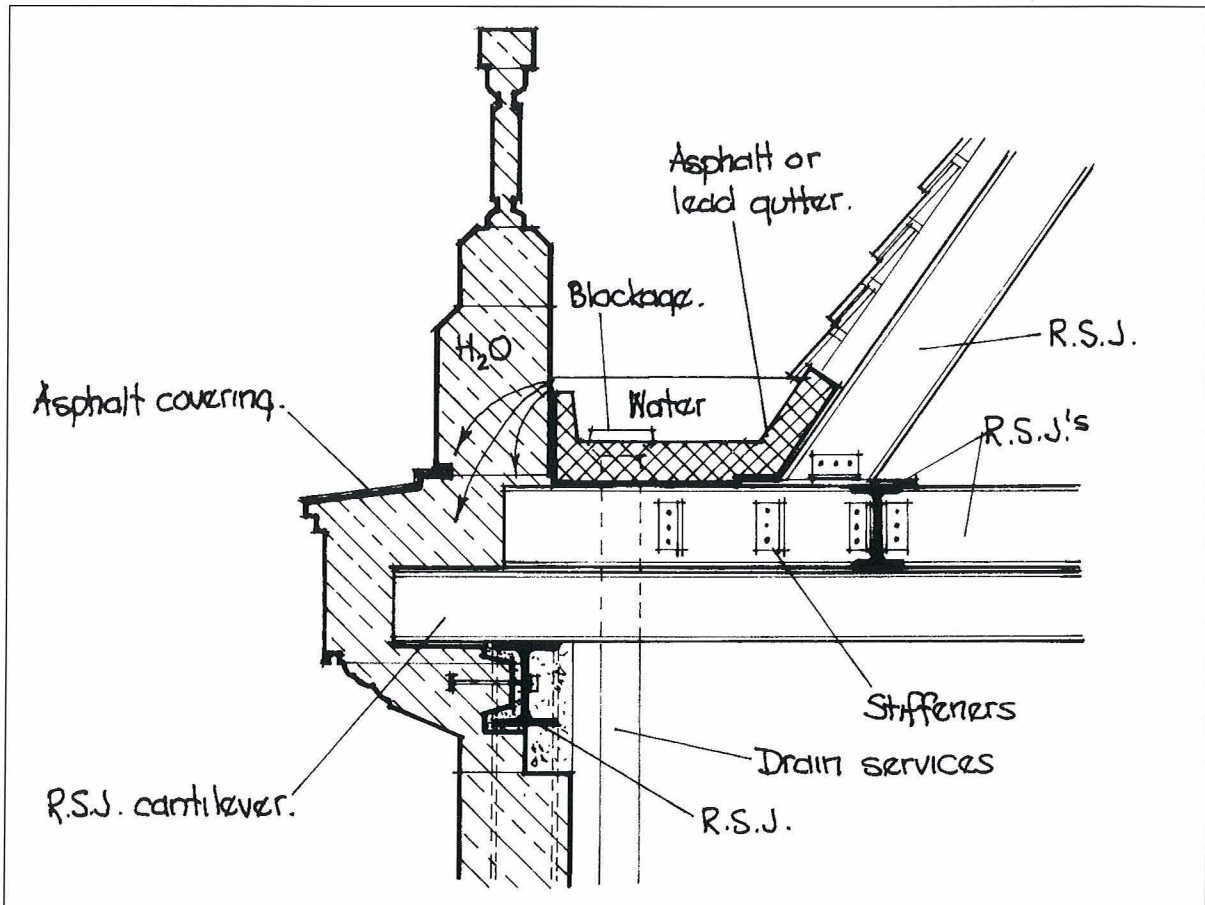
Figure 22. Typical construction of guttering and the associated problem of down-pipe blockage.

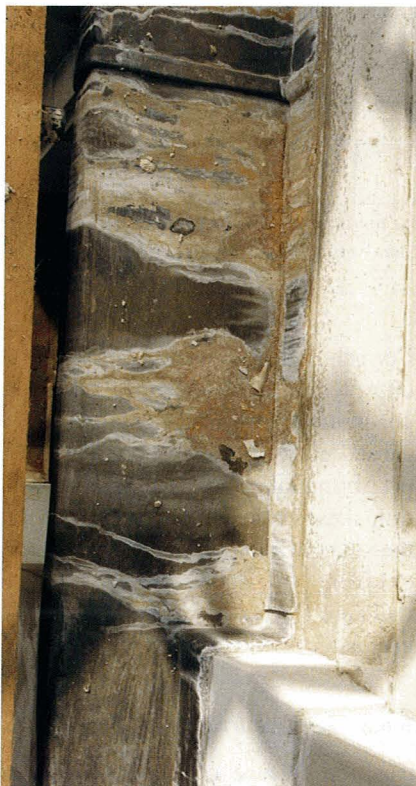
Figure 23. Staining of cornice cover flashing due to water overflow as a result of blocked guttering.

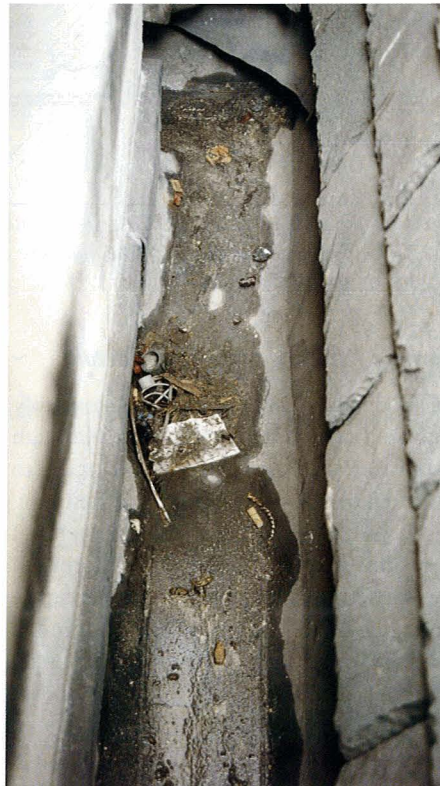
Figure 24. Blockage of rainwater outlet pipe in gutter.

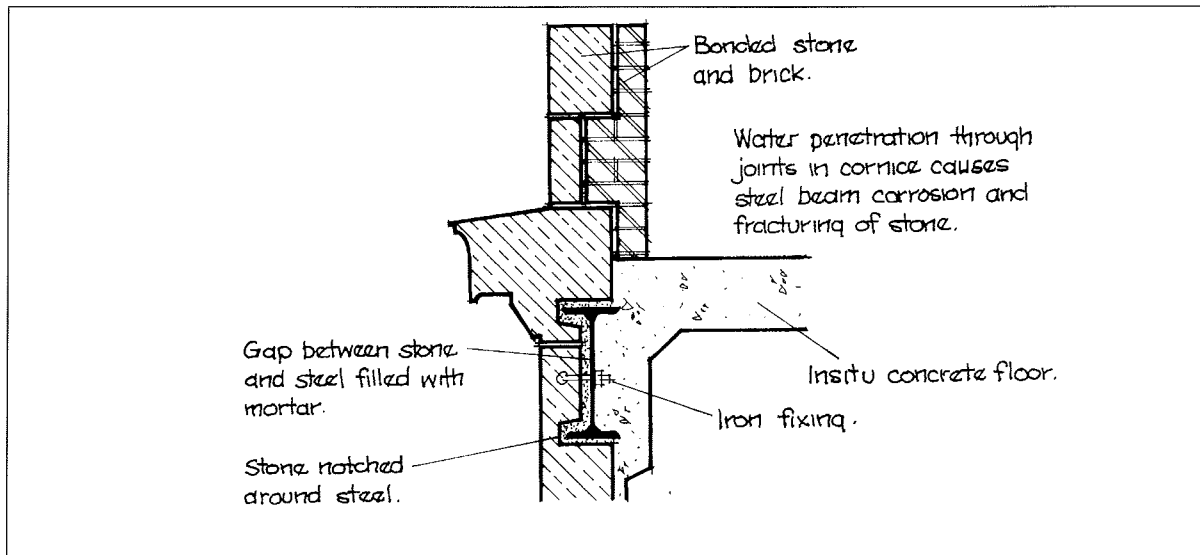
Figure 25. Typical stone/brick masonry design. Water penetration causes steel beam corrosion and fracturing of the stone/masonry.

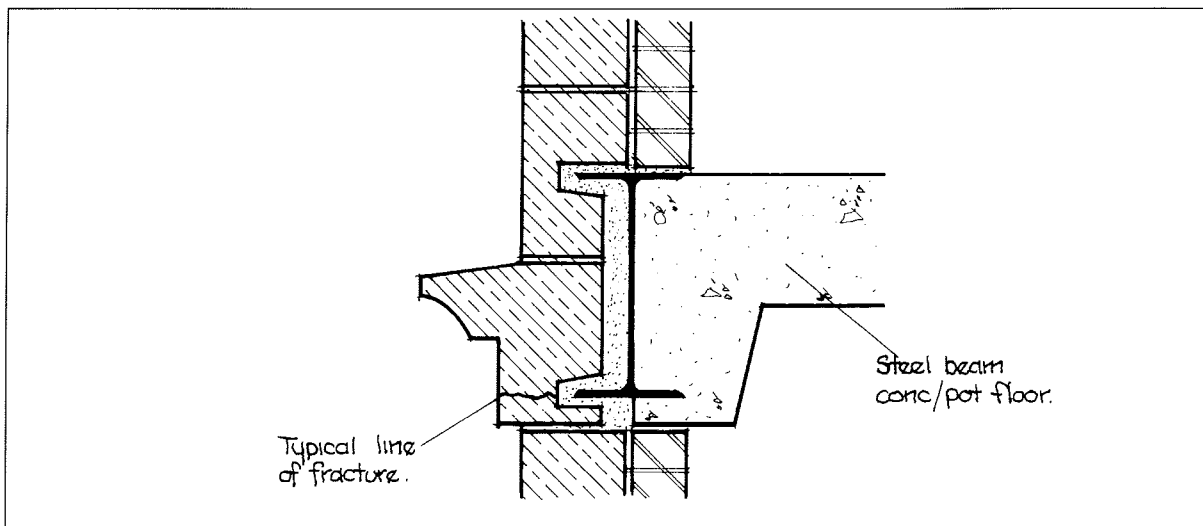
Figure 26. Typical terracotta/faience design. Water penetrates the terracotta through open or degraded joints. Due to the impervious nature of the firing skin or glazing, the moisture becomes entrapped resulting in corrosion of the underlying steel frame and cracking of the terracotta.

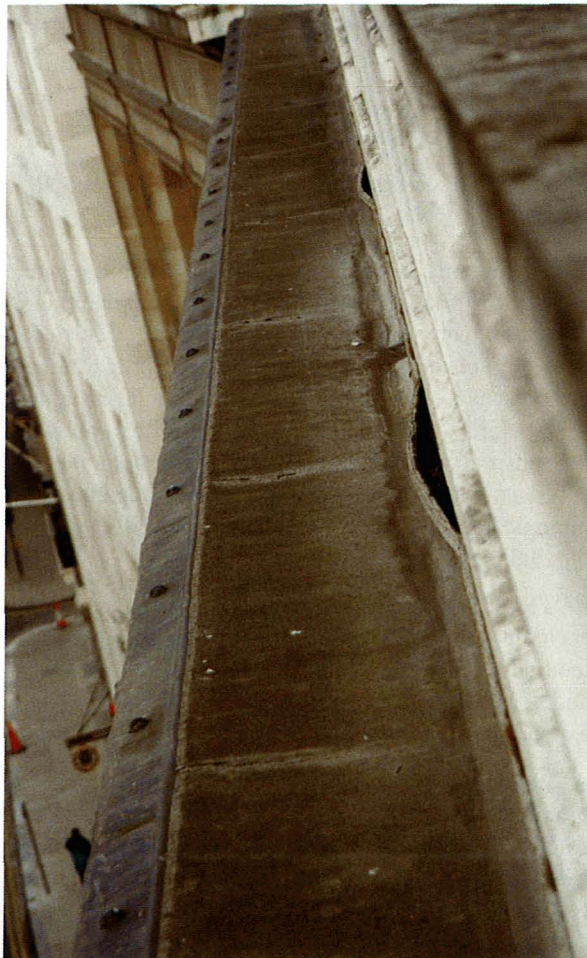
Figure 28. Detached asphalt on upstands and cracking due to thermal movements in the underlying stone allows the direct penetration of rainwater.

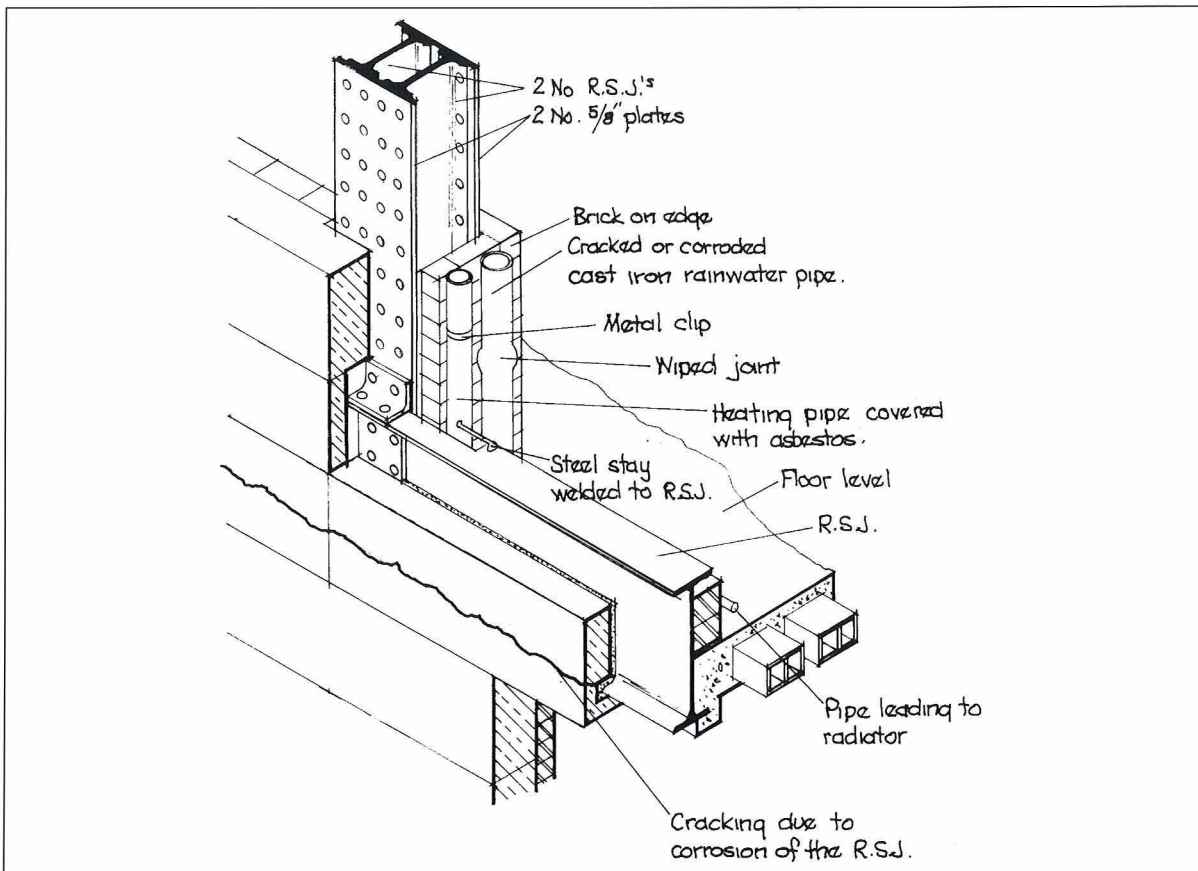
Figure 29. Cracked and corroded rainwater pipes allow saturation of the surrounding masonry and corrosion of the RSJ causing cracking of the stonework along the weakest points, i.e. at flange locations.

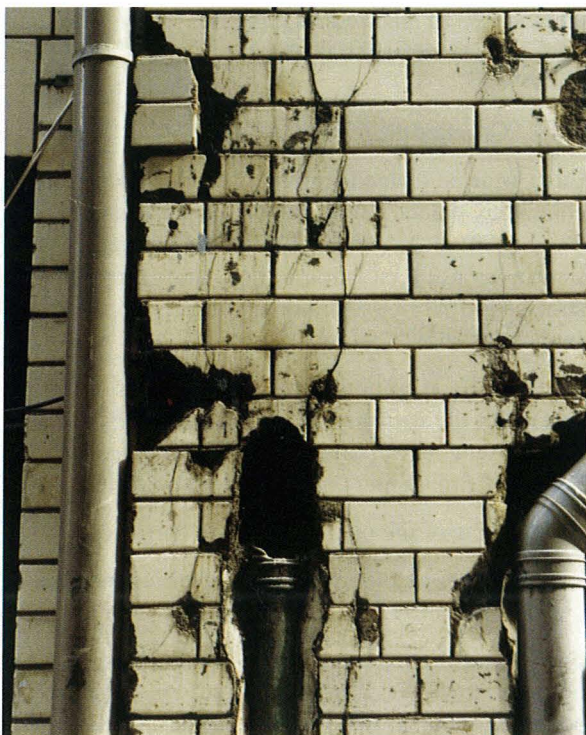
Figure 30. Failure of the glazed brick was attributable to corrosion of the steel frame resulting from leakage of the exiting rainwater pipe from within the wall.

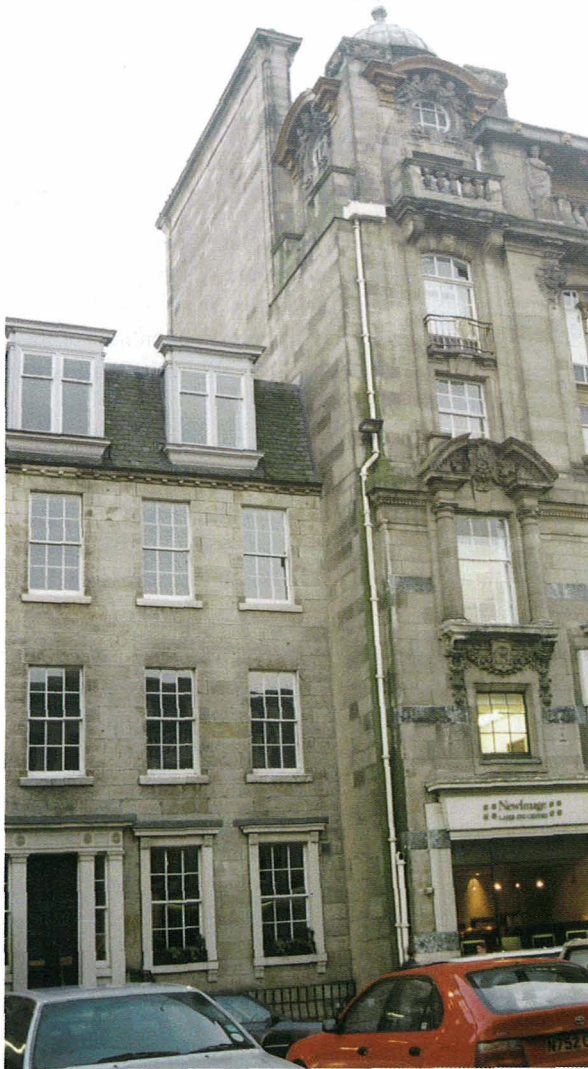
Figure 31. Biological growth around cracked rain water pipe indicating failure.

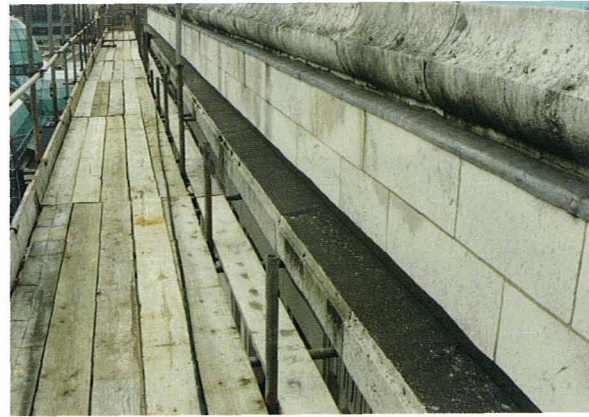
Figure 32. Bituminous waterproofing paint added to a cornice detail.

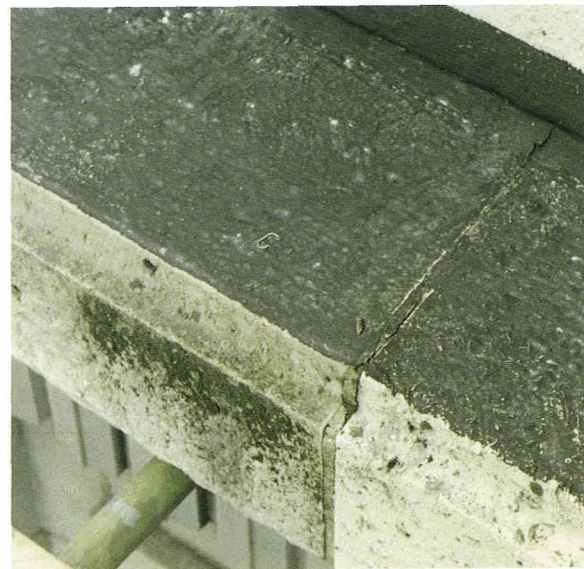
Figure 33. Closer inspection reveals failure of the bituminous waterproofing layer at ashlar joint locations due to thermal movements of the underlying masonry.

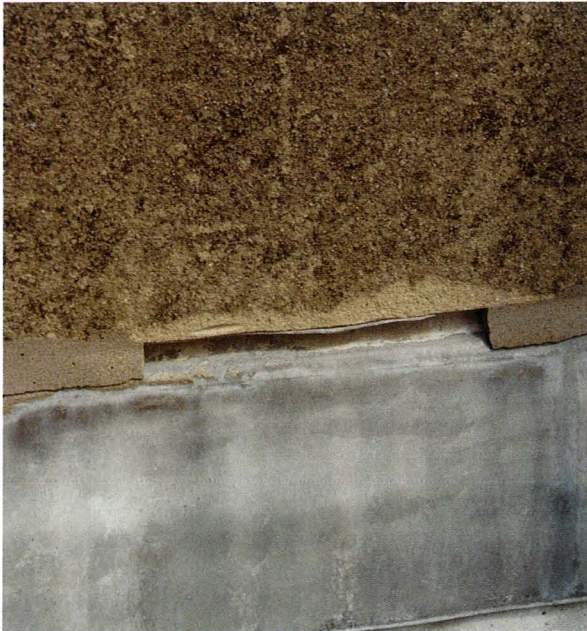
Figure 34. Poor ragging of a parapet flashing. Faults such as these can result in the rapid penetration of moisture and corrosion of the underlying steelwork due to water penetration behind the flashing.

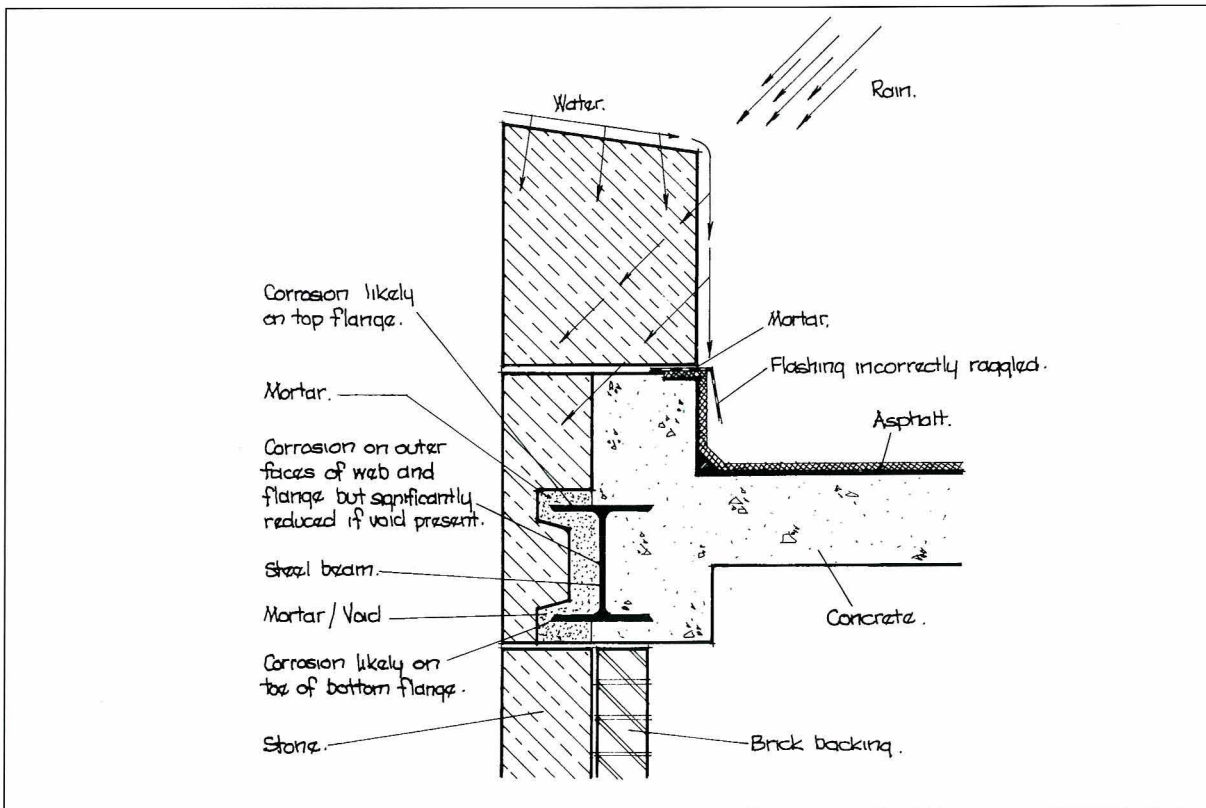
Figure 35. Sketch illustrating water penetration due to the faulty ragging of lead flashing. Note: water will also penetrate through porous stone and masonry in addition to other sources of entry such as cracked asphalt roofing.

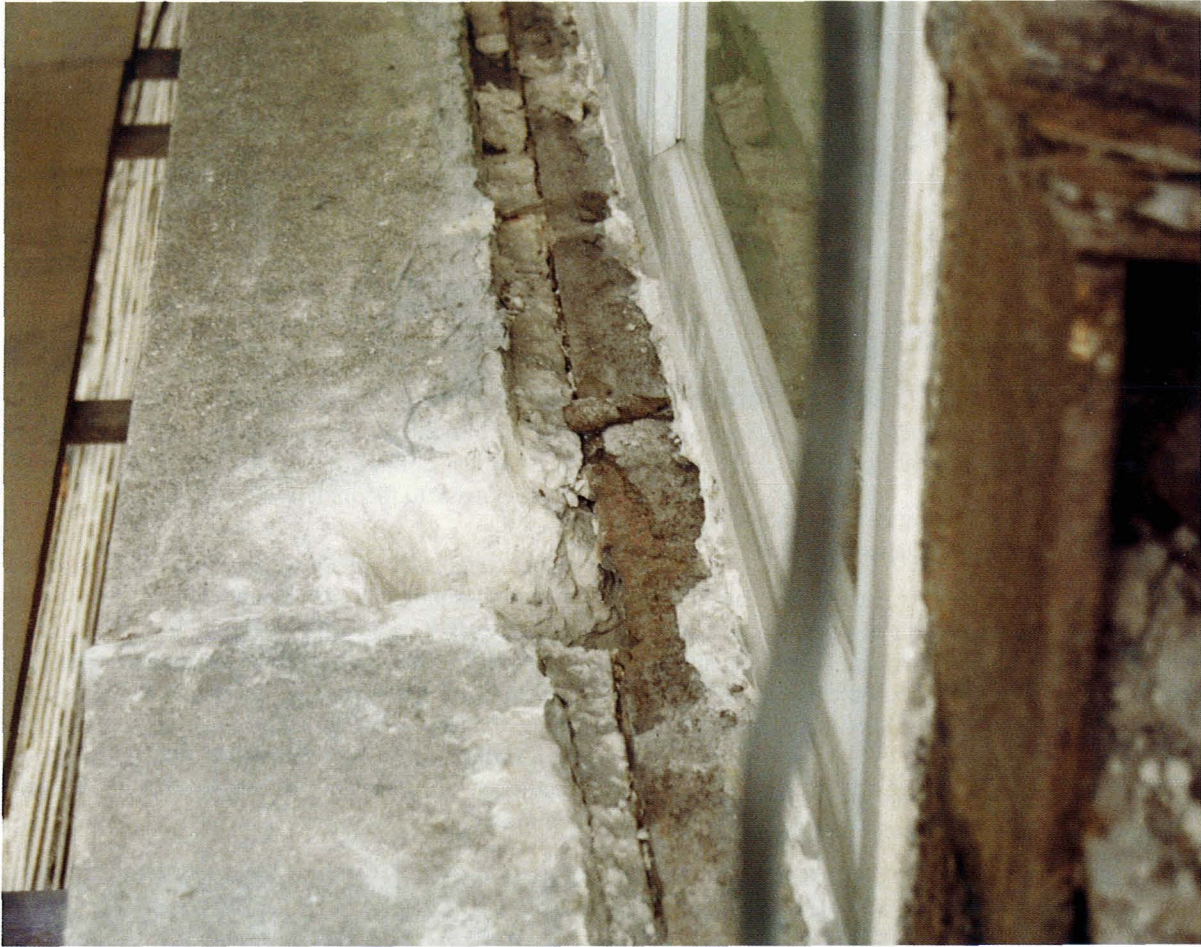
Figure 36. Poor quality window replacement can result in the penetration of water. Note - the corrosion of underlying steel work with insufficient concrete cover.

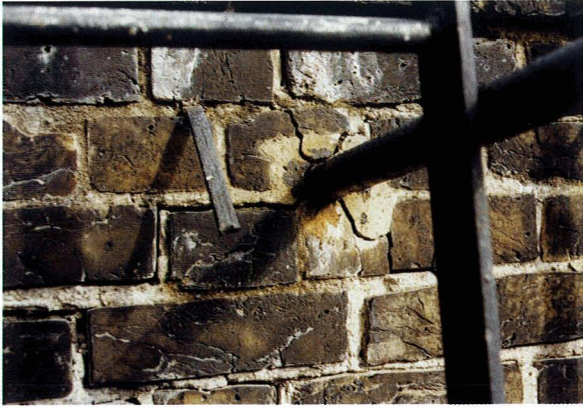
Figure 37. Photograph showing cracking of brick masonry due to corrosion of the fire escape fixing.

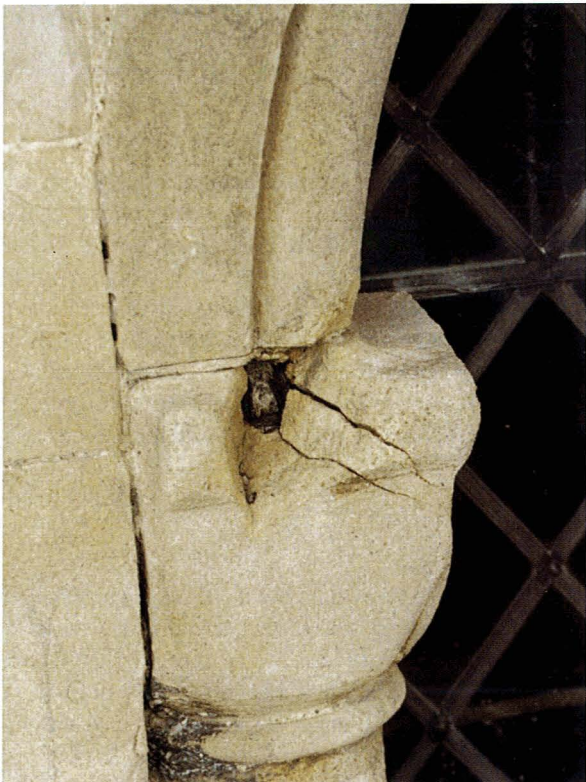
Figure 38. Damage caused by the corrosion of iron and steel fixings has been known for many years. This figure shows damage caused by the corrosion of a small iron fixing. In steel framed buildings the corrosion of any iron or steel fixings results in a similar problem. However, cracks and damage to the façade allows the direct penetration of moisture and corrosion of the steel frame.

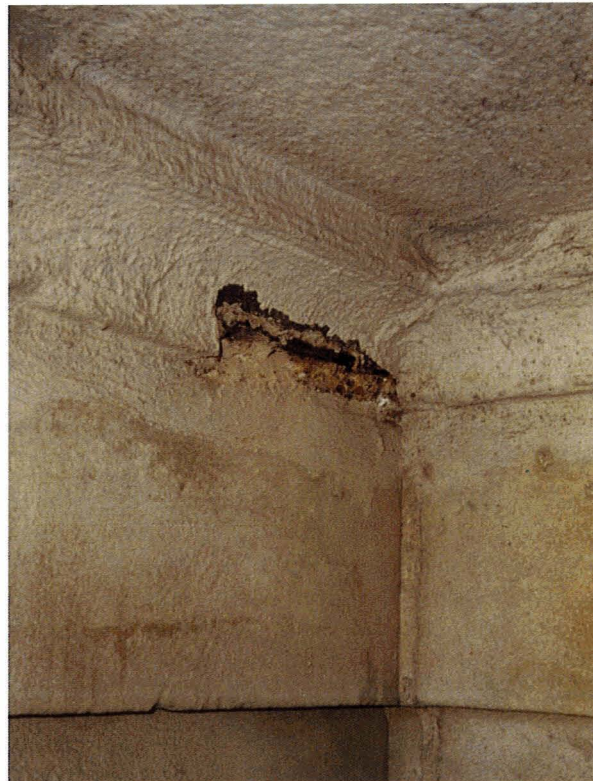
Figure 39. Spalling of a high level cornice repair due to corrosion of the mild steel fixing.

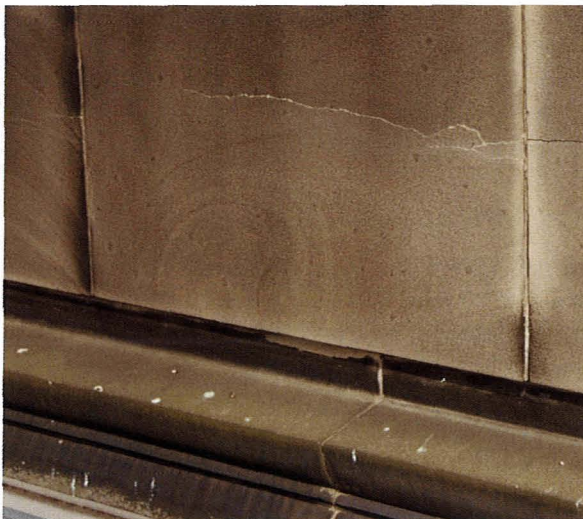
Figure 40. Photograph showing crack in a sandstone parapet. Fine cracks such as these are easily missed in binocular surveys or inspections from a distance.

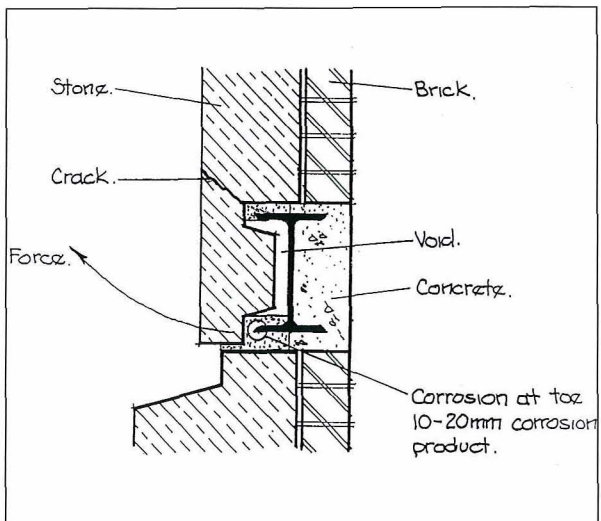
Figure 41. Sketch illustrating the initiation of cracking of Figure 40, due to expansive corrosion products on the beam flanges.

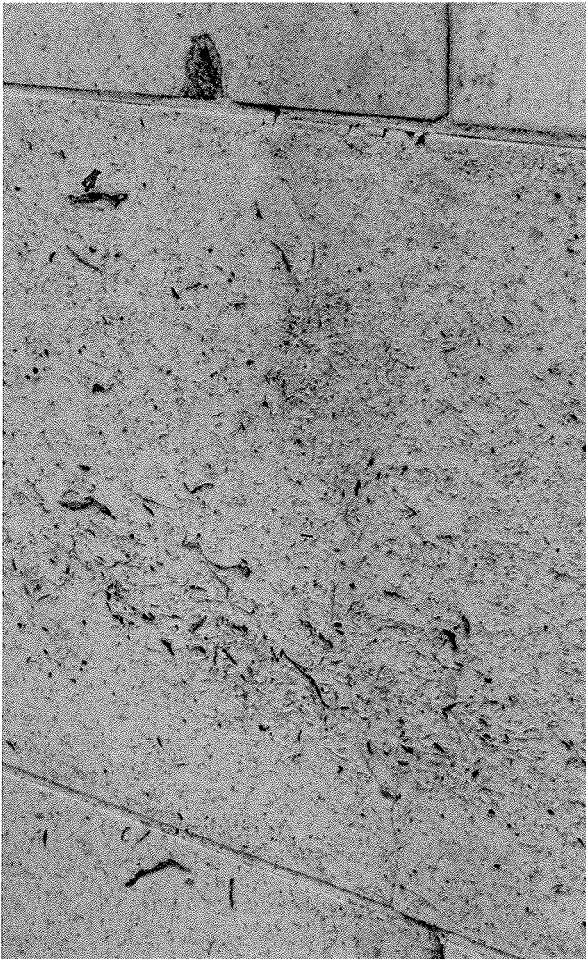
Figure 42. Viewing from a north easterly direction in this Portland stone building, the corrosion induced cracking is easily missed.

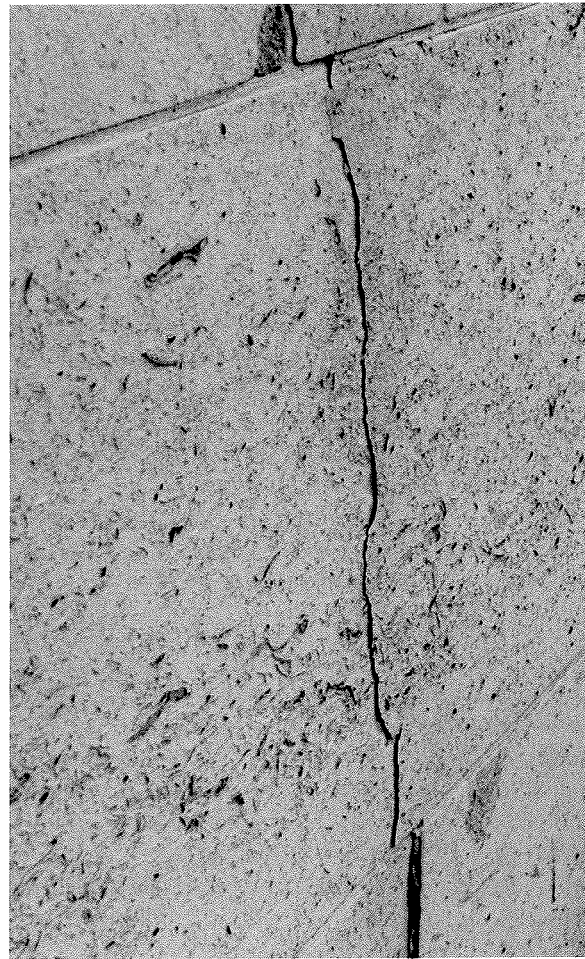
Figure 43. Viewing from the south easterly direction reveals the significant level of cracking due to corrosion of the underlying steel column.(see Figure 44)

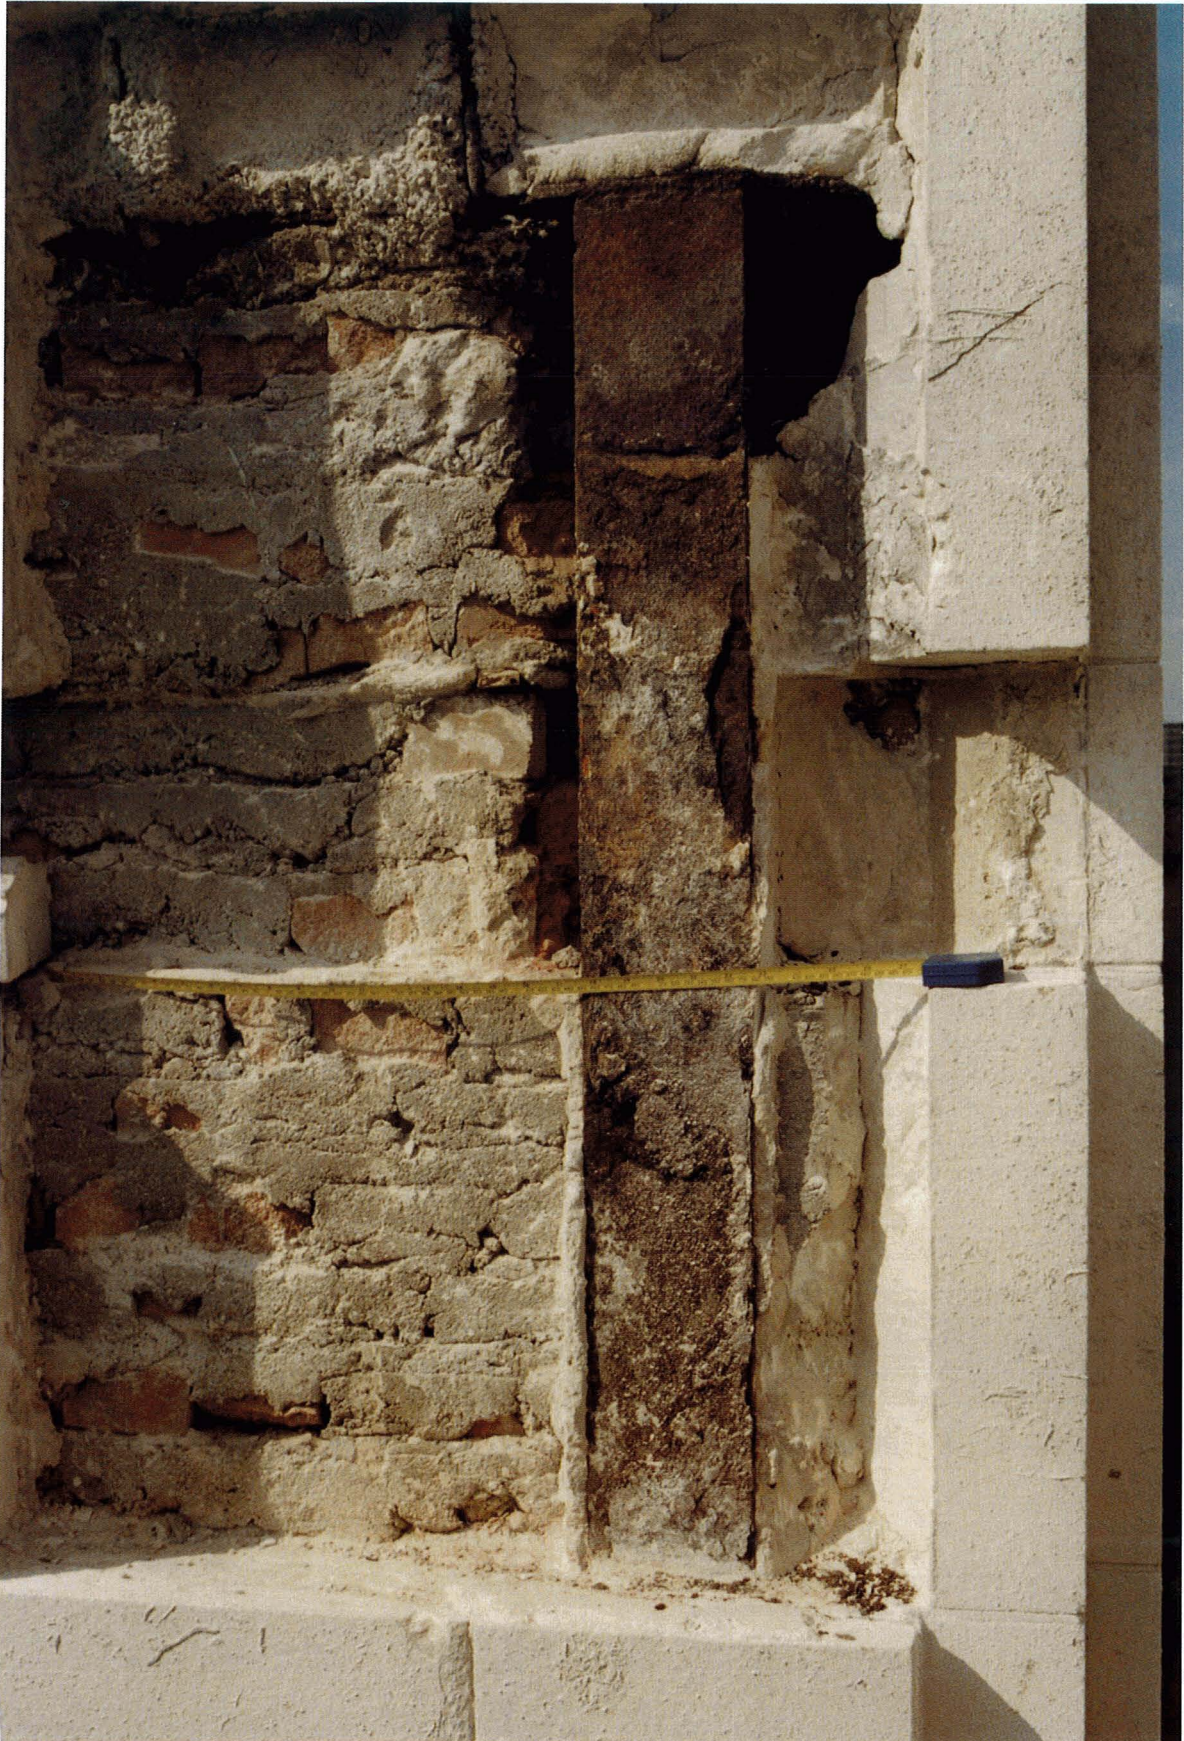
Figure 44. Removal of cracked and associated stones confirms corrosion of the column flange as the cause of cracking as shown in Figures 42 and 43.

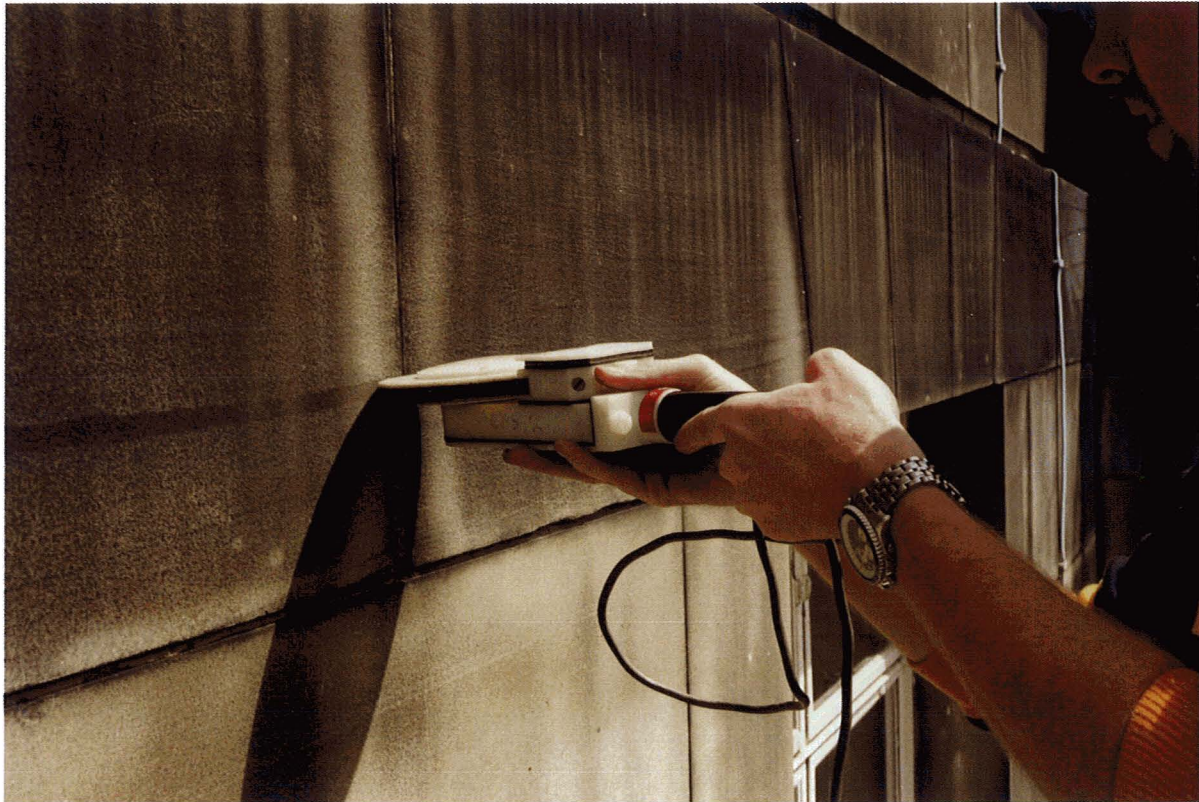
Figure 45. Potential mapping.

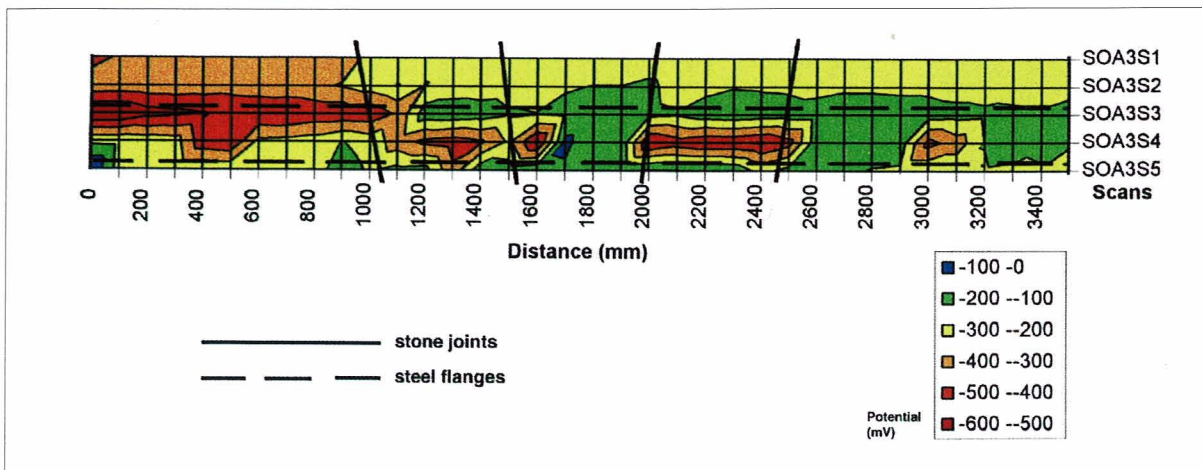
Figure 46. Potential map of figure 45. Solid lines represent stone joints and broken lines give the location of the steel beam. For the Silver/Silver Chloride (Ag/AgCl) half cell probe used in the above testing programme orange and red areas indicate a high probability of corrosion.

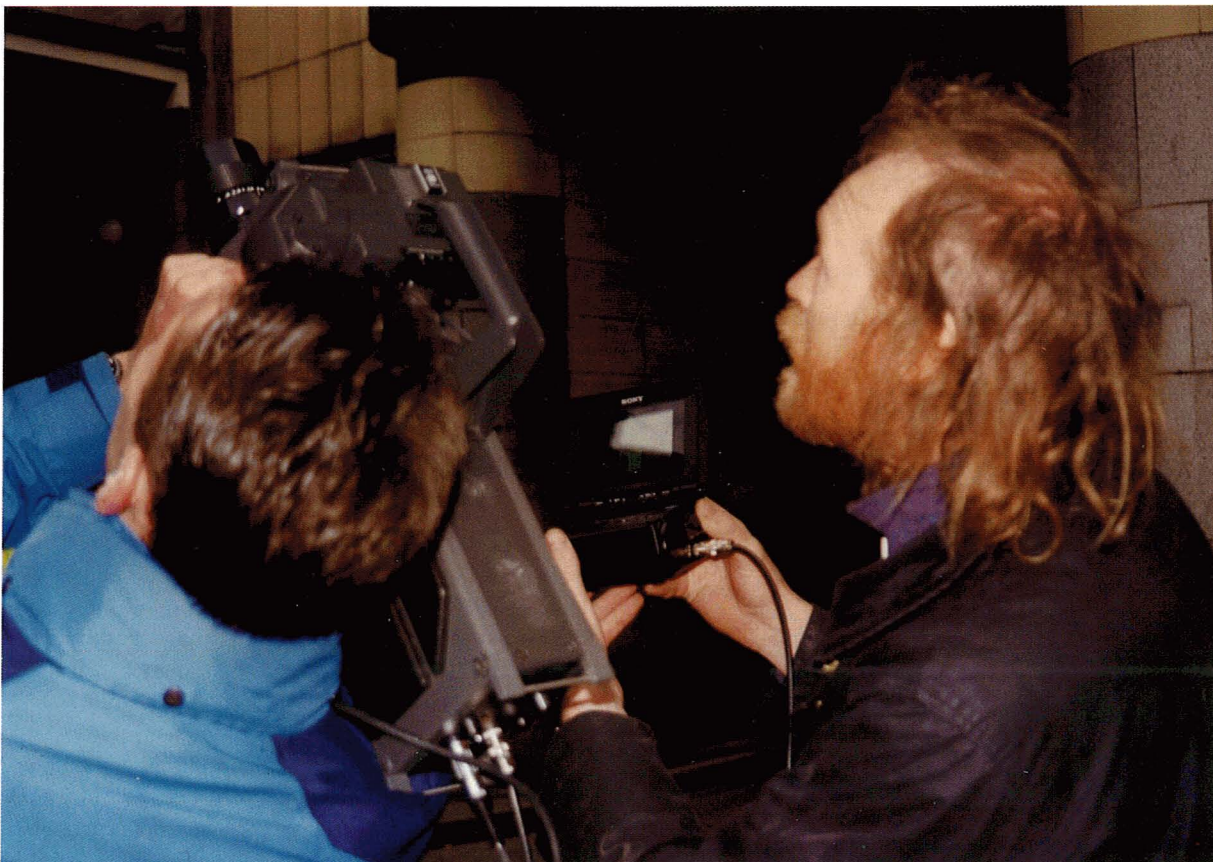
Figure 47. Infra-red thermography measurements.

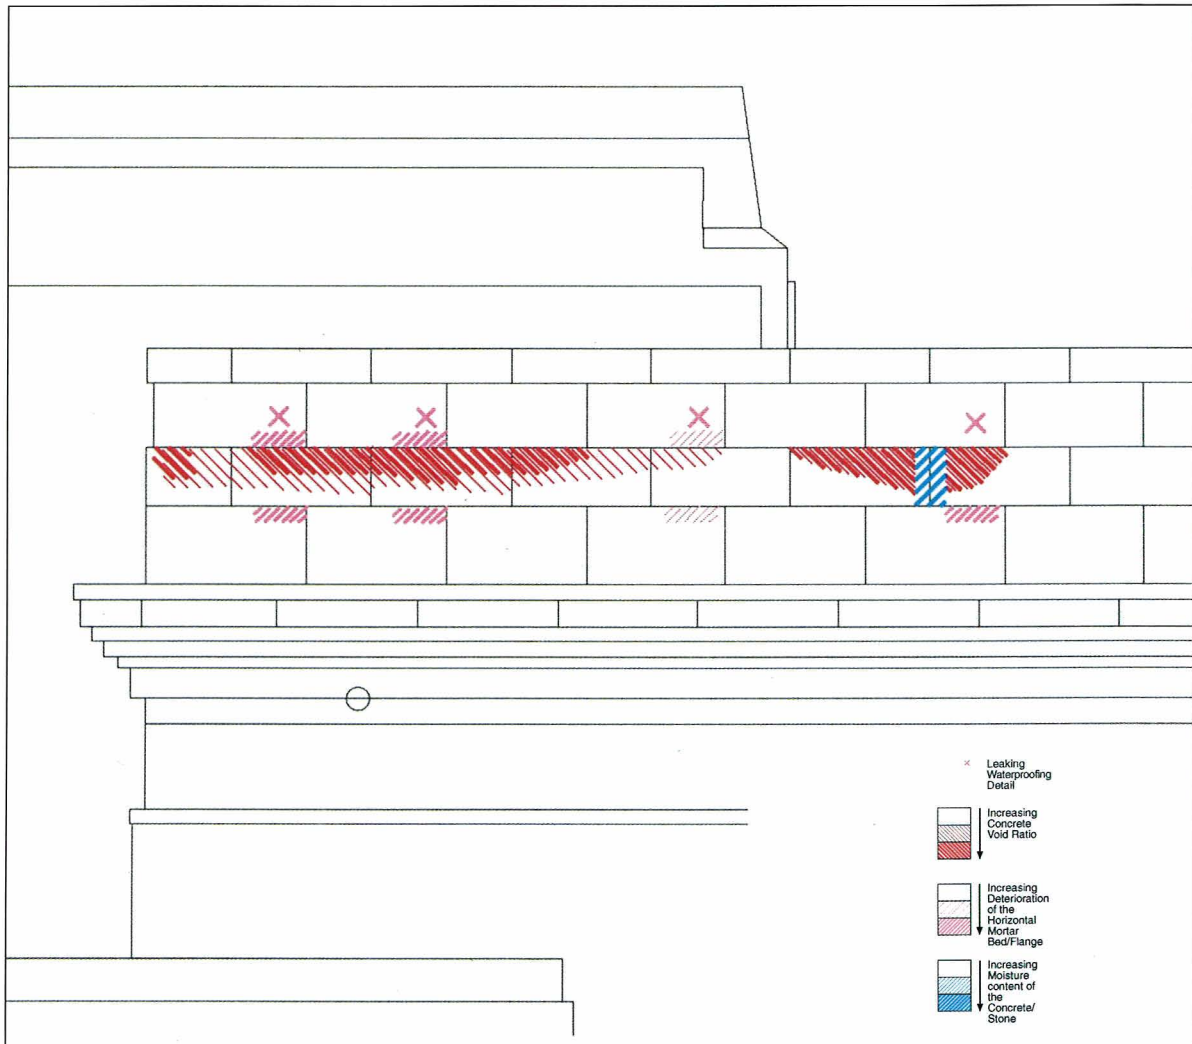
Figure 48. Impulse radar data showing the locations of voids behind a section of Portland stone parapet wall. The darker shading indicates a greater level of voidage behind the Portland stone façade and the crosses indicate a leaking roof detail.

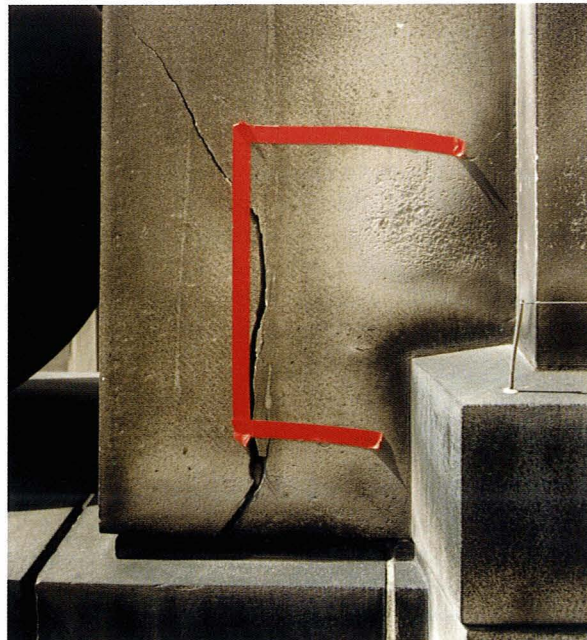
Figure 49. The location of a corroding steel section is identified with a magnetometer and marked with red tape. Its position in relation to the cracking indicates corrosion related damage.

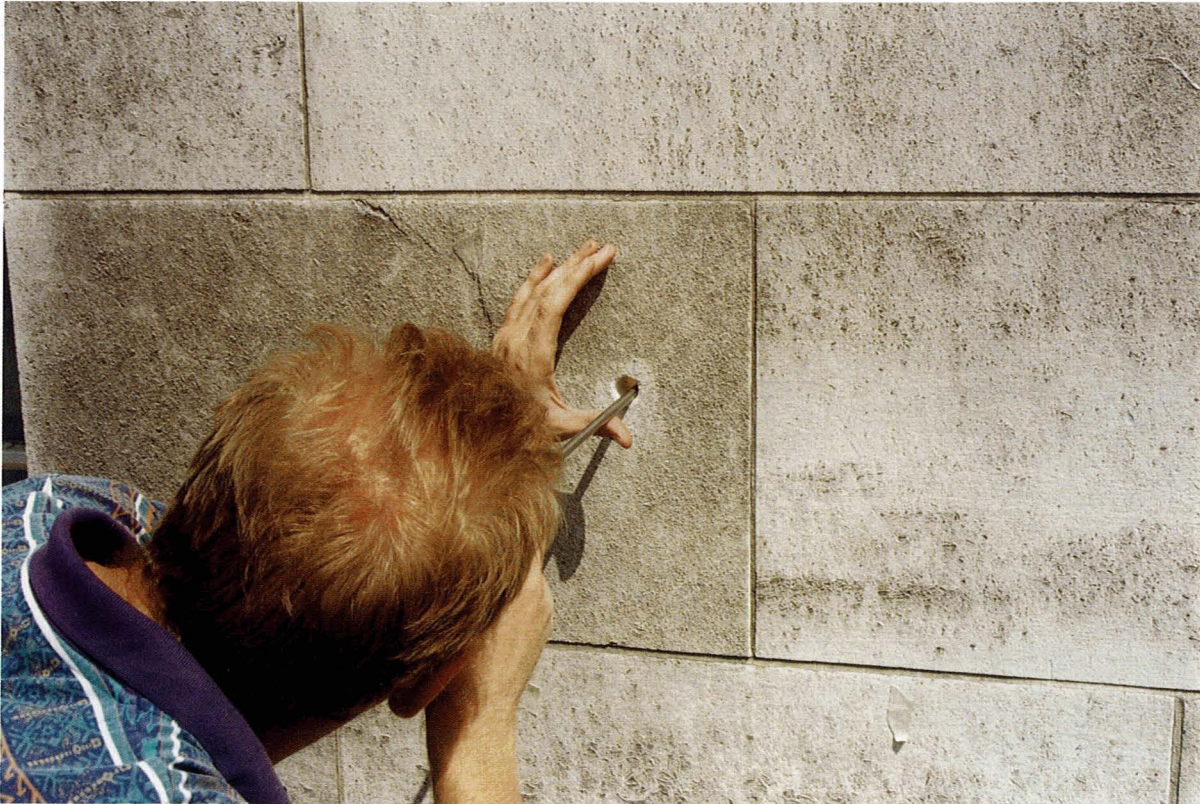
Figure 50. Endoscope in use.

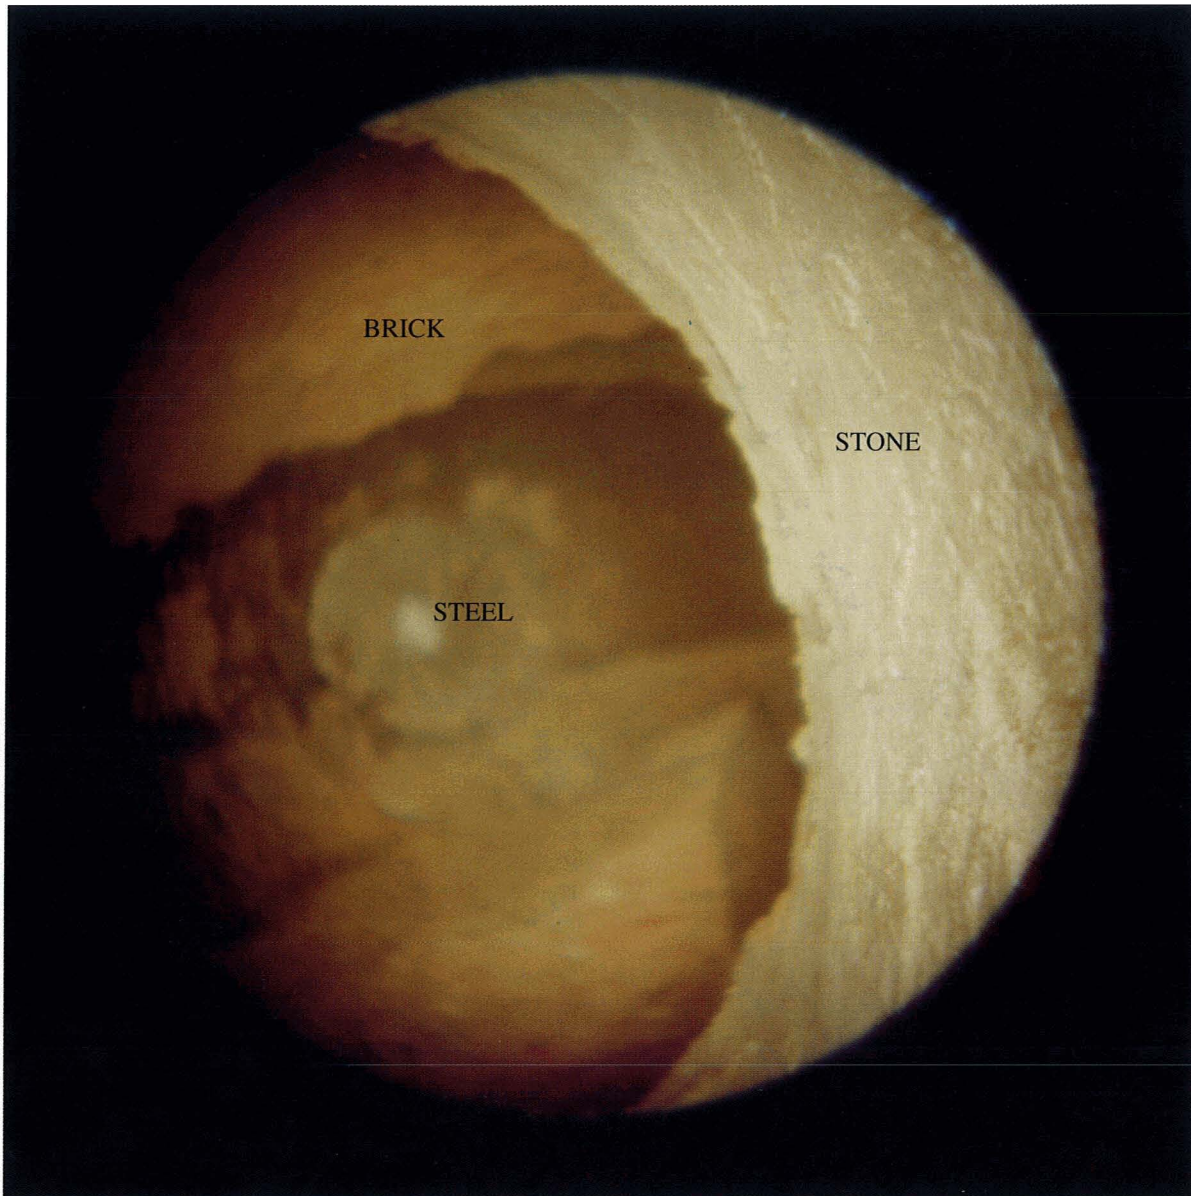
Figure 51. Photograph taken using an endoscope showing the corroding steel, Portland stone, brick in-fill and small cavity between the brick in-fill and steel beam.

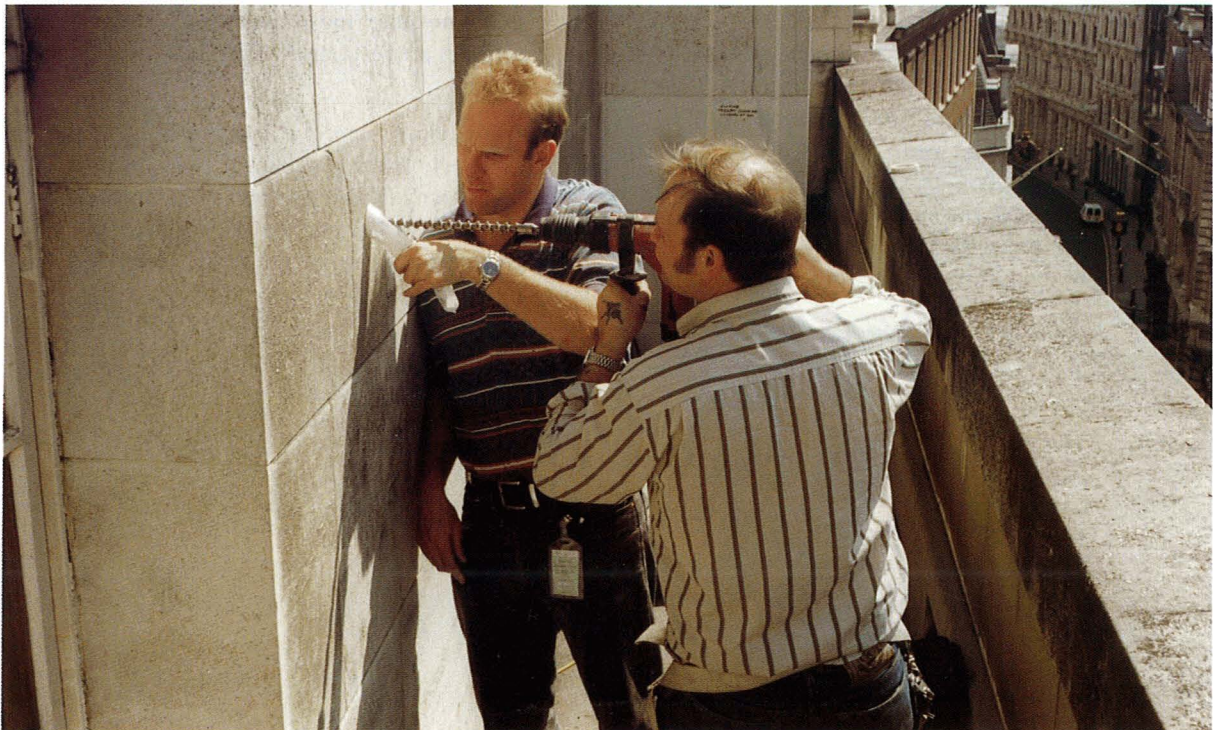
Figure 52. Collection of dust samples for laboratory analyses of moisture content, chloride level and composition. Note: Permission will be required for the drilling holes in Listed Buildings for dust sampling etc.

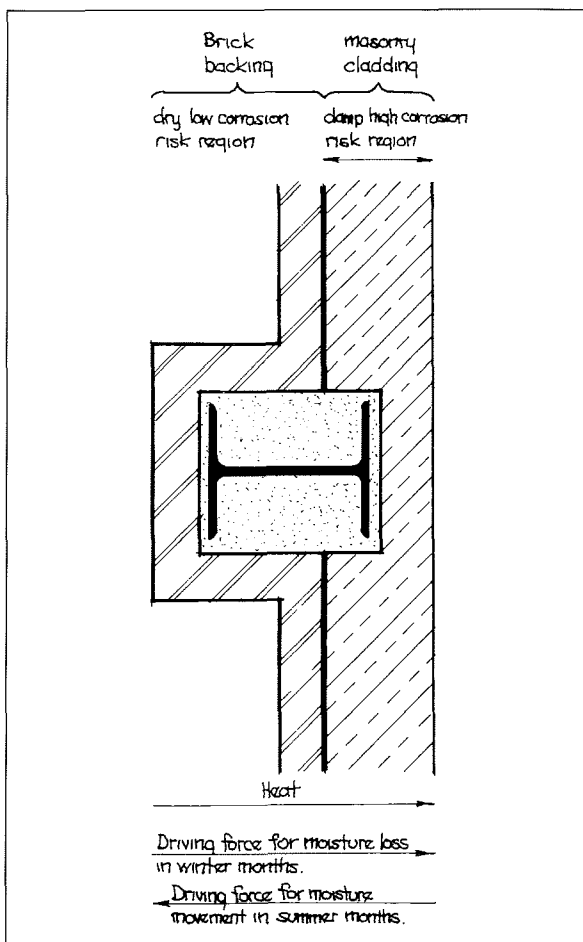
Figure 53. Driving force for moisture movement diagram.
