TECHNICAL
ADVICE
NOTE

CORROSION IN
MASONRY CLAD
EARLY 20TH
CENTURY STEEL
FRAMED
BUILDINGS

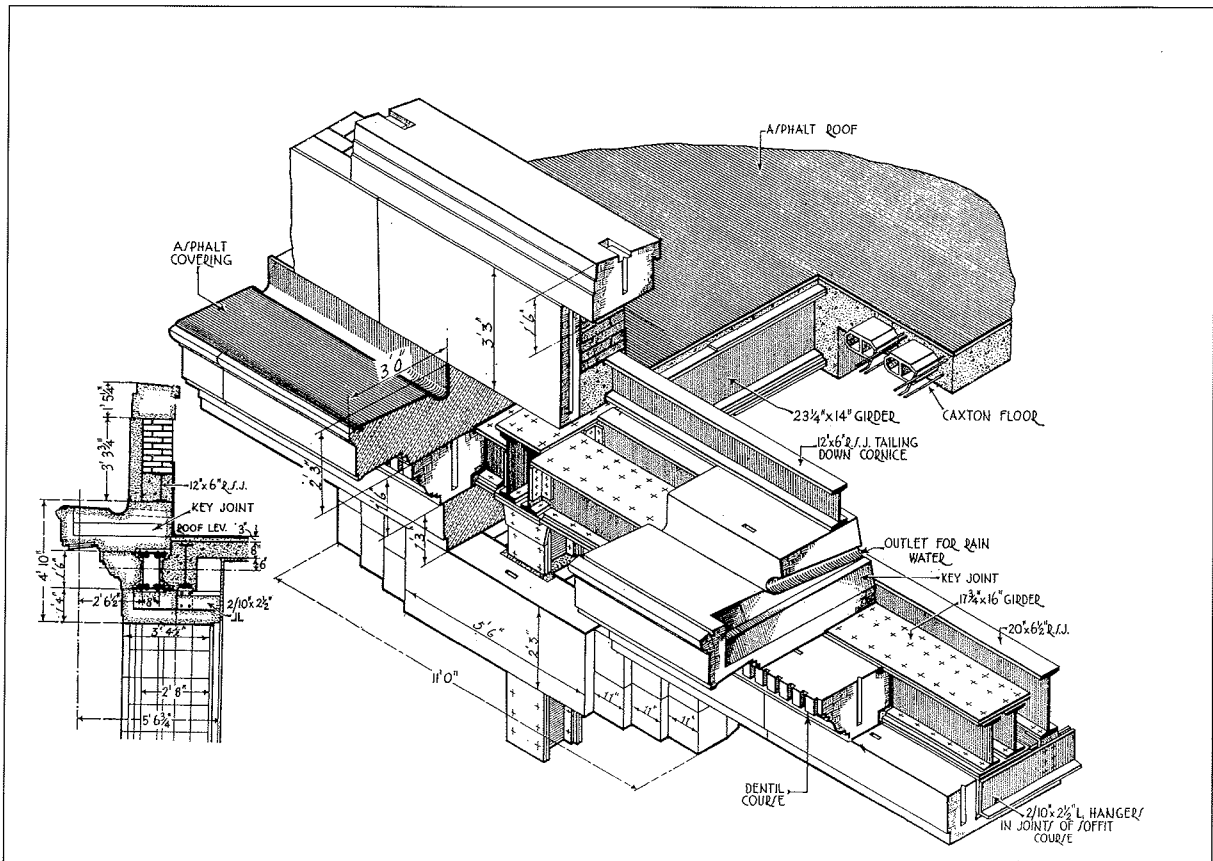
Figure 54. The construction of a Cornice. (Warland; "Modern Practical Masonry")

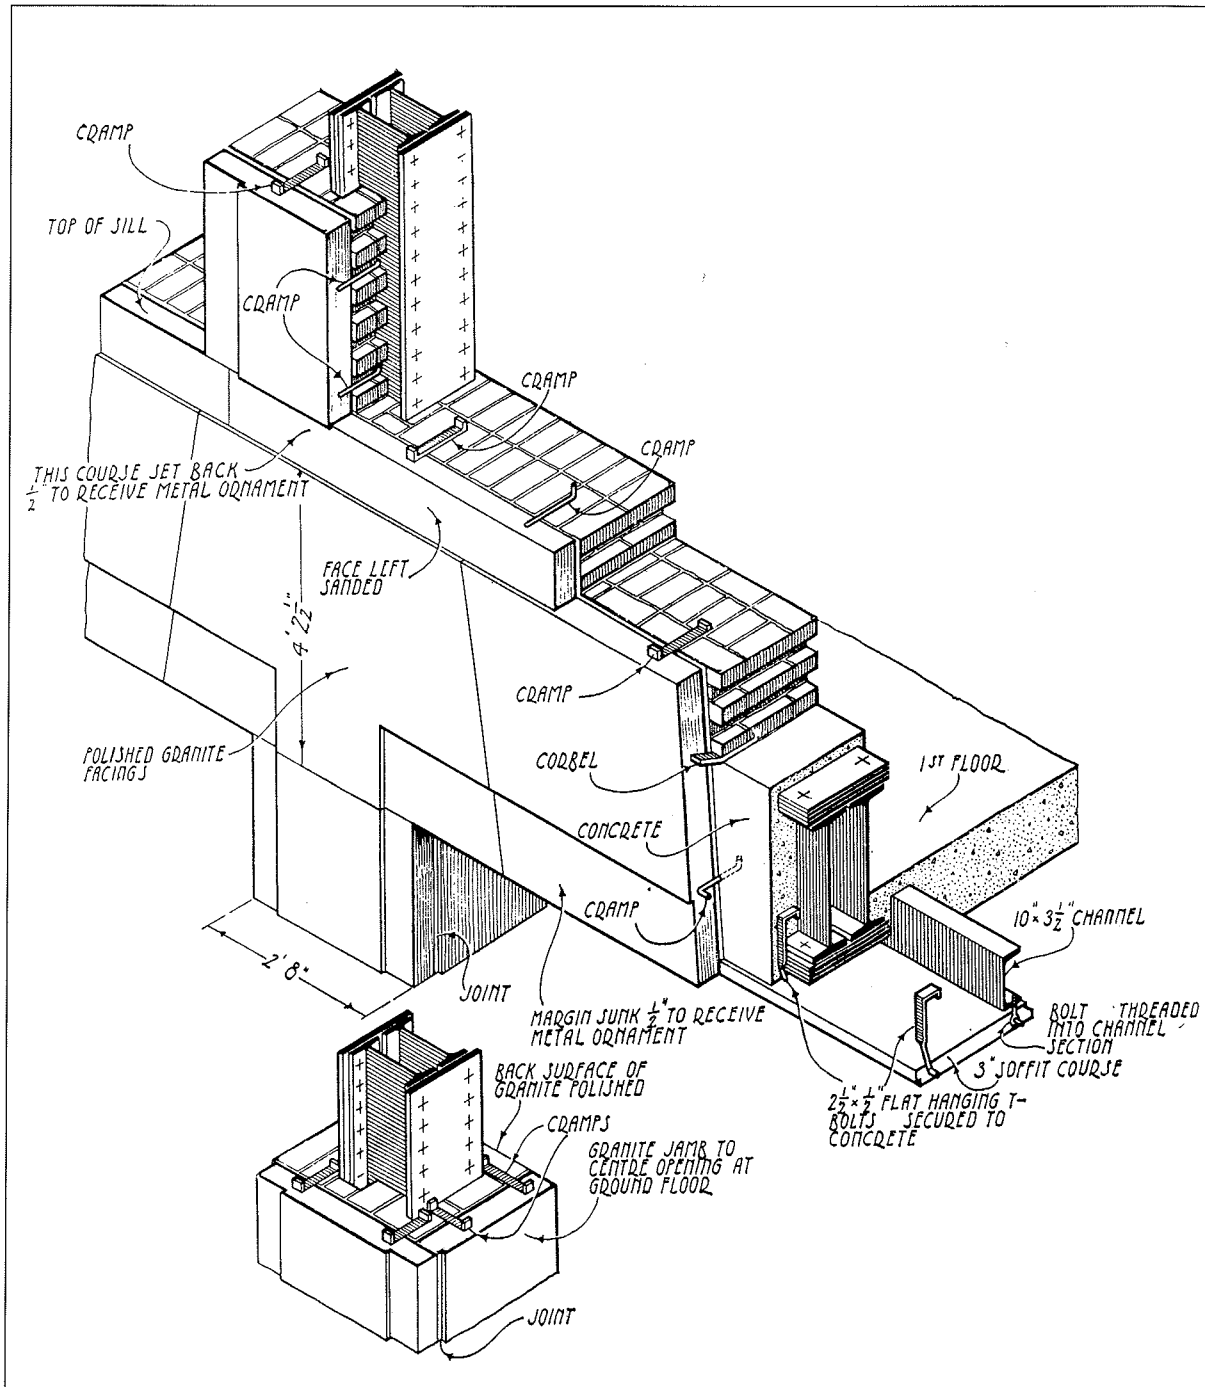
Figure 58. Slab facings of a external wall. (Warland; "Modern Practical Masonry")

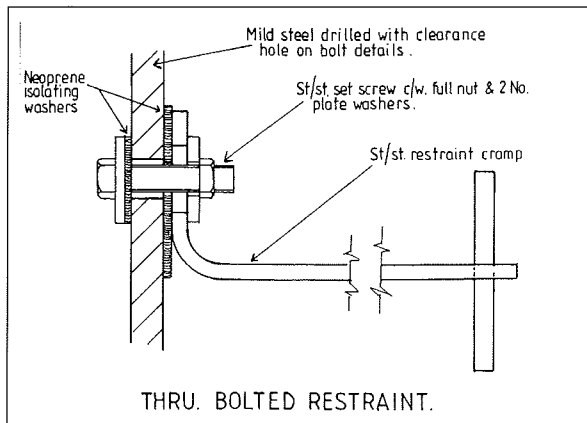
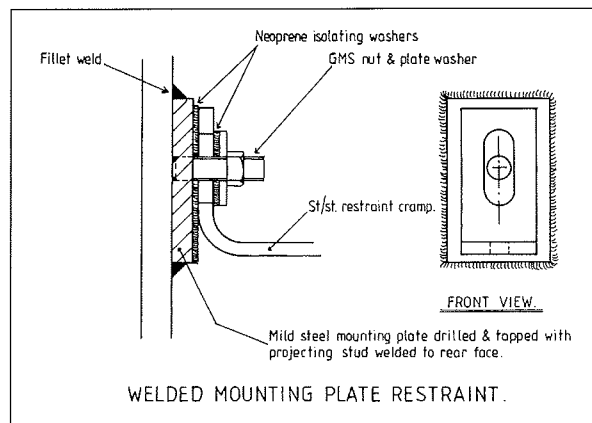
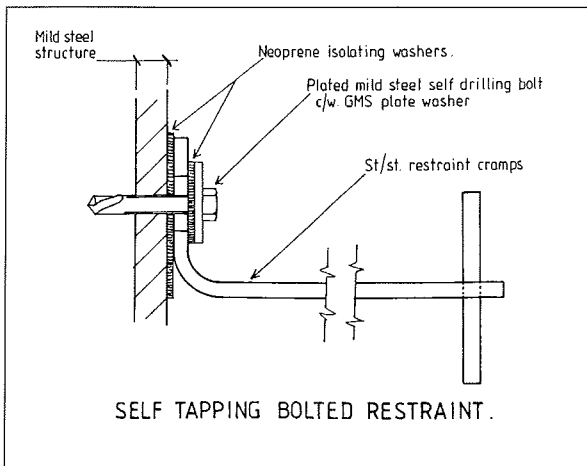
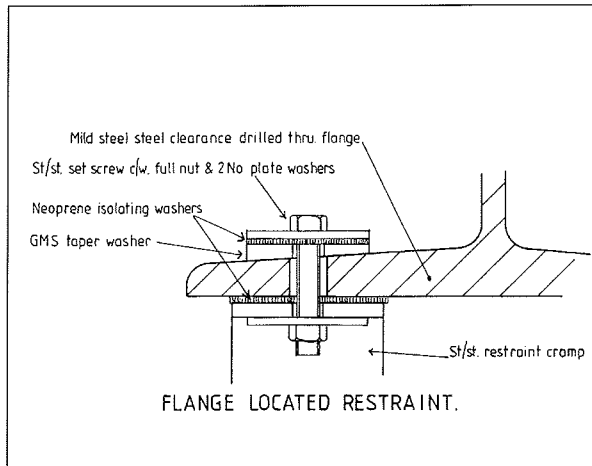
Figures 59 to 62. Suggested bolted restraint methods used for reinstatement of repaired masonry. It is of importance that the stainless steel is isolated from the steelwork using the isolators shown to prevent galvanic corrosion at the bimetallic contact.

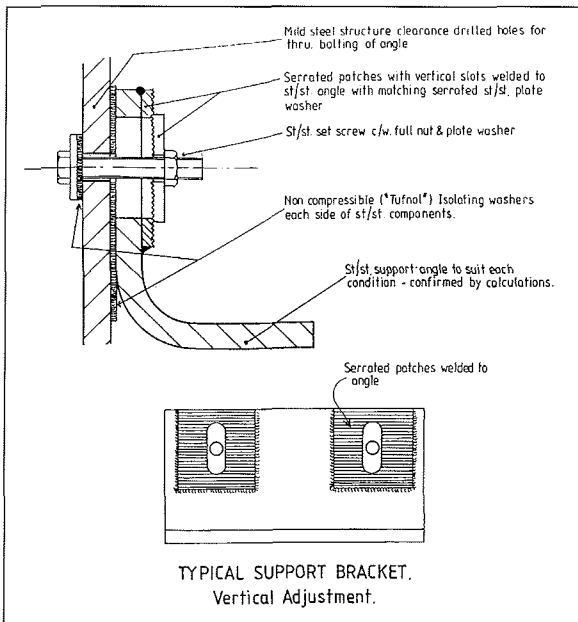
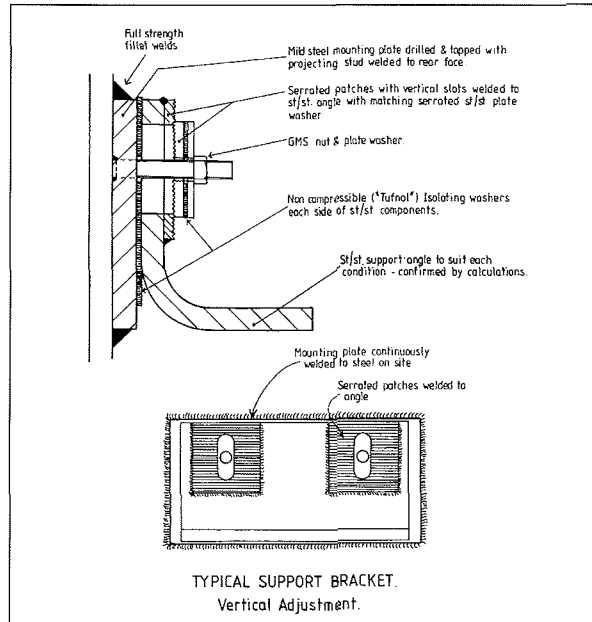
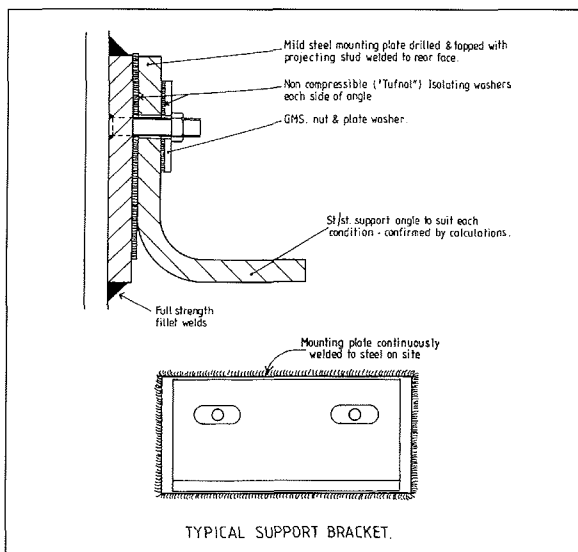
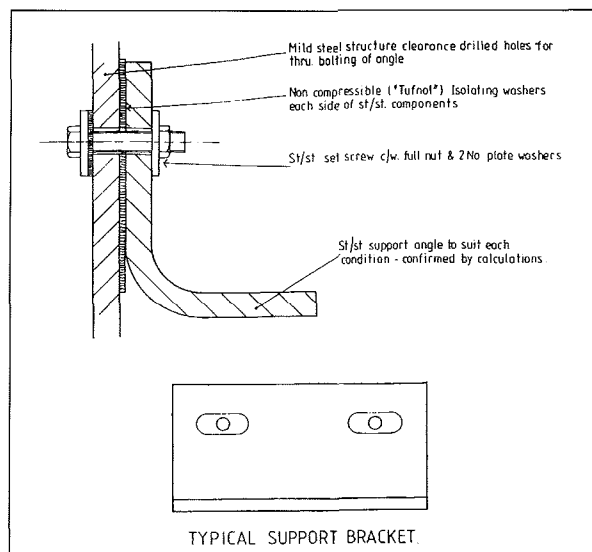
Figures 63 to 66. Typical stainless steel support brackets used for reinstatement of repaired masonry. It is of importance that the stainless steel is isolated from the steelwork using the isolators shown to prevent galvanic corrosion at the bimetallic contact.

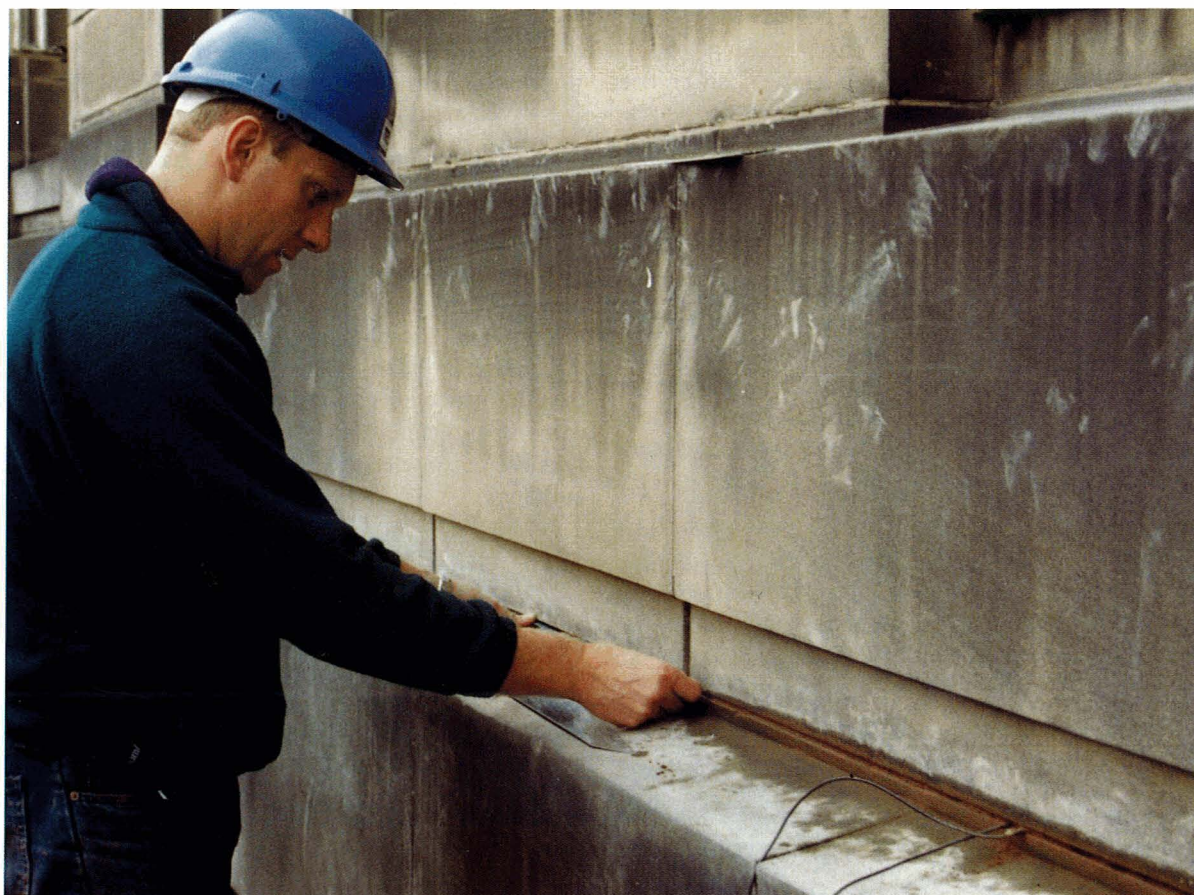
Figure 67. Installation of a mesh ribbon anode into the beds of ashlar stonework.

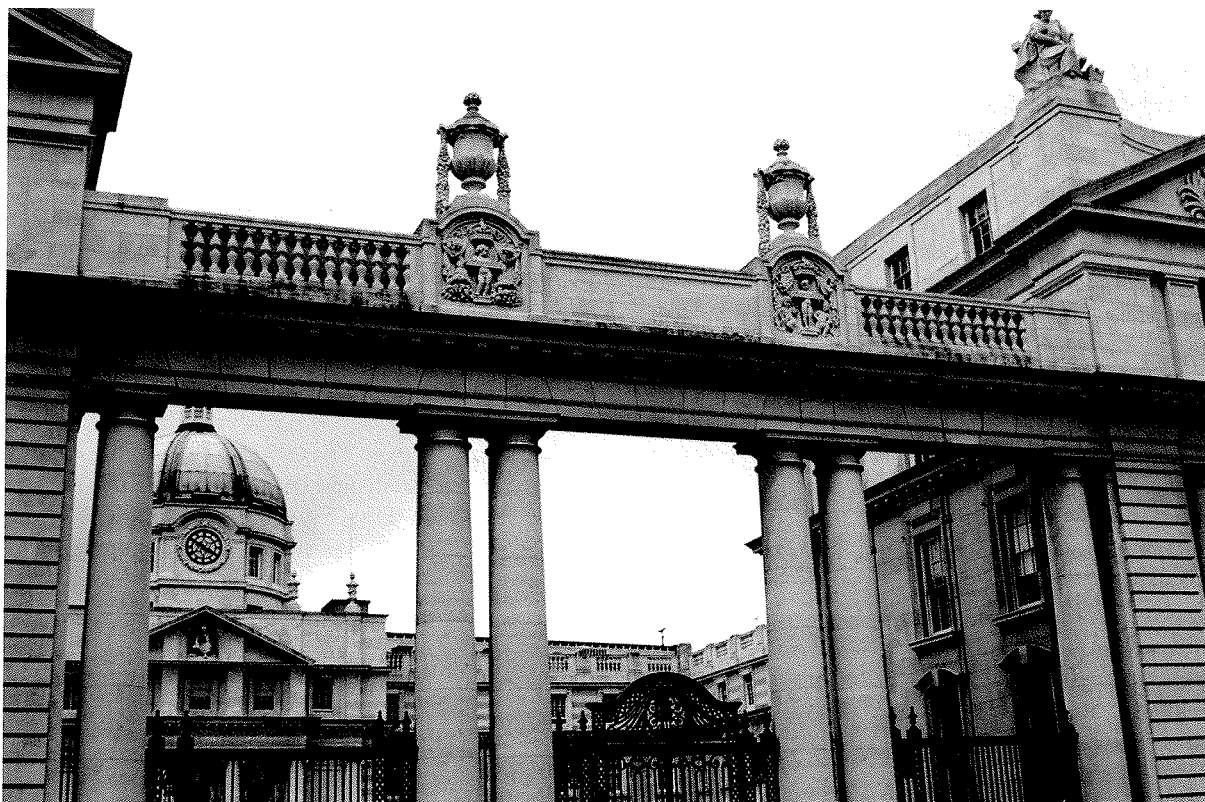
Figure 68. The entrance colonnade to the Royal College of Science, Dublin (1991), the first full scale cathodic protection system for the protection of corroding steel 'I' sections.

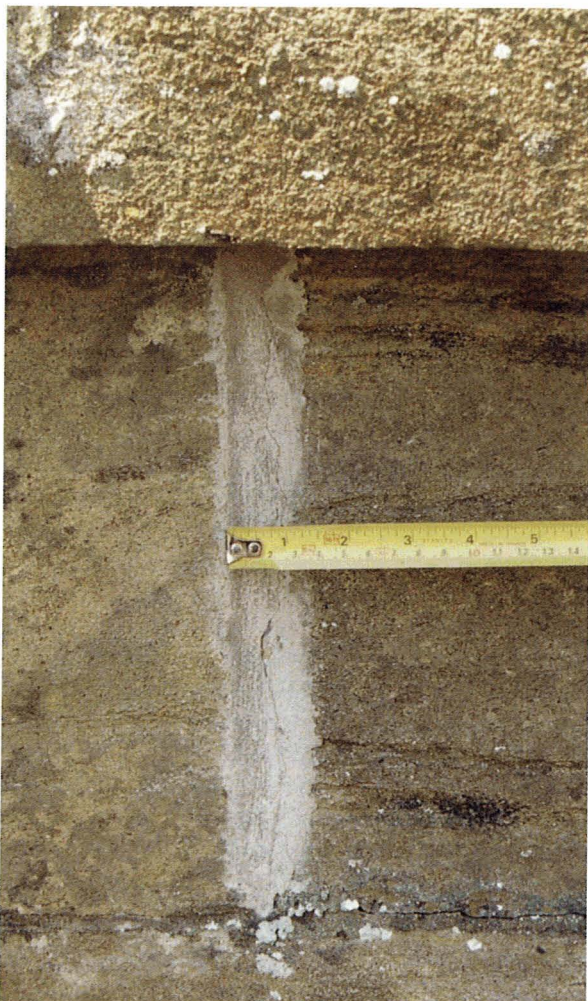
Figure 69. Poor quality repairs to ashlar jointing. Note the poor workmanship, inappropriate materials and failure to treat the cracked horizontal joint. Repairs such as these are not acceptable on a Listed Building and they may cause later problems to the façade.

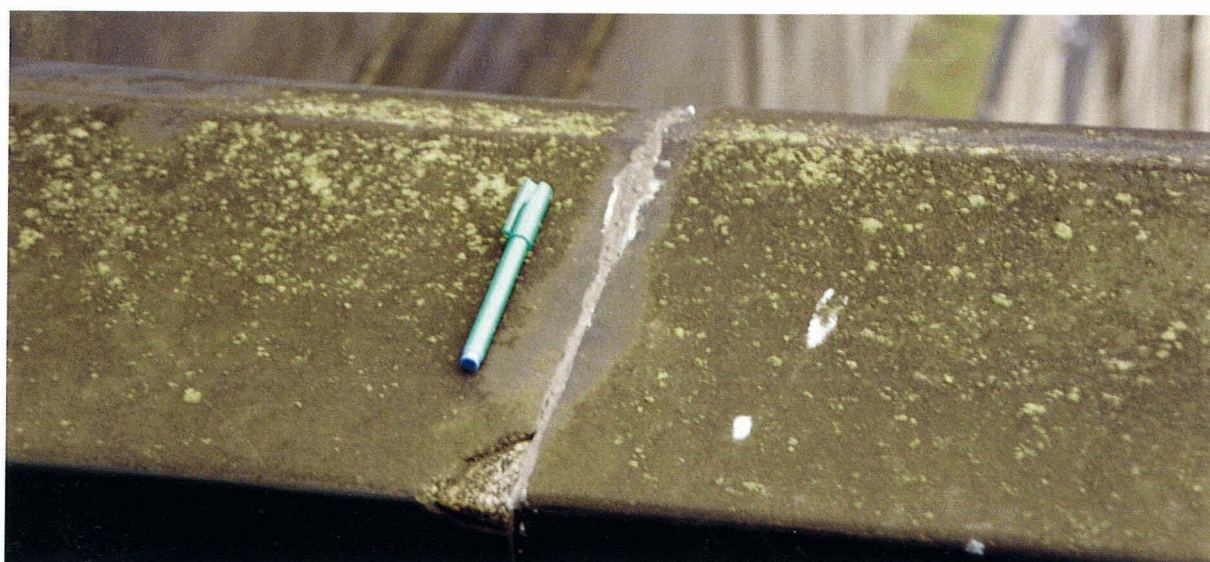
Figure 70. Sealant staining due to inappropriate materials selection on the coping stones of a sandstone parapet wall.

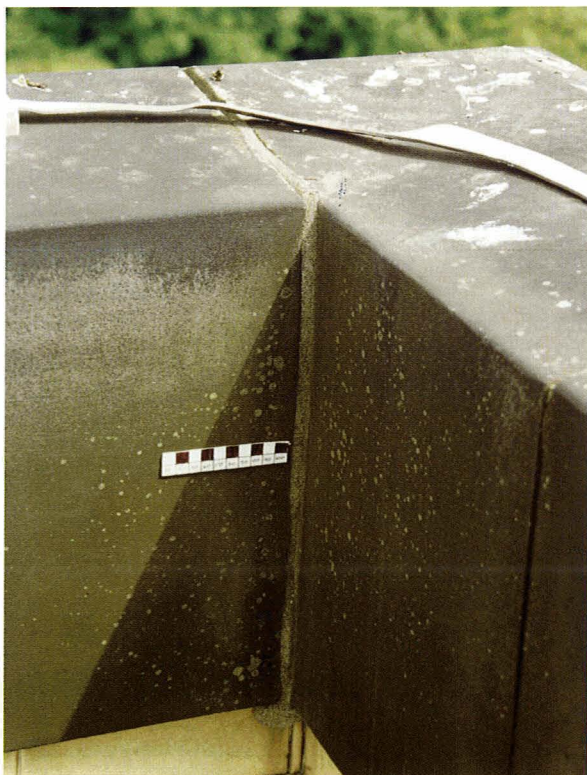
Figure 71. The installation of a precompressed tape sealant to a parapet joint.

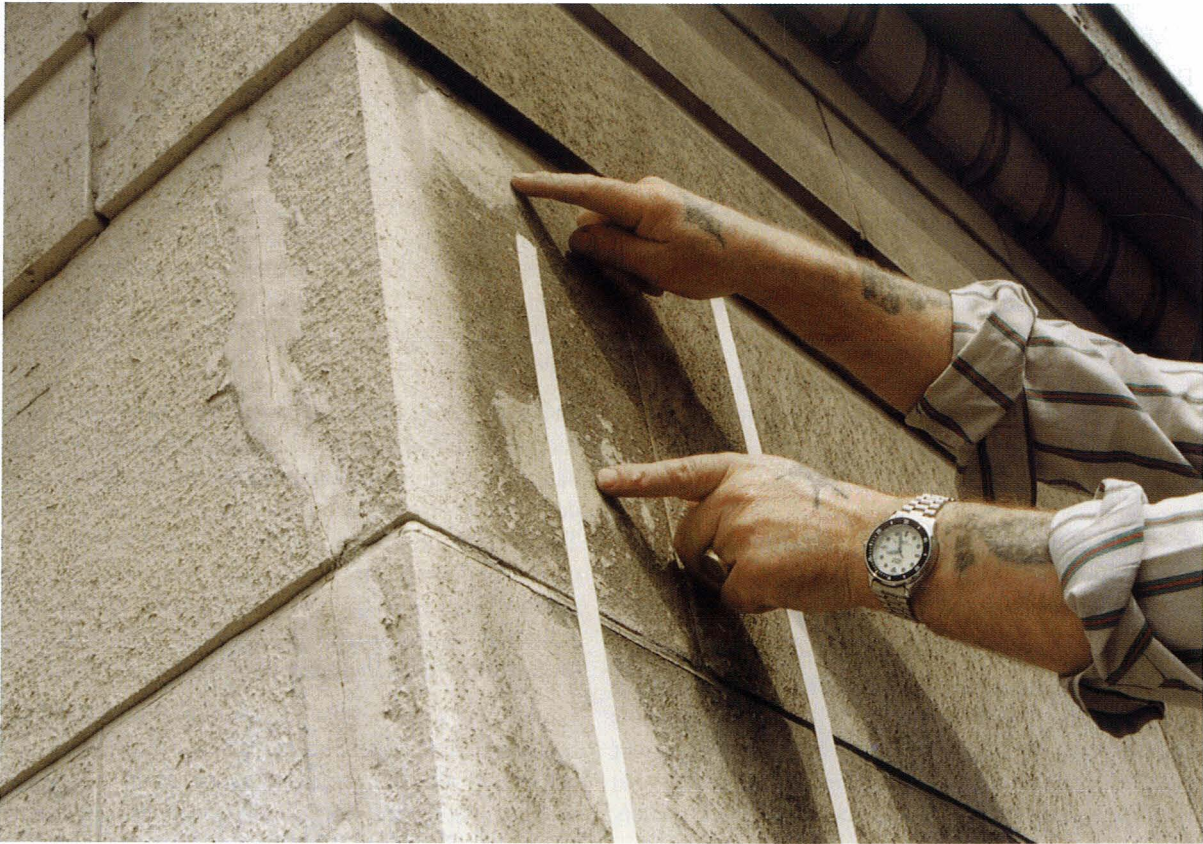
Figure 72. Repairs carried out on a Portland stone façade using stainless steel pinning. The tape marks the flanges of the underlying steel and the mason points to the pin locations.

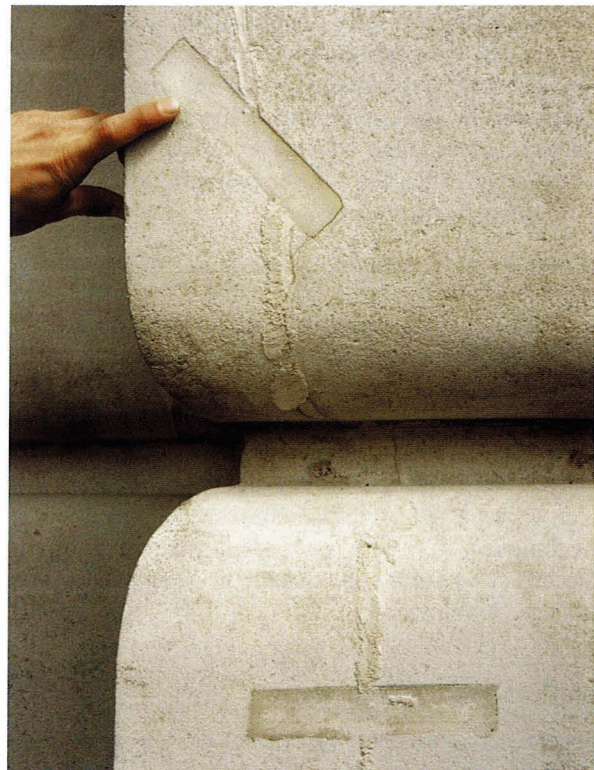
Figure 73. 'Dog cramps' on a Portland stone building.

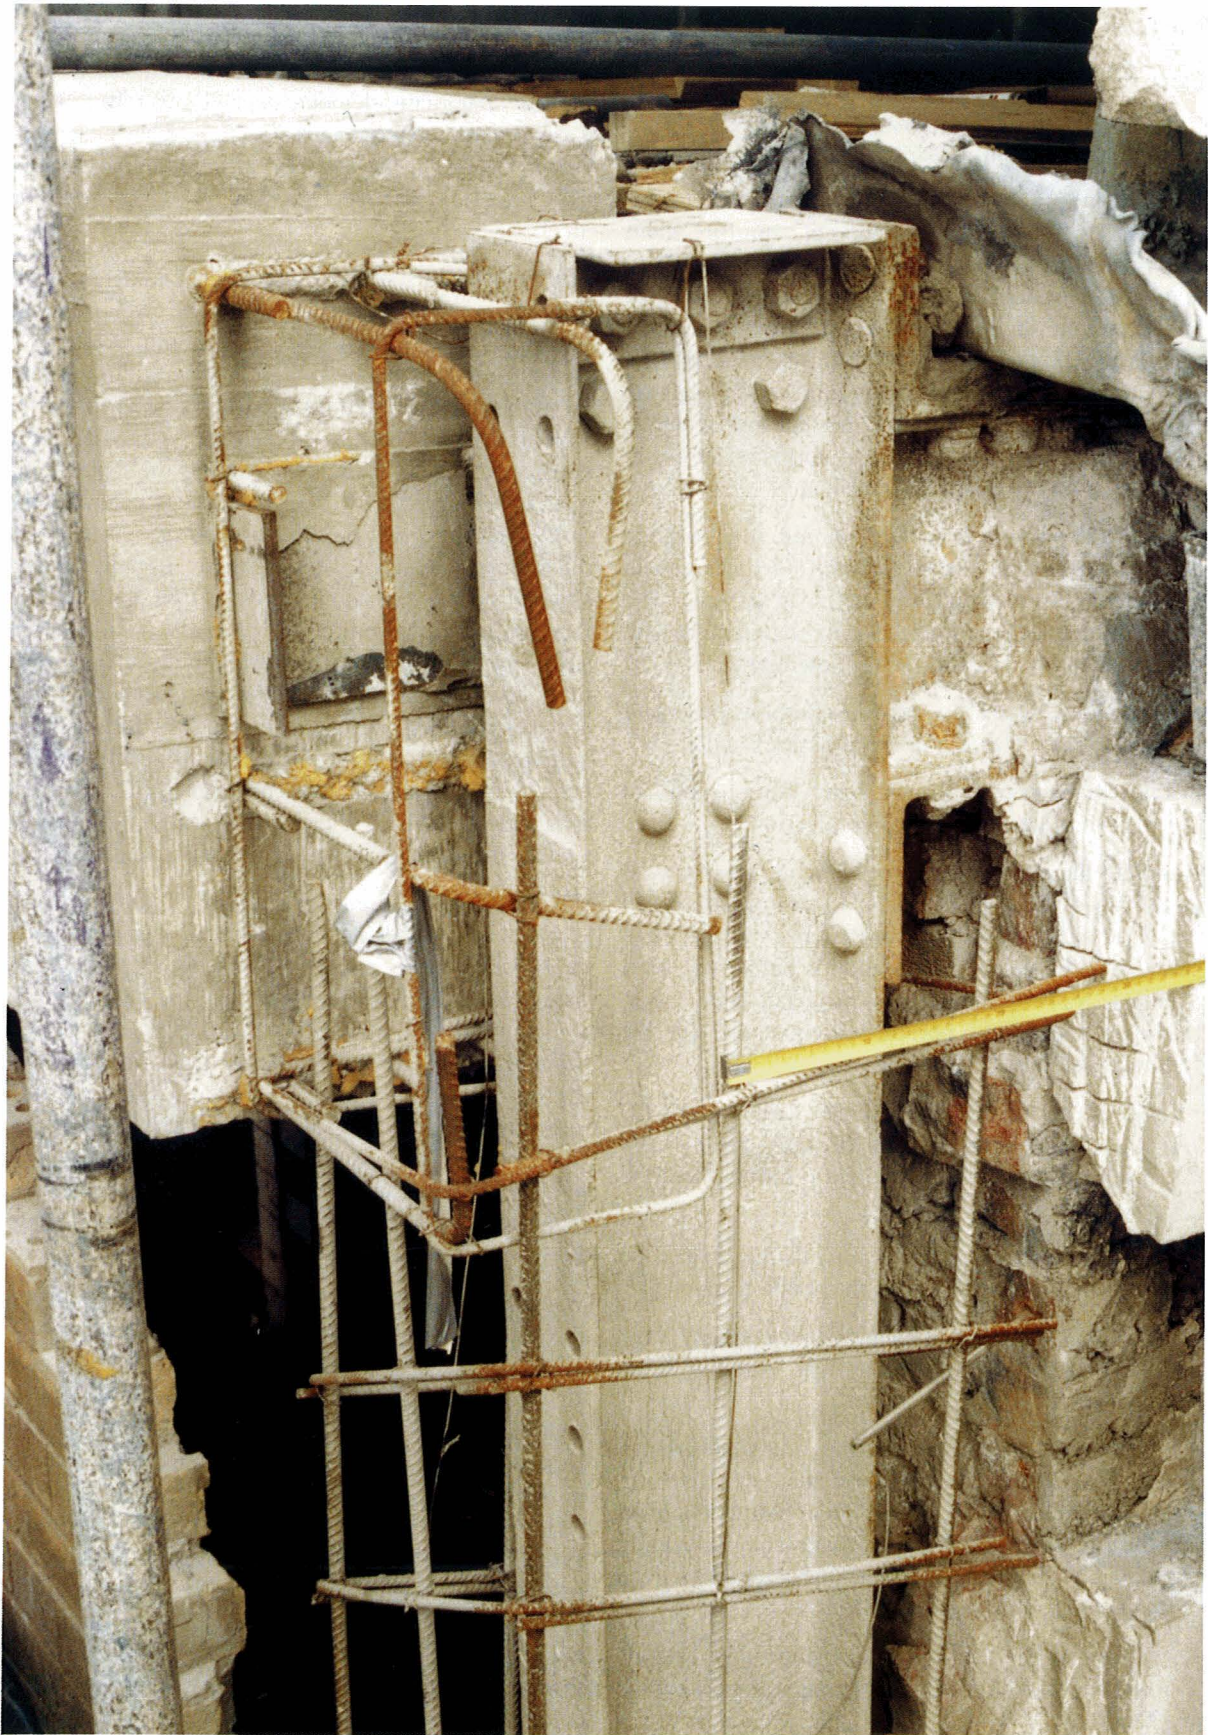
Figure 74. Preparation for the concrete encasement of a steel 'T' section.

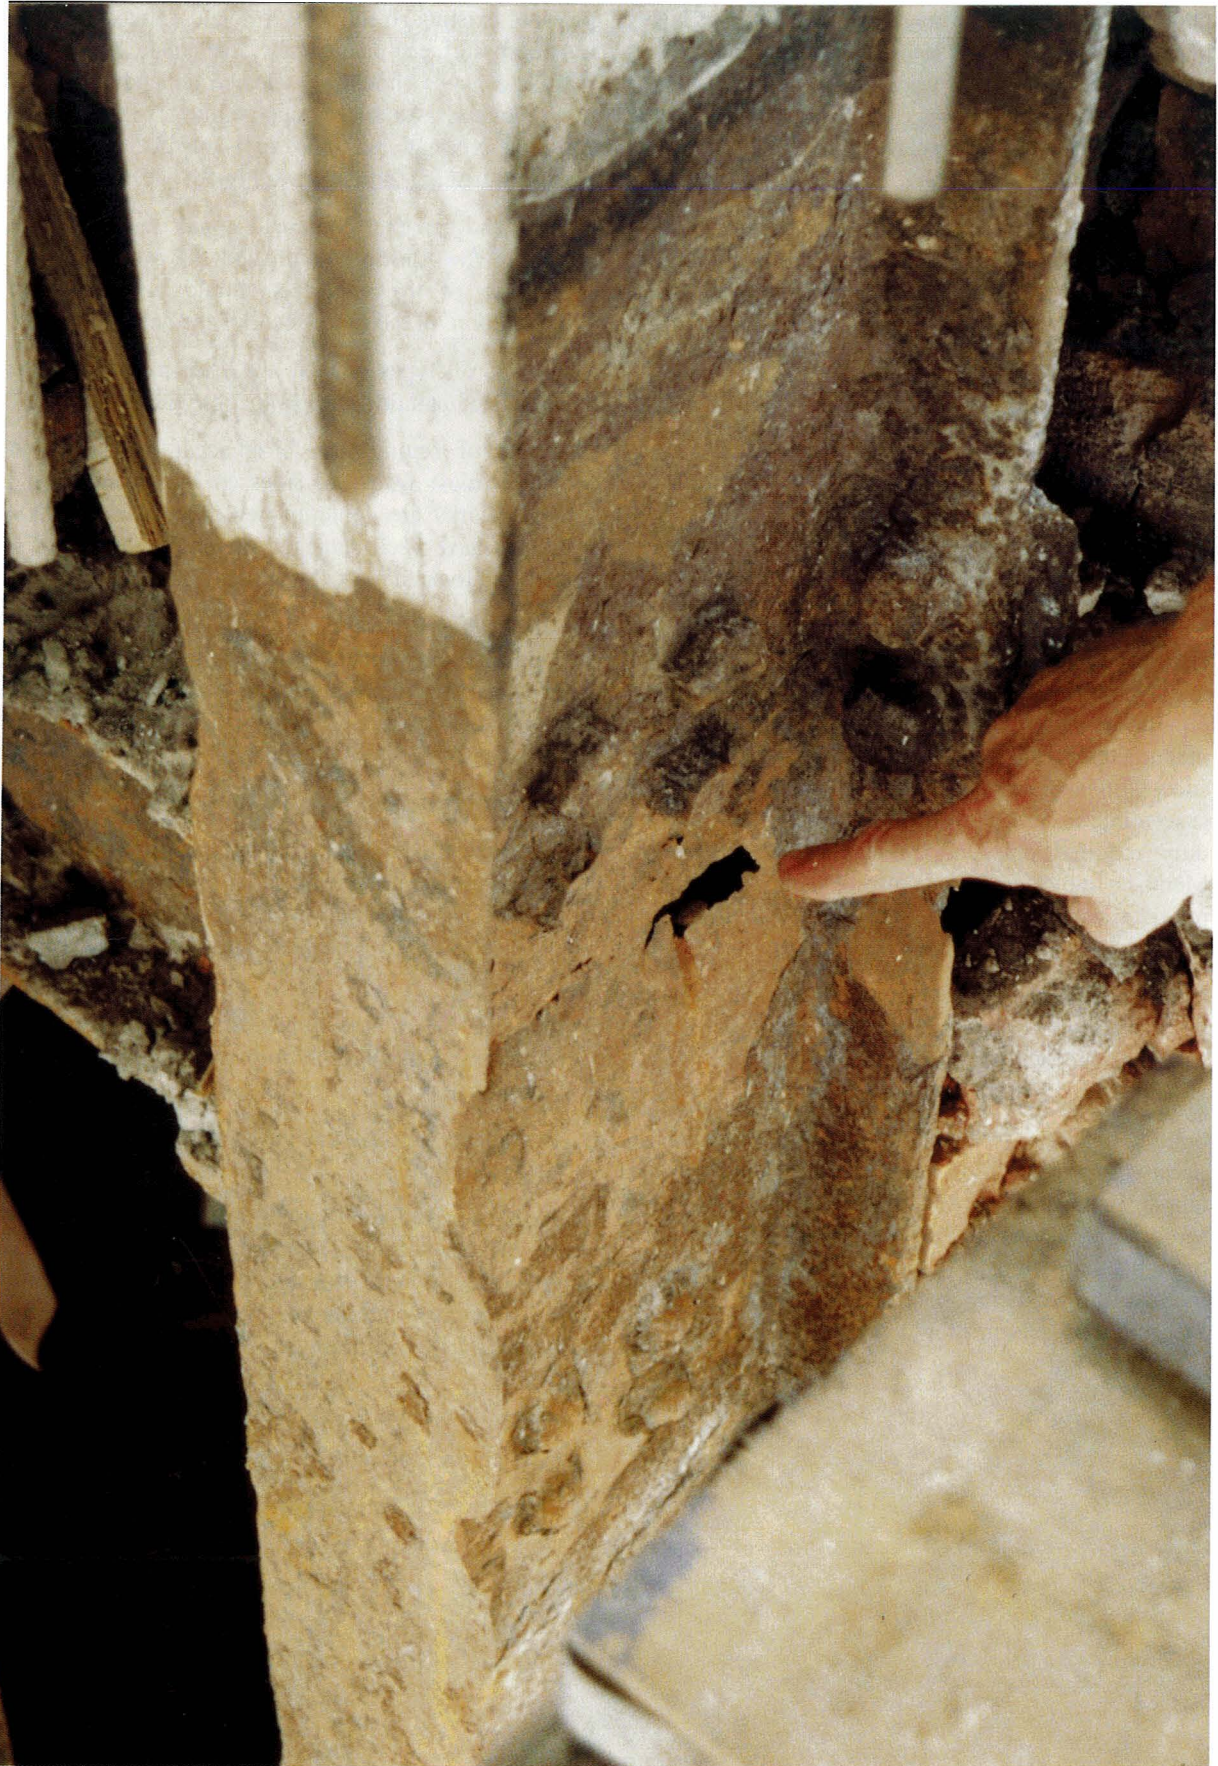
Figure 75. Severe corrosion of a structural steel column. Corrosion in this case was attributed to alteration of the building environment that resulted in wetting of the steel column.
